# 4 Seasons Home Inspection, LLC

Inspection Date: June 09, 2018 Saturday 10am- 1pm  
Client Name: buyer (buyer@gmail.com)  
Inspection Address: # street town nj  
Emails: lawyer@aol.com  
Inspected by: Linda Geczi home inspection lic. #24GI00061500

Approximate Age: ~1941 (77yrs.)  
Style: Single family, Cape  
Main Entrance Faces: S  
State of Occupancy: Occupied  
Weather Conditions: 75-80°F  
Ground cover: damp

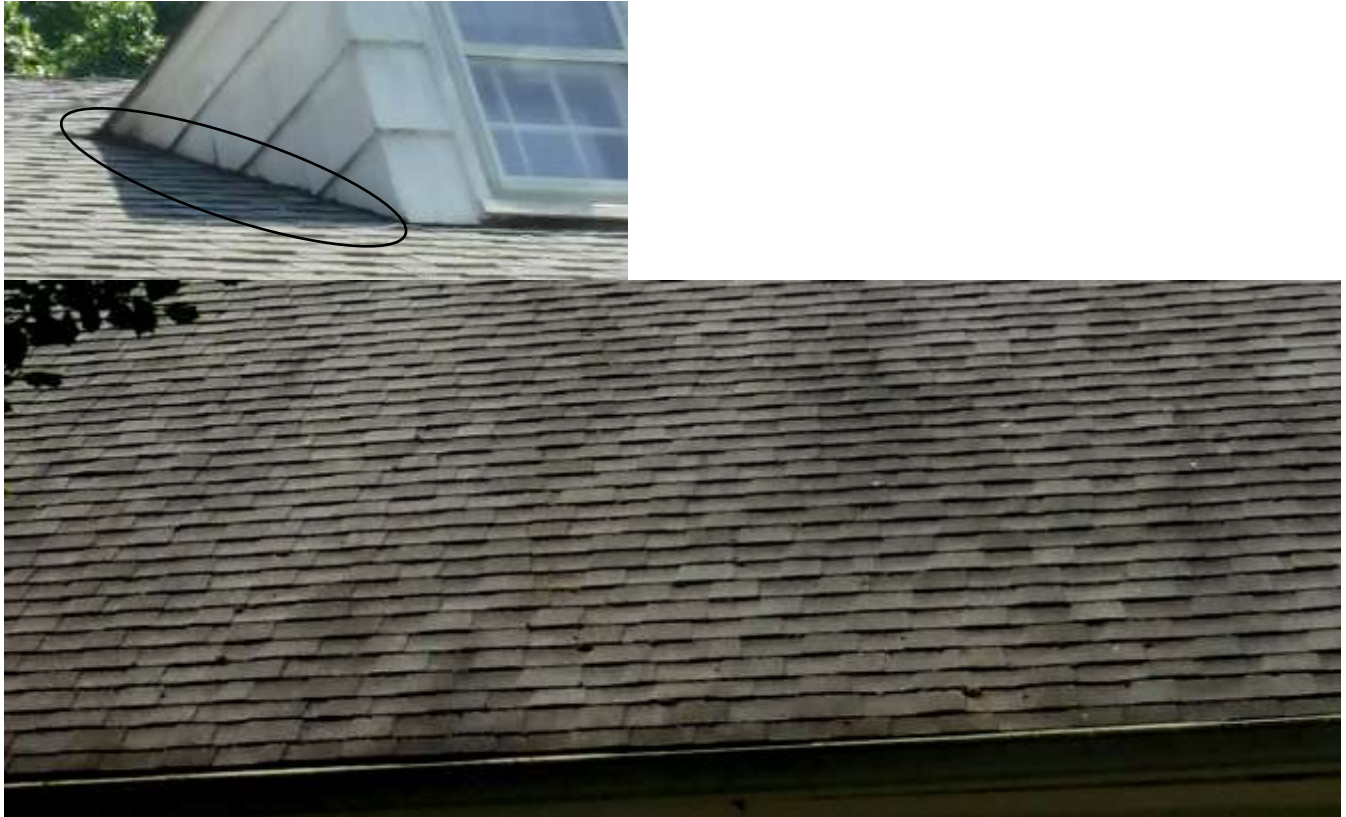
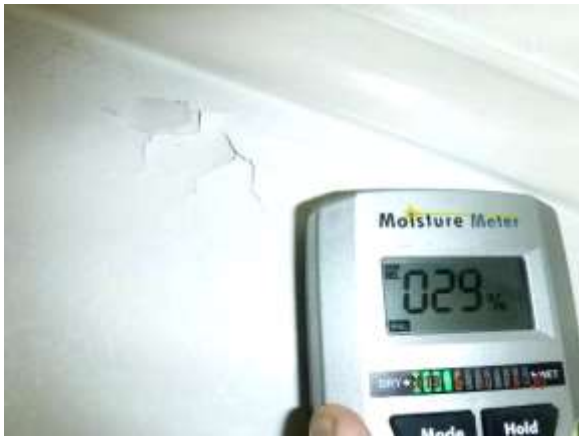
Figure 1 Example of heavy moss build, granular loss, curling, staining, brittle, etc.

1. **Recommend a qualified roofer or building contractor evaluate roof for tear off/replacement, ventilation & insulation and gutters.**

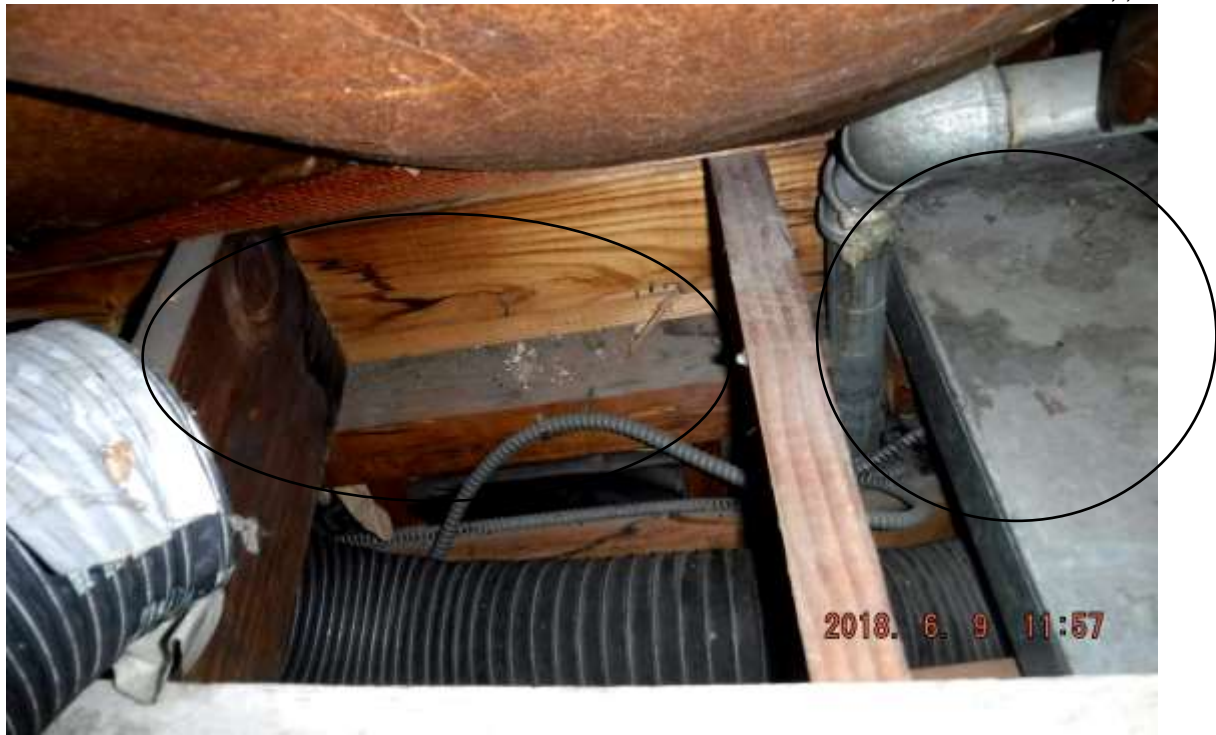
**Figure 2** Example of water stains/active leaking in attic.

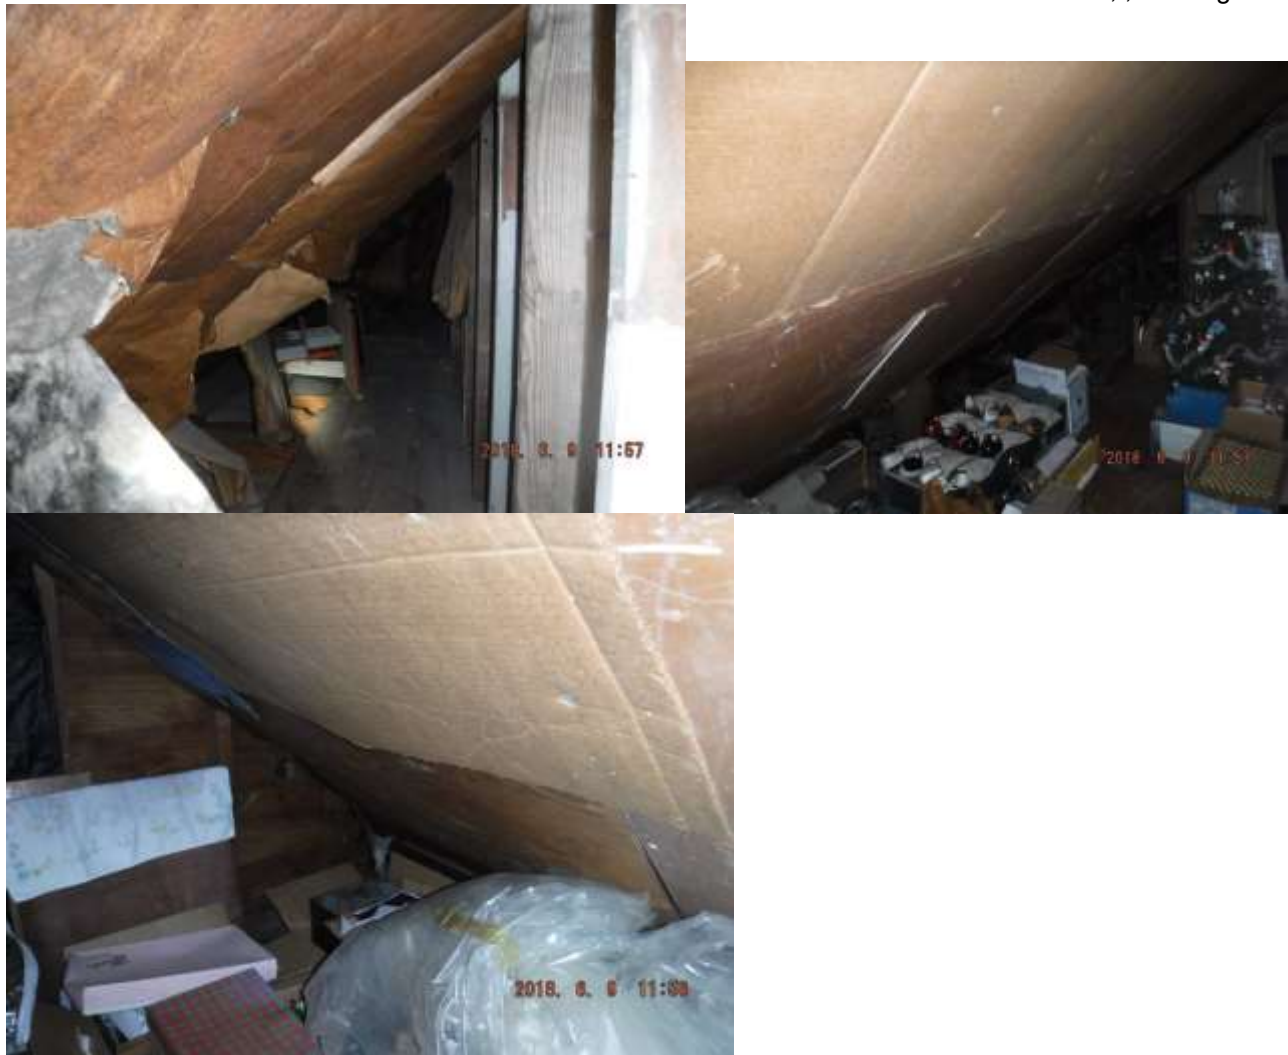
**Figure 3 Insulation & cardboard against the rafters; improper installation. Insulation should be on the living spaces or knee walls to avoid condensation build-up, heat and moisture damage.**

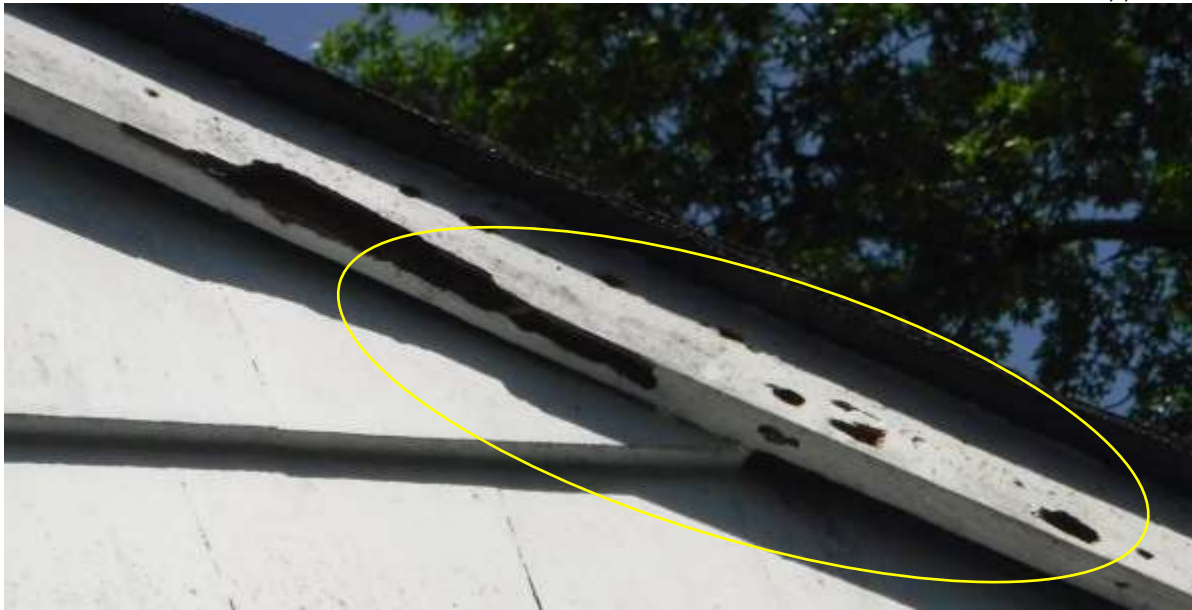
Figure 4 Example of carpenter bee damage. See separate NPMA-33 Wood destroying insect report.

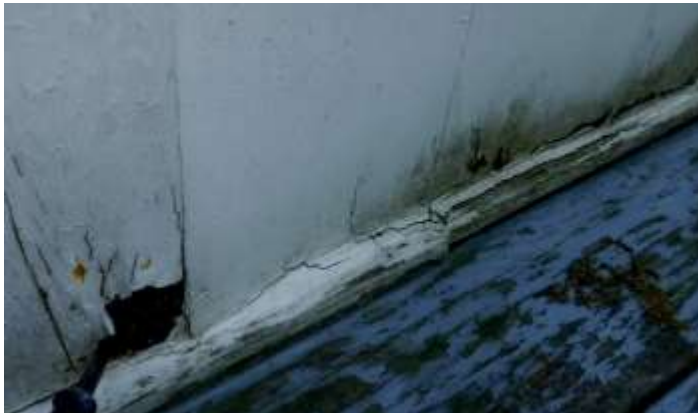
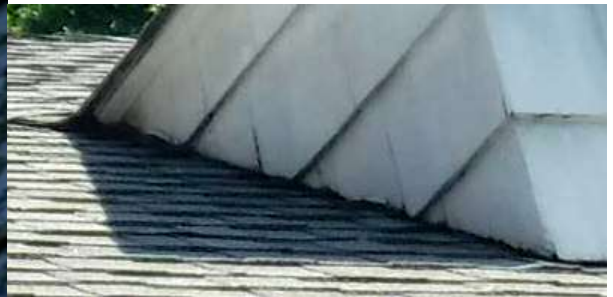
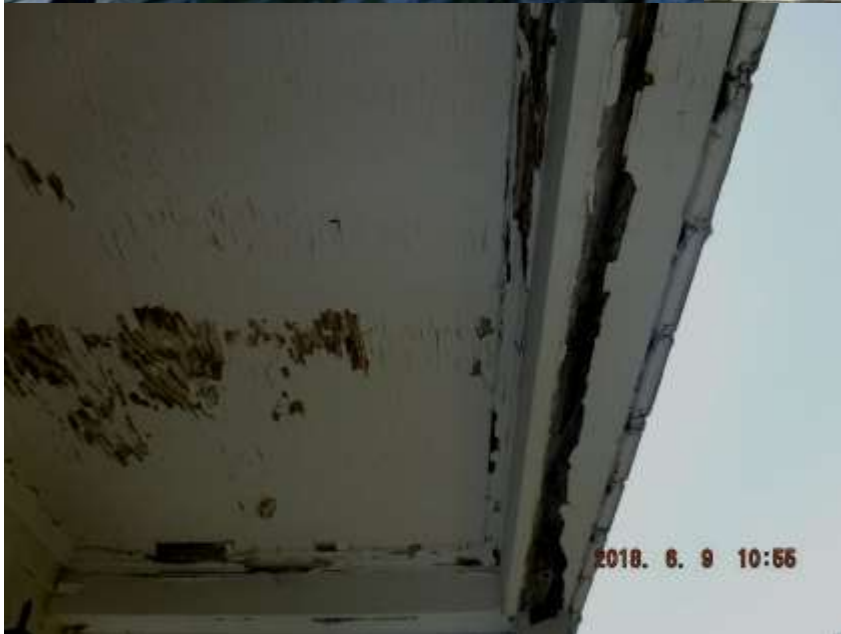
2. The siding was old or original to home; open gaps, corners, etc. There was flaked paint, wood rot/damage, carpenter bee damage/staining and overall lack of maintenance. There were foundation cracks visible on exterior (basement foundation and enclosed porch raised slab) and partially visible in basement. Recommend an exterior siding/building contractor evaluate extent of siding/wood/exterior damage and advise on repairs and painting including any concealed water/wood destroying insect damage before closing & contractual limitations.

Figure 5 Examples of siding/exterior rot and peeled paint; poorly maintained exterior & systems.

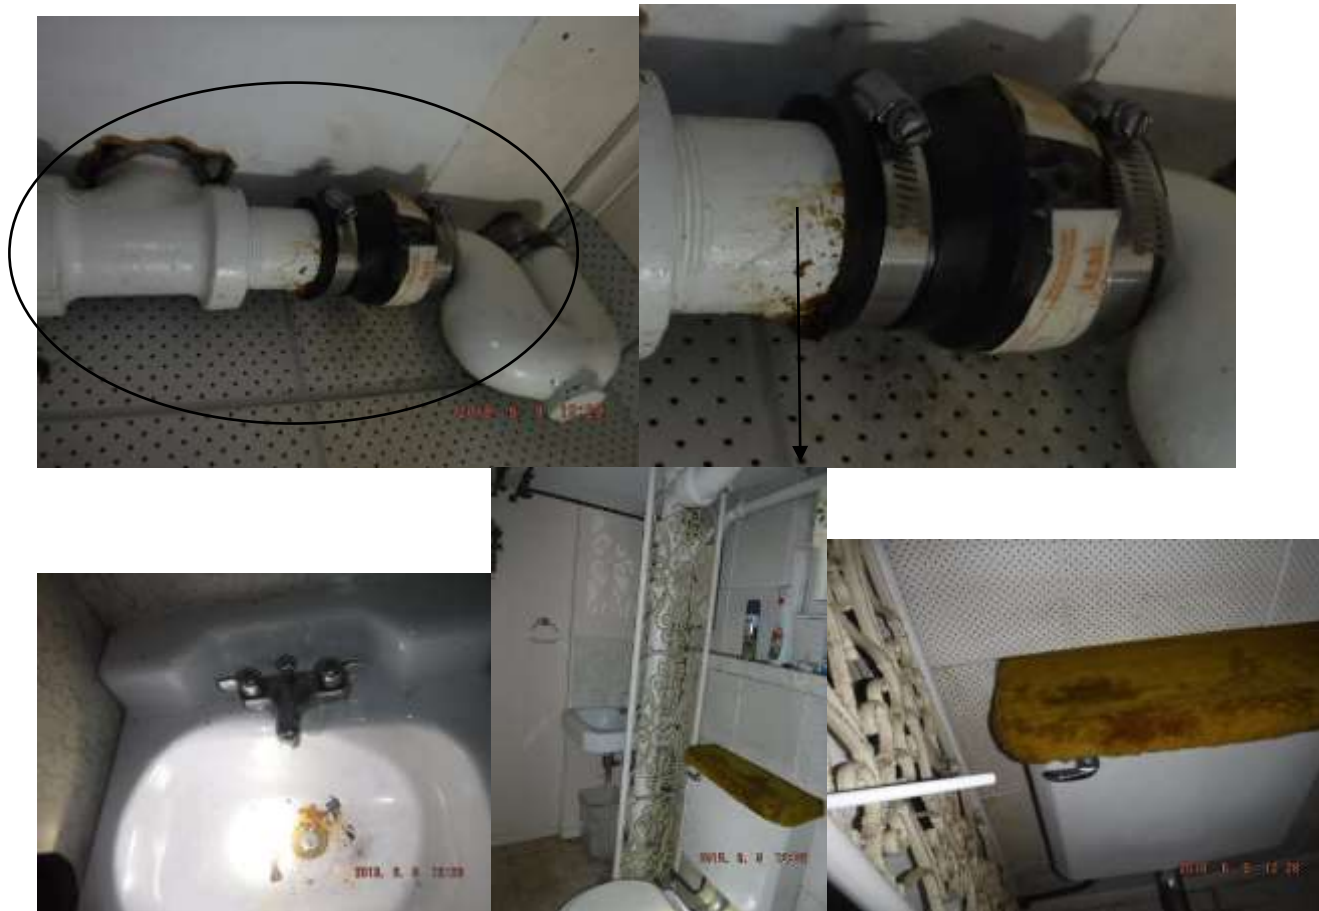
**1/2 BATH:** The bathroom had old sink and toilet, shut off or not in use and not functioning; poor condition. Recommend a bathroom contractor evaluate for complete upgrades; not a functioning bathroom. Do not use this bathroom until renovated by a bathroom contractor. There was exposed galvanized piping and patch Fernco type rubber coupling in ceiling for bathroom above; leaking/oozing at corrosion and patch.

**Figure 6** Basement 1/2 bathroom was not functional; do not use. Have a bathroom contractor evaluate and advise on complete renovations, plumbing, electrical, etc.

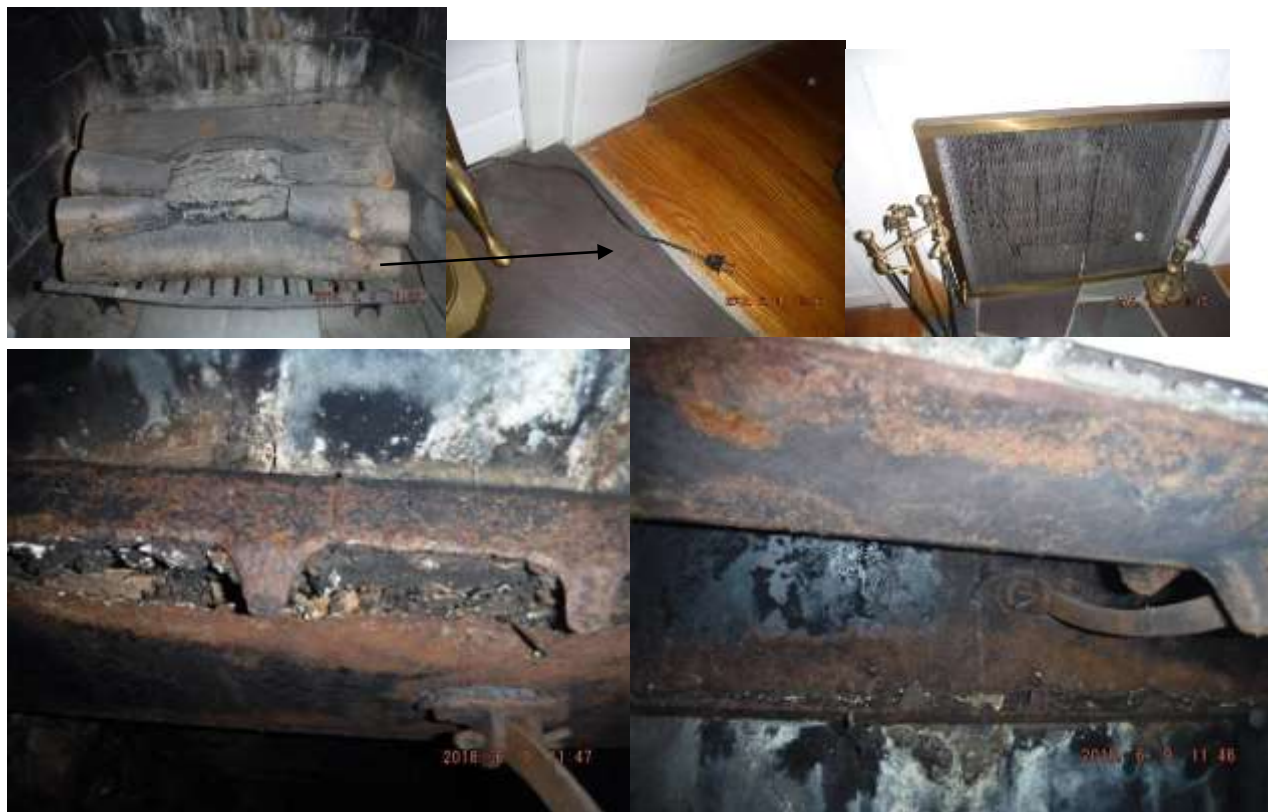
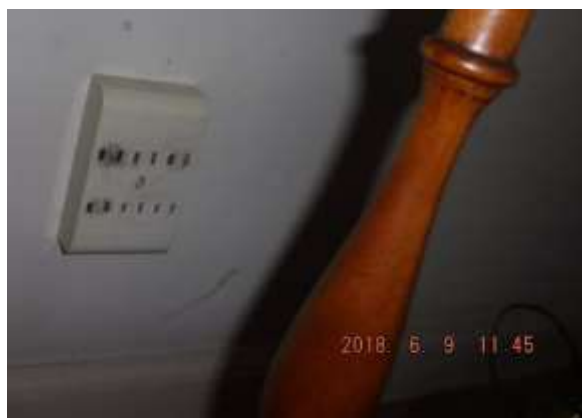
Figure 7 Example of multiplier on outlets and scorch marks; not recommended for fire safety.

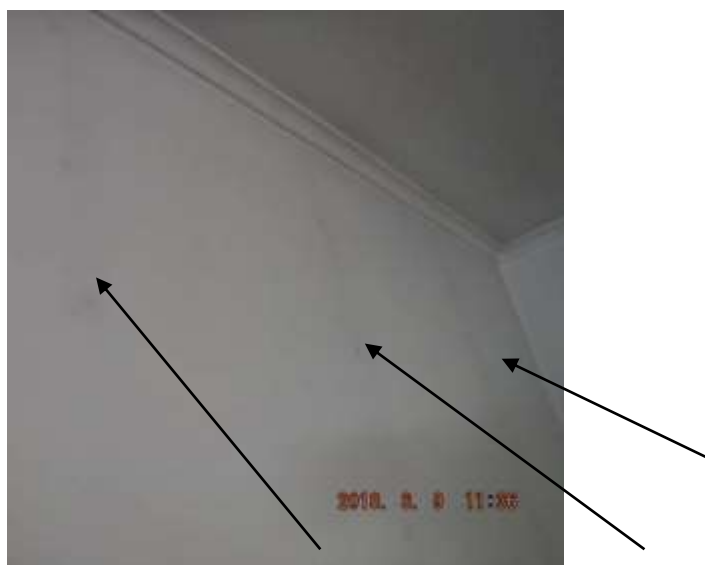
**MASTER BEDROOM :** There was ghosting on walls or drywall in the home; related to inadequate insulation & ventilation. Recommend a ventilation & insulation contractor evaluate home and advise on proper mix of these components. There were two prong outlets; recommend an electrician upgrade to tamper resistant 3 prong grounded outlets. There were active water stains/leaks in the room; see roofing section comments.

**Figure 8** Example of dark streaks outlining the wall studs and nail pops in the home; ghosting or thermal bridging.

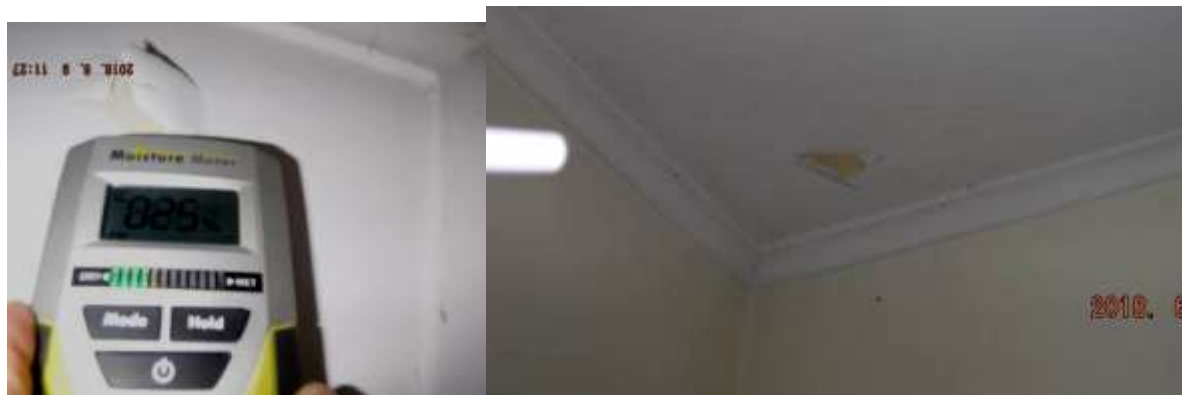
Figure 9 Example of flaked paint, water stains and active moisture/leaking; see roofing section comments.

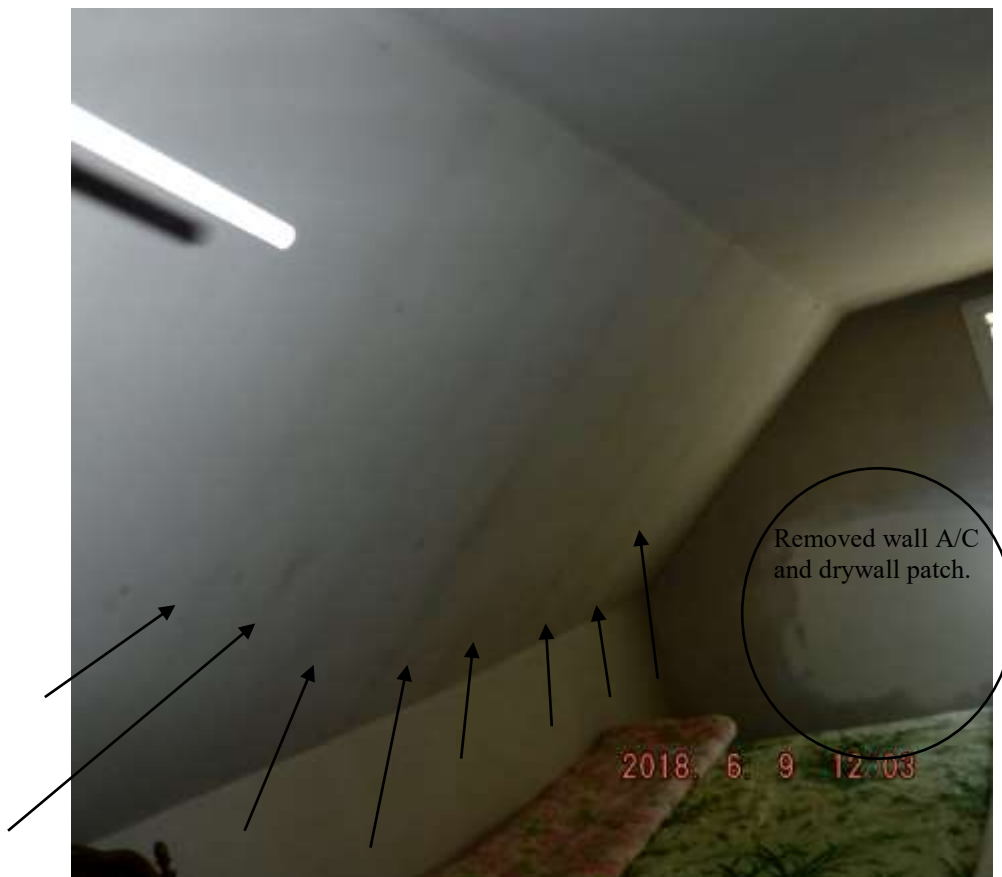
Figure 10 Example of "Ghosting or thermal bridging" in the home. Recommend an insulation & ventilation contractor evaluate home and advise on a proper mix of both. See roofing & attic section comments.

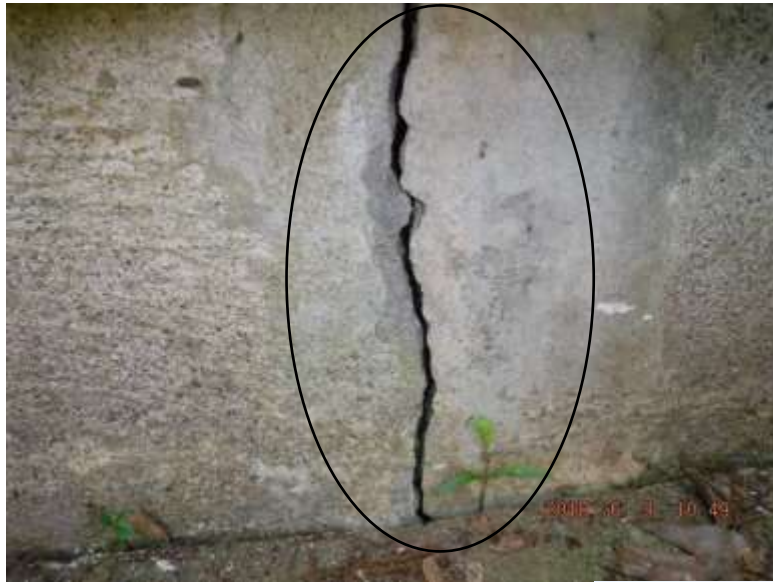
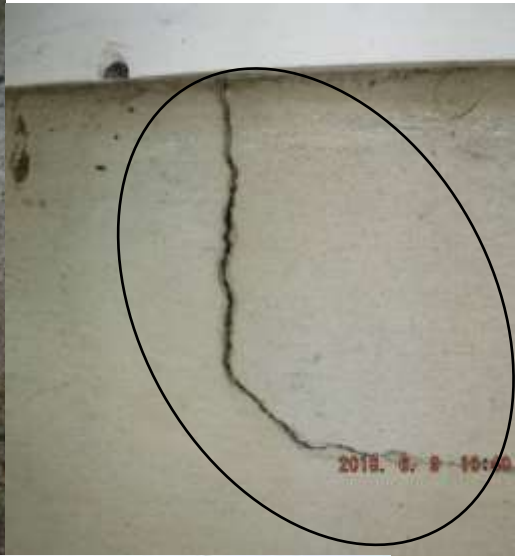
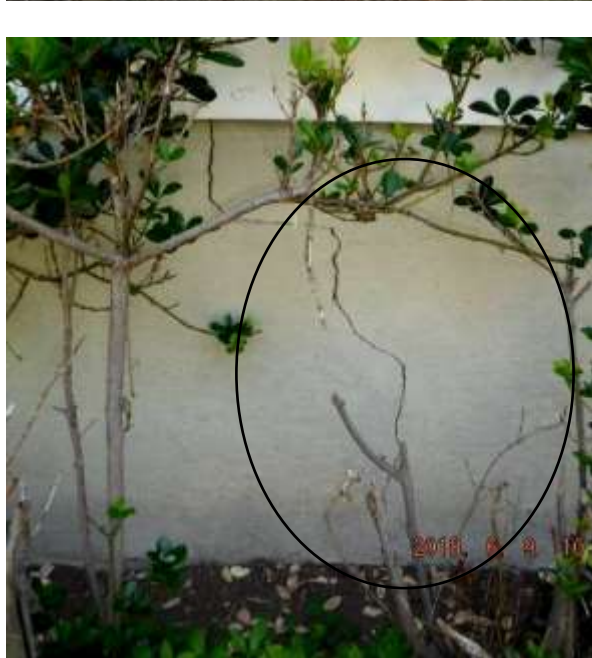
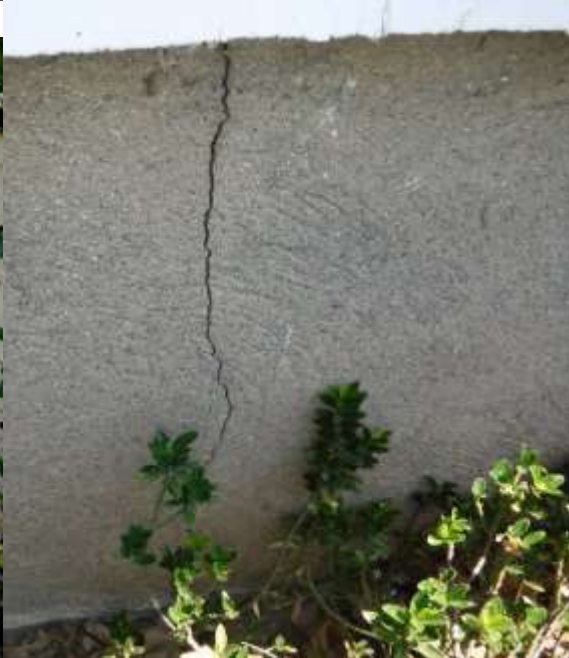
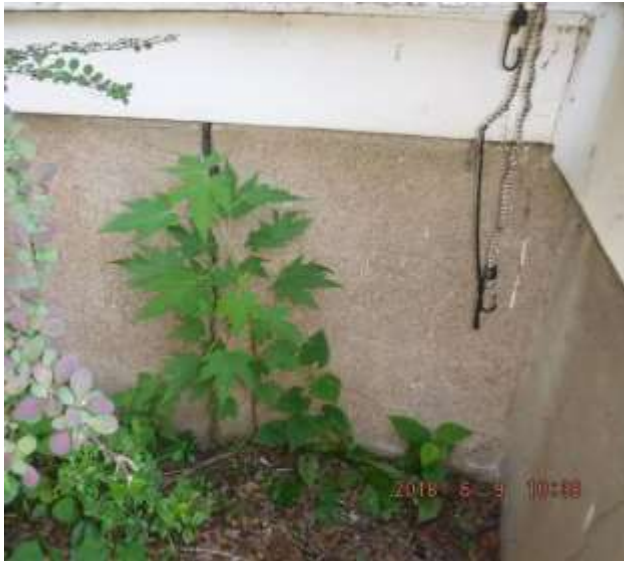
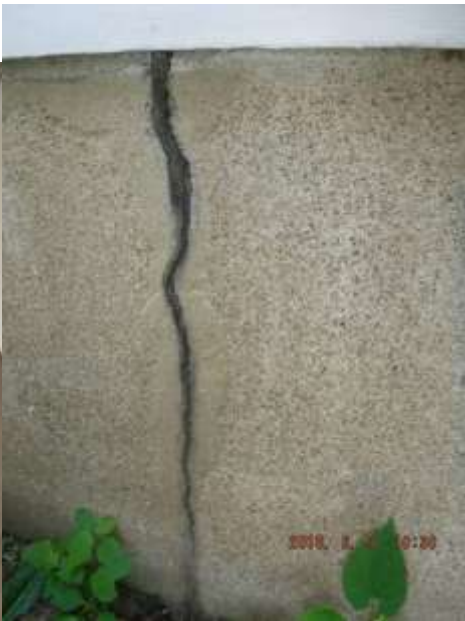
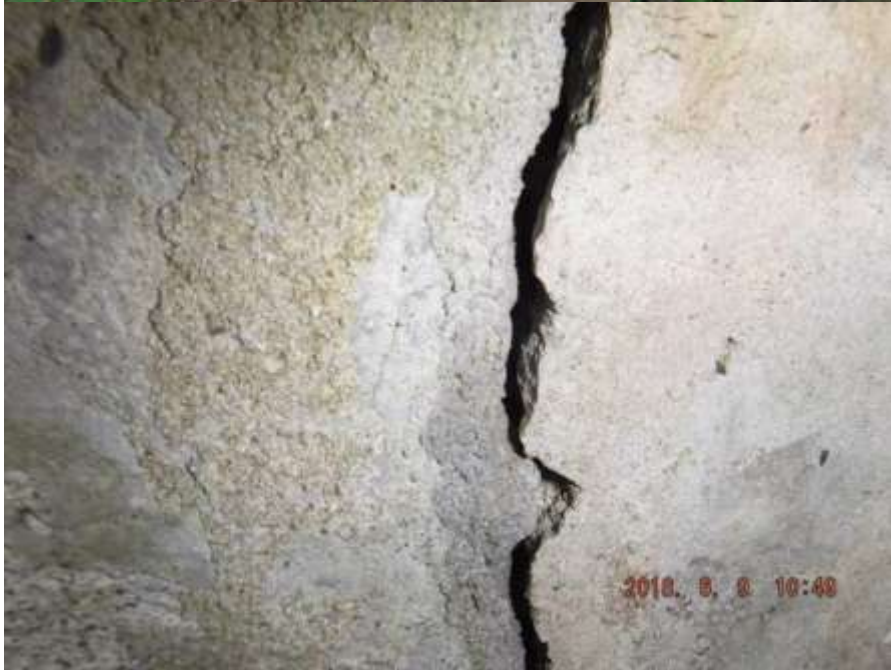
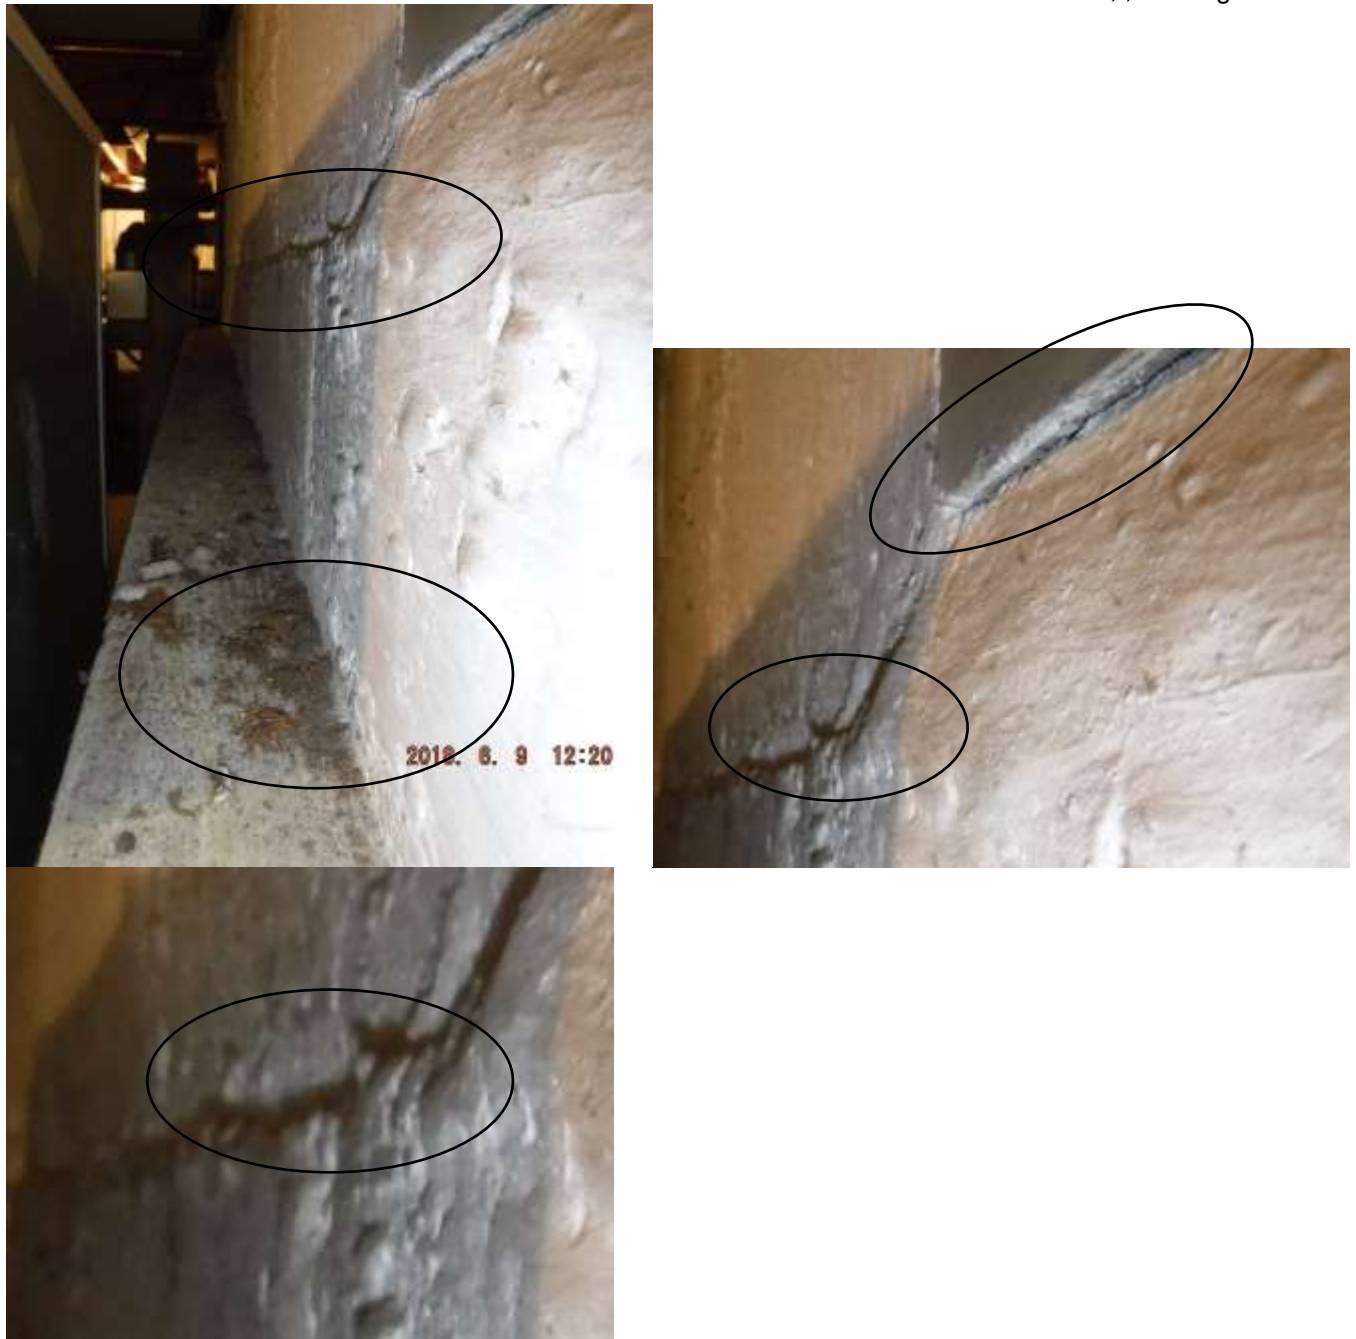
**EXAMPLES OF FOUNDATION CRACKS AND TERMITE TUBES/DAMAGE:**

**Figure 11 Foundation cracks and termite shelter tubes; limited view peeking behind finished wall studs.**

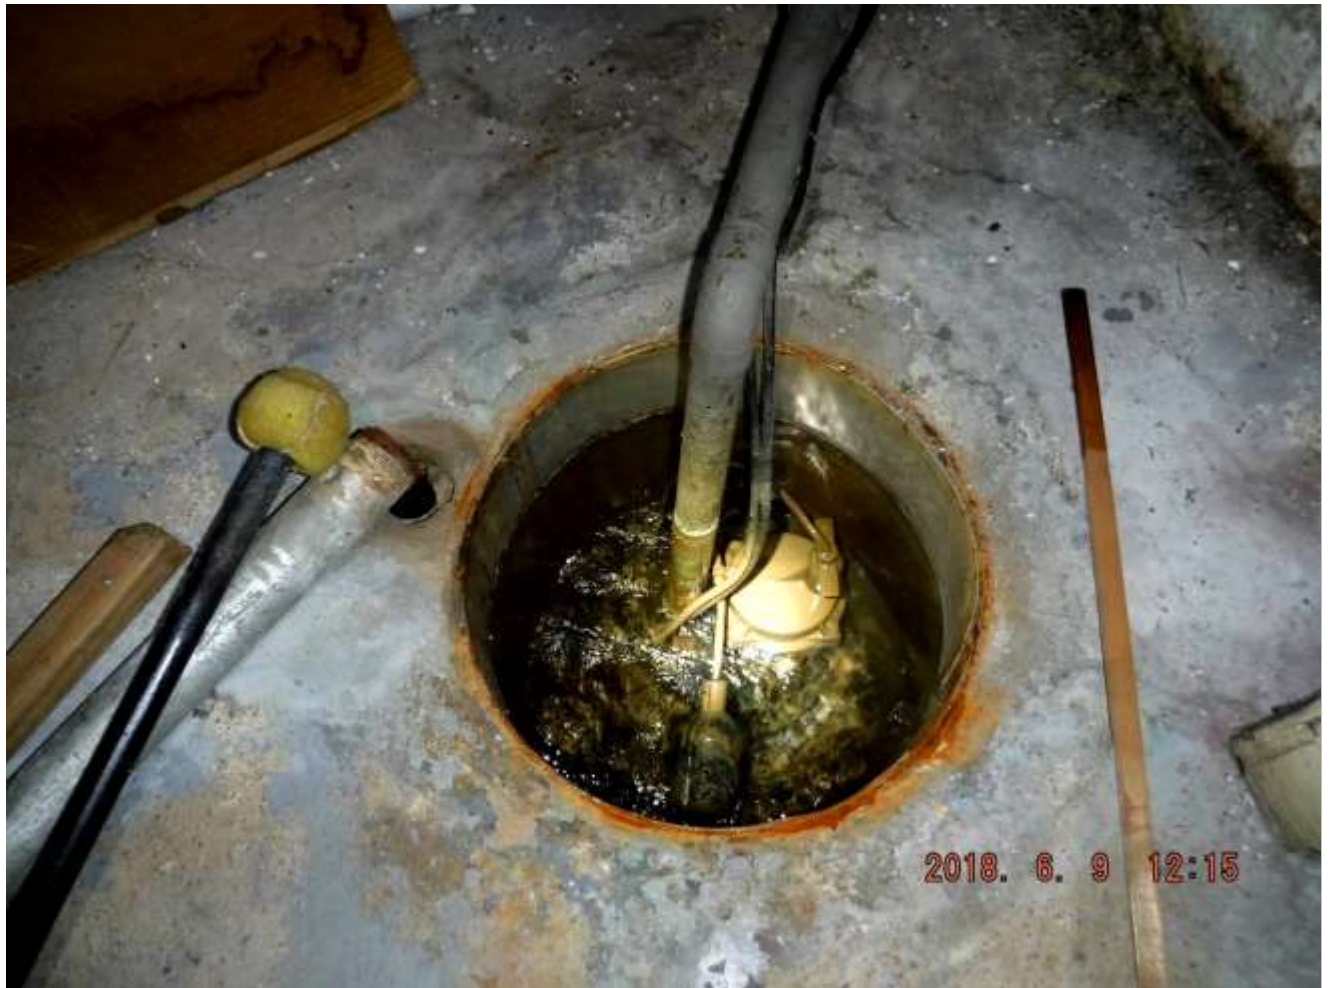
**Figure 12 Sump was nearly filled, no check valves, no cover, no dedicated outlet/GFCI, etc.**

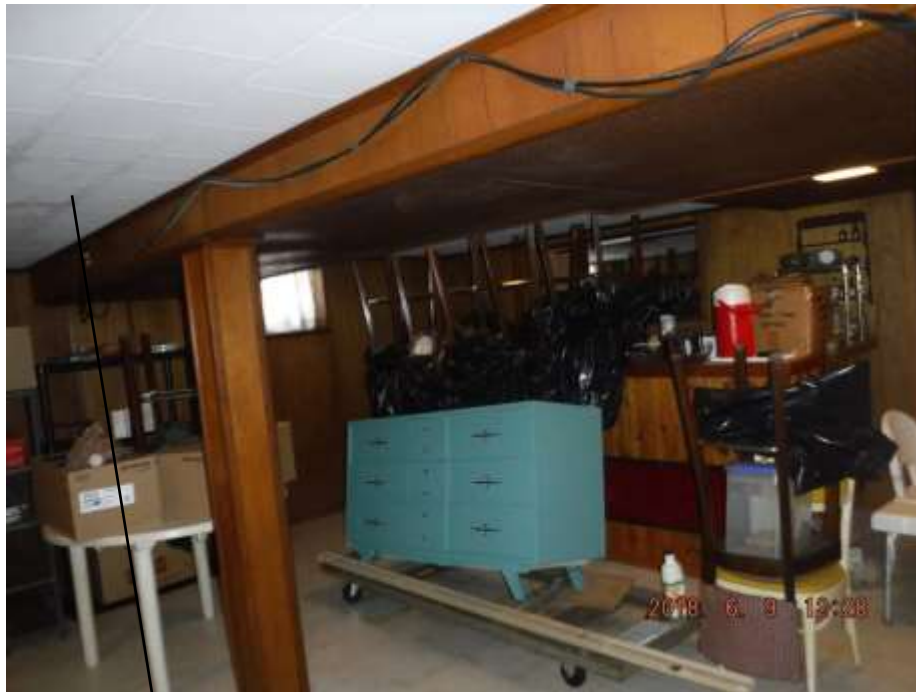
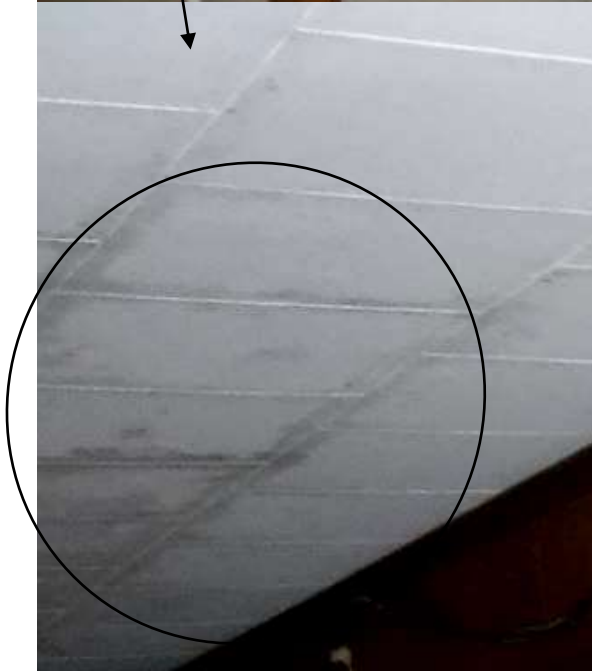
**Figure 13** Finished basement (concealed structure) and mold-like spotting on ceiling tiles or surfaces. Follow-up with a mold or environmental contractor for that service and inspection; beyond the scope of a home inspection.

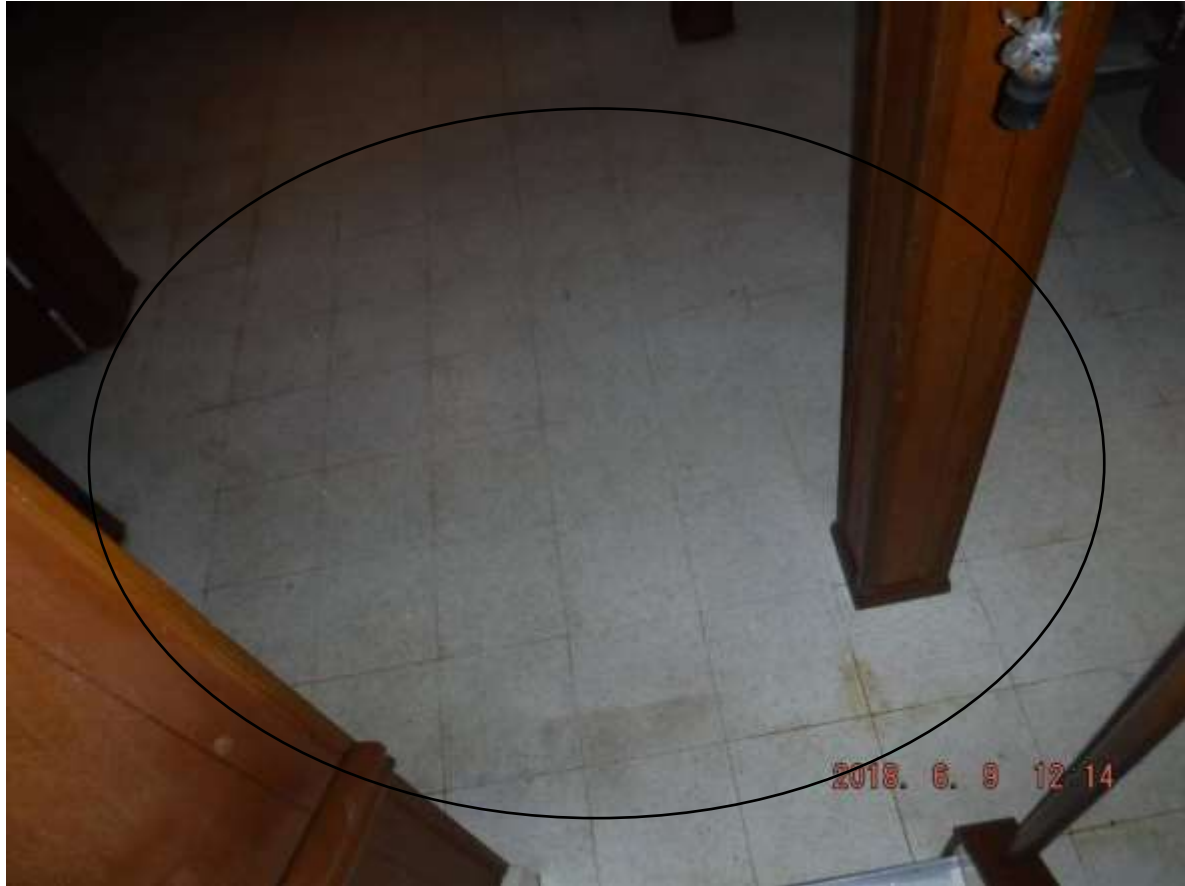
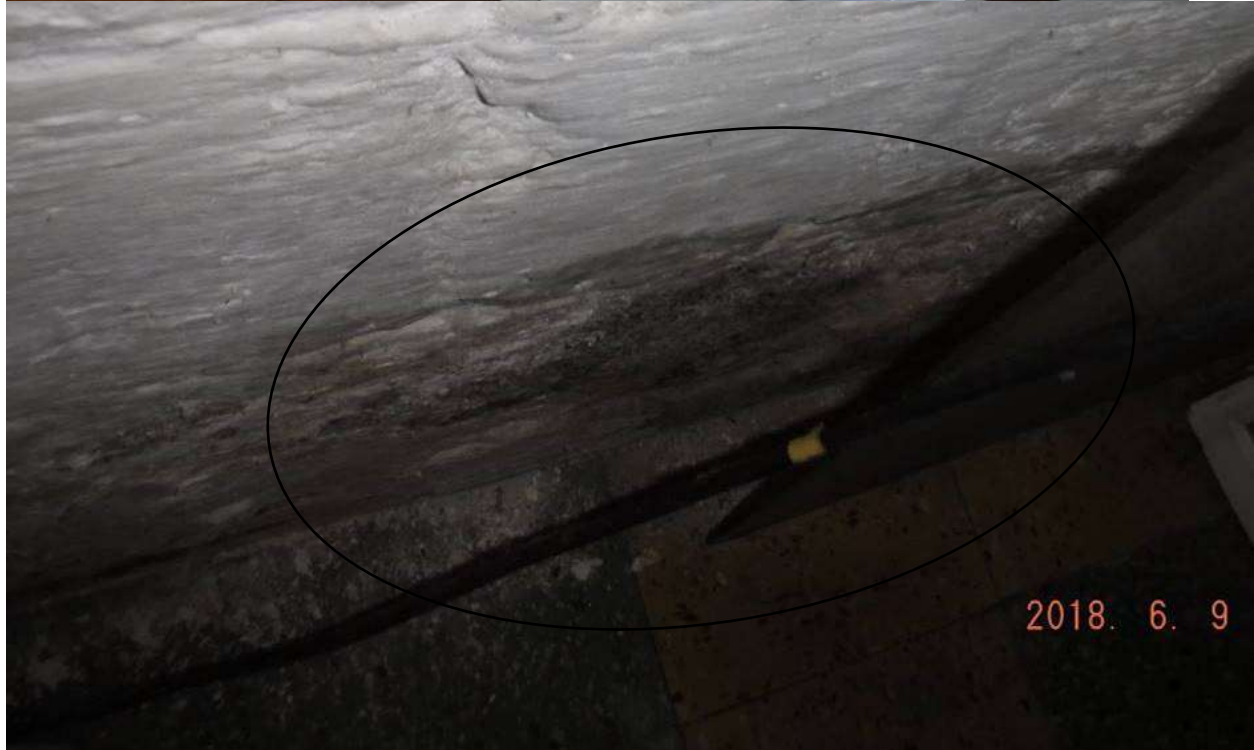
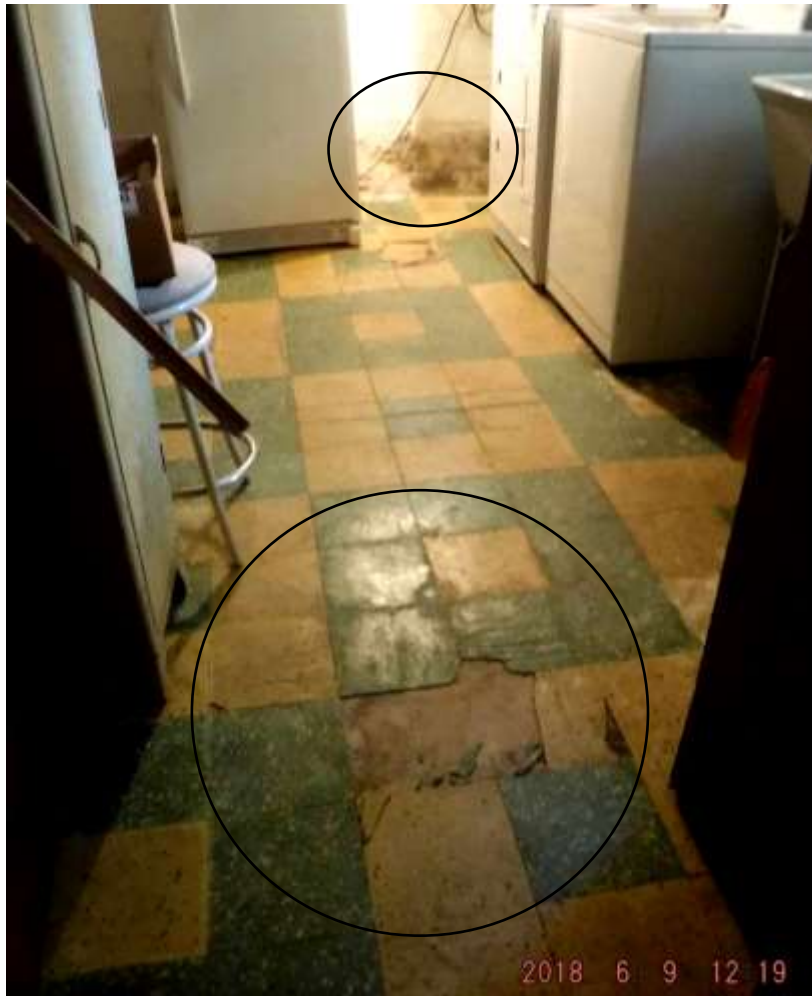
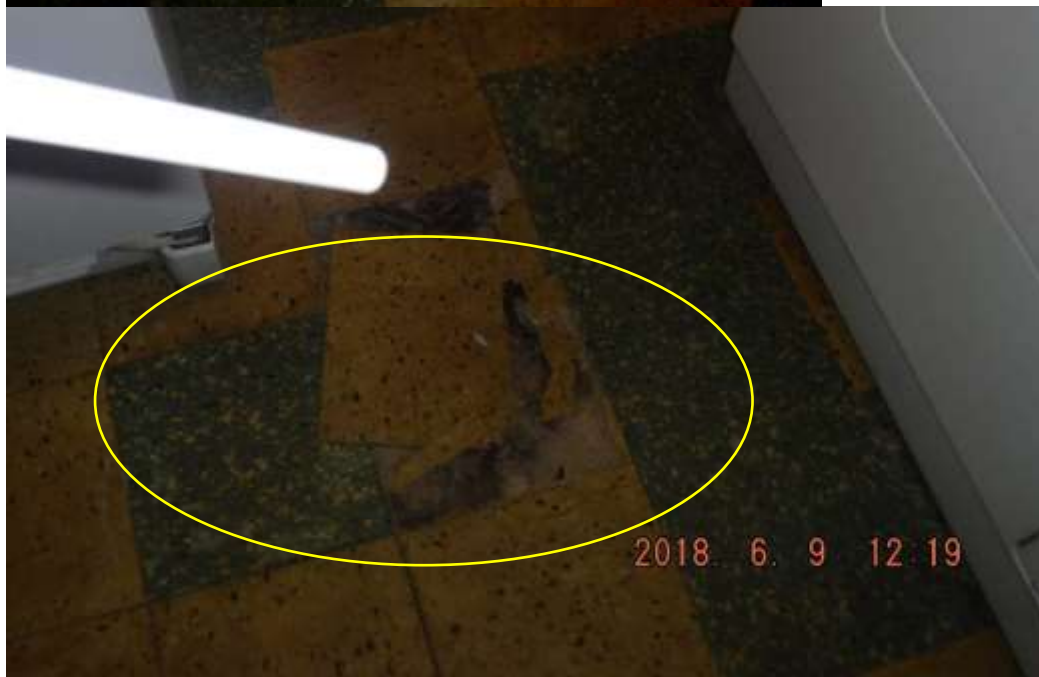
3. **There were water damaged floor tiles; stick down larger tiles and 9x9" asbestos like tiles visible in basement. Recommend an environmental contractor evaluate tiles and advise on removal. Asbestos and environmental inspection & testing is beyond the scope of a home inspection.**

**Figure 14** Example of asbestos-like floor tiles; water damaged/broken. Follow-up with an asbestos or environmental contractor.

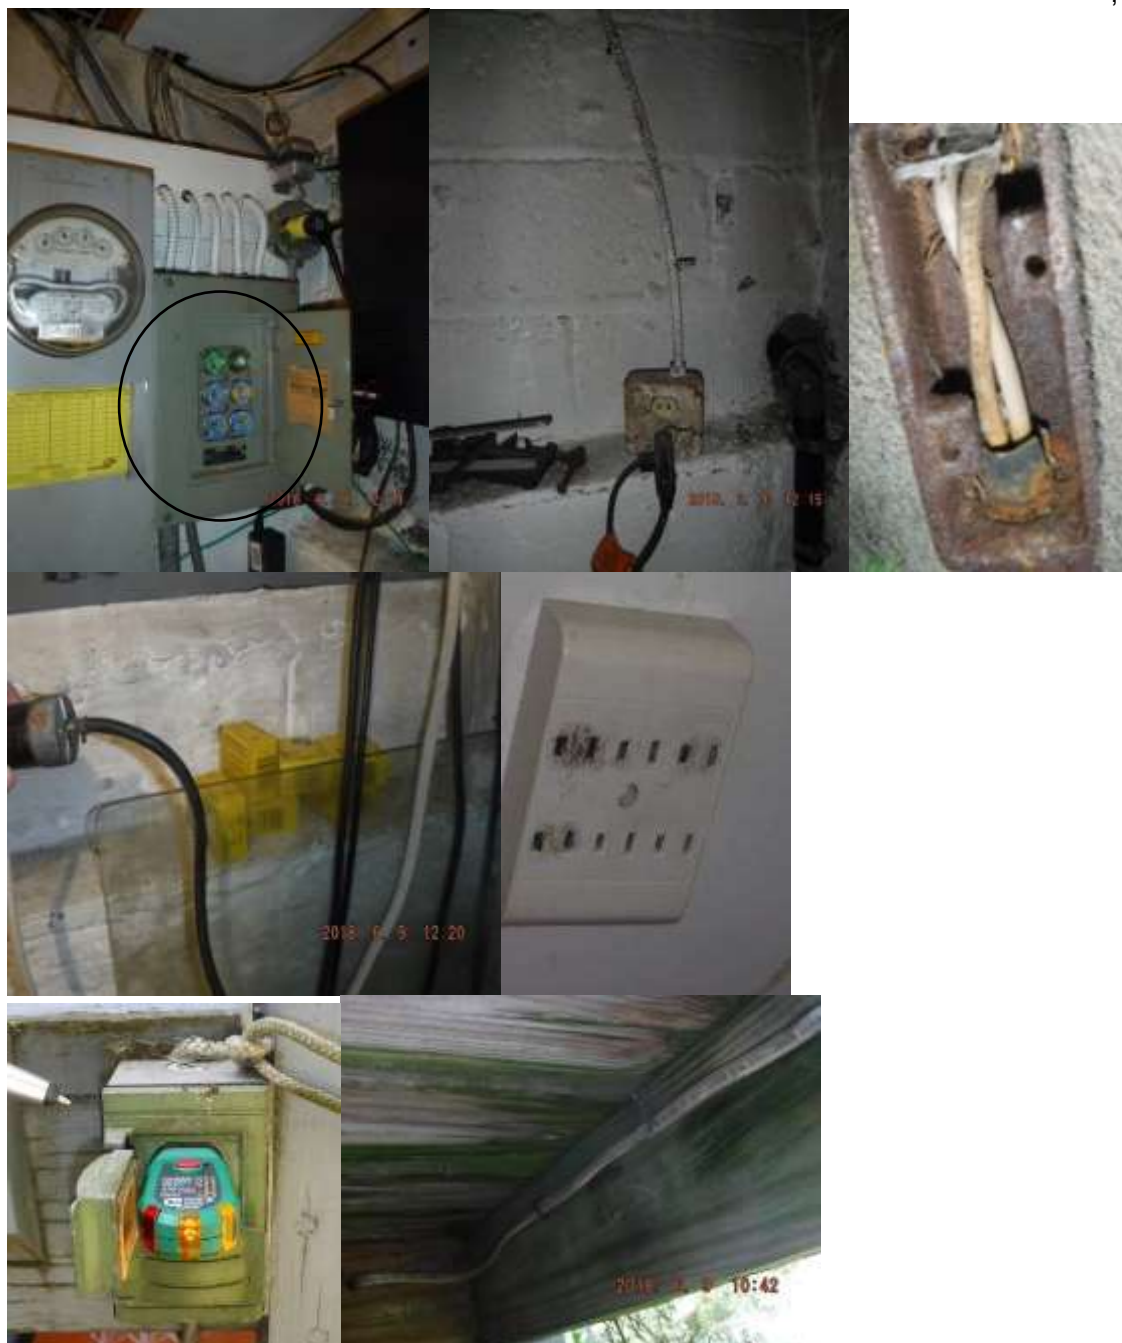
1. The home had original 6 glass fuse electrical panel; obsolete and should be replaced before moving into home. The service drop cable on exterior was frayed/cracks (safety hazard), older outlets, reversed polarity, open grounds, handyman wiring/installations/unsafe, loose electrical boxes/wires/cables/outlets, open junction boxes, white Romex indoor wiring used on exterior, missing covers (exterior junction box & devices), extension cords/improper wiring, outlet multipliers, scorched outlets/overloading, missing outlets in bathrooms, no GFCI outlets, 2 prong ungrounded outlets, etc. Home needs electrical upgrades throughout home, garage and exterior. Recommend a licensed electrician evaluate all electrical in home and the service panel (needs replacement) and advise on all electrical upgrades throughout the home before closing & contractual limitations.

**Figure 15** Examples of the old glass 6 fuse panel and older electrical. The home needs electrical upgrades throughout the home.
