4 Seasons Home Inspection, LLC

Inspection Date: February 26, 2018 Monday 12pm- 4pm
Client Name: buyer (buyer@gmail.com)
Emails: lawyer@aol.com
Inspection Address: # street town, nj xxxxx
Inspected by: Linda Geczi home inspection lic. #24GI00061500

BUILDING DATA

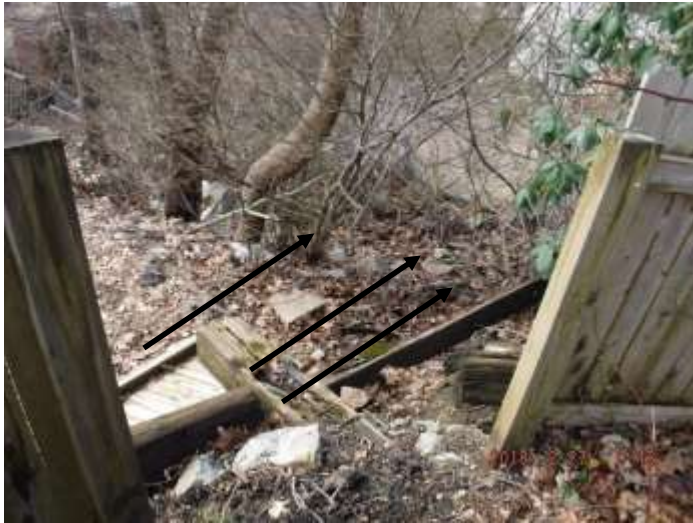
Figure 1 Steep drop off and missing/broken fencing. Fencing was loose, leaning, damaged and missing sections; safety hazards/dangerous.

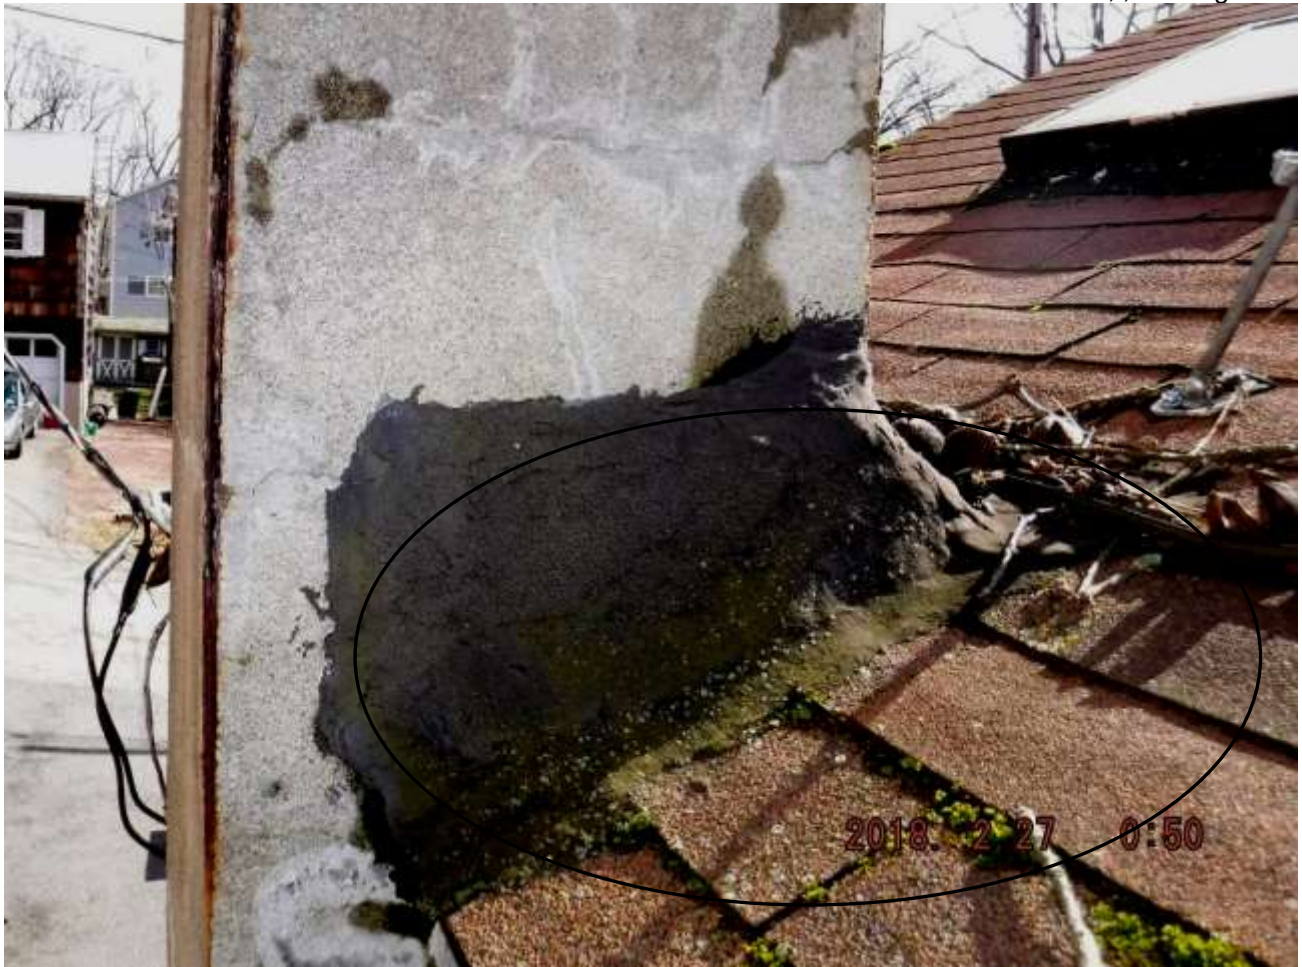
- 1. The roof was old and past expected life. There was granular/aggregate lose, curling, widening keyways, tarred/cracked roof junctures/chimney/penetrations, nail pops, cracking, brittle/sun or heat damage, exposed felt, moss build-up, chipped/broken edges, cupping, leaking around skylights (vapor seal breaks/cloudy), poor ventilation, etc.; poor condition. There was poor ventilation; see roofing section comments. There was pine sap beads on rafters/roof lumber and dark rings around roofing nails; indicative of hot humid attics. Ventilation appears inadequate. Hot humid attics will typically shorten life of roof, can potentially cause heat damage (splits, delamination, etc.) and conducive to mold/mildew. Recommend a building contractor and/or roofer evaluate roof for extent of wood/water damage, roof replacement (tear off), gutters, ventilation and skylights before closing & contractual limitations.**

Figure 2 Roof was in poor condition; have evaluated for replacement, metal/proper flashings (no tarring), skylights, ventilation, gutters.

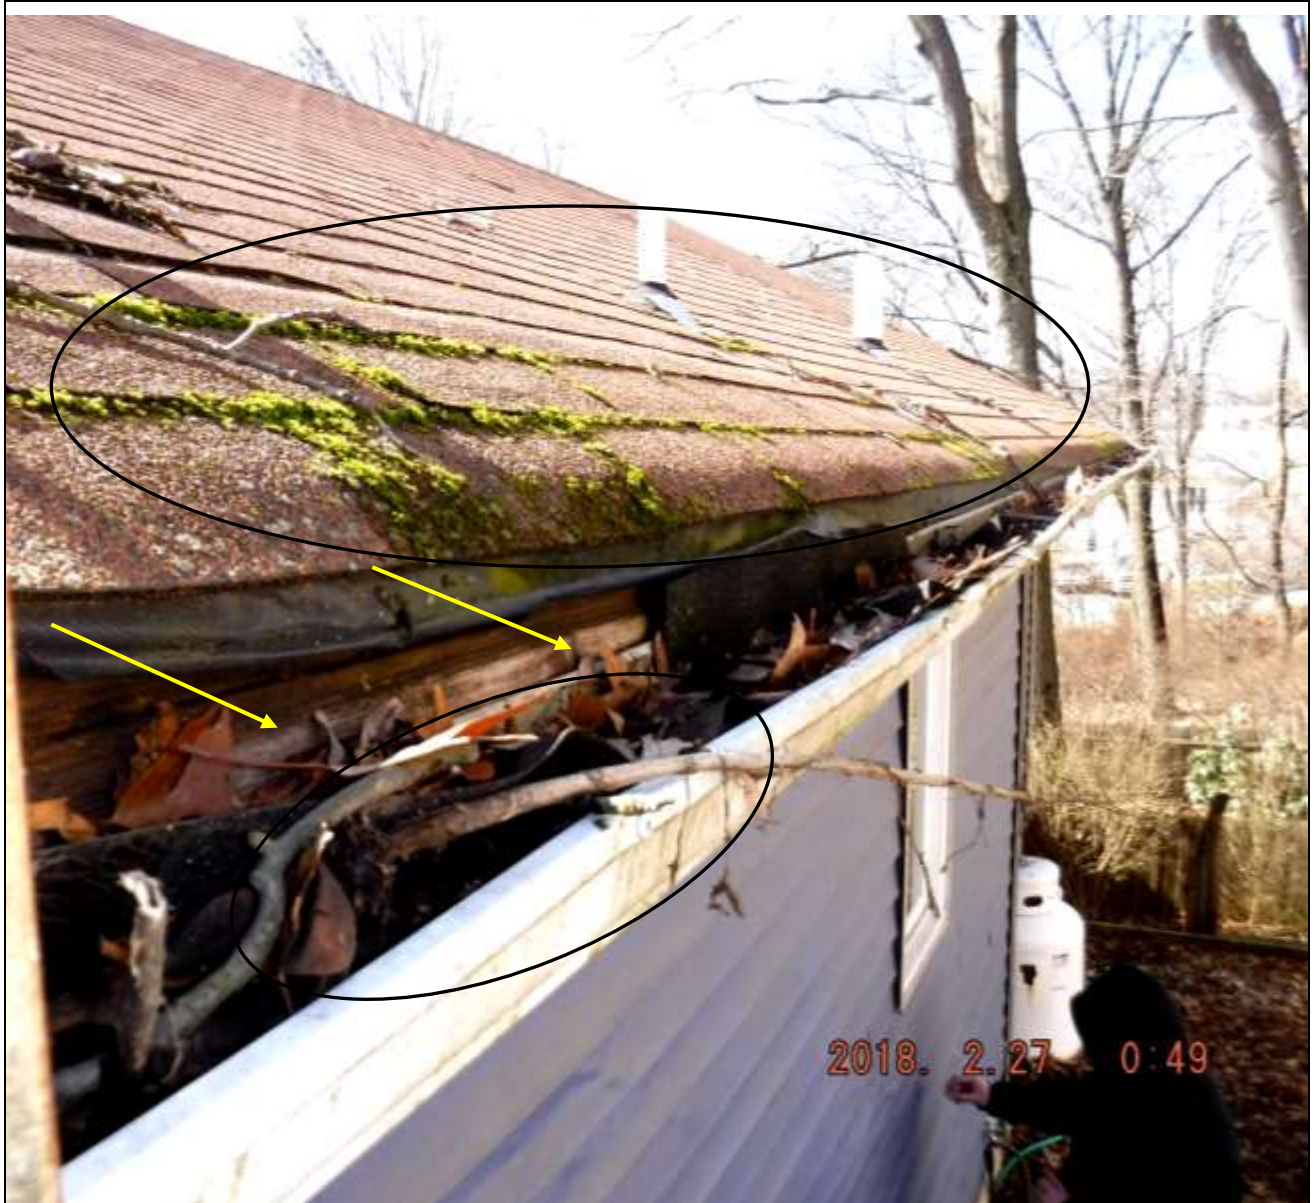
Figure 3 Water damaged/exposed wood, roof shingles old and poor condition. Recommend a roofer evaluate roof and advise on roof replacement, ventilation, gutters, skylight before closing & contractual limitations. Gutters, roof and exterior were in poor condition; see roofing, gutters, exterior/siding comments.

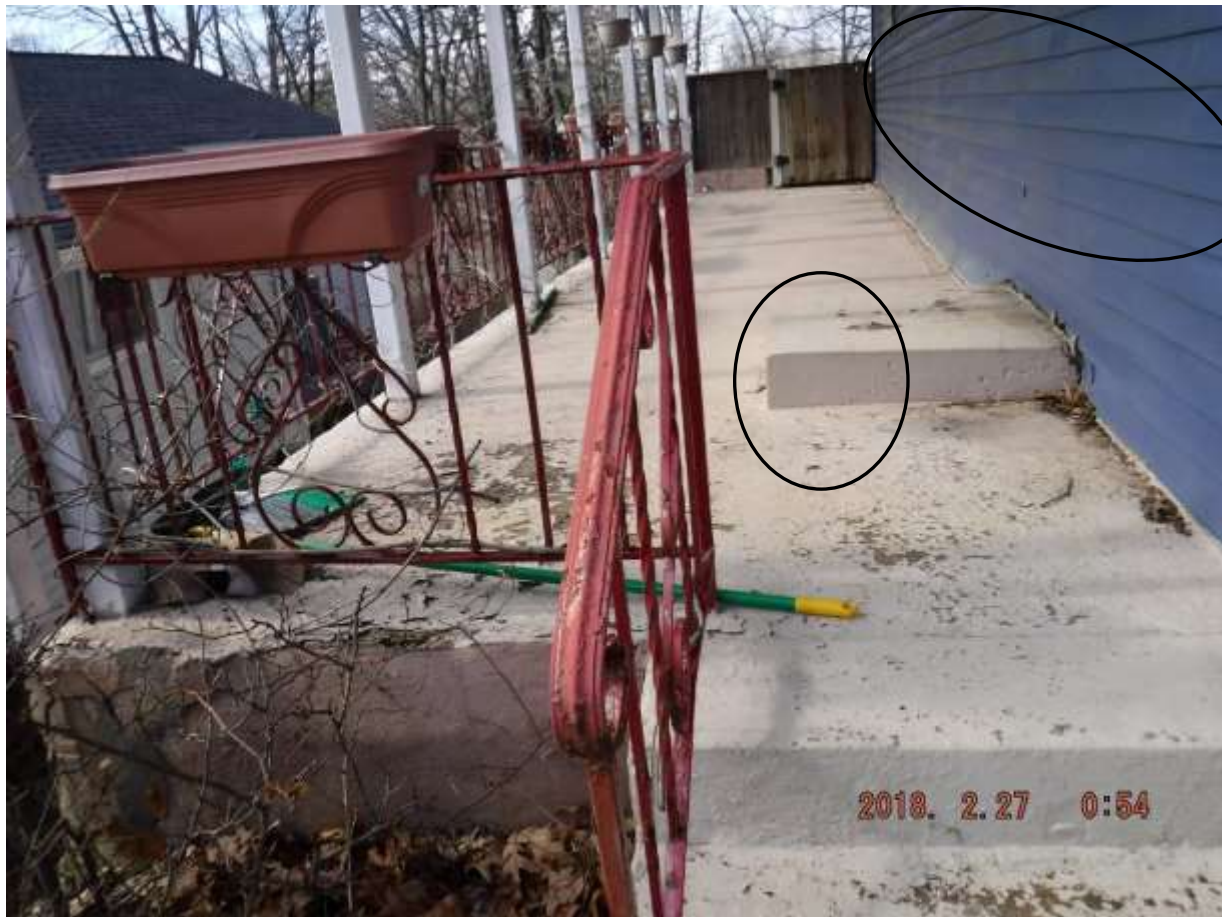
Figure 4 Slab from an enclosed door in living room. Siding had heat damage and wavy or buckled; further evaluate siding and causes before closing and contractual limitations.

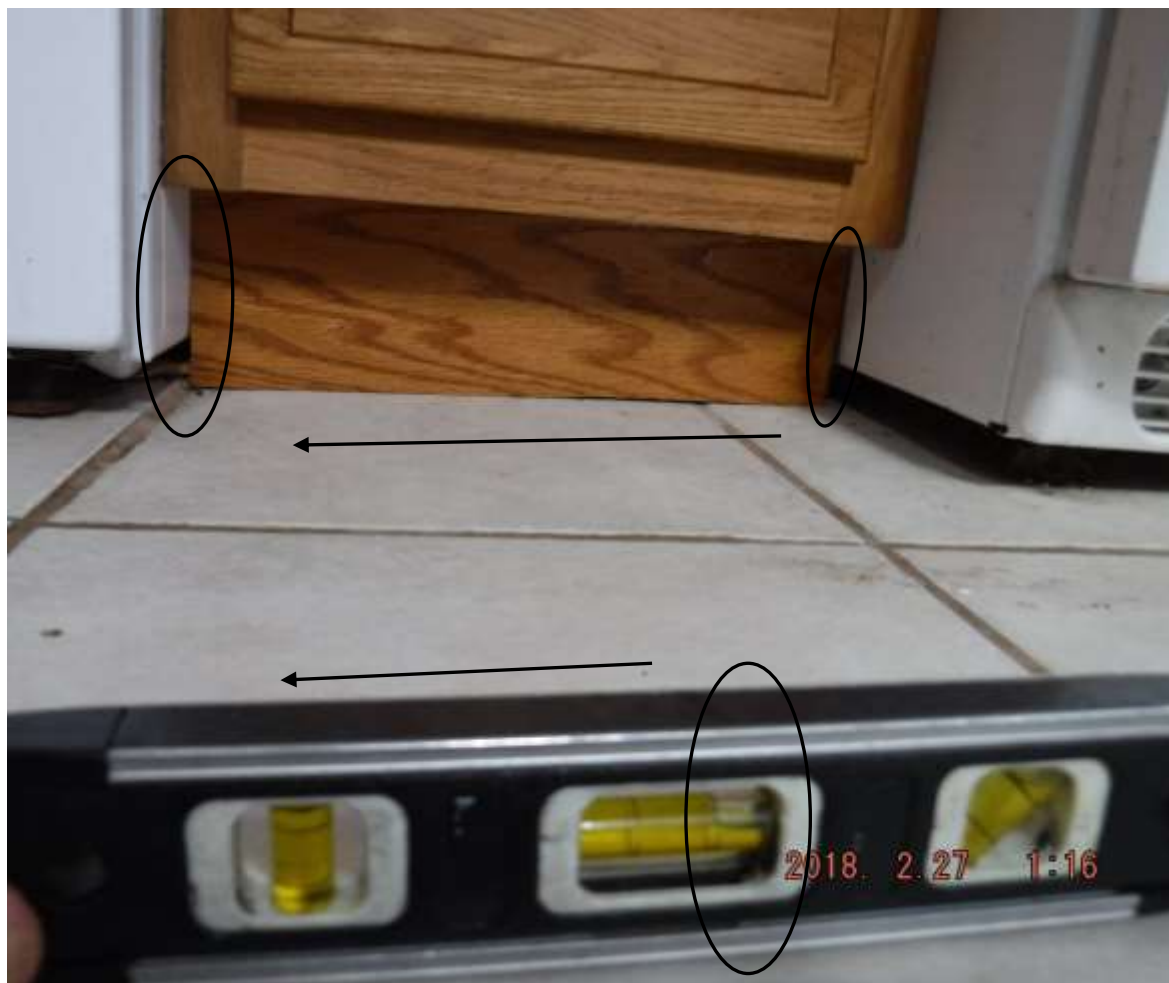
Figure 5 Example of sloped flooring and wedged base cabinet molding. See structural comments in basement and pg. 2 main concerns.

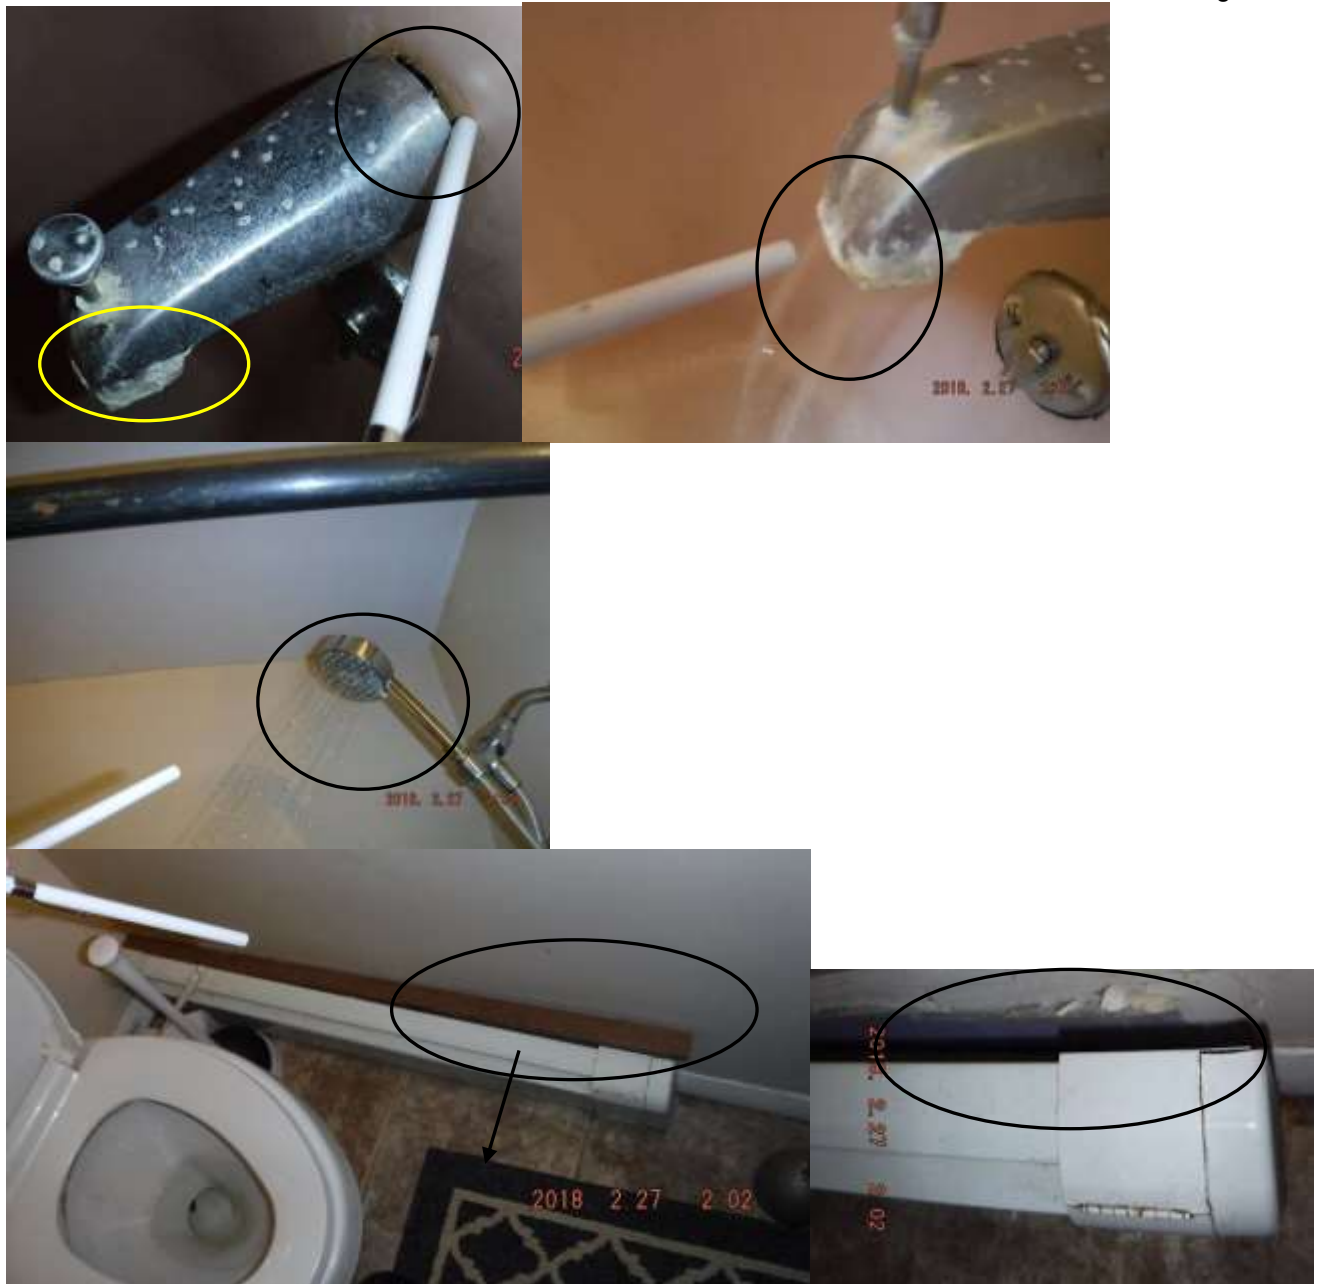
Figure 6 Example of loose baseboards in home; have an HVAC contractor evaluate/secure for safety.

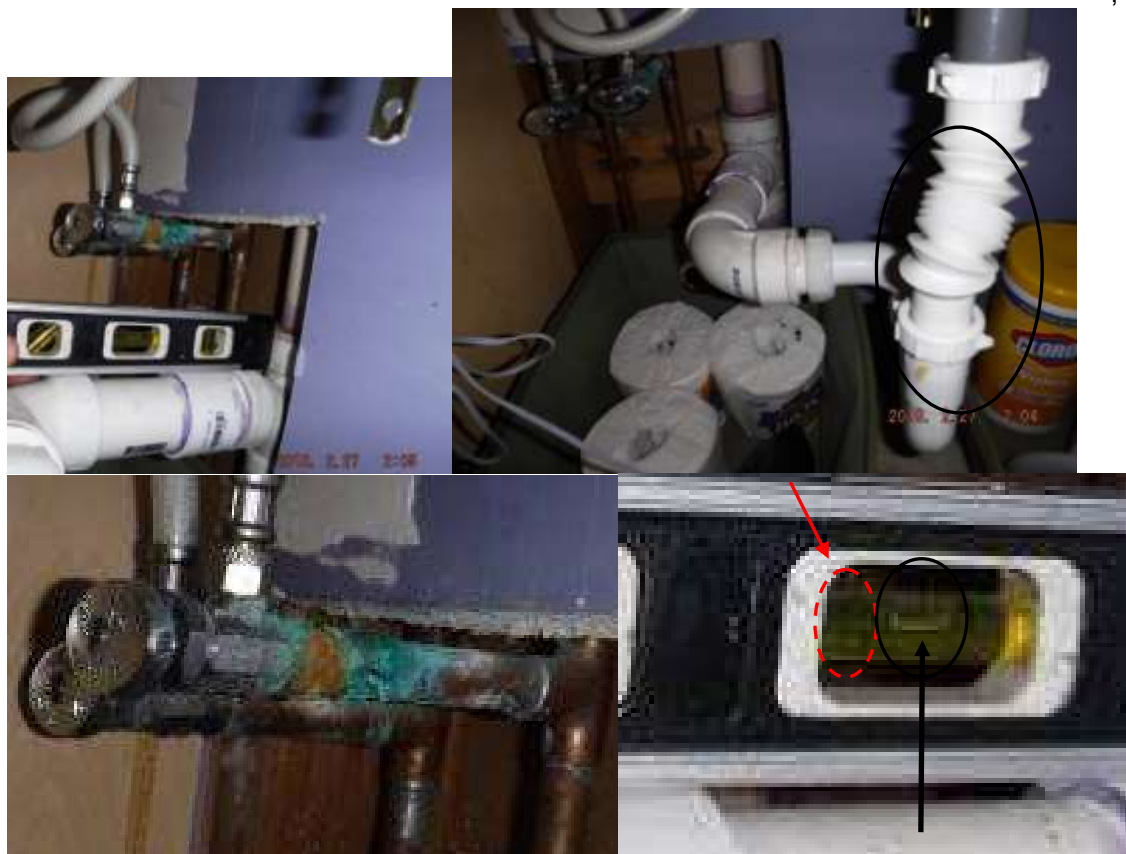
Figure 7 Example of corrosion, improperly pitched drain piping, flexible connector, etc.; improper drain installation. Recommend a licensed plumber evaluate all corrosion, drain installations and advise on repairs/corrections.

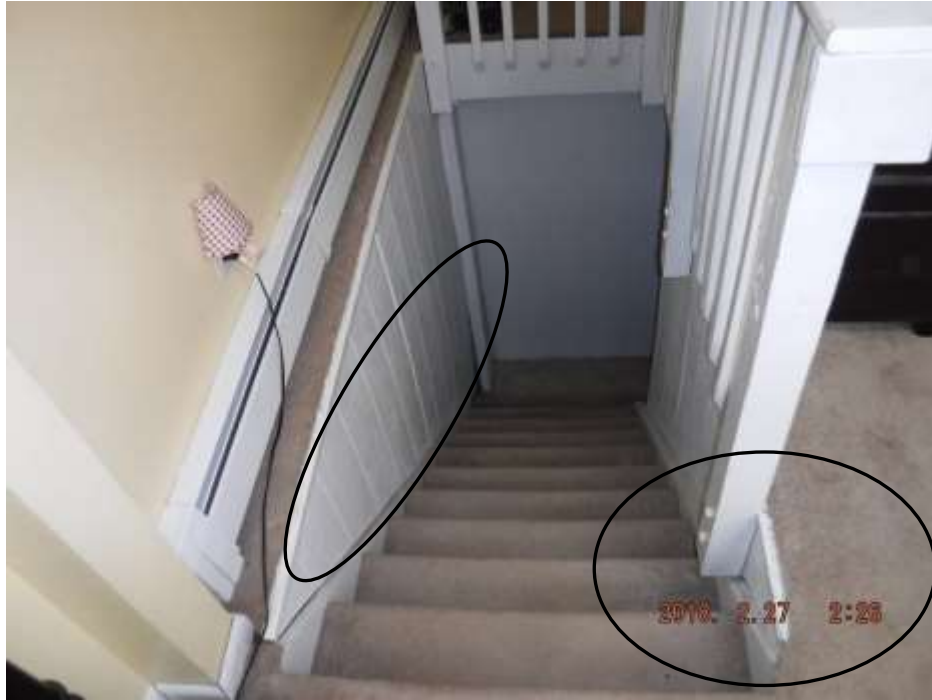
Figure 8 Railings should extend all the way across the steps and railing on steps for safety.

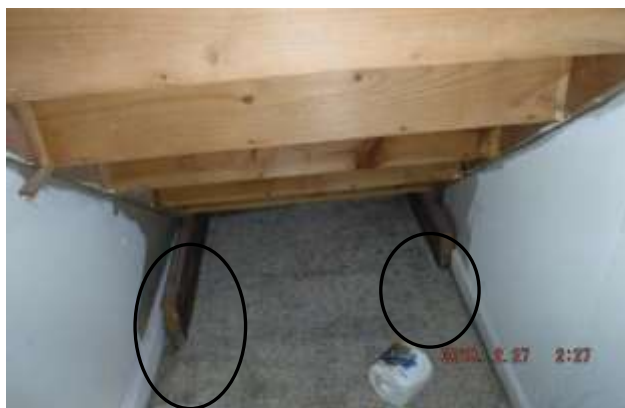
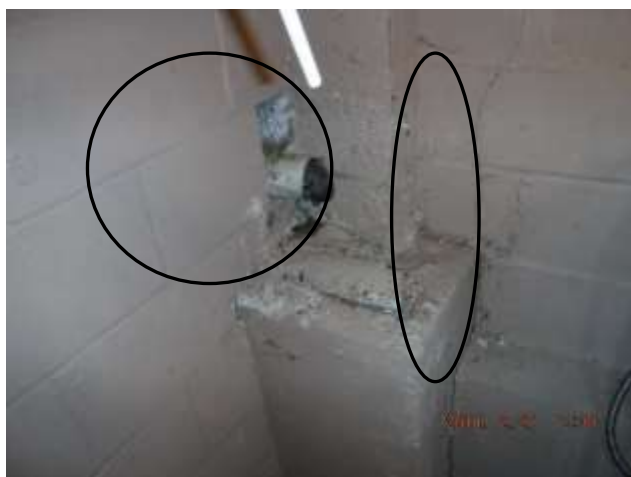
Figure 9 Abandoned piping or drains in basement; rule out an abandoned septic on property before closing. Example of foundation cracks and deepened basement or modified crawl space.

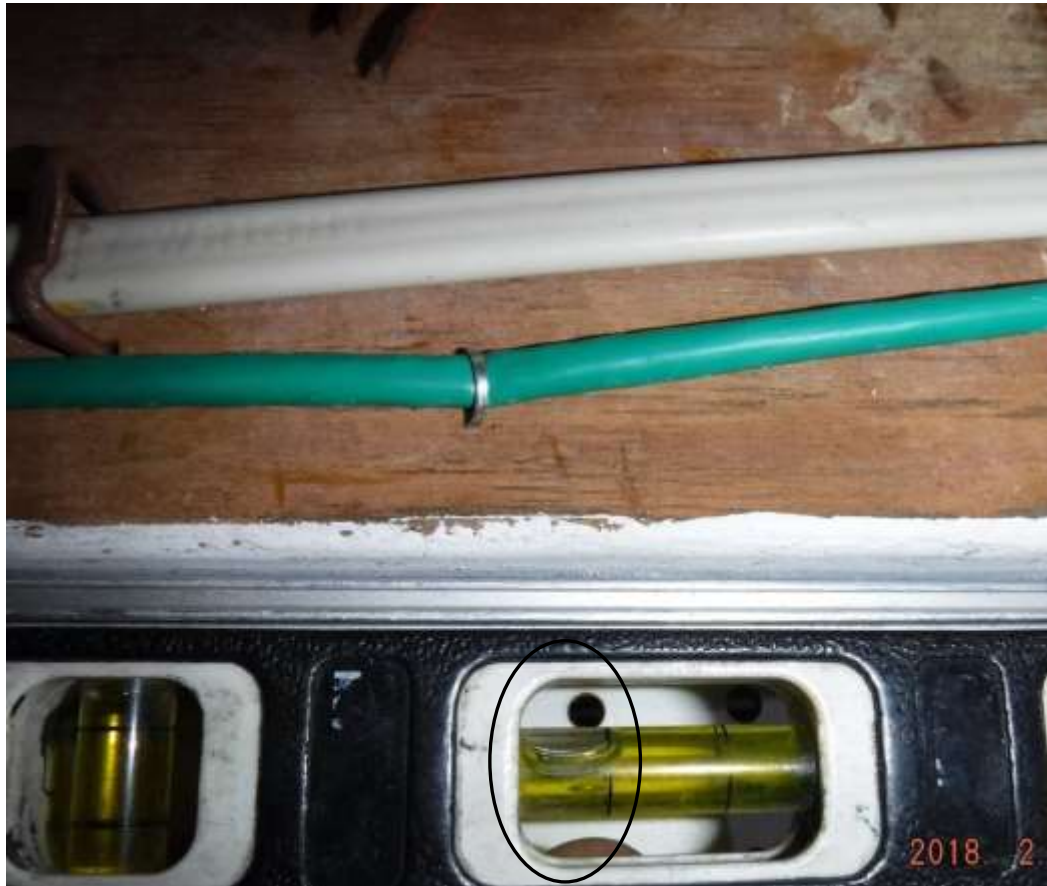
Figure 10 Broken/cracked built up beam on right basement; sloped flooring throughout the home.

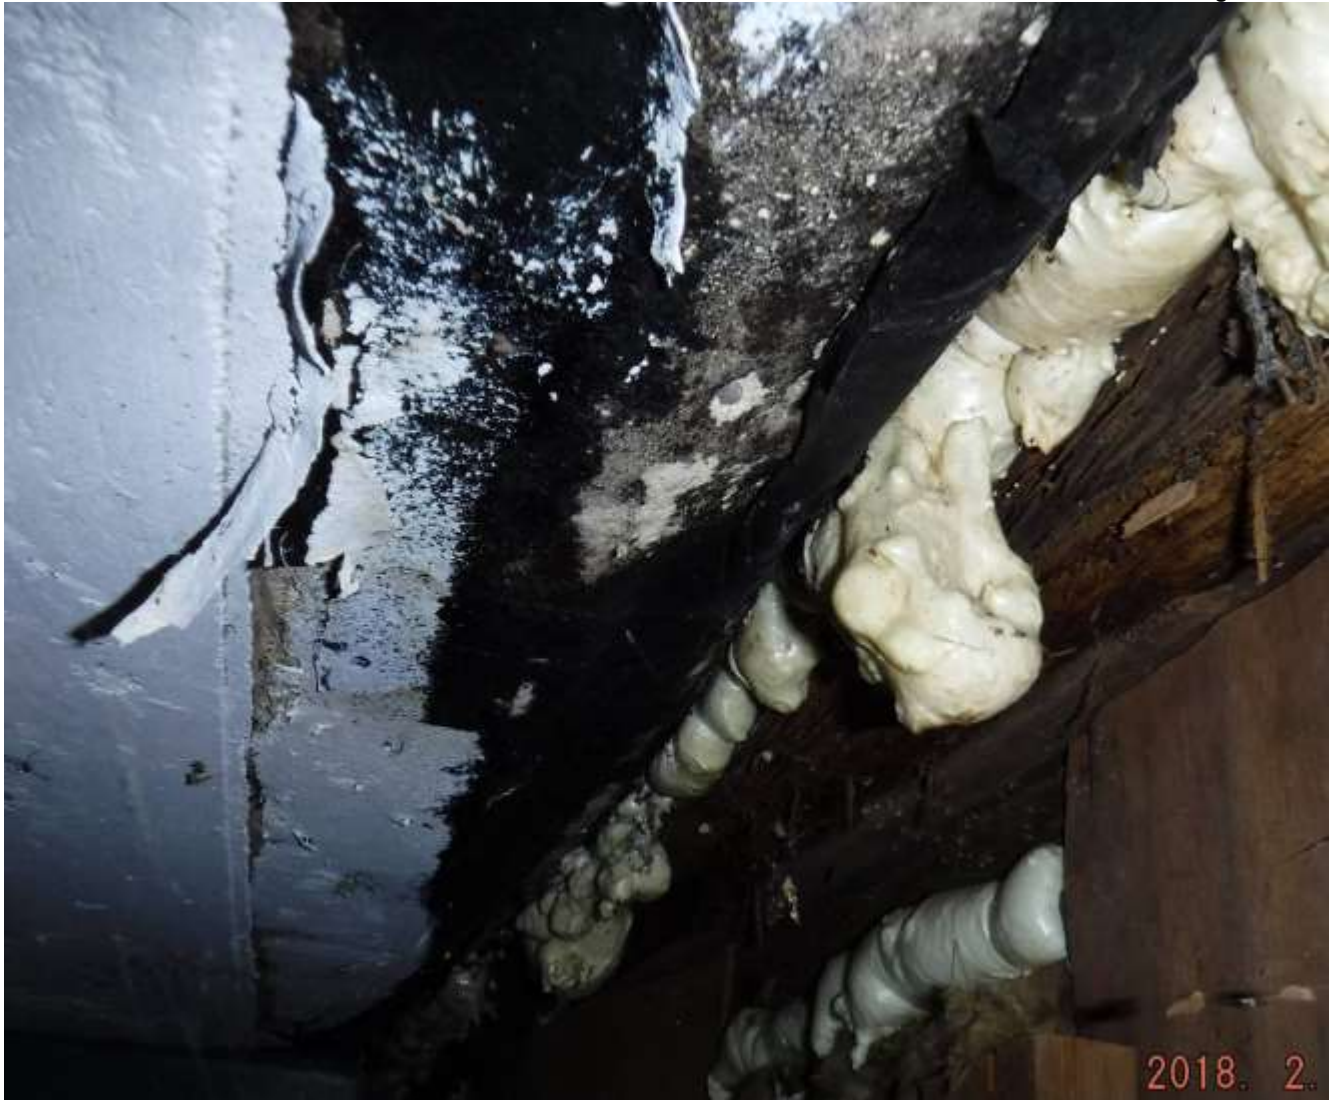
Figure 11 Example of damaged beam, rot and spray foam along the structure.

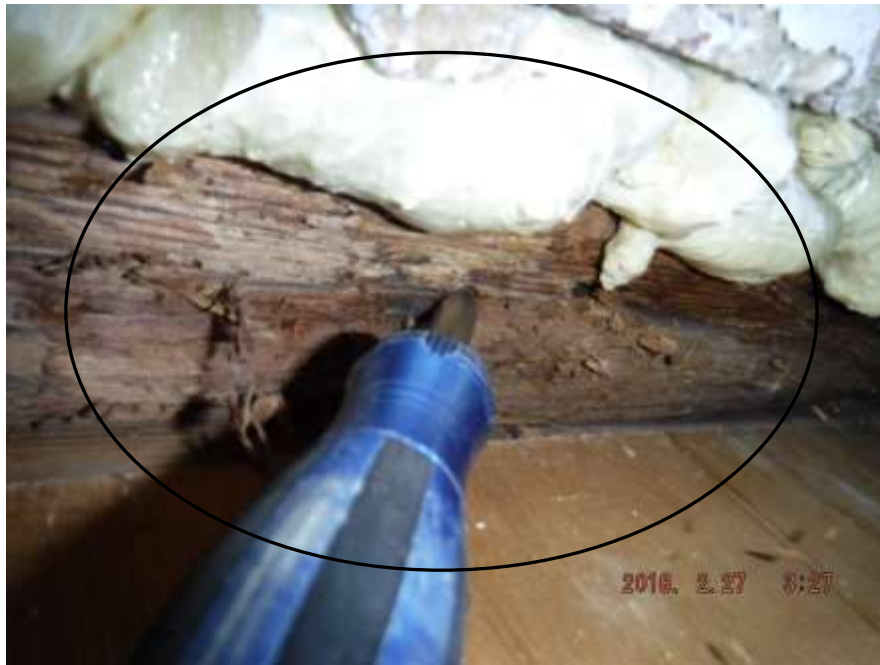
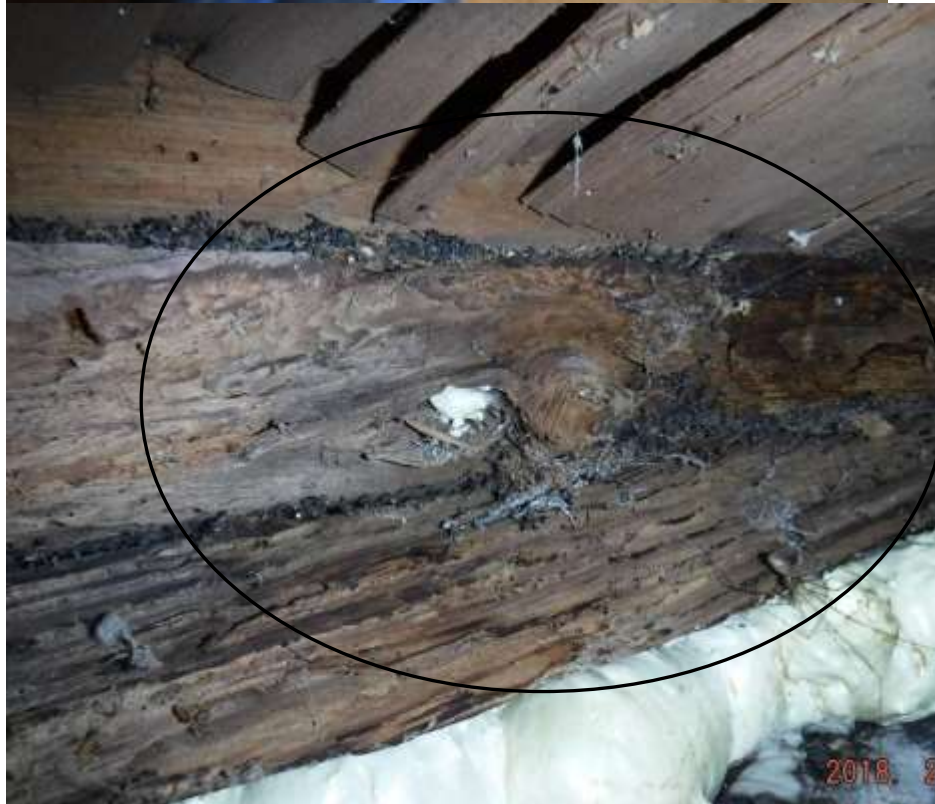
2. **WOOD DESTROYING INSECT/DAMAGE**: There was water and wood destroying insect (WDI) damage on a triple beam and wood paneling below the beam on left side of the home. See separate NPMA-33 Wood destroying insect report. Recommend a structural carpenter and engineer (PE) evaluate structure and extent of damage and advise on all structural repairs. Recommend a licensed Pest Company treat for carpenter ant and further evaluate any other WDI infestation when repairs evaluated.

Figure 12 Moisture & carpenter ant damage to a beam on left side, mice droppings and carpenter ant frass.

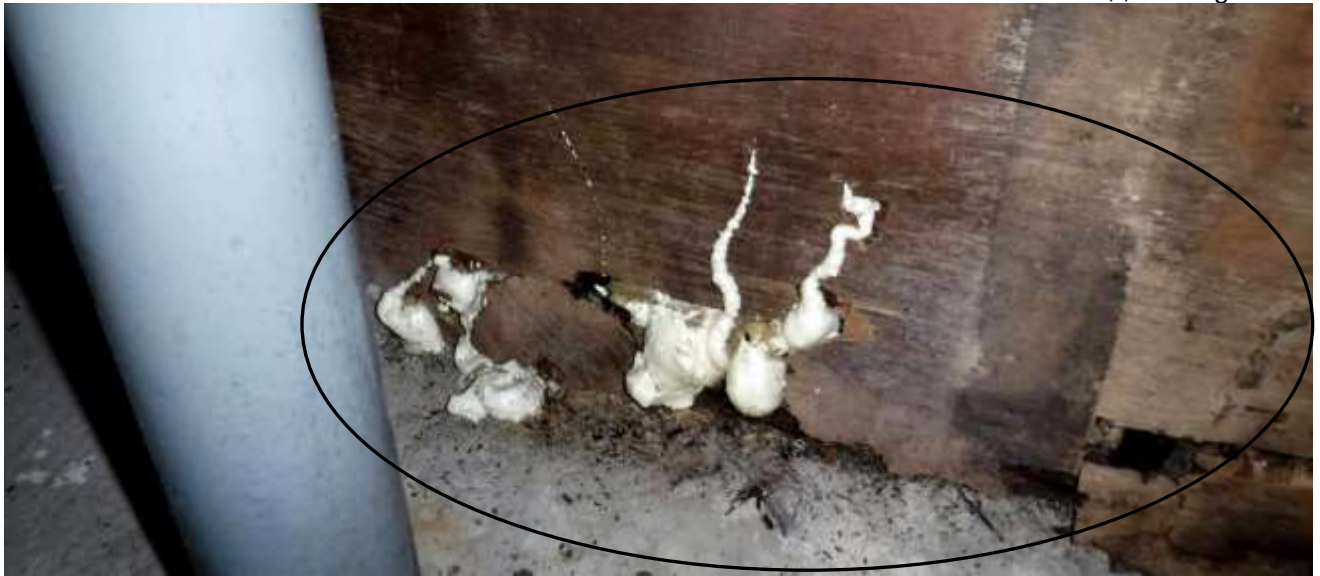
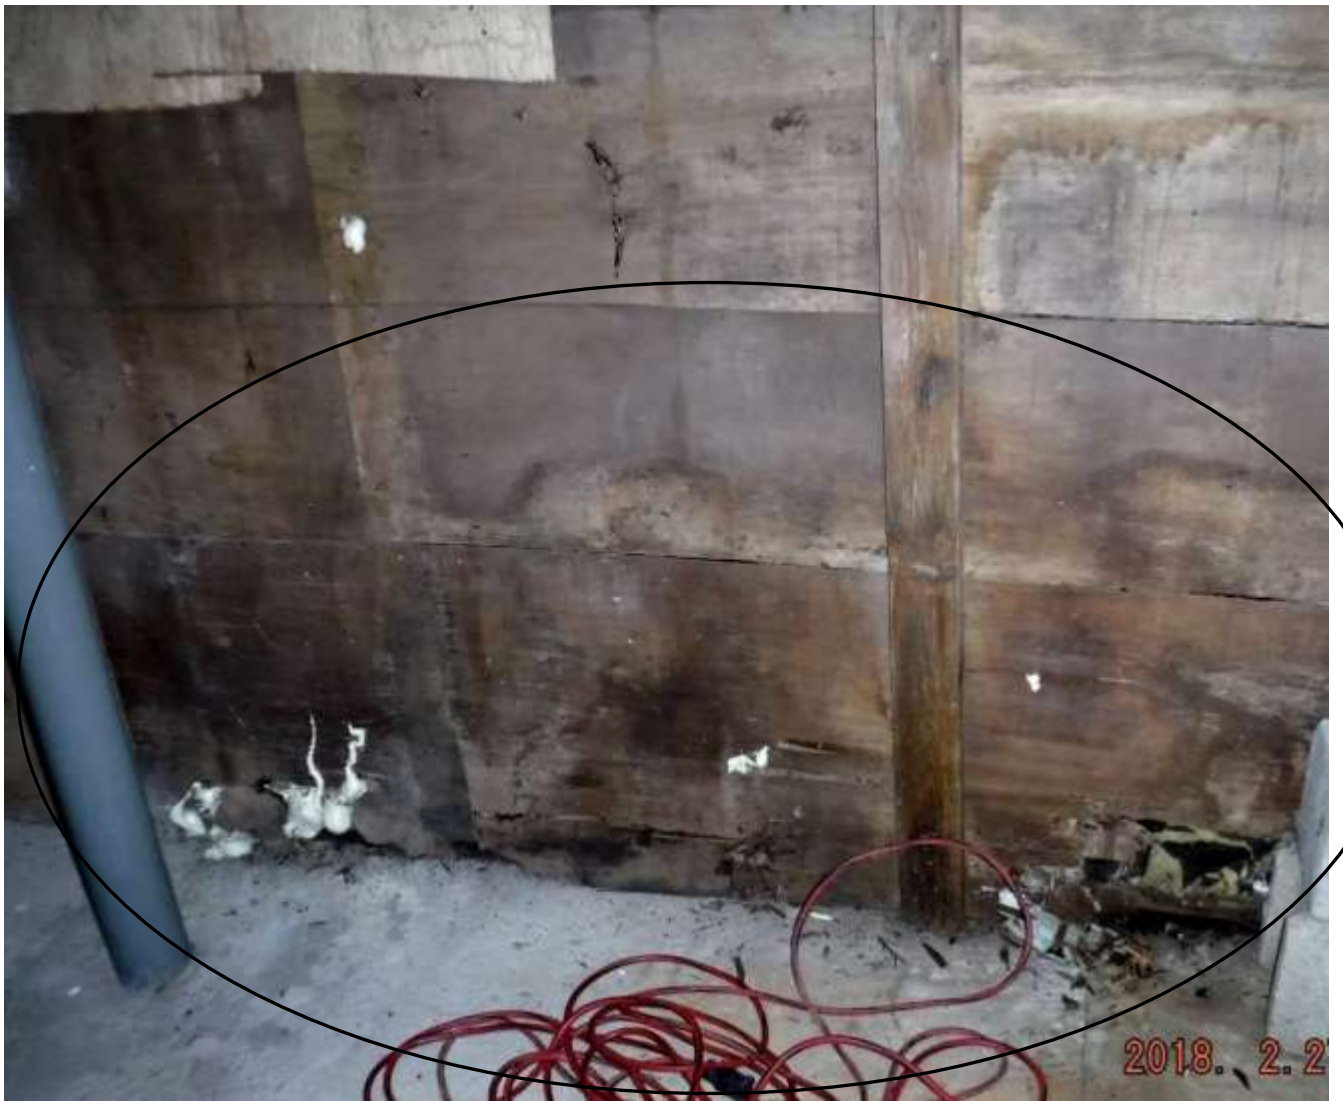
Figure 13 Water & dark staining, wood damage on wall under a damaged beam in basement.

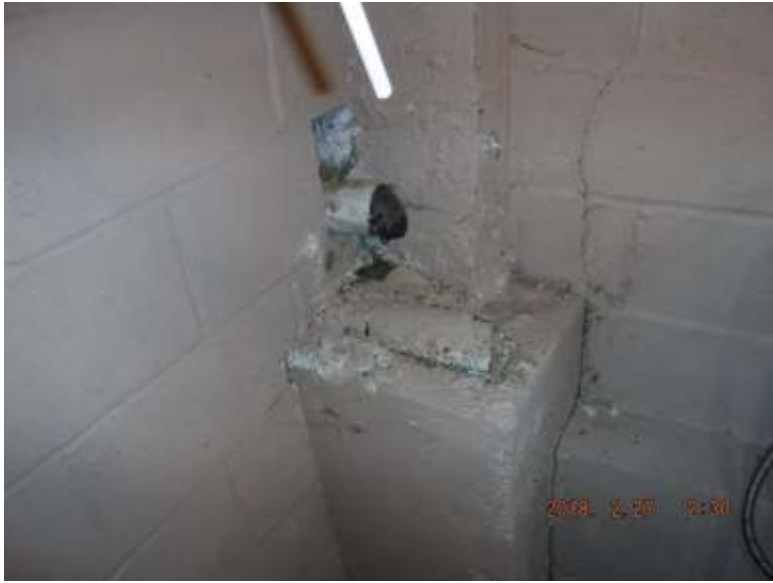
3. **ABANDONED PIPING/DRAINS**: There was indication that there may be a past septic on property; cut off or terminated waste piping in basement on rear wall. Further evaluate with the township or health department for follow-up to see if a septic system was removed on property. Septic systems if existing and not properly terminated can pose a potential sink holes or safety hazard.

Figure 14 Further evaluate abandoned drains or piping in basement to rule out an abandoned septic on property.
