# 4 Seasons Home Inspection, LLC

## RECEIPT

Inspection Date: June 15, 2015 Monday 12pm- 3pm  
Client Name: Buyer ([buyer@gmail.com](mailto:buyer@gmail.com))  
Emails: [lawyer@gmail.com](mailto:lawyer@gmail.com)  
Inspection Address: # street, town , nj xxxxx  
Inspected by: Linda Gecz home inspection lic. #24GI00061500

## BUILDING DATA

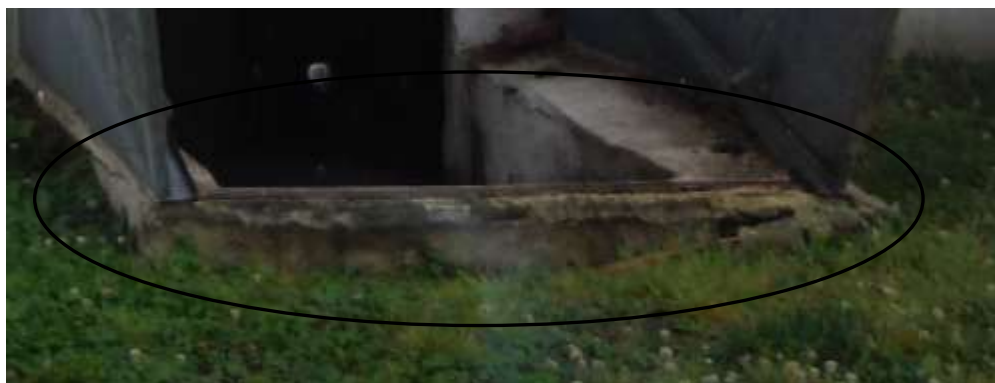
Figure 1 Water damaged concrete on the Bilco curbing and basement walkout.

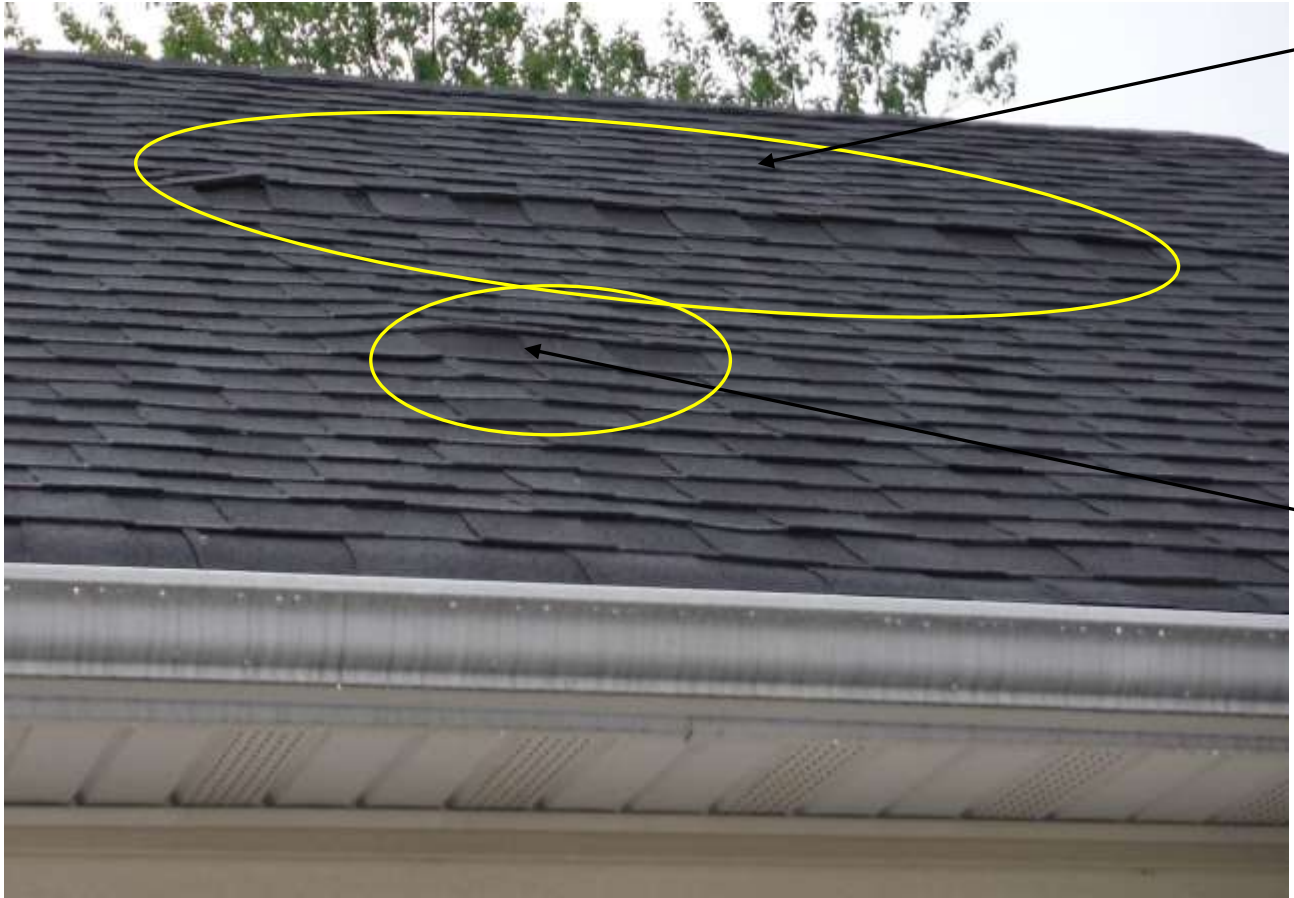
Figure 2 Have a qualified roofer evaluate roof and make repairs where needed; lifted shingles/humps on roof. See attic section comments.

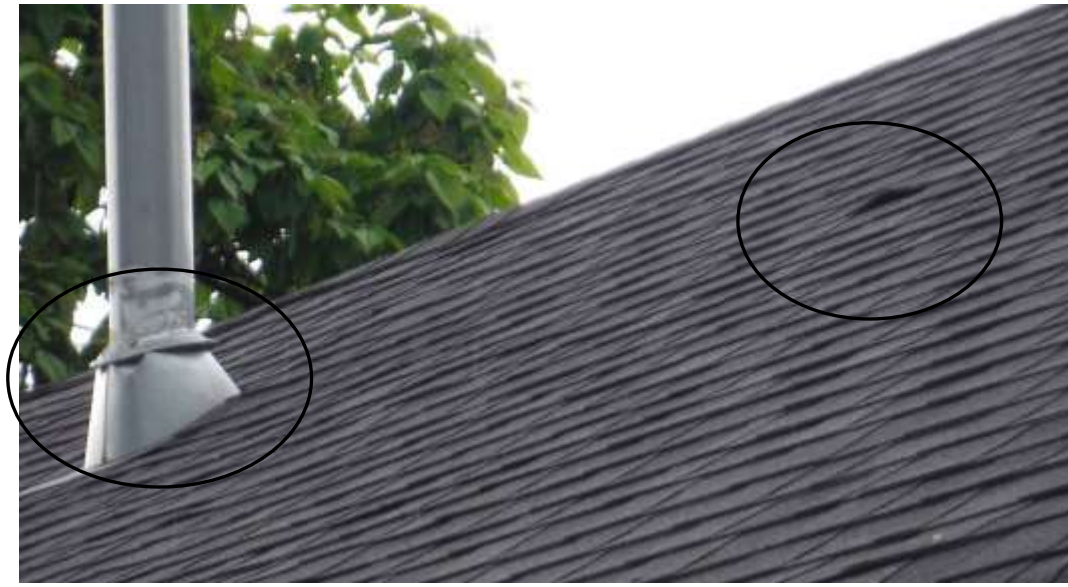
**Figure 3 Chimney dented/crimped, white condensate visible in attic; drafting concerns. Chimney was not installed properly; safety hazard/dangerous. Water entry points at gaps on chimney.**

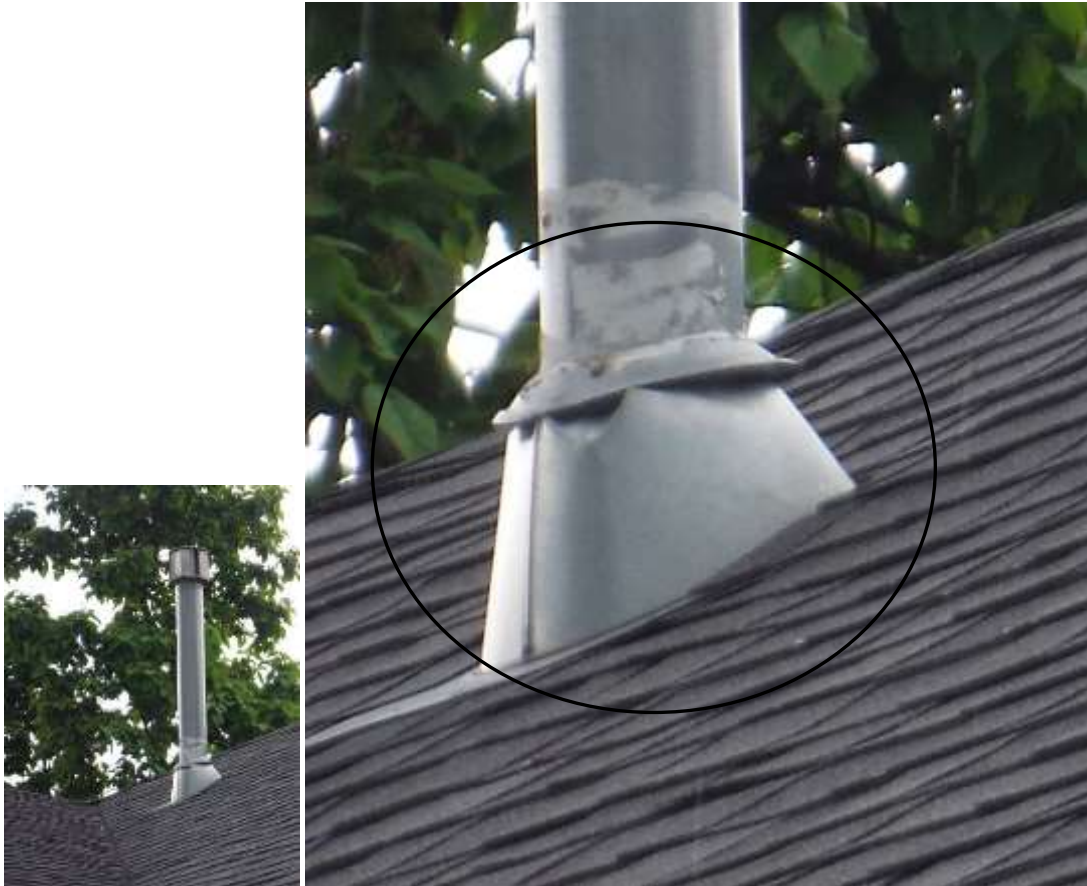
**Figure 4 Chimney was dented/crimped/gaps, white condensate residue (joints/connections); improper installation/drafting concerns/safety concerns.**

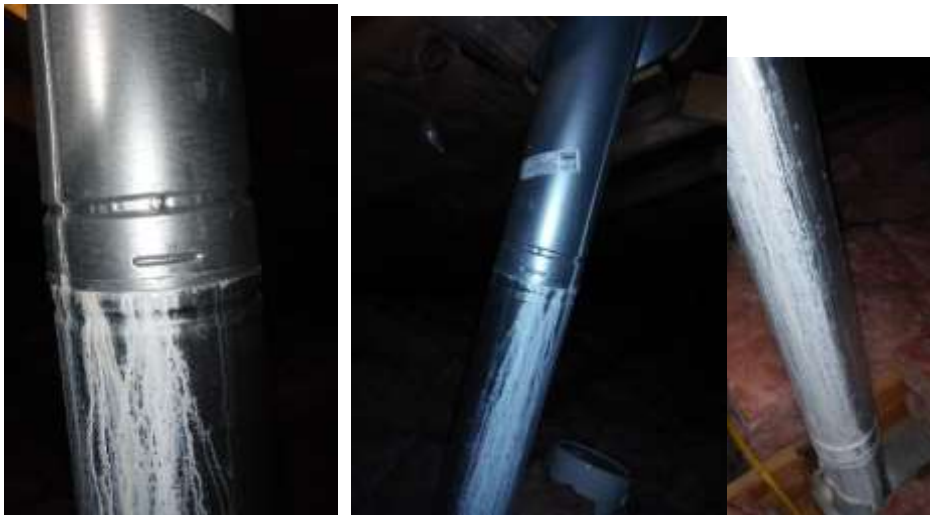
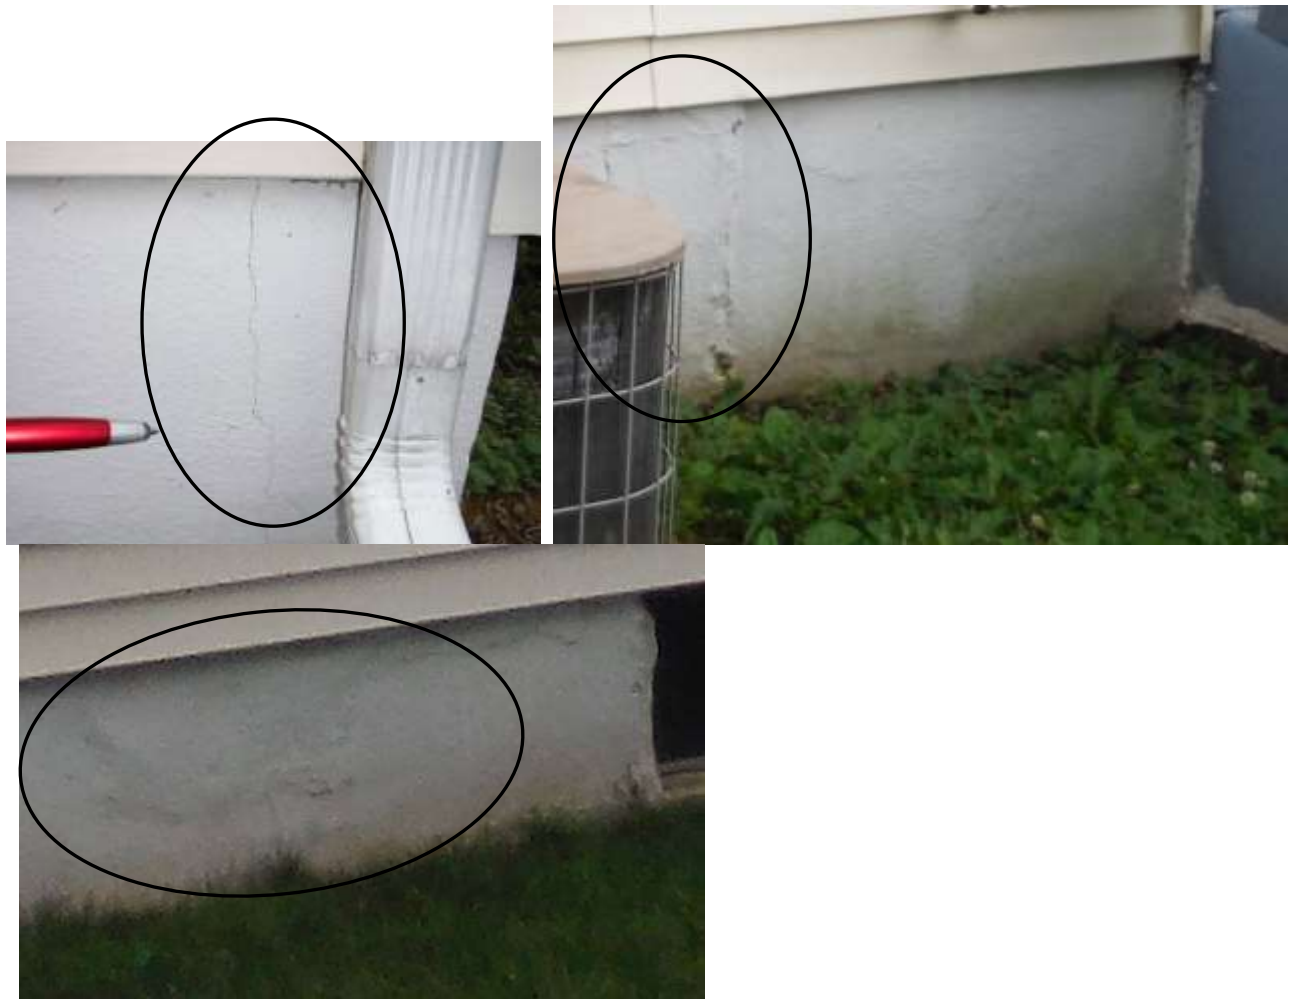
**Figure 5 Examples of foundation cracks & patched cement on home as viewed from exterior. Have a foundation repair contractor or structural mason evaluate/repair all cracks/damage where needed. Inspect basement & crawl spaces when made accessible; see basement & crawl space section comments.**

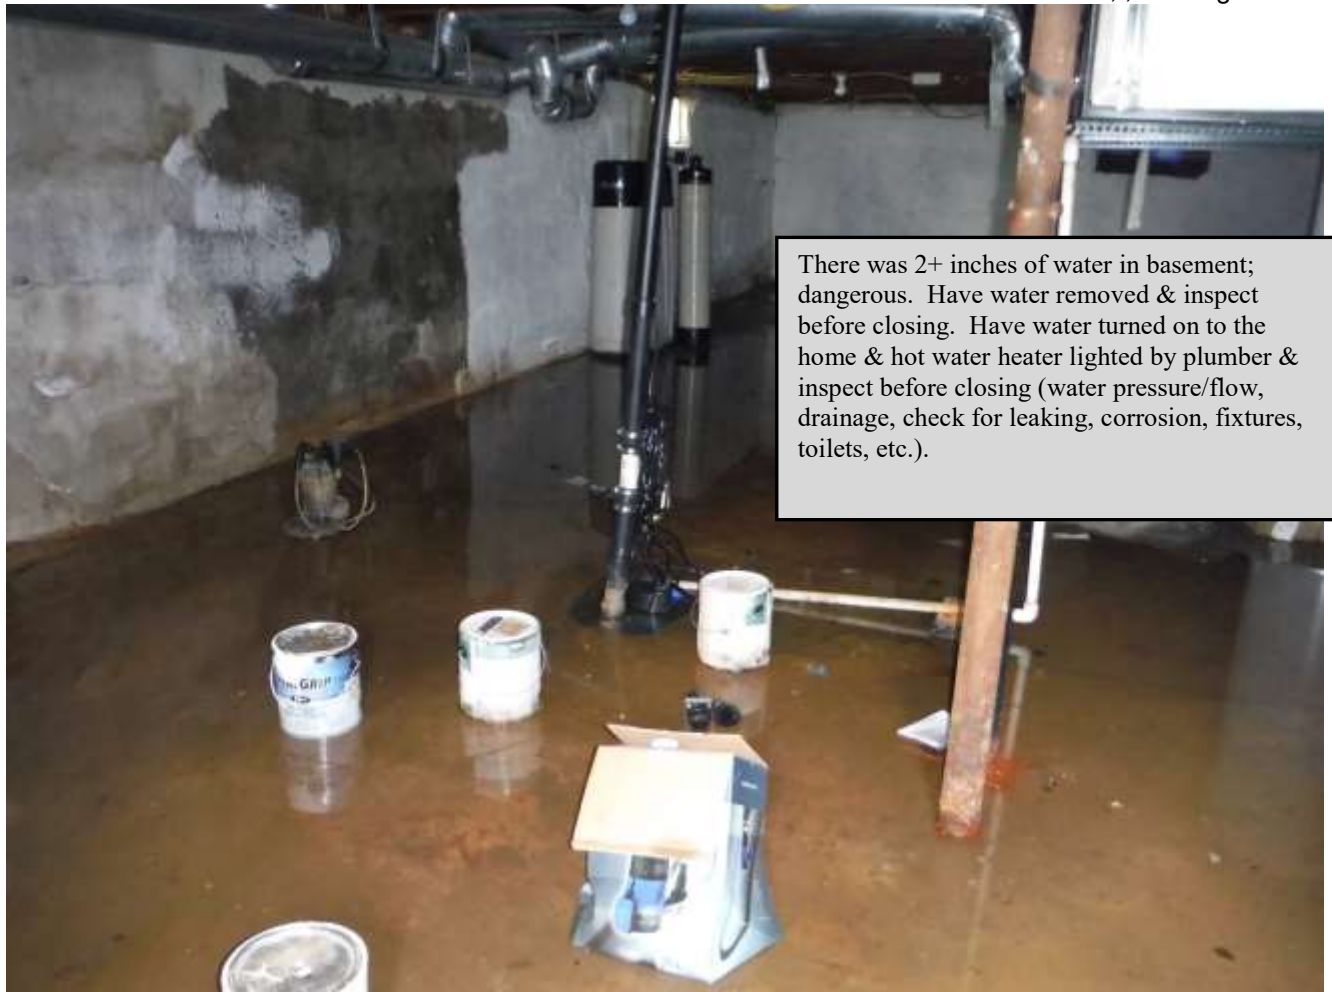
2. The basement had standing water (at least 2" or more) and the submersed pump was plugged into a ceiling outlet and not working. There was very limited access & dangerous to walk in water with electric present. A surface pump was lying on floor in water; unplugged. Have a wet basement contractor evaluate for water management system(s)/French/perimeter drains, sump pumps/pit/check valve and pipe to exterior. The sump pit was small/narrow, handyman/improperly installed and piped to the municipality drain pipe; not allowed in New Jersey. The basement had ongoing seepage or wet conditions; water stains, efflorescence, patched walls, dark staining (possible mold), etc. Have the wet basement/foundation contractor evaluate walls for clean-up/mitigation, crack repairs, etc. before closing. The charcoal radon canister could not be placed for testing due to the standing water & high moisture in basement. Radon was finally set 6/23/15 after two attempts when water recessed somewhat around the perimeter and retrieved 6/26/15. The basement could not be accessed still due to water on floor. Refer to the radon lab report for results. Recommend inspecting basement & crawl spaces when made accessible; follow-up with structural carpenter & building contractor(s) & licensed professionals for all systems not accessible at time of inspection before closing.

**Figure 6** Basement had 2+ inches of water on floor; inaccessible.

There was 2+ inches of water in basement; dangerous. Have water removed & inspect before closing. Have water turned on to the home & hot water heater lighted by plumber & inspect before closing (water pressure/flow, drainage, check for leaking, corrosion, fixtures, toilets, etc.).

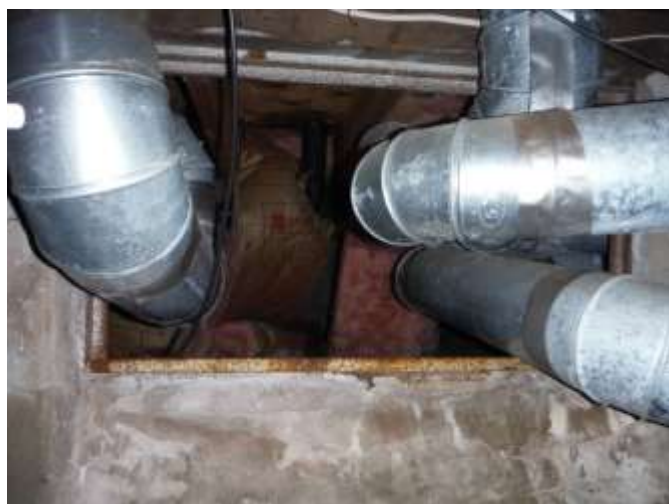
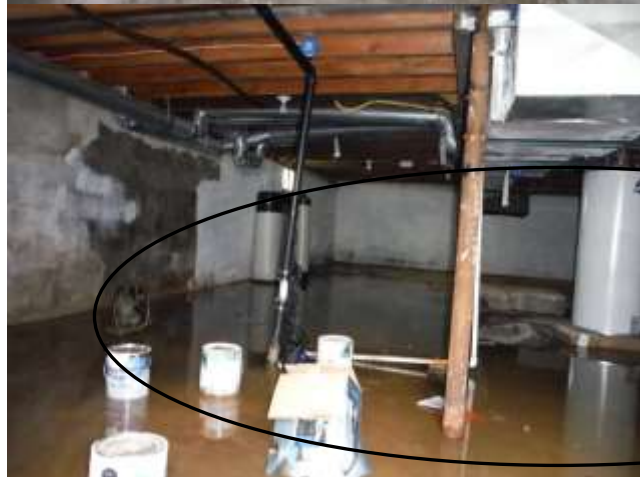
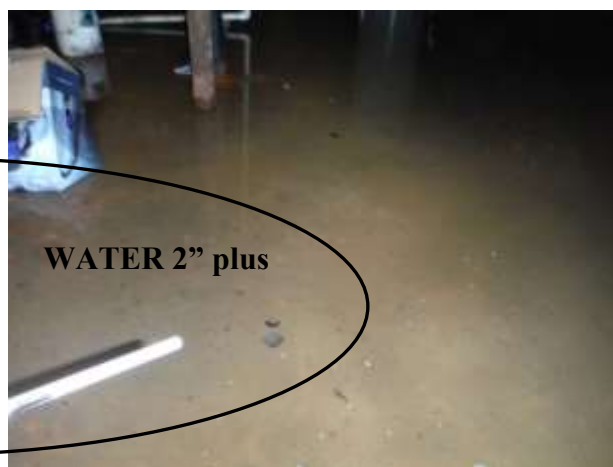
**CRAWL SPACE/SLAB ON GRADE :** The crawl spaces were inaccessible; left crawl had ducts going into opening; limited view. Recommend a building contractor or HVAC contractor remove for access and have structural carpenter evaluate the crawl spaces along with the basement structural defects/deficiencies. See basement section comments.

Figure 7 Left addition crawl space had duct work & insulation along with water (2" plus) on basement floor (camera zoom shot); inaccessible.

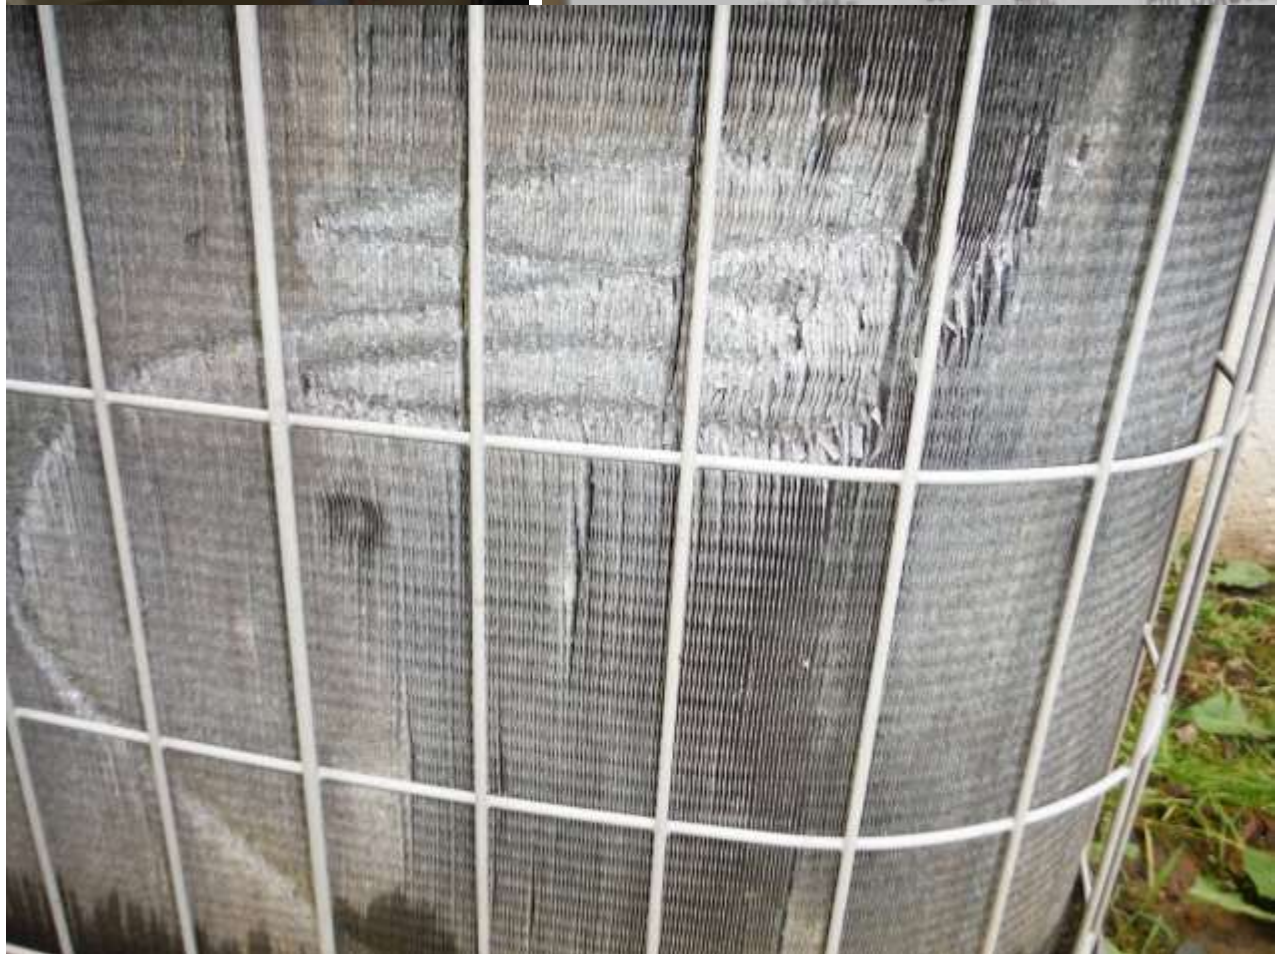
1. The A/C was not cooling properly and old/past expected life. Recommend a qualified HVAC contractor evaluate for replacement.

Figure 8 York condenser SN# WFKM010373 (K=2001)\*- past expected life/damaged fins & not cooling properly.
