# 4 Seasons Home Inspection, LLC

Inspection Date: May 03, 2018 Thursday 10am- 1pm  
 Client Name: buyers (buyer@gmail.com)  
 Emails: lawyer@aol.com  
 Inspection Address: # street town nj xxxxx  
 Inspected by: Linda Geczi home inspection lic. #24GI00061500

Approximate Age: ~1960's  
 Style: Single family  
 Main Entrance Faces: N  
 State of Occupancy: Occupied  
 Weather Conditions: 70 °F  
 Ground cover: damp

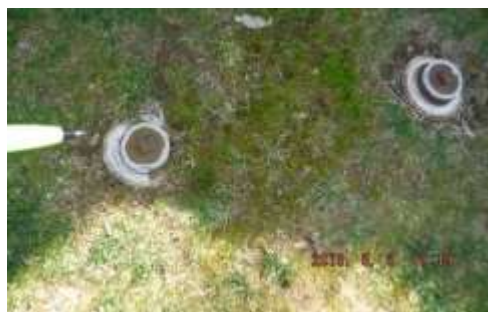
Figure 1 There were two raised cleanouts; further evaluate to see what these are for ( ex- gutters or house plumbing); unknown. These pose a trip hazard.

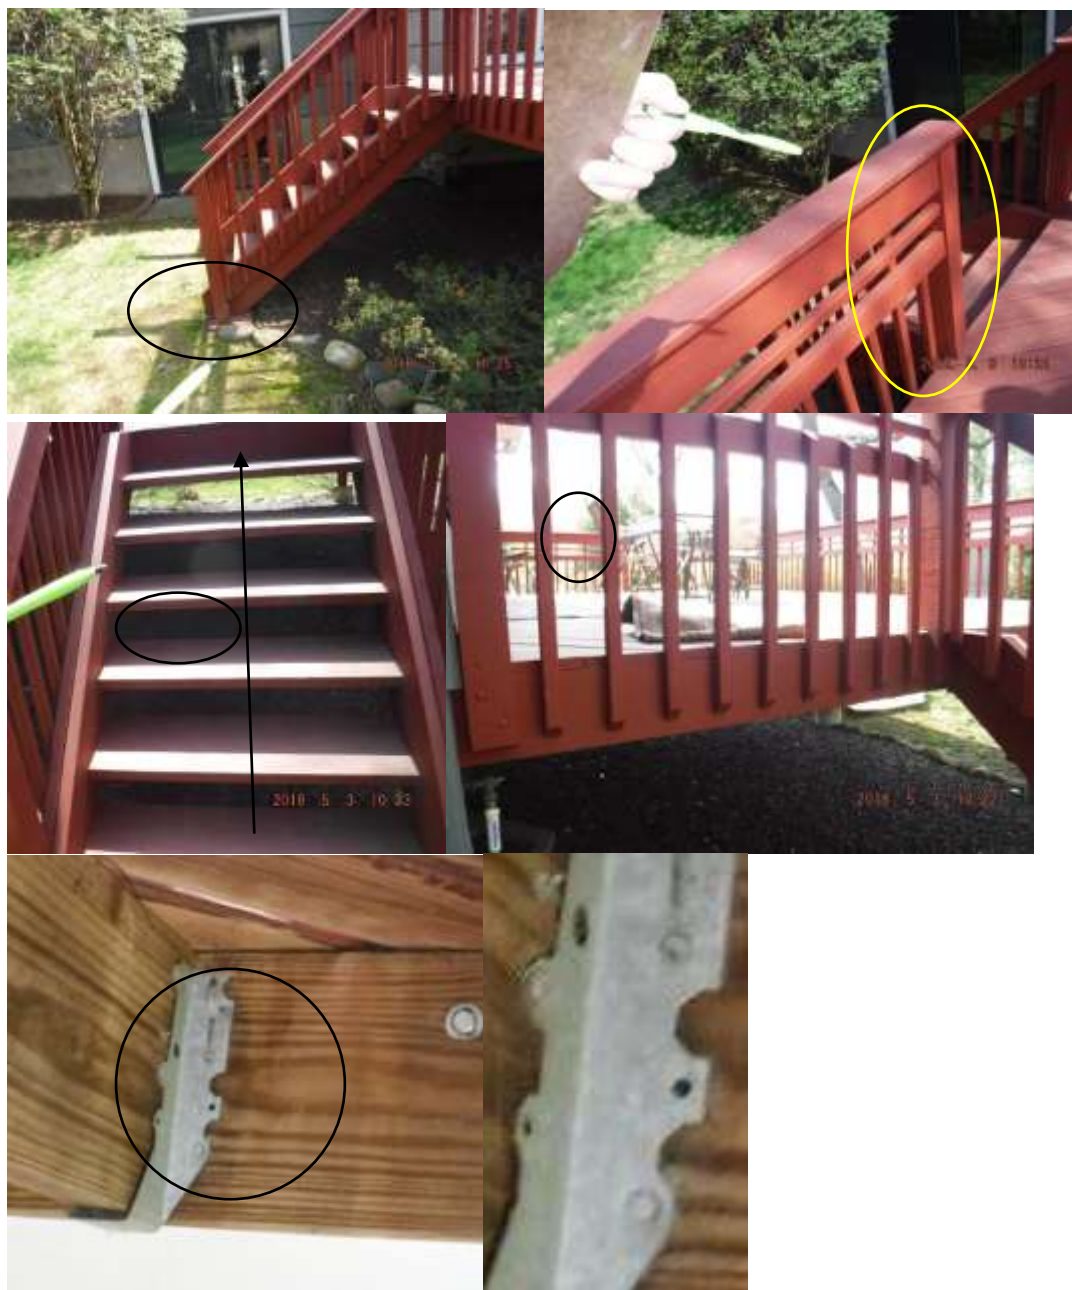
**Figure 2** Example of older deck construction and unconventional by today's building practices. The deck was older and past expected life. The balusters were wide (small child safety concern), missing middle stringer & steps not boxed in (trip hazard), railings on low side (potential safety concern), steps in contact with soil (no visible footer), heavily painted, drying cracks, missing nails in floor joist hangers (need to be filled for proper supports), house/deck flashings not visible or present, etc. Recommend a carpenter or building contractor evaluate deck and advise on repairs/upgrades/replacement due to age.

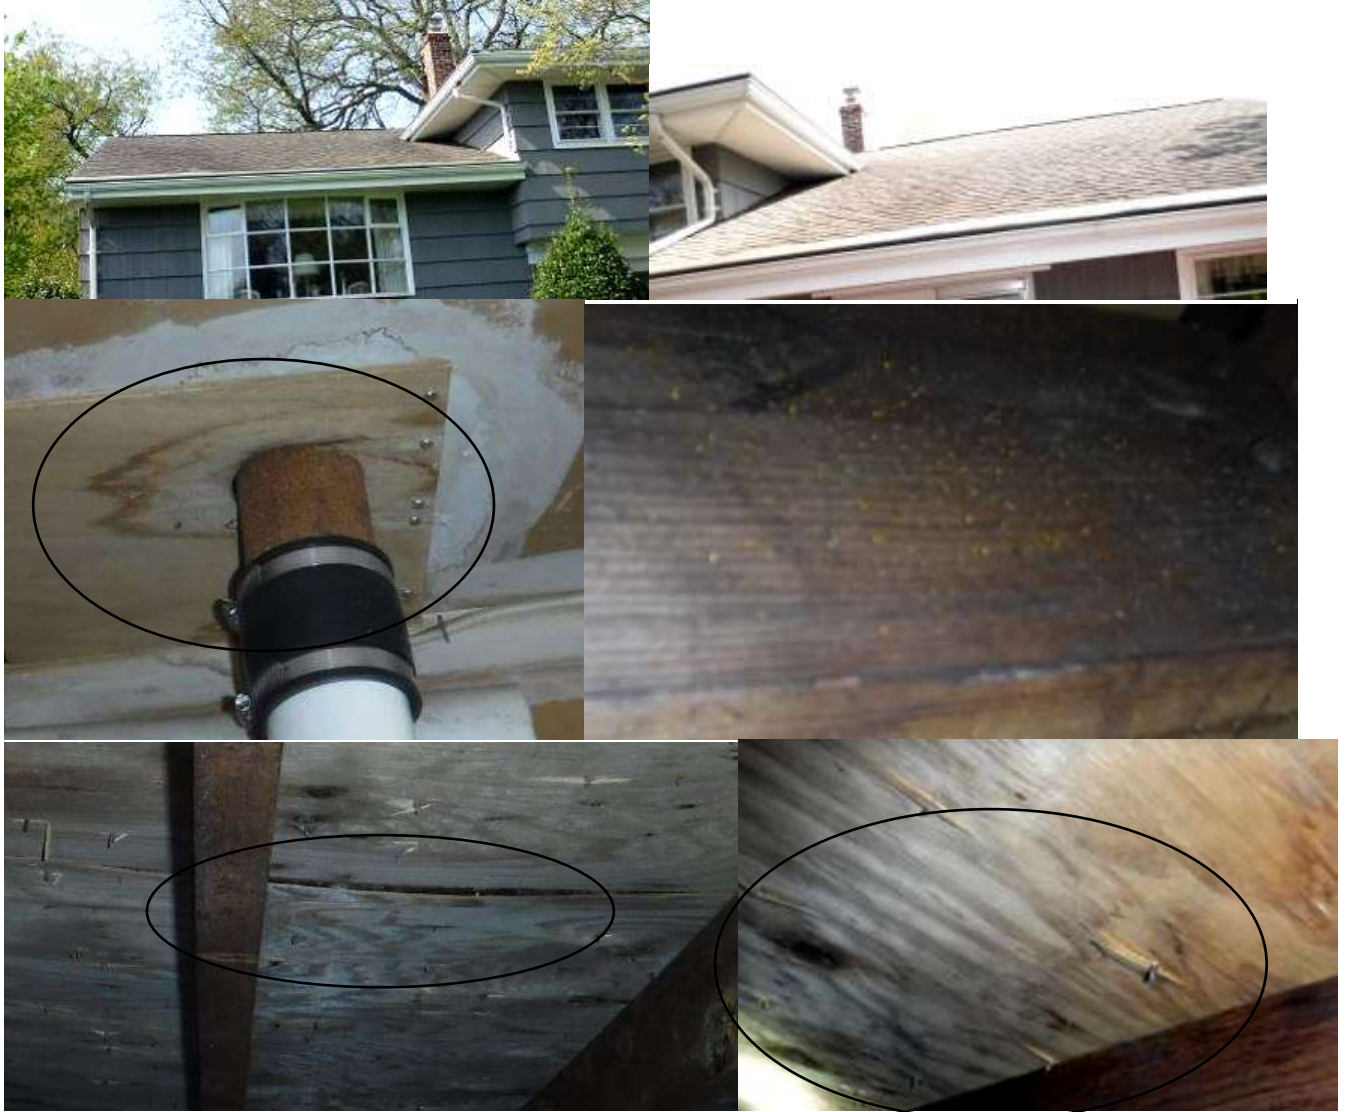
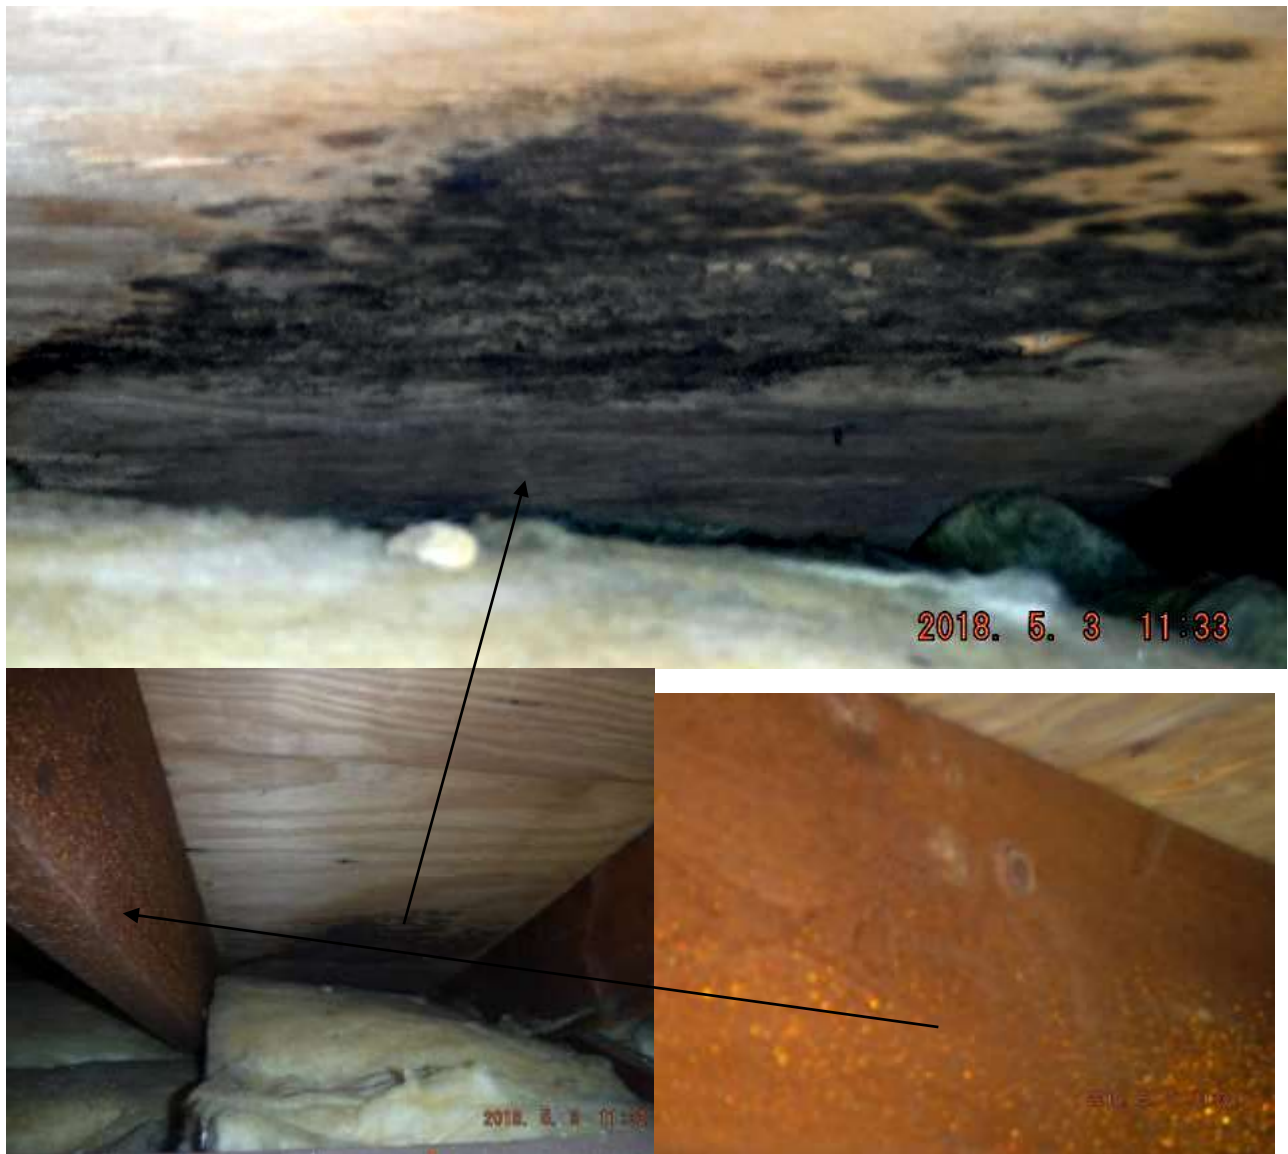
1. The roof was past expected life. There was aggregate/granular loss, moss build-up, curling, cupping, lifted shingles, water stains (garage & attic), dark streaks on shingles, pine sap beads on rafter or roof structure, poor ventilation/hot attic, brittle/heat damaged sheathing, dark mold like staining on sheathing & attic wall insulation, etc. Recommend more ventilation (ex- perforated soffits & baffles at eaves, ridge venting, etc. among other ventilation). Recommend the roofer advise on best options for maximizing the ventilation in attic. Hot humid and poor ventilated attics will shorten life of roof and potentially cause heat & moisture damage to wood or roof structure. Recommend a mold contractor evaluate the dark black mold like staining and advise. Damaged sheathing (ex- heat damage, brittle) and dark mold like staining should be evaluated for replacement and/or by a qualified mold or environmental contractor. Mold and environmental identification and inspection is beyond the scope of a home inspection. Recommend a roofer evaluate /advise on roof replacement, ventilation & gutters.

Figure 3 Example of dark mold like staining and pine sap beads; poor ventilation, hot & humid conditions.

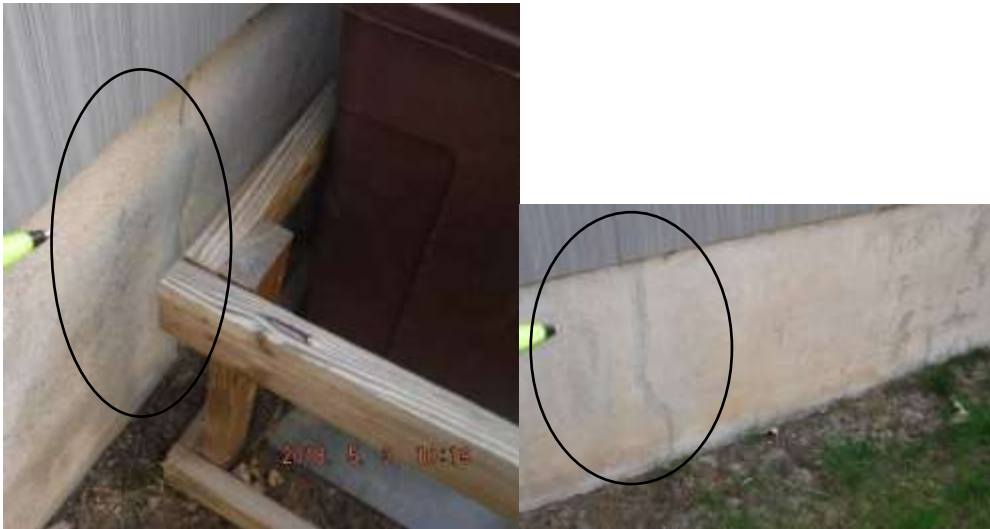
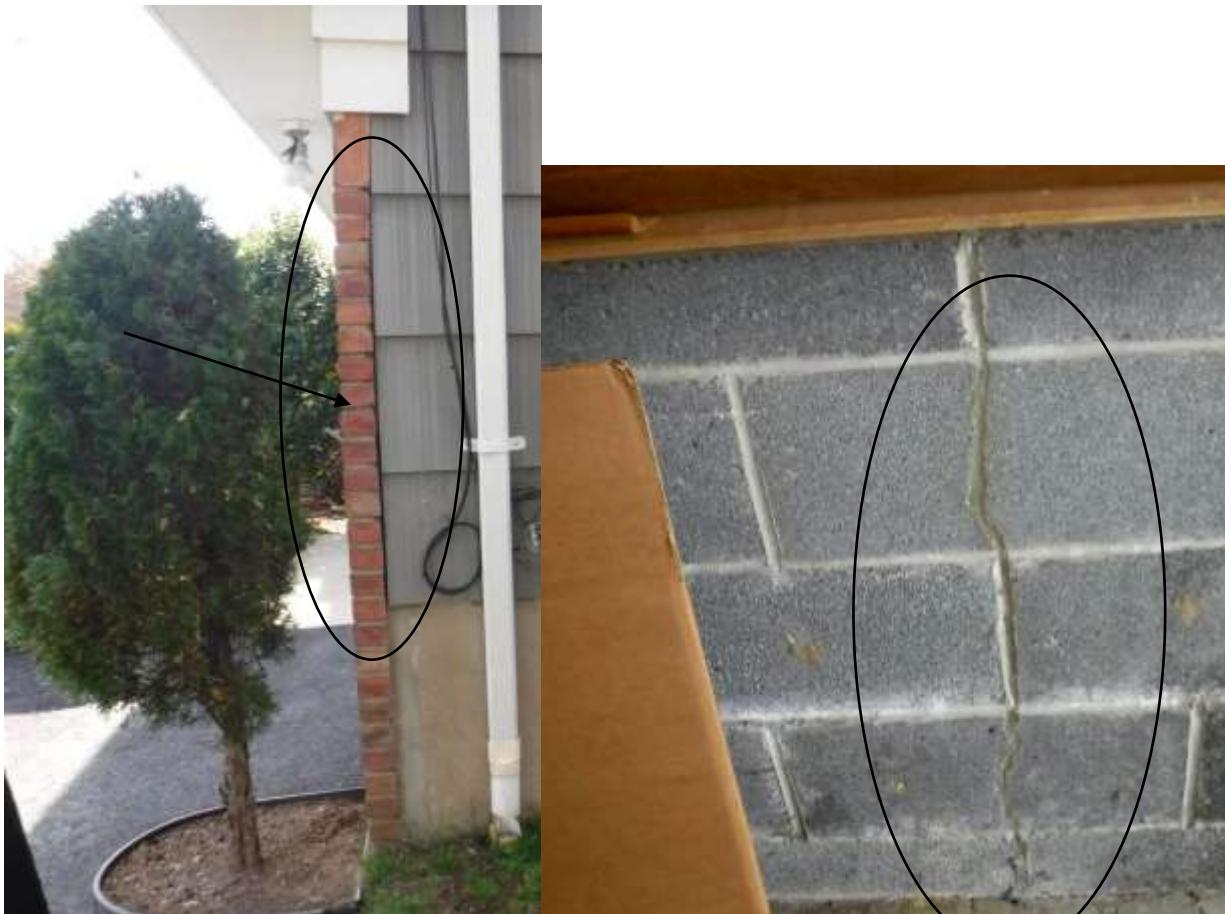
2. The wood siding and brick veneer was older or original to home. There was a slight bow on brick veneer as viewed at the wood siding & brick corner or junctures; gaps present and water entry points. Gaps can let water behind siding and cause rusting on strapping or attachments. Recommend a siding contractor evaluate siding, verify that attachments are holding brick veneer and advise on any repairs before closing. Junctures and gaps should always be sealed to maintain water tight seals. Siding or exterior should be maintained for proper cladding protection. There were cracks on foundation and/or parge coating visible on exterior, garage and basement. Recommend a mason or foundation repair contractor evaluate all cracks and make repairs where needed and rule out any concealed cracks or damage. Older home will have settled over the years and cracks and settling should be addressed by qualified contractors where needed. The basement and lower level (slab) was finished and structure inaccessible).

**Figure 4** Examples of foundation cracks; exterior, garage, etc. The brick veneer had gap and slight bow; have evaluated by siding contractor before closing & contractual limitations.

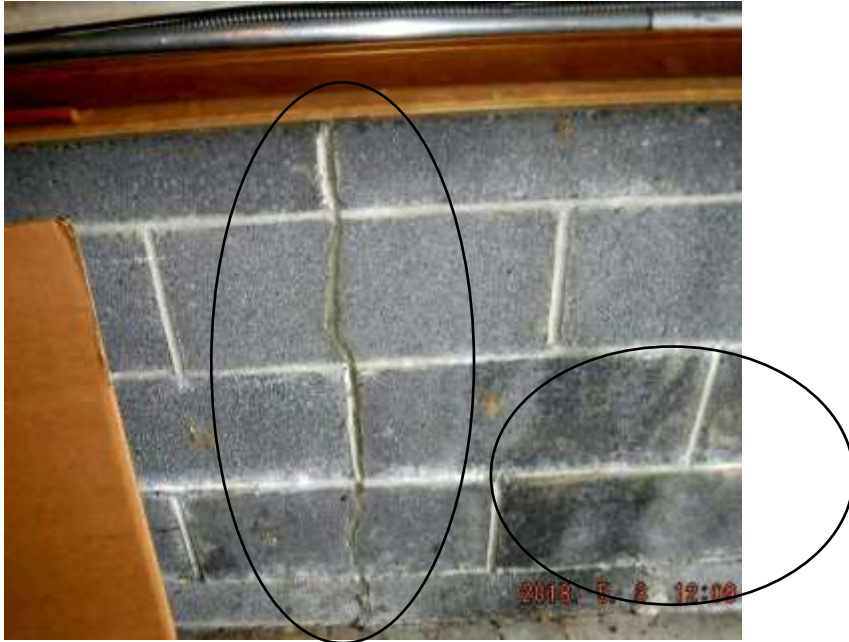
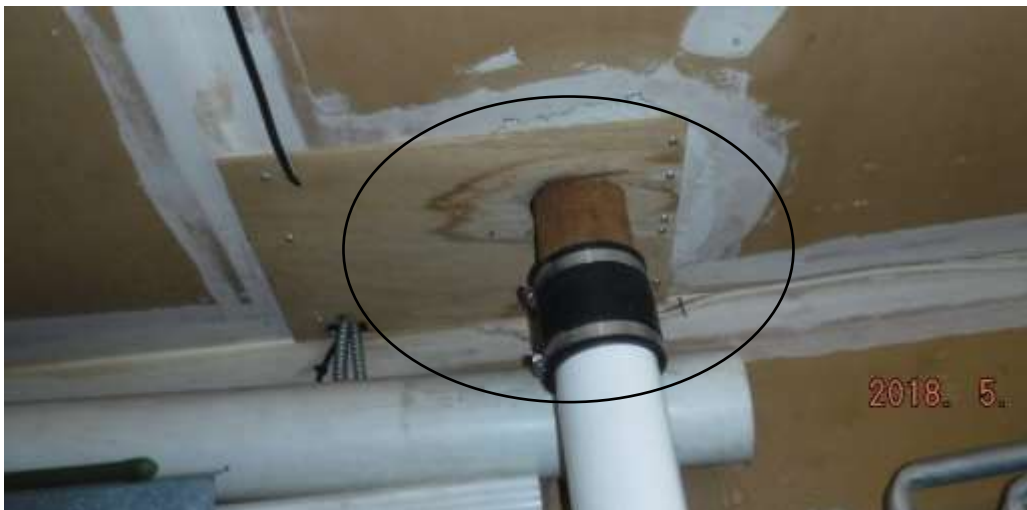
Figure 5 Water or moisture stains around a PVC plumbing vent in garage and foundation walls. Recommend a licensed plumber further evaluate and advise on any active leaking or rule out. See grading & drainage comments.

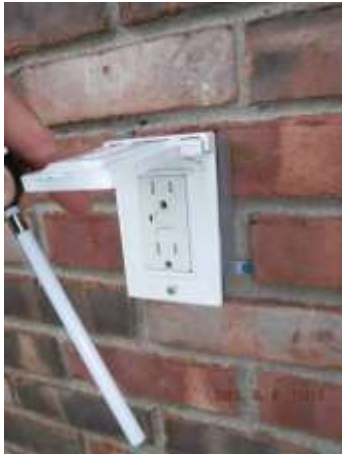
1. The GFCI in front was found tripped and would not reset. Recommend asking sellers if there is a switch or a GFCI that was tripped and not obvious that must be reset for this outlet to also reset. If not, recommend having evaluated by electrician.
2. There were foundation and/or parge coat cracks visible on exterior and garage. Recommend a foundation contractor or structural mason evaluate all cracks and advise on repairs.
3. There were water/moisture stains around a PVC plumbing vent in garage and attic; recommend a plumber further evaluate by roofer. Roof was very old and past expected life; see roofing section comments.

**Figure 6 The GFCI in front was found tripped and would not reset; further evaluate and retest when repaired or resolved.**

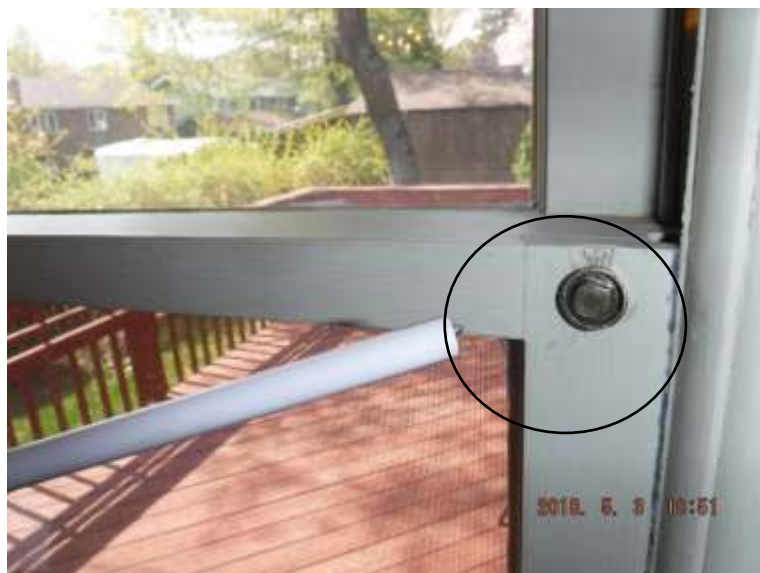
**DINING ROOM :** The windows were locked with a corner nail or hardware. Follow up with sellers for the key or device to open the windows. Recommend checking windows before closing.

**Figure 7** Example of window locks in the home; inaccessible. Recommend having locks opened up and check windows.

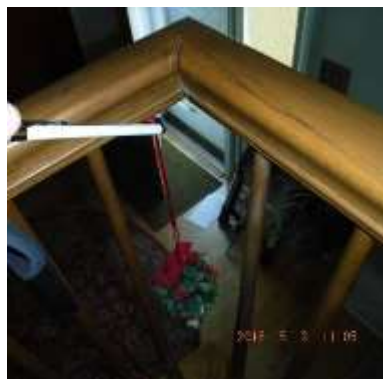
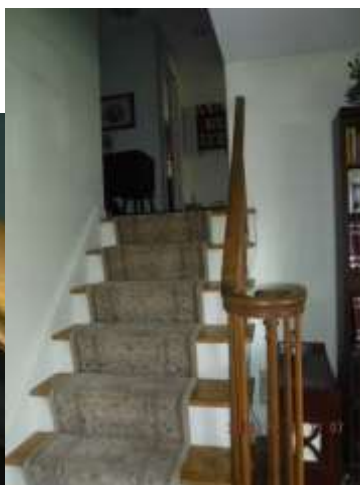
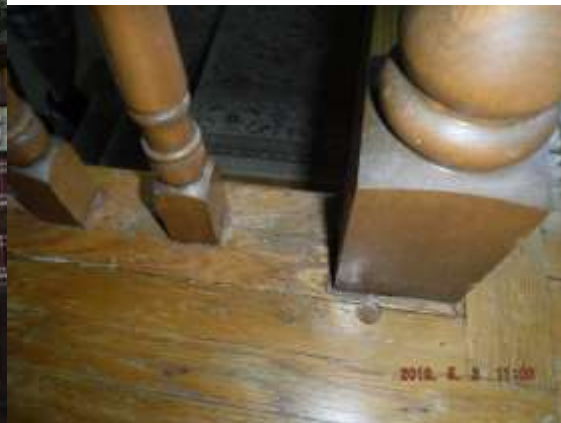
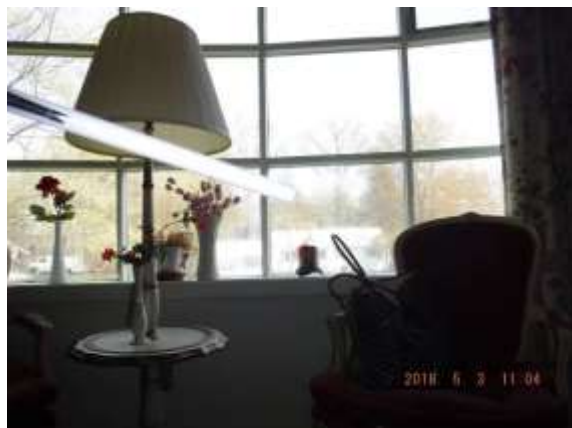
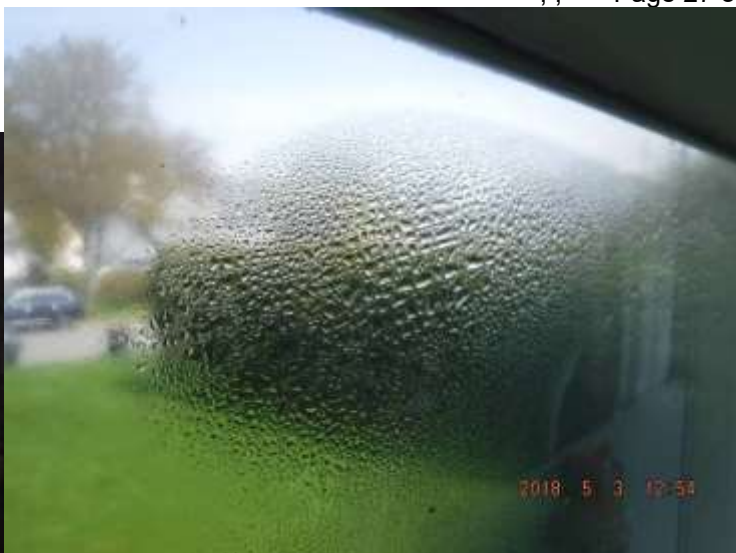
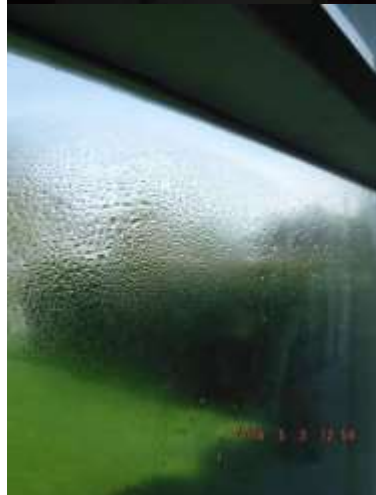
1. **Recommend a window installer evaluate front window for replacement; active moisture/leaking, flaked paint and water stains.**
2. **The railing on steps was very loose and splits on the wood flooring around the railing. Recommend a carpenter evaluate the railing and make repairs.**

**Figure 8 Active leaking/moisture, water stains, flaking paint, vapor seal breaks, etc. Recommend a window installer evaluate window for replacement/repairs and rule out any concealed damage.**

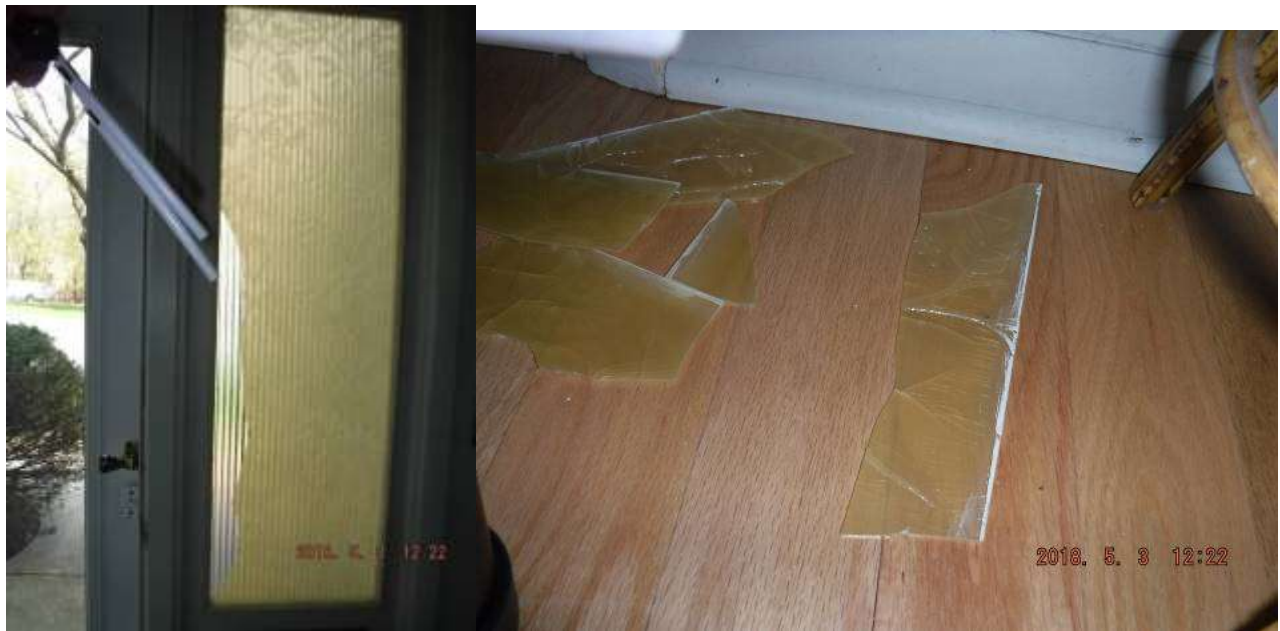
Figure 9 Yellowed plastic panel over glass on front door.

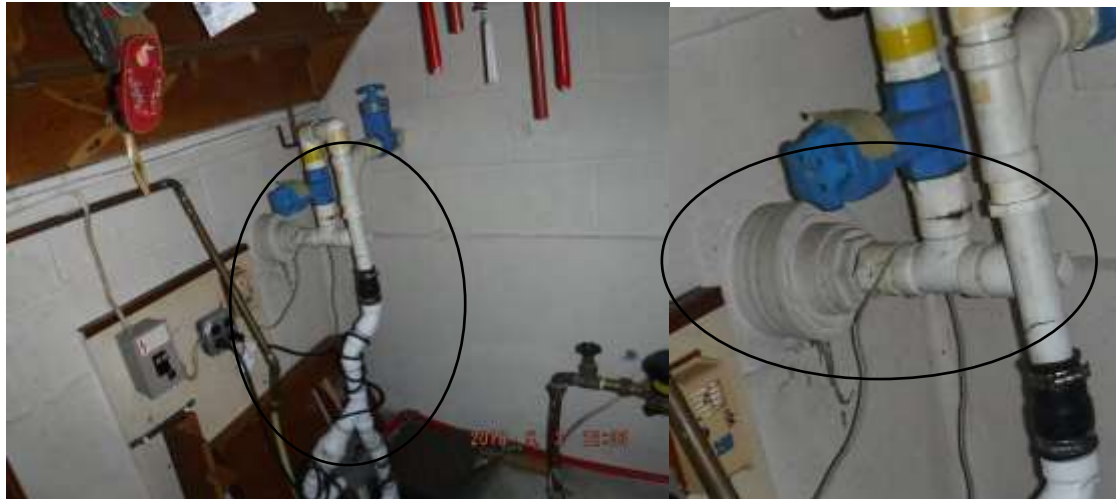
Figure 10 A1 sump pump/Liberty water powered pump was piped to the municipality drain; improper installation and not allowed in NJ.

1. Recommend a licensed plumber pipe sump to outside; should not be piped to municipality sewer (not legal in most NJ municipalities).
2. There were dark stains, spotting or moisture stains on paneling. Mold and environmental testing & inspection are beyond the scope of a home inspection. Follow up with a mold or environmental company for that service.

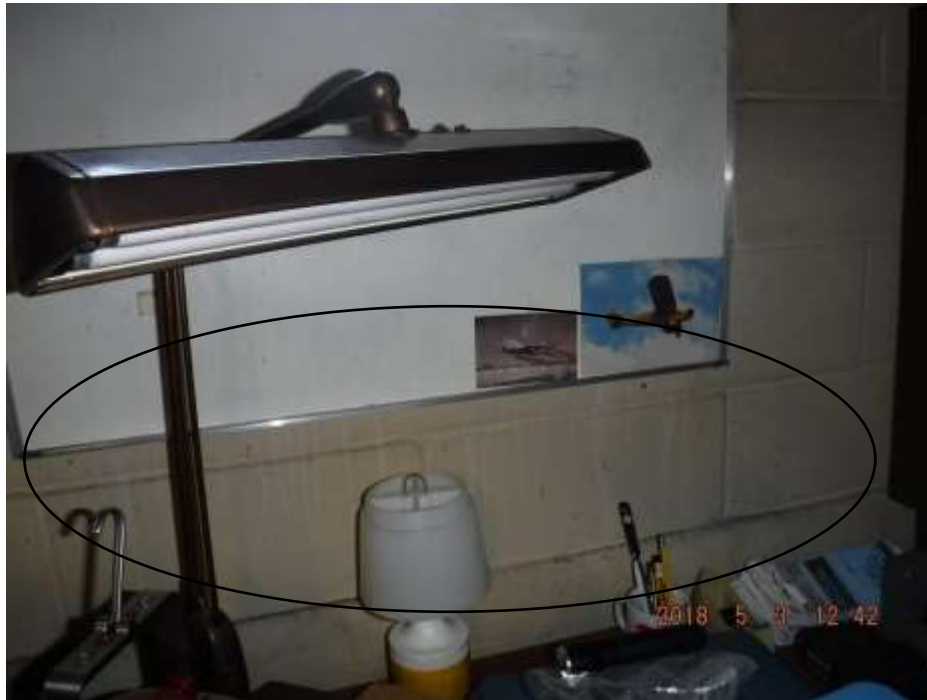
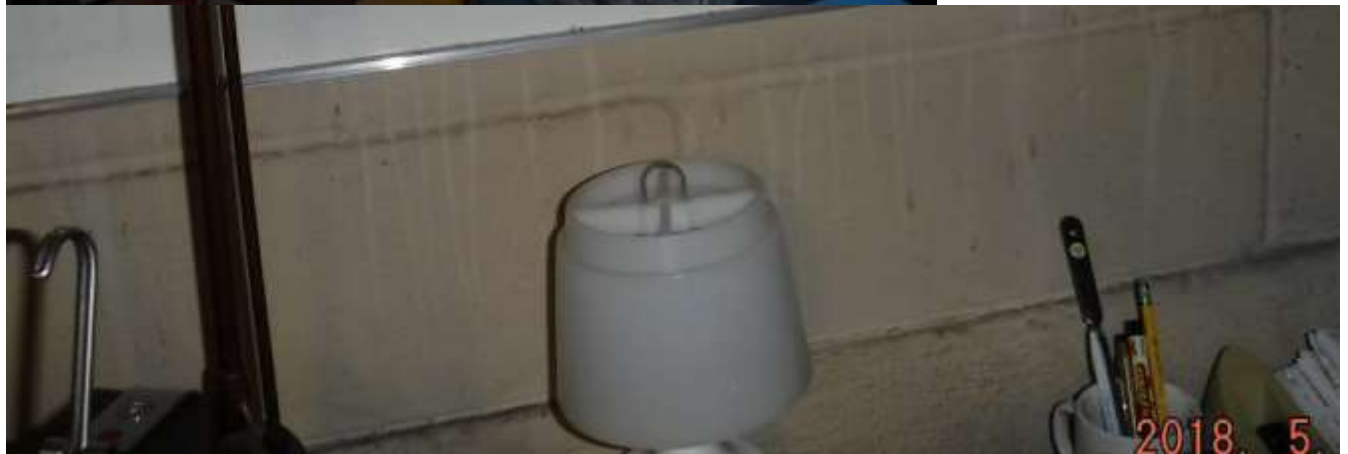
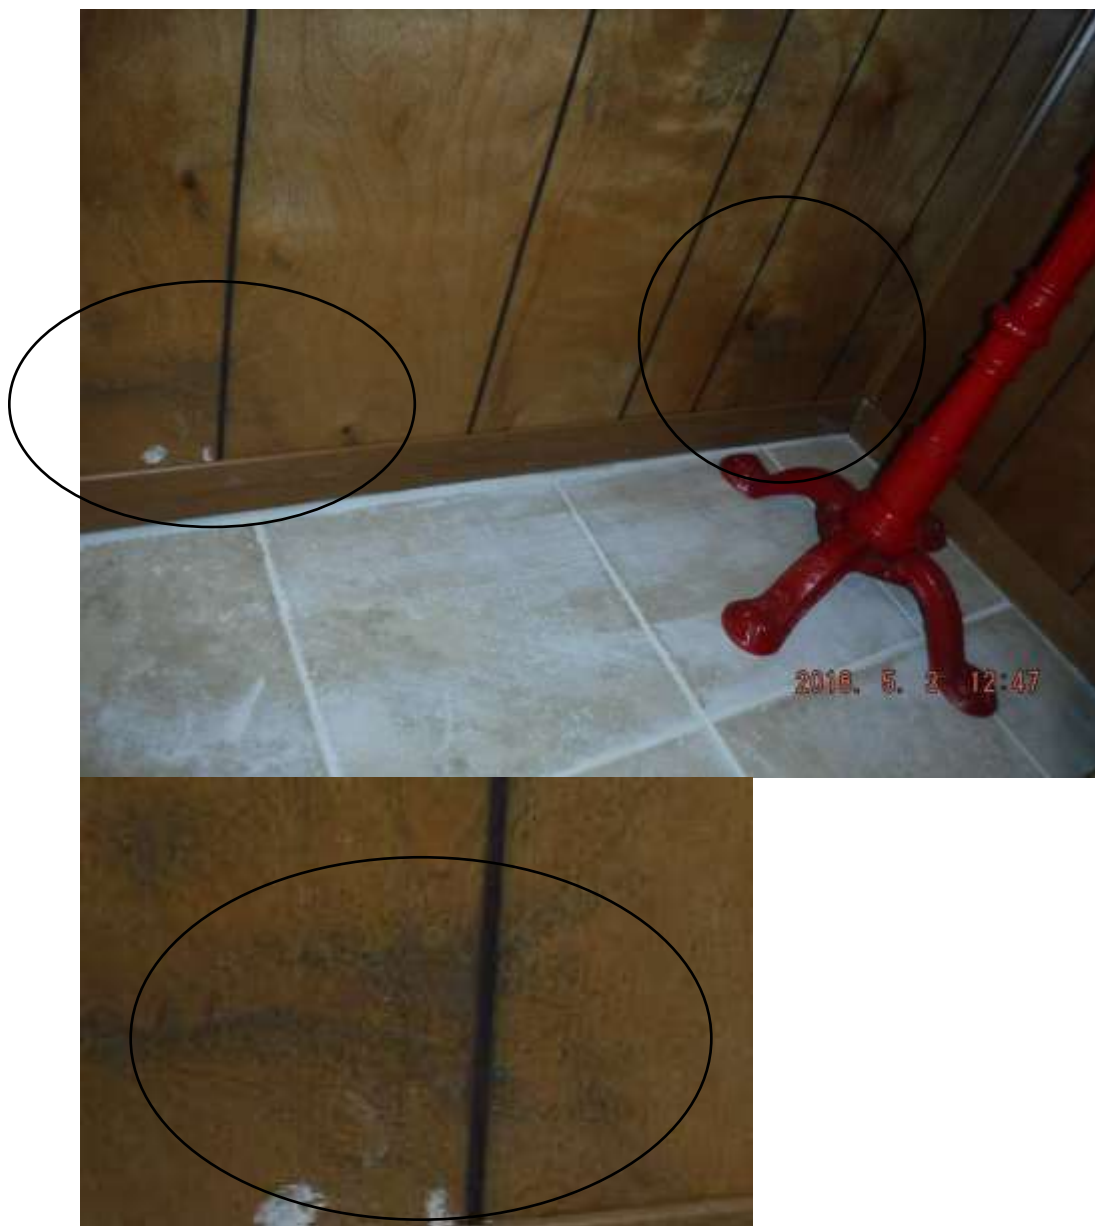
3. There was observed seepage or water stains on basement ceiling tiles, foundation walls, around basement windows and wood paneling. There were dark stains or spotting on wood paneling; indication of mold like substance. Mold and environmental identification, testing or inspection is beyond the scope of a home inspection. Follow-up with an environmental company for that service. Recommend a grading & drainage contractor evaluate and advise on corrections, add bubble covers (basement windows), etc.; correct exterior conditions. Recommend a wet basement damp proofer contractor evaluate for system(s) to maintain a dry basement. The sump pump/Liberty pump was installed improperly.

**Figure 11** Example of water & dark stains on painted foundation walls or paneling in basement; limited view due to storage, wall hangings, finished basement. There were dark stains, spotting or moisture stains on paneling. Mold and environmental testing & inspection are beyond the scope of a home inspection. Follow up with a mold or environmental company for that service.

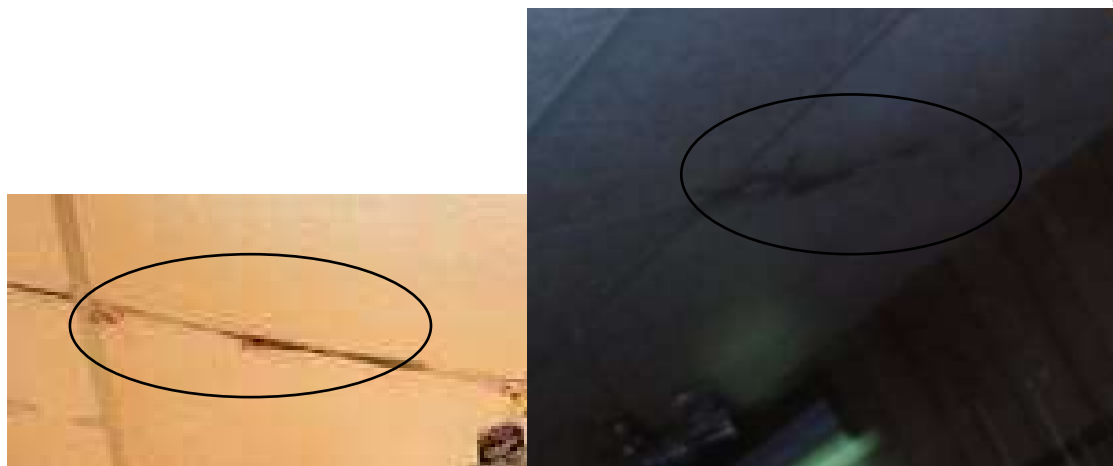
Figure 12 Water stains on ceiling tiles; further evaluate by a licensed plumber.

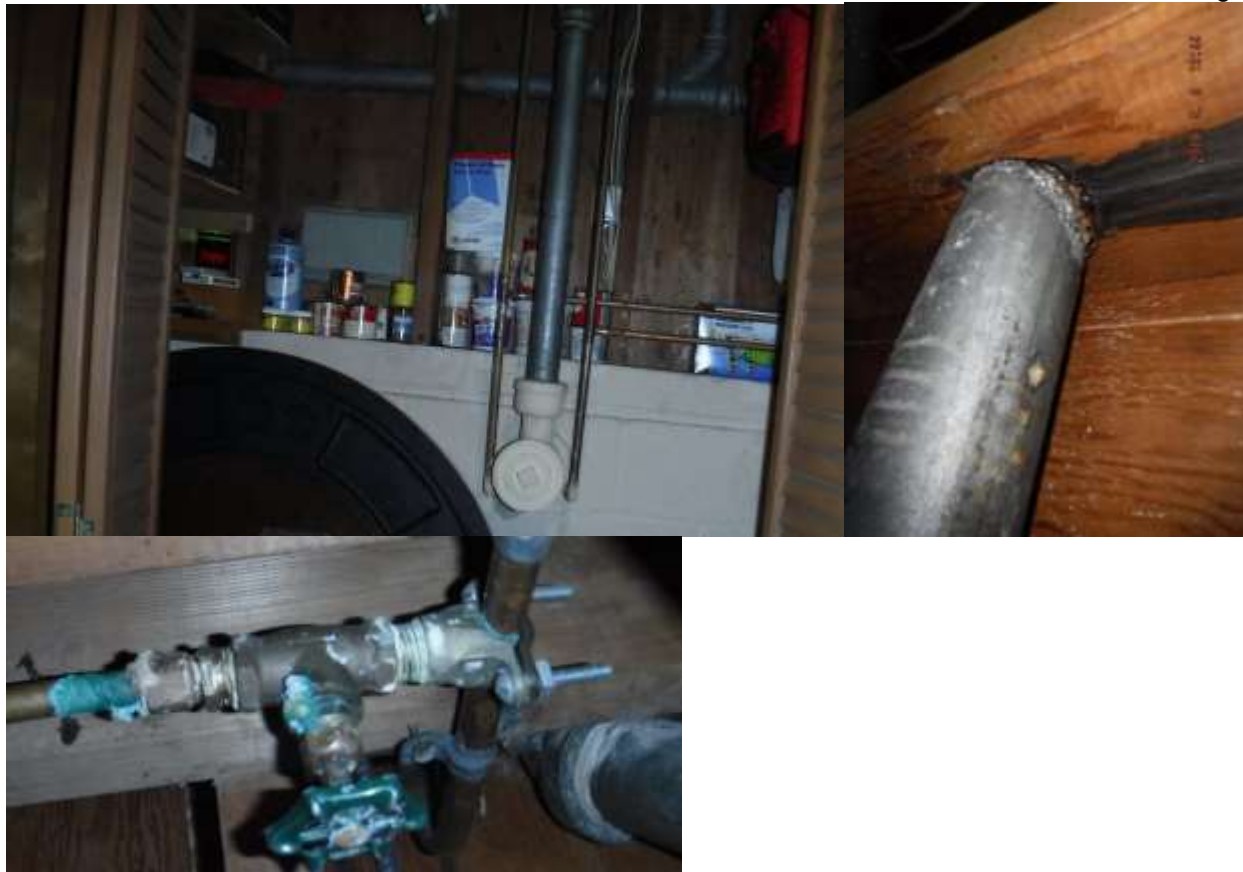
1. **There were cleanouts in yard; unknown. There were older gate valves, mix of plumbing materials & ages (piping, galvanized, fittings, gate valves, fixtures, etc.), corrosion, calcium/mineral build-up, water stains (basement ceiling tiles, attic plumbing vents, garage ceiling), sump pump connected to municipal sewer, older manual sewer ejector pump (slop sink), older/original bathrooms & kitchen, etc. Recommend a licensed plumber evaluate plumbing in home and advise on plumbing upgrades/repairs and bathroom & kitchen upgrades.**

Figure 13 Examples of older plumbing, corrosion, water stains/leaks, etc.

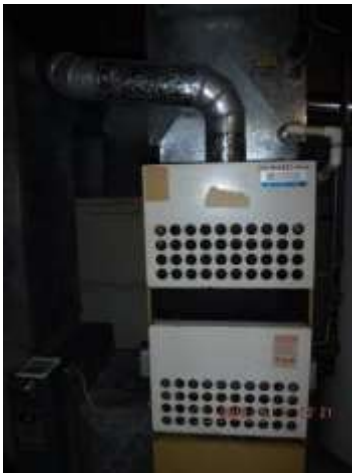
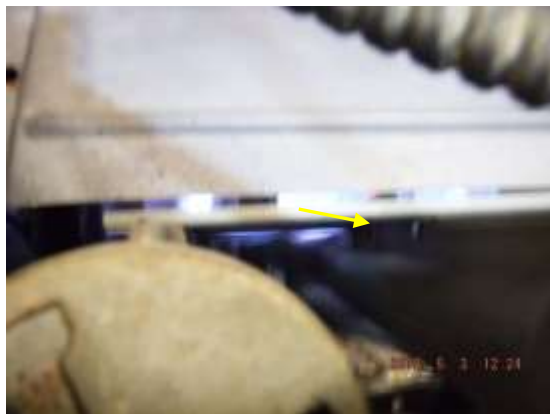
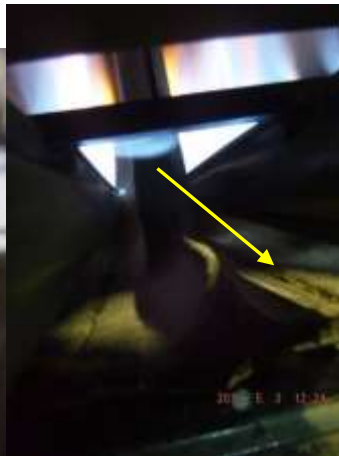
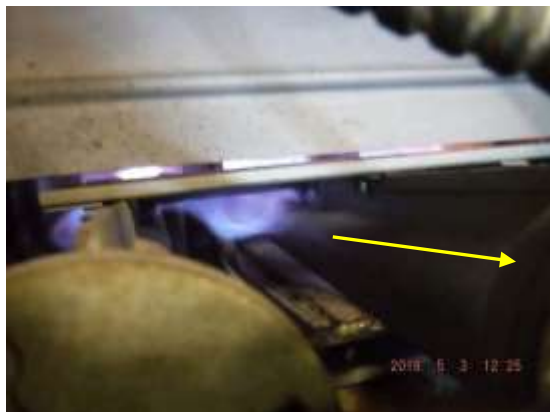
1. **Recommend a property tank sweep to rule out any possibility of buried oil tank before closing and contractual limitations.**
2. **The furnace was very old, past expected life and poor condition. There was rust and yellow flickering flame, flame rollout, etc. Flame rollout can occur for a number of reasons (ie.- cracked heat exchanger, clogged/defective heat exchanger, poorly maintained, past life, drafting, etc.). Recommend a qualified HVAC contractor evaluate the heating system immediately and advise on replacement along with the condensing unit (worn tag or sun bleached/appears older). Recommend a certified chimney contractor evaluate chimney and advise on any repairs, liners, rain caps, etc. for fire/life/safety.**

**Figure 14** Example of flickering yellow flame and flame rollout when blower kicked on; have an HAVC contractor evaluate furnace for replacement (safety concerns).

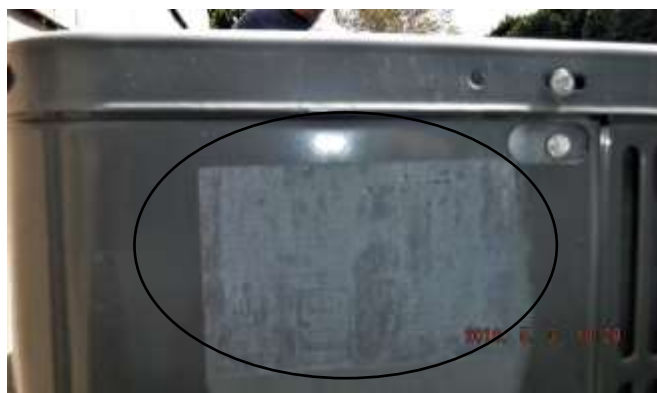
**Figure 15** Data tag on condensing unit was worn off; indication of possible older unit. Have evaluated along with the furnace by an HVAC contractor.

1. Recommend an HVAC contractor evaluate the heating and cooling and advise on replacement. See heating section comments.

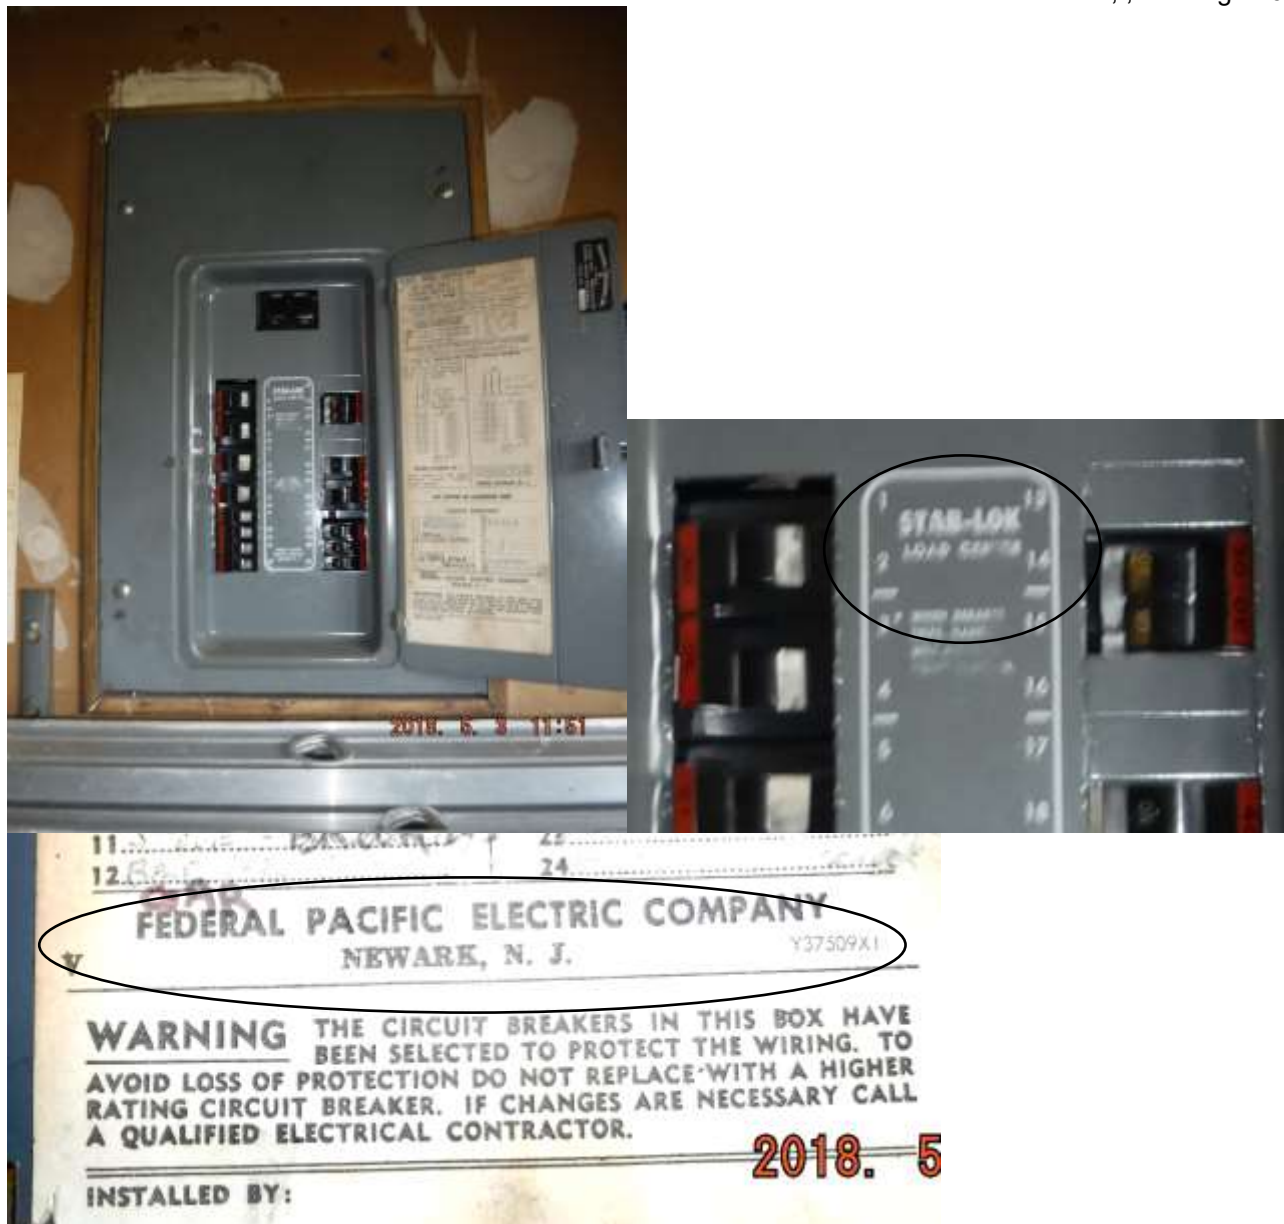
1. The GFCI in front was found tripped and would not reset. Recessed lights should be checked to verify IC rating or in contact with insulation in attic for fire safety. Some areas were missing insulation in attic near these fixtures. There were older outlets & switches, 2 prong ungrounded outlets, painted over outlets and a Federal Pacific Electric (FPE) Stab-Lok electrical panel. The FPE panels have known latent fire safety hazards and should be replaced for fire/life/safety. Recommend a licensed electrician evaluate the homes electrical (devices, electrical panel) and advise on repairs and upgrades for safety.
2. Recommend tamper resistant outlet for child safety when replacing outlets.

Figure 16 Recommend a licensed electrician evaluate panel for replacement. Federal Pacific Electric Stab-Lok panels are known latent fire hazards.
