4 Seasons Home Inspection, LLC

Inspection Date: January 21, 2018 Sunday 10am- 2:10pm
 Client Name: Buyer (buyer#gmail.com)
 Emails: lawyer@gmail.com
 Inspection Address: # street town nj xxxxx
 Inspected by: Linda Geczi home inspection lic. #24GI00061500

BUILDING DATA

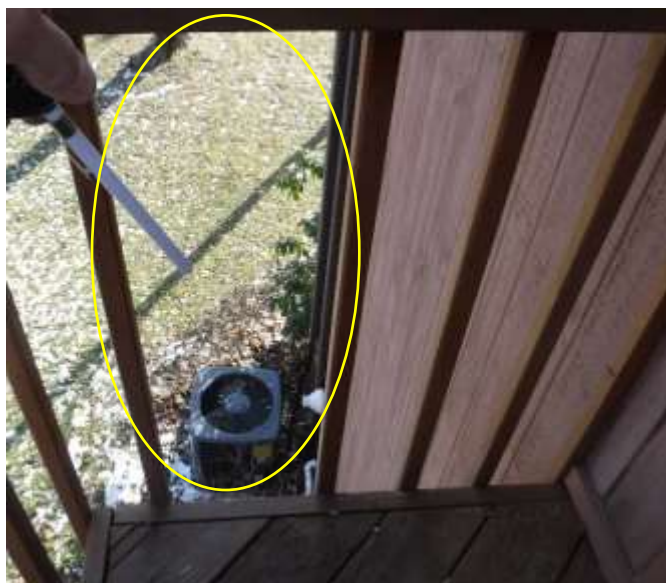
3. The upper balcony had missing baluster; safety hazard/dangerous. Recommend a carpenter add baluster/repair for safety.

Figure 1 Recommend a carpenter evaluate balcony and make repairs; missing baluster/dangerous/safety hazard.

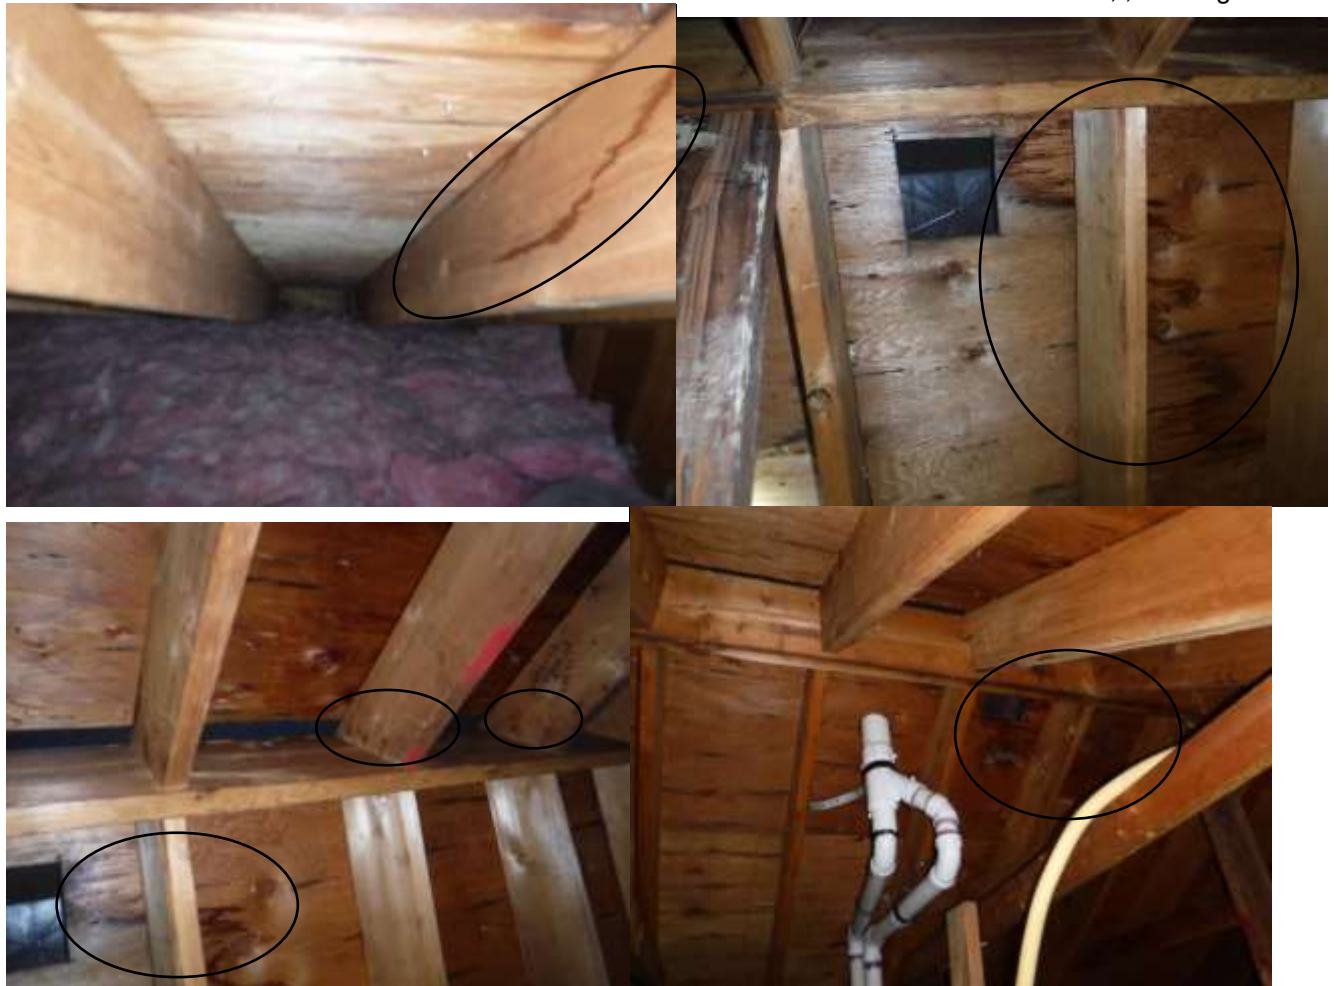
Figure 2 Examples of water stains (camera zoom); inaccessible. Follow up with roofer to make sure water stains in attic are old and not active. Recommend a secure catwalk in attic for roof inspection and for servicing the HVAC equipment, ducts, etc.

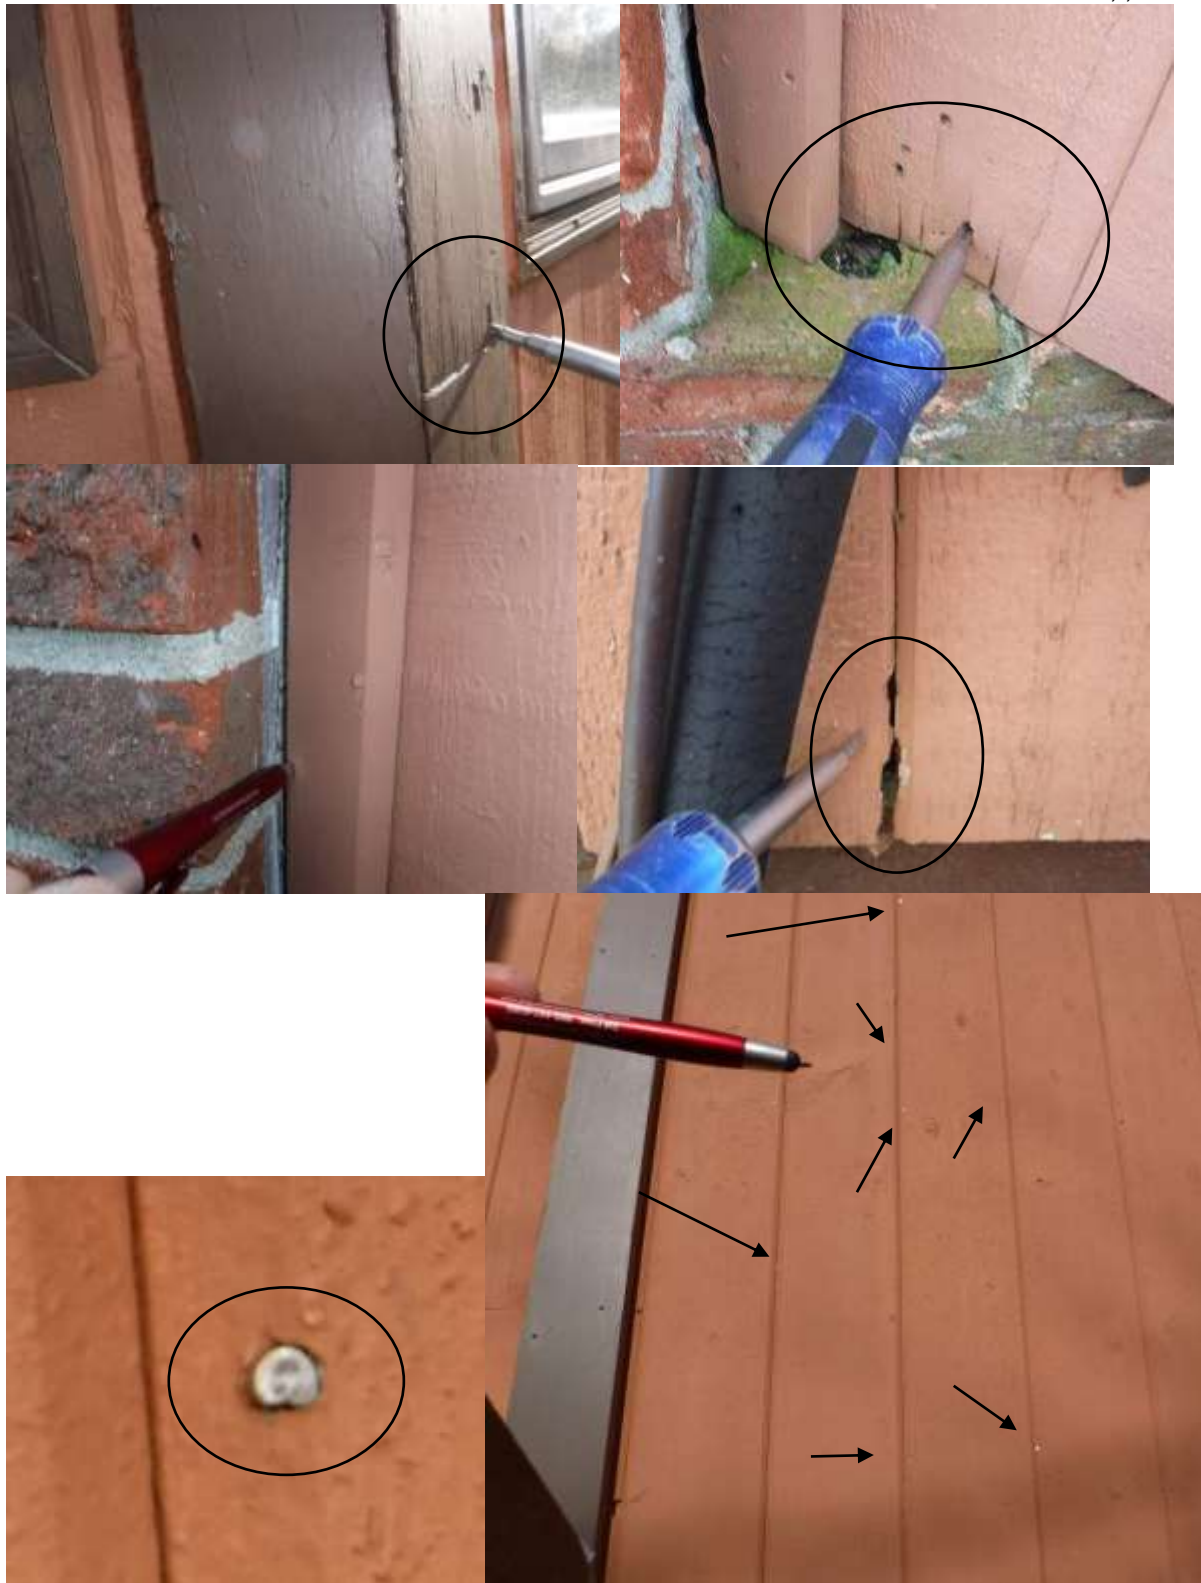
2. There was visible siding & trim rot on wood exterior and numerous shiny nails added to the wood siding. There were separated wood trim and gaps. There were some exposed open webbing of brick veneer; water entry points. Recommend a siding or exterior contractor evaluate extent of wood rot/damage, trim junctures/gaps/separation, nails, open webbing on brick veneer and advise on all repairs and the nails. Recommend caulking and sealing all junctures. Discuss flashing, wrapping and PVC (Azek) type trims and exterior components with the siding contractor to upgrade or eliminate ongoing wood rot or water damage. There were foundation cracks visible on exterior and some in the basement. The basement was filled with boxes on floor and perimeter and well as shelving; inaccessible. Recommend a structural mason or building contractor evaluate all foundation cracks, missing mortar and advise on repairs.

Figure 3 Numerous shiny nail heads on siding, wood siding & trim rot/water damage; further evaluate with siding contractor.

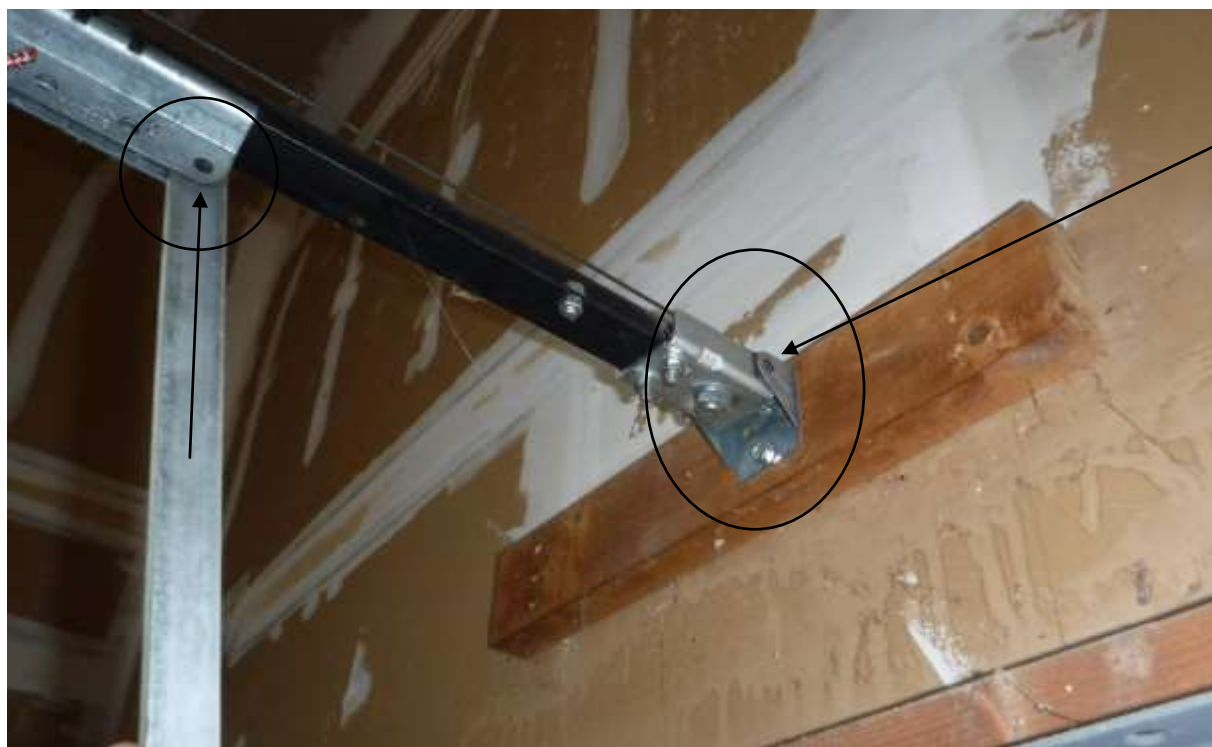
Figure 4 The door banged or made noise when tested and closed. The hinge on left popped out of the silver bracket mounted on the black bar. There was missing bolt on the mounting bracket that holds the black horizontal bar; dangerous/safety hazard. Recommend a garage door installer evaluate all doors and hardware and make repairs for safety.

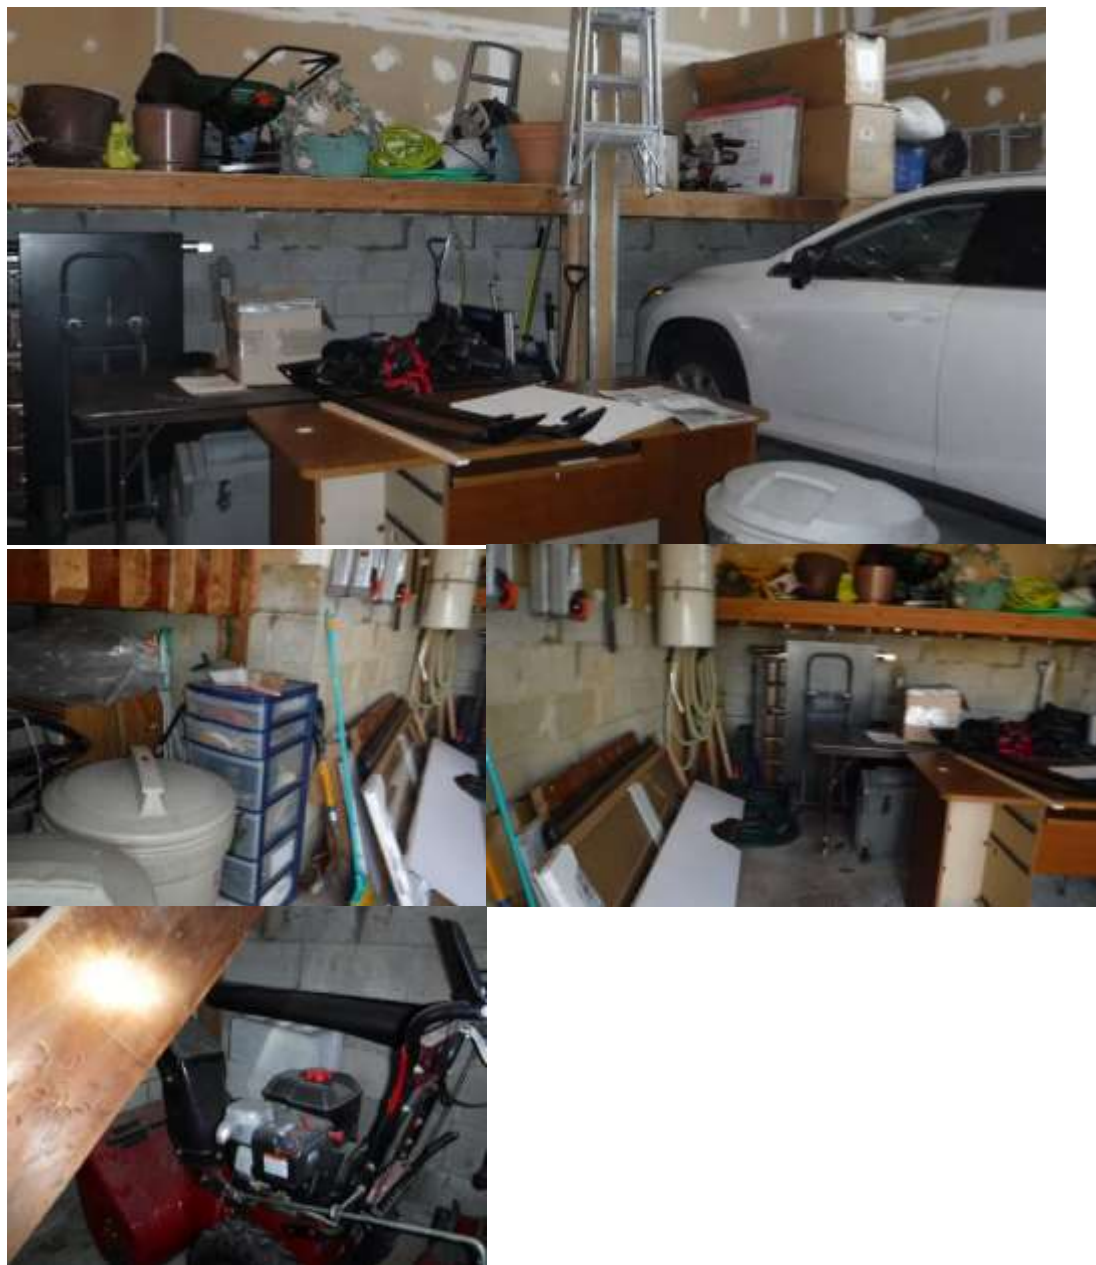
2. Recommend correcting exterior conditions conducive to seepage; moisture stains on foundation walls.
3. Inspect all areas and test outlets when clutter, storage removed and accessible before closing.

Figure 5 Inaccessible outlets, perimeter, flooring; car, storage, clutter in garage. Inspect all areas and outlets when storage removed. Water/moisture/efflorescence stains on foundation.

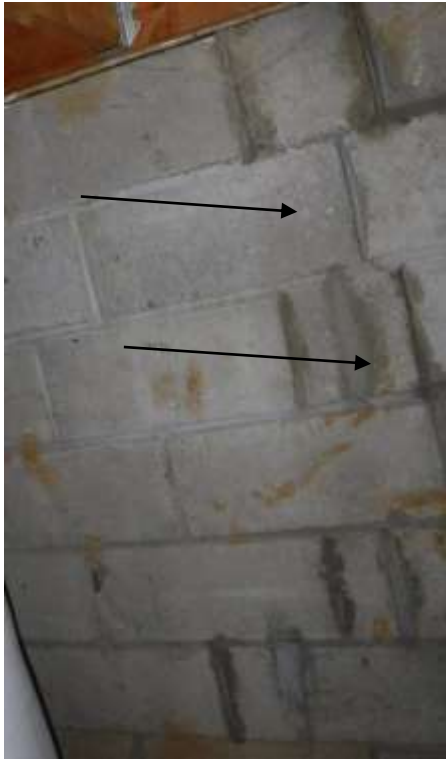
Figure 6 Example of cracks on foundation; see structure comments pg.2. There was perimeter storage and clutter in garage; limited view.

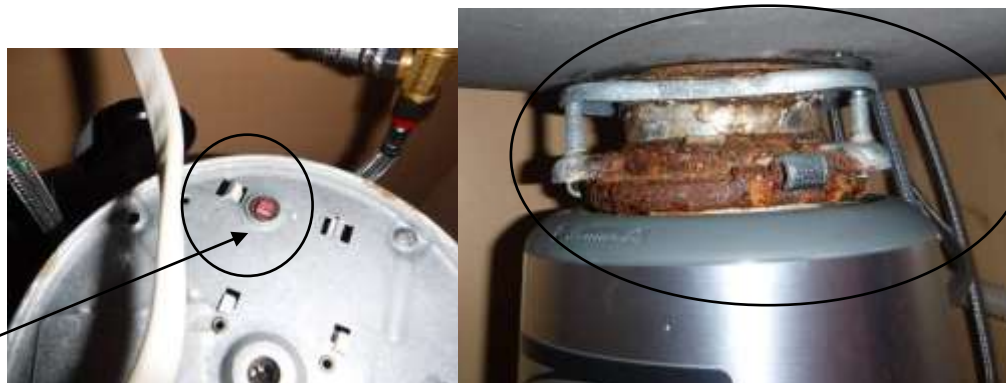
1. Recommend a licensed plumber evaluate the drain basket/garbage disposer connection for replacement; rusted/heavy corrosion.

Figure 7 On left, red reset button if tripped, rest to restore power. The right photo is the corrosion on drain basket and garbage disposer connector; have licensed plumber evaluate for replacement.

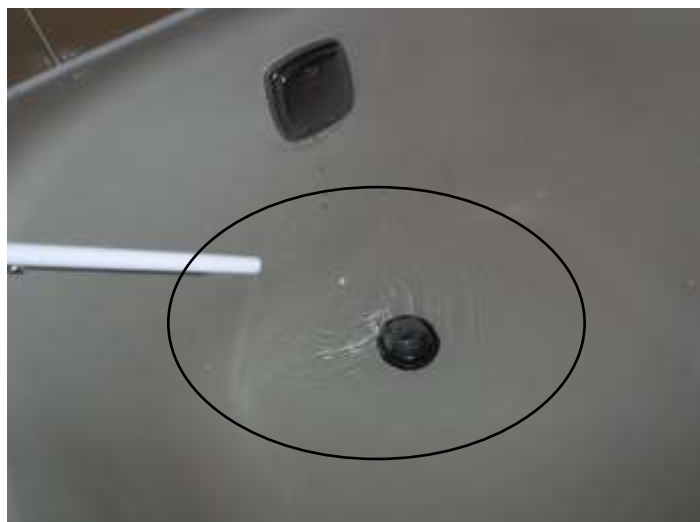
1. Recommend a licensed plumber evaluate calcium/mineral deposits, stiff handles, slow drainage and advise on repairs.

Figure 8 Slow drainage; have a plumber evaluate drainage and advise on repairs.

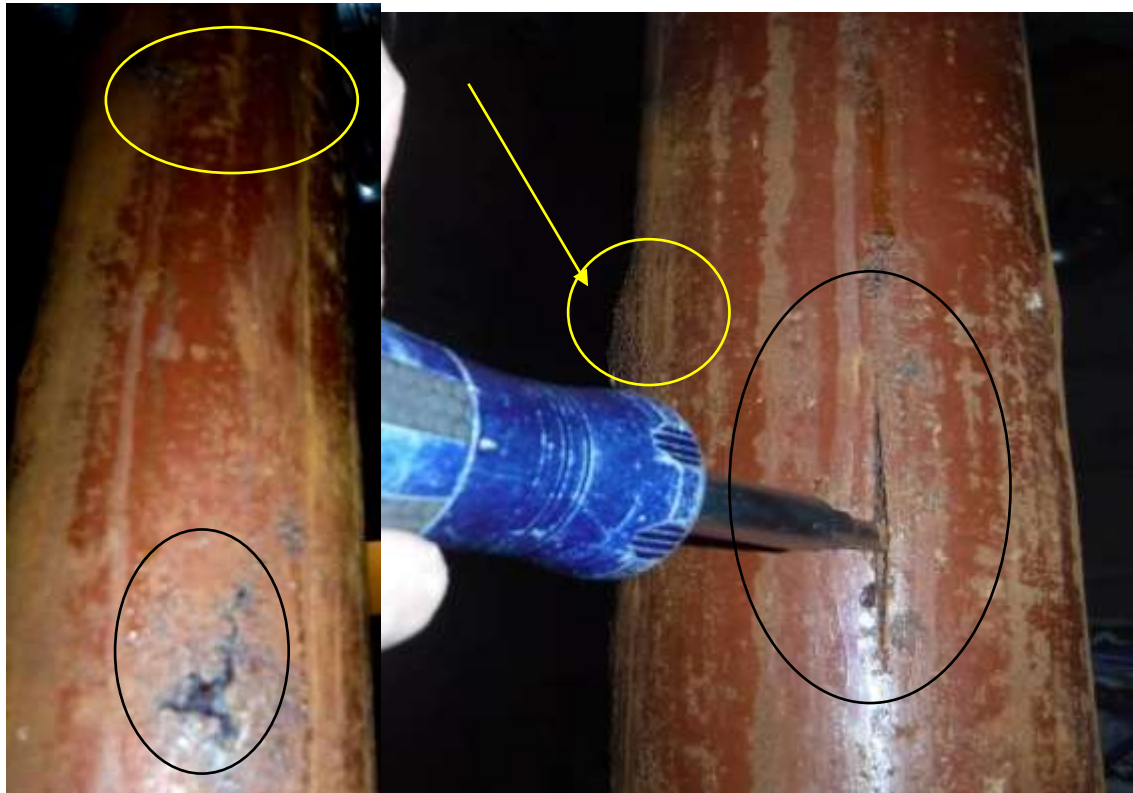
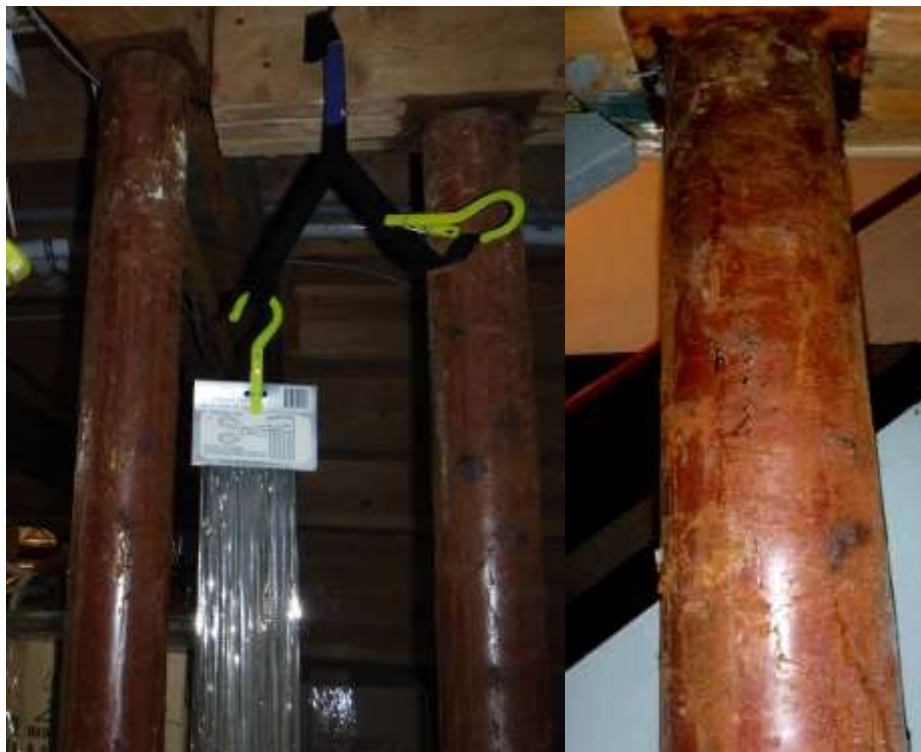
- 2. There were slope floors and canted doorways in the home. The lally columns in basement were in poor condition; blistered, exfoliation, water weeping through the rust when blisters touched, rust/corrosion on floor and columns. Columns should be maintained in rust/corrosion free painted condition; these are structural components under the main beams or girders. There were approximately 8 lally columns in basement and similar poor condition; compromised structural integrity. Recommend a structural carpenter evaluate all columns for replacement, advise on flooring and canted doorways before closing & contractual limitations. All columns should have a vapor barrier under base to prevent wicking water into the columns. There were foundation cracks visible on exterior and some in the basement. The basement was filled with boxes on floor and perimeter and well as shelving; inaccessible. Recommend a structural mason or building contractor evaluate all foundation cracks and advise on repairs.**

Examples of the corroded lally columns in basement (~8): heavy corrosion, blisters/weeping water from inside when pressed, exfoliation, splits on columns, rust/water drip marks, etc; compromised structural integrity on all lally columns.

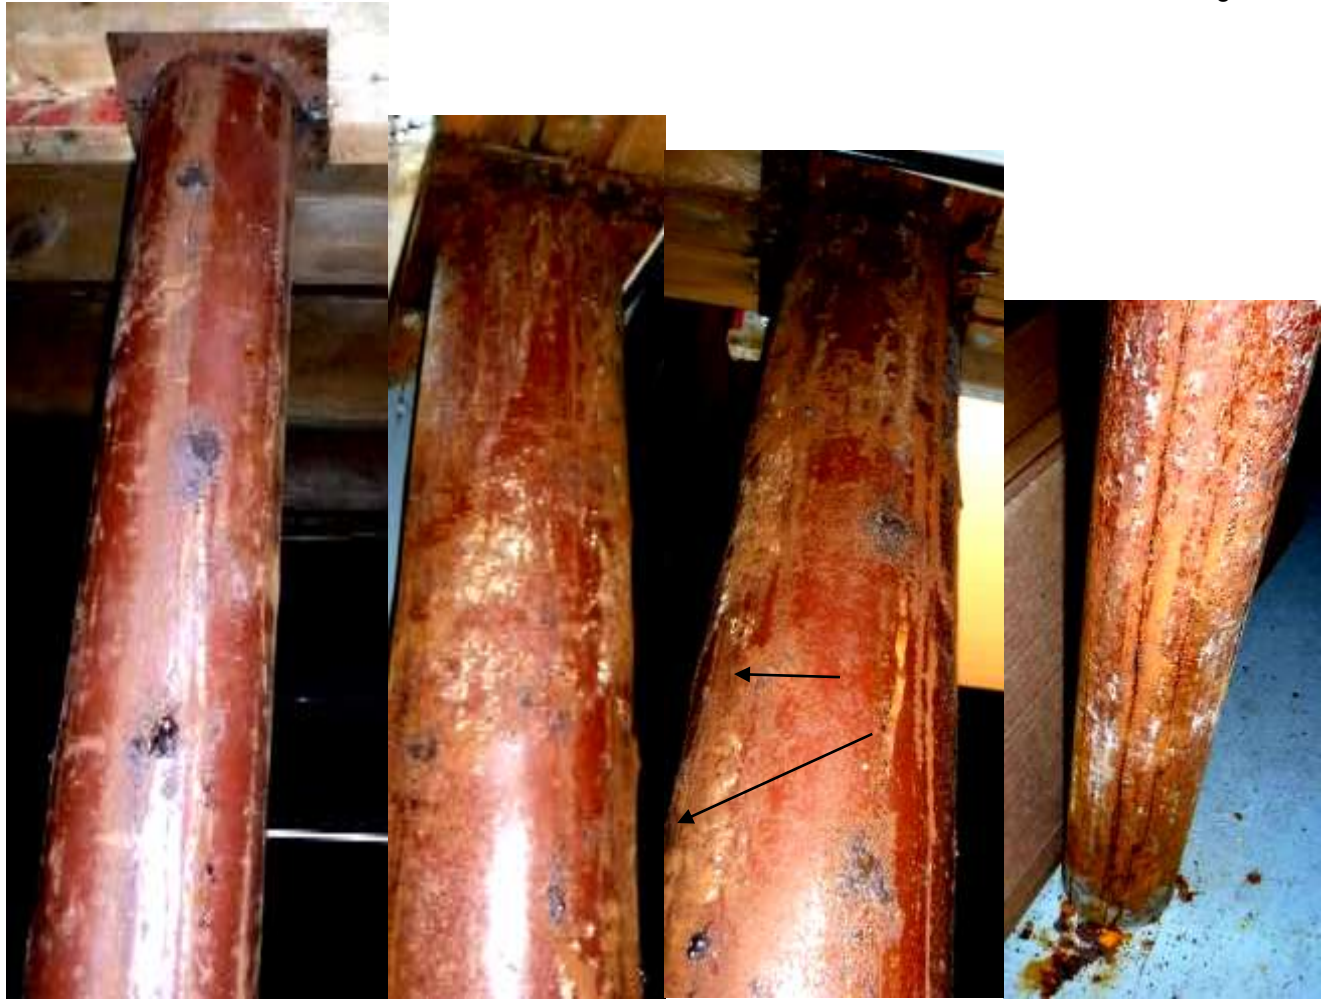
Examples of water stains, efflorescence, seepage

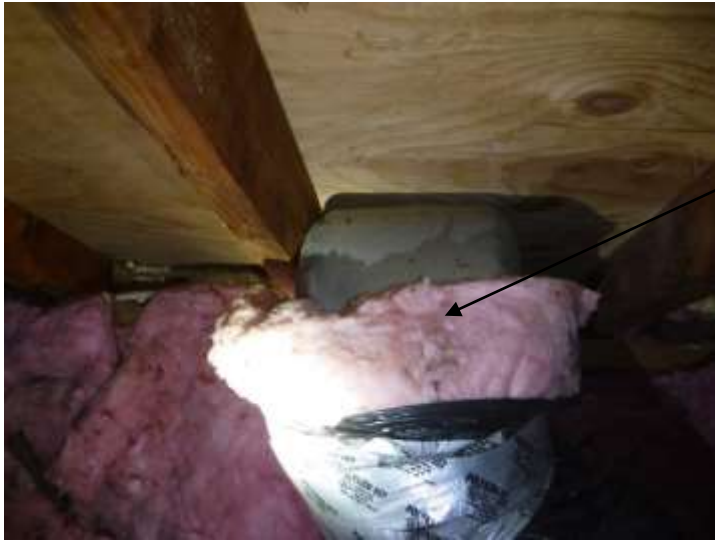
4. Add HVAC ties on ducts where missing in attic and add proper metal duct tape where tape dried out in basement. The PVC condensate piping was discharging into the channel of the free floating slab floor; water & slime in the channel. Recommend a condensate pump and discharge to the sump pump to remove water out of the basement.

Figure 10 Example of loose ducts ; recommend adding HVAC strapping/ties where needed in the attic/basement/home.

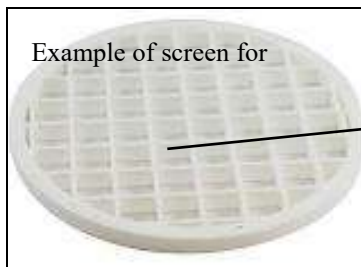
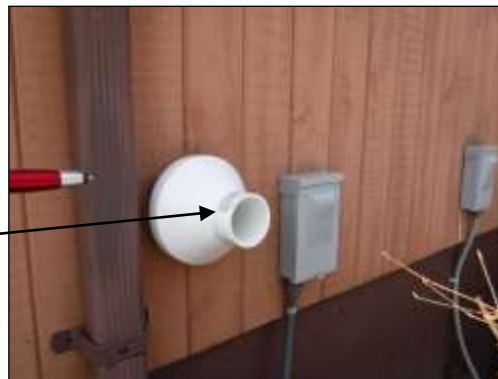
5. Recommend a vent screen PVC exhaust/vent for the furnace to keep out animals, etc.

Figure 11 Recommend a vent screen PVC exhaust/vent for the furnace to keep out animals, etc.
