## 4 Seasons Home Inspection, LLC

### buyer # street Town nj xxxxx

Inspection Date: June 05, 2015 Friday 10am- 2:45pm

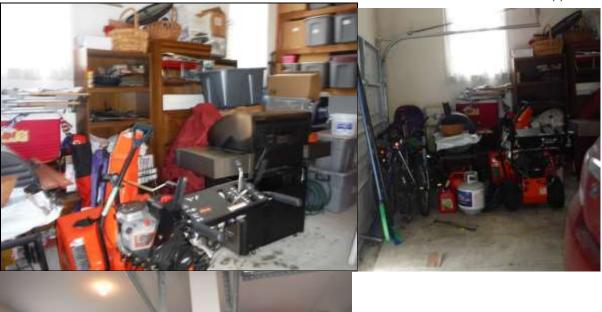
Figure 2 Garage had wall to wall & perimeter storage everywhere; inaccessible. Have removed and inspected for termite & structure before closing. See NPMA-33 Termite report.
