4 Seasons Home Inspection, LLC

Inspection Date:	October 24, 2015 Saturday 1-5 pm
Client Name:	Robert & Donna (name@gmail.com)
Emails:	lawyer@gmail, realtor@gmail
Inspection Address:	#street, west NJ xxxxx
Inspected by:	Linda Geczi building inspection lic. #24GI00061500

Approximate Age:	1880s build
	With recent renovations past 10+ yrs.
Style:	Light commercial/Luncheonette/Catering
Main Entrance Faces:	N
State of Occupancy:	Occupied business
Weather Conditions:	~48-50°F
Ground cover:	dry

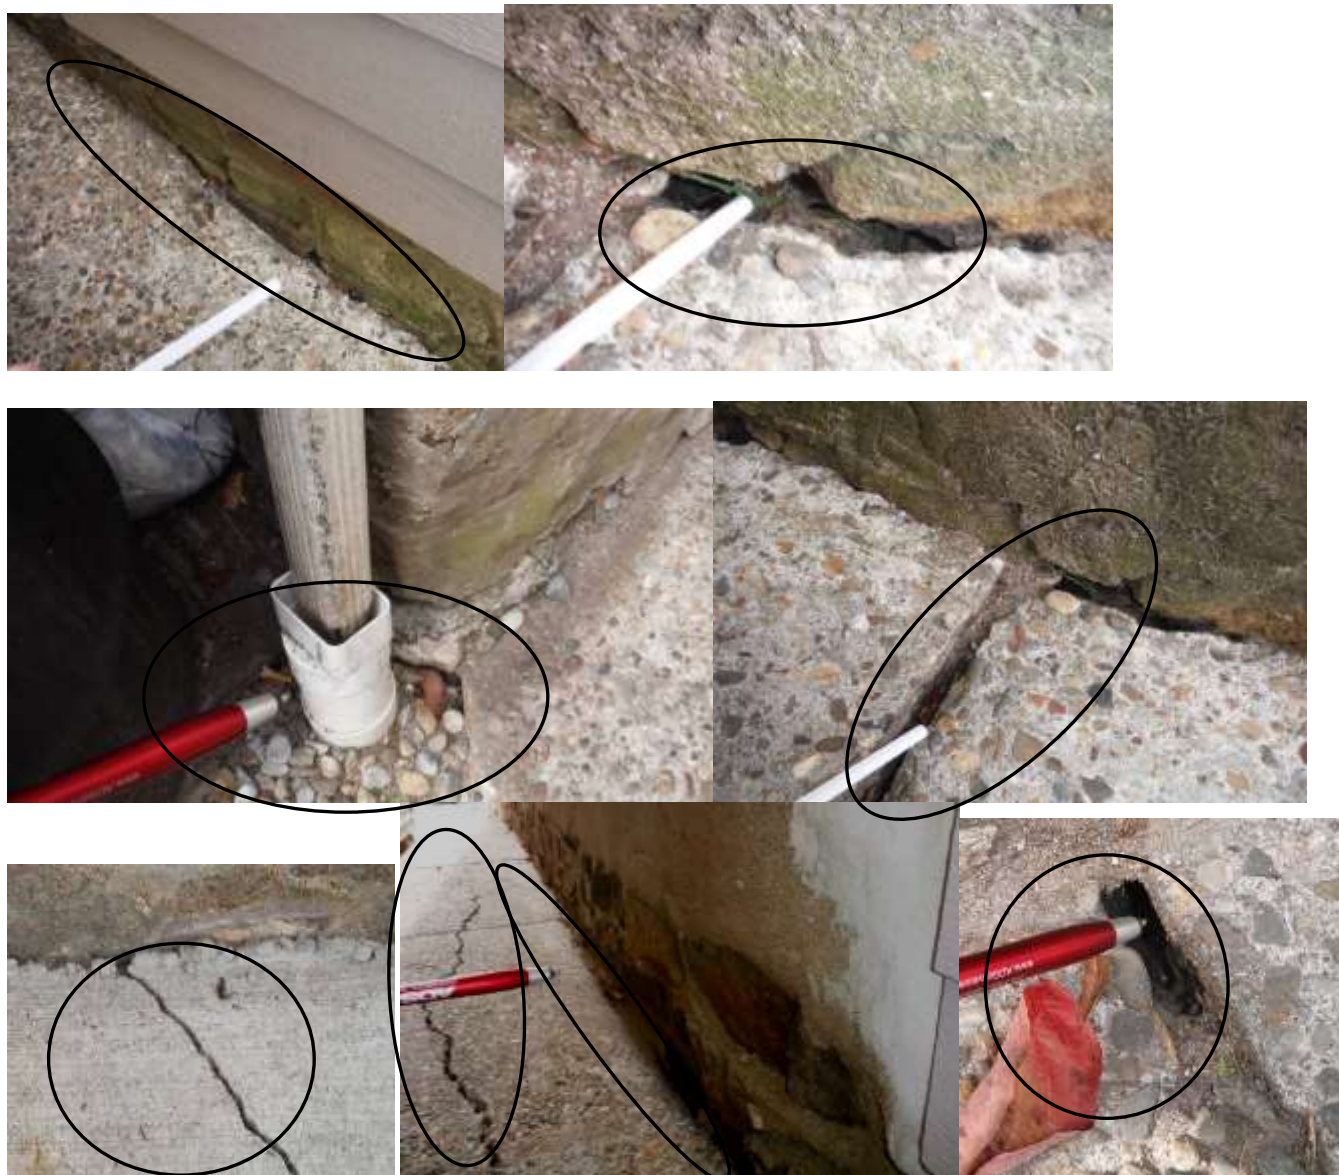
There were gaps between the walks and foundation- seal all foundation & concrete walk junctures. There were cracked walks in front and left side (alley). Have a mason or building contractor evaluate walks and make repairs.

Figure 1 Examples of gaps, concrete cracks or openings at the sidewalk/foundation junctures; have a contractor make repairs along with proper drainage. Left side of building had poor drainage; right and rear right sides were inaccessible.

2. Recommend a drainage & grading contractor evaluate the alleys and rear behind building and advise on drainage options- poor drainage. Conditions or poor drainage is conducive to wet crawl, potential foundation/structure damage and attracting wood destroying insects. There was a bowed wall and foundation on left side as well as evidence of wood destroying insects in crawl space.

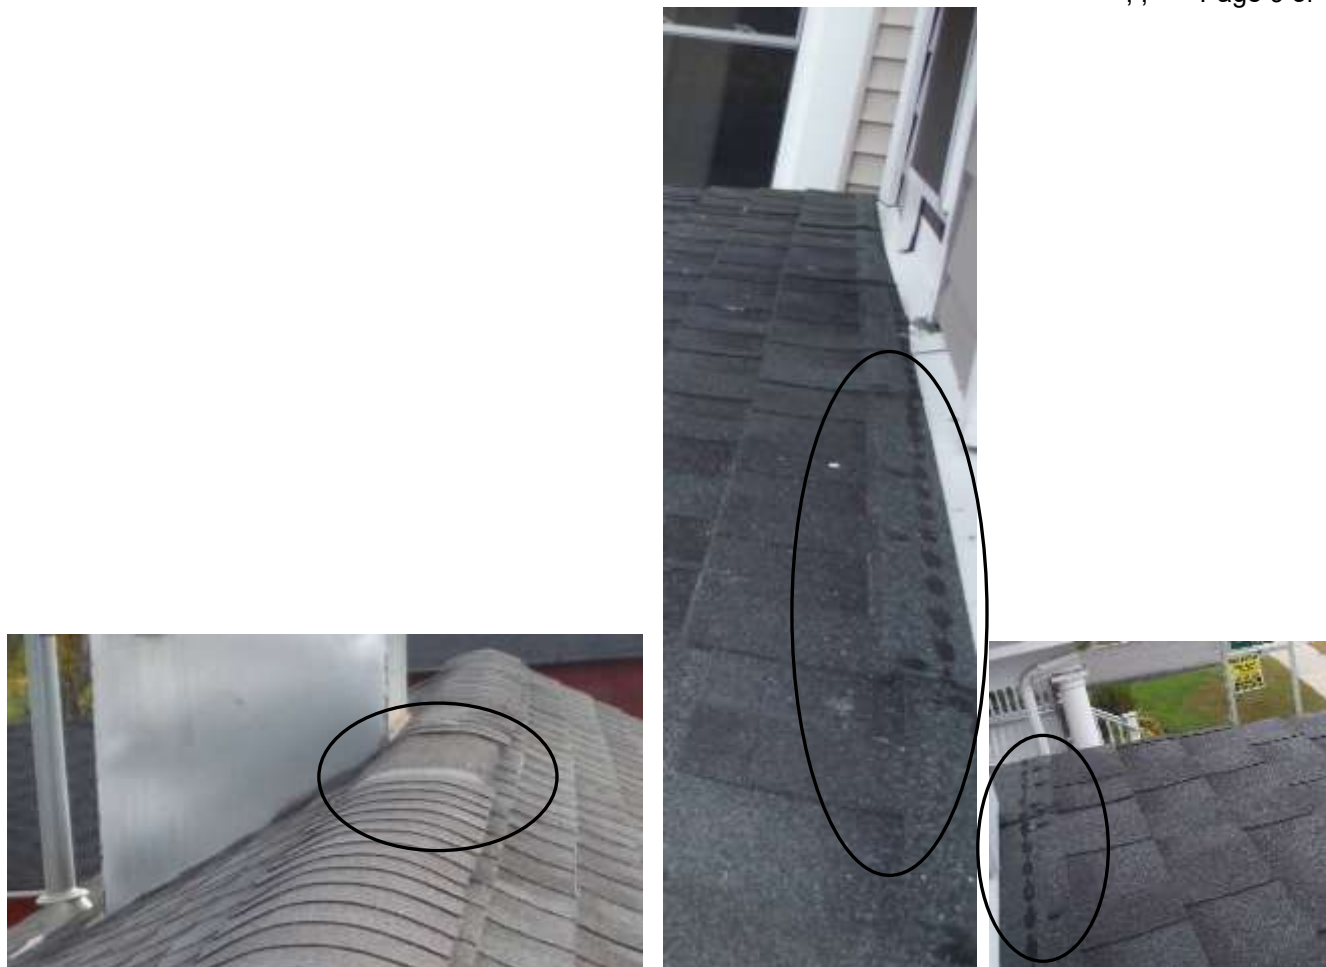
1. There were missing ridge cap shingles towards the middle of roof; limited view from ladder by the front parapet wall. There were moisture stains/spackled/patched ceiling around the hot water heater vent in utility room. There were no visible drip edge flashings; recommended. The front lower roof had low slope and dimensional shingles; not recommended on pitches less than a 4/12 slope. Recommend keeping snow & debris/leaves off this roof to avoid leaking. Have roofer inspect roof yearly to ensure leak free condition. Gutters should be cleaned often as needed to maintain free flowing condition. There were tarred nail heads on the lower roof under the upper windows; can crack & leak. Have a qualified roofer evaluate roof and advise on all repairs and rule out any active leaks (ex- flashings/pipe covers/flanges, etc.). Have a siding contractor evaluate rotted trim, missing flashings (under & around windows), etc. There were holes or damage on left side perforated soffits; have siding or exterior contractor make repairs.

Figure 2 Appears to be missing ridge cap shingles near roof vent. Tarred nail heads; tar will crack /potential leak points.

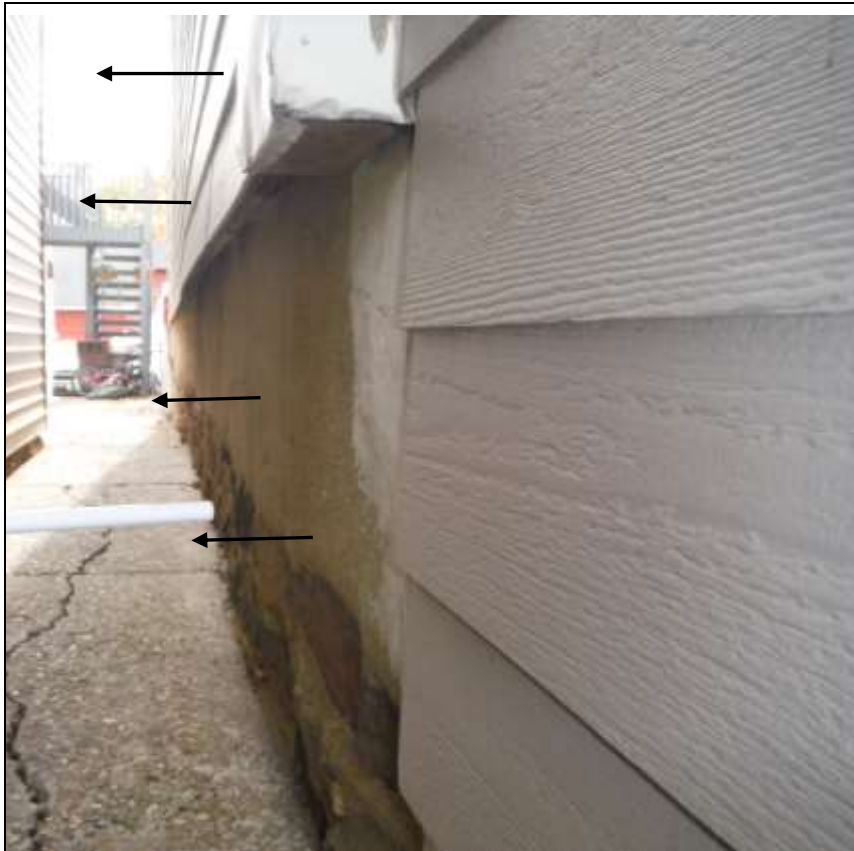
- Stone foundation- there was bulged foundation (left side), patched, repaired, cracks (corners), water seepage into crawl space

Figure 3 Bowed wall and foundation; left side building. Recommend a structural mason evaluate foundation and advise on repair, repointing, etc. Have a siding contractor or qualified building contractor evaluate bowed wall, loose siding and advise. Recommend a structural engineer (PE) evaluate structure and advise on any structural repairs.

Condition: Have a structural mason evaluate the foundation & advise on all repairs, repointing, and bulge. Follow-up with sellers to see if the foundation & left wall bulge was addressed with the most recent renovations. Check for documents pertaining to the structural changes, rehab, renovations, structure,
 Marginal Poor- bulged (left side) Cracks, gaps, missing mortar

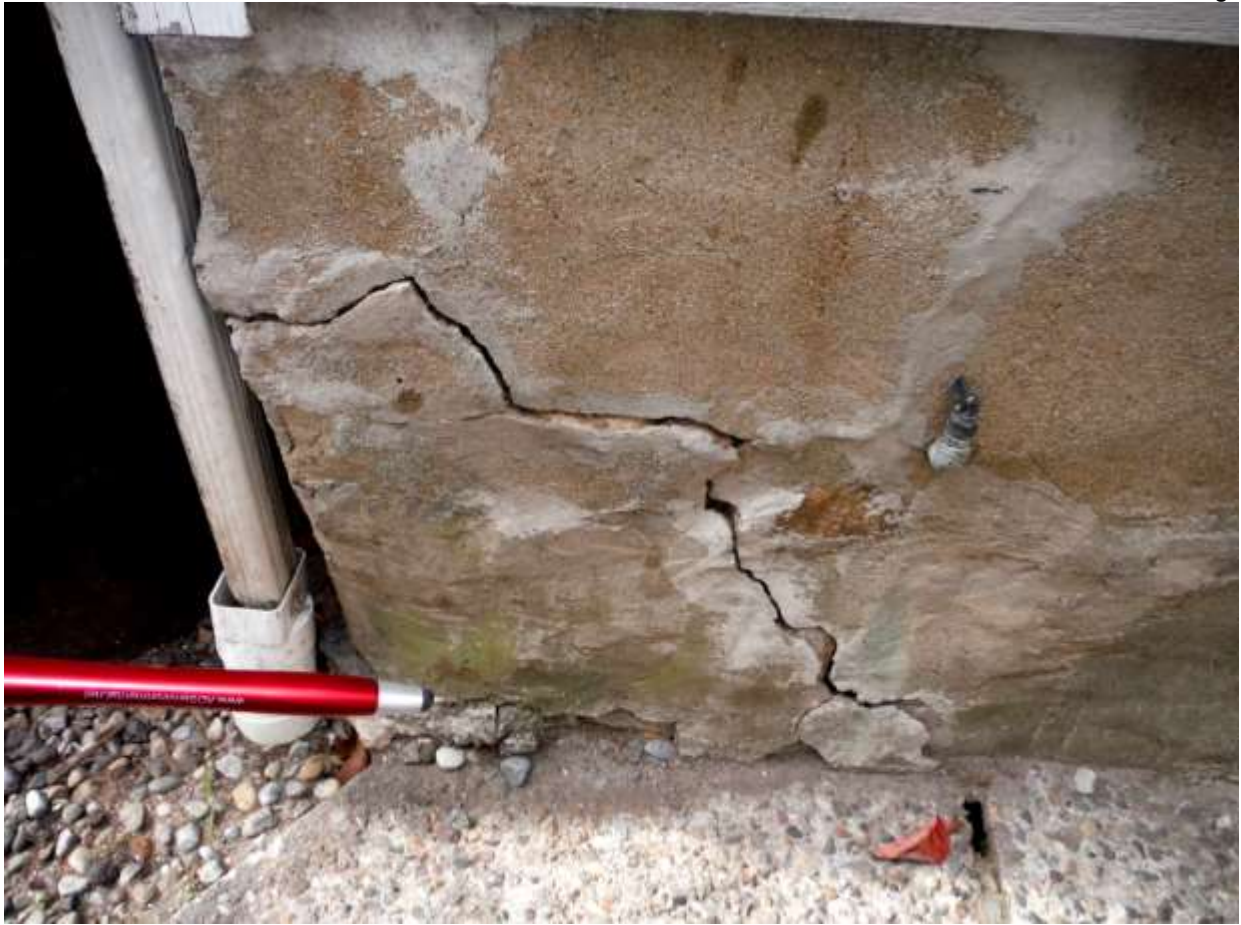
Figure 4 Foundation cracks corner in rear left side by bowed wall.

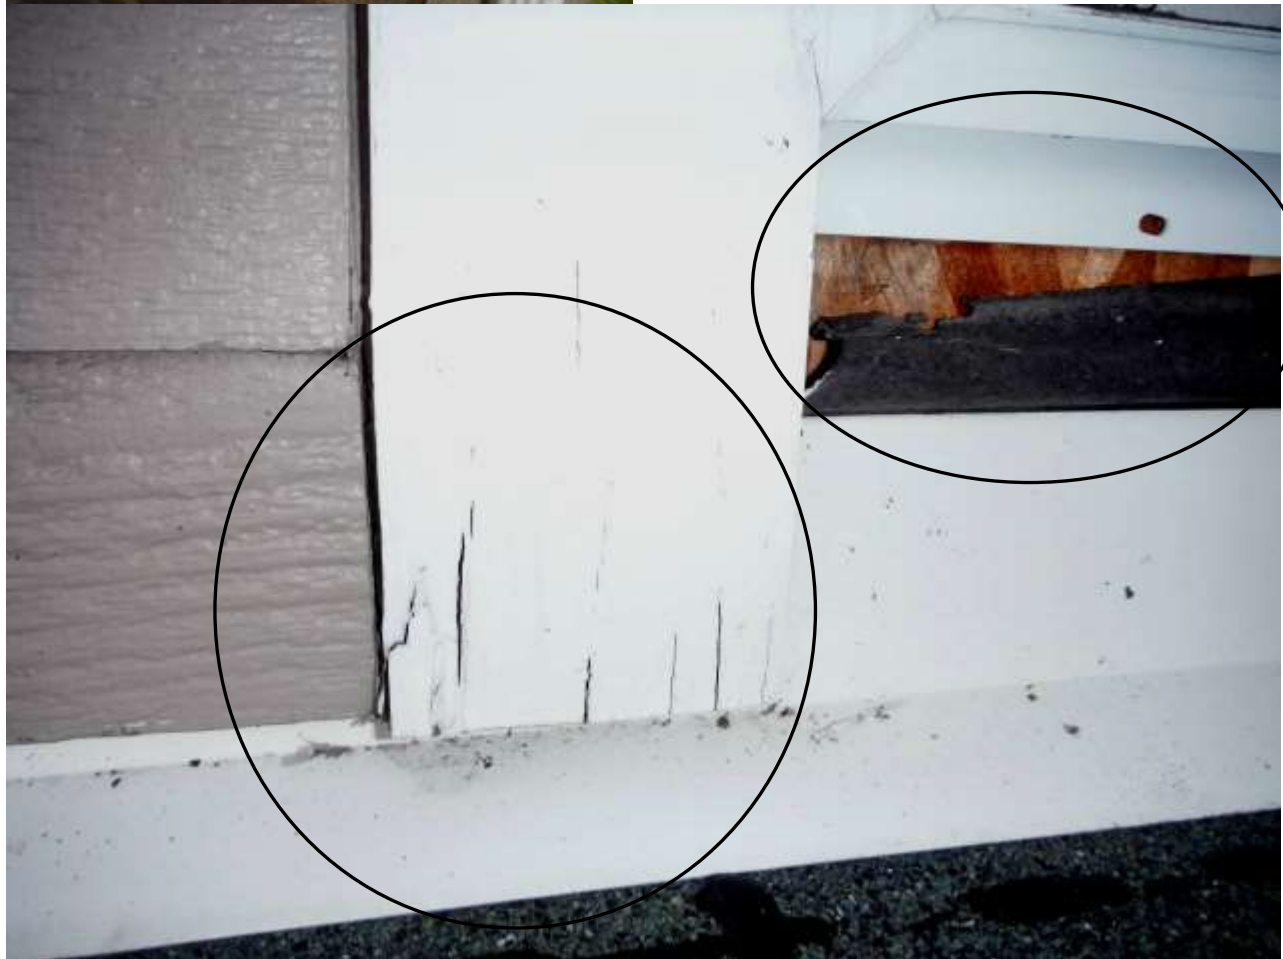
Figure 5 Example of rotted wood trim and missing flashings under all the upper windows; water entry points.

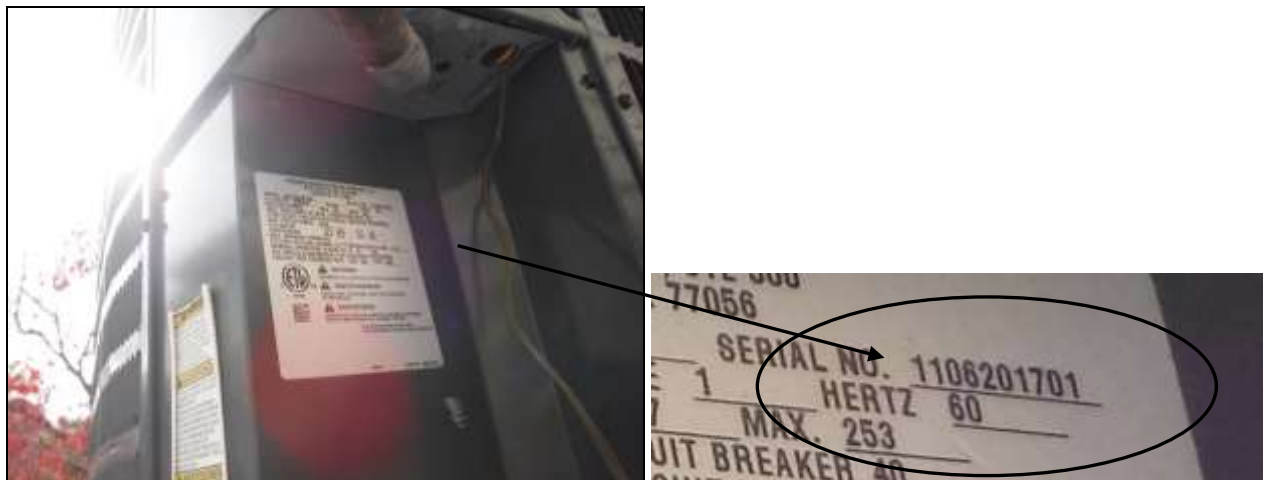
Figure 7 Goodman Serial number 1106201701= Year 2011 and Month = 06 or June manufactured date.

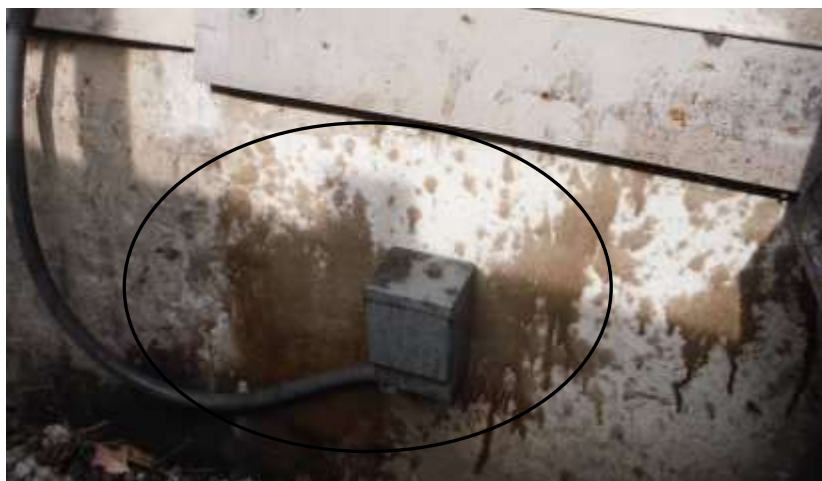
Figure 8 Recommend protecting the A/C disconnect from grease/garbage; can damage electrical cable and box.

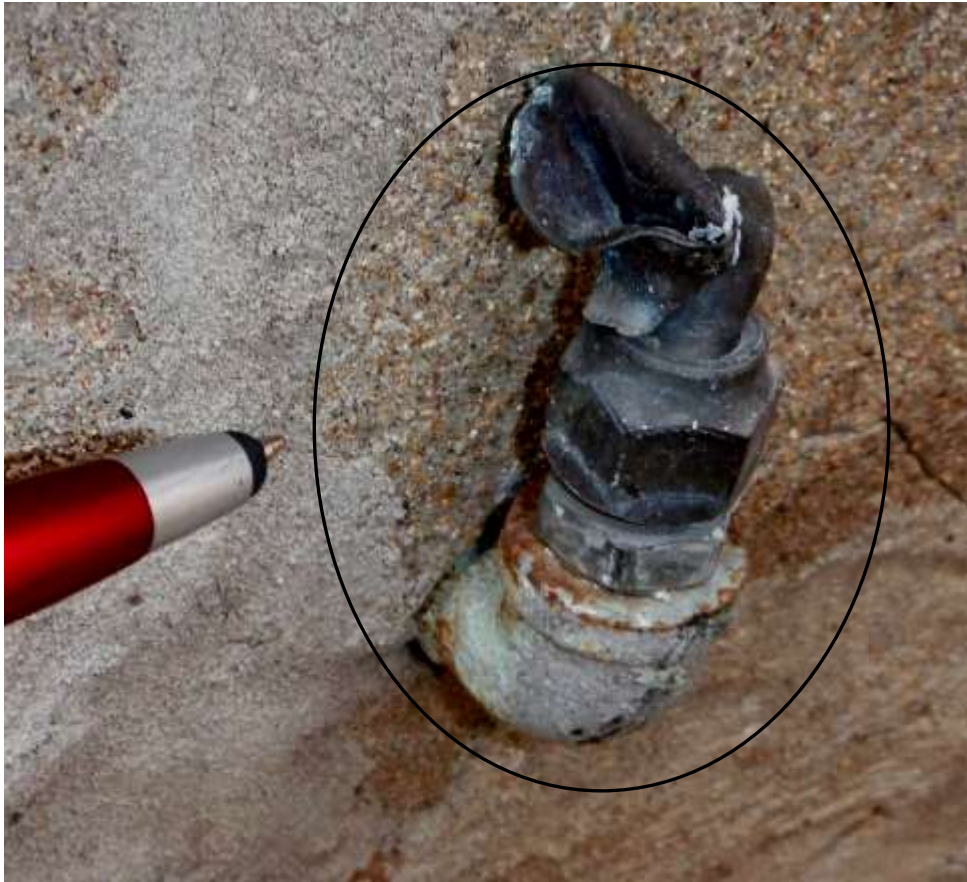
Figure 9 Further evaluate abandoned piping on exterior left side in rear by a licensed plumber. All abandoned piping should be removed and foundation sealed. Rule out any buried oil tanks on property.

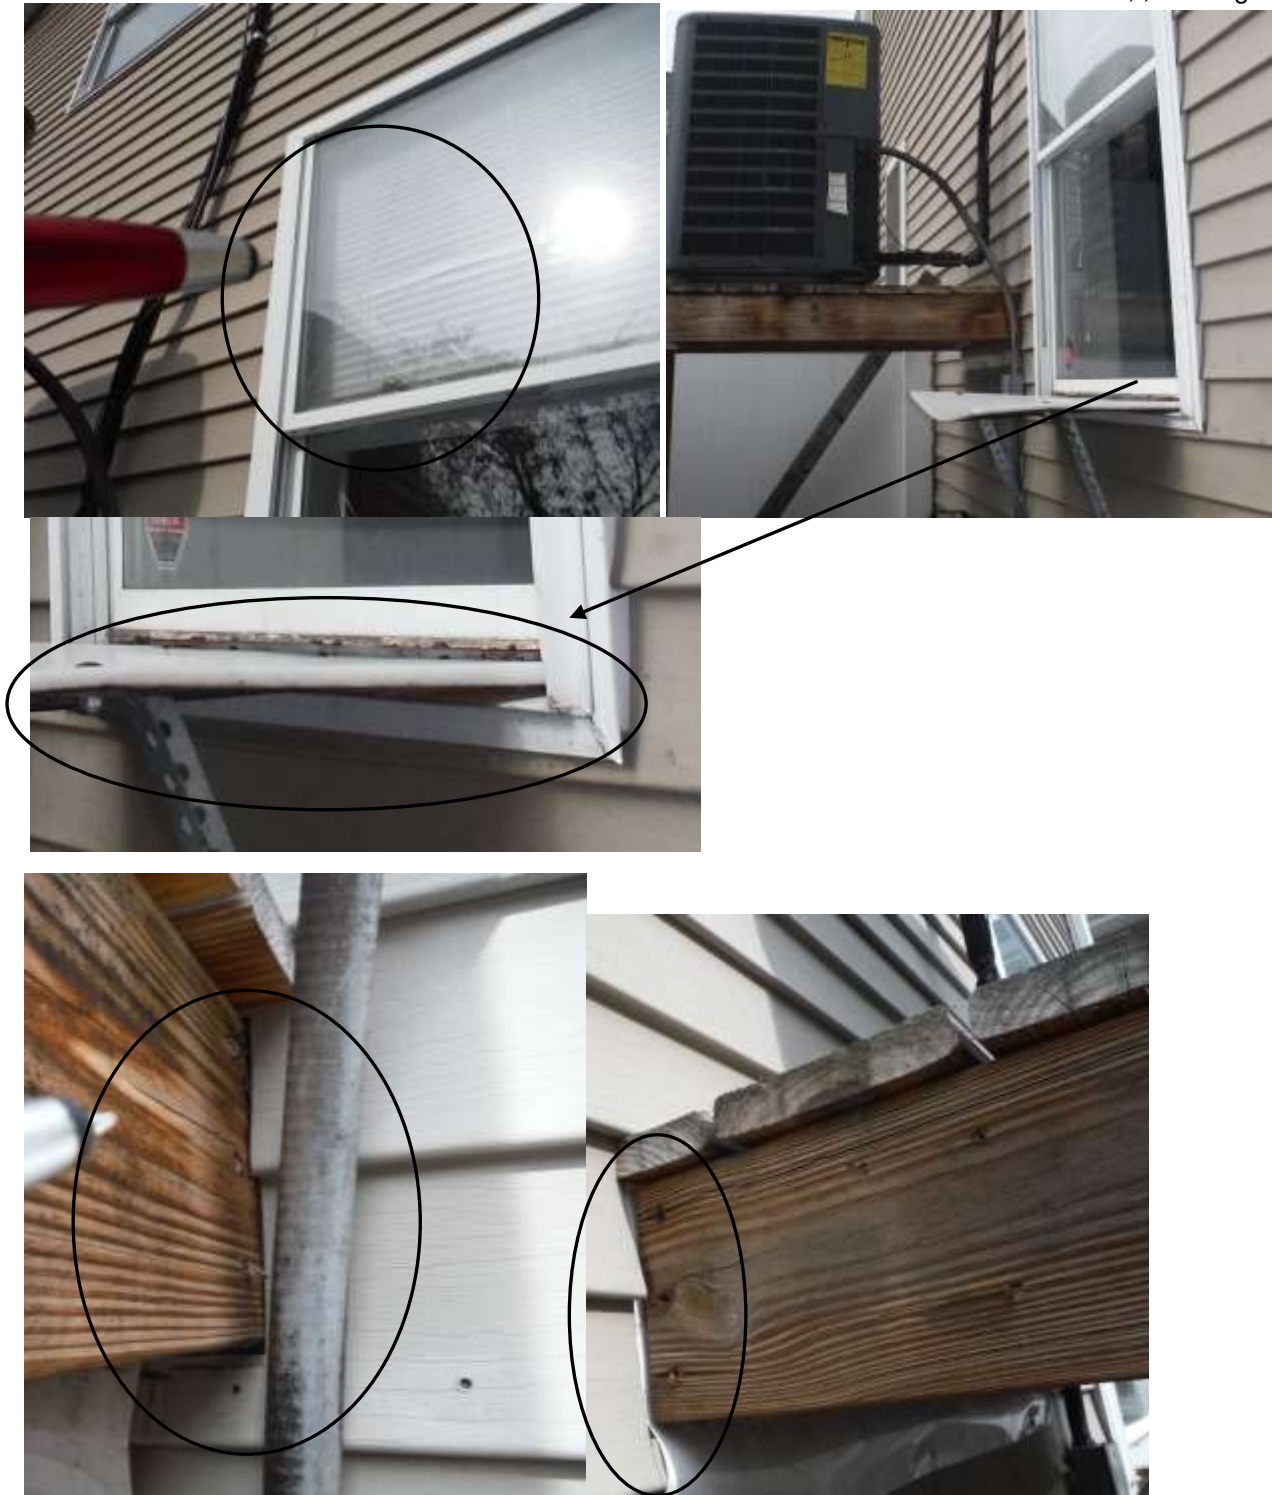
Figure 10 Cracked window pane, bent frame and not flashed properly; rear kitchen area. A shelf was added to this window; appears to be for a window A/C unit. There was improper flashing around the wood shelf for the Goodman condenser; water entry points.

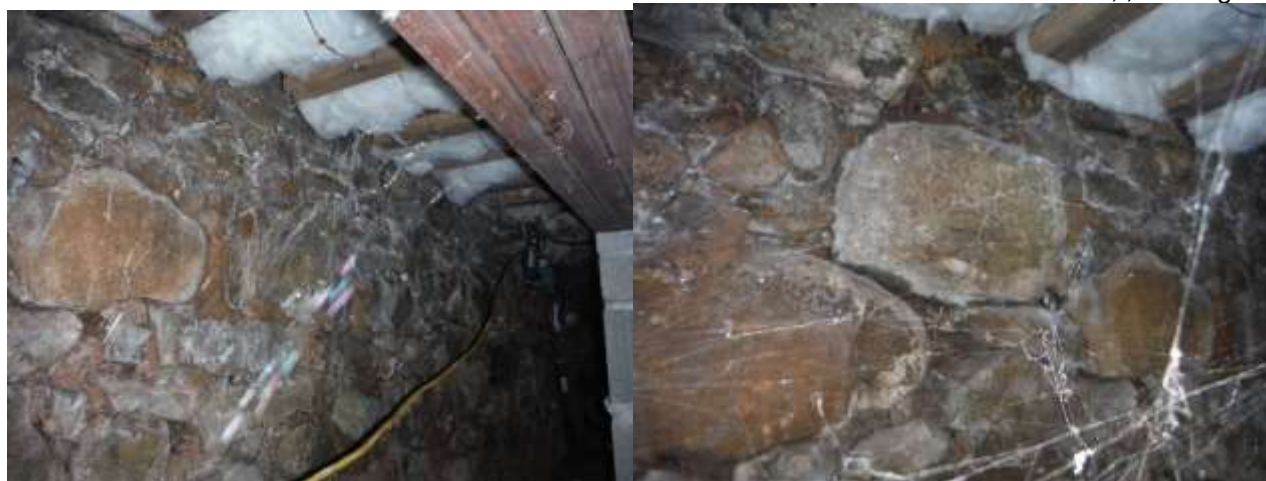
Figure 11 Example of efflorescence (white salts), seepage, wet/water stains, moist humid conditions in the crawl space.

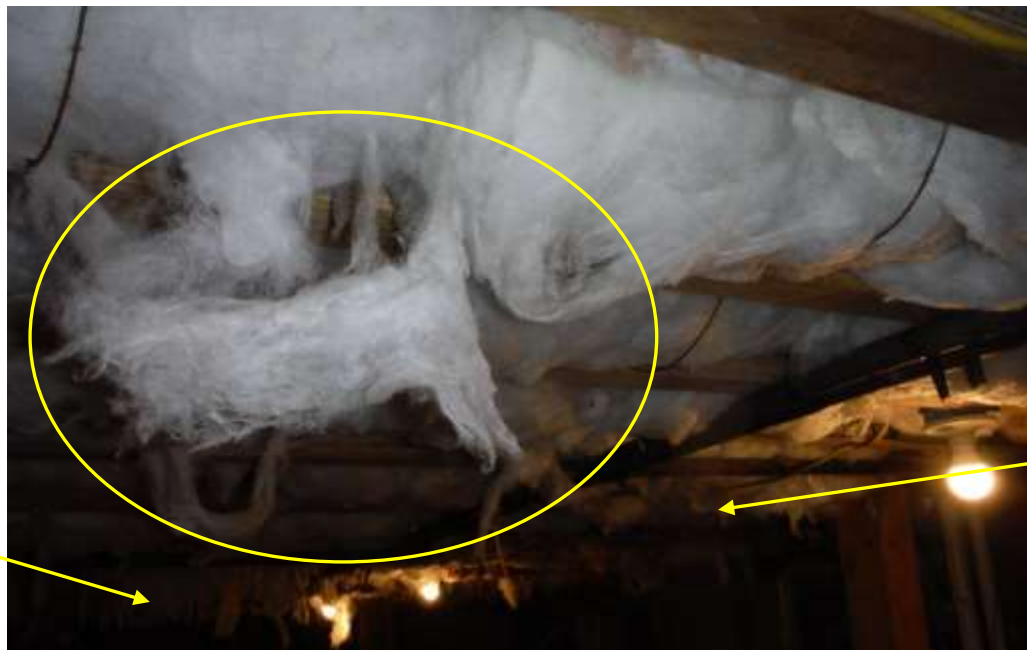
Figure 12 Insulation, wire hangers and metal in crawl (plumbing, strapping, etc.) was rusted; high humidity & seepage in crawl space. Recommend a wet crawl space contractor evaluate crawl and advise on dehumidification, ventilation and water management system.

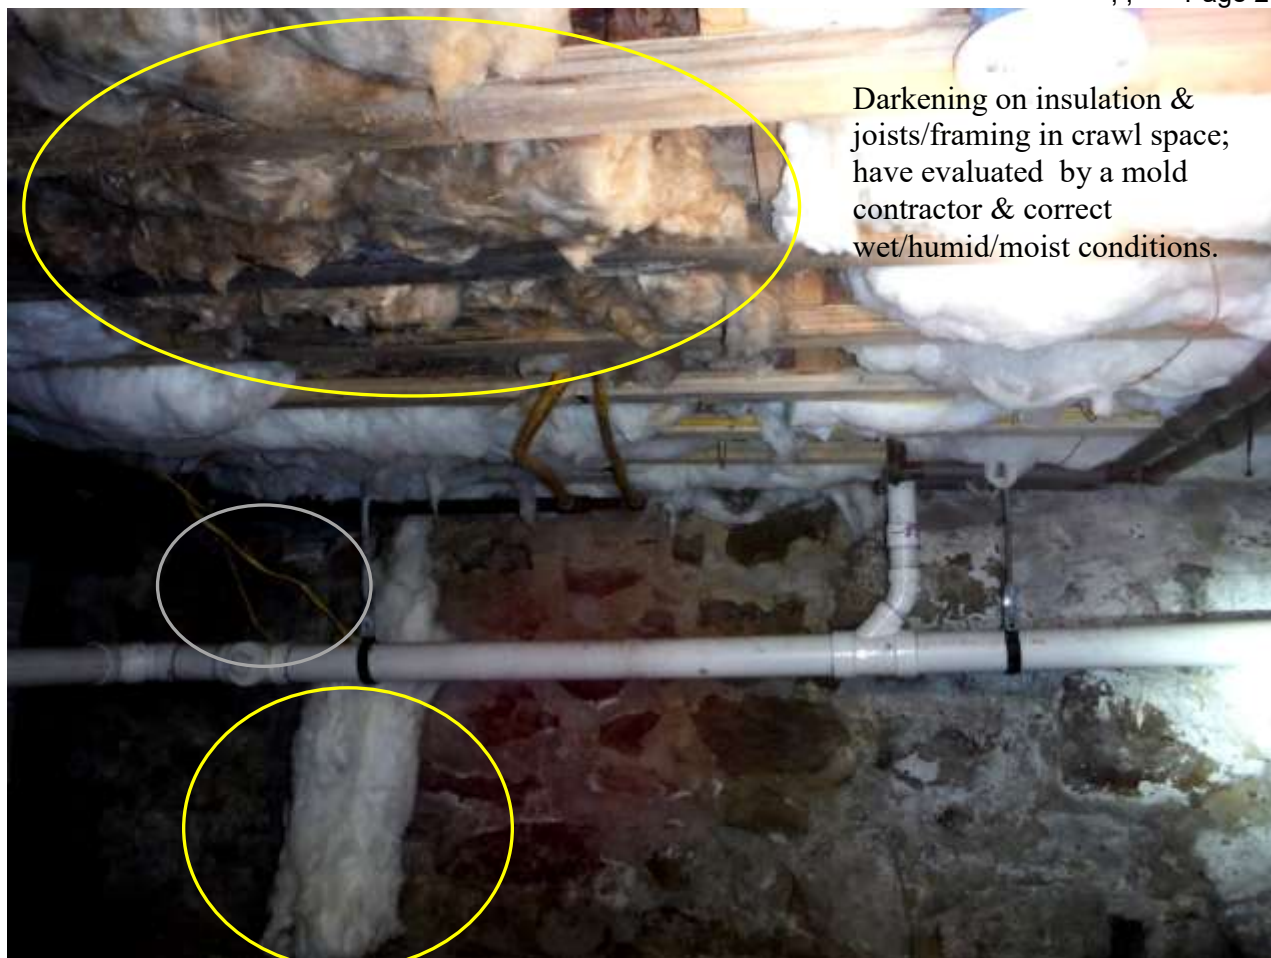
Darkening on insulation & joists/framing in crawl space; have evaluated by a mold contractor & correct wet/humid/moist conditions.

Figure 13 Loose/hanging insulation, sagging/moist insulation. Darkening on fiberglass insulation; possible mold/mildew. There were loose electrical wires; have secured where needed. Crawl was wet/seepage and insulation, plumbing, metal (insulation hangers, strapping, etc.) was corroded or rusted. See plumbing section; corrosion on plumbing and water meter.

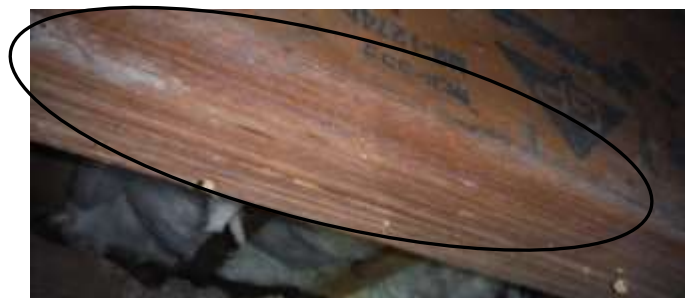
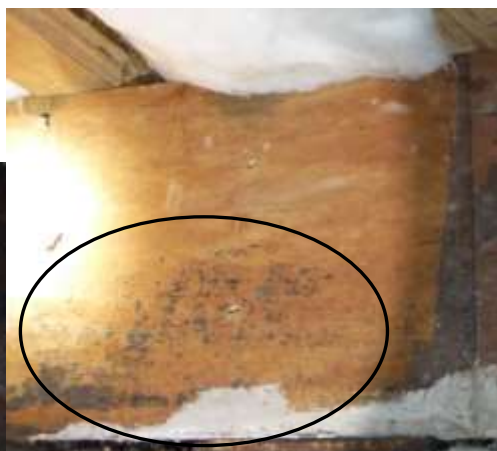
Figure 14 Example of gray film and darkening on joists and framing in crawl; possible mold.

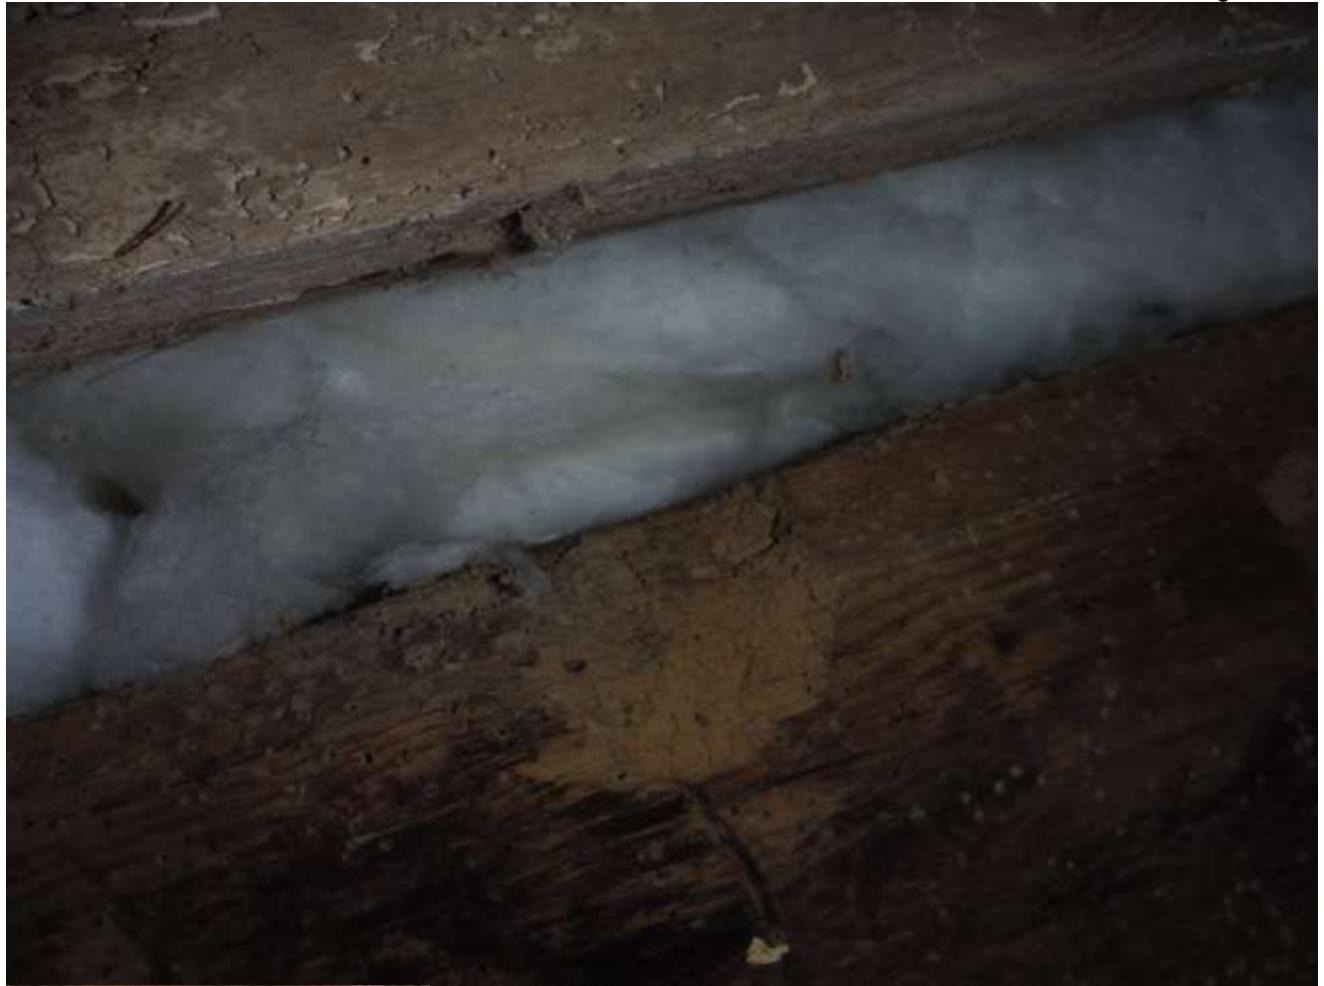
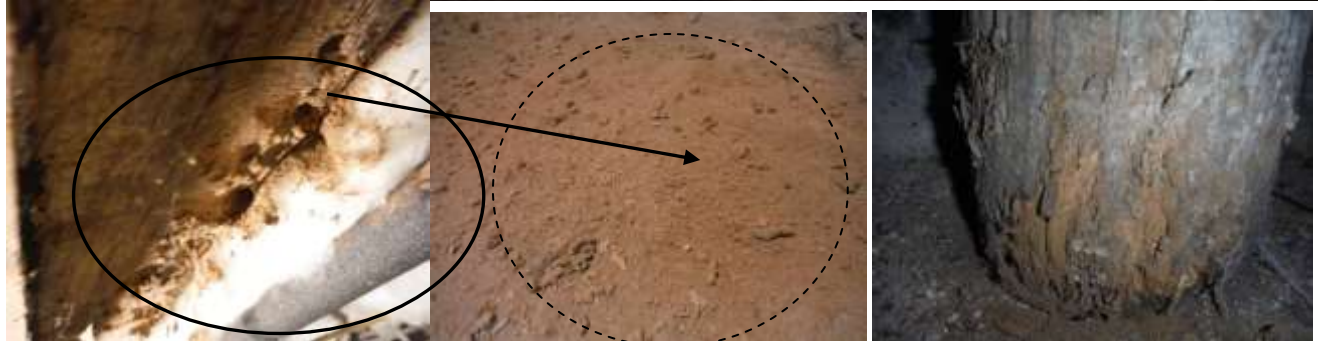
Figure 15 Examples of damaged heavy timber and debris or damaged wood fallen onto floor when heavy timber probed.

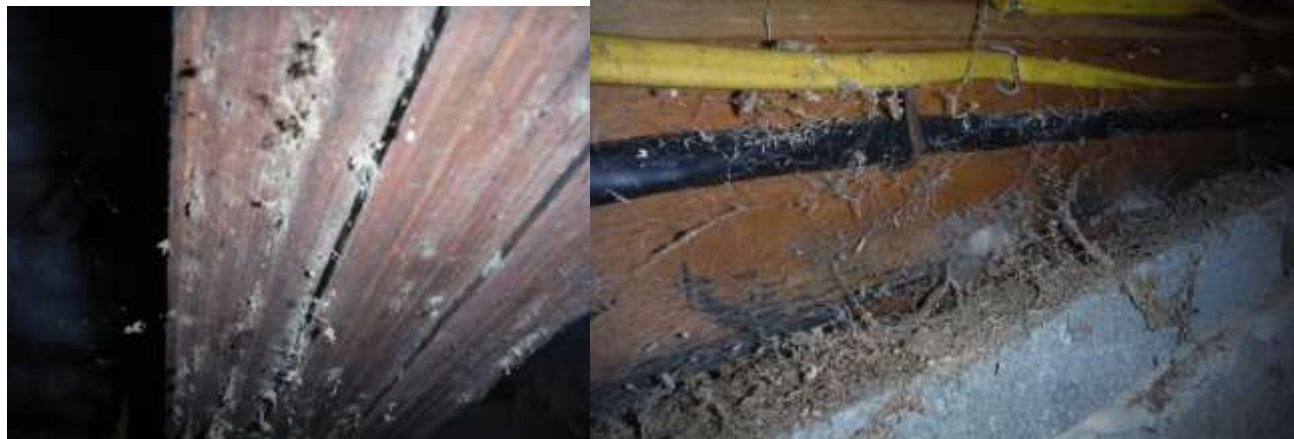
Figure 16 Example of carpenter ant frass & bodies; on insulation (ceiling & pipe), floor, joists, foundation, etc. Conditions in crawl are wet/seepage/high humidity; have all conditions on exterior and crawl corrected (ventilation, humidity, seepage, etc.).

4. **Recommend a licensed Pest Company treat for all wood destroying insects; see separate NPMA-33 Wood destroying insect report.**

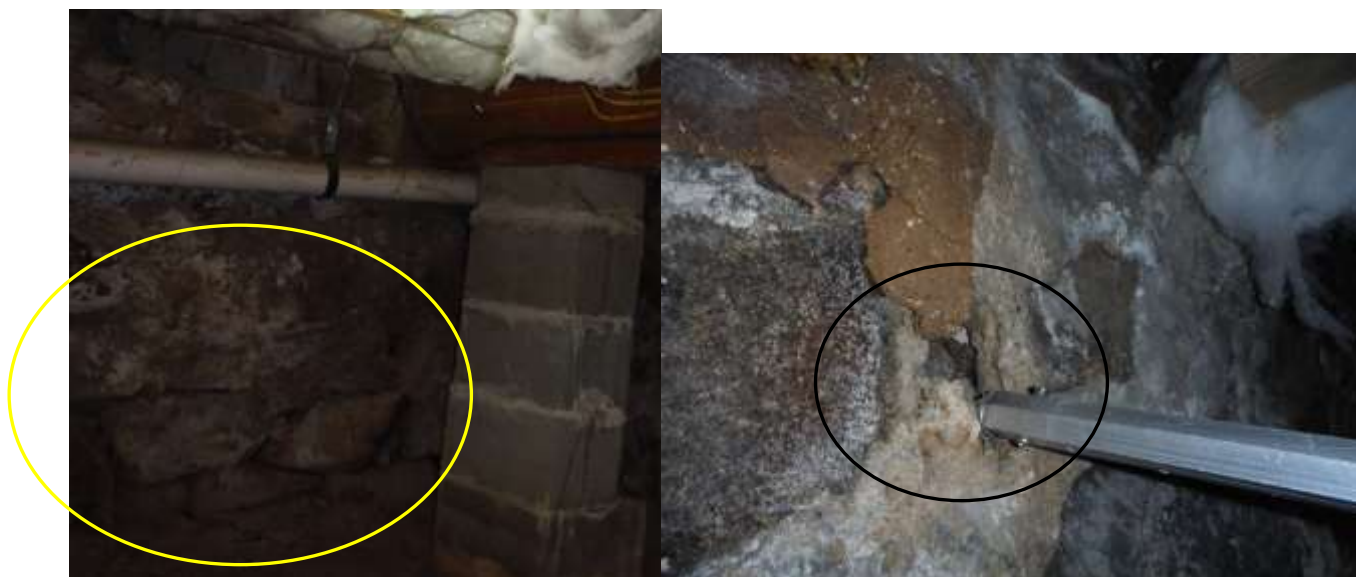
Figure 17 Example of holes, gaps, missing mortar on stone foundation. Recommend a structural mason evaluate foundation and make repairs. Recommend a structural engineer (PE) evaluate bulged wall(s) on left. The right side and rear of exterior was inaccessible.

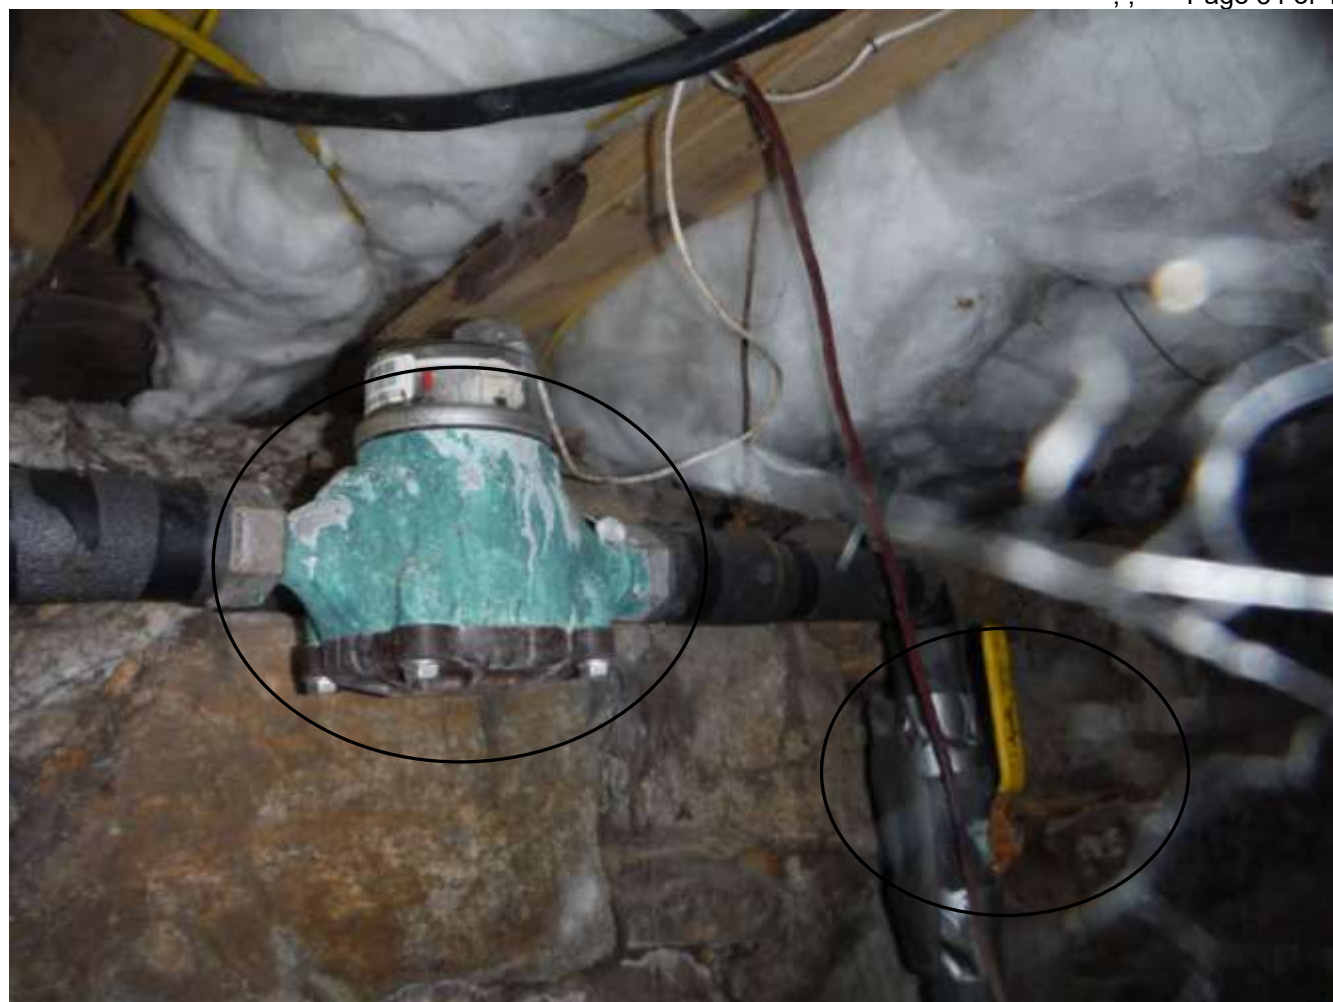
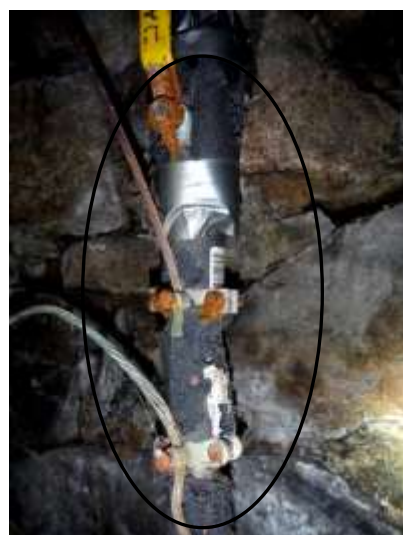
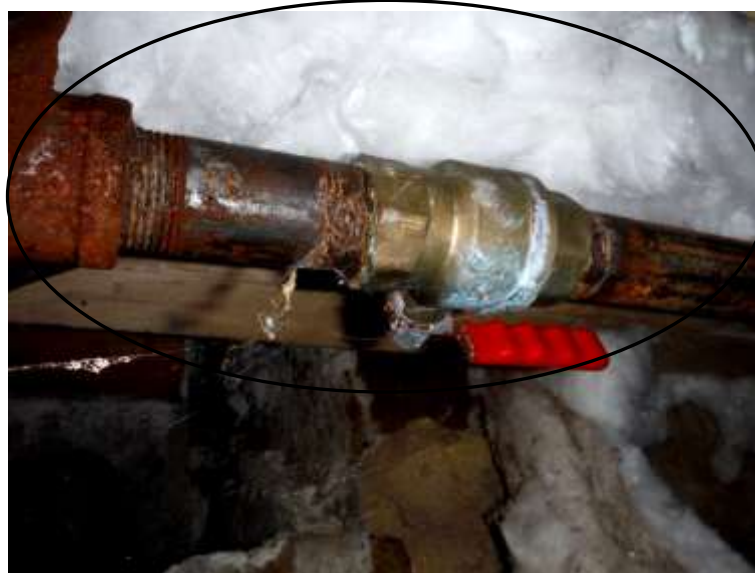
Figure 18 Example of corrosion on water meter, piping, fittings, ball valve(s), black gas piping, etc. Crawl was wet/seepage/high moisture and poor ventilation; conducive to rust/corrosion, potential structural structure/water damage and attracting wood destroying insects. Insulation in ceiling was sagging & moist; have evaluated for dehumidification and ventilation (poor). Pipe insulation was chewed; mice or rodents.

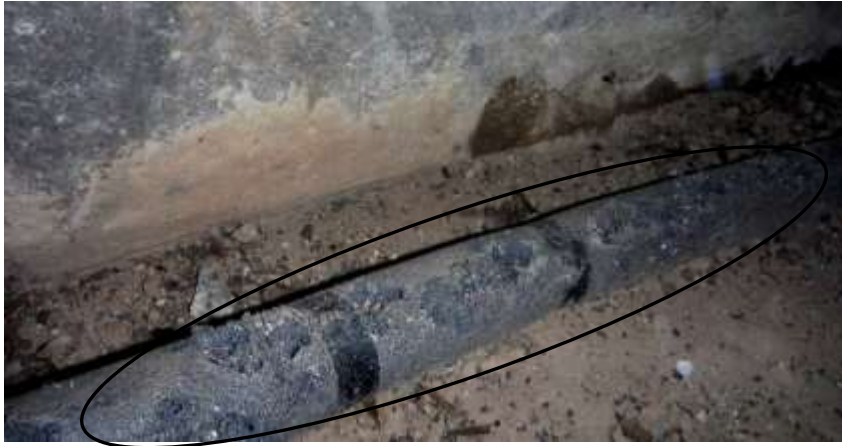
Figure 19 Chewed pipe insulation in crawl space; have rodents/mice addressed by a licensed Pest company. Recommend a structural mason repair/seal/repoint foundation.

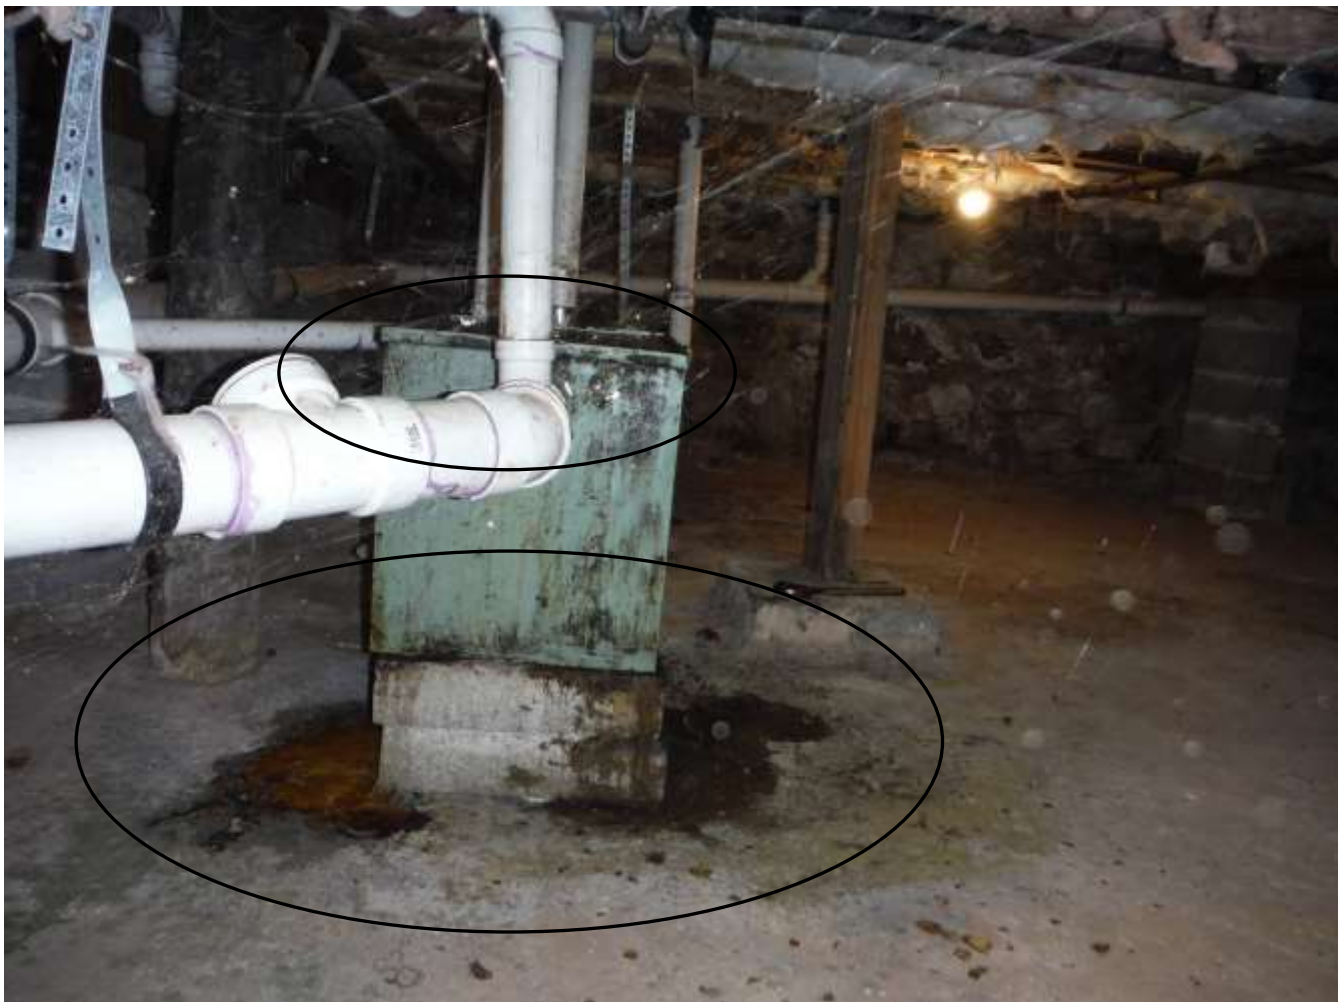
Figure 20 Grease on floor and the trap in crawl; have evaluated for clean-up, check grease trap for level and leaks.
