4 Seasons Home Inspection

Property Condition Assessment Report Summary

Address removed- example Scotch Plains, NJ

Inspection Date: December 01, 2011 10am

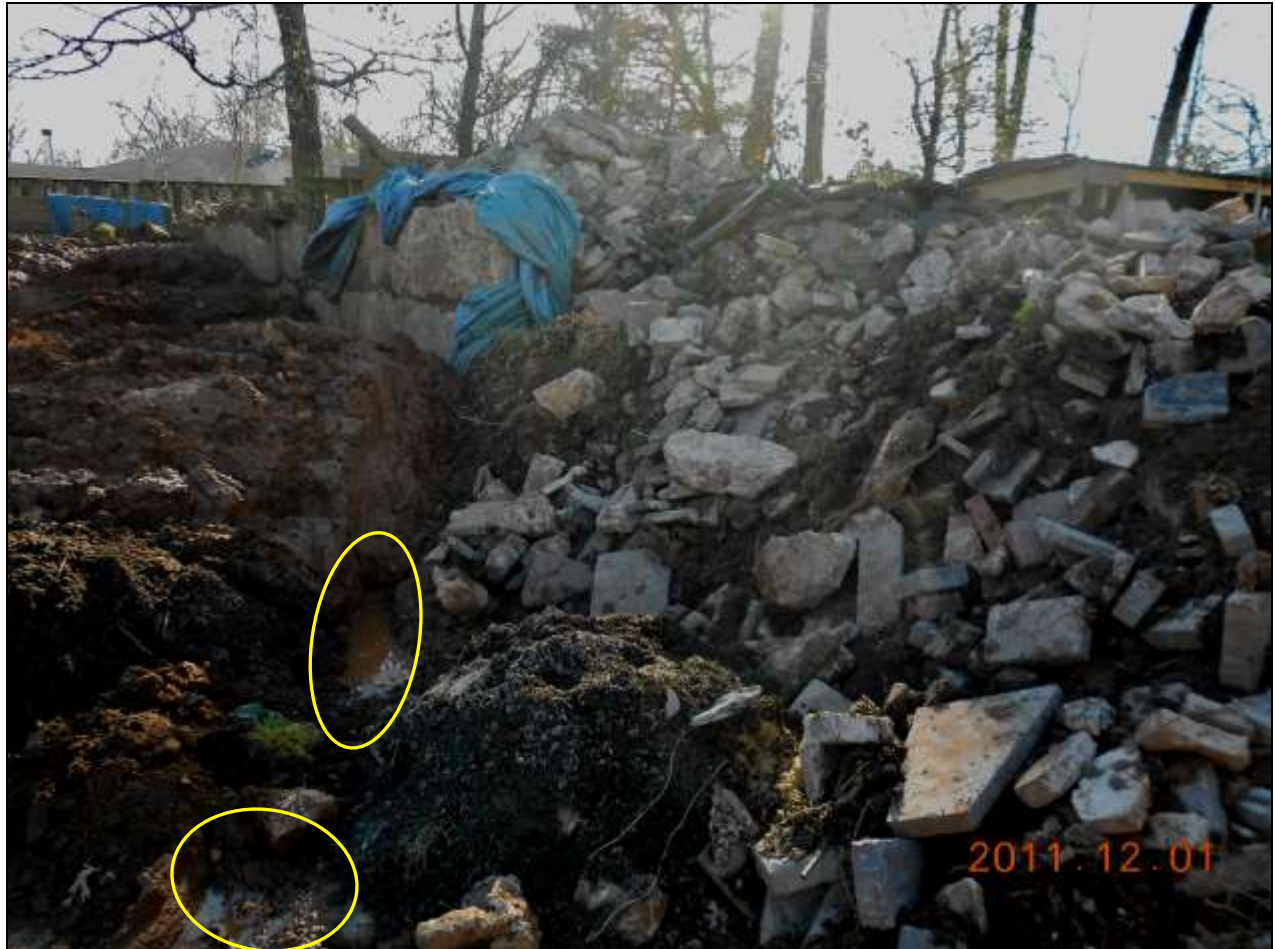
Figure 1 Concrete, debris, steep dirt or construction piles, water and mud; unsafe conditions and unsightly.

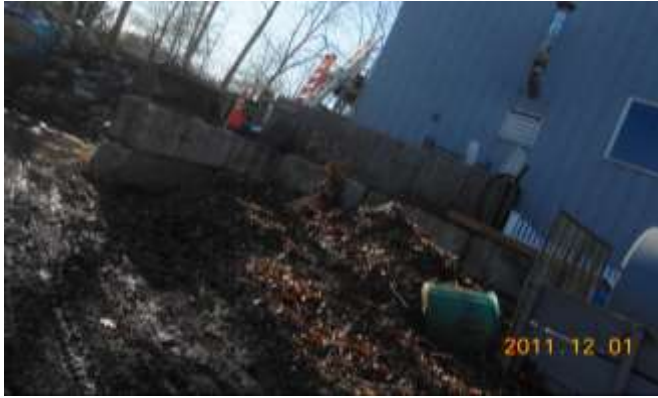
Figure 2 Property very muddy, poor drainage and erosion.

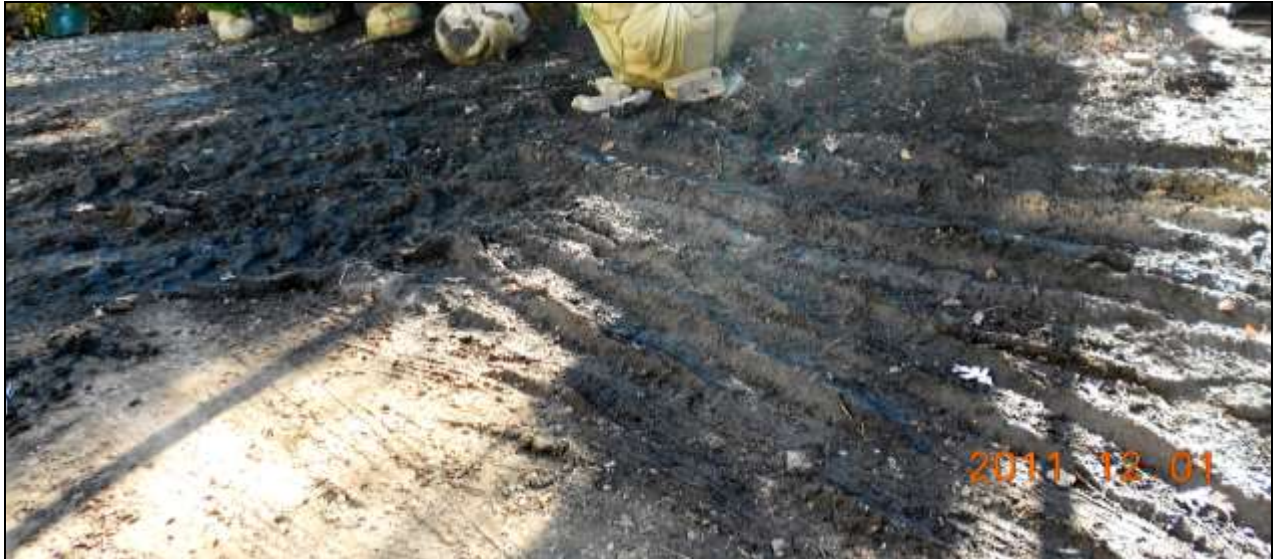
Figure 3 Thick wet mud or ruts around property from vehicles and poor drainage. Recommend stone, gravel or asphalt where for vehicular traffic. Drainage needs to be corrected; confer with a drainage/soils contractor or engineer.

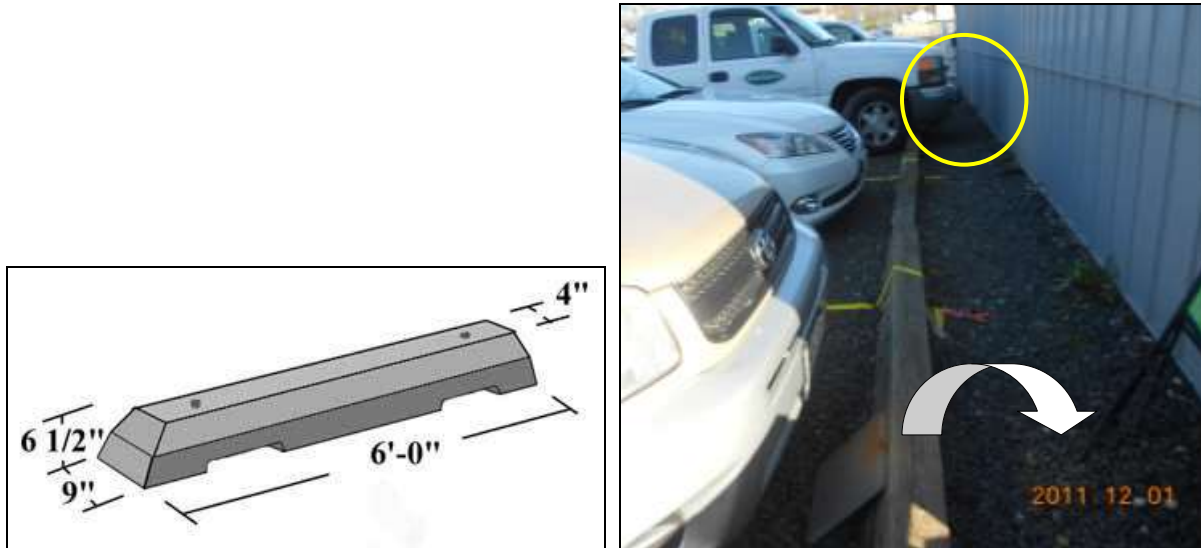
Figure 4 (A) Consider a precast parking chock to protect front of building. (B) Truck was very close to siding of building; wood wheel stops were leaning, failed and not performing as intended.

- **Protection/barriers *-** Add bollards near door entrance in front by parking area, in rear right corner of building where damaged by trucks or equipment vehicles. Add precast concrete parking chocks or wheel barriers in front parking area to protect building from vehicular damage.

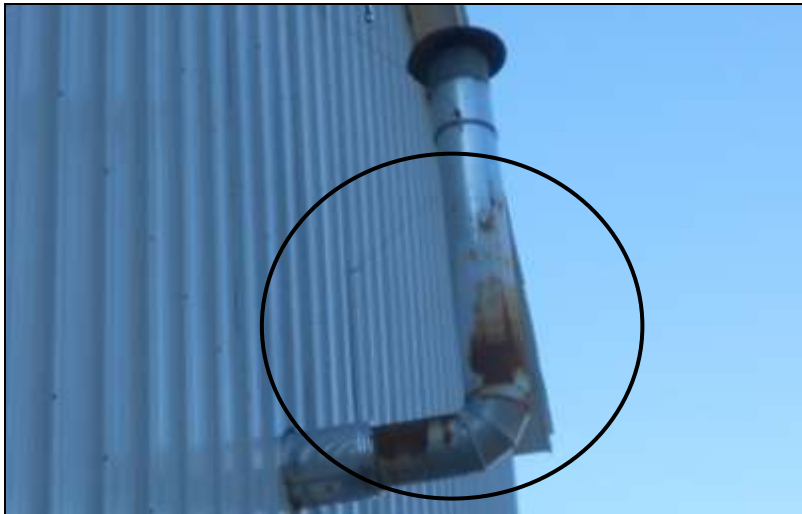
The chimney and venting had concerns. The metal chimney on exterior was very corroded or rusted. The vent connector to chimney had soot and heat scorch marks on vent and at seams. The vent connector was not pitched correctly; flat slope. System gives indication of poor venting, possible back drafting or possible blockage; ***potential fire and carbon monoxide hazard***. Recommend having chimney evaluated by a qualified technician or chimney contractor and obtain all specifications for height and installation from manufacturers. Recommend having this done and unit serviced before using for the current heating season for fire safety. Obtain all required permits for installed chimney and waste oil heater as per Local Township.

Figure 5 Metal chimney for the Omni waste oil burner was corroded. Have a chimney contractor evaluate. Vent connector off the furnace had heat/scorch marks and soot.

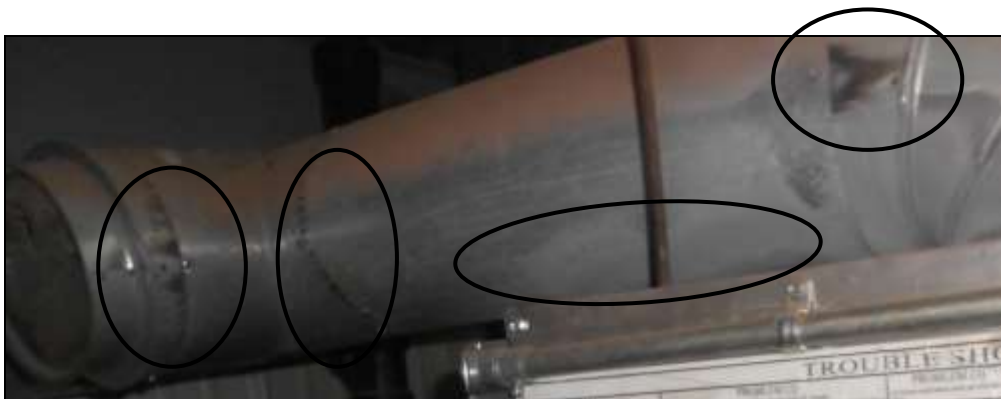
Figure 6 White hot spots and black scorch marks on vent connectors; gives indication of backdraft/improper drafting. Have chimney evaluated by a chimney contractor.

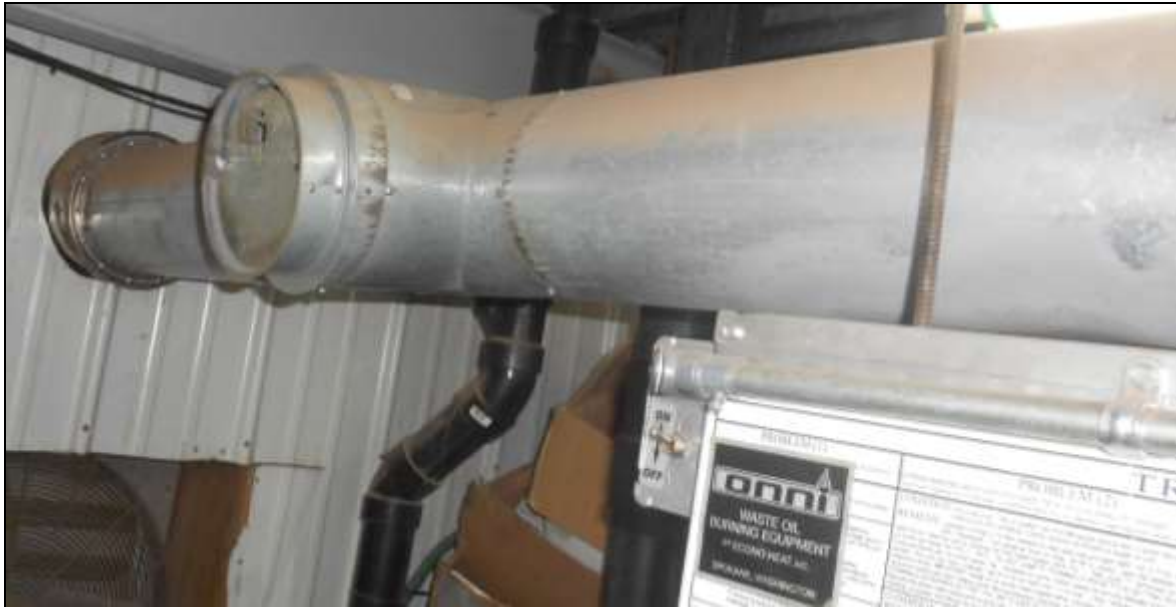
Figure 7 Vent connector was too flat; recommend a proper pitch for drafting.

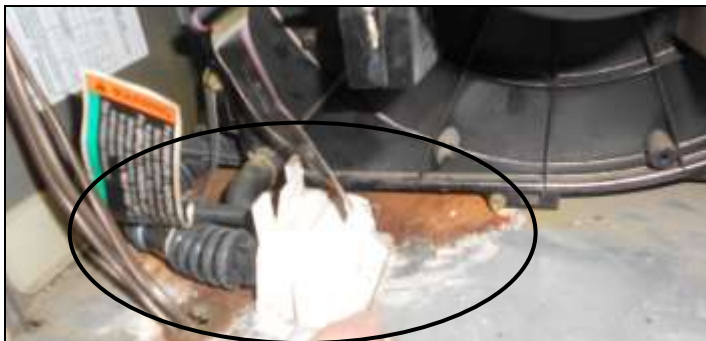
Figure 8 Corrosion or rust inside cabinet; have an HVAC contractor evaluate and service system.

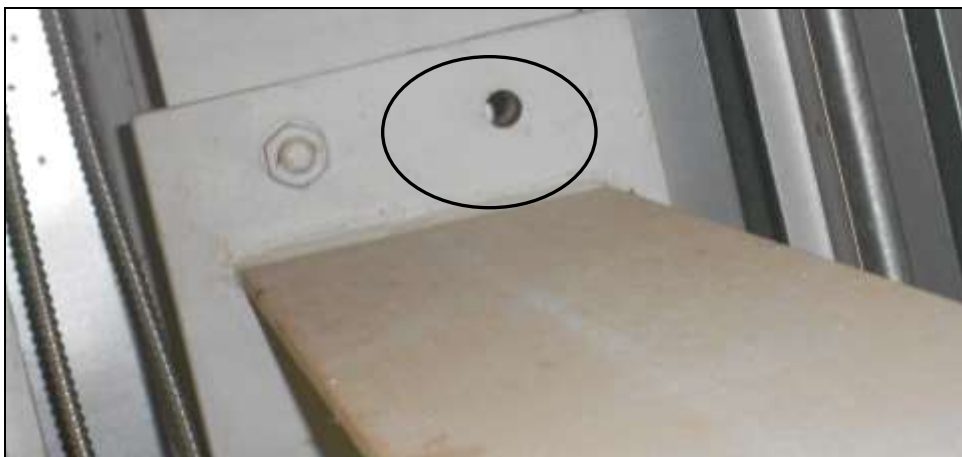
Figure 9 Missing bolt in top plate of the steel column. Add bolt and check all columns or connections to make sure bolts are installed and torqued to manufacturers or installation specifications.

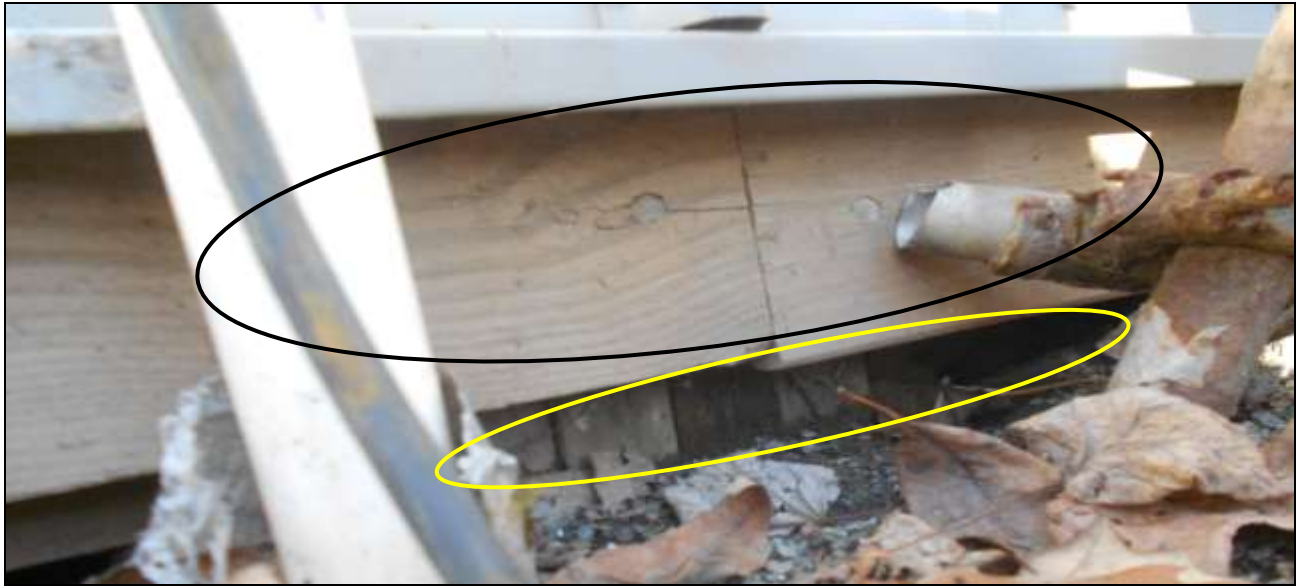
- There were 2x4's visible around under the man doors and or under the siding in some areas. Check the design specifications or engineering plans to see why the wood was installed and to see why siding was overhanging the slab; possible workmanship or installation concern. There was approximately 2-3 inches of siding over hang where randomly checked. Wood should not be in contact with soil to avoid rot and attracting termite or other wood destroying insects.

Figure 10 Wood 2x4s facing out and several (7+) nailed together perpendicular to the front 2x4. There was siding overhang approximately 2-3 inches where randomly checked in between storage against building. Check the building plans for the siding overhang and wood used under doors or perimeter.
