4 Seasons Home Inspection, LLC

Mr. and Mrs. New Construction
Street Address
Township, New Jersey zip code

Inspection Date: July 15, 2009 9am-9pm
Client Name: Client Name(Emails to send reports)
Inspection Address: Street Number, City, NJ
Inspected by: Linda Geczi home inspection lic. #24GI00061500

Detailed Summation begins on pg 5-23 w/pictures

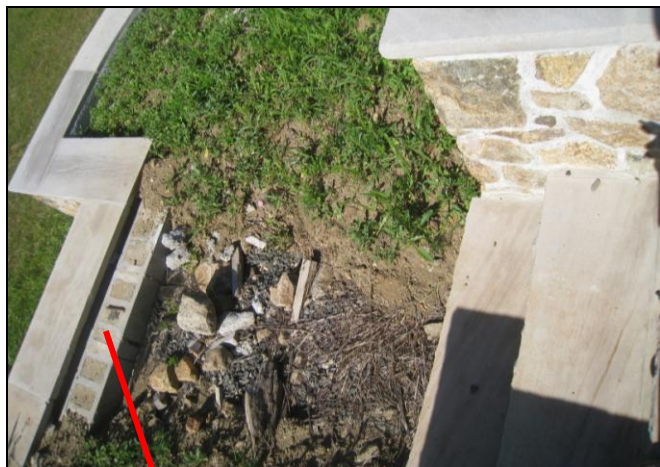
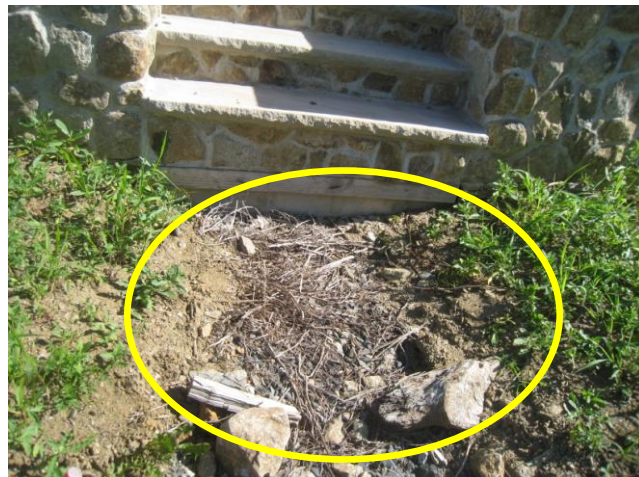
Figure 1 A & B Missing walk between retaining walls; fall hazard.

- 1.) Grading & drainage- Engineer evaluation for drainage
- 2.) Walkway connecting retaining walls missing & water under lower steps; safety concern
- 3.) Obtain all closed Permits on retaining wall/engineer drawings- safety railings
- 4.) Patio missing mortar, uneven, flat-slight pitch toward steps(drainage concerns)- Seal all joints/keep level

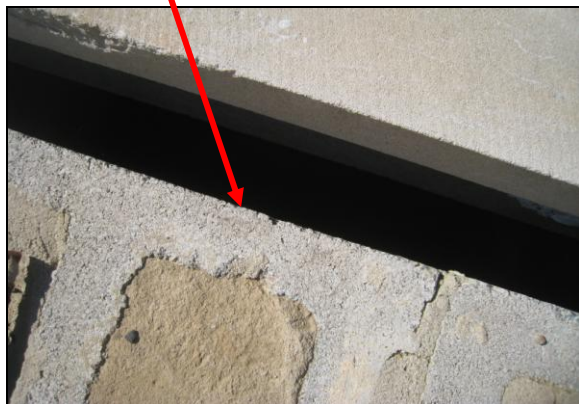
Figure 2 Wide gap, stagnant water inside below lower steps; drainage & safety concerns.

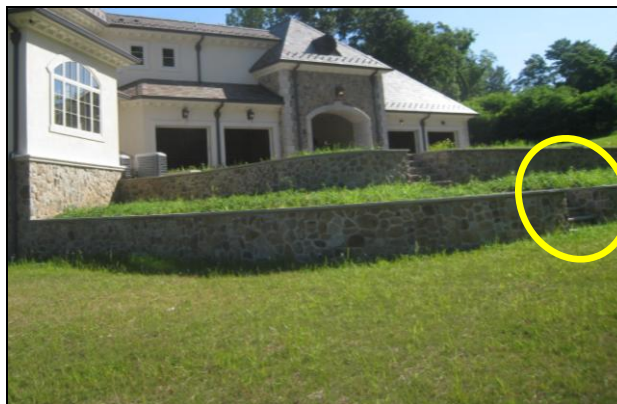
Figure 3 No railings, missing walk connecting walls

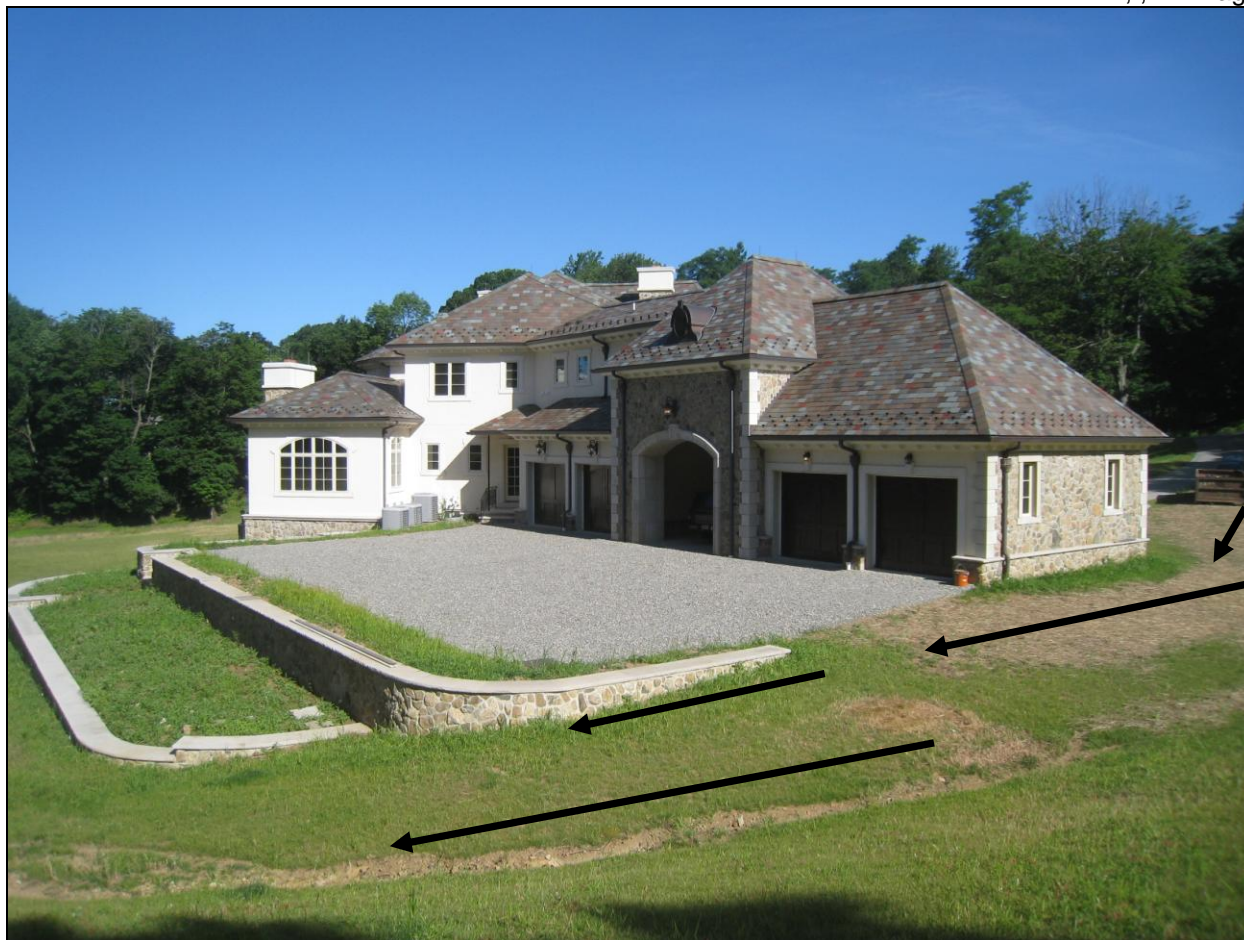
Figure 4 Deep ruts where water washing away soil from front driveway to side/rear property; drainage concerns.

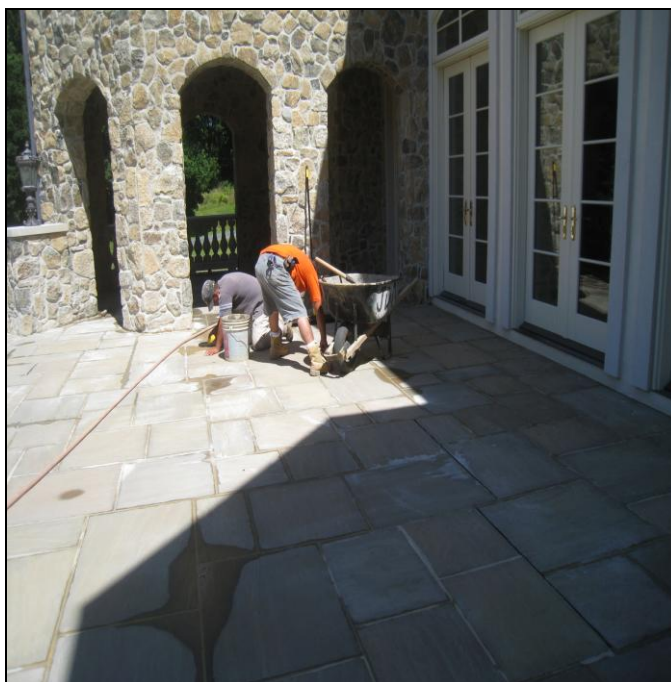
Figure 6 Workers making repairs on patio.

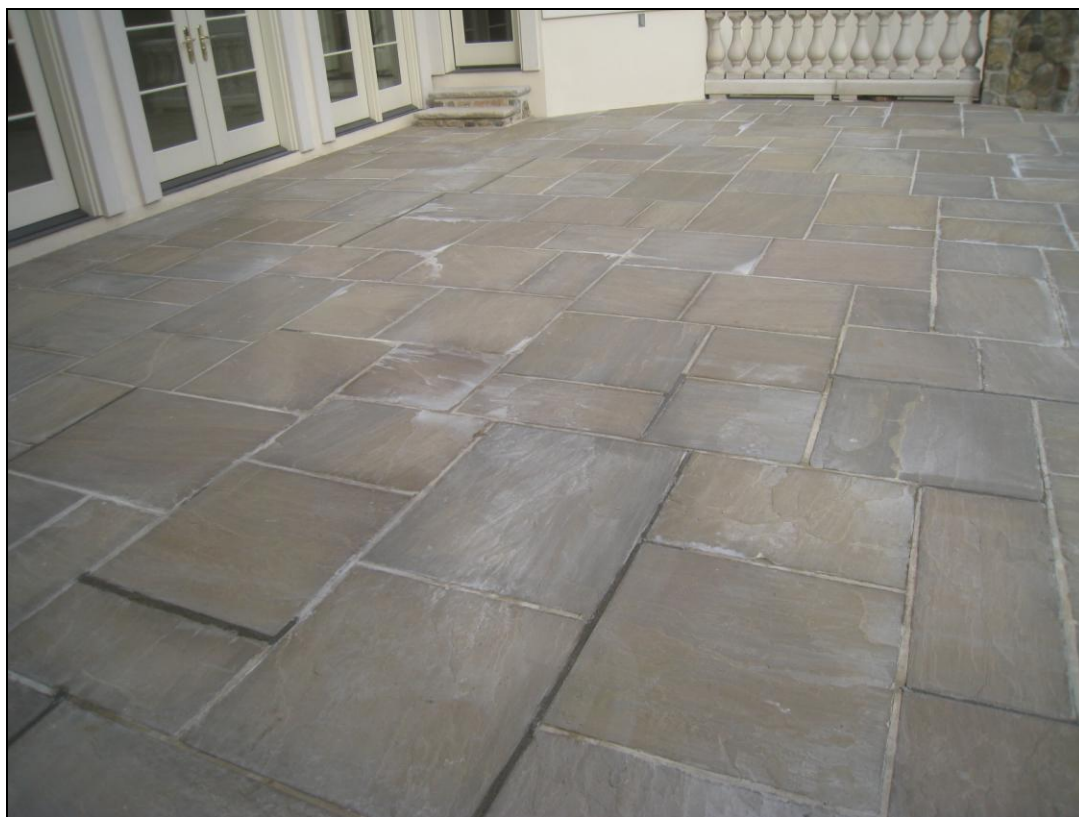
Figure 7 Many mortar repairs being made on patio. Some areas or joints raised.

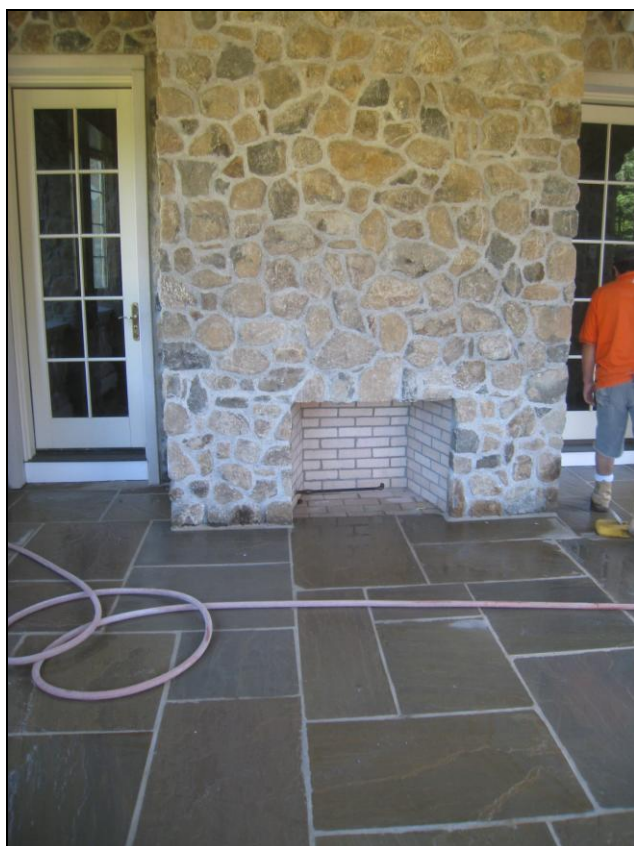
Figure 8 Slate/mortar repairs being made.

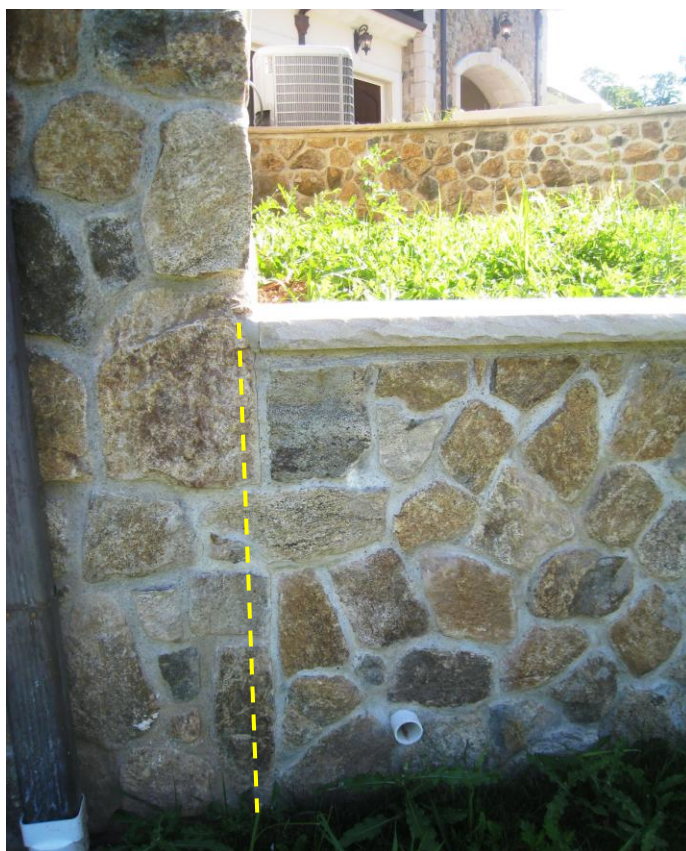
Figure 9 Vertical cracks at retaining wall/siding juncture

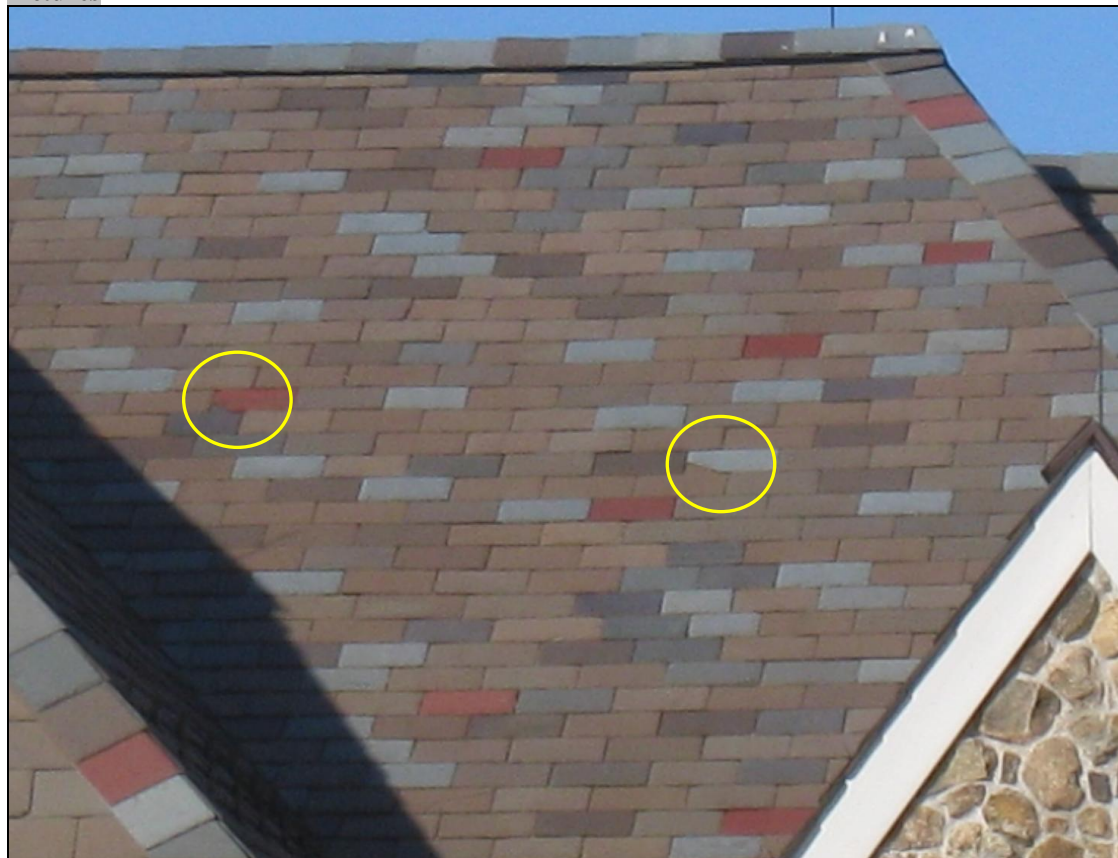
Figure 10 Examples of broken shingles

- 1.) Slate roof had several broken, chipped, split shingles- Have Slate roofer make evaluation/ repairs

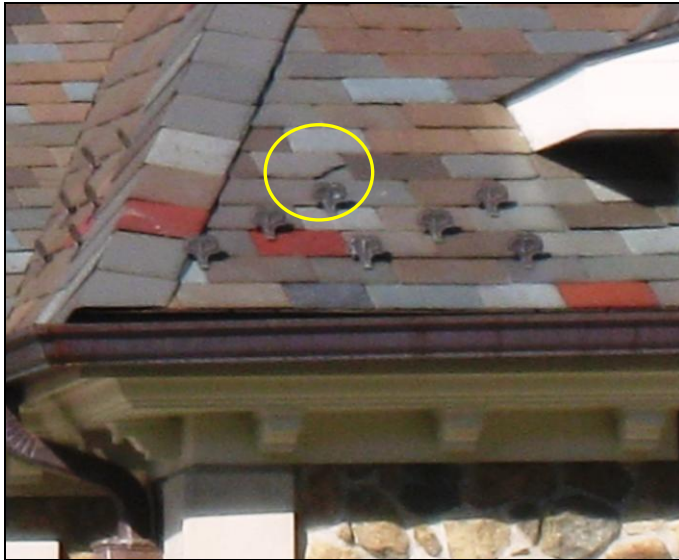
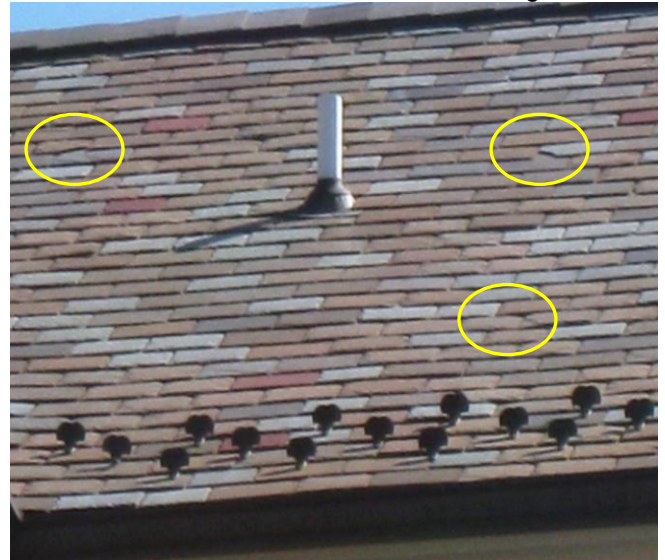
Figure 11 A & B Example of broken slate shingles

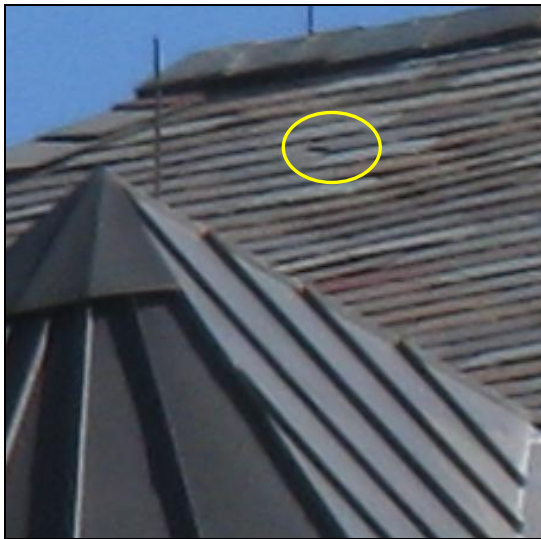
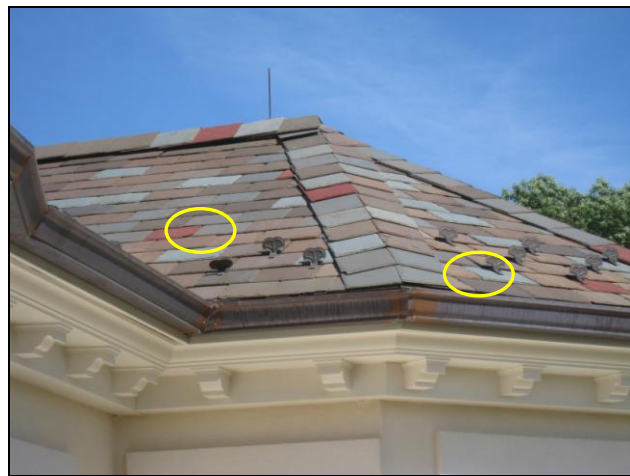
Figure 12 A, B & C Examples of broken or chipped slate.

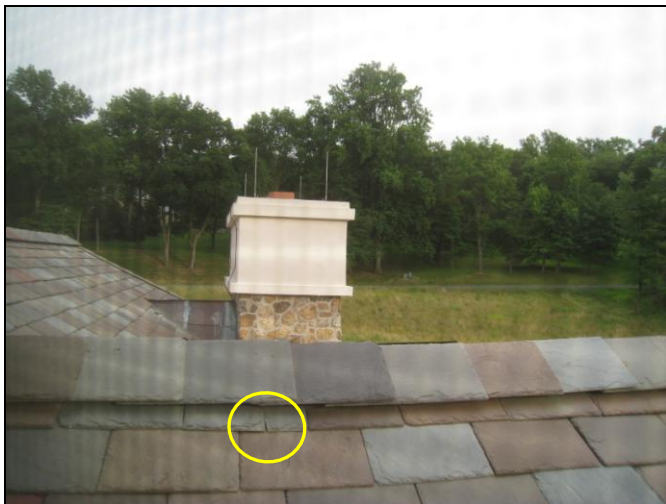
Figure 13 Split shingle

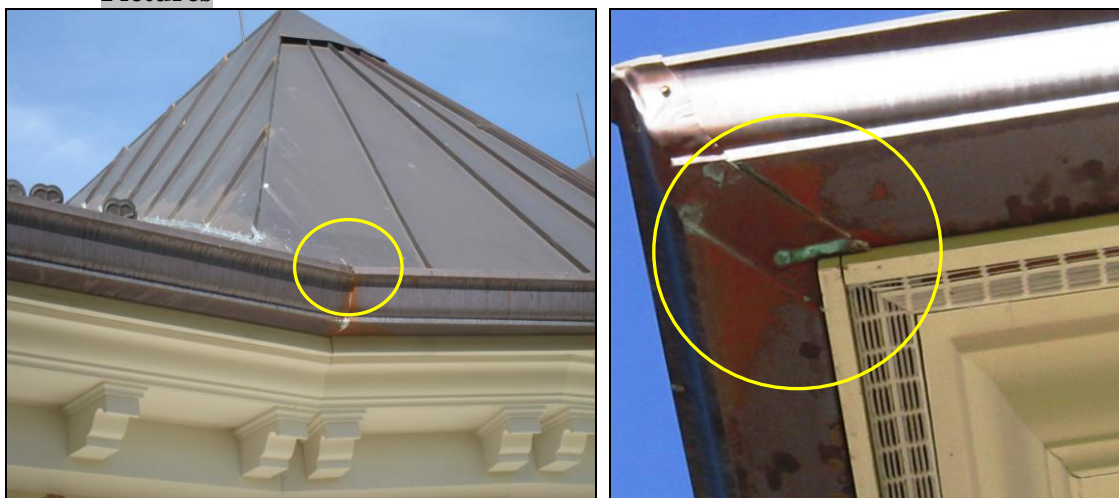
Figure 14 A & B Leaking at junctures

- 1.) Gutters leaking at corners, seams, junctures and spillage along main runs- Have gutters evaluated & corrections/repairs made. Soil ruts visible and stains on siding or EIFS.
- 2.) Recommend Structural engineer evaluate outcrop off rear kitchen; cracks
- 3.) All gaps, mortar and cracks on cladding & trim needs to be properly sealed/evaluated

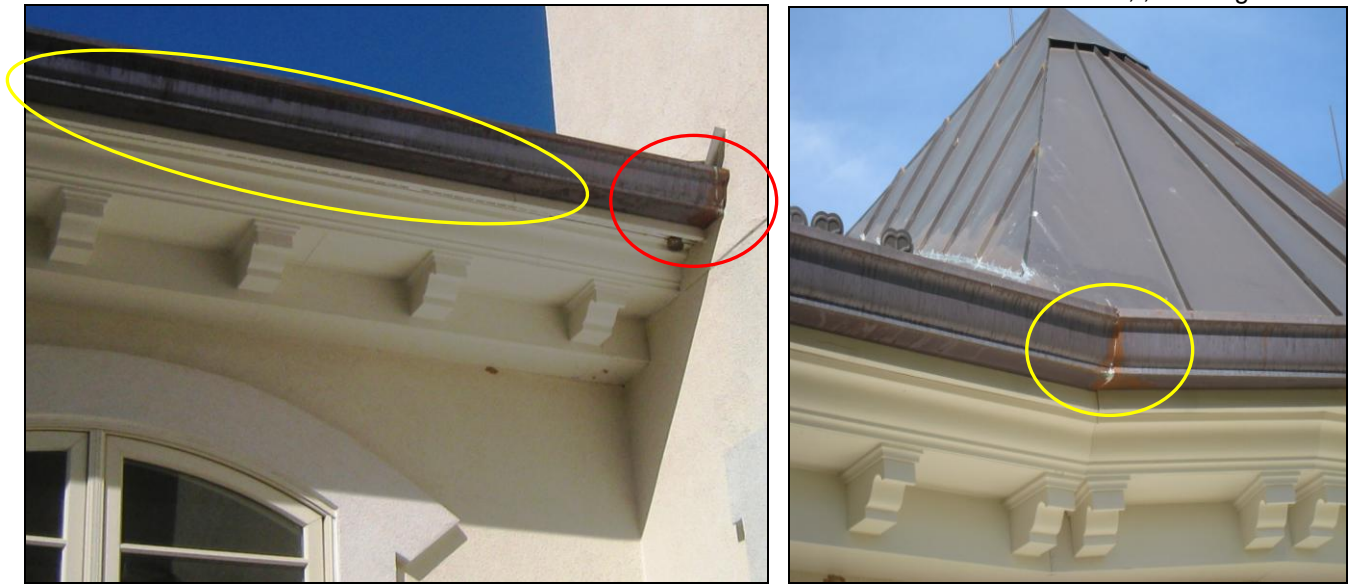
Figure 15 A, B, C & D Indication of leaking gutters and spillage marks. Ruts in soil below.

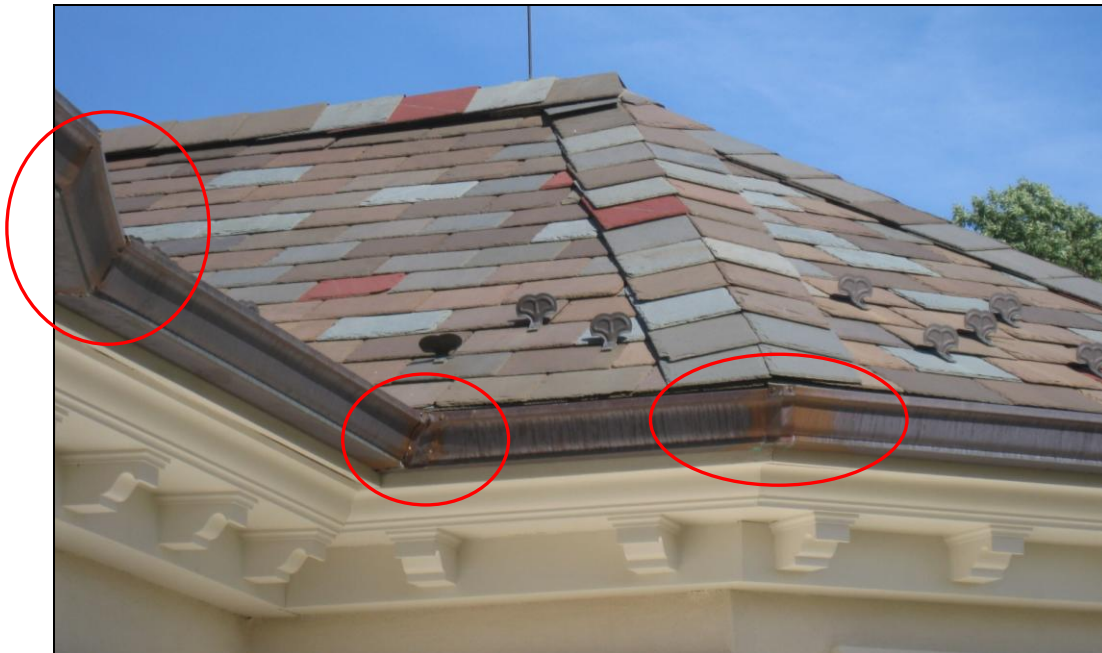
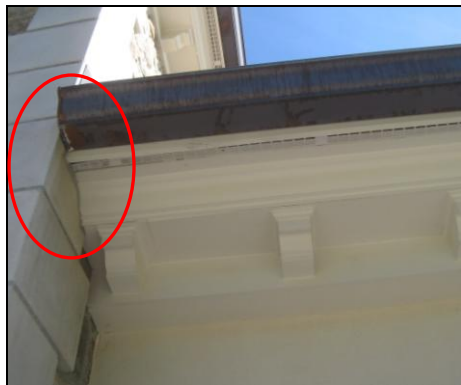
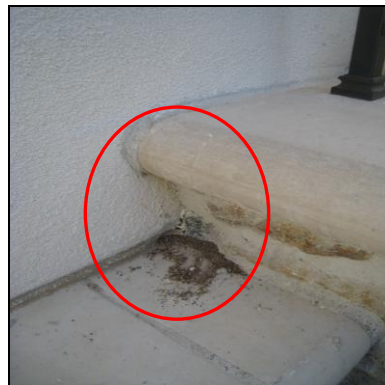
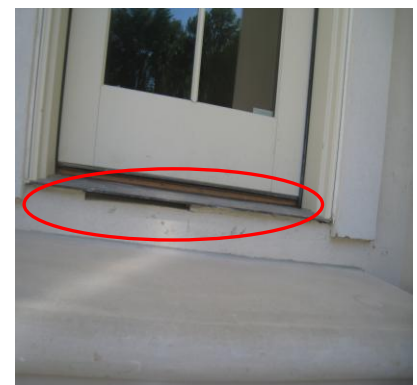
Figure 16 Gaps in caulking/mortar and ant hills. Gaps under rear door.

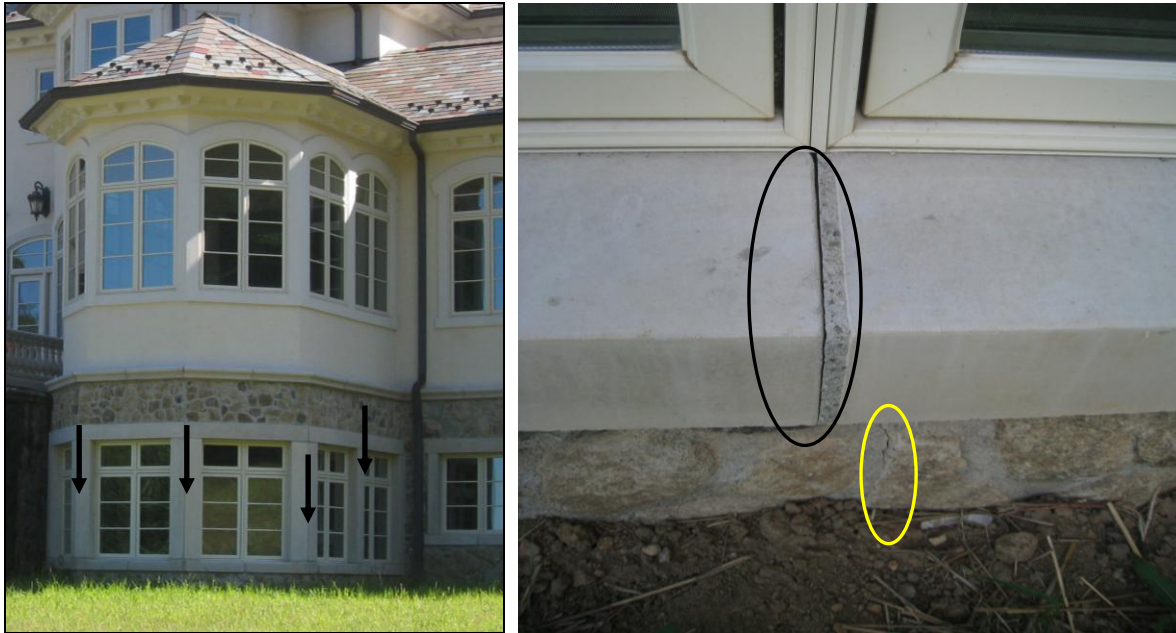
Figure 21 Several vertical cracks all around outcrop main kitchen area. Recommend evaluation by Structural Engineer; structural concern.

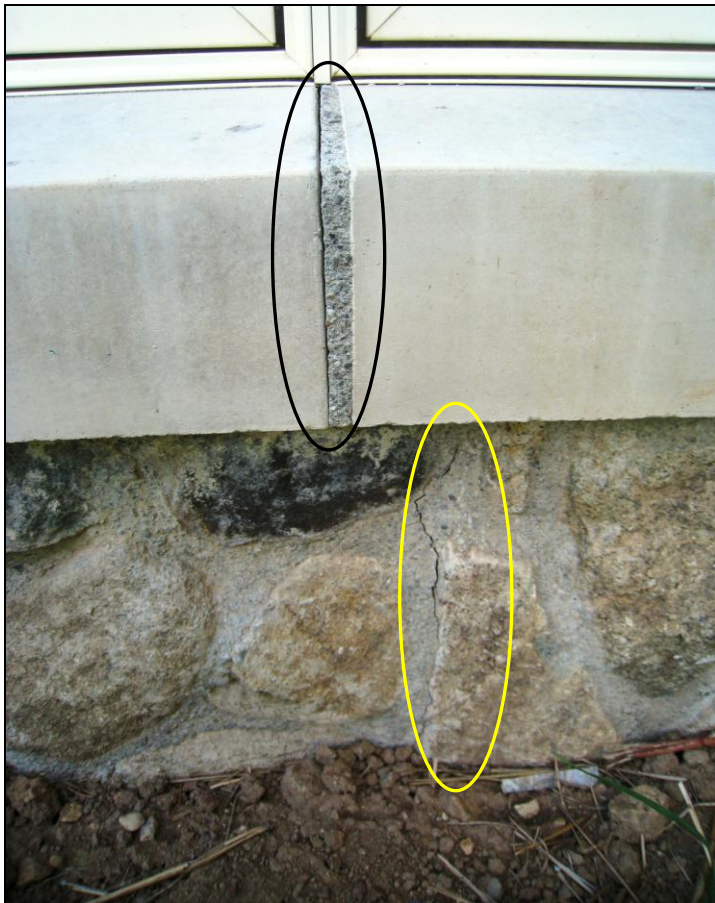
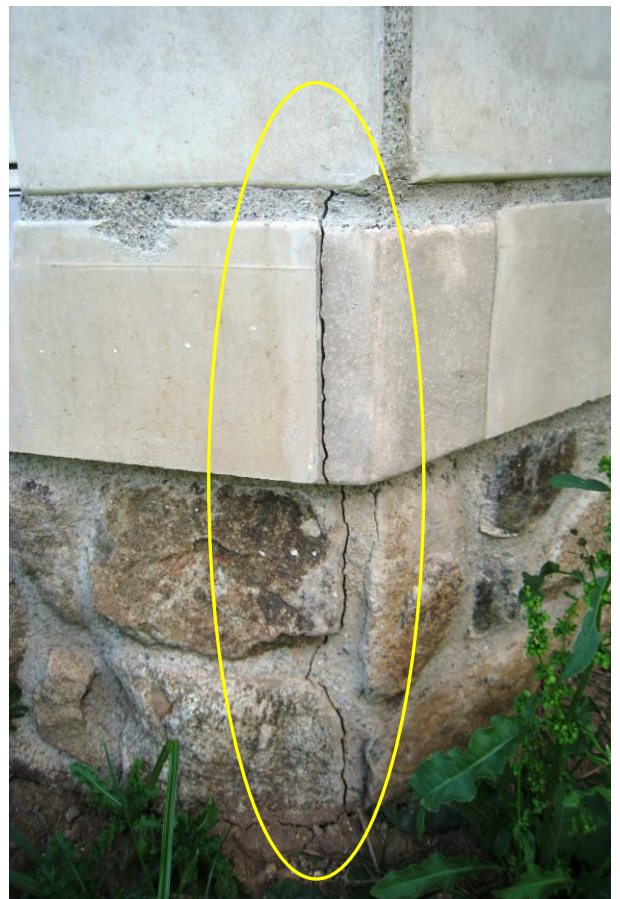
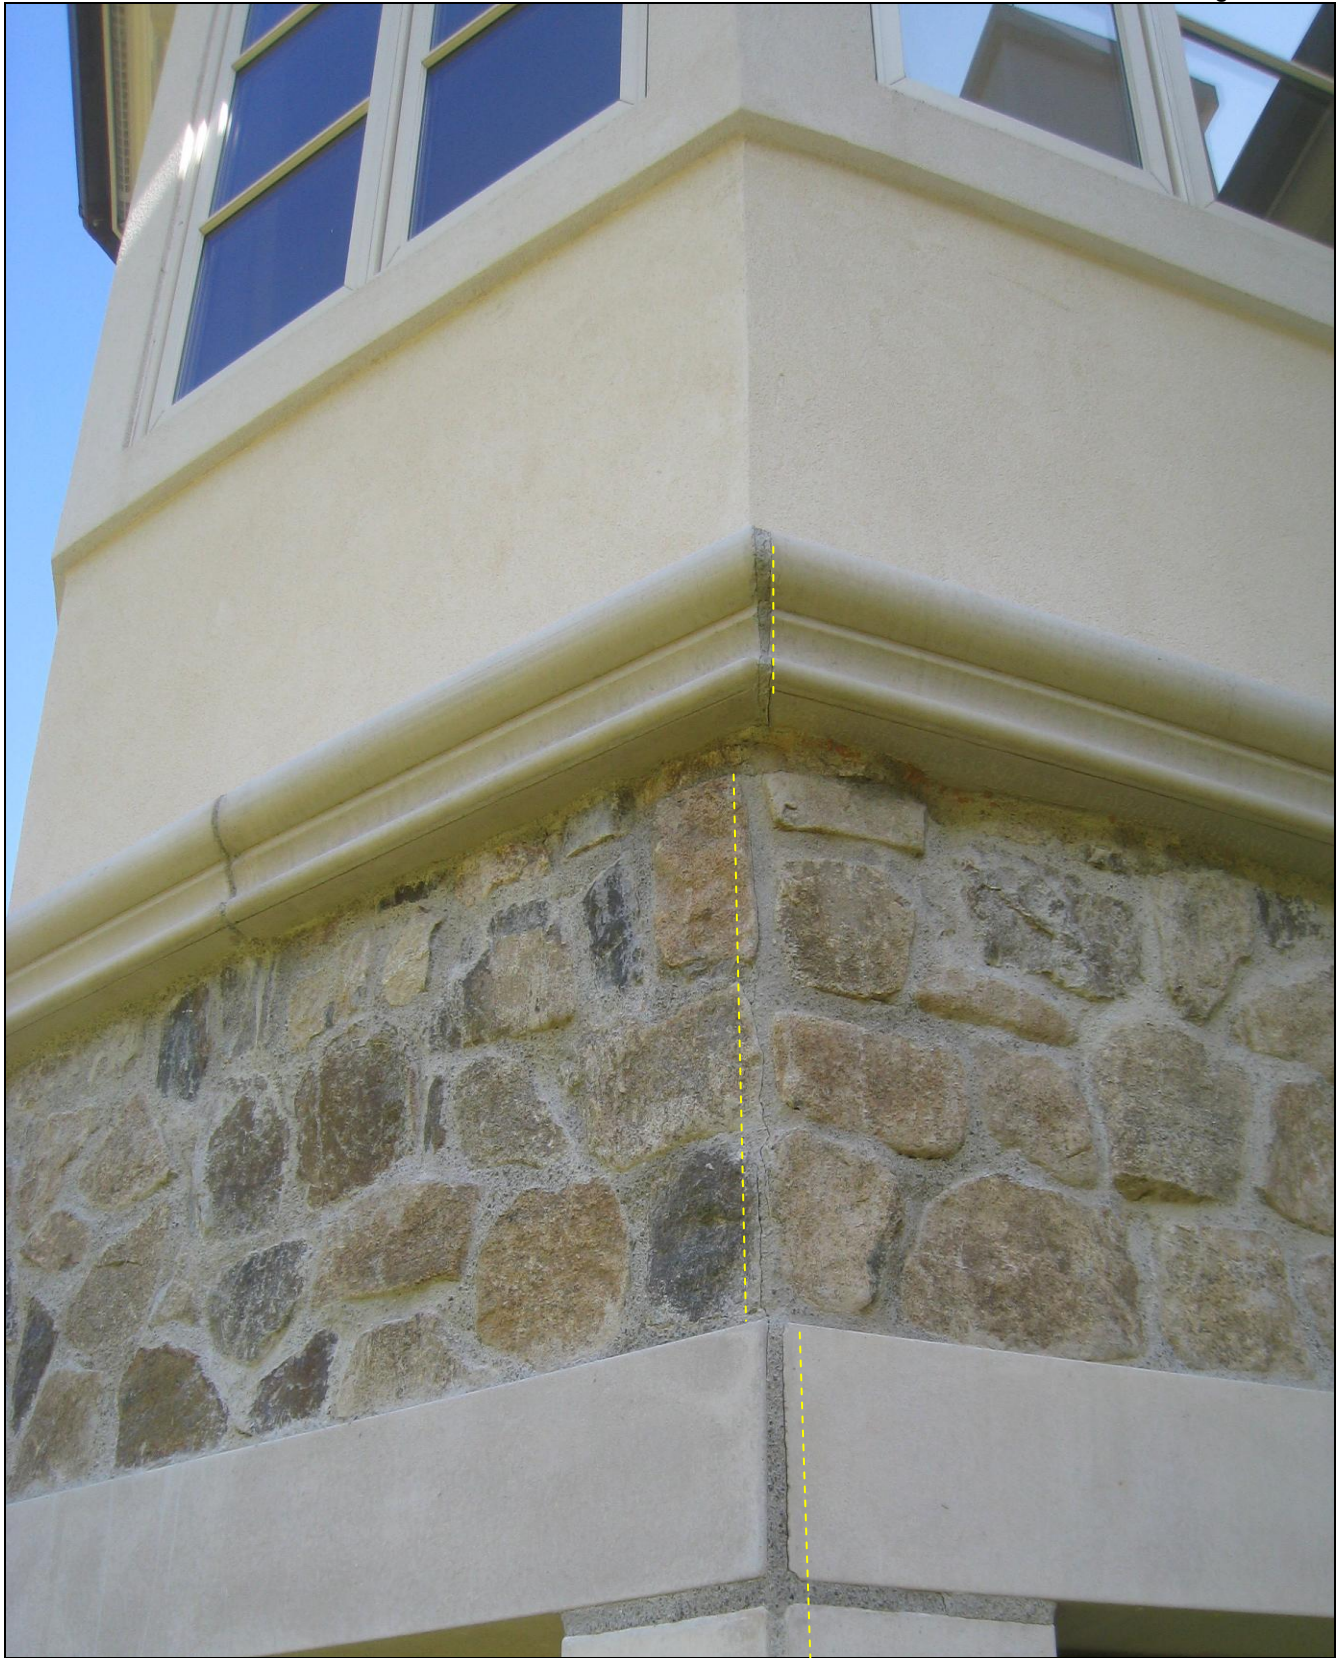
Figure 22 Examples of vertical cracks all around kitchen outcrop

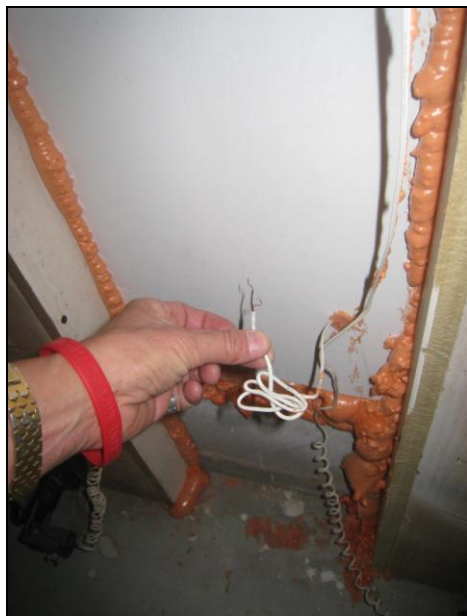
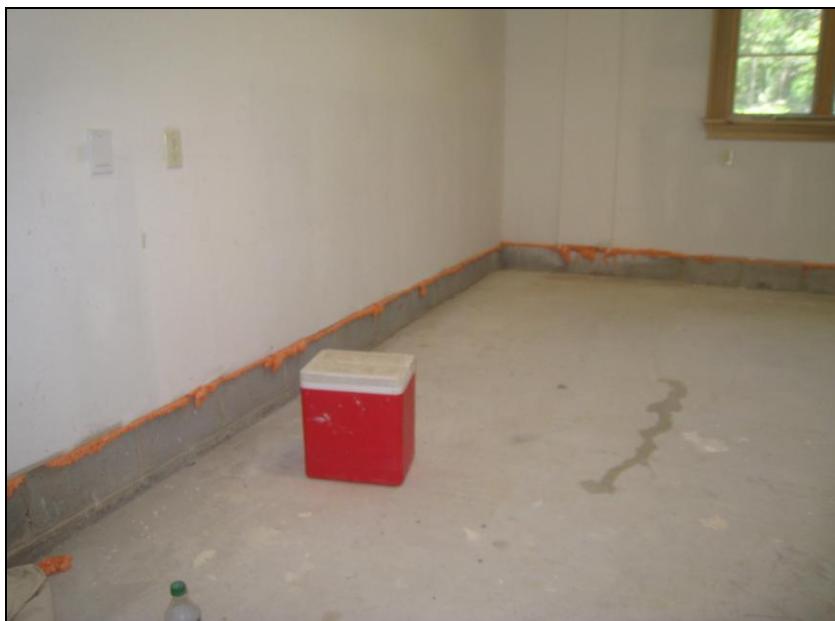
Figure 23 Loose wires by garage doors; further evaluate. Expansion foam everywhere; not recommended.

- 1.) A/C condensers not level, loose wires in rear grouping.
- 2.) Expansion foam everywhere in garage; not recommended

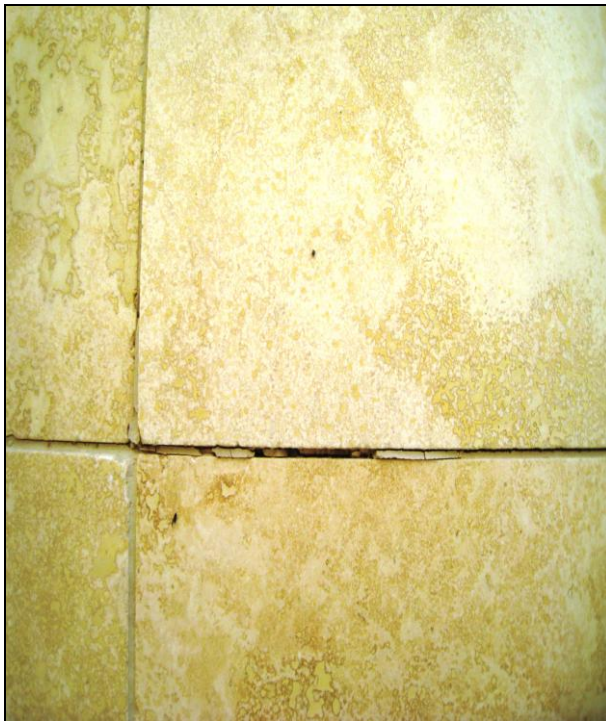
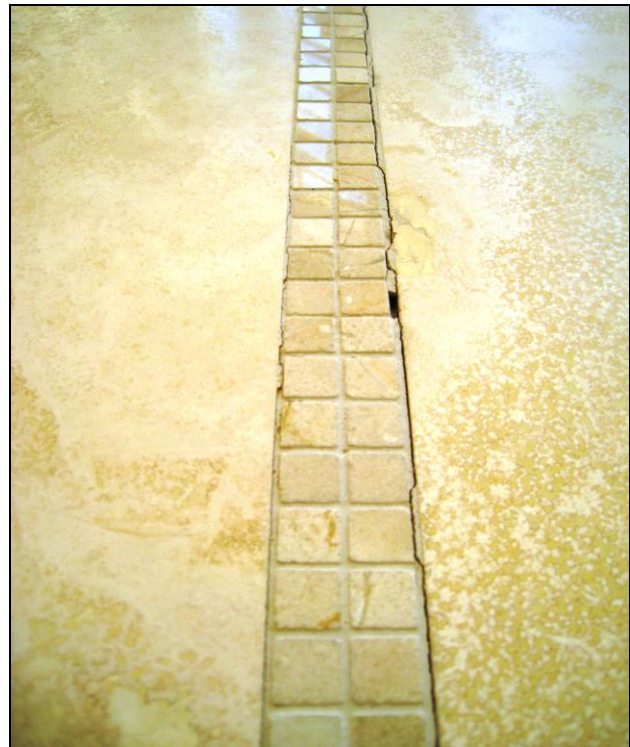
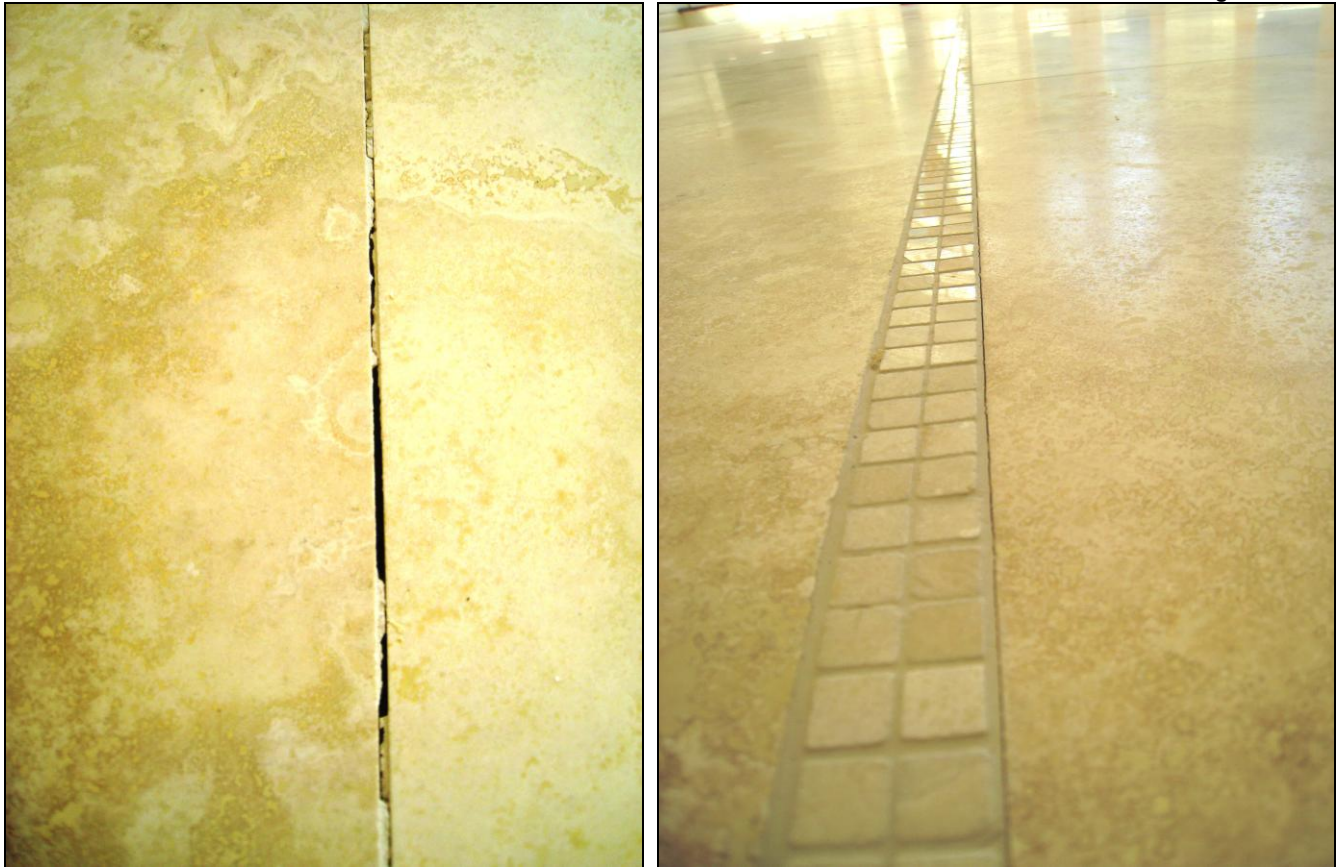
Figure 24 Numerous cracks on tiled flooring in living room; have evaluated and corrected.

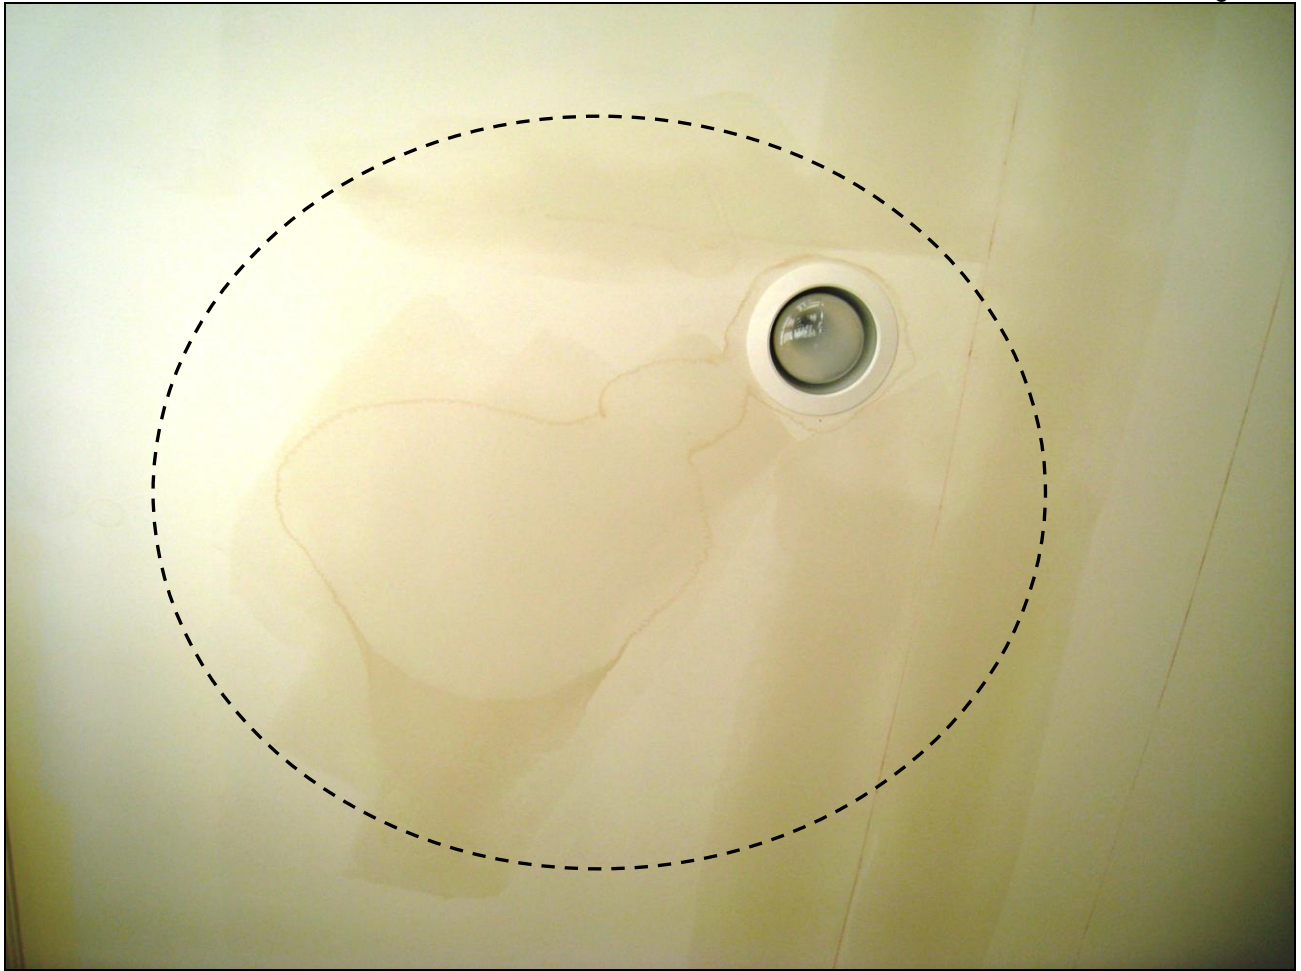
Figure 25 Water stains; indication of leaking above. See roofing section.

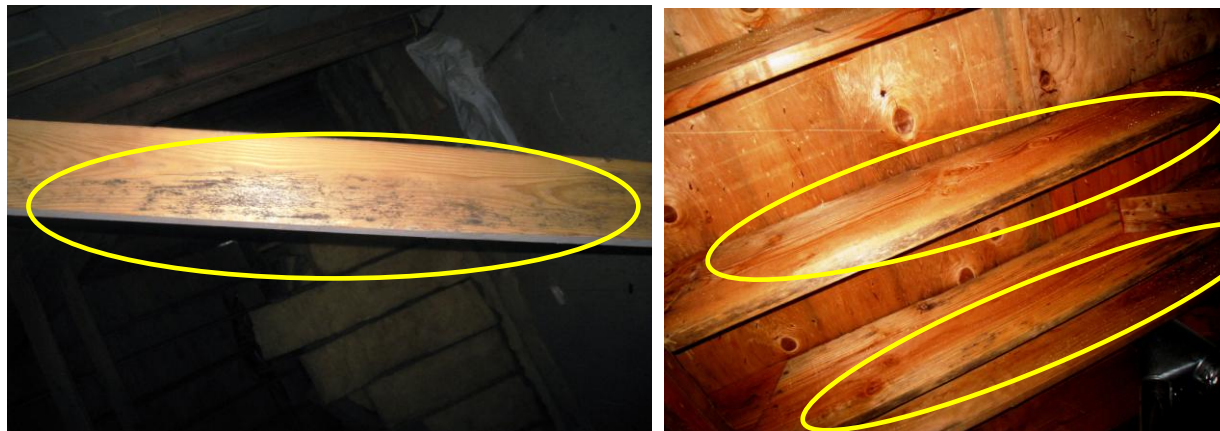
Figure 26 Examples of Possible mold; further evaluate and mitigate as per contractor & testing.

- 1.) Follow-up with builder or contractor on all flooring concerns in home
- 2.) Possible mold in attics; attics very hot/lack of proper ventilation. Testing & further evaluation recommended by ventilation contractor and mold testing/mitigation company.

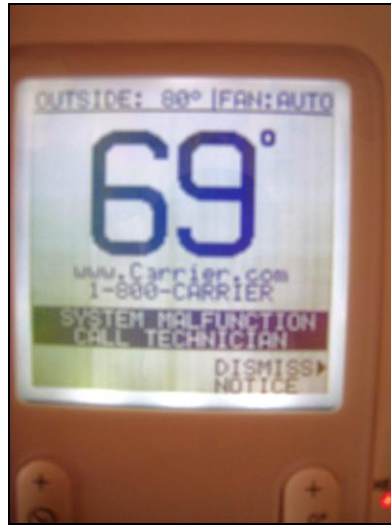
Figure 27 # Units gave this message when heat or HVAC tested.

HEATING: Typical life expectancy of furnace is approximately 25 yrs when maintained properly. Units are approximately 6 yrs old. Recommend cleaning ducts yearly or as needed. *Ducts were very dirty in all rooms; filled with construction debris.* Recommend changing filters as per manufacturers recommendation. Typically there are 30, 60 or 90 days filters on market; personal choice. Recommend a yearly service or tune up on HVAC system. Recommend a "Home Warranty." *Floor heating in master bath did not get hot when tested; have checked before closing. Furnaces #1, 3, and 4 did not operate when tested. Units #2, 5 and 6(attic) were functioning when tested. Thermostats for the non functioning units displayed the message as follows: System Malfunction Call Technician. Recommend a technician evaluate the HVAC systems and floor heat on second floor before closing.*

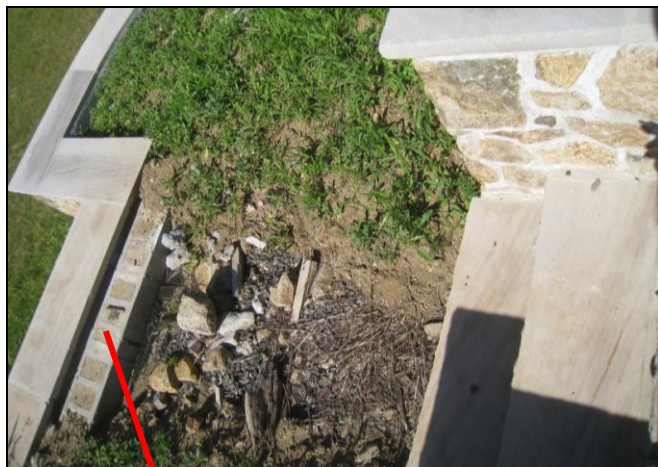
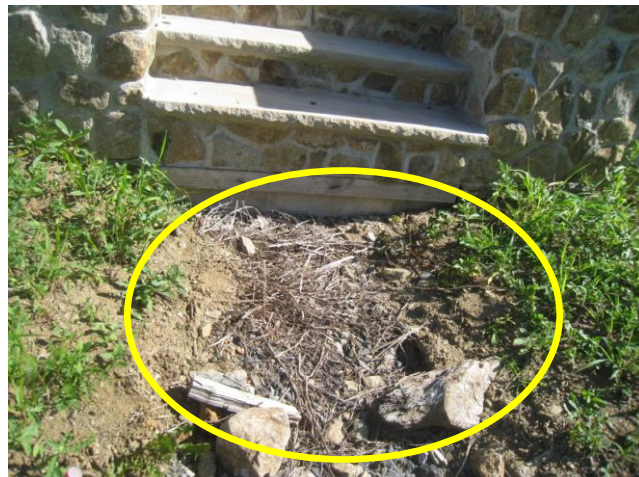
Figure 28 A & B Missing walk between retaining walls; fall hazard.

- 1.) Grading & drainage- Engineer evaluation for drainage
- 2.) Walkway connecting retaining walls missing & water under lower steps; safety concern
- 3.) Obtain all closed Permits on retaining wall/engineer drawings- safety railings
- 4.) Patio missing mortar, uneven, flat-slight pitch toward steps(drainage concerns)- Seal all joints/keep level

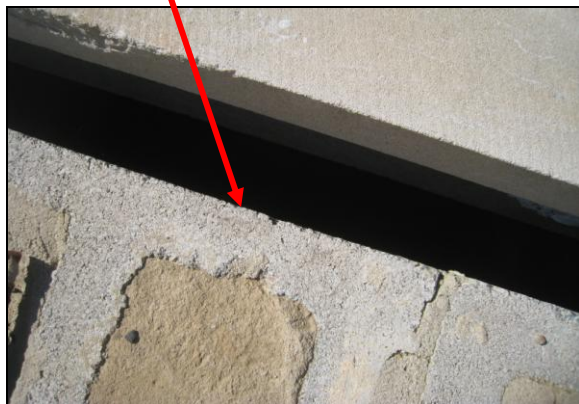
Figure 29 Wide gap, stagnant water inside below lower steps; drainage & safety concerns.

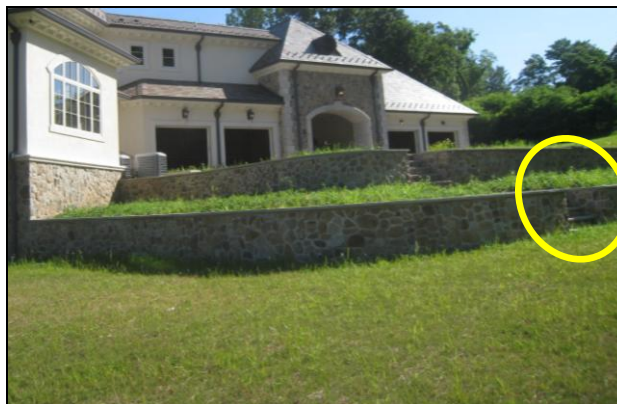
Figure 30 No railings, missing walk connecting walls

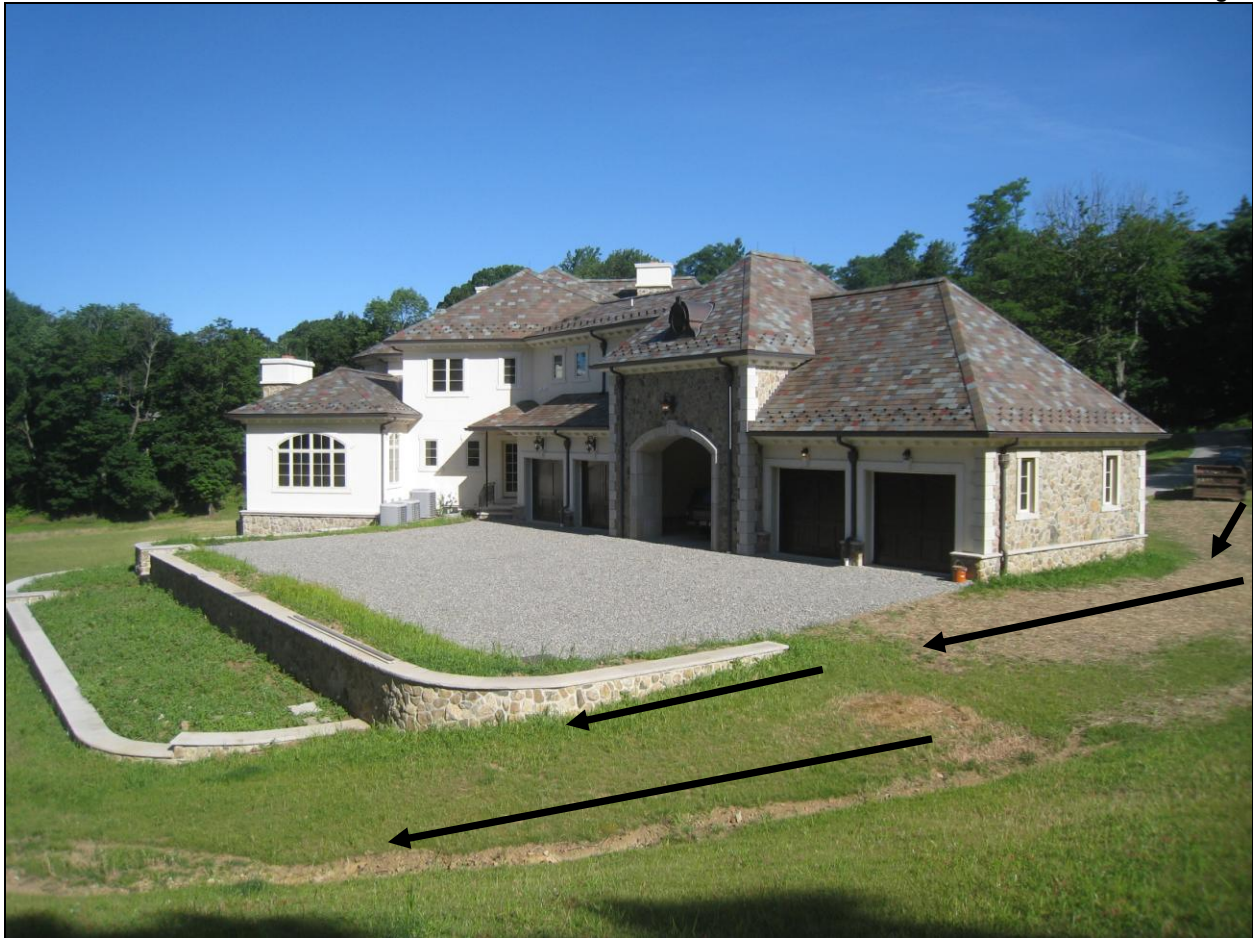
Figure 31 Deep ruts where water washing away soil from front driveway to side/rear property; drainage concerns.

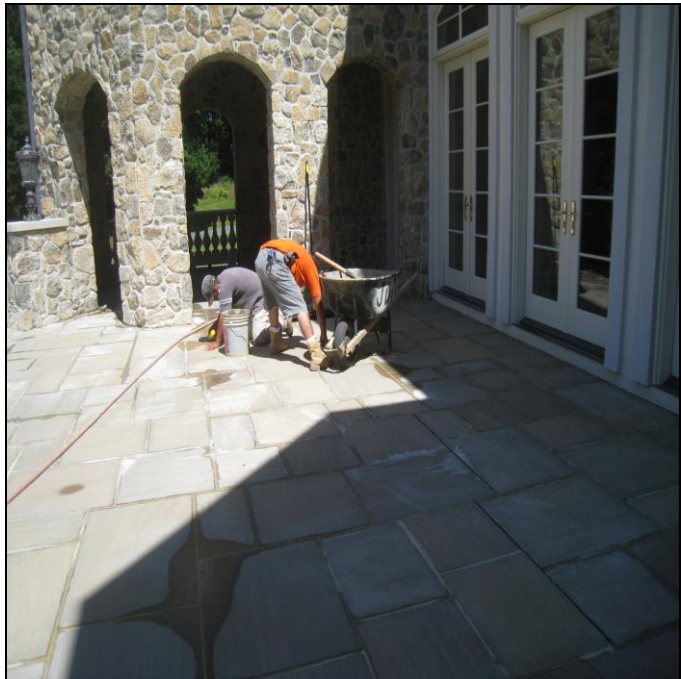
Figure 33 Workers making repairs on patio.
