4 Seasons Home Inspection, LLC

Mr. and Mrs. New Construction
Street Address
Township, New Jersey zip code

Inspection Date: July 15, 2009 9am-9pm
Client Name: Client Name(Emails to send reports)
Inspection Address: Street Number, City, NJ
Inspected by: Linda Geczi home inspection lic. #24GI00061500

Detailed Summation begins on pg 5-23 w/pictures

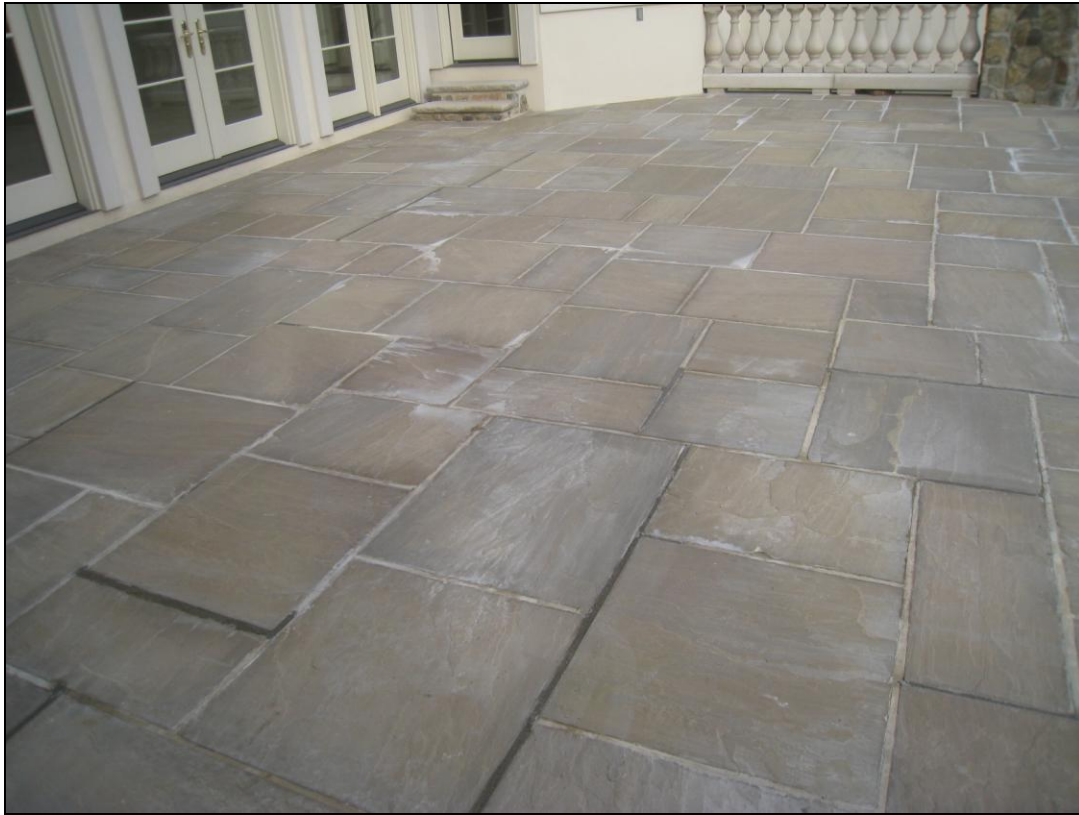
Figure 34 Many mortar repairs being made on patio. Some areas or joints raised.

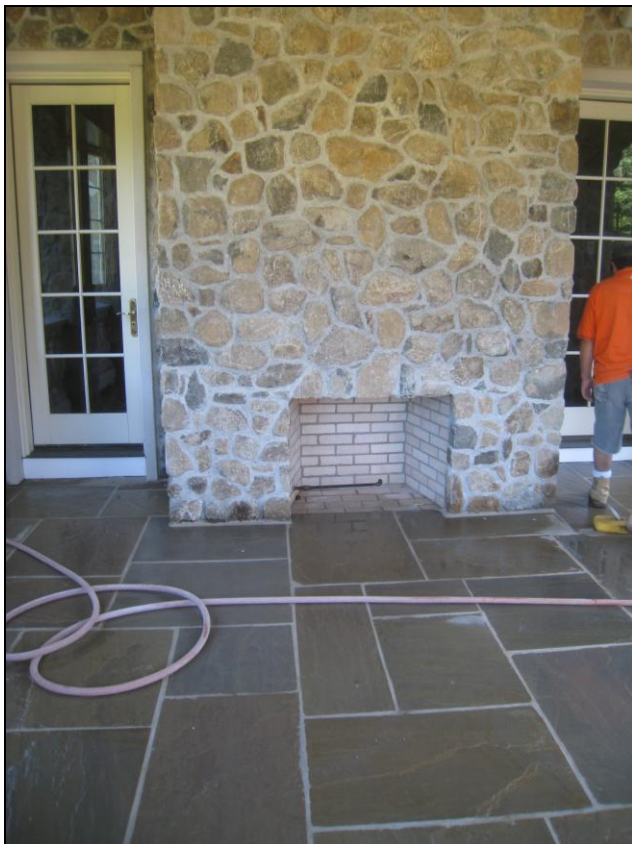
Figure 35 Slate/mortar repairs being made.

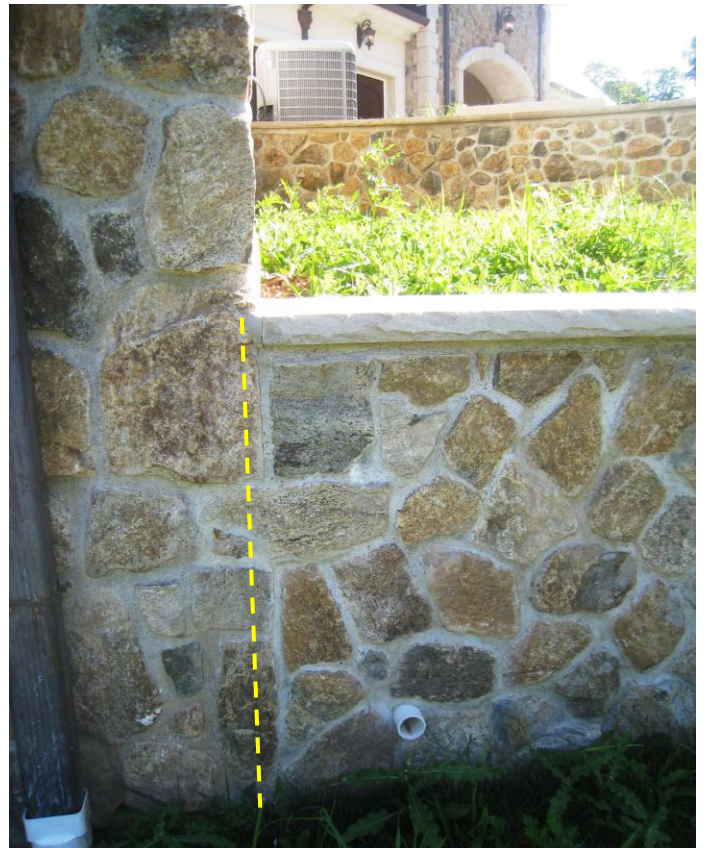
Figure 36 Vertical cracks at retaining wall/siding juncture

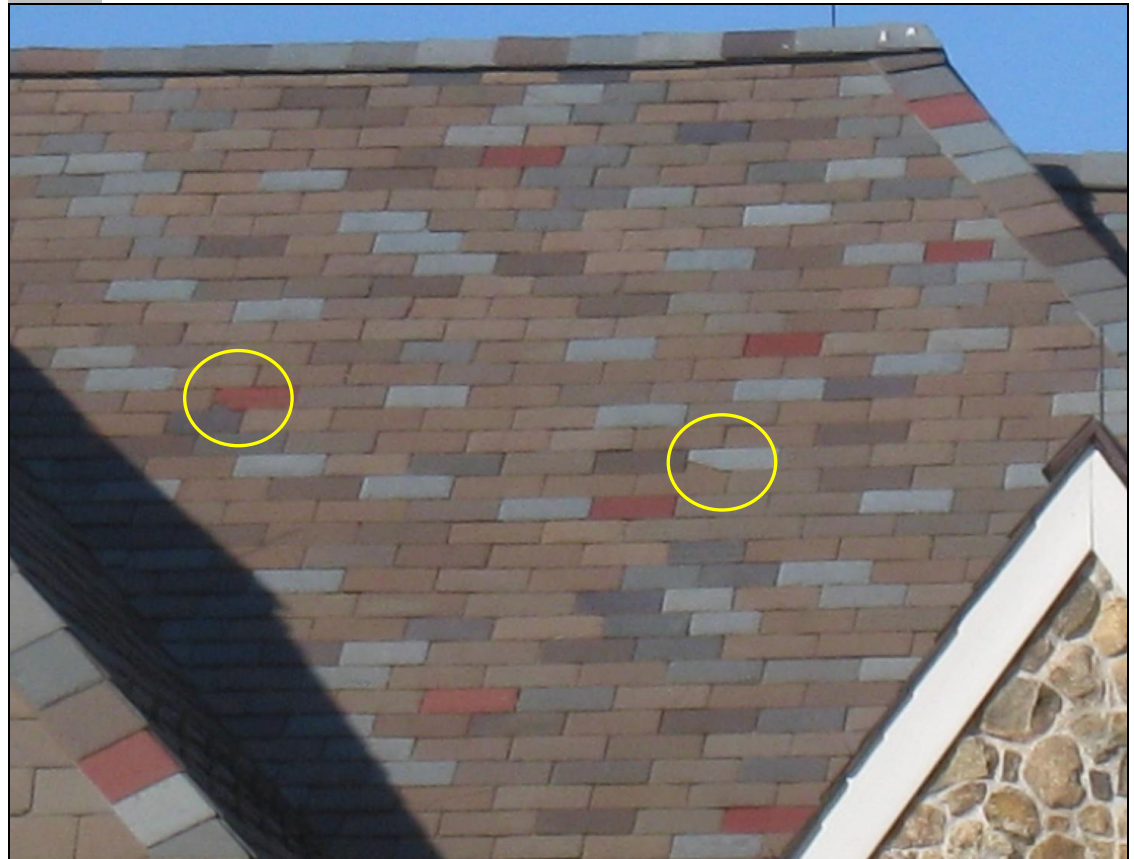
Figure 37 Examples of broken shingles

1.) Slate roof had several broken, chipped, split shingles- Have Slate roofer make evaluation/ repairs

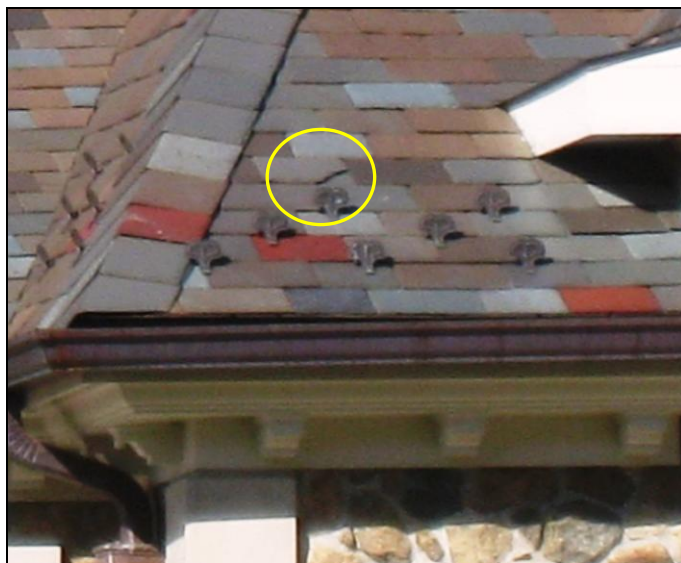
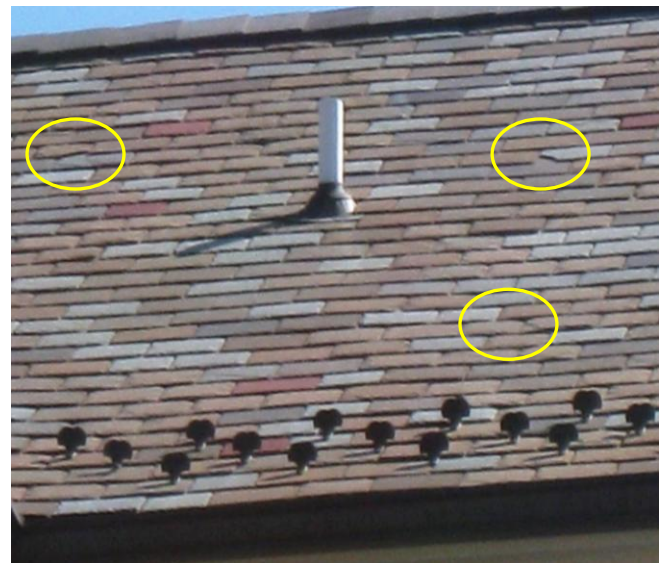
Figure 38 A & B Example of broken slate shingles

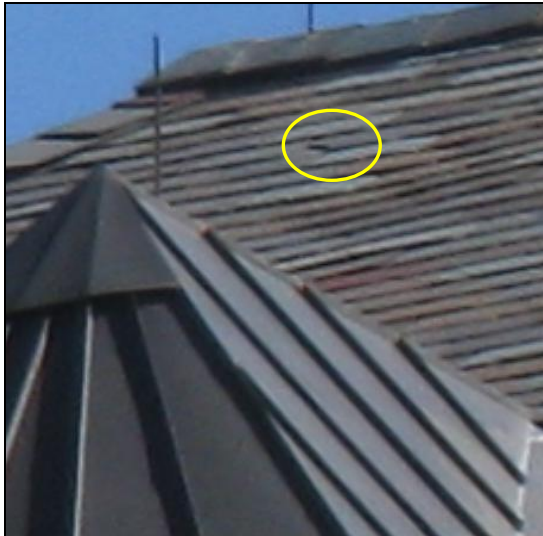
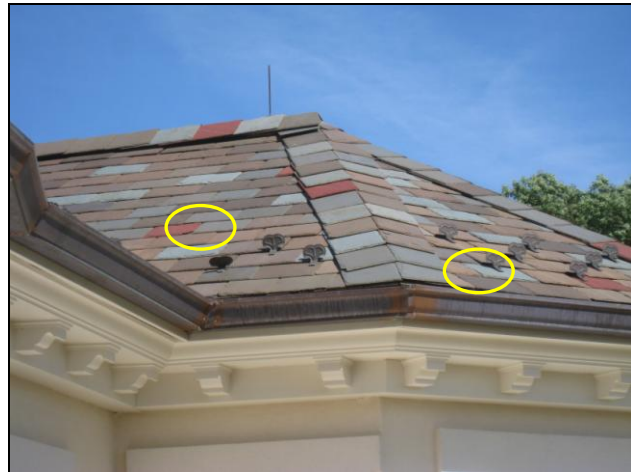
Figure 39 A , B & C Examples of broken or chipped slate.

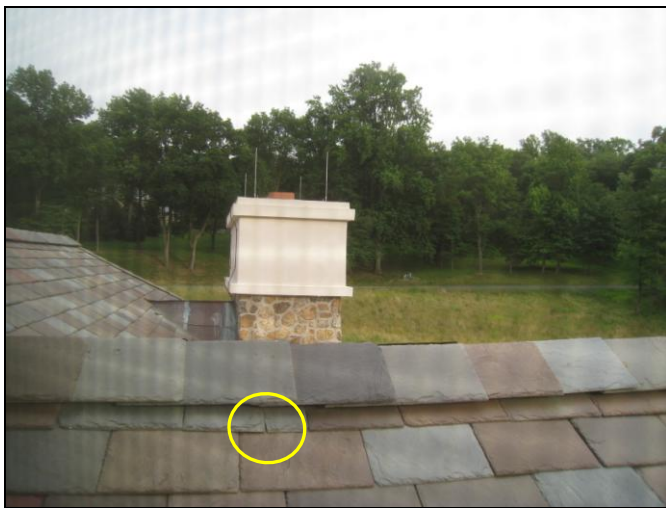
Figure 40 Split shingle

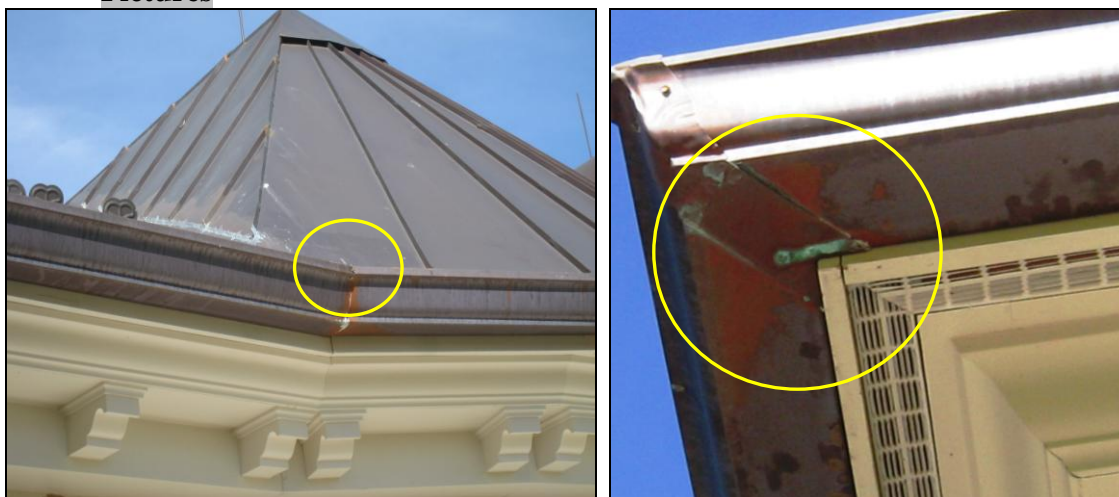
Figure 41 A & B Leaking at junctures

- 1.) Gutters leaking at corners, seams, junctures and spillage along main runs- Have gutters evaluated & corrections/repairs made. Soil ruts visible and stains on siding or EIFS.
- 2.) Recommend Structural engineer evaluate outcrop off rear kitchen; cracks
- 3.) All gaps, mortar and cracks on cladding & trim needs to be properly sealed/evaluated

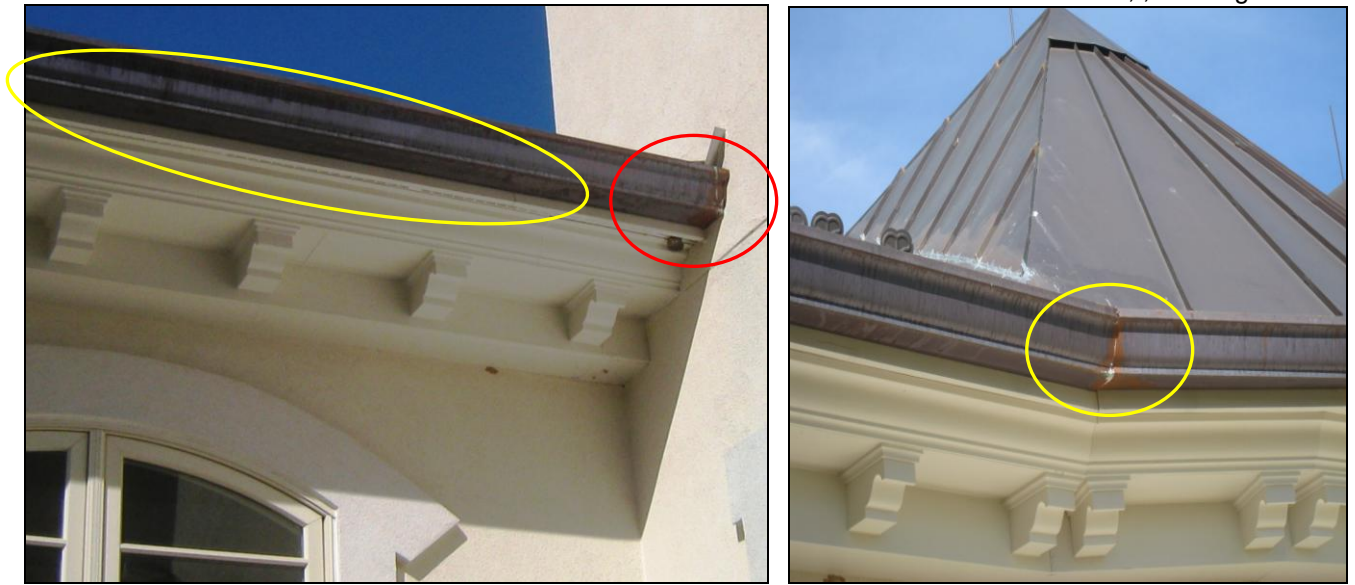
Figure 42 A, B, C & D Indication of leaking gutters and spillage marks. Ruts in soil below.

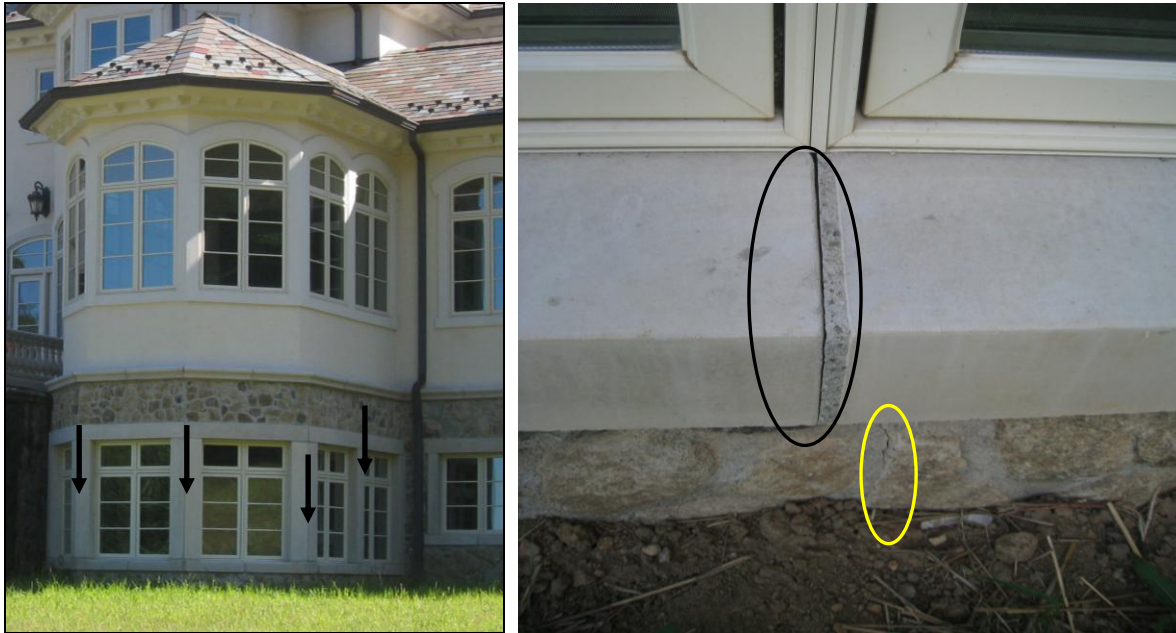
Figure 48 Several vertical cracks all around outcrop main kitchen area. Recommend evaluation by Structural Engineer; structural concern.

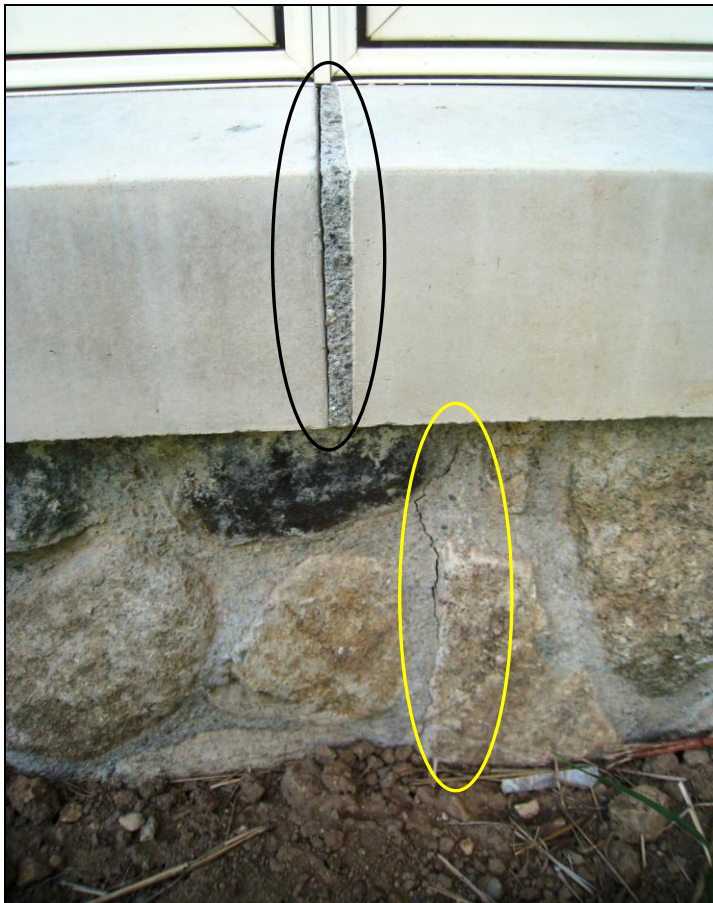
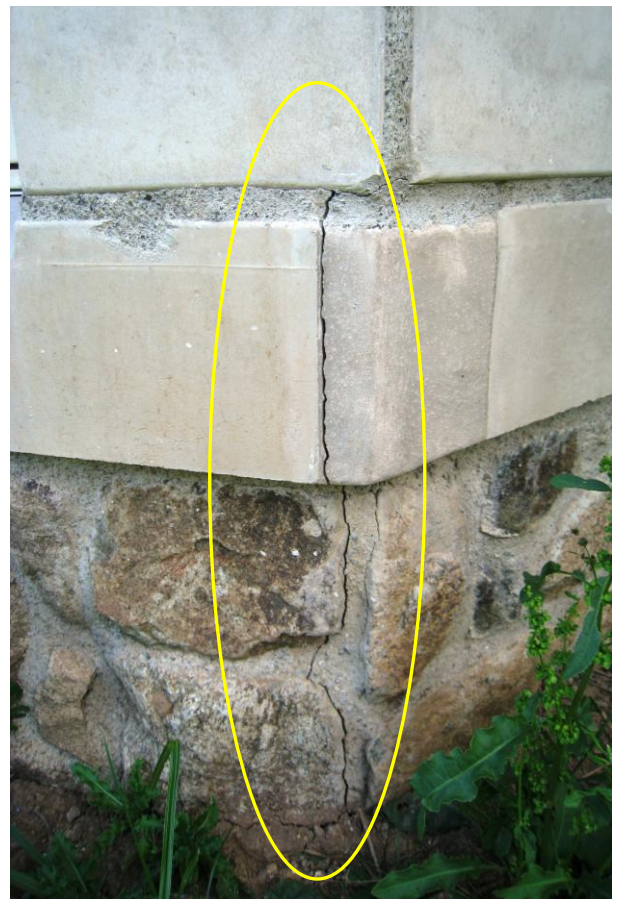
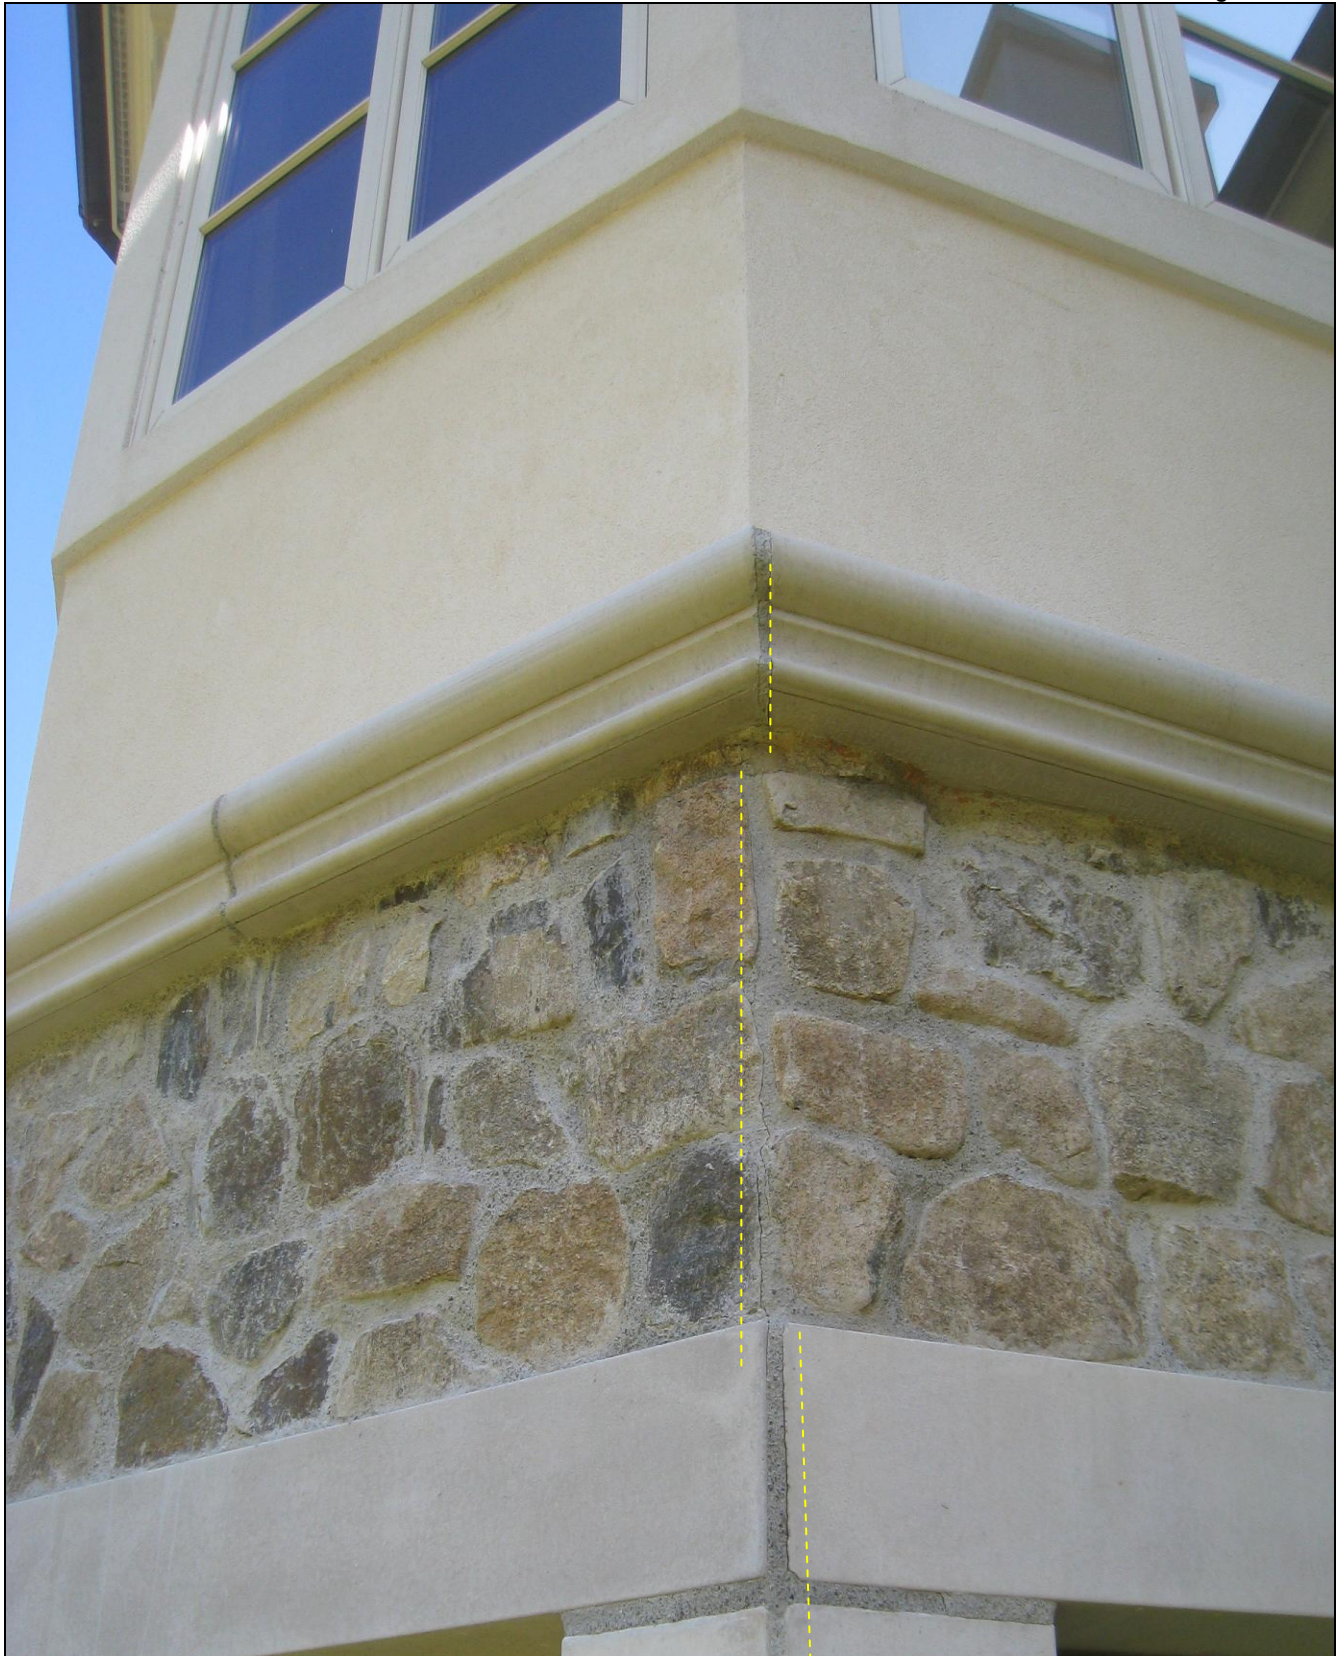
Figure 49 Examples of vertical cracks all around kitchen outcrop

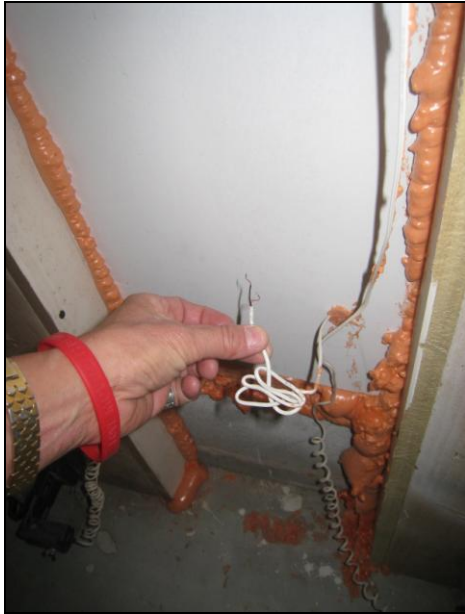
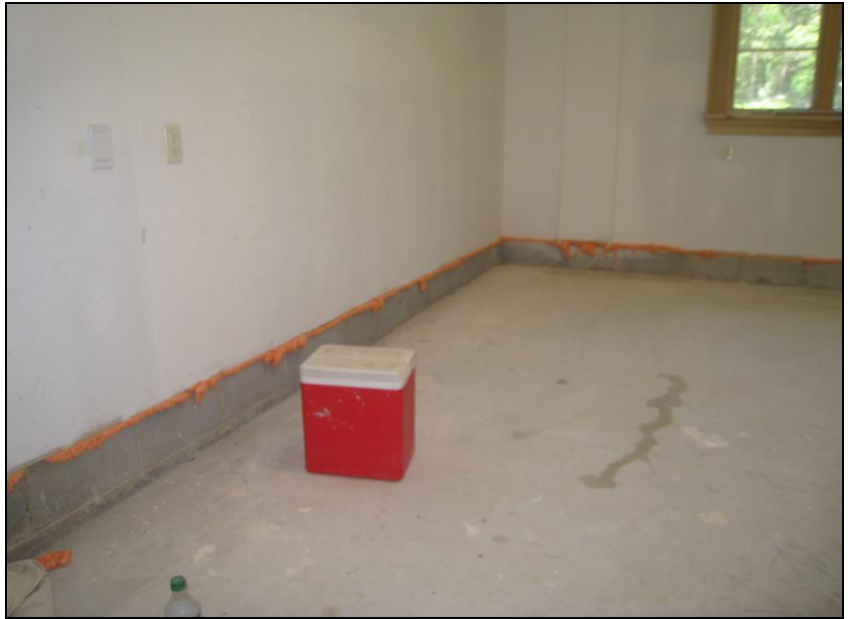
Figure 50 Loose wires by garage doors; further evaluate. Expansion foam everywhere; not recommended.

- 1.) A/C condensers not level, loose wires in rear grouping.
- 2.) Expansion foam everywhere in garage; not recommended

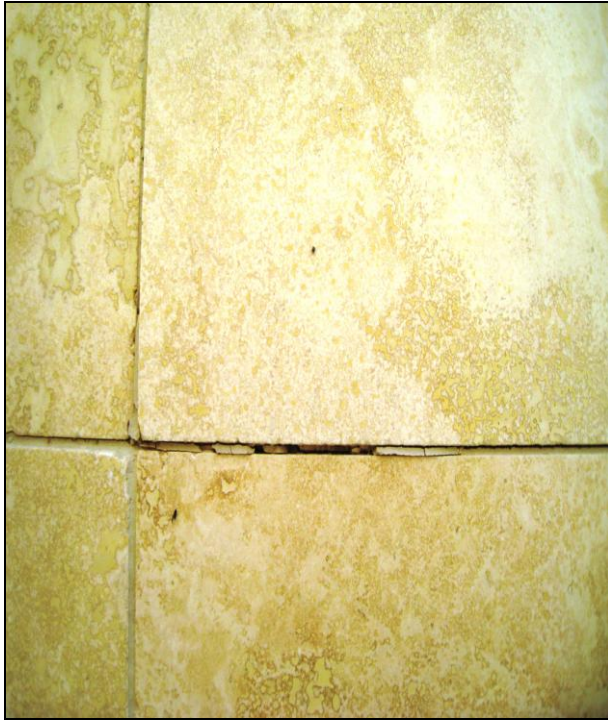
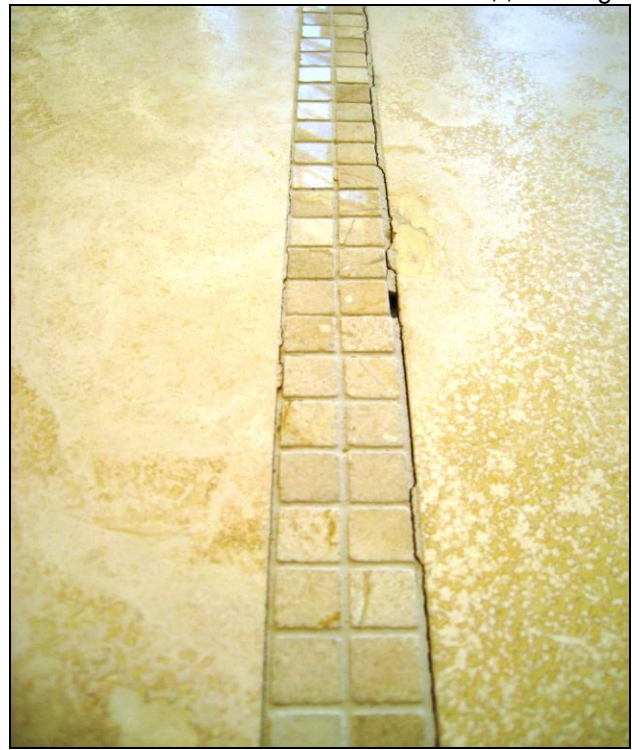
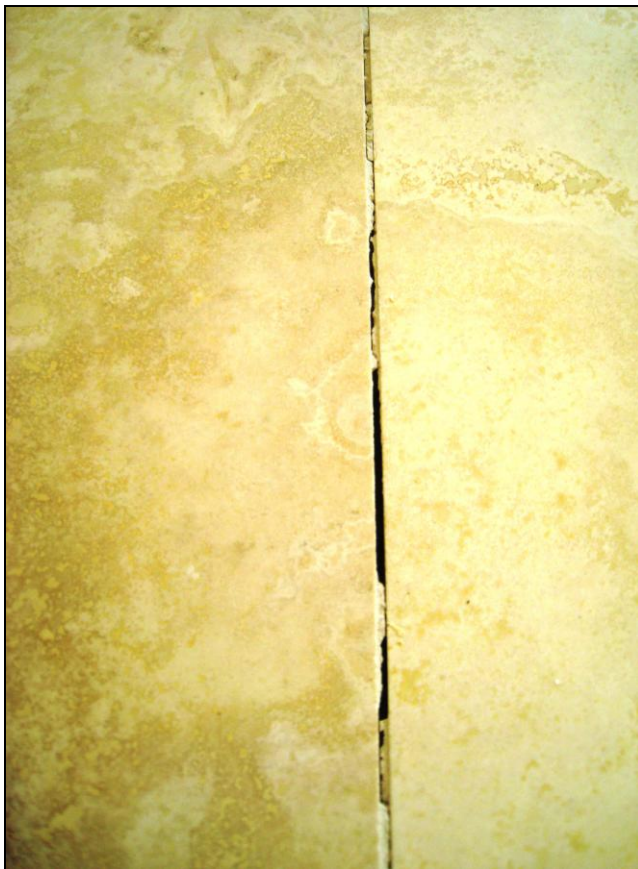
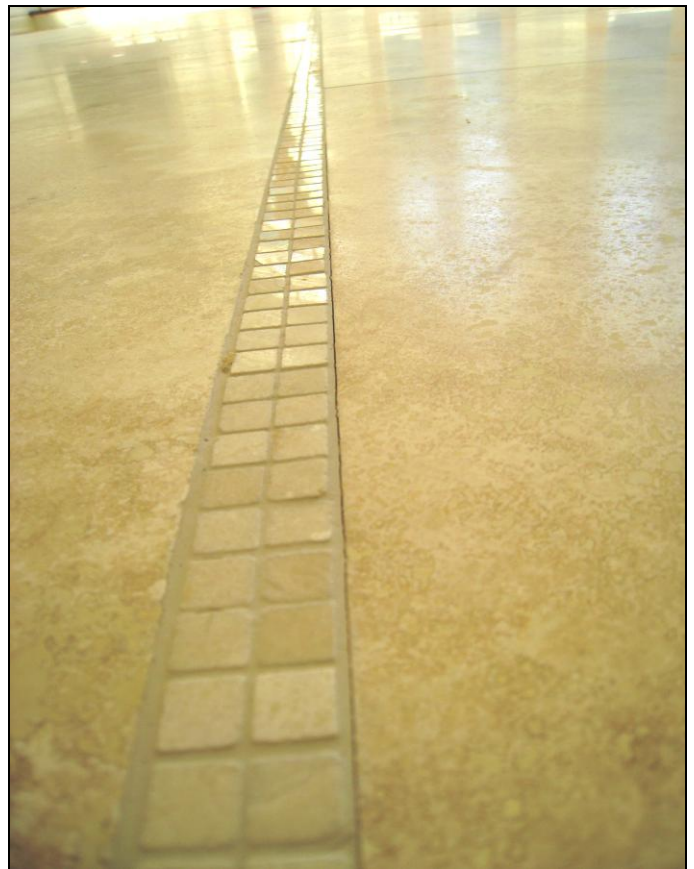
Figure 51 Numerous cracks on tiled flooring in living room; have evaluated and corrected.

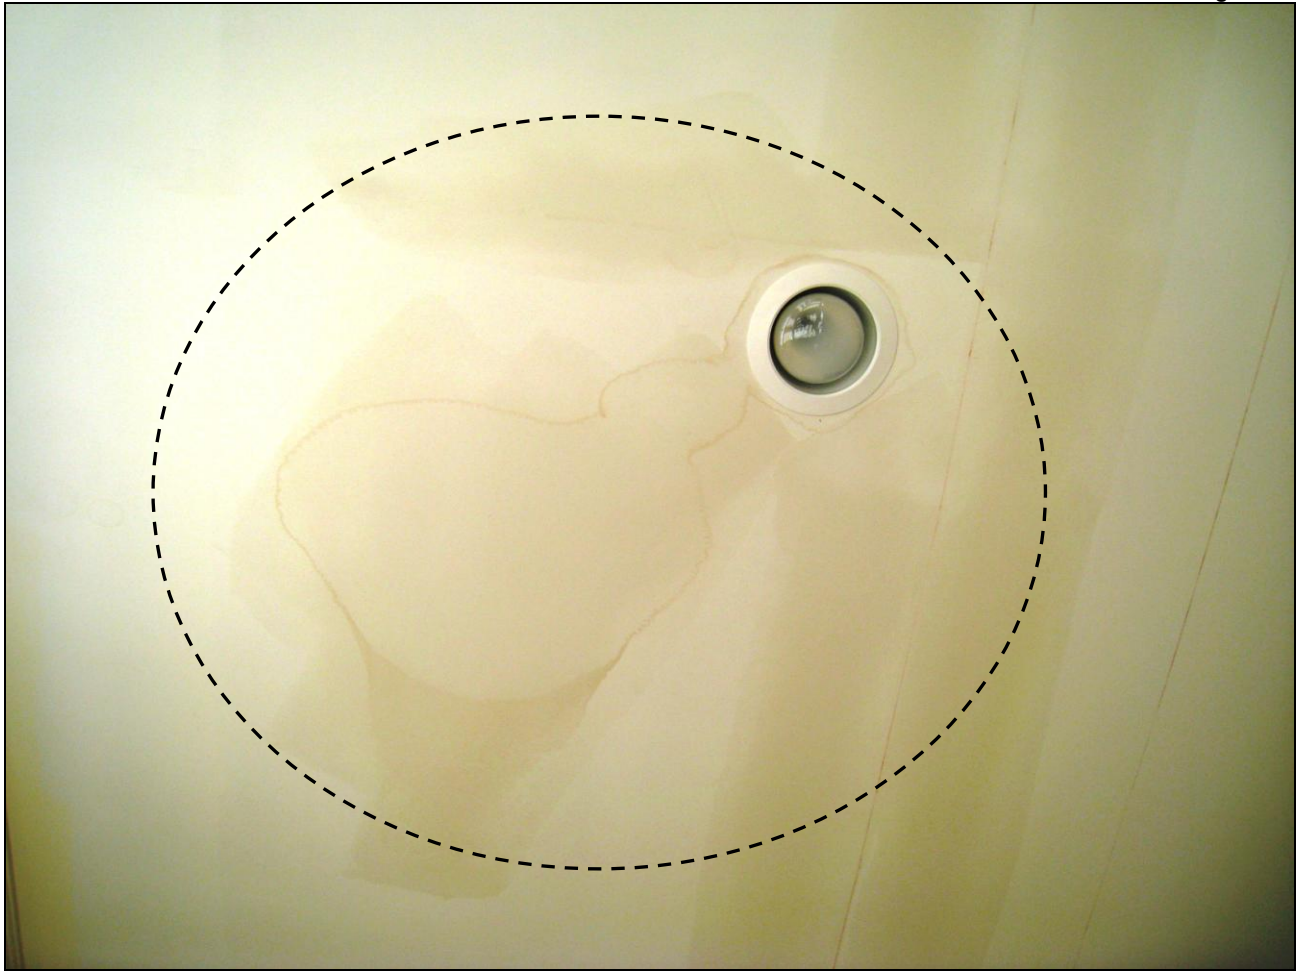
Figure 52 Water stains; indication of leaking above. See roofing section.

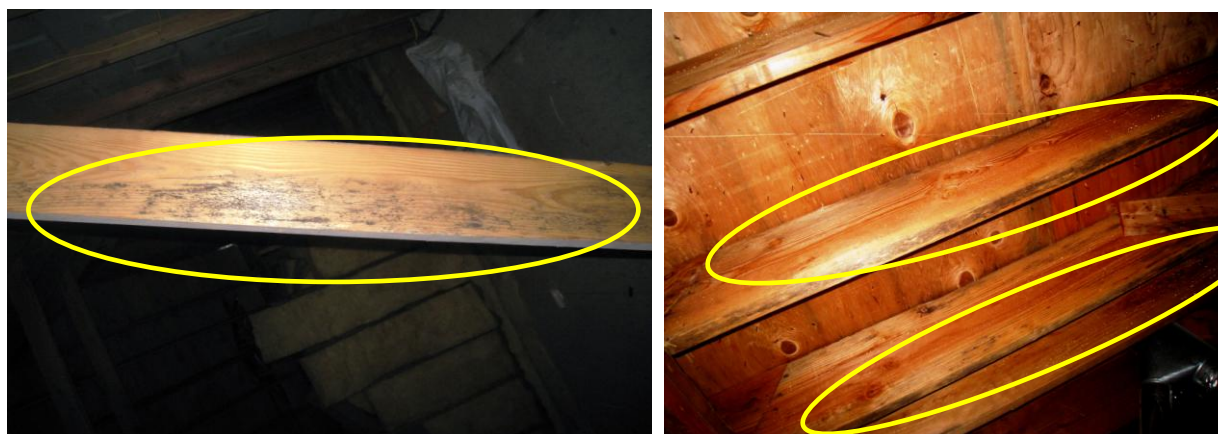
Figure 53 Examples of Possible mold; further evaluate and mitigate as per contractor & testing.

- 1.) Follow-up with builder or contractor on all flooring concerns in home
- 2.) Possible mold in attics; attics very hot/lack of proper ventilation. Testing & further evaluation recommended by ventilation contractor and mold testing/mitigation company.

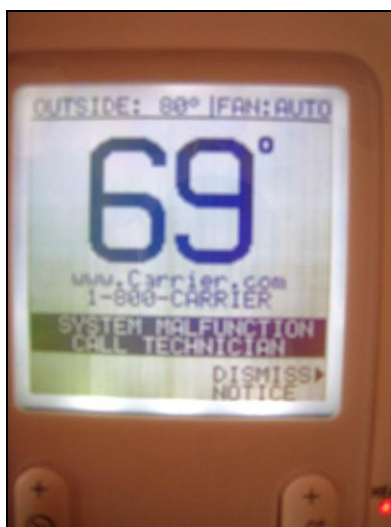
Figure 54 # Units gave this message when heat or HVAC tested.

HEATING: Typical life expectancy of furnace is approximately 25 yrs when maintained properly. Units are approximately 6 yrs old. Recommend cleaning ducts yearly or as needed. **Ducts were very dirty in all rooms; filled with construction debris.** Recommend changing filters as per manufacturers recommendation. Typically there are 30, 60 or 90 days filters on market; personal choice. Recommend a yearly service or tune up on HVAC system. Recommend a "Home Warranty."
Floor heating in master bath did not get hot when tested; have checked before closing. Furnaces #1, 3, and 4 did not operate when tested. Units #2, 5 and 6(attic) were functioning when tested. Thermostats for the non functioning units displayed the message as follows: System Malfunction Call Technician. Recommend a technician evaluate the HVAC systems and floor heat on second floor before closing.
