4 Seasons Home Inspection, LLC

Inspection Date: March 30, 2016 10am- 1pm
Client Name: buyer (buyerbuyer@hotmail.com)
Emails: lawyer@aol.com
Inspection Address: # city, nj xxxxx
Inspected by: Linda Geczi home inspection lic. #24GI00061500

Approximate Age: ~ early 1900's
Style: Single family
Main Entrance Faces: W
State of Occupancy: Occupied
Weather Conditions: 42 °F
Ground cover: damp

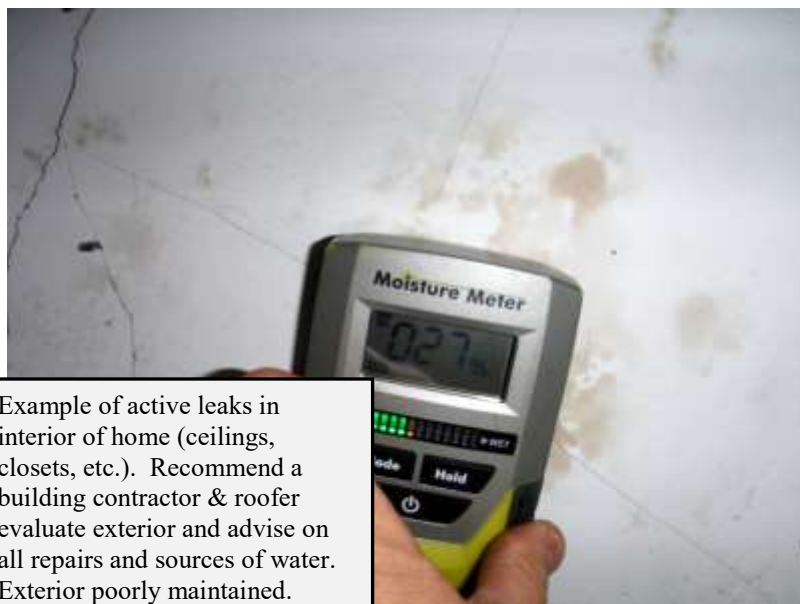
1. **There were active leaks in the interior of home (ceilings/walls). The exterior was poorly maintained; tarred roof penetrations/chimney/junctures, rotted siding/trim/window/frames, missing siding/roof flashings, gaps/holes, wood to soil contact (enclosed porch crawl spaces), siding patched/damaged; water entry points into home. Recommend roofer and/or qualified building contractor evaluate exterior components (roof, siding/trim/windows/flashings, etc.) and advise on all repairs/replacements. Obtain the closed permits for roof from township and any warranty from roofer if applicable and transferrable.**
2. **Recommend removing TV & Dish equipment off roof; will leak at roof fasteners. Roofs and chimneys should not be used to mount equipment.**

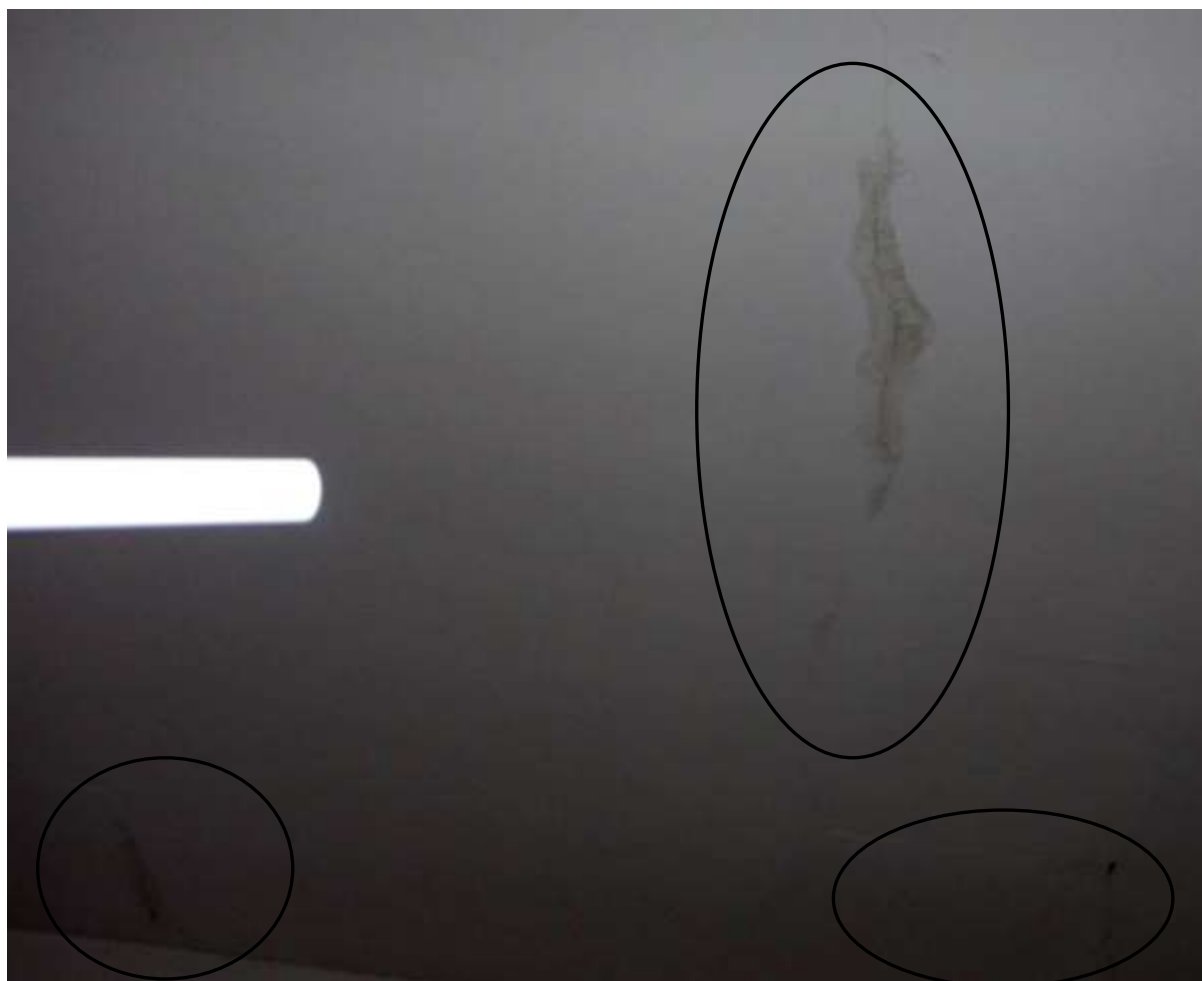
Example of active leaks in interior of home (ceilings, closets, etc.). Recommend a building contractor & roofer evaluate exterior and advise on all repairs and sources of water. Exterior poorly maintained.

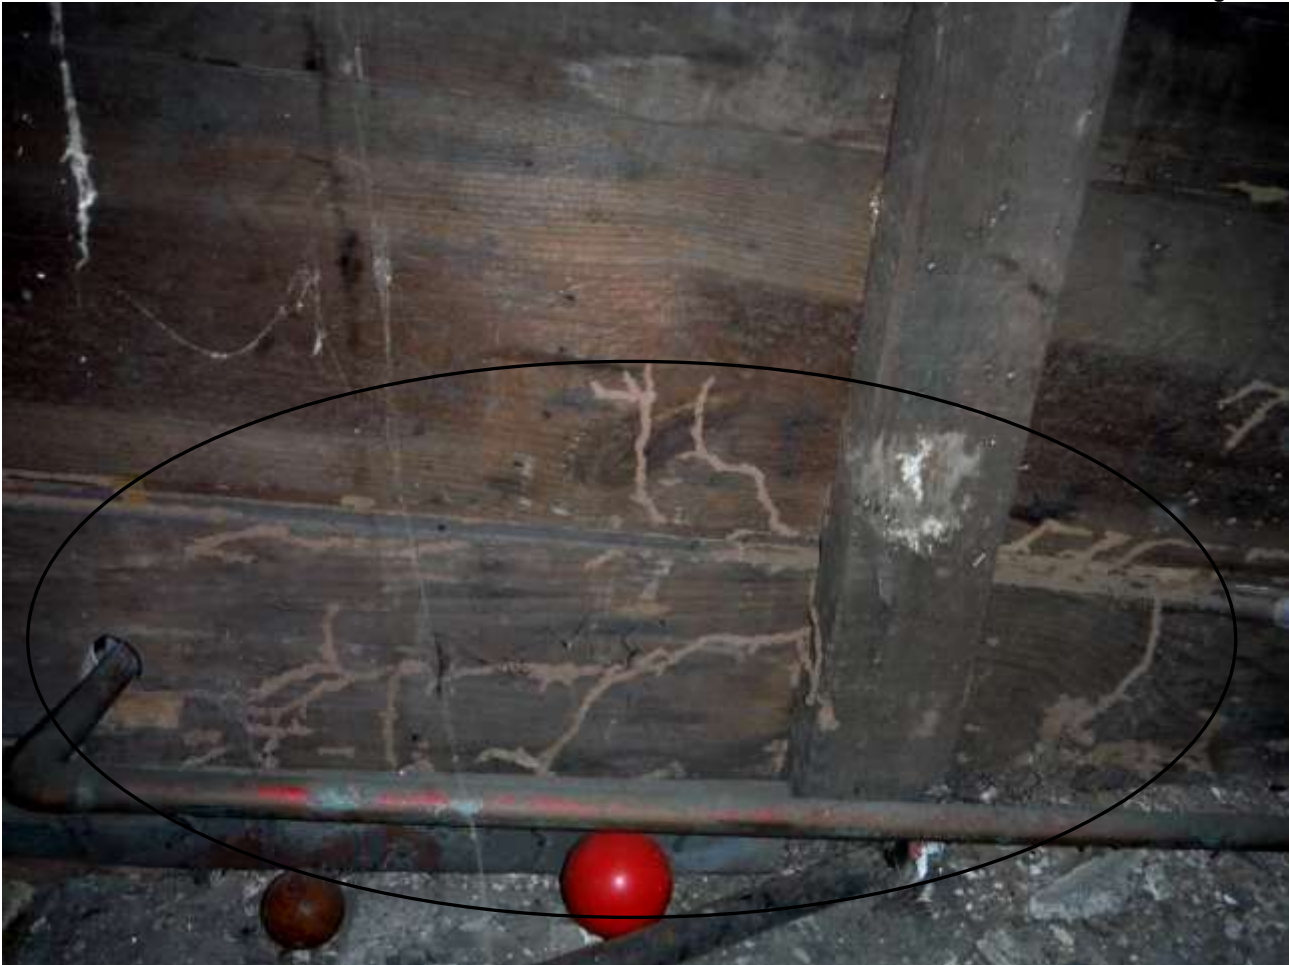
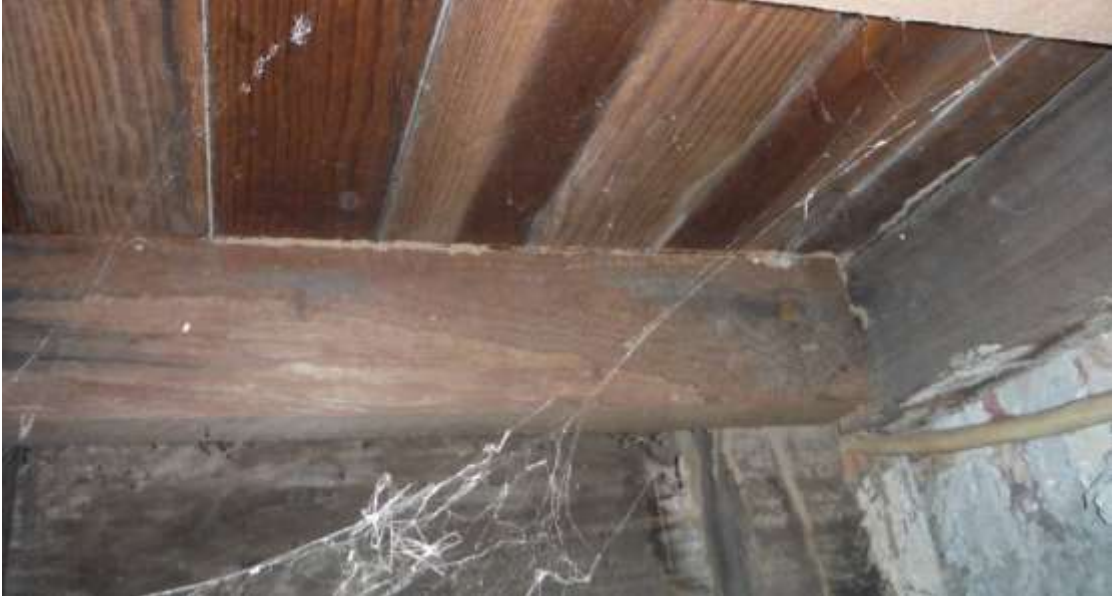
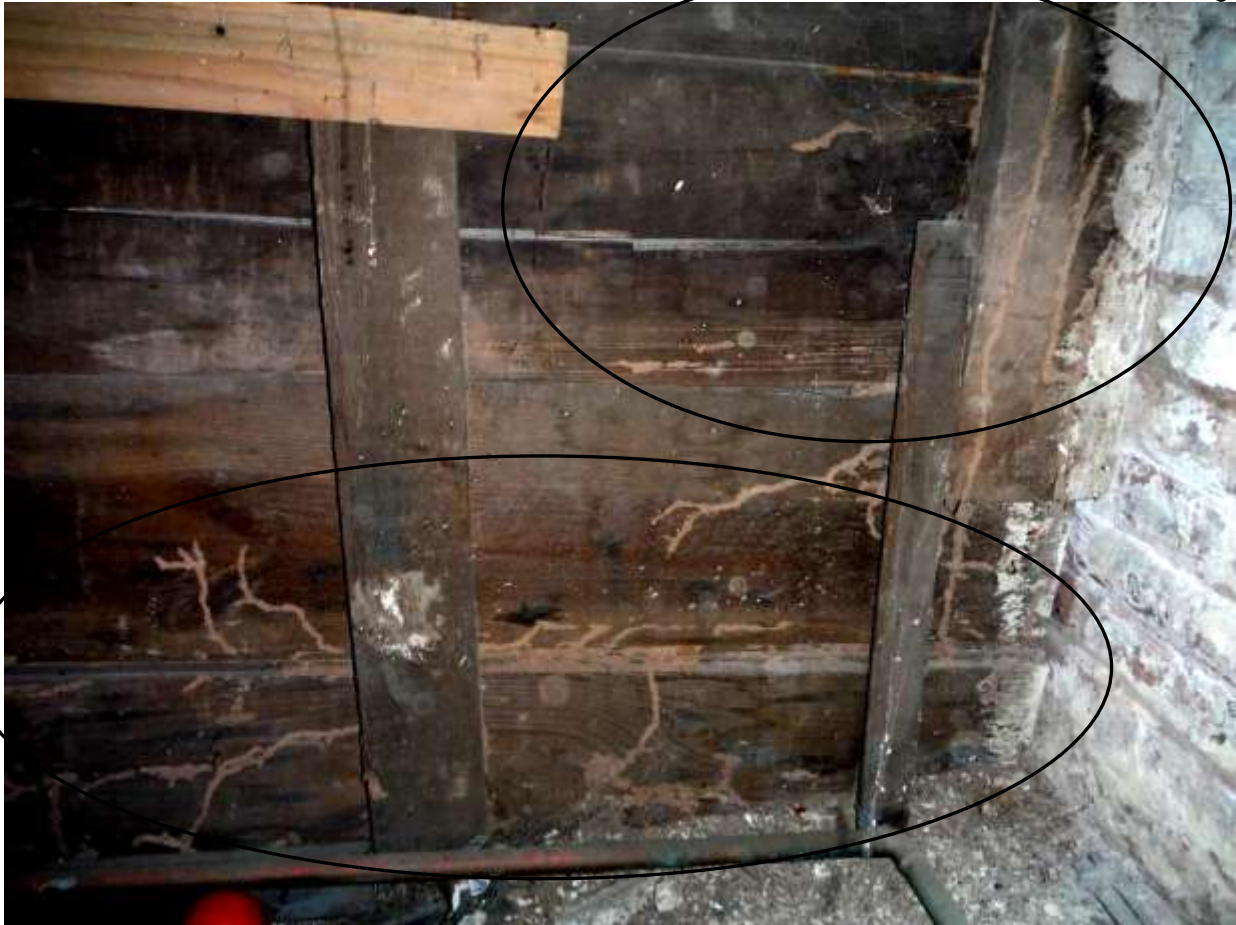
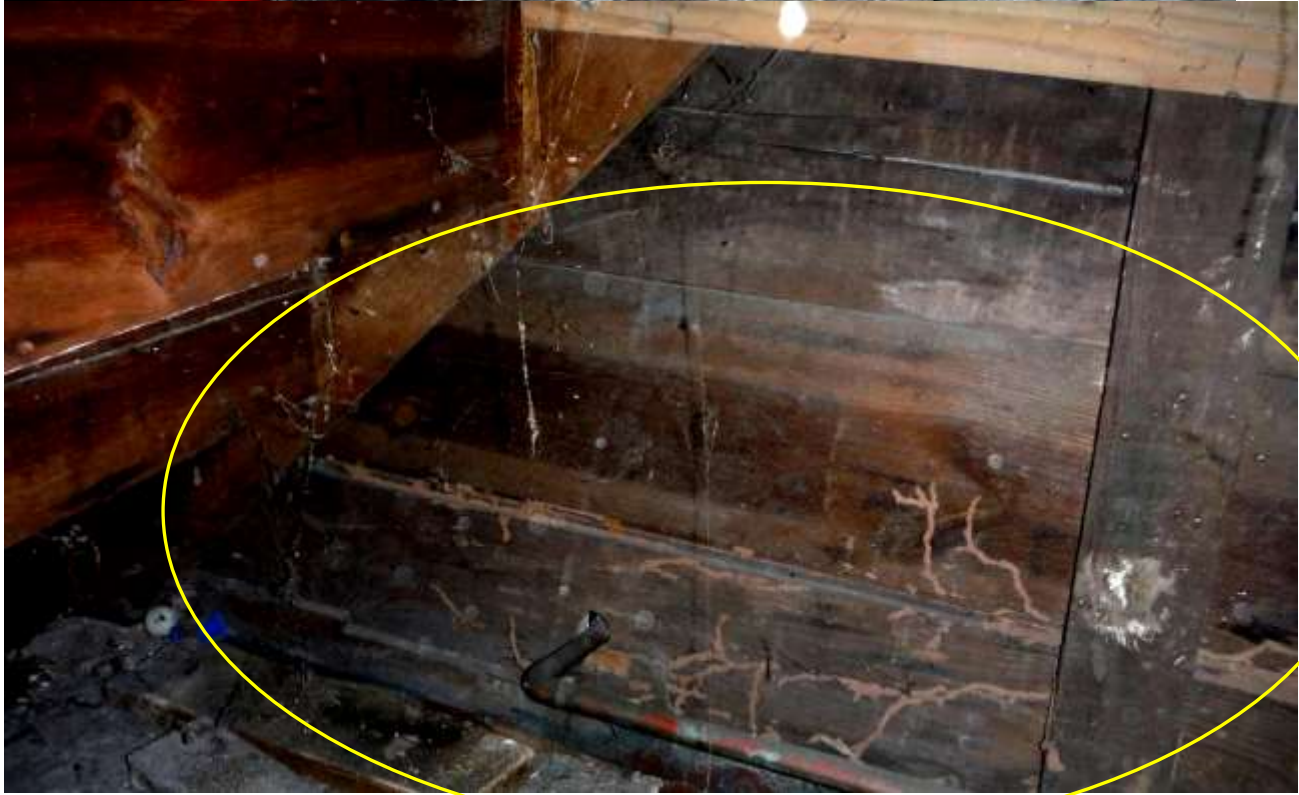
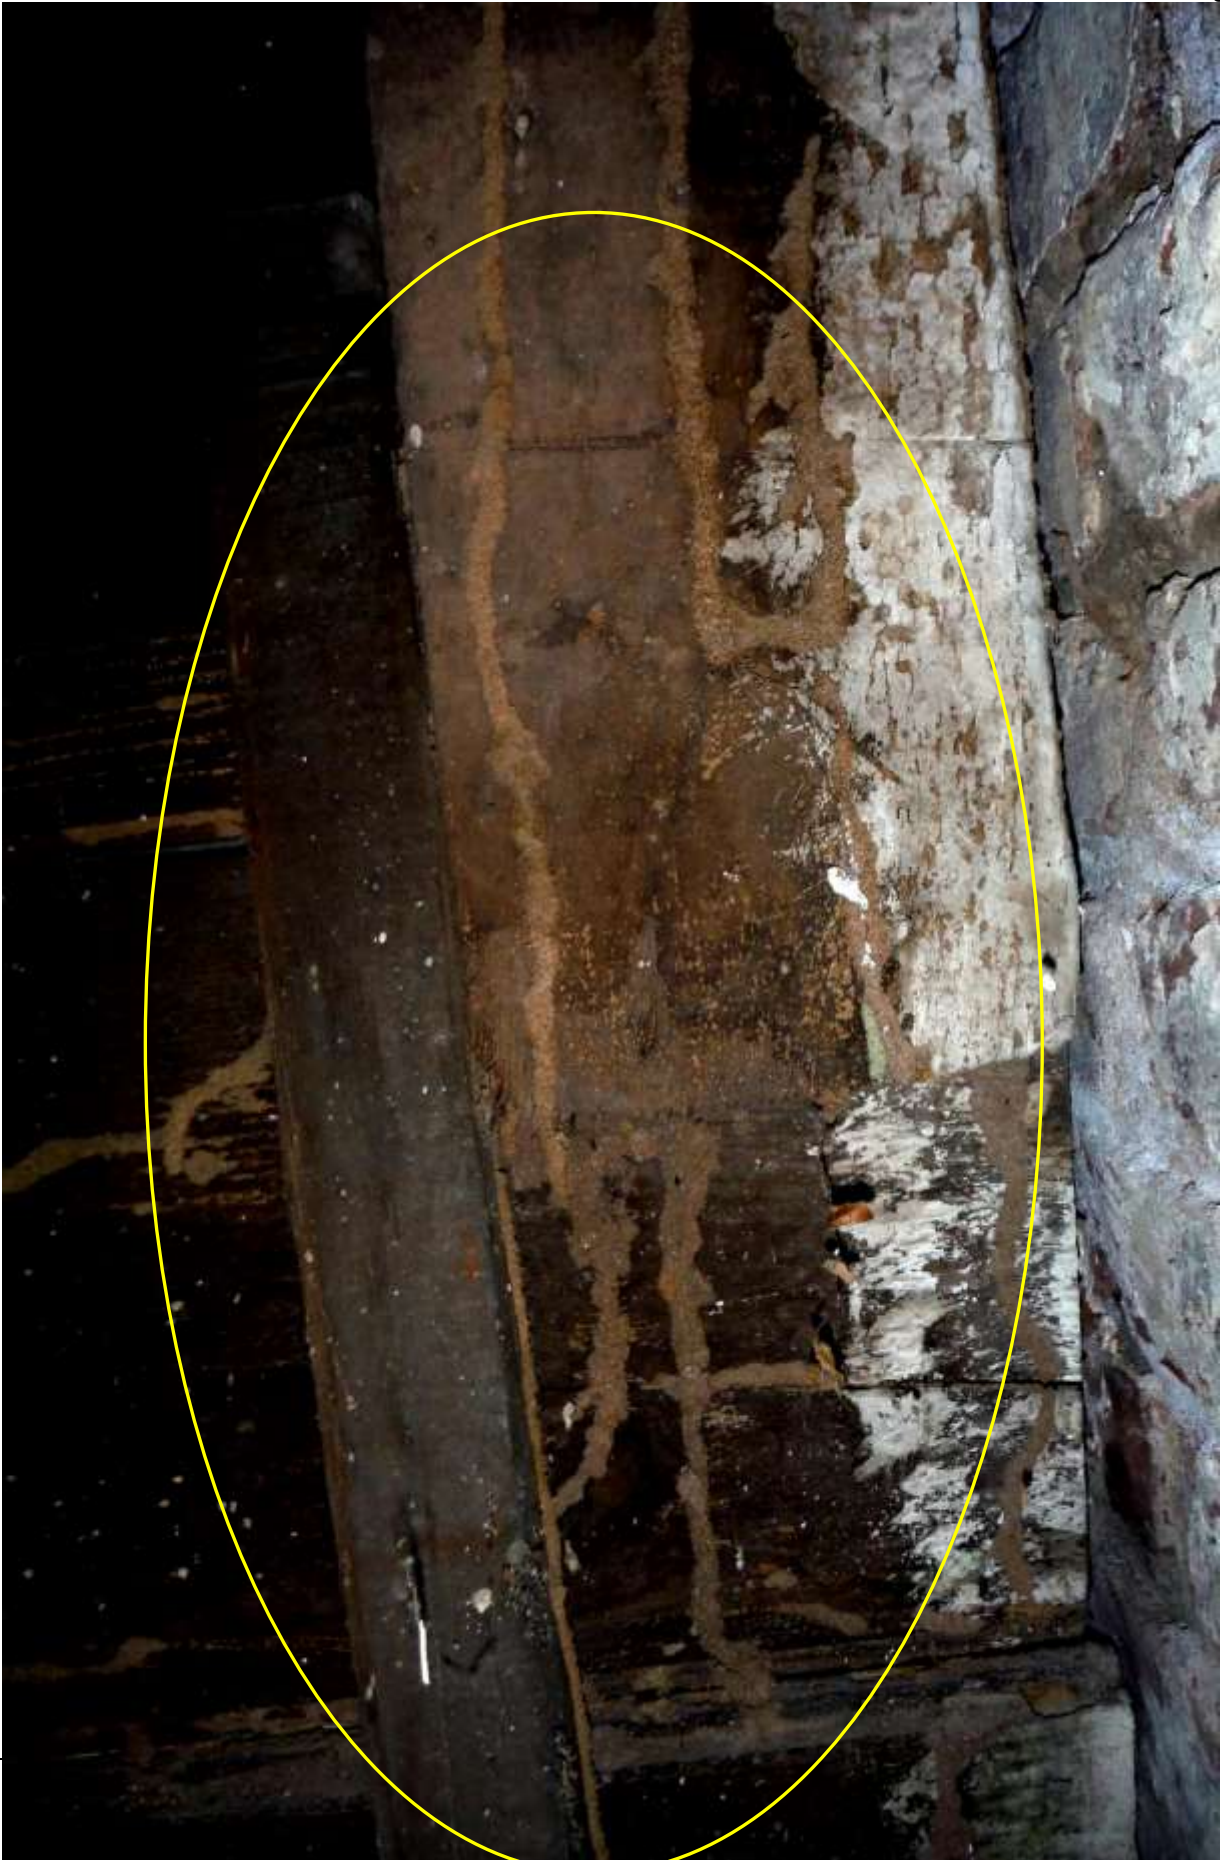
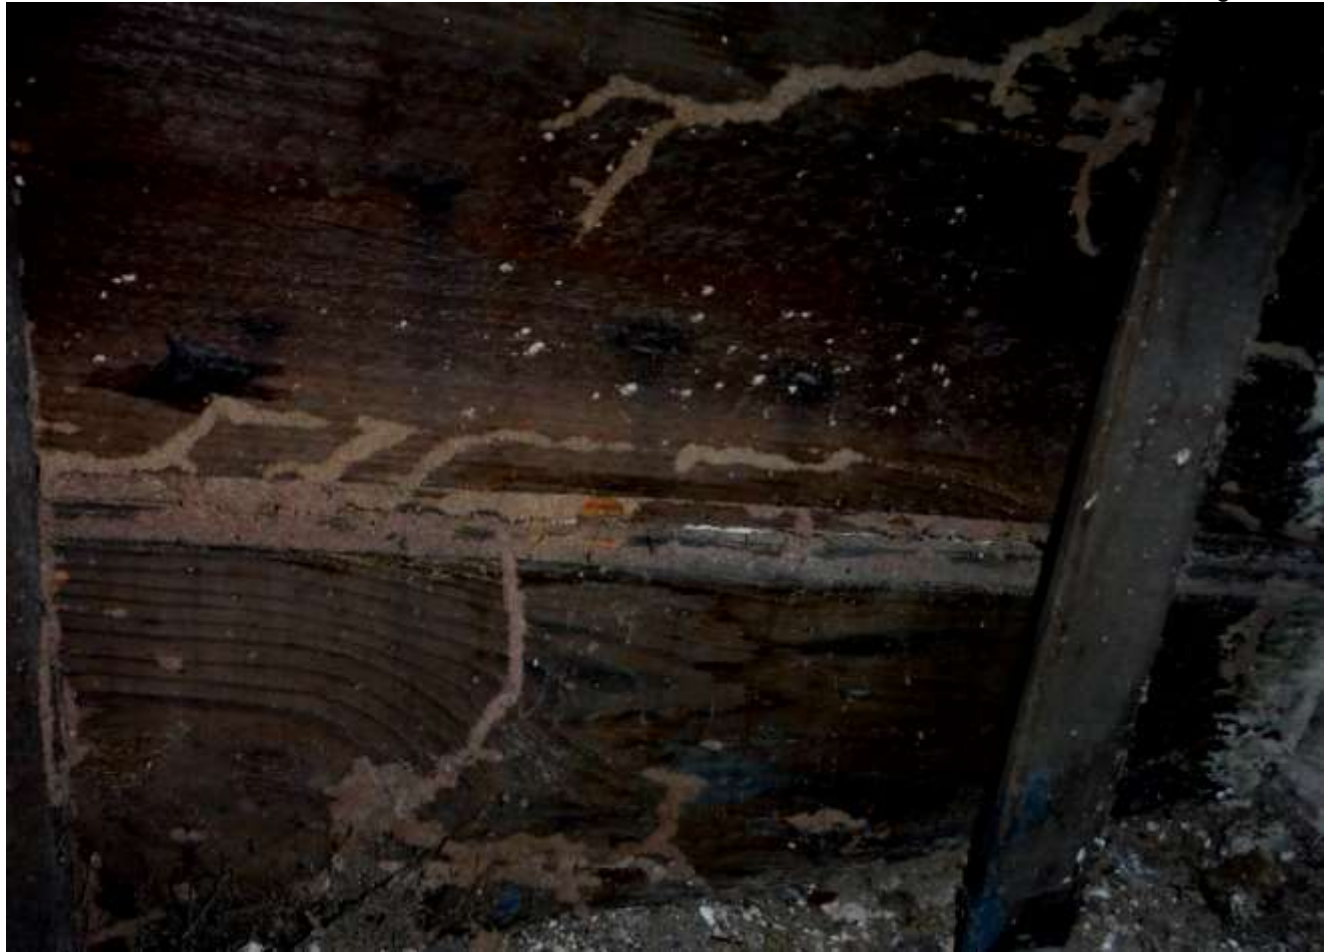
1. There were termite shelter tubes and visible damage observed in basement walk out and under the basement steps. Basement was finished (ceilings, walls, styro foam insulation, covered columns, joists, structure, etc.) and structure inaccessible. Conditions on exterior are conducive to wet basement/seepage and water & wood destroying insect damage. Recommend a building contractor evaluate exterior (siding, trim, windows/frames, roof/siding/chimney/plumbing flashings, grading & drainage, etc.) and advise on repairs/replacements. Active leaks observed in interior rooms Attic, 3rd floor and second floor, attic, etc. Recommend a structural carpenter or qualified building contractor evaluate termite damage, rule out or determine extent of termite/water/structure damage and advise on all structural repairs. The crawl spaces under the front and rear enclosed porches were inaccessible; recommend access and have inspected along with basement & termite.

2. Recommend a grading & drainage contractor and a wet basement/damp proofer contractor evaluate the property and advise on water management, grading & drainage and exterior repairs (see exterior/siding/gutters/etc.). The exterior was conducive to water seepage, leaks and attracting wood destroying insects.
