4 Seasons Home Inspection, LLC

Inspection Date: February 12, 2018 Monday 10am- 12:20pm
Client Name: buyer (buyer@gmail.com)
Emails: lwyer@gmail.com
Inspection Address: # street, jersey shore, NJ xxxxx
Inspected by: Linda Geczi home inspection lic. #24GI00061500

Approximate Age: ~ 1922 orig.
Style: Single family-
Home built over a two car garage structure
Main Entrance Faces: S
State of Occupancy: occupied
Weather Conditions: 50- 55 °F, moderate rain
Ground cover: Heavy rain past 24 hrs./ wet

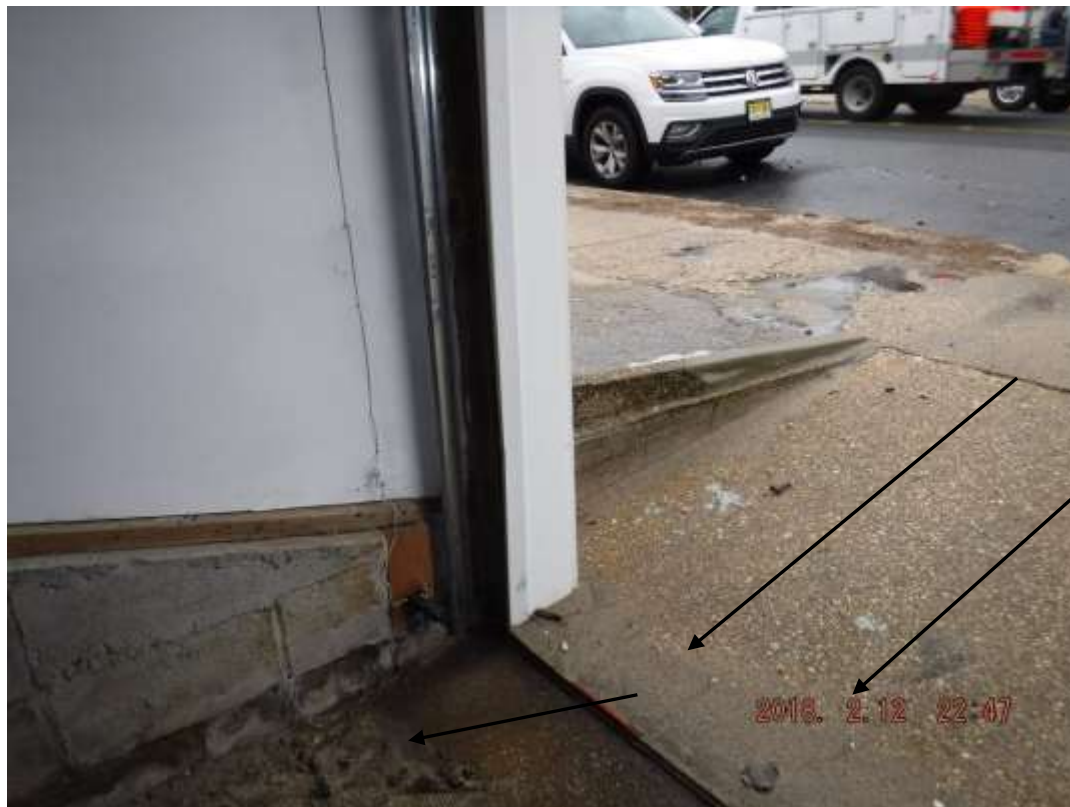
1. The driveway is pitched toward the garage; water entry into the garage. Recommend drainage across the garage or pitching away from the structure. The patio in rear was older; settling, cracks, etc. and pitched toward the home. There was observed efflorescence in garage and water stains; see garage section comments. Water was entering the structure from garage/driveway, roof, siding & trim, etc. Recommend a grading & drainage contractor evaluate exterior and advise on grading & drainage and water management system(s) before closing & contractual limitations to maintain a dry structure. Exterior conditions are conducive to wet/seepage, mold like conditions and attracting wood destroying insects. There was a strong musty or mold like odor in the garage and two rear finished rooms. Mold and environmental identification/inspection/testing is not part of inspection and beyond the scope of a home inspection. Follow up with a mold contractor or environmental company for that service.

Figure 1 Water entering the garage, wet foundation walls, wet sand floor and musty mold like odor in garage and rear finished rooms.

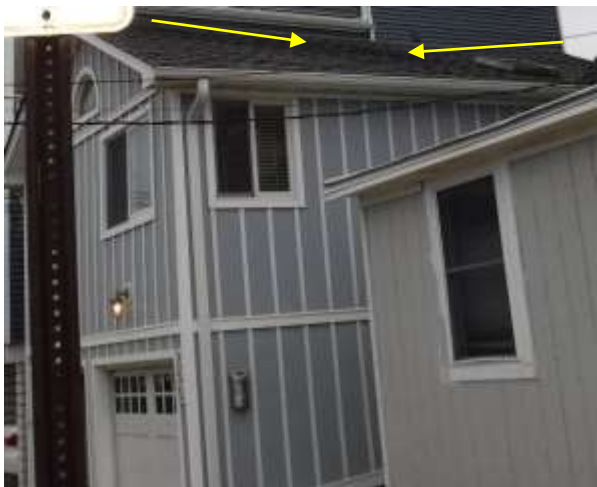
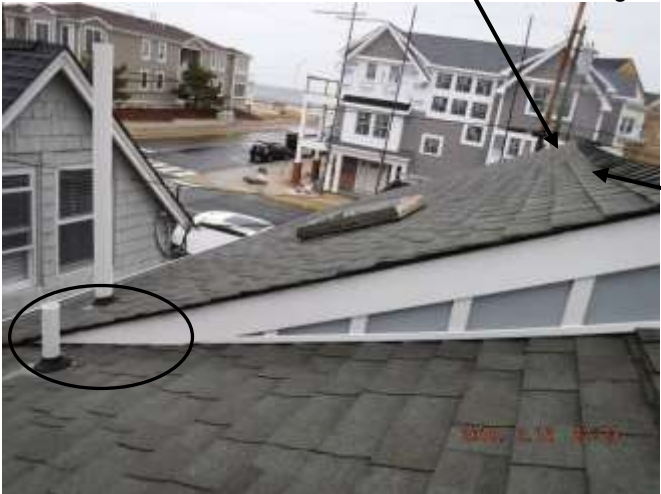
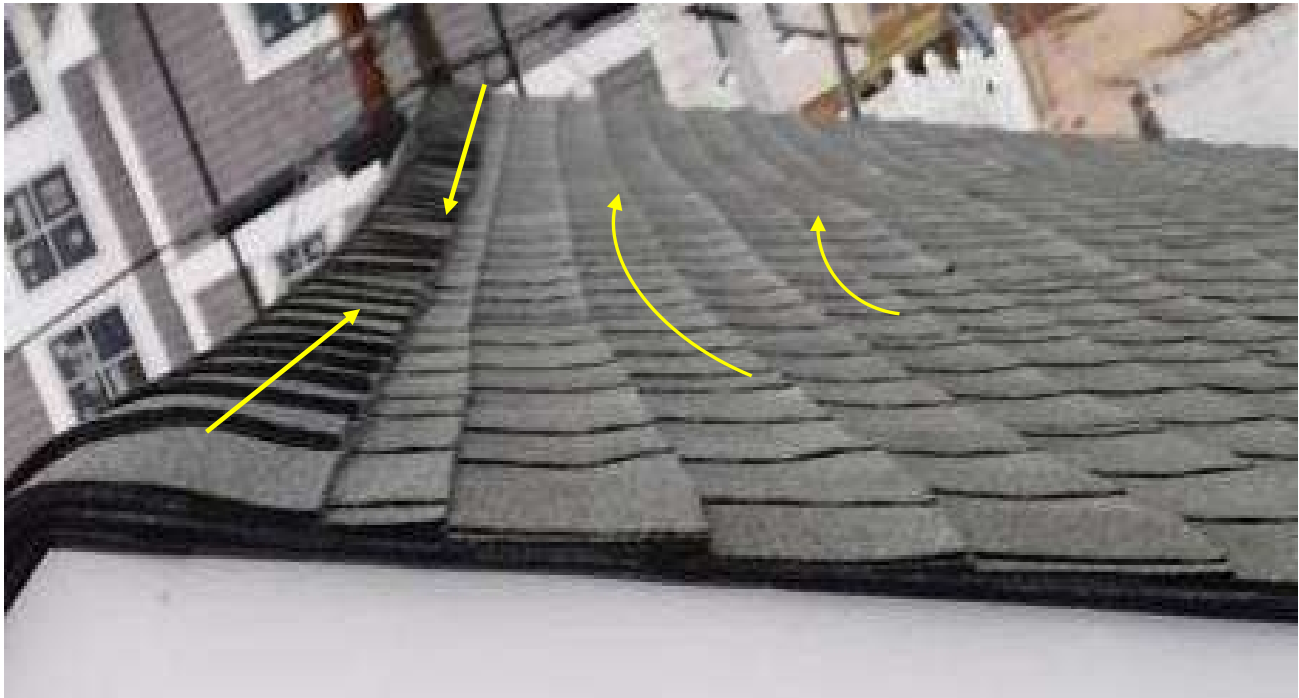
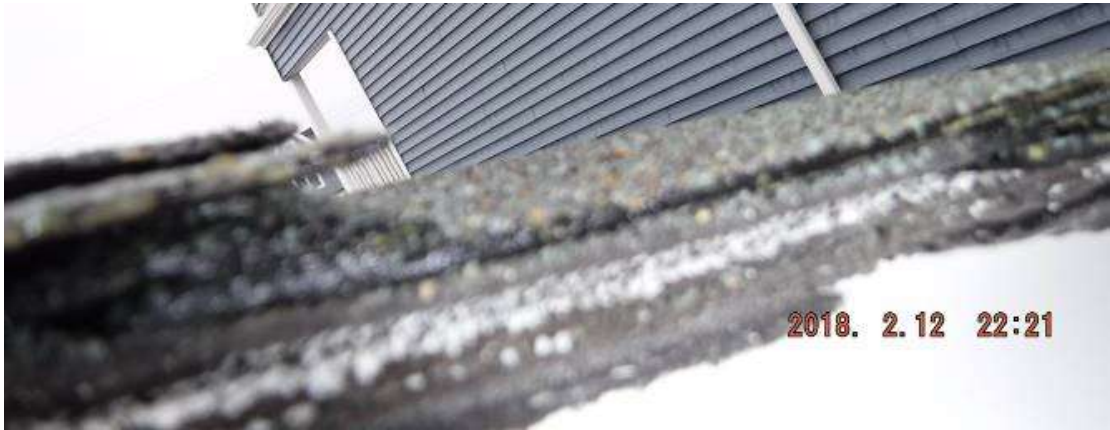
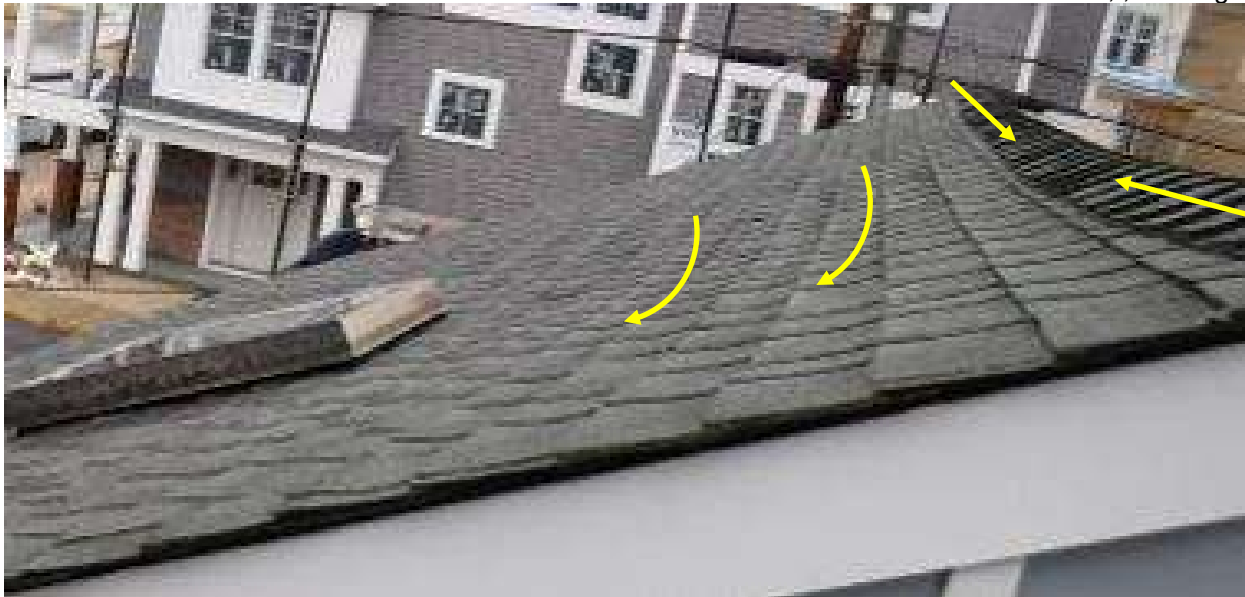
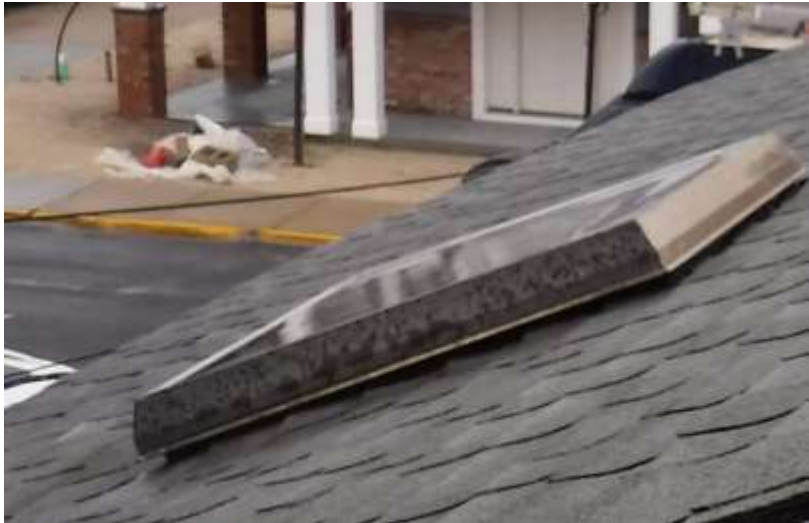
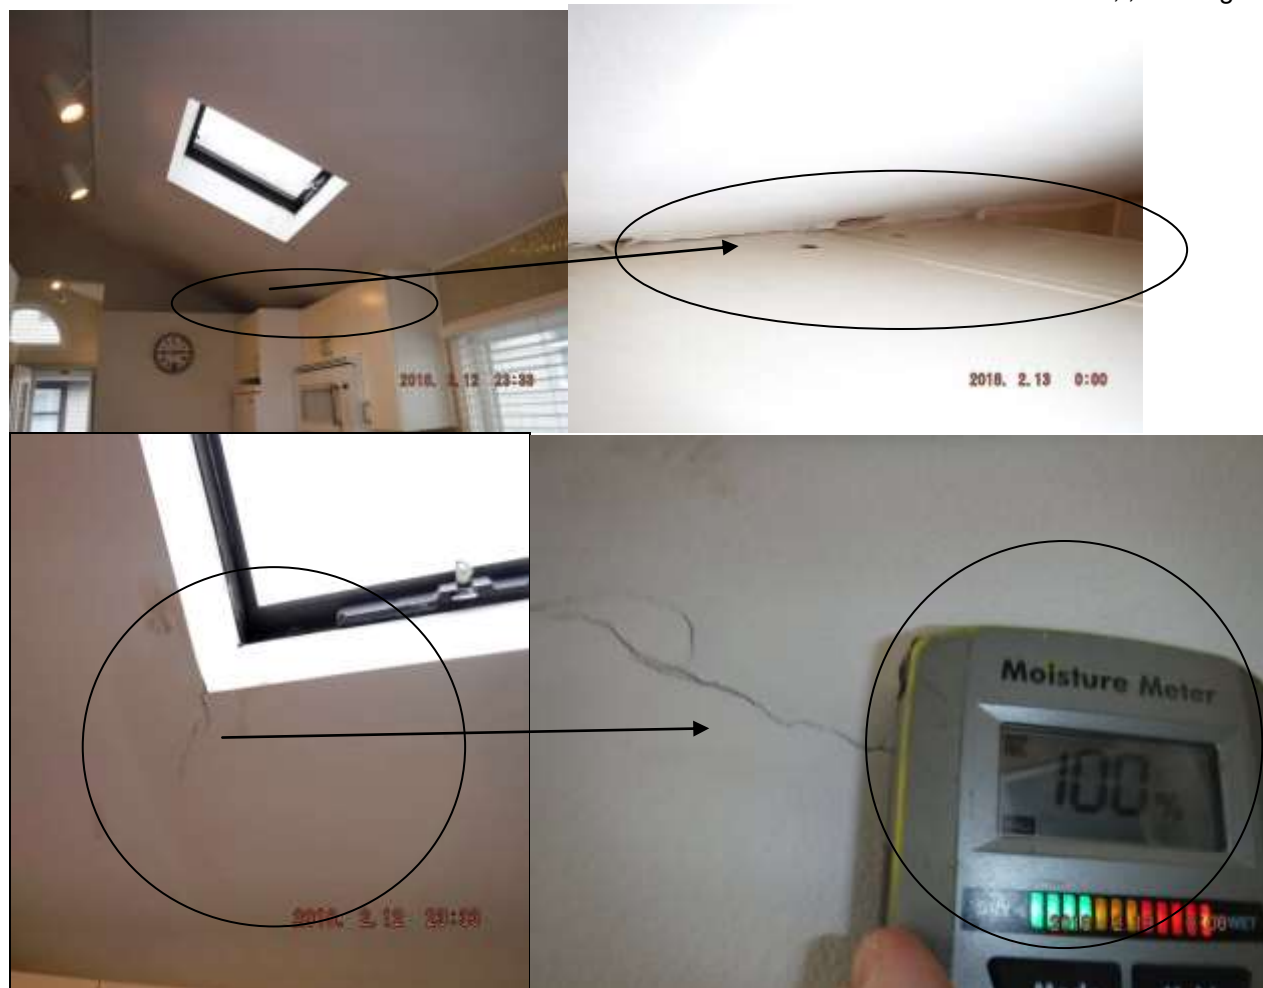
Figure 2 Examples of active leaking (100%) in kitchen; water stains/yellowing and peeled paint on drywall around skylight and above cabinets.

2. There was active leaking around the skylight and over the upper cabinets; water stains, yellowing and peeled paint visible. See roofing section comments. There was dark wood flooring or water stains; active moisture. Recommend a building contractor and/or roofer evaluate all water sources and advise on repairs.

Recommend roofer evaluate and advise on costs of roof structure, tear off& shingles, flashings, ventilation & insulation, skylights, gutters before closing and contractual limitations.

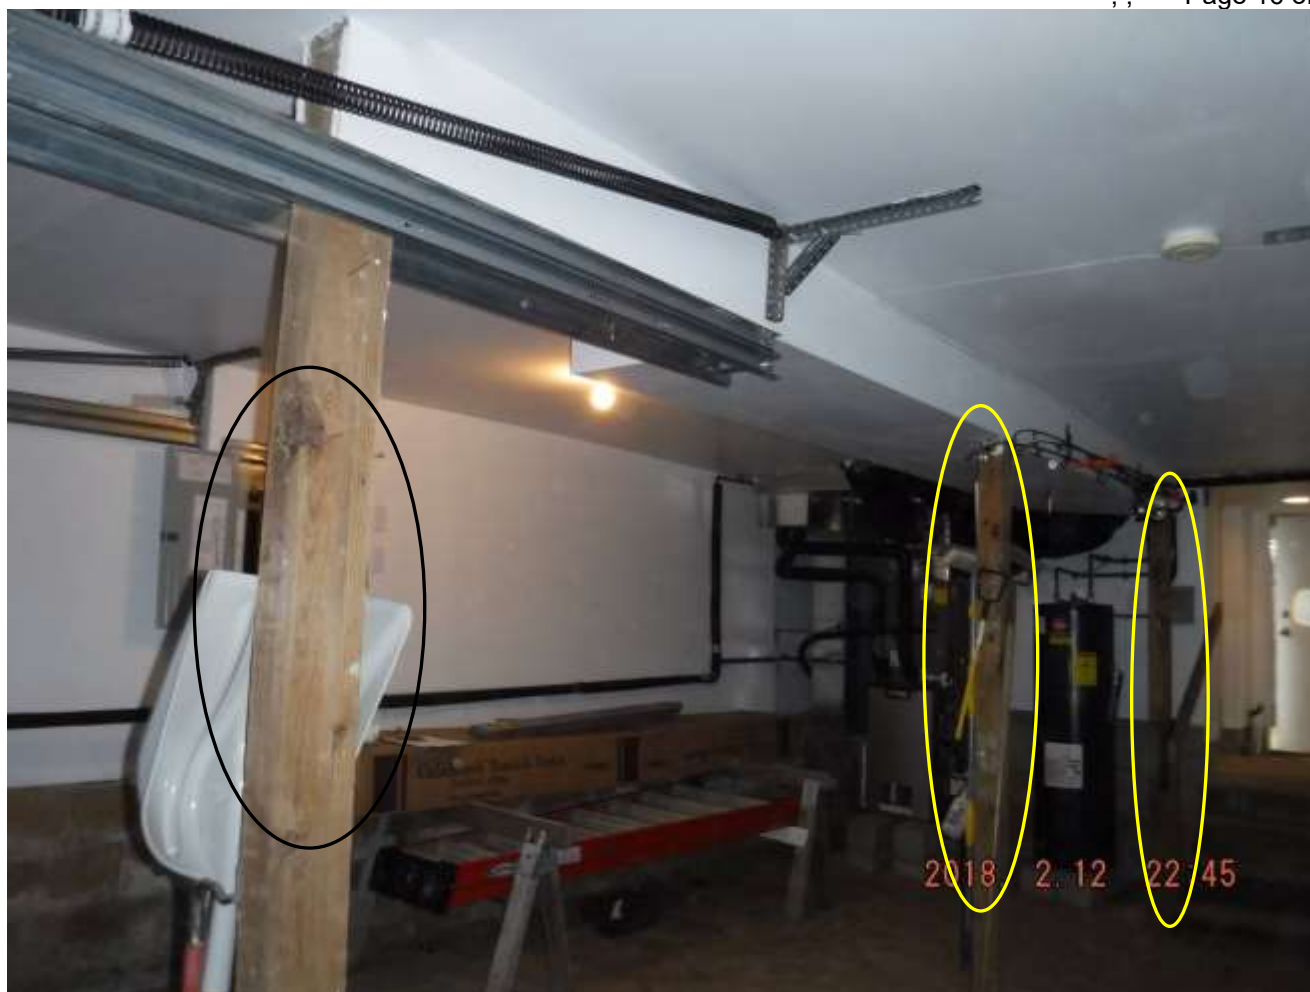
Figure 3 The 4x4" wood columns; under sized and not spaced properly; sloped flooring above in finished main rooms.

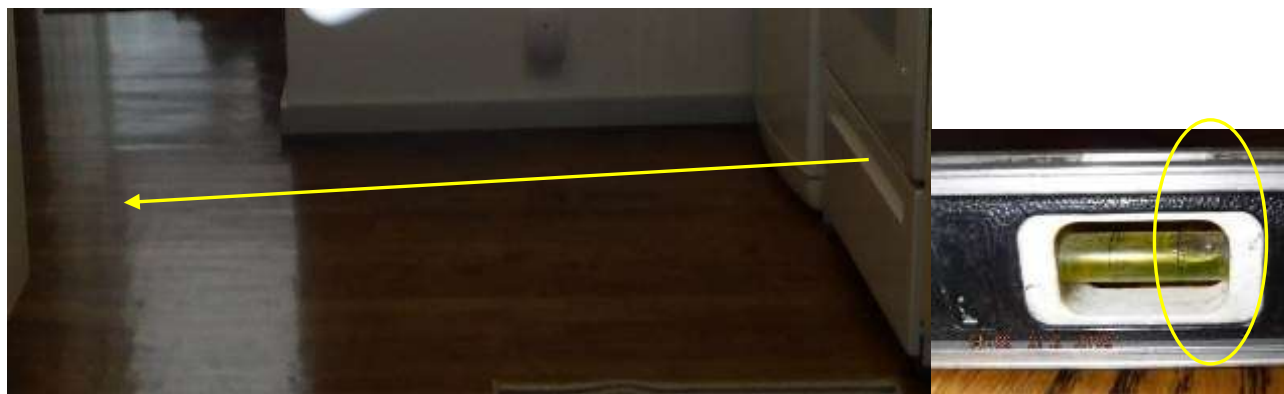
Figure 4 There were structural defects/deficiencies observed in the home. See pg. 2 Main concerns.

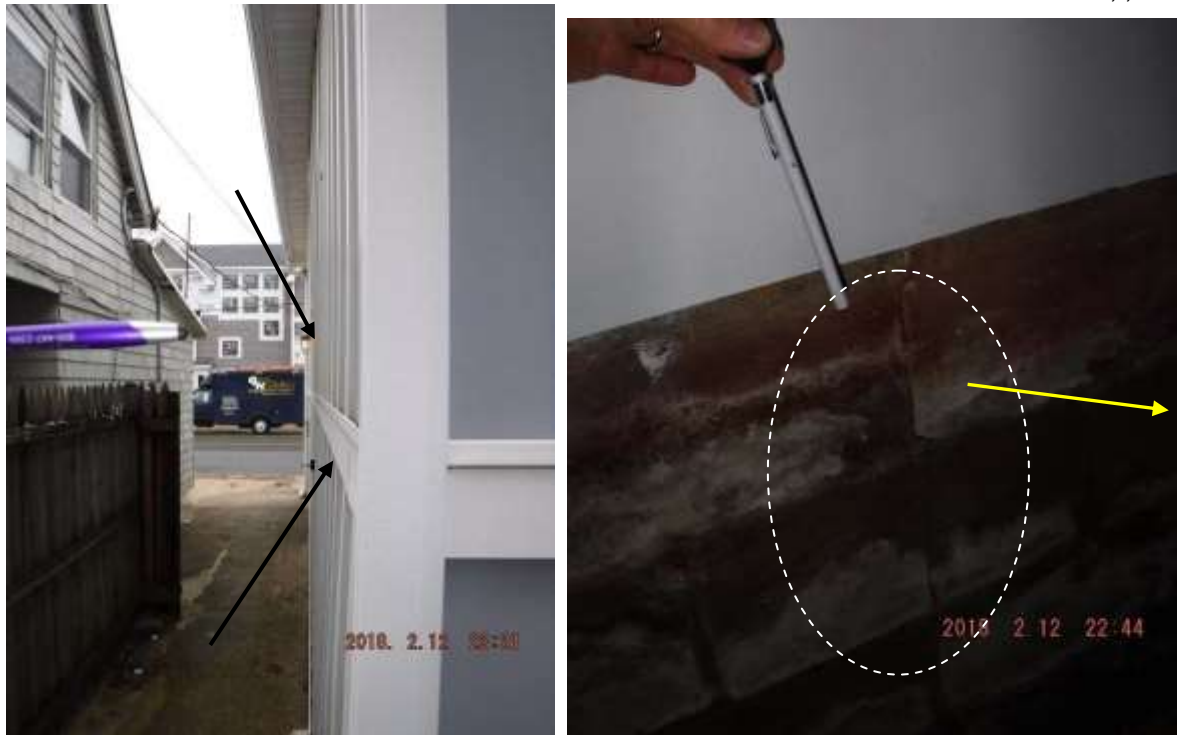
Figure 5 Example of bowed walls as viewed on exterior. The foundation walls in garage had cracks and bowed inward.

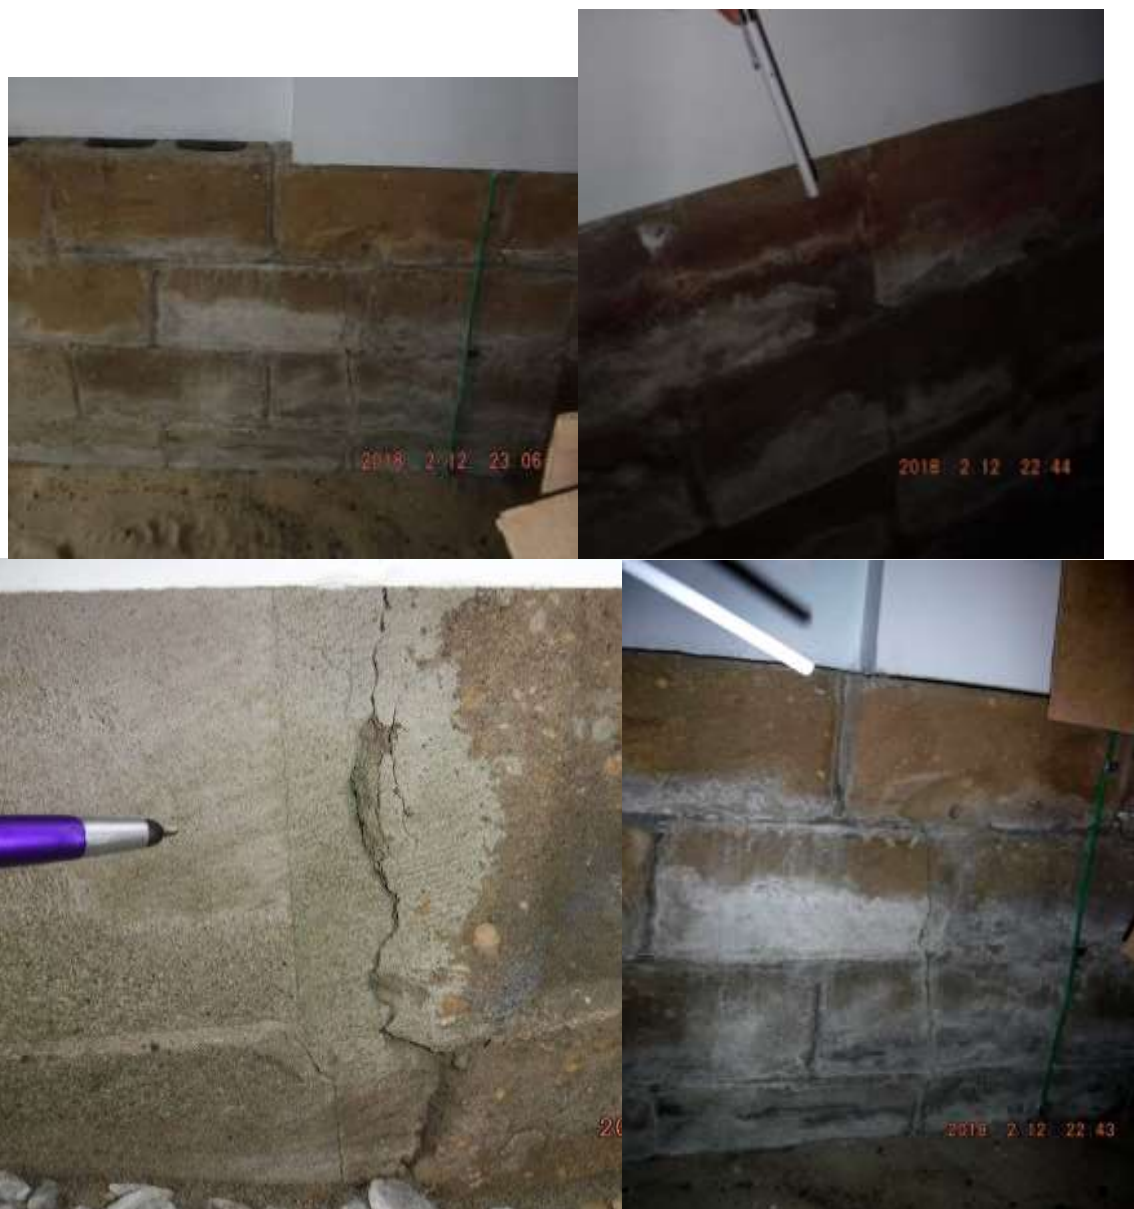
3. There appears to be two types and ages of foundation block with the rear section newer than the front section; possible expansion or modification to home after time of build. There were vertical & step cracks with some going through the block as viewed in garage. The two rear rooms in garage were finished and structure inaccessible. There were structural concerns, specifically the roof framing, exterior walls, foundation block (bowed & cracks), main beam and posts/columns. The roof had rafter spread and pronounced dip along the ridge board & sheathing as viewed on ladder from rear steps and at street level on either side. The home was finished up to the roofline and no access to the roof structure. Exterior walls/siding bow inward and interior drywall in rooms have cracks, wavy or not plumb. The main girder was boxed in with drywall in garage and had 4x4" wood posts under the beam and in contact with the sand filled garage floor (footers not visible or not verified as existing). The wood posts are undersized, unconventional and conducive to moisture and wood destroying insect damage. The flooring on either side of the home slopes toward the center main beam or girder. There were material defects or structural deficiencies observed in the home as defined by *Standards of Practice 13:40-15.16 Standards of Practice 13:40-15.16*. It is strongly advised to have a structural engineer (PE) evaluate the structure and advise on all repairs. There

Figure 6 Examples of foundation cracks (vertical & step) go through the block; visible in garage and exterior. Foundation and sand floor was wet; water seepage into the garage and rear two finished rooms on lower level.

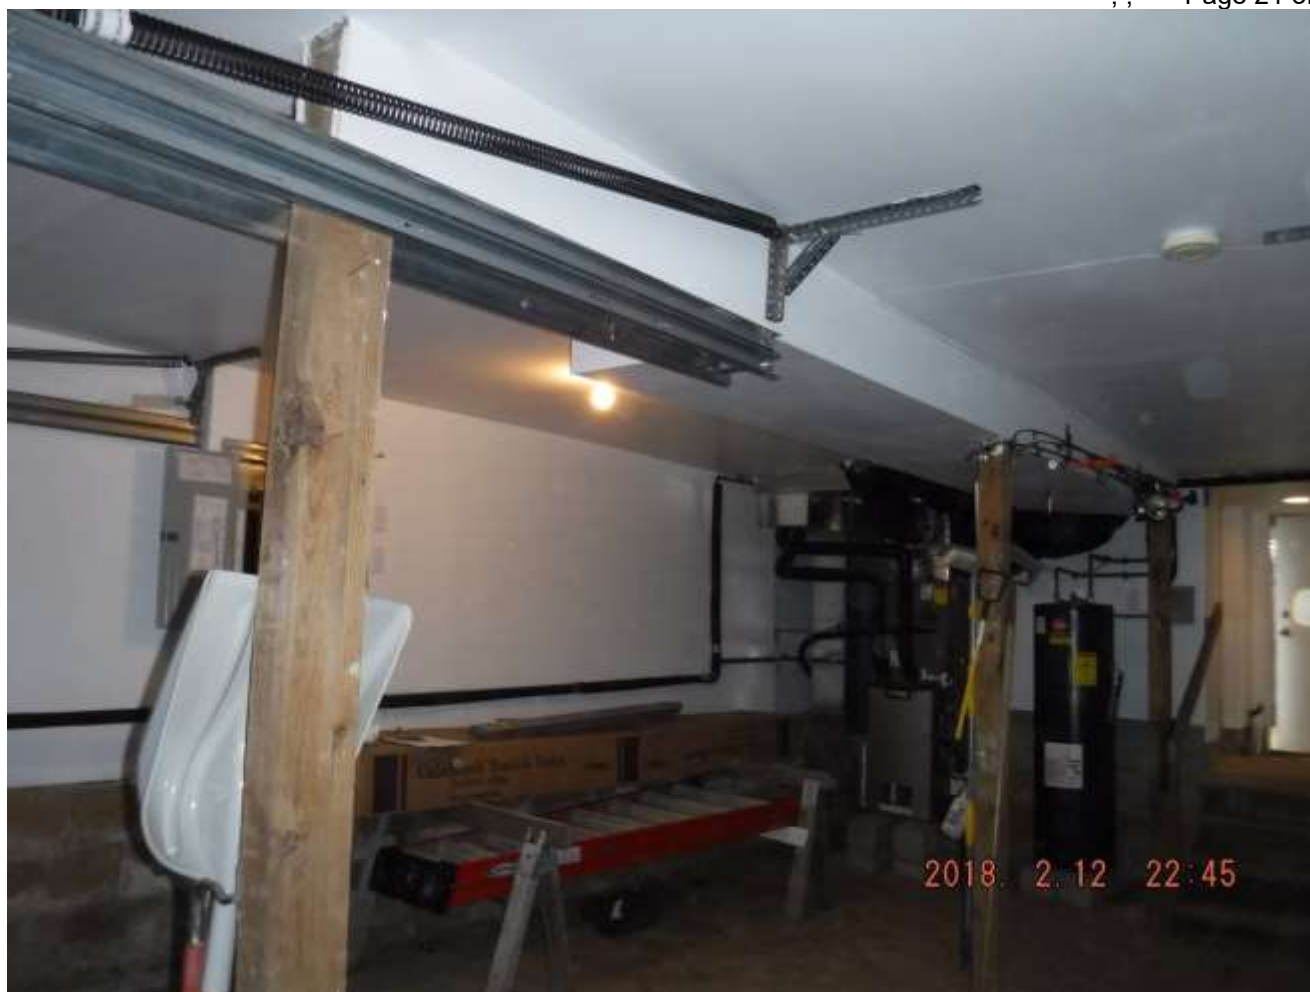
Figure 7 The wood 4x4" posts were undersized and not spaced properly. There were sloped floors in the home above and bowed walls & foundation. See structural comments pg.2. Recommend adding bollards in front of the furnace and water heater for safety.

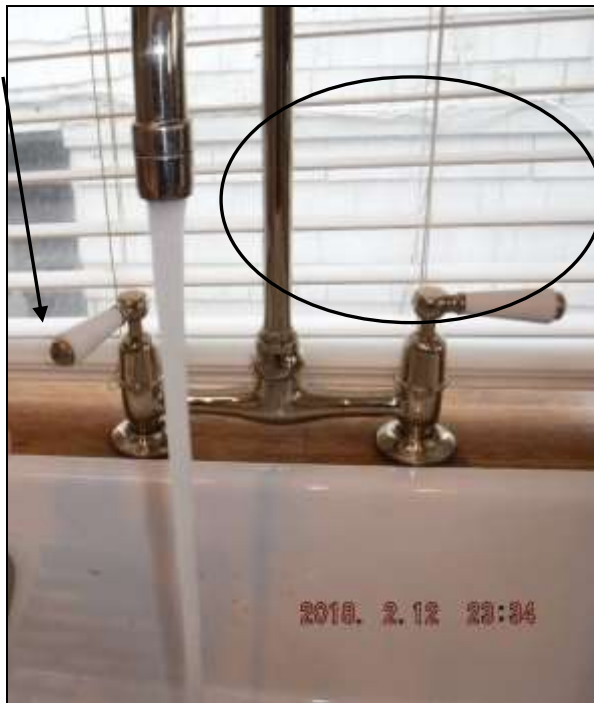
Figure 8 Window blocked by the counter top; unconventional/improper. Recommend a building contractor evaluate and advise. Windows should not be blocked.

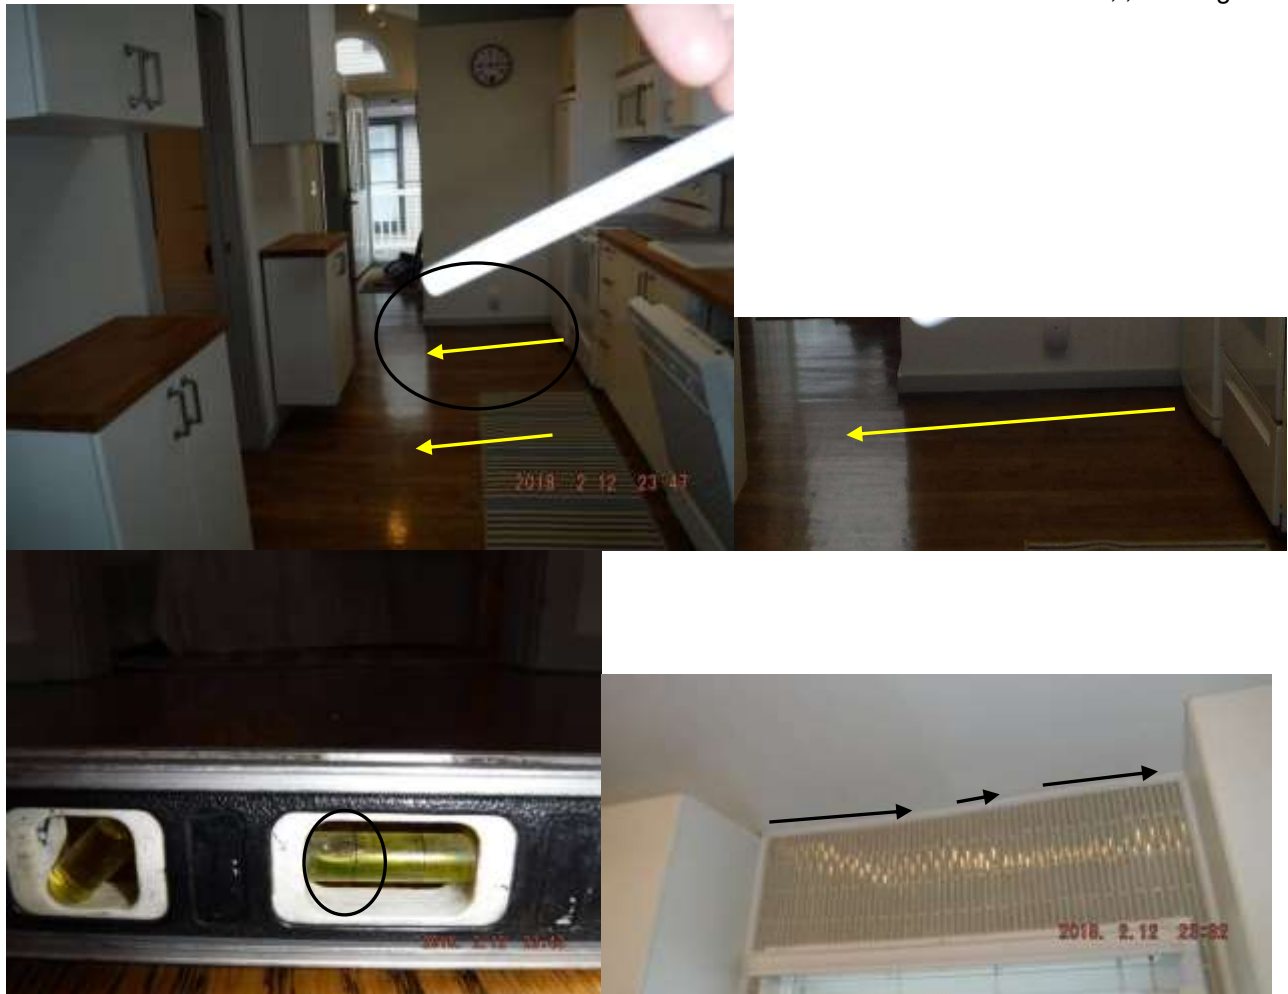
Figure 9 Example of sloped flooring and wavy or bowed walls throughout the home; structural concerns/defects.

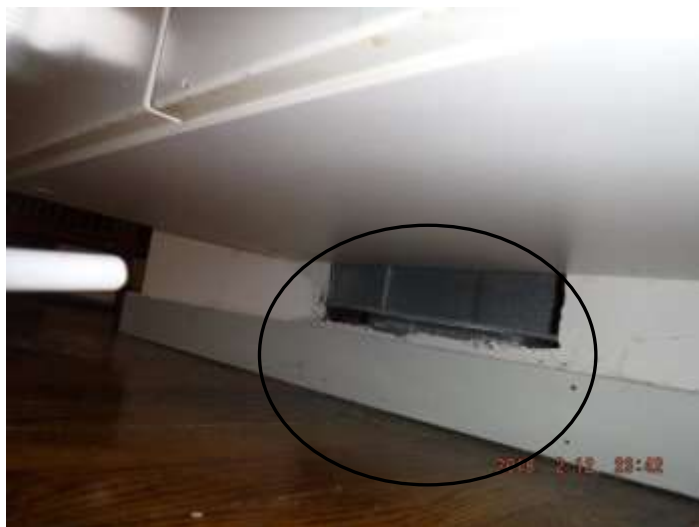
3. There was an open HVAC register under a wall mounted lower cabinet on the center wall; vents, registers and returns should not be covered. Recommend an HVAC contractor evaluate and advise on relocation of vent or cabinet.

Figure 10 Partially covered HVAC register; improperly installed cabinet. Have an HVAC contractor and/or building contractor evaluate and advise on vent relocation or cabinet relocation.

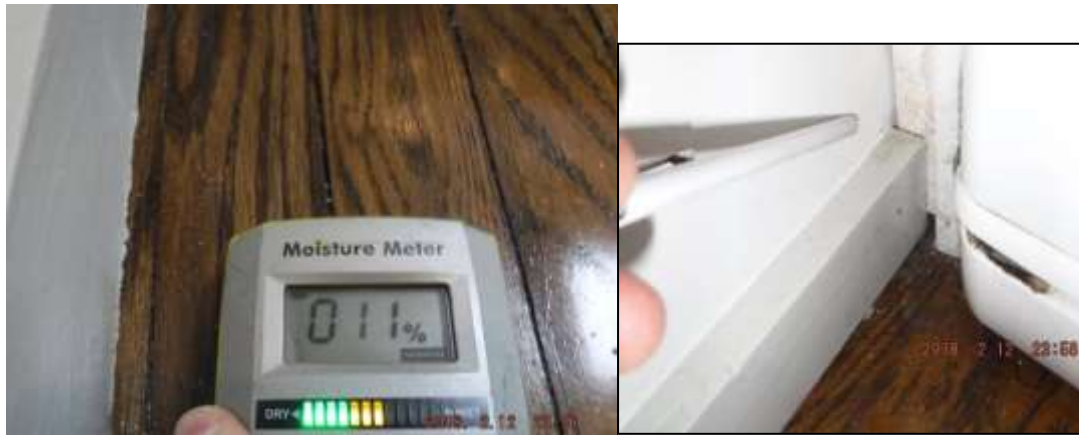
Figure 11 Example of active moisture and dark water stains on wood floor in kitchen adjacent to the bathroom and roof & skylight leaks. Recommend a building contractor determine all water/leak sources and advise on repairs before closing.

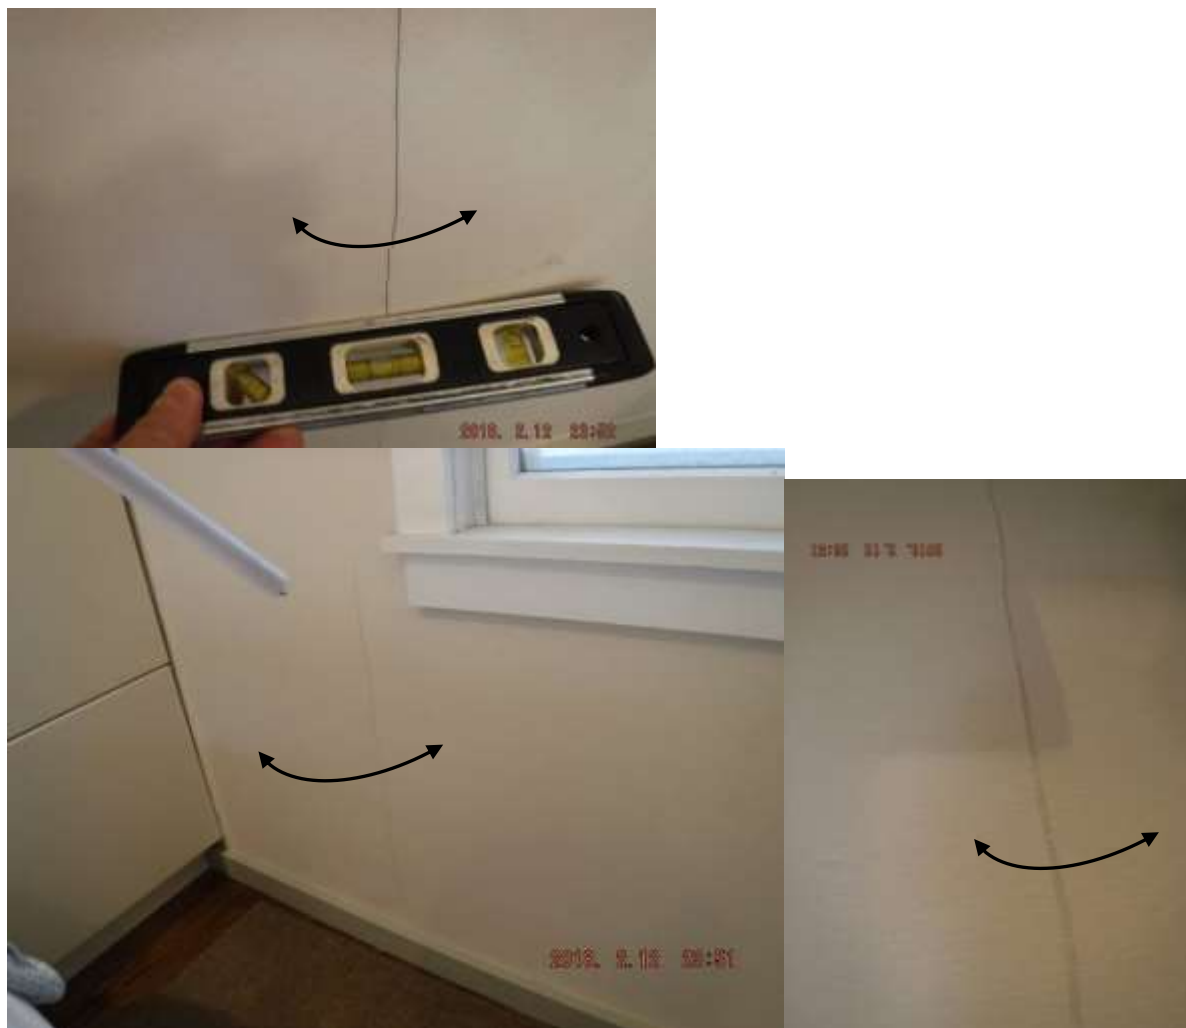
MASTER BEDROOM : There were cracks and bowed wall. See structural comments pg.2- main concerns.

Figure 12 The level rocked when placed on wall; not flat or plumb. Wall had cracks and bowed; see structural comments pg. 2.
