4 Seasons Home Inspection, LLC

buyer
street
Town nj

Inspection Date: April 29, 2015 Wednesday 10am- 3pm
Client Name/Emails: buyer(buyer@hotmail.com)
Inspection Address: \$ street, town, nj xxxxx
Inspected by: Linda Geczi home inspection lic. #24GI00061500

Approximate Age: ~1950's
Style: Single family
Main Entrance Faces: N
State of Occupancy: Occupied
Weather Conditions: 39-42°F
Ground cover: damp

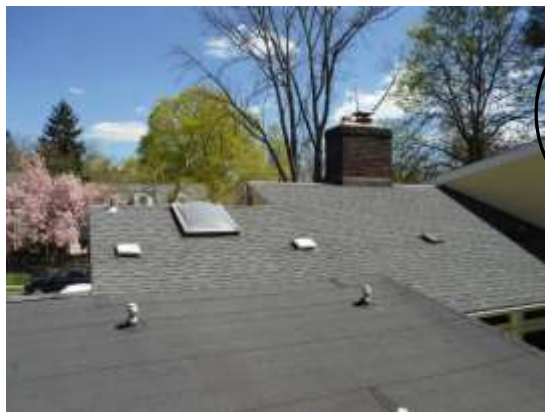
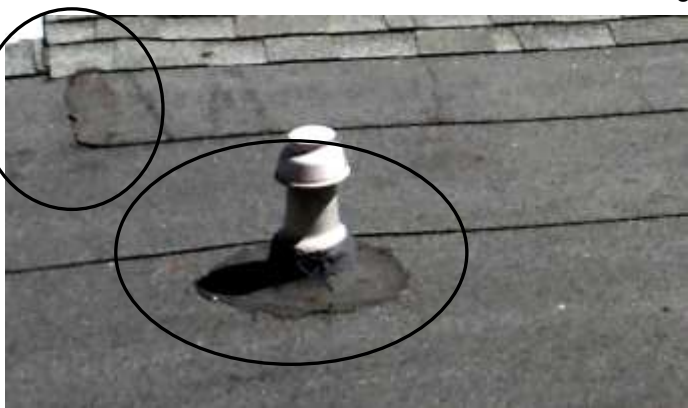
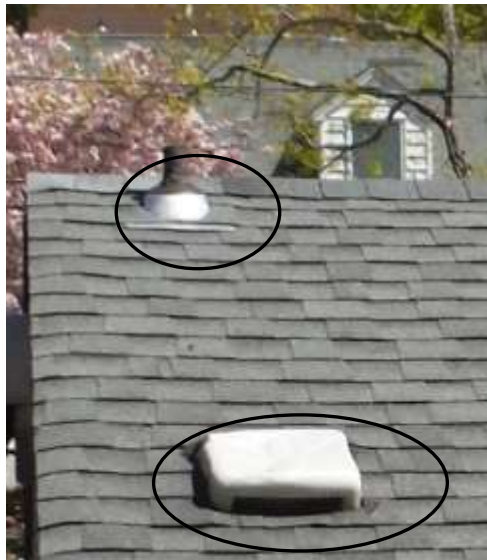
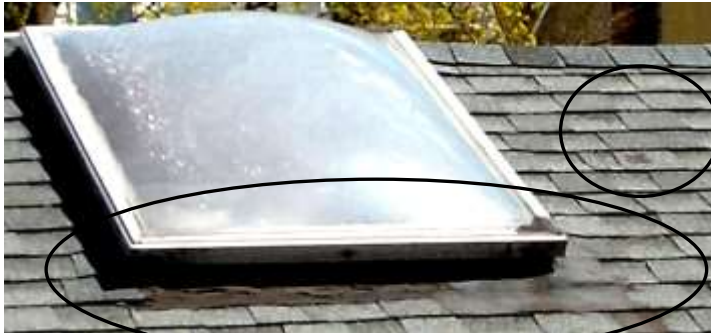
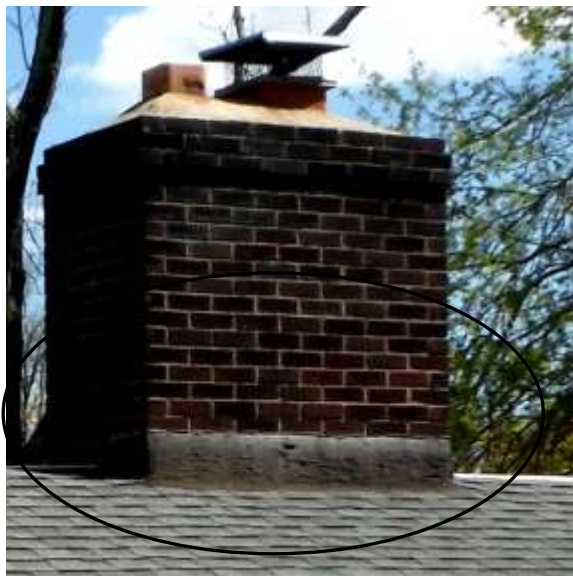
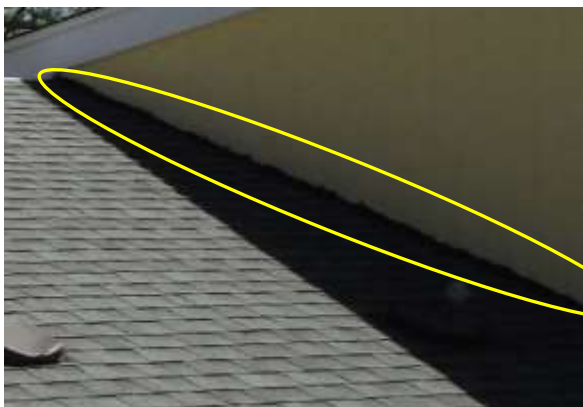
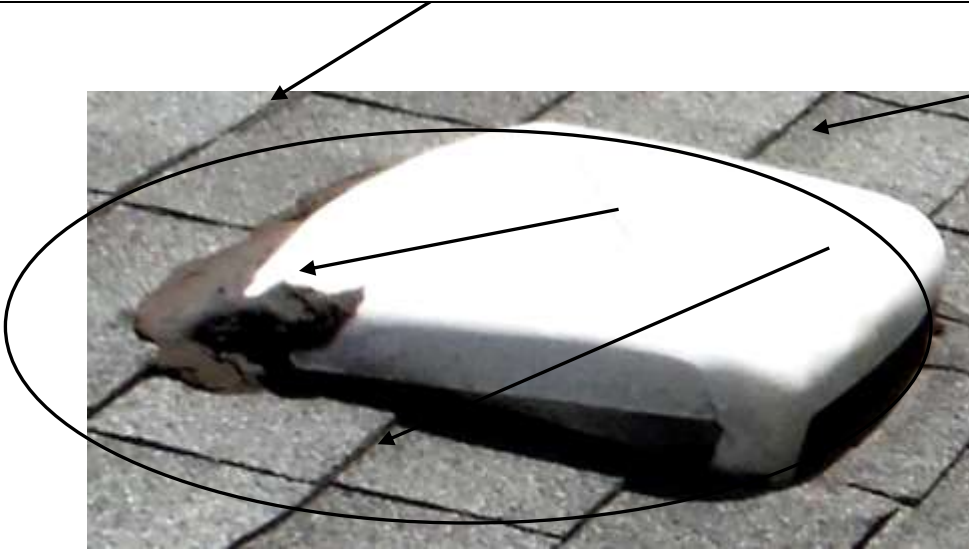
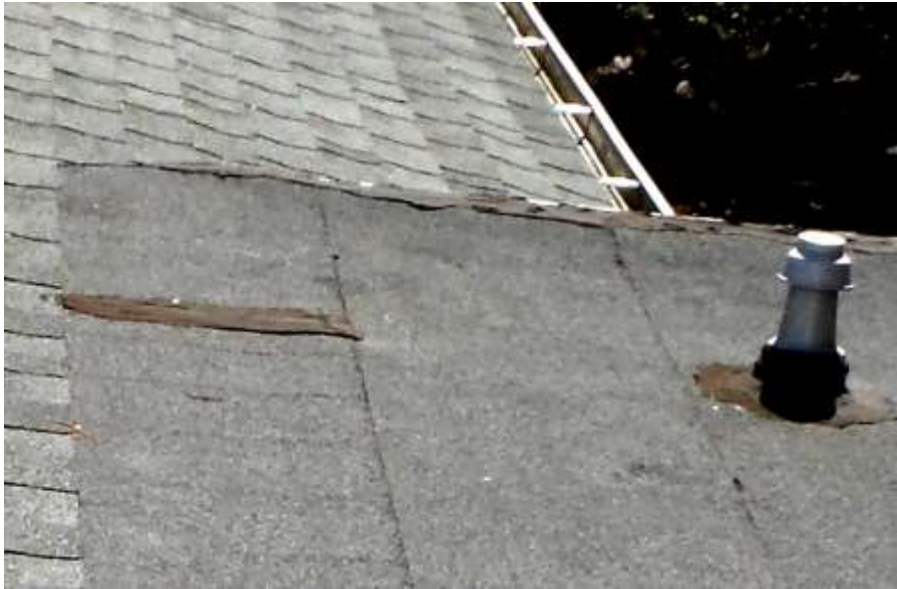
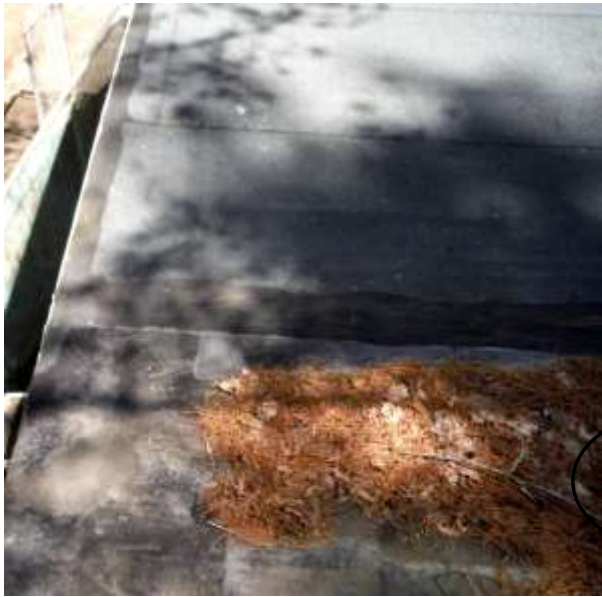
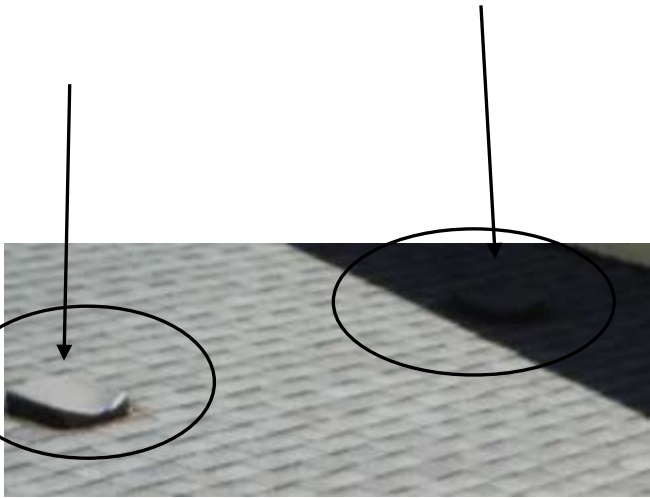
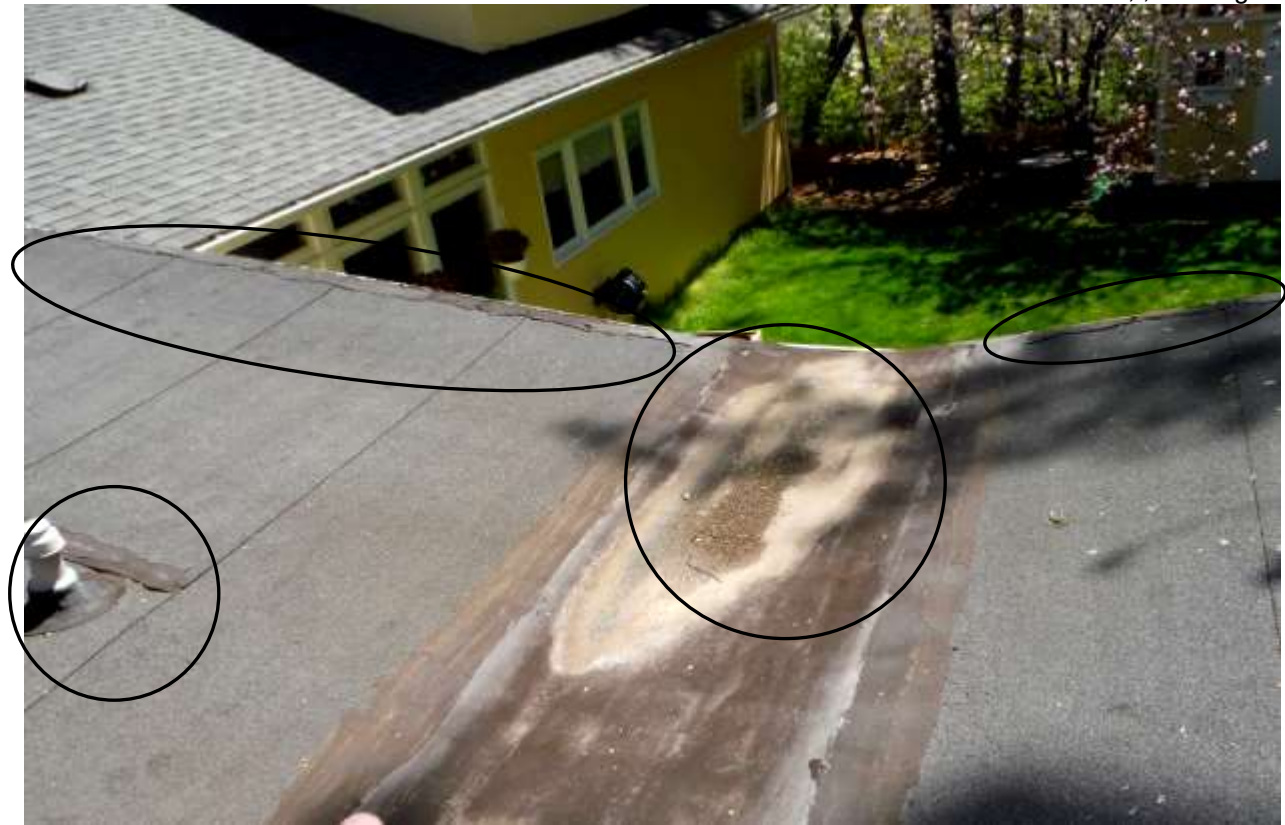
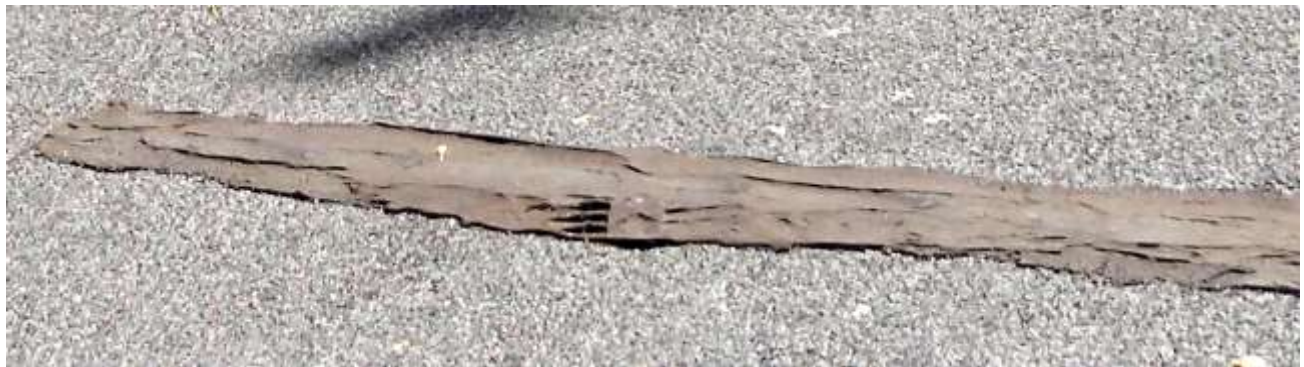
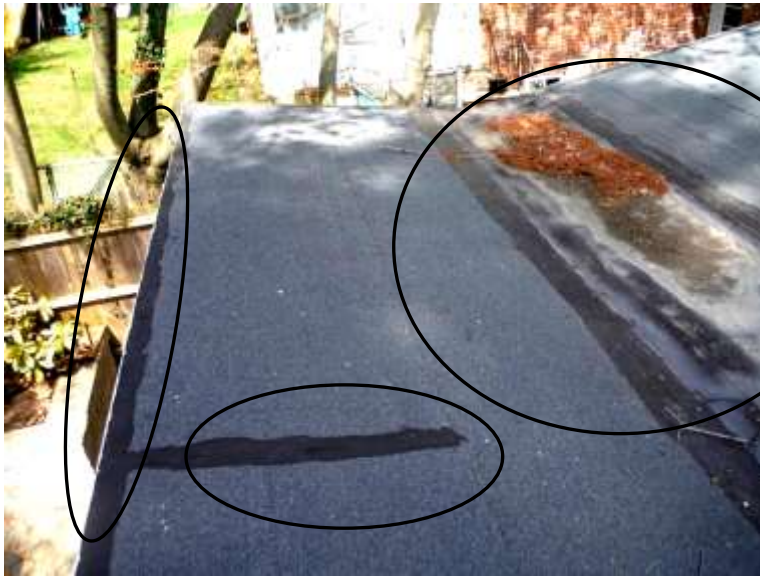
1. **There was poor drainage on roof (gutters not present or partial), tarred roof (butterfly)/siding/side walls/roof junctures/skylights, roof vents/plumbing vents/etc. There were active leaks in the interior of home and garage. Recommend a qualified roofer evaluate roof, flashings/tarred areas/junctures, etc. and advise on roof, flashings (plumbing pipe covers/chimney/ skylight/roof vents/etc.) and advise on all repairs/replacements and gutters.** Recommend replacing/upgrading skylights (very old/cloudy/crackled). Recommend more ventilation; discuss with a qualified roofer (ex. - perforated soffits, etc.). Have contractor rule out any concealed water & insect damage in home.**

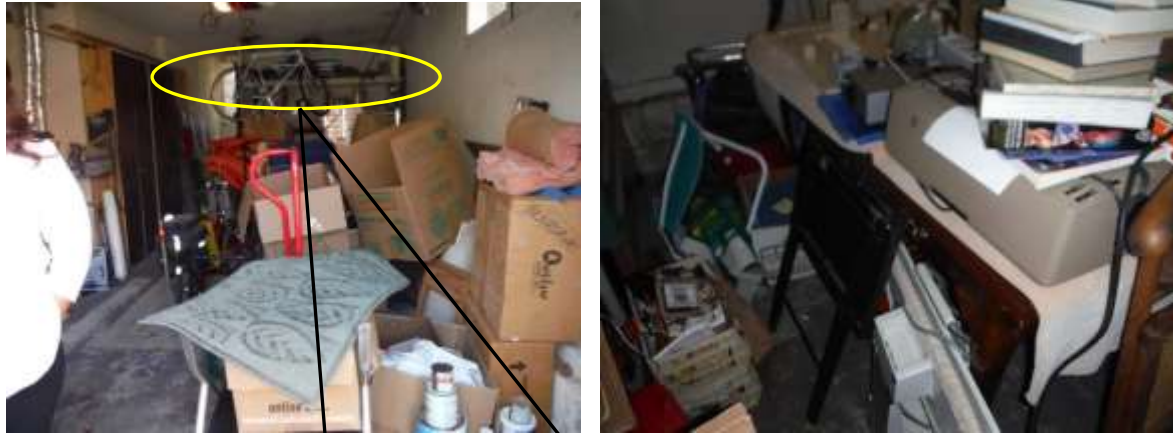
Figure 1 Check all areas when storage removed; inaccessible areas.

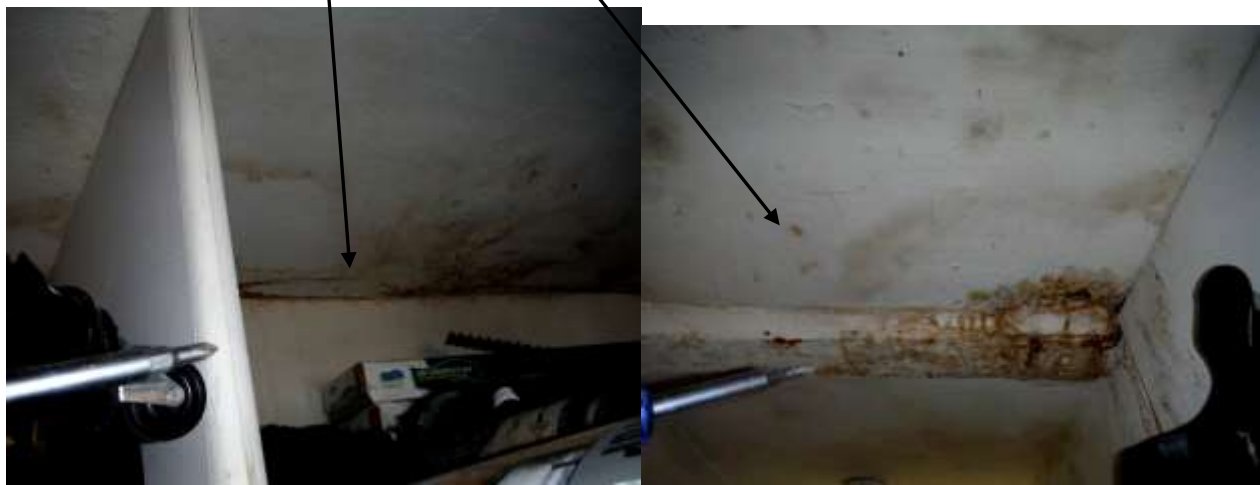
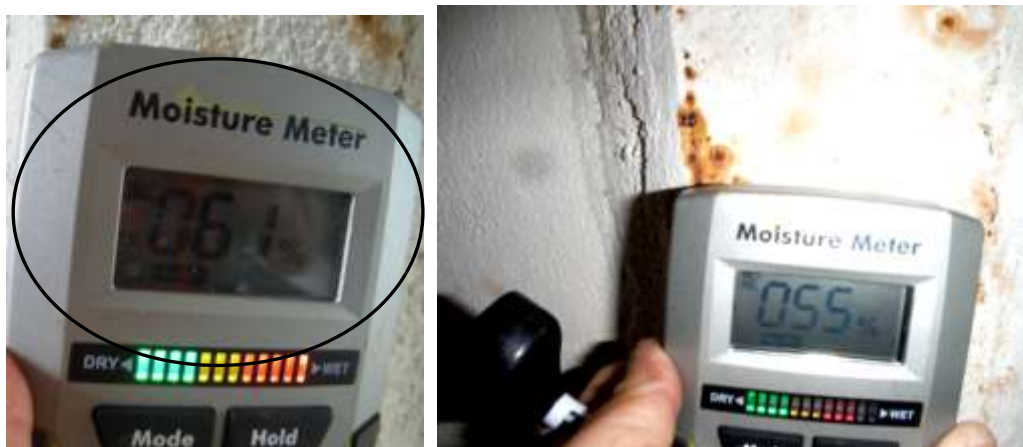
Figure 2 Rear butterfly roof leaking into garage and kitchen.

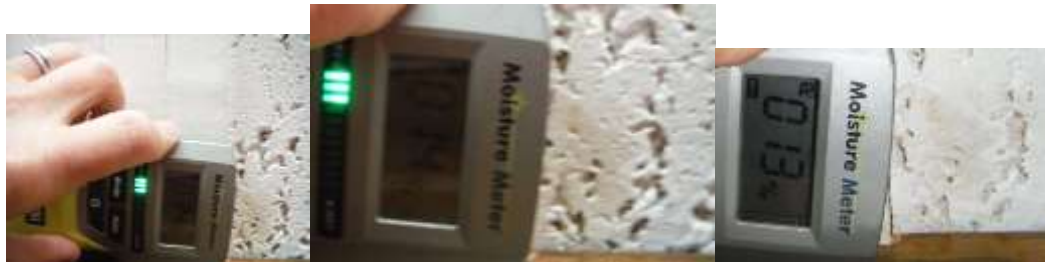
1. There were active leaks in kitchen & water stains. See roofing section comments.
2. Recommend GFCI outlets for safety.
3. There were additions or structural modification made to home; obtain closed permits as required by township before closing.

Figure 3 Active moisture on stains in kitchen.

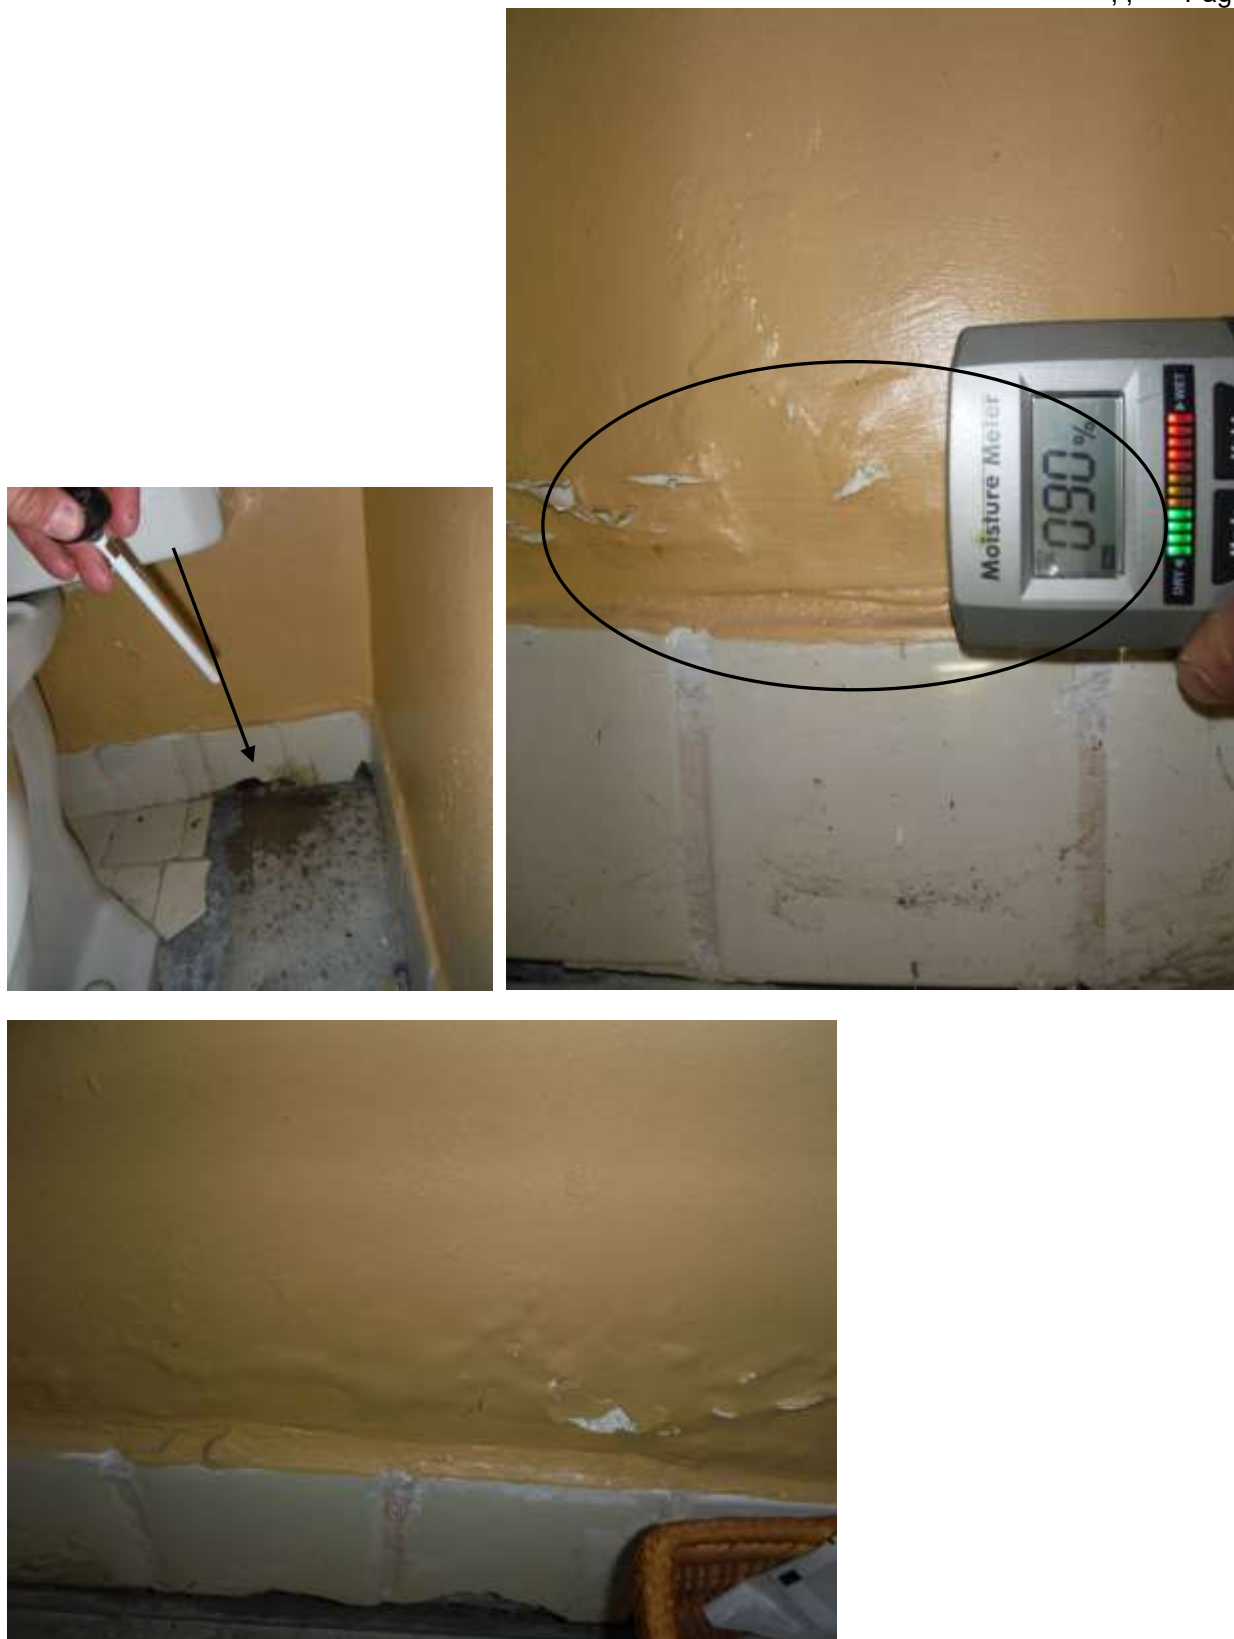
1. There was leaking toilet, seepage/peeled paint/damaged drywall and efflorescence. Recommend a bathroom contractor and plumber evaluate bathroom and advise on repairs & upgrades/renovations.

Figure 4 Water damage, efflorescence, peeled paint; seepage.

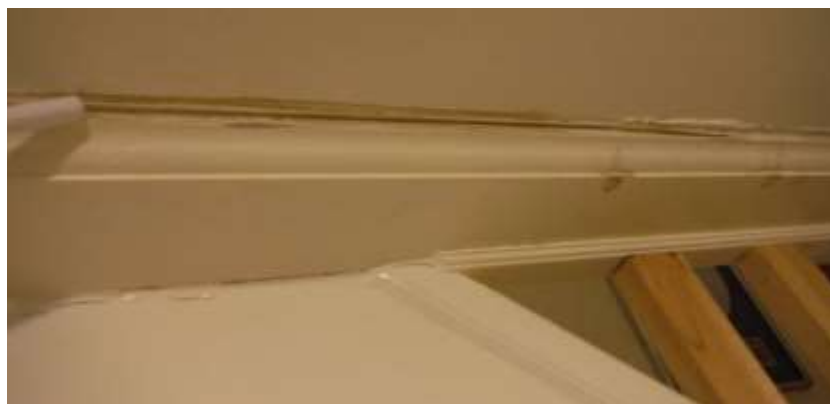
Figure 5 Moisture stains around ceiling/molding on stairwell to basement; tested dry at time of inspection. Ask history for stains; unknown.

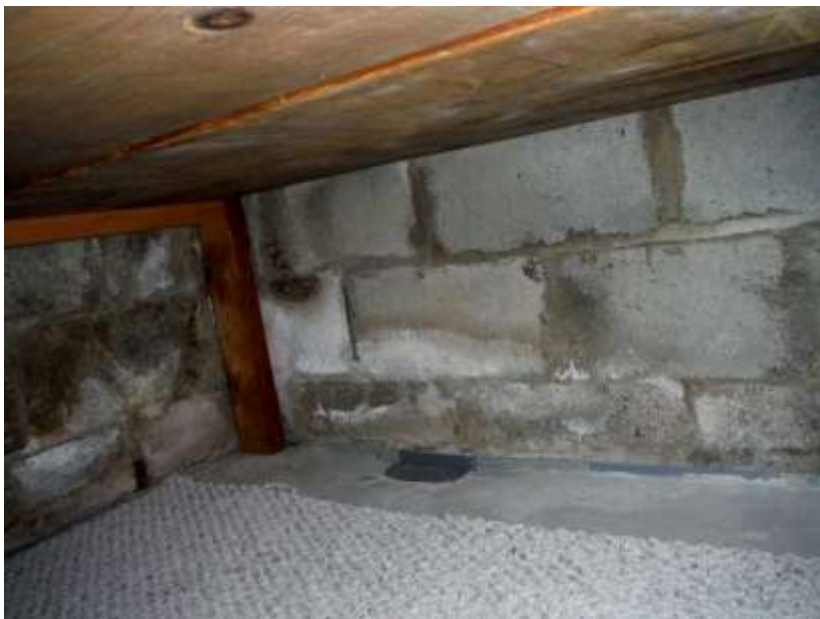
Figure 7 Example of seepage/water stains/efflorescence in basement; limited view due to finished basement.
