4 Seasons Home Inspection, LLC

Inspection Date: May 30, 2018 Wednesday 10:30am- 2:20pm
Client Name: buyer (buyer@optonline.net)
Emails: attorney@gmail.com
Inspection Address: # street, town, nj xxxxx
Inspected by: Linda Geczi home inspection lic. #24GI00061500

BUILDING DATA

Approximate Age: ~1965
Style: Single family
Main Entrance Faces: W
State of Occupancy: Occupied
Weather Conditions: light rain, cloudy 75 °F
Ground cover: wet

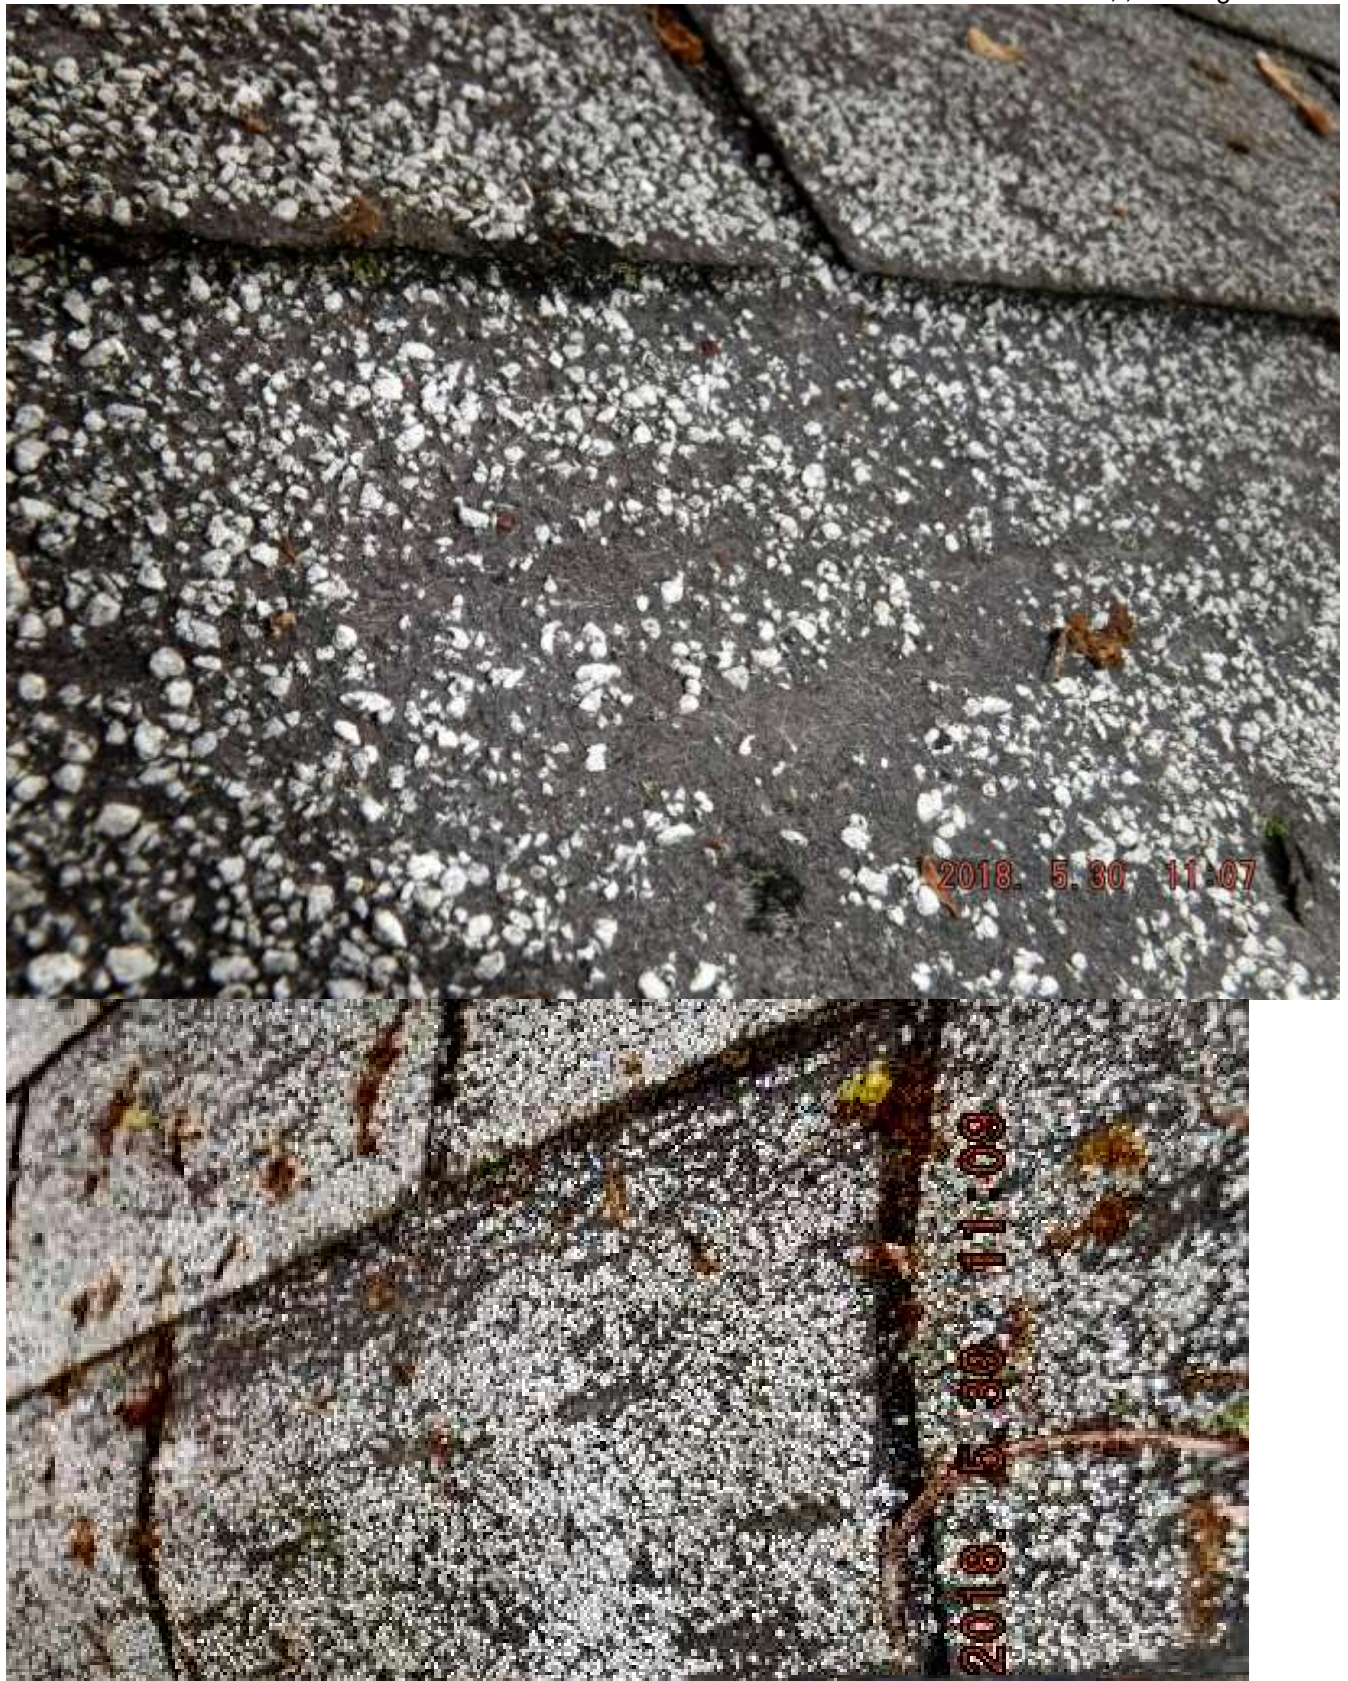
Figure 1 Example of extensive aggregate loss and exposed backing.

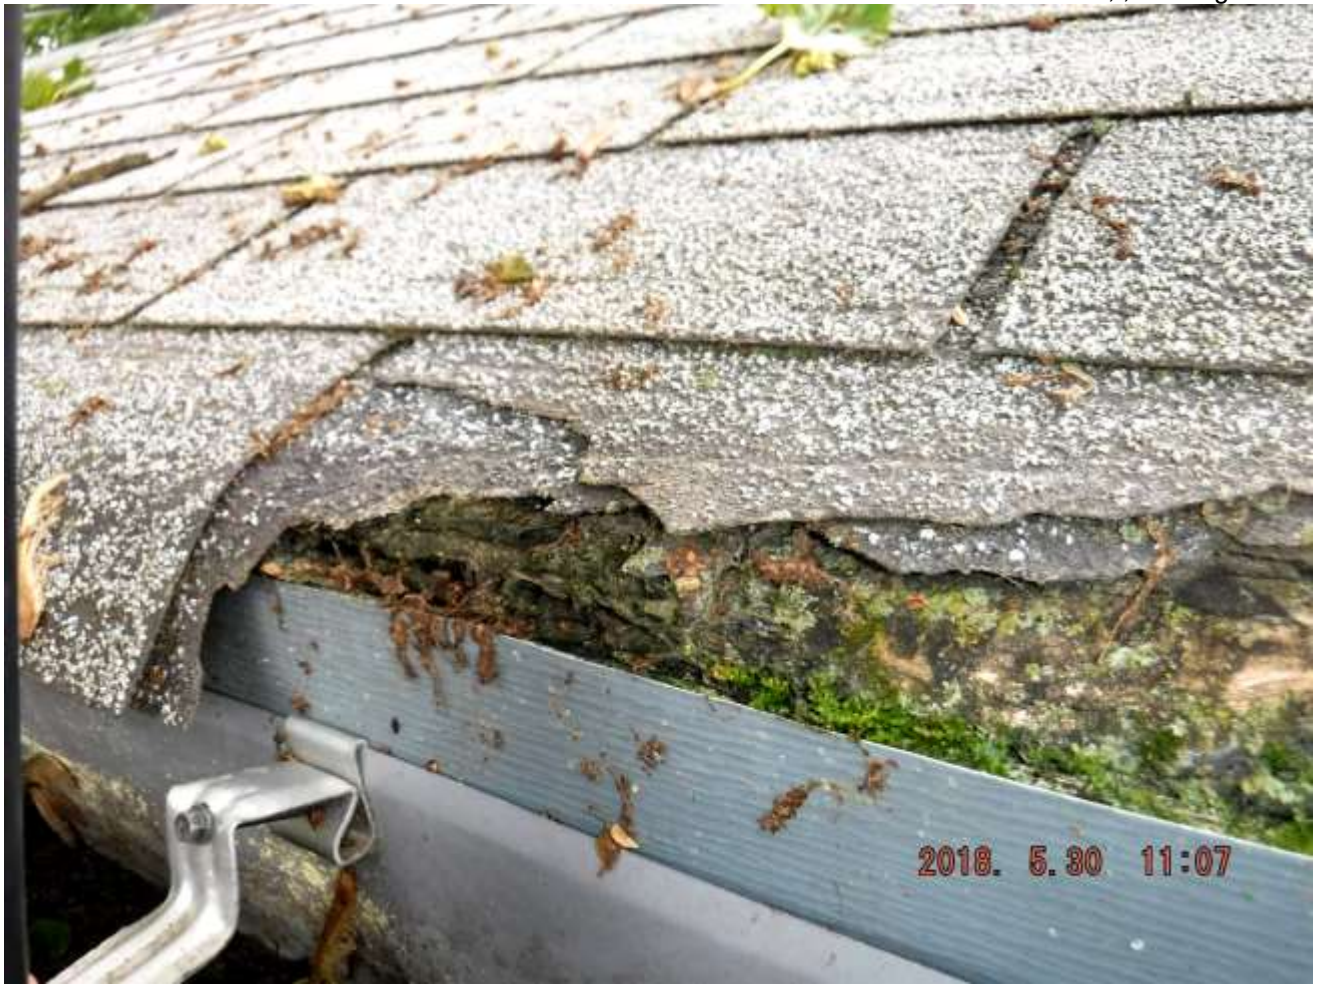
Figure 2 Example of damaged sheathing, moss, damaged shingles, etc.

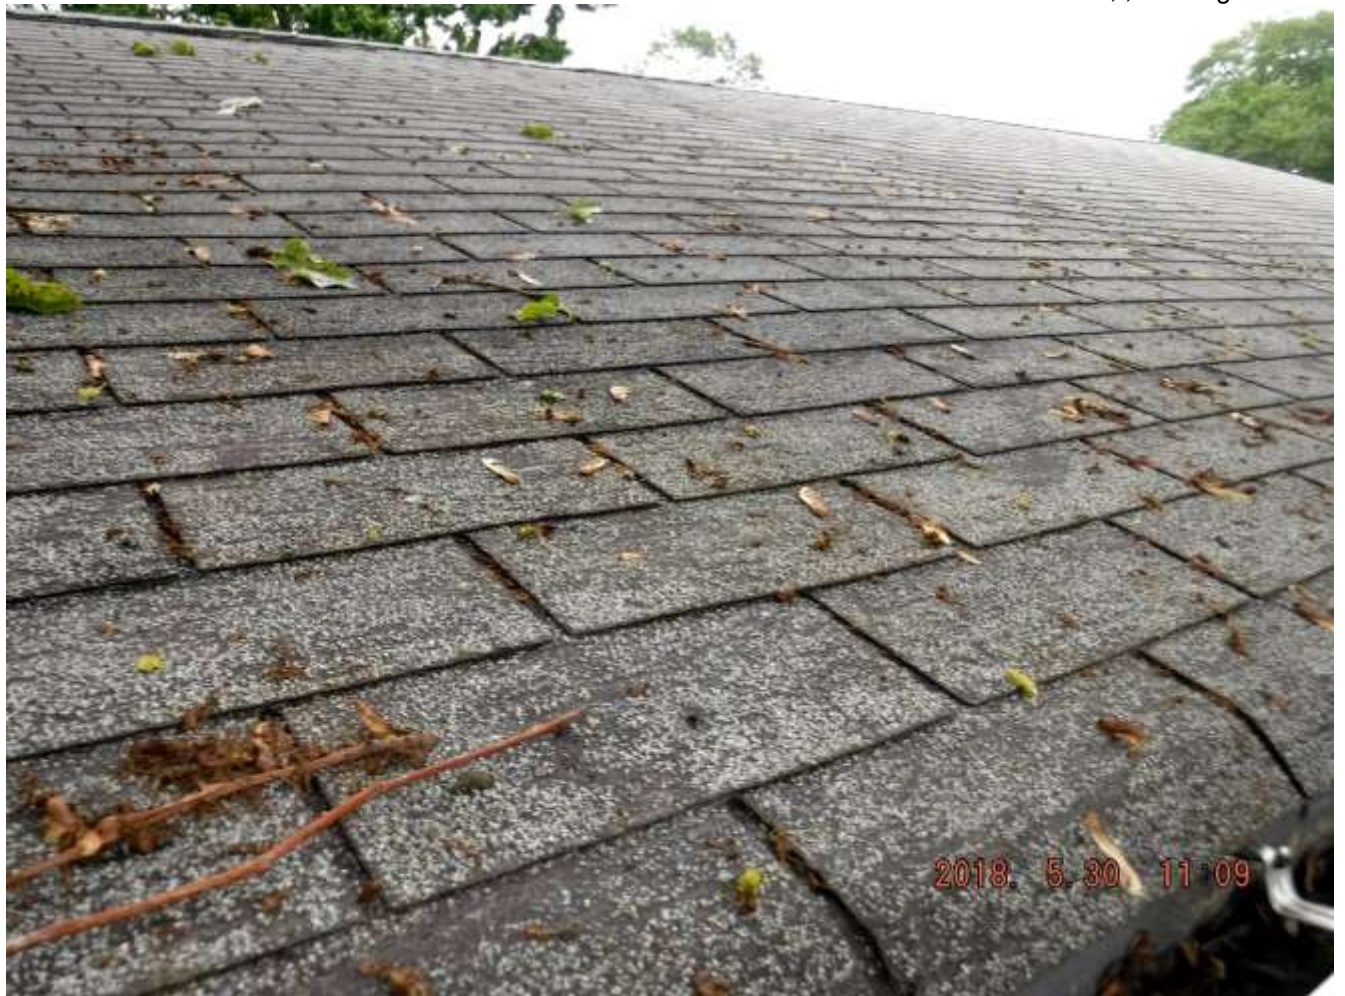
Figure 3 Much of the granules or aggregate was gone and backing visible or exposed.

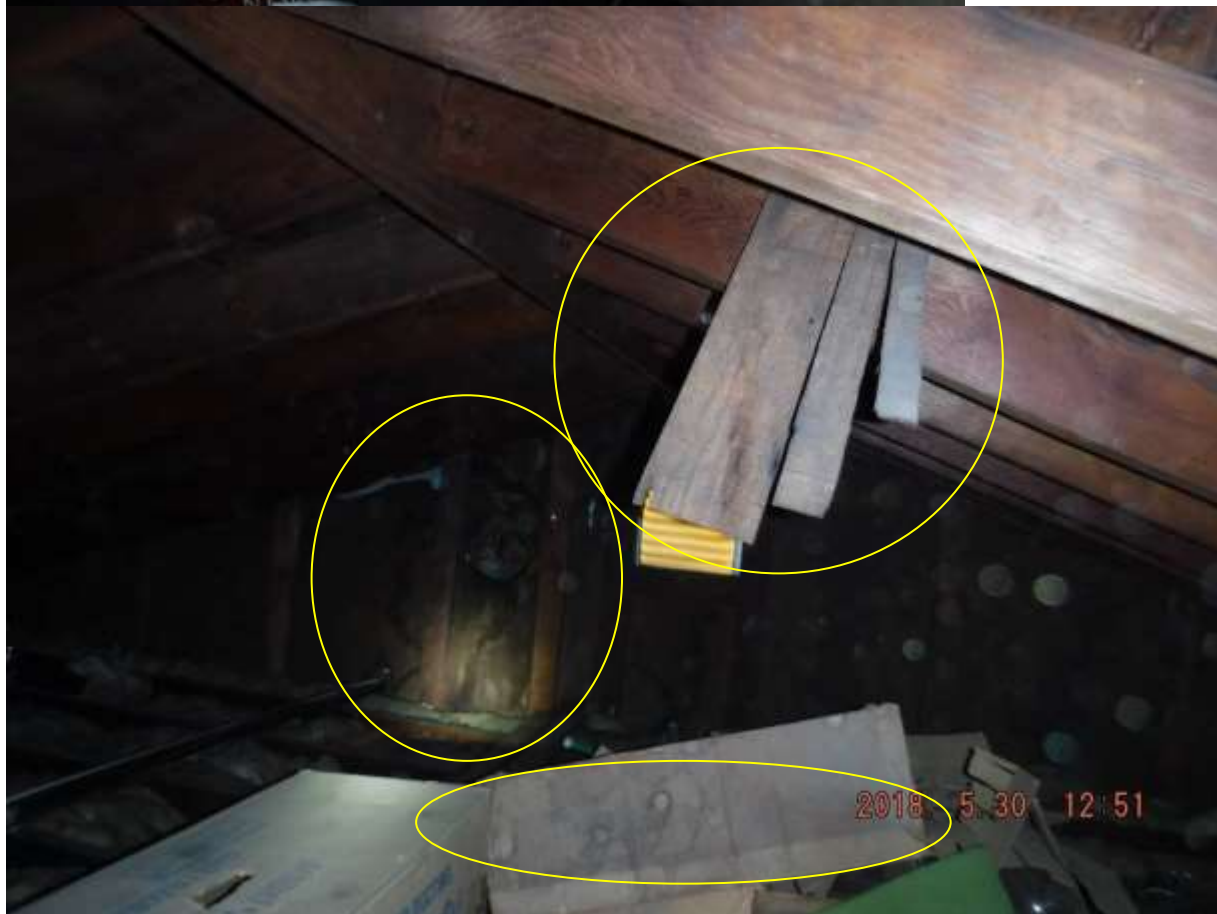
Figure 4 Example of water stains and peeled/delaminated sheathing (some hanging). Roof was poorly ventilated and leaking.

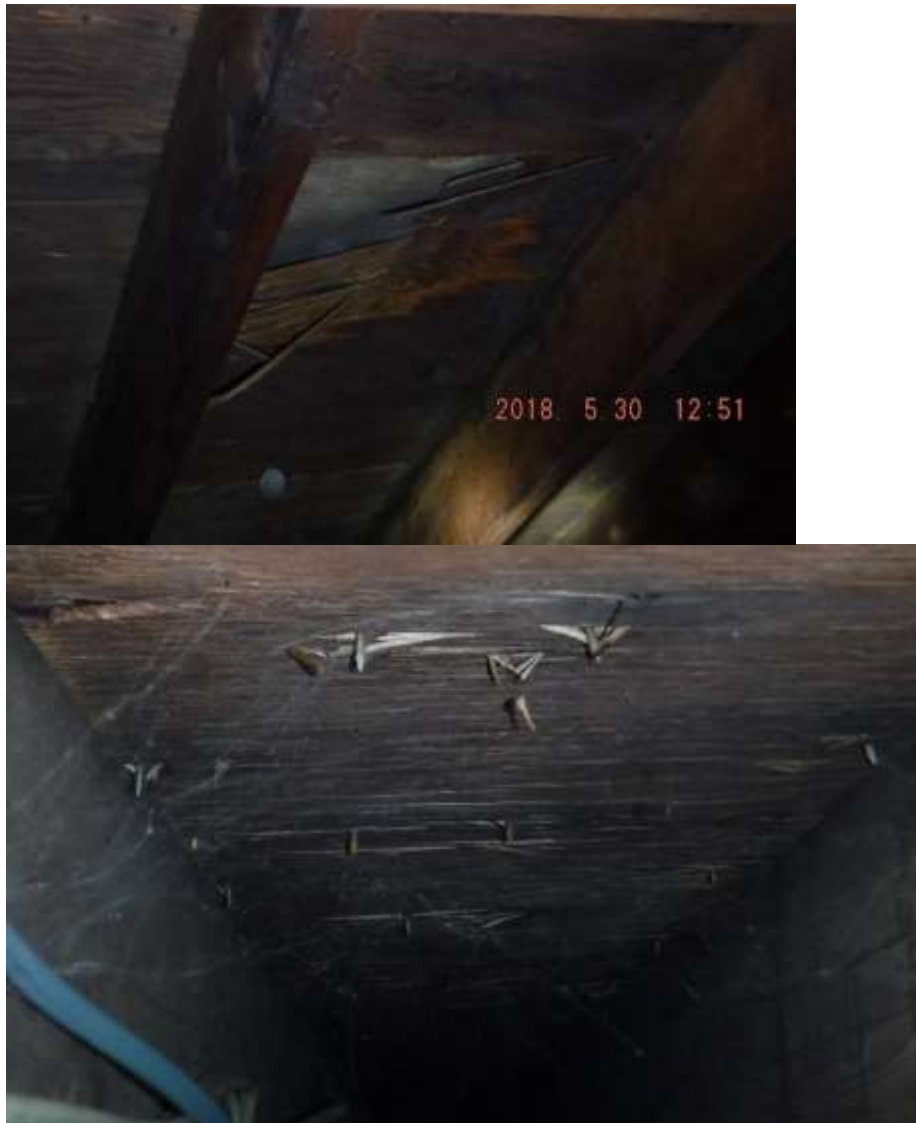
Figure 5 Example of sheathing splits/heat damage/brittle; poor ventilation.

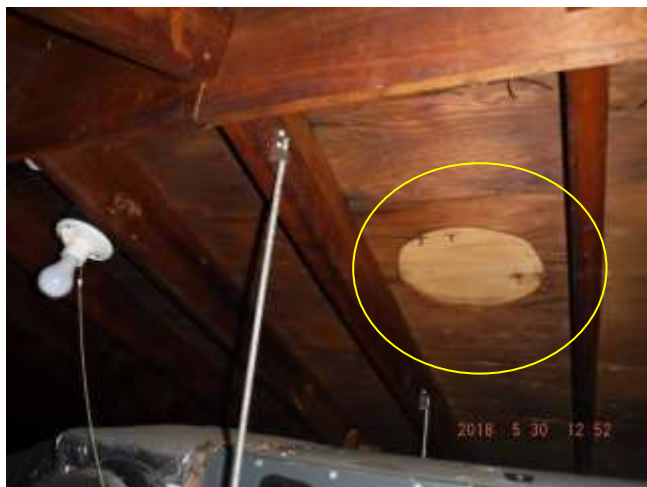
Figure 6 Example of closed roof fan(s); poor ventilation in attic.

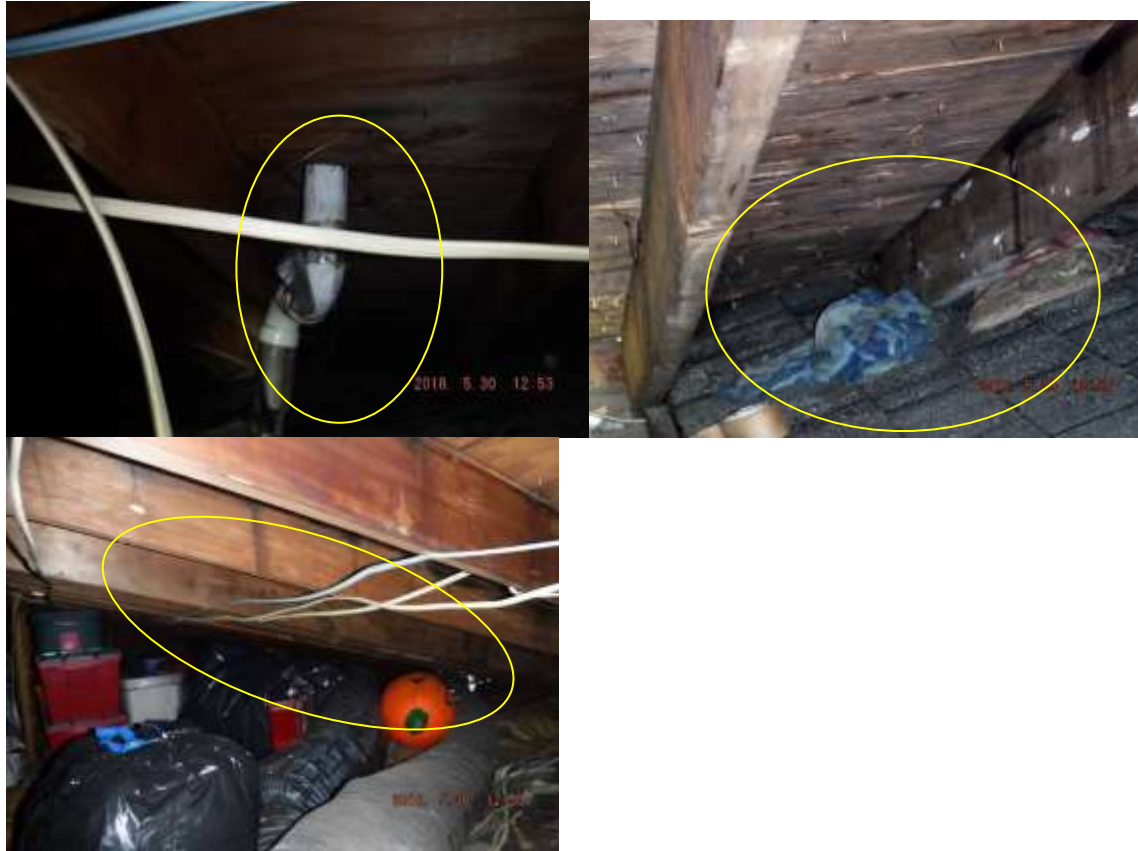
Figure 7 Example of packed storage in attic, wet rags under roof leaks, leaking roof penetrations, rusted nails, delamination/splits, etc.; poor roof condition.

Recommend roofer evaluate and advise on costs of tear off/sheathing/new roof/flashings/ventilation/gutters

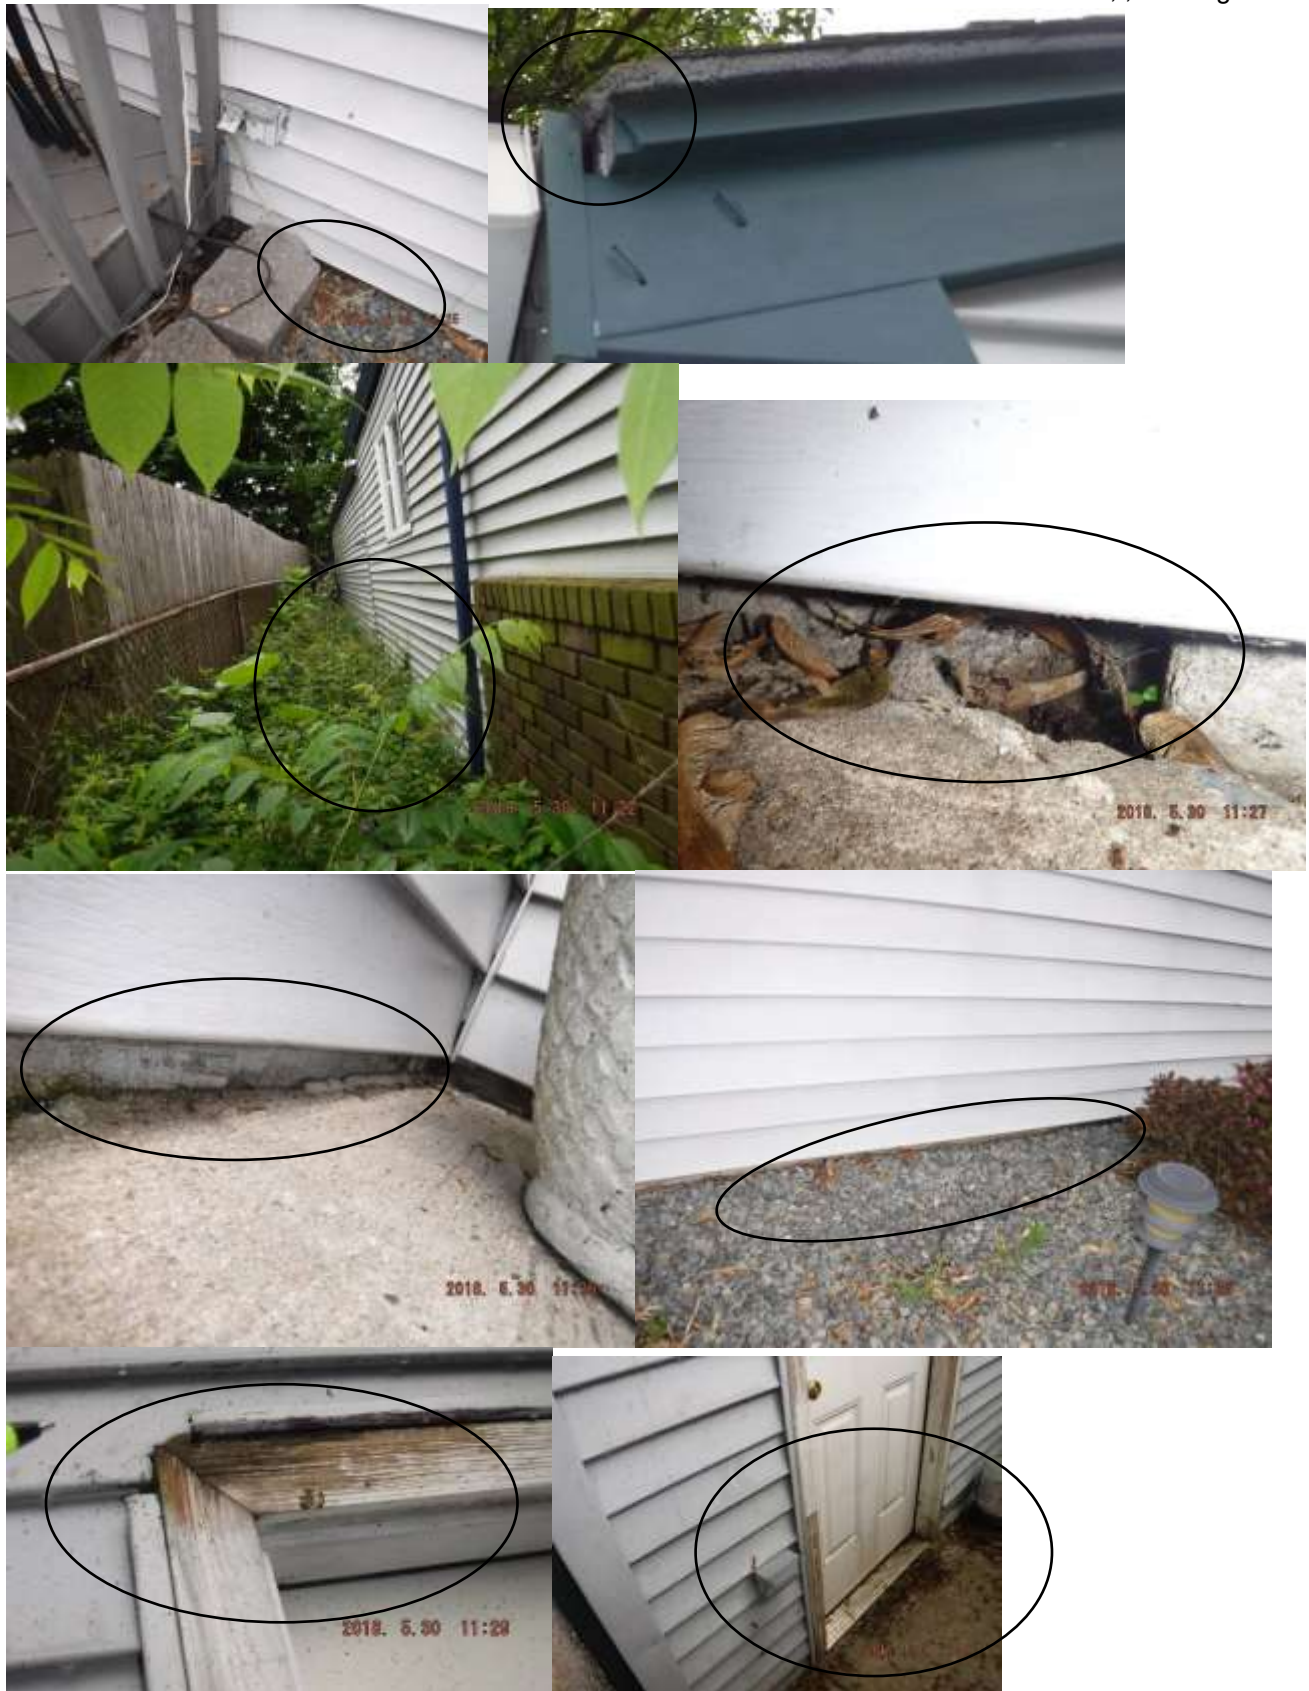
Figure 8 Examples of exterior siding: improper clearance, buckled siding, loose, gaps, improper trim/J-molding cuts, flashings missing or inadequate, cracks/gaps on slab foundation, etc.

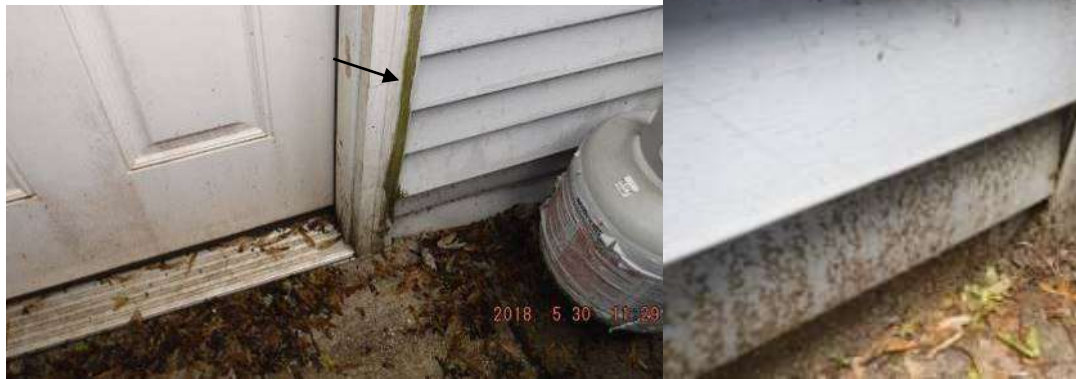
Figure 9 Example of siding in soil and buckled.

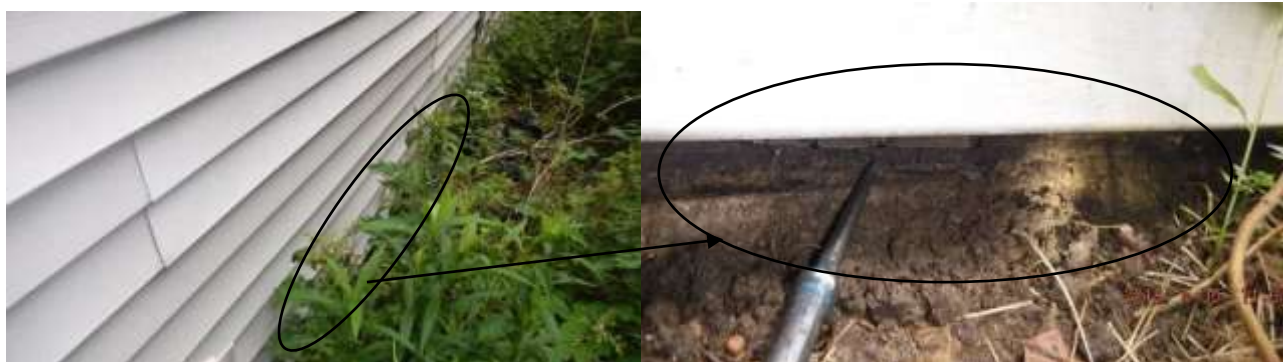
Figure 10 Example of moisture and termite damage on slab construction; limited view due to high weeds or overgrowth. See structural comments in crawl space and pg.2. main concerns. There was extensive termite damage on sills in crawl space; limited access due to low height in crawl.

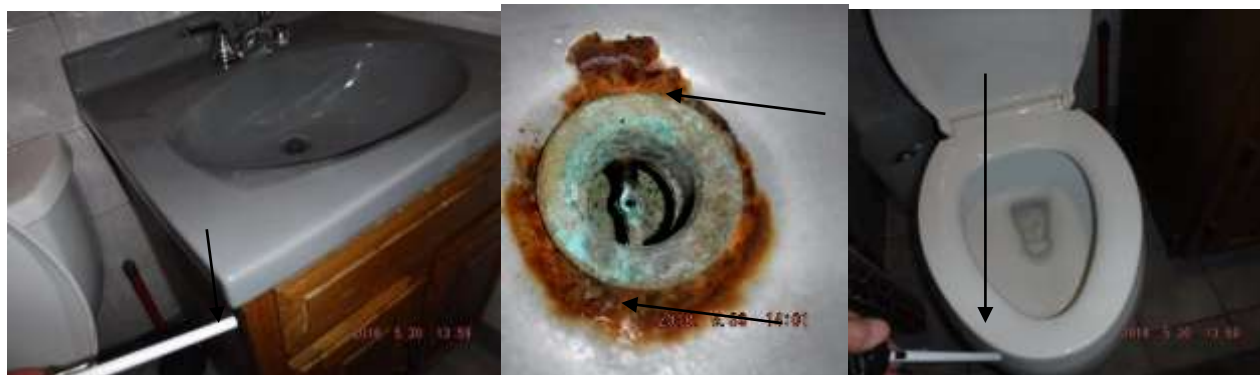
Figure 11 Vanity top was not secured down, toilet was loose and tub/drains was corroded and holes. There were water stains visible in several areas in the crawl space and leaking plumbing; see plumbing section comments.

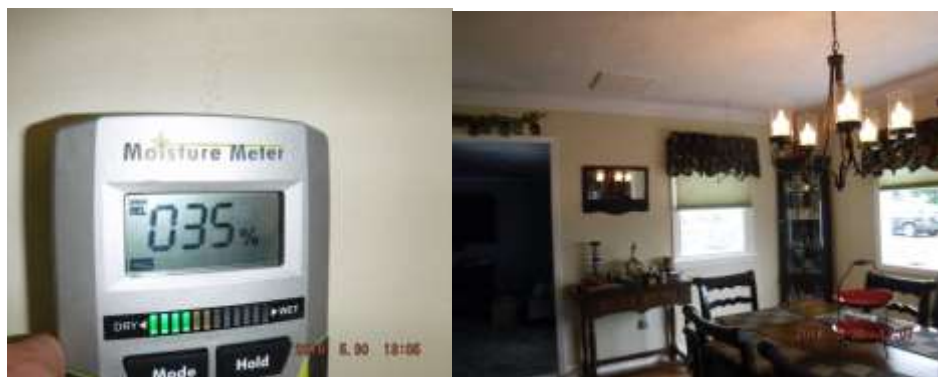
Figure 12 Moisture around windows when spot-checked; further evaluate by exterior/siding contractor.

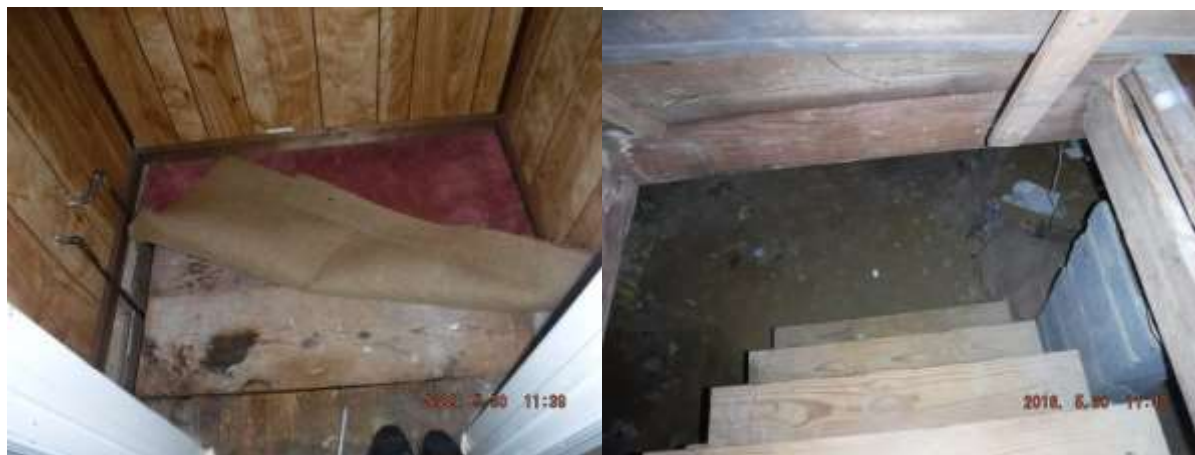
4. The wood steps in the crawl were steep, narrow, not boxed in, no railing, low headroom, etc.; safety concerns. Use caution when entering the crawl and discuss upgrades and railing with a carpenter for safety. The crawl space floor hatch cover was made of three separate boards with a few nails and cross board and not safe to walk upon. Recommend replacing the cover with a solid board or panel cover for safety.

Figure 14 Recommend a carpenter evaluate floor hatch, steps and advise on upgrades, railing, etc. for safety.

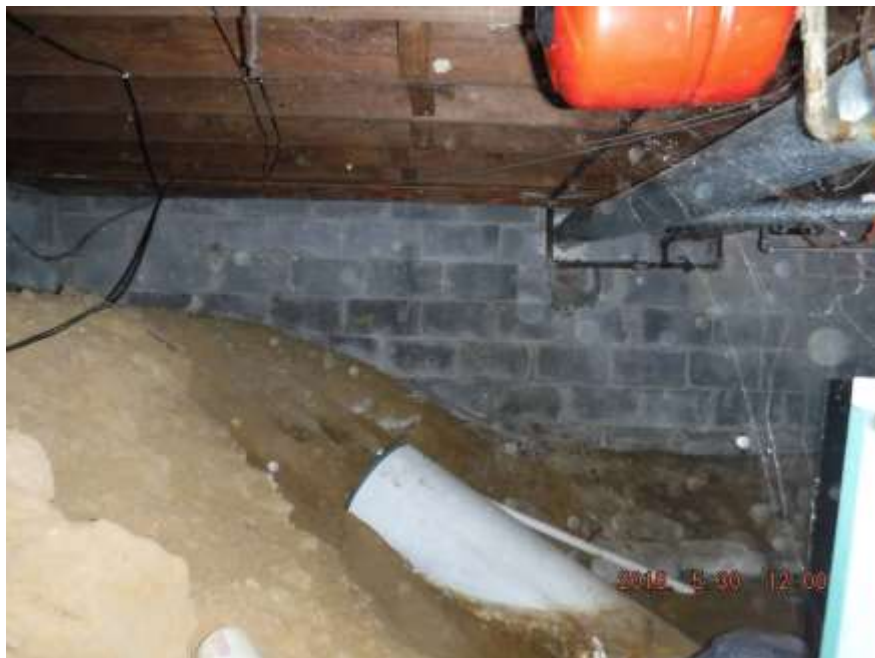
Figure 15 Example of depended dirt floor, foundation cracks, old water heater in dirt, wet dirt/seepage, etc.

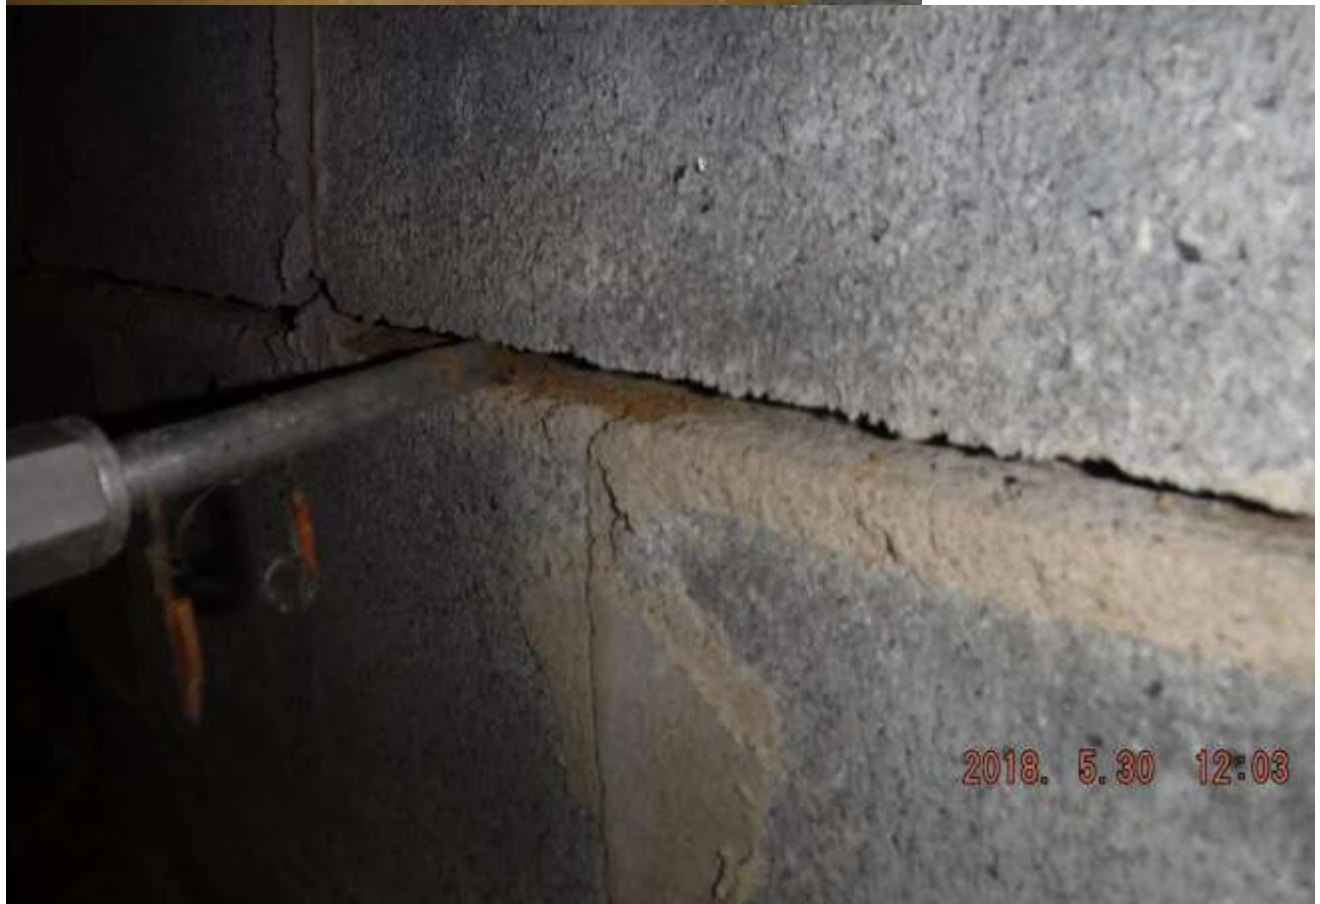
Figure 16 Example of areas with approximately 1/2" opening are bowed wall(s).

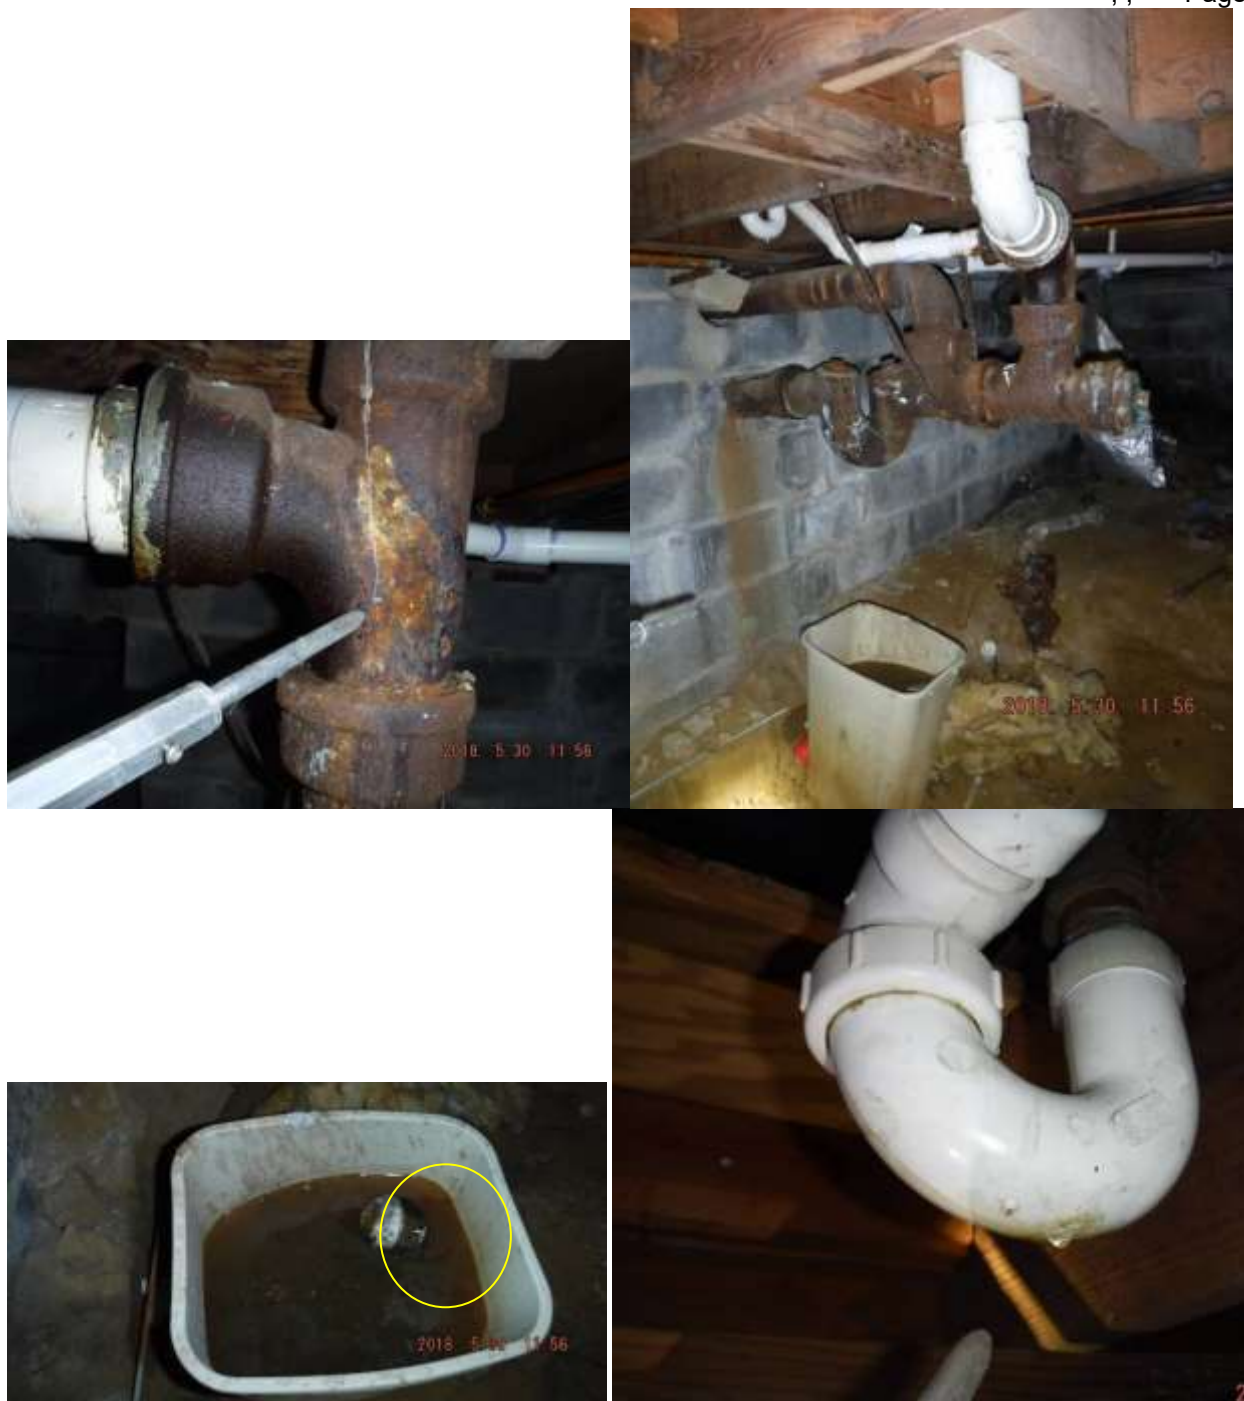
Figure 17 Example of corroded plumbing, leaking and brown water filled in a catch bucket. Recommend a licensed plumber evaluate all plumbing in home and advise on repairs/upgrades.

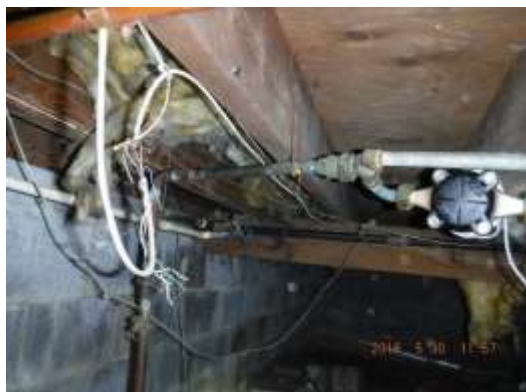
Figure 18 Partial view of water meter & gate valve shutoff. Gate valves tend to stick, leak and difficult to close to operate in an emergency. Recommend upgrading to single handle ball valves on main and in home.

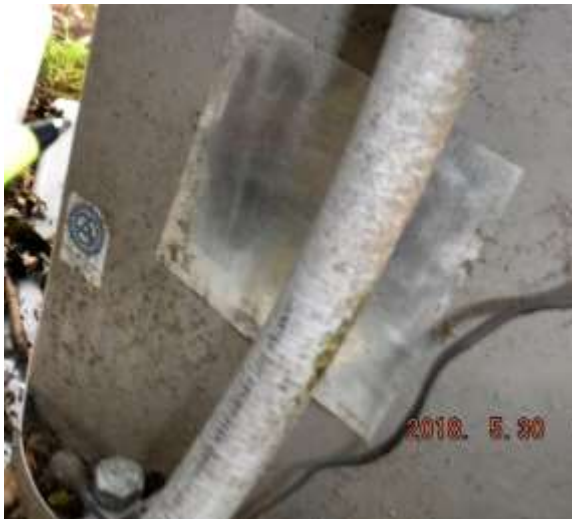
Figure 19 Data tag on condensing unit was worn off; appears very old.

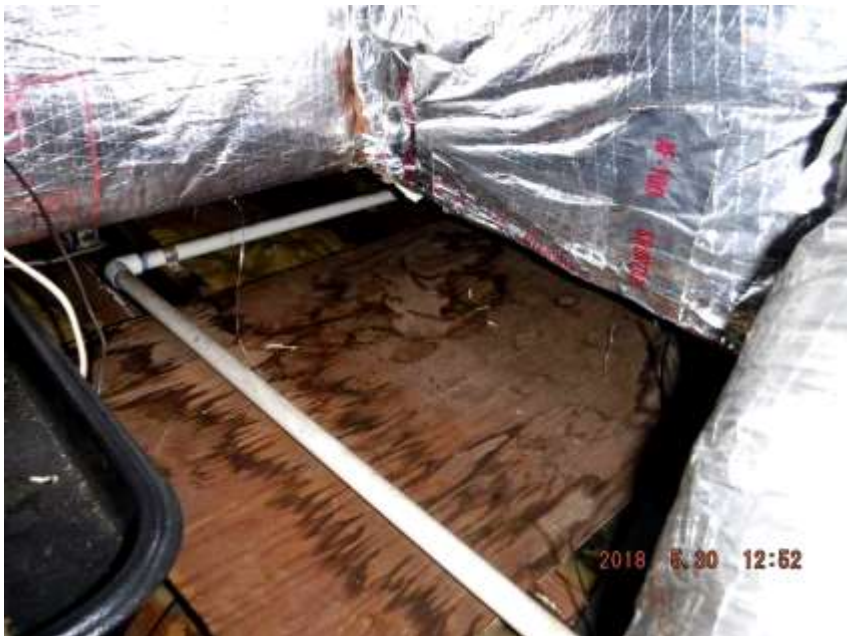
Figure 20 Example of condensate or water stains around the air handler in attic; recommend an HVAC contractor evaluate cooling system/service and advise before closing. Cooling not tested to avoid leaking or condensate damage should unit not function properly and potentially cause damage to interior rooms.

2. Recommend a building contractor add secure flooring in attic to access the air handler/HVAC equipment for safety.
