4 Seasons Home Inspection, LLC

Mr. Buyer
Bergen Cty, NJ

Inspection Date: May 02, 2018 Wednesday 12pm- 5pm
Client Name: Bob Buyer (Buyer@hotmail.com)
Emails: lawyer@lawfirm.com
Inspection Address: # street, town, NJ xxxxx
Inspected by: Linda Geczi home inspection lic. #24GI00061500

Approximate Age: ~118 yrs.
Style: Mixed Use-
2nd FL Apt. & retail store front
Main Entrance Faces: N
State of Occupancy: Vacant
Weather Conditions: 70 °F
Ground cover: damp

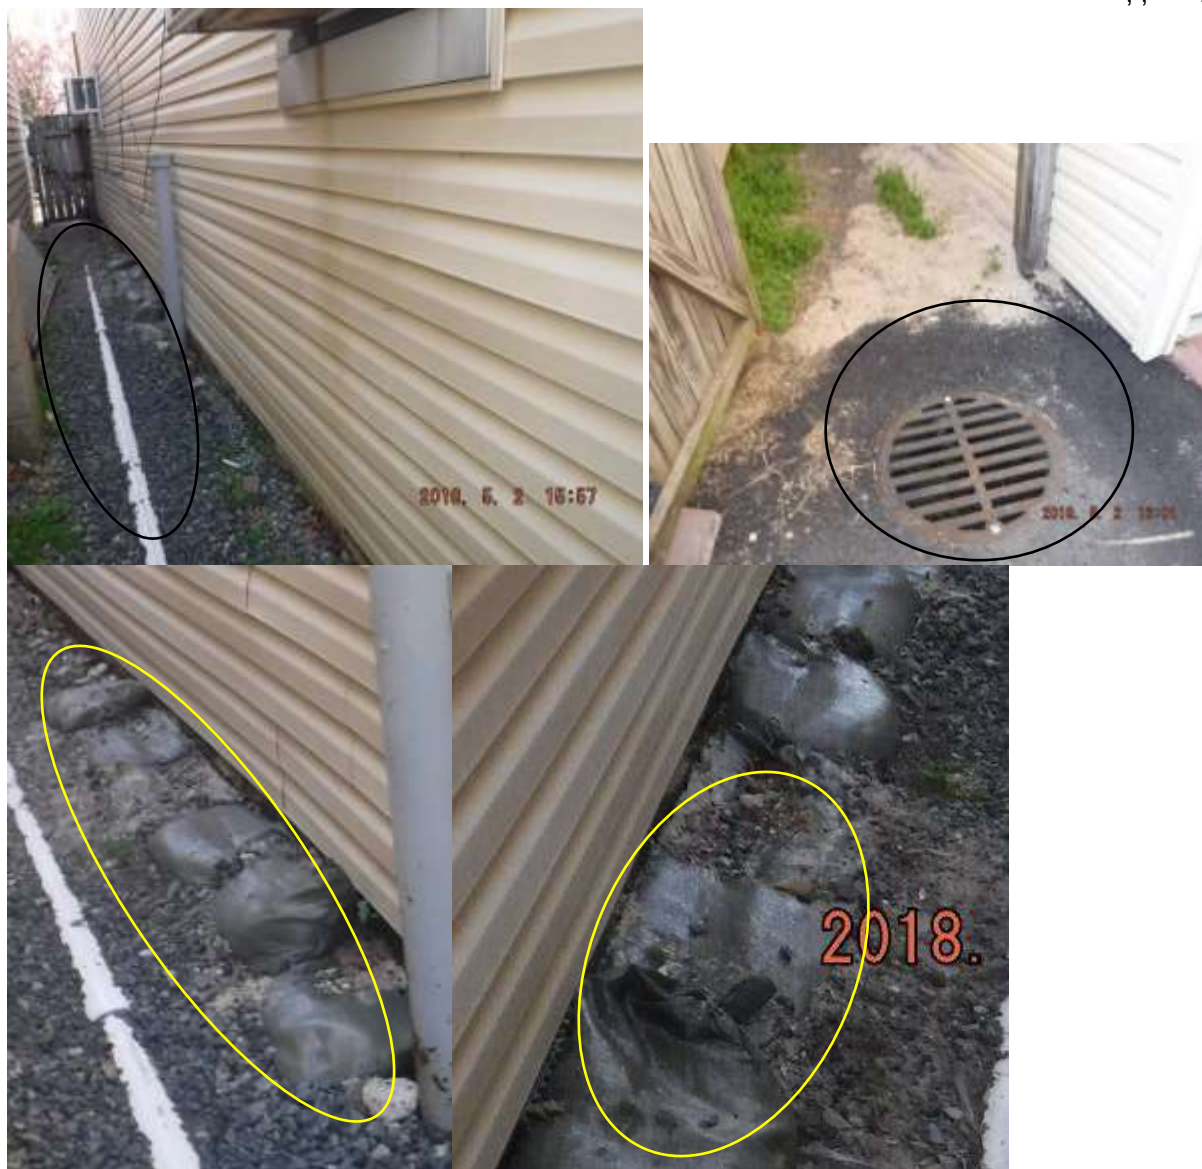
Figure 1 Follow up with Clinton boro to see if they maintain and service the drains in alley; not tested or accessible. There were several sand bags around the slab foundation and neighboring stores; indicative of flood measures.

1. Follow up with Clinton boro to see if they clean & maintain the drainage system and if these drains have mitigated water issues for the stores on this block . Recommend further evaluation by a grading & drainage contractor to see if there are other measures or options to improve grading & drainage or water management measures around the building to maintain a dry structure. Slab construction is close to grade or soil and is vulnerable to seepage. Grading & drainage must be a priority to avoid water damage, structure damage and attracting wood destroying insects.

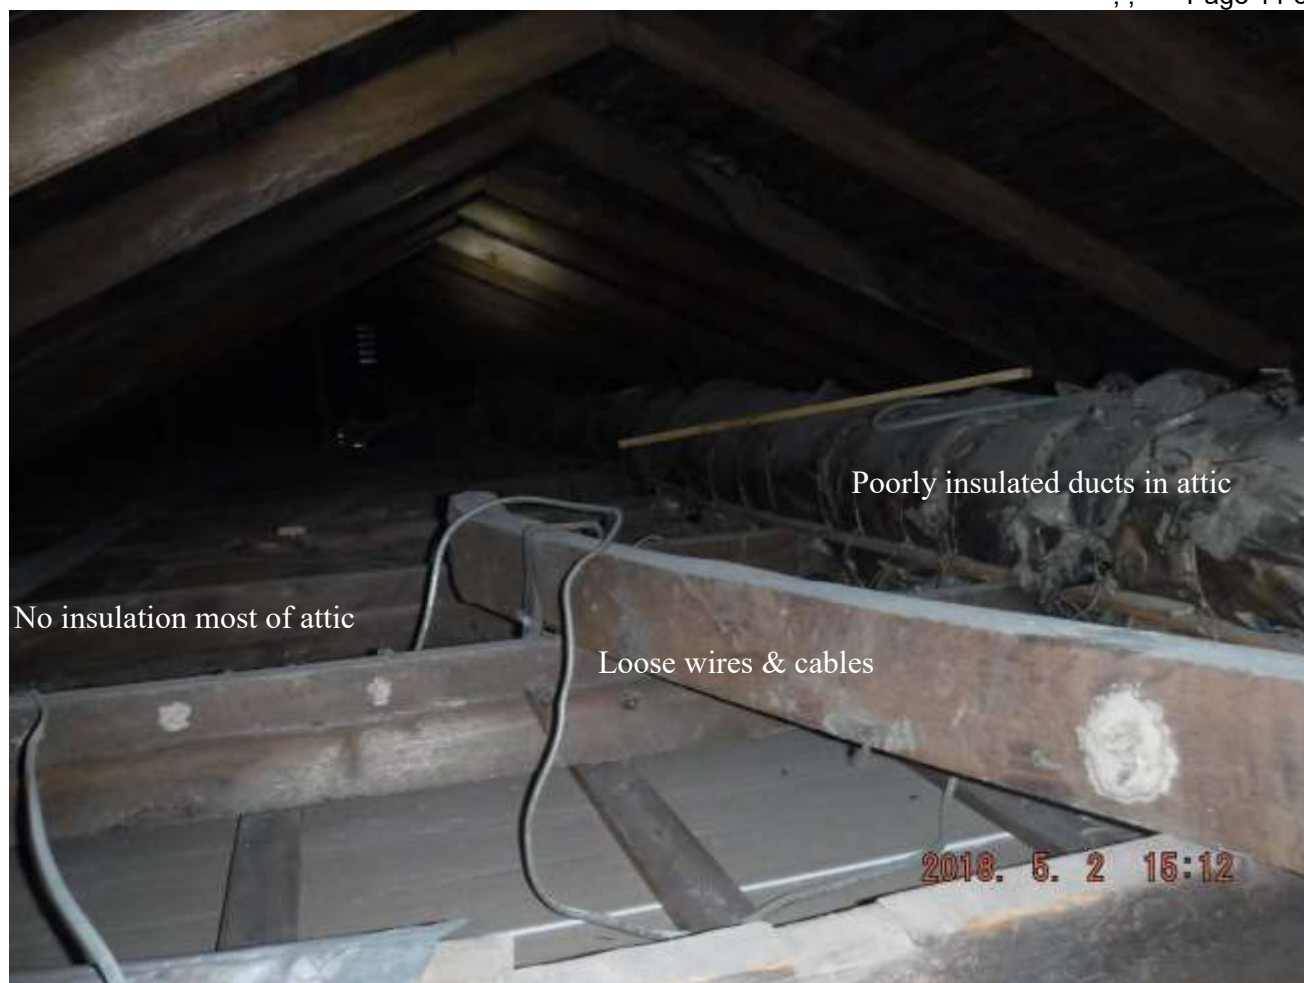
Poorly insulated ducts in attic

No insulation most of attic

Loose wires & cables

Figure 2 Main front section of attic; no insulation, poorly wrapped insulation on ducts and loose wires. Roof structure was substandard and had deficiencies and past expected life.

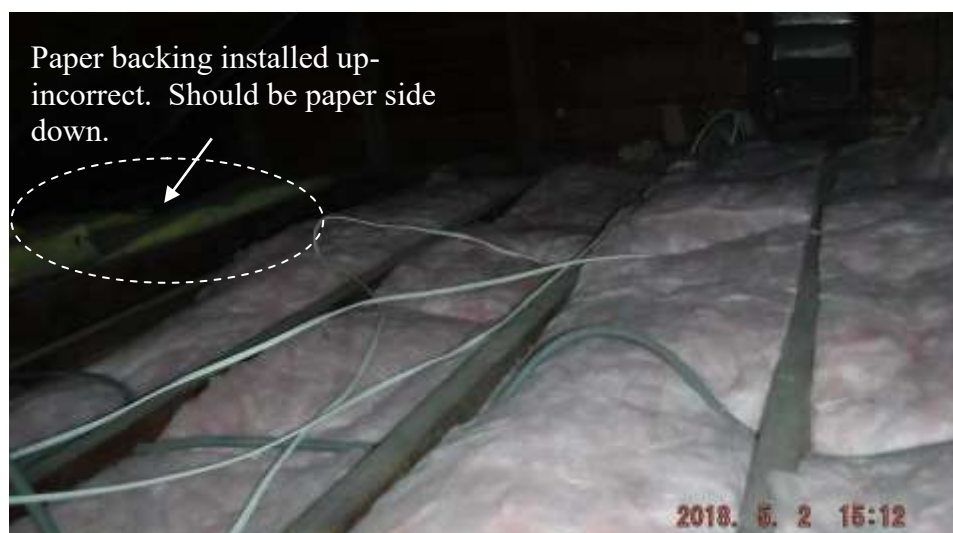
Paper backing installed up-incorrect. Should be paper side down.

Figure 3 Small rear addition of attic had insulation and was installed with paper backing or vapor barrier up; should have paper side down on living space of house. There were missing section of insulation in rear and all of front main house. Attic was poorly ventilated and little or no insulation. There were loose electrical wires in attic; have electrician correct wiring.

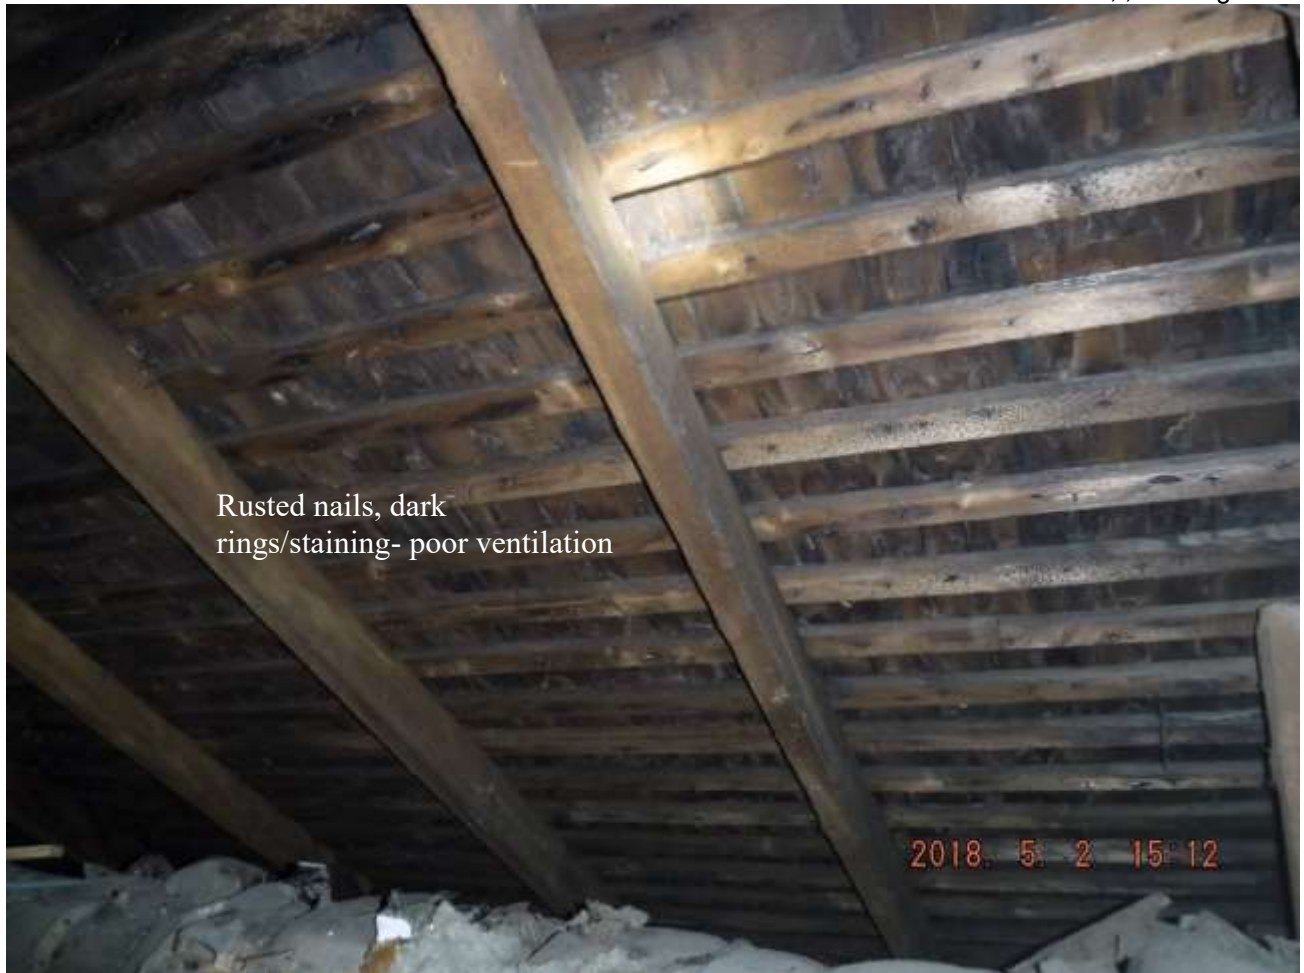
Rusted nails, dark
rings/staining- poor ventilation

Figure 4 Cedar shingles under asphalt shingles, rusted nails, no collar ties, poor ventilation, etc. Roof is past its life and has structural concerns. Recommend a structural engineer (PE), roofer and or building contractor further evaluate roof & structure and advise on structure repairs, roof replacement, ventilation & insulation and gutters.

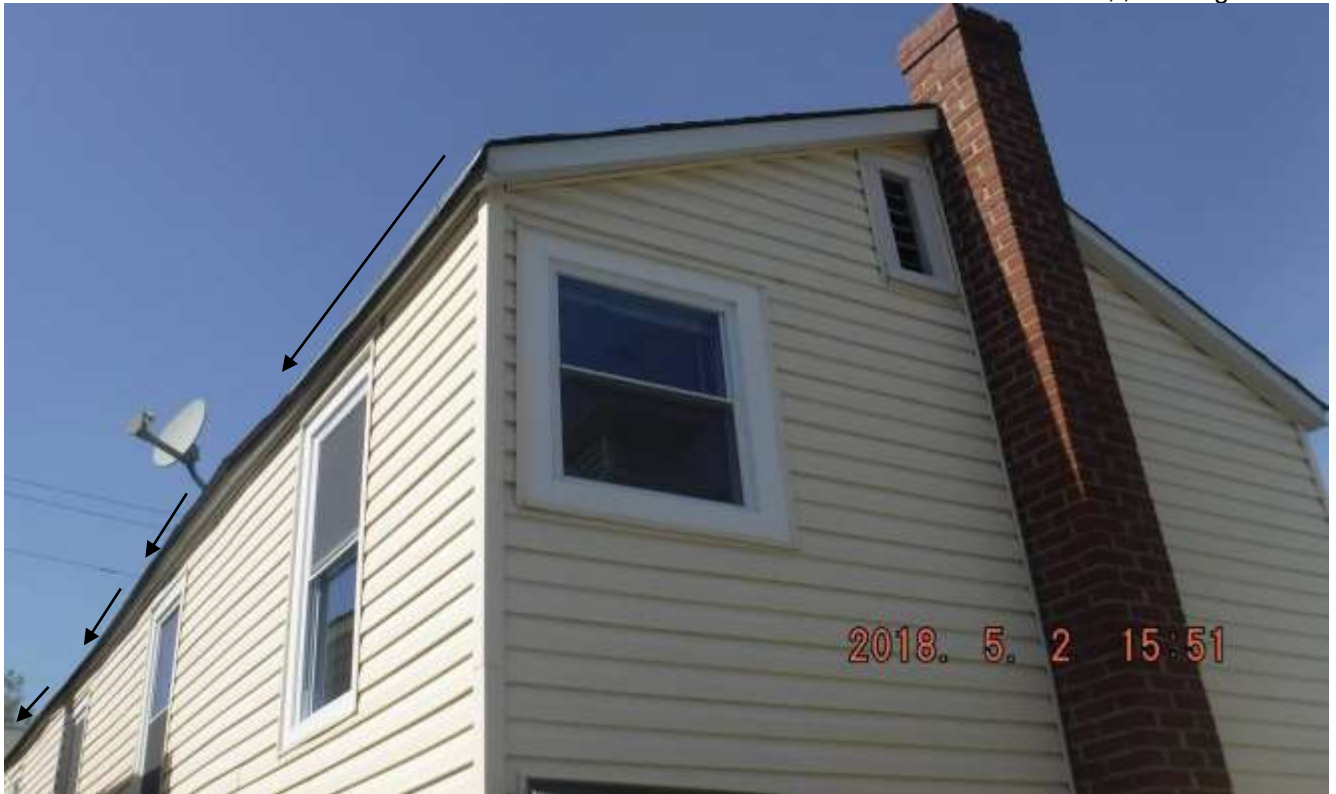
Figure 5 Asphalt tab roof over cedar shingles (no sheathing), past life, no gutters, poor ventilation & insulation and structural concerns/deficiencies.

Recommend roofer evaluate and advise on costs tear off, sheathing & lathe removal, roof structure, roofing, gutters & ventilation before closing & contractual limitations

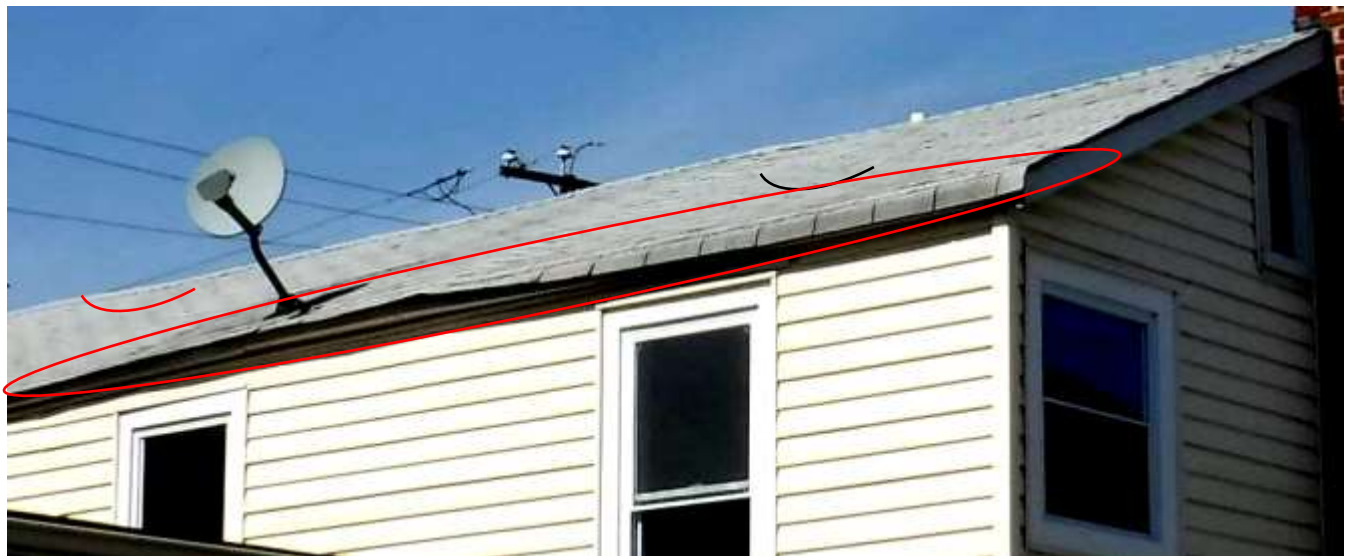
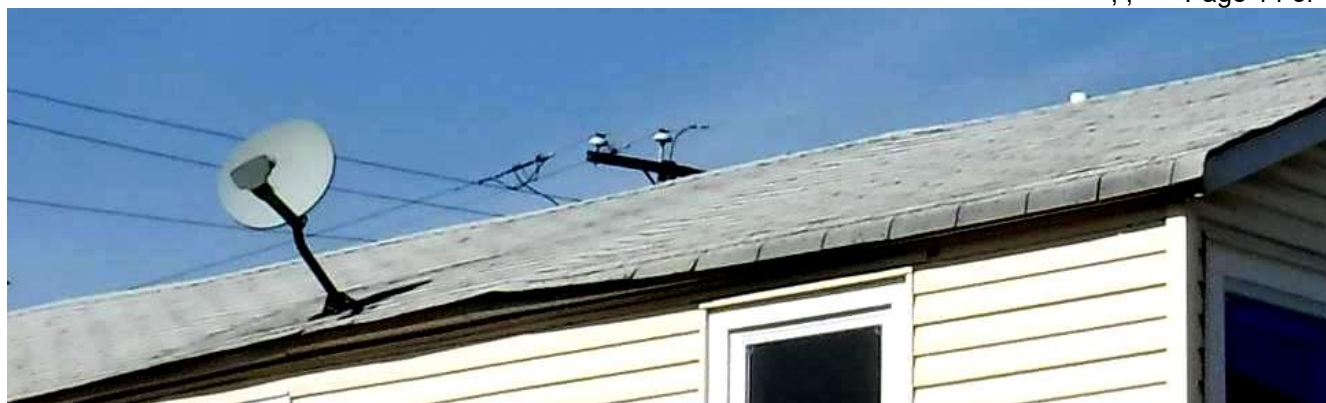
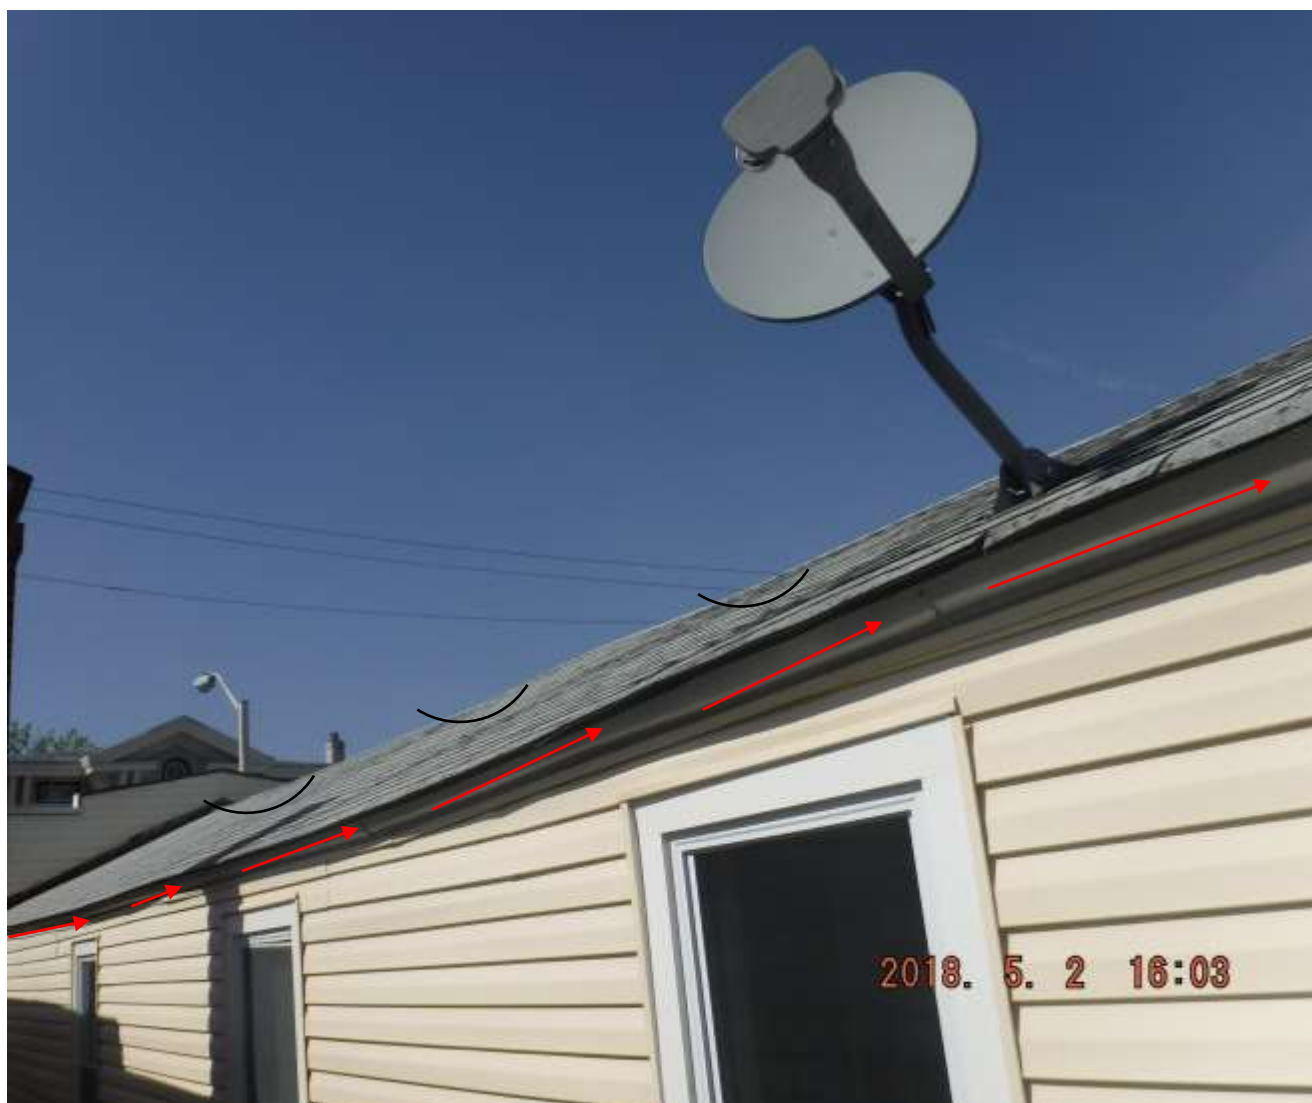
Figure 6 Walls on both sides were bowed and roof had waviness, depressions and structural deficiencies. Recommend further evaluation by a structural engineer (PE), roofer and or building contractor along with the structure of the building. See siding section comments.

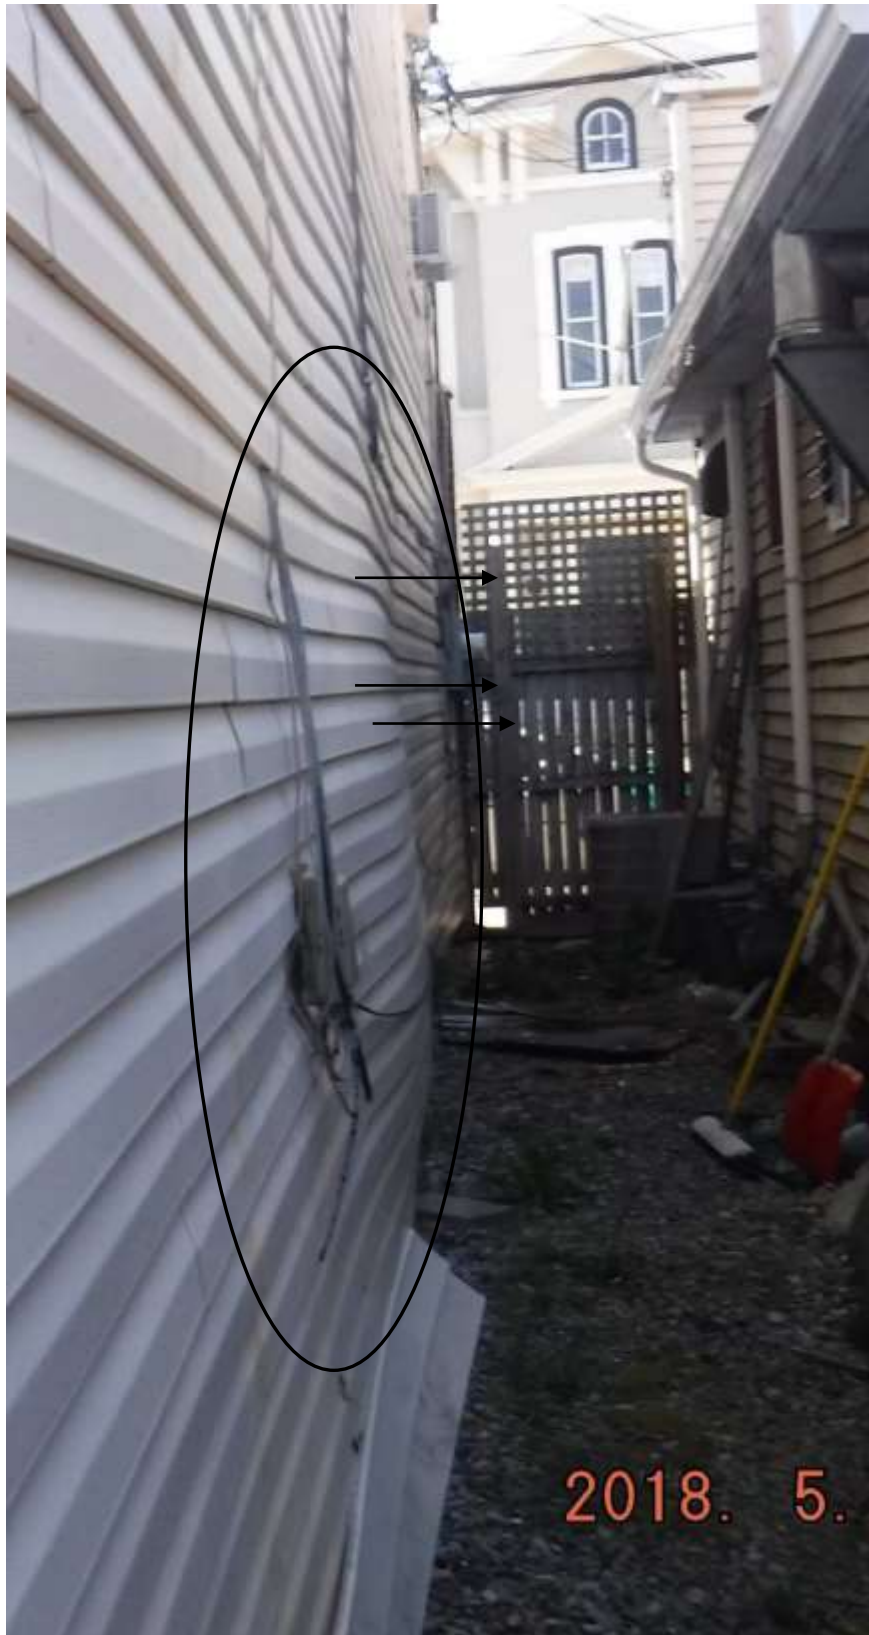
Figure 7 Example of bulging walls; left side depicted. There were bulges on left and right as well as upper and lower. There were structural concerns in the home (flooring, roof, etc.).

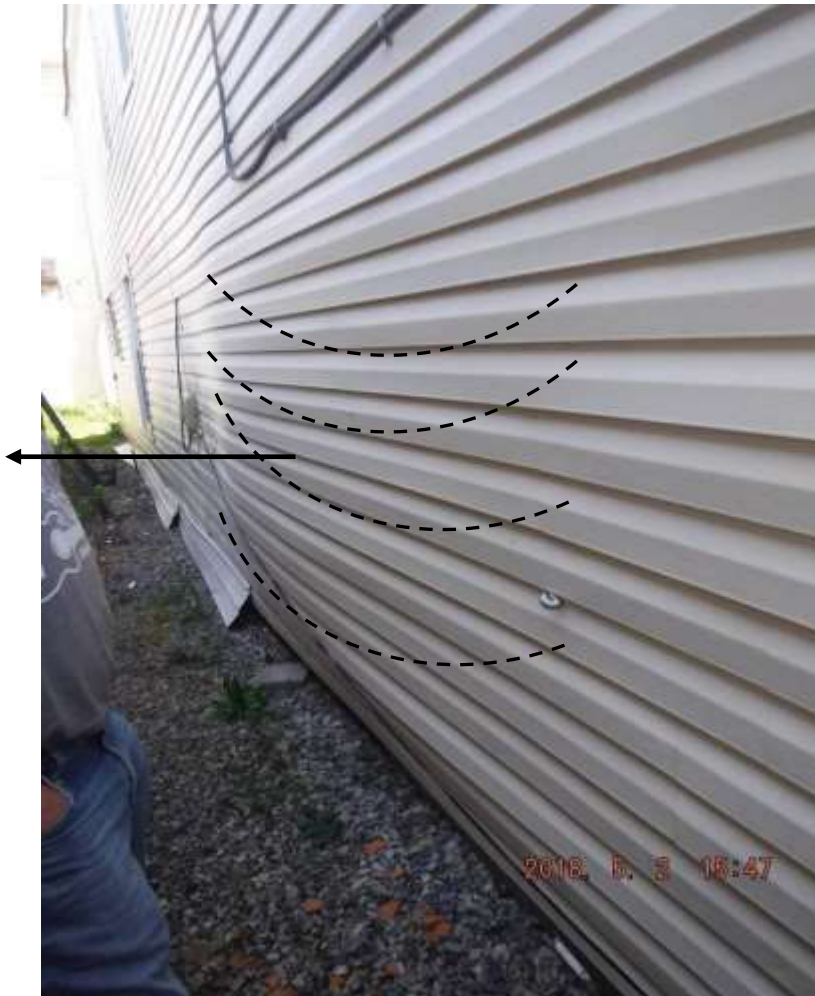
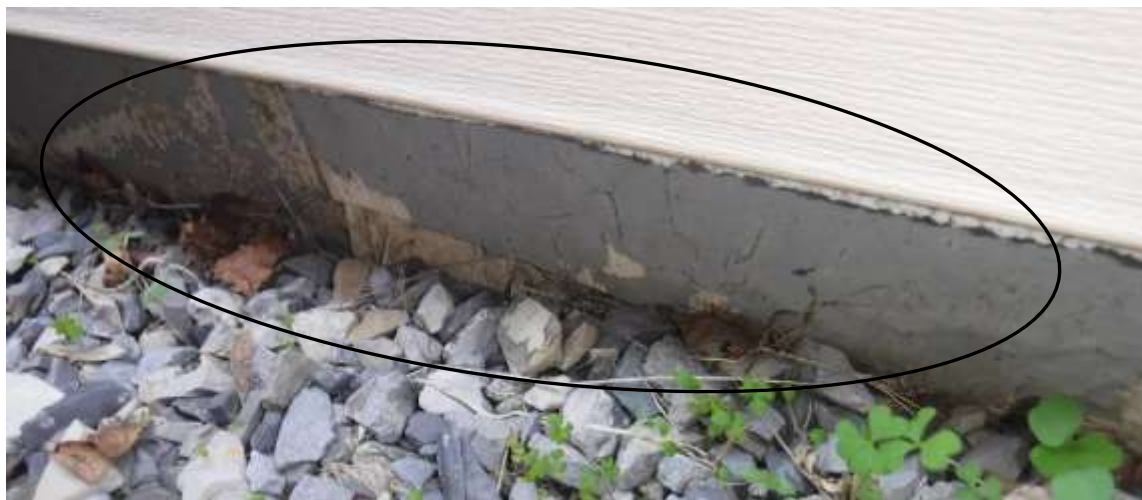
Figure 8 Visible asbestos like siding (painted gray) slipped down and loose under the vinyl siding.

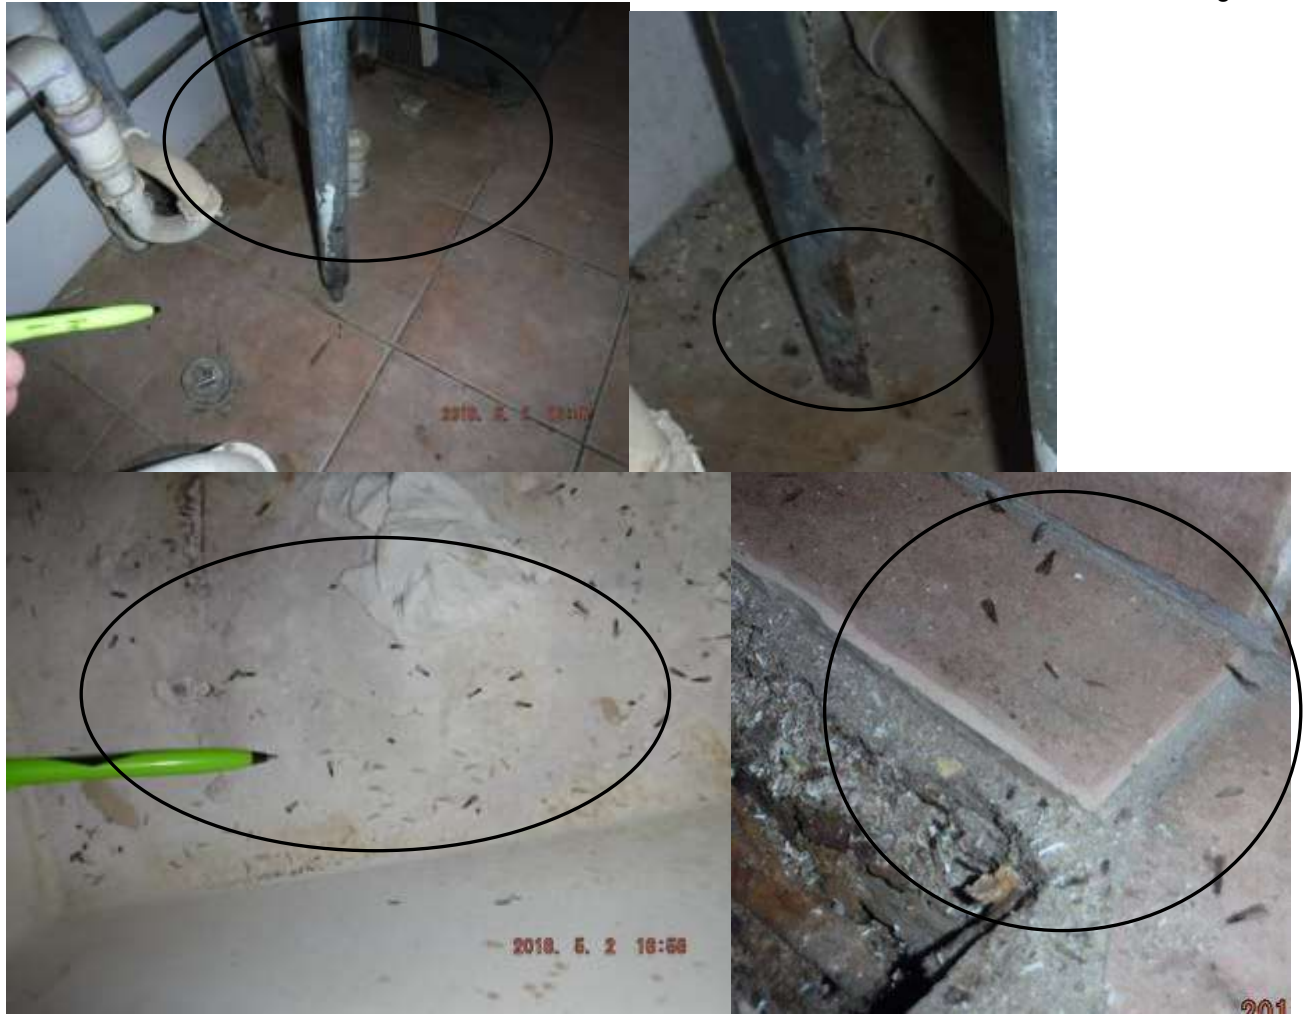
Figure 9 Termite swarmer wings and body parts. See separate NPMA-33 Wood destroying insect report.

- 1. There were swarmer wings and bodies observed in the store in the white slop sink and floor by trap. Recommend a licensed Pest Company treat for termite. See separate NPMA-33 Wood destroying report.**

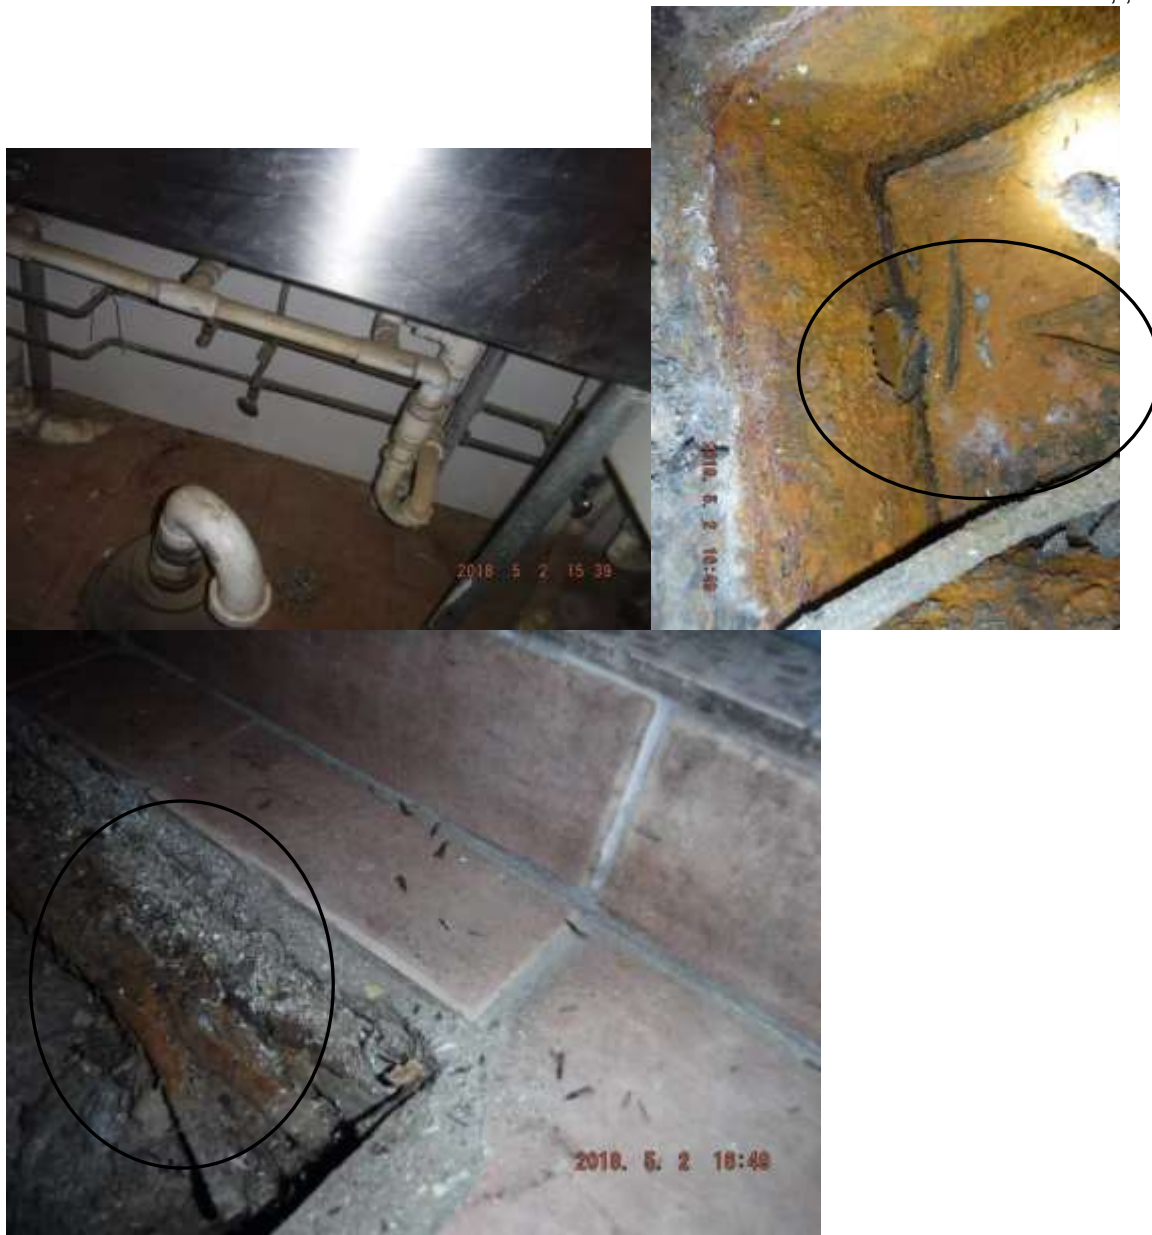
Figure 10 Rusty floor trap and termite swarmer wings & body parts.

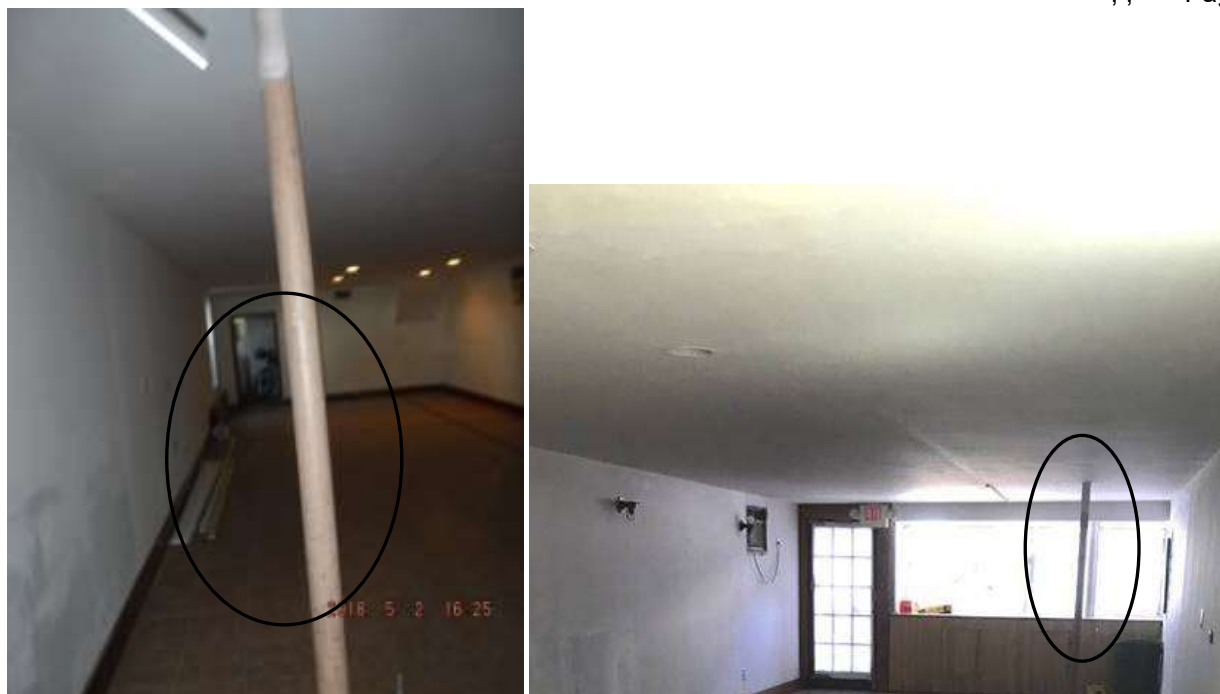
Figure 11 Two visible lally columns and structural concerns in the building. Follow up with the structural engineer (PE) for evaluations before closing & contractual limitations.

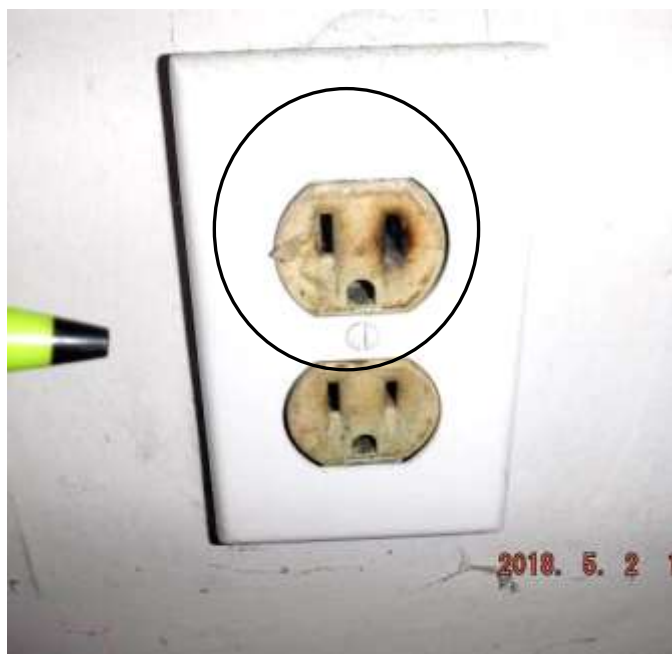
Figure 12 Recommend a licensed electrician evaluate scorched outlet and make repairs/replacement; overloaded or heavy draw appliance. Discuss all electrical needs with the electrician for the apartment and the business needs and upgrade and install power, devices, outlets, fixtures, lighting, etc.

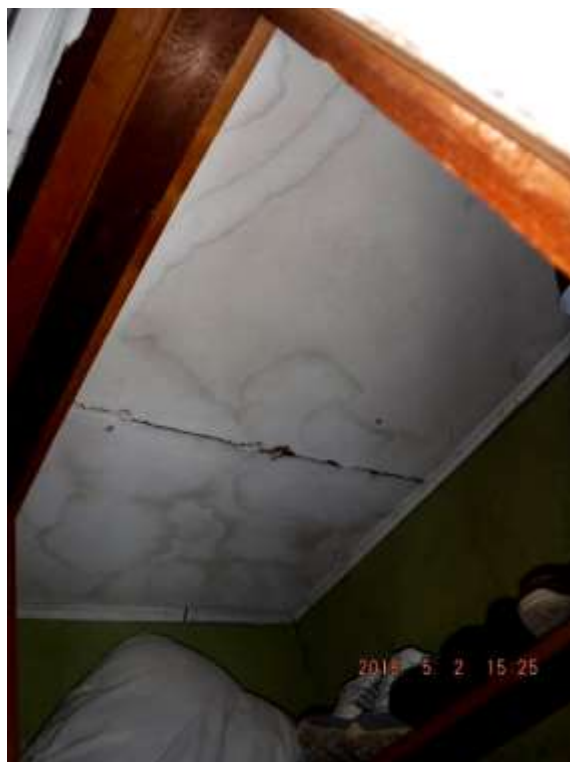
Figure 15 Water stains on closet; see roofing section comments.

1. Recommend replacing roof; see roofing section comments.
