4 Seasons Home Inspection

Property Condition Assessment Report Data

Address, Berkeley Heights, NJ

File Number: 1154_ClientFileNumber

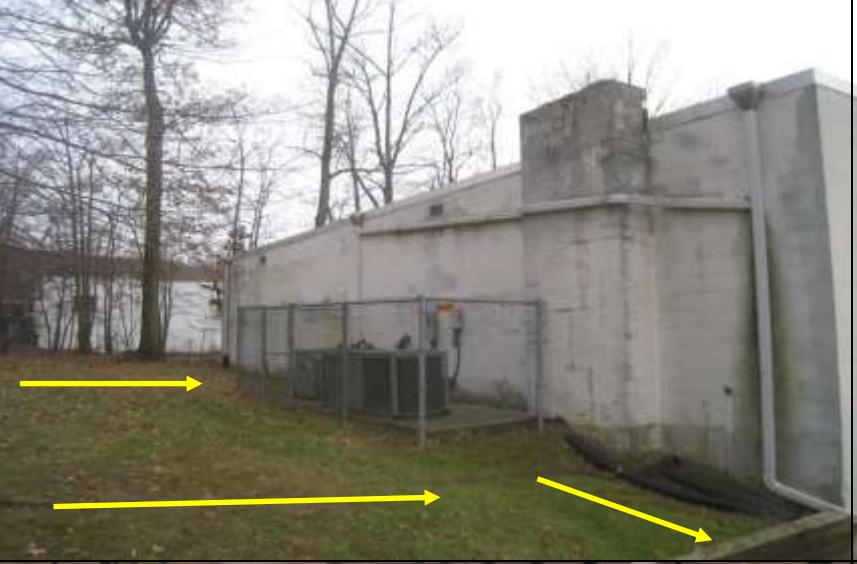
<p>Photo # 1- (Topology) General slope downward from rear or east property toward Russo Place. Water draining toward rear of building, and parking lot on north side and around south corner of building. Arrows indicate general flow or drainage.</p>

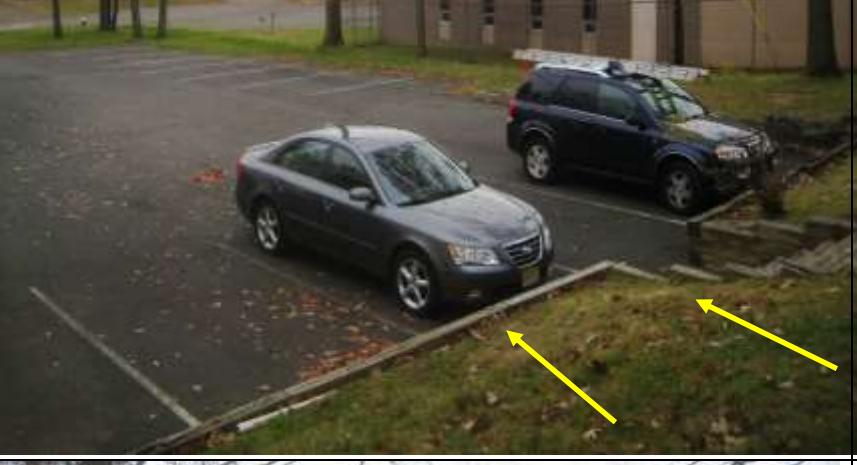
<p>Photo # 2- Grading and water runoff onto north parking lot and rail road tie retaining walls. RR ties were leaning, failed, and infested with insect damage. There was no railing or lighting on steps; safety concern.</p>

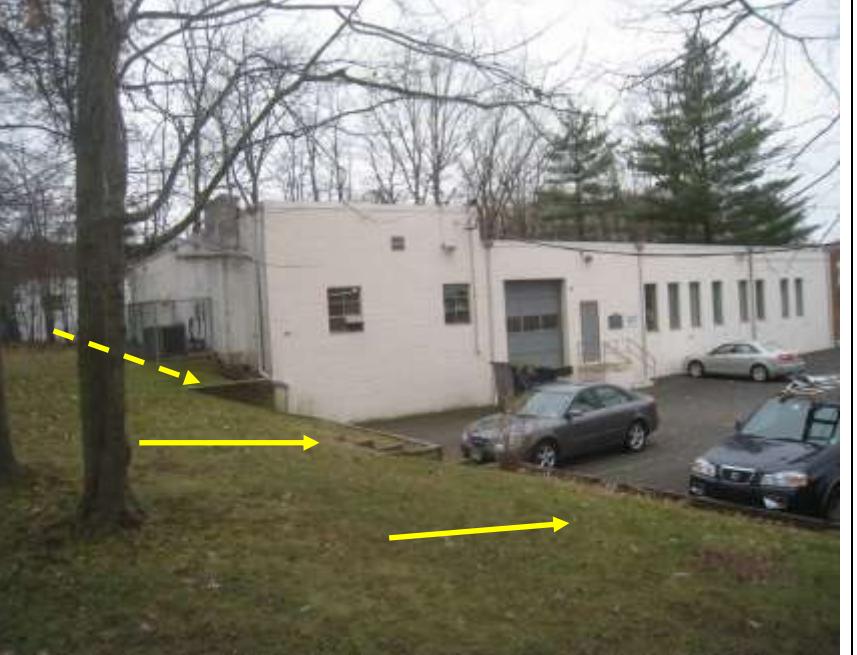
<p>Photo # 3- Water drainage from east end property contributing to failed and rotted rail road ties.</p>

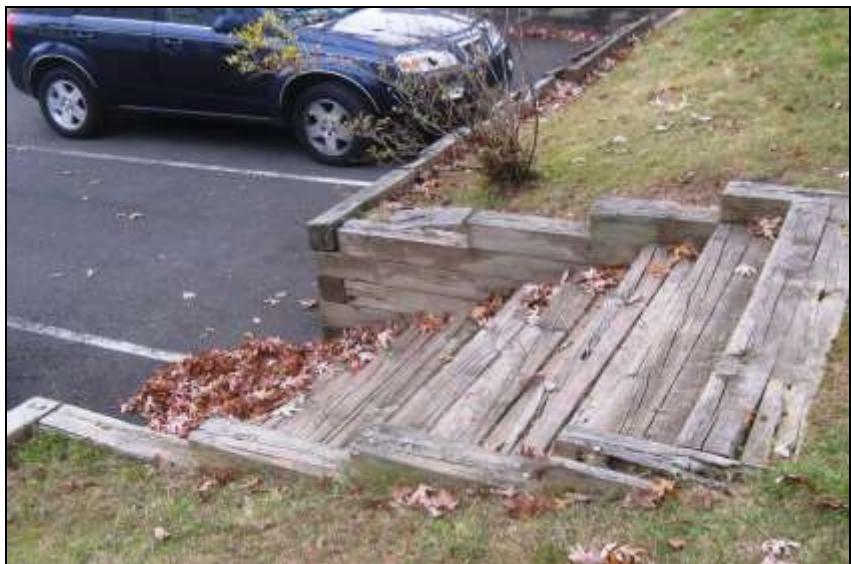
Photo # 4 – Rotted RR tie steps; no railings and lighting over steps. No railings along RR tie retaining walls.

Wood in contact with soil not recommended. Water damage and wood destroying insect damage observed.

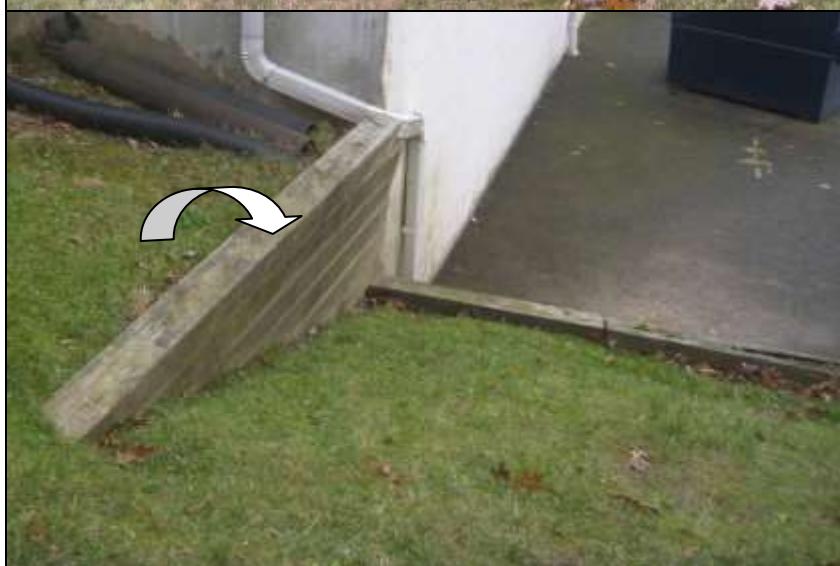
Photo # 5- RR tie retaining wall leaning or failed. Wood ties on property were rotted and had insect and water damage.

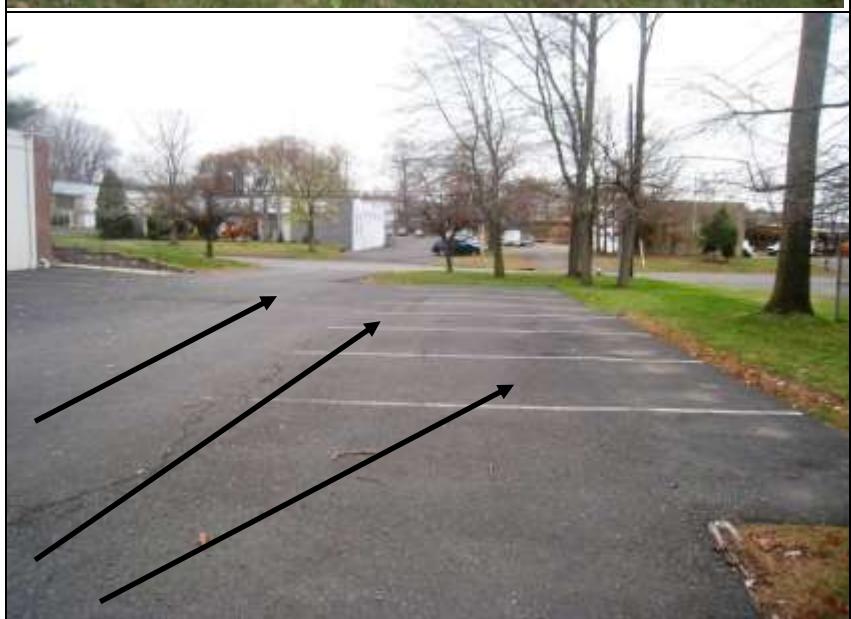
Photo # 6-.Gentle slope from east to west toward Russo Place.

No observed drains or storm drains on parking lot.

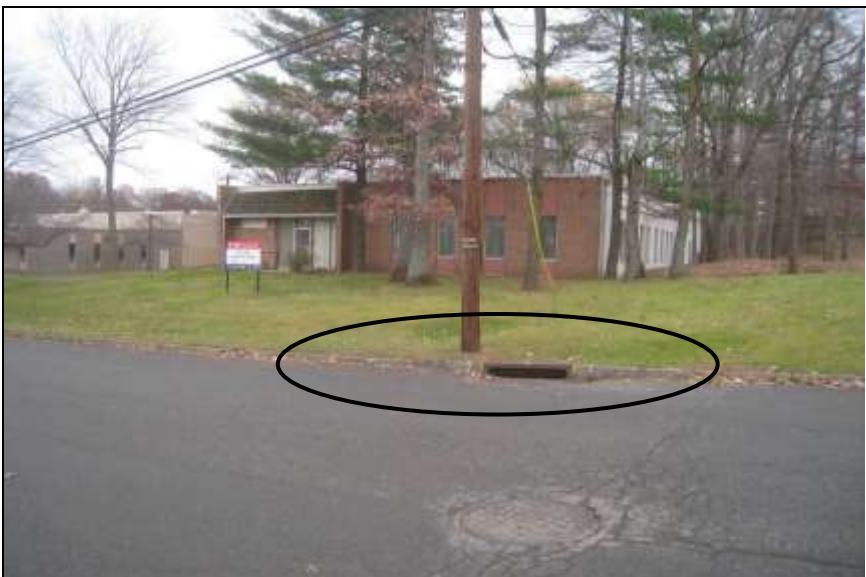
Photo # 7- Observed storm drain just past SW corner of building along Russo Place.

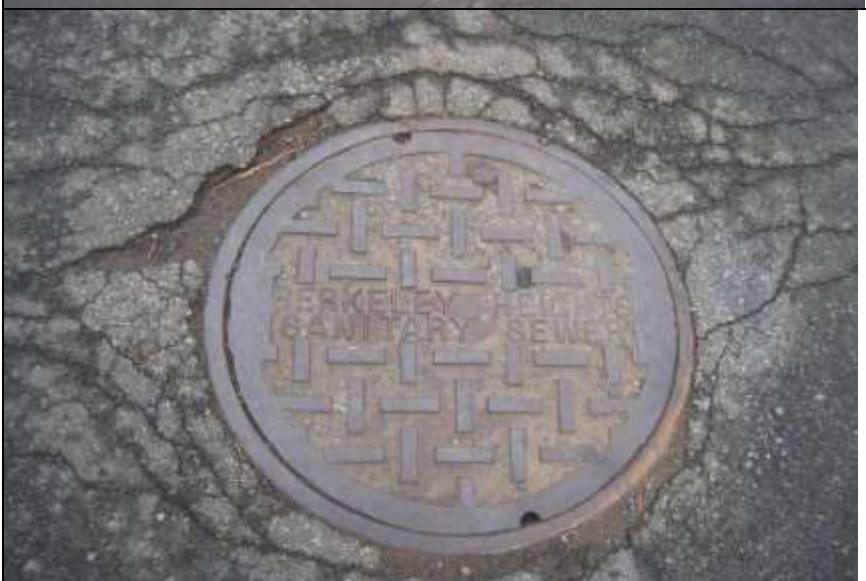
Photo # 8- Manhole cover indicating "Berkeley Heights Sanitary Sewer" just beyond the storm drain.

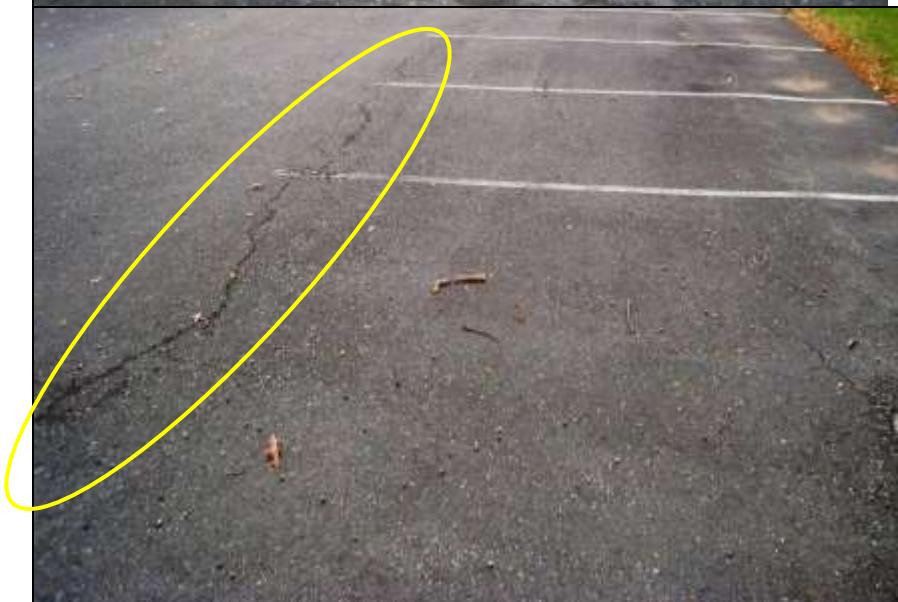
Photo # 9- Parking lot has settling or drying cracks and faded parking space markings.

Fill & seal cracks, top coat seal for continued maintenance. This also lends its self to "curb appeal" for a business or complex.

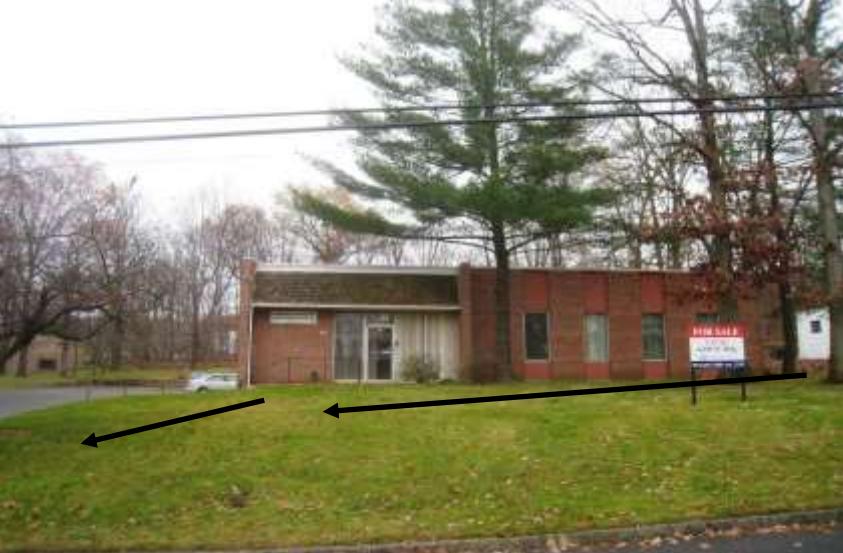
<p>Photo # 10- Grading pitched from S to N along right and front sides of property. Water drains close to building.</p> <p>Moisture detected inside front entrance on lower walls in vestibule.</p>

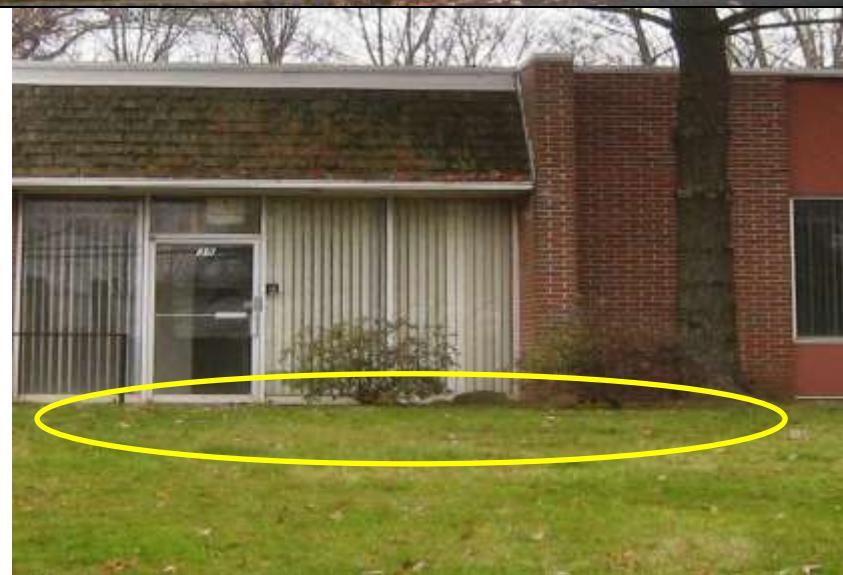
<p>Photo # 11- Close-up of #10 indicating water entry into the front entrance at slab foundation and door frame assembly.</p> <p>Recommend upgrading glass door assembly and seals to correct water entry.</p>

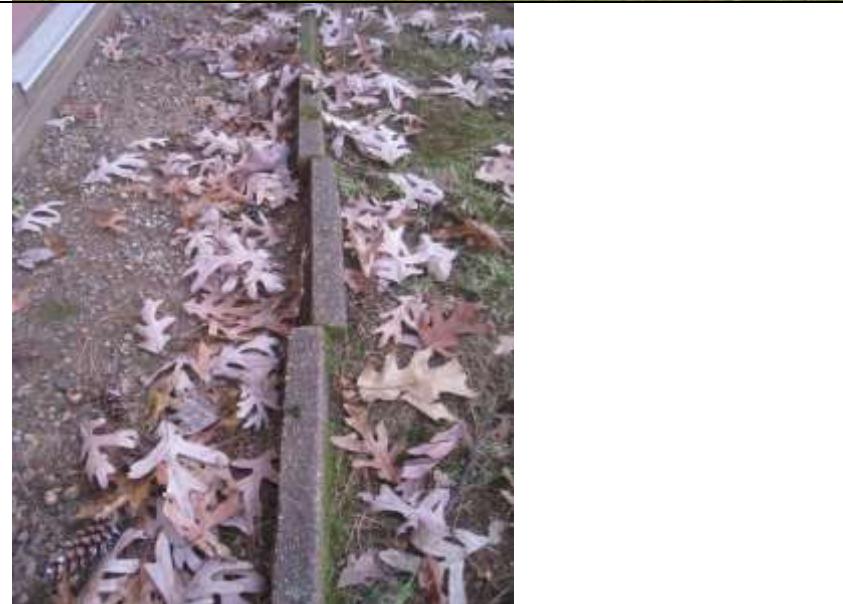
<p>Photo # 12- Landscape curbing or borders and stones against front entrance.</p> <p>Water will retain against slab foundation and infiltrate interior. Conditions conducive to water damage, mold and wood destroying insects or organisms.</p>

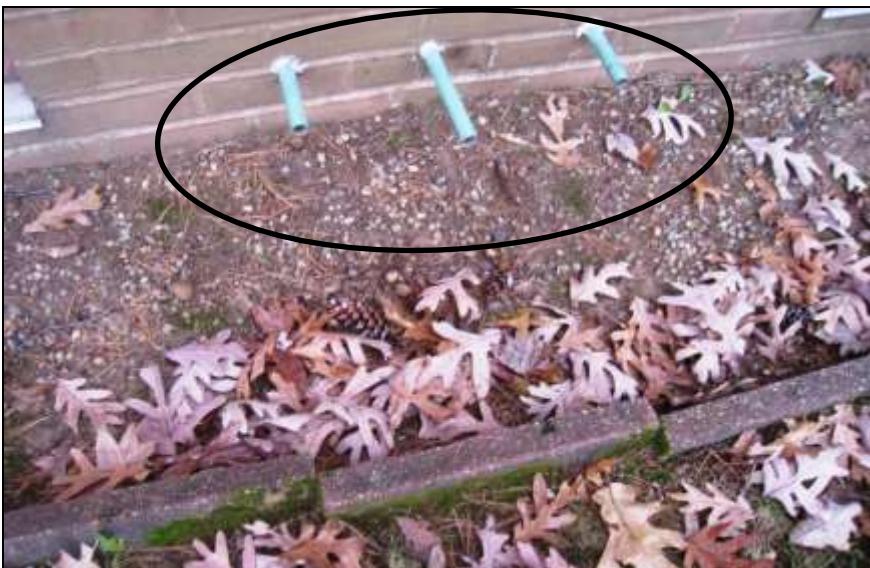
Photo #13- Same area as #12 above depicting 3 condensate tubes from the Valance cooling system.

These tubes are all around building discharging close to building when used in hot weather and when wood destroying insect activity is higher. Recommend a solution to tie into a drain system to keep water away from slab foundation and front entrance.

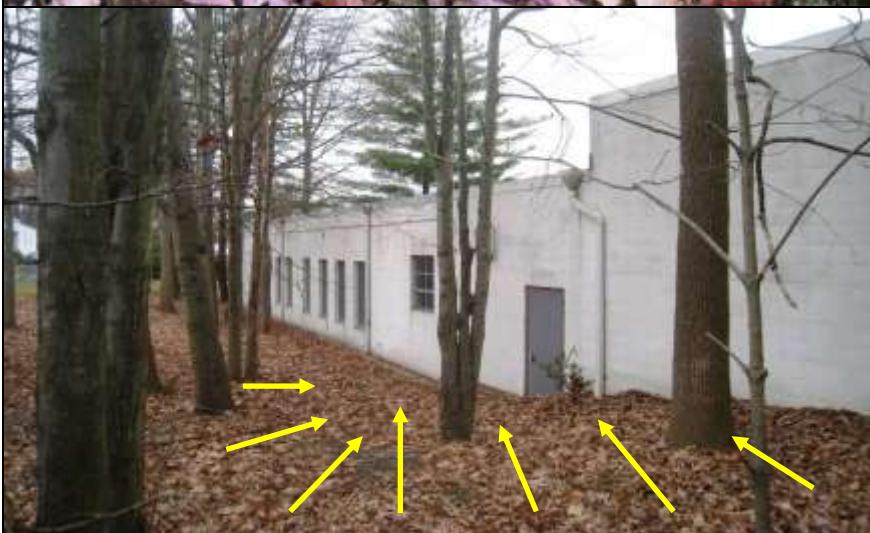
Photo # 14- SE corner of building looking toward Russo Place on right side of building. Grading knee deep in leaves and grading pitched toward rear door by print shop/mail room.

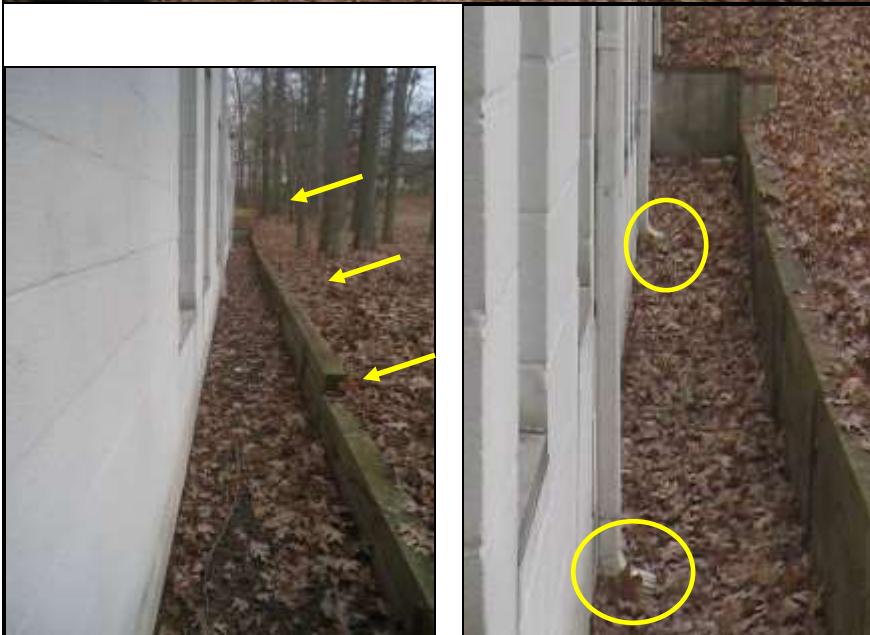
Photo # 15- South side depicting RR tie retaining wall leaning and WDI damage.

There were no visible drains in recessed area and rain leaders from scuppers discharging into area against slab foundation.

Condensate tubes discharging into area along with scuppers.

Conditions **very conducive** to water infiltration and WDI infestation.

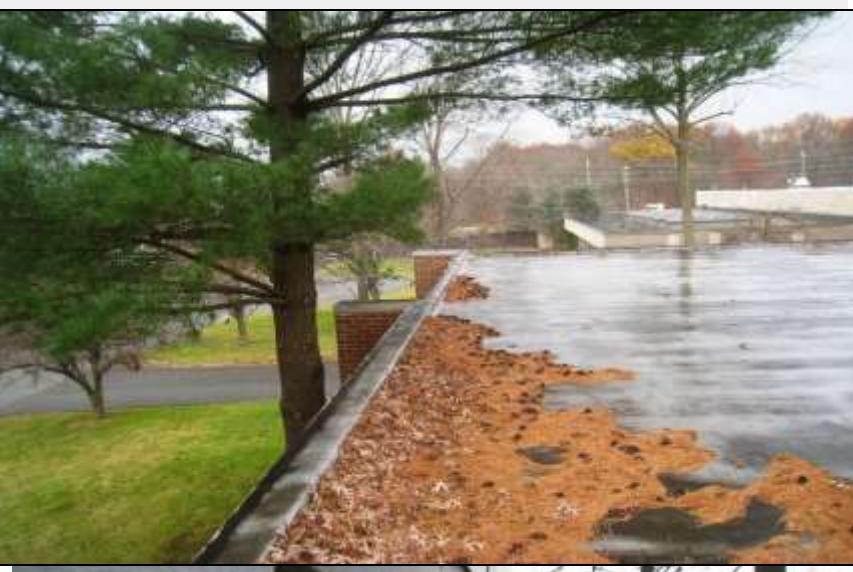
<p>Photo # 17- West side or front, overhanging pine trees, leaves and pine cones.</p> <p>Have trees cut back or removed away from structure. Check with township to see if there are any rules about trees.</p>

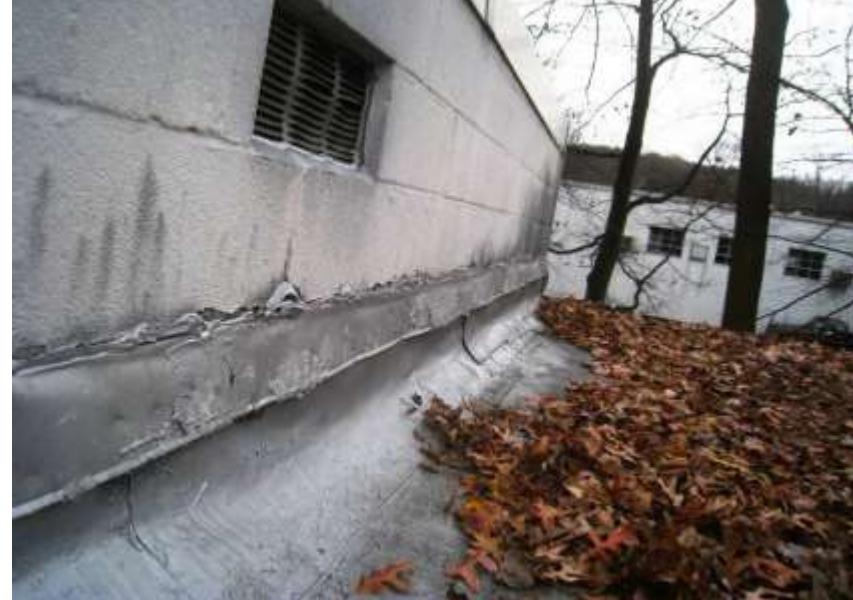
<p>Photo # 18- Cracked tar on side wall flashing where front section meets rear raised flat roof.</p> <p>Piles of leaves along juncture.</p>

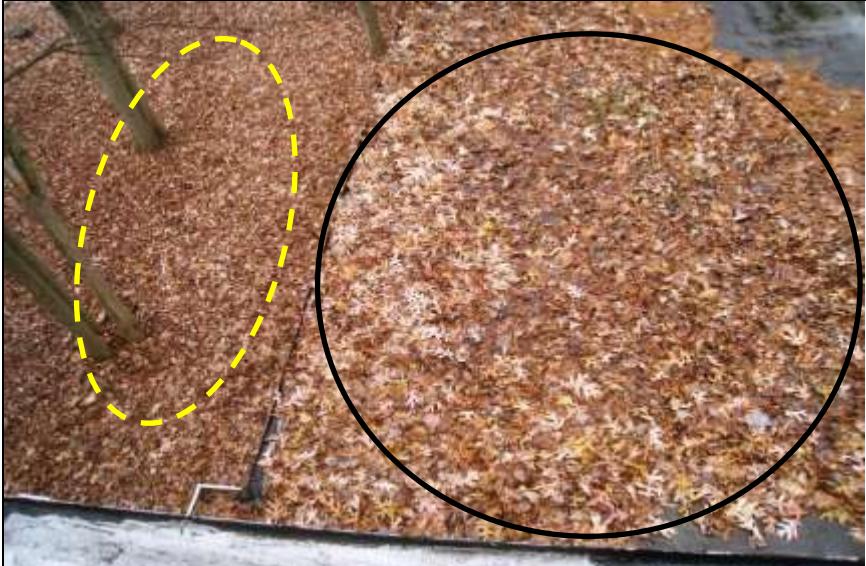
Photo # 19-. Deep piles of leaves along south wall or right side. Deep piles of leaves below among the dense trees.

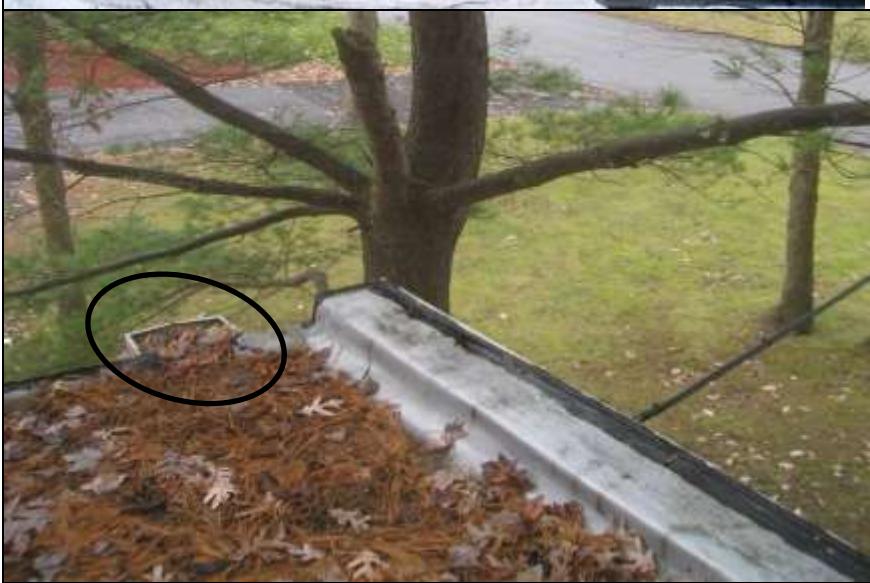
Photo # 20- Leaves and dirty scuppers.

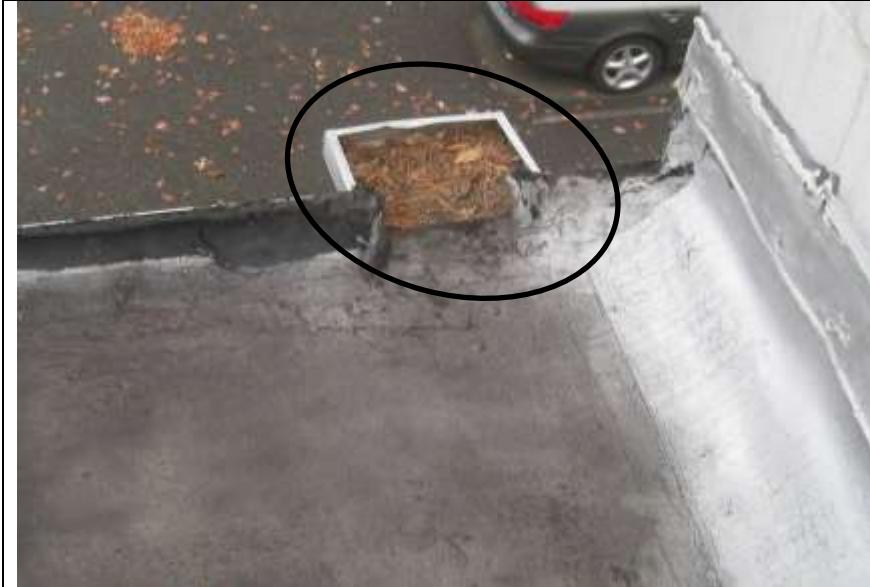
Photo # 21- Clogged scupper and cracks on tarred flashings.

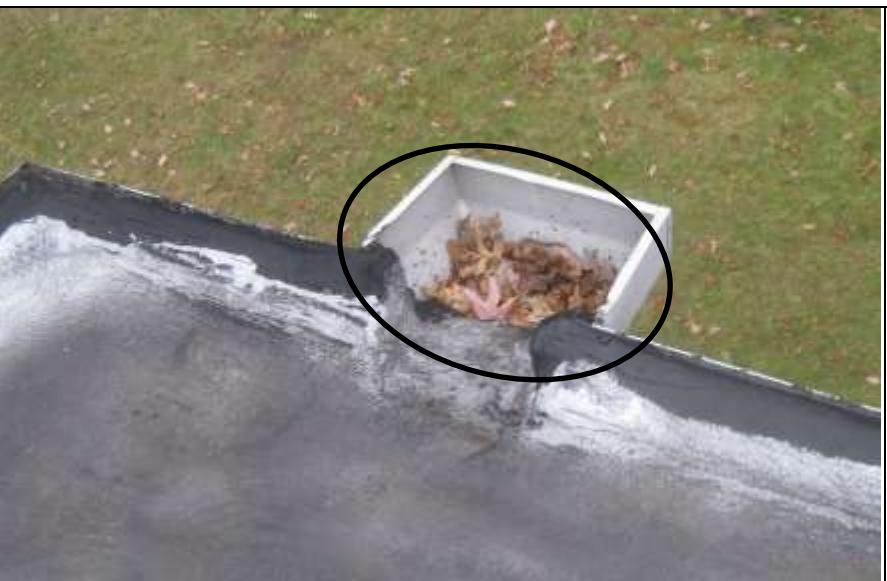
<p>Photo # 22- Clogged scupper</p>

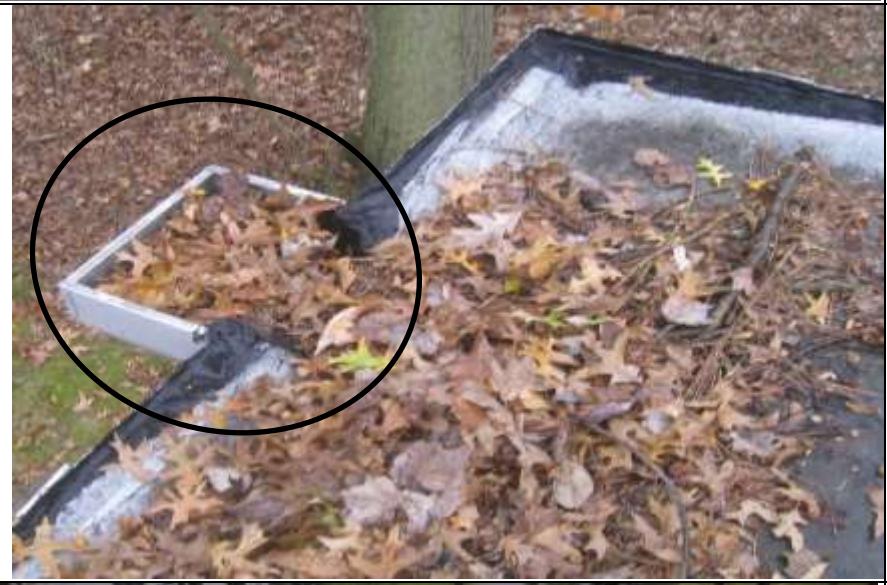
<p>Photo # 23 – All scuppers were clogged with leaves and tree debris.</p>

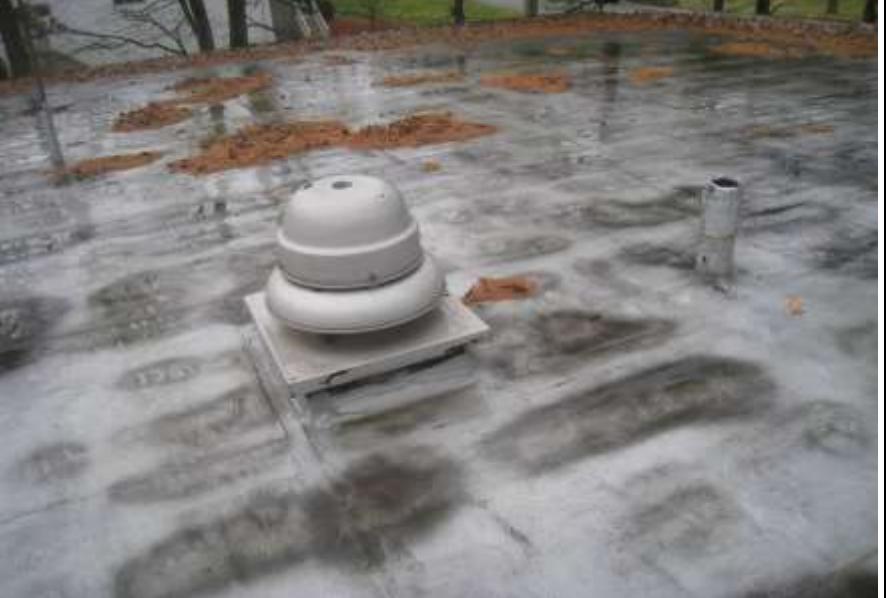
<p>Photo # 24- Leaves and water ponding.</p>

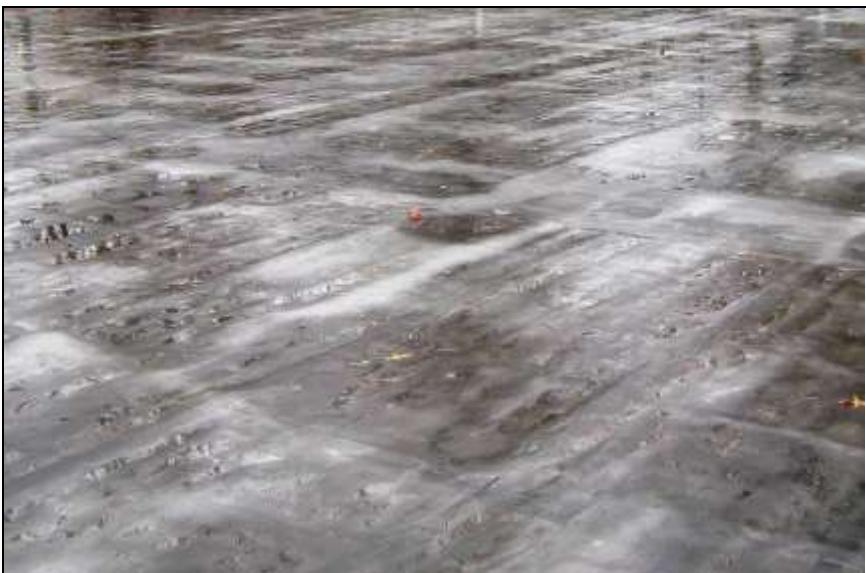
Photo # 25- Water ponding on roof.

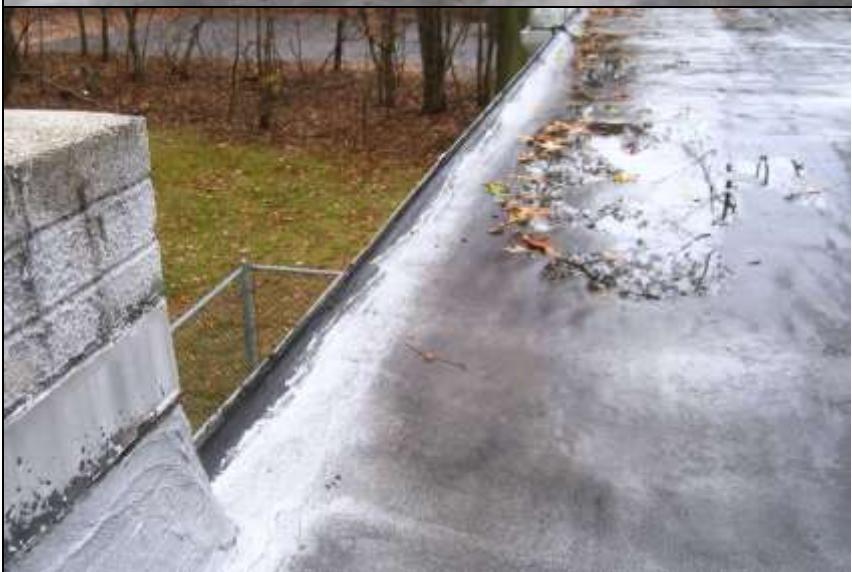
Photo # 26- Water ponding on roof.

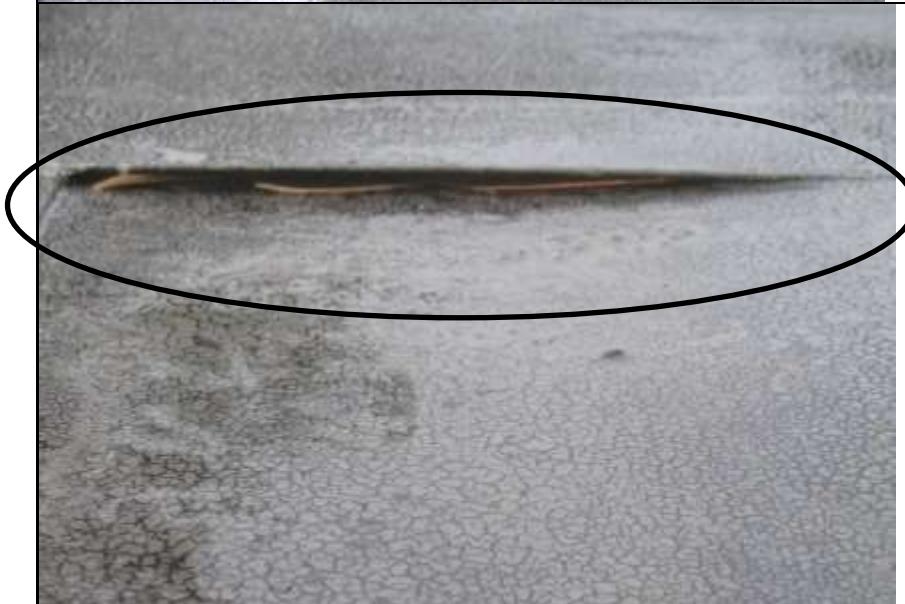
Photo # 27- Typical example of lifted seams; water entry points.

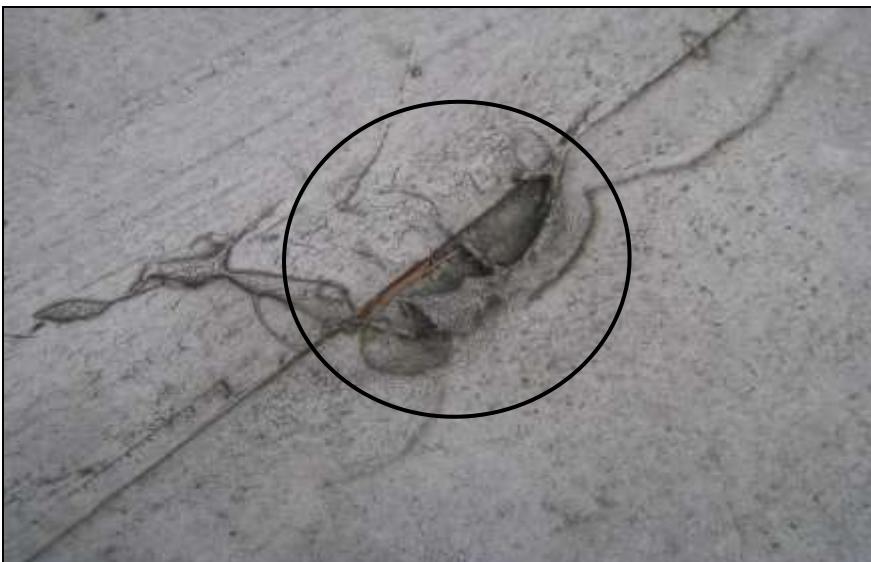
Photo #28- Typical example of puncture, digs or holes; water entry points.

Foot traffic should be monitored on roof; no deep work boots treads that can puncture or damage a roof. Often stones stick in bottoms of work boots.

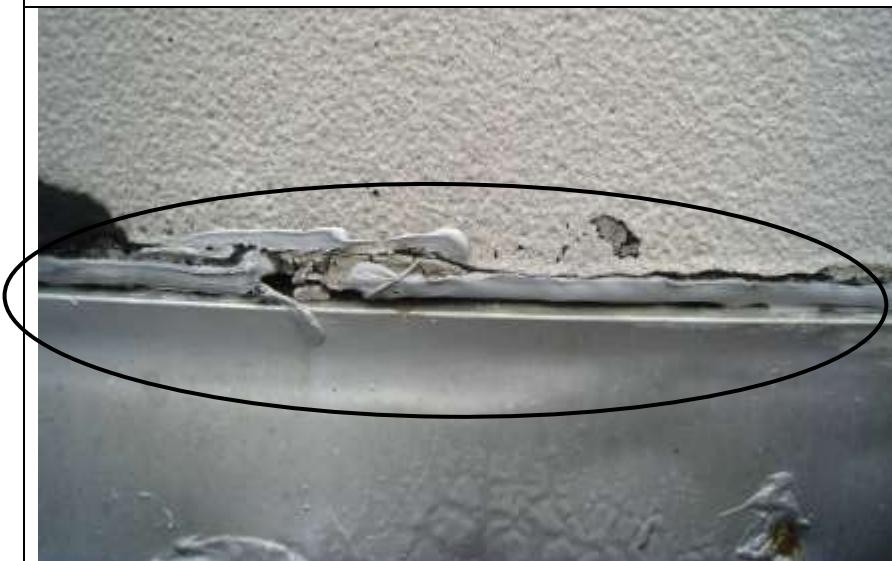
Photo # 29- Typical of split or open seams on metal flashing; water entry points.

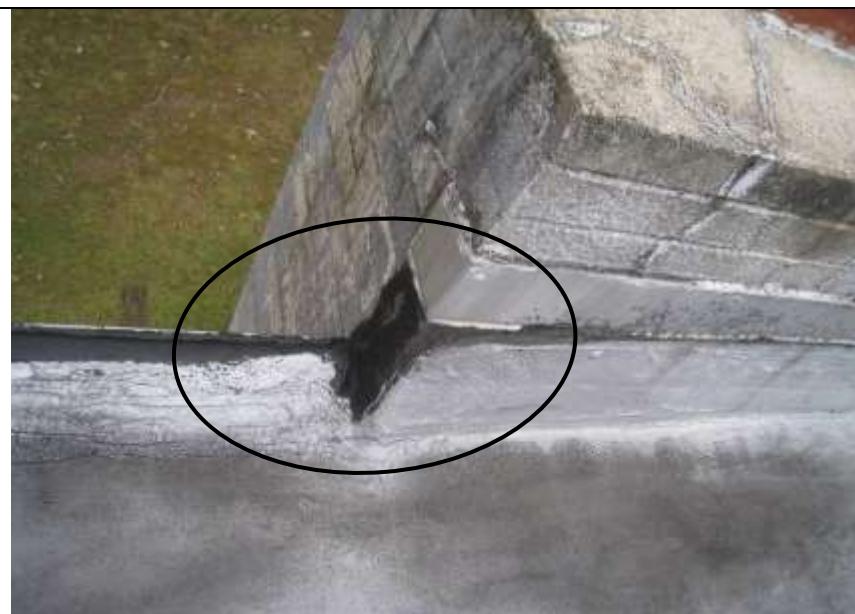
Photo # 30- Example of tarred flashings; vulnerable areas for leaks.

All flashings must be checked and maintained leak free.

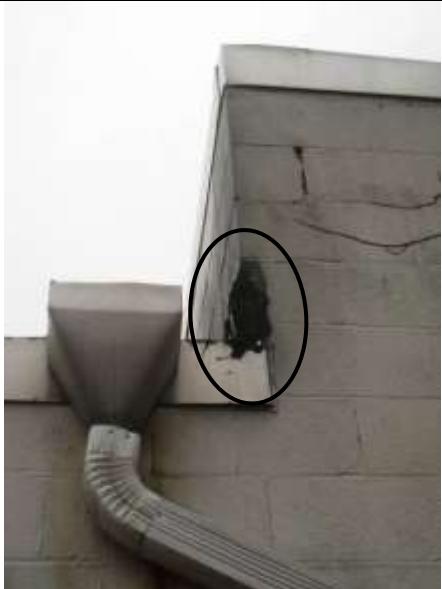
Photo # 31- Juncture where lower flat roof meets side wall of upper flat roof. Have all tarred flashings checked to ensure no leaks. Tarring not recommended in place of a metal mechanical installed component.

Tar cracks with Sun's UV rays and allows water penetration.

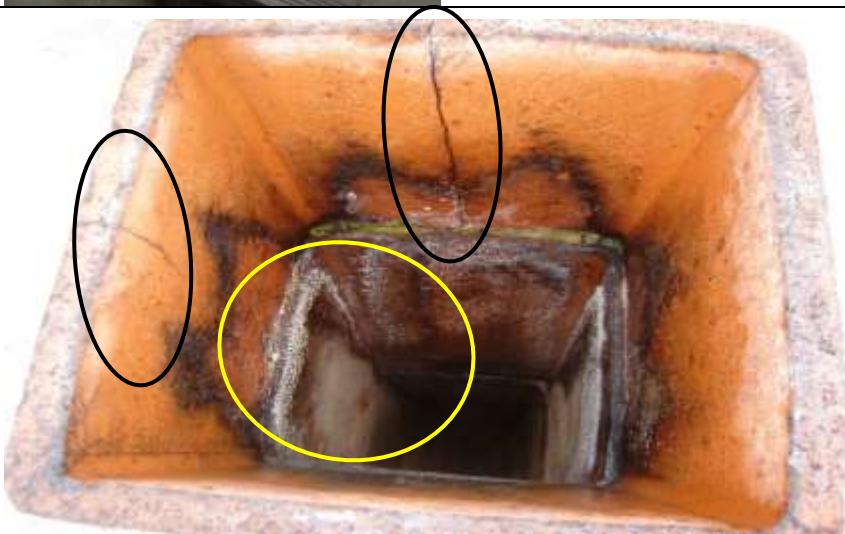
Photo # 32- Cracks, efflorescence(water entry), discoloration and deterioration inside active flue for boiler.

Have chimney contractor evaluate for liner and all masonry repairs.

Recommend a single rain cap across all three flues with spark arrestor to keep out birds, squirrels and raccoons.

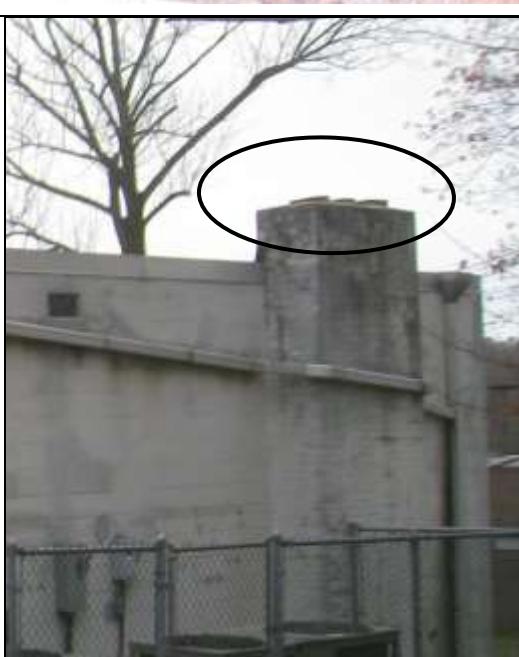
Photo # 33- Three chimney flues, 1 in use for gas boiler.

Recommend a chimney contractor evaluate for liner and all masonry repairs.

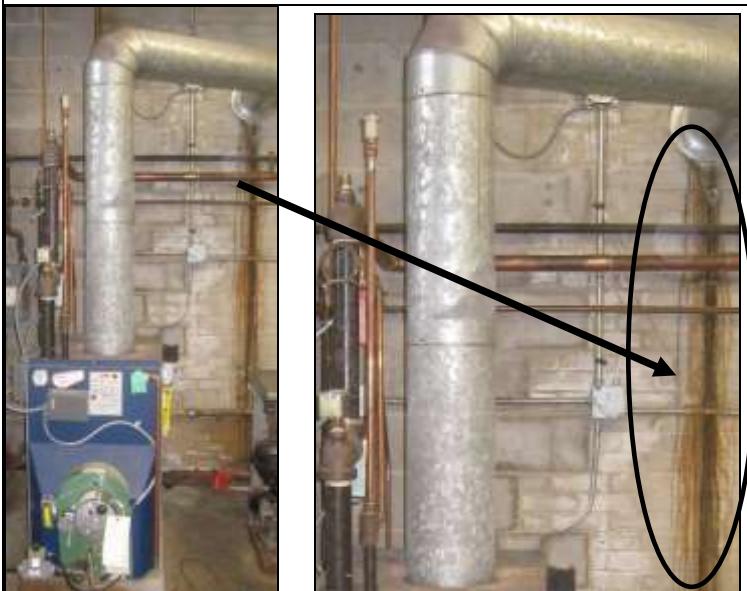
Photo # 35- Condensate drip marks below vent connection to chimney from boiler.

Indication of chimney water infiltration and or back draft concerns. Have chimney sweep clean and chimney contractor evaluate for liner and proper drafting.

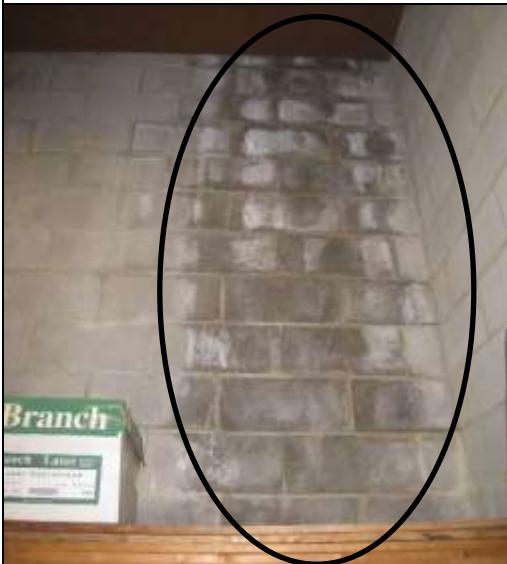
Photo # 36- Heavy efflorescence in rear SE corner of building; indication of water infiltration from roof, gutters or flashings. Have roofer evaluate and make all repairs.
