4 Seasons Home Inspection

150 Maple Avenue #128, South Plainfield, 07080

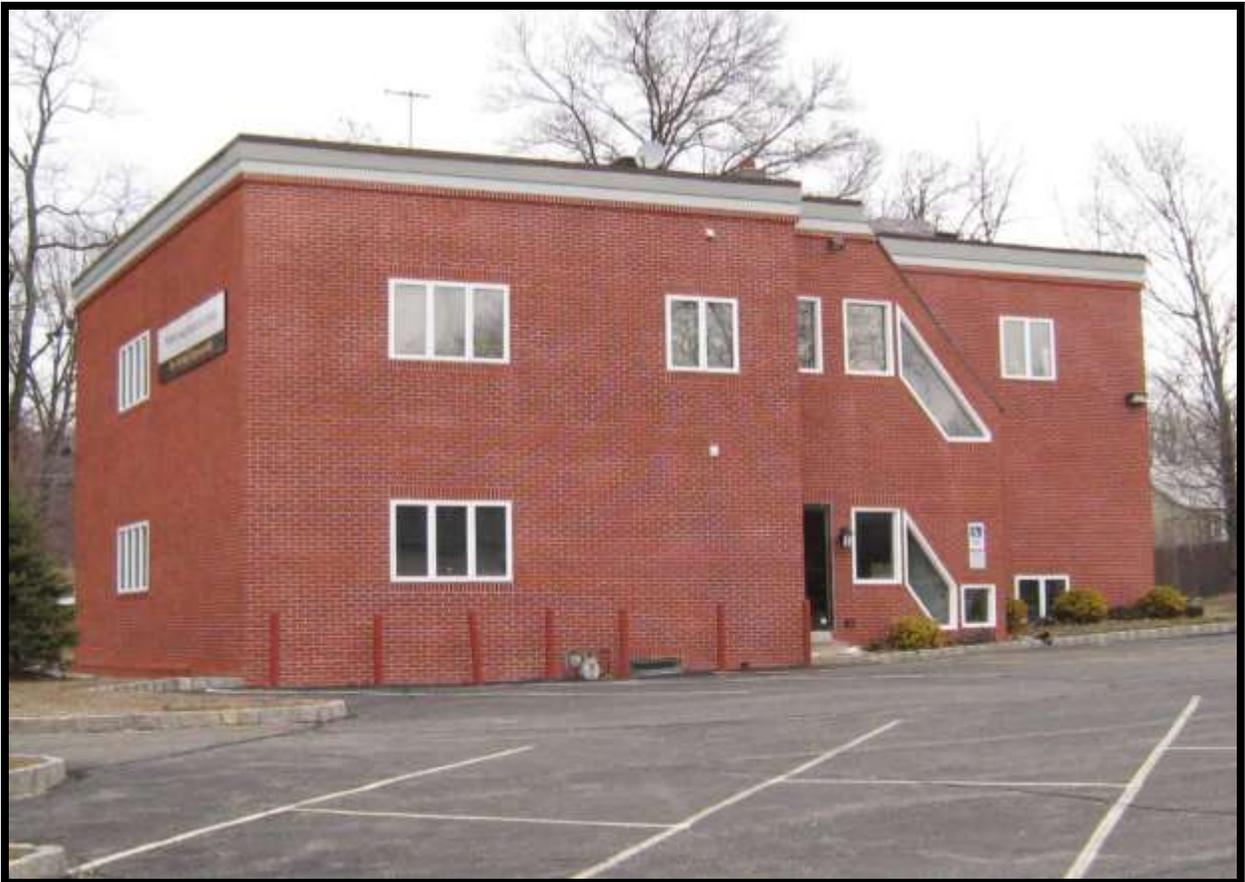
9876 Commercial Road, North West, NJ 12345

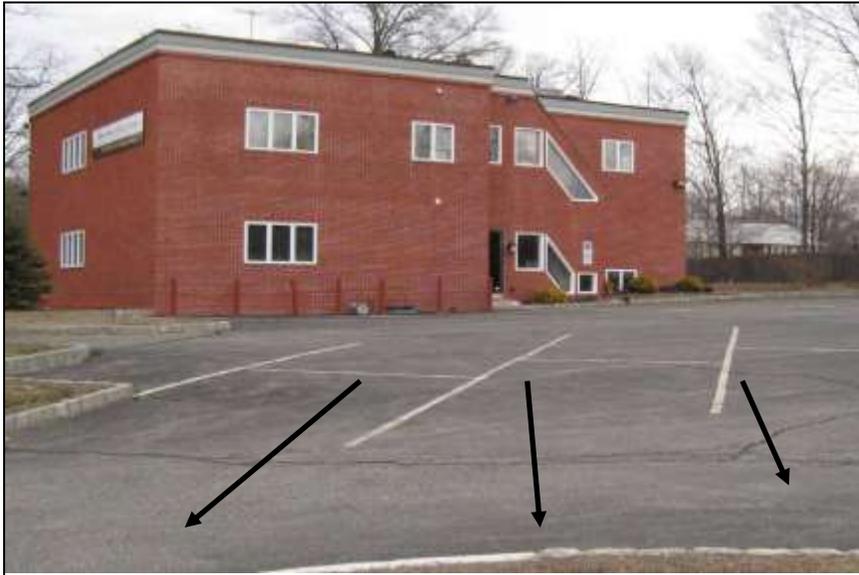
Photo # 1- (Topology) General slope toward Commercial Road toward parking lot drains. Arrows point toward two drains along Belgian block curbing.

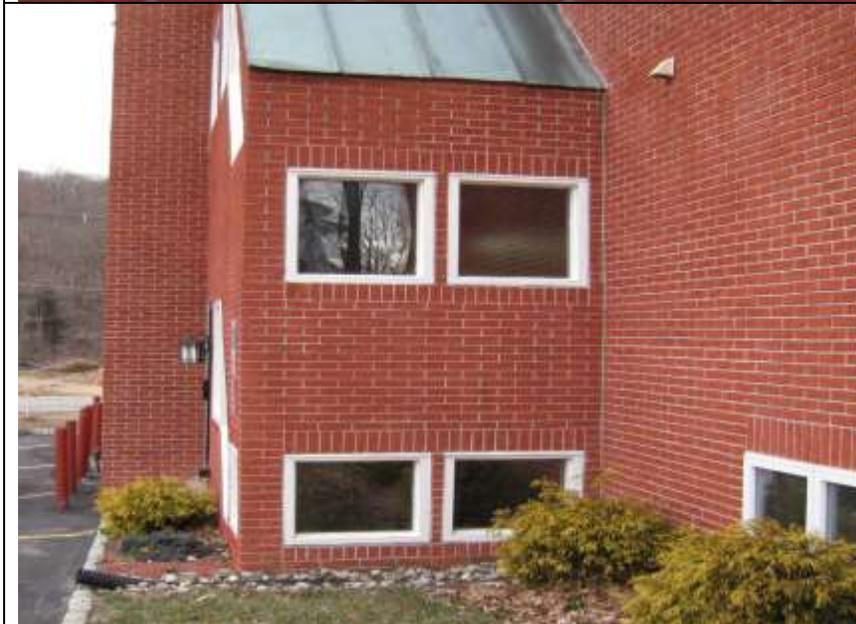
Photo # 6- Copper roof drains onto ground below where stones and black drainage tiles is positioned. Drainage tile has flat pitch and tips upwards toward curbing. Drainage is not adequate and water tends to collect against foundation. Consider adding gutter and rain leader to improve water drainage.

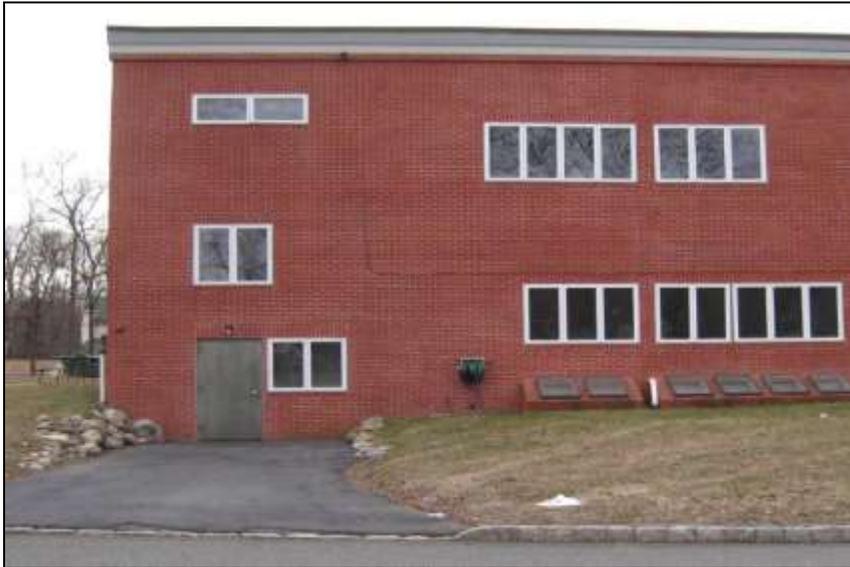
Photo # 7- (Topology)- North east left corner of building. Drainage toward rear metal door that shows rust and corrosion.

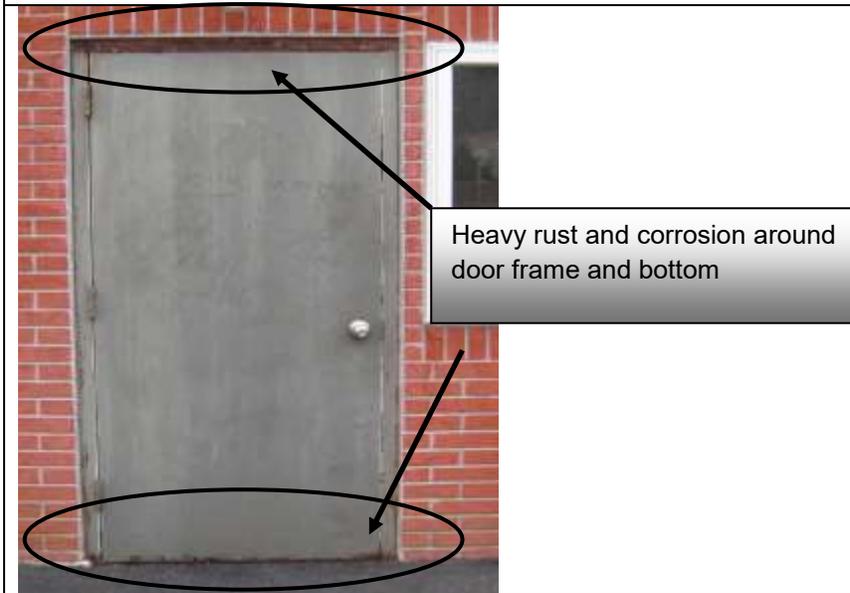
Photo # 8- Water drains toward metal door. Heavy rust and corrosion around door bottom and door frame.

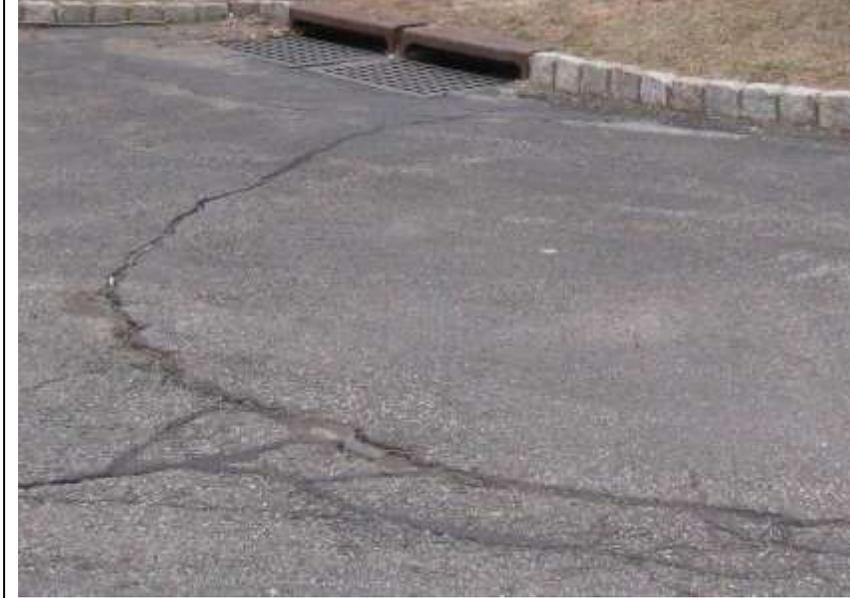
Photo # 9- parking lot is worn, settled, large cracks and in need of patch work, top coat sealing and continued maintenance. This also lends its self to "curb appeal" for a business or complex.

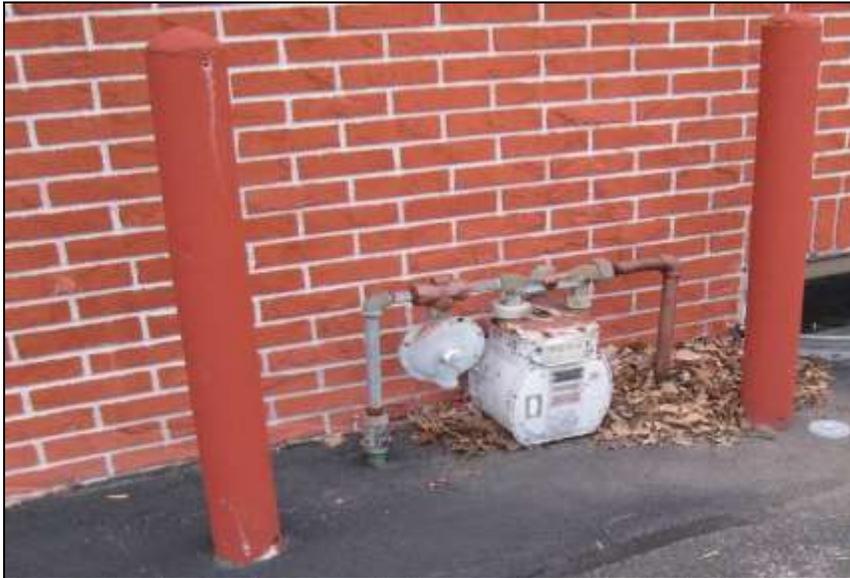
Photo # 10- Crash barriers are close to the gas meter and building not affording optimal protection against accidental vehicle contact from oblique angle. Recommend a third barrier in front and between existing barriers.

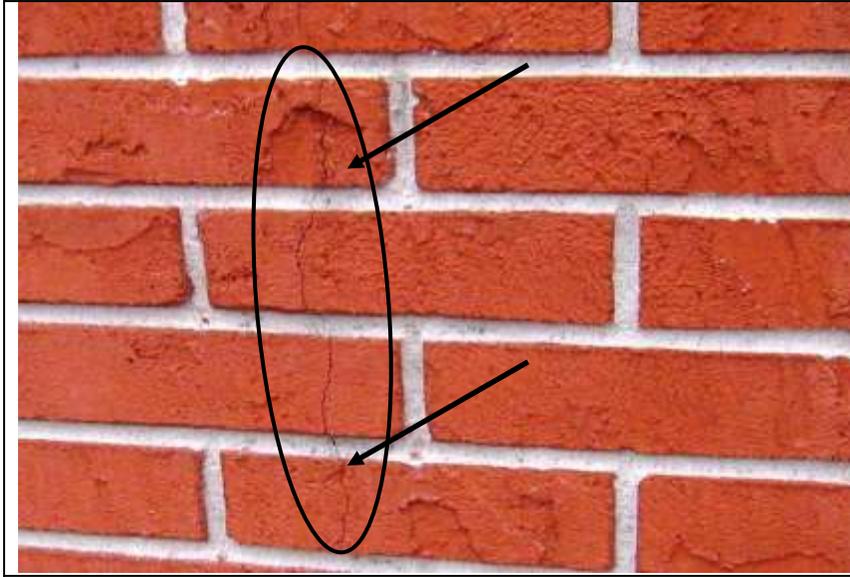
Photo # 11- Hairline cracks systemic throughout the brick faced cladding; typical of stucco-like cladding applications

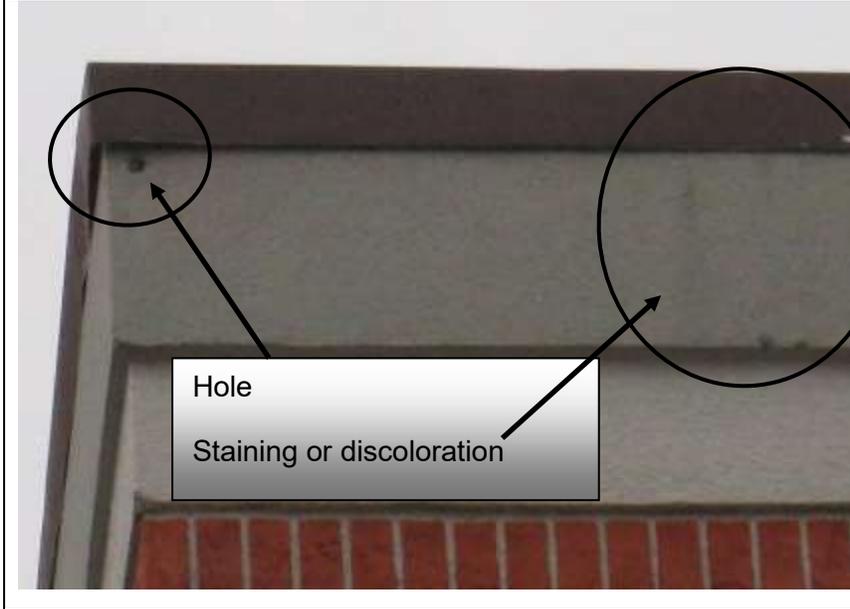
Photo # 12- There were sections of older EIFS ("exterior insulation and finish systems" or often referred to as "synthetic stucco") on top trim just below parapet wall. There was hole(s) and water staining visible around upper cladding.

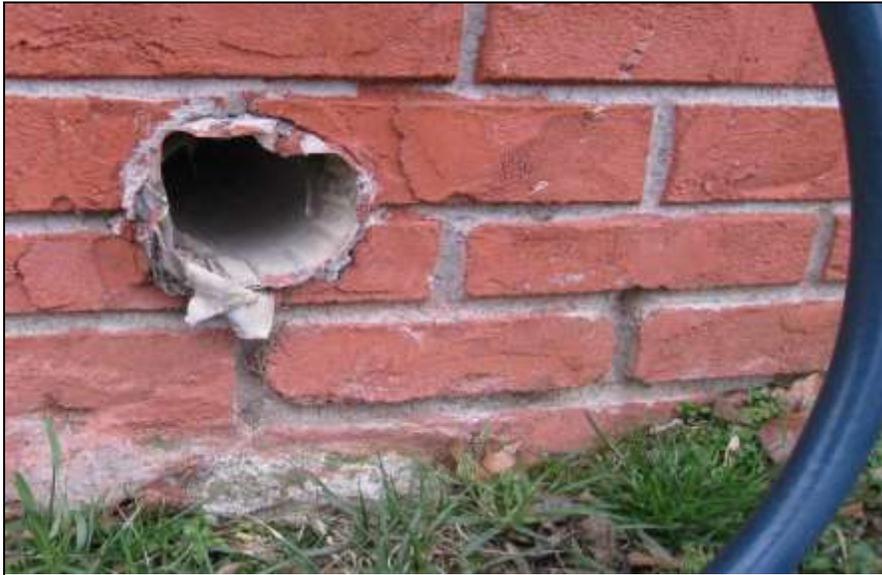
Photo #13- Possible past dryer vent; not able to verify. Further evaluation needed. If abandoned and not in use, recommend properly sealing to keep out rodents, animals or insects.

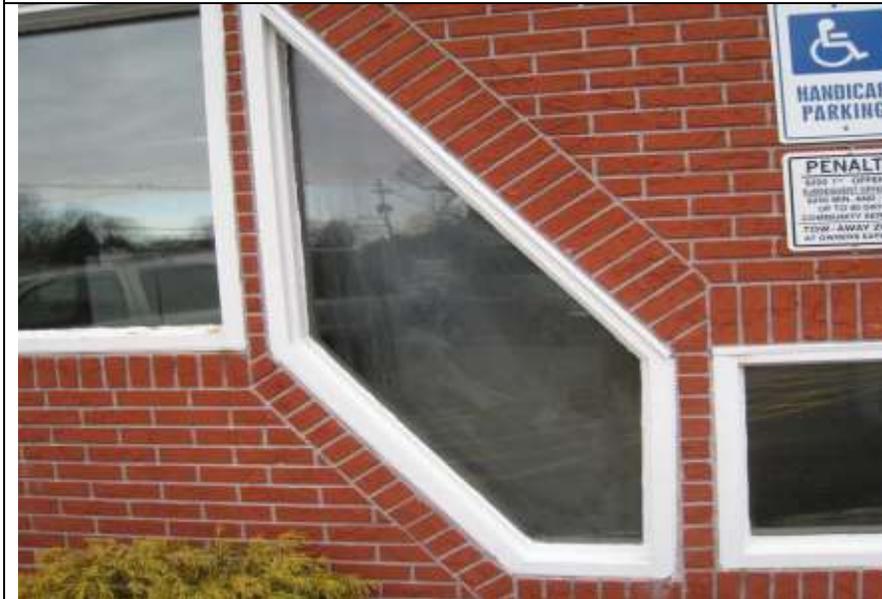
Photo # 14- Cracked panes and vapor seal breaks. Presents a cut and safety hazard. Windows should be replaced.

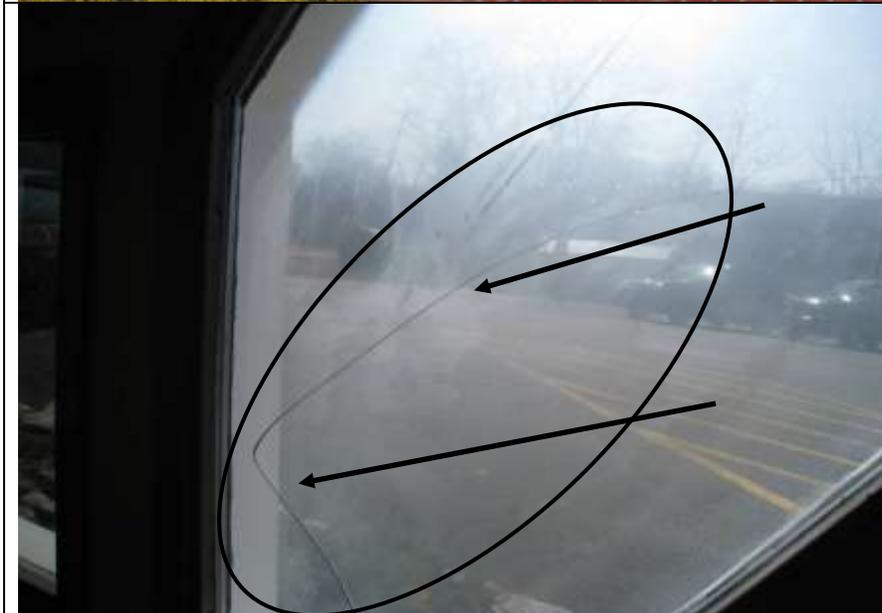
Photo # 15 – Cracked glass as viewed from inside hallway south side parking lot. Safety cut hazard. Windows should be replaced where cracked and broken vapor seals.

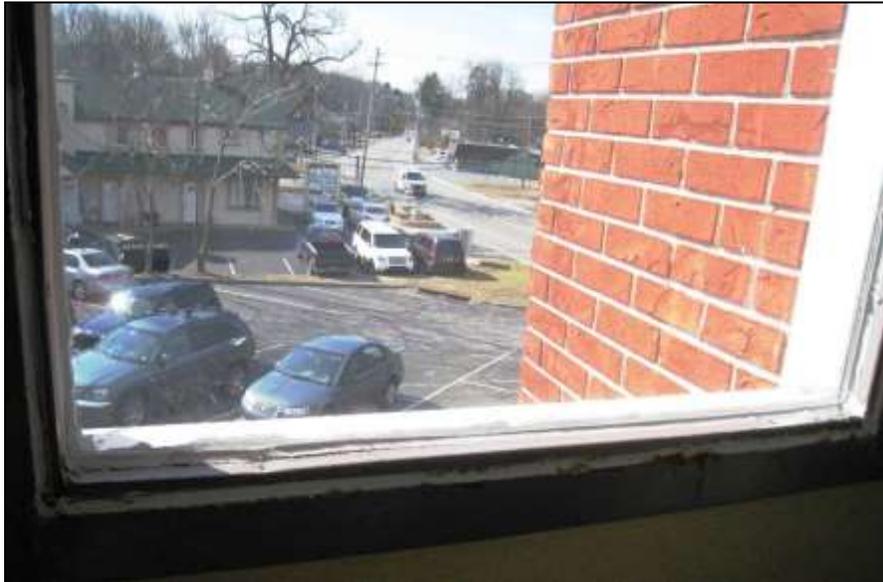
Photo # 16- Heavy caulking and rust around inside of older windows. Recommend proper repairs or replacement.

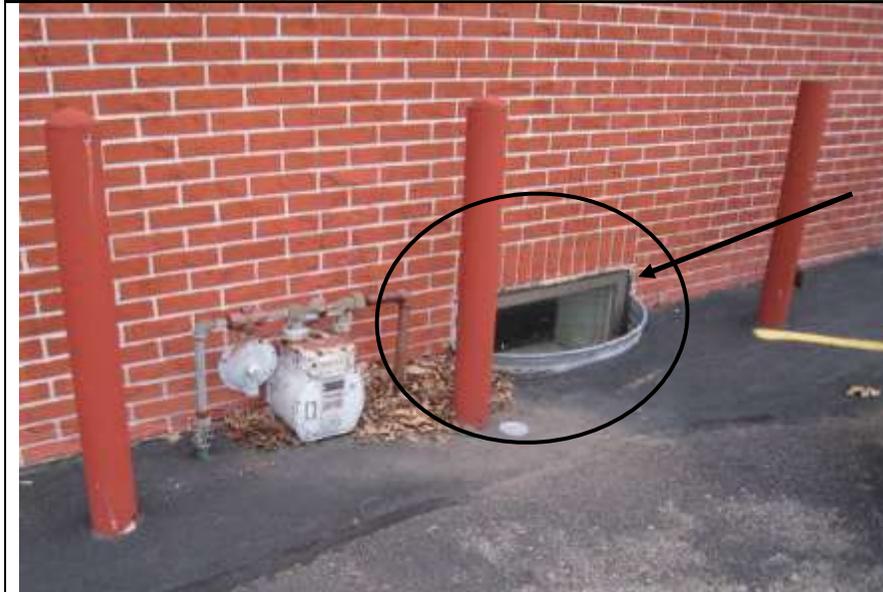
Photo # 17- No window well cover installed. Rain, ice and snow will collect in well and infiltrate into basement.

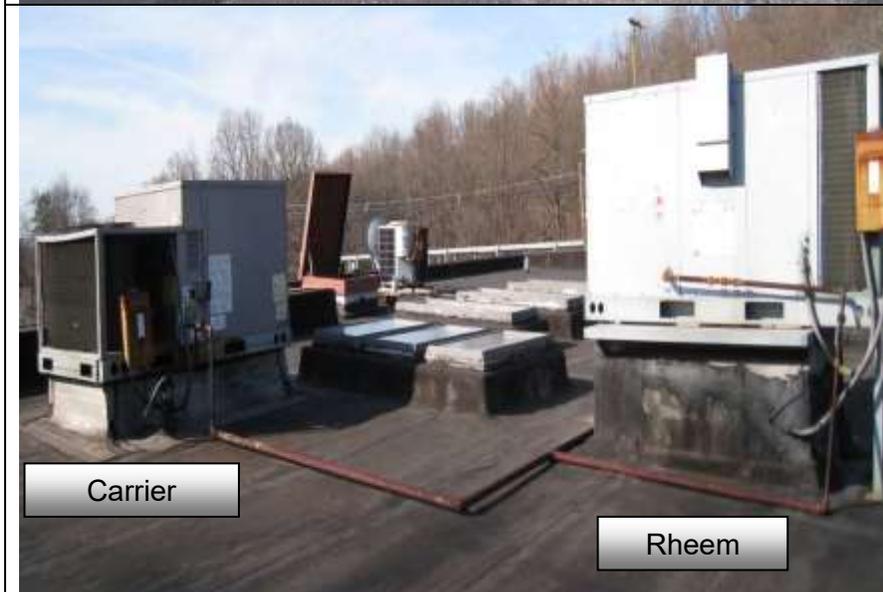
Photo # 18- East side roof, Carrier (left) ~10yrs old and Rheem packaged unit (right) 2004 manufacturing date on unit. Units have very rusted gas supply lines and disconnects.

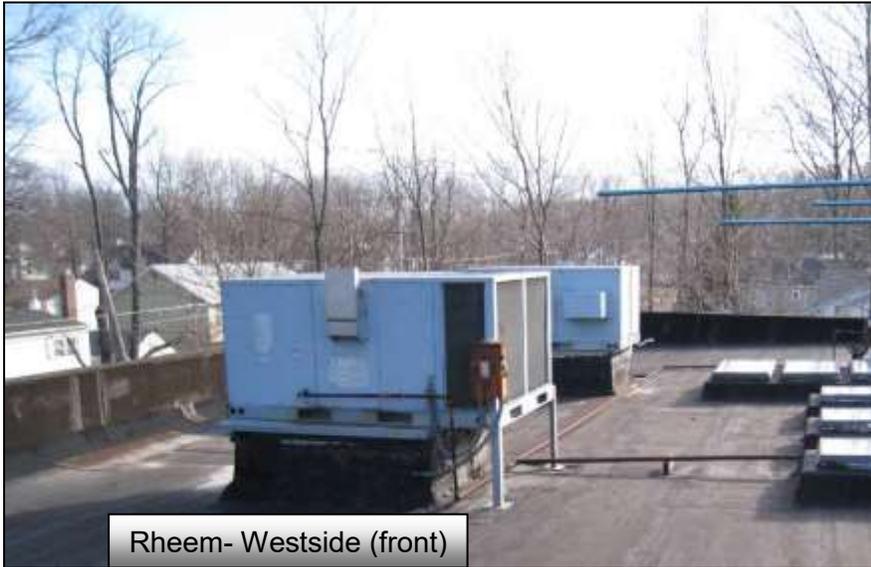
Rheem- Westside (front)

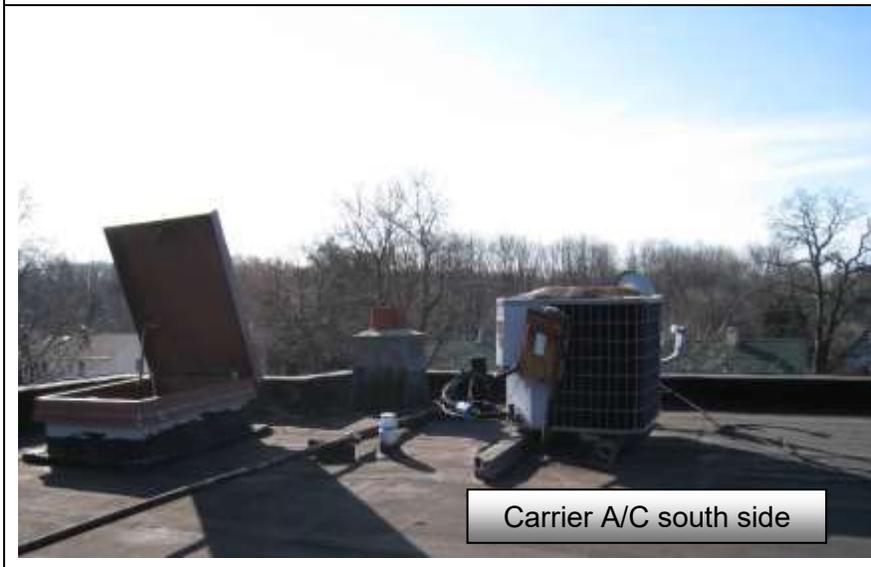
Carrier A/C south side

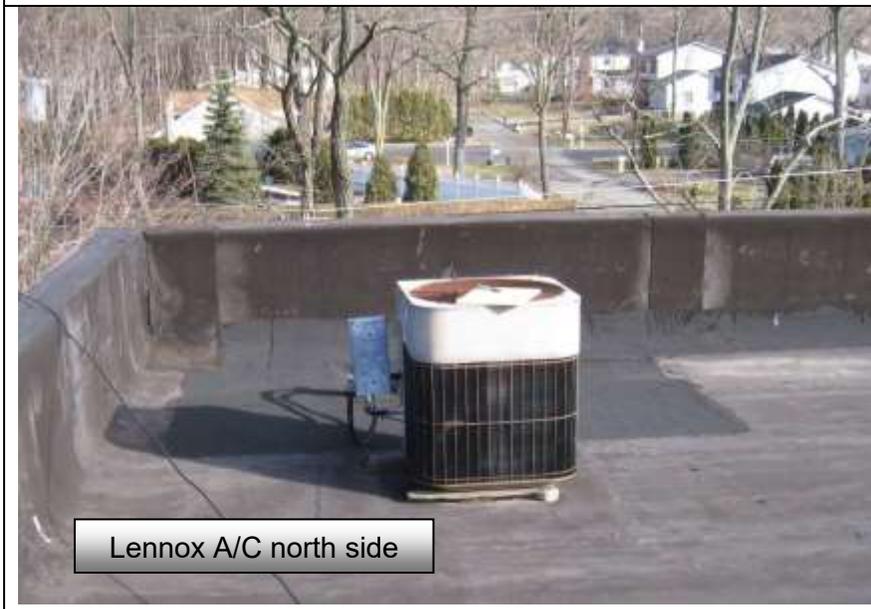
Lennox A/C north side

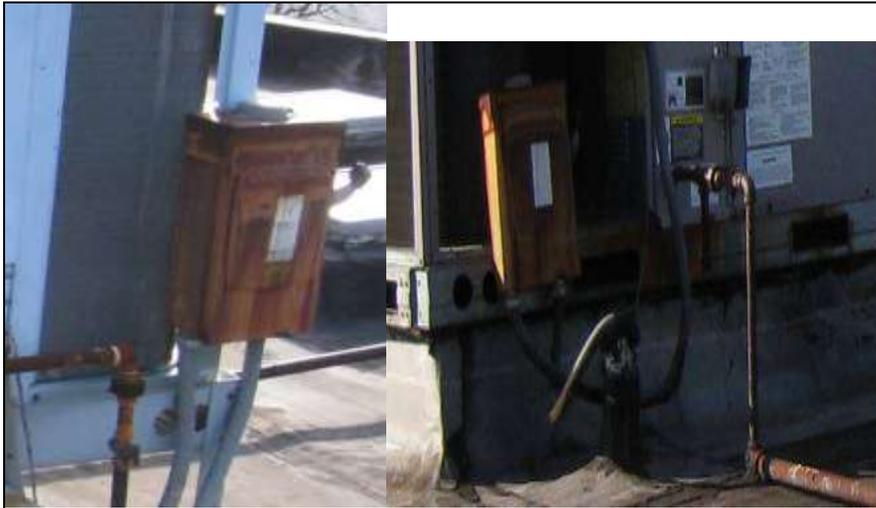
Photo # 22- Typical of the rusted disconnects on all RTU's and A/C compressors. Rusted black iron gas lines and fittings.

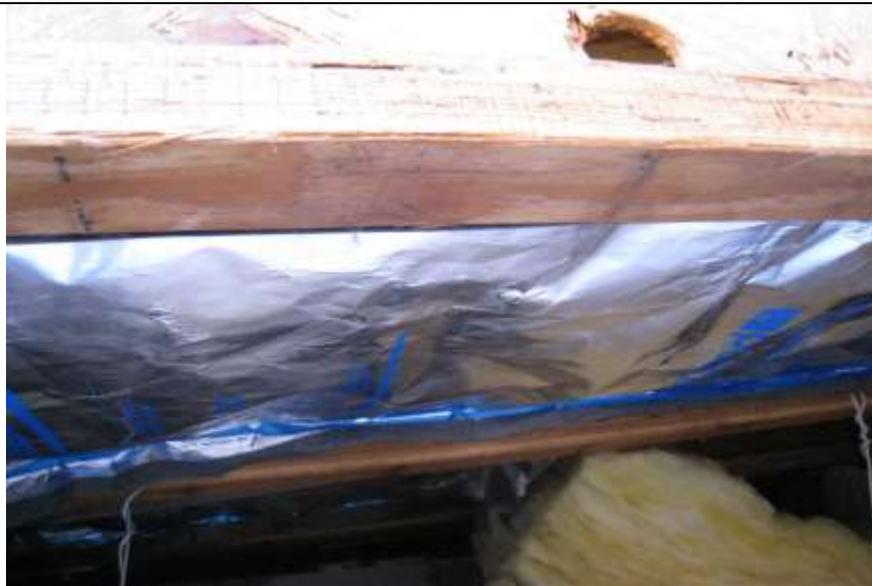
Photo # 23 & 24- Partial view of roof structure as viewed on ladder at roof scuttle opening peering through acoustic ceiling tiles. Insulation, was installed between decking and acoustic tiles (below-not visible in picture). Some black iron gas pipes, electrical and ductwork visible and covering framing.

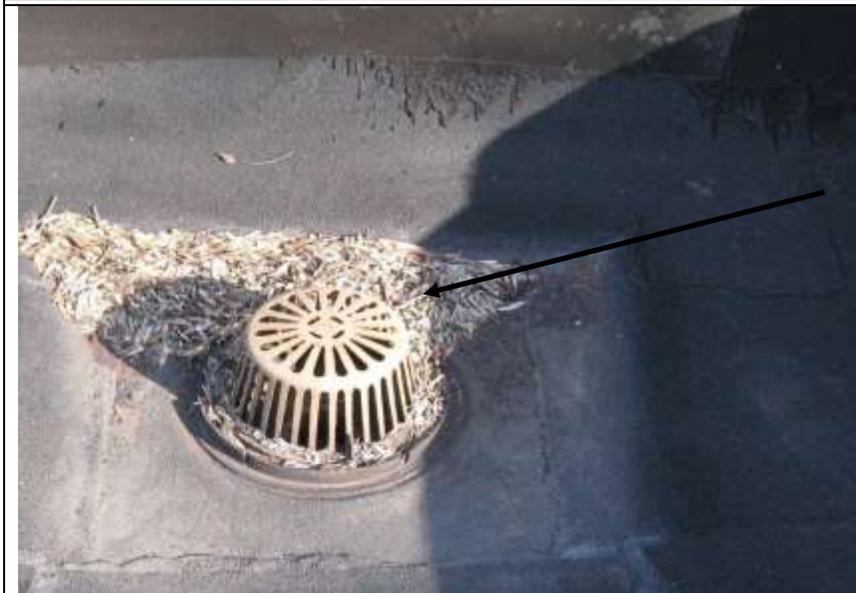
Photo # 26- Debris in depression around drain. Monthly inspections are recommended and cleanings to keep clear for proper flow.

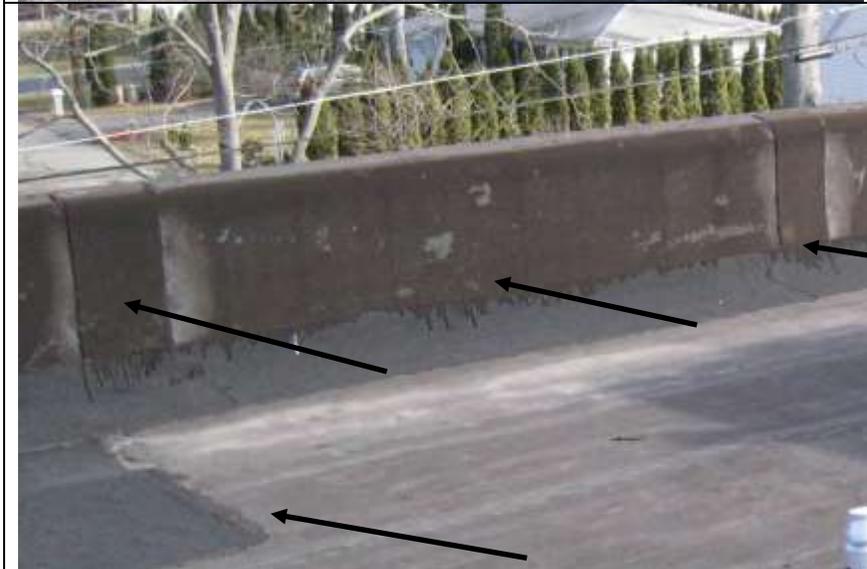
Photo # 27- Patching along north wall

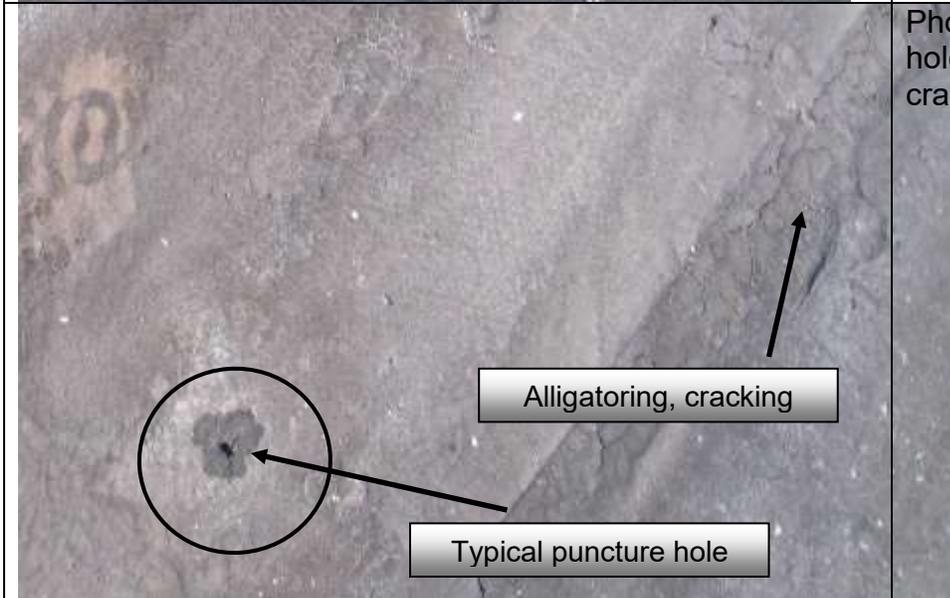
Photo # 30- Typical puncture hole and Alligating and cracking

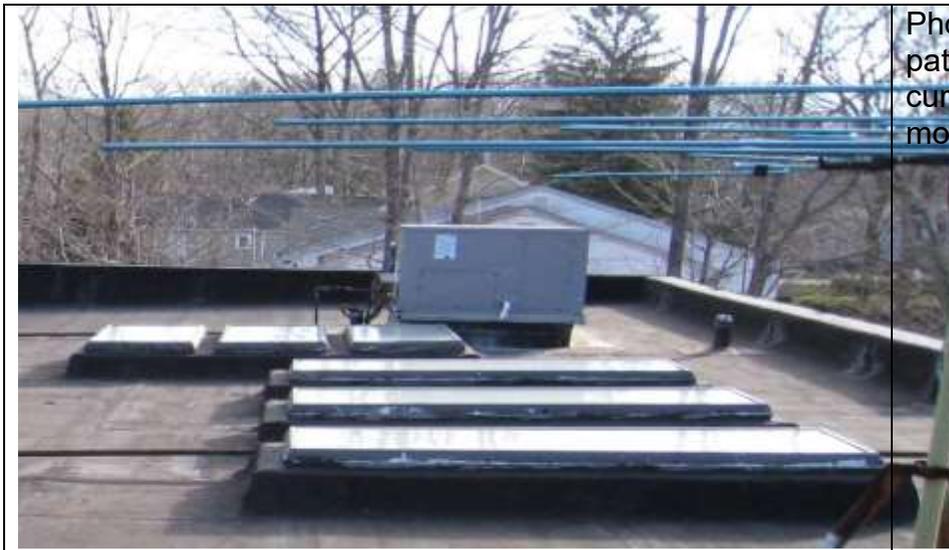
Photo # 31- Tarring and patching around skylight curbing. Old TV antennae mounted on roof top.

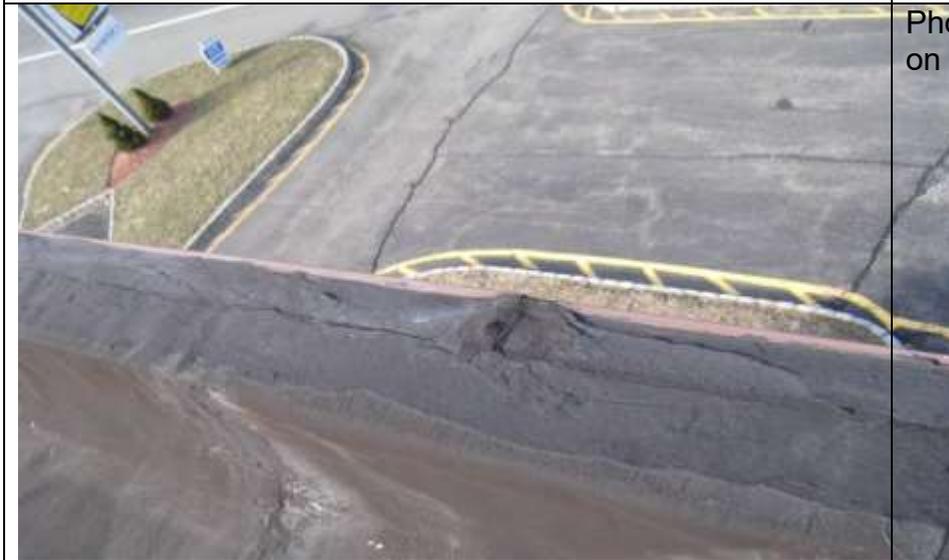
Photo # 32- Typical of cracks on parapet walls

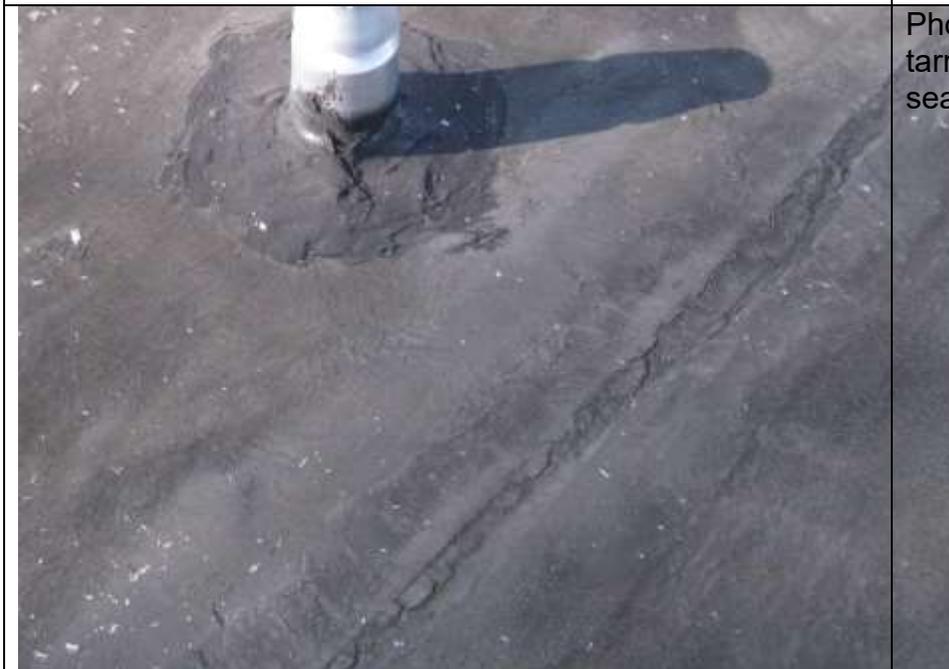
Photo # 33- Cracking and tarring around penetrations, seams, membrane

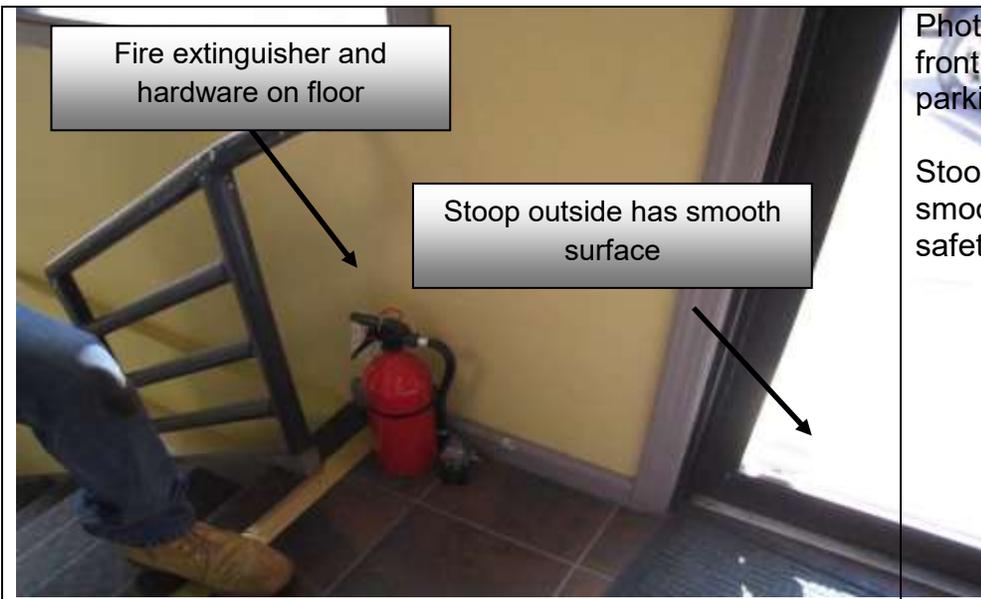
Fire extinguisher and hardware on floor

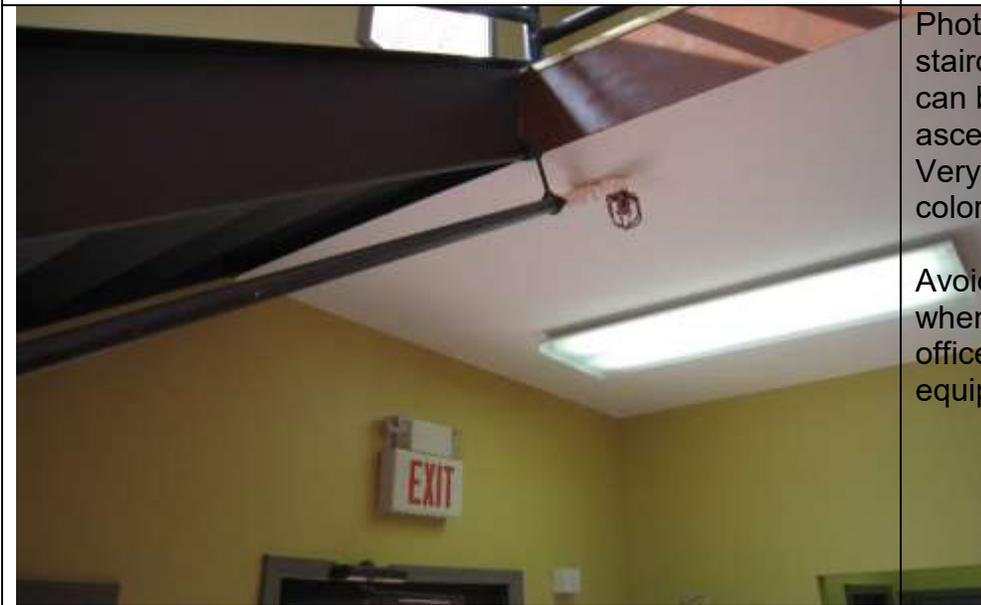
Photo # 35- 1st floor staircase. Sprinkler piping can be easily grabbed when ascending up to 2nd floor. Very similar to hand rail in color, size and convenient.

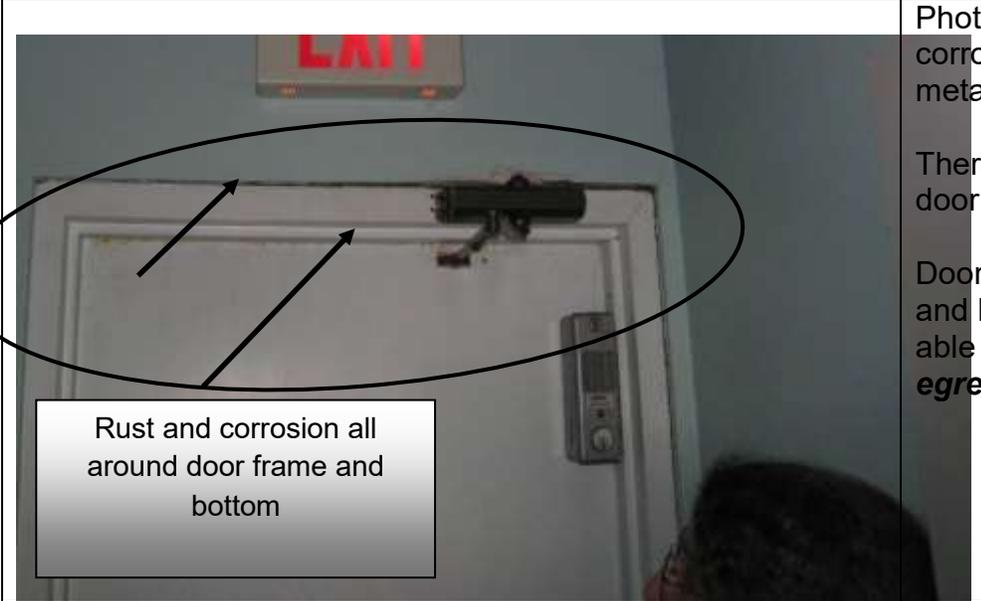
Rust and corrosion all around door frame and bottom

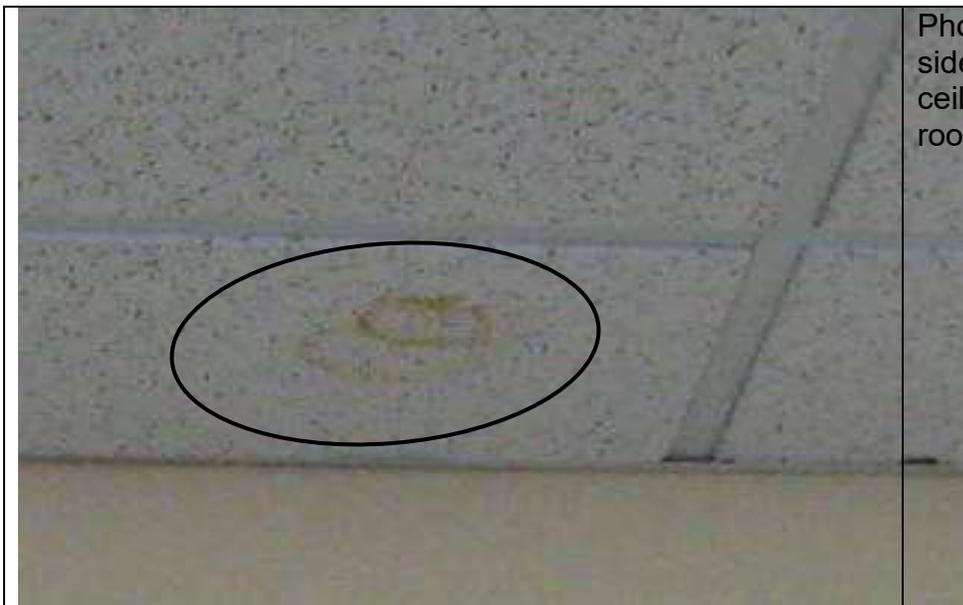
Photo # 37- 2nd floor west side empty room. Typical of ceiling stains found. Monitor rook for leaks.

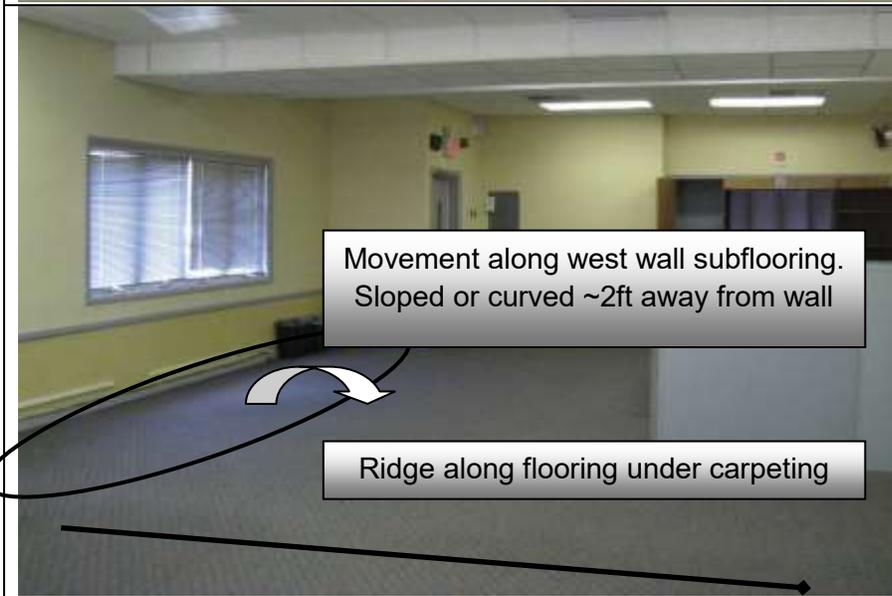
Photo # 38- 2nd floor west side empty room. Movement in sub flooring along west wall by windows. There is a curve or slope ~2ft away from wall. Not able to evaluate below carpeting.

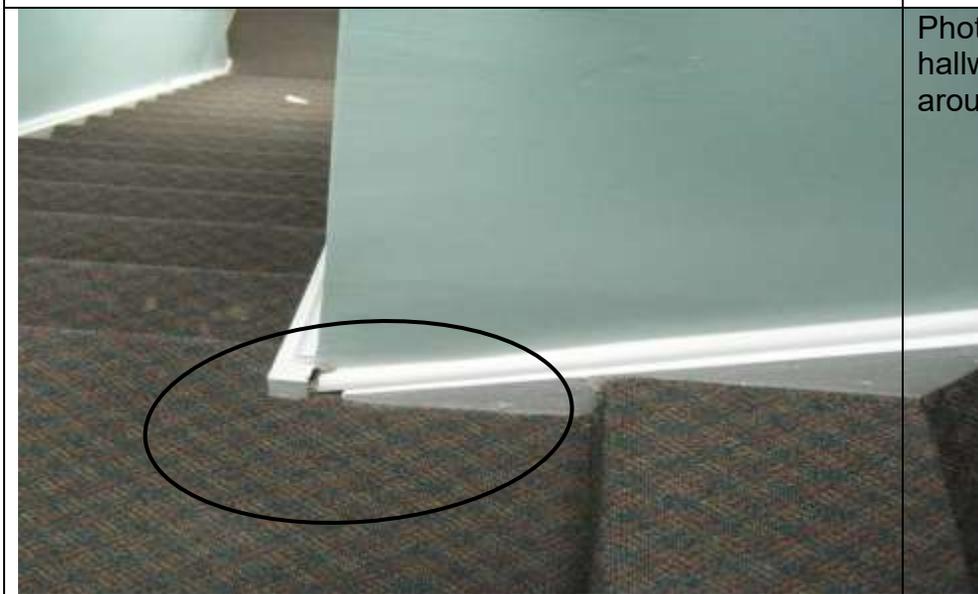
Photo # 39- 2nd floor north hallway. Trim sticking out around bend- trip fall hazard.

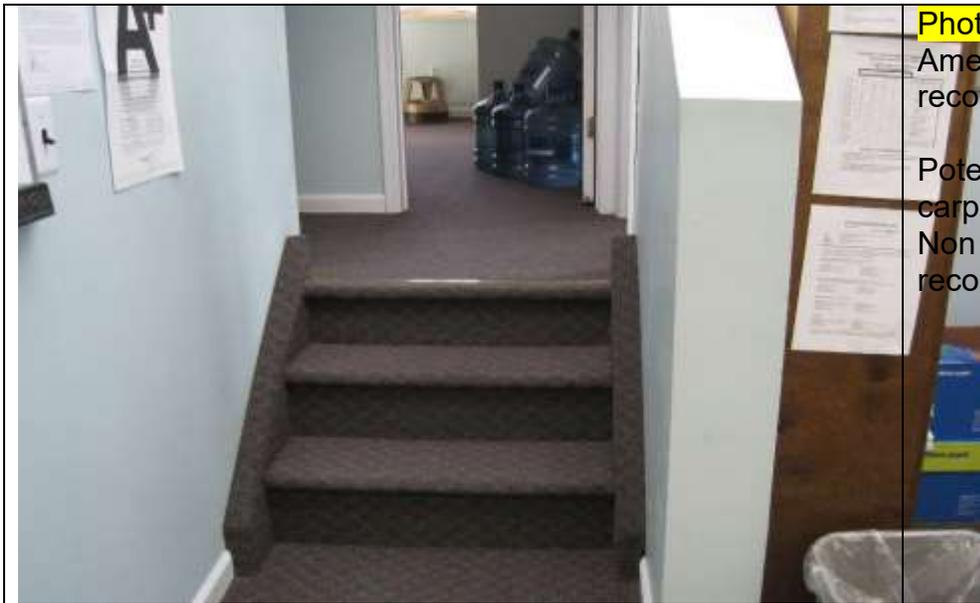
Photo # 40- 2nd floor Prime America. Hand railings are recommended for safety.

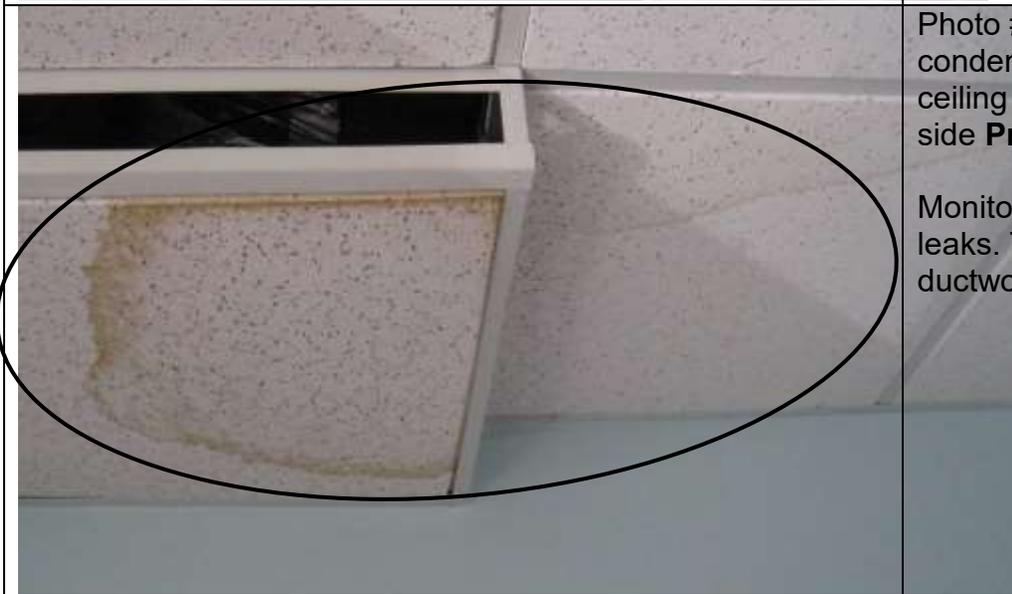
Photo # 42- Water or condensate stains on acoustic ceiling tiles in upper south side **Prime America** office.

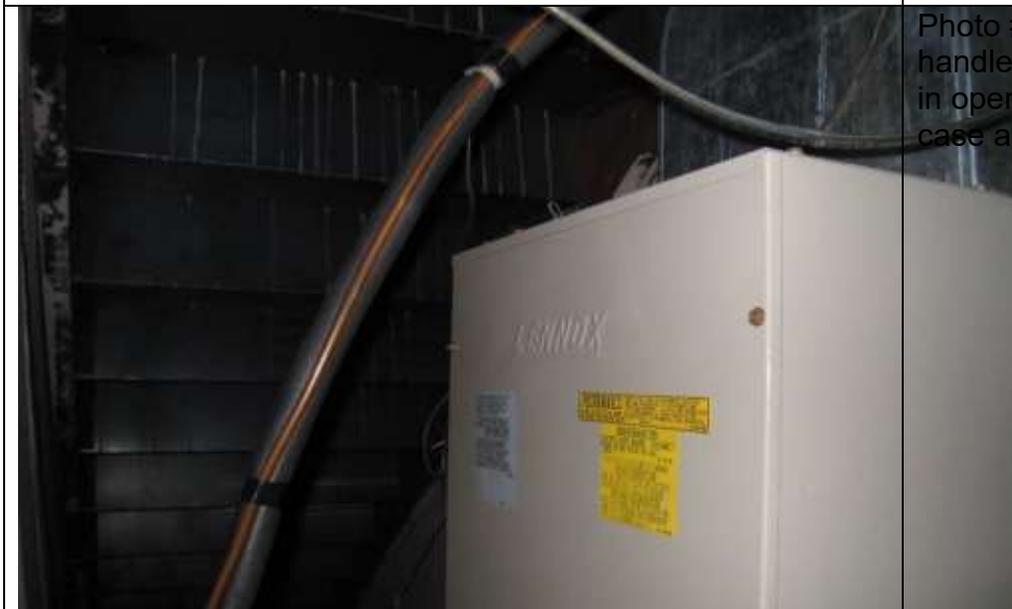
Photo # 43- Lennox air handler is located behind wall in open room, first floor. Stair case above has rust; monitor.

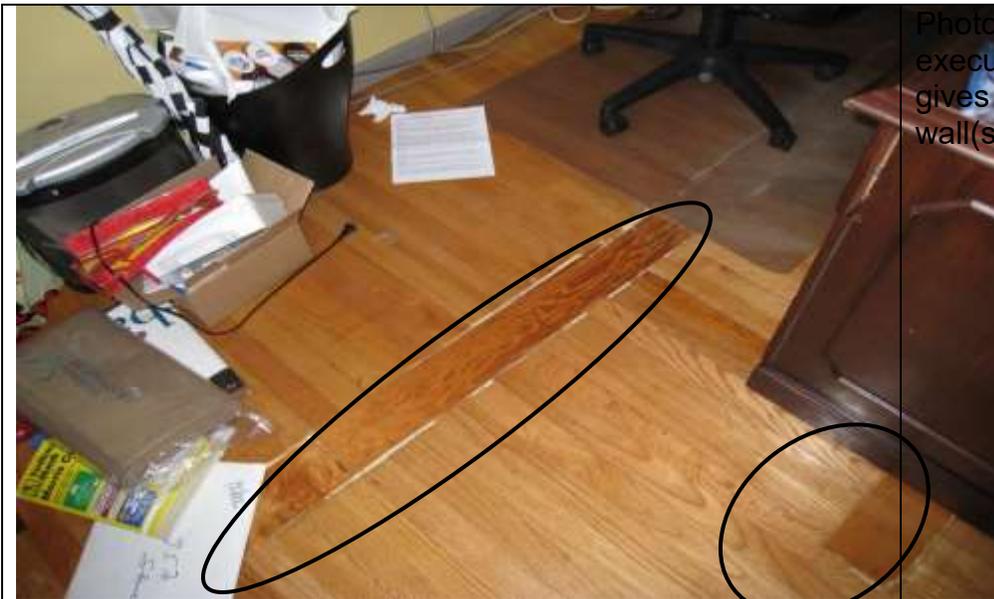
Photo # 44- 1st Floor owners executive office. Flooring gives indication of removed wall(s) or closet.

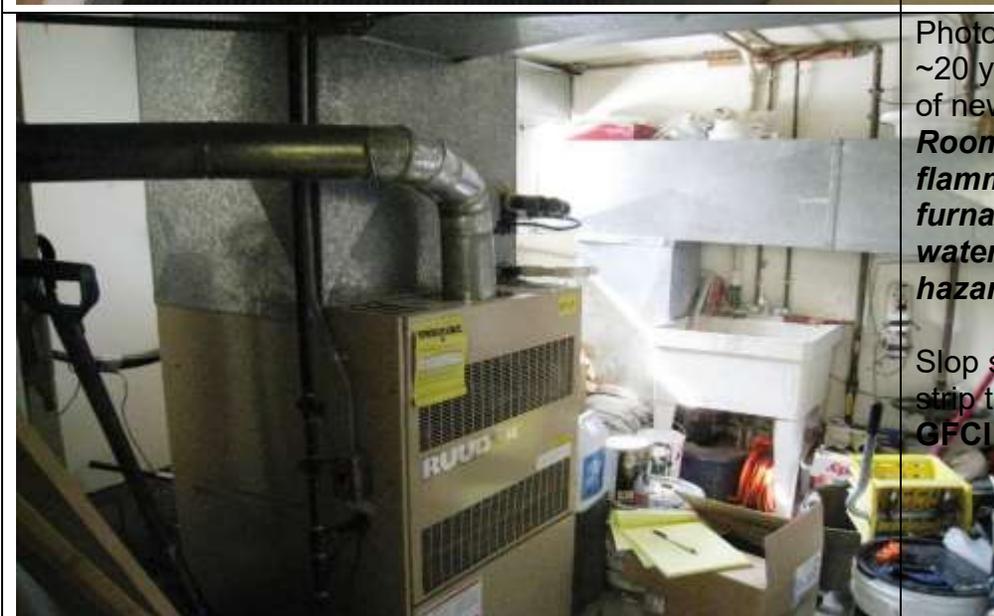
Photo # 46- Rudd furnace, ~20 yrs old or installed at time of newest addition.

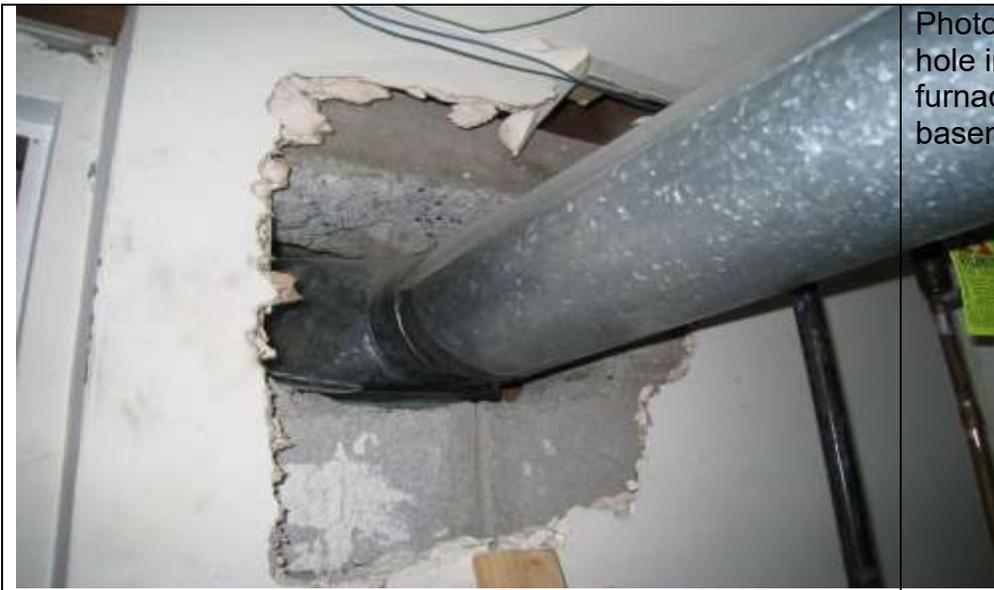
Photo # 47- Punched out hole in CMU wall behind Rudd furnace in mechanical room basement

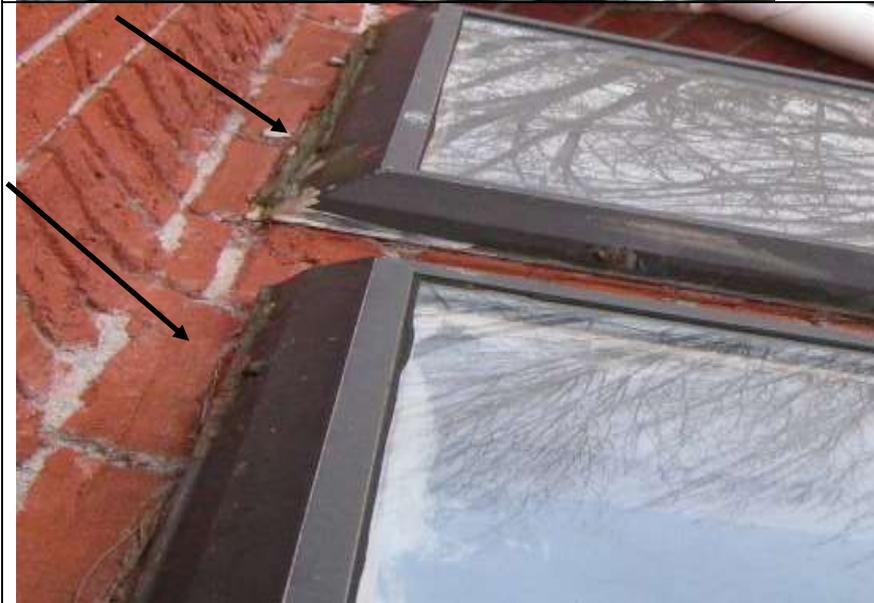
Photo # 51- Heavy caulking around skylights. Cracks, gaps and sprayed expansion foam visible from interior kitchen
