4 Seasons Home Inspection

150 Maple Avenue #128, South Plainfield, 07080

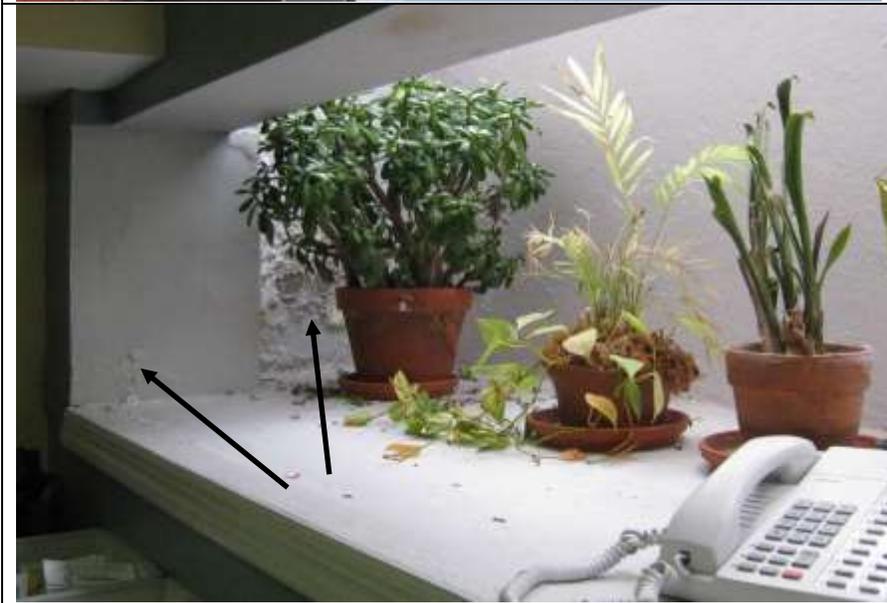
Photo # 52- Efflorescence, peeled paint; indication of water intrusion

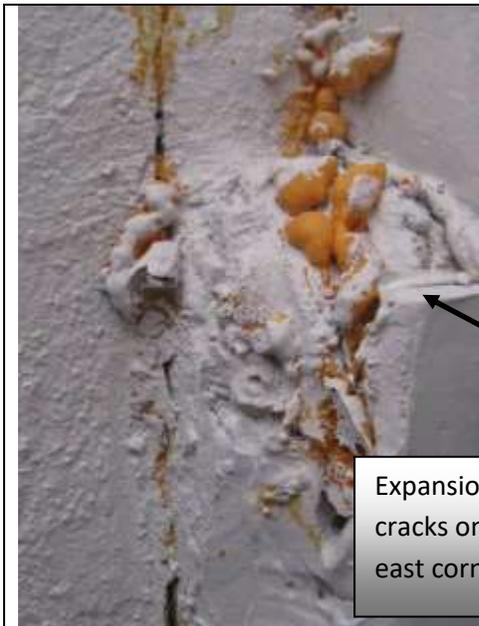
Expansion foam filled in masonry vertical cracks on window well skylights north east corner

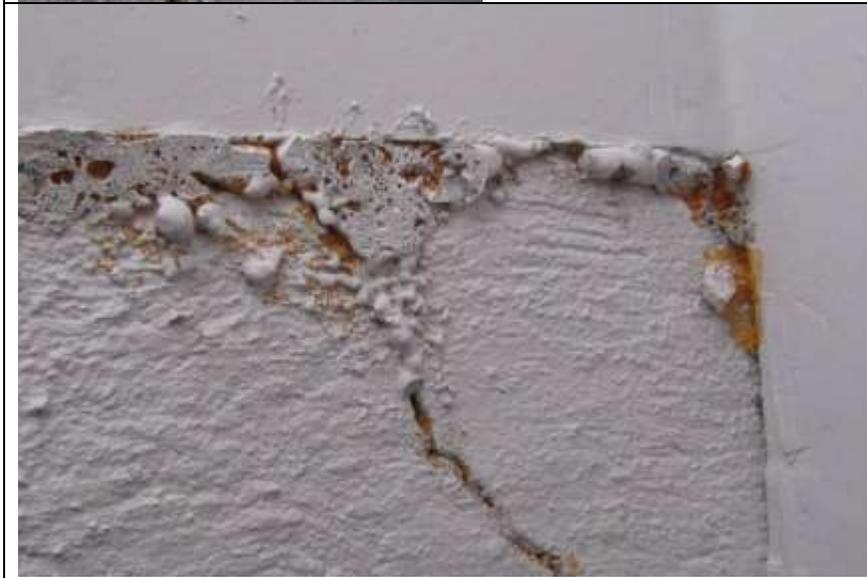
Photo #57- cracked top edge of CMU walls just below skylights. Filled with expansion foam

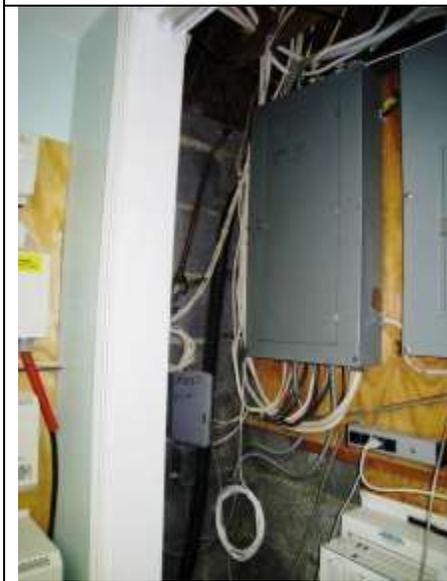
Photo # 58- Main electric panels In basement closet, inadequate clearance to panel. **Fire hazard.**
