4 Seasons Home Inspection, LLC

Inspection Date: September 15, 2009 1:30pm
Client Name: Client(Email Addresses to receive Reports)
Inspection Address: Street Number, City, NJ
Inspected by: Linda Geczi home inspection lic. #24GI00061500

Approximate Age: ~60 yrs
Style: Single Family
Main Entrance Faces: S
State of Occupancy: Vacant, distressed property
Weather Conditions: Sunny ,75°F
Ground cover: Dry

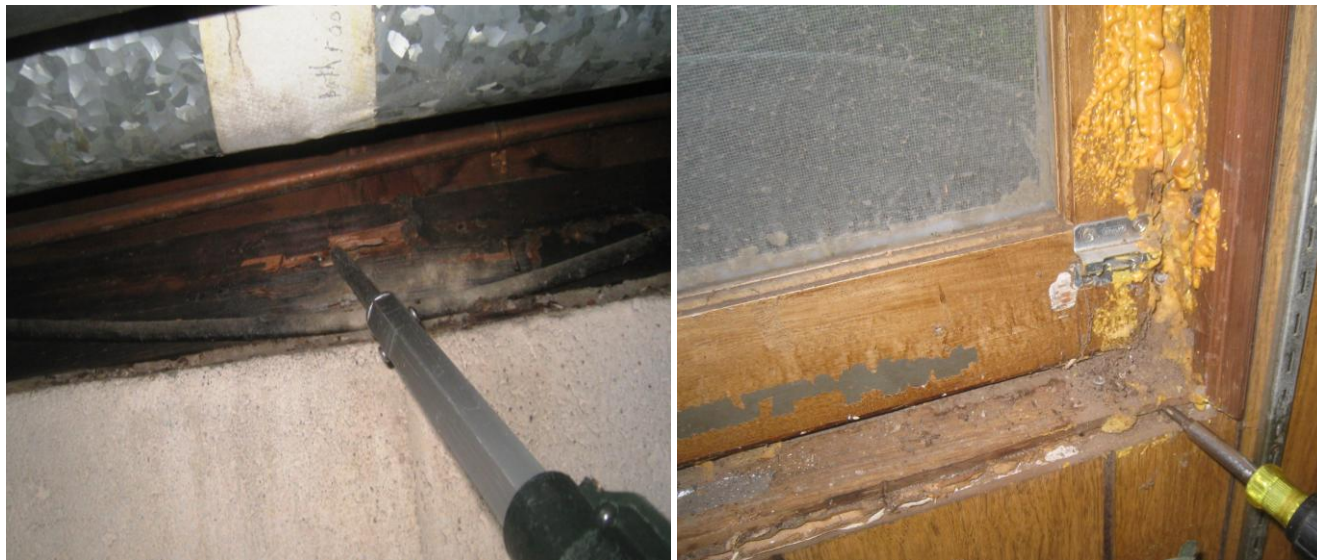
Figure 1 Sill damage, wood destroying insect. Have structural carpenter evaluate extent of all damage. Potential damage behind all wall and ceiling coverings.

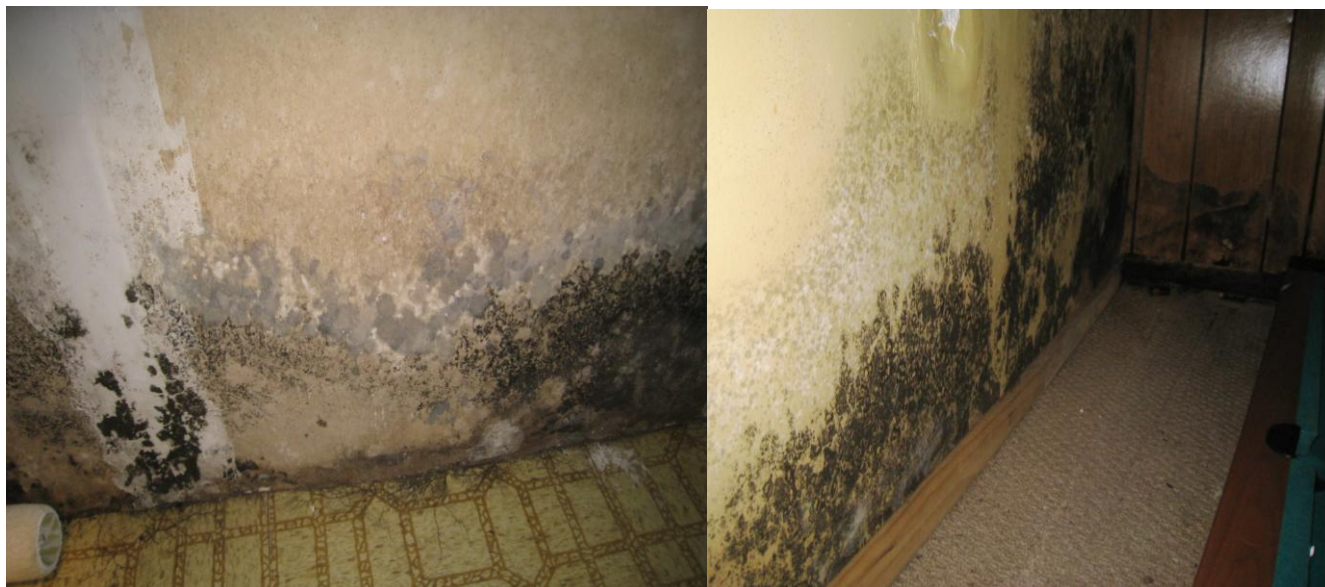
Examples of Mold in Basement

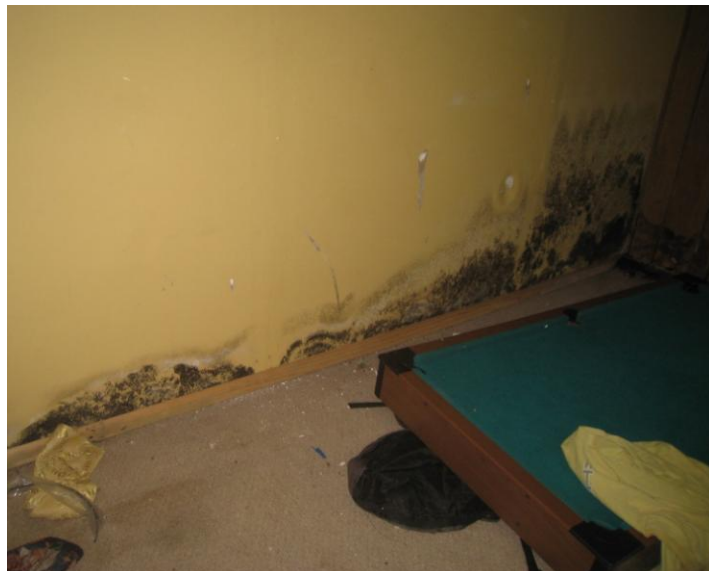
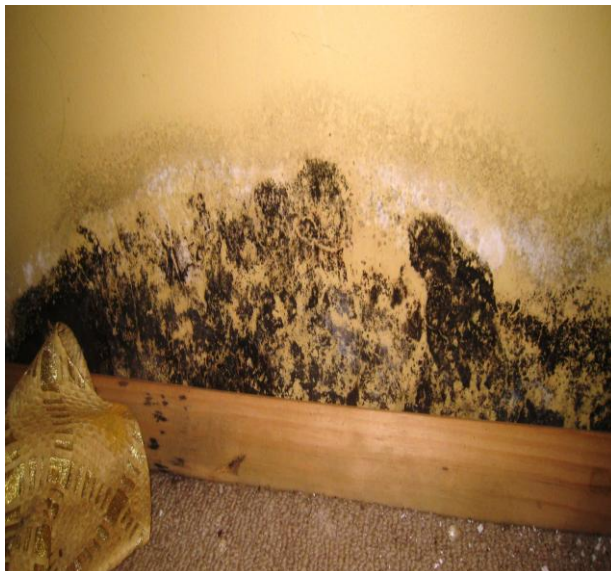
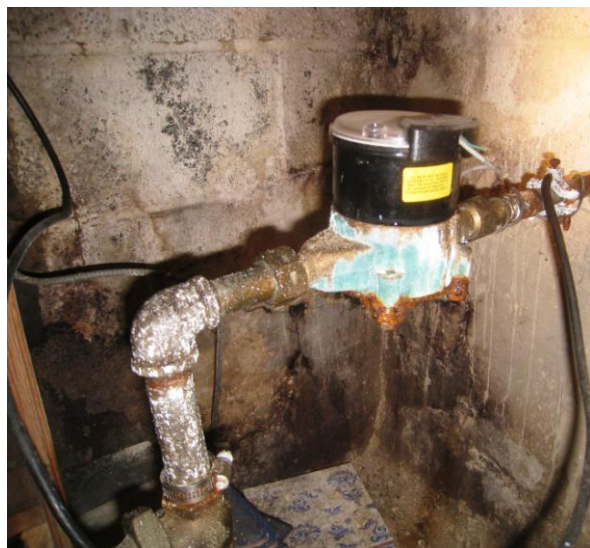
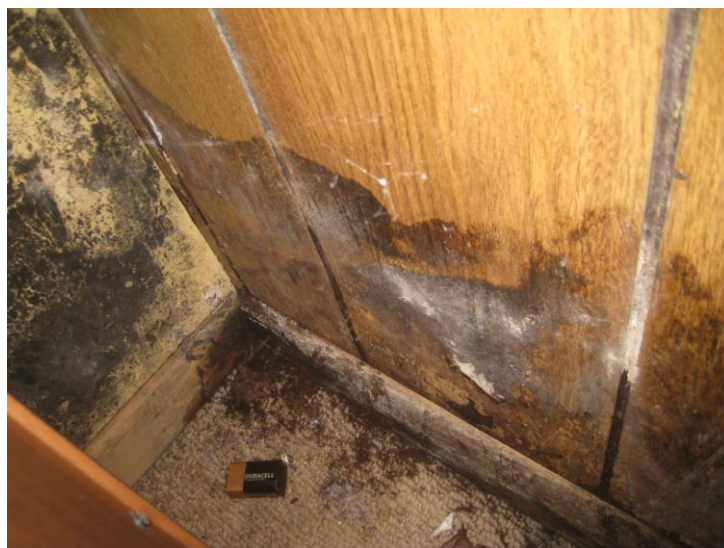
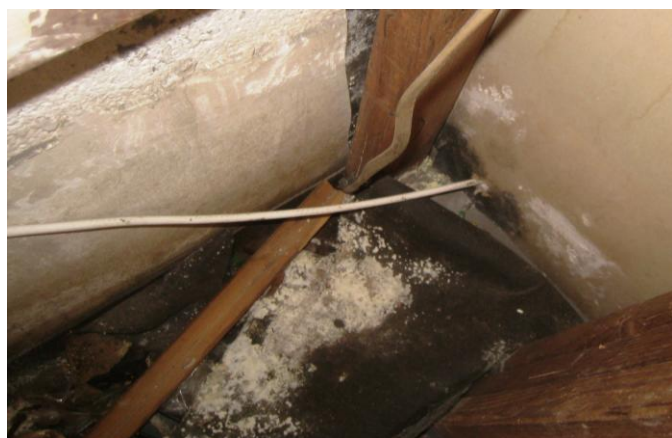
Examples of Mold in Basement

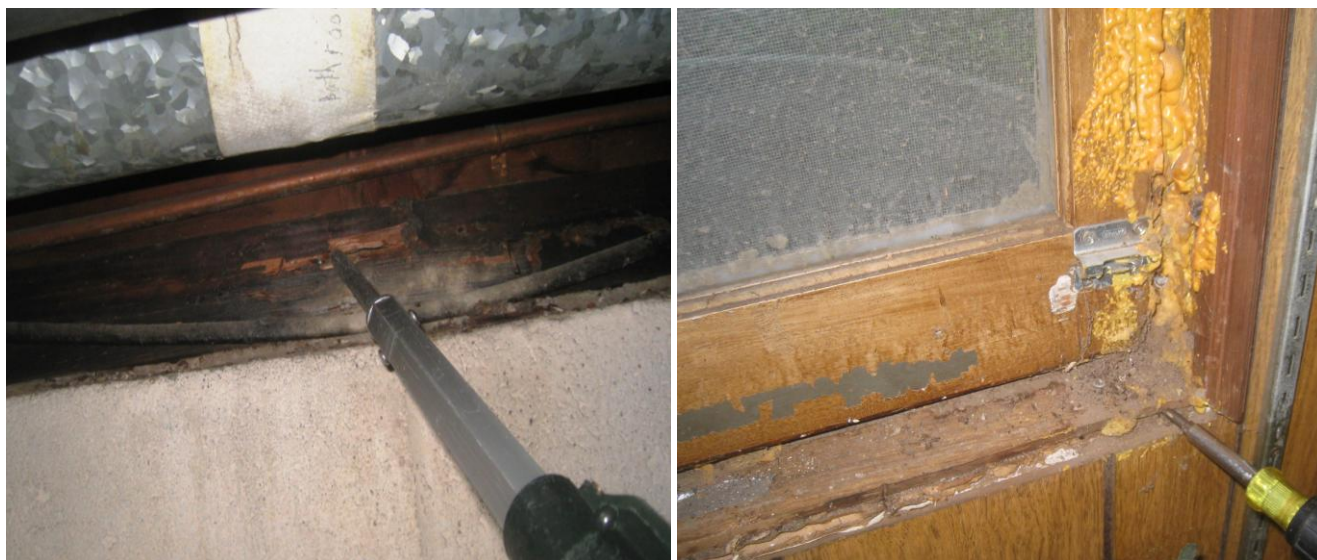
Figure 2 Sill damage, wood destroying insect. Have structural carpenter evaluate extent of all damage. Potential damage behind all wall and ceiling coverings.

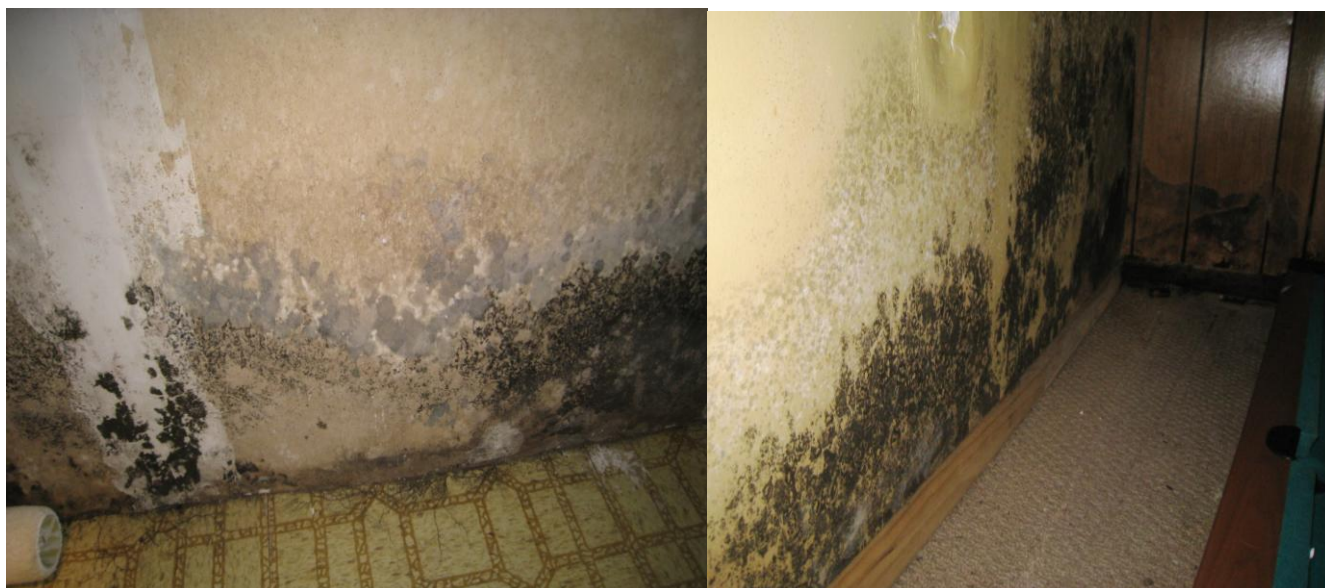
Examples of Mold in Basement

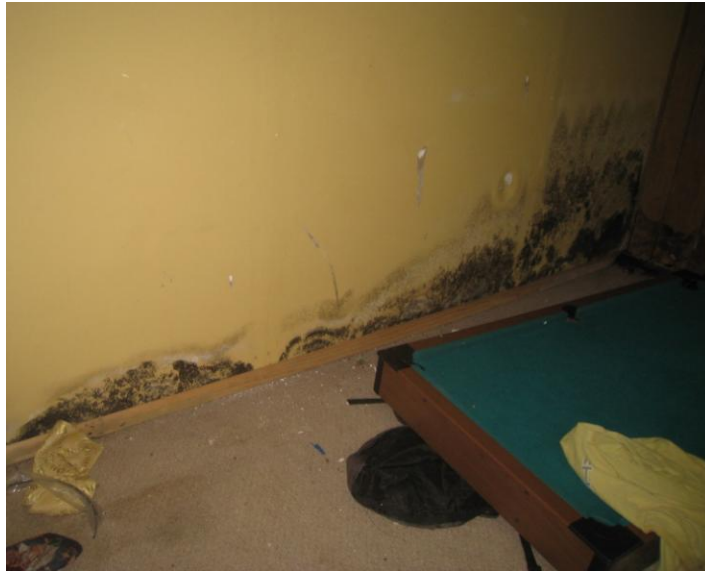
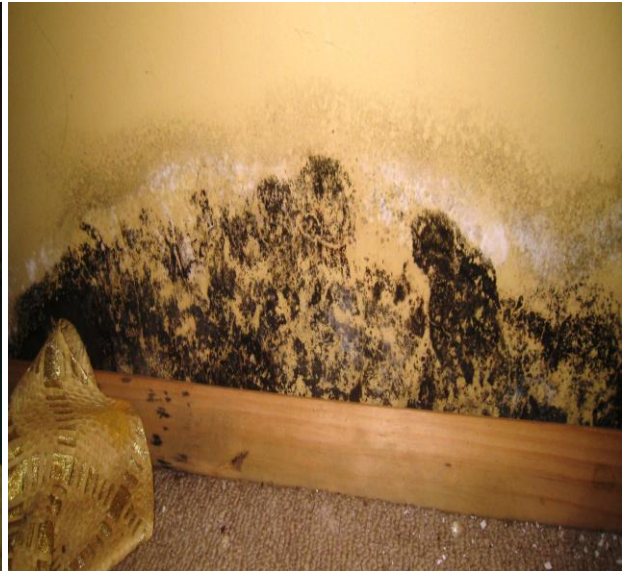
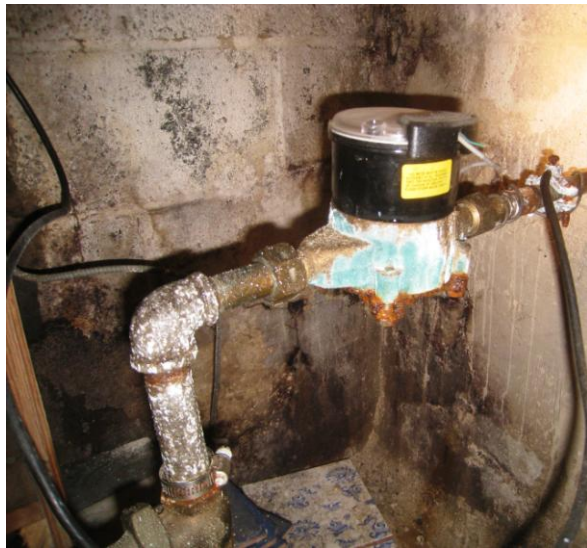
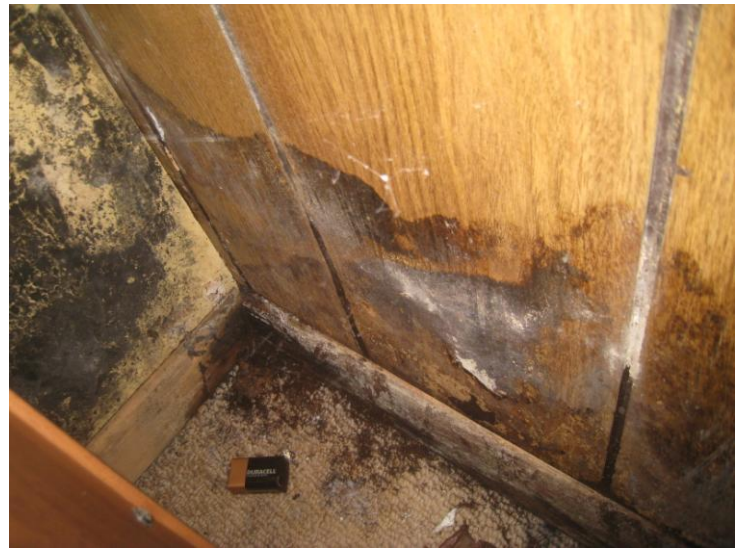
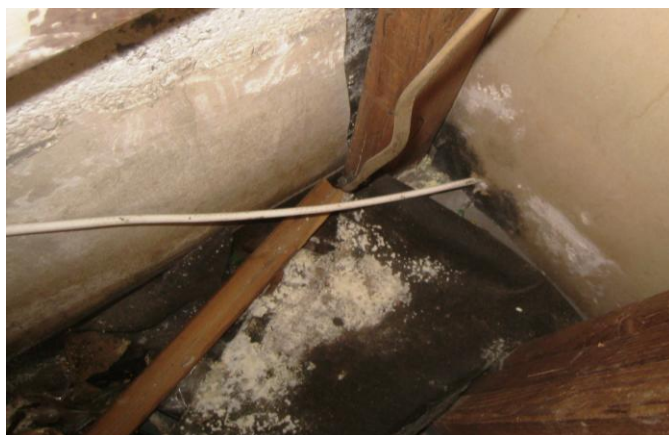
Examples of Mold in Basement
