4 Seasons Home Inspection, LLC

150 Maple Avenue, #128, South Plainfield, NJ 07080

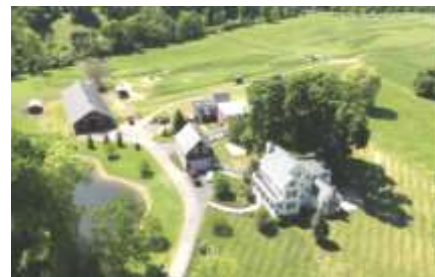
Inspection Date:	March 19, 2013 9am- 5:35pm
Client Name:	Alex & Mary (buyer@gmail.com)
Emails:	Realtor@aol.com; Lawyer@gmail.com
Inspection Address:	# street, north west, NJ xxxxx
Inspected by:	Linda Geczi home inspection lic. #24GI00061500

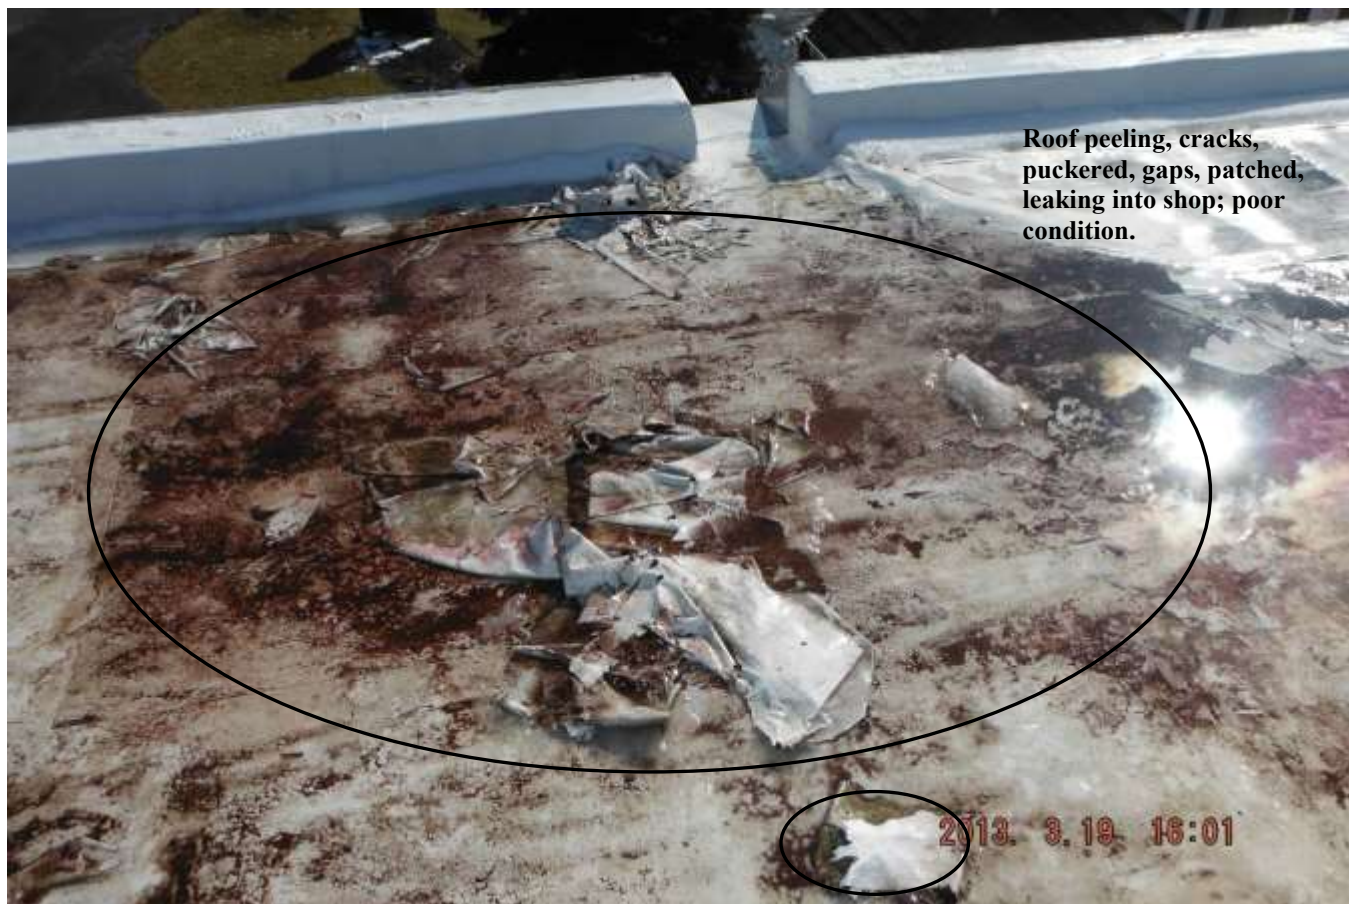
Roof peeling, cracks, puckered, gaps, patched, leaking into shop; poor condition.

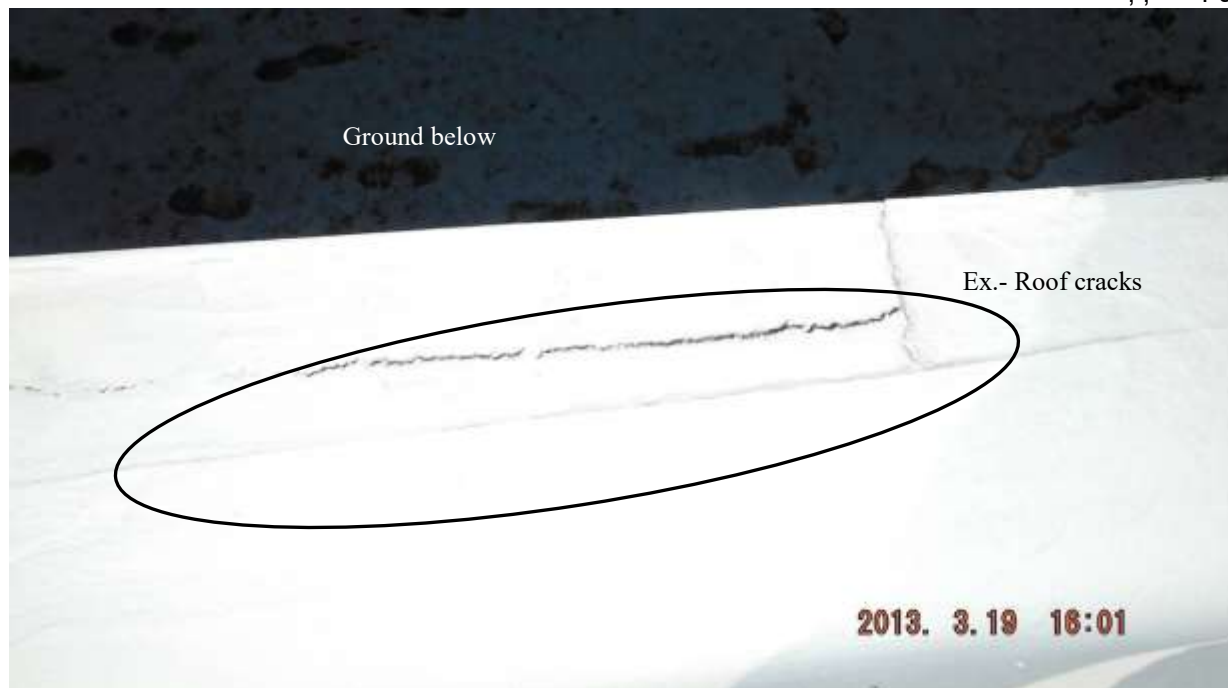
Figure 2 Example of cracks on roof; leaking and poor condition/very old and patched.

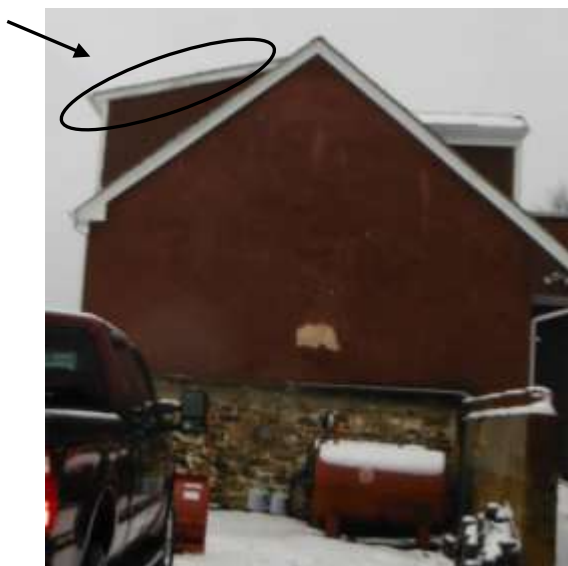
Figure 3 Low sloped roof appeared to be tab asphalt (view on edge of snow covered roof). Asphalt shingles on pitches lower than 4/12 are prone to leaks.

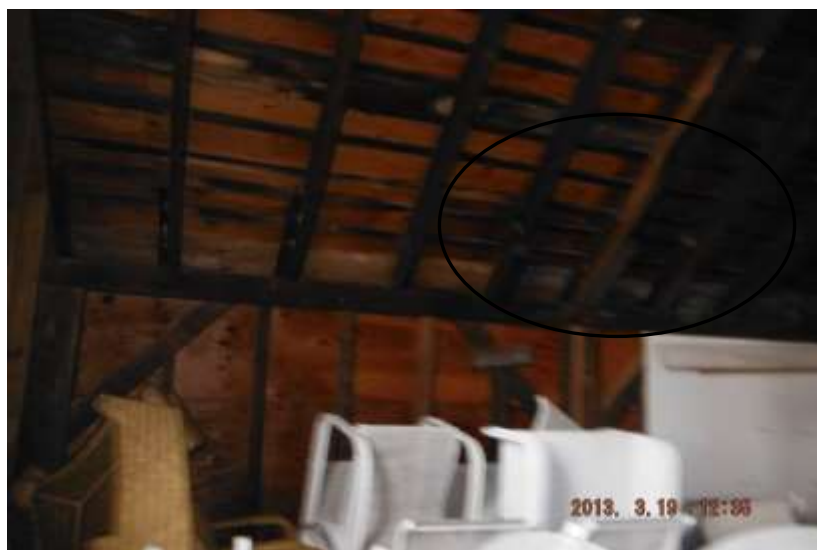
Figure 4 Garage had old asphalt roof. There were water stains visible inside from second floor; leaking.

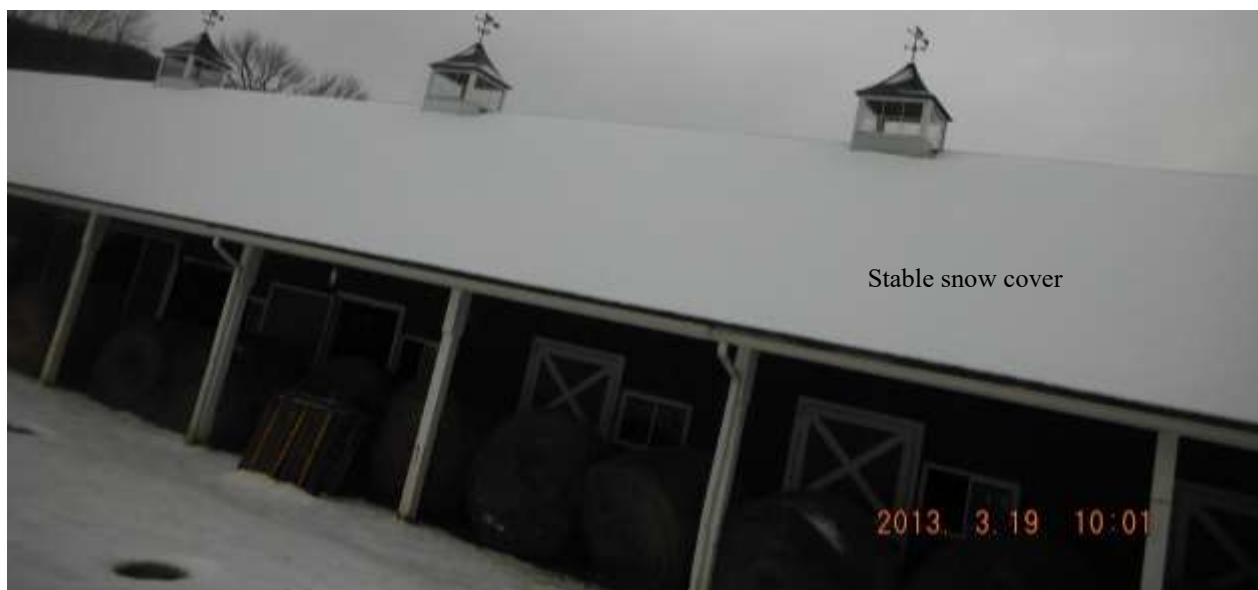
Plywood installed over old lathe-possibly an old cedar (lower roof in front)

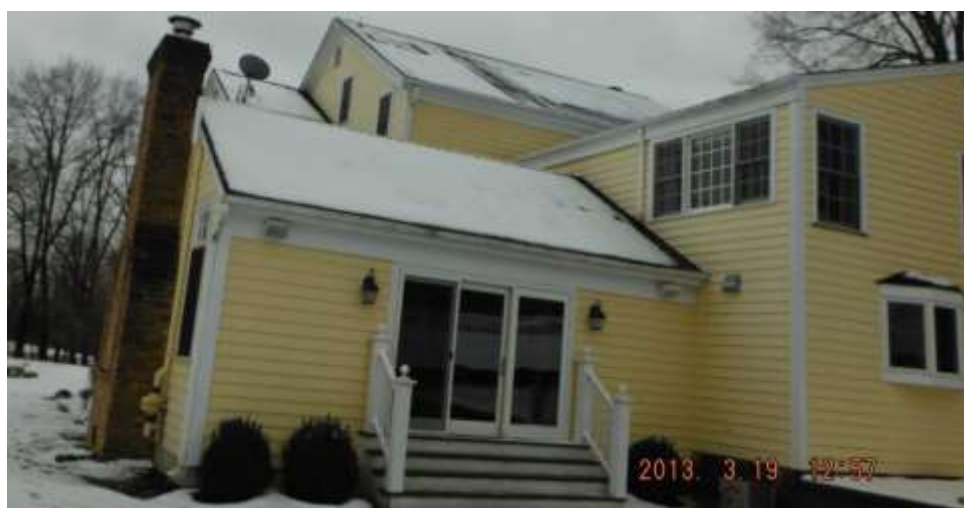
Figure 6 Snow cover; partial view during the day as snow changed to freezing rain. Recommend more ventilation on all roofs; poor or inadequate.

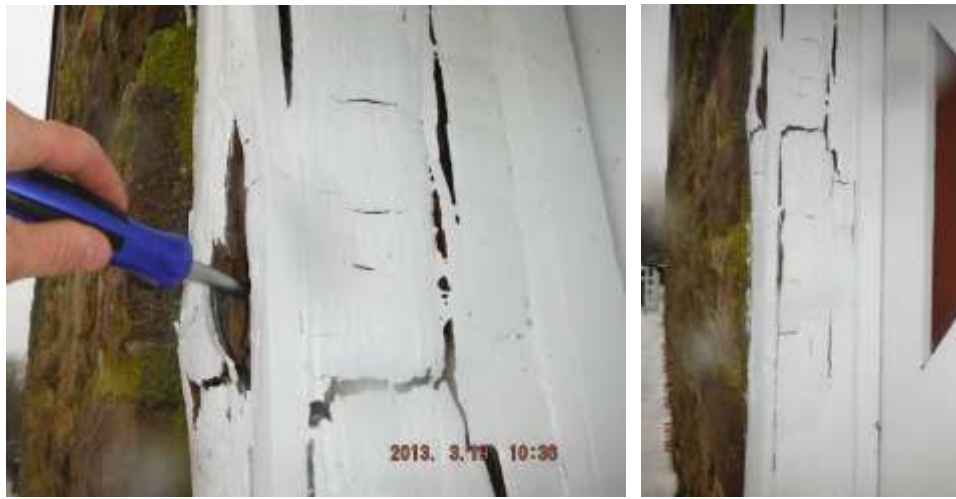
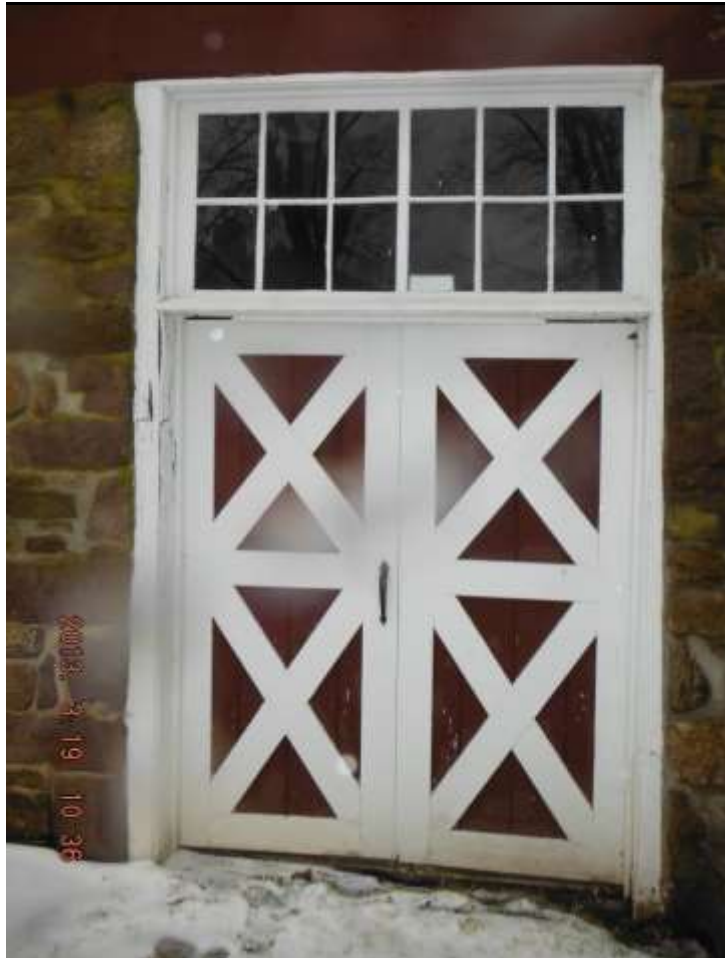
Figure 7 Guesthouse exterior water damage on side door and window units. Have window & door installer evaluate for replacement/repairs and flashings. Gutters need to be addressed on all buildings.

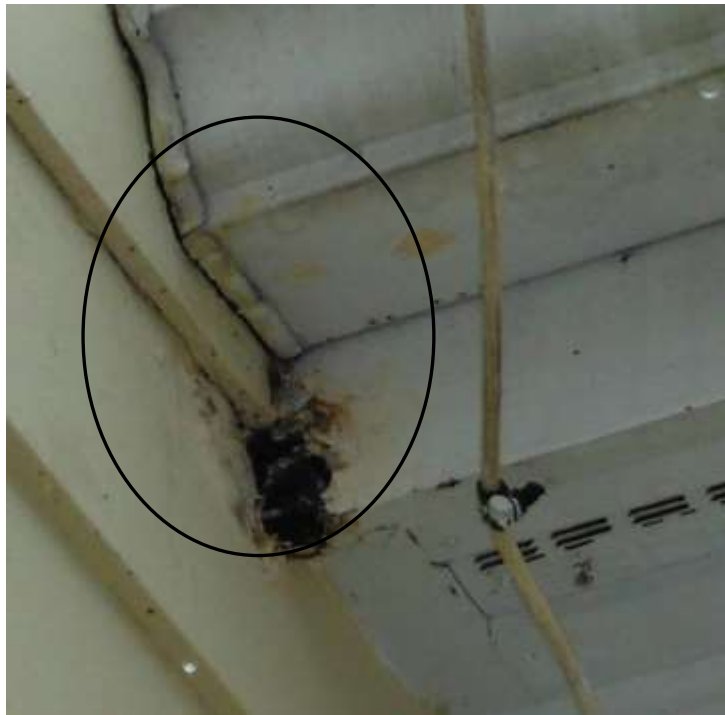
Figure 8 Leaking gutters and exterior siding/cladding rot.

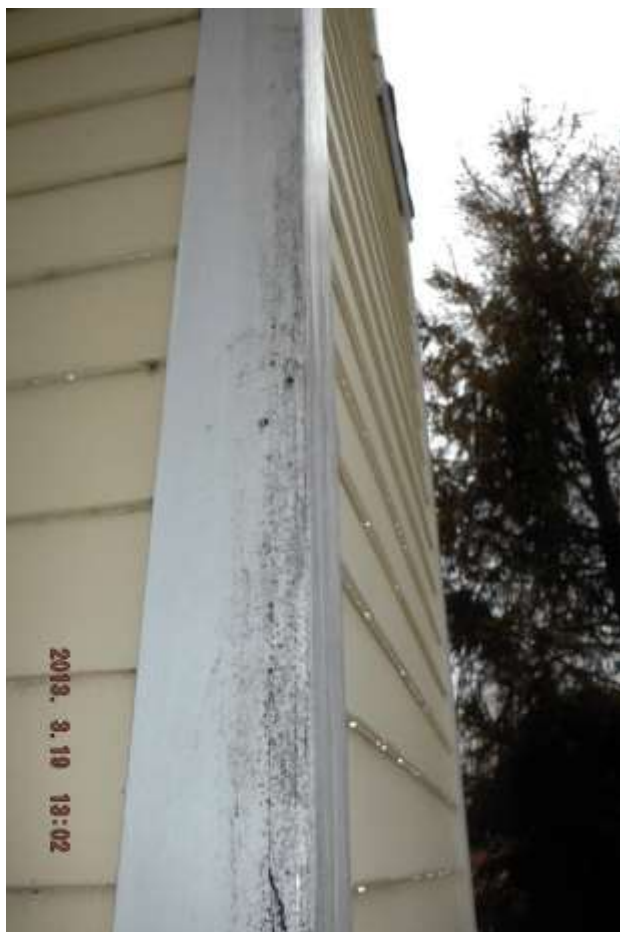
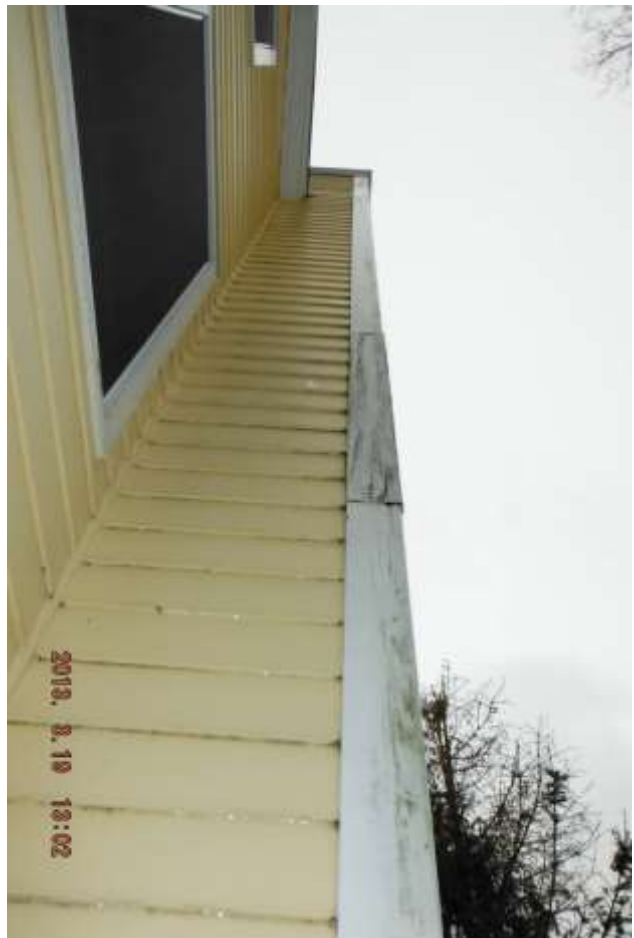
Siding in contact with soil; need 6-8" clearance.

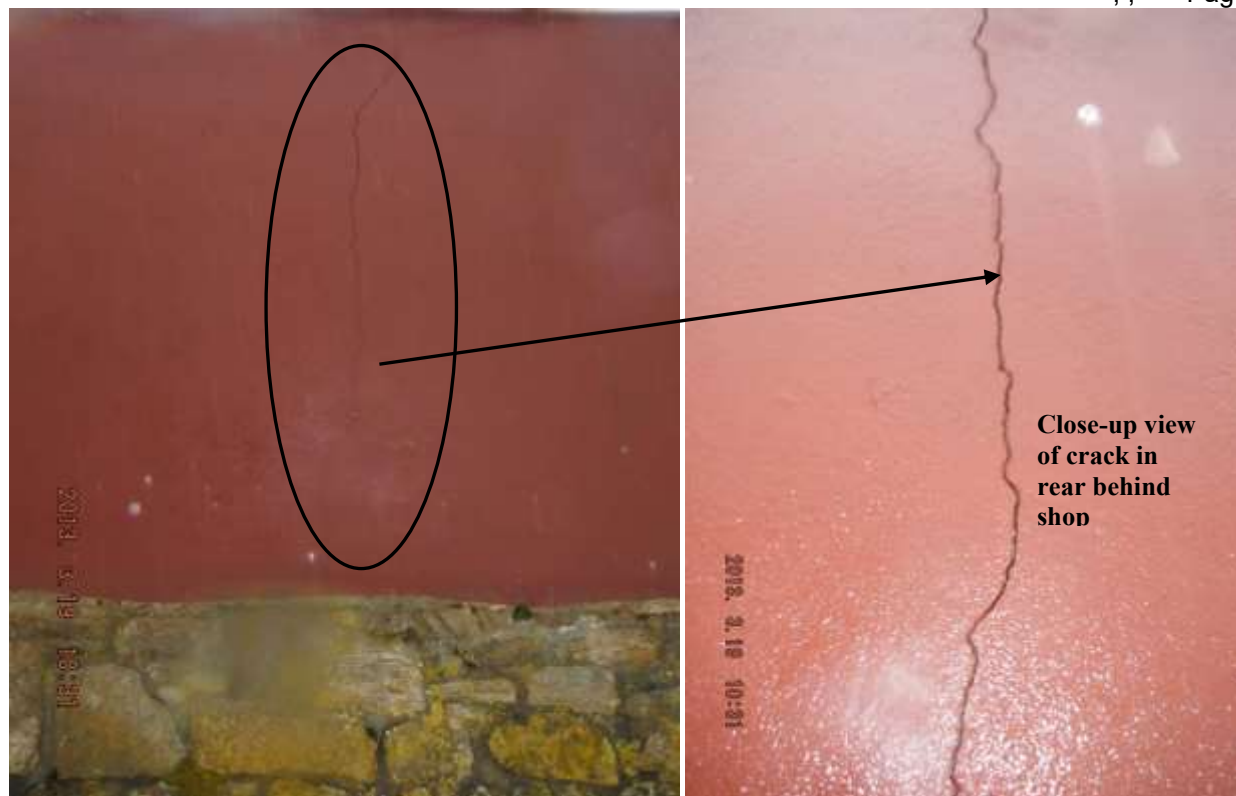
- 3. There is an overall twist or racking of the structure; deficiencies or defects exist. The walls were not square and pushed out as viewed inside garage and on exterior; unstable. There was powder post beetle, termite, and carpenter bee/ant damage or evidence observed; have treated by licensed pest company and all damage repaired. Recommend a barn/garage mortise & tenon restoration contractor evaluate and advise on all repairs or course of action.**

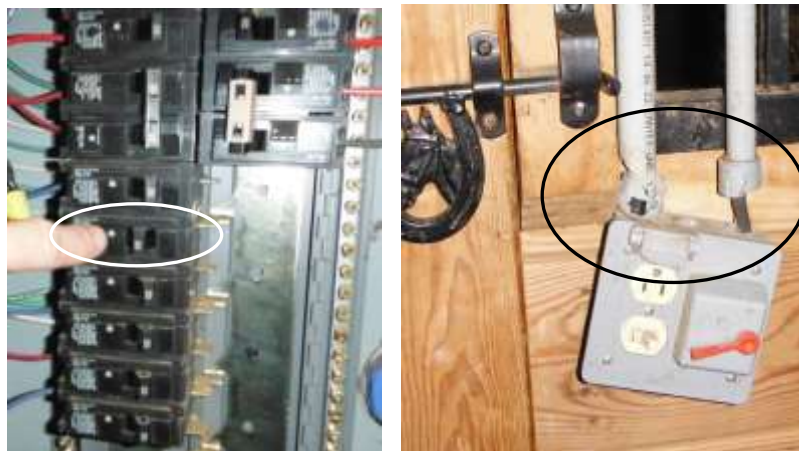
Figure 9 Breaker buzzed and tripped. Numerous extension cords and devices plugged into outlets in stalls; overloaded/fire safety concern. There was a damaged outlet mounted on outside of a stall approximately half way down center.

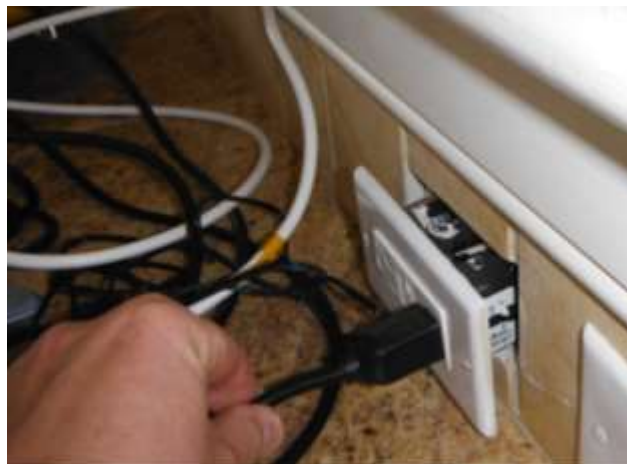
Figure 10 Have outlet repaired by electrician; shock hazard.

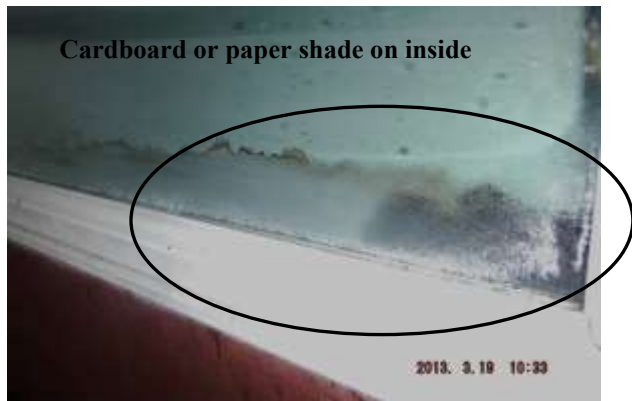
Figure 11 Example of vapor seal breaks on guesthouse windows; older thermo pane type. Have a window installer evaluate all windows and make repairs/replacement where needed.

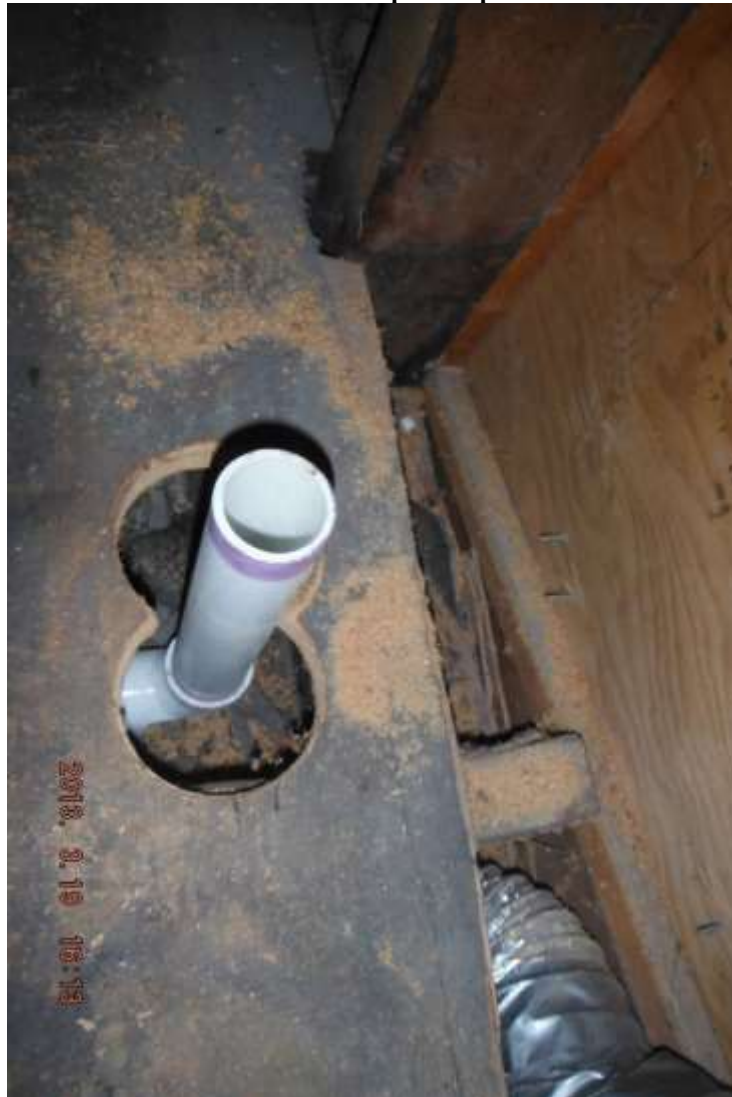
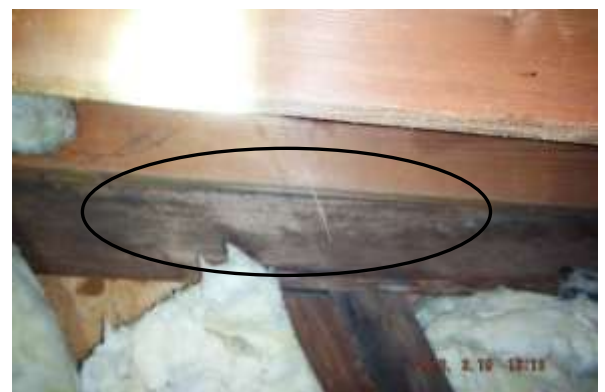
Figure 12 (A) Plumbing vent terminates in attic knee wall by air handler; have plumber evaluate and advise on corrections. (B) example of powder post beetle damage/frass. See basement and structure comments.

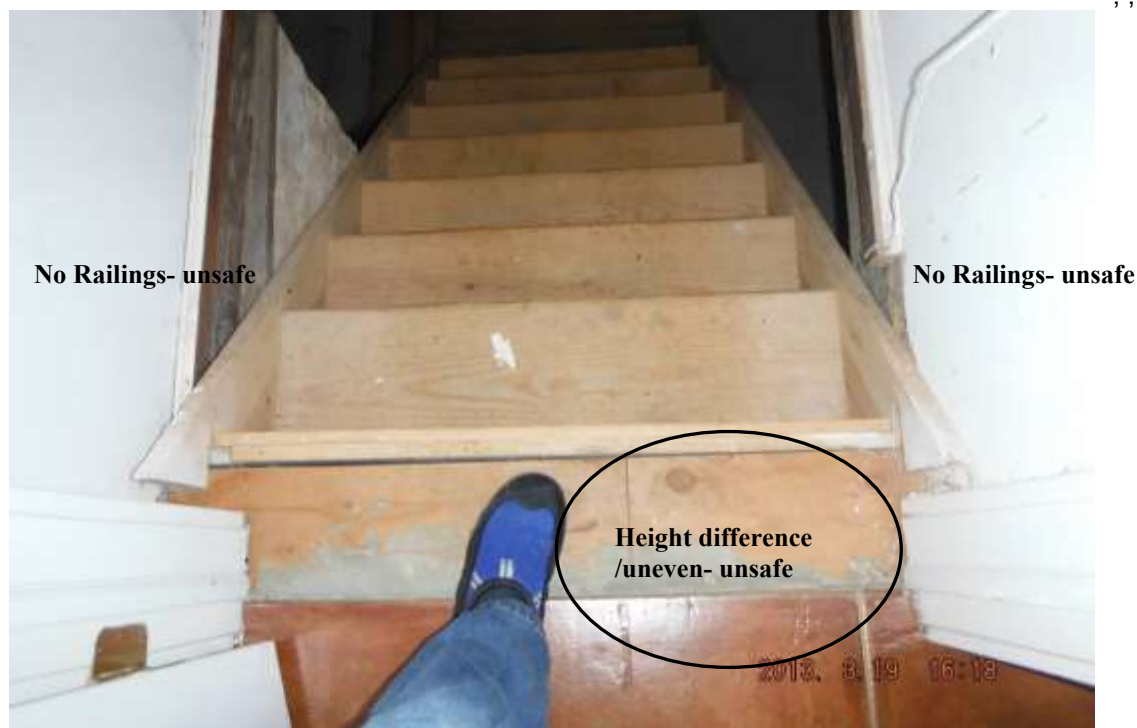
Figure 13 Have a contractor or carpenter repair the uneven heights between the kitchen floor and the wood just inside the basement at top of steps. Add railings for safety, and on basement landing to right; safety hazard. Have stringers trimmed at bottom; trip hazard.

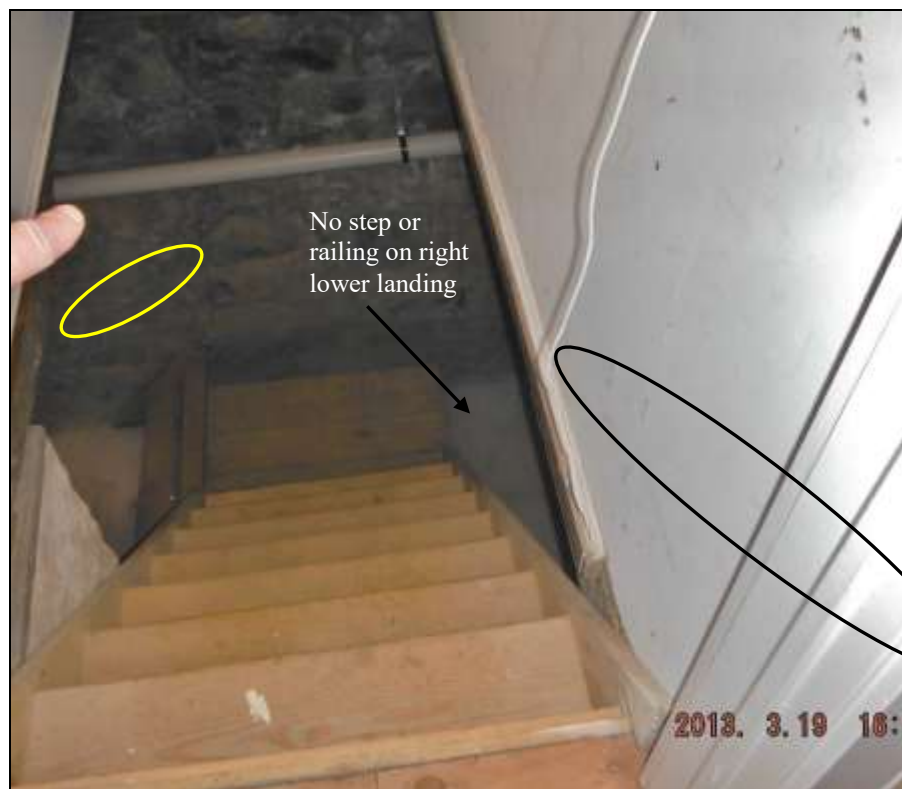
Figure 14 Lower landing unsafe; no railing or step to right side. Recommend railing on all steps.

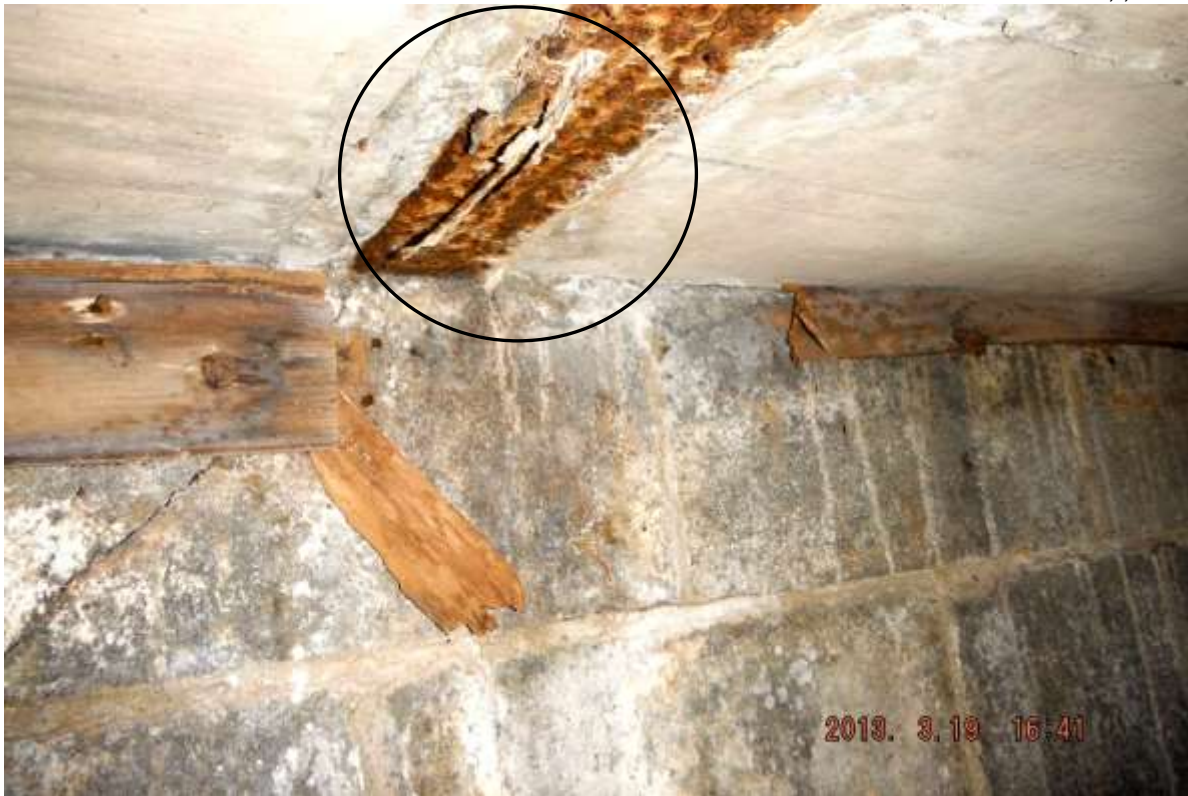
Figure 15 Corroded metal floor supports under front steps in well storage room. There was termite damage on wood in front room.

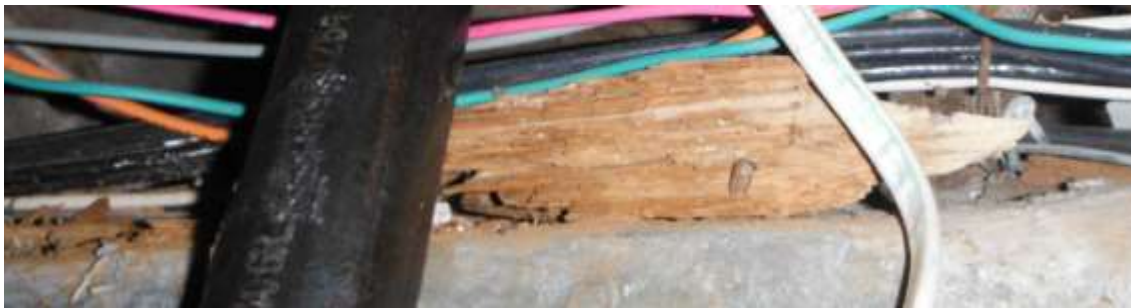
Figure 16 Termites damage sills, joists, sub-flooring in basement. Have structural carpenter determine the extent of damage.

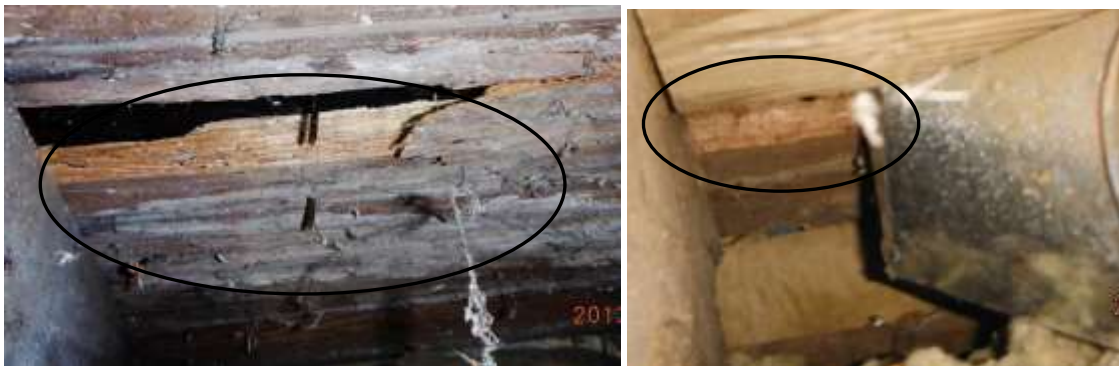
Figure 17 Termites damage sills, joists, sub-flooring in basement. Have structural carpenter determine the extent of damage.

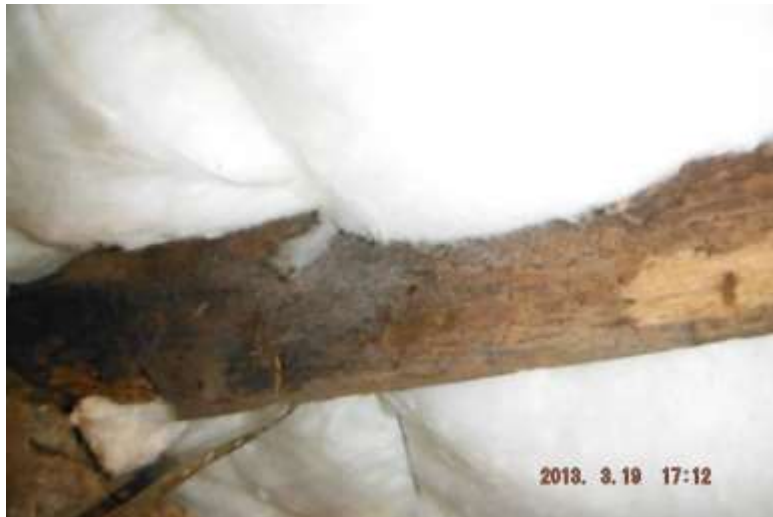
Figure 18 Example of powder post beetle damage. Have a structural carpenter determine extent of all wood destroying insect damage before closing.

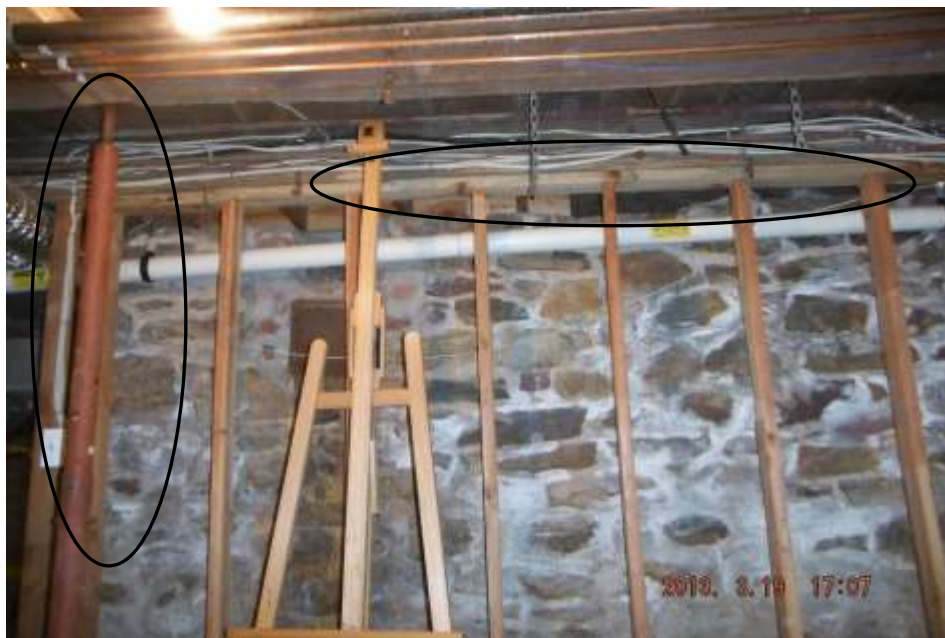
Figure 19 Have all structural repairs evaluated by a structural engineer or qualified building contractor before closing. There were structural concerns and handyman repairs.

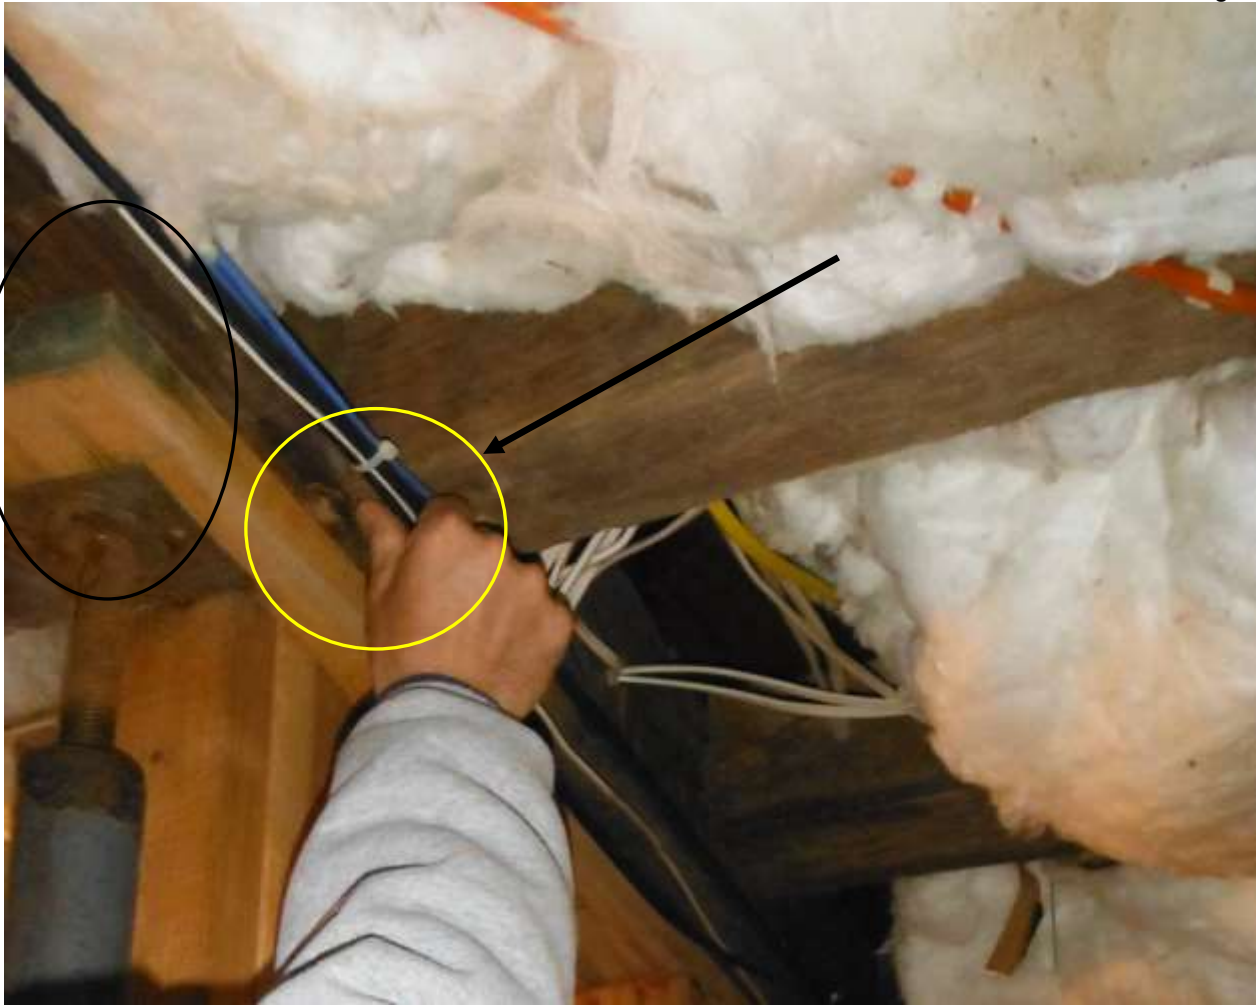
Figure 20 Handyman repairs; have structural engineer evaluate repairs and structure and advise on all needed structural repairs.

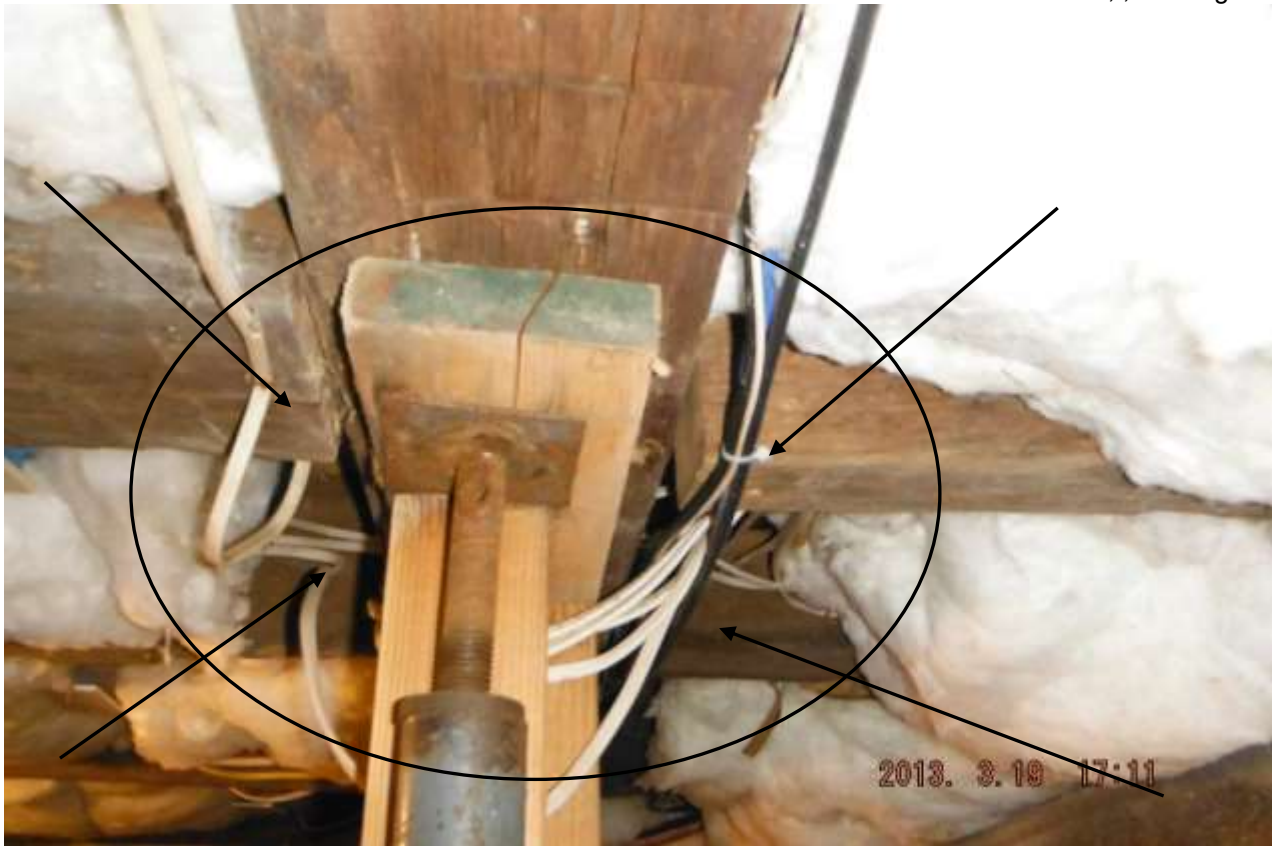
Figure 21 Improperly repaired structure in basement; handyman or improper.

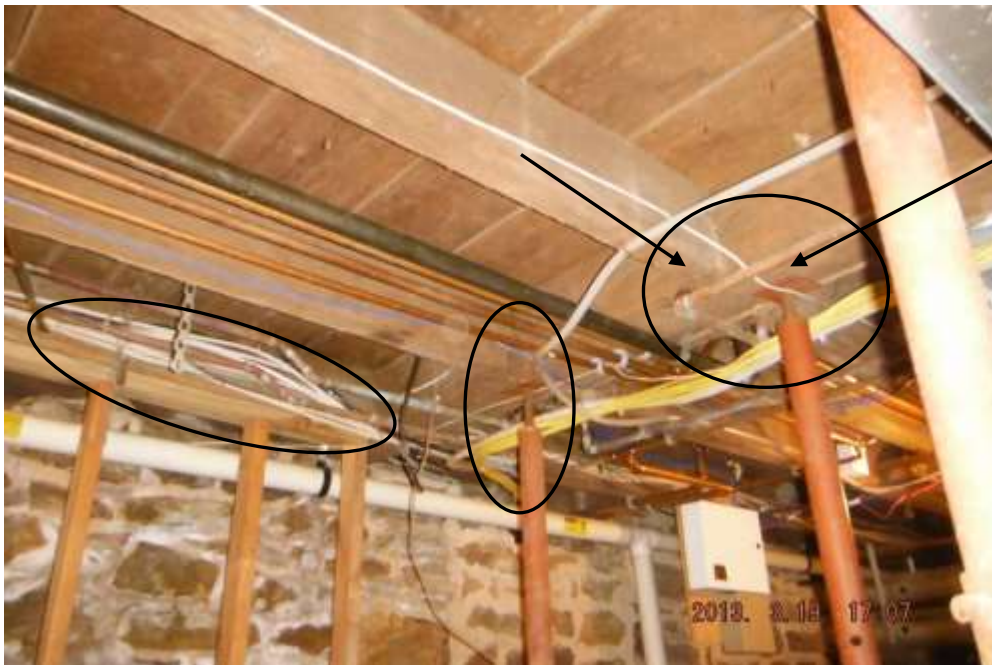
Figure 22 Have structural engineer or qualified building contractor evaluate repairs and structure in home.

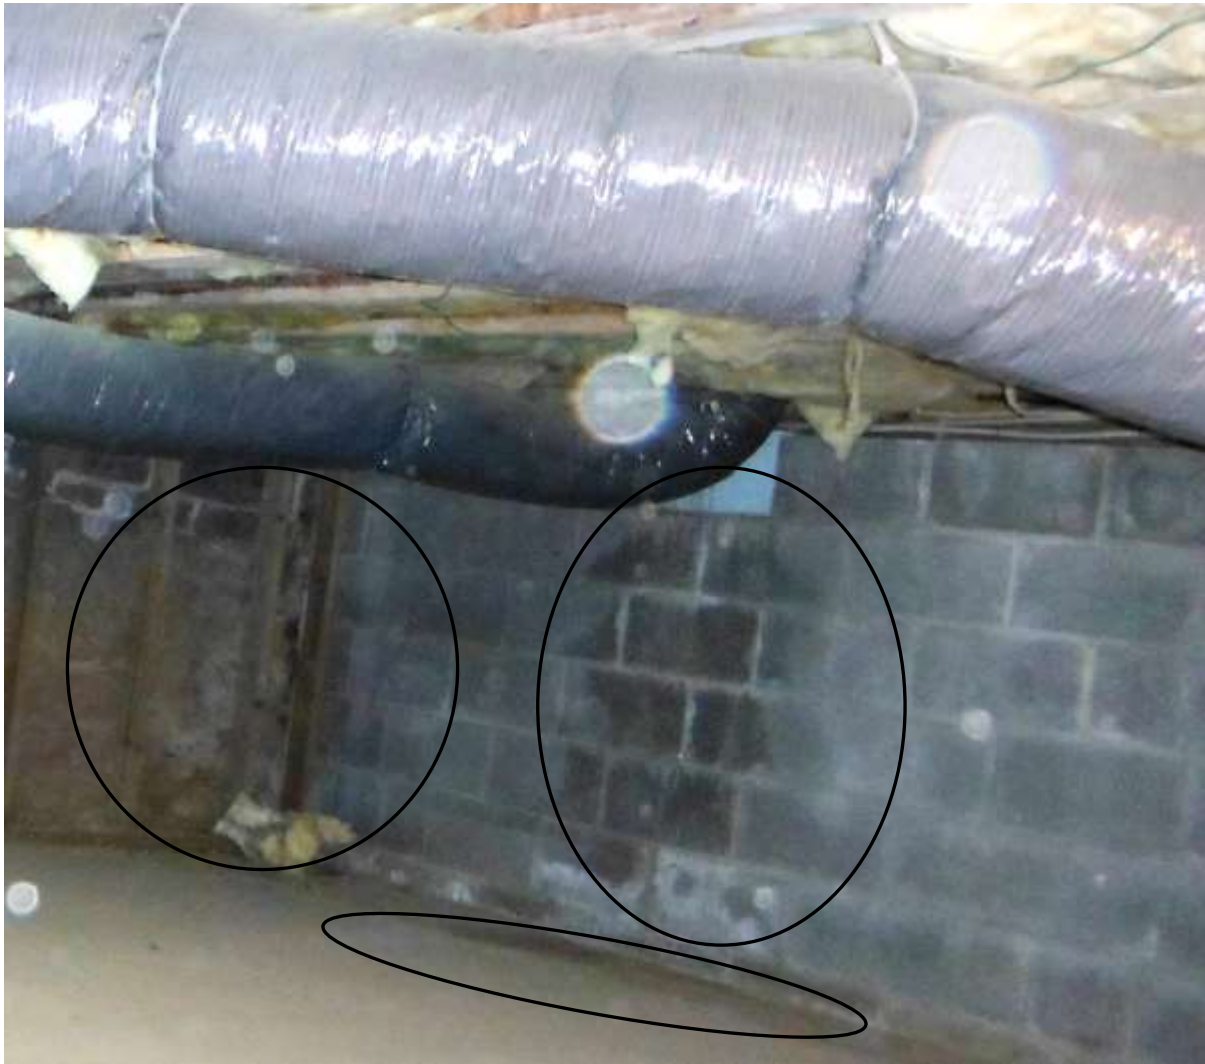
Figure 23 Seepage in crawl space and vents were closed with foam. Moisture needs to be removed; correct grading & drainage, gutters and installer dehumidifier.

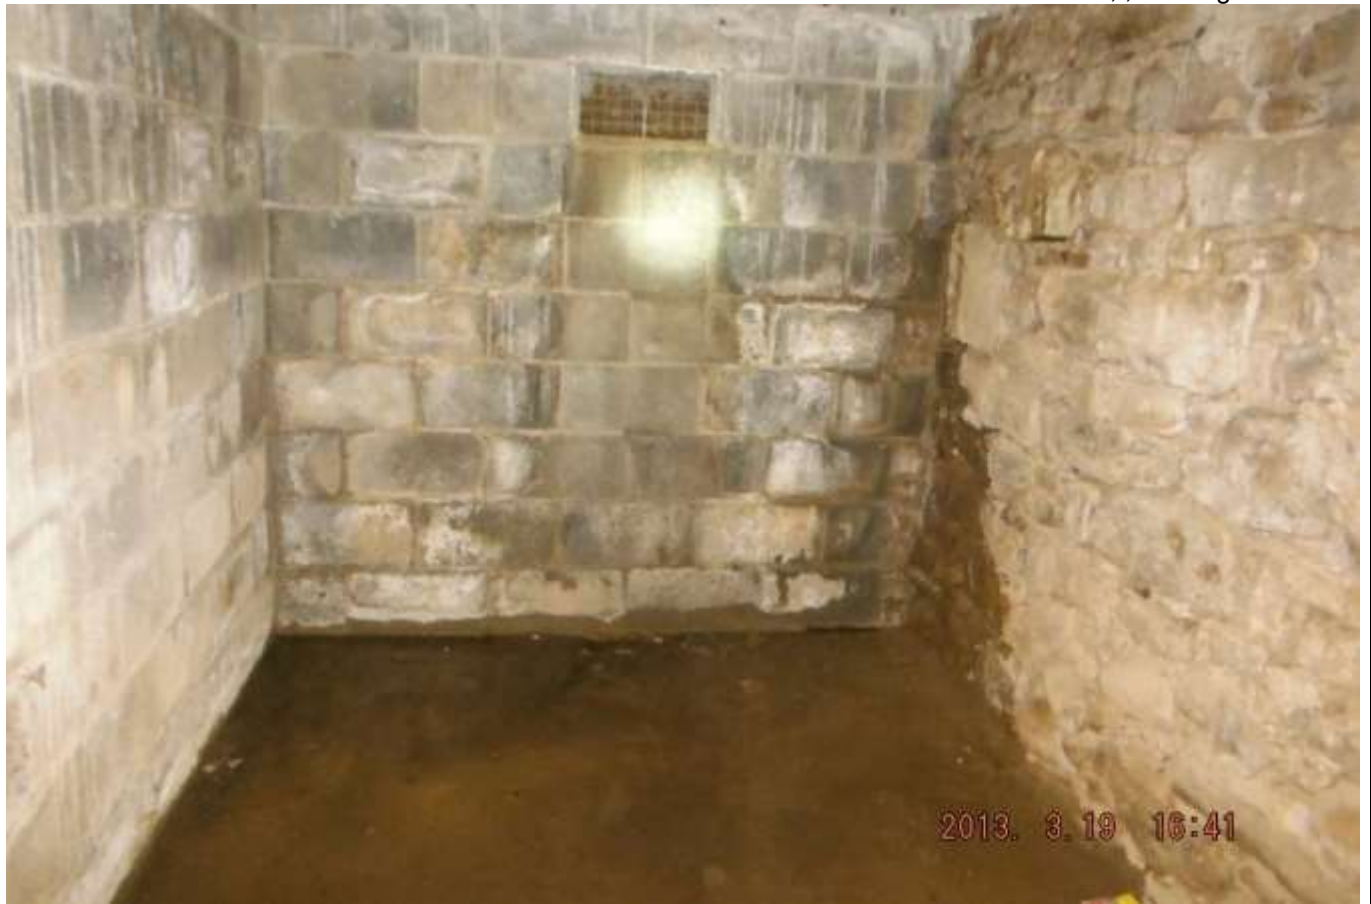
Figure 24 Water coming into basement; seepage.

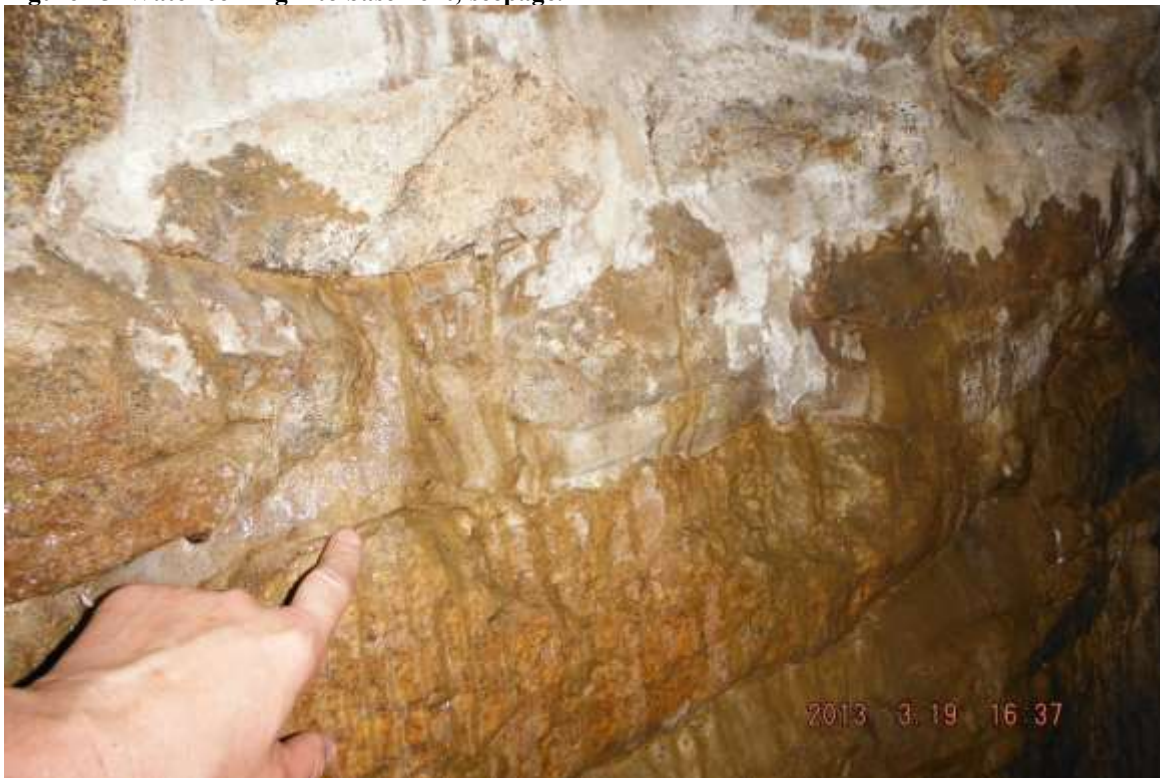
Figure 26 Water coming into basement; seepage.

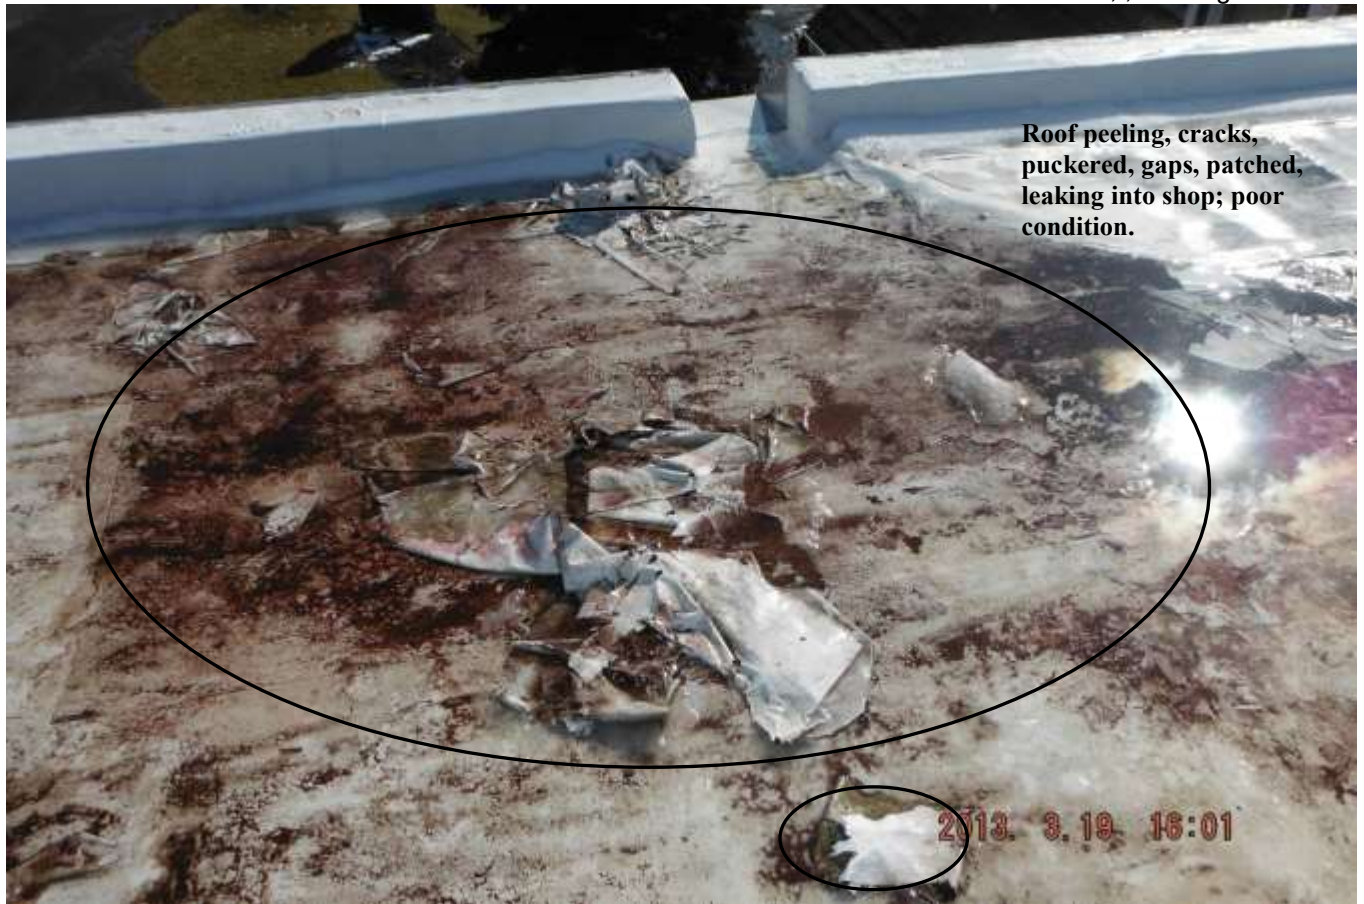
Roof peeling, cracks, puckered, gaps, patched, leaking into shop; poor condition.
