4 Seasons Home Inspection, LLC

150 Maple Avenue, #128, South Plainfield, NJ 07080

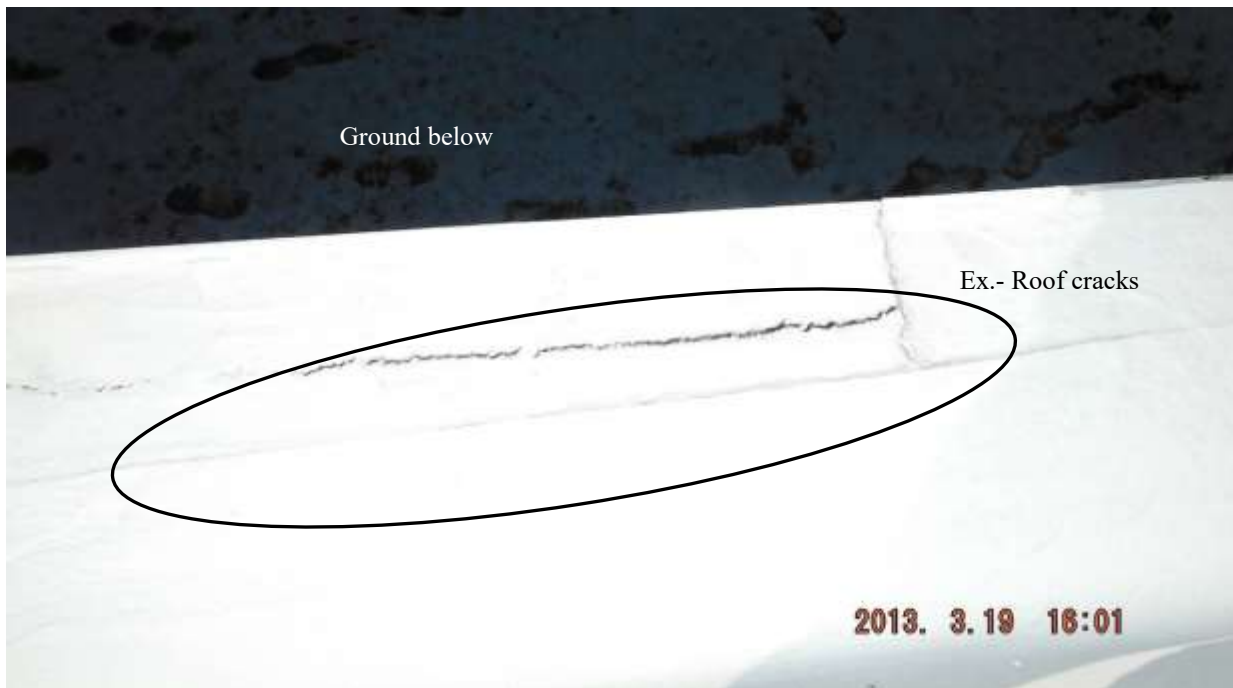
Figure 28 Example of cracks on roof; leaking and poor condition/very old and patched.

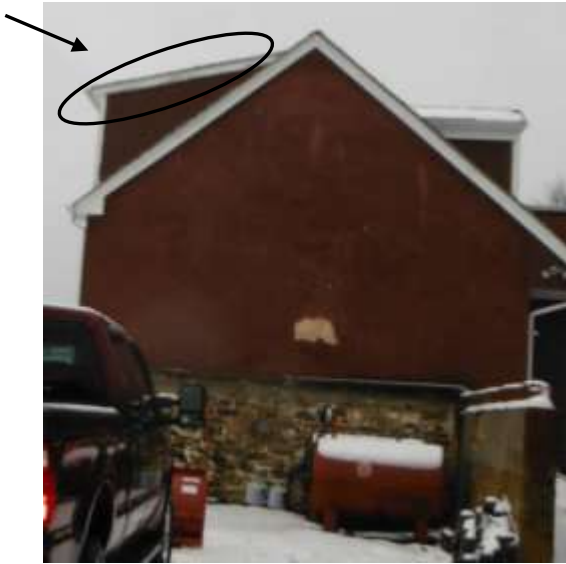
Figure 29 Low sloped roof appeared to be tab asphalt (view on edge of snow covered roof). Asphalt shingles on pitches lower than 4/12 are prone to leaks.

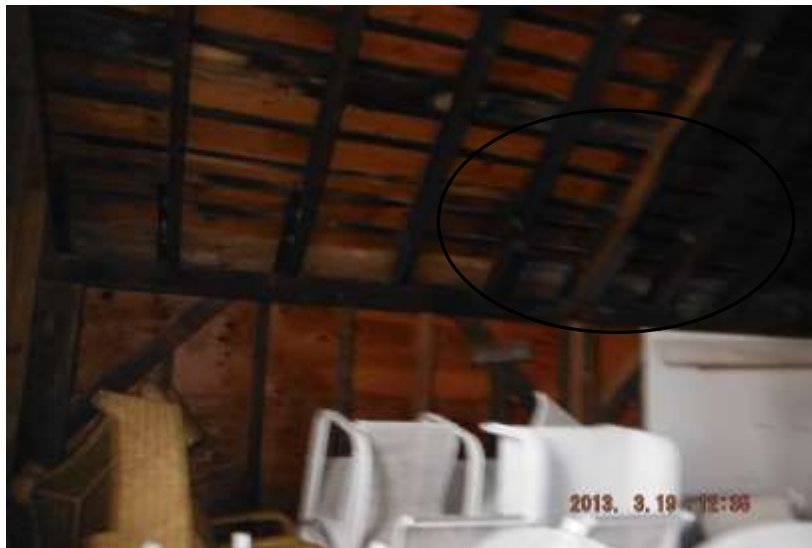
Figure 30 Garage had old asphalt roof. There were water stains visible inside from second floor; leaking.

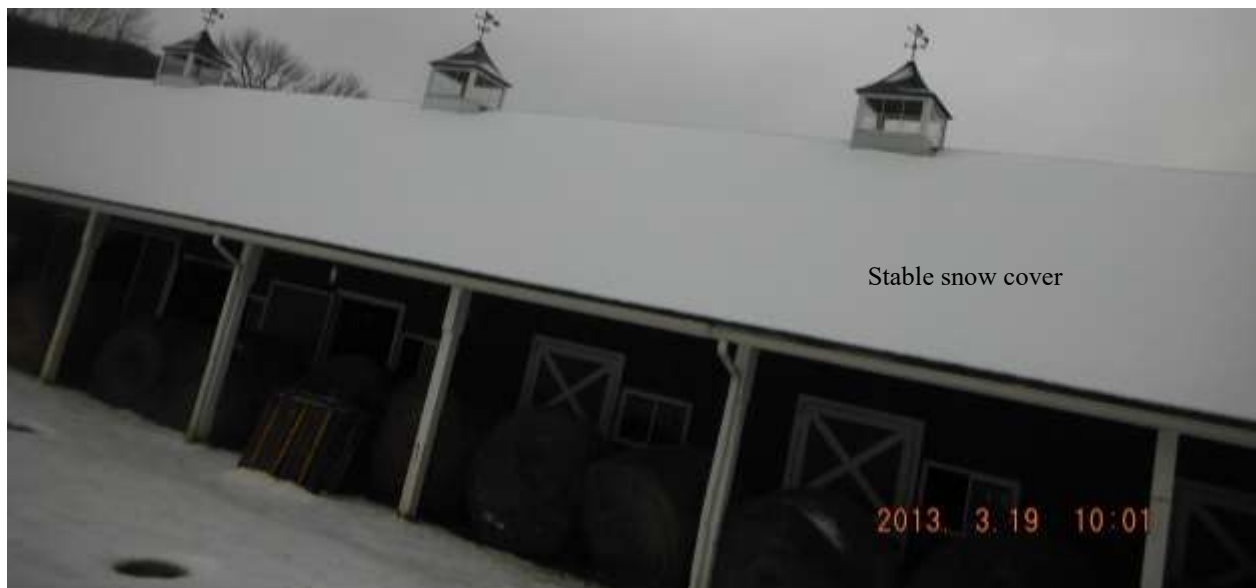
Plywood installed over old lathe-possibly an old cedar (lower roof in front)

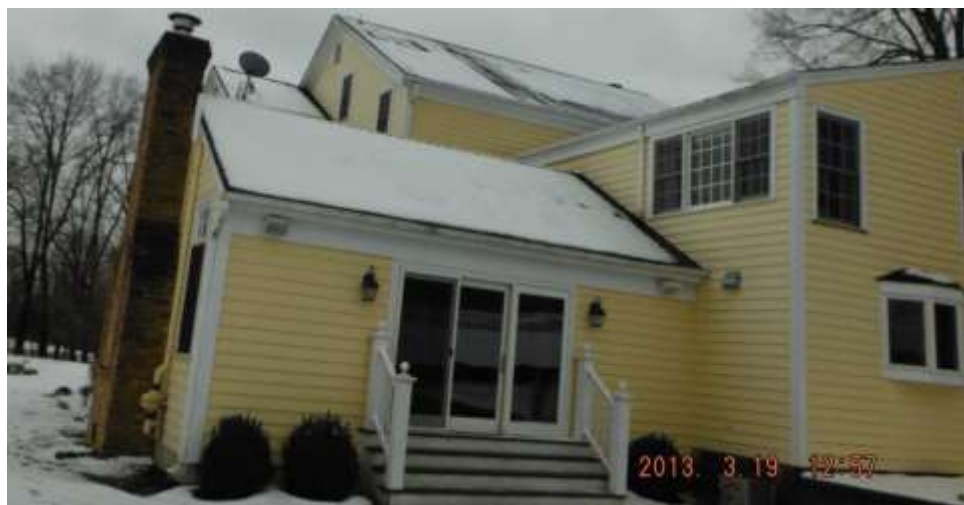
Figure 32 Snow cover; partial view during the day as snow changed to freezing rain. Recommend more ventilation on all roofs; poor or inadequate.

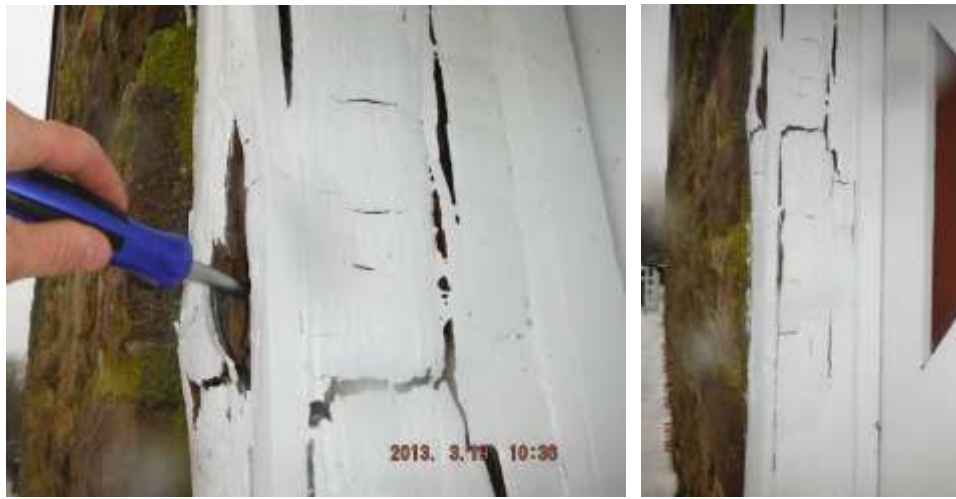
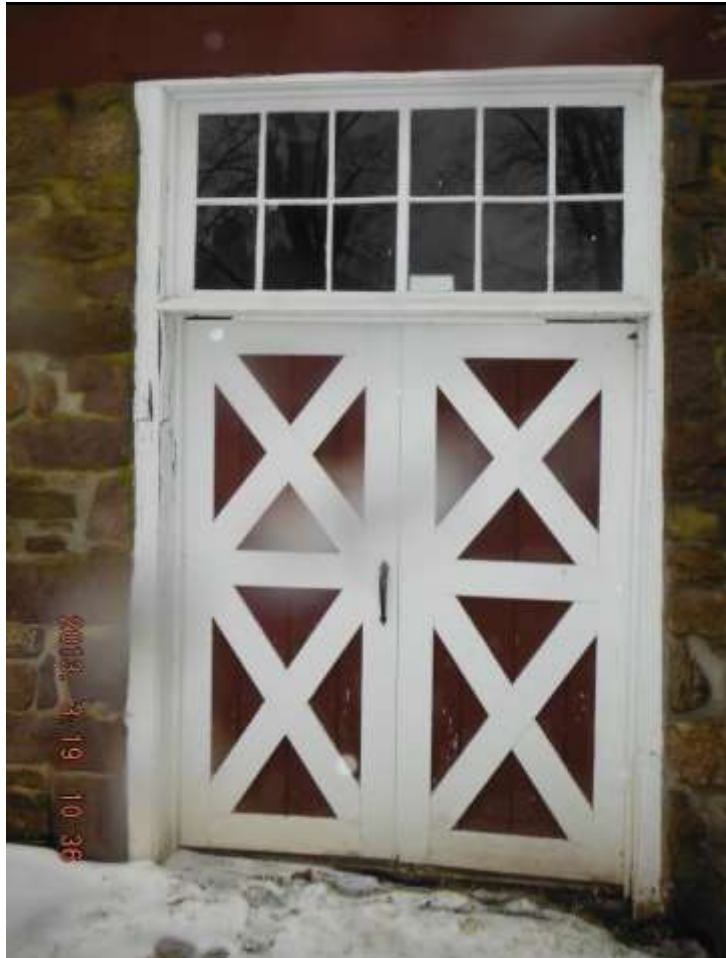
Figure 33 Guesthouse exterior water damage on side door and window units. Have window & door installer evaluate for replacement/repairs and flashings. Gutters need to be addressed on all buildings.

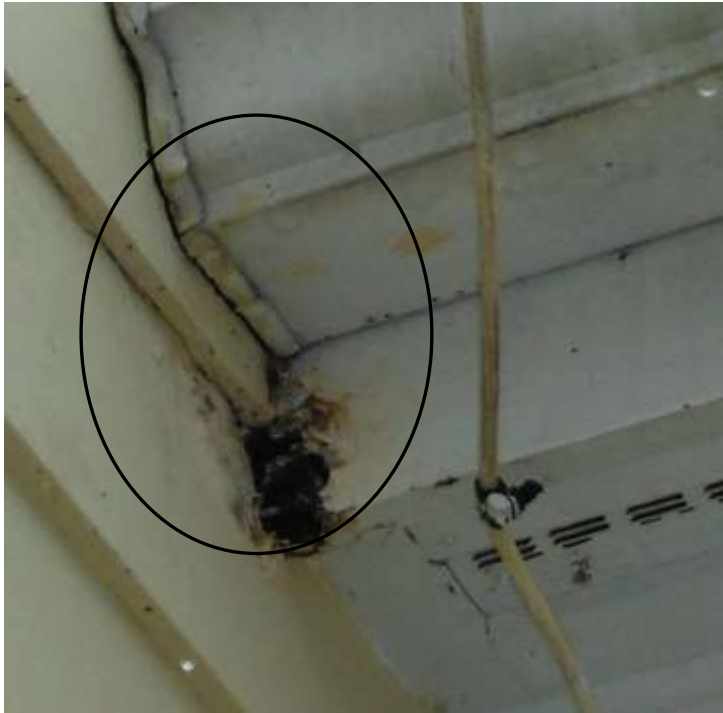
Figure 34 Leaking gutters and exterior siding/cladding rot.

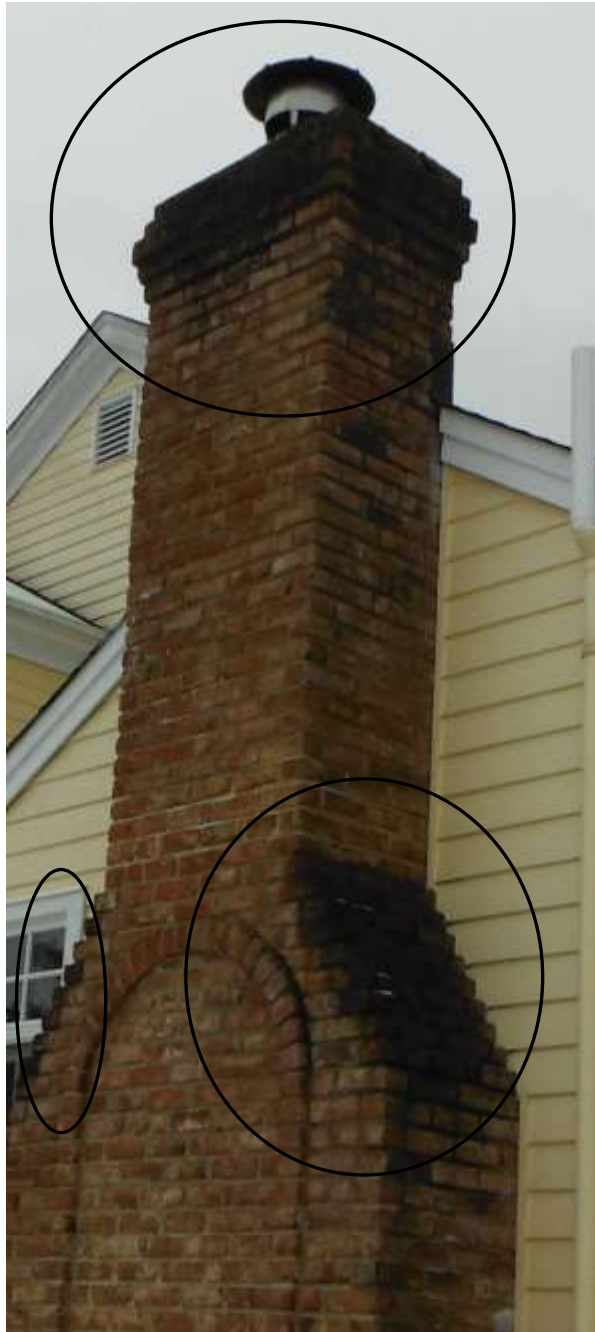
EXTERIOR/ELECTRICAL/AC/HEAT PUMP/GARAGE**SERVICE ENTRY**

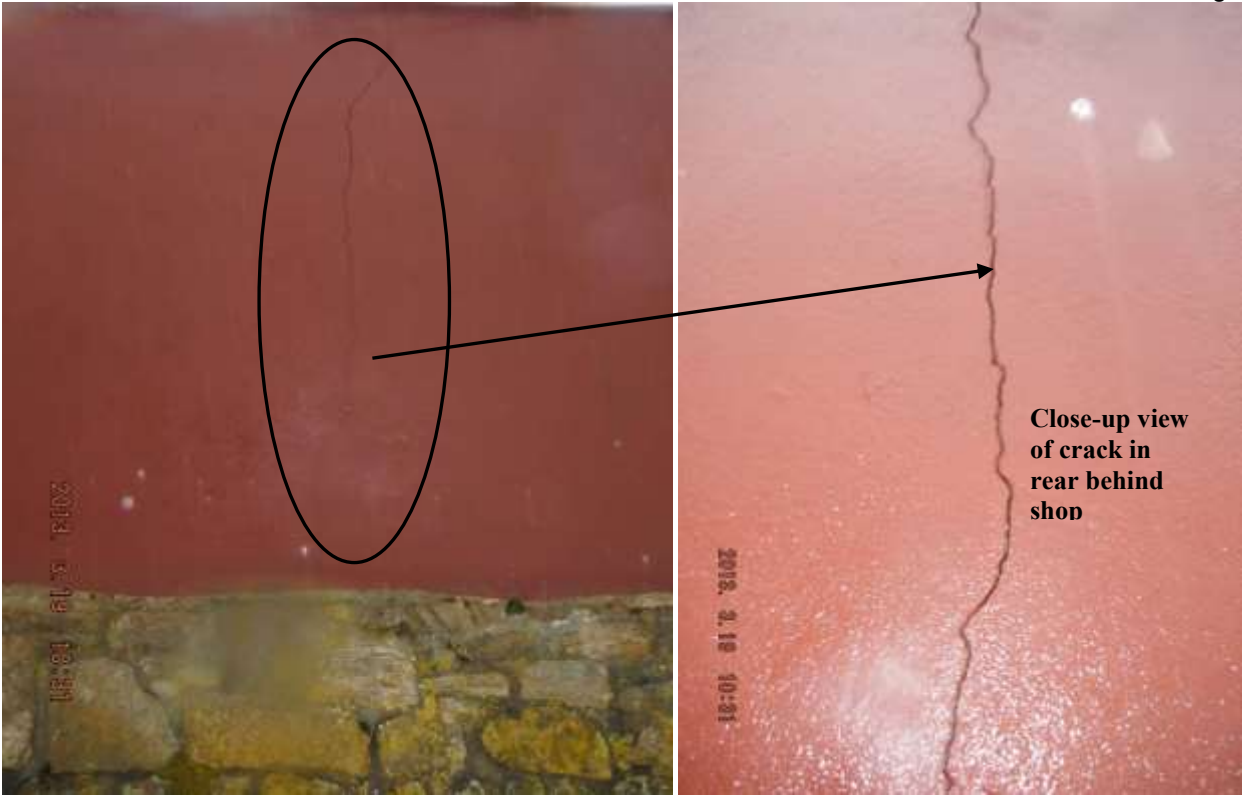
OUTBUILDINGS**STABLE 18 STALLS HORSES****LANDSCAPING AFFECTING FOUNDATION** (See remarks page)

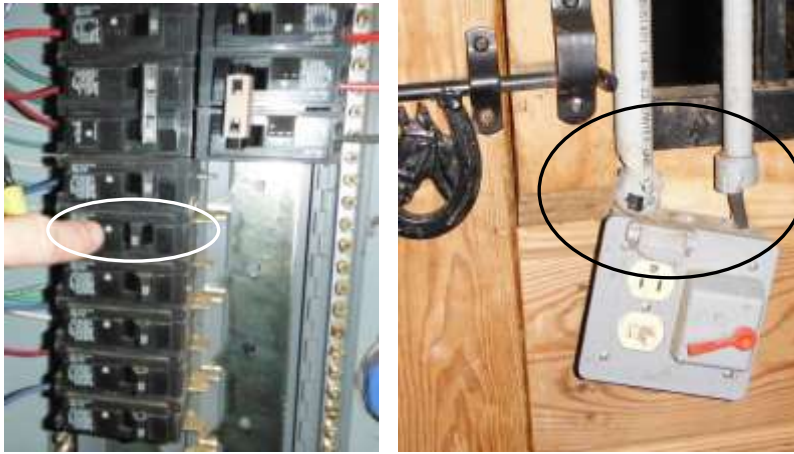
Figure 35 Breaker buzzed and tripped. Numerous extension cords and devices plugged into outlets in stalls; overloaded/fire safety concern. There was a damaged outlet mounted on outside of a stall approximately half way down center.

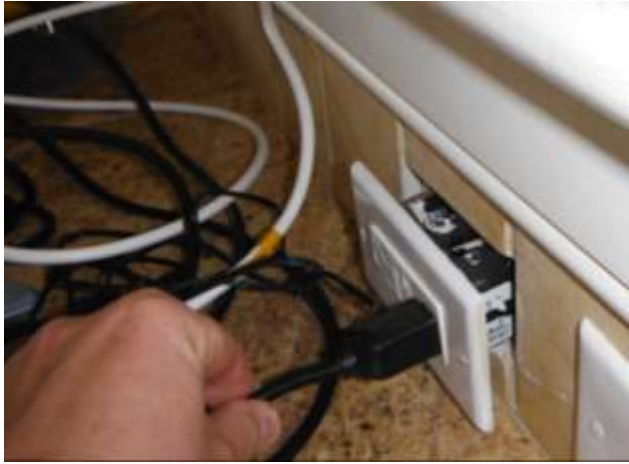
Figure 36 Have outlet repaired by electrician; shock hazard.

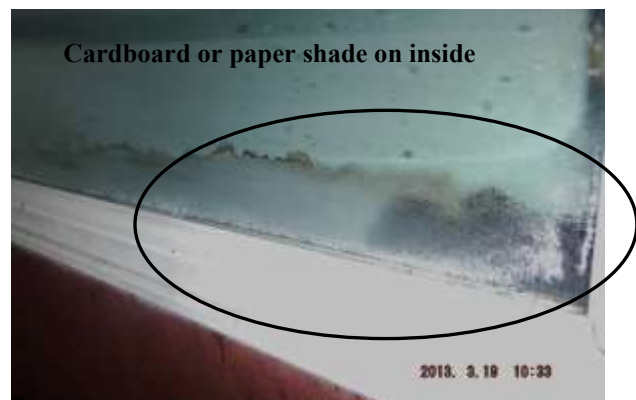
Figure 37 Example of vapor seal breaks on guesthouse windows; older thermo pane type. Have a window installer evaluate all windows and make repairs/replacement where needed.

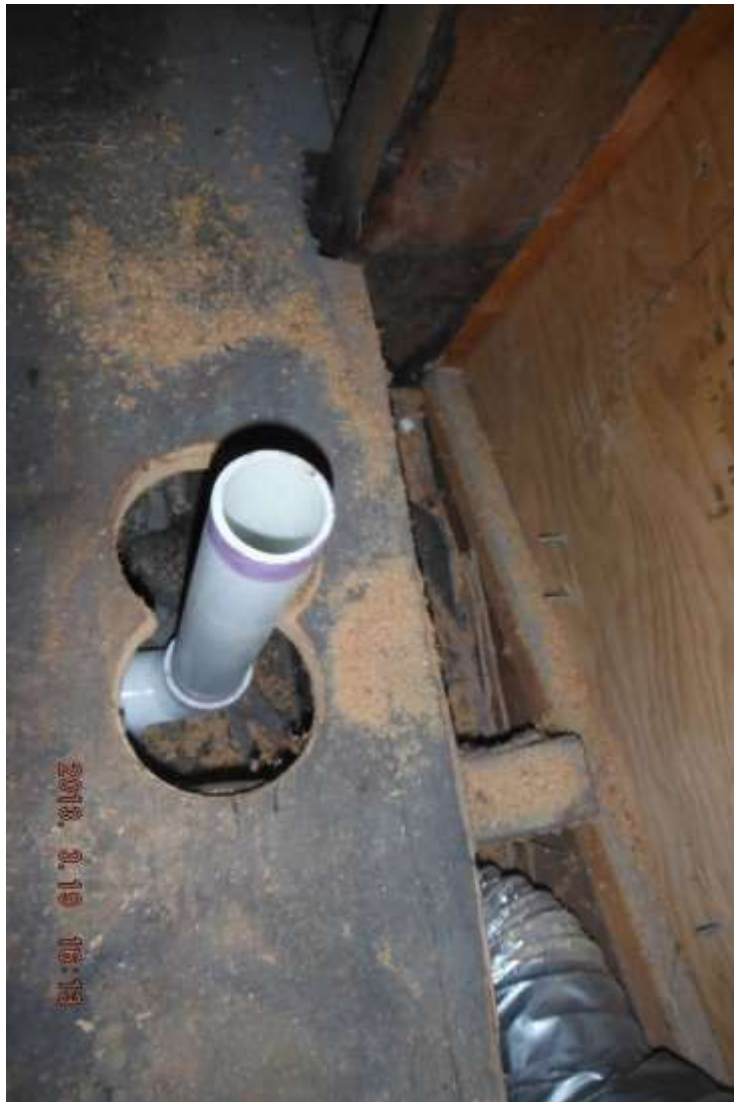
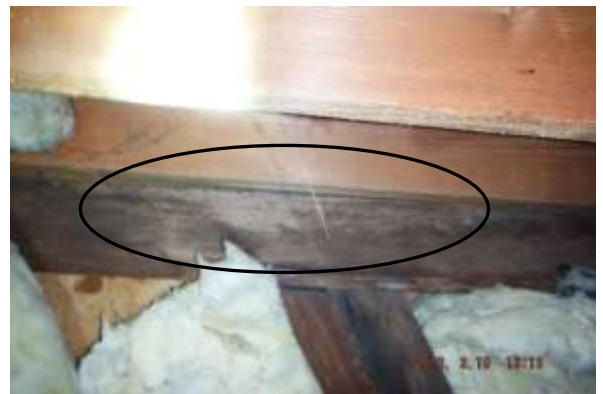
Figure 38 (A) Plumbing vent terminates in attic knee wall by air handler; have plumber evaluate and advise on corrections. (B) example of powder post beetle damage/frass. See basement and structure comments.

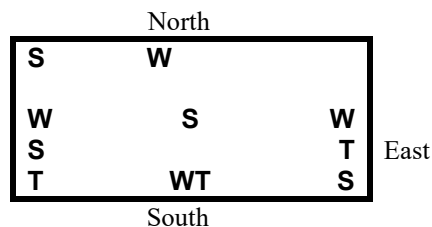
FLOOR **Material:** Concrete Dirt/Gravel Not visible Other

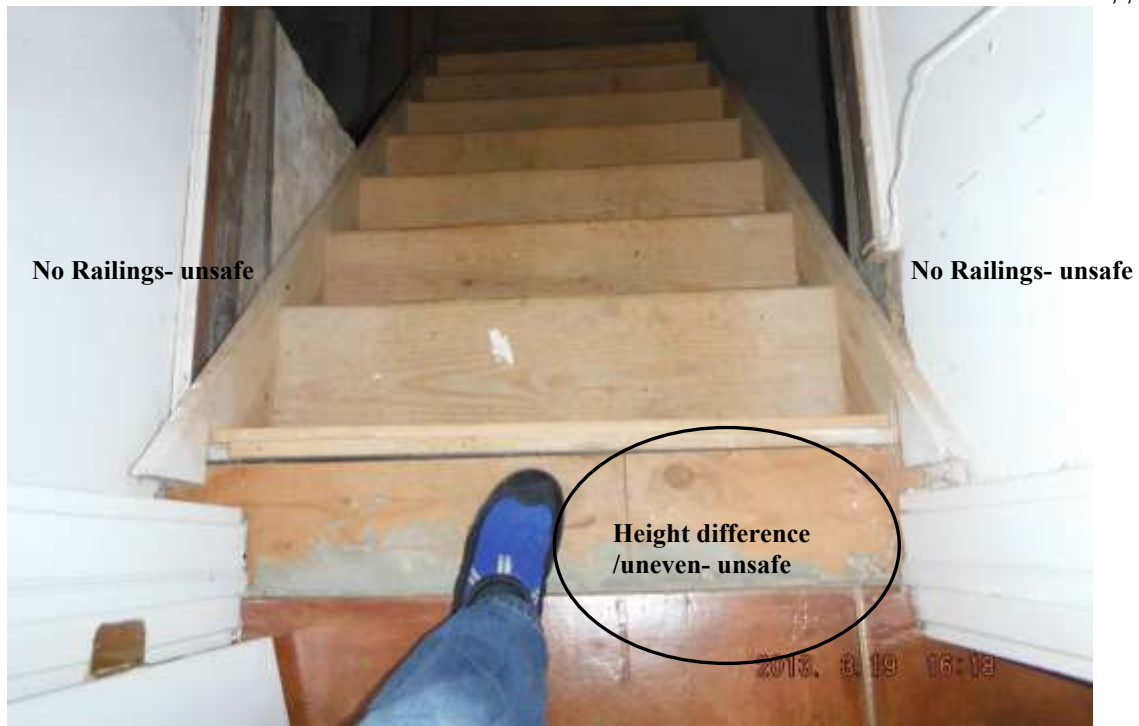
Figure 39 Have a contractor or carpenter repair the uneven heights between the kitchen floor and the wood just inside the basement at top of steps. Add railings for safety, and on basement landing to right; safety hazard. Have stringers trimmed at bottom; trip hazard.

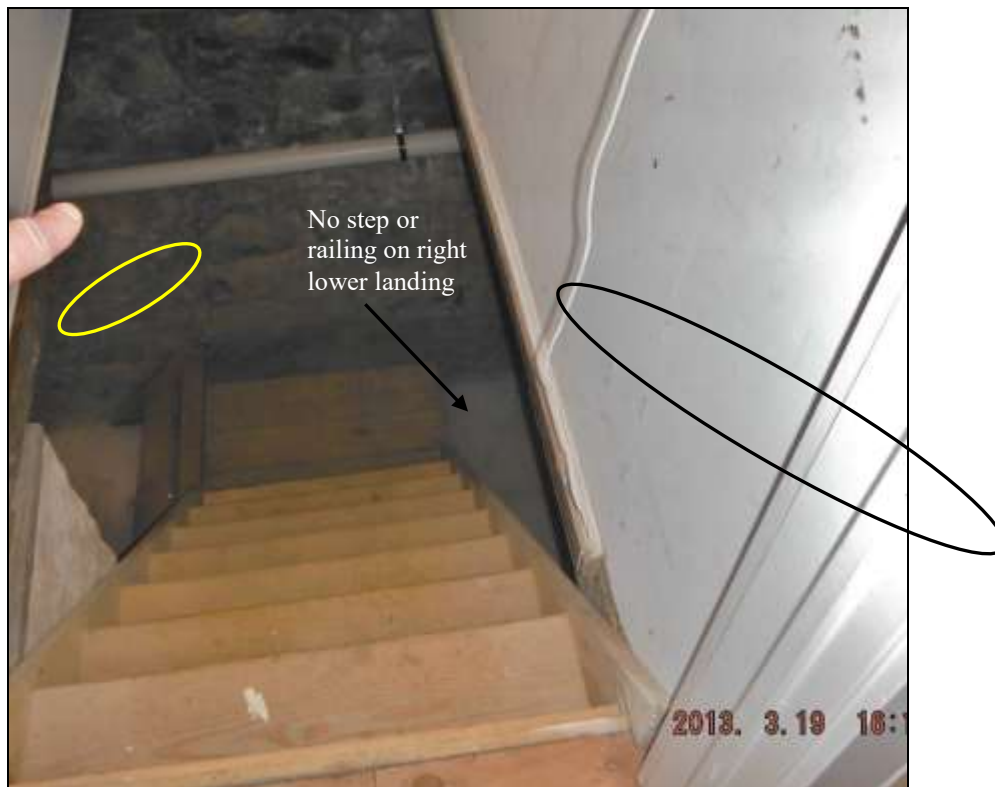
Figure 40 Lower landing unsafe; no railing or step to right side. Recommend railing on all steps.

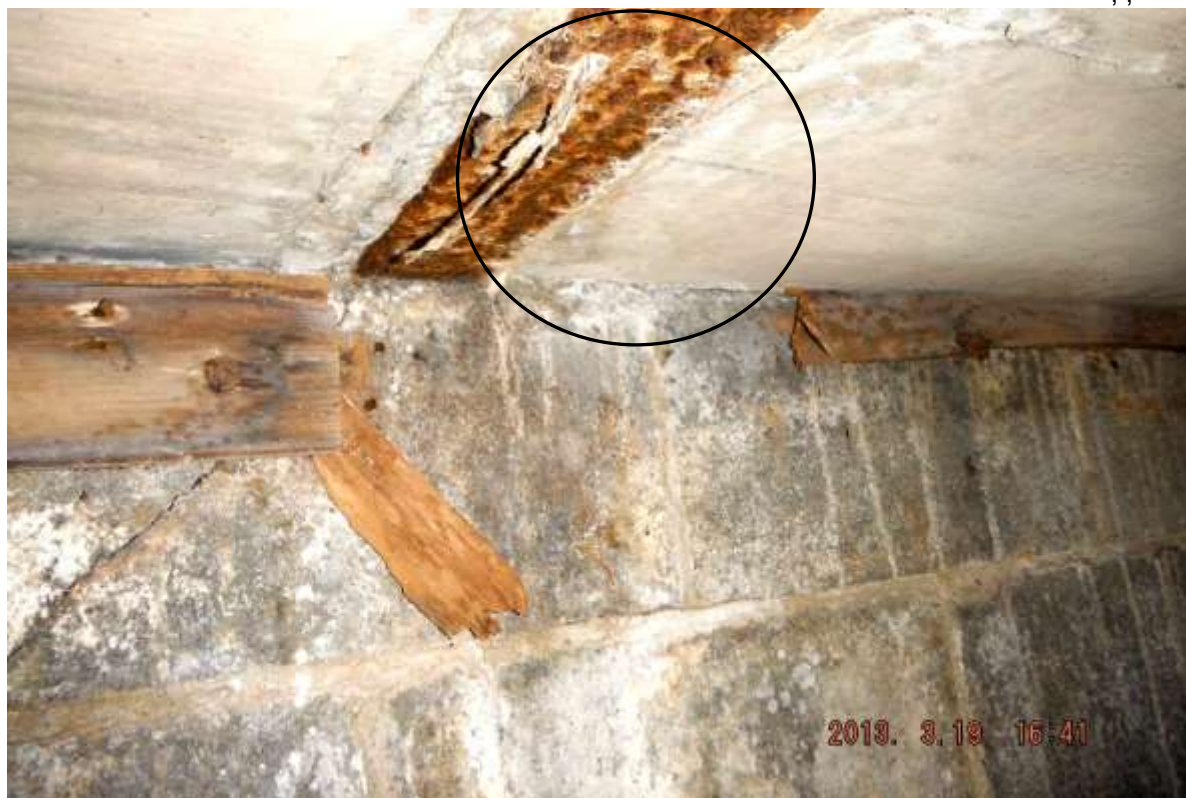
Figure 41 Corroded metal floor supports under front steps in well storage room. There was termite damage on wood in front room.

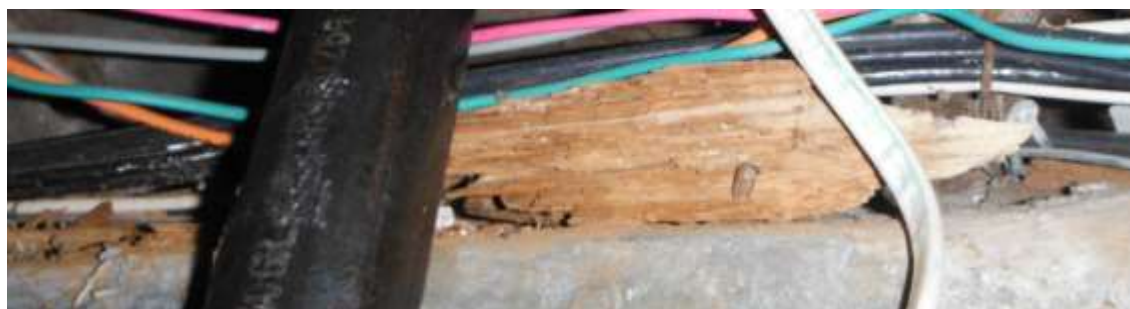
Figure 42 Termites damage sills, joists, sub-flooring in basement. Have structural carpenter determine the extent of damage.

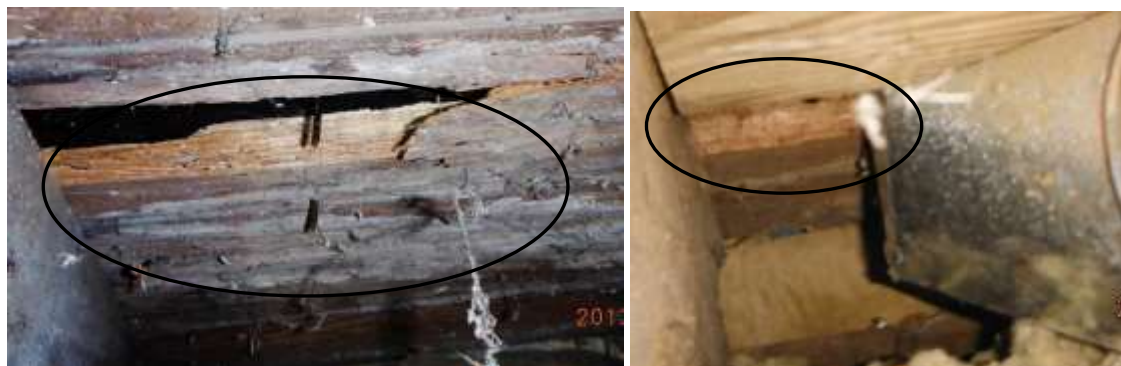
Figure 43 Termites damage sills, joists, sub-flooring in basement. Have structural carpenter determine the extent of damage.

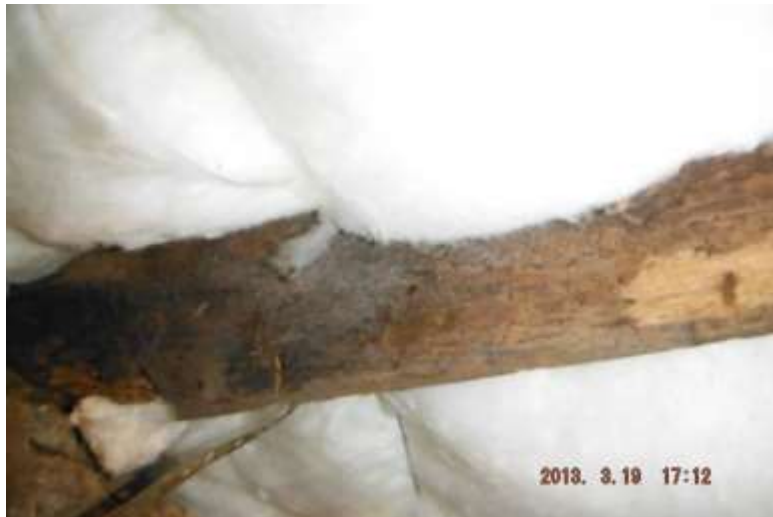
Figure 44 Example of powder post beetle damage. Have a structural carpenter determine extent of all wood destroying insect damage before closing.

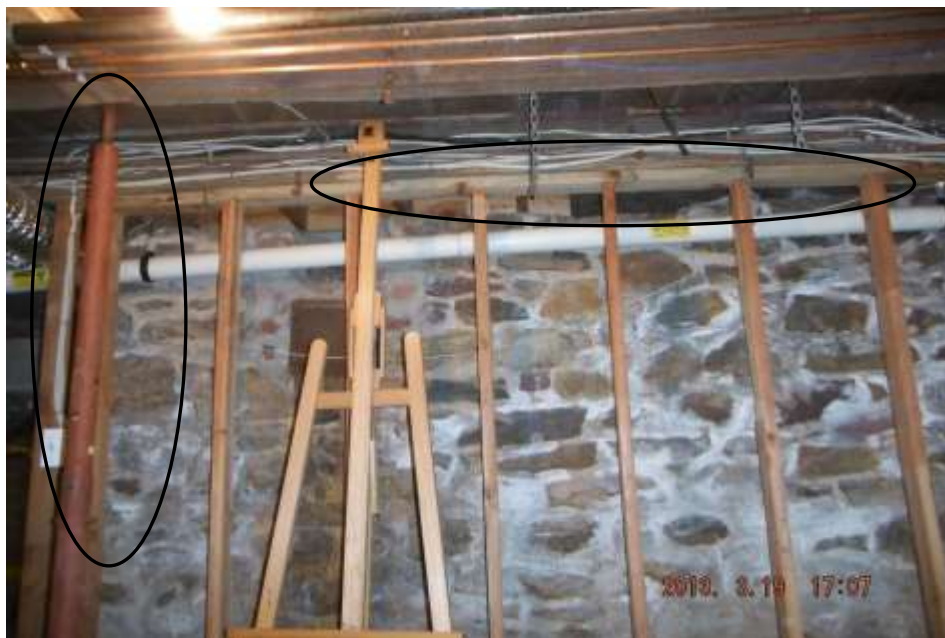
Figure 45 Have all structural repairs evaluated by a structural engineer or qualified building contractor before closing. There were structural concerns and handyman repairs.

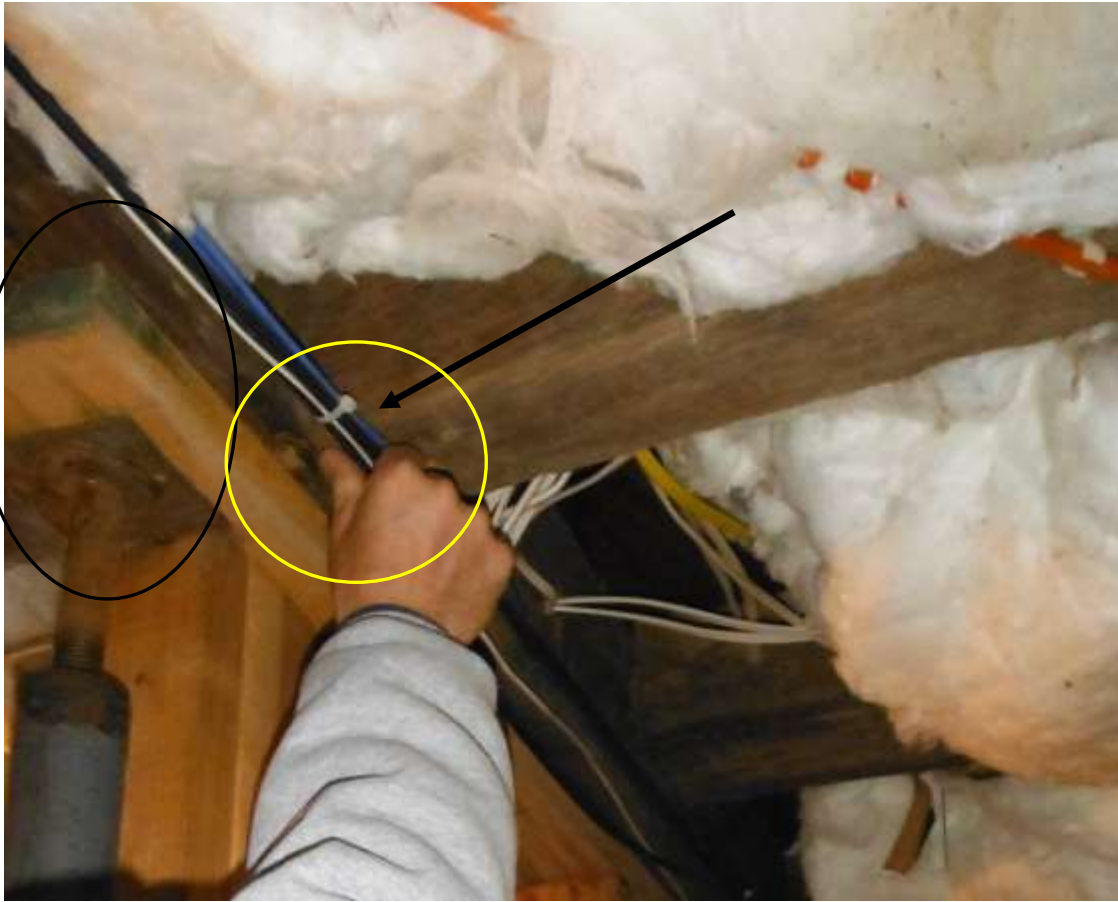
Figure 46 Handyman repairs; have structural engineer evaluate repairs and structure and advise on all needed structural repairs.

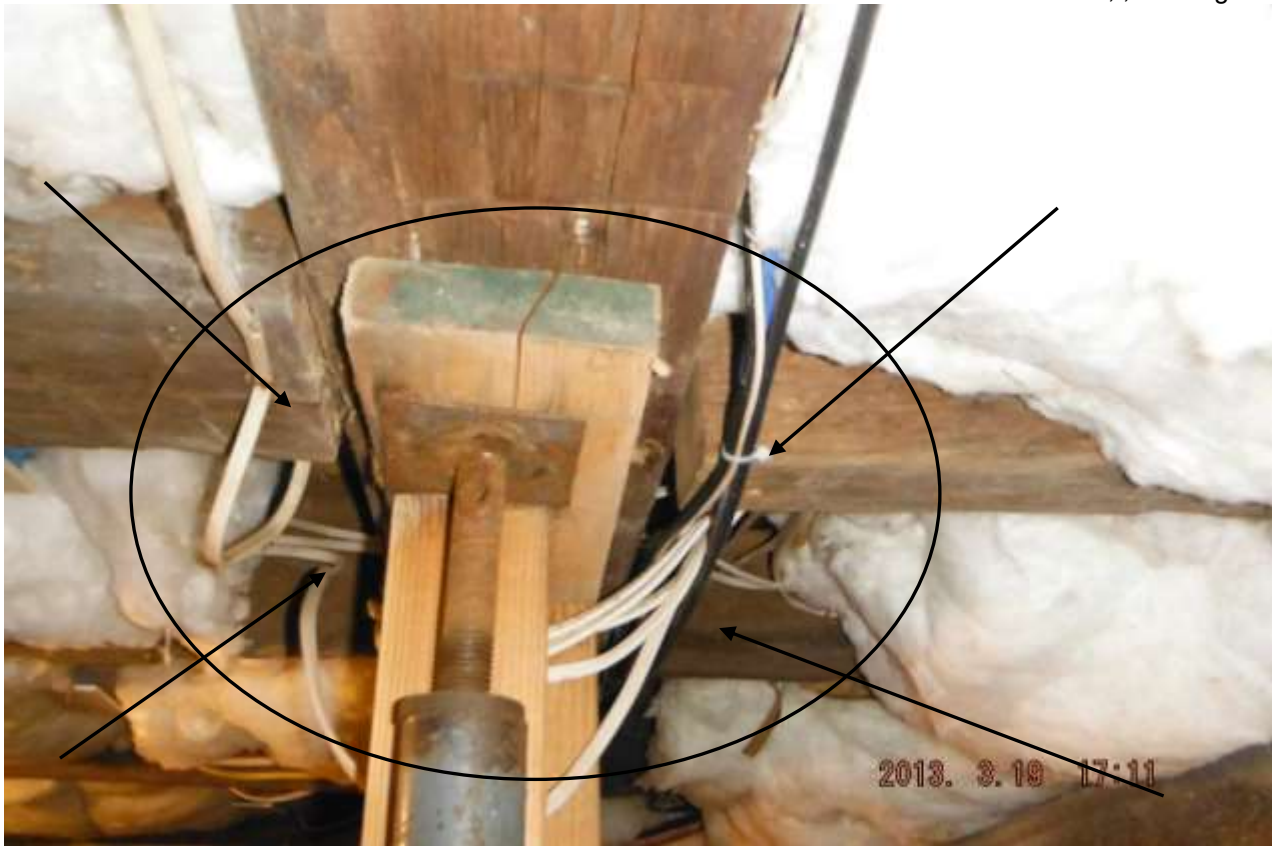
Figure 47 Improperly repaired structure in basement; handyman or improper.

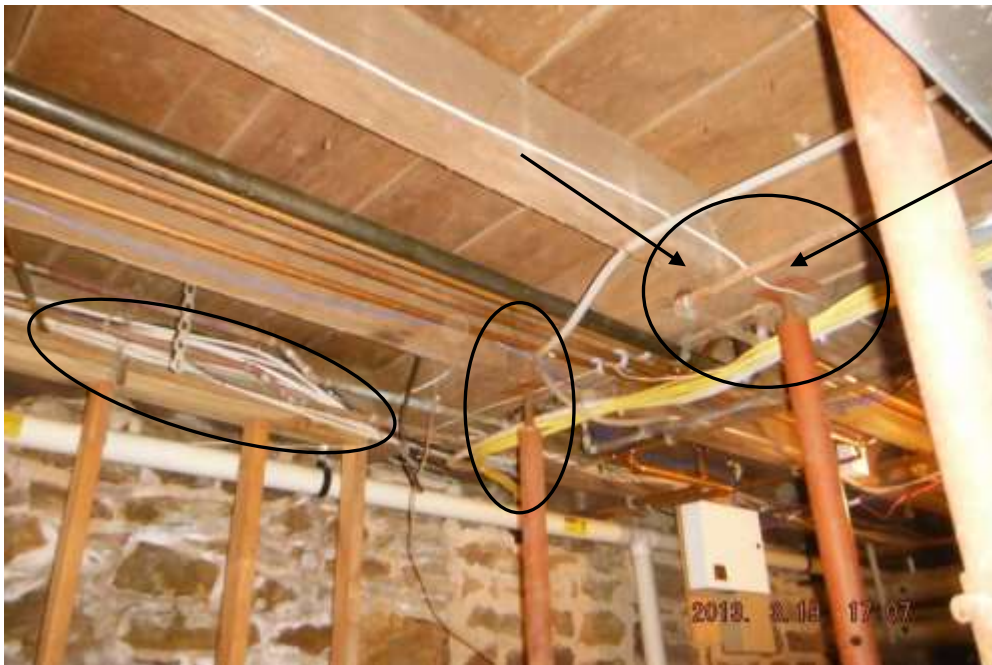
Figure 48 Have structural engineer or qualified building contractor evaluate repairs and structure in home.

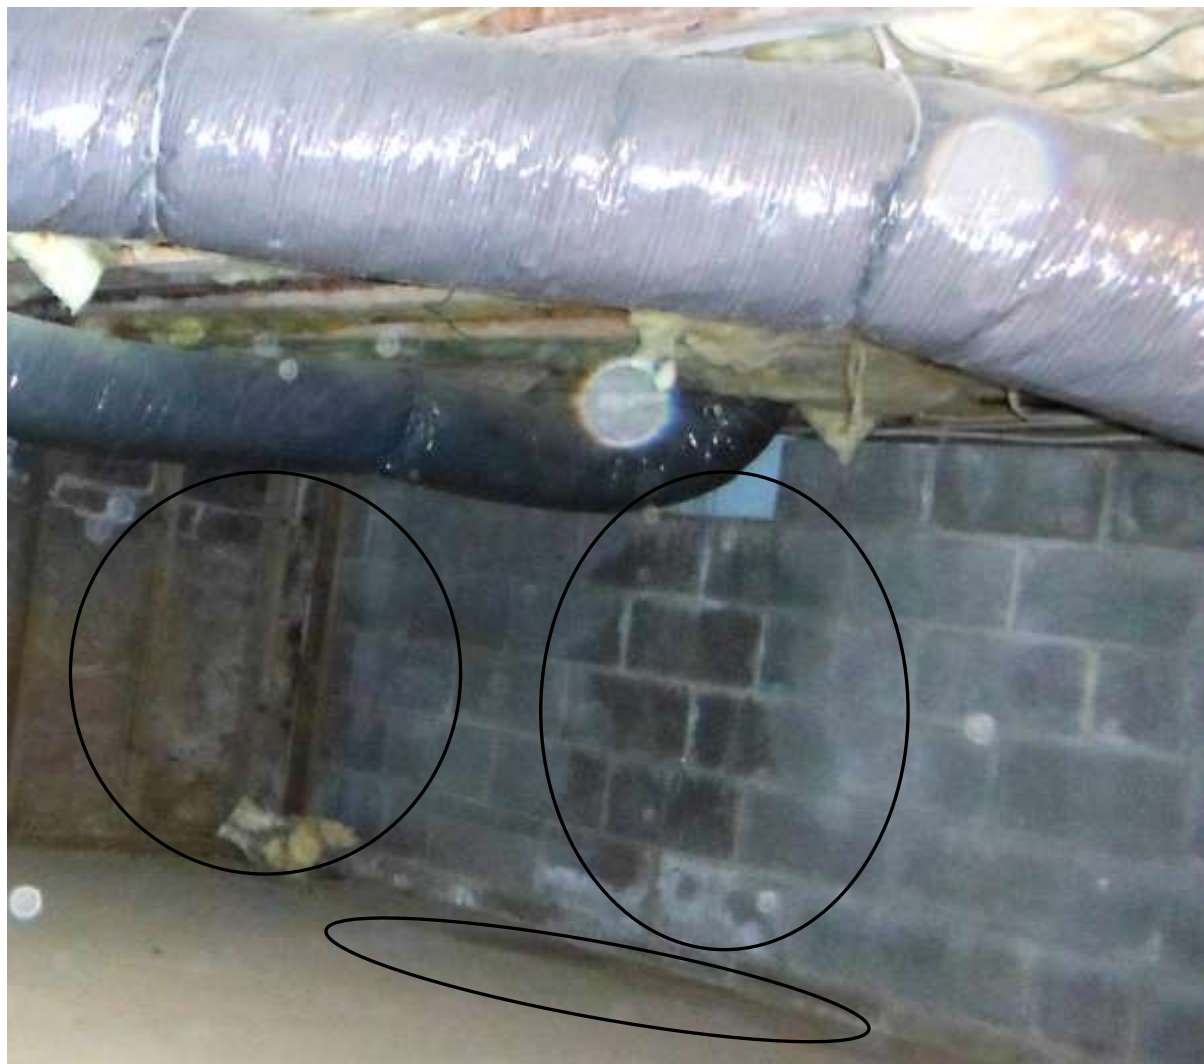
Figure 49 Seepage in crawl space and vents were closed with foam. Moisture needs to be removed; correct grading & drainage, gutters and install dehumidifier.

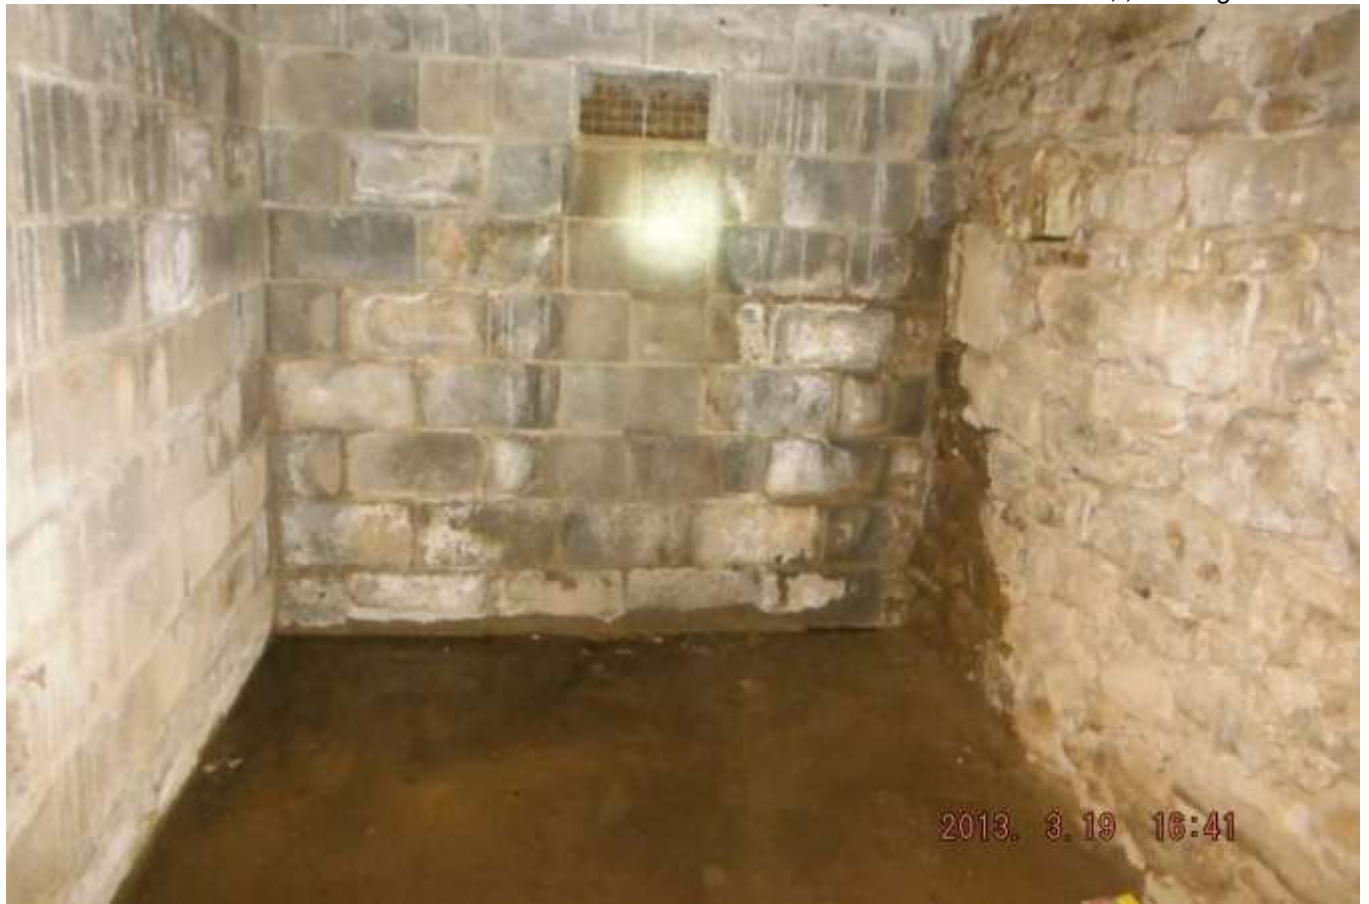
Figure 50 Water coming into basement; seepage.

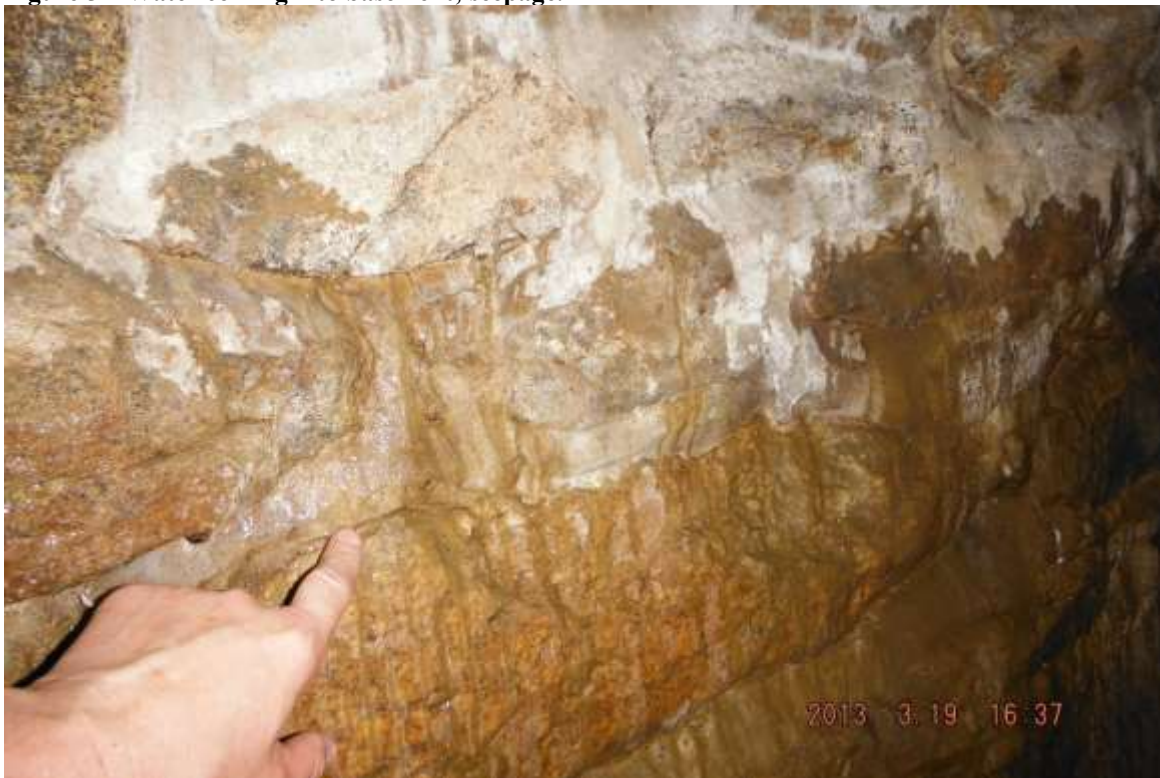
Figure 52 Water coming into basement; seepage.
