4 Seasons Home Inspection, LLC

150 Maple Avenue, #128, South Plainfield, NJ 07080

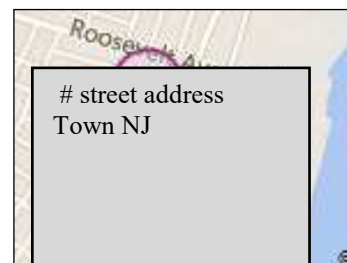
Inspection Date: July 21, 2016 Thursday 10am- 2pm
Client Name: Bob Buyer(buyer@gmail.com)
Inspection Address: # Street, town, NJ xxxxx
Inspected by: Linda Geczi home inspection lic. #24GI00061500

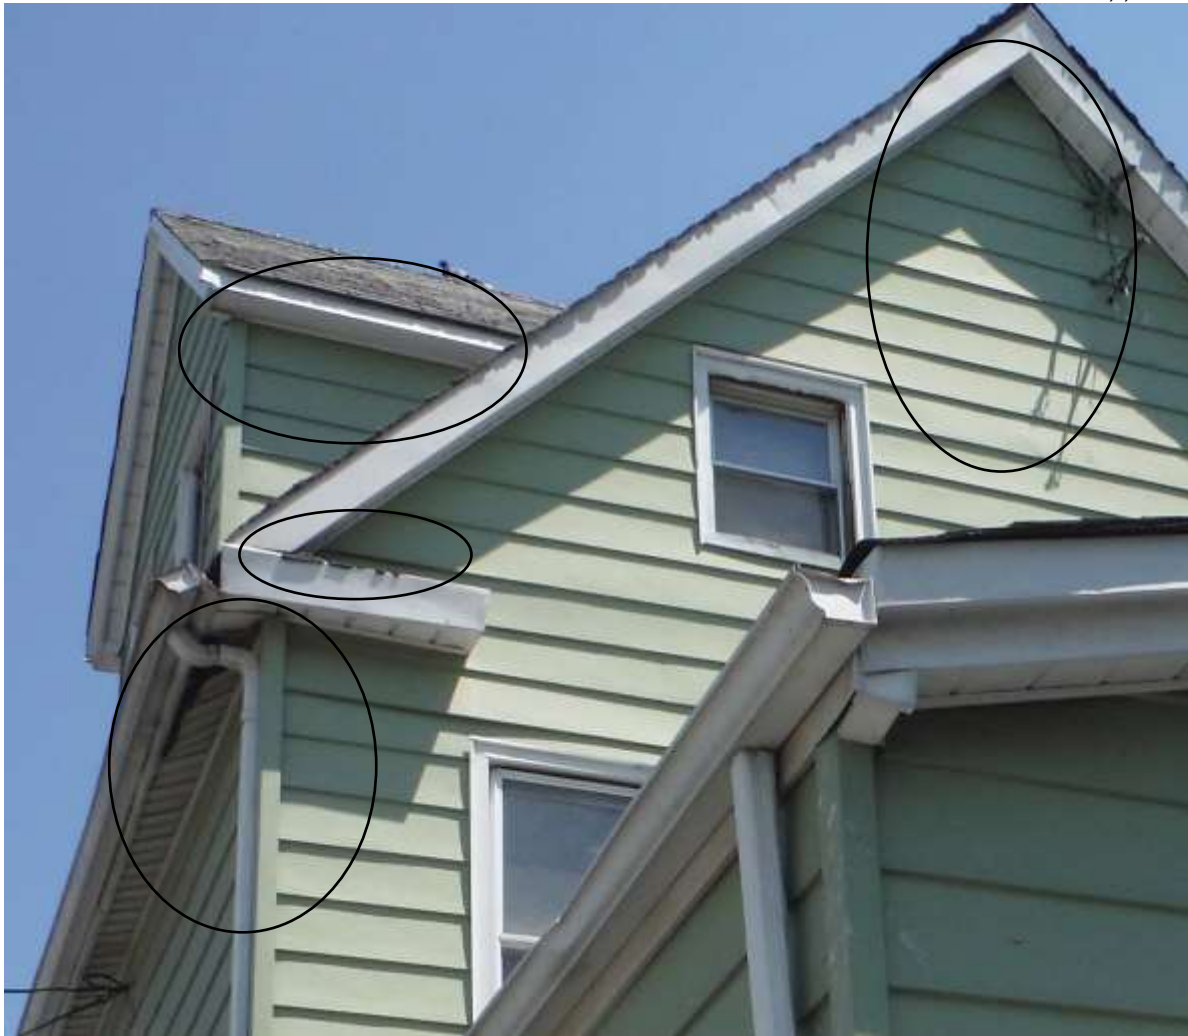
Figure 1 Roofs in poor condition; leaking into interior, water damage, etc. Have all water, mold-like and structure damage determined by building contractor and roofer.

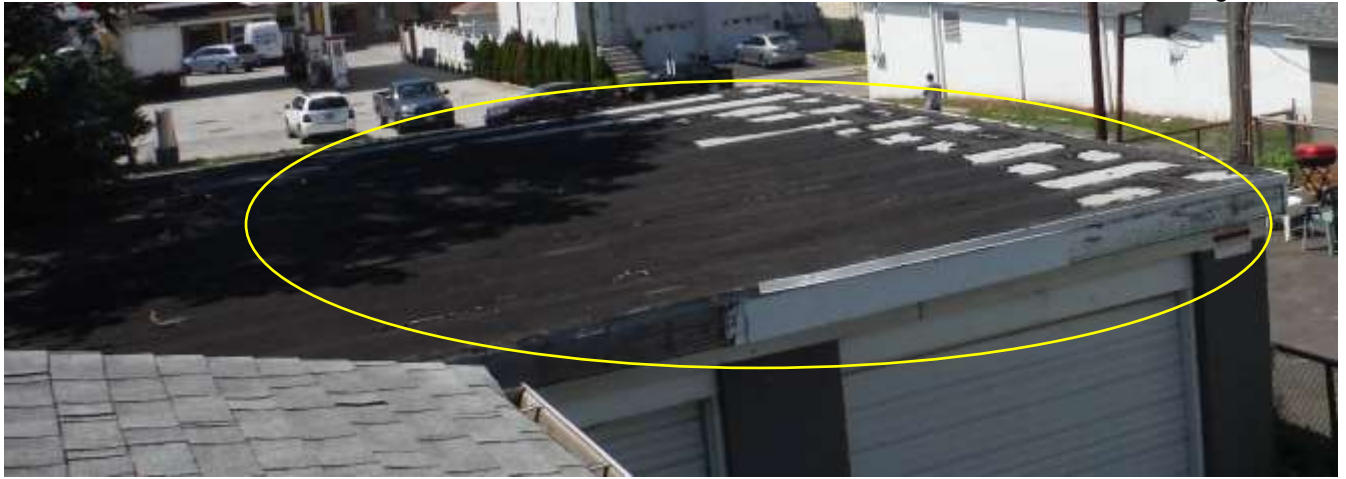
Figure 2 Roofs on home and garage were in poor condition, leaking and damage in interior and concealed areas.

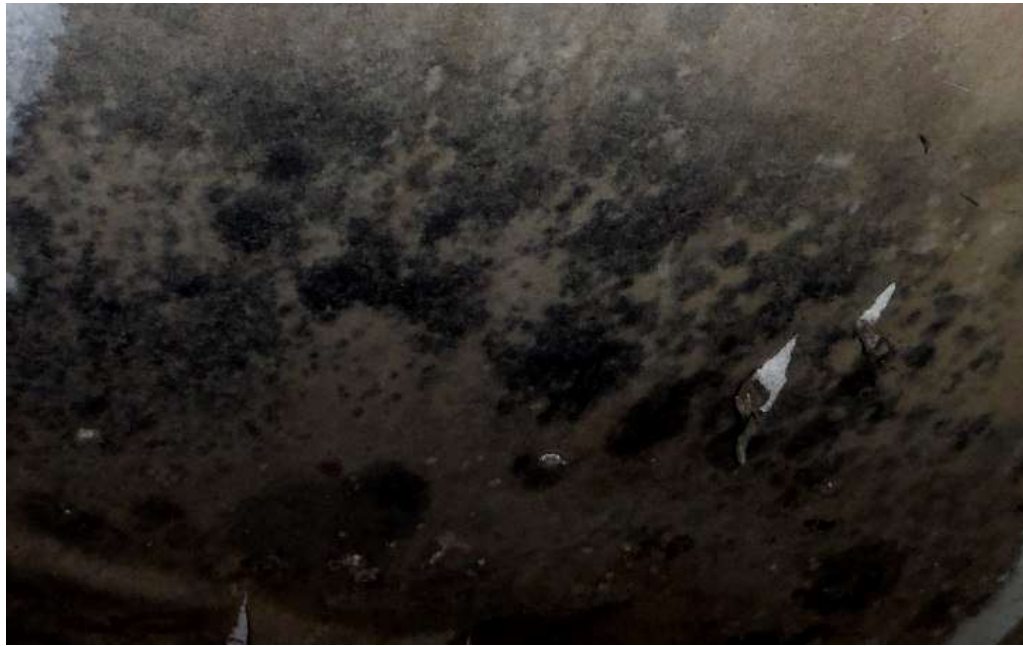
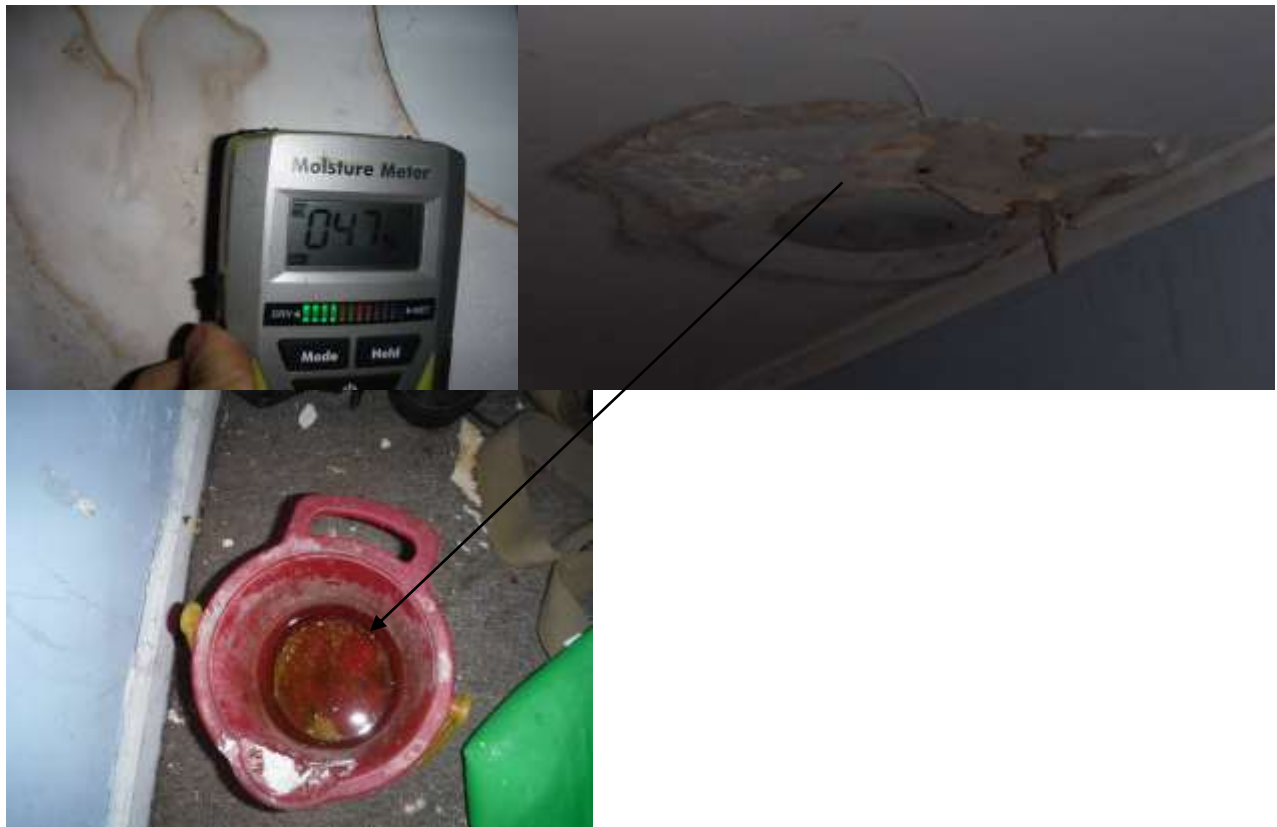
Figure 3 Water leaking through a ceiling light; dangerous.

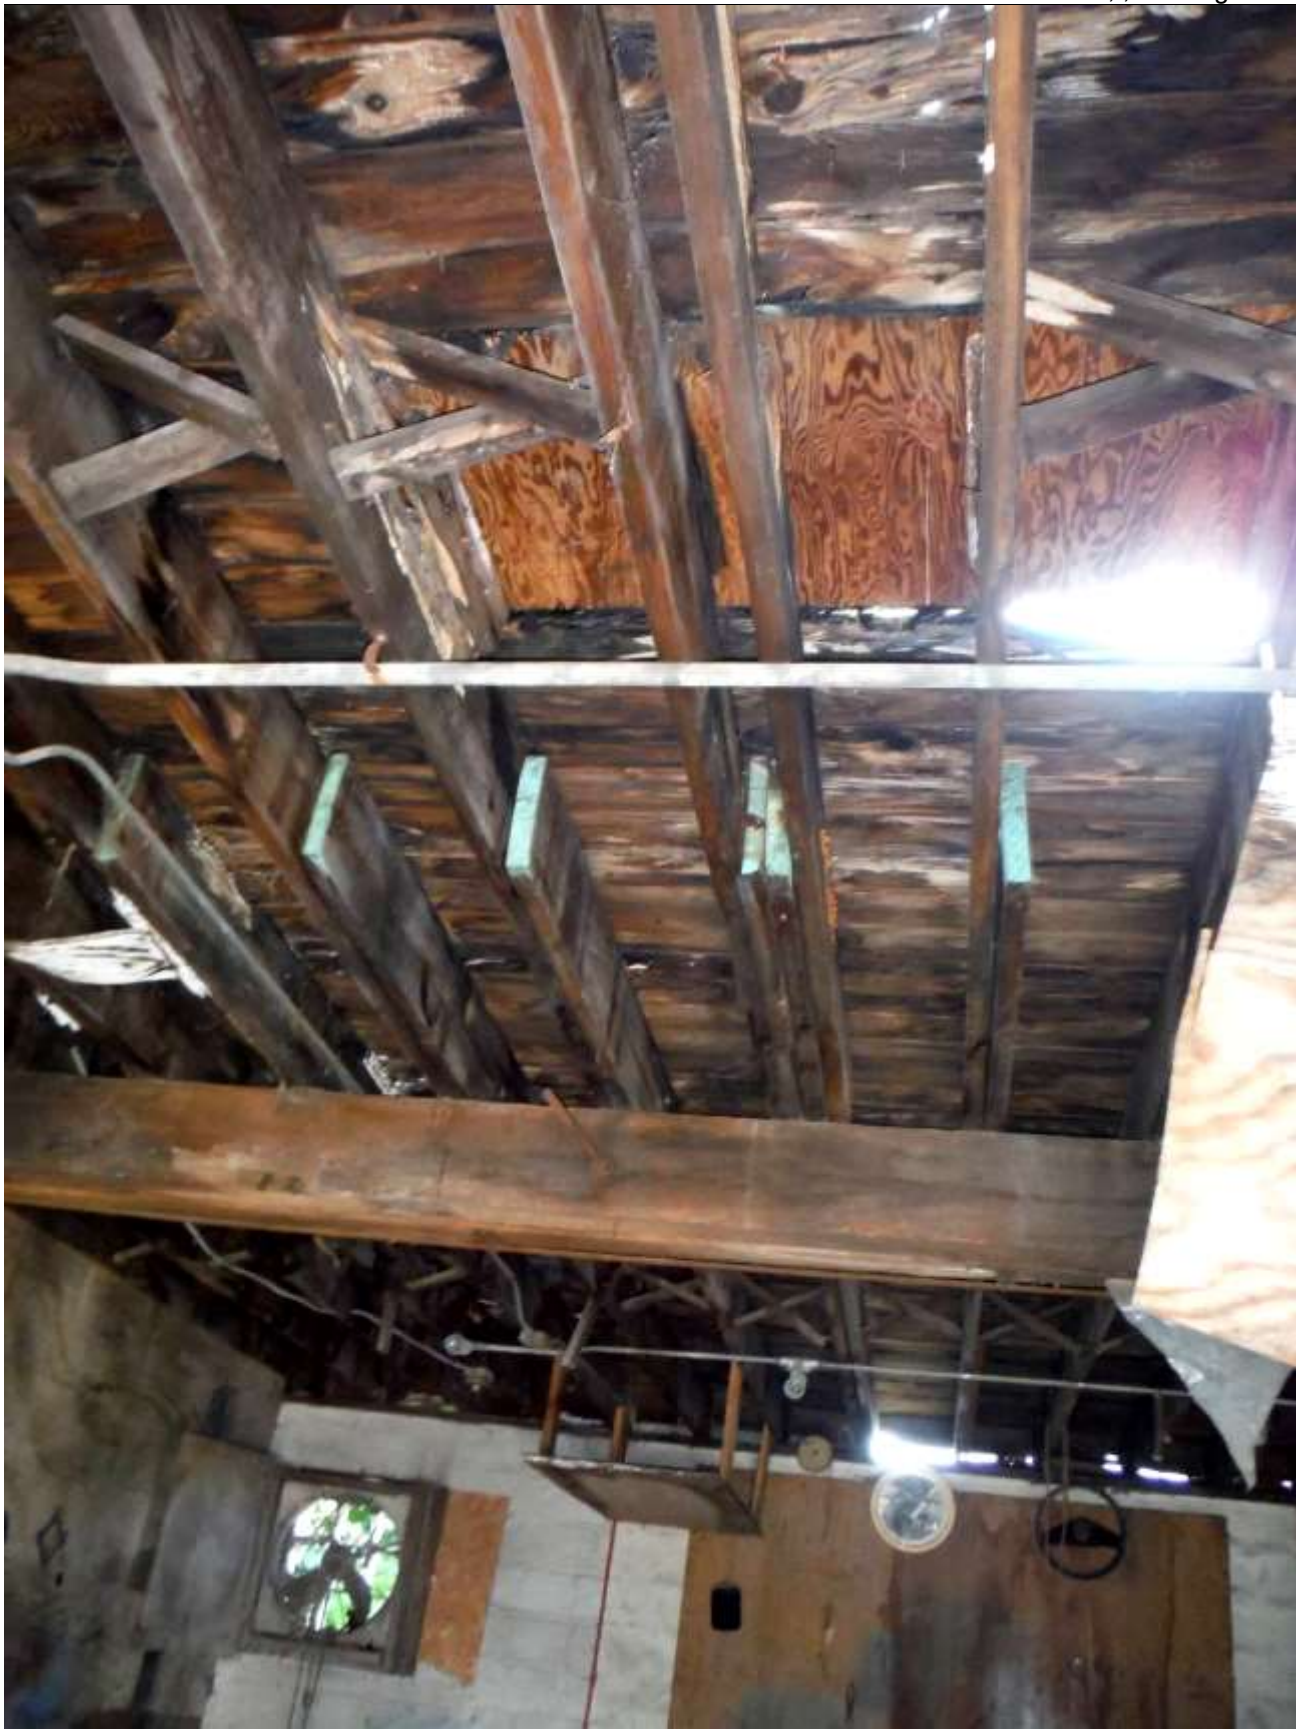
This confidential report is prepared exclusively for Client on contract for them to rely on and not transferrable.

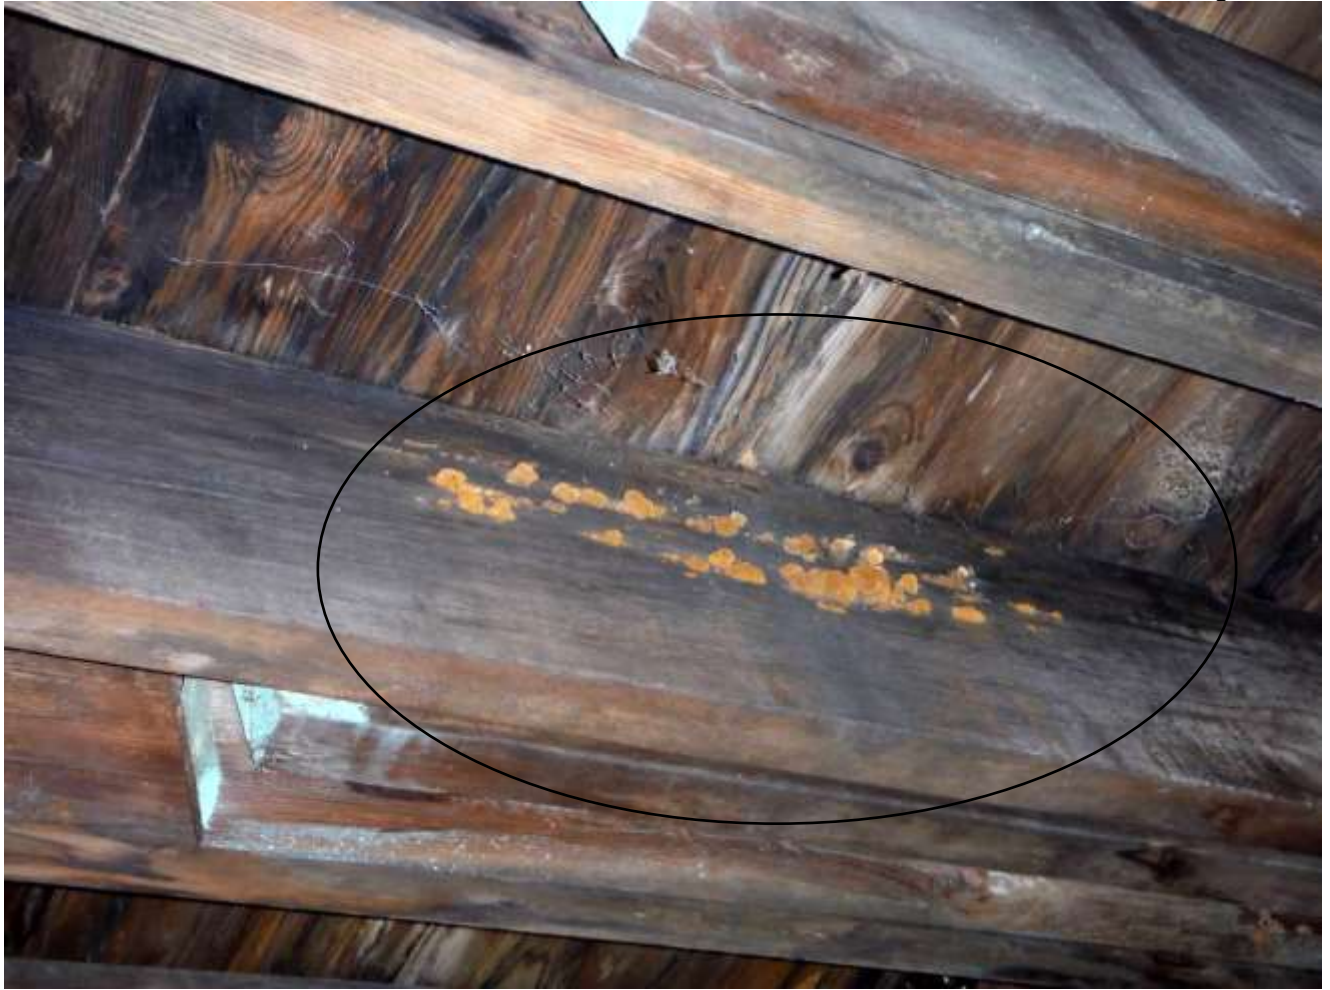
Figure 4 Orange mold-like substances on roof structure; water damaged/rotted/mold-like. Roof have severe water damage; recommend a building contractor evaluate roof structure and roof for tear off/replacement, gutters, ventilation and extent of structural damage & repairs.

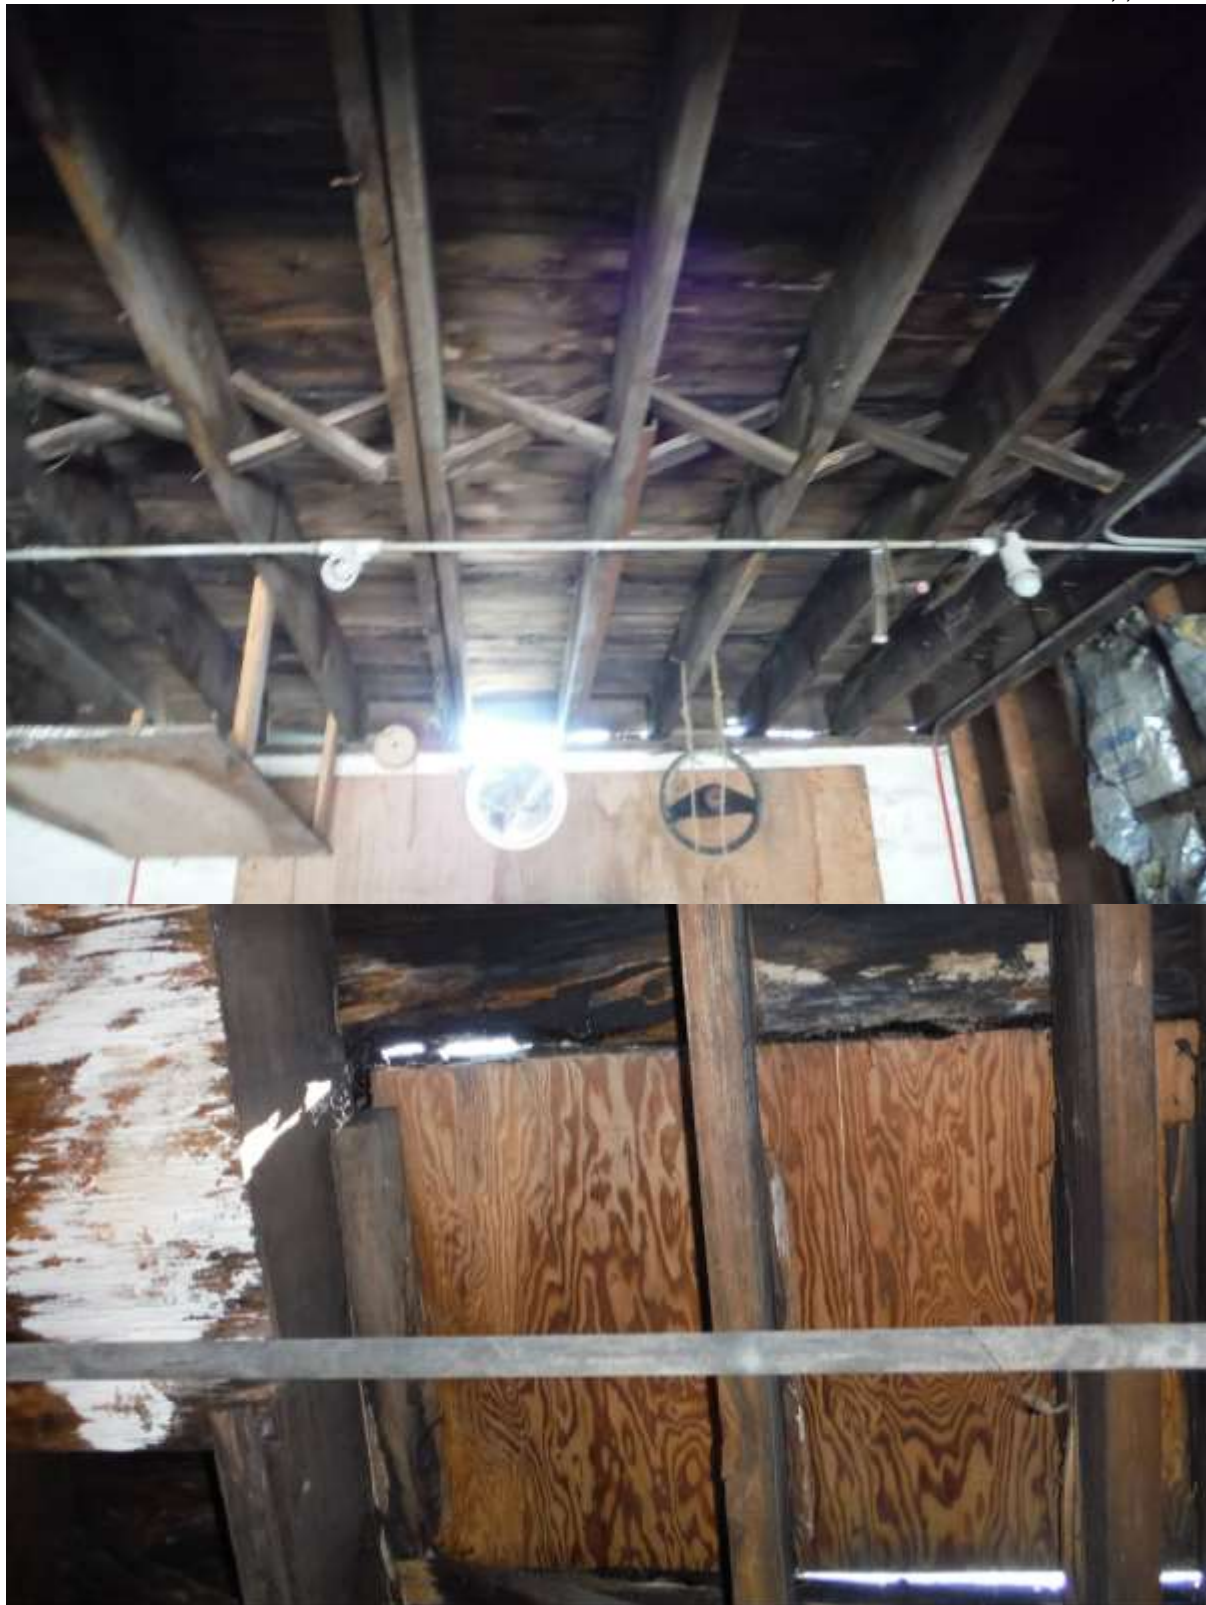
Figure 5 Holes/daylight in garage roof everywhere; extensive damage to roof /structure; have a roofer & building contractor evaluate & advise on tear off & mitigation/rehab.

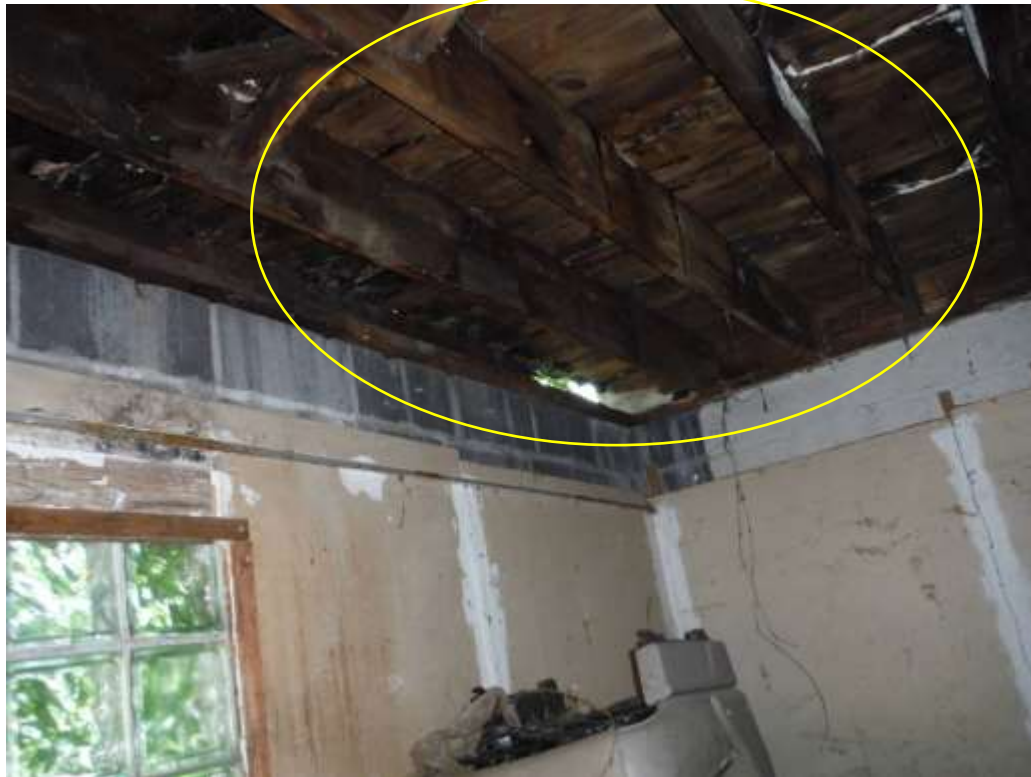
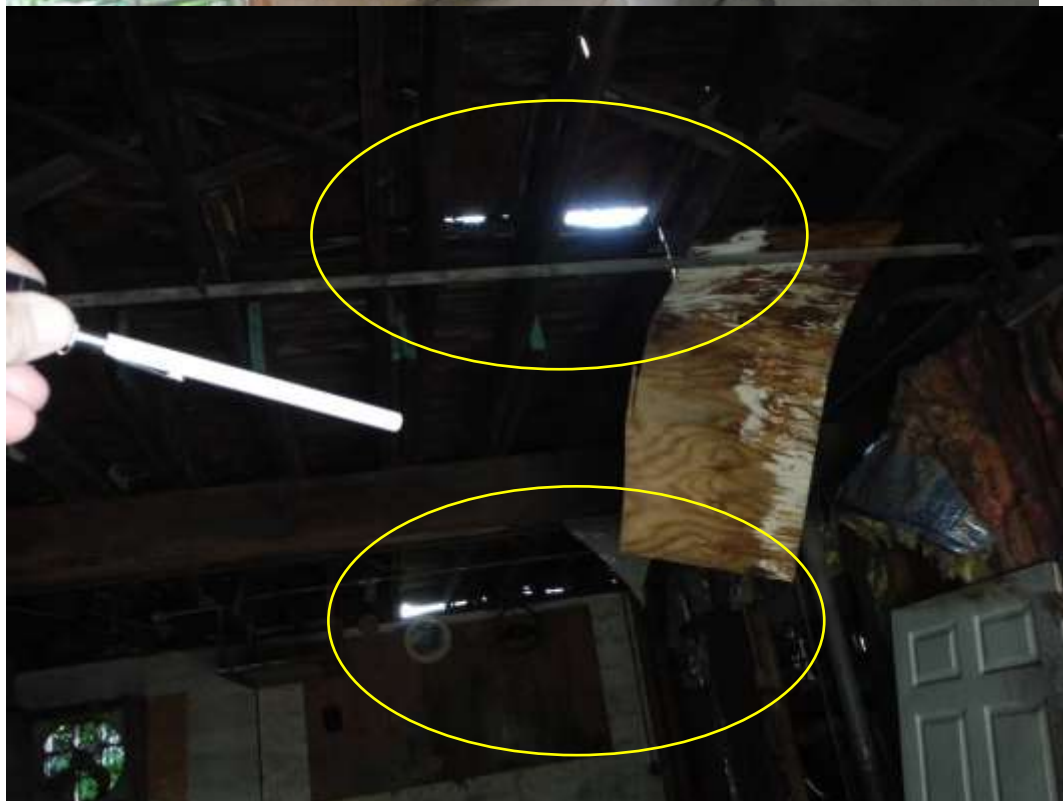
Figure 6 Roof deteriorated; daylight, leaks, rot, damage everywhere. Recommend a building contractor evaluate advise on roof structure & roof removal/replacement.

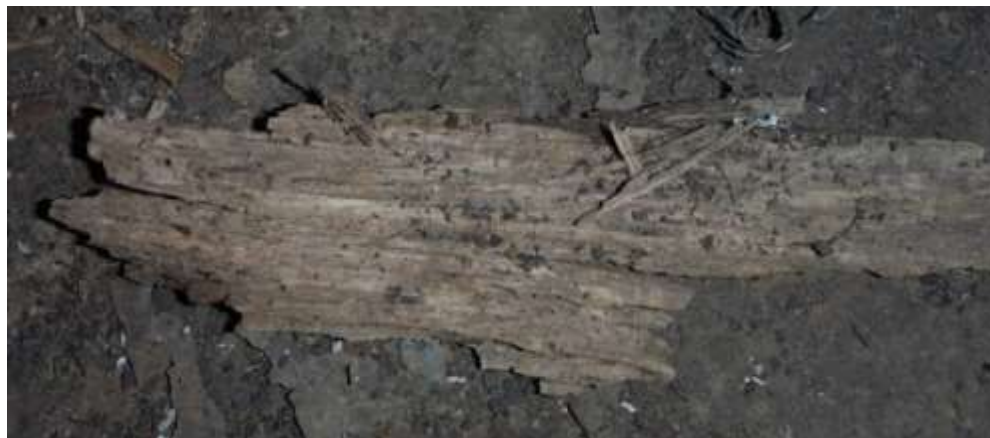
Figure 7 Example of water and wood destroying insect damage in garage.

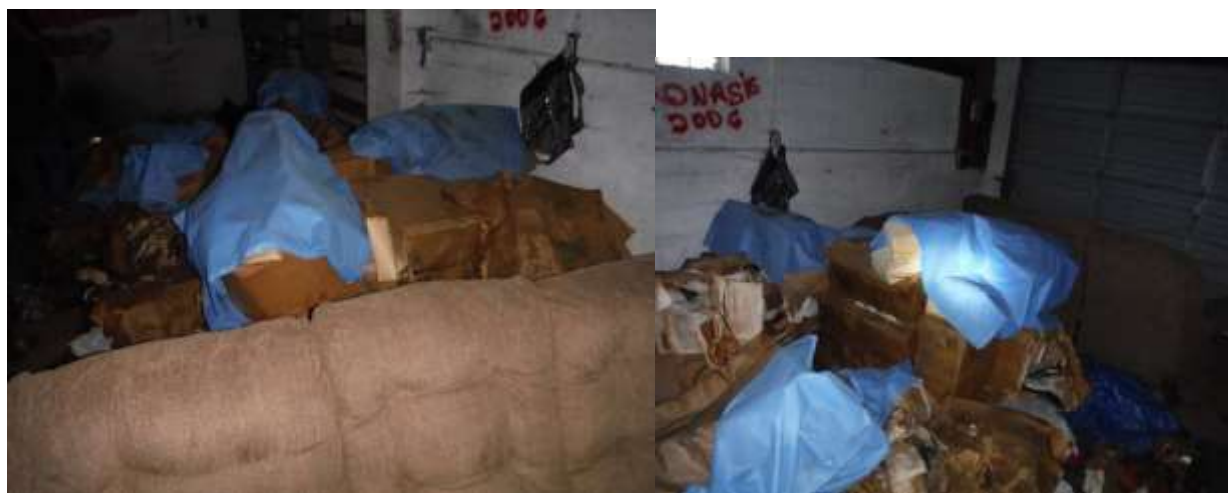
Figure 8 Wet/moldy rotted storage in garage.

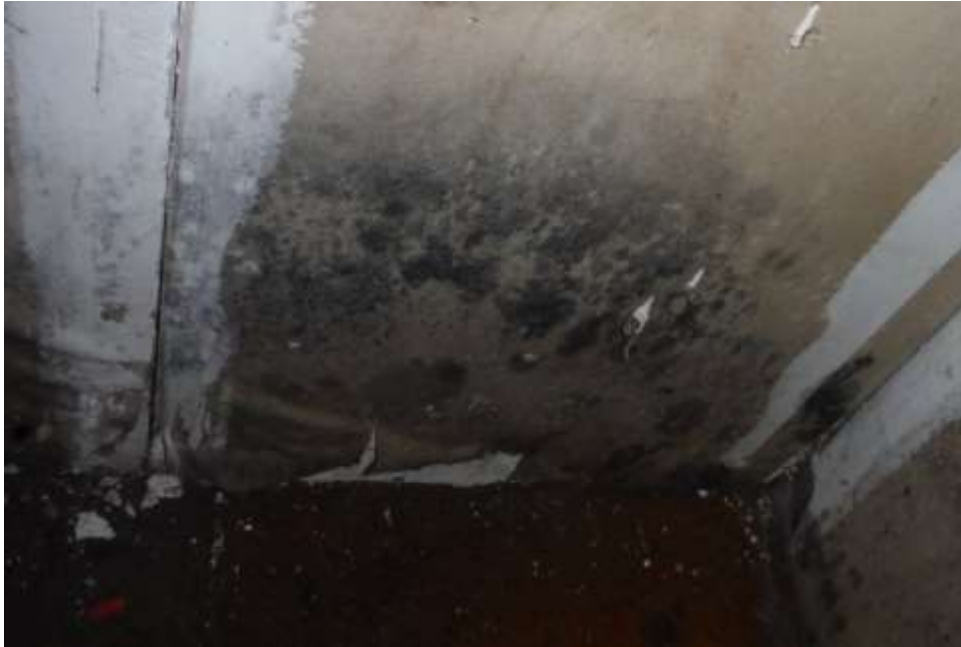
Figure 9 Example of mold-like conditions.

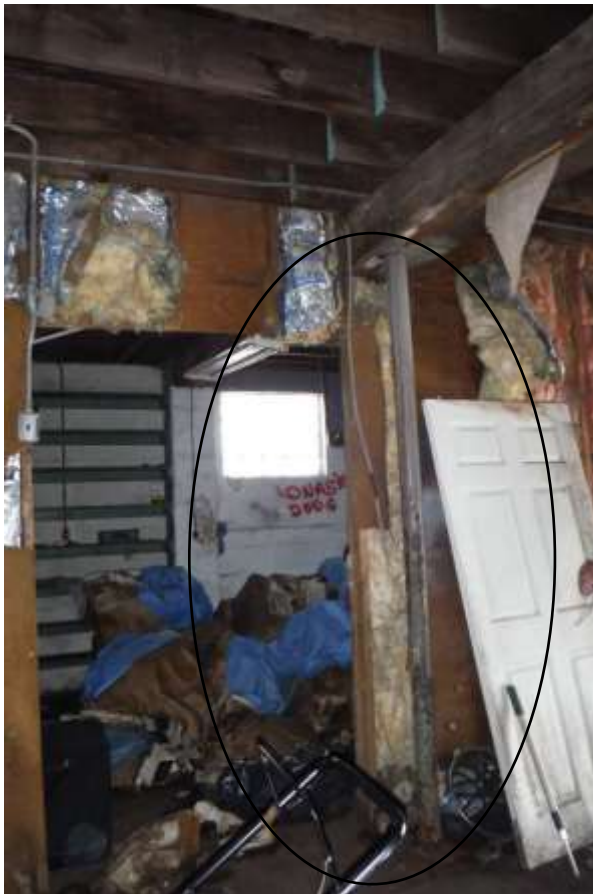
Figure 10 Rusted lally column, structural modifications, leaking roof/leaks/damaged roof structure, etc. Recommend a structural engineer (PE) and building contractor evaluate/advise on all repairs.

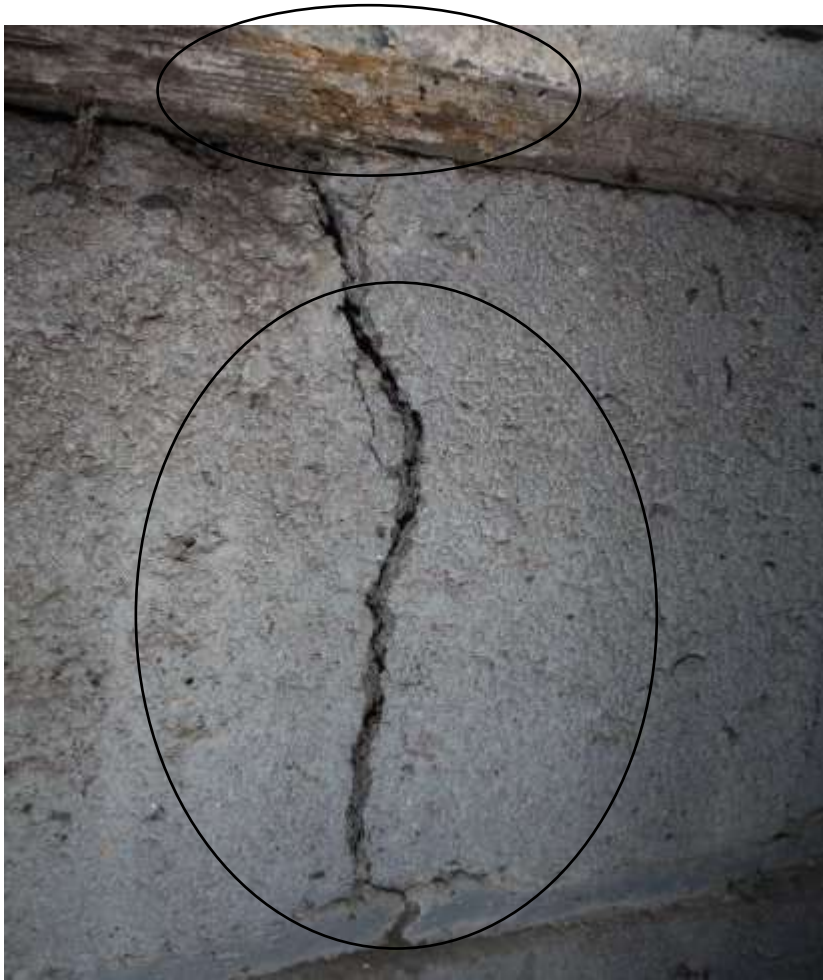
Figure 11 Example of foundation cracks.

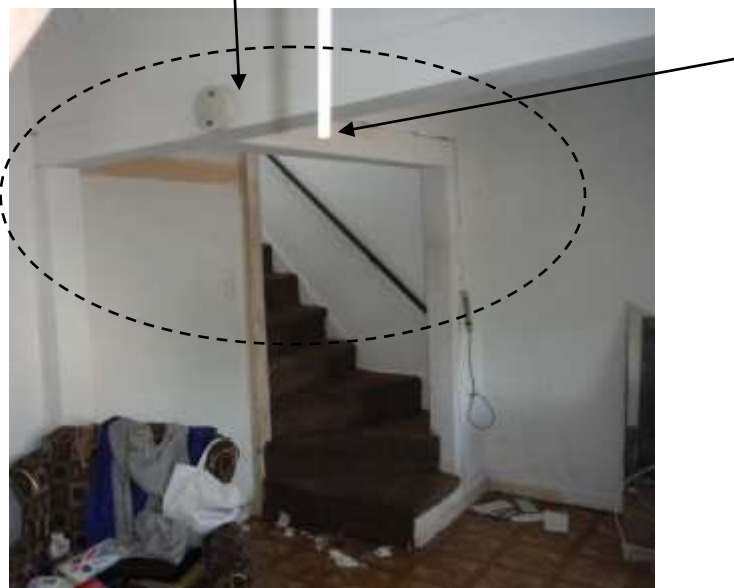
Figure 12 Sagging, sloped flooring, indication of removed walls/altered structure, etc.

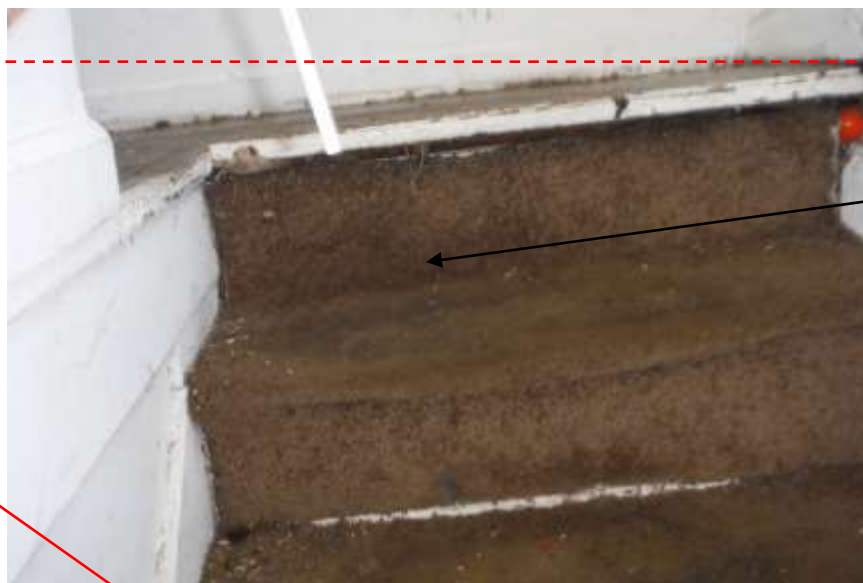
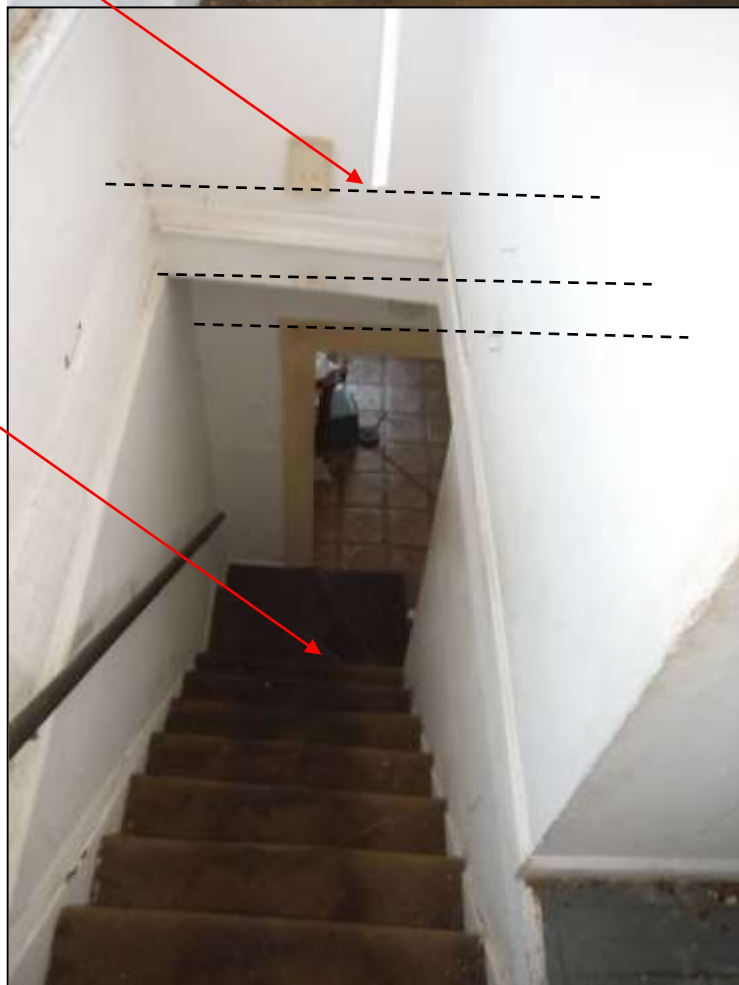
Figure 13 Sloped staircases, canted walls/doorways, etc. in the home; structural concerns. Recommend a structural engineer (PE) evaluate all structure in the home. Recommend obtaining all history for structural modifications, removed walls, fire damage, etc. before closing and contractual limitations. Stairwell to 3rd floor had trip/fall hazard; open first step off landing.

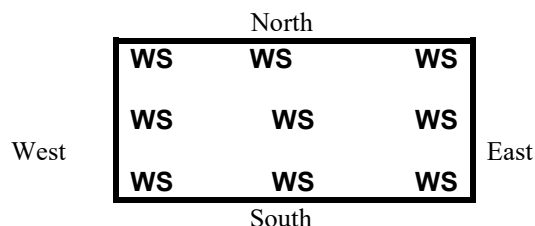
FLOOR **Material:** Concrete/ Dirt/Gravel Plants growing in floor & wood floor sills

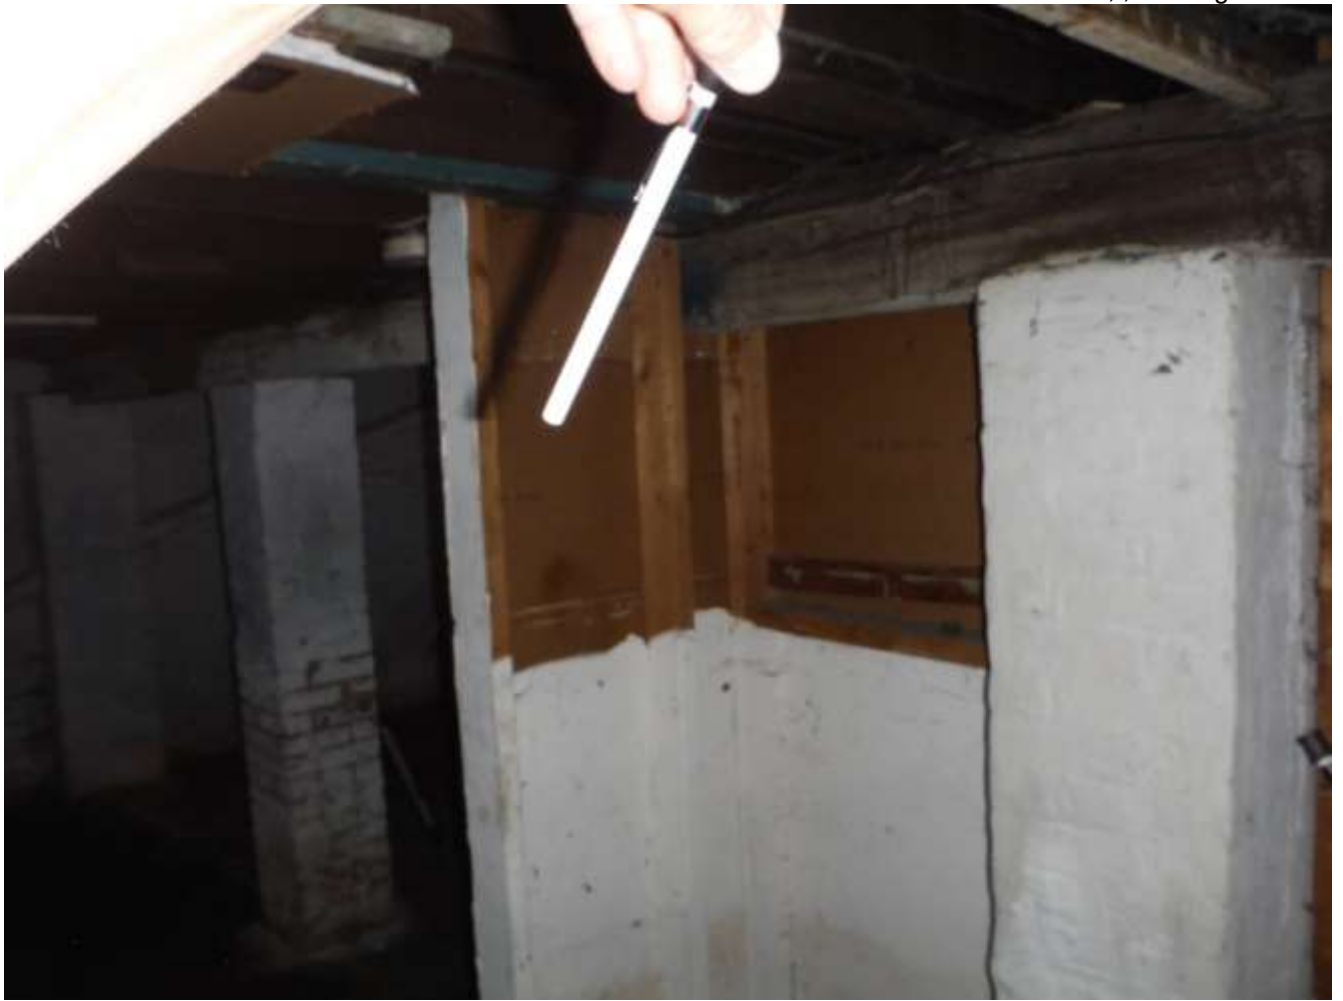
Figure 15 Main beam/girder sagging between brick columns. Center columns > 8ft. apart (should be less than). Deterioration and water damaged columns.

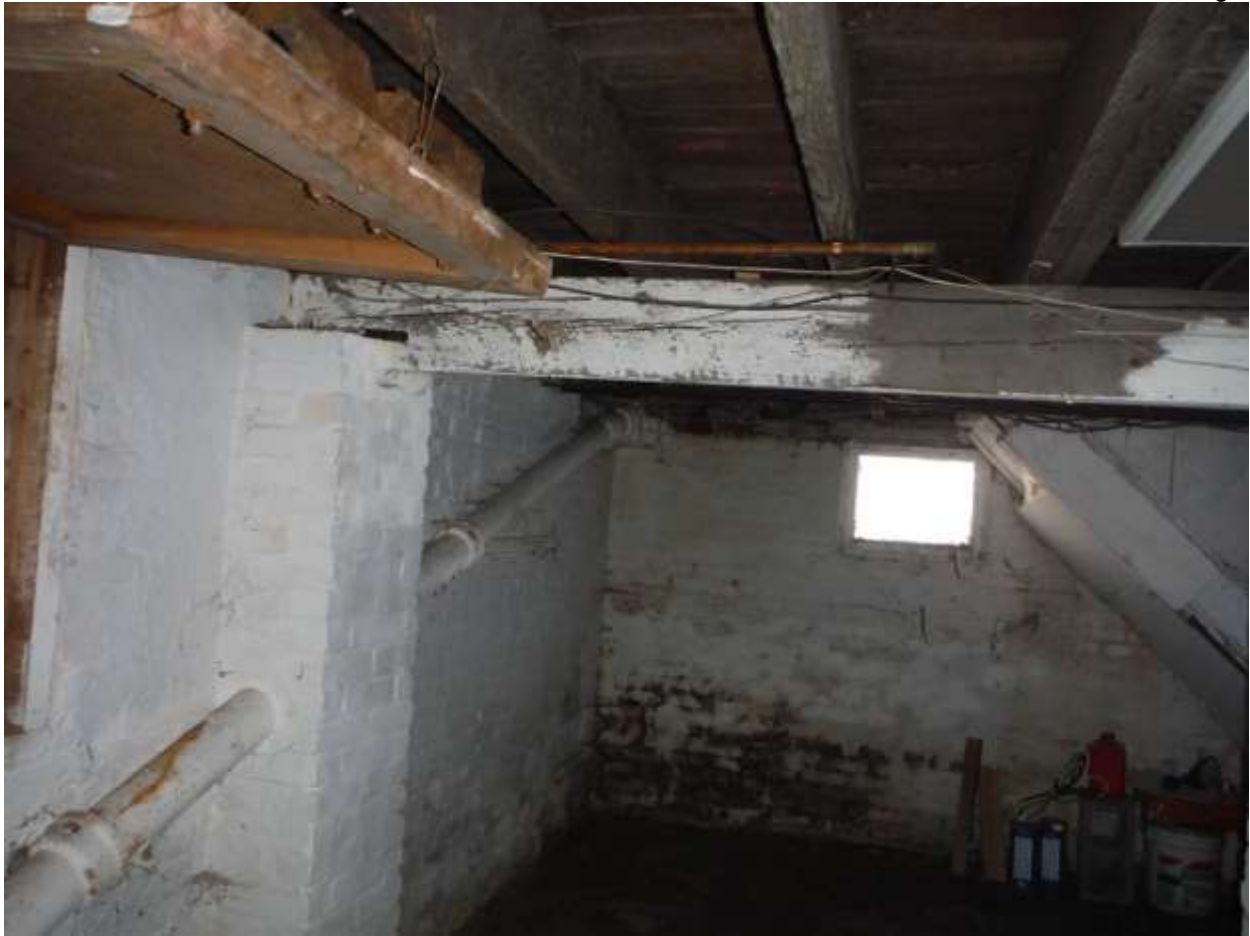
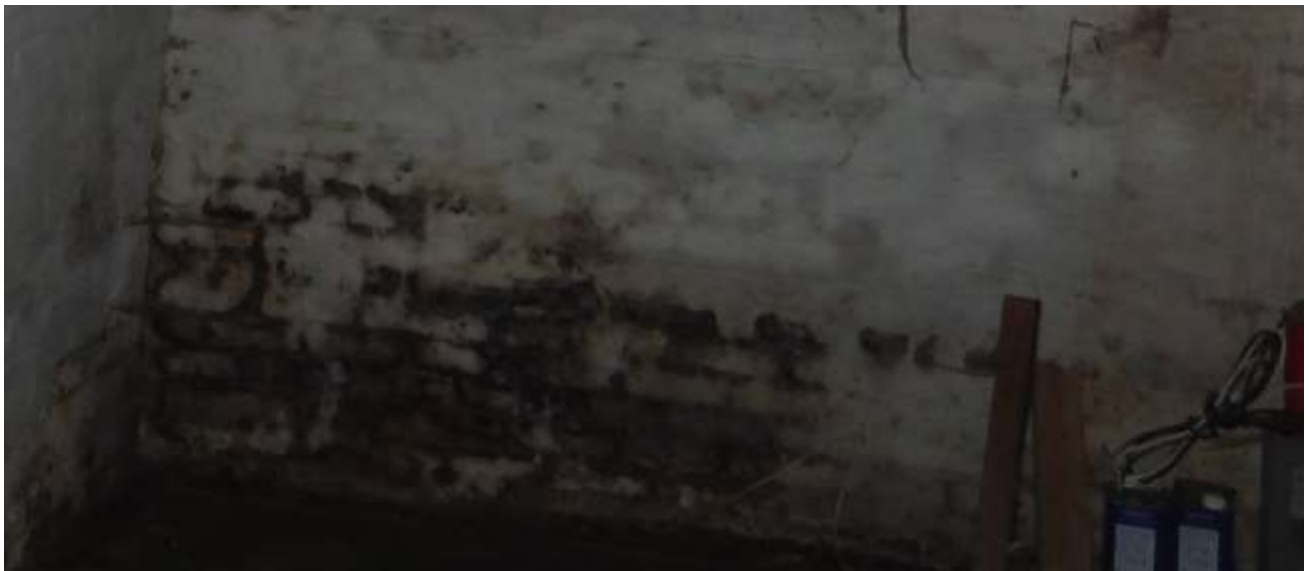
Figure 16 Mold-like staining; have evaluated by mold/environmental contractor.

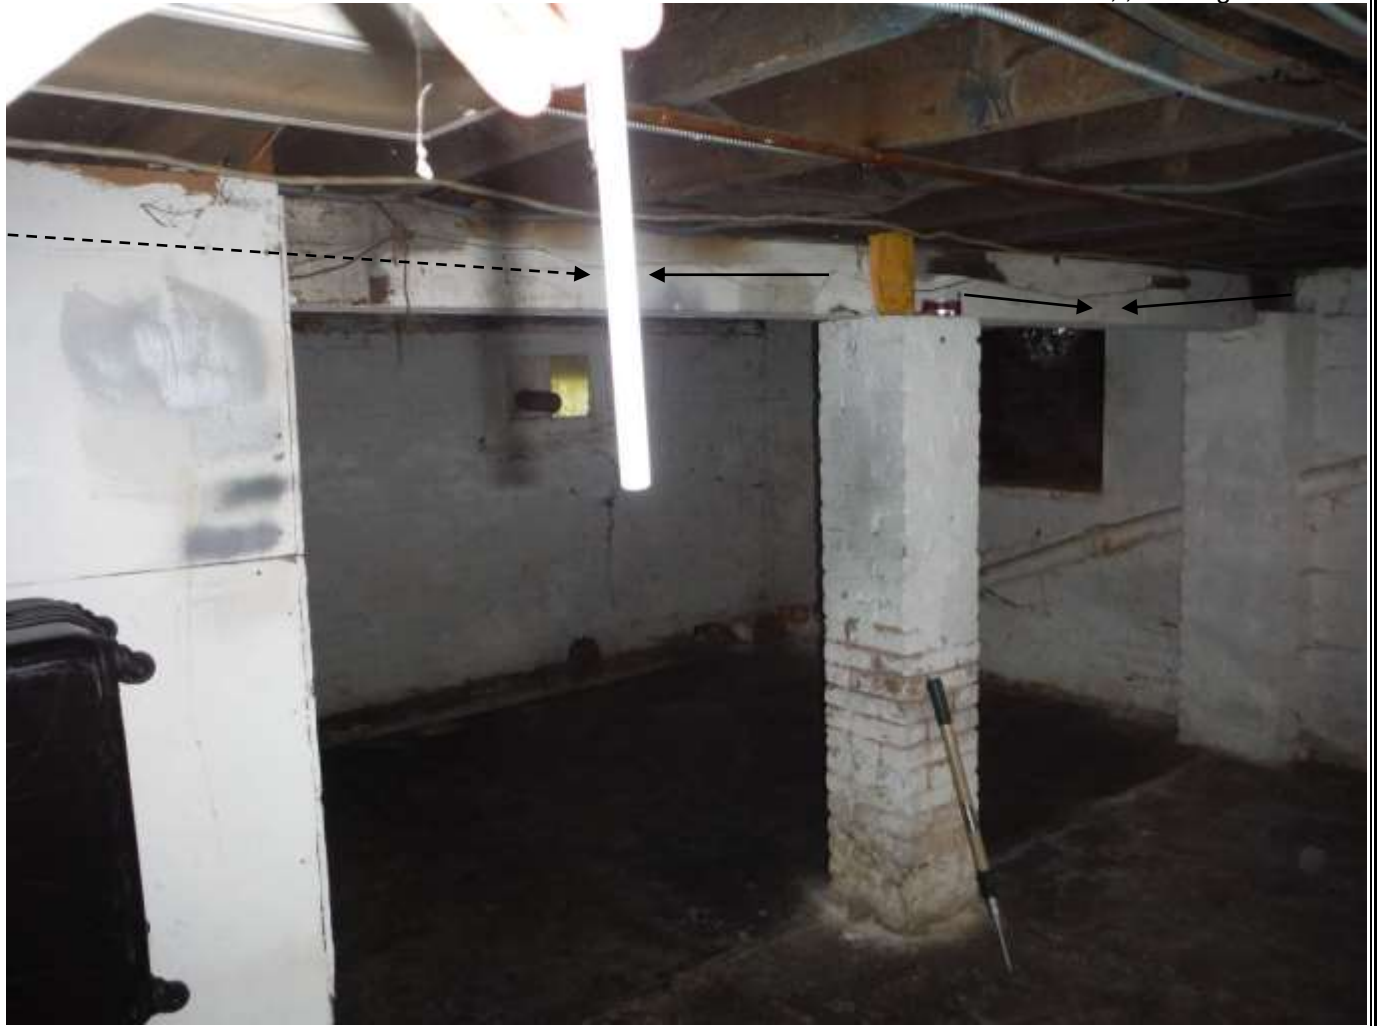
Figure 17 Sagging twisted beam/girder. The girder and floor joists were sagging, sloped spongy flooring/damaged throughout the home.

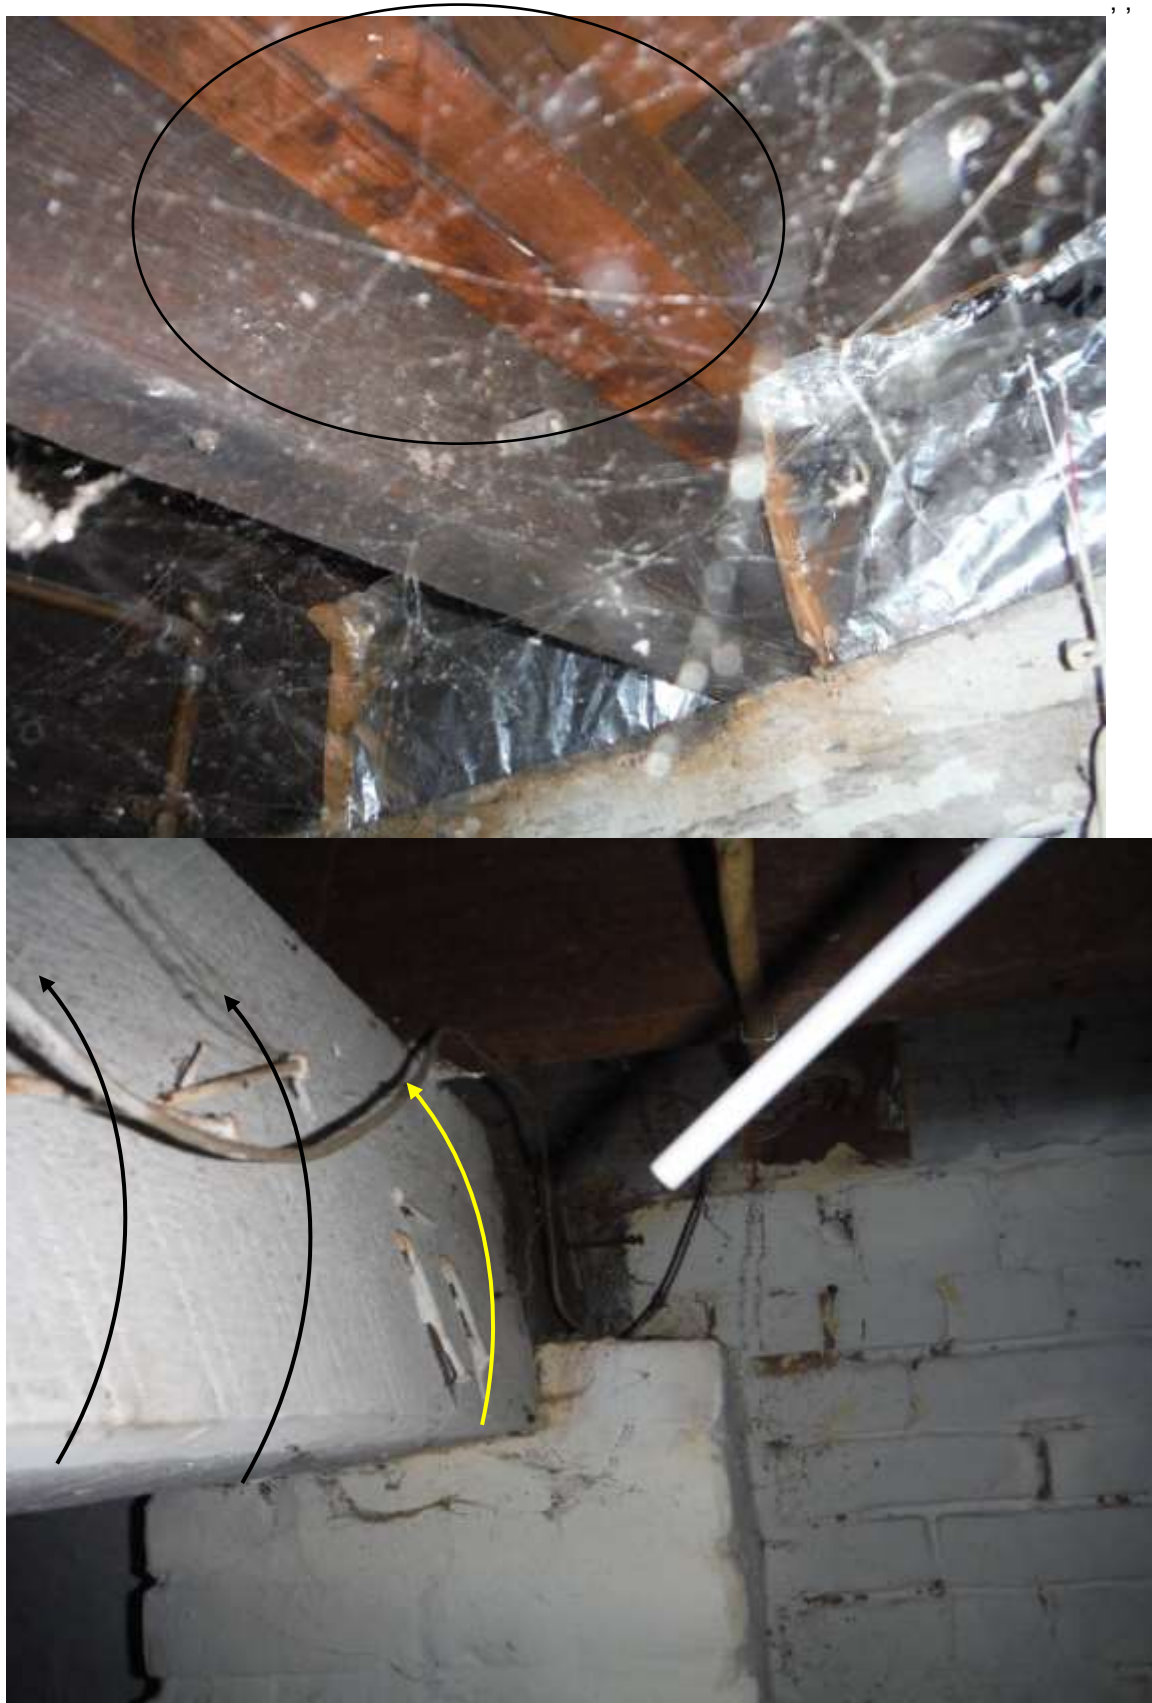
Figure 18 Twisted main beam/girder in basement. Floor joists and beam were sagging, flooring/subflooring spongy/deflection or movement when walked upon; structural defects/deficiencies observed in the home.
