4 Seasons Home Inspection, LLC

150 Maple Avenue, #128, South Plainfield, NJ 07080

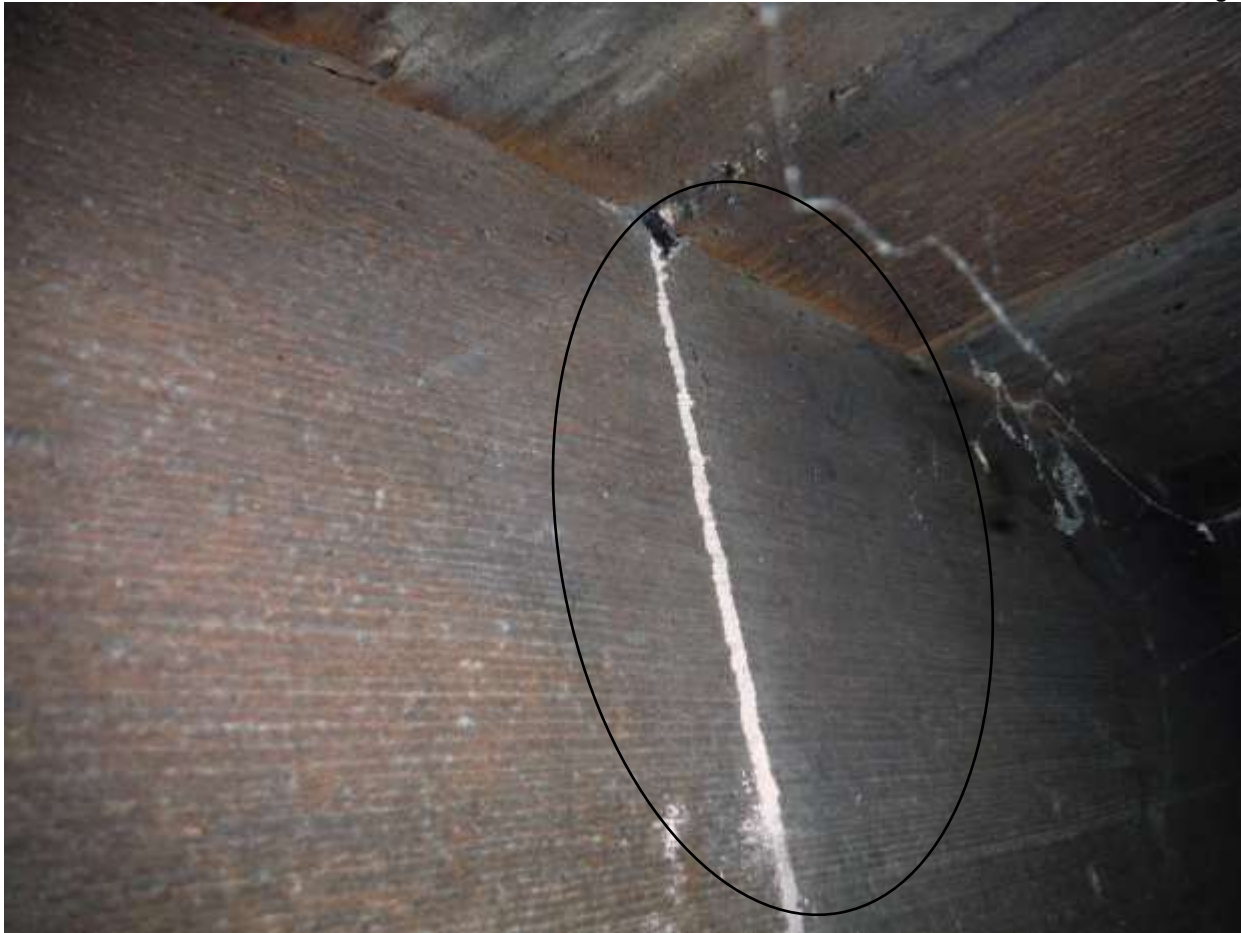
Figure 19 Example of termite shelter tubes on joists or framing. See crawl space section comments.

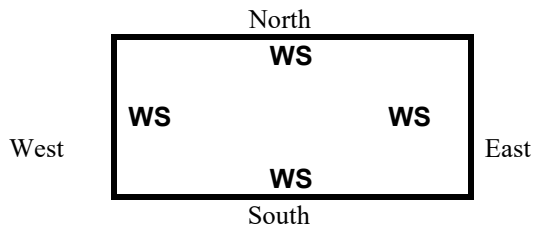
W= Wet, seepage, water damage, wood destroying insect damage

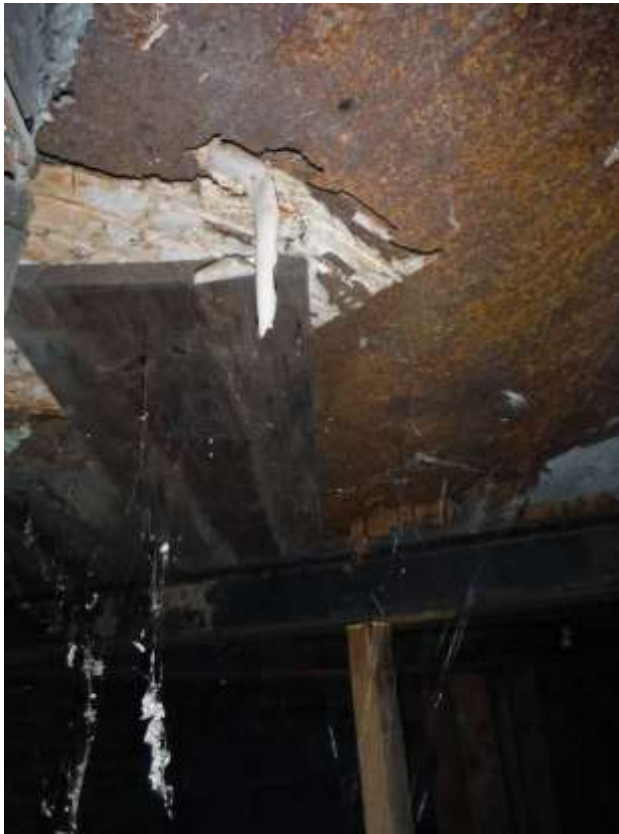
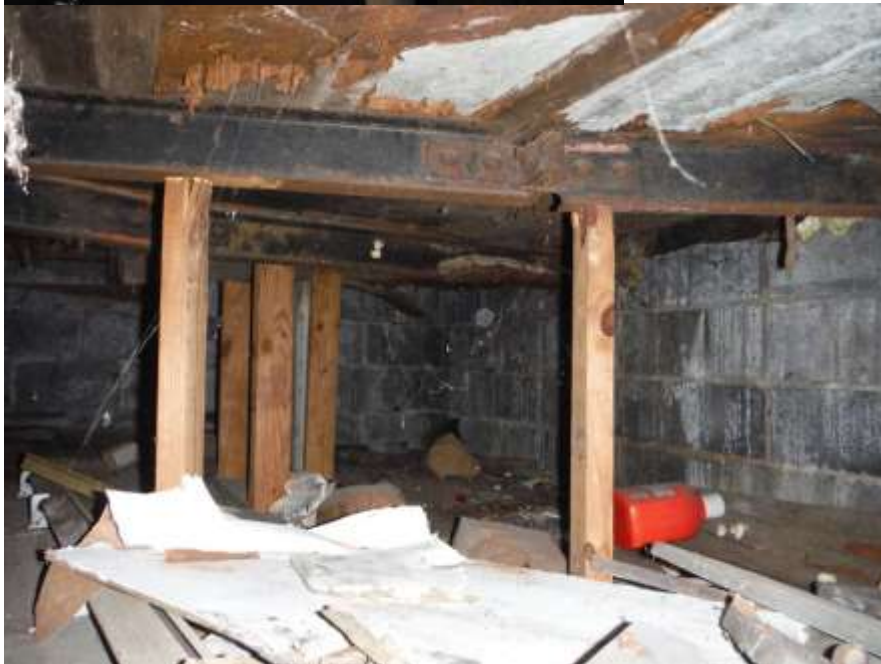
There was clutter/debris in front and rear crawl spaces. Repairs/patched or handyman (improper) visible in front crawl at opening; inaccessible.

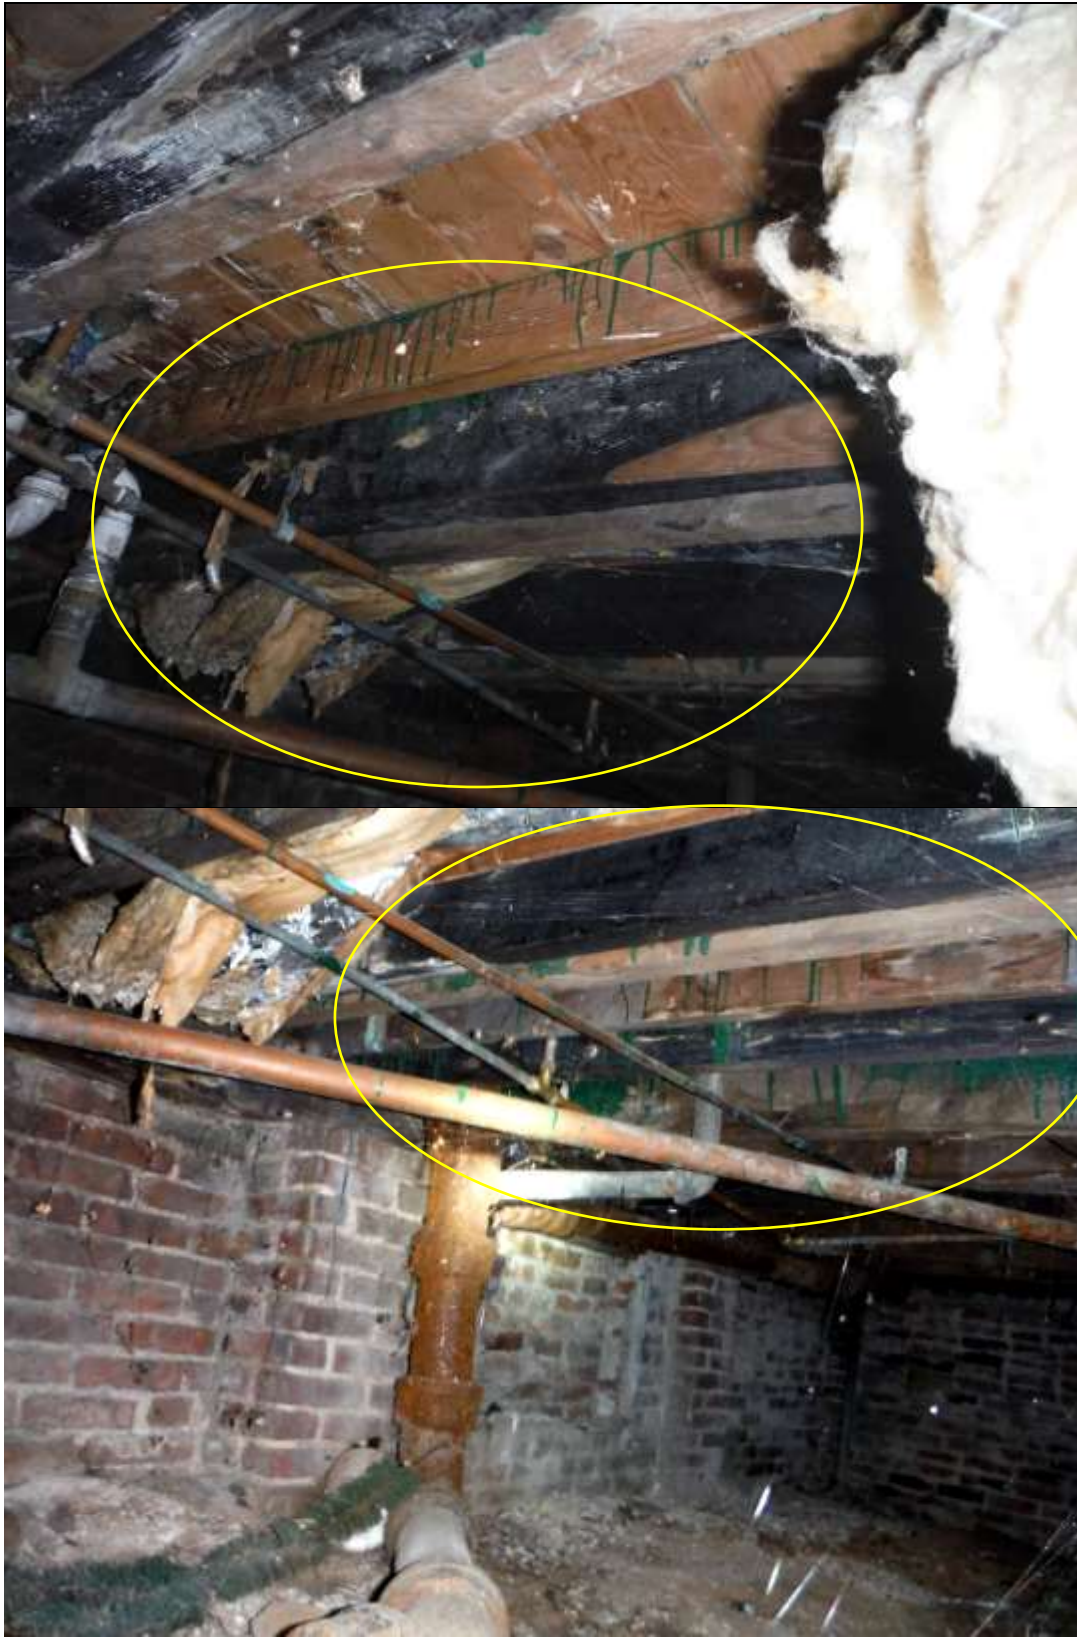
Figure 20 Examples of charred/fire damaged wood in rear crawl space. All structure must be evaluated by a **structural engineer (PE)** and advise on all repairs. Flooring was warped and spongy in the home. **Obtain all history for fire & water damage before closing.**

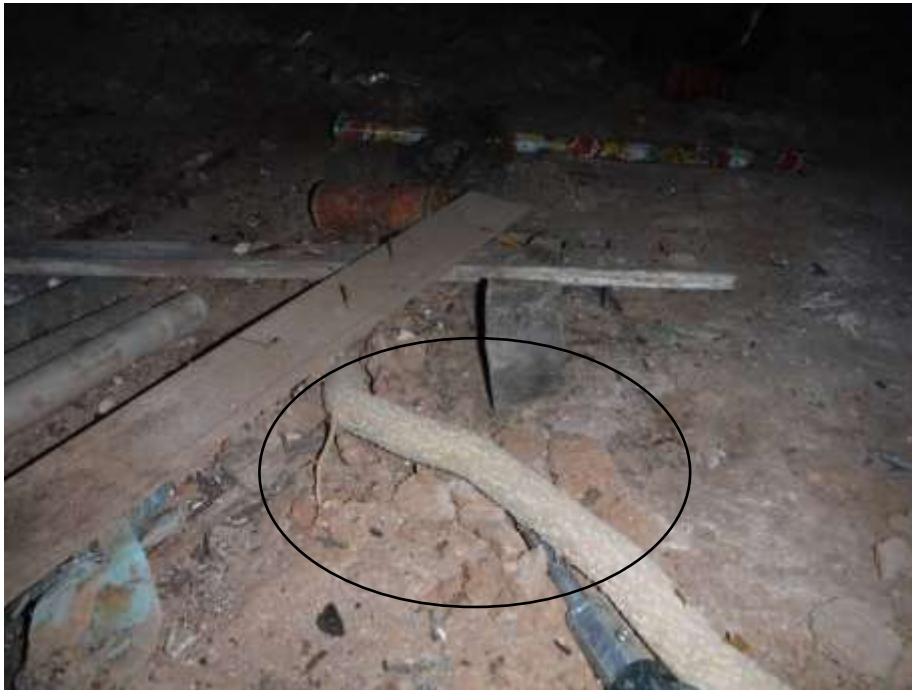
Figure 21 Tree roots, debris, nails/boards (unsafe) conditions.

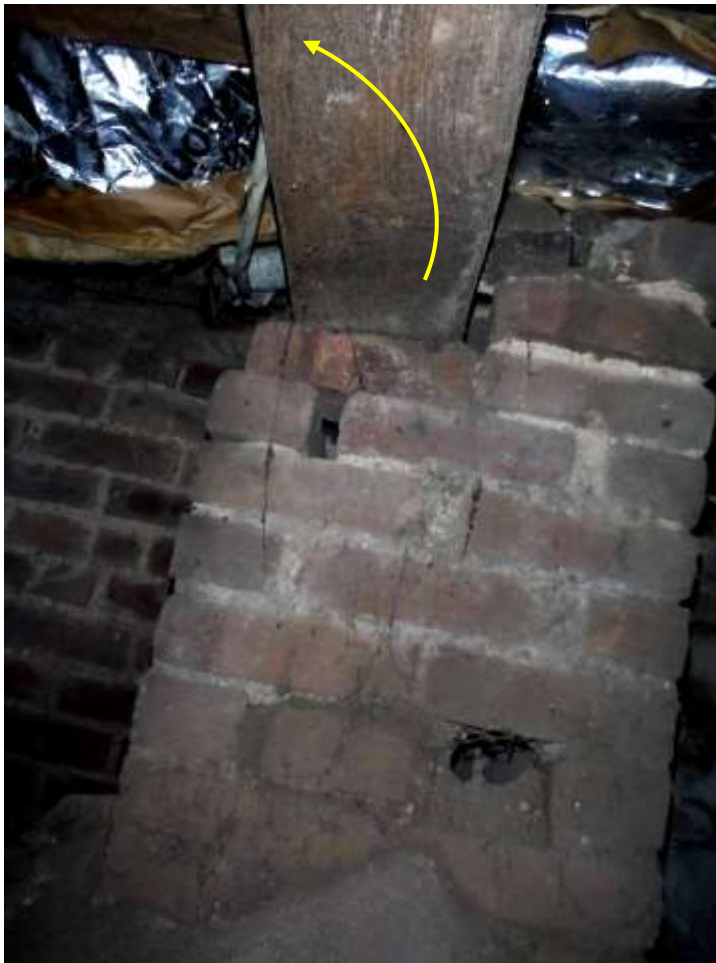
Figure 22 Damaged columns and warped framing (joists, beams, subflooring/flooring, etc.).

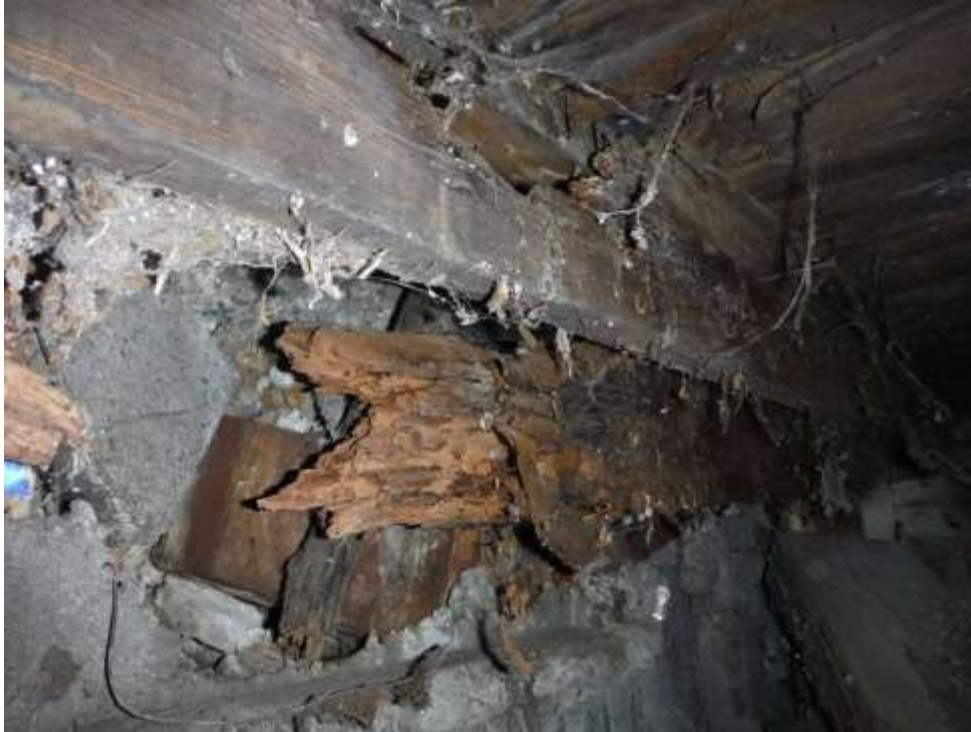
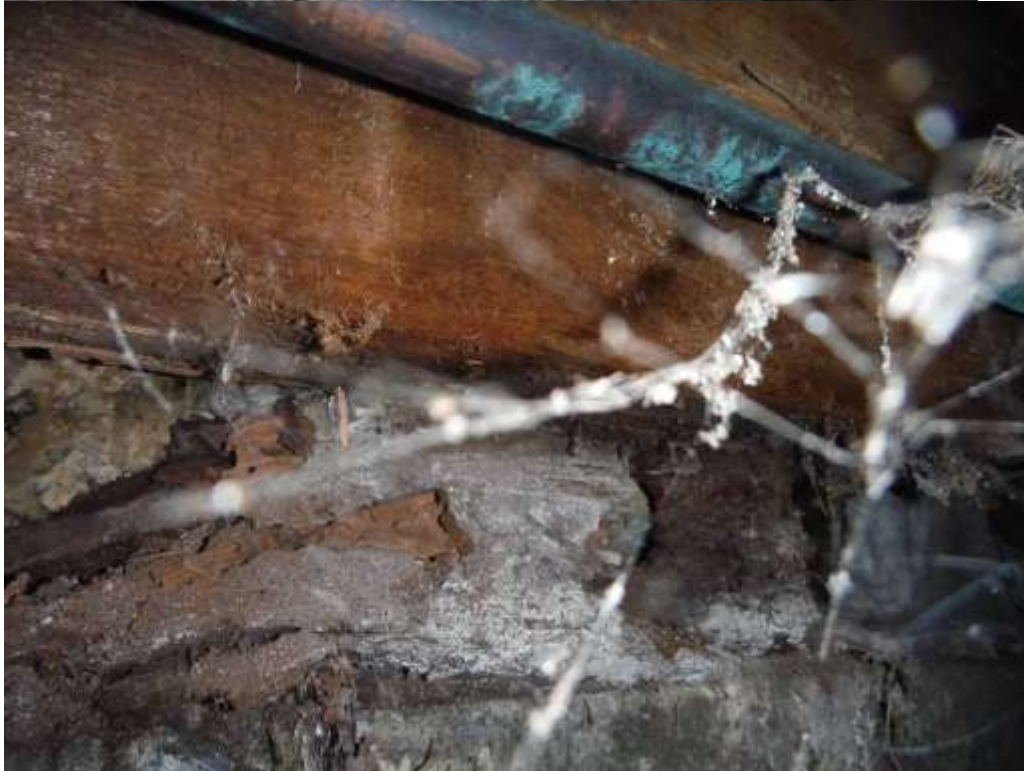
EXAMPLES OF WATER & WOOD DESTROYING INSECT DAMAGE: (wood boring beetle/powder post, termite and carpenter ant. There was warped/sloped, spongy flooring throughout the home. There was charred and sistered joists in the rear crawl space. **Obtain all fire history for the home.** Fire may have occurred a long time ago; check with the fire department or Boro records.

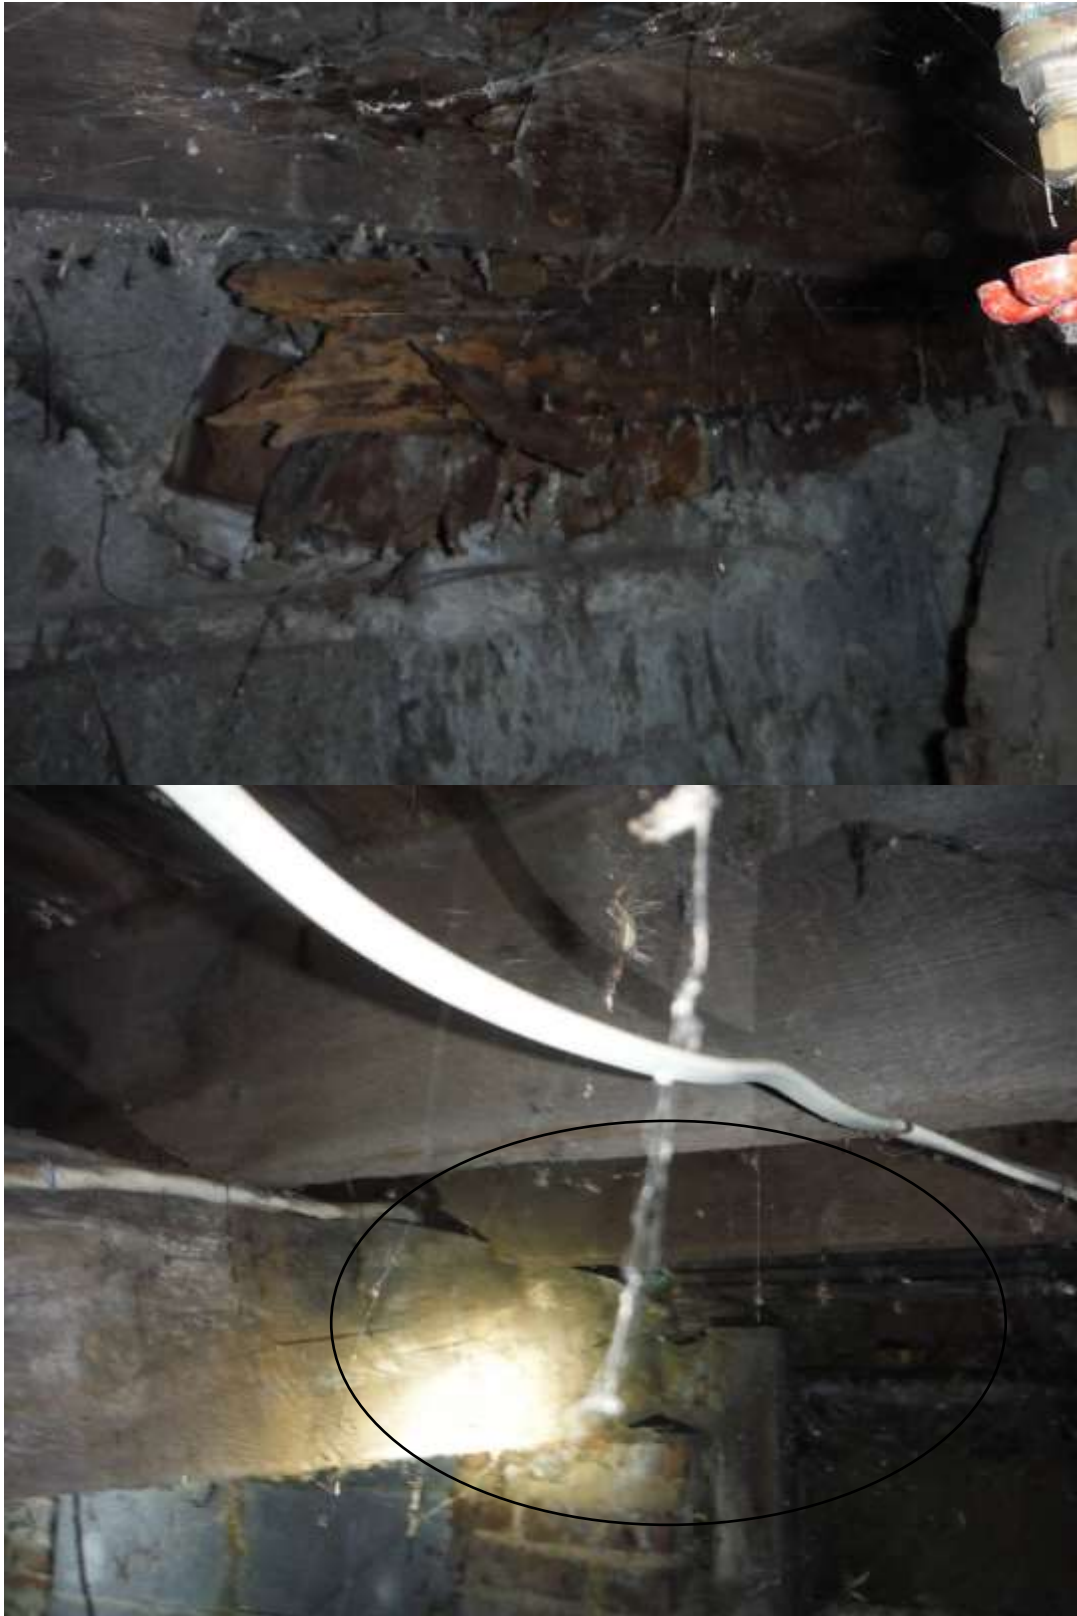
Figure 23 Example of column, girder and floor joist structure damage; extensive. Recommend a structural engineer (PE) and building contractor evaluate extent of water/mold/fire damage in the home. Sub flooring, joists and beams or framing breaking up when touched or probed. There is indication of water & fire damage in the home. Flooring in all floors were warped and spongy; concealed or inaccessible on upper levels.

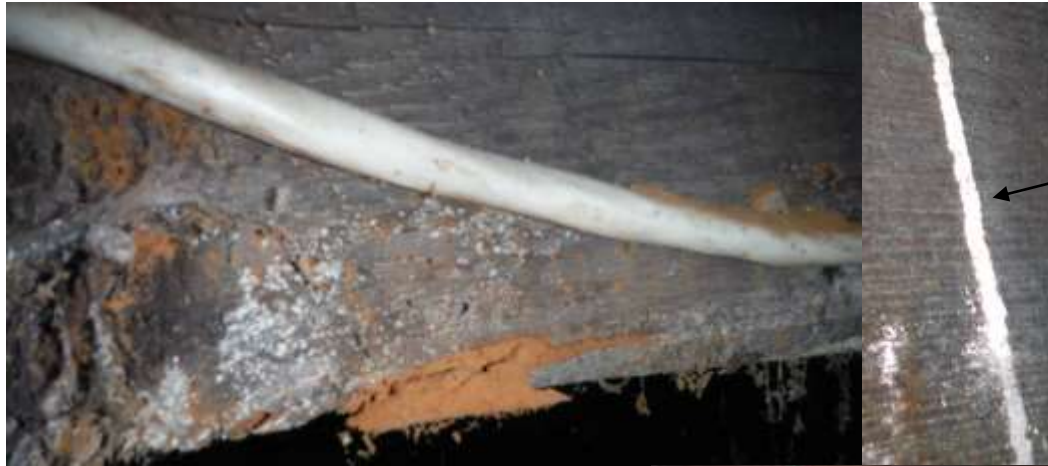
Example of Termite tube

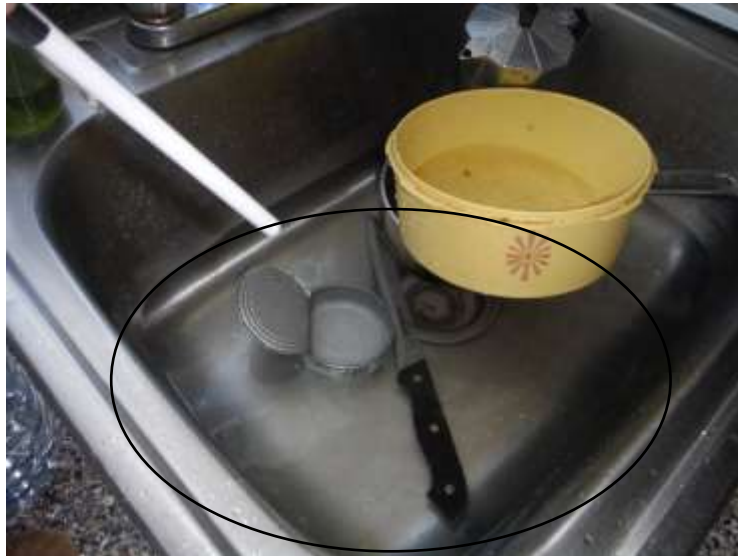
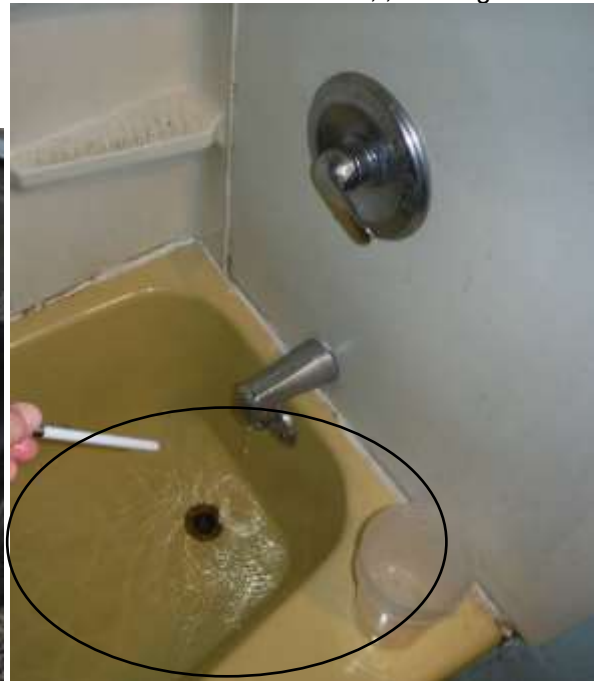
Figure 24 Examples of poor drainage in the home; backing up when water tested on fixtures.

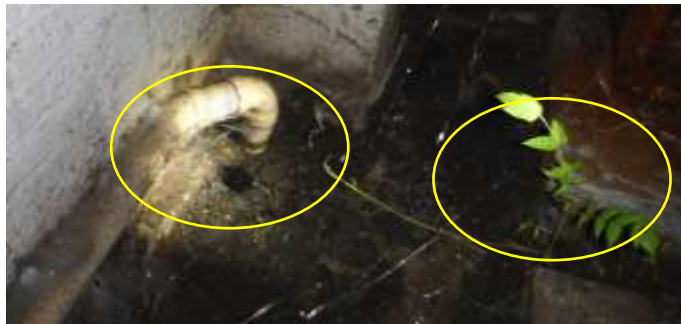
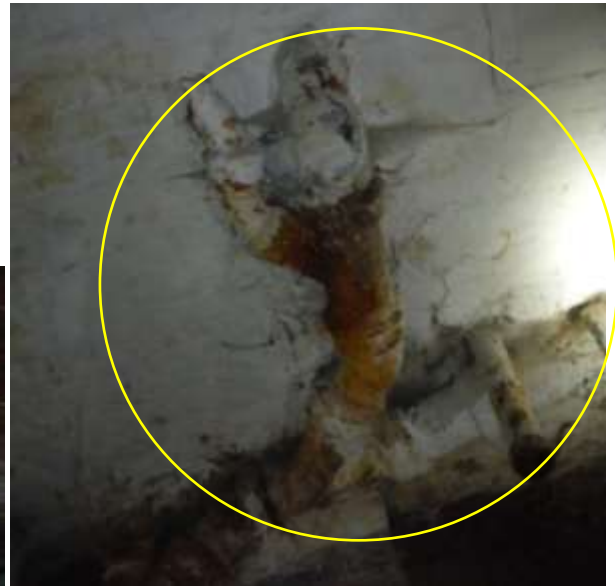
Figure 25 Plumbing drain goes into the basement floor; unknown of in sewer line or under slab. Recommend further evaluation. There was unconventional/improper plumbing and cut off & open sewer drains in the home. Basement & crawl spaces had wet conditions, dirt and plants growing out of floors.

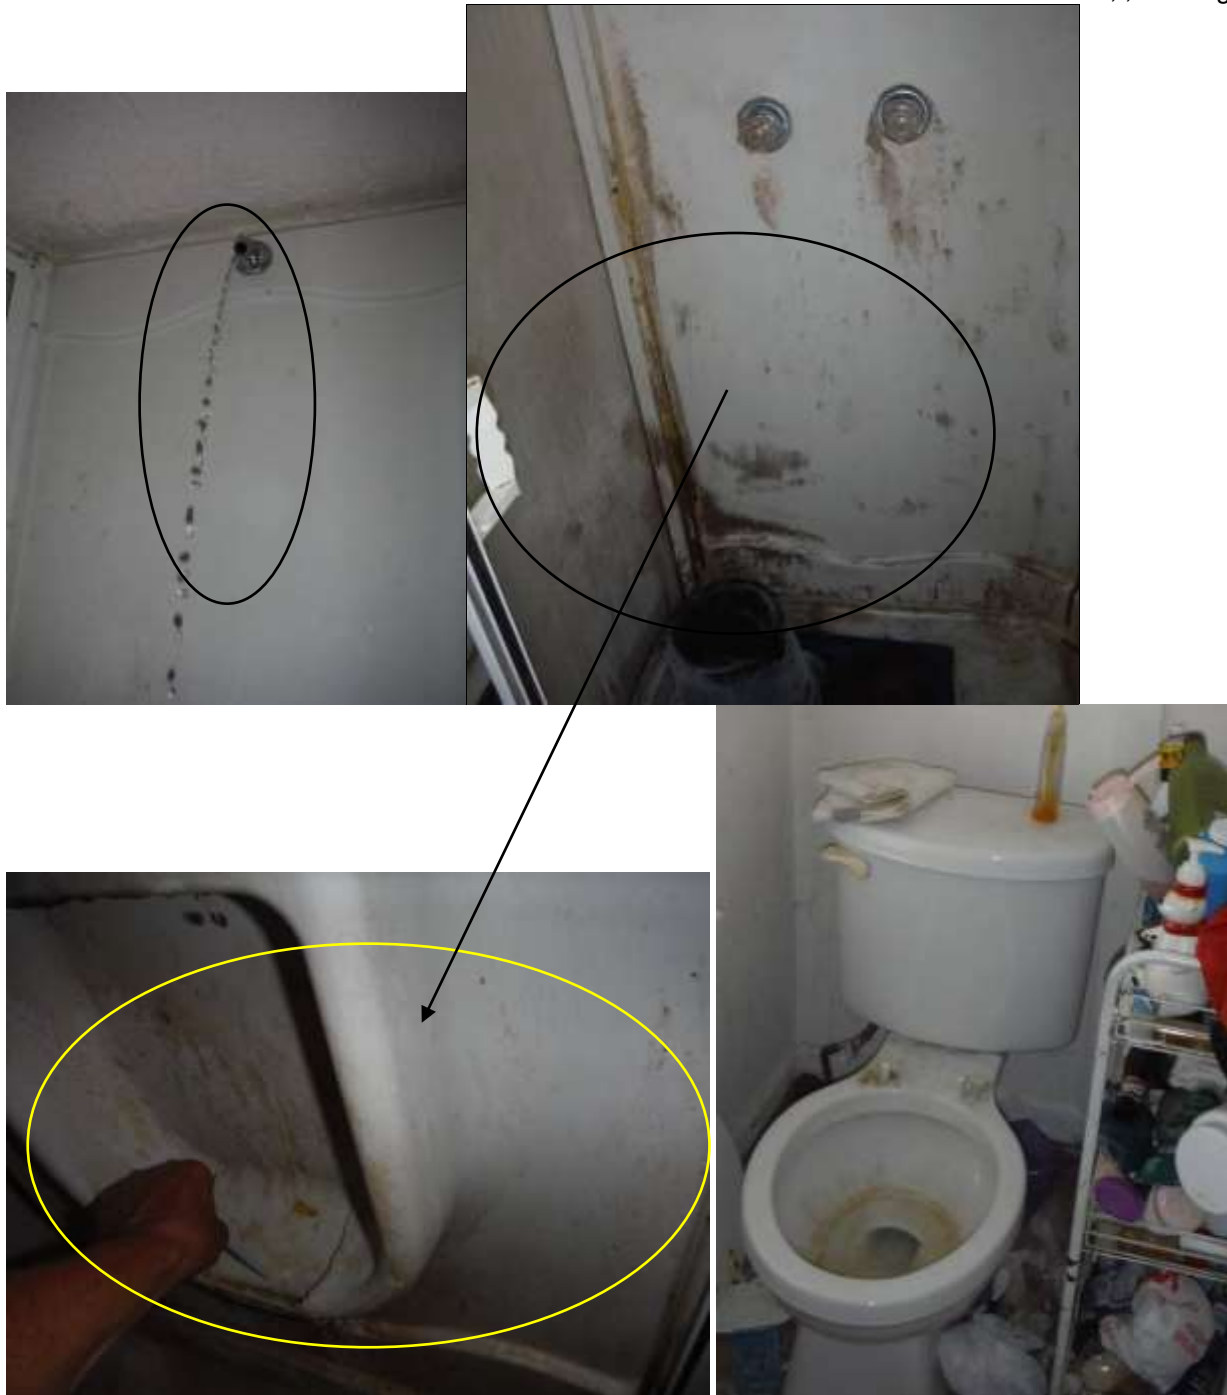
Figure 26 Unusable bathroom; need gutting, upgrades, plumbing & electrical in the home. Water damage, mold-like substances in the home. Recommend a mold contractor or environmental company evaluate all mold and asbestos and environmental substances; beyond the scope of a home inspection.

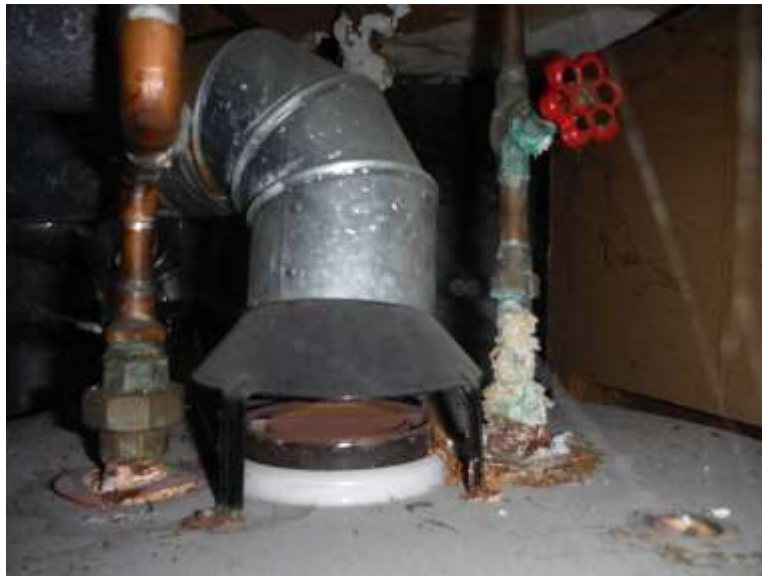
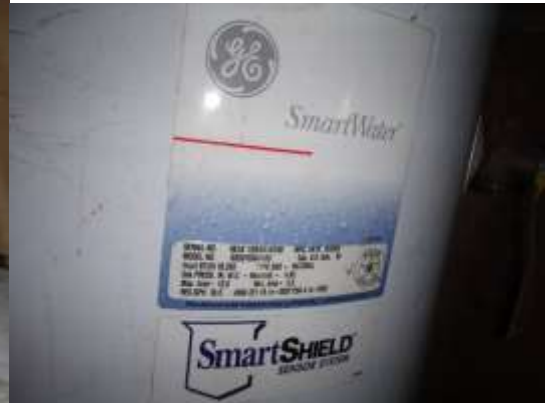
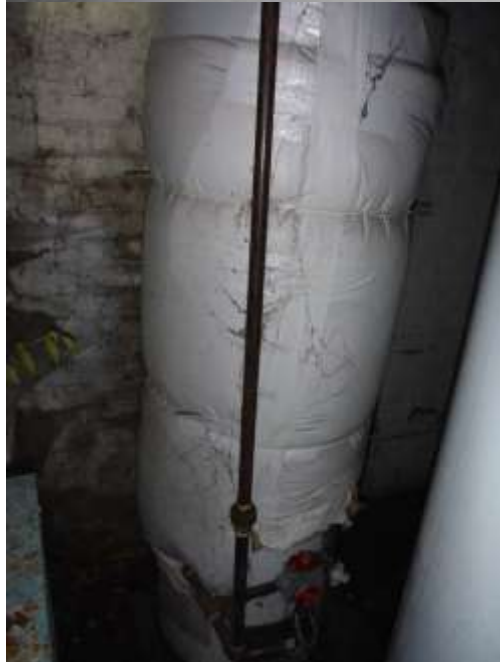
Figure 27 There was no hot water in the home at time of inspection. Water heaters and boilers were in poor/unsafe condition. Recommend a licensed plumber and boiler contractor evaluate all mechanicals for replacement. These must be replaced; dangerous condition.

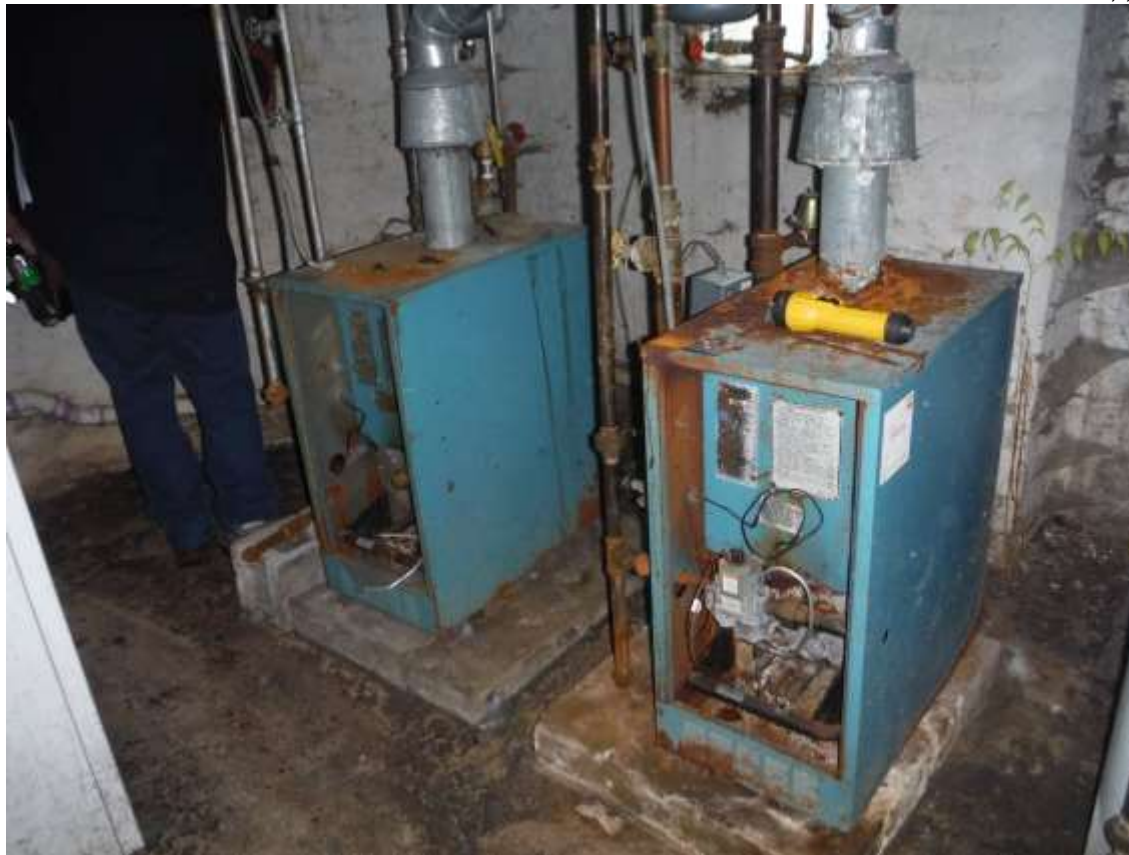
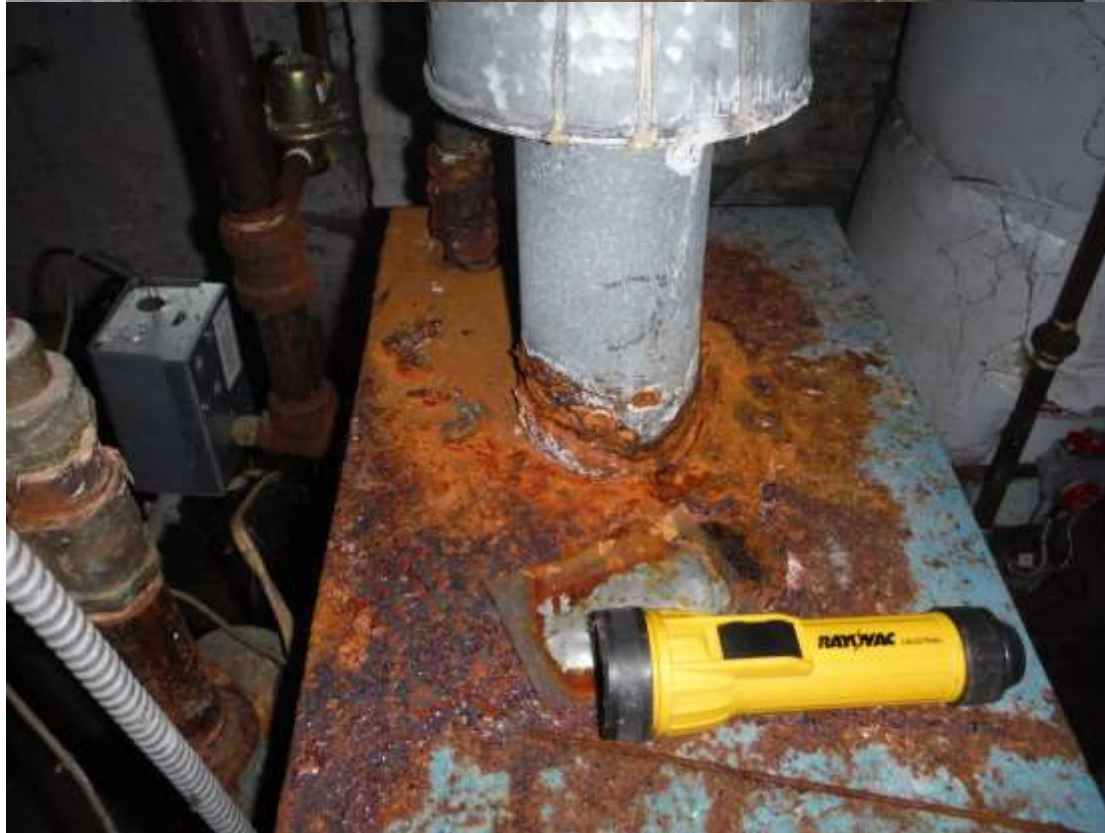
Figure 28 Boilers unsafe not tested/part removed/apart; unsafe/not functioning.

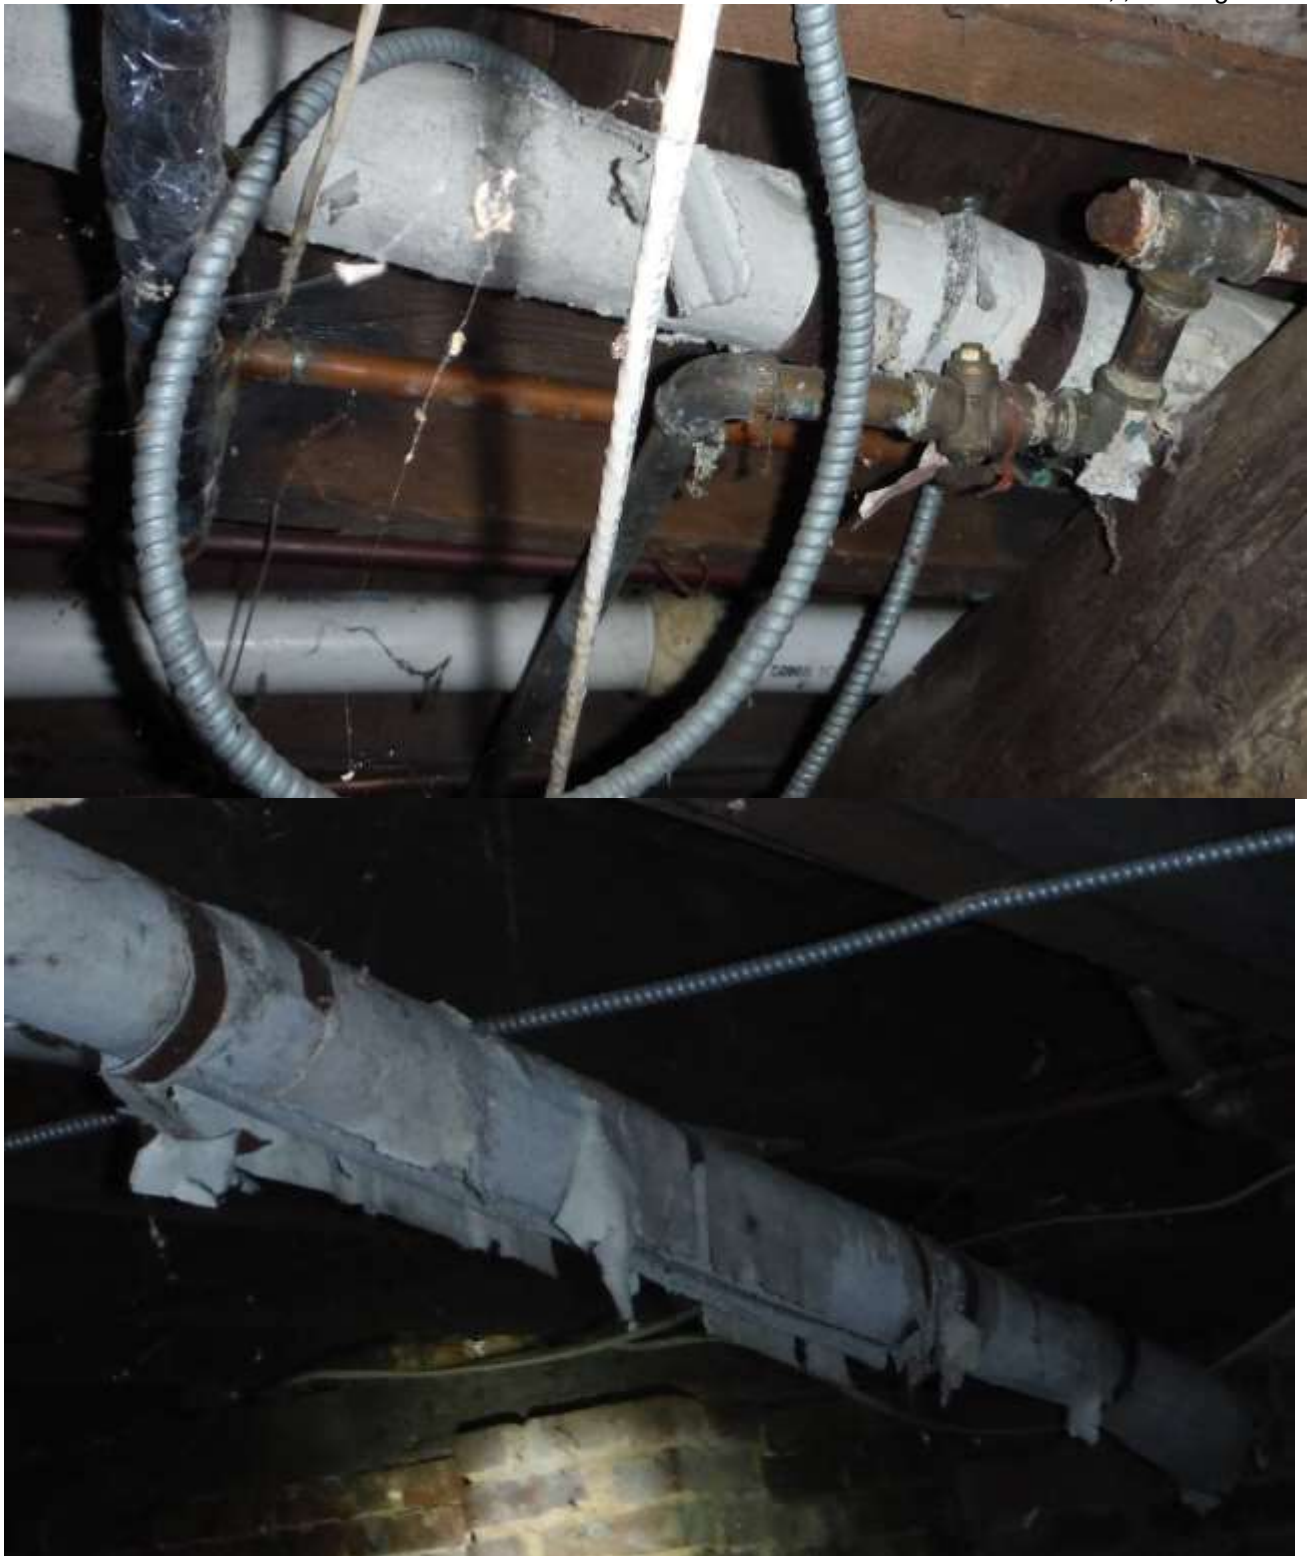
Figure 29 Example of white asbestos-like insulation on heating pipes in the home.

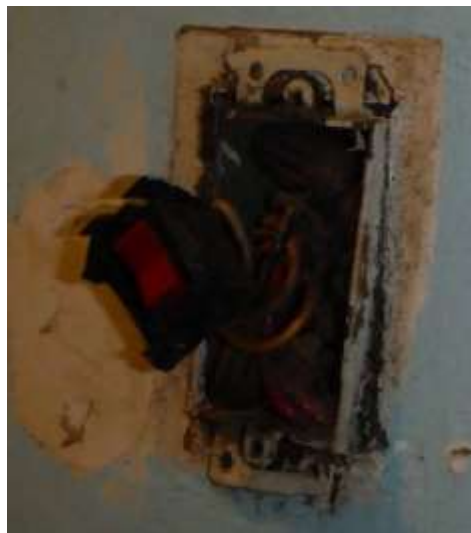
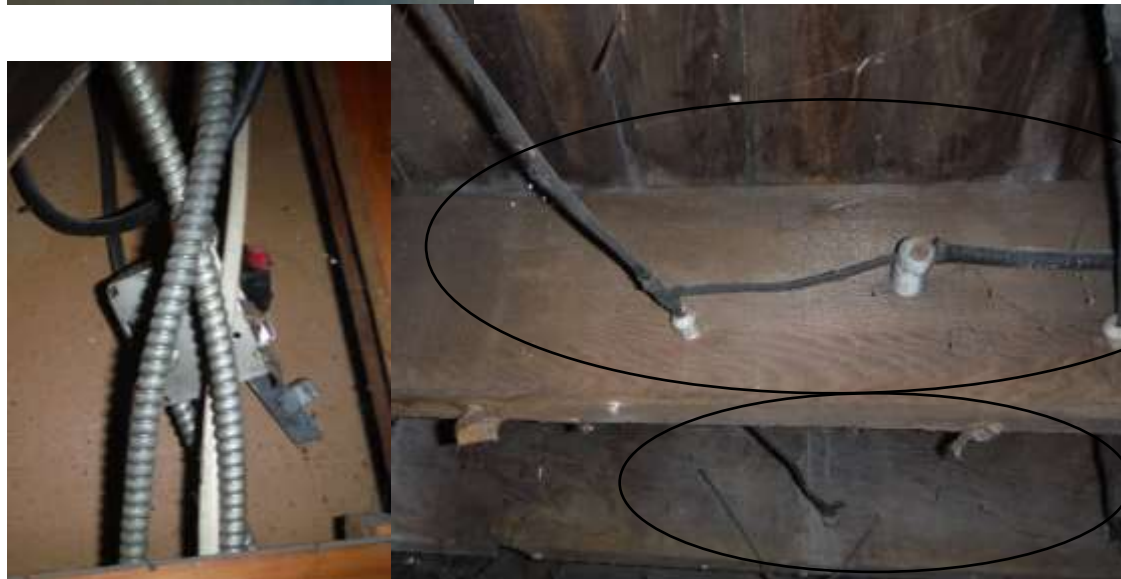
Figure 30 Examples of electrical concerns. See garage section comments.
