4 Seasons Home Inspection, LLC

150 Maple Avenue, #128, South Plainfield, NJ 07080
www.4SeasonsHI.com 1-877-547-7383

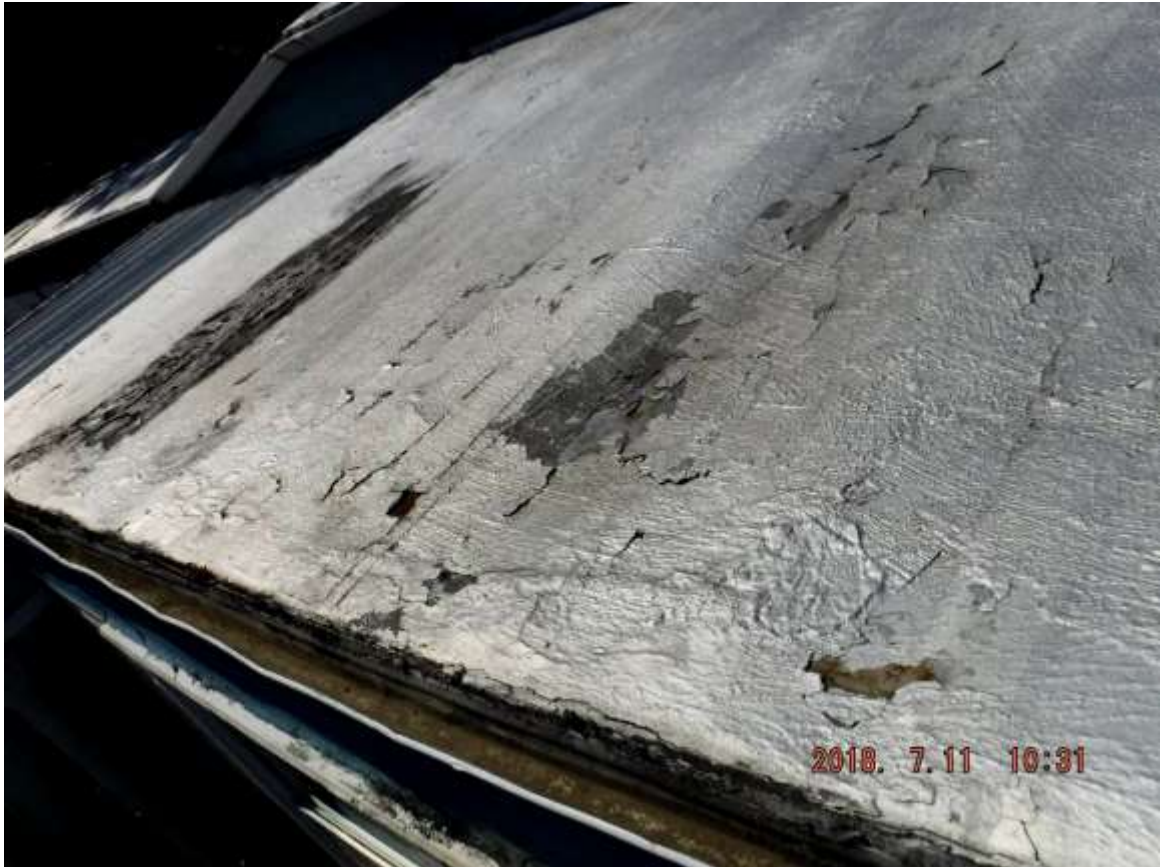
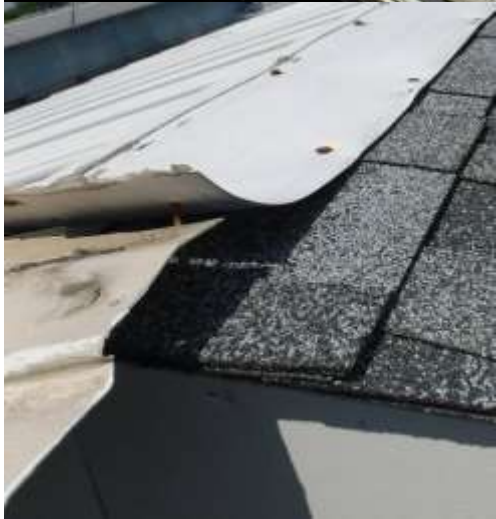
1. The roof was original to trailer home, integral to the top of trailer and in poor condition. There were cracks, uneven surfaces, flaked/peeled sliver paint, tarred/patched, gaps at roof/siding junctures & flashings (open for leaks), granular loss (asphalt shingles), plumbing vents too short & tarred, gutters in poor condition/bent/leaking, water stains/damage in ceiling/wall interior, etc. Recommend a qualified trailer/mobile home restoration contractor evaluate roof/gutters and advise on restoration of roof & add new gutters.

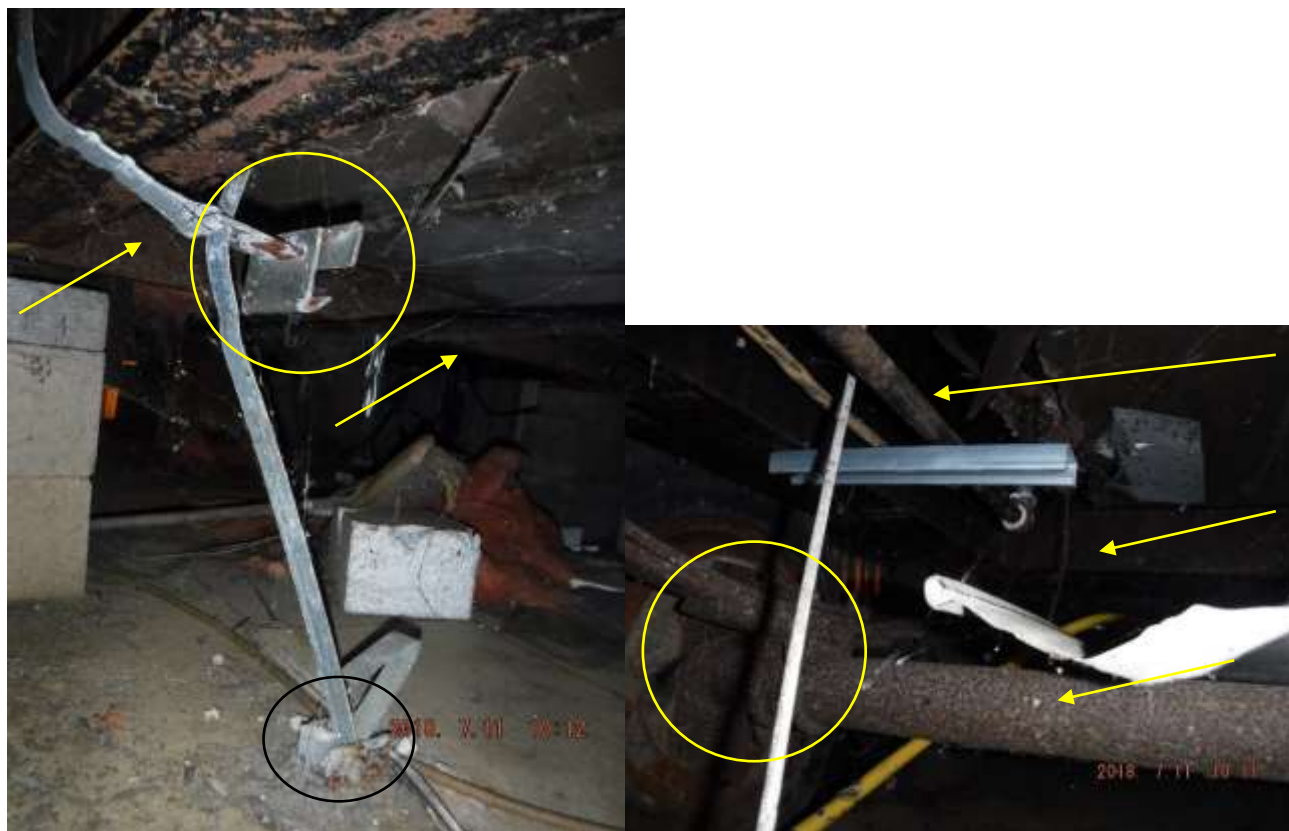
Figure 1 Examples of rust/corrosion, anchors not attached, loose or slack on tie downs, chassis/frame, wheels/axels, etc. Recommend having all anchors & tie downs evaluate/corrected or replaced where needed.

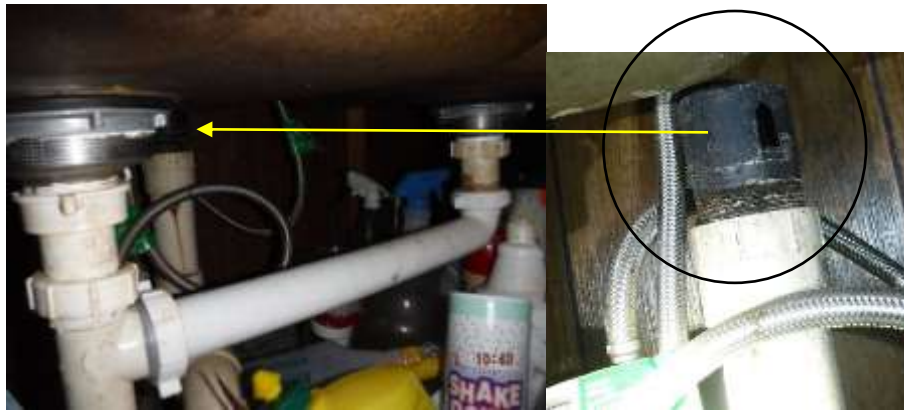
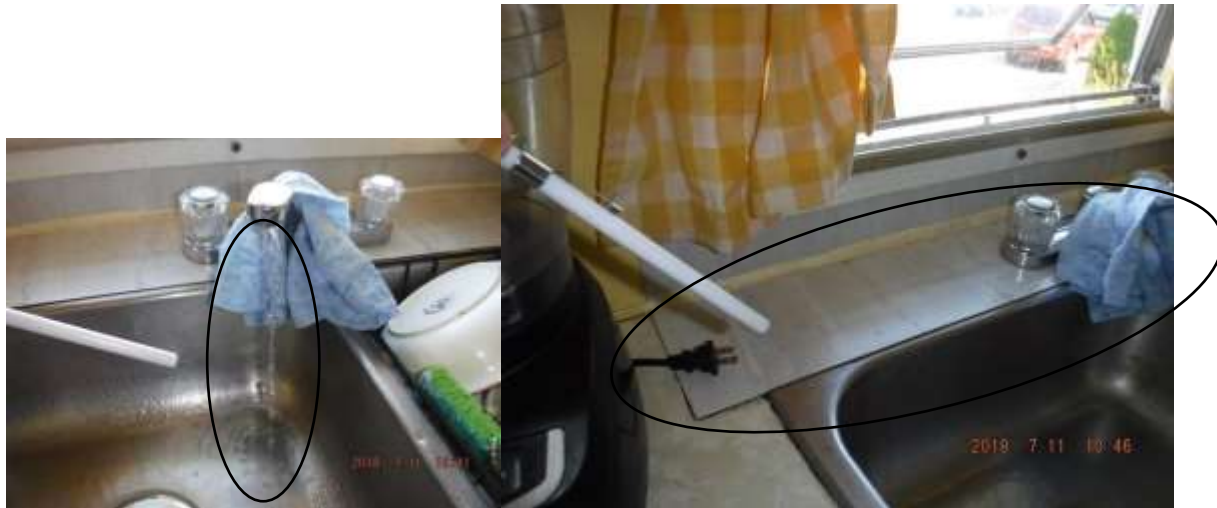
1. **Recommend a licensed plumber evaluate the air admittance valve/water stains/if allowed by local authorities, drainage, water pressure/flow, leaks, corrosion, extent of water damage to flooring or concealed damage and advise on all plumbing repairs/upgrades and damage repairs before closing & contractual limitations.**
2. **There were structural concerns or defects observed; sloped, uneven, wavy, movement, etc. in the flooring when walked upon. See plumbing section comments & photos.**
3. **Recommend replacing windows in the home; see window section comments.**

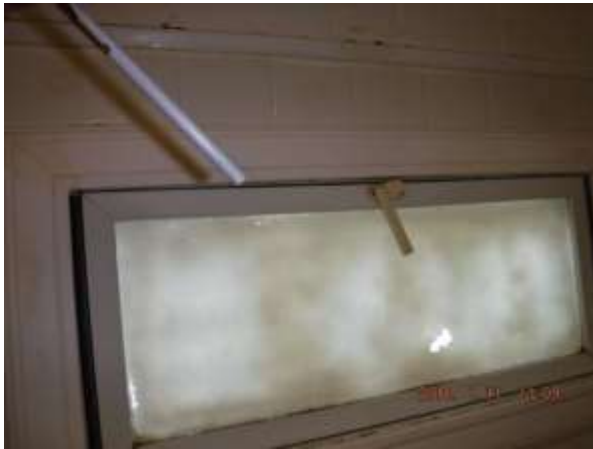
Figure 2 Warped window; not opening. See window section comments.

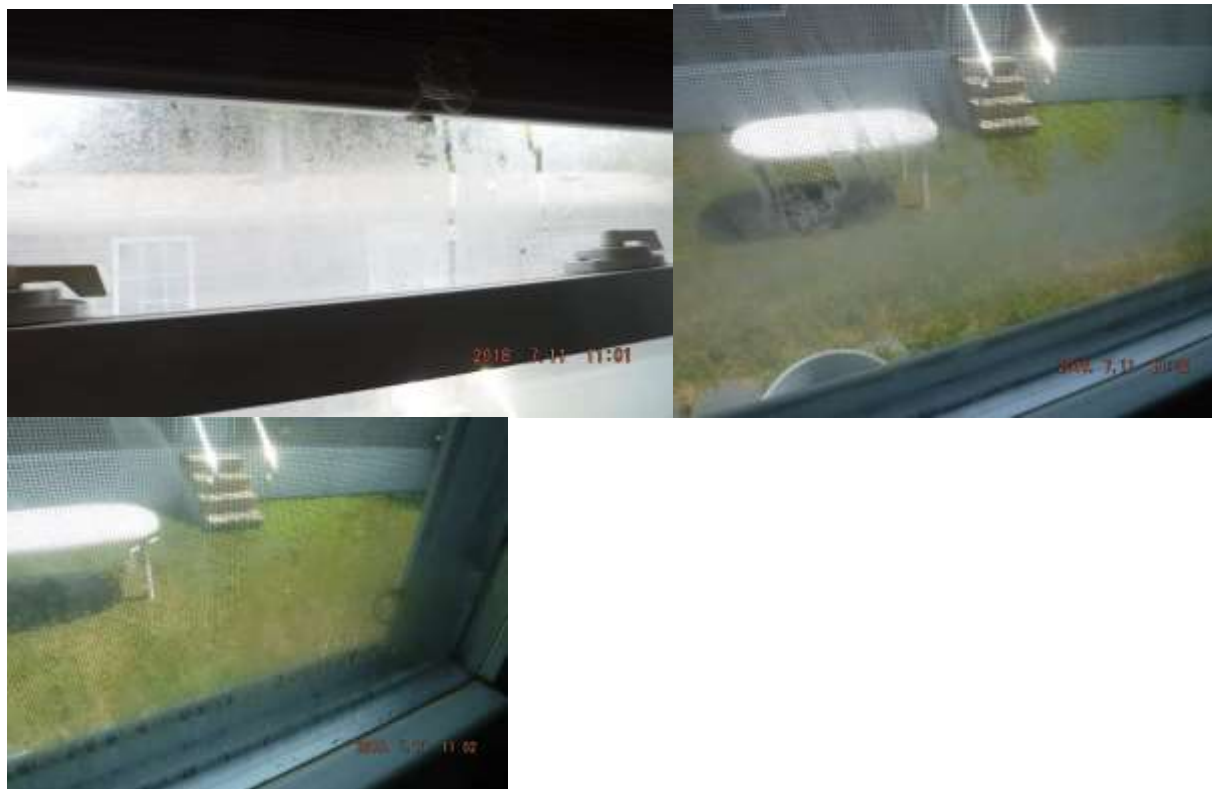
Figure 3 Example of vapor seal breaks; recommend replacing window in the home. See window section comments.

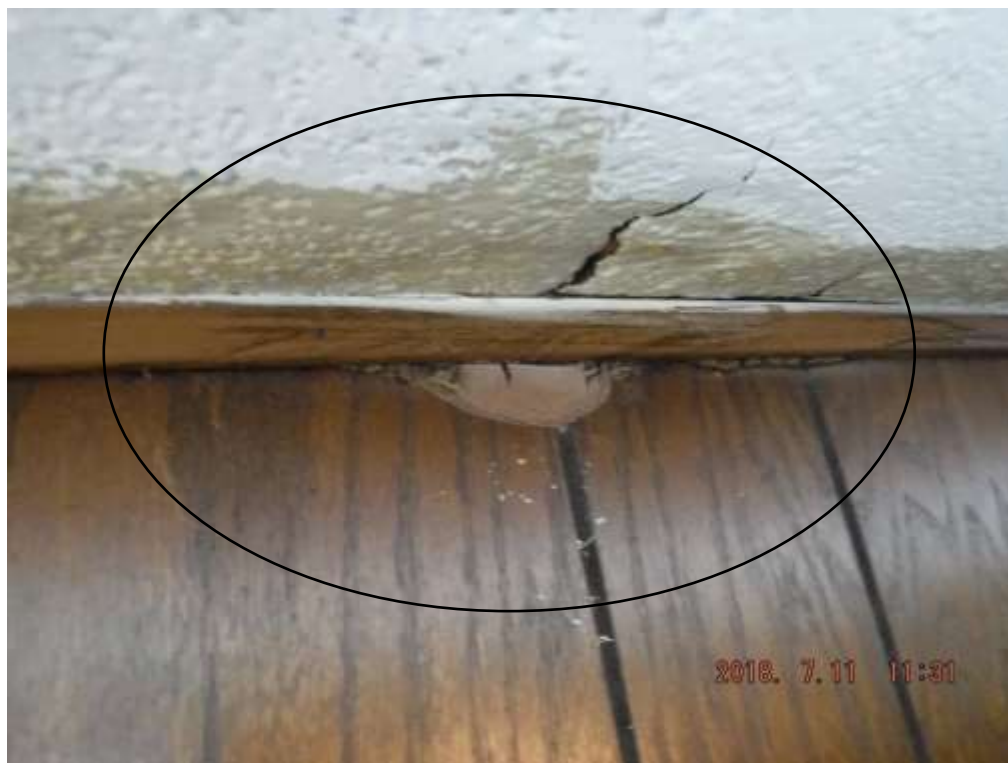
Figure 4 Water damage on ceiling/wall; see roof & exterior section comments.

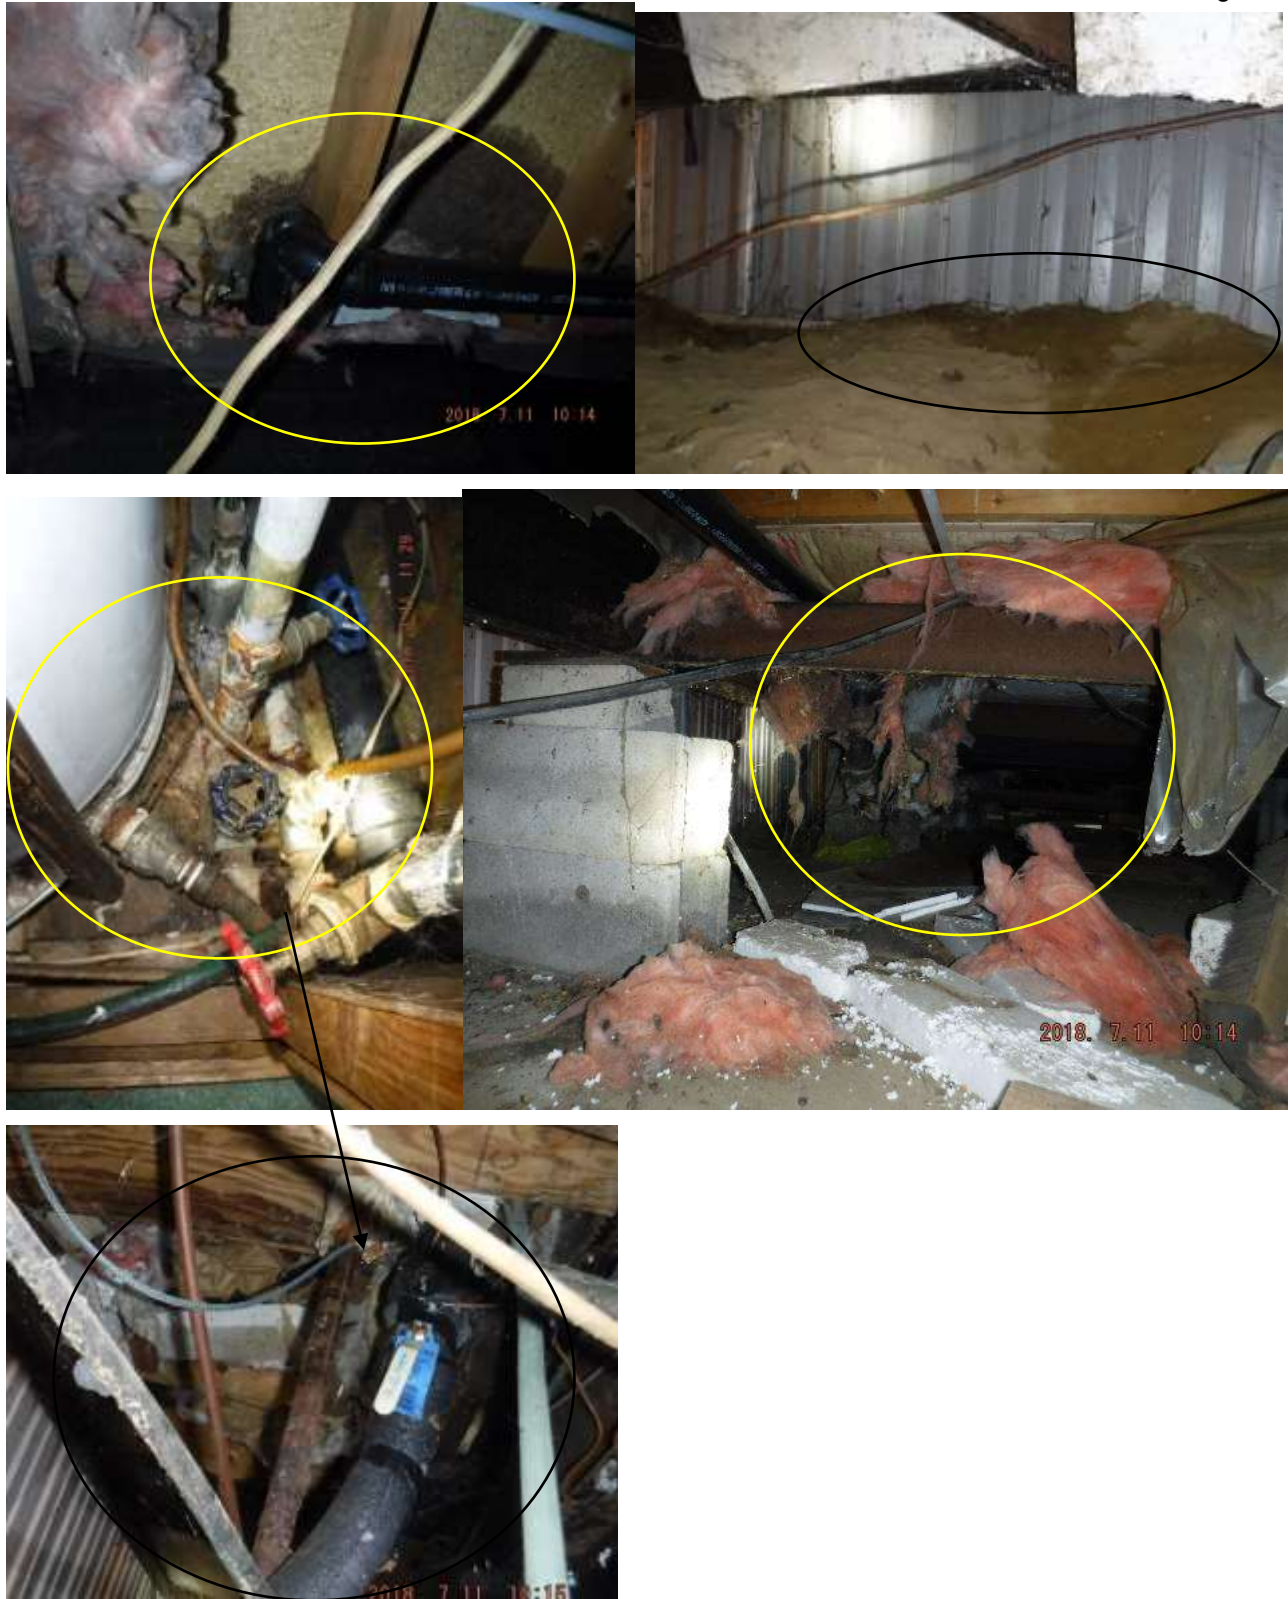
Figure 5 Examples of leaking/corroded plumbing and water stains & damage under the home on subflooring, insulation and fiberboard coverings. Mice droppings visible under home and in side home. Have all damaged repaired, holes sealed and plumbing repaired/replaced.

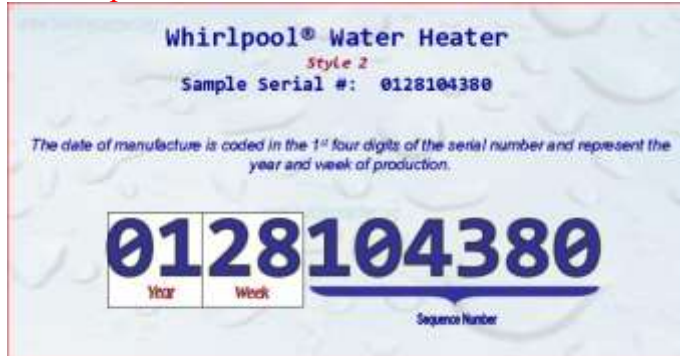
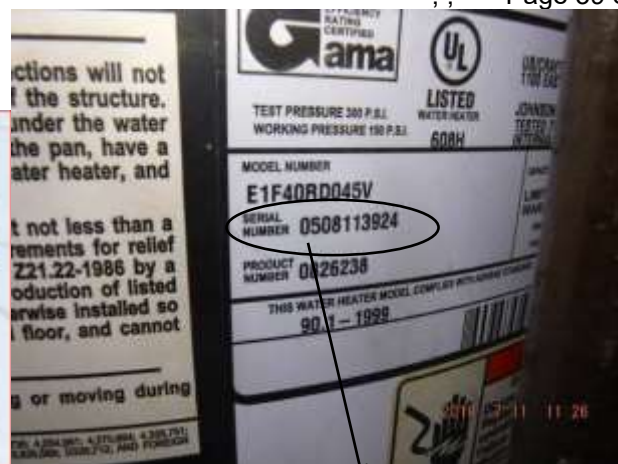
Figure 6 First two number represents year (example on blue label). The water heater in home was 2005 mfg. date or 13 yrs. old and a warranty on label of 6 yrs. Tank was in poor condition and should be replaced immediately.

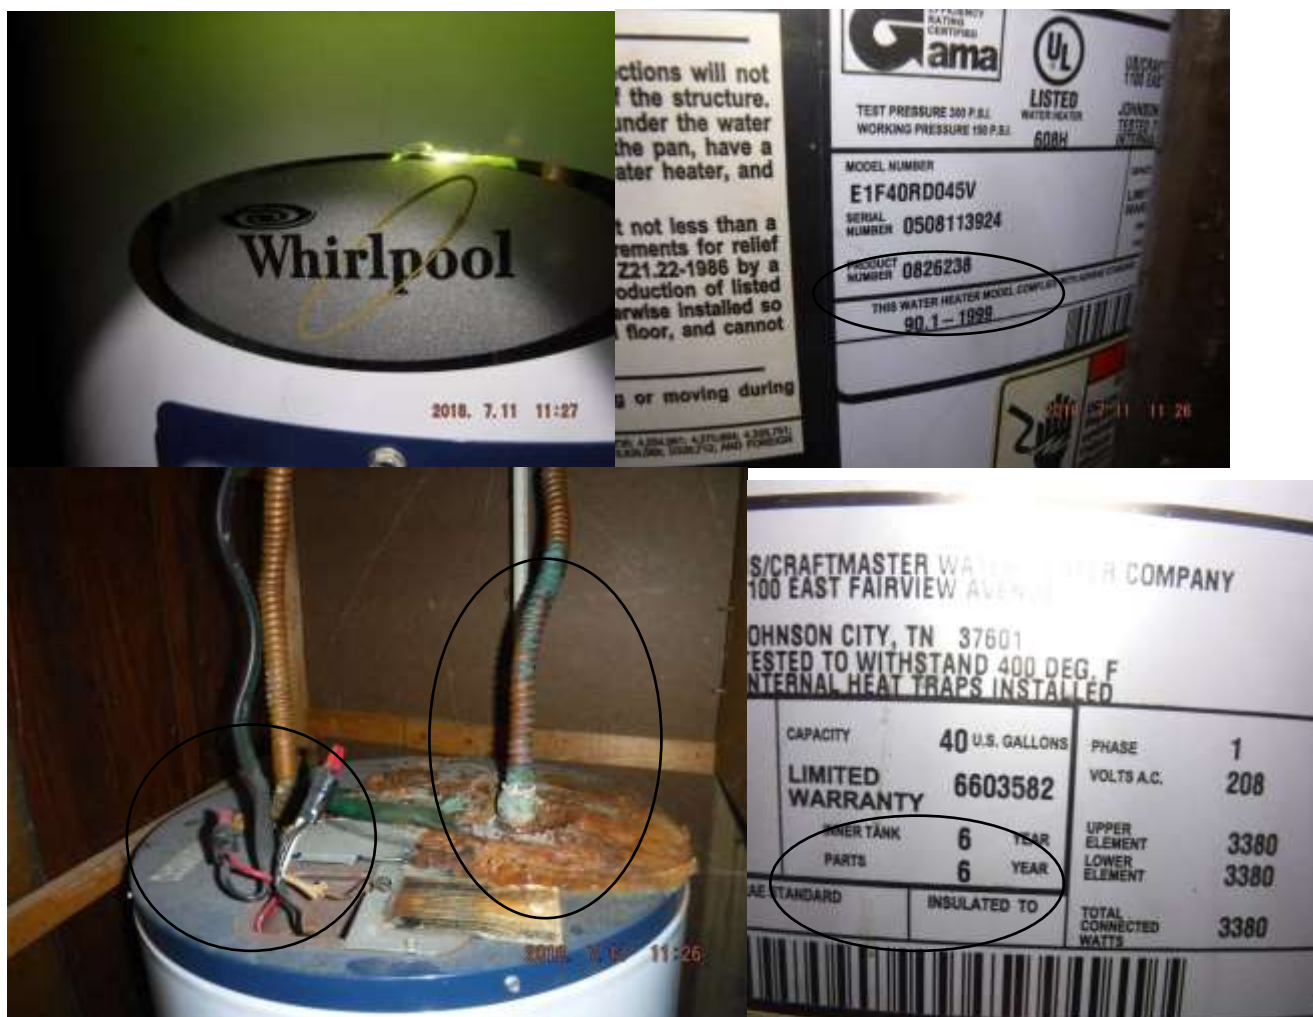
Figure 7 Whirlpool electric water heater in poor condition; electrical wires not recessed in top & covered (shock hazard), heavy corrosion on tank, flexible water lines & BX wiring

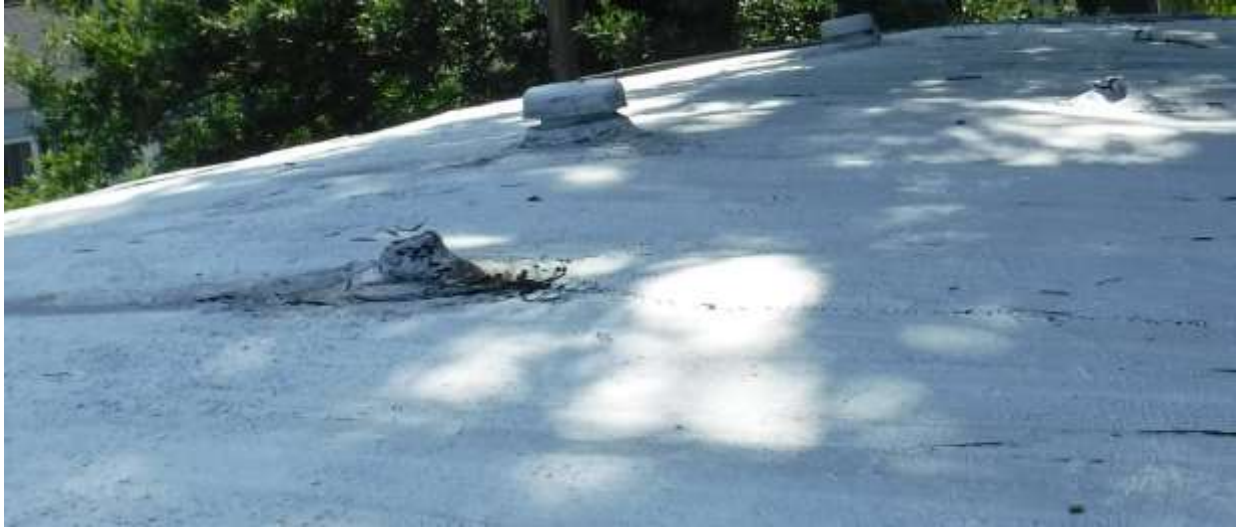
Figure 8 Very short plumbing vent(s); have plumbing vents and the air admittance valve (AAV) evaluated by a licensed plumber & advise on repairs and if AAV allowed by local authorities.

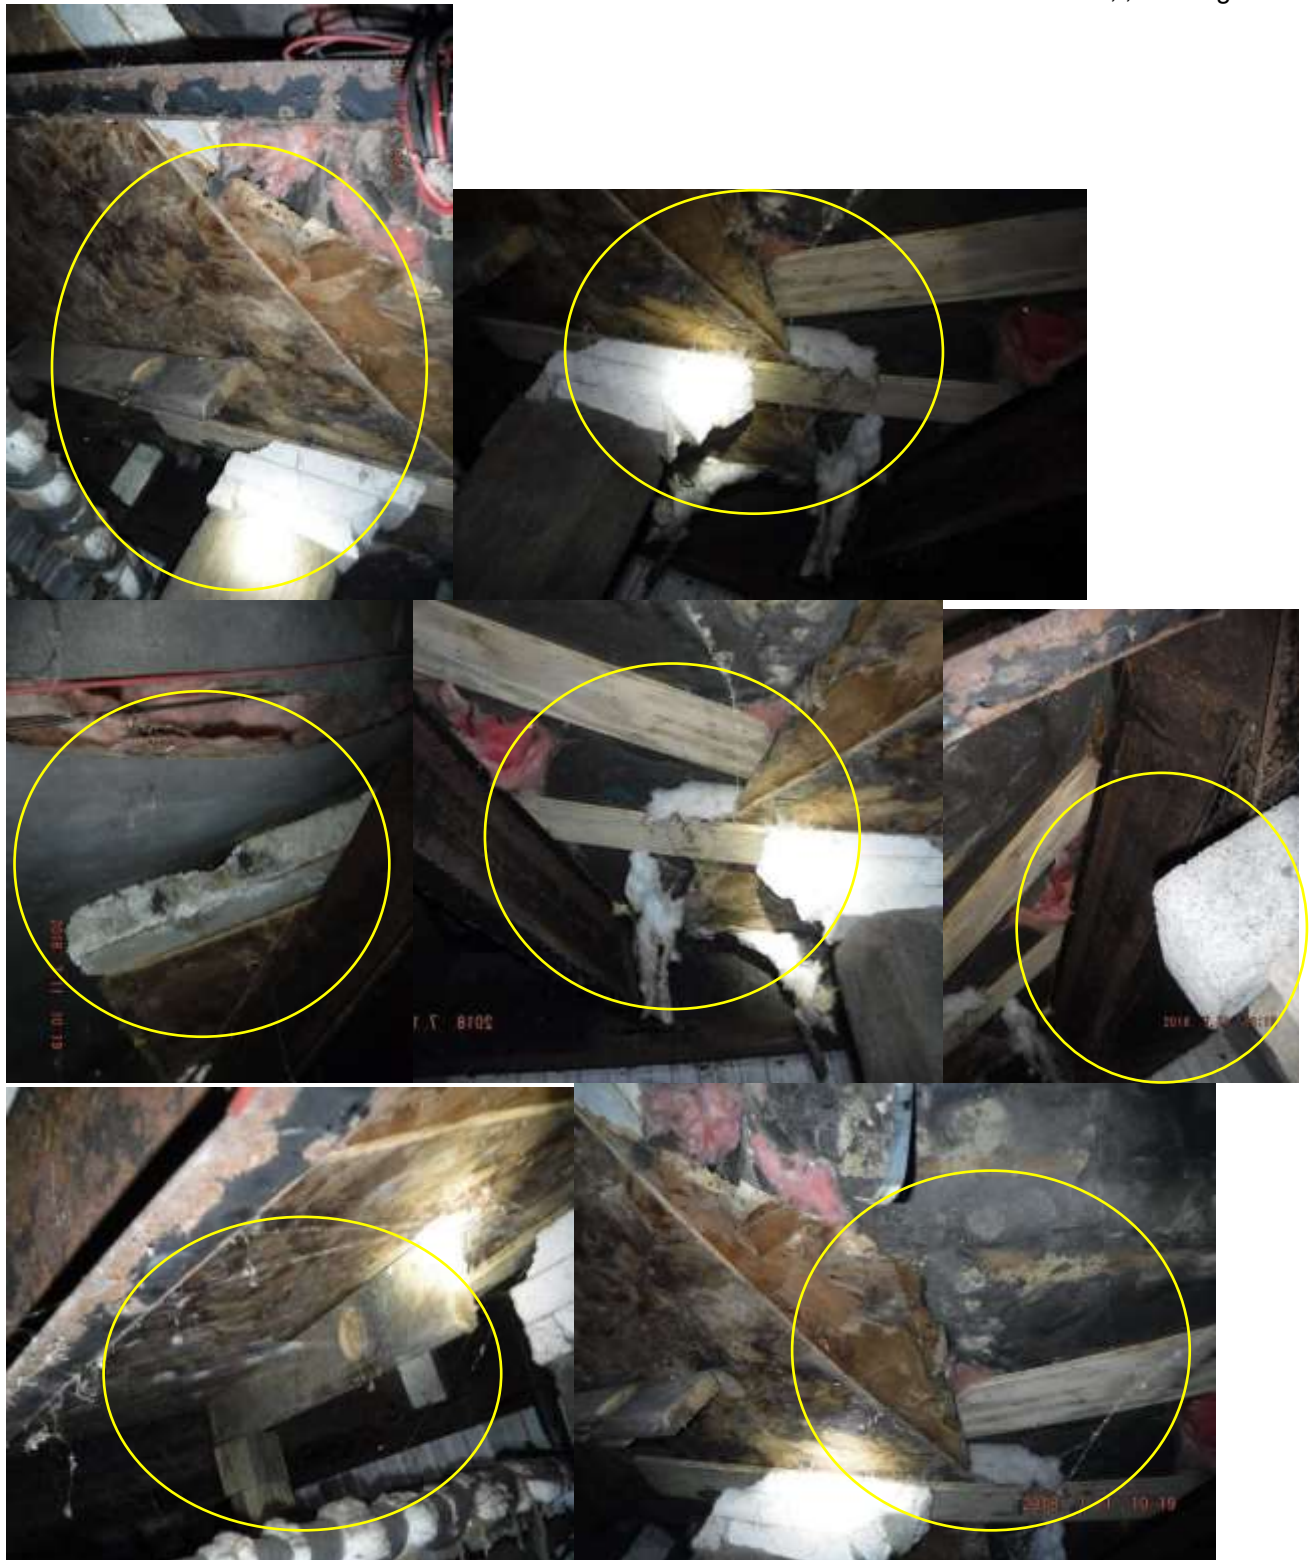
Figure 9 Examples of damaged sub flooring and/or floor joists/structure, dark mold like substances, shimmed with pieced or lumber or boards where sagging, etc.; structural concerns/defects.

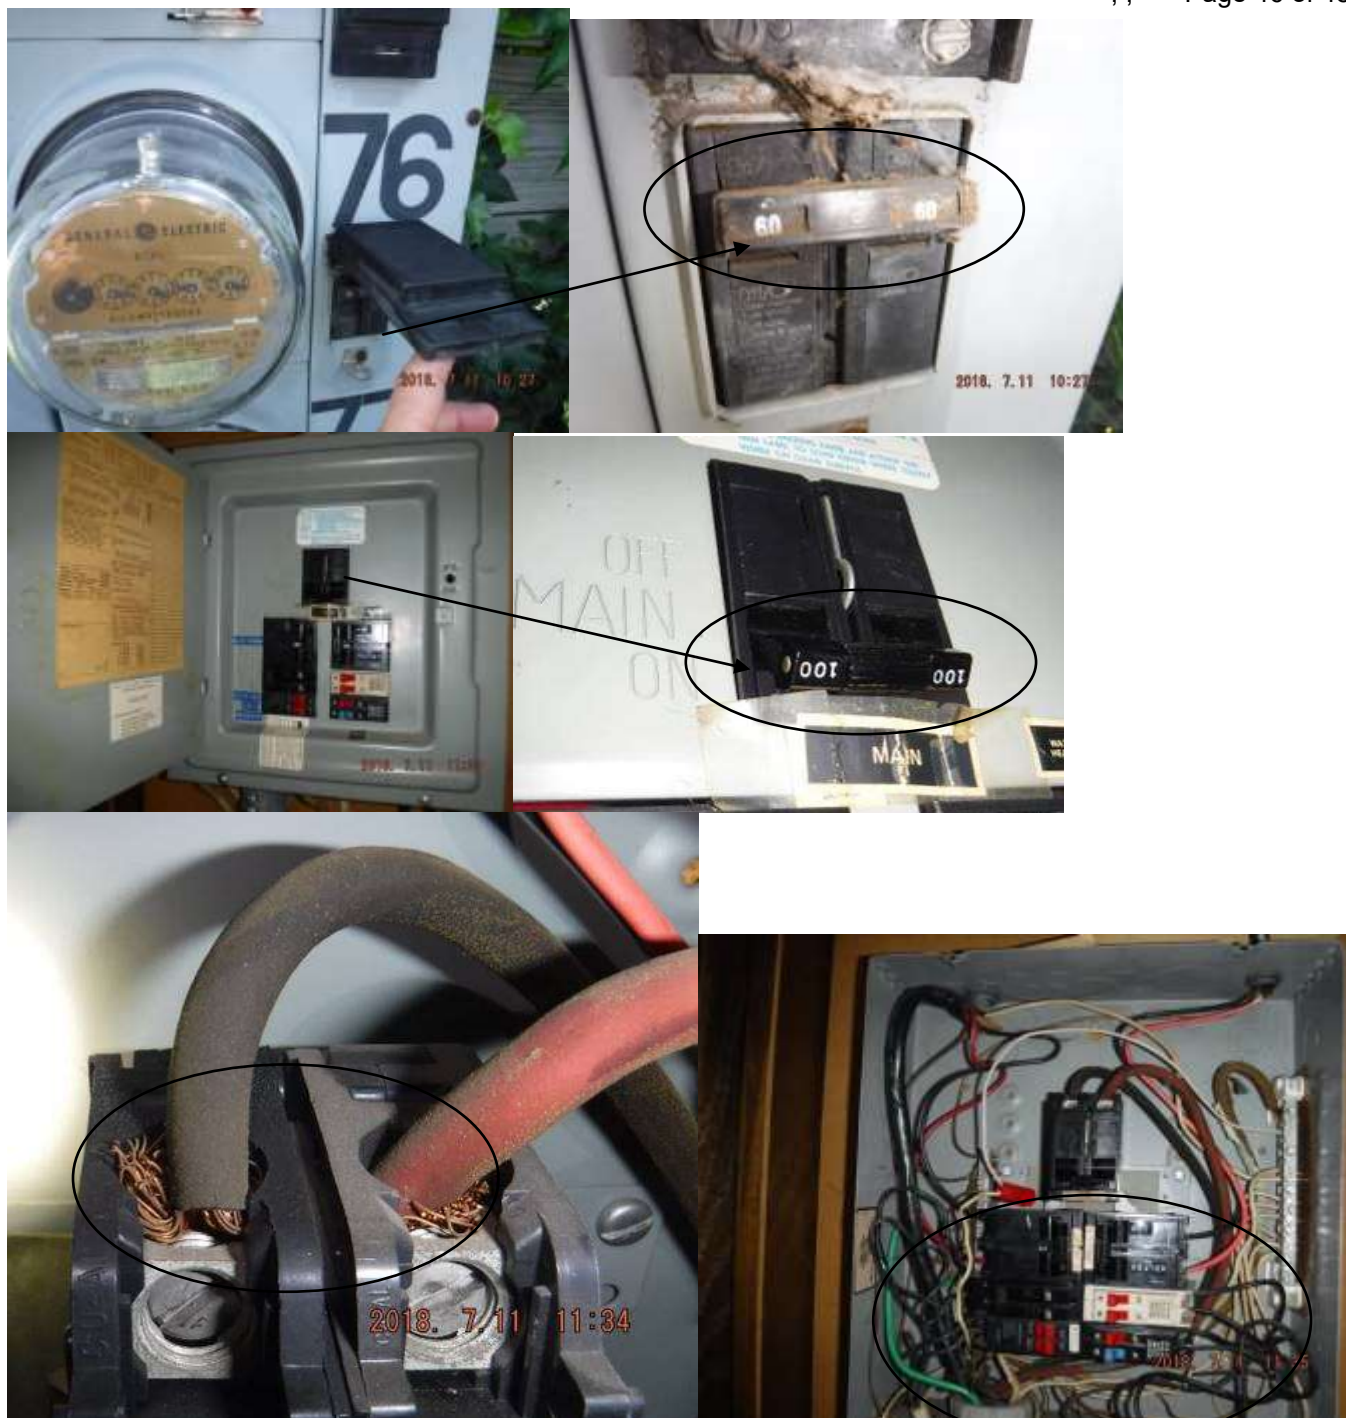
Figure 10 Sub panel was installed unconventional electrical practices; safety concerns.
