# 4 Seasons Home Inspection, LLC

1308 Centennial Avenue, Suite 160, Piscataway NJ 08854  
[www.4SeasonsHI.com](http://www.4SeasonsHI.com) 1-877-547-7383

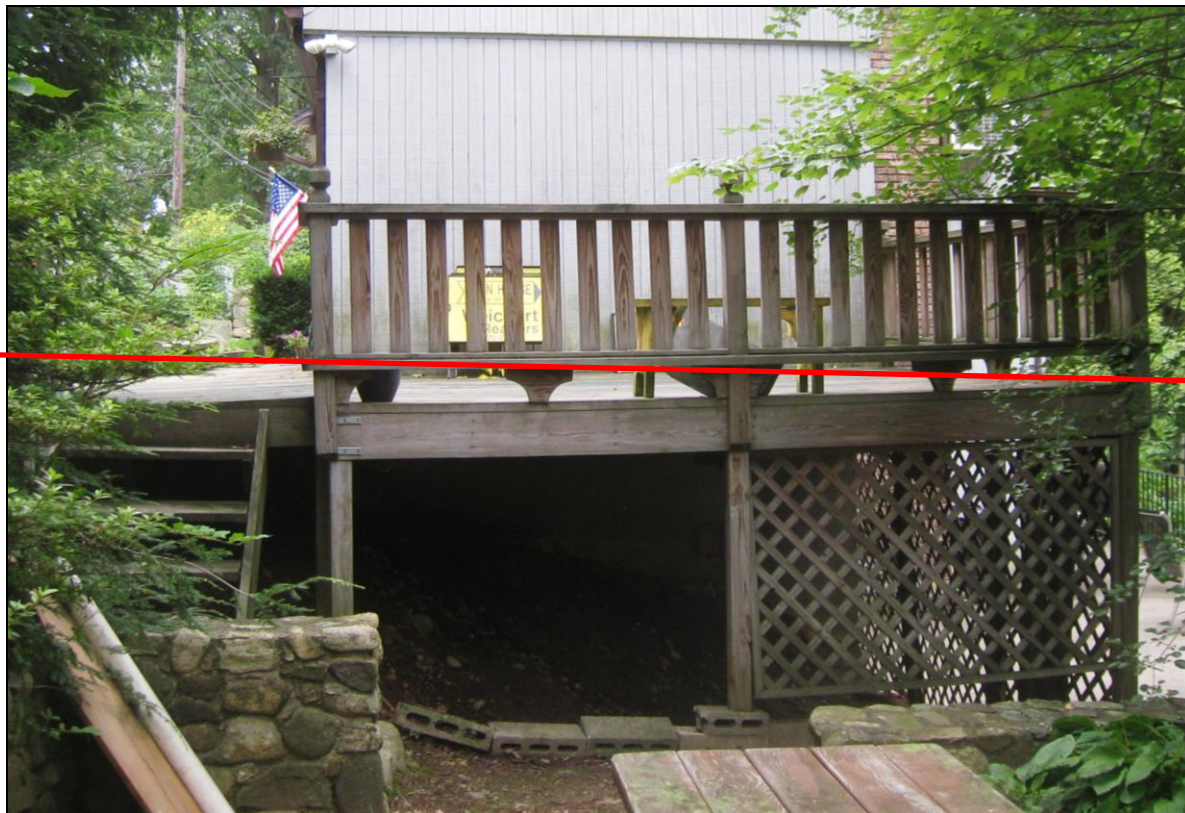
**Figure 1 Deck sloped, not properly attached to house, no flashings, no footings for vertical columns & steps, railings too low; unsafe structure.**

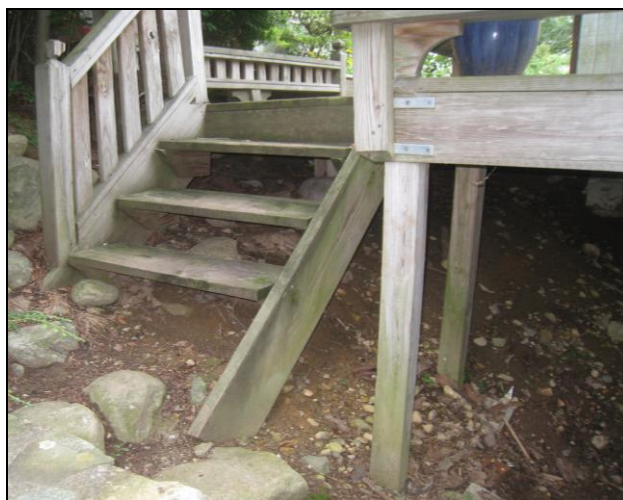
**Figure 2 Deck steps improperly supported/constructed.**

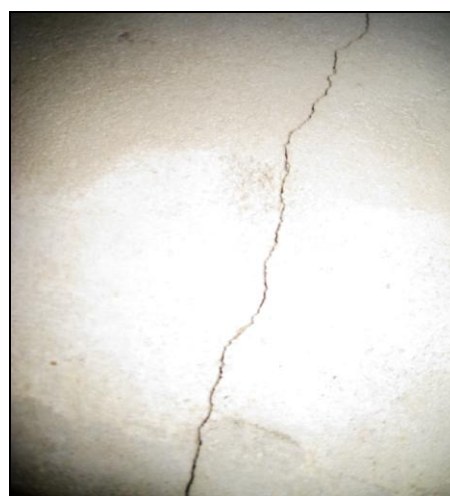
**Figure 3 Examples of foundation cracks; evaluate.**

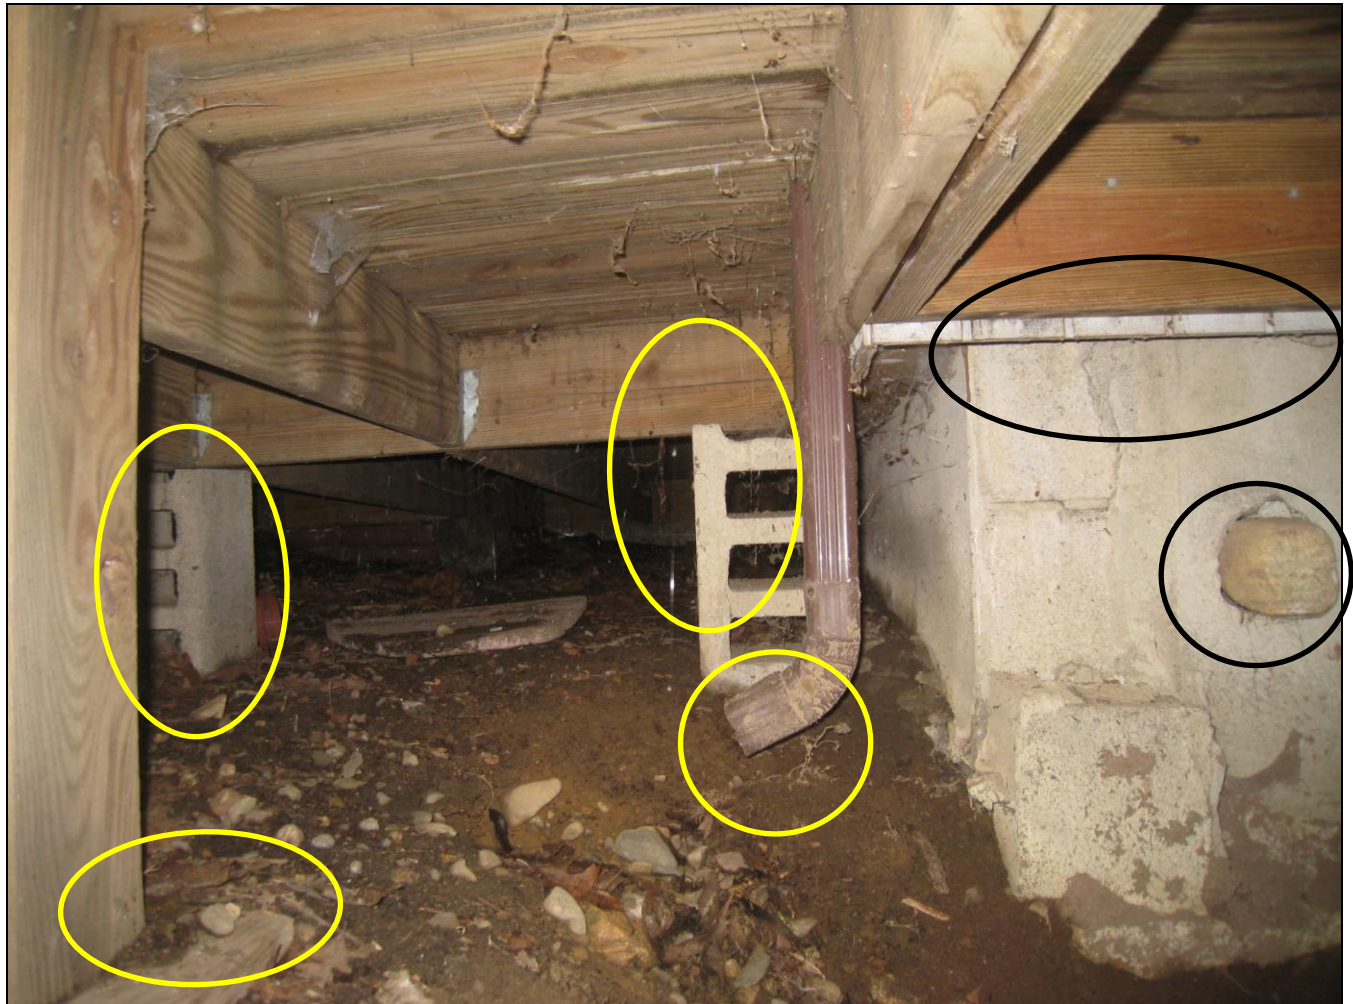
Figure 4 Deck improper construction; structural safety concern. Rain leader discharging near foundation; water infiltration and soil erosion. There is a rock stuffed into a hole on foundation; unconventional repair.

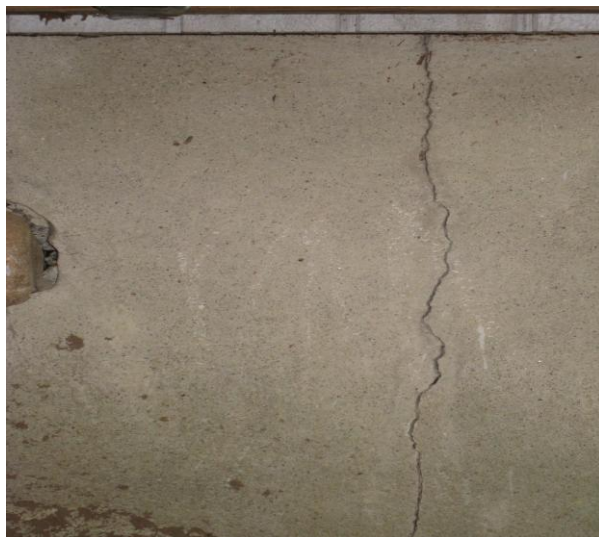
Figure 5 Foundation cracks visible under decking; have evaluated with structure.

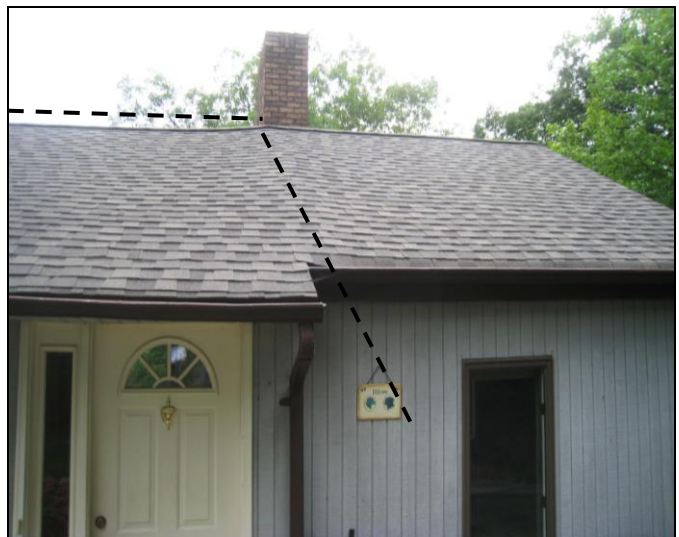
Figure 6 Right side addition; difference in roofline/dip. Obtain all township permits.

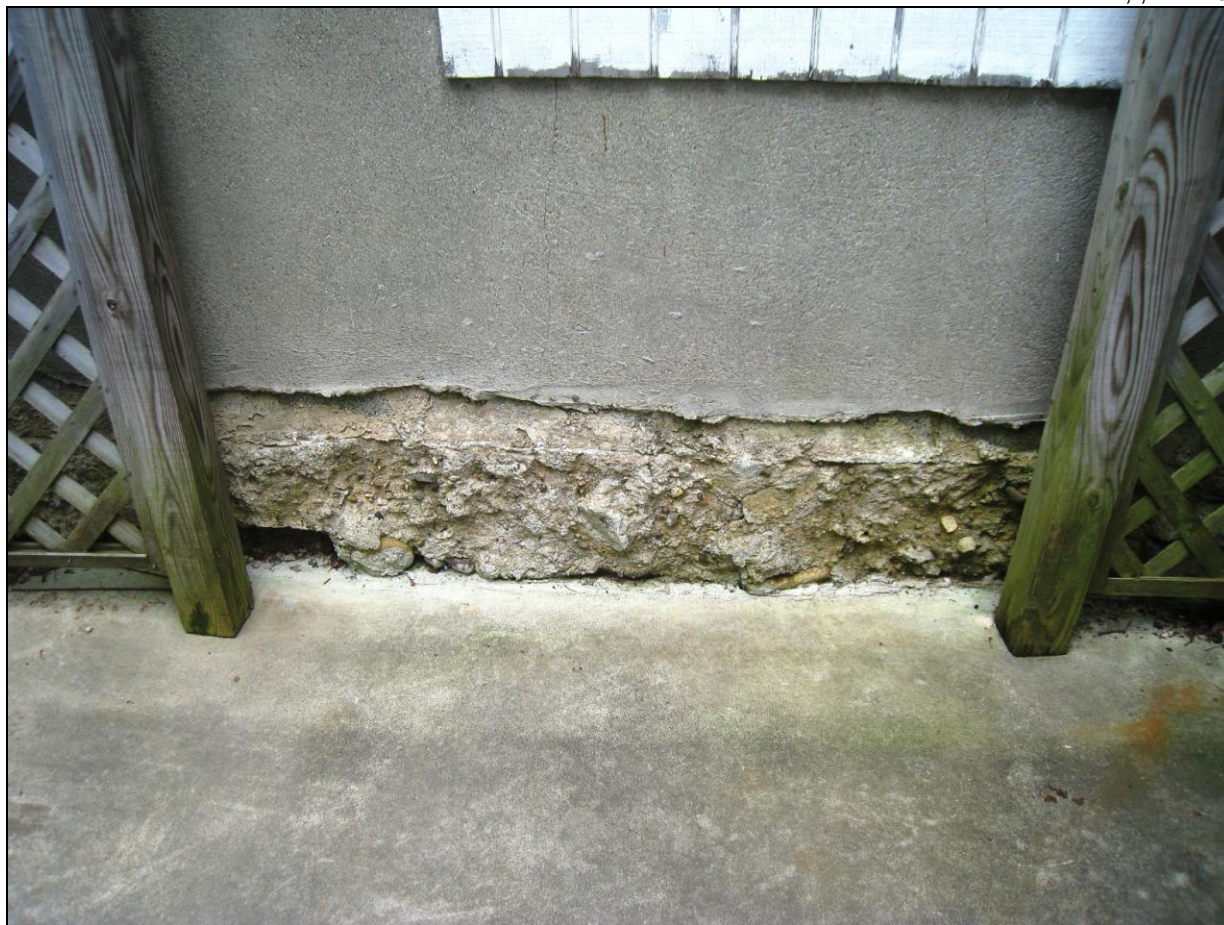
**Figure 7 Exposed footers on crawl ; view from concrete patio in rear. Have structure evaluated.**

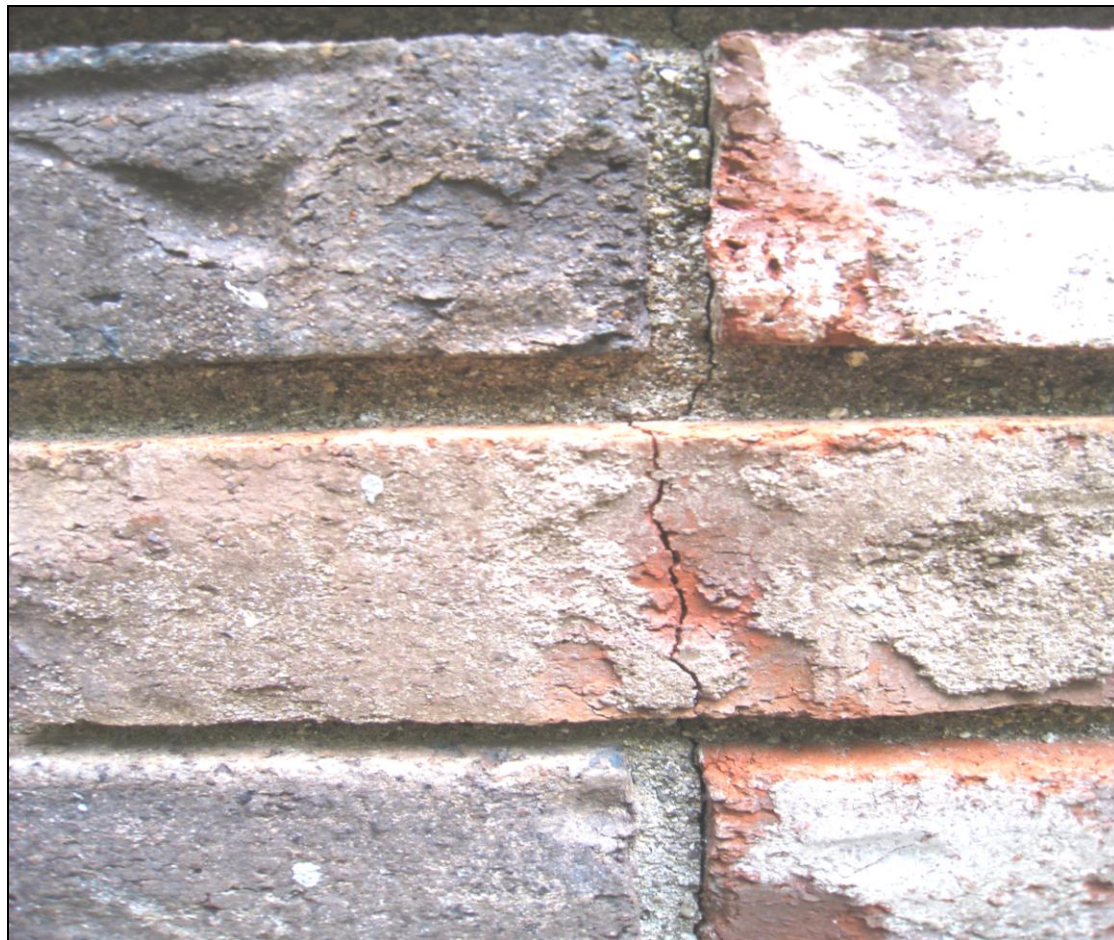
**Figure 8** Example of cracks through brick and mortar on rear chimney; have chimney contractor evaluate

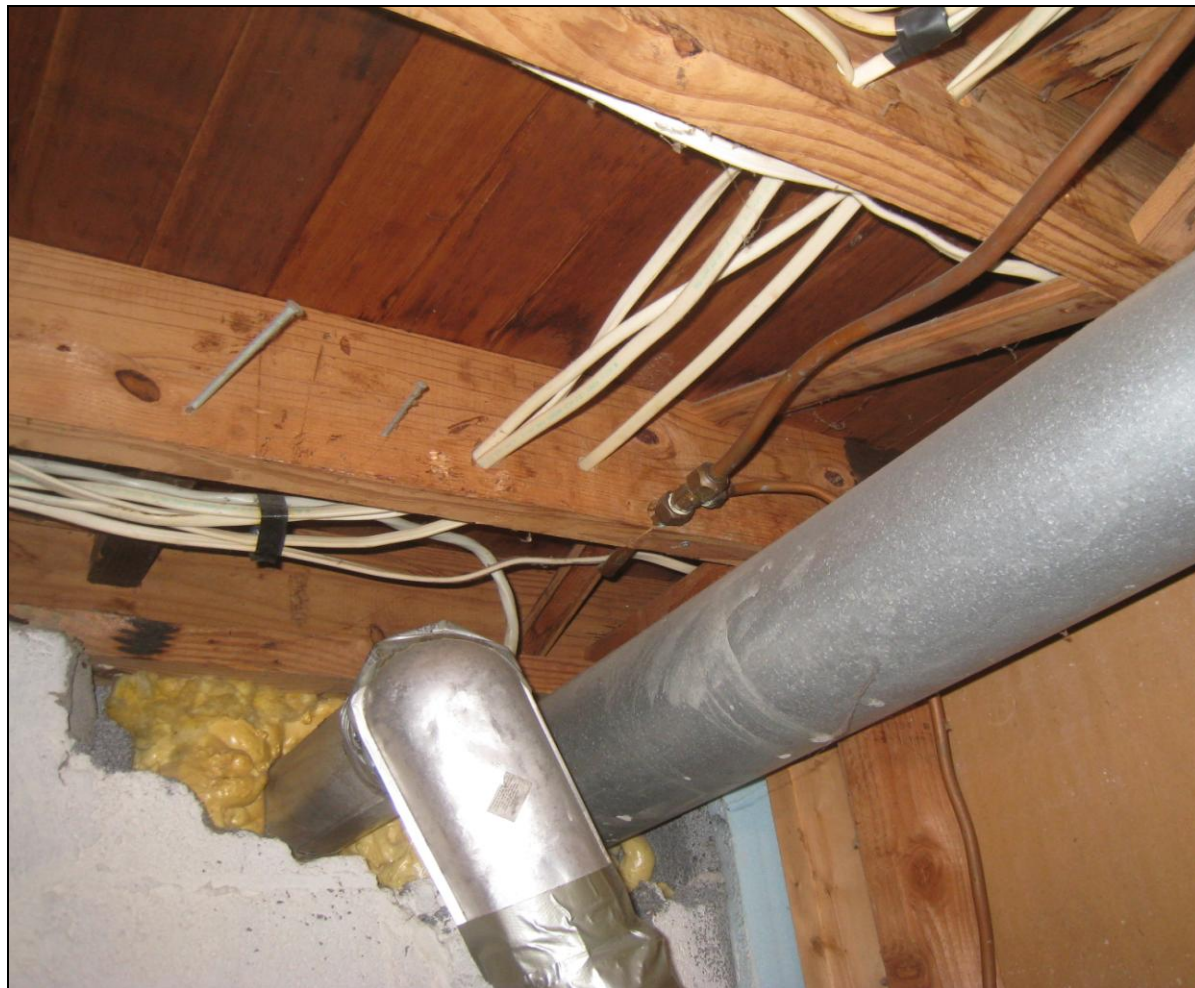
**Figure 9** Damaged concrete wall where vented installed; have structure evaluated. Expansion foam is not recommended as a seal or repair.

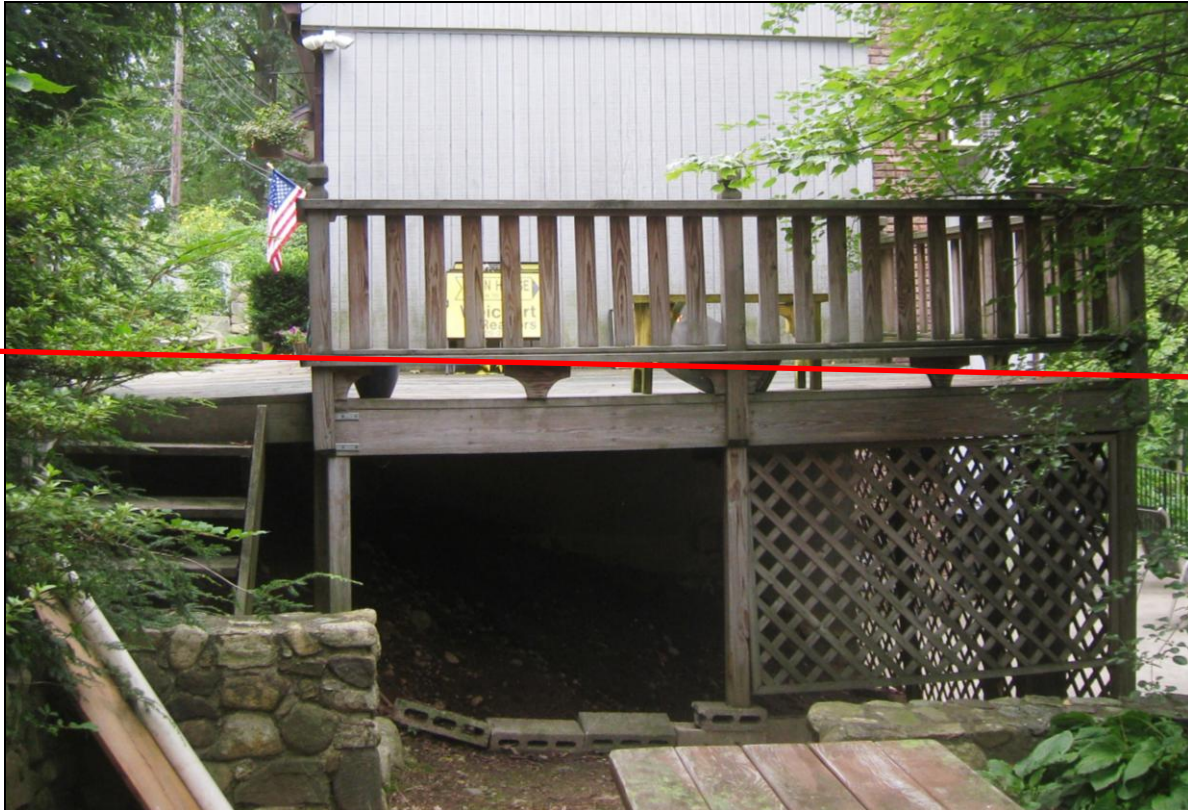
Figure 10 Deck sloped, not properly attached to house, no flashings, no footings for vertical columns & steps, railings too low; unsafe structure.

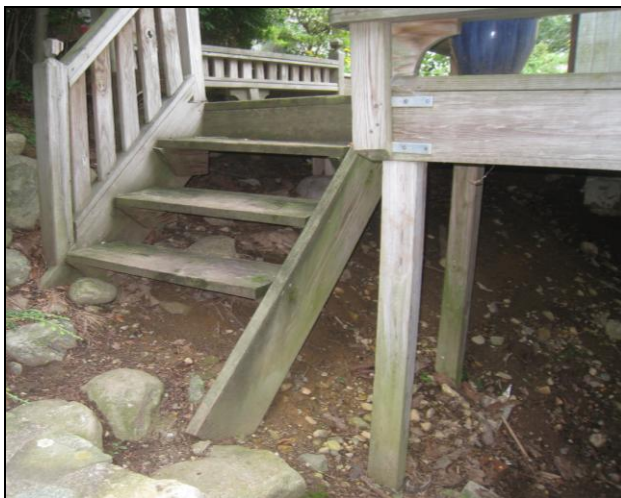
Figure 11 Deck steps improperly supported/constructed.

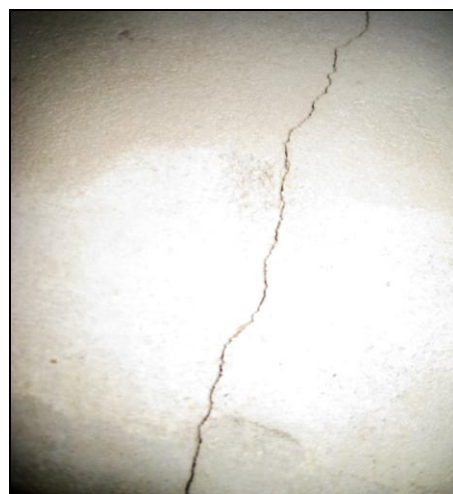
Figure 12 Examples of foundation cracks; evaluate.

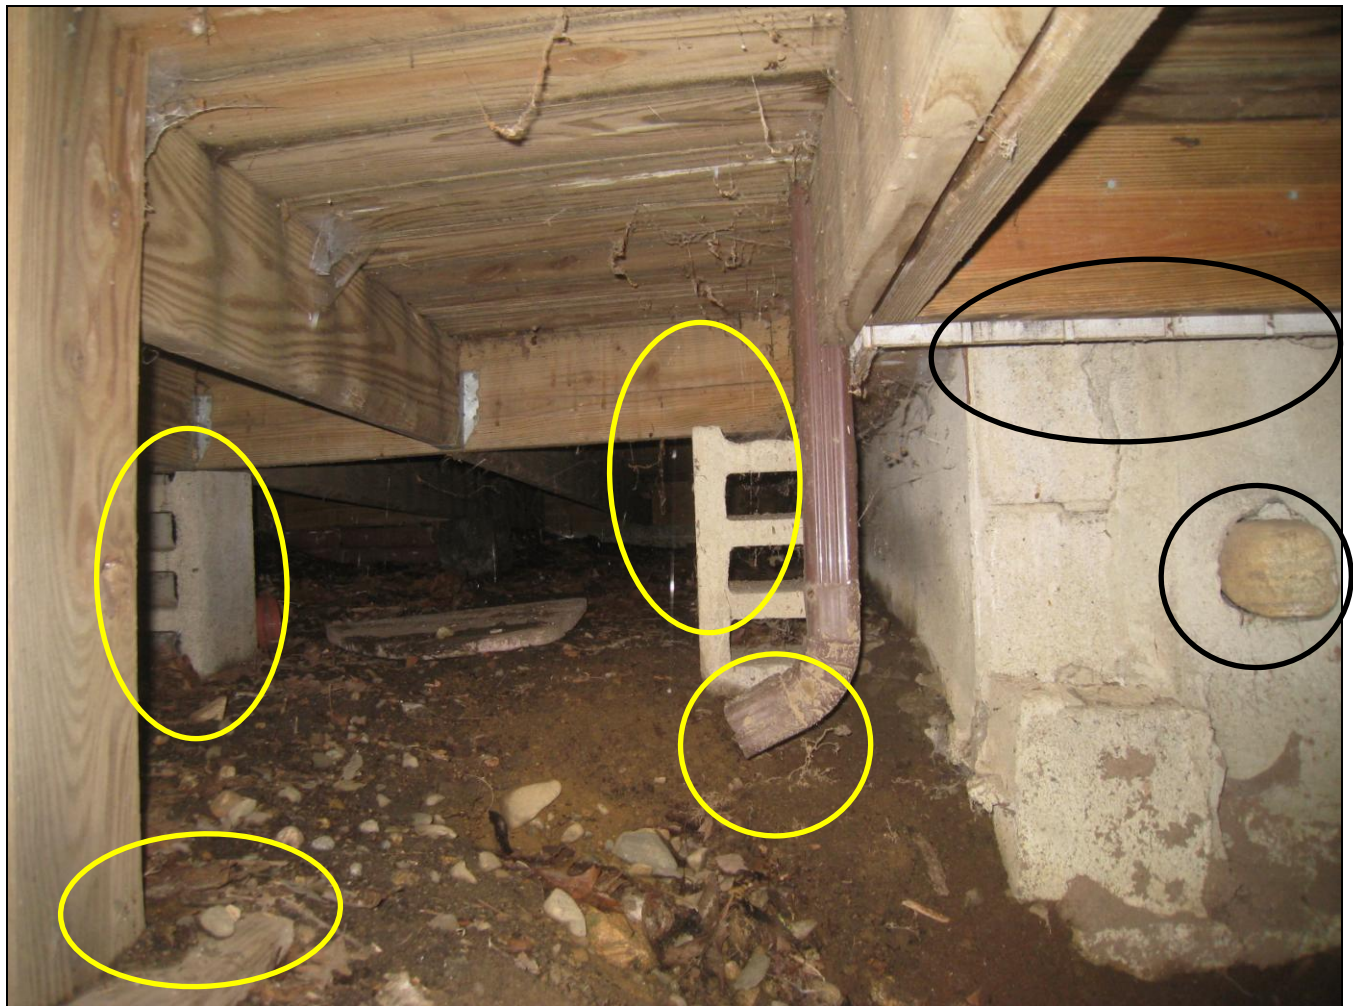
**Figure 13 Deck improper construction; structural safety concern. Rain leader discharging near foundation; water infiltration and soil erosion. There is a rock stuffed into a hole on foundation; unconventional repair.**

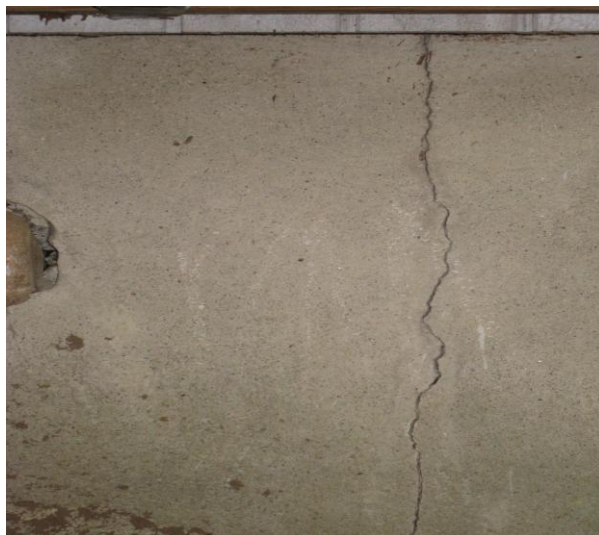
**Figure 14 Foundation cracks visible under decking; have evaluated with structure.**

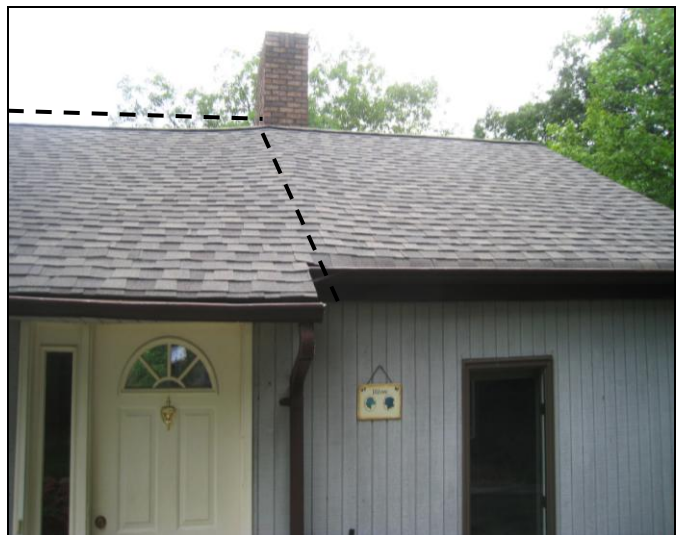
**Figure 15 Right side addition; difference in roofline/dip. Obtain all township permits.**

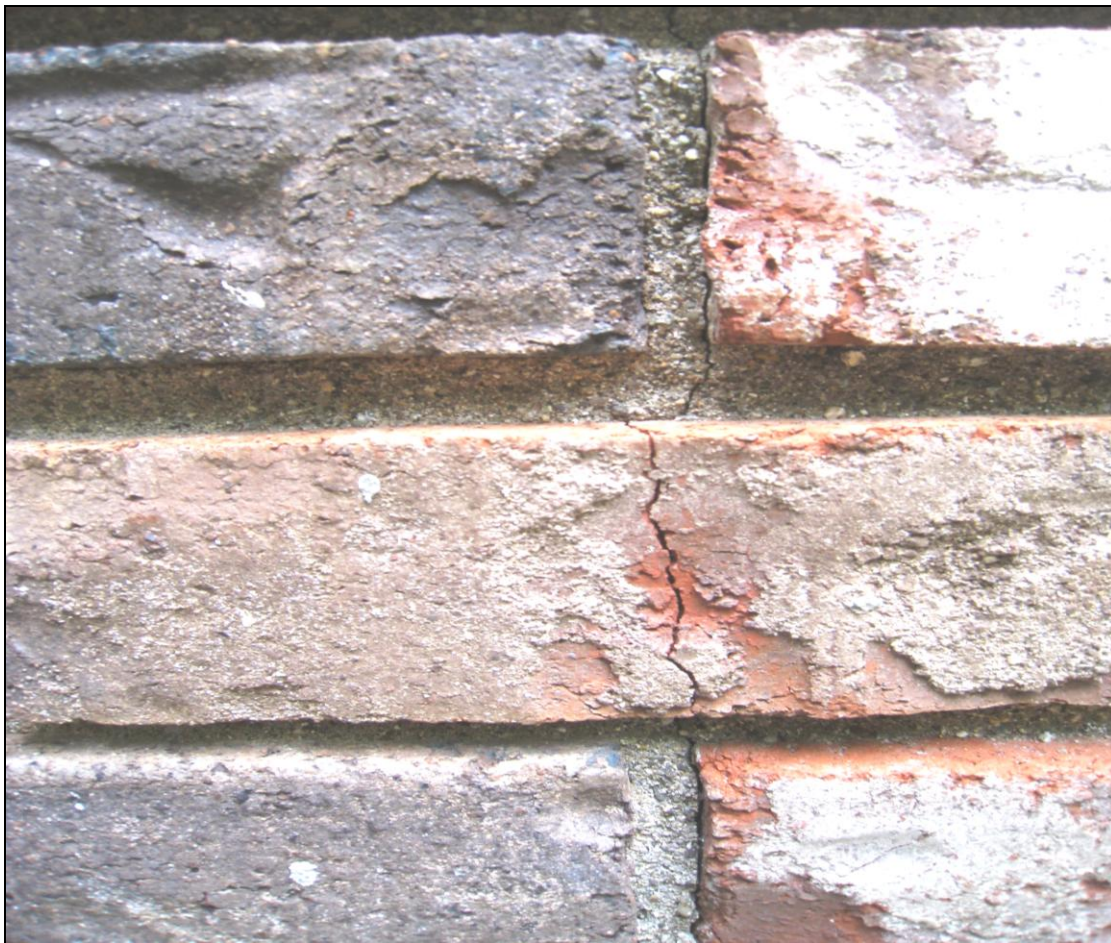
Figure 17 Example of cracks through brick and mortar on rear chimney; have chimney contractor evaluate

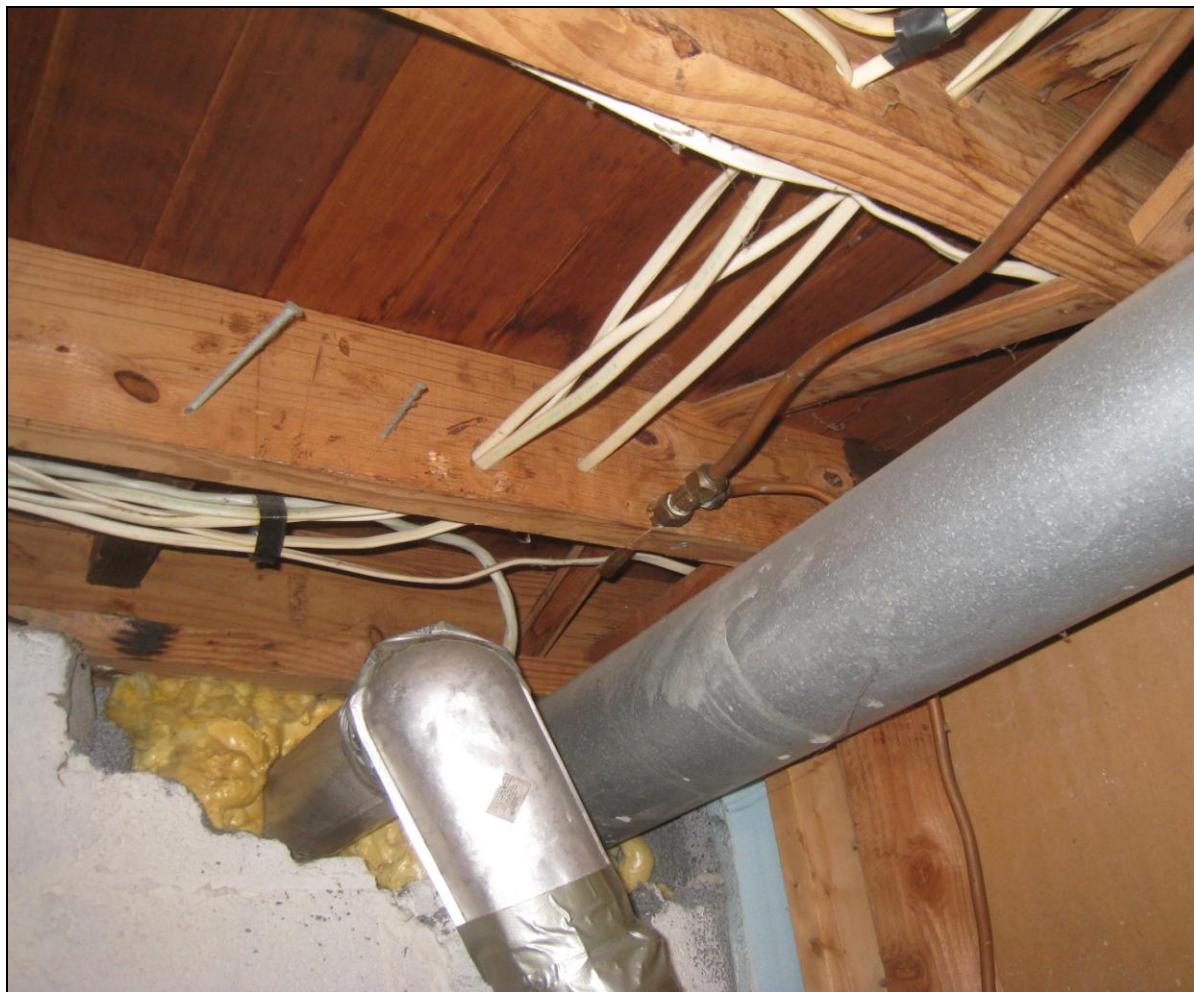
**Figure 18** Damaged concrete wall where vented installed; have structure evaluated. Expansion foam is not recommended as a seal or repair.
