4 Seasons Home Inspection, LLC

150 Maple Avenue, #128, South Plainfield, NJ 07080

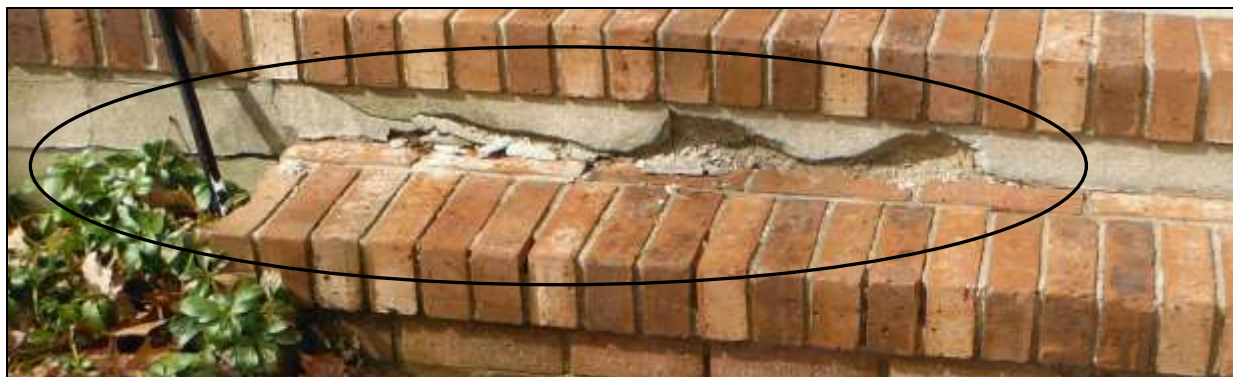
Figure 1 Have a mason evaluate/repair steps.

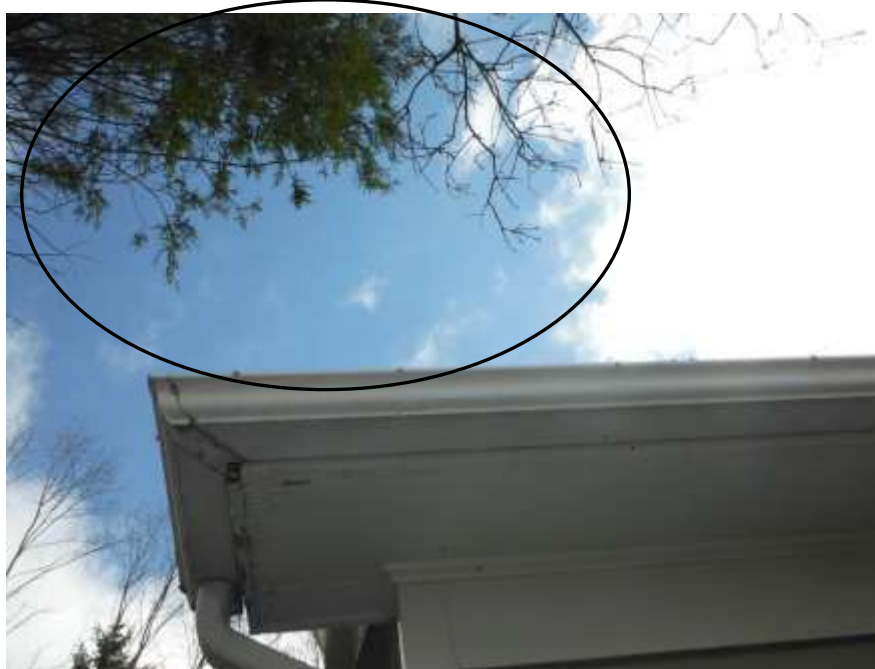
Figure 2 Remove all overhanging trees; carpenter ants, dirty gutters, etc.

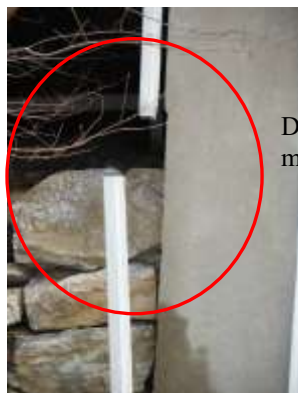
Disconnected & poorly maintained gutters.

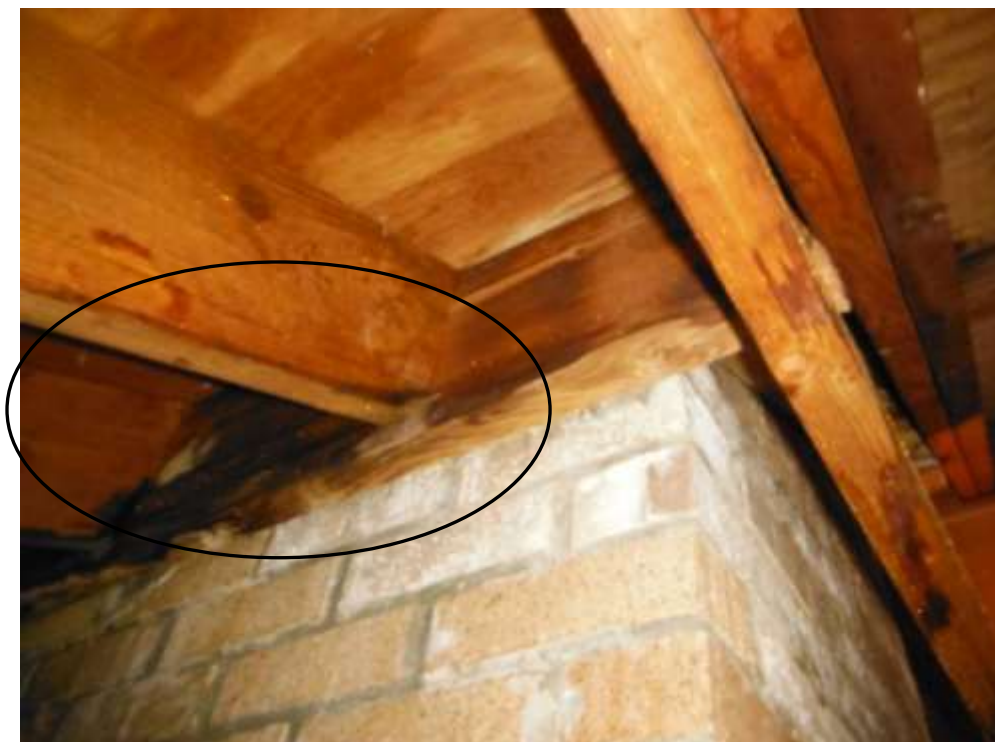
Figure 3 Leaking and efflorescence around chimney; view in attic.

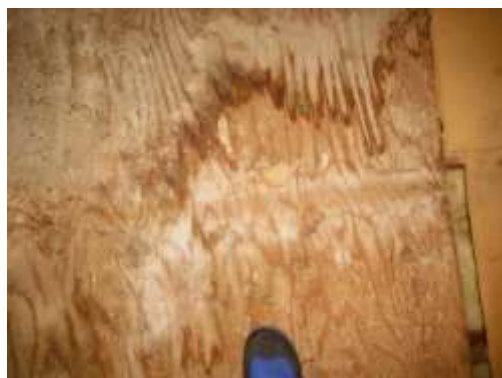
Figure 4 Water stains/leaking into attic.

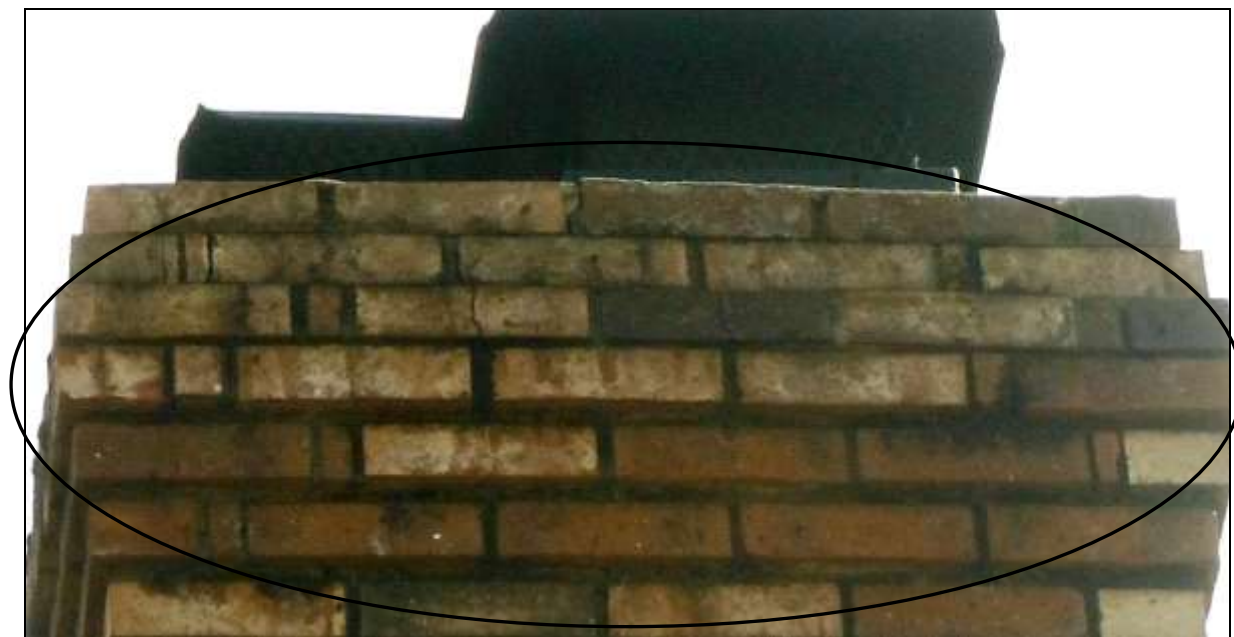
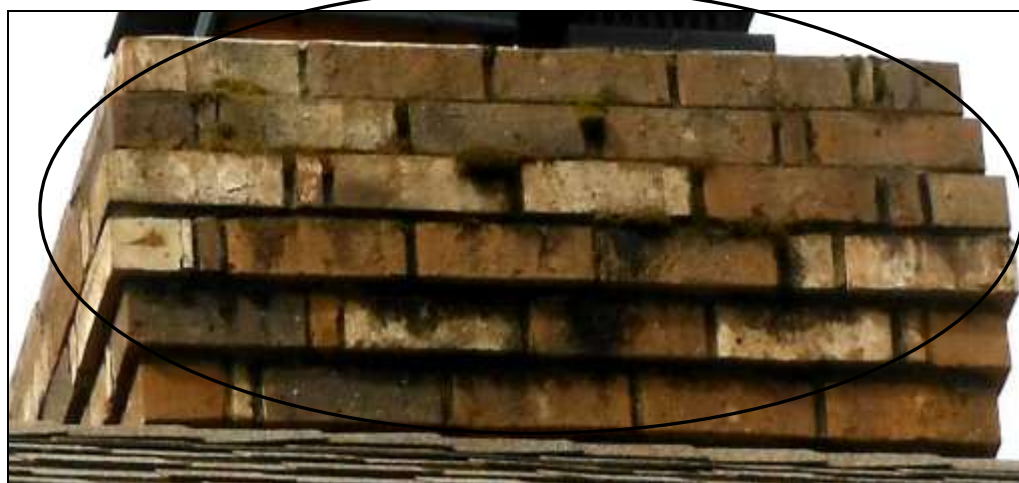
Examples of exterior water, carpenter bee, carpenter ant, wood pecker damage.

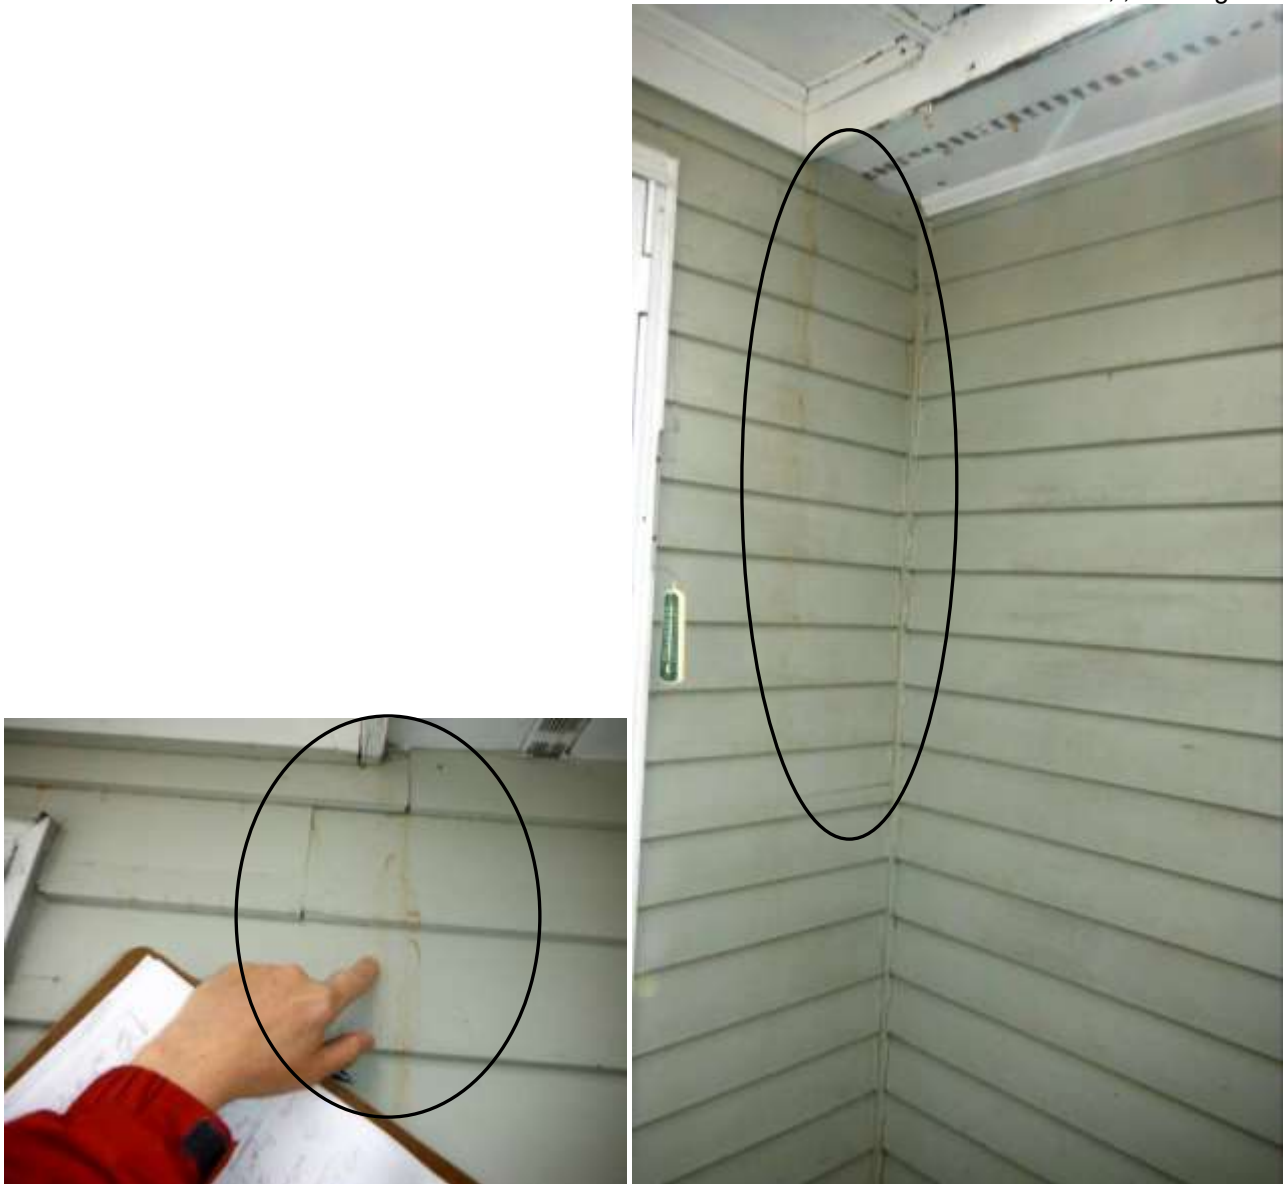
Figure 5 Leaking, water stains, poorly maintained exterior.

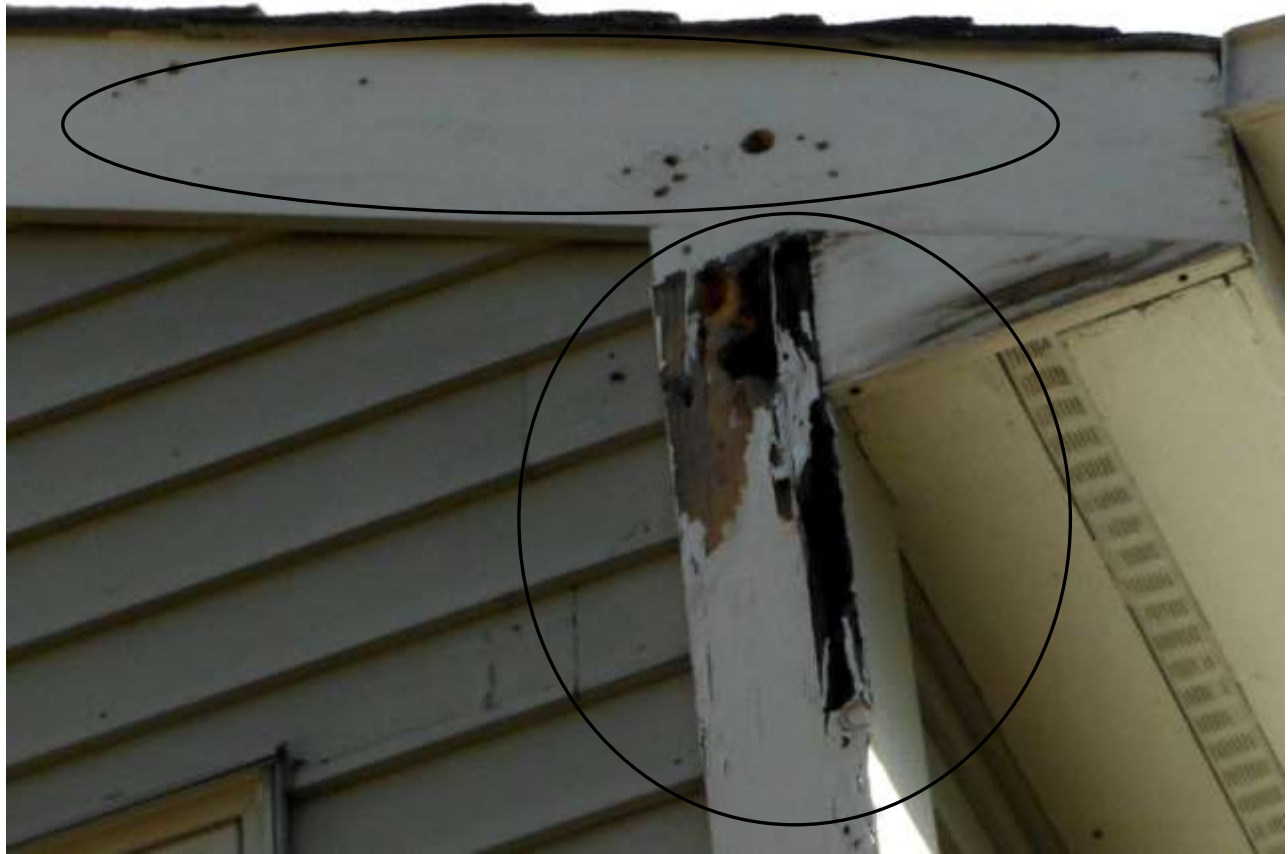
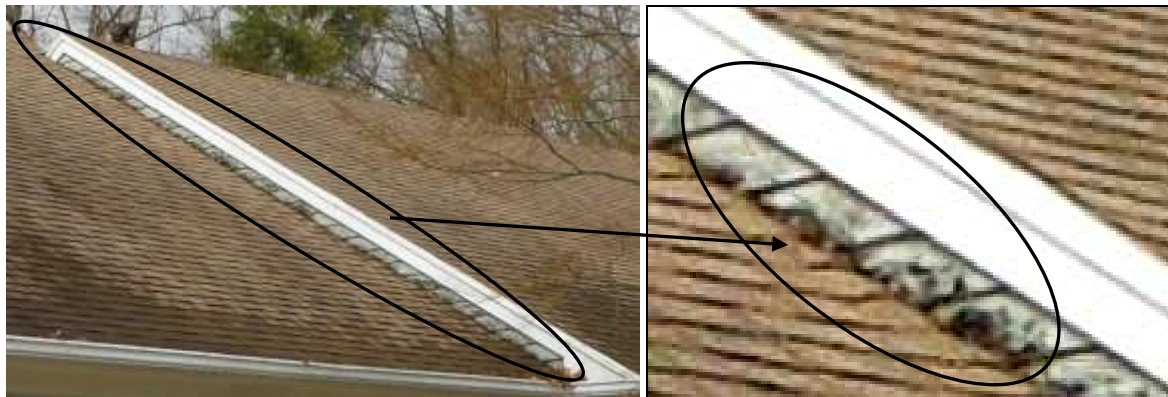
Figure 6 Rot on siding side wall/rook junctures.

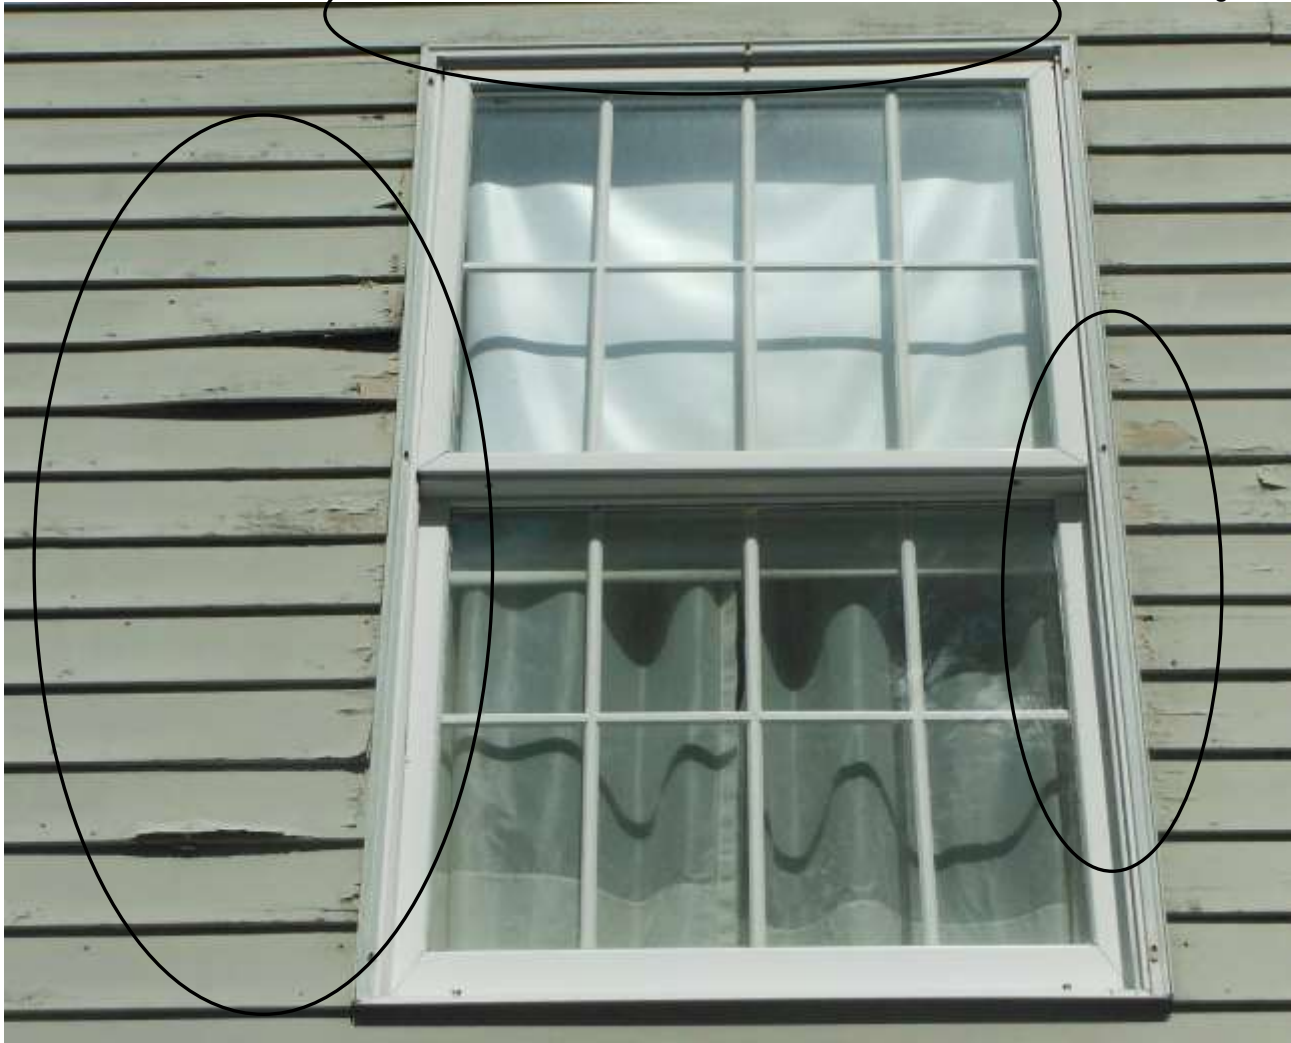
Figure 7 Siding water damaged, warped, rot, etc. Missing flashings over windows, doors, etc.

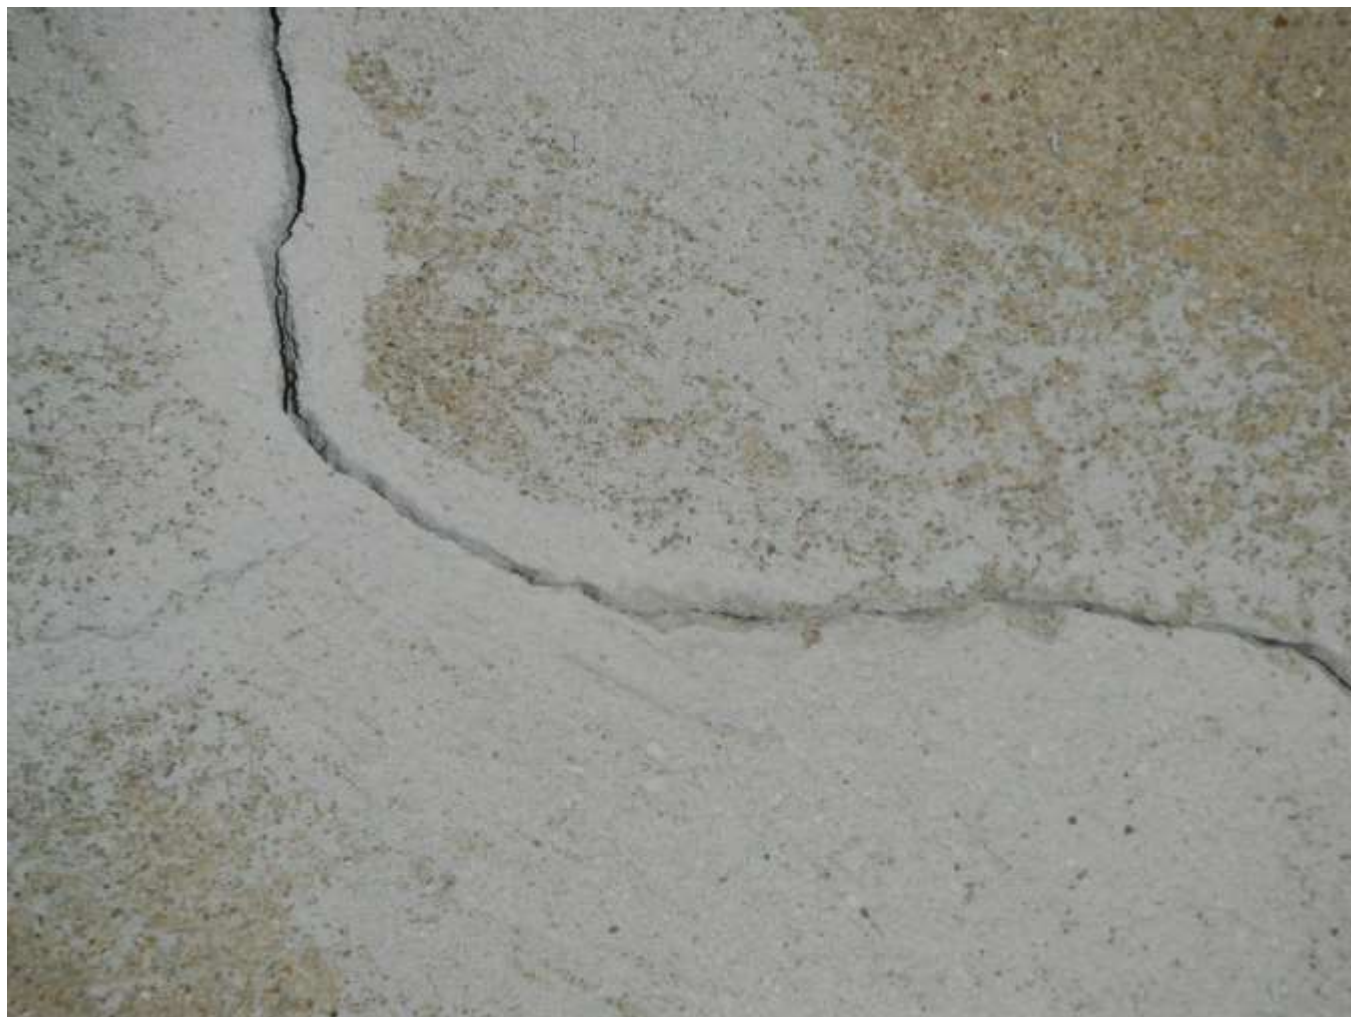
Figure 8 Foundation cracks; have foundation contractor, engineer or building contractor evaluate all foundation cracks and make repairs.

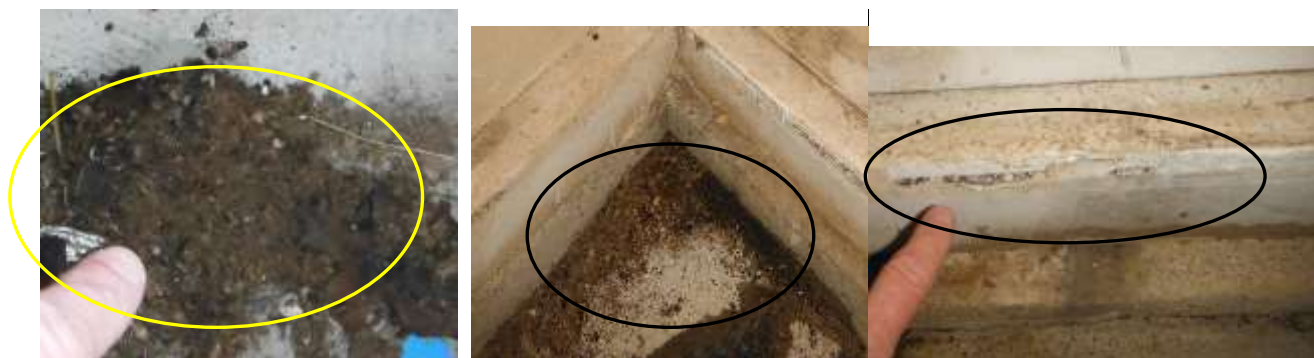
Figure 9 Carpenter ant frass/nest, damage, and chewed paper; have a licensed Pest Company treat for all wood destroying insects.

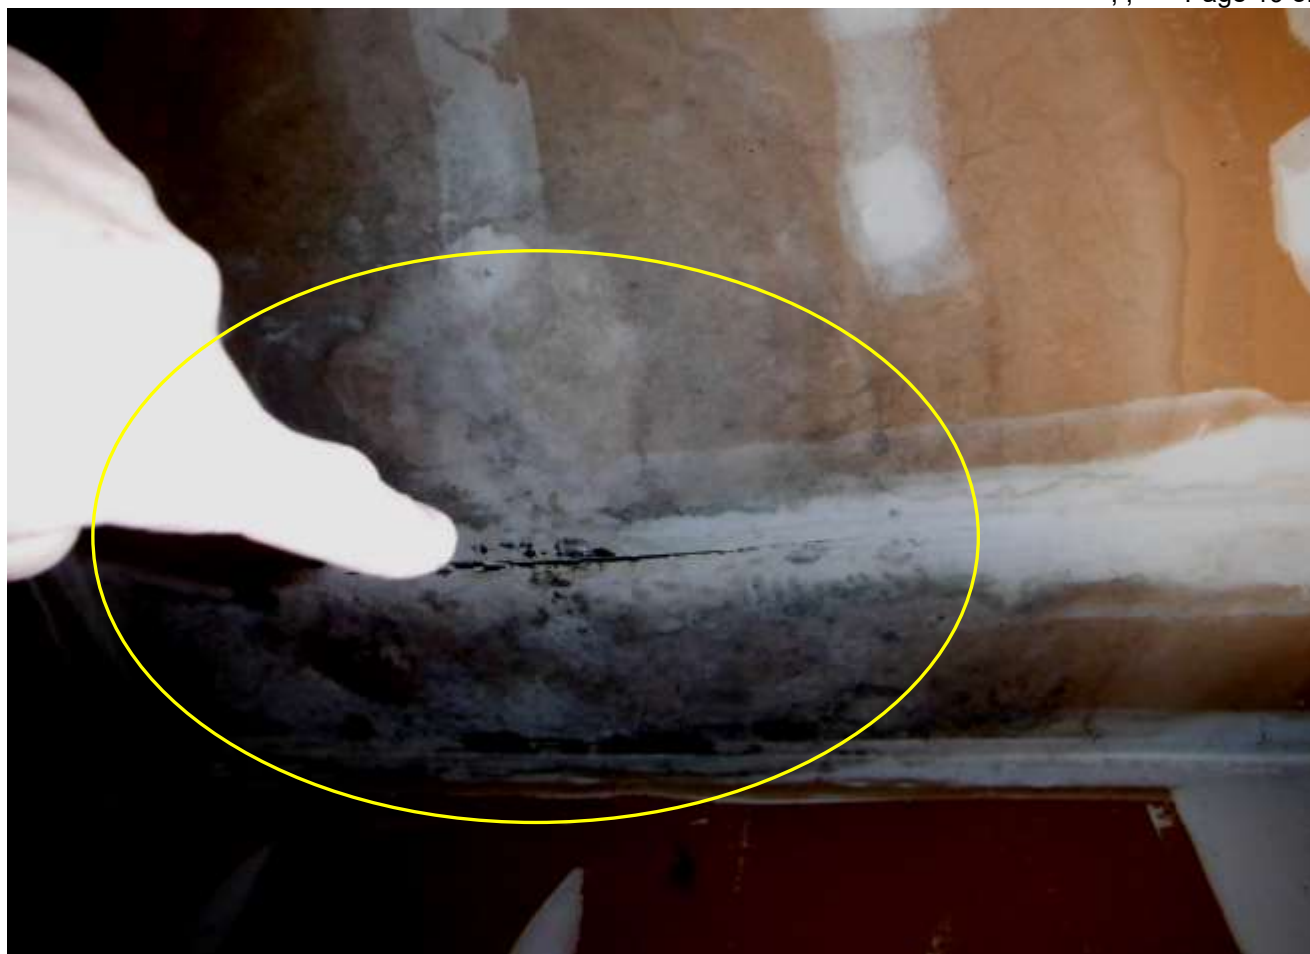
Figure 10 Example of roof leaking & water damage in garage. Have a structural carpenter evaluate extent of all damage including water, mold like staining & insect before closing. The home was poorly maintained and needs upgrades and repairs everywhere.

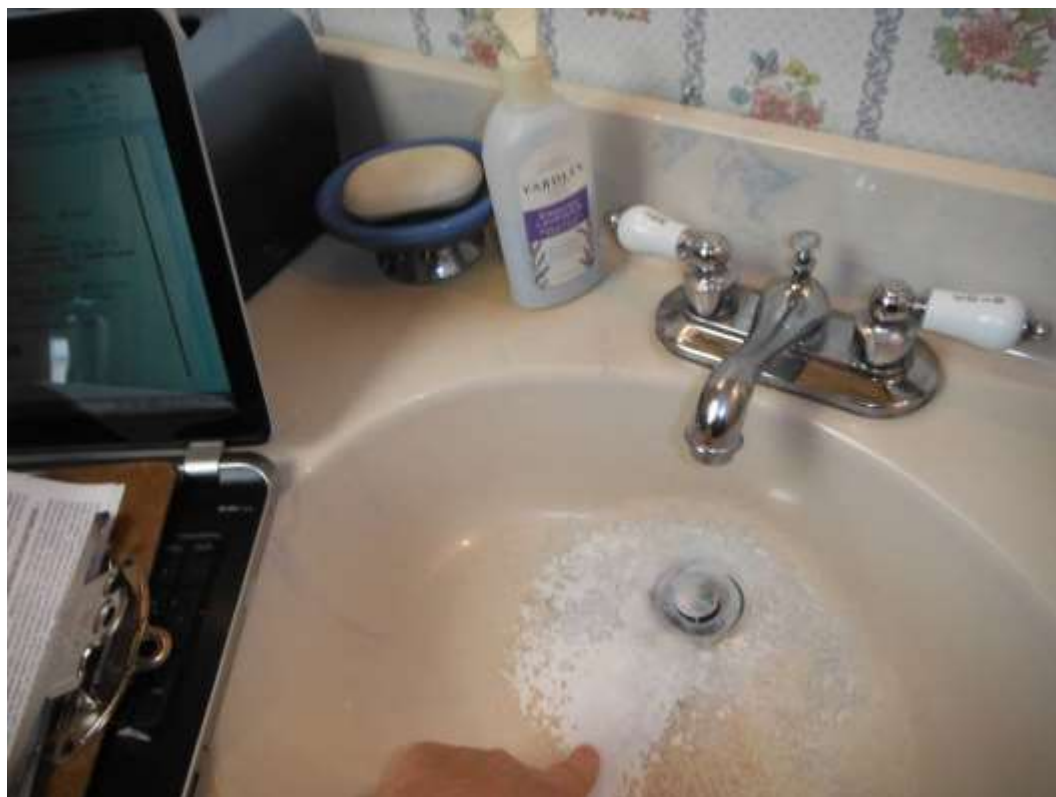
Figure 11 Cracked & damaged sink basin; hygiene/health and leak concerns.

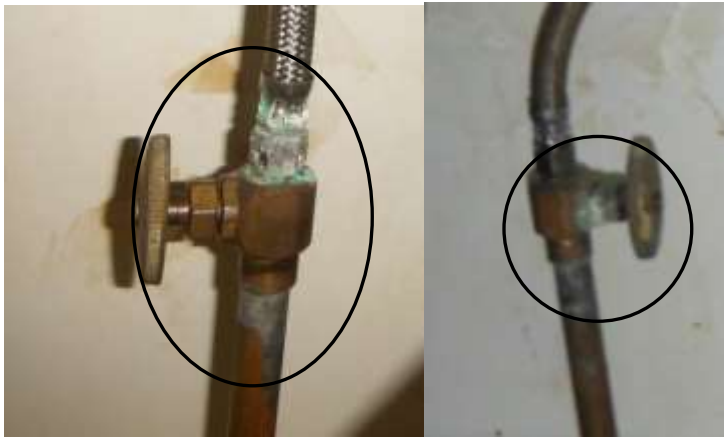
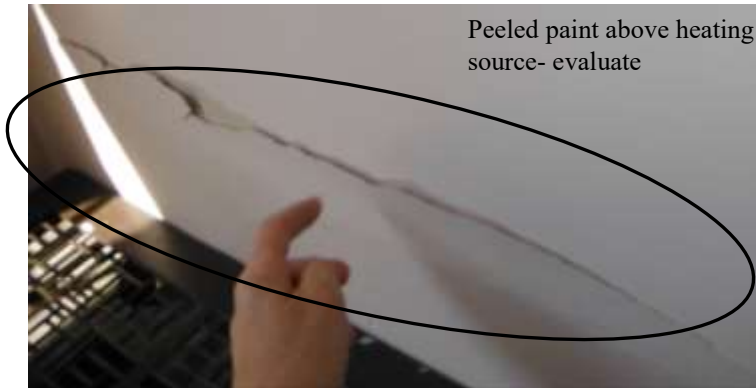
MAIN BATH : The fan was not working; humming motor/safety concern. Have an electrician evaluate the exhaust fan and repair/replace. There was leaking around the skylight ; have replaced. Recommend cooler light bulbs; exposed vanity lighting with incandescent bulbs can get hot or cause burns if touched. There was erratic spraying on sink faucet; grit and calcium deposits in the aerator.

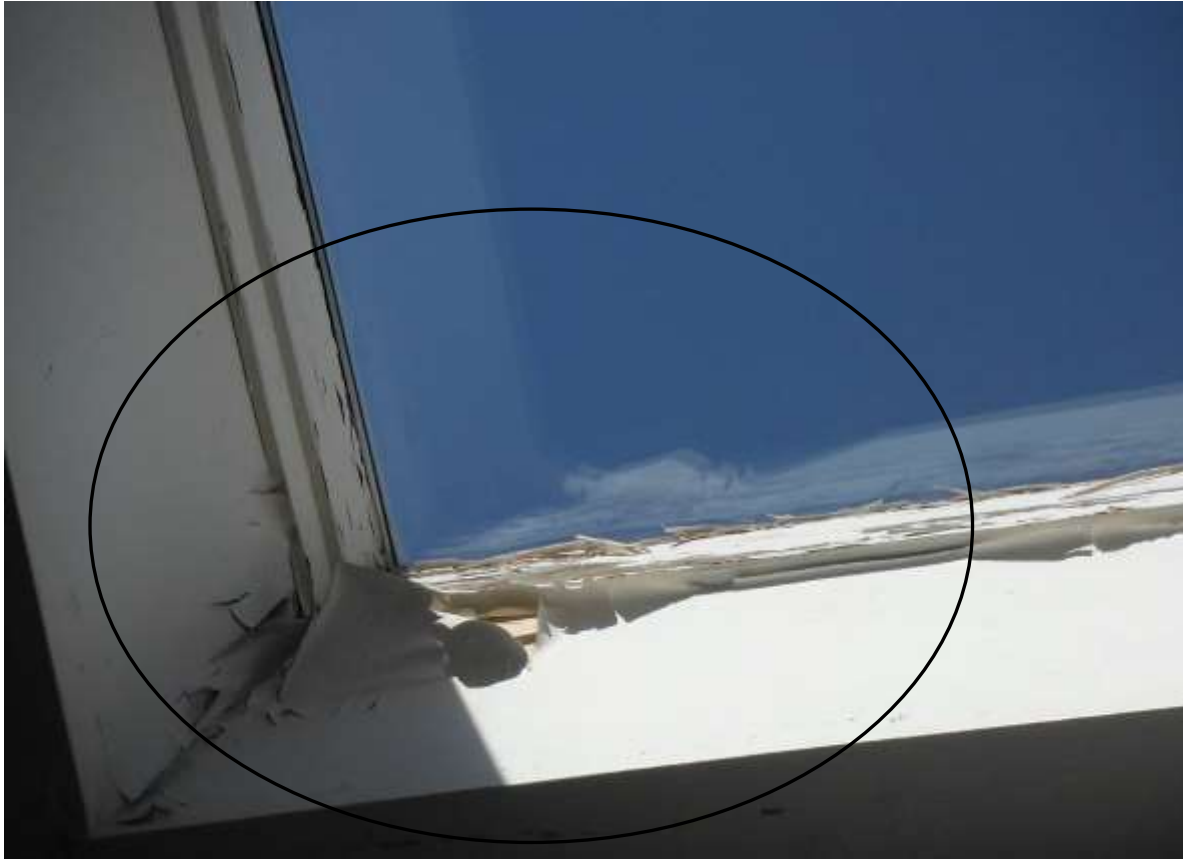
1. There was leaking skylight; have skylights replaced with roof. See roofing section comments.
2. Have an electrician evaluate the exhaust fan and repair/replace for safety; humming motor.

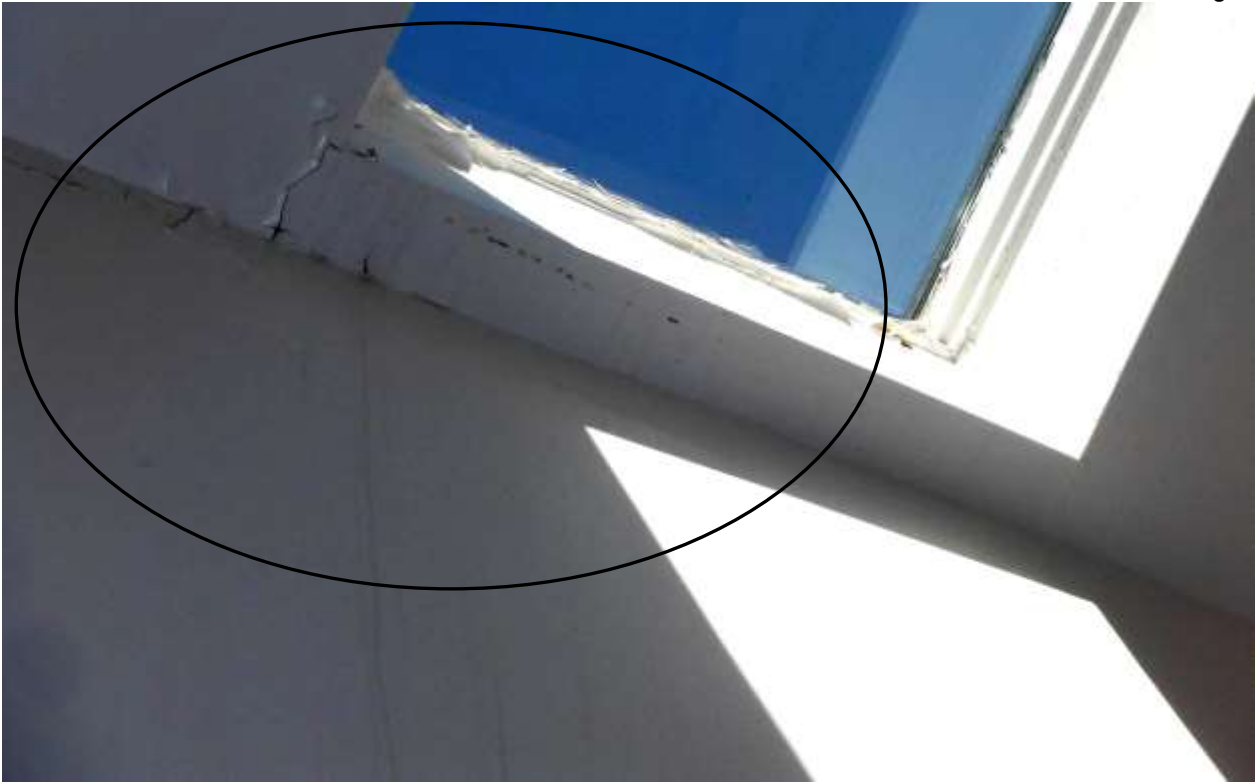
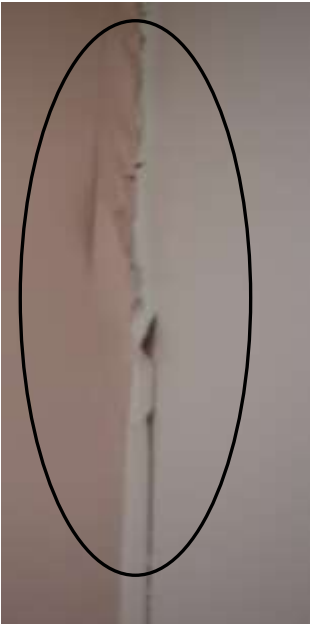
BATH BASEMENT (unconventional)** : The old sink appears to be from a kitchen, a toilet was added and a low quality shower stall. This bathroom was added by handyman or non-professional skill; poor condition. Recommend a bathroom contractor evaluate bathroom and have upgraded with township permits; unconventional, improper installations and lacking proper building practices.** There was opened ceiling and plumbing repairs; gives indication of frozen pipes and plumbing repairs. There was no heat source in bathroom; need heat in bathrooms. There was heavy corrosion and leaking on plumbing in this bathroom. The bathroom needs to have proper exhaust fan(not working & no cover), GFCI outlets, heating source, and approved by all local building practices and required permitting. Have all dark staining where leaking in home checked for mold; beyond the scope of a home inspection.

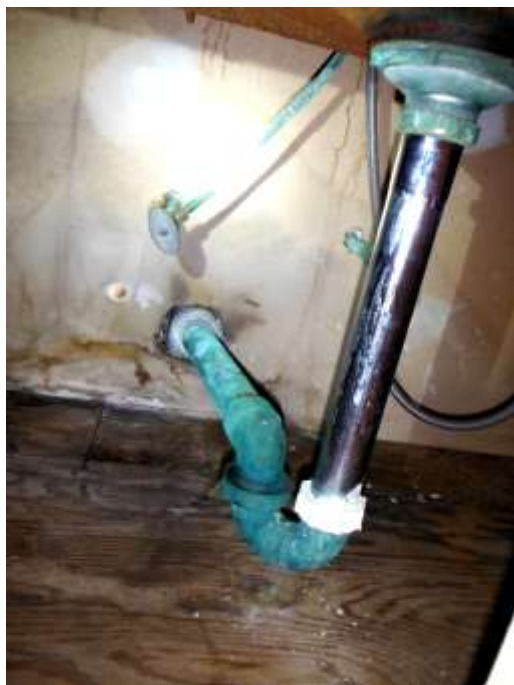
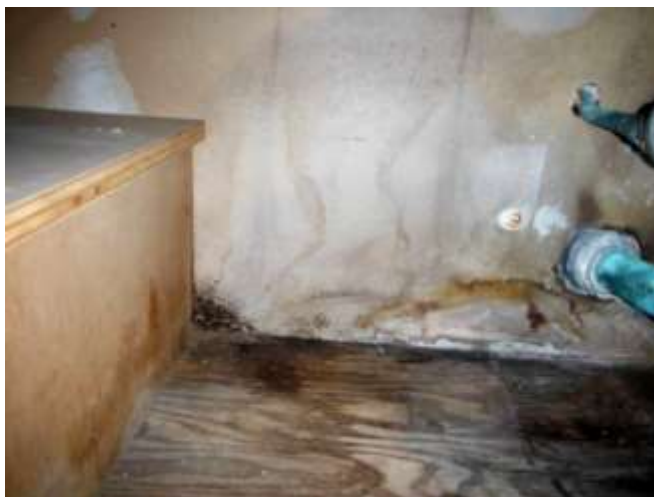
Figure 12 Leaking, corrosion, old plumbing; have licensed plumber evaluate for plumbing upgrades throughout the home.

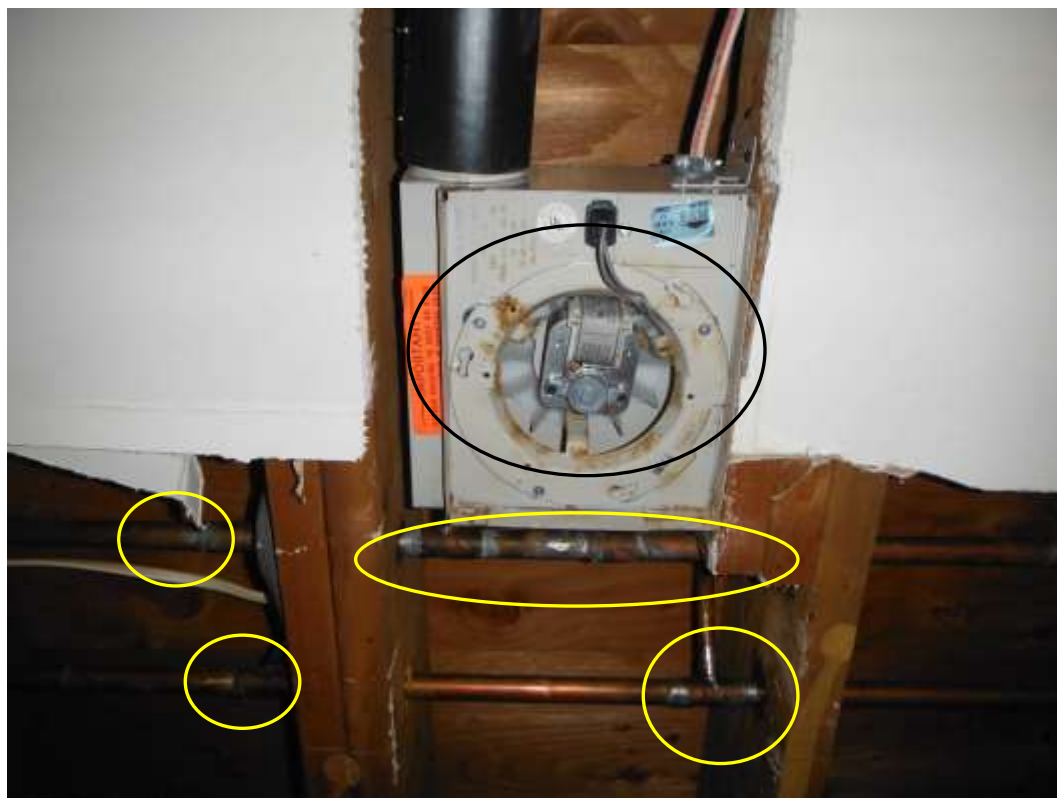
Figure 13 Opened ceiling and plumbing repairs; indication of frozen pipes/leak repairs. Have a bathroom contractor evaluate bathroom and upgrade with required permits.

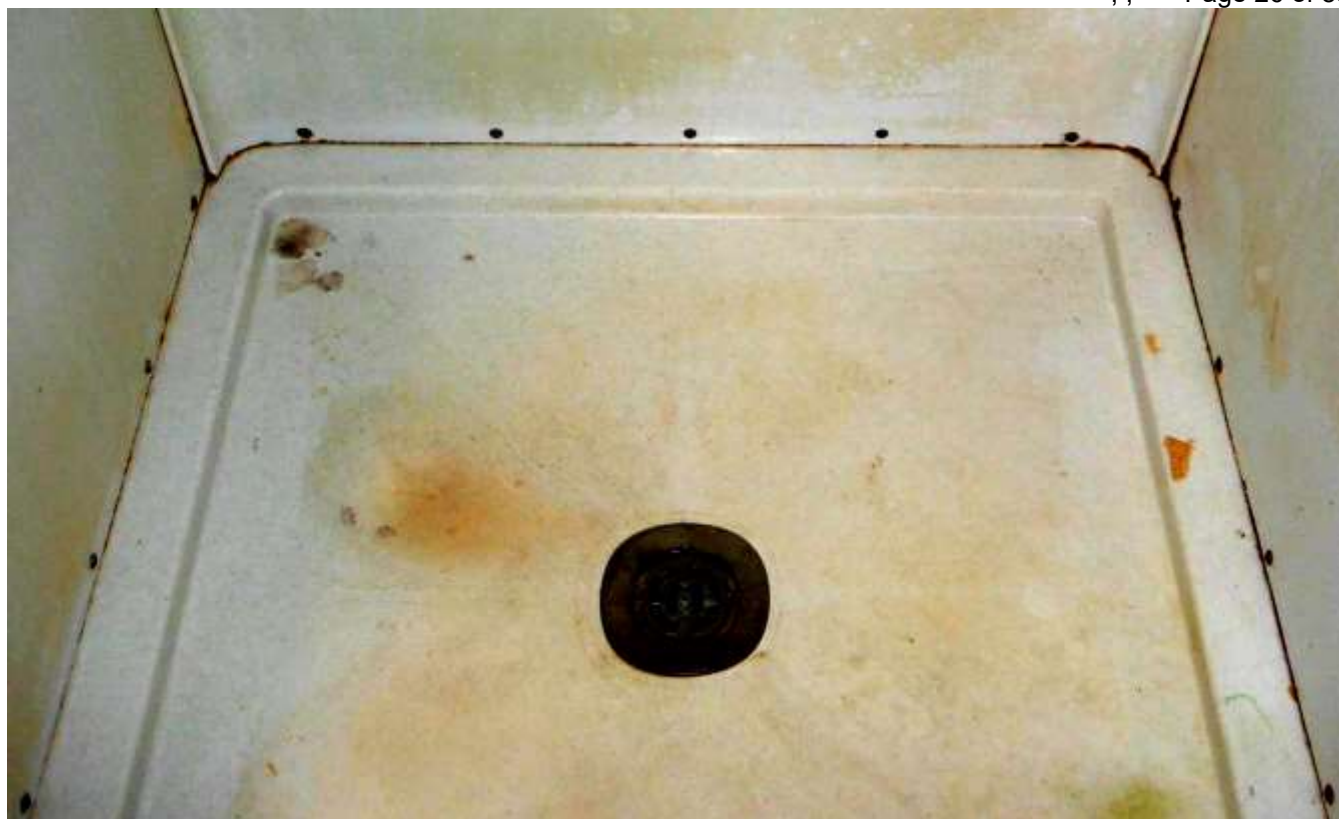
Figure 14 Recommend a bathroom contractor evaluate the bathroom and advise on all upgrades. Low quality/poor shower stall; rusted, stained, etc.

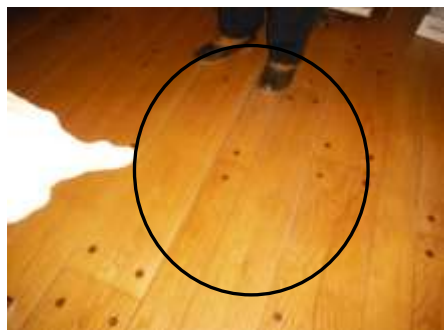
Figure 15 Have humps/warped boards/structure evaluated by contractor or engineer.

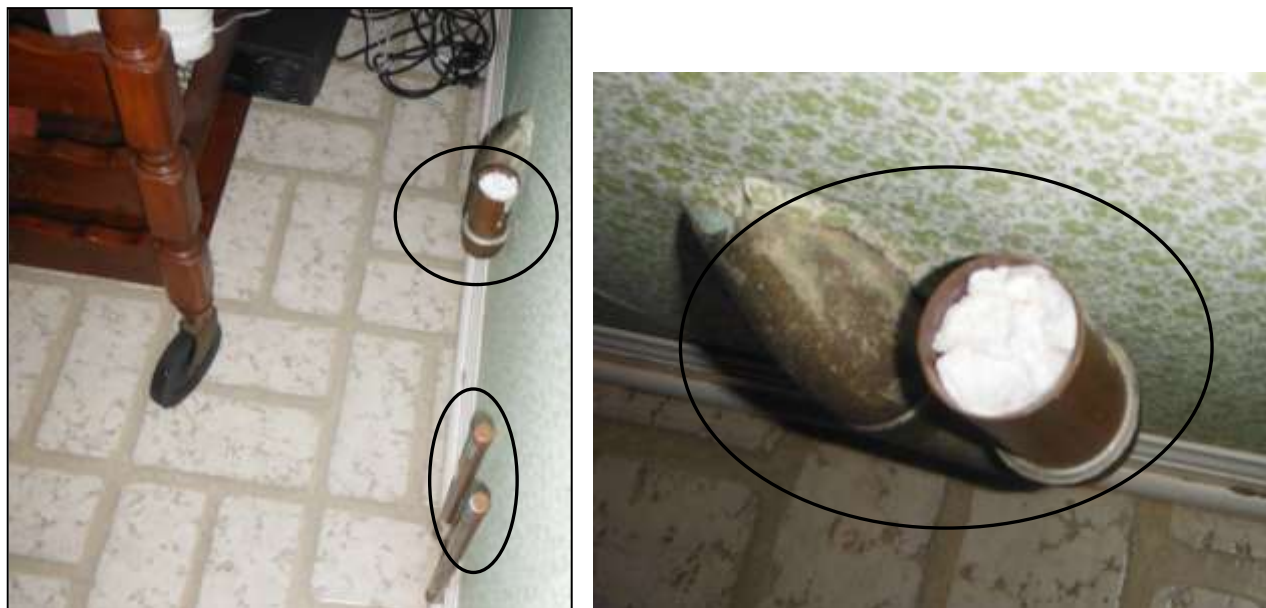
Figure 16 Drain with rag inside; have plumber cap off or remove all plumbing from below.

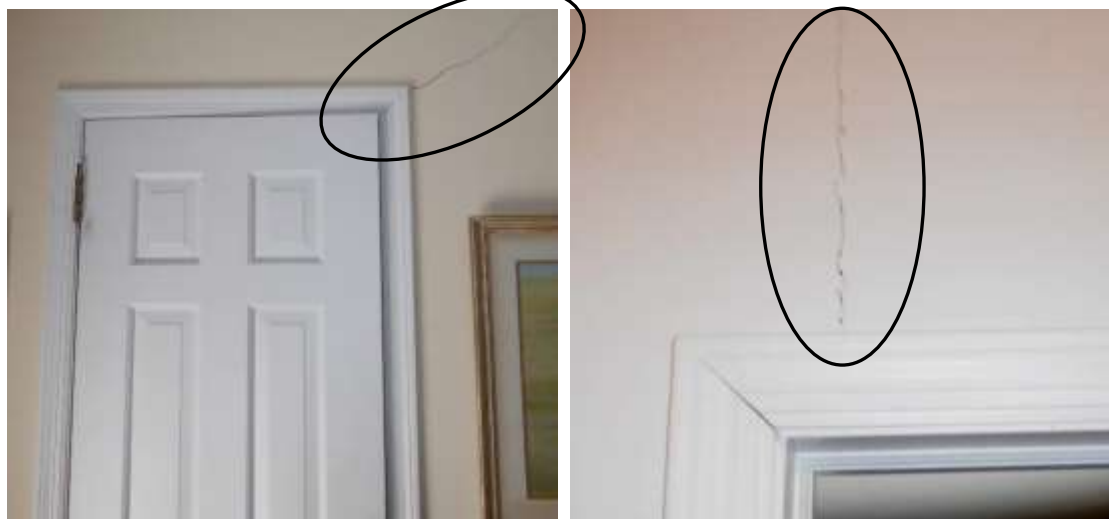
1. Have a structural contractor (builder, engineer, structural carpenter, etc.) evaluate the structure; canted doorway, door not closing/not plumb, crack through into closet, etc. **

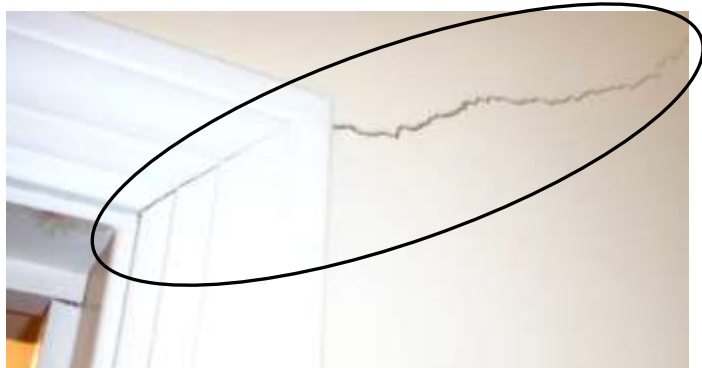
#2 BEDROOM REAR LEFT : There was inadequate heat in this room; two registers on right wall. There was an old gas space heater installed over one of the floor registers; unconventional/handyman installation. Gas space heater in this room and basement were not tested; recommend removal by contractor. Have an HVAC (heating & cooling)contractor evaluate for proper heating & cooling. This room appears added after time of build; obtain all closed permits for all structural additions & modifications.

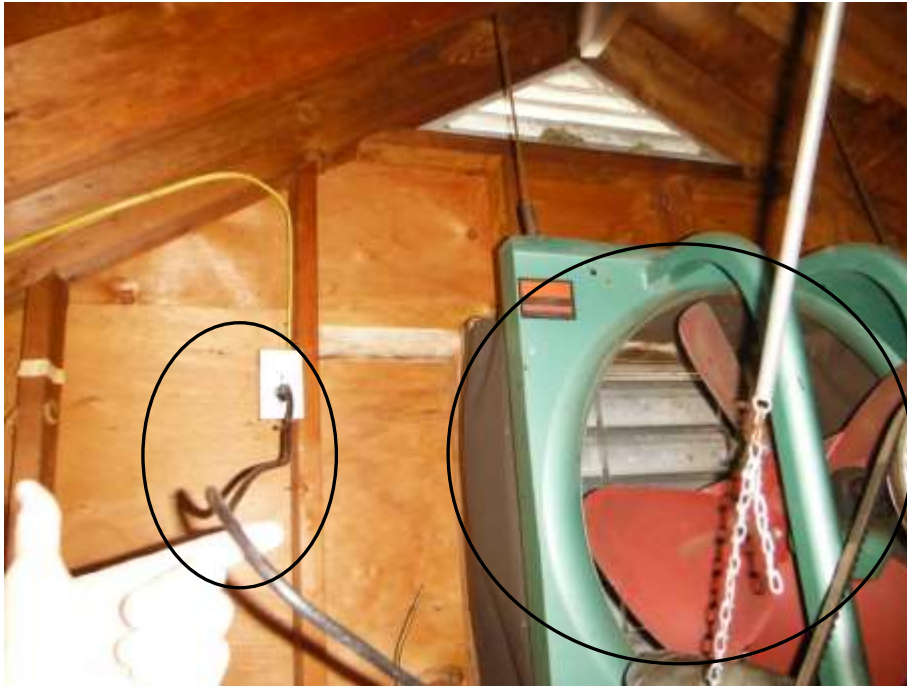
Figure 17 Attic fan had not grille and not wired with power switch; safety hazards.

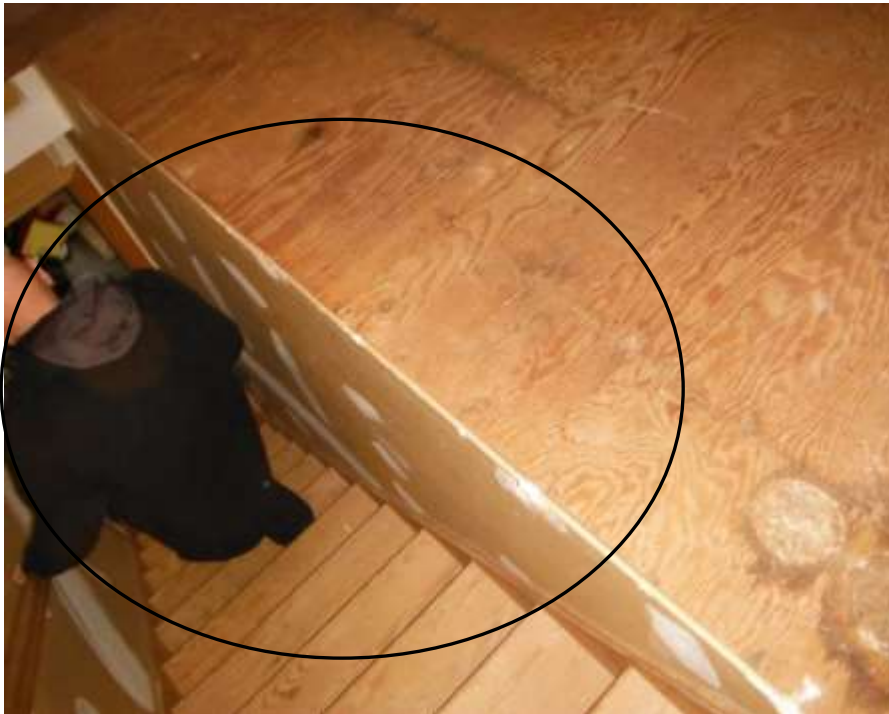
Figure 18 Need a railing for safety.

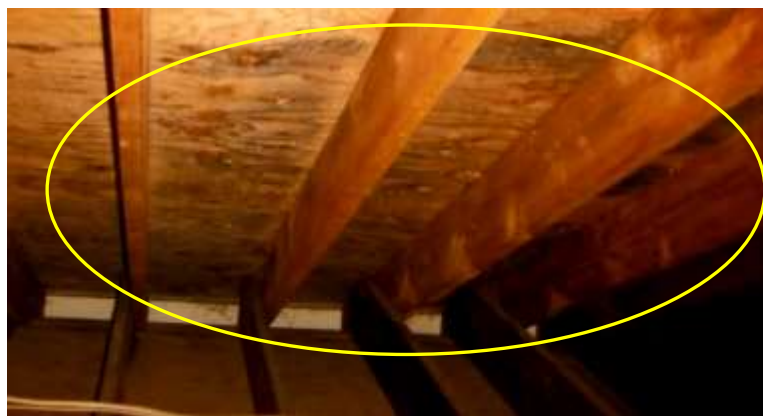
Figure 19 Example of mold like staining in attic; have affected plywood evaluated for replacement.

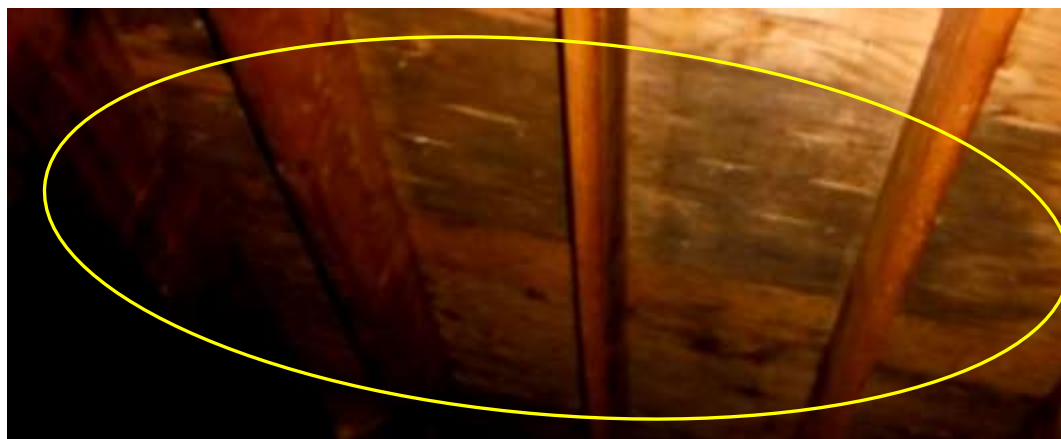
Figure 20 Example of mold like staining in attic; have affected plywood evaluated for replacement.

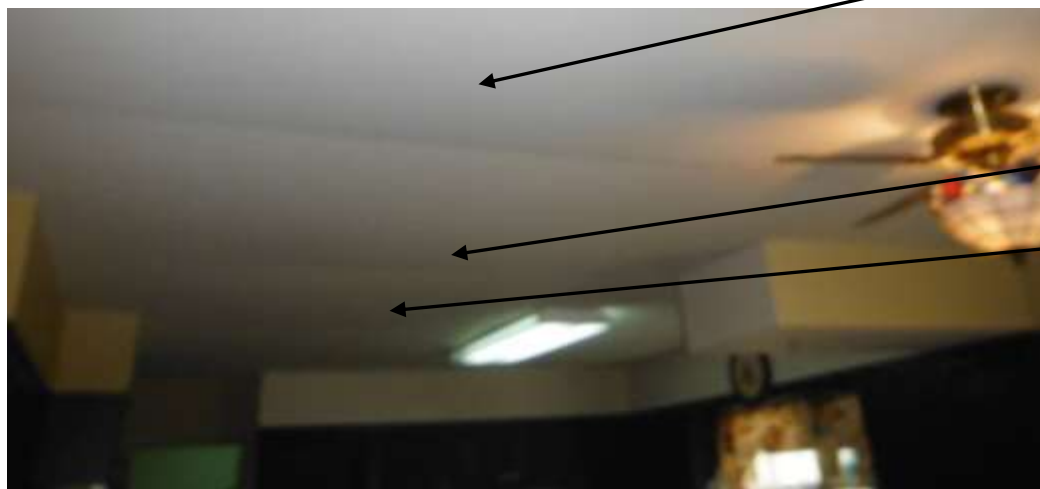
Figure 21 Example of drywall sagging & visible joint lines throughout house; have contractor evaluate and advise on repairs.
