4 Seasons Home Inspection, LLC

150 Maple Avenue, #128, South Plainfield, NJ 07080

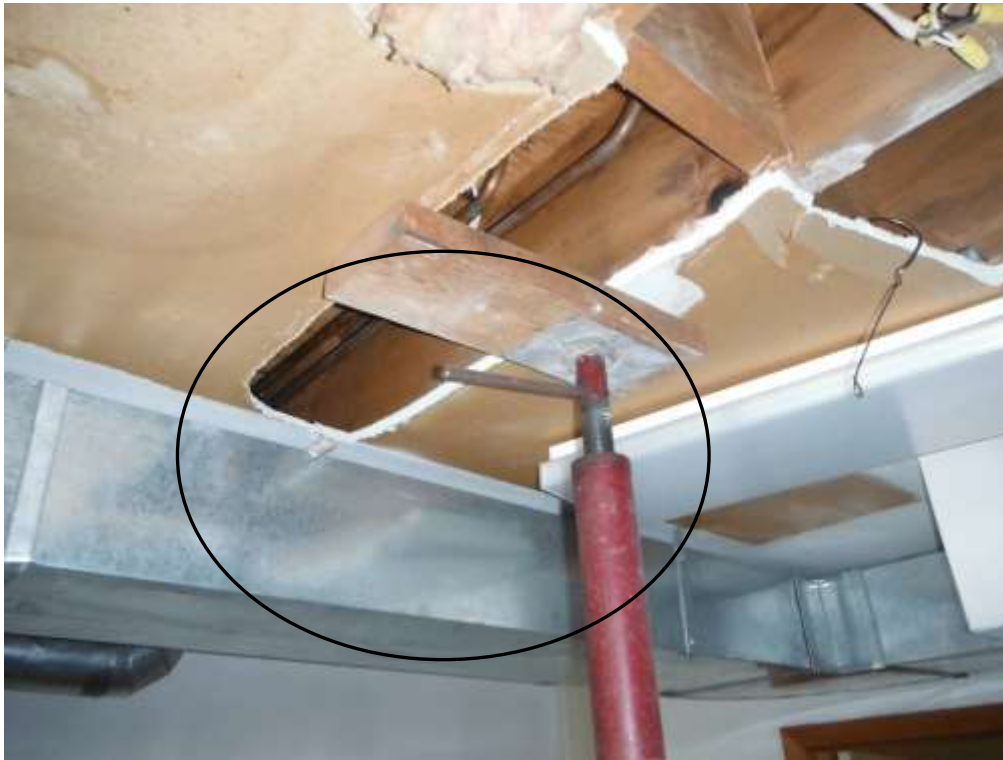
3. **There was water seepage in basement; staining and efflorescence observed. Have wet basement damp proofer contractor evaluate for water management system(s) to ensure a dry basement. Have gutters replaced with roof and correct all negative grading & soil erosion on exterior. See "grounds" section comments.**

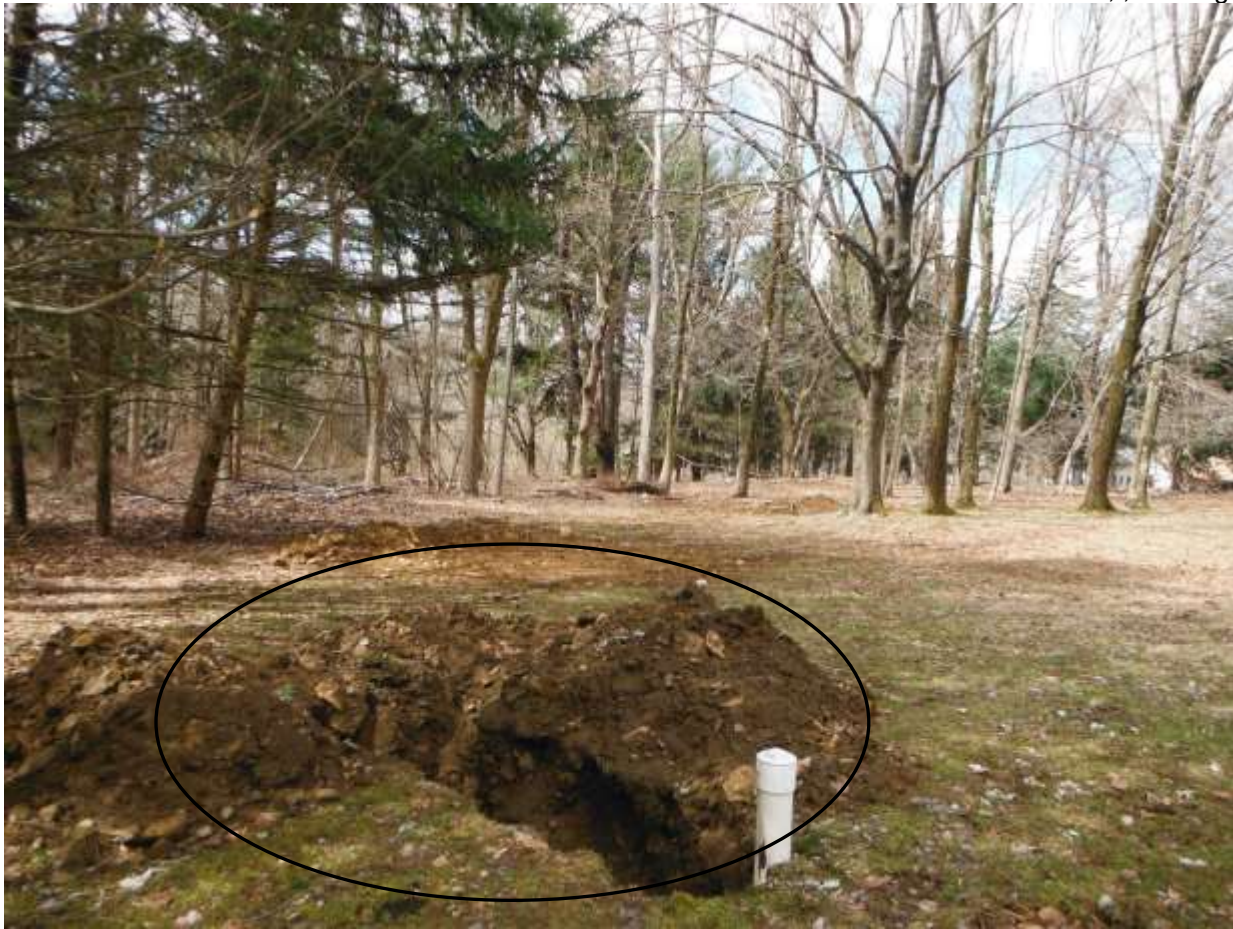
Figure 22 Open cavity for septic work or testing; fall hazard. Recommend fencing around open pit.

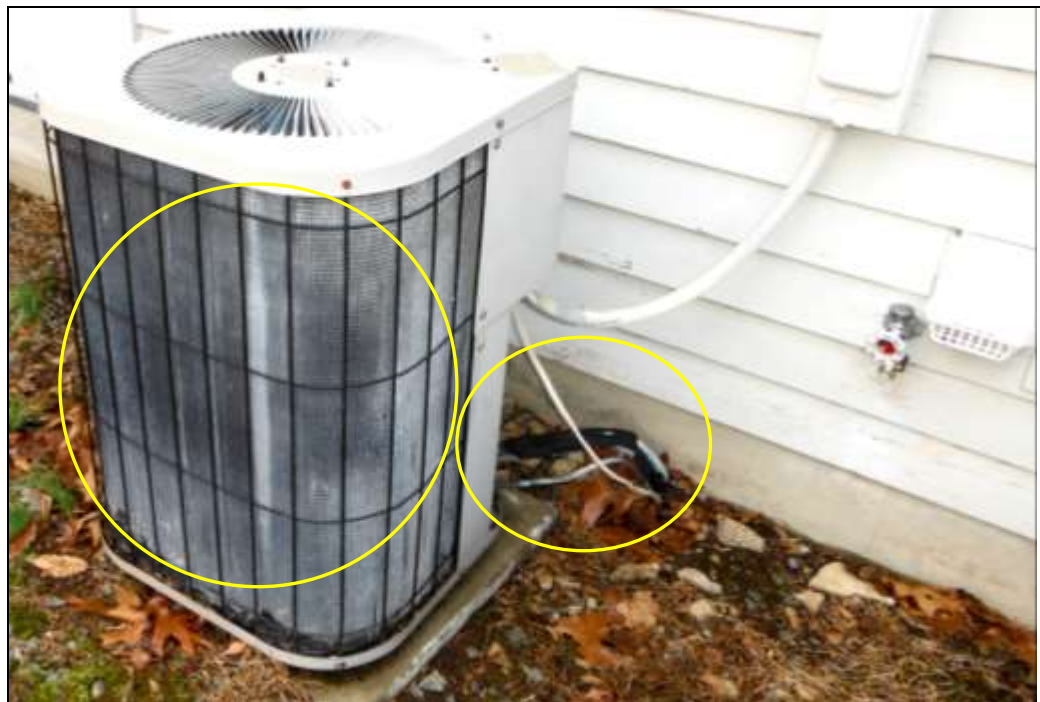
Figure 23 A/C past life & poor condition; damaged/flaking/oxidized fins, rust and corrosion, damaged insulation, etc.; have HVAC contractor evaluate the HVAC (heating & cooling) systems for replacements.

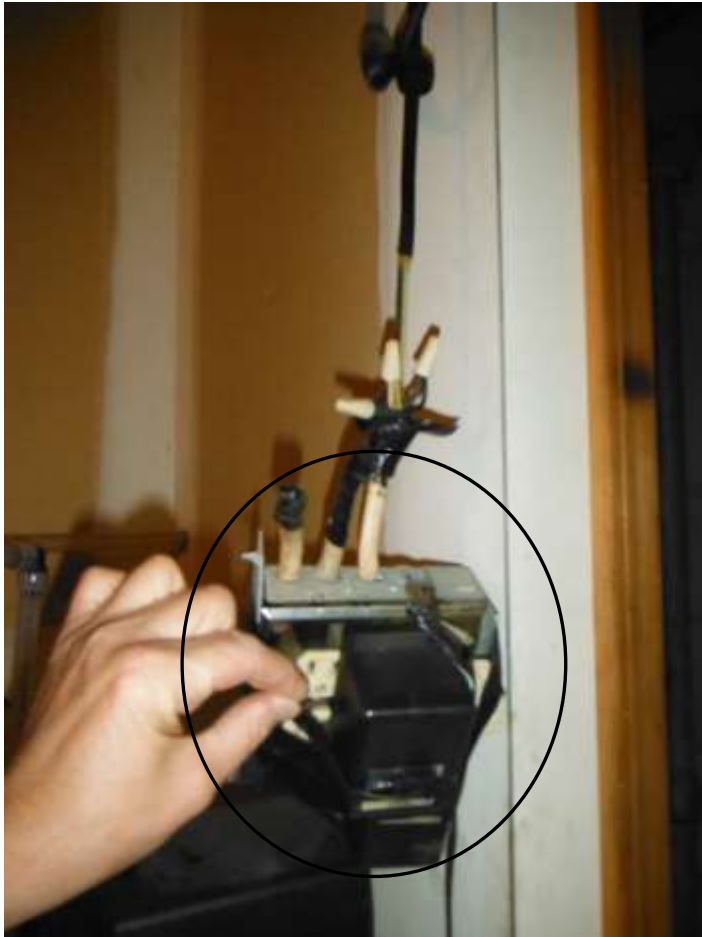
Figure 9 Example of handyman/improper /hazardous wiring or installations in home. Have a licensed electrician evaluate electrical and make corrections/repairs for safety.

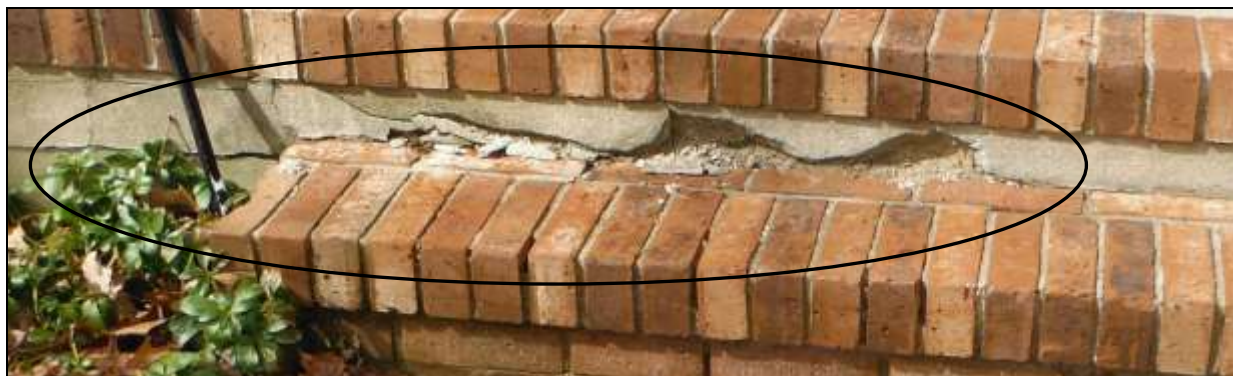
Figure 25 Have a mason evaluate/repair steps.

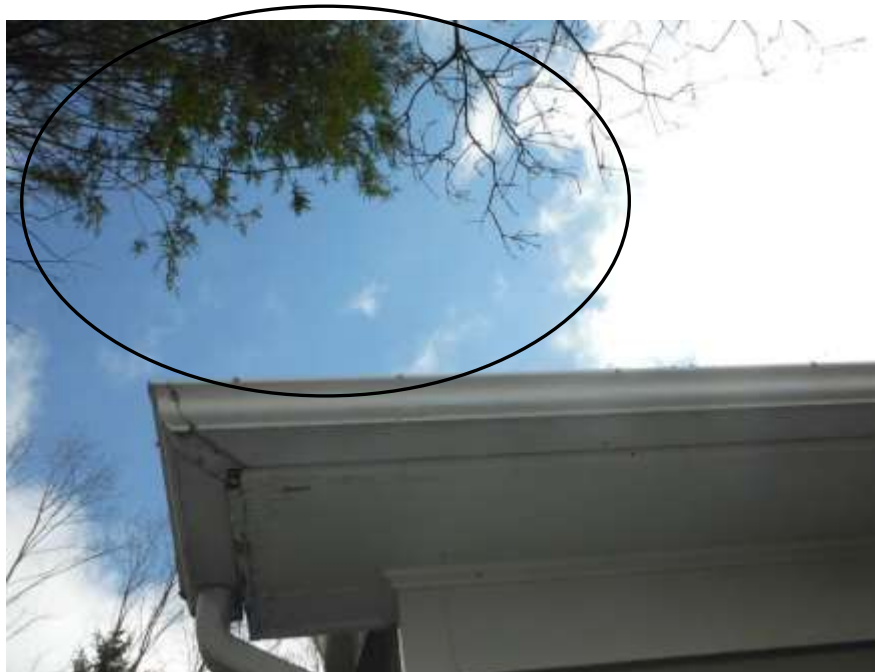
Figure 26 Remove all overhanging trees; carpenter ants, dirty gutters, etc.

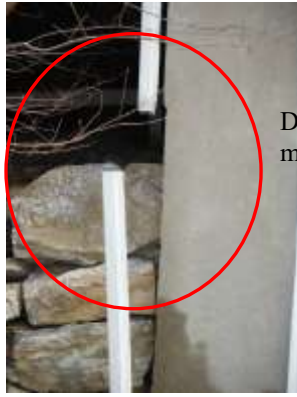
Disconnected & poorly maintained gutters.

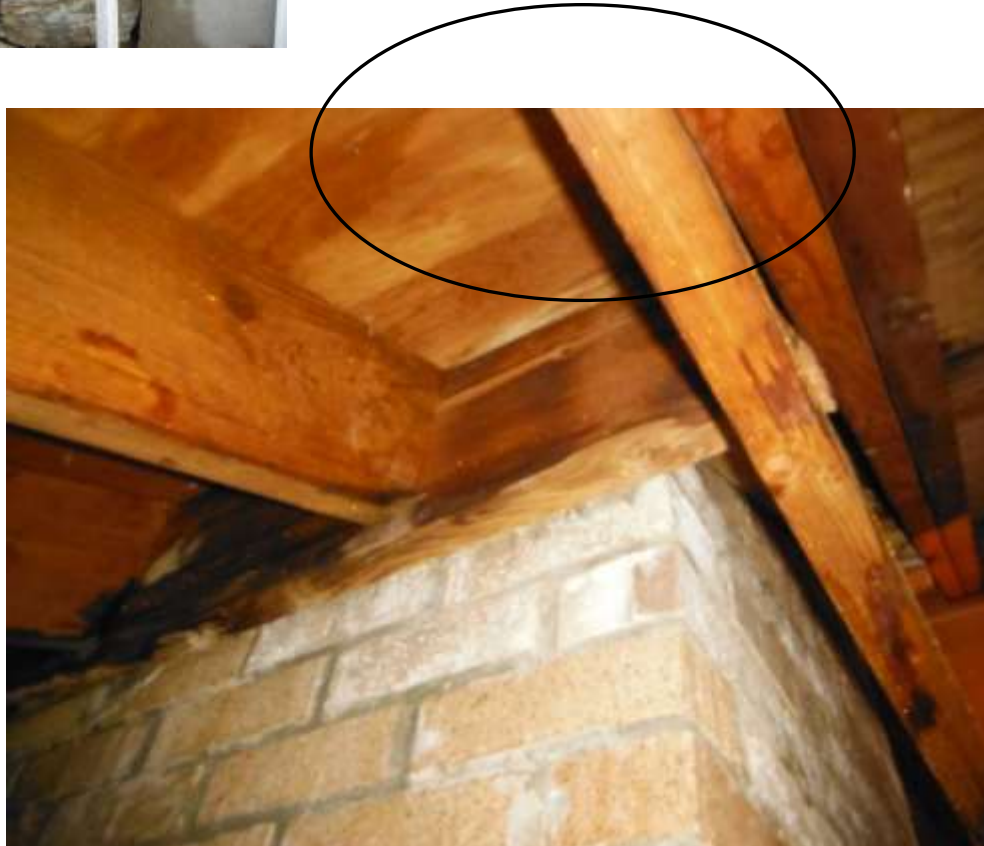
Figure 27 Leaking and efflorescence around chimney; view in attic.

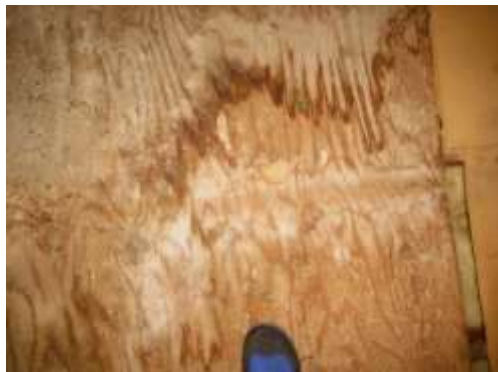
Figure 28 Water stains/leaking into attic.

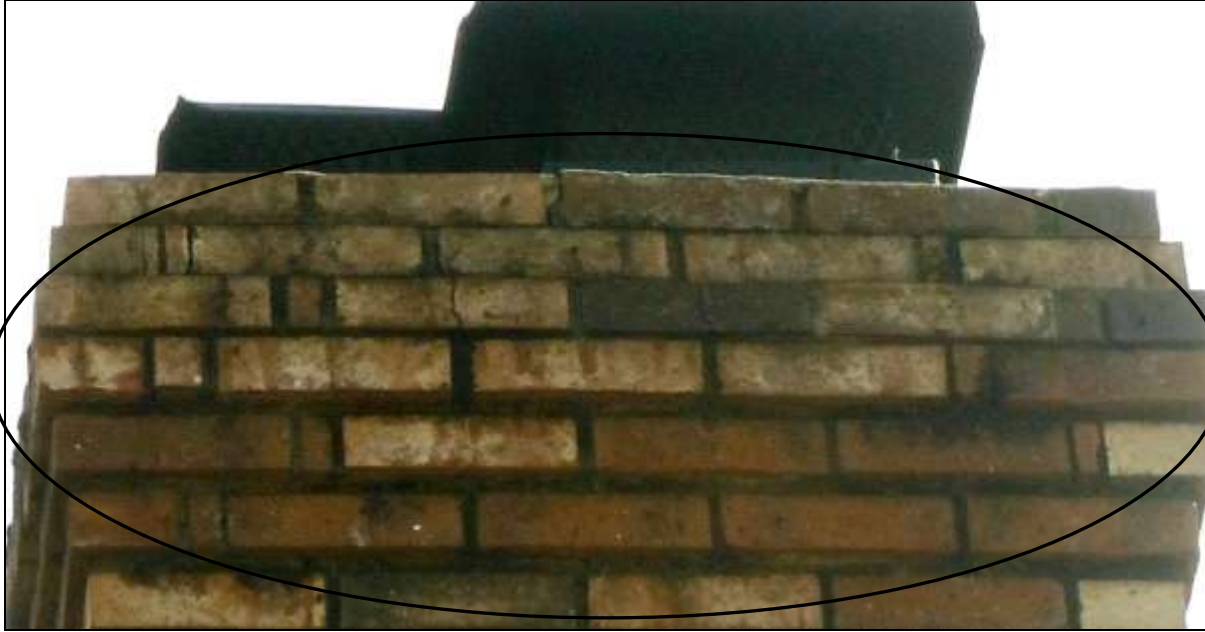
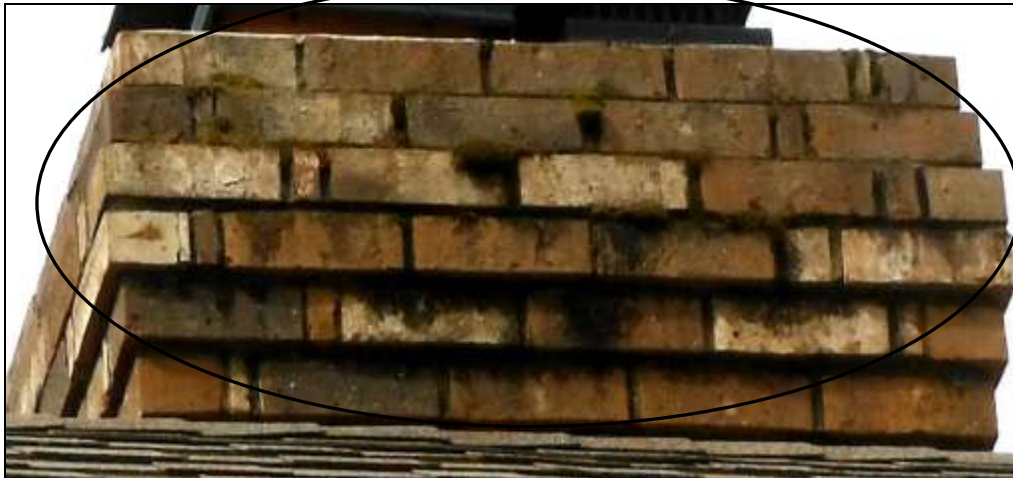
Examples of exterior water, carpenter bee, carpenter ant, wood pecker damage.

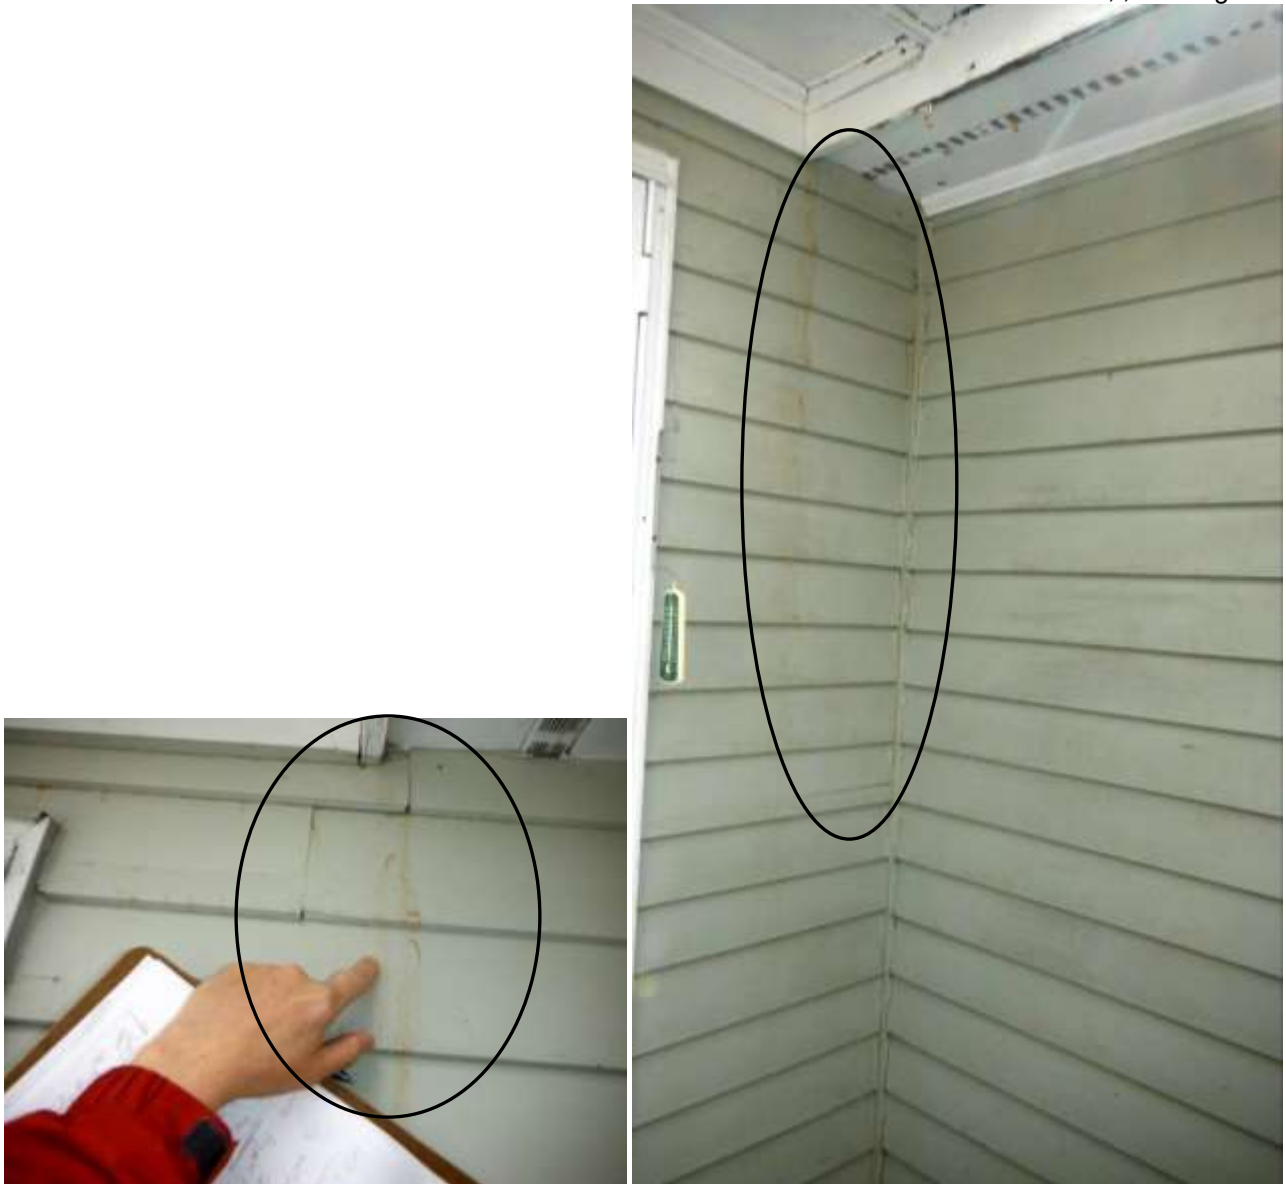
Figure 29 Leaking, water stains, poorly maintained exterior.

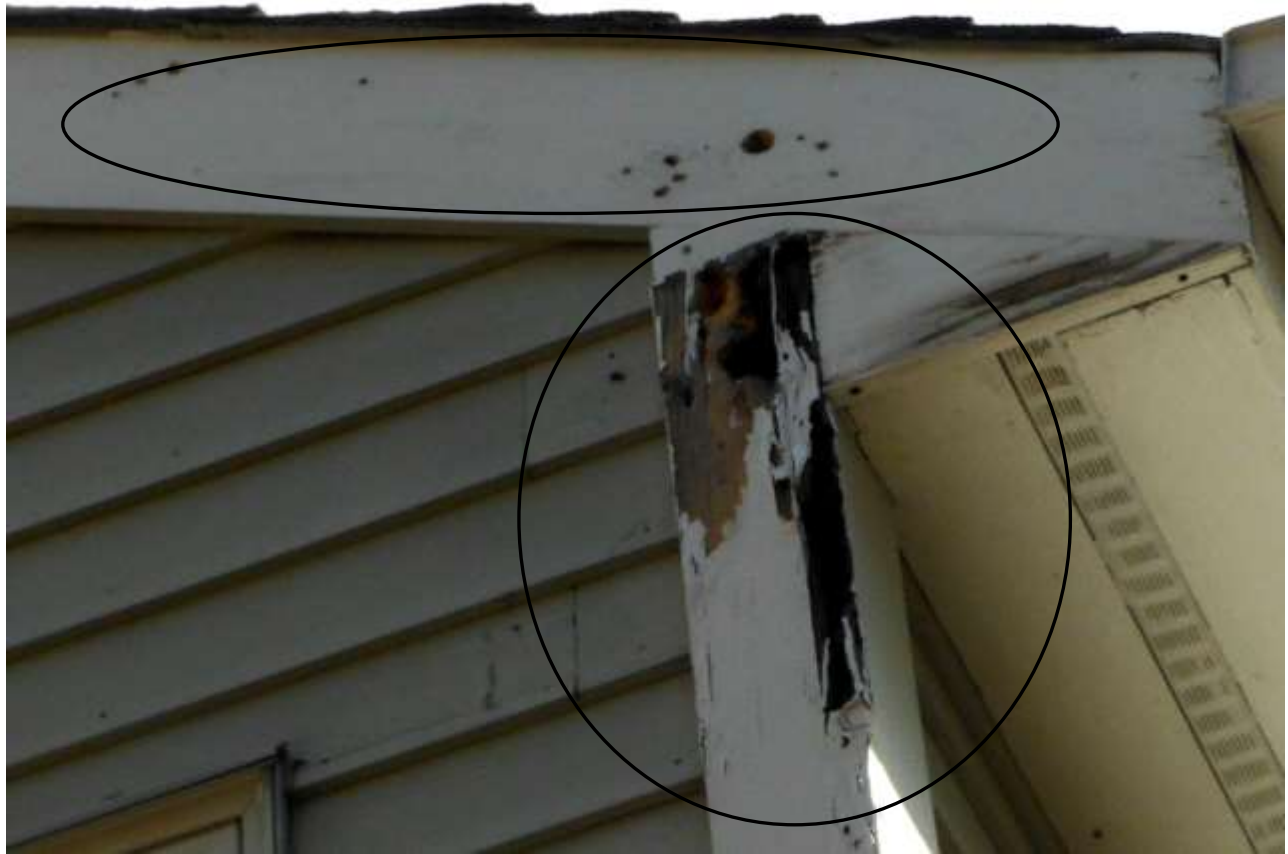
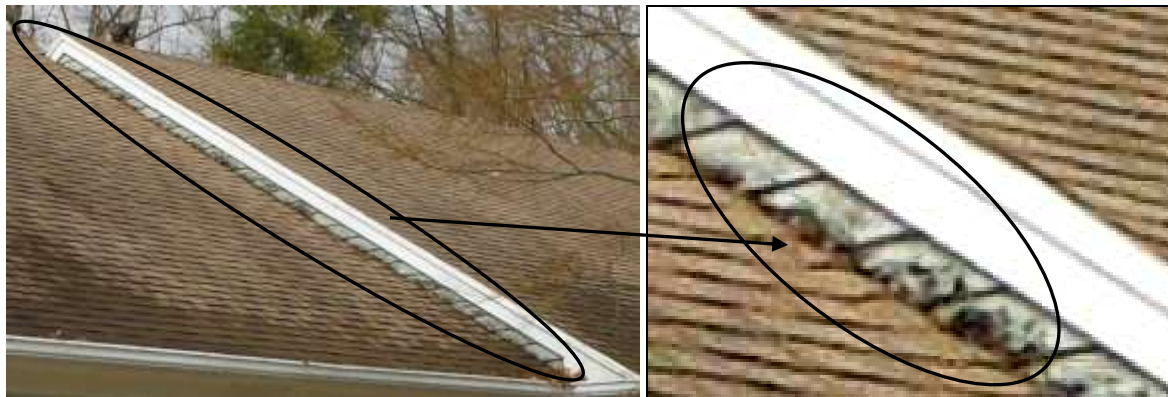
Figure 30 Rot on siding side wall/rook junctures.

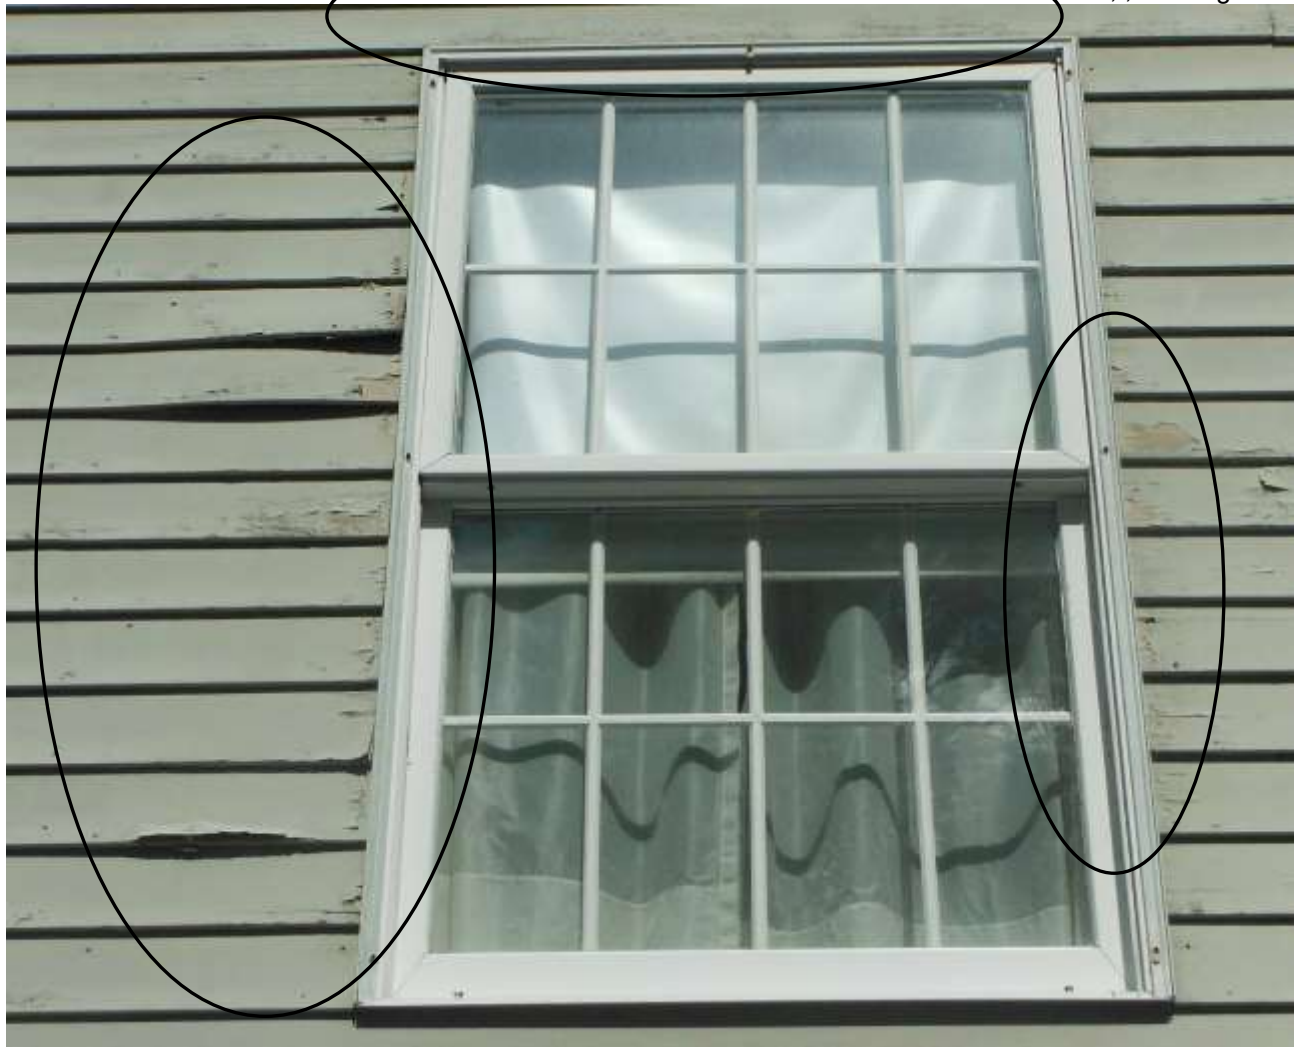
Figure 31 Siding water damaged, warped, rot, etc. Missing flashings over windows, doors, etc.

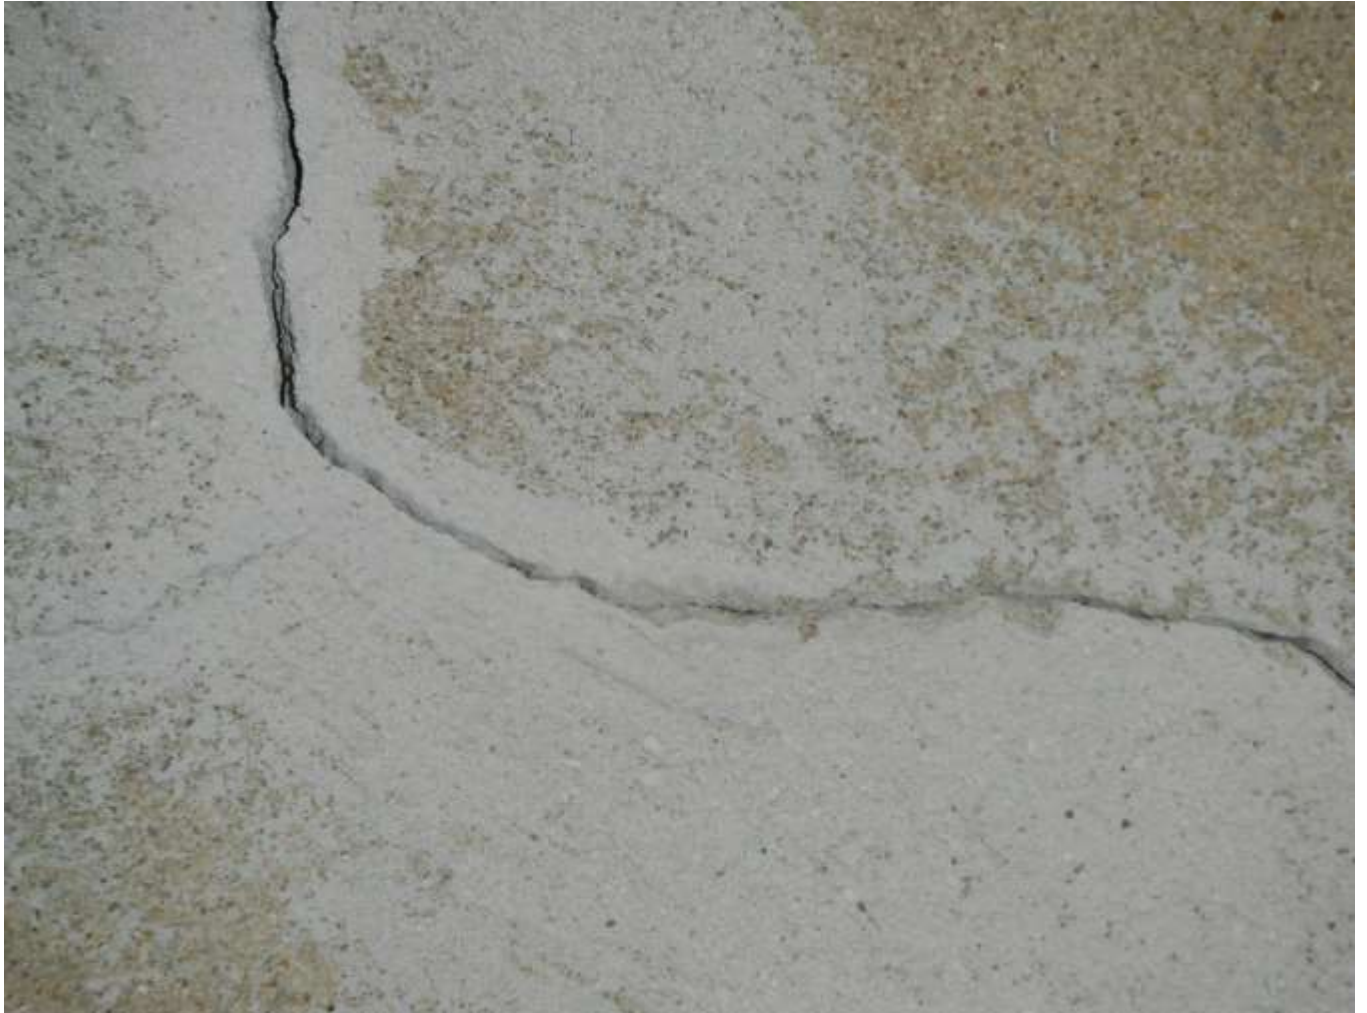
Figure 32 Foundation cracks; have foundation contractor, engineer or building contractor evaluate all foundation cracks and make repairs.

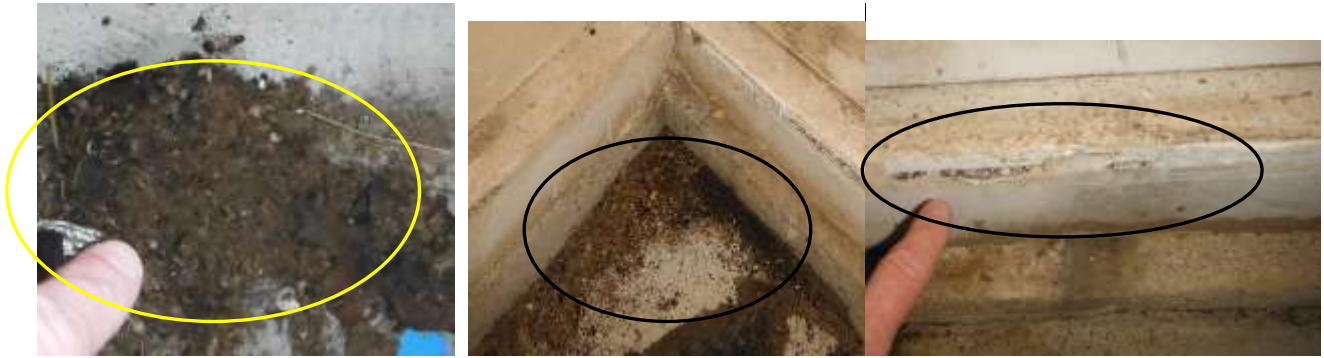
Figure 33 Carpenter ant frass/nest, damage, and chewed paper; have a licensed Pest Company treat for all wood destroying insects.

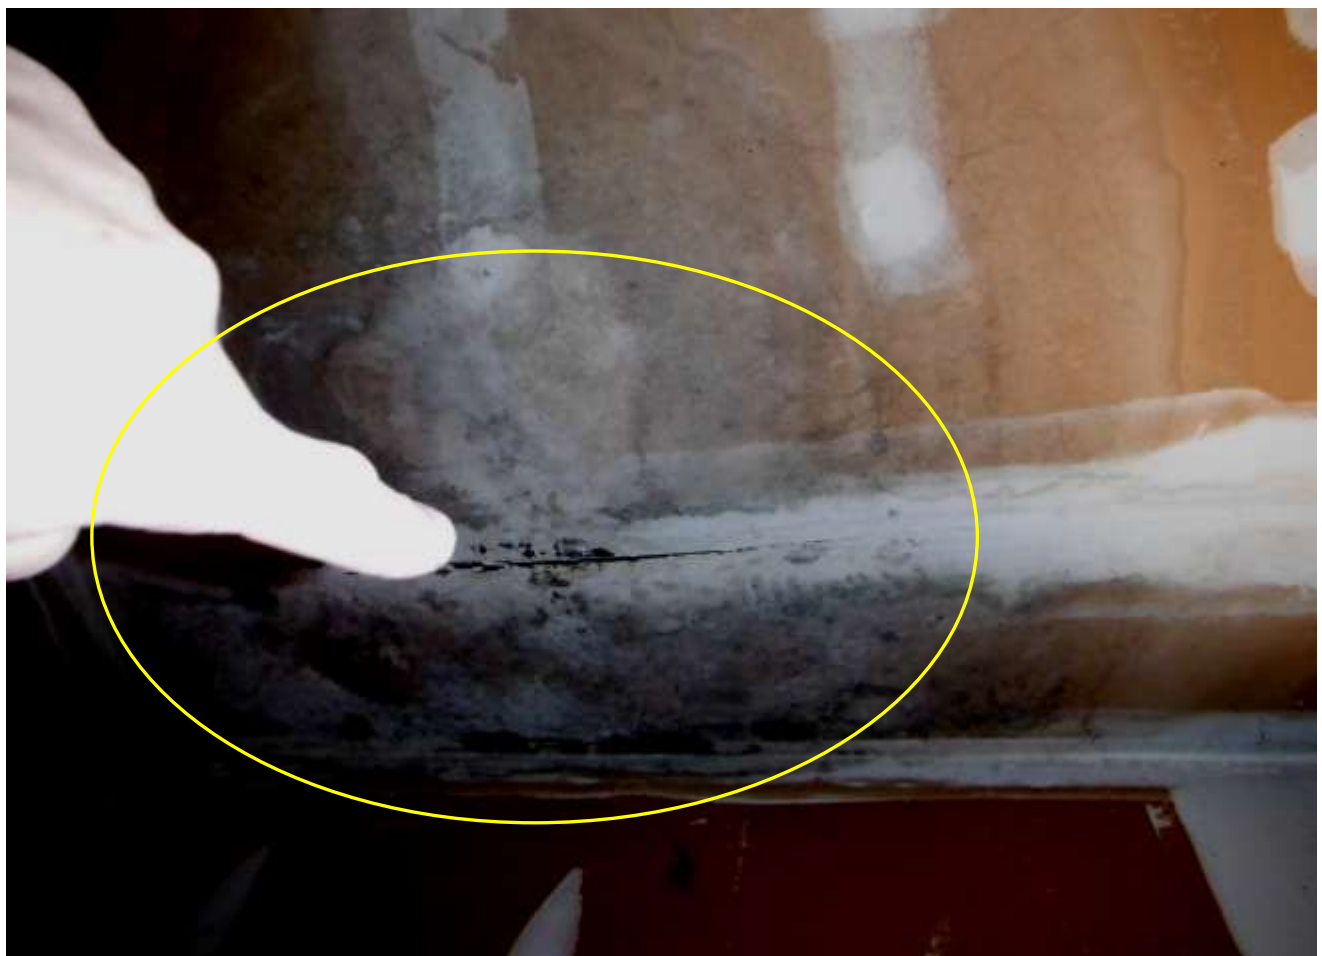
Figure 34 Example of roof leaking & water damage in garage. Have a structural carpenter evaluate extent of all damage including water, mold & insect before closing. The home was poorly maintained and needs upgrades and repairs everywhere.

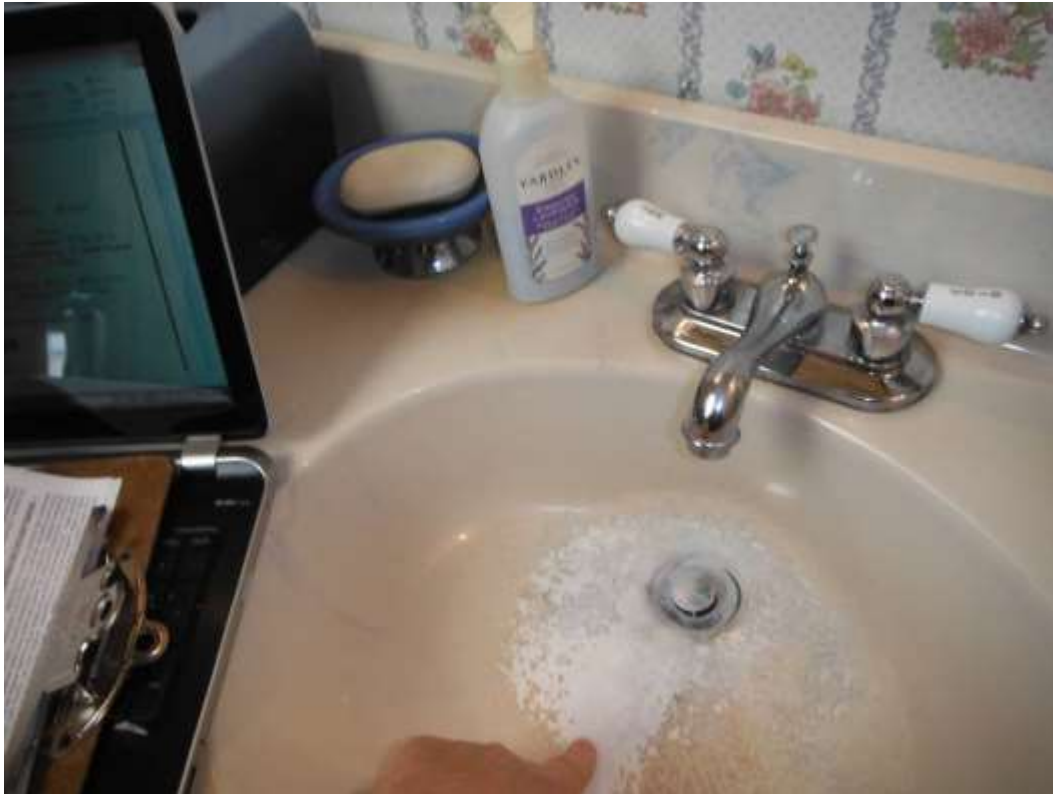
Figure 35 Cracked & damaged sink basin; hygiene/health and leak concerns.

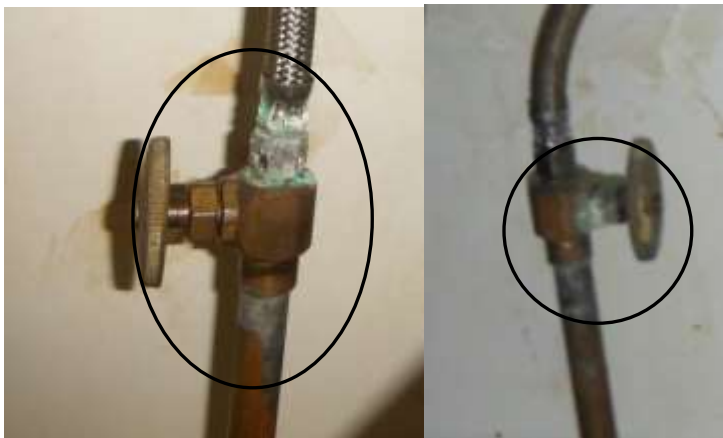
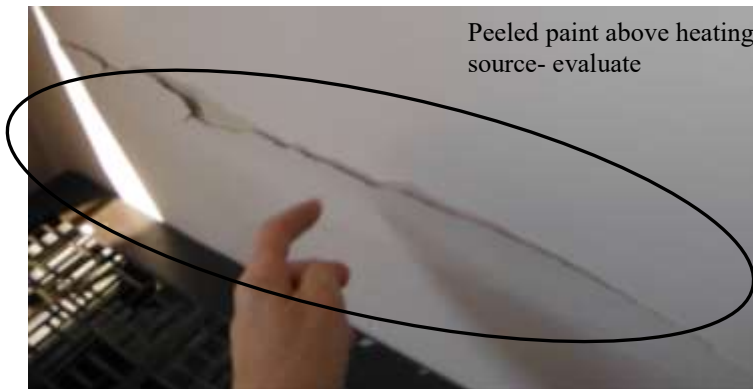
Peeled paint above heating source- evaluate

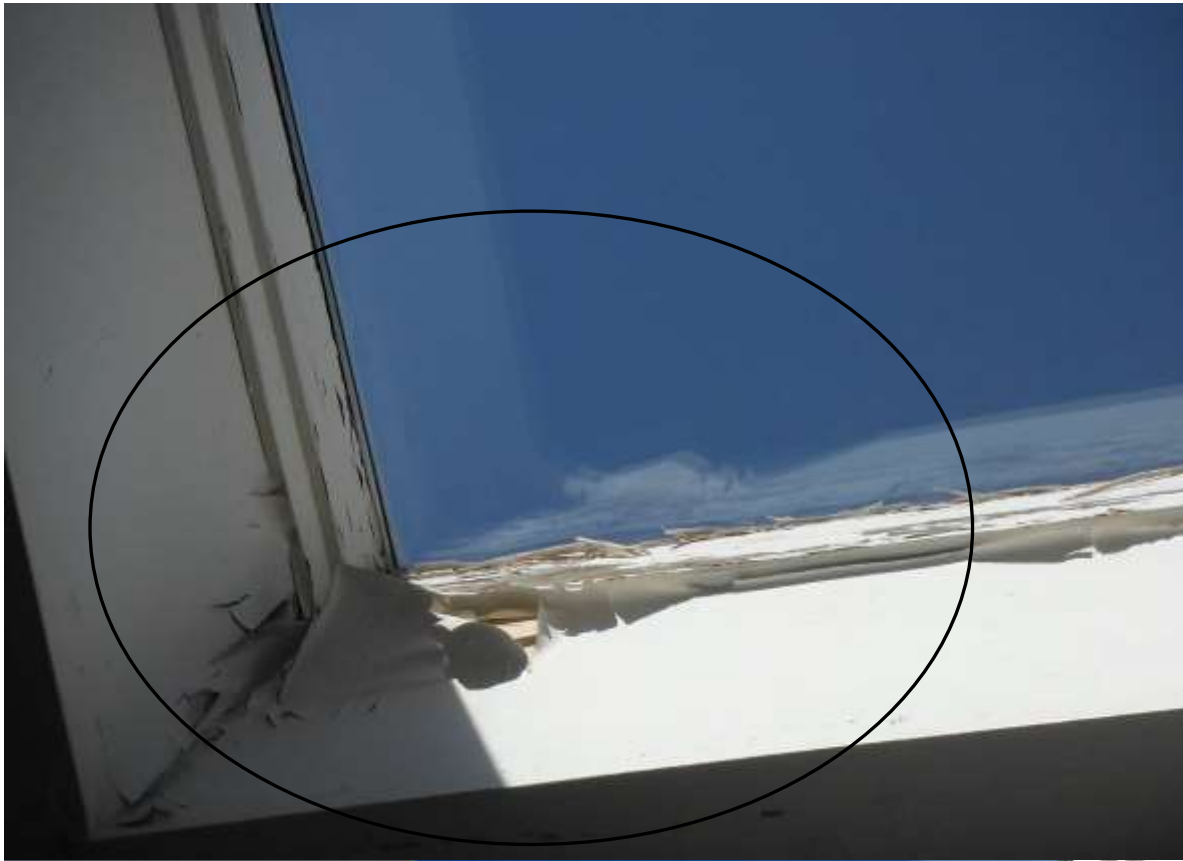
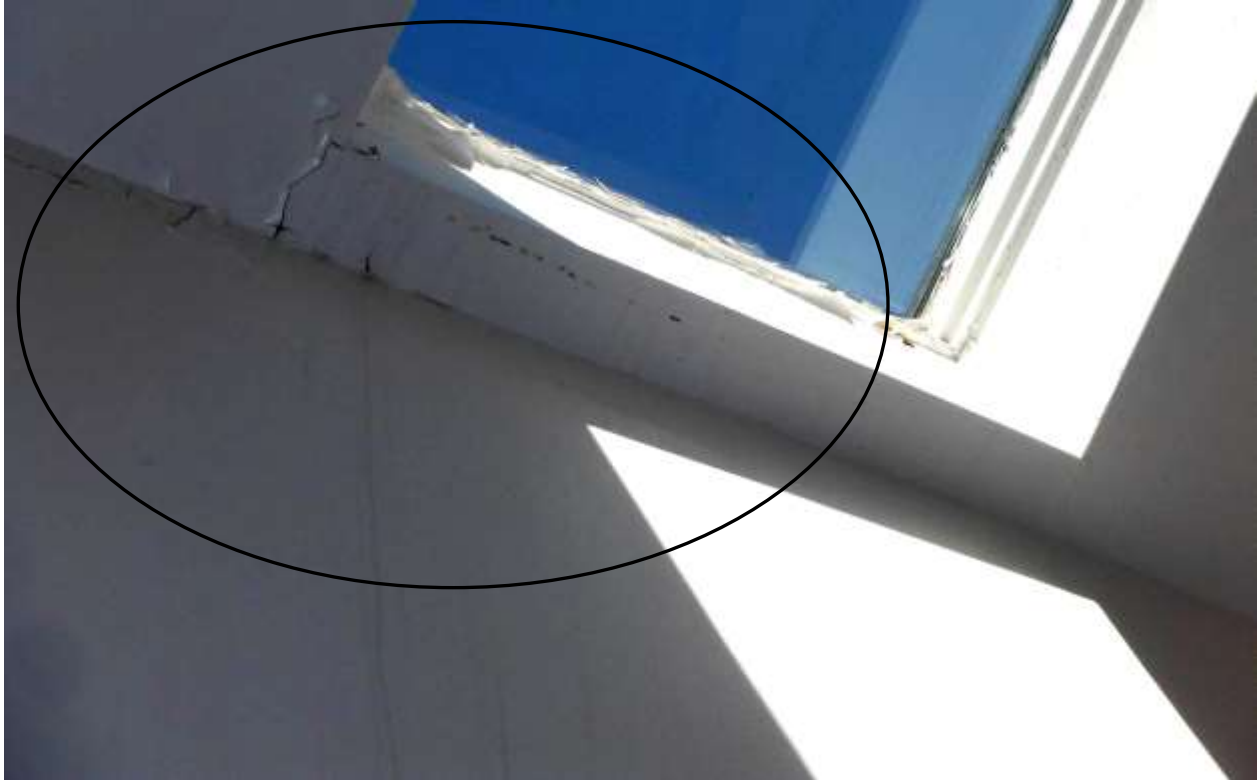
1. There was leaking skylight; have skylights replaced with roof. See roofing section comments.
2. Have an electrician evaluate the exhaust fan and repair/replace for safety; humming motor.

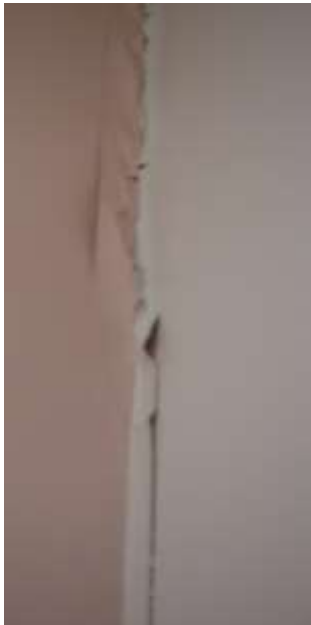
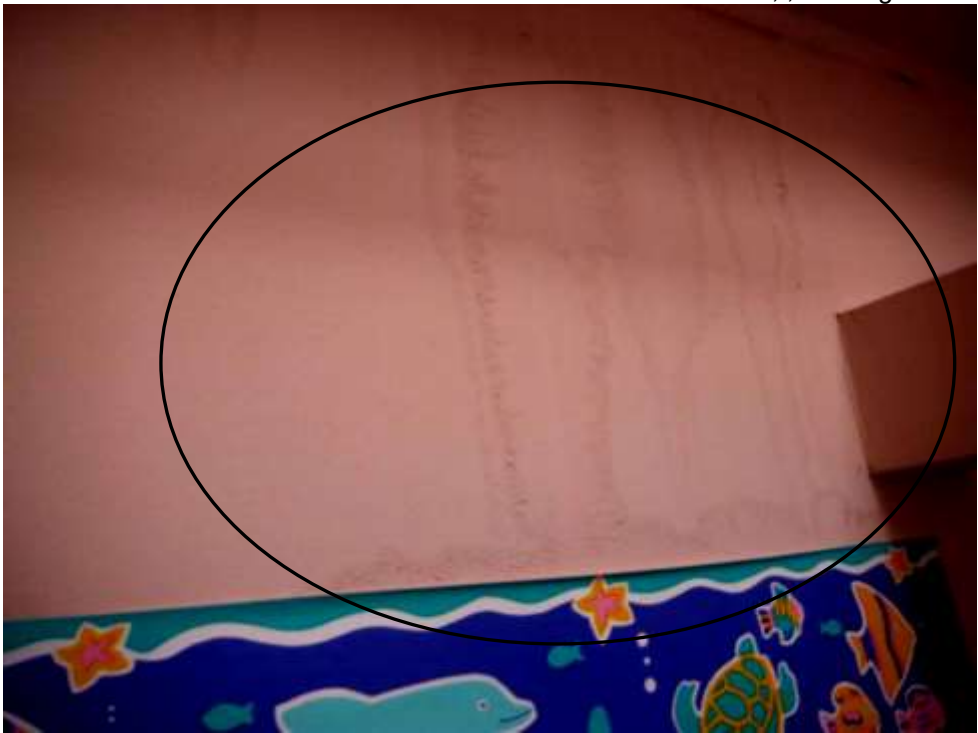
BATH: BASEMENT**SINKS / TUBS / SHOWERS**

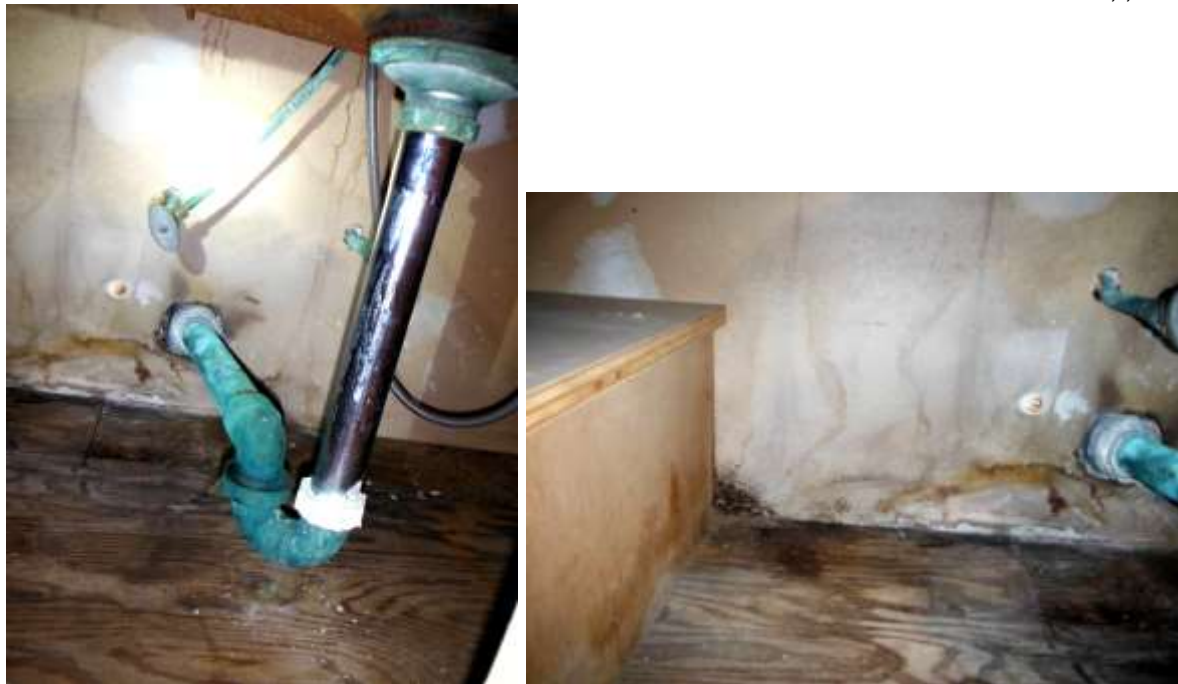
Figure 36 Leaking, corrosion, old plumbing; have licensed plumber evaluate for plumbing upgrades throughout the home.

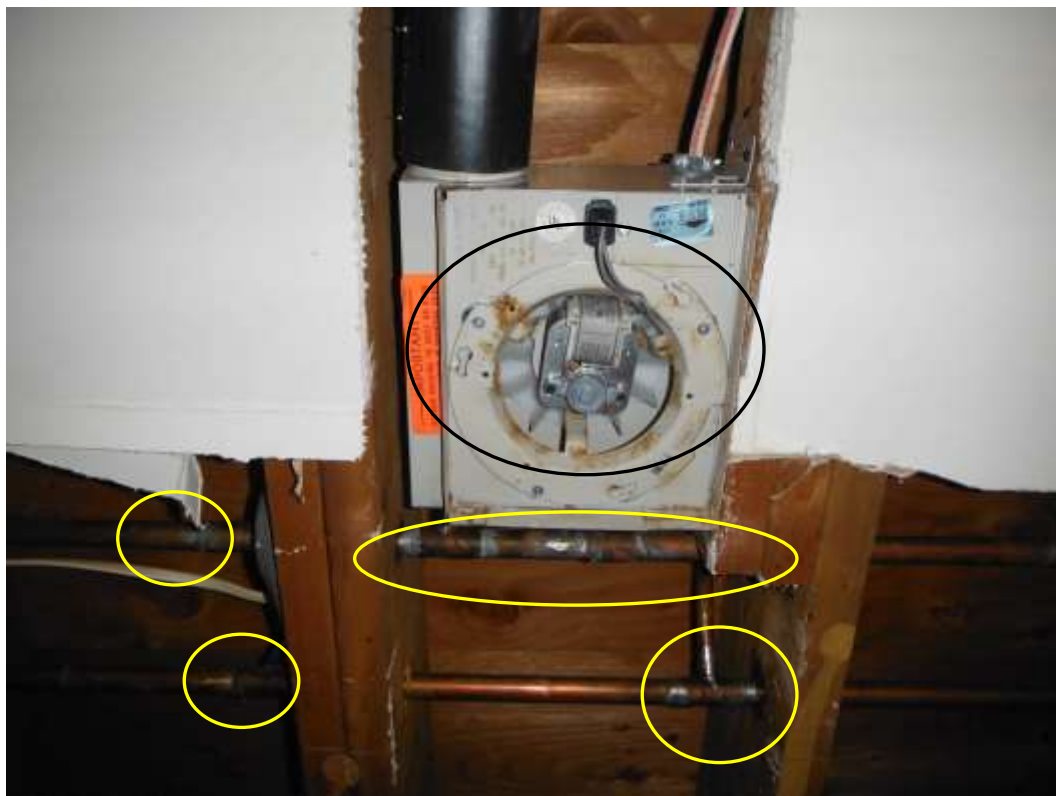
Figure 37 Opened ceiling and plumbing repairs; indication of frozen pipes/leak repairs. Have a bathroom contractor evaluate bathroom and upgrade with required permits.

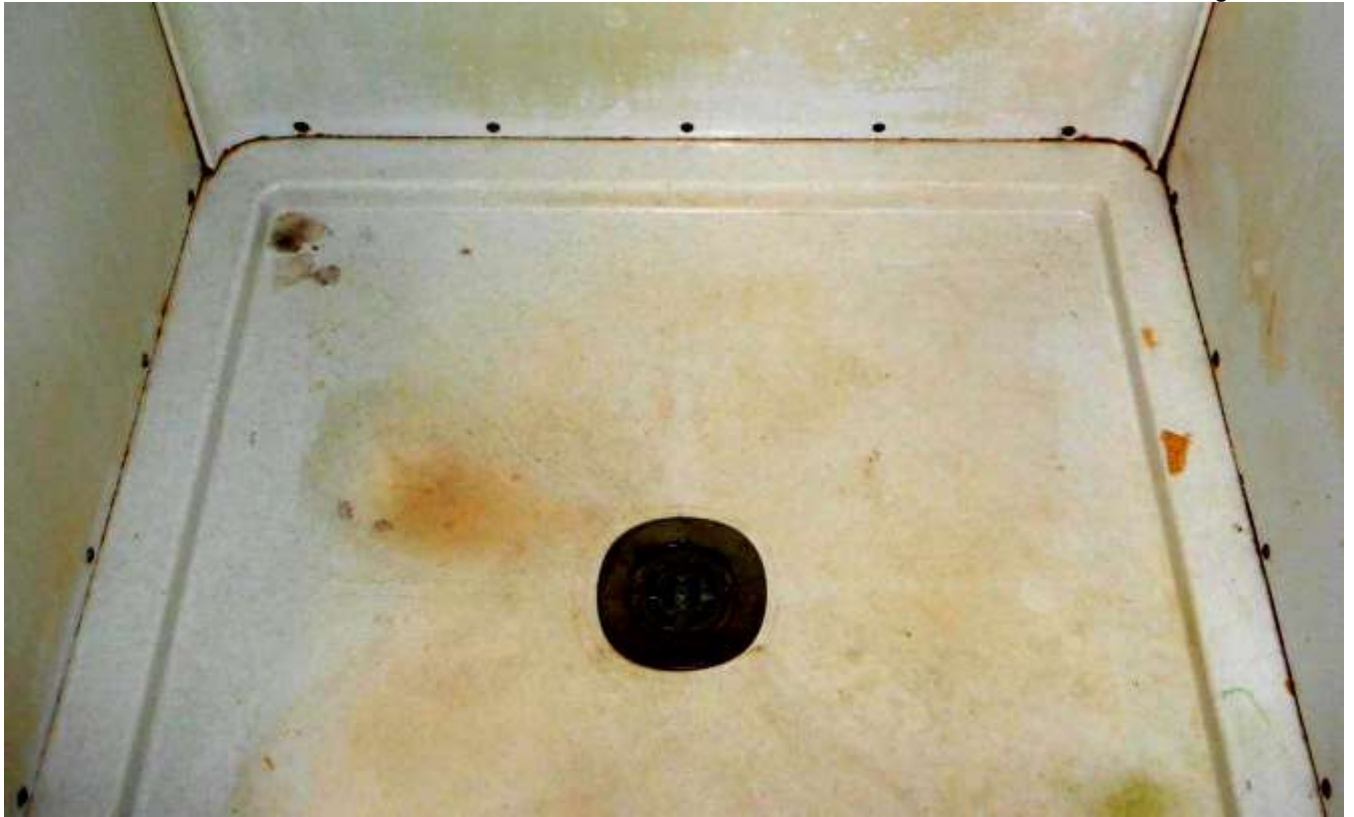
Figure 38 Recommend a bathroom contractor evaluate the bathroom and advise on all upgrades. Low quality/poor shower stall; rusted, stained, etc.

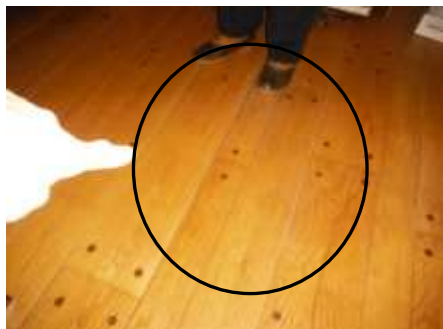
Figure 39 Have humps/warped boards/structure evaluated by contractor or engineer.
