4 Seasons Home Inspection, LLC

150 Maple Avenue, #128, South Plainfield, NJ 07080

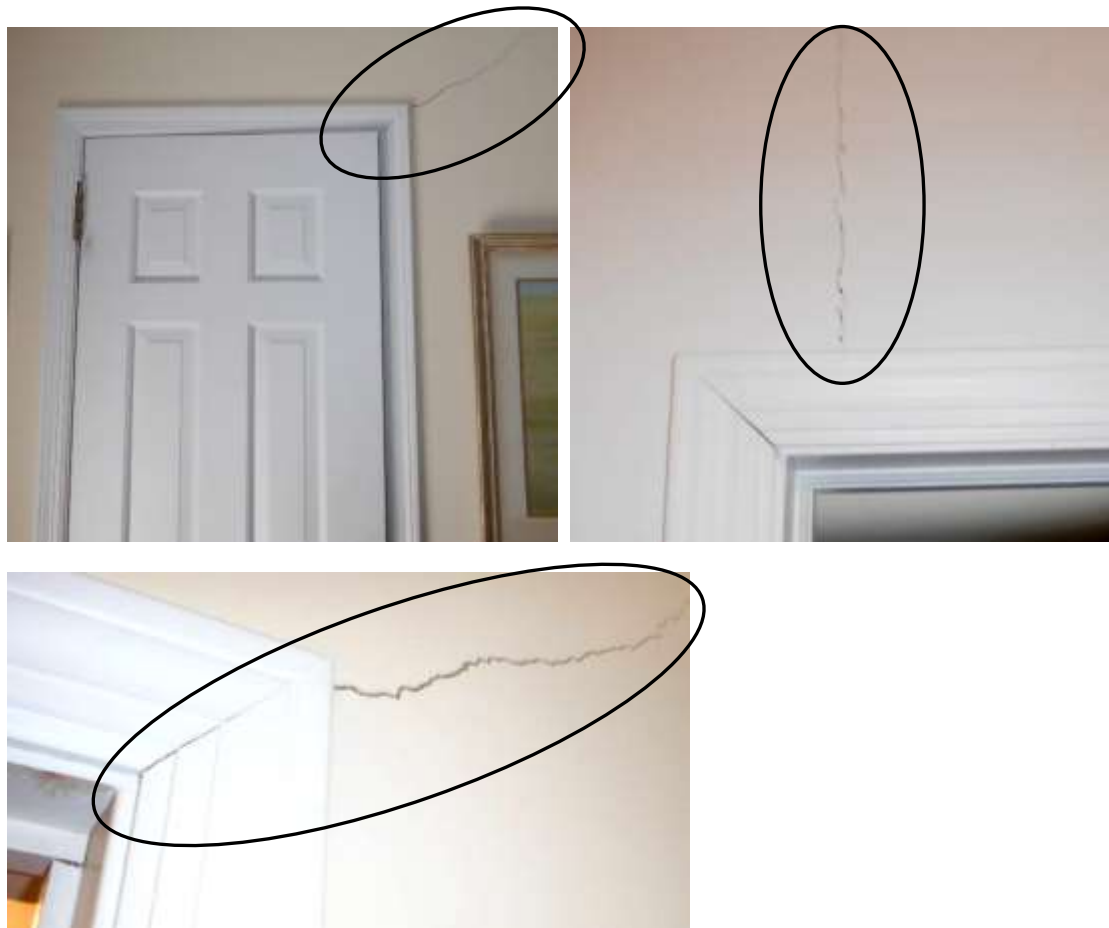
1. Have a structural contractor (builder, engineer, structural carpenter, etc.) evaluate the structure; canted doorway, door not closing/not plumb, crack through into closet, etc. **

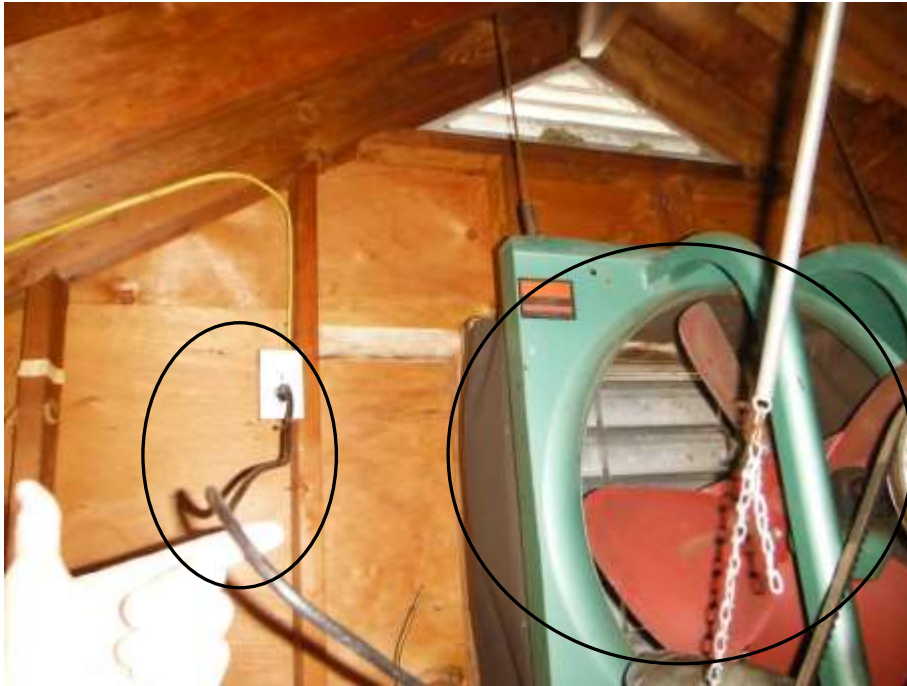
Figure 41 Attic fan had not grille and not wired with power switch; safety hazards.

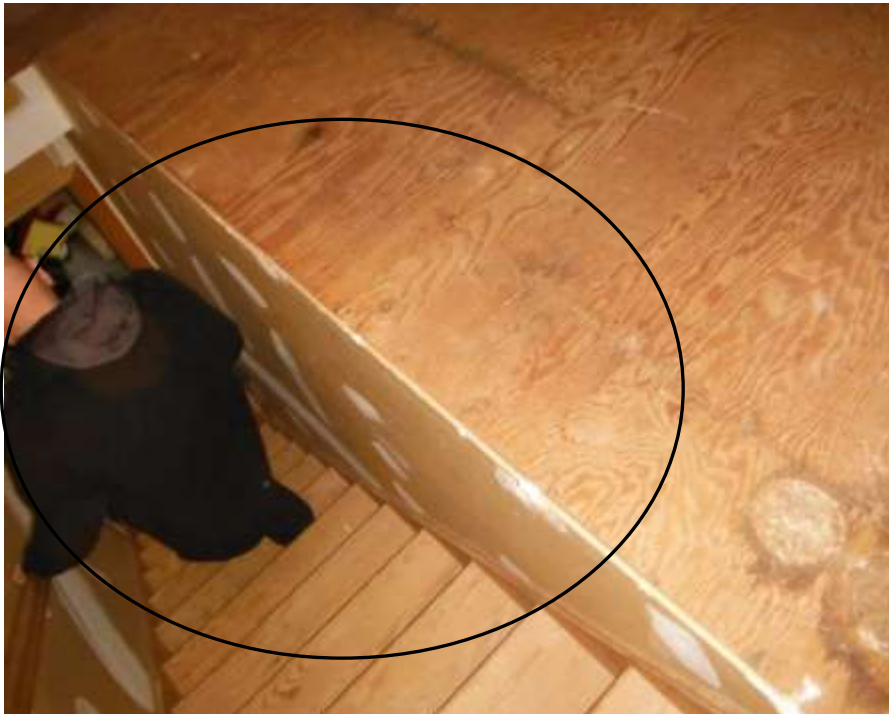
Figure 42 Need a railing for safety.

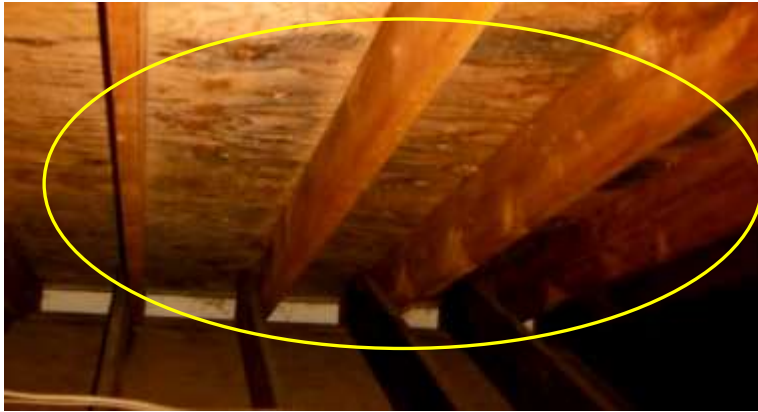
Figure 43 Example of mold like staining in attic; have affected plywood evaluated for replacement.

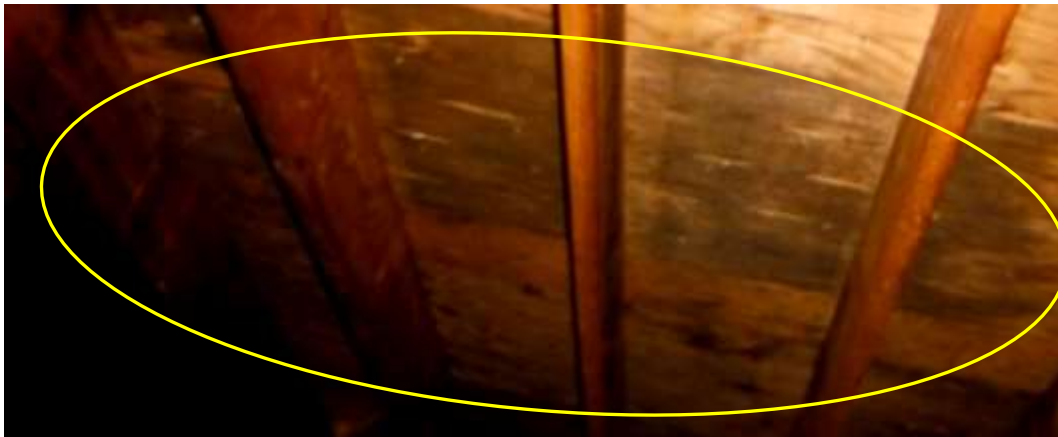
Figure 44 Example of mold like staining in attic; have affected plywood evaluated for replacement.

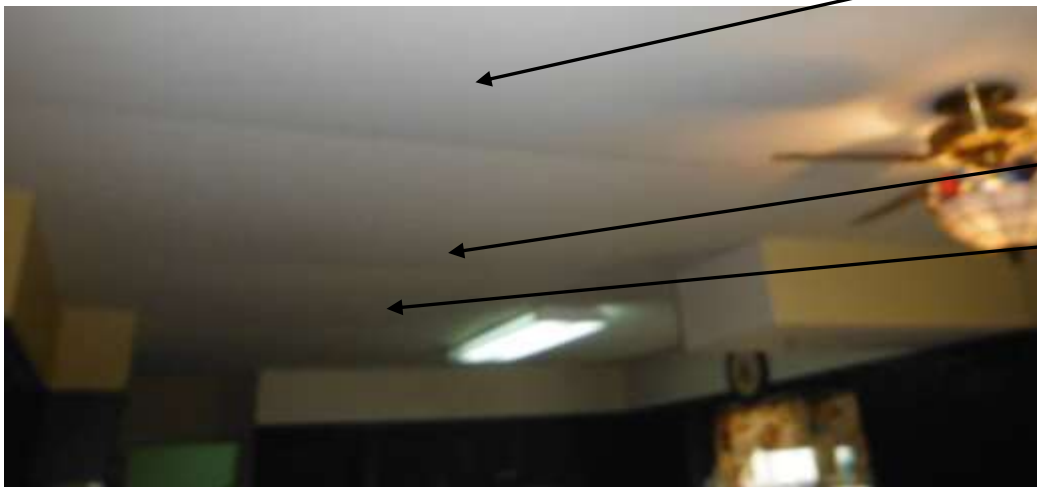
Figure 45 Example of drywall sagging & visible joint lines throughout house; have contractor evaluate and advise on repairs.

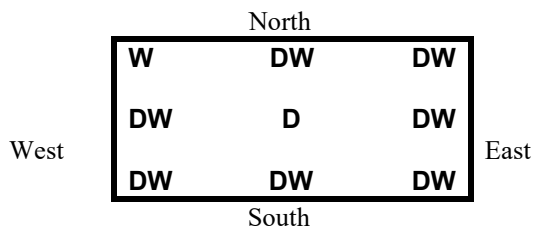
P = Paneling C = Crack(s)
 D = Drywall M = Monitor
 S = Storage E = Evaluate
 W=Water/moisture, seepage, efflorescence

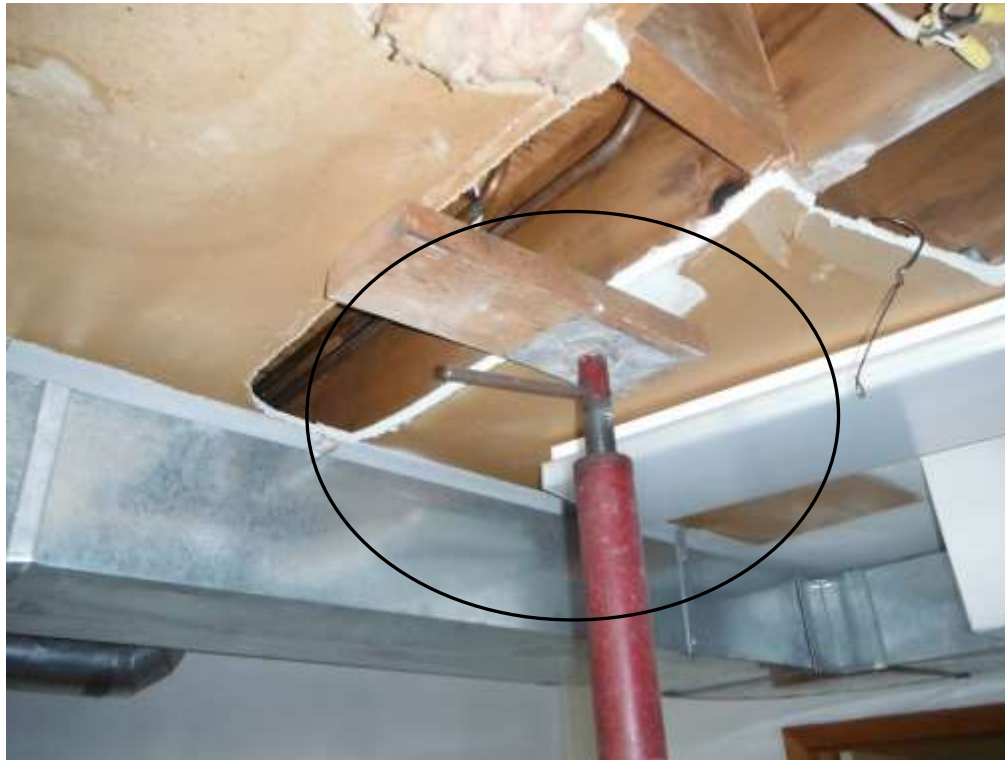
3. There was water seepage in basement; staining and efflorescence observed. Have wet basement damp proofer contractor evaluate for water management system(s) to ensure a dry basement. Have gutters replaced with roof and correct all negative grading & soil erosion on exterior. See "grounds" section comments.

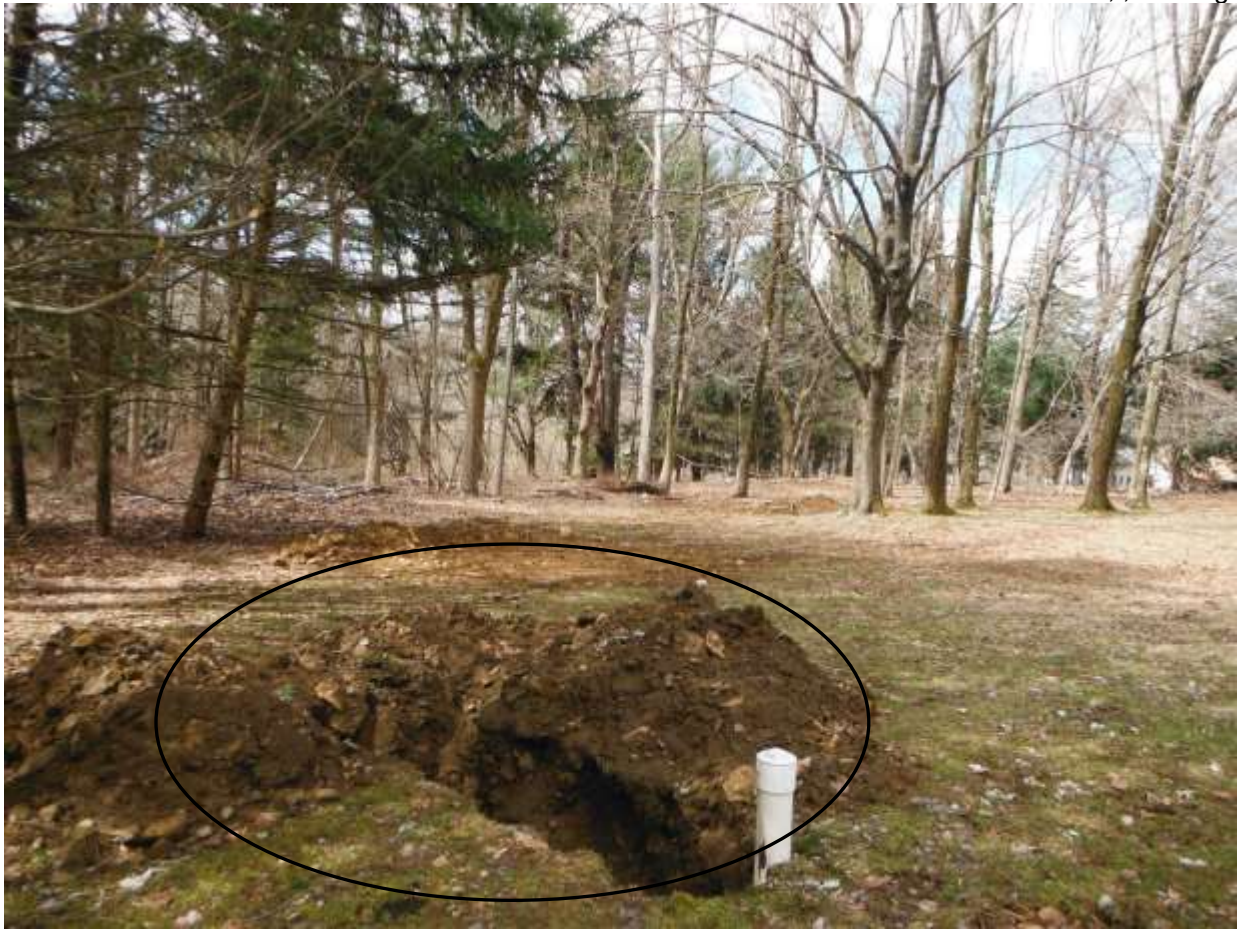
Figure 46 Open cavity for septic work or testing; fall hazard. Recommend fencing around open pit.

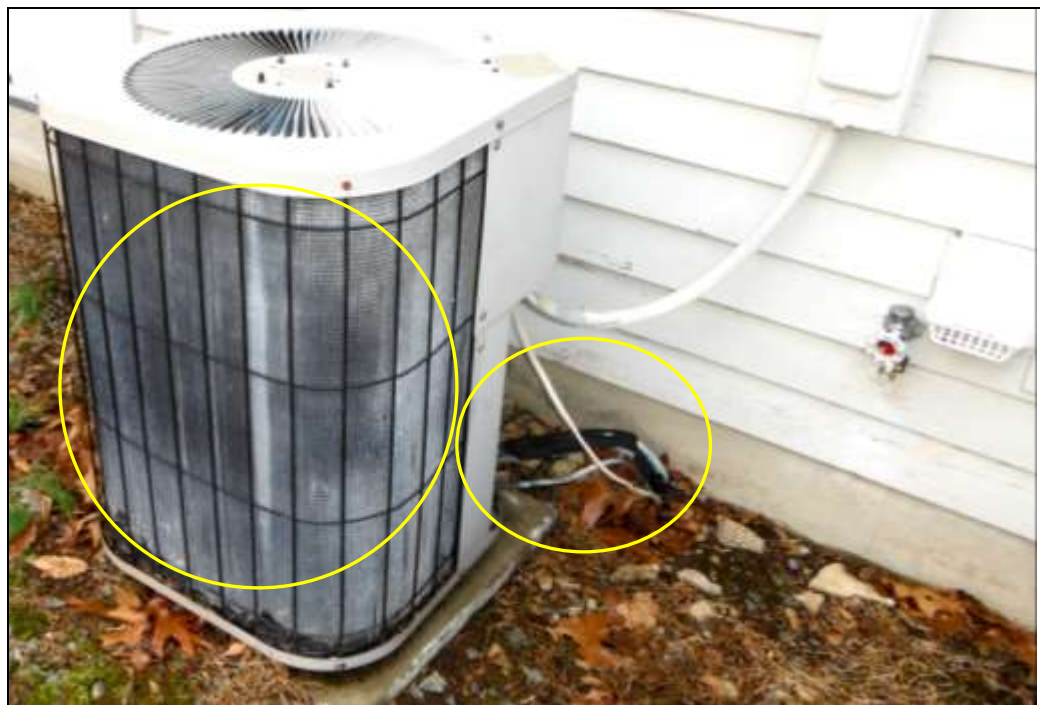
Figure 47 A/C past life & poor condition; damaged/flaking/oxidized fins, rust and corrosion, damaged insulation, etc.; have HVAC contractor evaluate the HVAC (heating & cooling) systems for replacements.

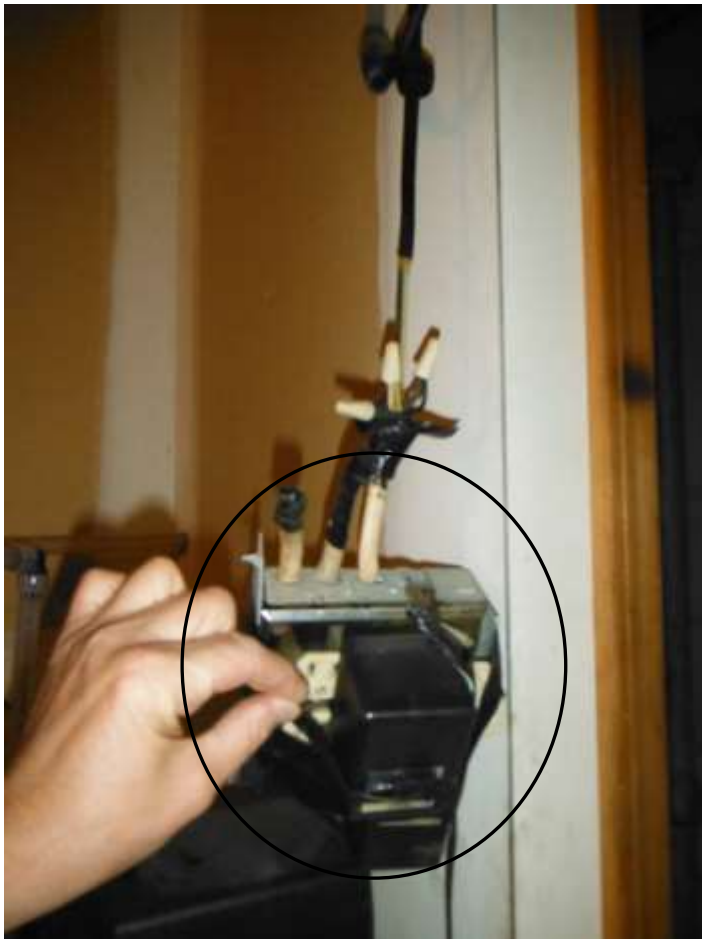
Figure 9 Example of handyman/improper /hazardous wiring or installations in home. Have a licensed electrician evaluate electrical and make corrections/repairs for safety.
