4 Seasons Home Inspection, LLC

150 Maple Avenue, #128, South Plainfield, NJ 07080
www.4SeasonsHI.com 1-877-547-7383

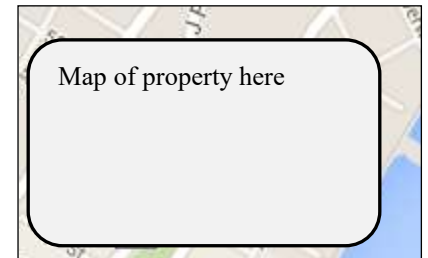
Inspection Date: September date/year
Client Name: -----
Emails: lawyer, realtor
Inspection Address: West New York, NJ 07093
Inspected by: Linda Geczí home inspection lic. #24GI00061500

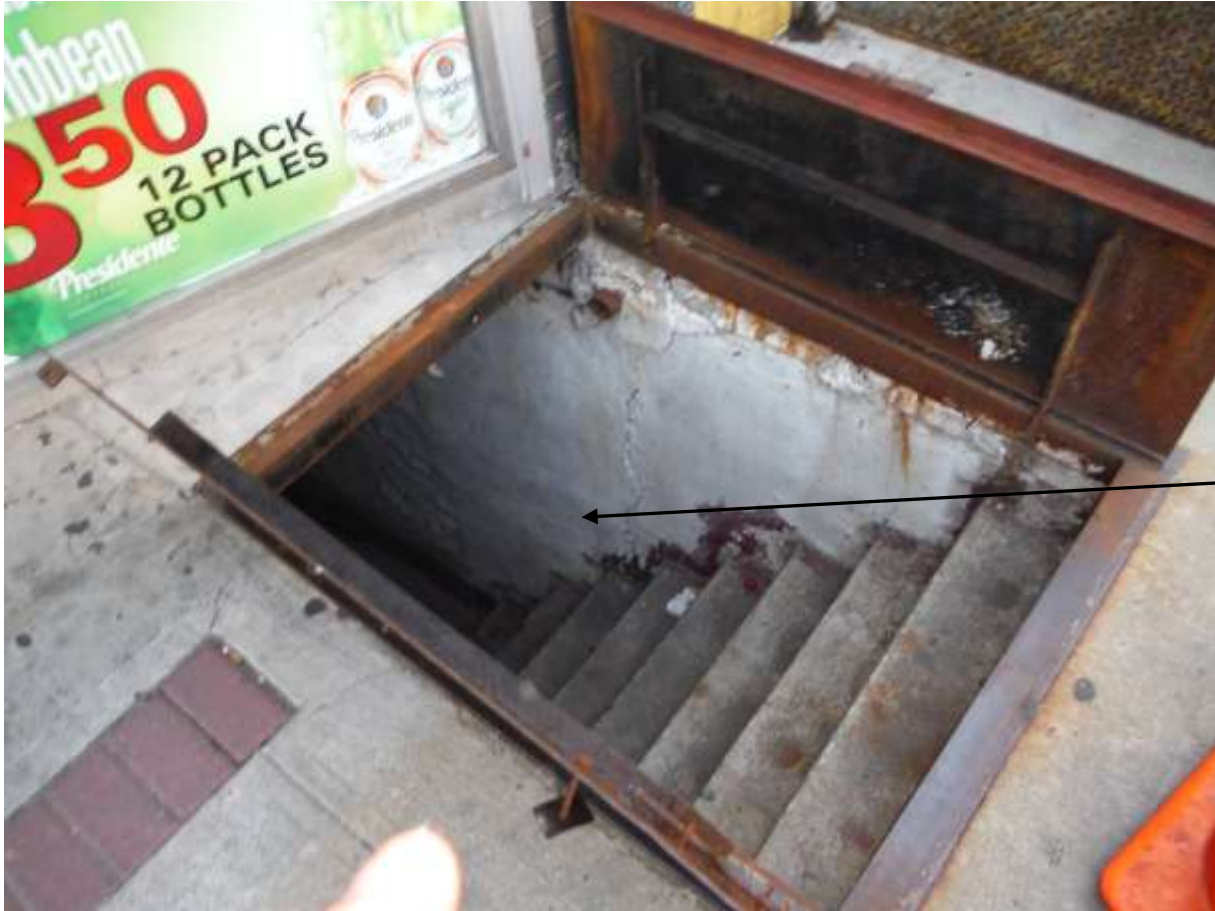
Figure 1 Dangerous; fall hazard to basement when door is left open. Follow-up with a safety supply company & consultant for railings, fencing and conveyor when receiving shipments or products for basement storage.

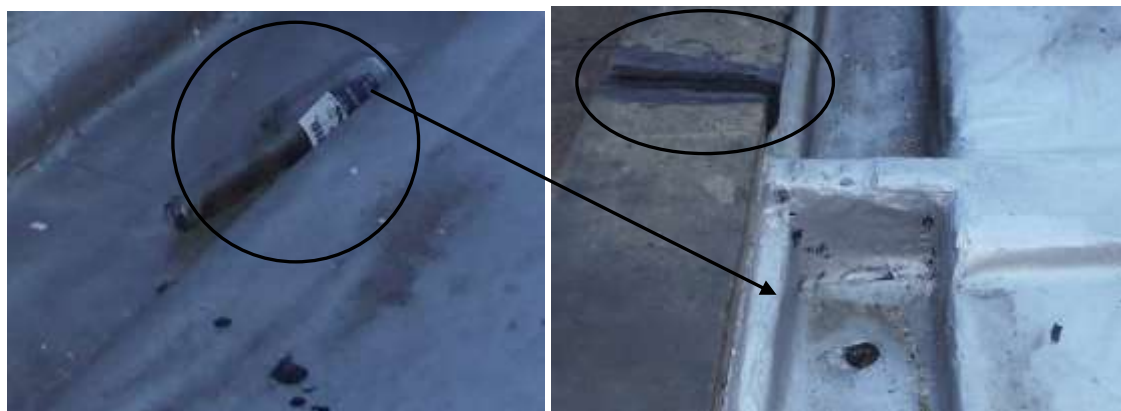
Figure 2 Beer bottle(s) found on roof and one stuck in the drainage hole for the handyman PVC piping.

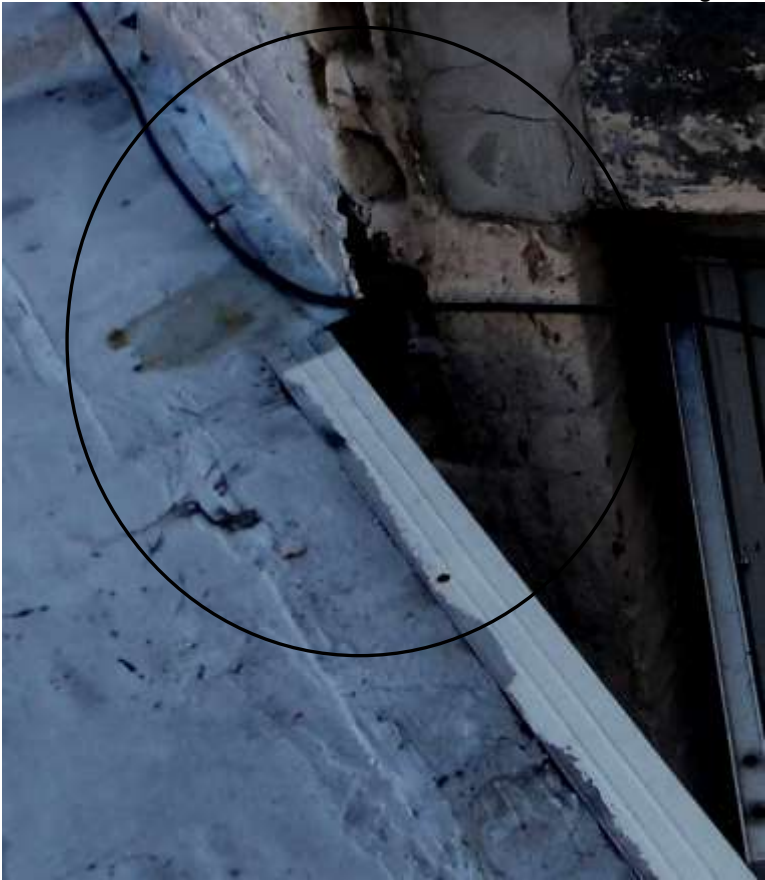
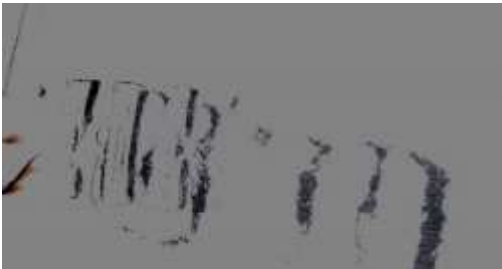
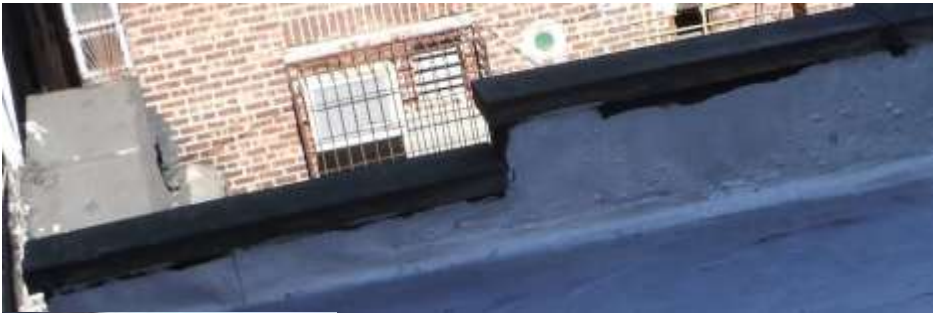
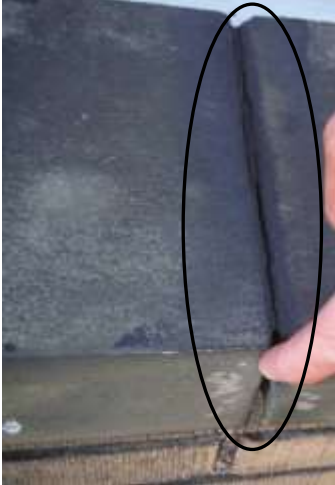
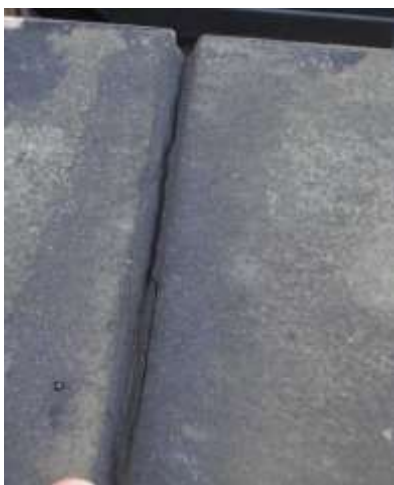
Main Building: random photos.

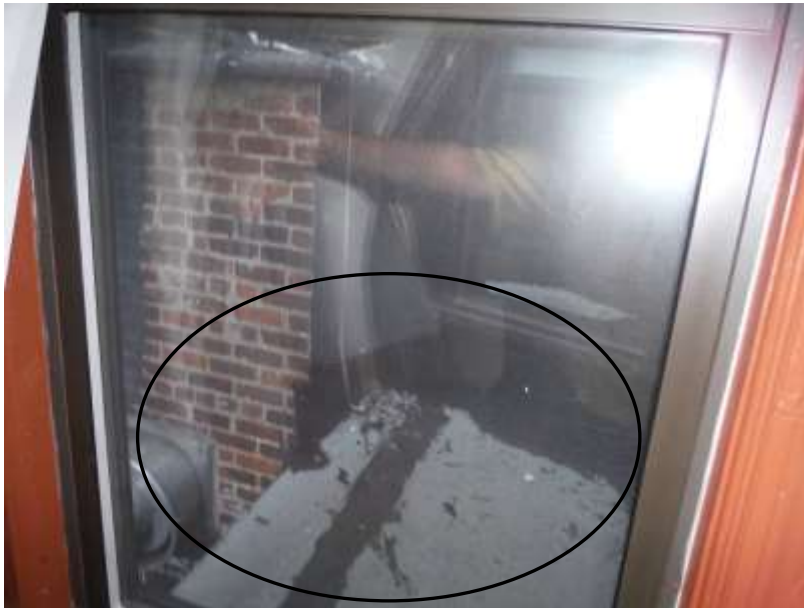
Figure 4 Poor roof conditions; lower main roof (view from apartment window).

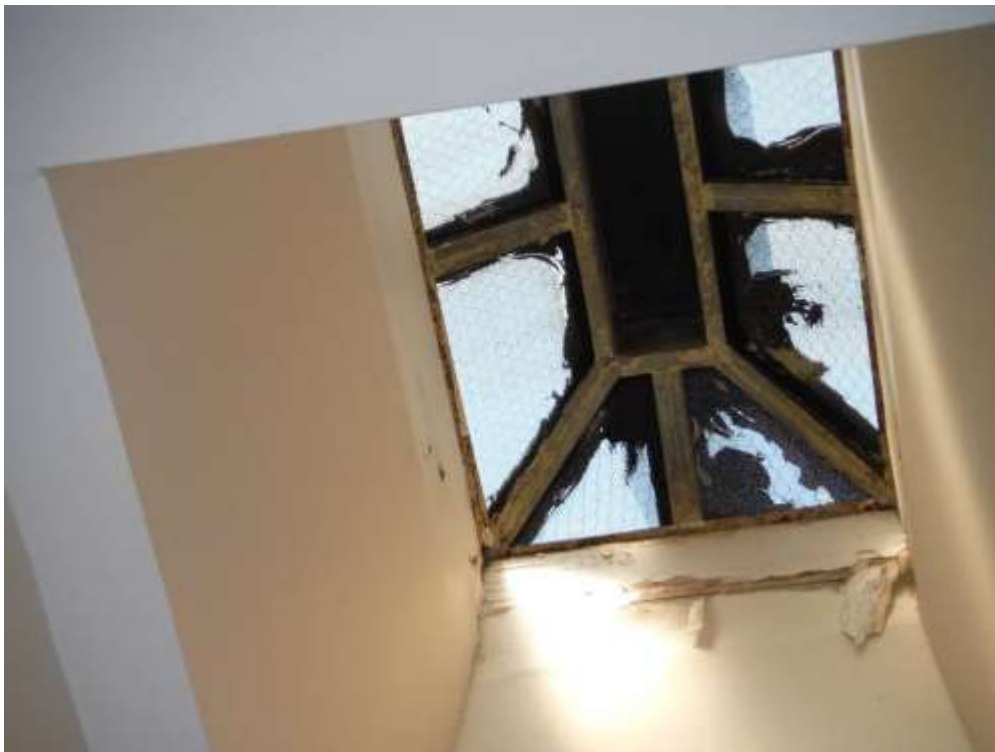
Figure 5 Tarred skylight. flaked paint, water stains; have roofer evaluate along with roof.

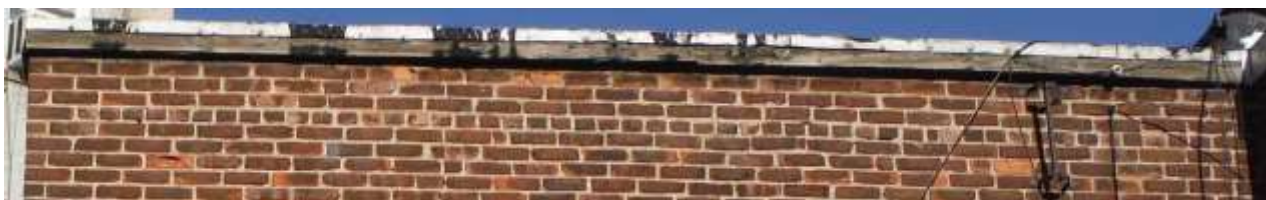
Figure 6 Exposed wood trim on top of building; have contractor evaluate/repair.

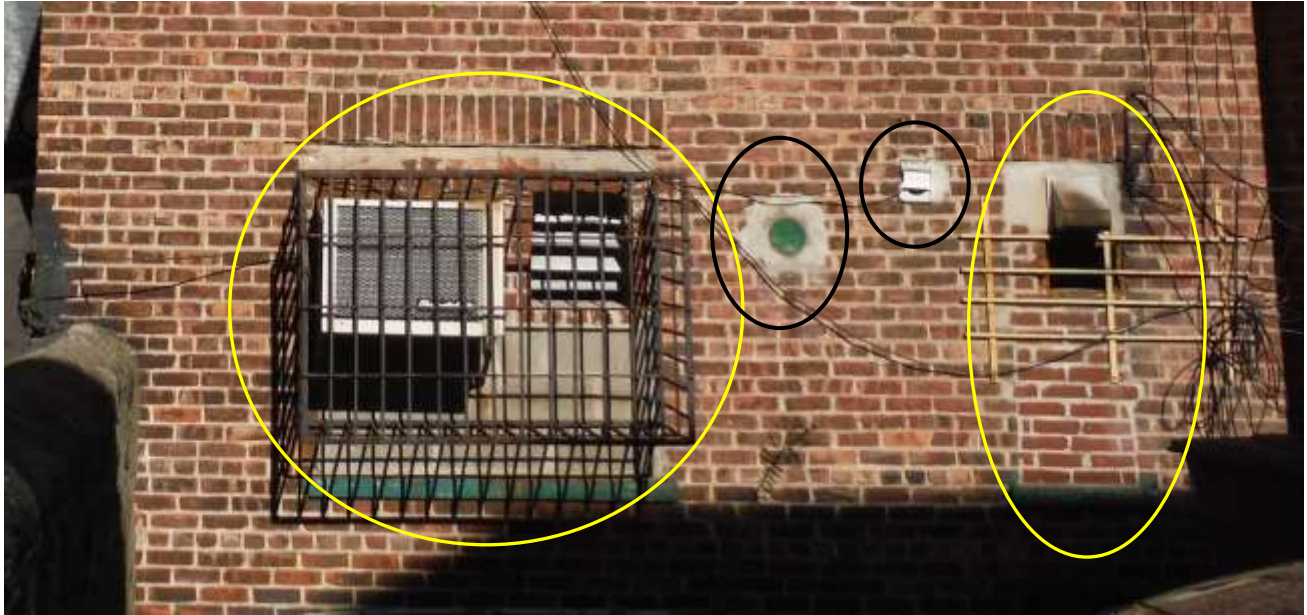
Figure 7 Two windows in rear were modified to make room for an A/C through wall unit and a vent. The right window was bricked up and a vent installed. Have a contractor seal up all open holes, remove old vents/blowers/abandoned equipment and replace broken vents where still in use.

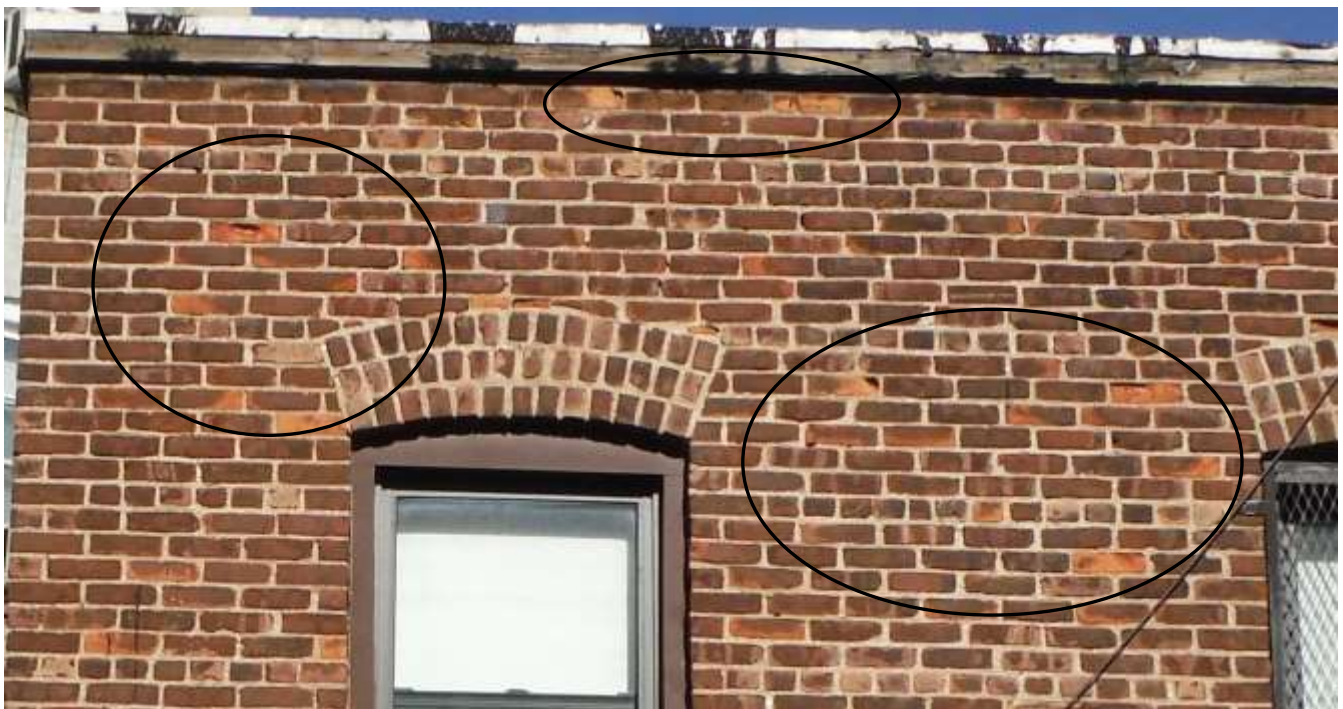
Figure 8 Brick damage; flaked, chipped, delaminated, water damage, efflorescence, cracks, etc.

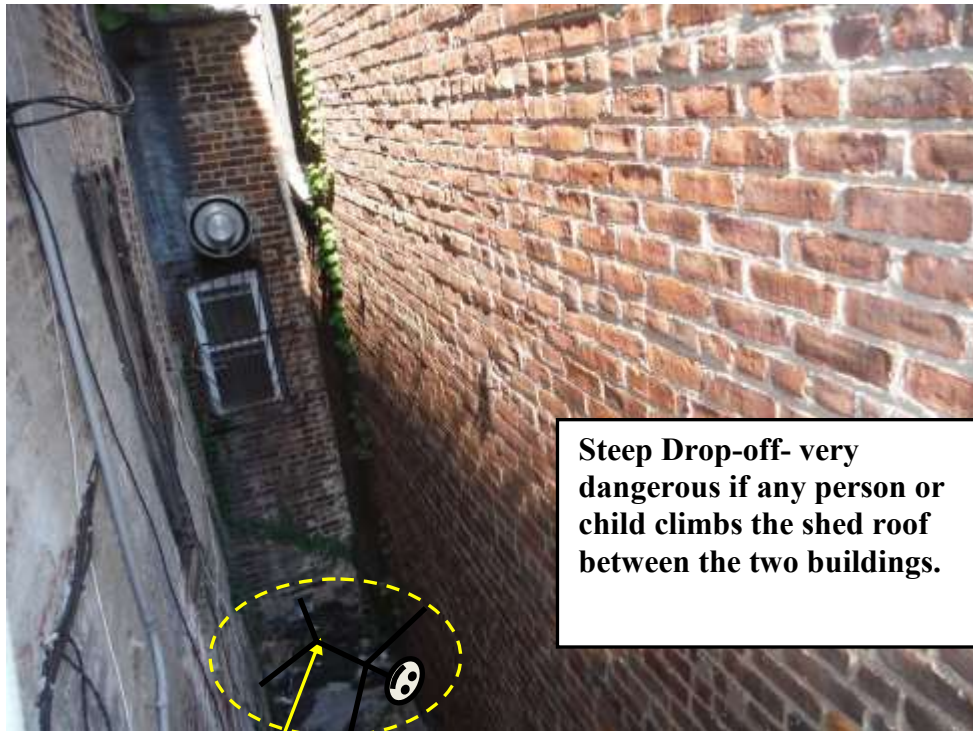
Figure 9 Steep drop-off as viewed on top of the shed roof between the two buildings; very dangerous!

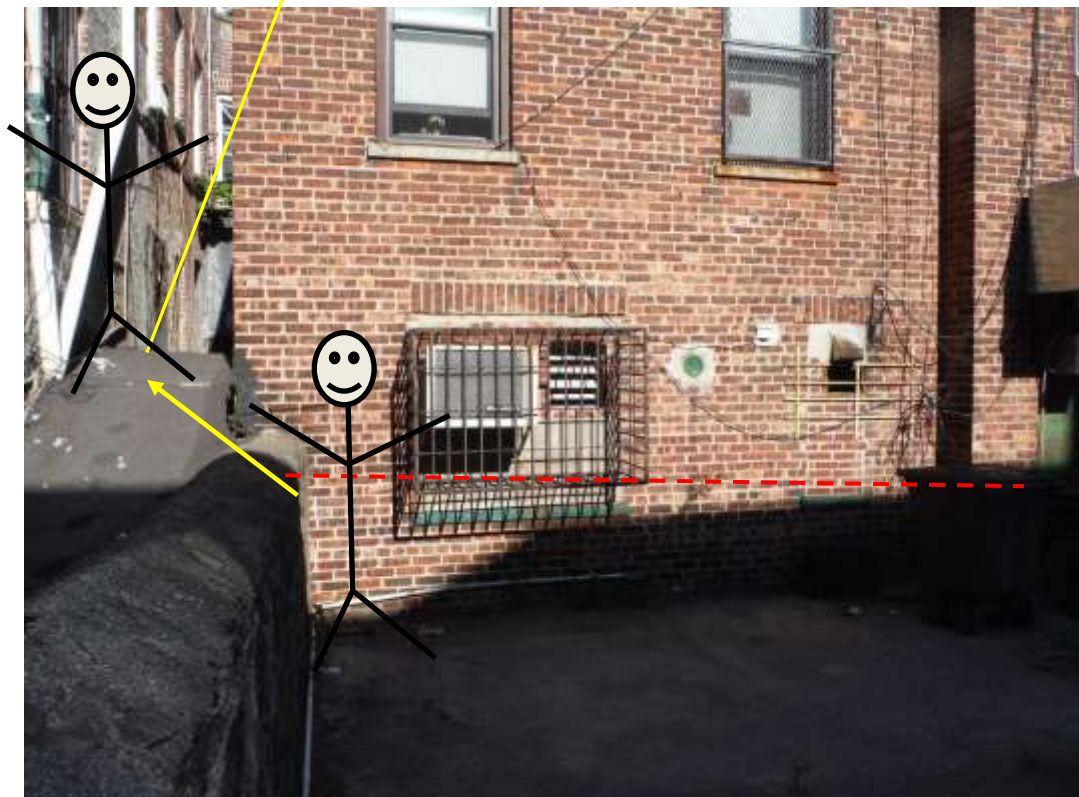
Figure 10 Notice the height of the garbage can to the retaining wall. The wall can easily be climbed and the shed roof walked upon. The shed roof is above a very steep drop off below; fall hazard & very dangerous. Recommend a tall grille, grate, fencing or railing on the shed roof between the buildings. See Appendix for examples of railings or safety grilles.

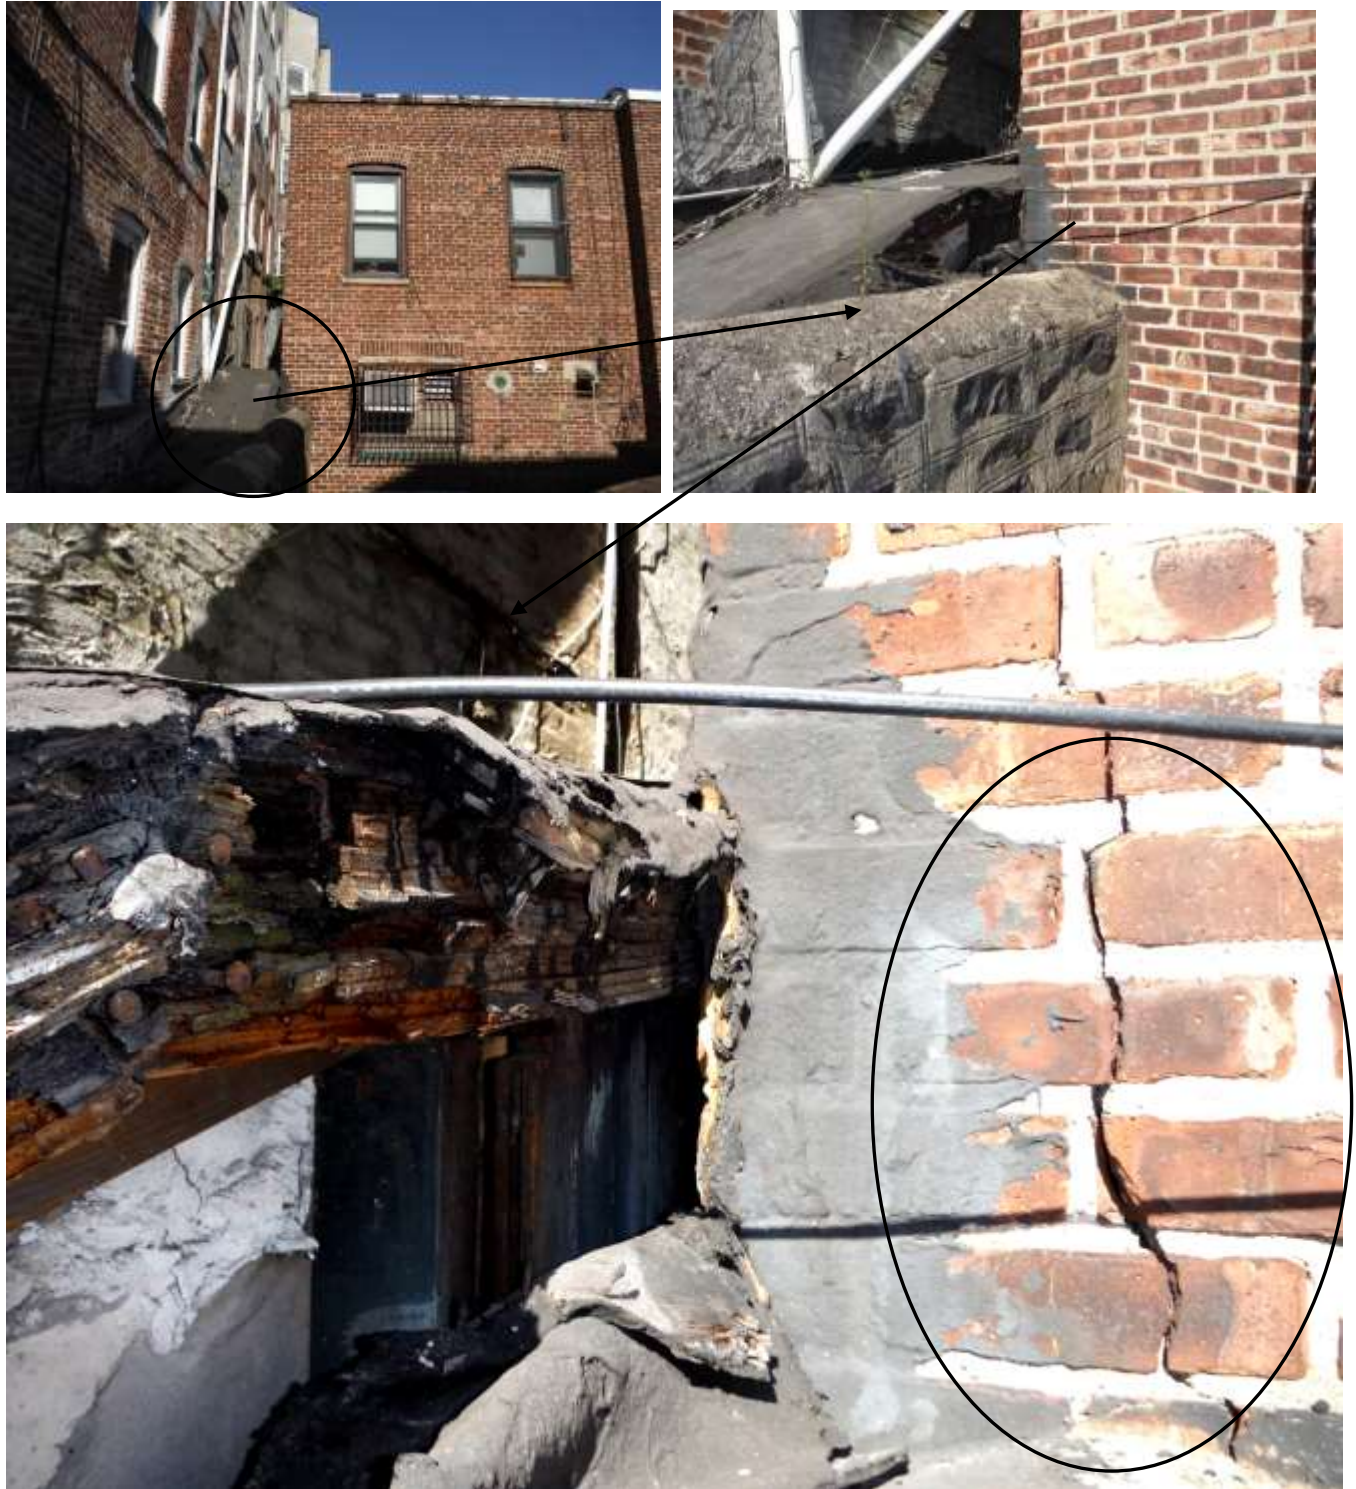
Figure 11 Structural cracks, rot on adjacent shed roof between buildings. Water entering cracks and damaged shed roof/structure. Have a structural contractor evaluate extent of damage and responsibilities of properties.

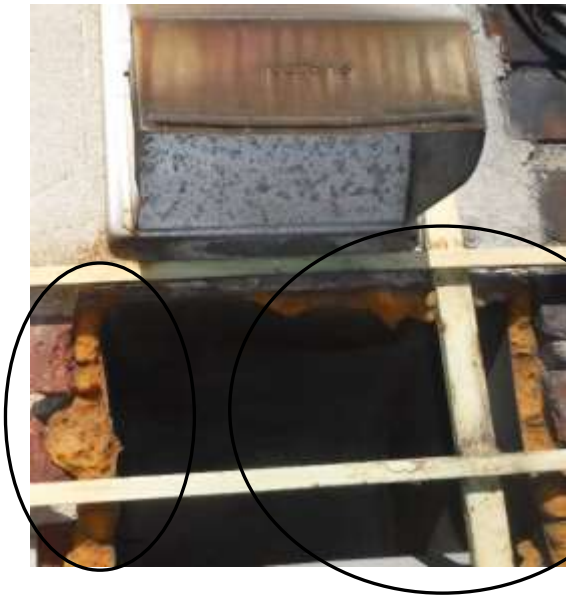
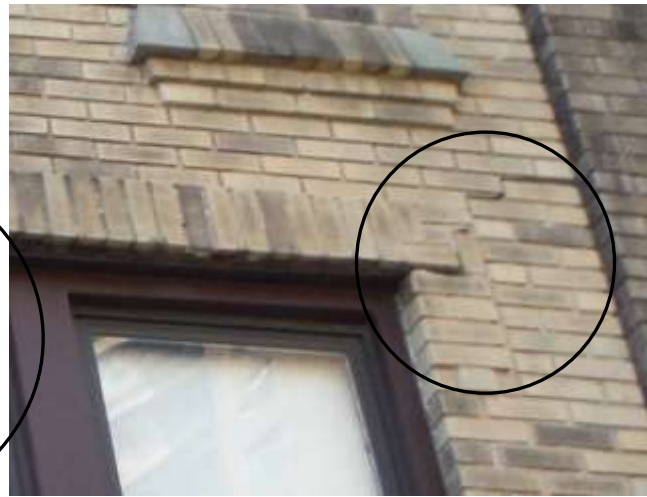
Figure 12 Siding steps cracks, movement.

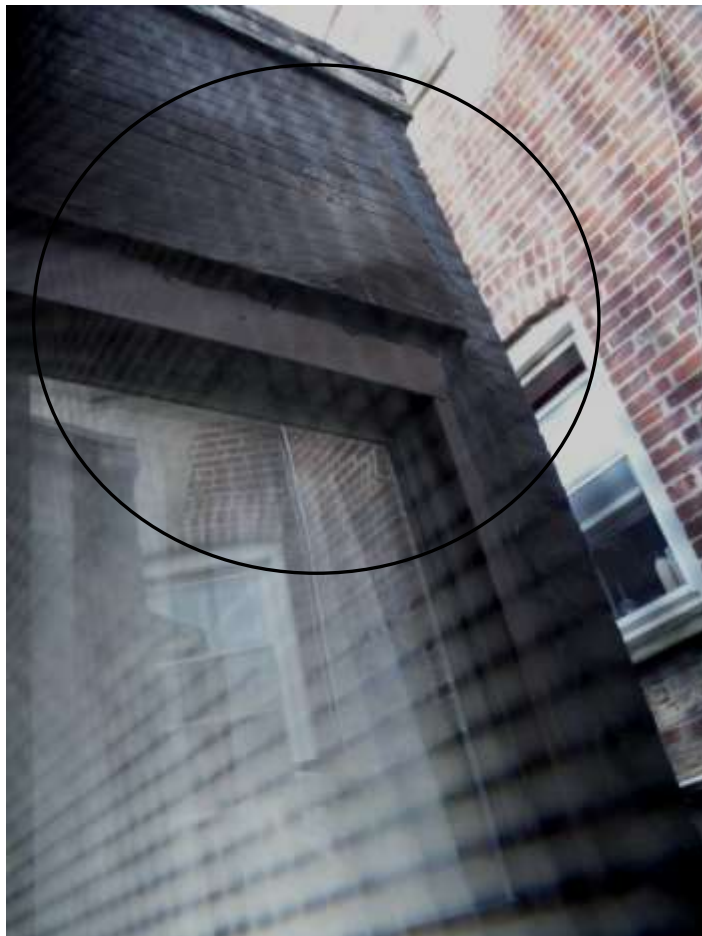
Figure 13 Buckled siding and tarred window & brick; view from apartment bathroom window. Right side of main building was inaccessible.

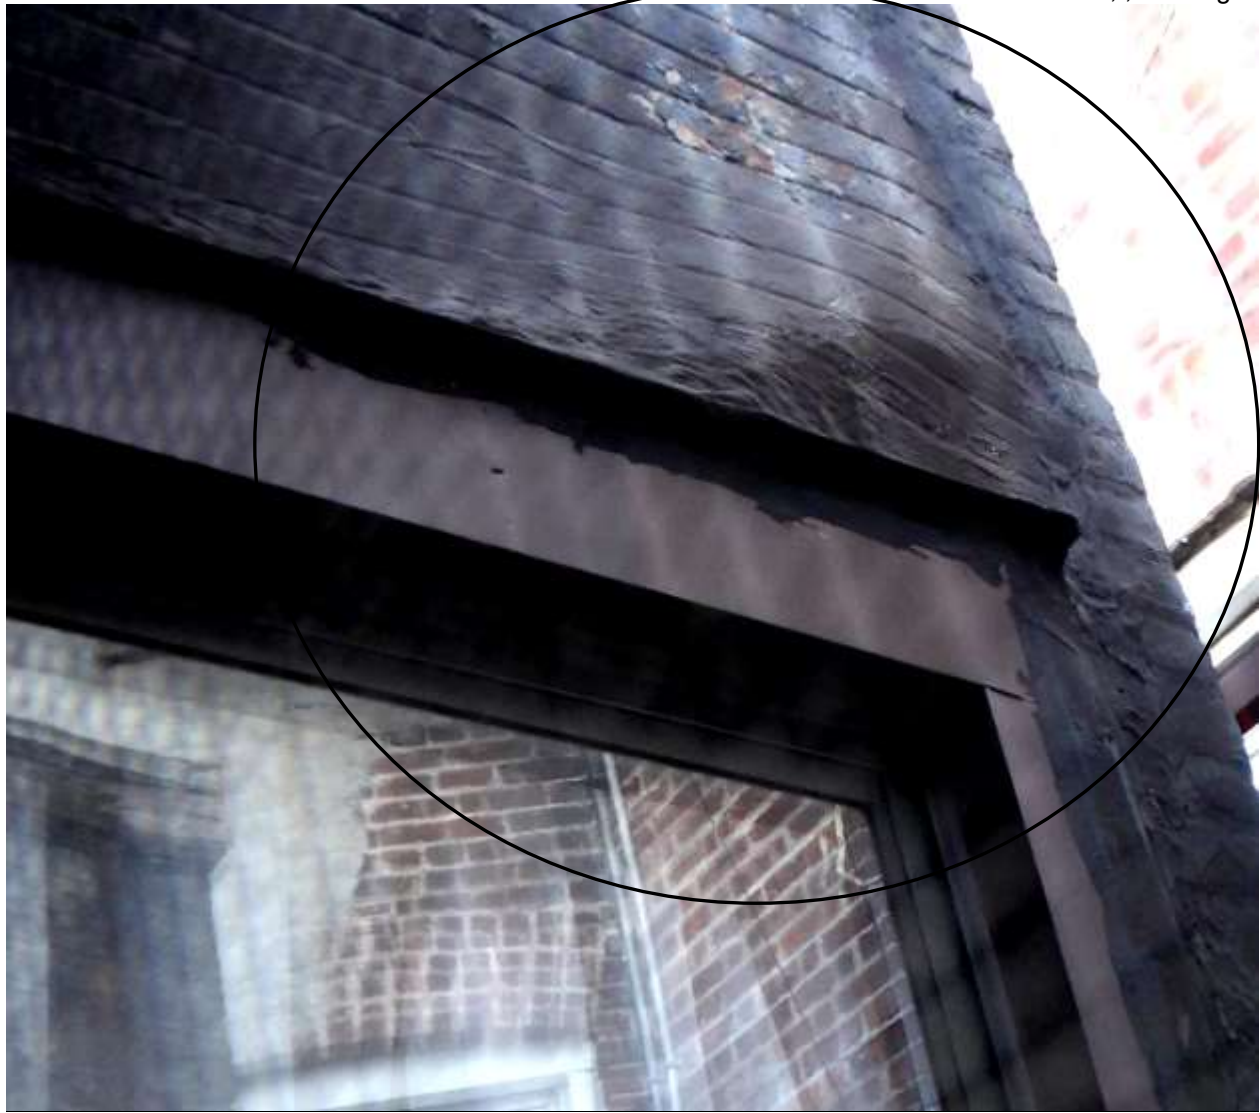
EXTERIOR/ELECTRICAL/AC/HEAT PUMP/GARAGE**SERVICE ENTRY**

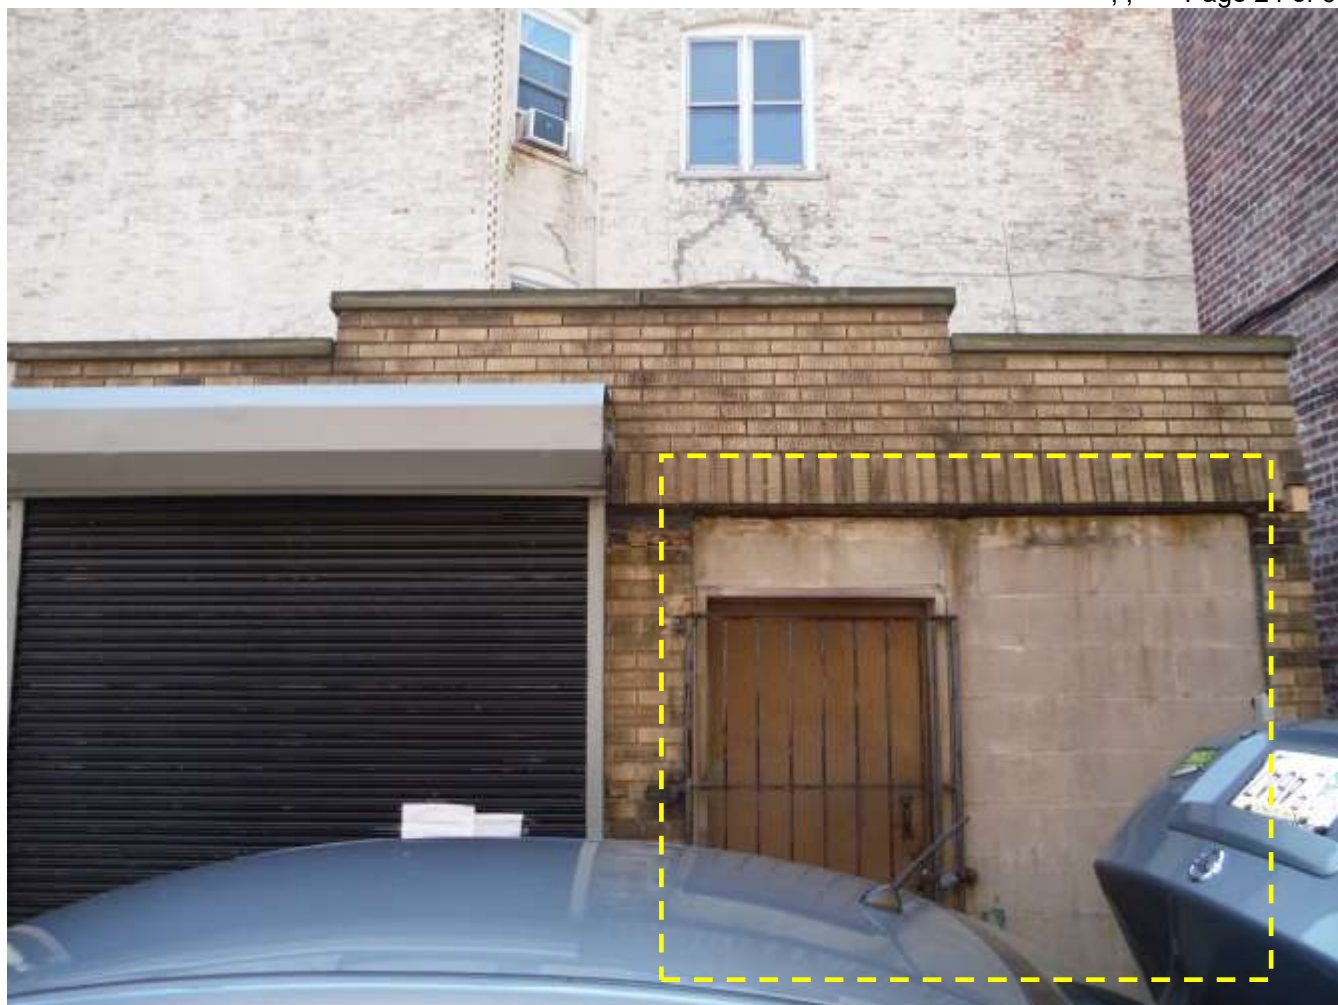
Figure 14 Left garage had roll type overhead door. The right door was blocked up and a man door installed. Both sides were filled with inventory; inaccessible.

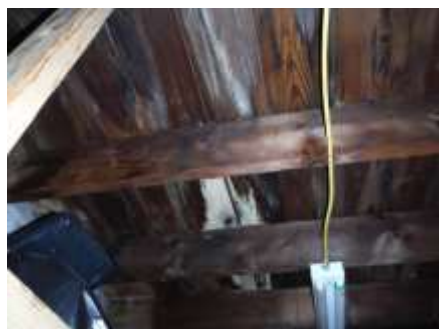
Figure 15 Water stains on roof sheathing.

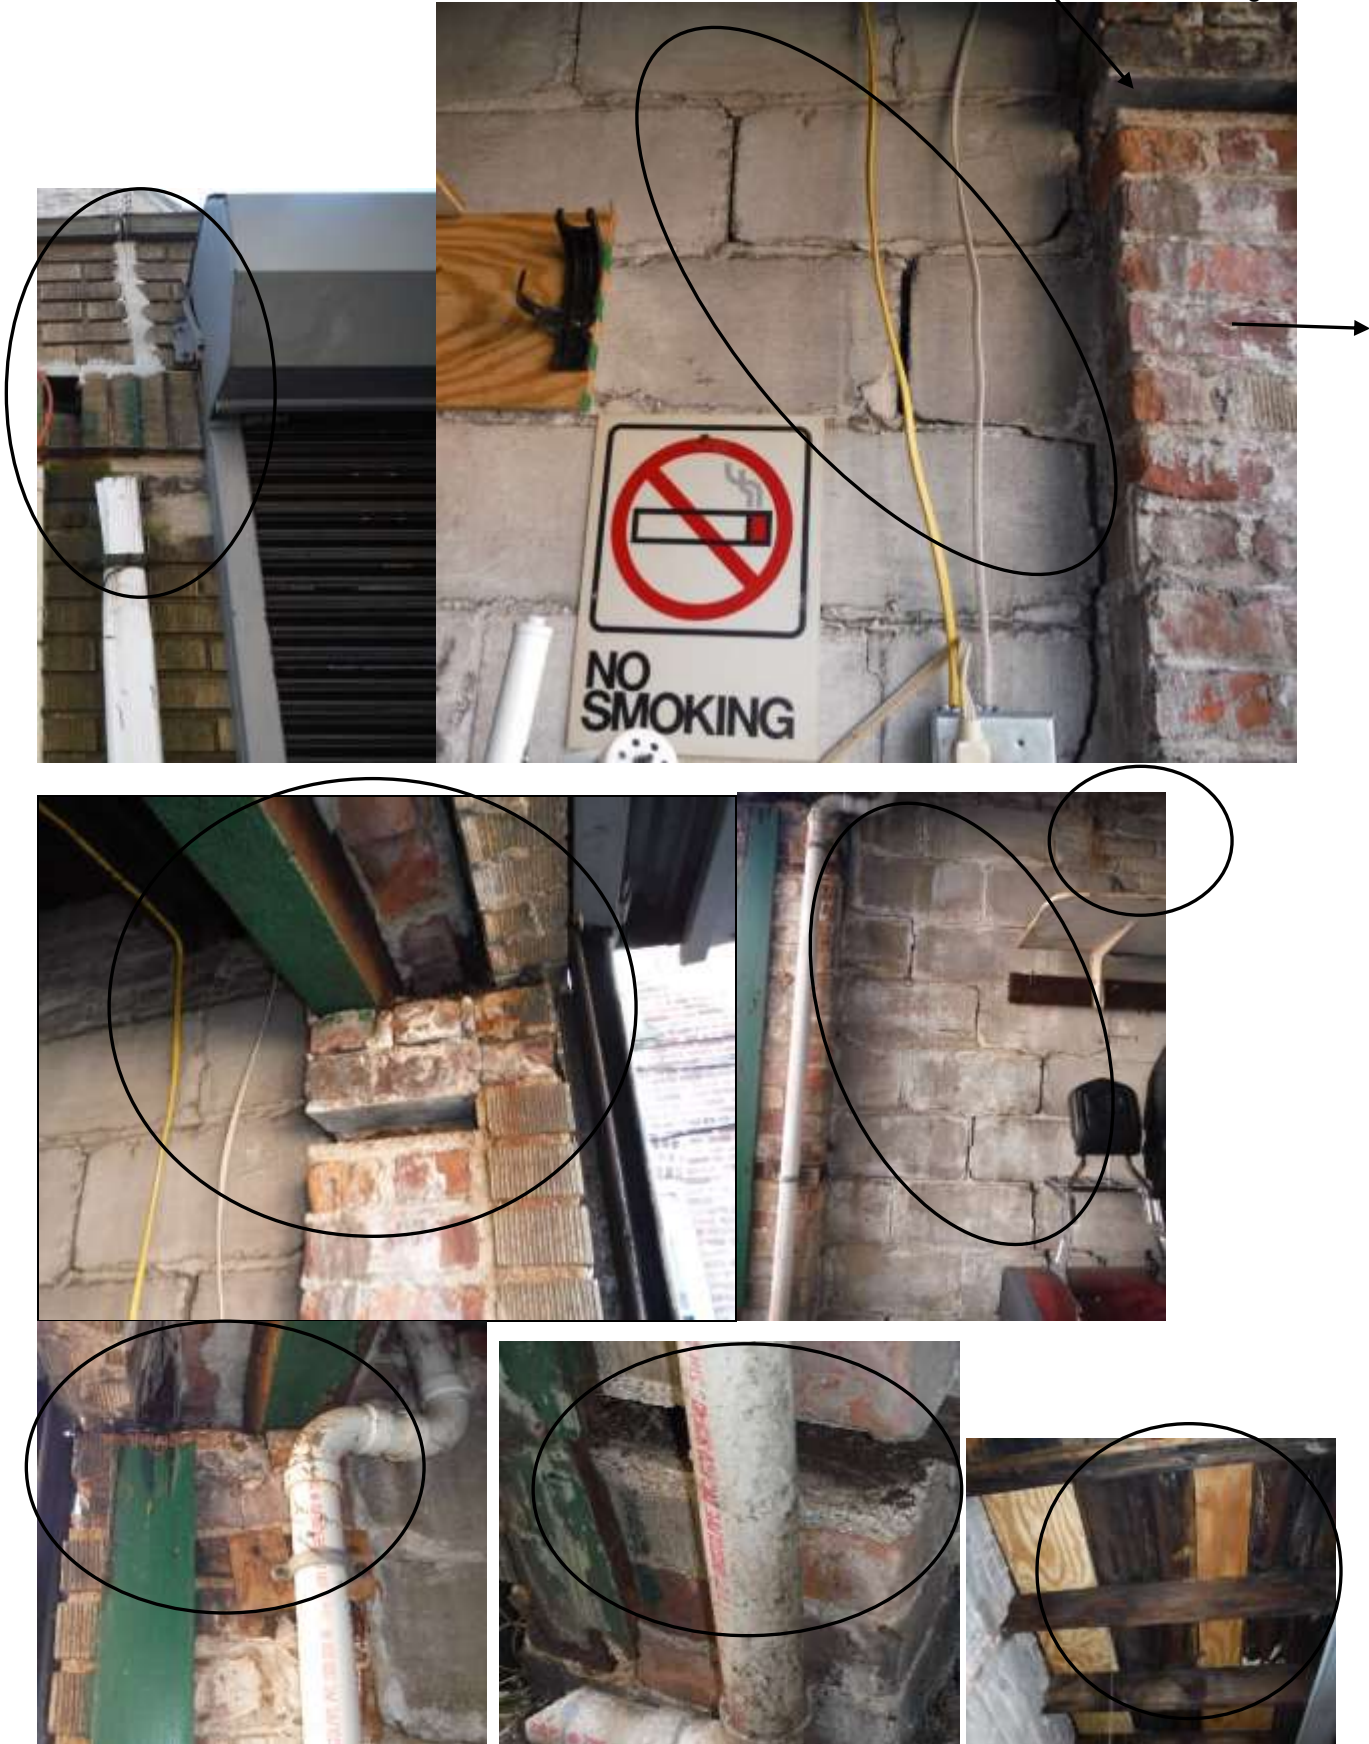
This confidential report is prepared exclusively for Client on contract for them to rely on and not transferrable.

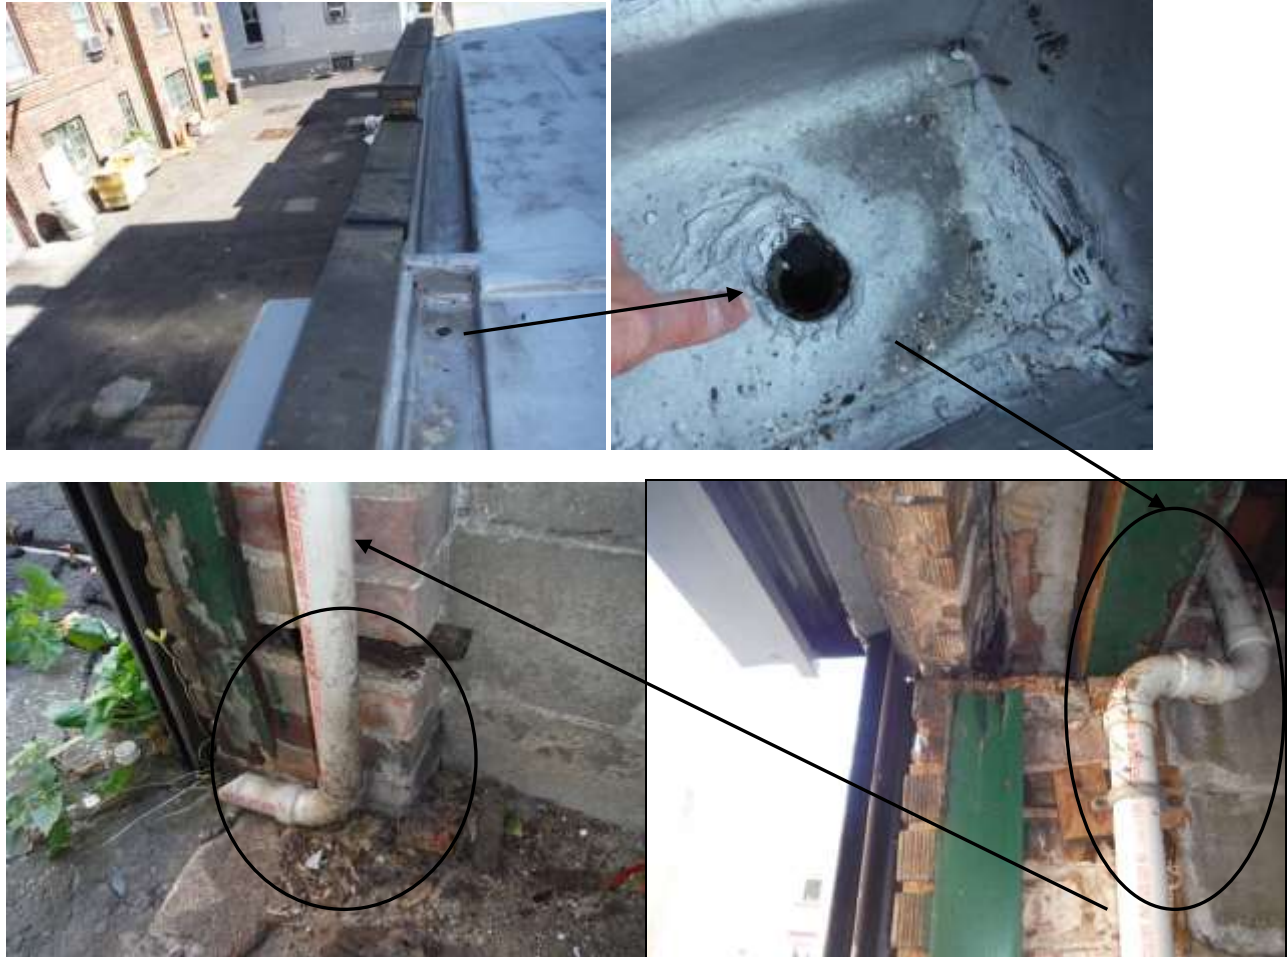
Figure 16 There was water damage to structure (walls, columns, roof sheathing) and a small PVC pipe installed from roof into garage and out the bottom of door. The drainage is too small/inadequate and handyman installation.

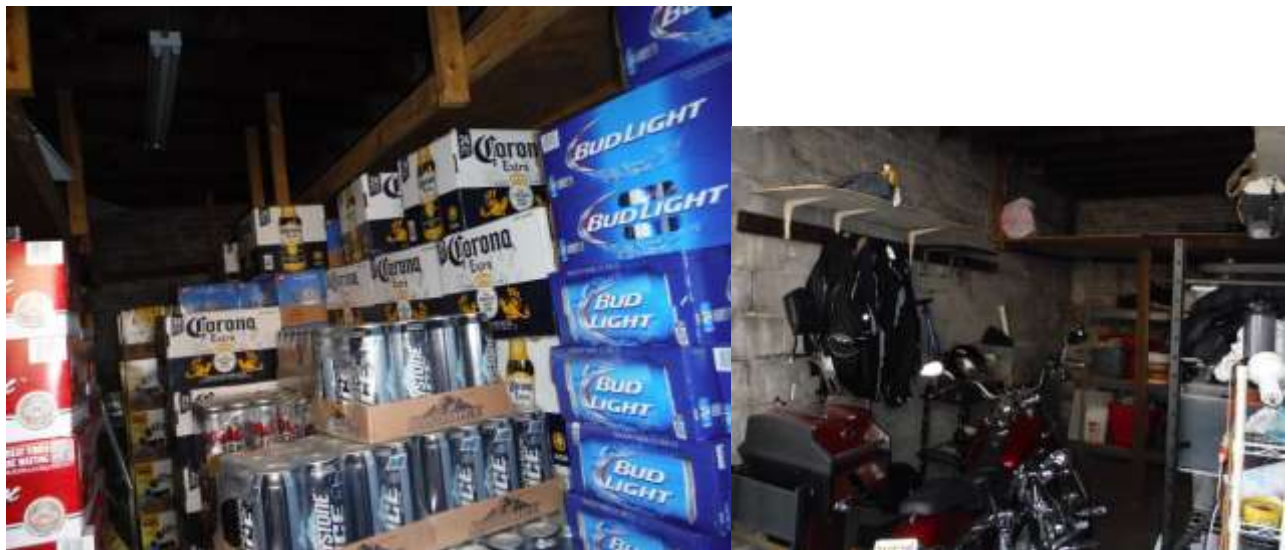
Figure 17 Storage in both garages; inaccessible. Check all garages when storage removed before closing.

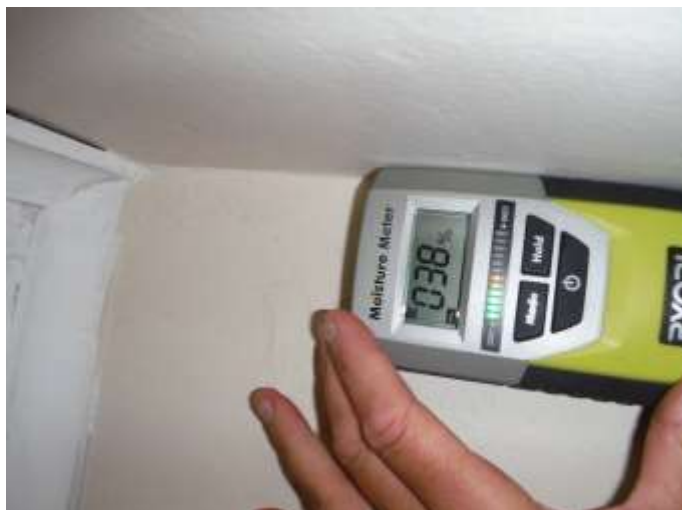
Figure 18 Active moisture detected in apartment rooms, closets and hallway.

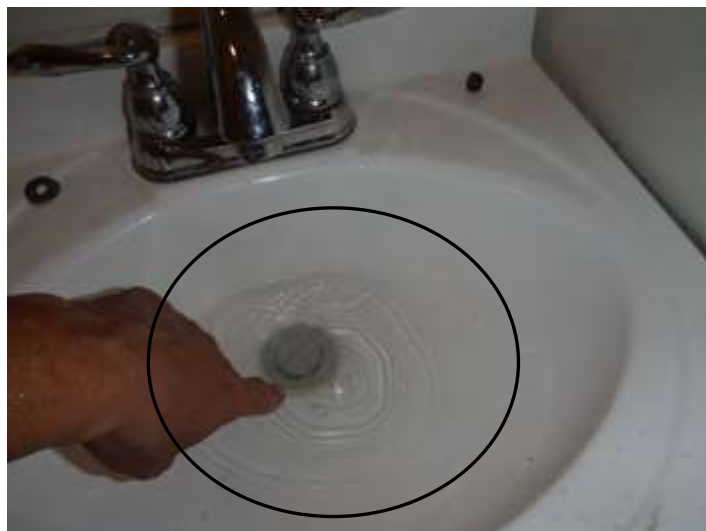
Figure 19 Have plumber evaluate slow drainage in building; see plumbing section comments.

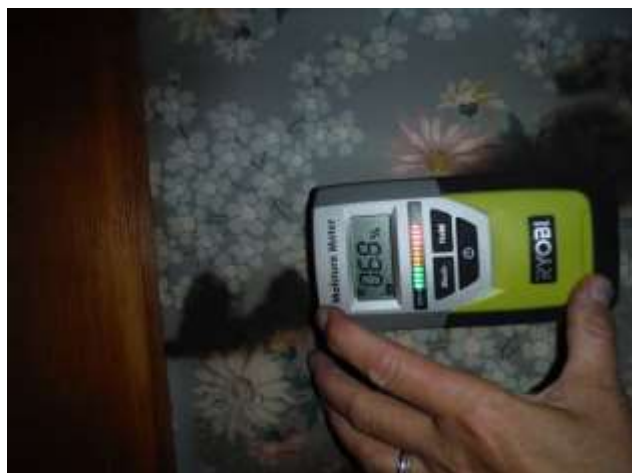
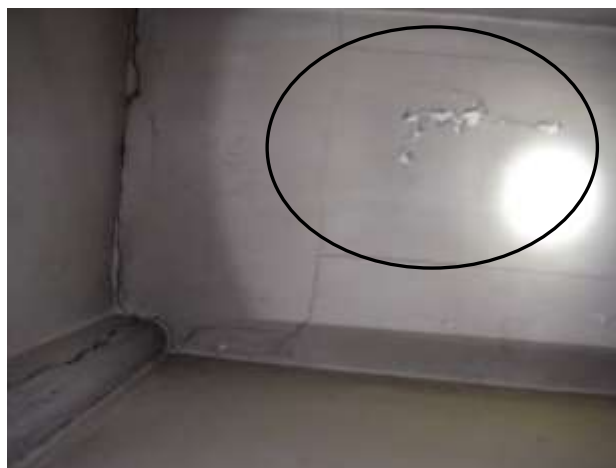
EXAMPLES OF WET/MOISTURE/FLAKED PAINT:

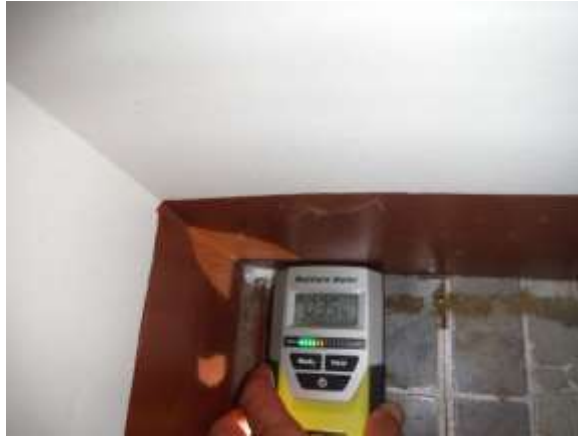
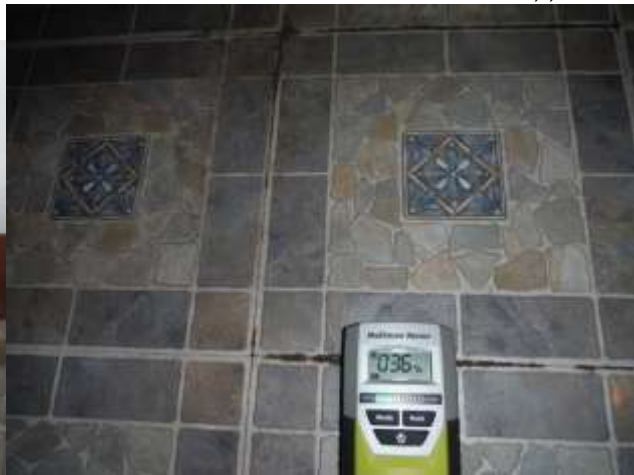
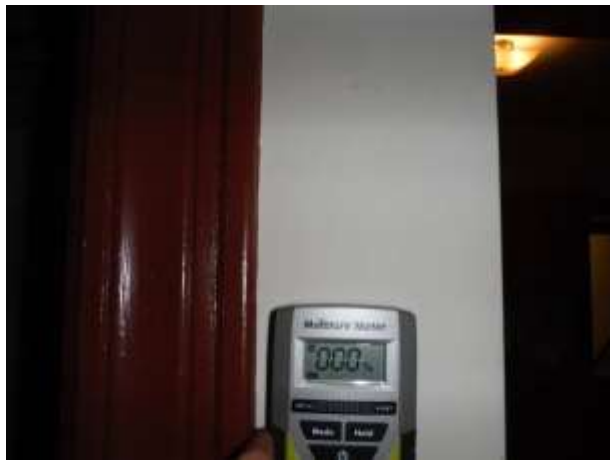
Figure 20 Random checking on inner wall where dry.

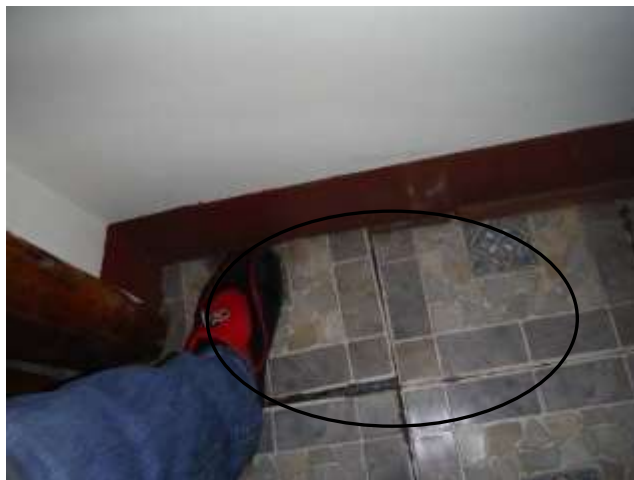
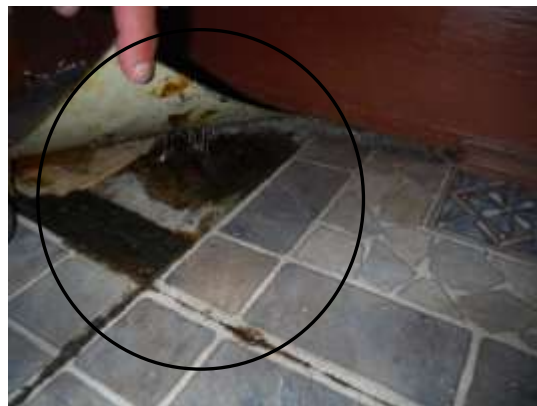
Figure 21 Soft/rot/depressions on floor where lifted or loose tiles. Tared or sticky glue/tar on all seams on flooring.

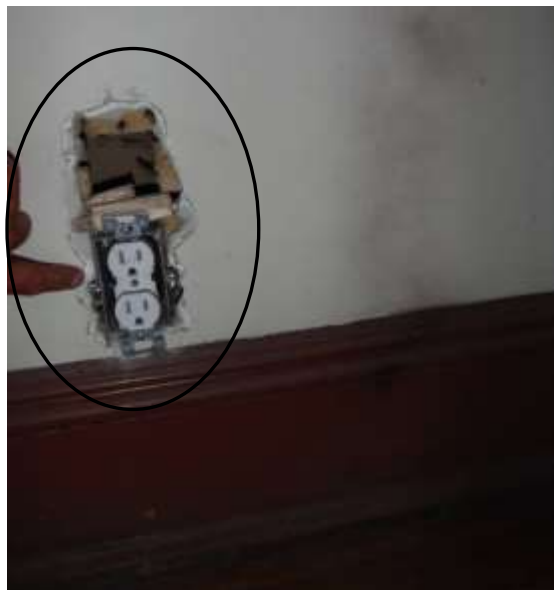
Figure 22 Example of electrical hazards in home.

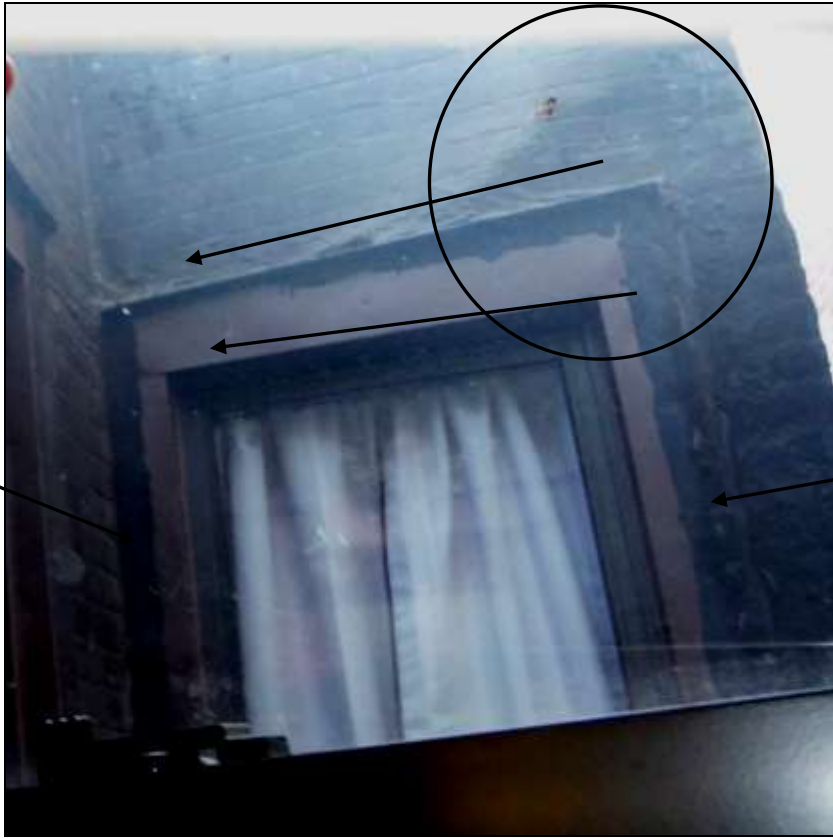
Figure 23 Buckled siding, canted windows, and tarring as viewed from apartment window.
