4 Seasons Home Inspection, LLC

150 Maple Avenue, #128, South Plainfield, NJ 07080
www.4SeasonsHI.com 1-877-547-7383

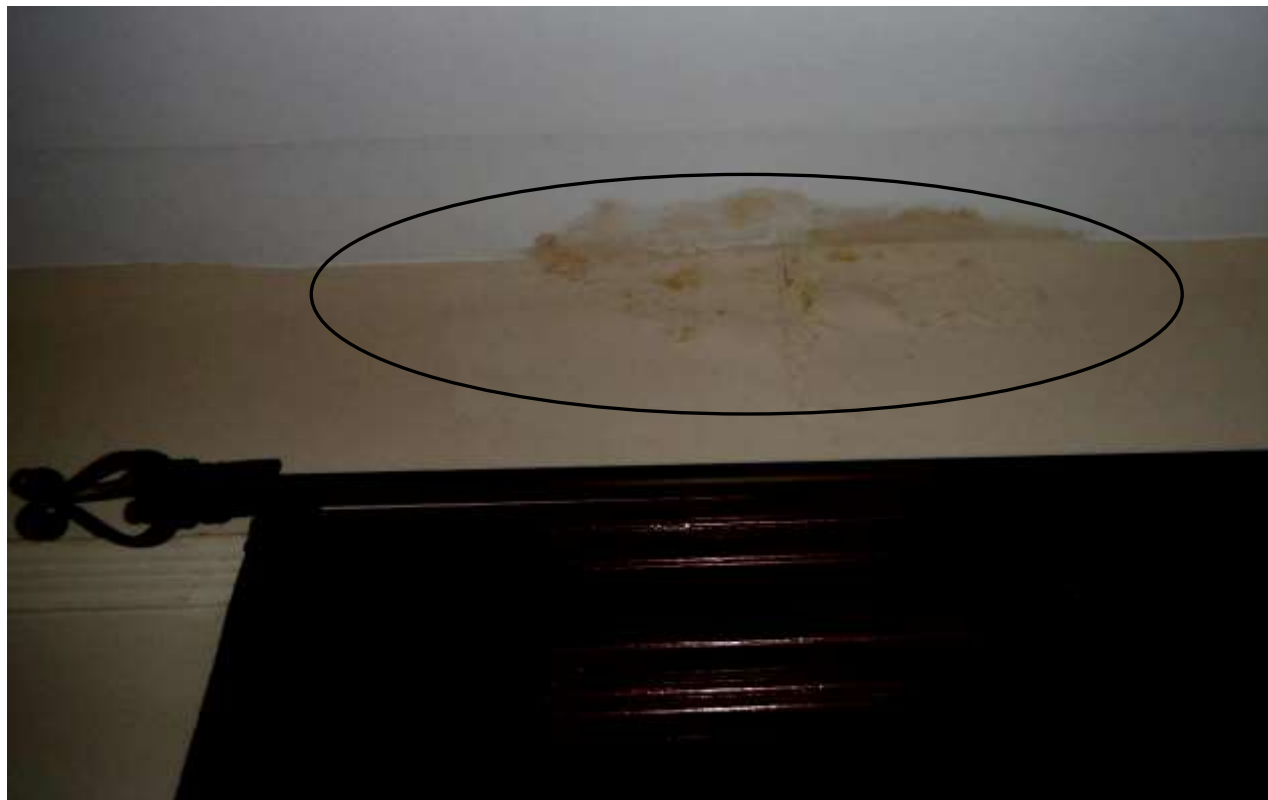
Figure 24 Flakes paint around ceiling water stains/leak; see roofing section comments.

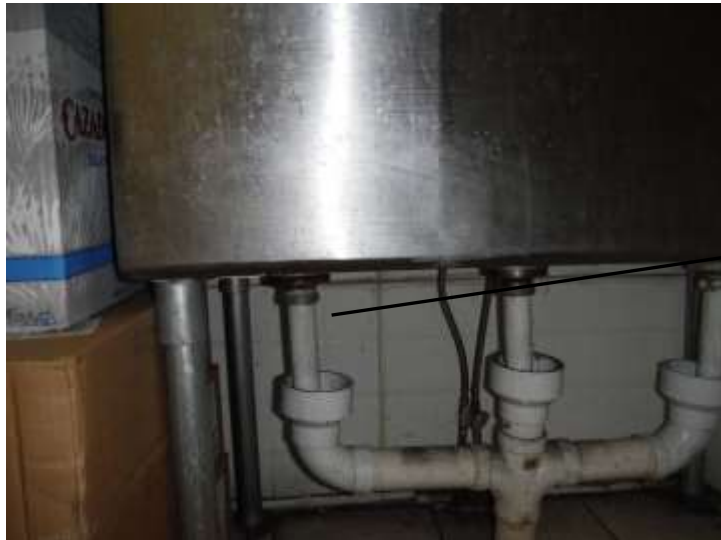
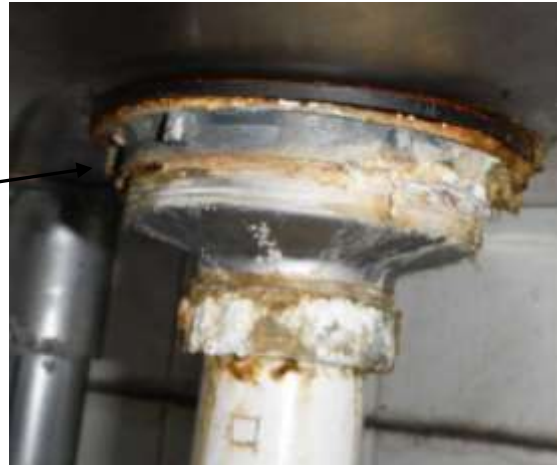
WINDOWS/FIREPLACES/HALL/ATTIC**INTERIOR WINDOWS / GLASS**

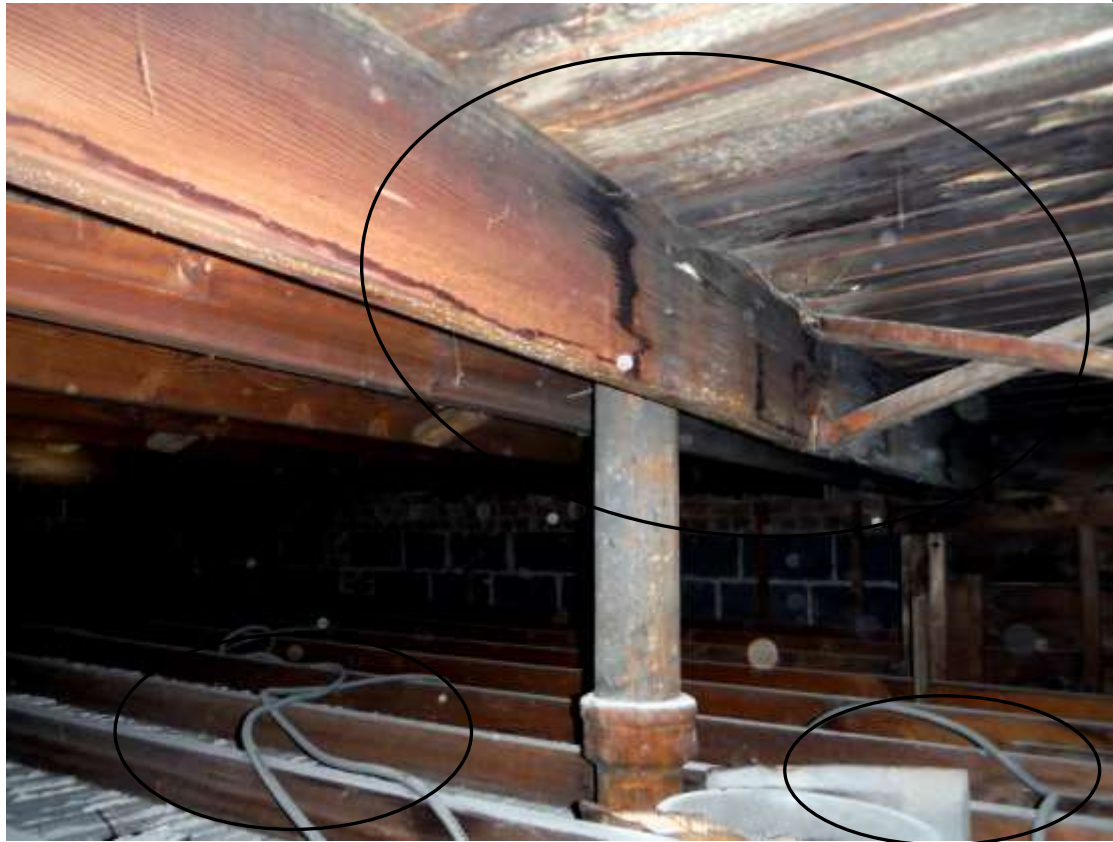
Figure 25 Water stains (fresh) and loose electrical wiring in attic; further evaluate with roofer and electrician.

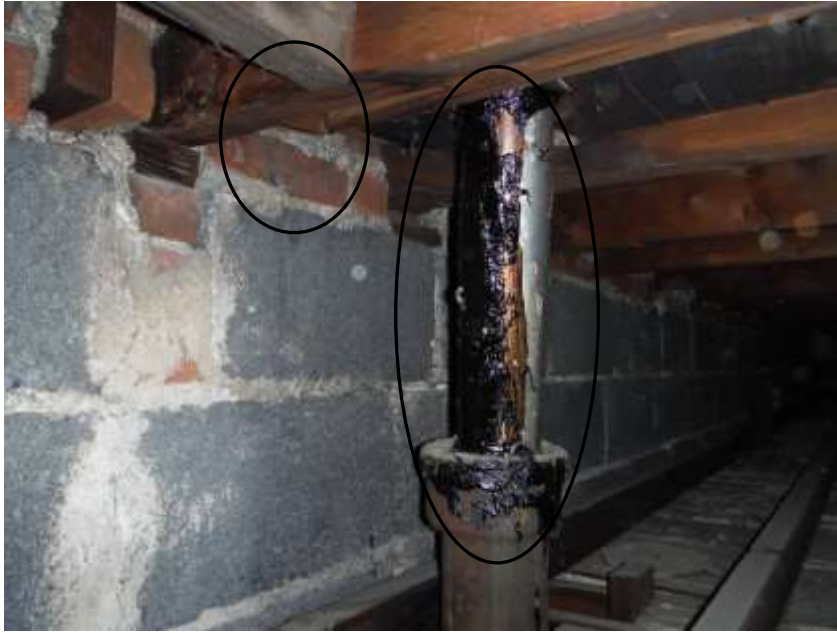
Figure 26 Cracks, splits, water rot, tarring, active leaks, etc. Have a roofer evaluate roof structure & advise on all roof and structural repairs.

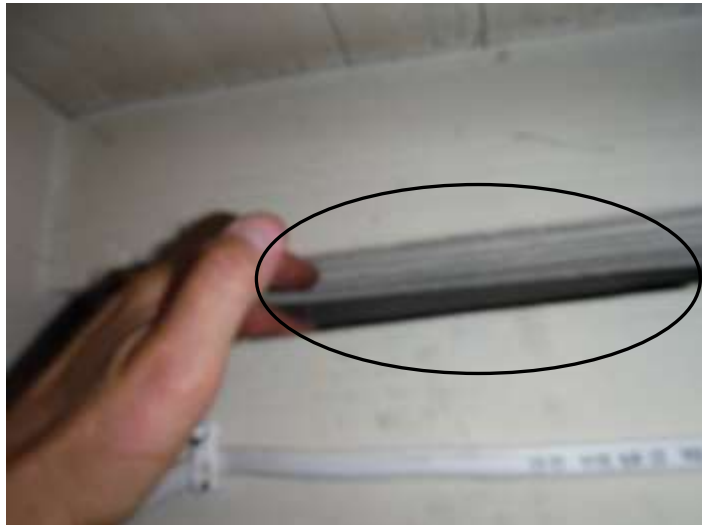
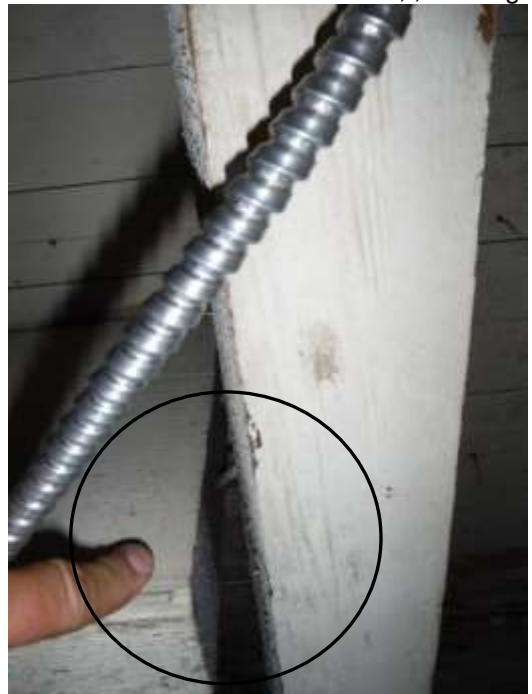
Figure 27 Split floor joists as viewed in basement. There were separated joists & nails; concern about weight above in store front.

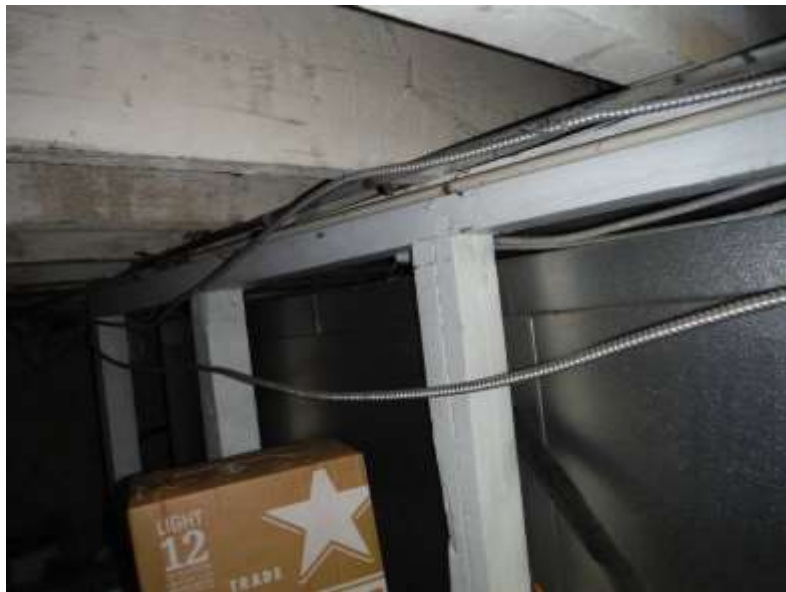
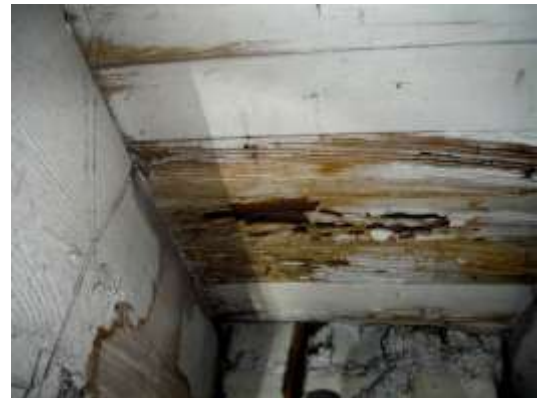
Figure 28 Example of braces added in basement; handyman. Leaking or water stains on sub flooring under water sources as viewed in basement; see plumbing section comments.

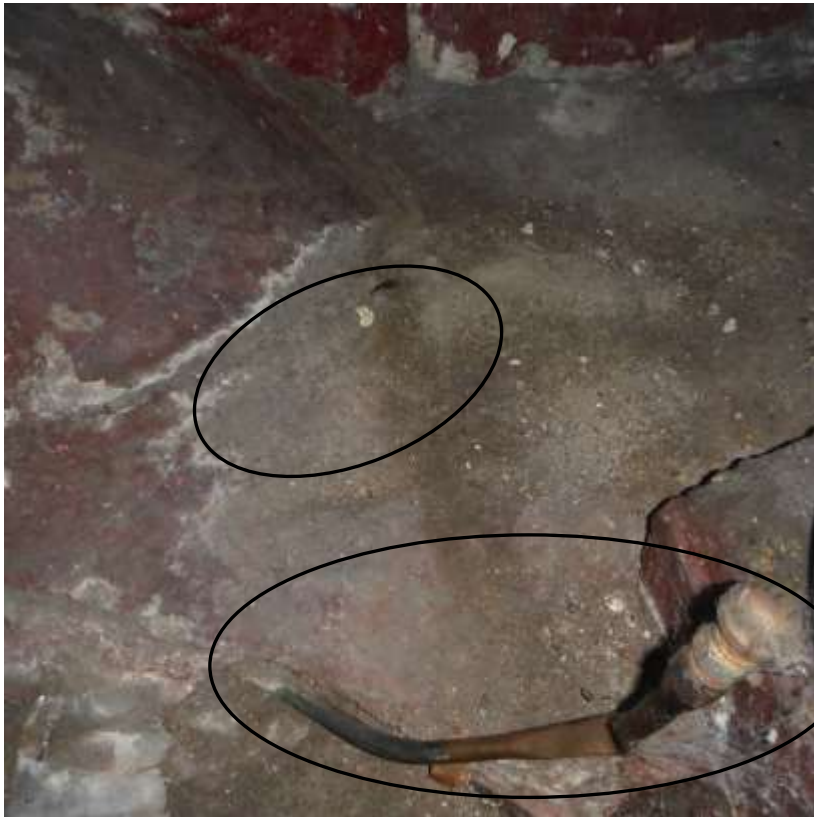
Figure 29 Recommend a property tank sweep to rule out any possibility of buried oil tanks on property before closing.

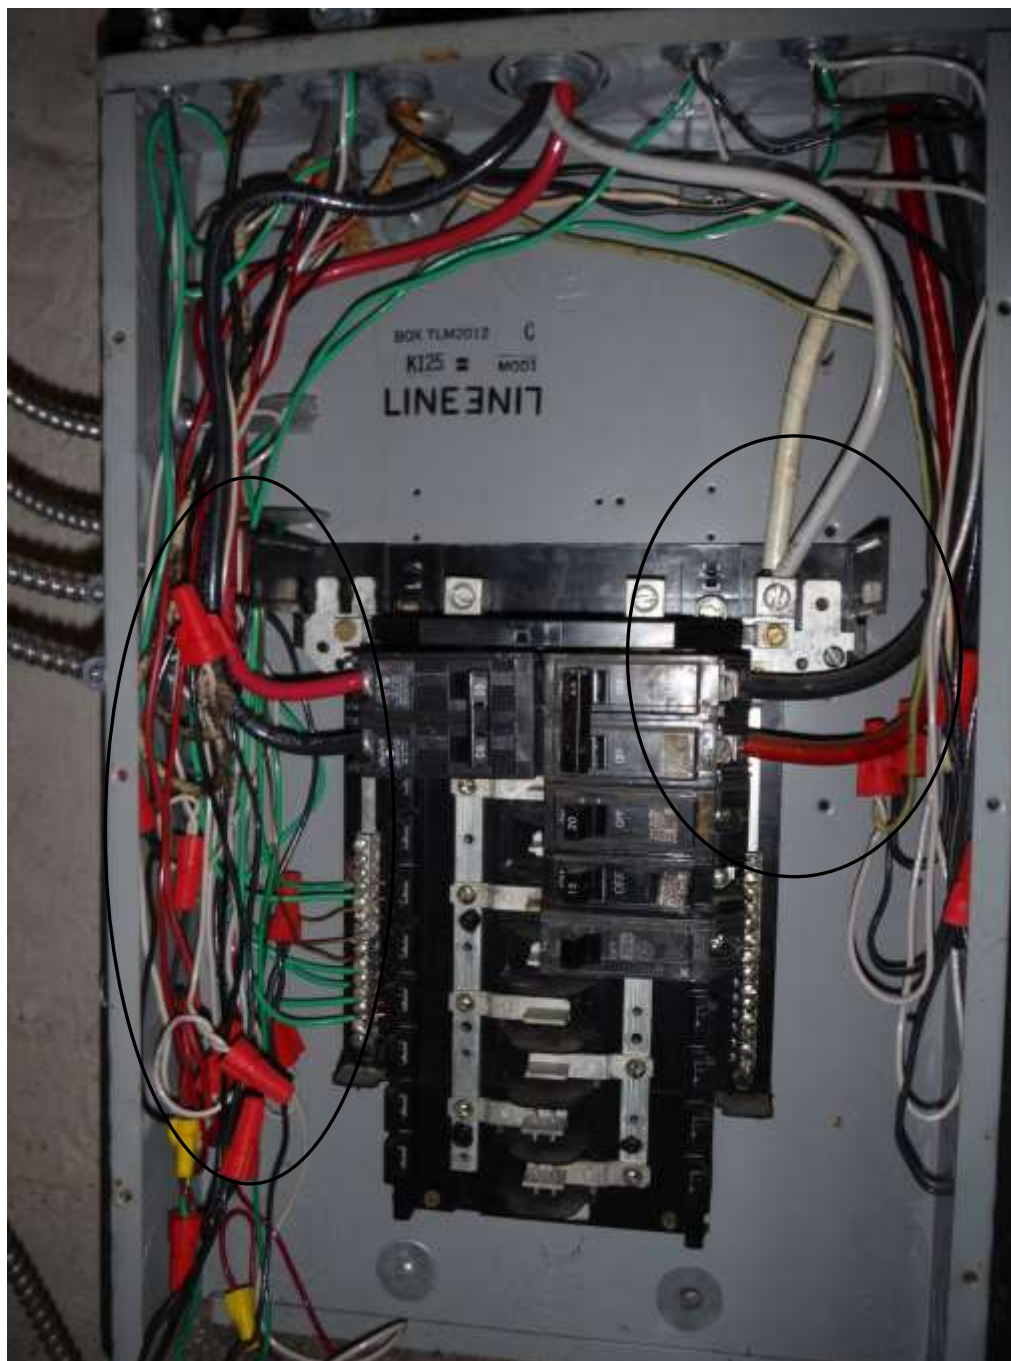
Figure 30 Sub panel in basement improperly wired, open breaker slots; dangerous. Have a licensed electrician evaluate all panels and electrical in building and garage.

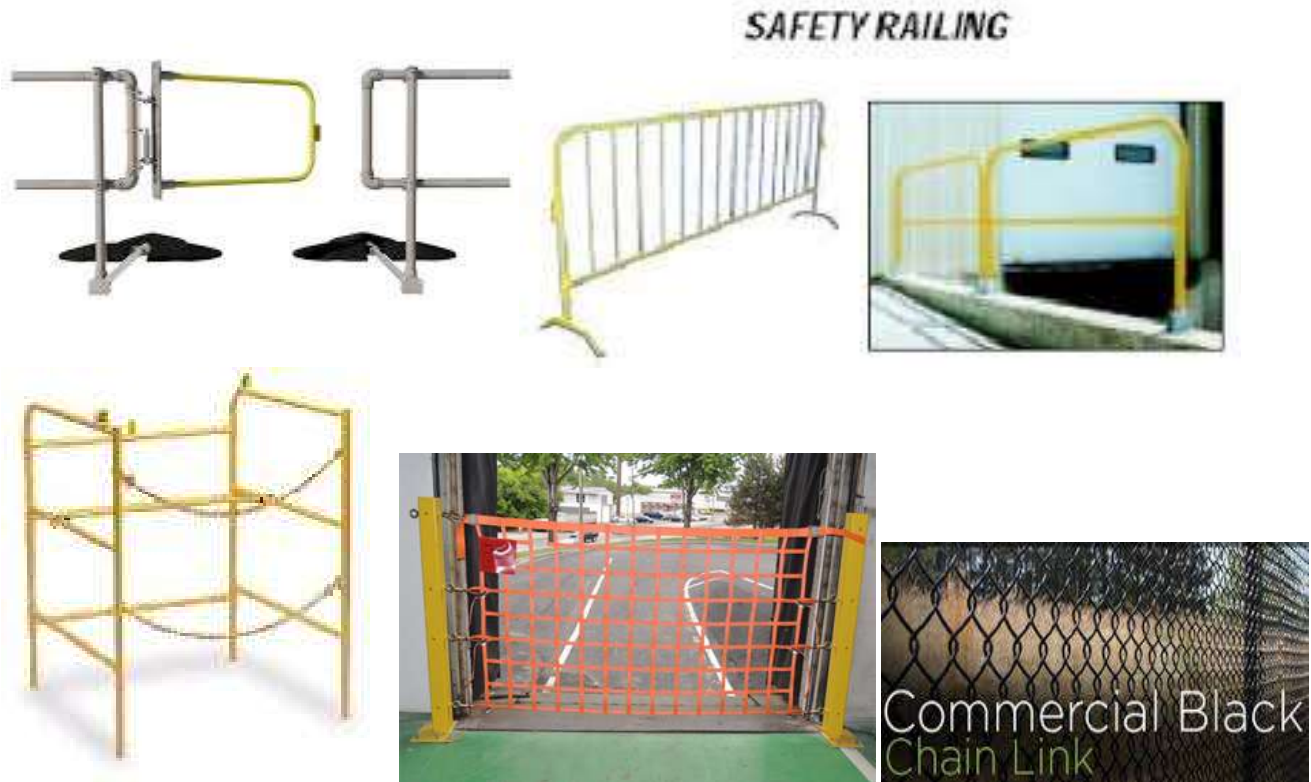
Figure 31 manhole railing

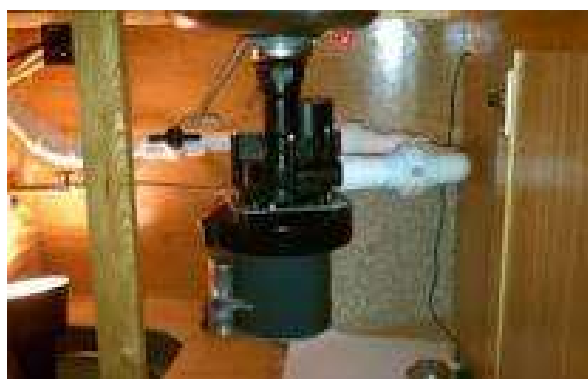
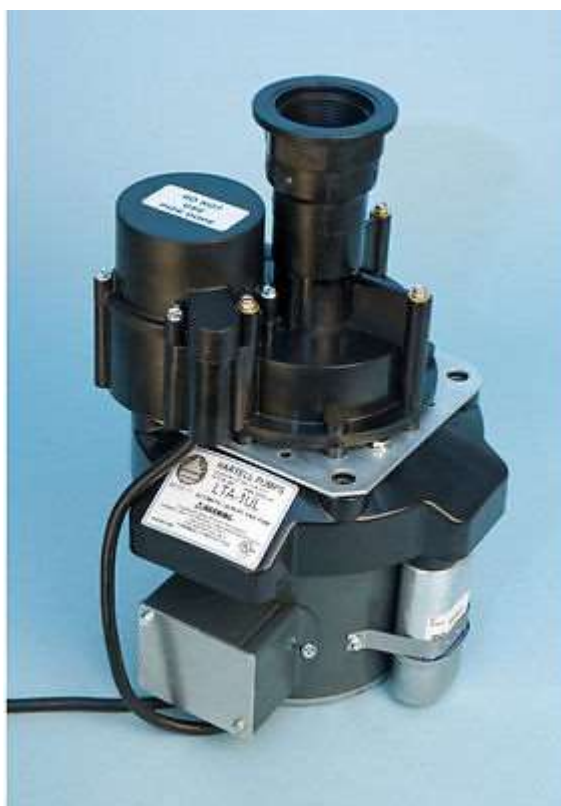
Figure 32 Direct mount pump goes under sink.

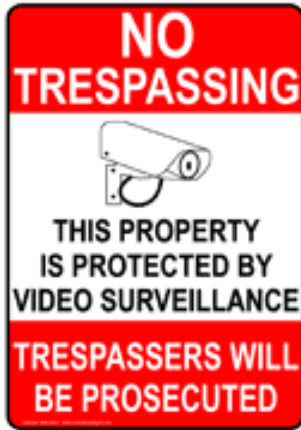
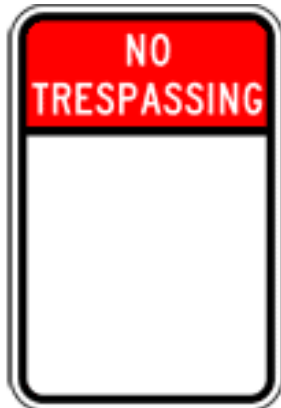
Add words for custom signs
