4 Seasons Home Inspection, LLC
 150 Maple Avenue, #128, South Plainfield, NJ 07080
www.4SeasonsHI.com 1-877-547-7383

Inspection Date: March 14, 2014 10:30am-12:30pm
 Client Name: name (buyer@aol.com)
 Emails: lawyer@gmail.com, realtor@aol.com
 Inspection Address: # Condo, street, town, NJ xxxxx
 Inspected by: Linda Geczi home inspection lic. #24GI00061500

Approximate Age: ~1920/100+ yrs.
 Style: Condo, Converted Co-op
 Main Entrance Faces: S
 State of Occupancy: Occupied
 Weather Conditions: Cold, 28-30°F
 Ground cover: damp, residual snow

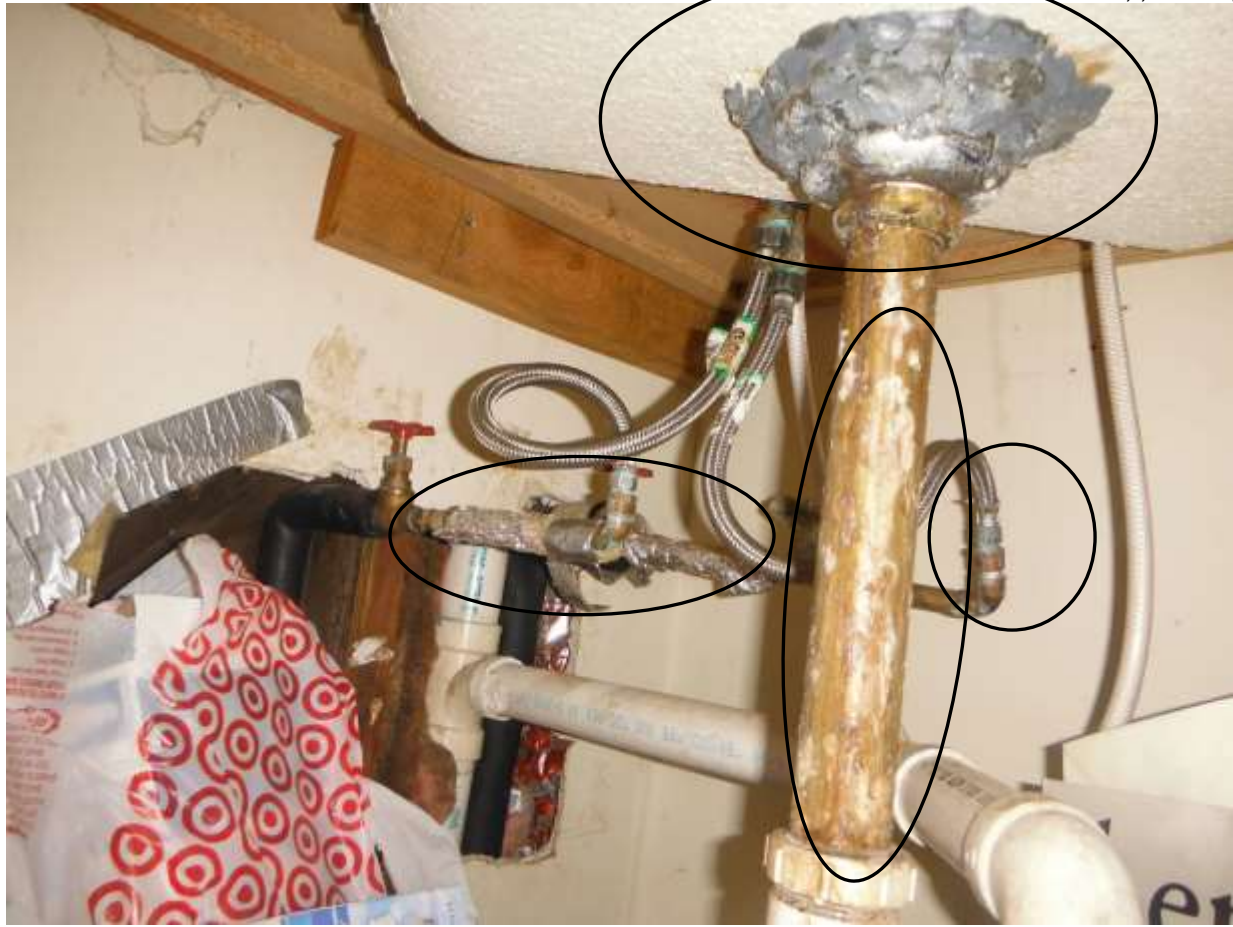
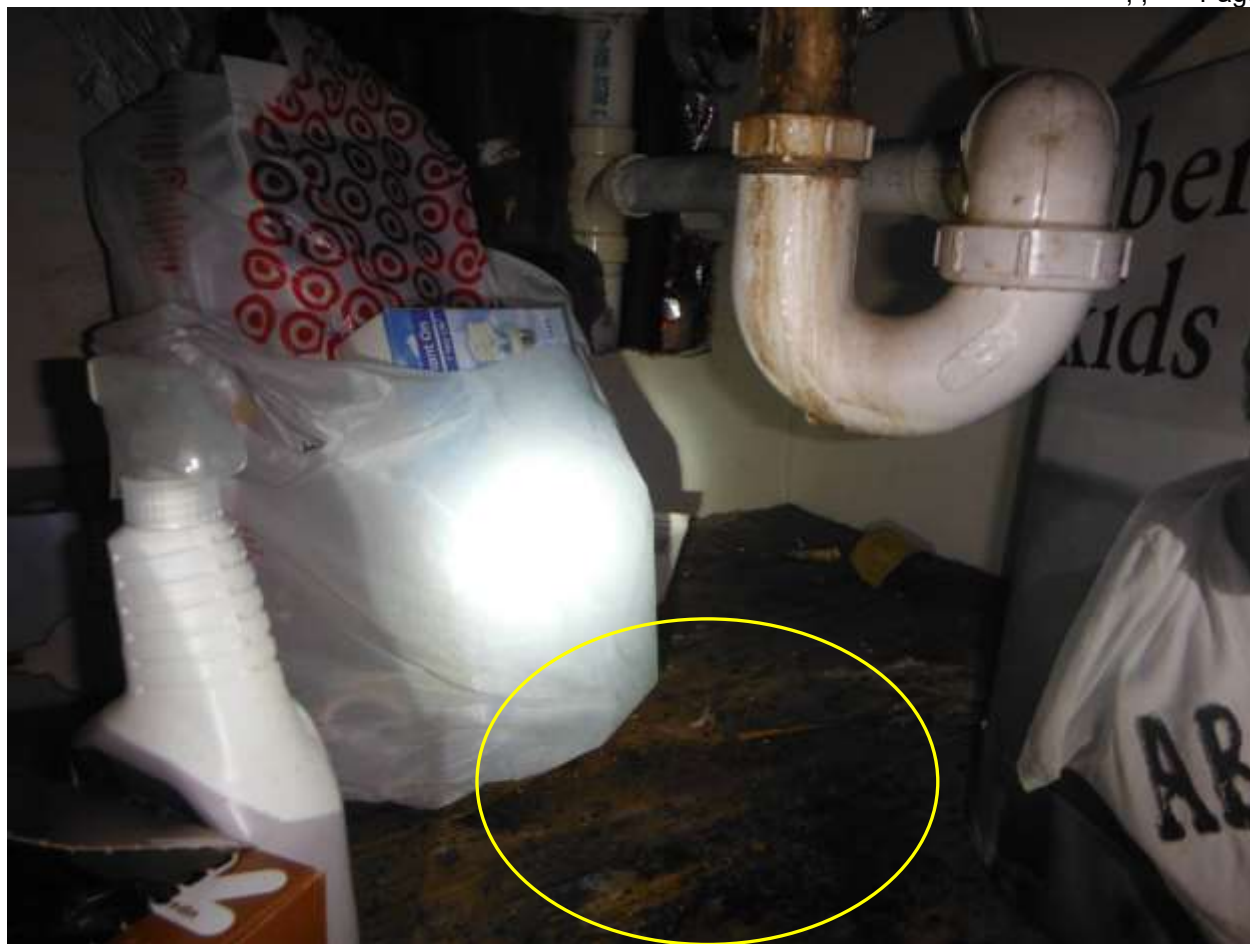
- 1. The sink drain basket and straight pipe/drain assembly was leaking; heavily puttied and water going onto bottom of cabinet shelf. Have the dark staining checked by contractor for mold or water damage; mold testing/inspection/identification is not part of a home inspection. There were water supply lines covered or wrapped with aluminum foil and stained; have evaluated. Recommend a licensed plumber evaluate plumbing and make all repairs. Recommend insulating piping and drains to avoid freeze damage; two cold walls.**

Figure 1 Leaking under sink from sink drain basket (heavily puttied), and drain assembly; have licensed plumber evaluate and repair. Have dark staining on cabinet bottom shelf further evaluated for mold. Identification, testing, and inspection of environmental or mold hazards is beyond the scope of a home inspection.

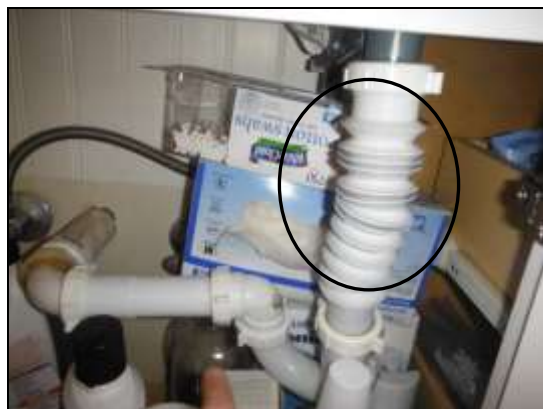
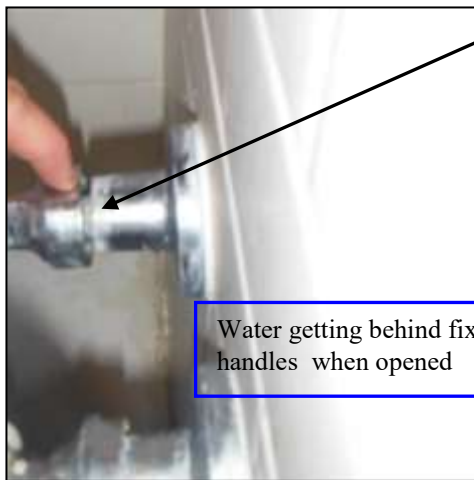
Figure 2 Unconventional/handyman or improper drain installation. Water getting behind the tub faucet handles; corrosion & calcium build-up. Have a licensed plumber evaluate and make all plumbing repairs.

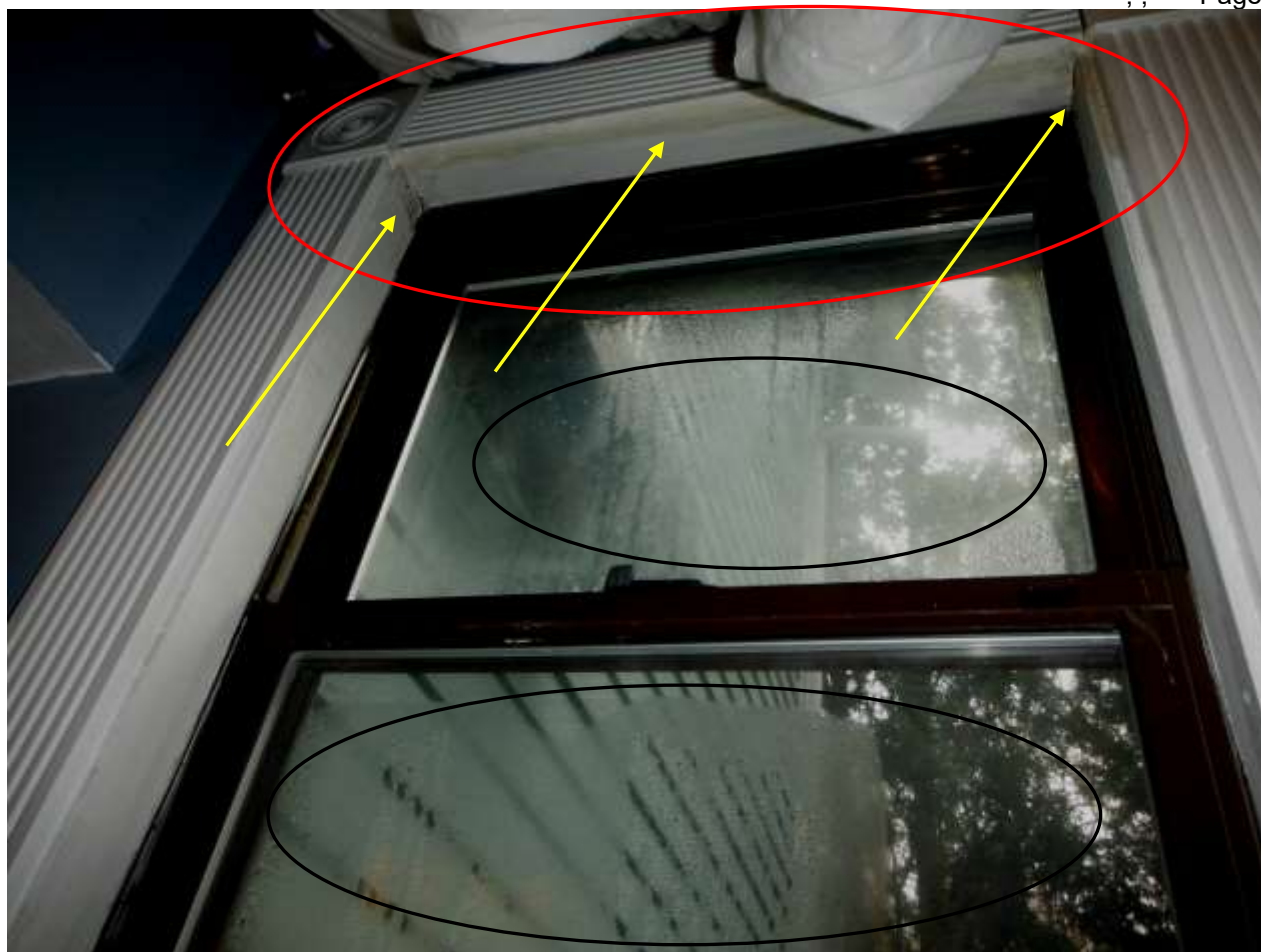
1. Window had vapor seal break, water stains and leaking around window frame; have window installer and carpenter or contractor evaluate and advise on all repairs/damage.
2. Bathroom tub knobs unconventional; water getting behind handles.** The drain in main bathroom was installed with flexible piping; tend to leak, clog and considered handyman or improper. Have a licensed plumber evaluate all plumbing concerns and make repairs/corrections.

Figure 3 Water stains/leaking around window frame and vapor seal breaks; have window installer evaluate and carpenter evaluate window and advise on all damage & repairs. See window section comments.

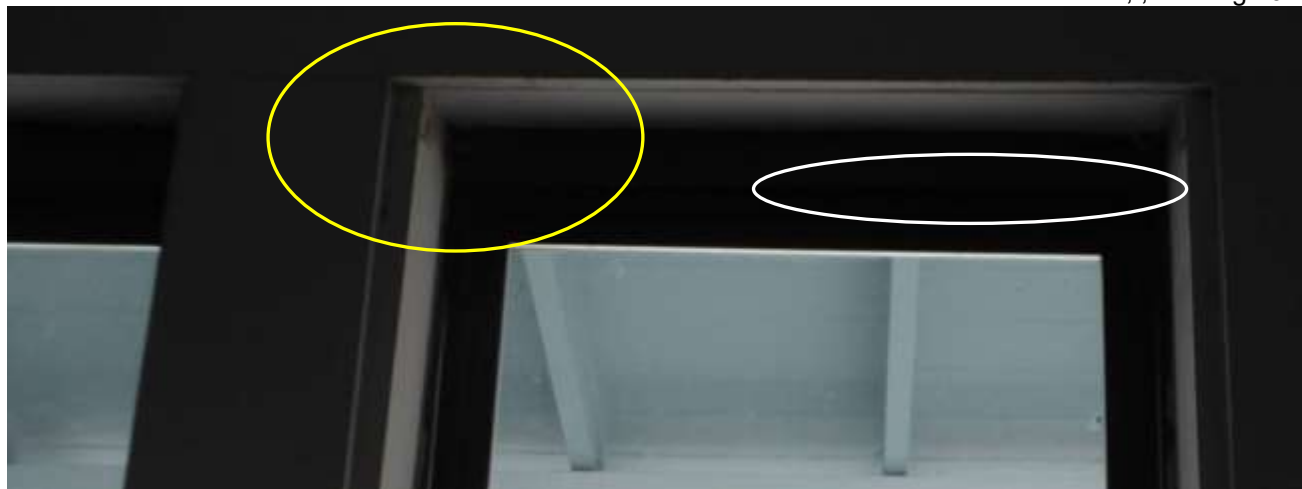
Figure 4 Example of water stains and gaps on windows in home where improperly installed and canted. See window section comments.

- 1. Have all windows in home evaluated/repairs by window installer and carpenter or building contractor before closing. Ask Co-op who is responsible for exterior of windows (ex- framing, trim, flashings, etc.) is repairs needed on exterior. Have all yellow stains/water stains checked around windows and rule out any damage.**

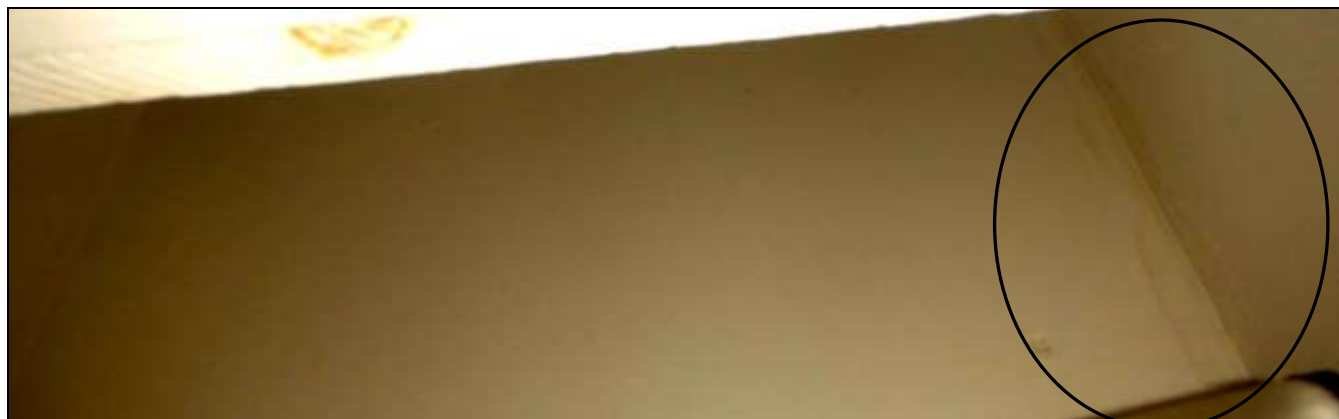
Figure 5 Water stains observed in interior of home especially around chimneys or adjacent to them. Have a roofer or building contractor evaluate all water sources and make repairs. Follow-up with Co-op to see who is responsible for exterior. Roof, gutters, flashings, etc. should be evaluated to determine all sources of leaking.

1. Follow-up with Co-op to have roof or exterior evaluated to determine all sources of leaking into interior; staining in closet adjacent to chimney. See kitchen section; water stains on chimney. See exterior section comments. Recommend removing items in closets or where storage/drapes/curtain/etc. to make full access and check for all interior leaks and have contractor repair all leaks.
2. There were vapor seal breaks and dropping window (unsafe); have all windows in home evaluated/repared.

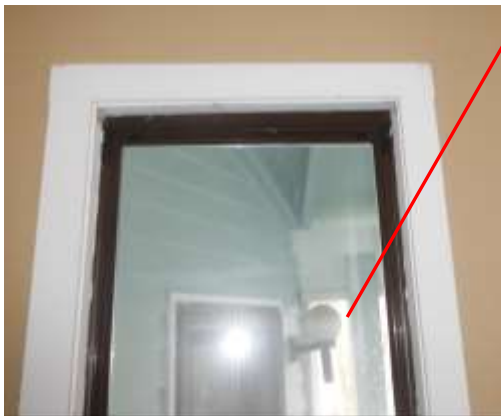
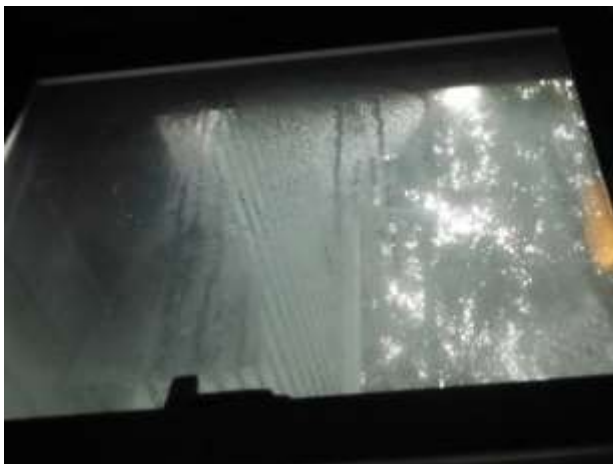
Figure 7 example of vapor seal breaks; have window installer Evaluate/repair and rule out any concealed damage by carpenter or building contractor.

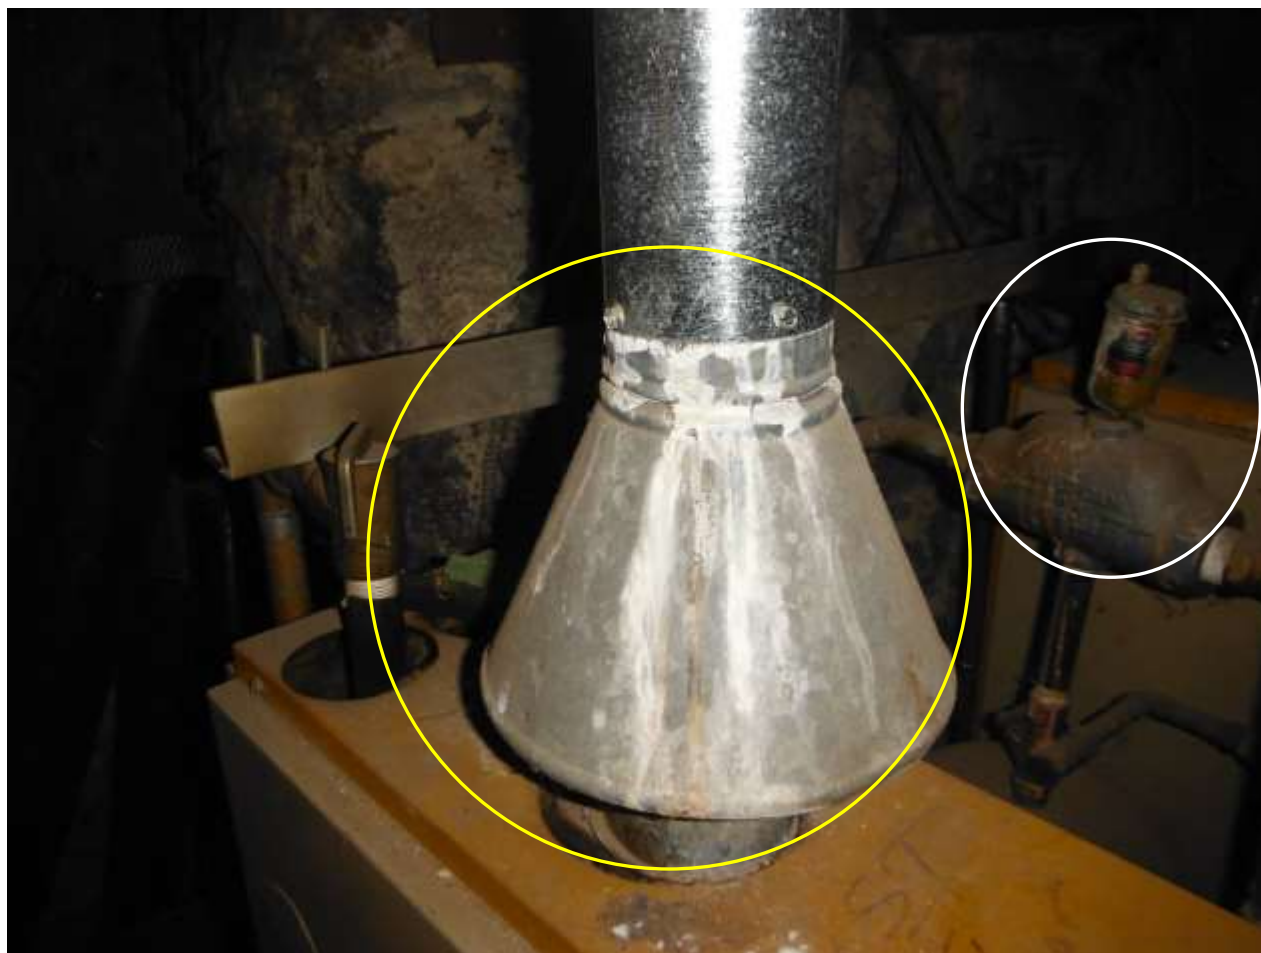
HEATING: The first floor and basement condo units share the same flue for the boilers and the hot water heaters. There was heavy condensate residue on all venting and appliances; drafting concerns. Recommend a chimney contractor evaluate the chimney & flues and advise on all repairs, liners, etc. for fire/life safety. The boiler was very old and no visible maintenance or service tags. Units had soot, rust, leaking air vent, corrosion and condensate residue; poorly maintained/safety concern. Follow-up with Co-op to see who is responsible for chimney/flue repairs, liners, etc. and protocol when the chimney appliance if shared by another condo unit. Recommend a boiler contractor or qualified plumber evaluate the boiler, venting and service the boiler along with the chimney inspection. Rule out any buried tanks on property due to age of home before closing. If no township permits for removed tank(s) or documentation, recommend a property tank scan to be certain there are no buried oil tanks.

Figure 8 White condensate residue; drafting/safety concerns. Rust, leaking air vent, soot, etc.; poorly maintained boiler. Have a boiler contractor service and make repairs; boiler near or past expected life.

1. Have a chimney contractor and licensed plumber evaluate the boiler, venting/flue and advise on all repairs and service/maintenance; poorly maintained/safety concerns. Plan and budget for a new boiler due to age of unit.
2. Follow-up with Co-op to see who is responsible for chimney/flue repairs, liners, etc. and protocol when the chimney appliance if shared by another condo unit.
3. Rule out any possibility of a buried oil tank on property before closing to be certain no tanks on property. If lack of documentation, recommend a property tank sweep. Check with township for removed tanks and permits.

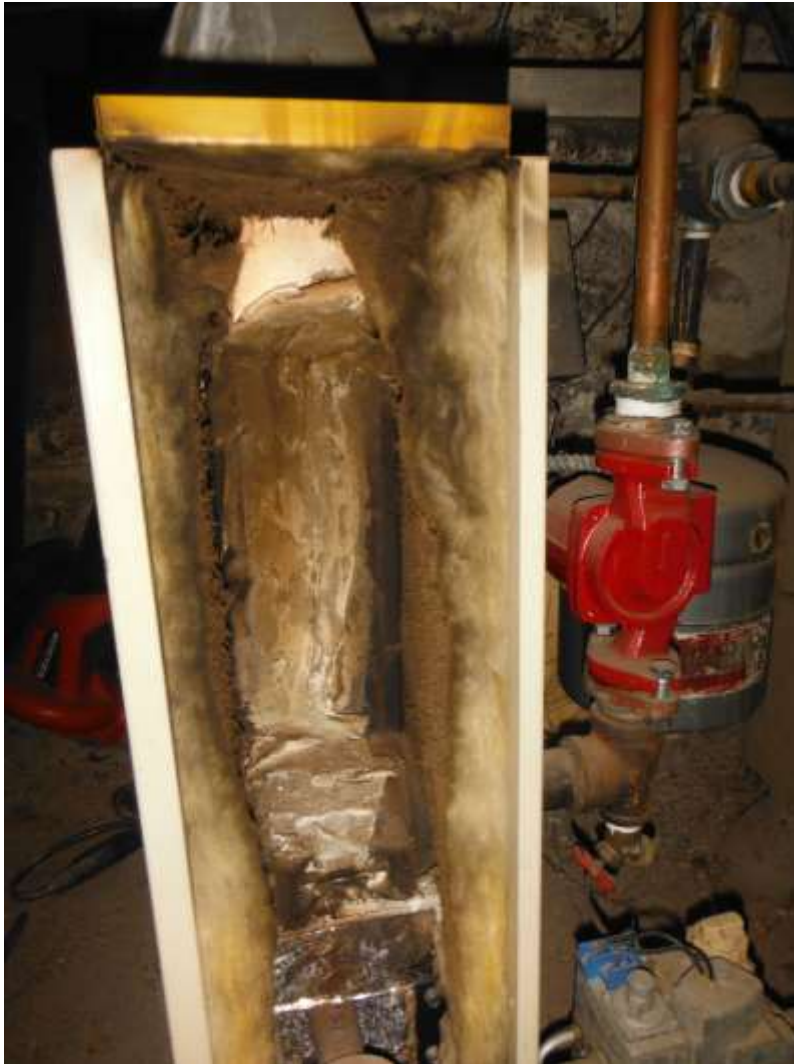
Figure 6 Poorly maintained boiler; have a boiler evaluate boiler and advise on repairs/replacement.

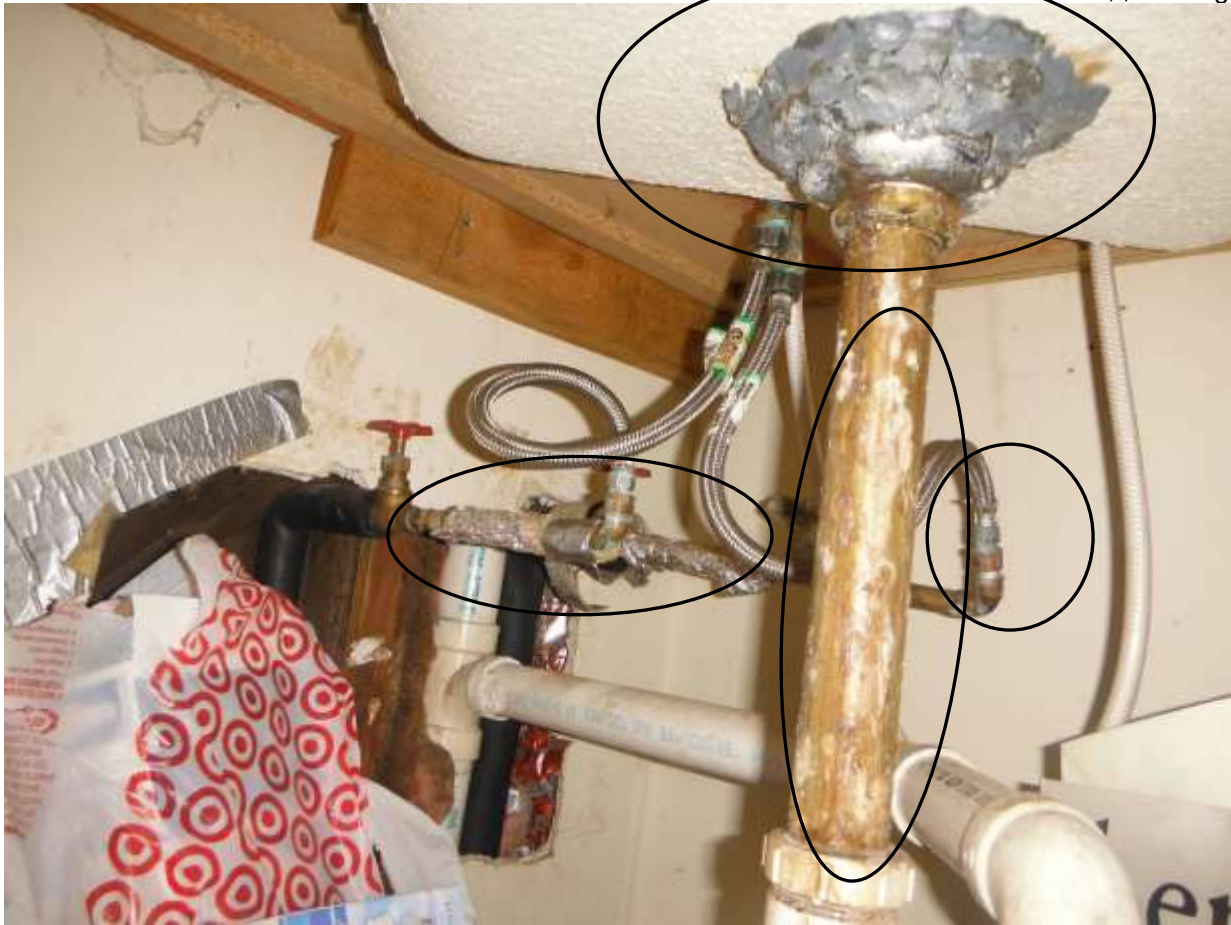
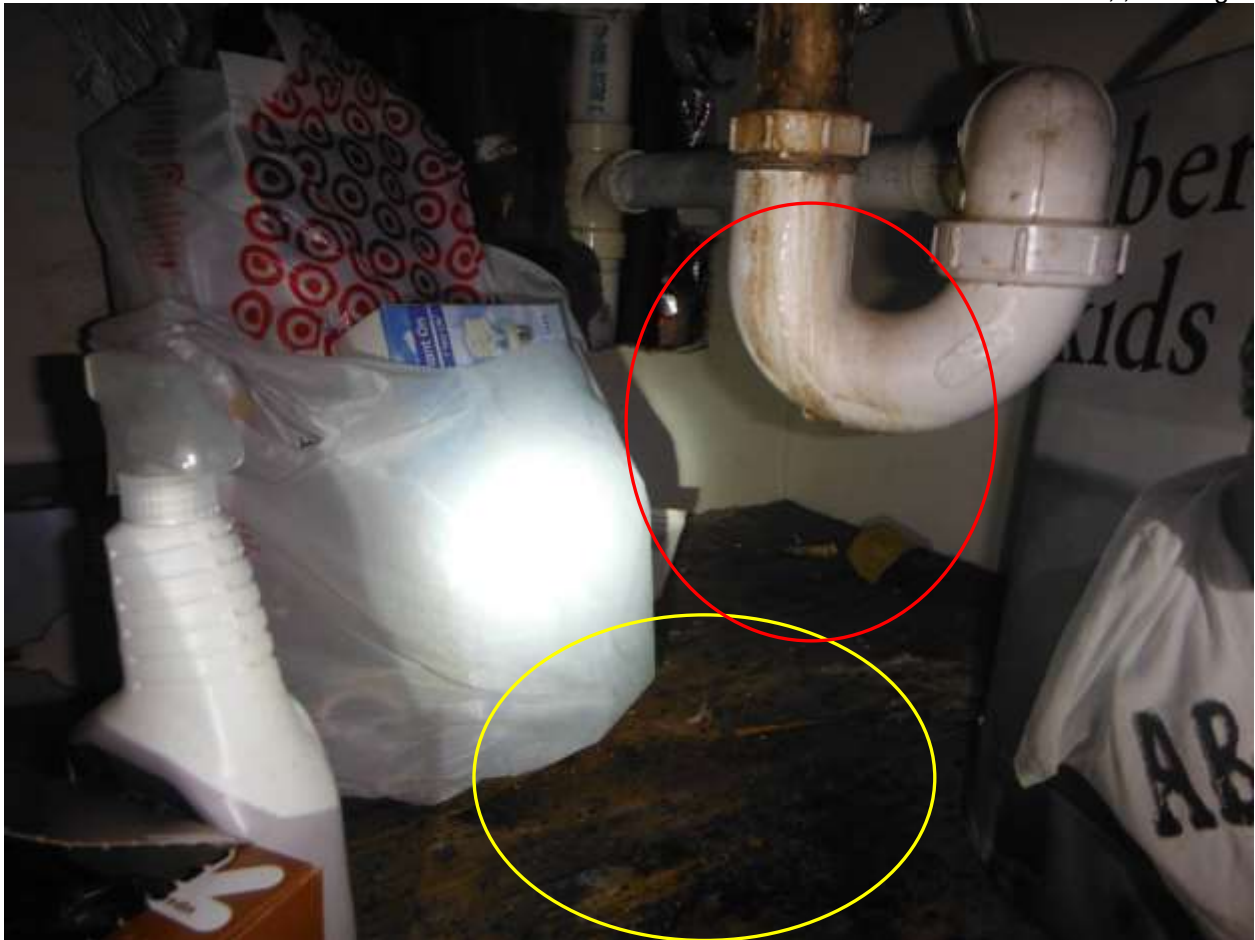
Figure 9 Leaking under sink from sink drain basket (heavily puttied), and drain assembly; have licensed plumber evaluate and repair. Have dark staining on cabinet bottom shelf further evaluated for mold. Identification, testing, and inspection of environmental or mold hazards is beyond the scope of a home inspection.

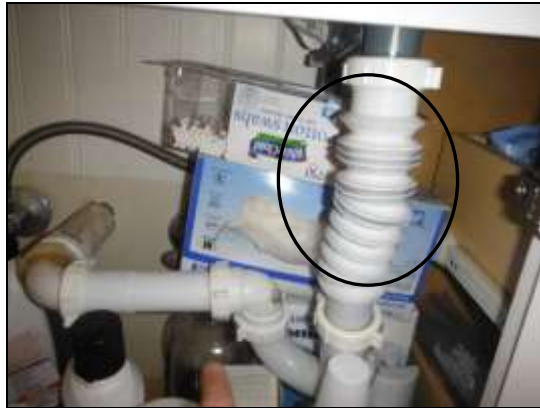
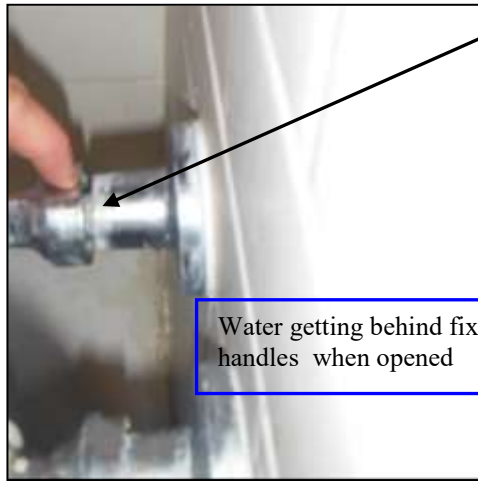
Figure 10 Unconventional/handyman or improper drain installation. Water getting behind the tub faucet handles; corrosion & calcium build-up. Have a licensed plumber evaluate and make all plumbing repairs.

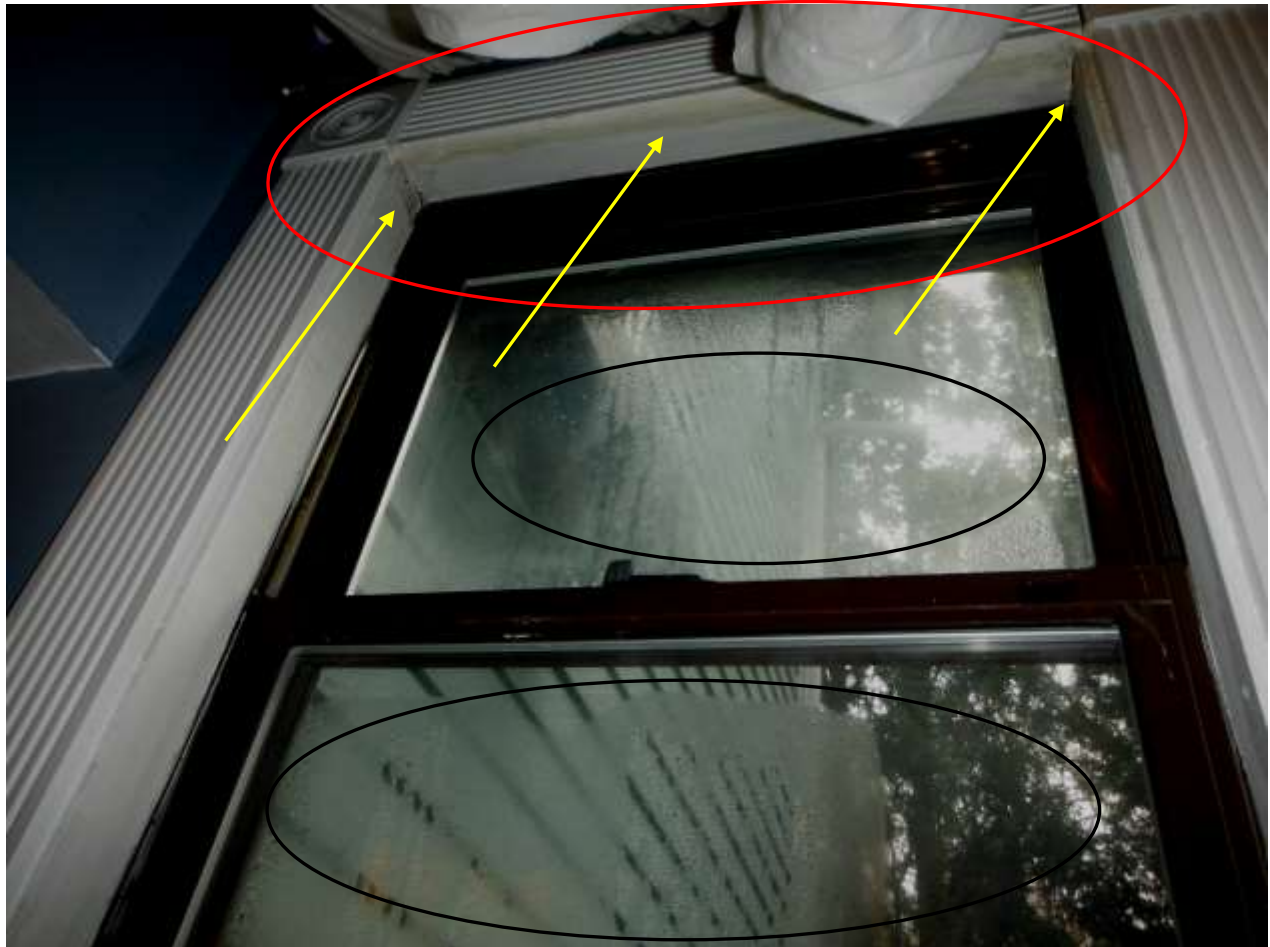
1. Window had vapor seal break, water stains and leaking around window frame; have window installer and carpenter or contractor evaluate and advise on all repairs/damage.
2. Bathroom tub knobs unconventional; water getting behind handles.** The drain in main bathroom was installed with flexible piping; tend to leak, clog and considered handyman or improper. Have a licensed plumber evaluate all plumbing concerns and make repairs/corrections.

Figure 11 Water stains/leaking around window frame and vapor seal breaks; have window installer evaluate and carpenter evaluate window and advise on all damage & repairs. See window section comments.

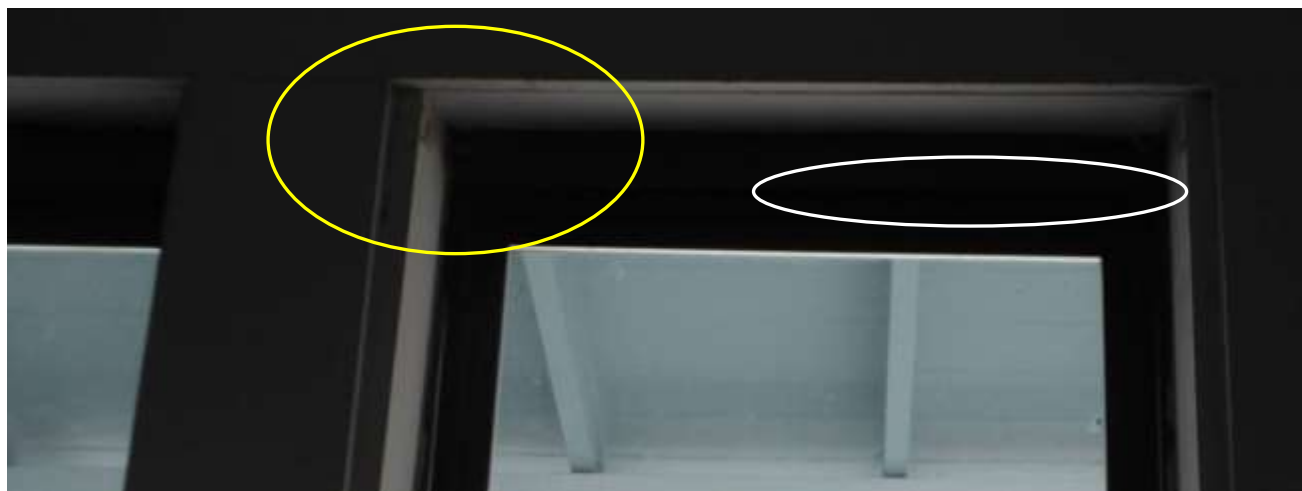
Figure 12 Example of water stains and gaps on windows in home where improperly installed and canted. See window section comments.

1. Have all windows in home evaluated/repairs by window installer and carpenter or building contractor before closing. Ask Co-op who is responsible for exterior of windows (ex- framing, trim, flashings, etc.) is repairs needed on exterior. Have all yellow stains/water stains checked around windows and rule out any damage.

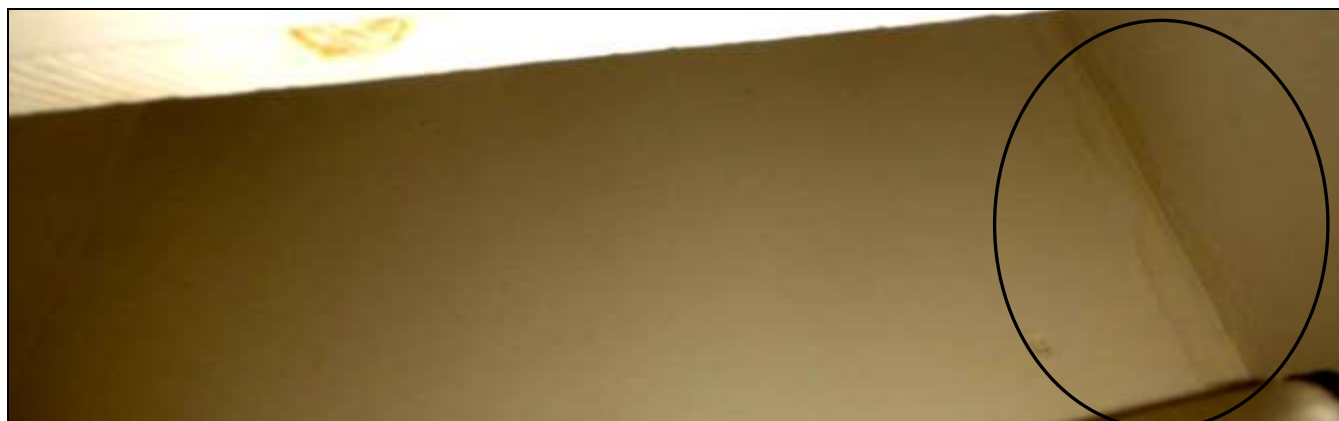
Figure 13 Water stains observed in interior of home especially around chimneys or adjacent to them. Have a roofer or building contractor evaluate all water sources and make repairs. Follow-up with Co-op to see who is responsible for exterior. Roof, gutters, flashings, etc. should be evaluated to determine all sources of leaking.

1. Follow-up with Co-op to have roof or exterior evaluated to determine all sources of leaking into interior; staining in closet adjacent to chimney. See kitchen section; water stains on chimney. See exterior section comments. Recommend removing items in closets or where storage/drapes/curtain/etc. to make full access and check for all interior leaks and have contractor repair all leaks.
2. There were vapor seal breaks and dropping window (unsafe); have all windows in home evaluated/repaired.

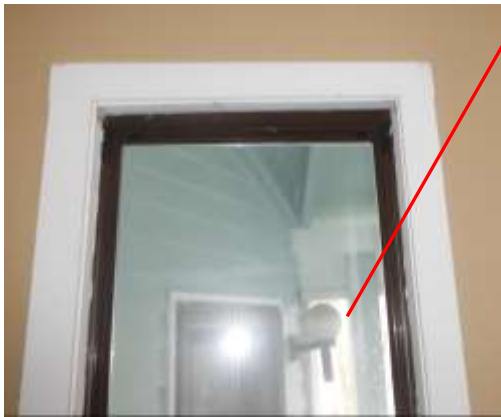
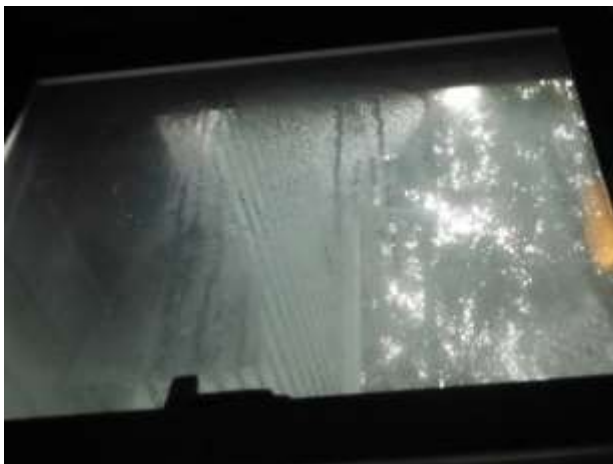
Figure 15 example of vapor seal breaks; have window installer Evaluate/repair and rule out any concealed damage by carpenter or building contractor.

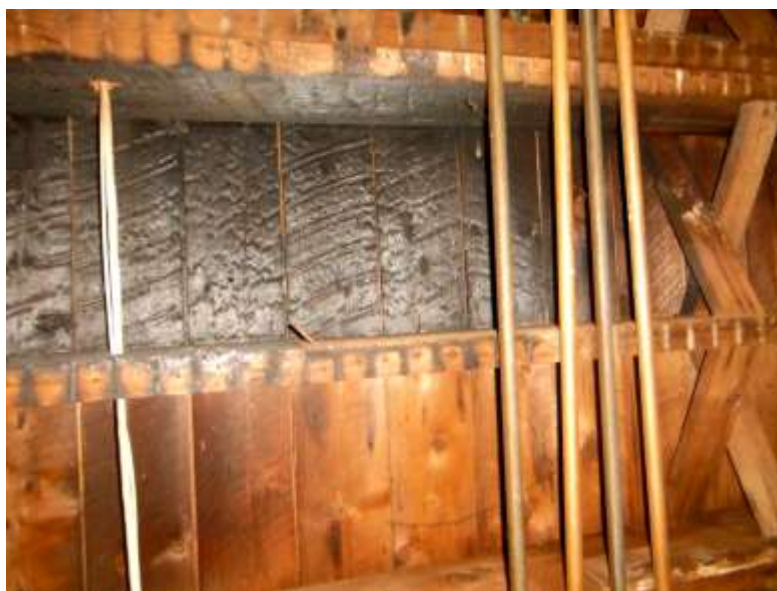
Figure 16 Observed fire damage in basement in common areas; follow up with the Association for fire damage.

1. **Basement is not owned by this condo unit; not part of this first floor condo inspection.* There were incidental observations while in the basement inspecting the mechanicals and electrical panel. Follow-up with the Co-op to see who is responsible for evaluating/inspecting the basement, crawl, structure, wood destroying insects, **fire history & repairs**, improper door framing, roof, exterior, etc.**

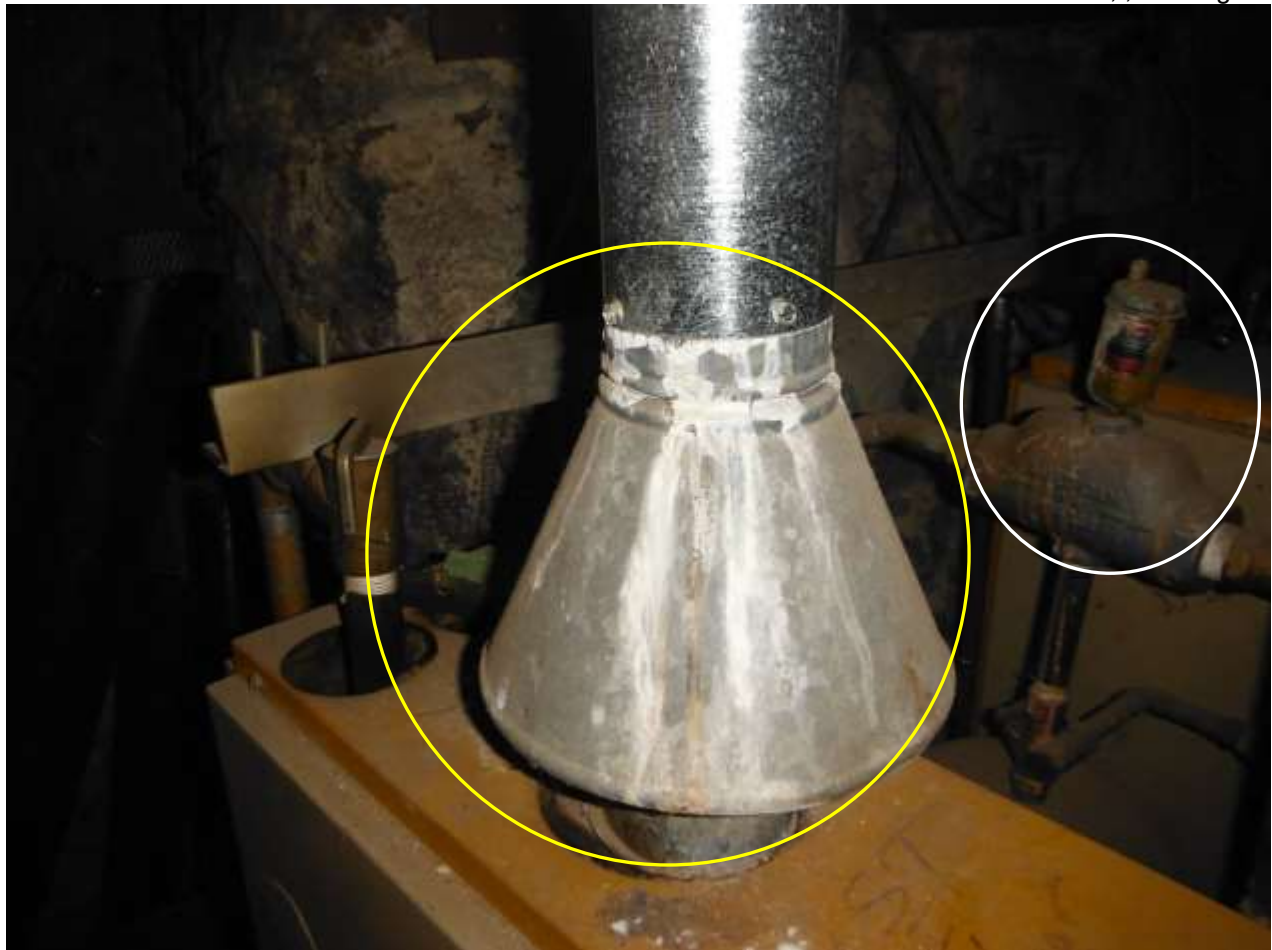
Figure 17 White condensate residue; drafting/safety concerns. Rust, leaking air vent, soot, etc.; poorly maintained boiler. Have a boiler contractor service and make repairs; boiler near or past expected life.

1. **Have a chimney contractor and licensed plumber evaluate the boiler, venting/flue and advise on all repairs and service/maintenance; poorly maintained/safety concerns. Plan and budget for a new boiler due to age of unit.**
2. **Follow-up with Co-op to see who is responsible for chimney/flue repairs, liners, etc. and protocol when the chimney appliance is shared by another condo unit.**
3. **Rule out any possibility of a buried oil tank on property before closing to be certain no tanks on property. If lack of documentation, recommend a property tank sweep. Check with township for removed tanks and permits.**

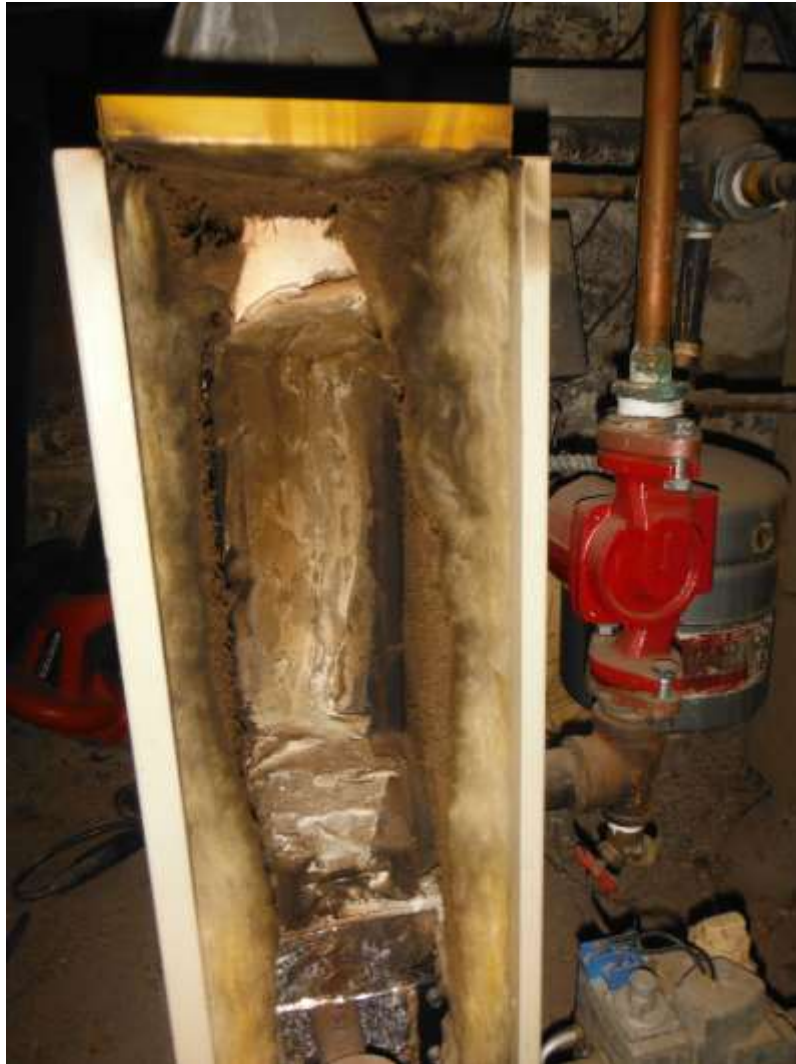
Figure 6 Poorly maintained boiler; have a boiler evaluate boiler and advise on repairs/replacement.
