4 Seasons Home Inspection, LLC

RECEIPT

BUILDING DATA

Approximate Age: ~1956 build
Style: Single family
Main Entrance Faces: E
State of Occupancy: Occupied
Weather Conditions: 75-80 °F
Ground cover: dry

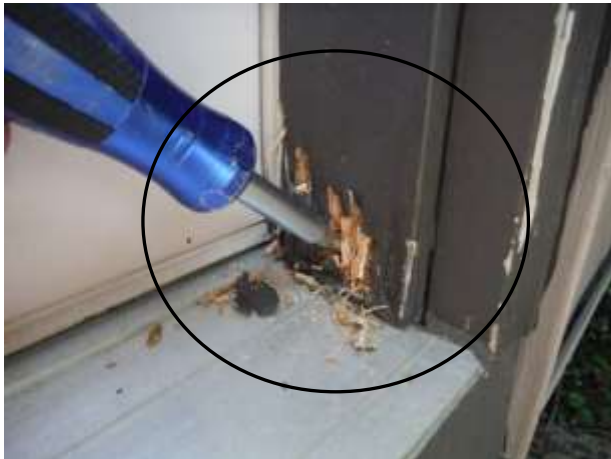
3. There was expansion foam sprayed in garage, under bottom of siding, in cracks, around basement windows, etc.; handyman sealant. Recommend having removed and properly sealed by a building contractor. The foam breaks down and attracts wood destroying insects/carpenter ant.

4. Have auto pressure reverse adjusted for safety; not working/unsafe.
5. There was water damage on rear man door frame; have carpenter make repairs.

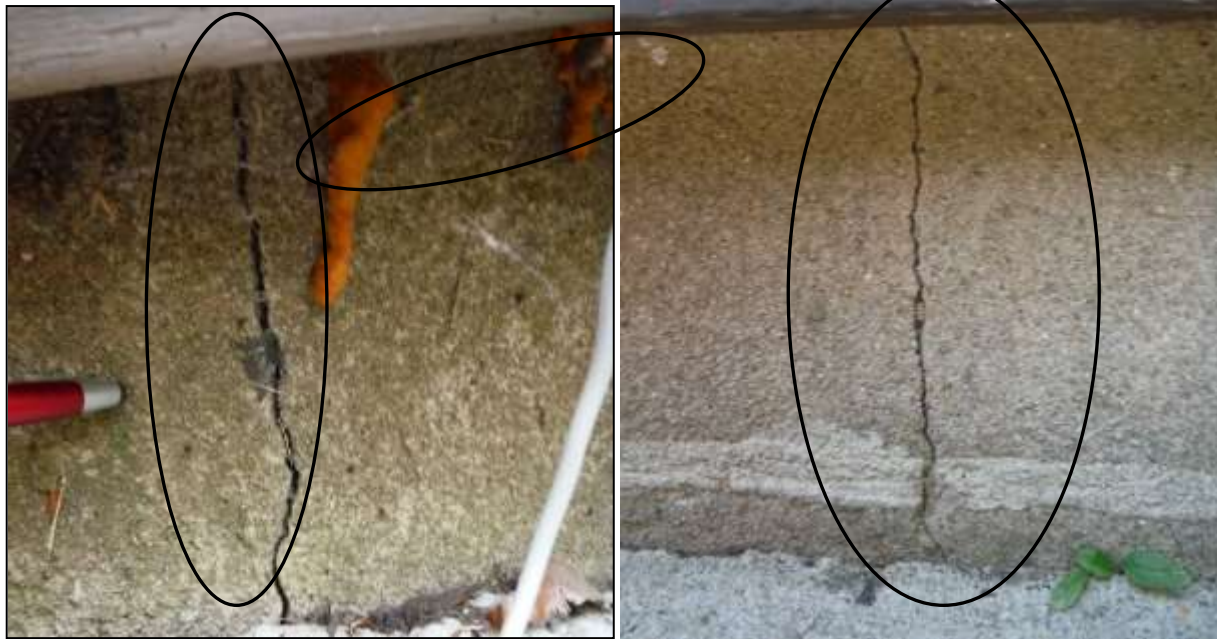
Figure 1 Examples of foundation cracks; have evaluated by a structural mason and/or engineer (PE).

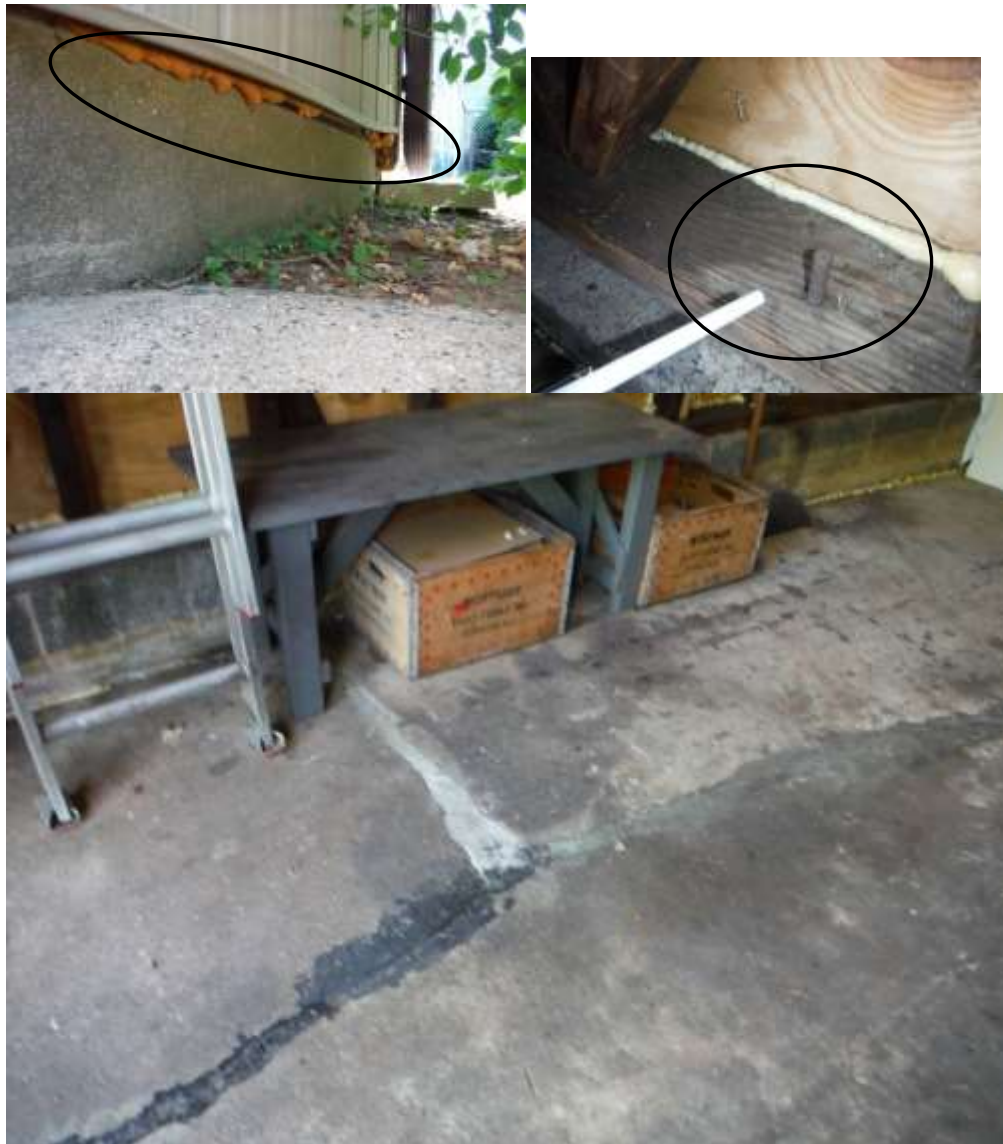
1. There was a missing nut on the foundation J-bolt; have structural carpenter evaluate/add where missing. There was large settling cracks on garage floor; water and/or frost heaved damage. There was foundation block displaced/movement visible in rear left in garage where patched or cemented & on exterior partially covered by shrubs. There were foundation cracks, parge cracks, flaked, etc. visible on exterior foundation. Recommend repair by structural mason or foundation repair building contractor before closing. There was clutter and partial wall covering in garage; limited access. Area should be cleared of items for structural carpenter & mason evaluations; see crawl and structural comments in report.

Figure 2 Damage to floor & foundation visible in garage; have a structural mason or qualified foundation repair contractor and/or structural engineer evaluate the homes structure (cracks & termite damage).

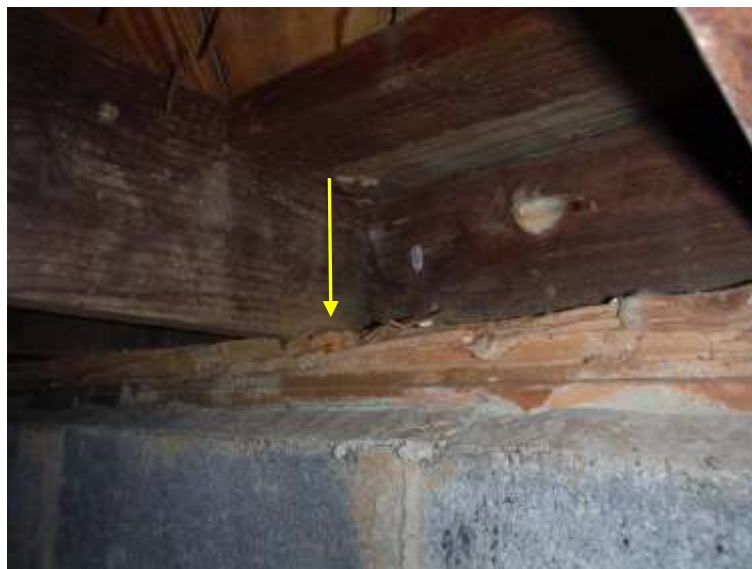
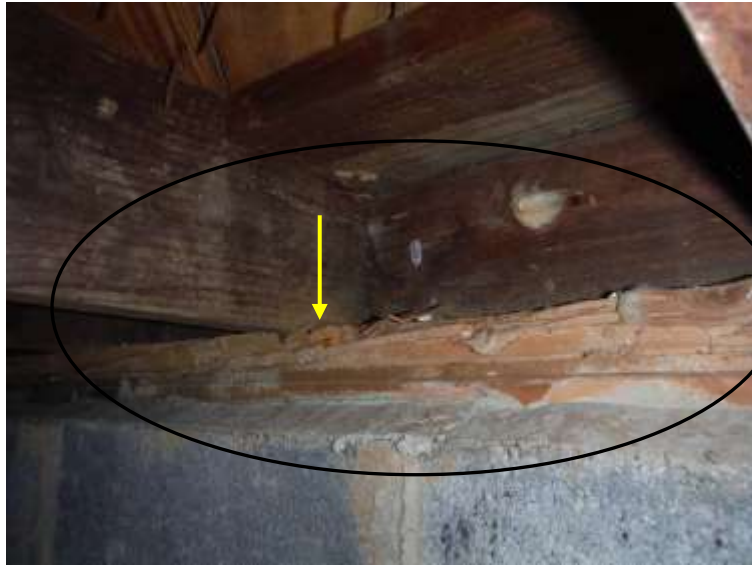
EXAMPLES OF TERMITE/STRUCTURAL DAMAGE/FOUNDATION CRACKS:

CRAWL SPACE : Evidence of termite (shelter tubes, scraped off tubes, scarring damage , structural damage (sills/plate, rim/band joists/framing) was visible in the crawl space. There was a bulged wall (drywall) on staircase to basement adjacent to the crawl space. Ceilings, walls must be opened up by the structural carpenter to access the structure and the extent of all termite & structural damage and repairs must be determined before closing. There were foundation cracks, some cracks go through the foundation block, unfilled drilled holes, loose or missing foundation mortar, open webbing, etc. Have a structural mason, qualified foundation building contractor and/or a structural engineer (PE) evaluate the structure and advise on all structural repairs. “Structural & Termite damage” or “Material defects” and structural damage exist. There were mice droppings, fur, seeds, acorns, etc. Have a licensed Pest Company evaluate and advise on rodent management. Mice or rodents can damage electrical wiring and pose potential health concerns.

1. **“Structural & Termite damage” or “Material defects” and structural damage exist . Have a structural carpenter, qualified mason/foundation repair building contractor and/or a structural engineer (PE) evaluate the homes structural damage/termite damage/foundation damage and advise on all repairs. Finished areas adjacent to the termite evidence in crawl must be opened up by the structural carpenter to determine extent of all termite/structural damage repaired.**
2. **There were mice droppings, fur, seeds, acorns, etc. Have a licensed Pest Company evaluate and advise on rodent management. Mice or rodents can damage electrical wiring and pose potential health concerns.**

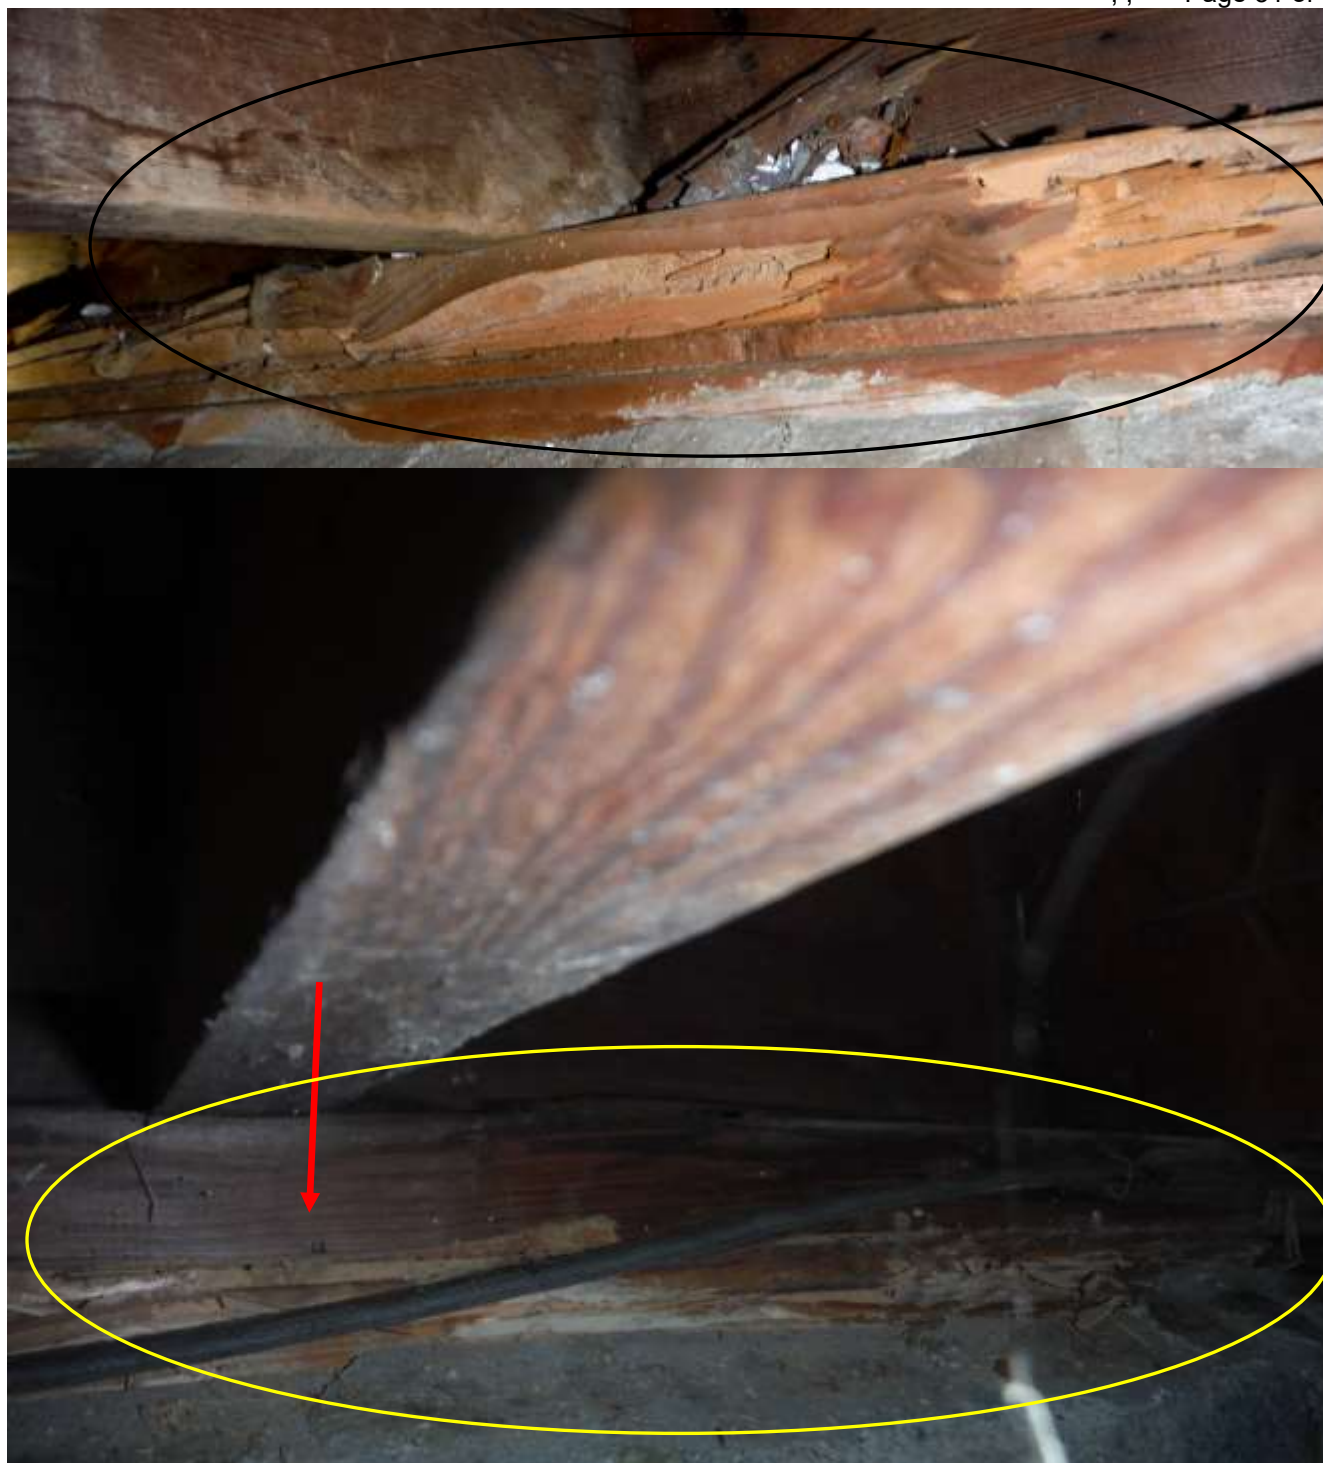
Figure 3 Joists compressing termite damaged sills; structural/material defects.

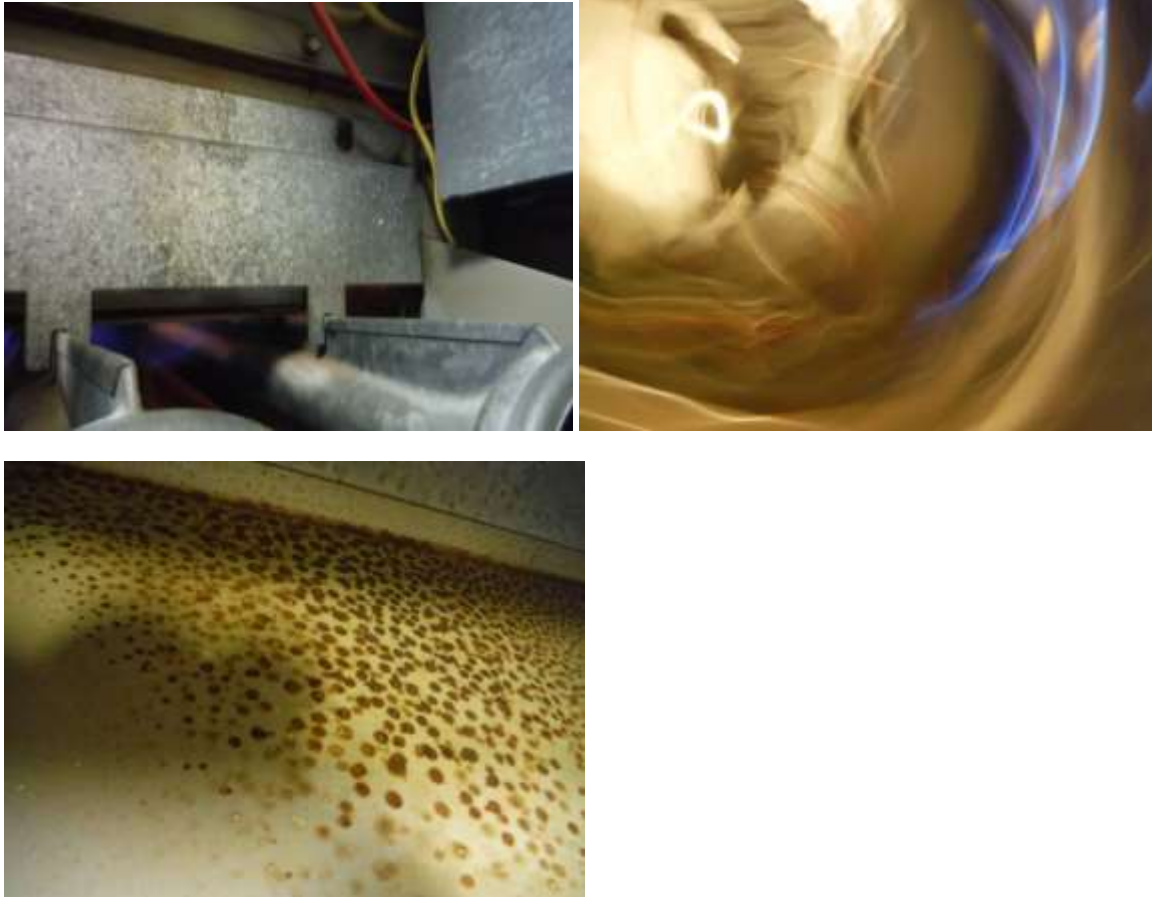
1. The heating & cooling systems were very old and past expected life. The furnace had flame rollout, scorch/heat marks condensate residue; drafting, life/safety concerns/dangerous.** Recommend a qualified HVAC contractor evaluate the heating & cooling for replacements; past expected life and safety concerns. Recommend a chimney contractor/sweep clean and evaluate chimney and verify liner for safety.

Figure 4 Furnace had flame rollout when blower kicked on; dangerous. Have a qualified HVAC contractor evaluate the heating & cooling systems for replacement; past life.
