# 4 Seasons Home Inspection, LLC

## CLIENT NAME address

Inspection Date: August 02, 2016 Tuesday 9am-1pm  
Client Name: CLIENT  
Emails: REALTOR  
Inspection Address: # street, south jersey xxxxx  
Inspected by: Linda Geczi home inspection lic. #24GI00061500

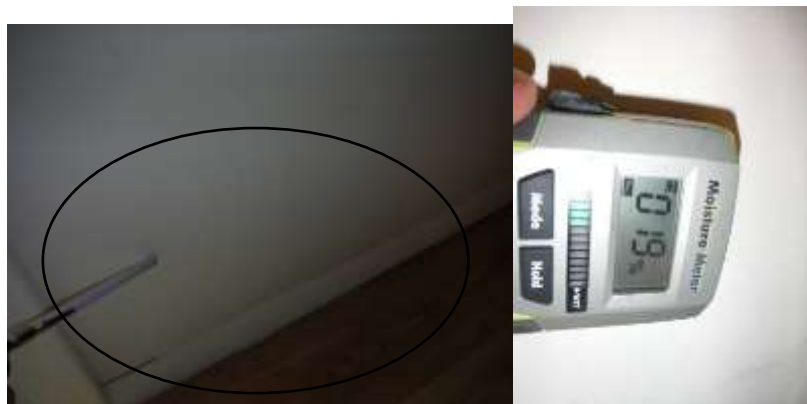
1. Recommend an electrician evaluate kitchen for GFCI outlets by sink, a dedicated outlet for refrigerator.
2. There was a patched area by the slider door; tested active moisture. Recommend contacting the Association for evaluation/identify the water sources & repairs.

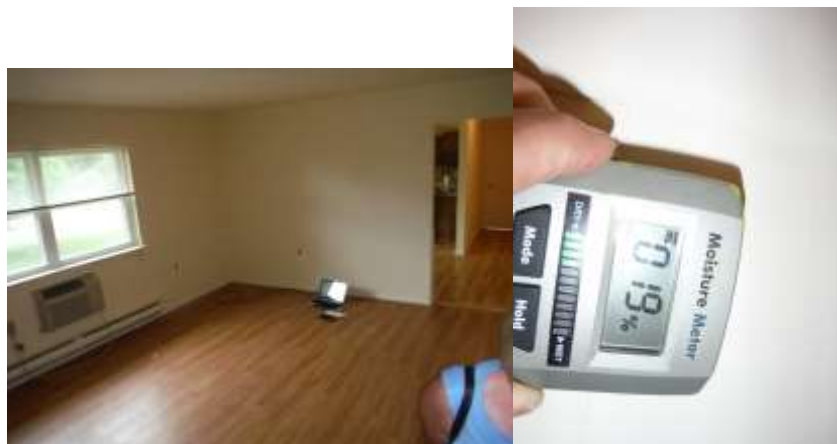
1. There were active leaks/moisture in the home around windows/walls, etc. Recommend a building contractor evaluate all water sources and make repairs.

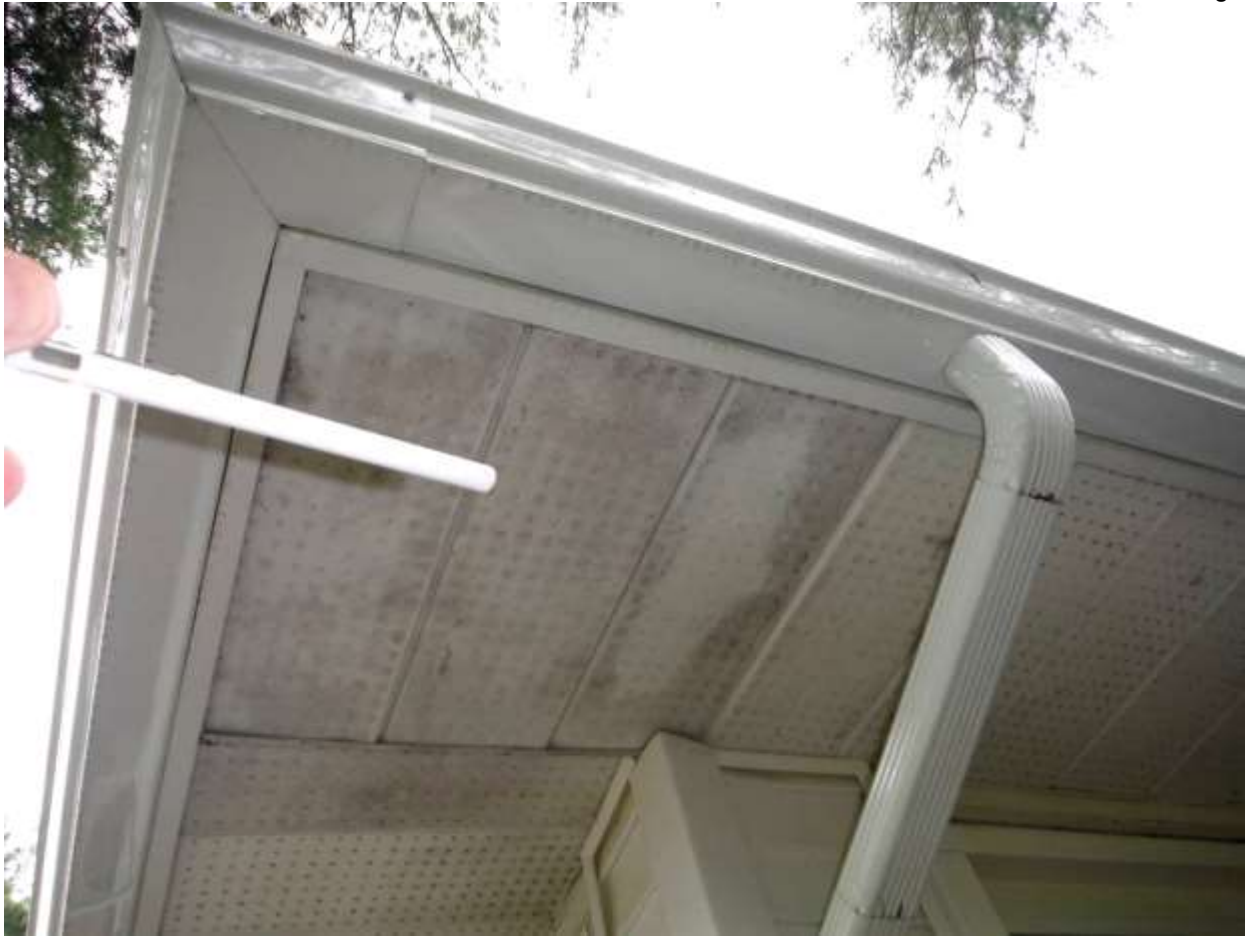
**SUN ROOM :** There were patched walls and loose peeled laminate flooring; active moisture/leaks. Recommend a building contractor evaluate/identify all water sources and make repairs in the home. The gutters were leaking into soffits, between gutters and fascia and down siding. There was black discoloration on perforated soffits; insulation blocking eaves in attic/no air flow/poor ventilation. The windows had improper capping; back pitched and water drains toward the window or home. Recommend contacting the Association to see who is responsible for repairs before closing and contractual obligations.

**Figure 1 Example of soffits, leaking, dark staining, etc.- have evaluated by the Association before closing and all repairs where leaking & water sources into the interior.**

1. **Recommend contacting the Association to see who is responsible for repairs before closing and contractual obligations.**

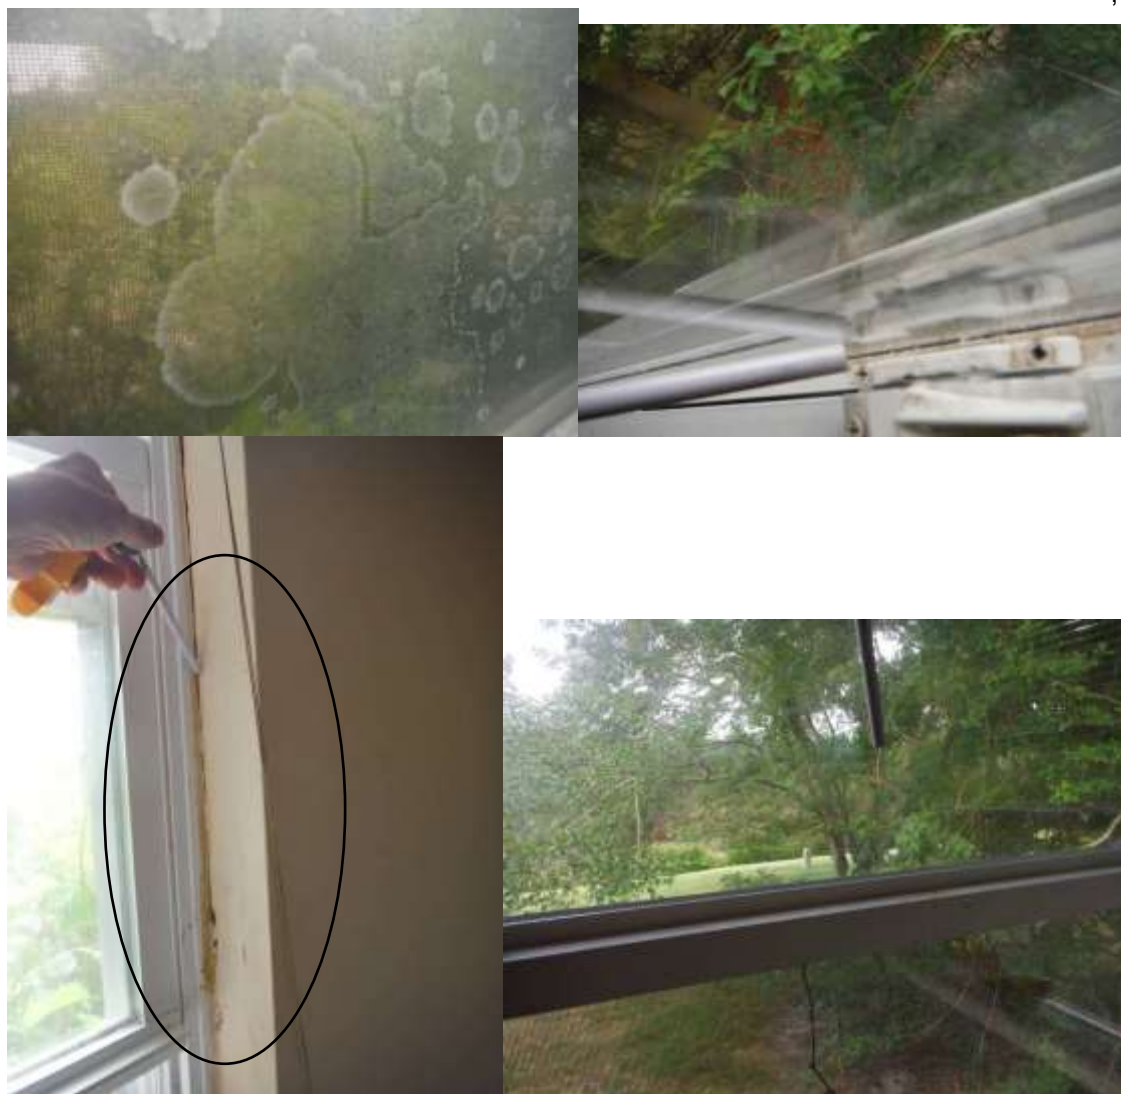
**MASTER BEDROOM :** See heating section comments. The windows were not installed properly; gaps, water damage (carpenter ants coming out of window), gaps, daylight, not aligning, difficult to open/close, etc. There was water damage around side window. There was active moisture in interior rooms of the home. There was improperly capped windows (back pitched/drains toward the window & walls), leaking gutters/soffits/fascia, loose door & window flashings/wrapping/capping, loose brick, etc. Recommend contacting the Association to see who is responsible for repairs/corrections. Recommend a window installer and exterior building contractor identify & repair all water leaks/sources. Recommend a window & door installer evaluate all doors & windows and advise on repairs/replacements, flashing, capping, etc. to maintain protection and leak free interior. There was a knob on wall; unknown switch. Have an electrician evaluate & advise on purpose.

**Figure 2** Example of vapor seal breaks, water damage (carpenter ants coming out of window rot), locks not aligned, window sashes not aligned, etc.

1. Recommend a window & door installer evaluate all doors & windows and advise on repairs/replacements, flashing, capping, etc. to maintain protection and leak free interior.
2. See heating section comments; baseboards old and poor condition.
3. There were active leaks/moisture in room and throughout the home. Follow-up with the Association for evaluations, responsibilities and repairs.

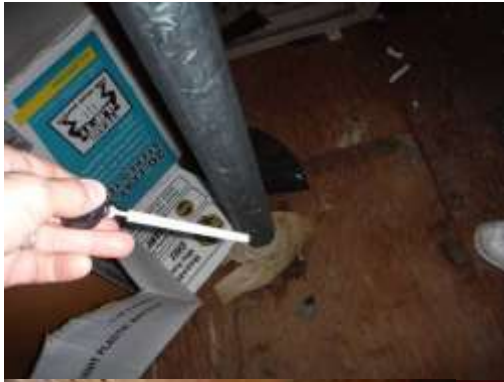
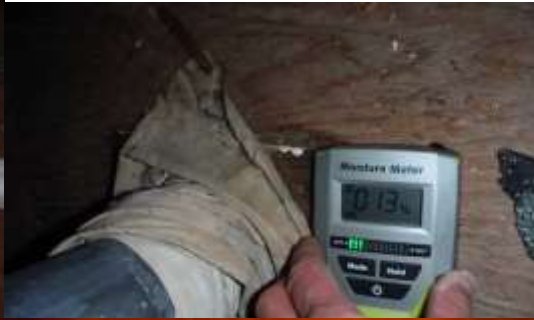
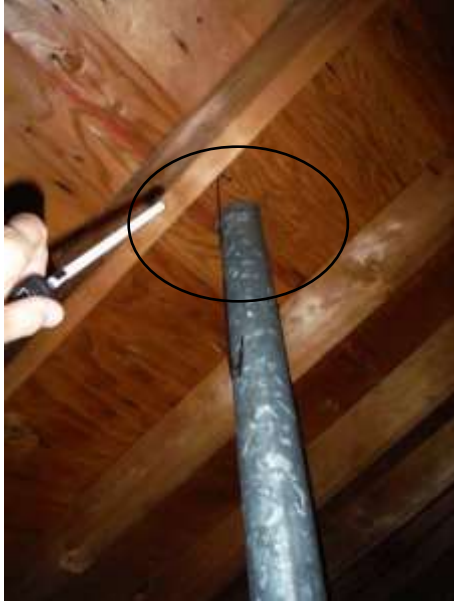
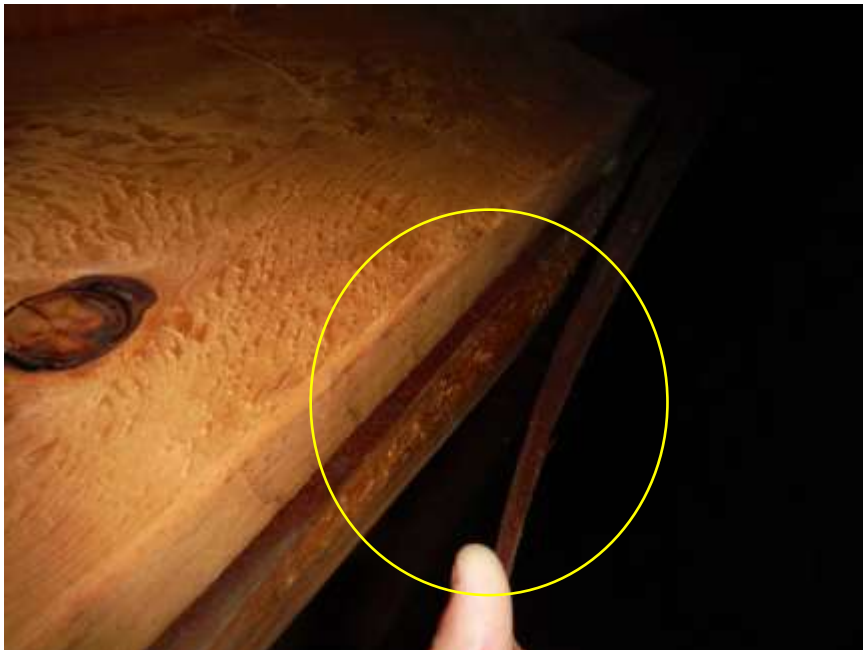
- 2. There was daylight/leaking around the bathroom fan through the roof; have the Association evaluate & make proper repairs. Tarring & caulking not recommended; will crack and leak. Recommend proper pipe covers/flashings.**

- 3. Recommend following up with the township for all CO and smoke detector requirements; not part of home inspection.**
- 4. There was a split or crack on end of a rafter; have repaired by carpenter.**

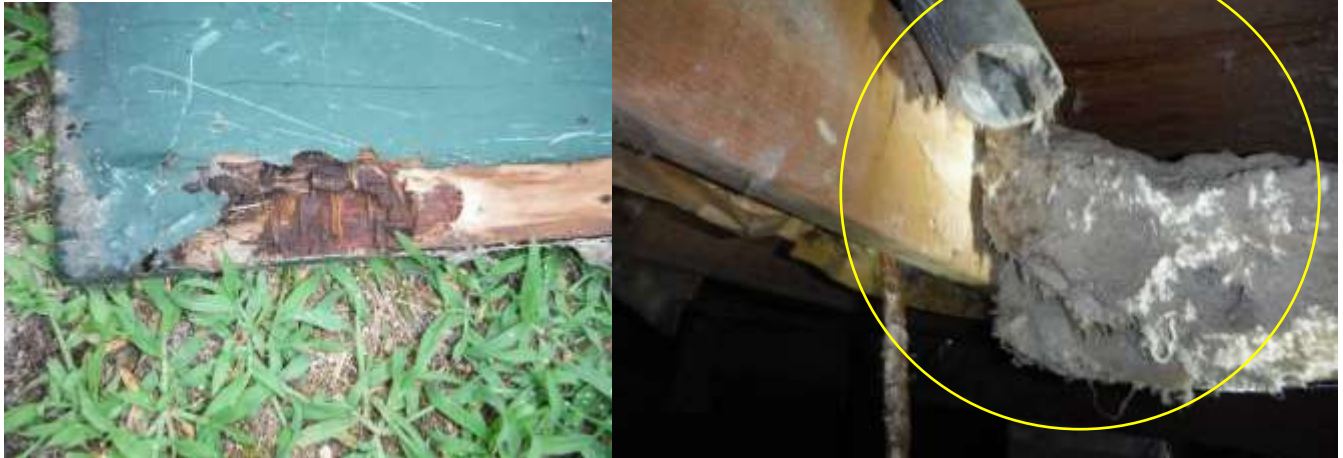
**CRAWL SPACE/SLAB ON GRADE :** The dryer vent for this unit and the neighbor vents directly into the crawl space; dryer lint on floor, walls, wood/structure. Recommend venting to the exterior; contact the Association to see who is responsible for corrections; fire hazard, adds moisture in crawl and attracts wood destroying insects. There was observed carpenter ant in crawl, exterior, window frames, broken crawl cover, etc. There was a well gauge/piping; ask Association who is responsible for the well equipment. Well water & related equipment is not part of home inspection. Recommend following up with a well service company for well testing and inspection; beyond the scope of a home inspection. The crawl cover was broken and water entering the opening; replace cover to crawl space. Follow-up with Association for cover; recommend non-wood cover. There was wet hanging insulation and missing insulation. The insulation was installed backwards or improperly; vapor barrier should be installed with vapor barrier against the heated or living space. Recommend a building contractor remove wet insulation; no longer effective when wet. Check all areas of wood/sub flooring/joists when insulation removed and accessible for inspection. There was rusted nails, hangers, and anything metal in the crawl space; high moisture/wet conditions and musty/moldy/mildew odor. Recommend a wet crawl space contractor evaluate the crawl space for encapsulation, sump pump/drains and dehumidification. Recommend having the grading & drainage corrected on exterior and all gutters pitched away and extended at least 6-8 ft. away from foundation for drainage. There was negative grading and low spots, trees & shrubs too close, etc. ; conducive to retaining water, seepage and attracting wood destroying insects. Recommend contacting the Association to evaluate the gutters, exterior, window trim/capping, fascia, soffits, etc. There was leaking behind gutters, fascia, soffits, windows/doors, etc.; active moisture in the interior of home. The crawl space was very wet; holes/damaged cover, standing water, wet insulation/improperly installed, negative grading & poor drainage, trees/shrubs too close to house, etc. Recommend contacting the Association to see who's responsible for corrections, repairs, seal siding/loose bricks, holes in trim/soffits, etc. to maintain a dry crawl space and home. Recommend a wet crawl space contractor evaluate the crawl space for encapsulation, sump pump/drains and dehumidification.

**Figure 3 Rotted crawl space cover; have replaced. Example of dryer vent and lint terminating in crawl space; have vented to exterior.**

- 2. The dryer vent for this unit and the neighbor vents directly into the crawl space; dryer lint on floor, walls, wood/structure. Recommend venting to the exterior; contact the Association to see who is responsible for corrections; fire hazard, adds moisture in crawl and attracts wood destroying insects.**

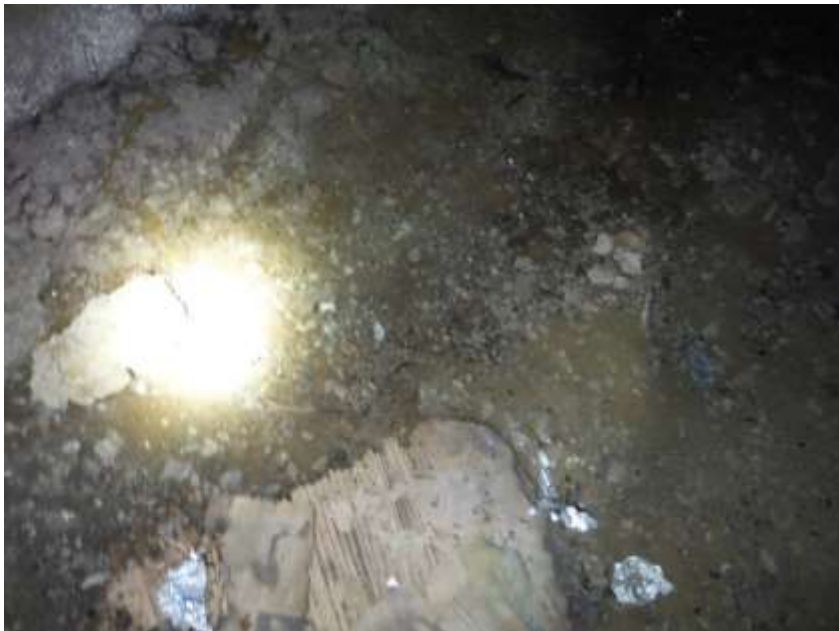
**Figure 4 Puddles at opening, wet sandy soil, dryer lint, wet insulation, musty/mildew odor, etc. Recommend a wet crawl space contractor evaluate the crawl space for encapsulation, sump pump/drains and dehumidification. Recommend venting dryers to exterior (including neighbor).**

- 1. The crawl space was very wet; holes/damaged cover, standing water, wet insulation/improperly installed, negative grading & poor drainage, trees/shrubs too close to house, etc. Recommend contacting the Association to see who's responsible for corrections, repairs, seal siding/loose bricks, holes in trim/soffits, etc. to maintain a dry crawl space and home. Recommend a wet crawl space contractor evaluate the crawl space for encapsulation, sump pump/drains and dehumidification. Recommend replacing insulation when wet crawl encapsulated and dry. Have sub flooring, joists, structure evaluated for any water/moisture damage when insulation removed and metal hangers or rusted metal repaired/replaced where needed.**

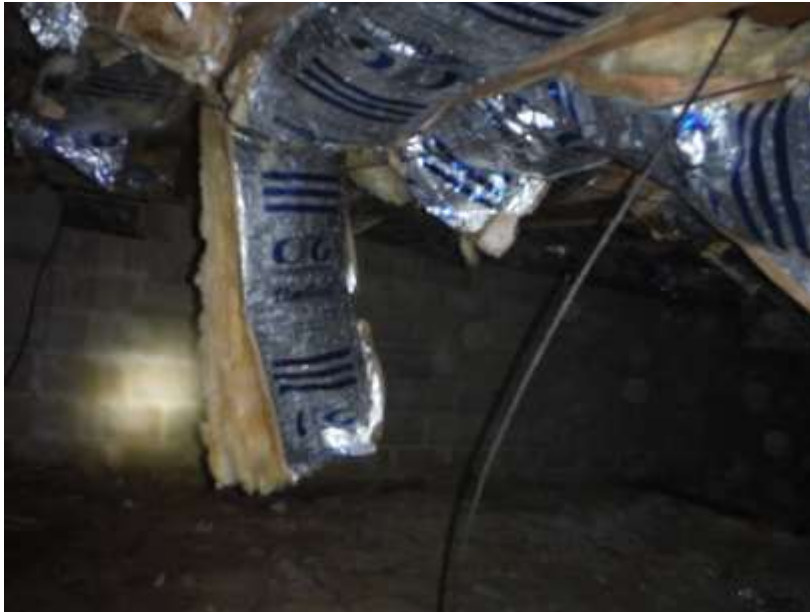
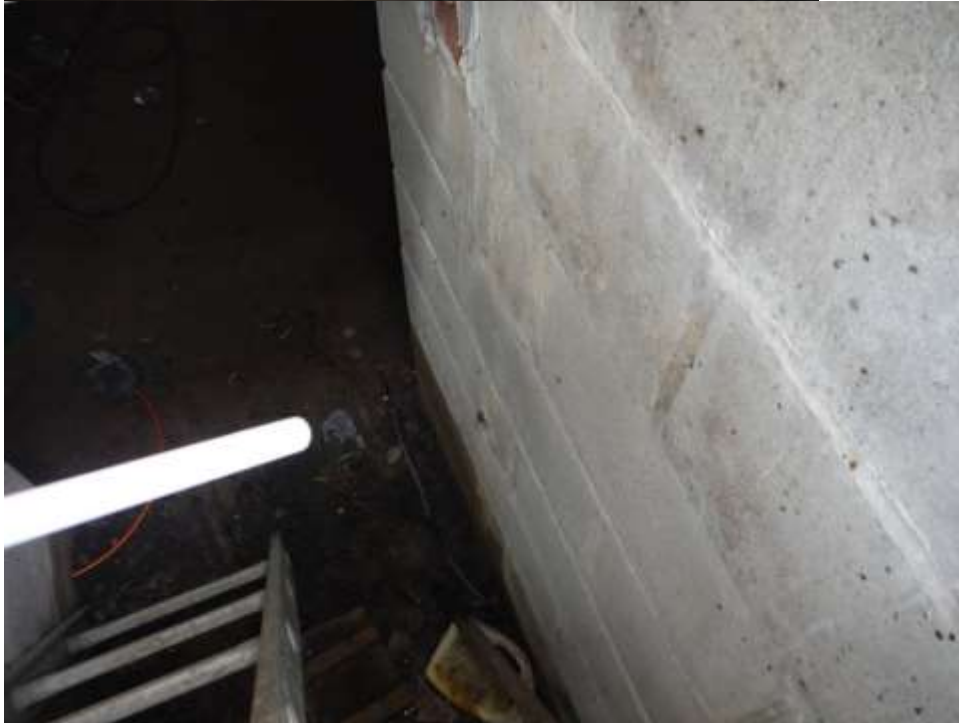
**Figure 5 Example of wet conditions in the crawl space; have evaluated for grading & drainage, extend gutters, replace cover to crawl and have evaluated for encapsulation ( vapor barrier, sump pump/drains and dehumidifier).**
