# 4 Seasons Home Inspection, LLC

## RECEIPT

Inspection Date: January 23, 2018 Tuesday 10am- 2:30pm  
Client Name: buyer name (buyer@gmail.com)  
Inspection Address: # street, town, NJ xxxxx  
Inspected by: Linda Geczi home inspection lic. #24GI00061500

Approximate Age: ~1994  
Style: Single family  
Prefab/modular (attic & basement 2 halves visible)  
Main Entrance Faces: E  
State of Occupancy: Vacant  
Weather Conditions: 45-50°F  
Ground cover: wet

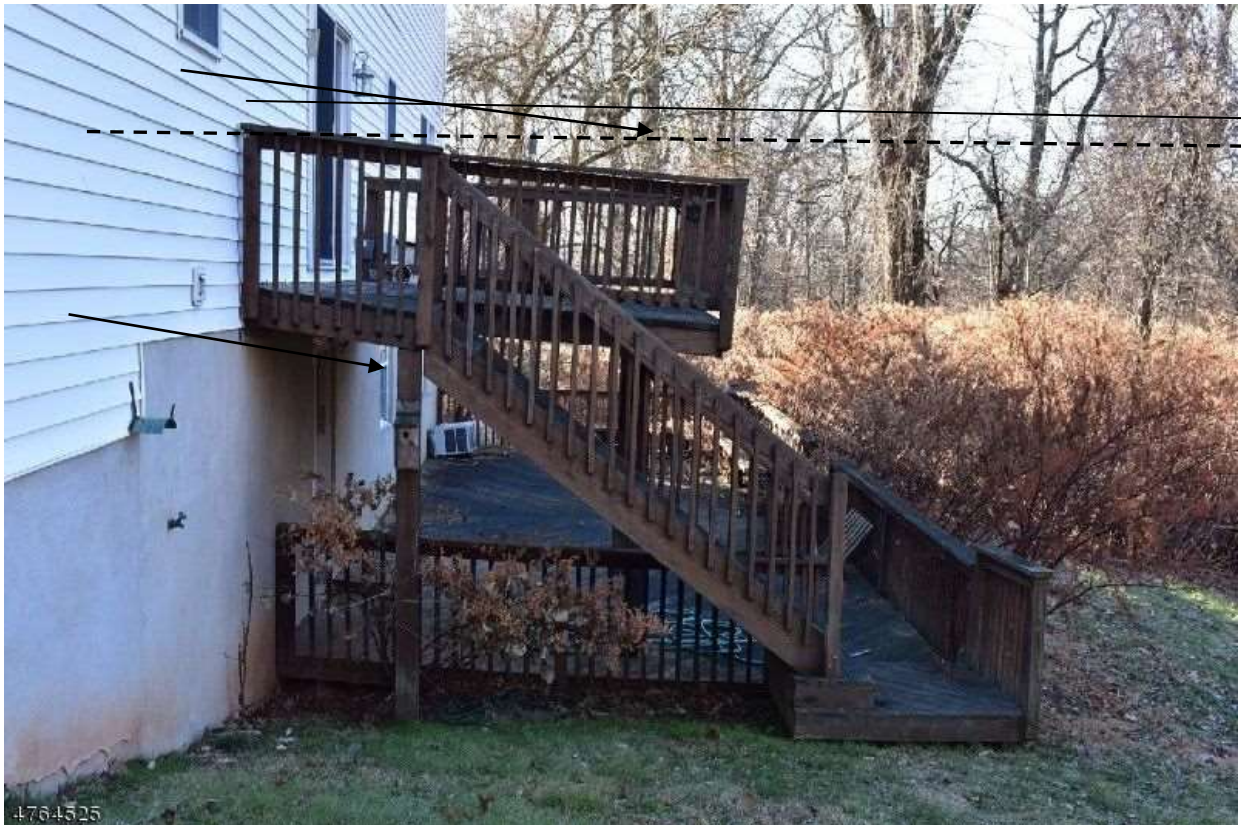
Figure 1 Lower deck sinking and built on grade or soil and upper deck and steps are sloping and pulling away from house; dangerous.

1. The front steps were damaged, the front door assembly was protruding out, water damaged, buckled siding around door/steps, dark staining/mold-like. Recommend a building contractor evaluate the steps and front door assembly for replacement and determine all concealed damage.
2. The yard was ponding water, ruts, soggy, muddy, holes, erosion and poor drainage in yard. There was observed seepage in the basement and garage. Recommend a grading & drainage contractor and wet basement contractor evaluate and advise on grading & drainage/erosion control and water management systems.
3. The deck was unsafe and dangerous; do not walk upon decking. Decking was sinking, sloped, pulling away from house, broken lumber, slimy/moss impregnated, nail pops, cracked wood, improperly sized joist hangers, etc. Do not use the deck ; dangerous.

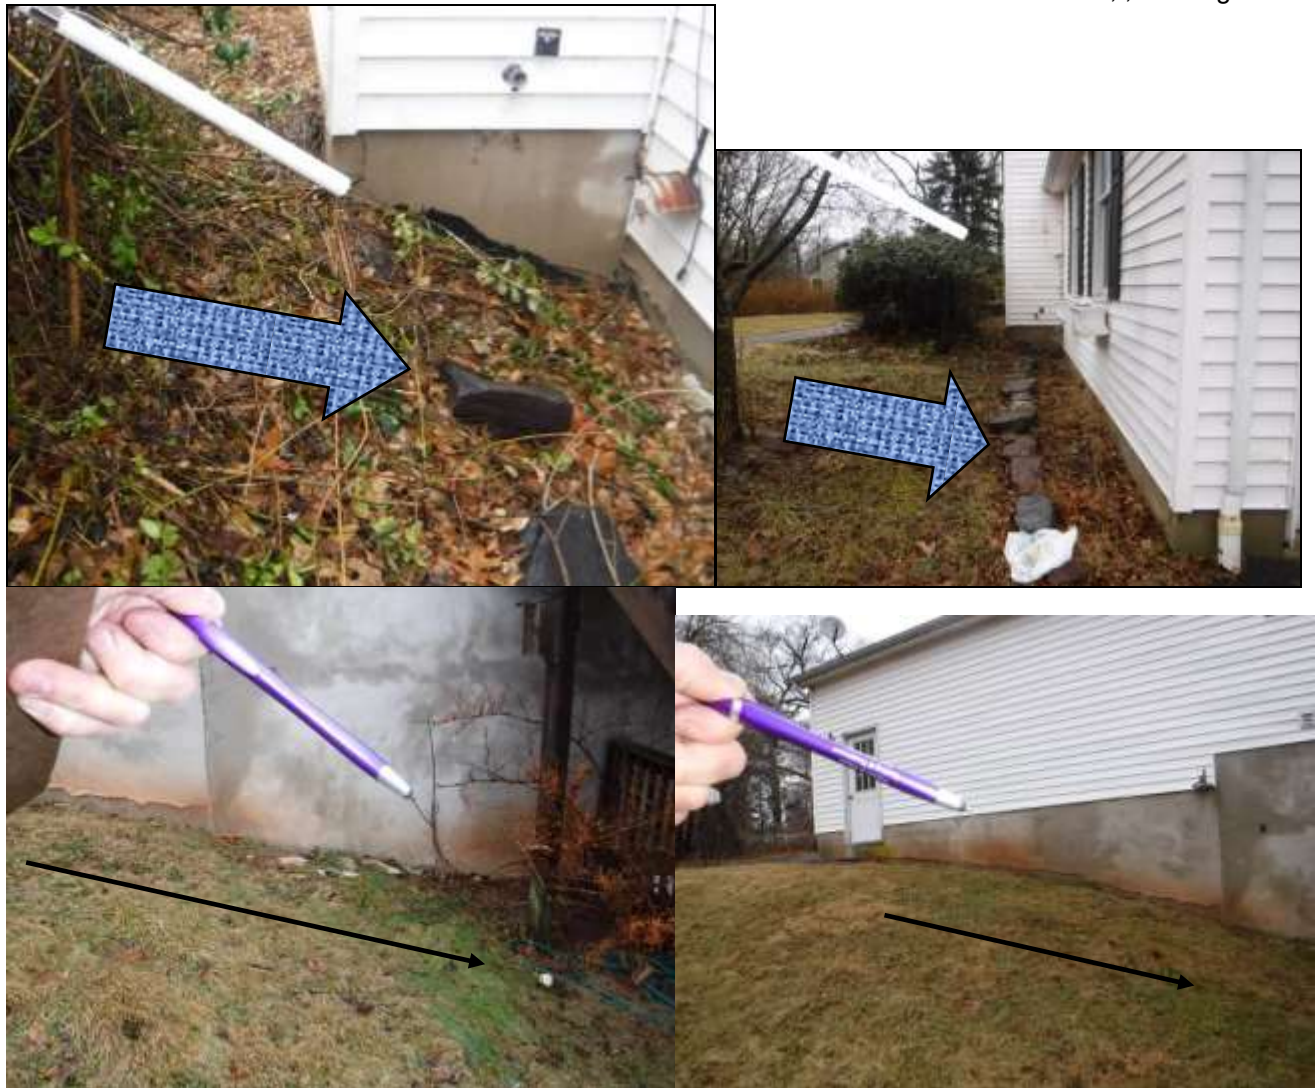
**Figure 2** Examples of negative grading and erosion; water drains toward the foundation/basement. There was observed seepage in the basement and garage. Recommend a grading & drainage contractor and wet basement contractor evaluate and advise on grading & drainage and water management systems.

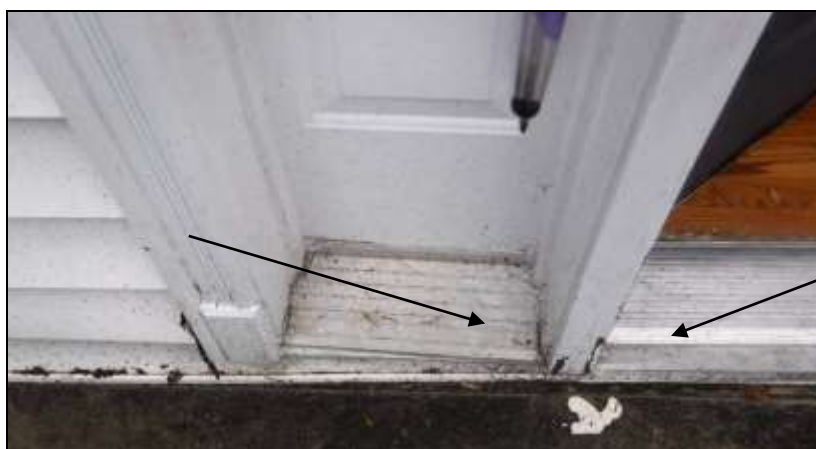
**Figure 3** The front door assembly was damaged; have a building contractor evaluate for replacement including concealed damage.

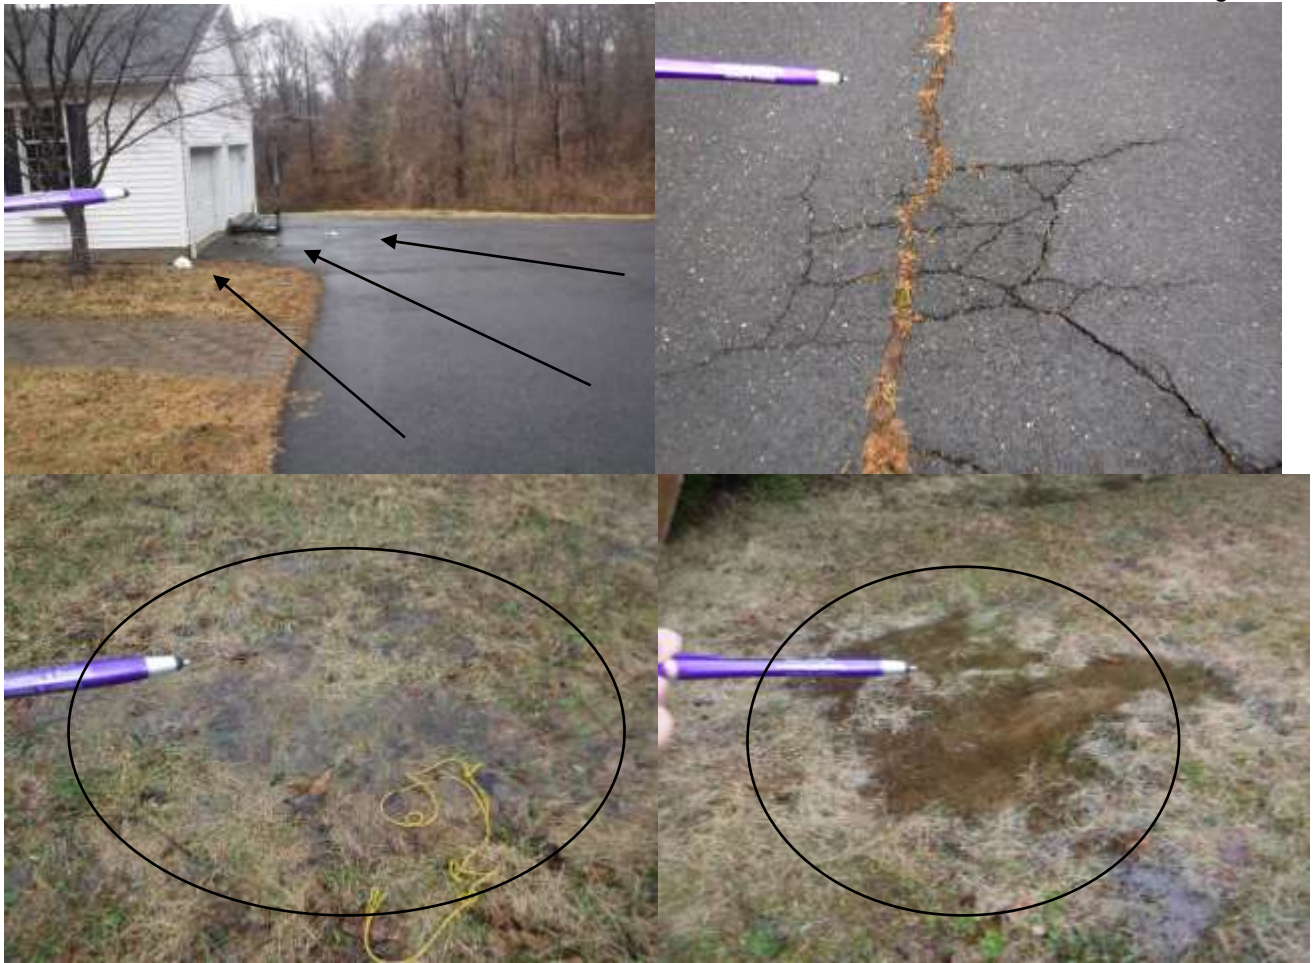
**Figure 4 Example of drainage concerns. Water drains off the driveway towards the garage and ponding in the yard. The driveway had water damage, deep cracks and no drainage across the garage.**

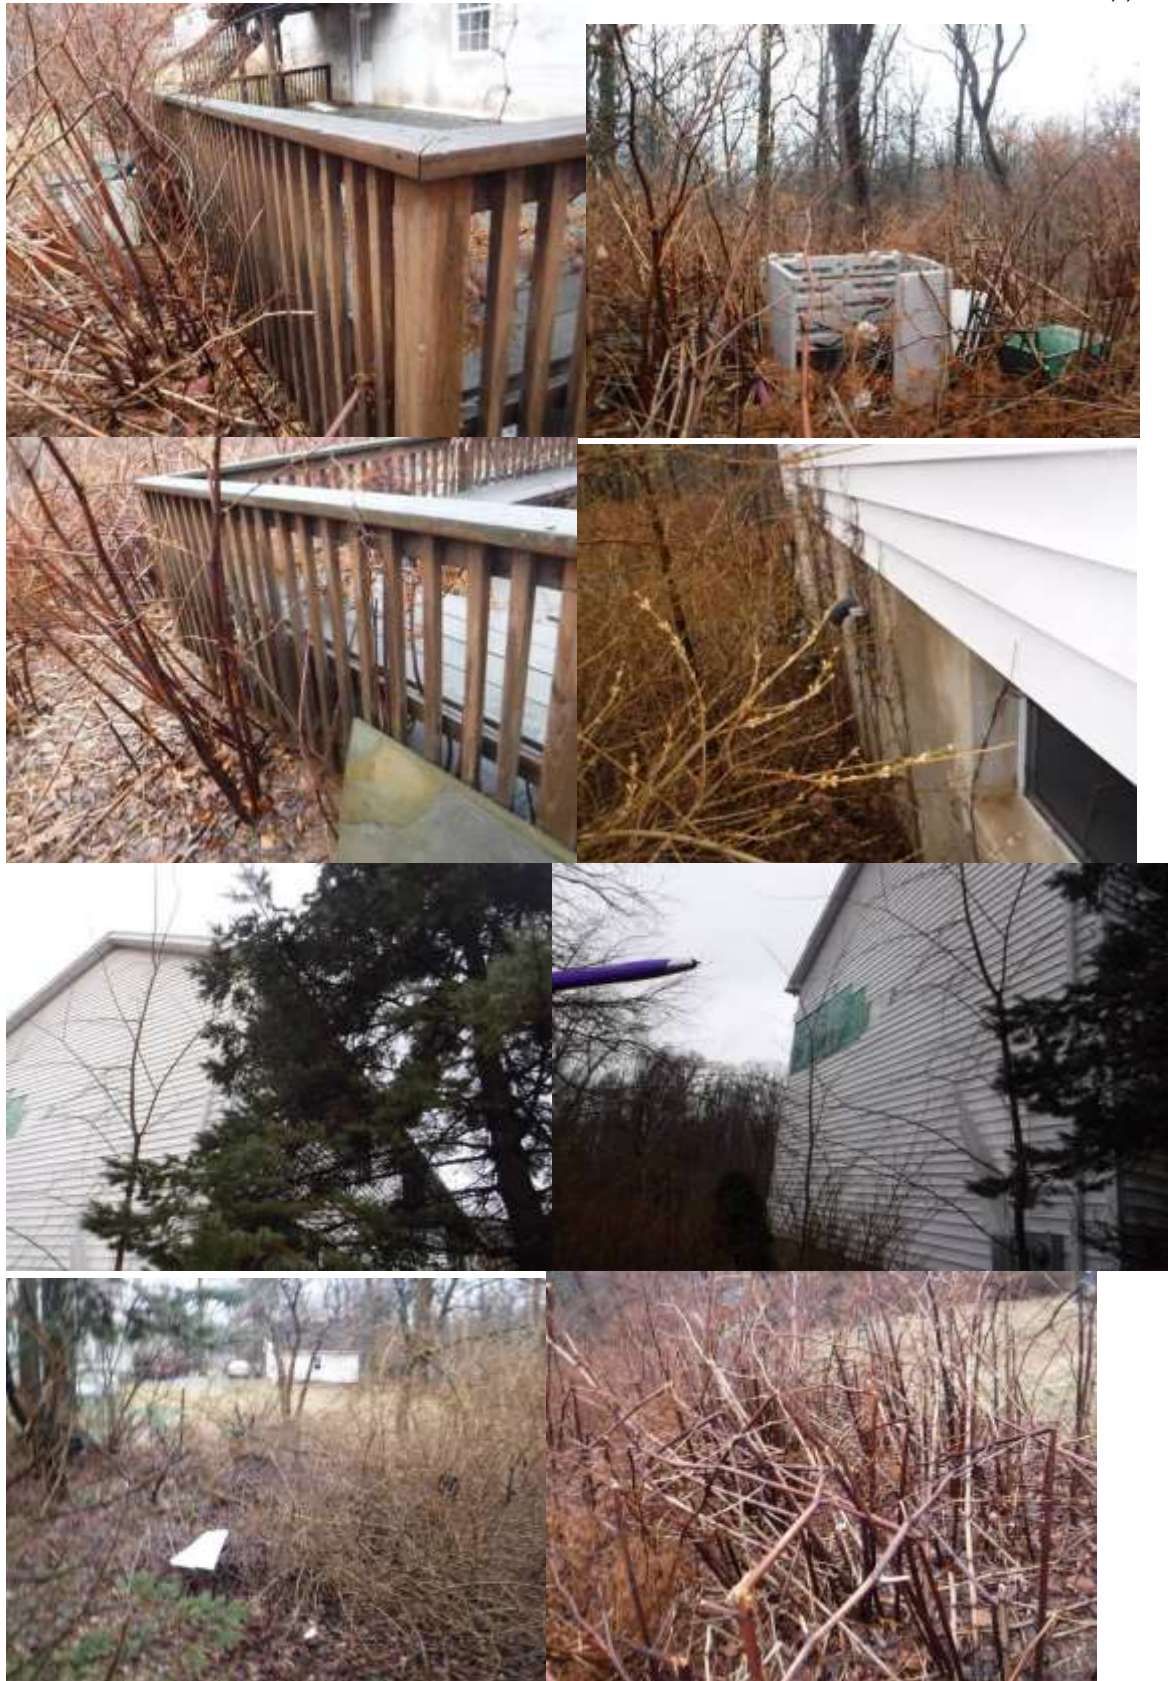
Figure 5 Examples of overhanging trees, shrubs & tree too close, overgrowth, weeds, high grass, trash/items in yard, etc.

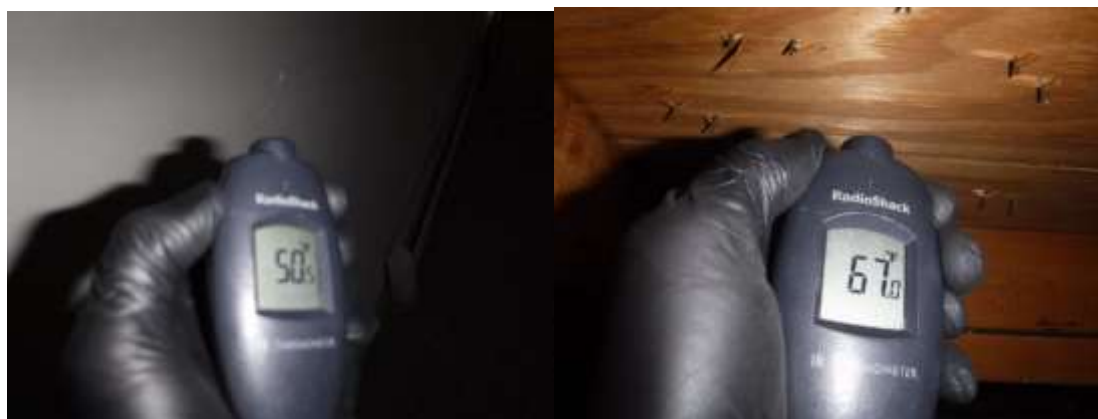
Figure 6 Almost 20F hotter in attic and 50F in house and outside; poor ventilation.

1. Recommend a roofer evaluate for tear off, new roof, gutters and ventilation.

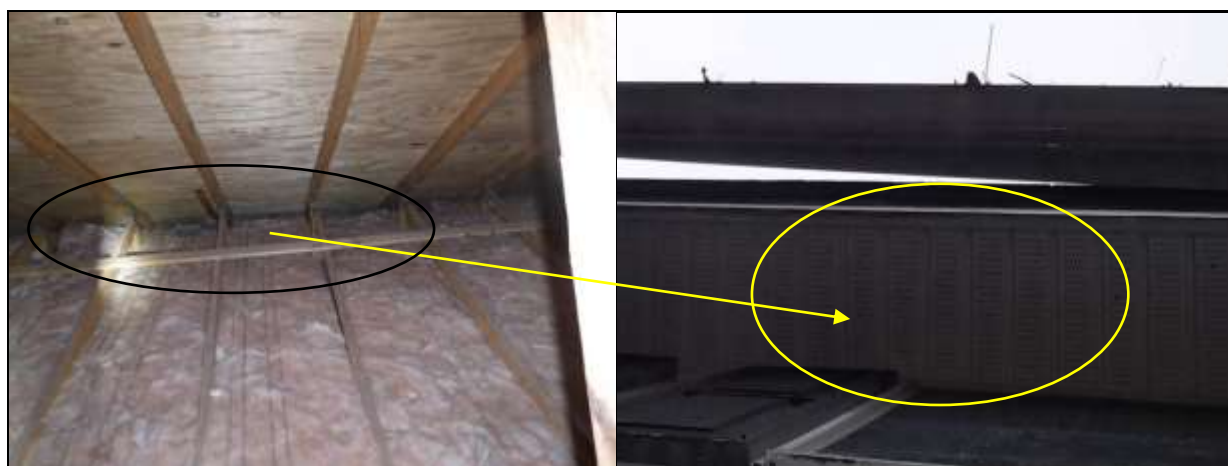
Figure 7 Insulation blocking perforated soffits; no air flow. Hot humid attic shortens life of roof and promotes mold like growth and potentially damage roof structure.

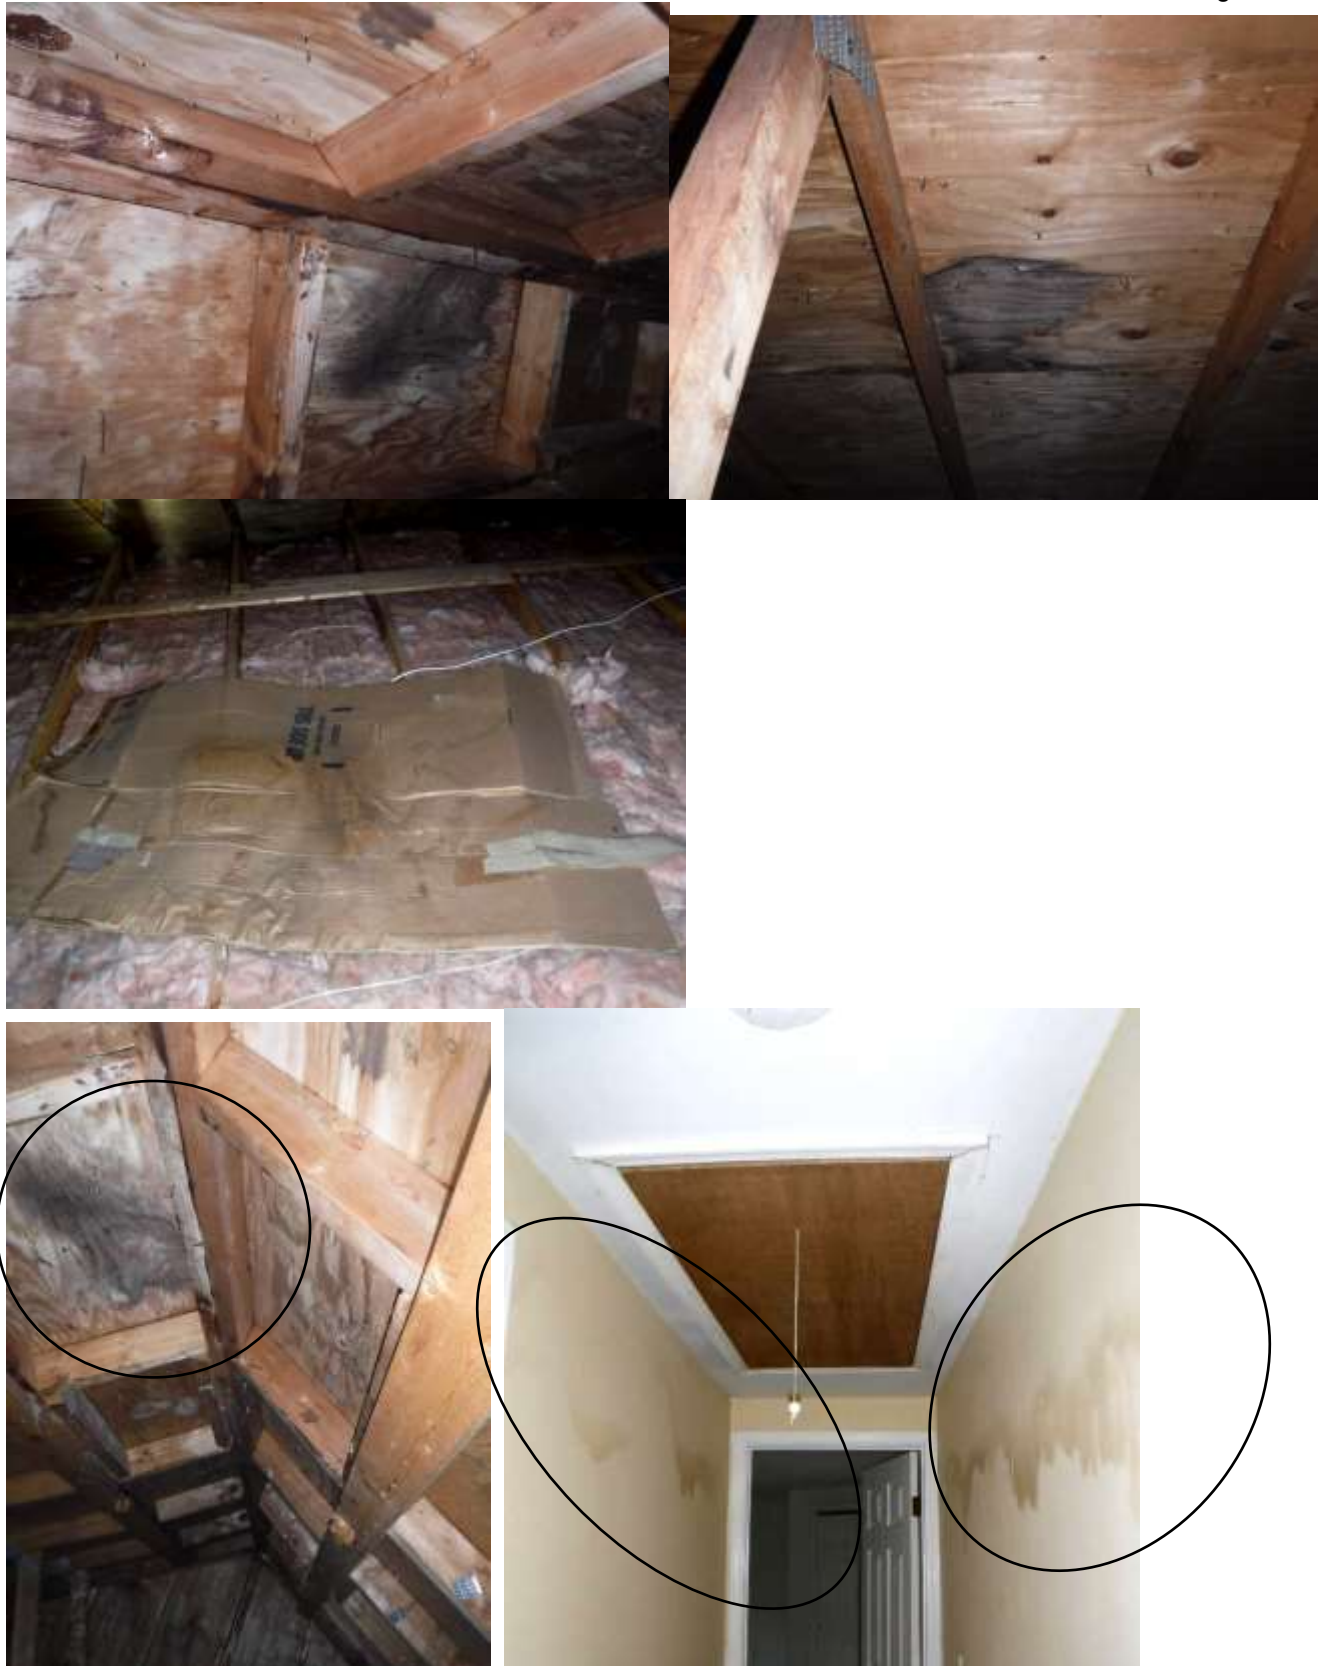
Figure 8 Examples of water stains/leaks in attic. See other sections comments; active leaks in home.

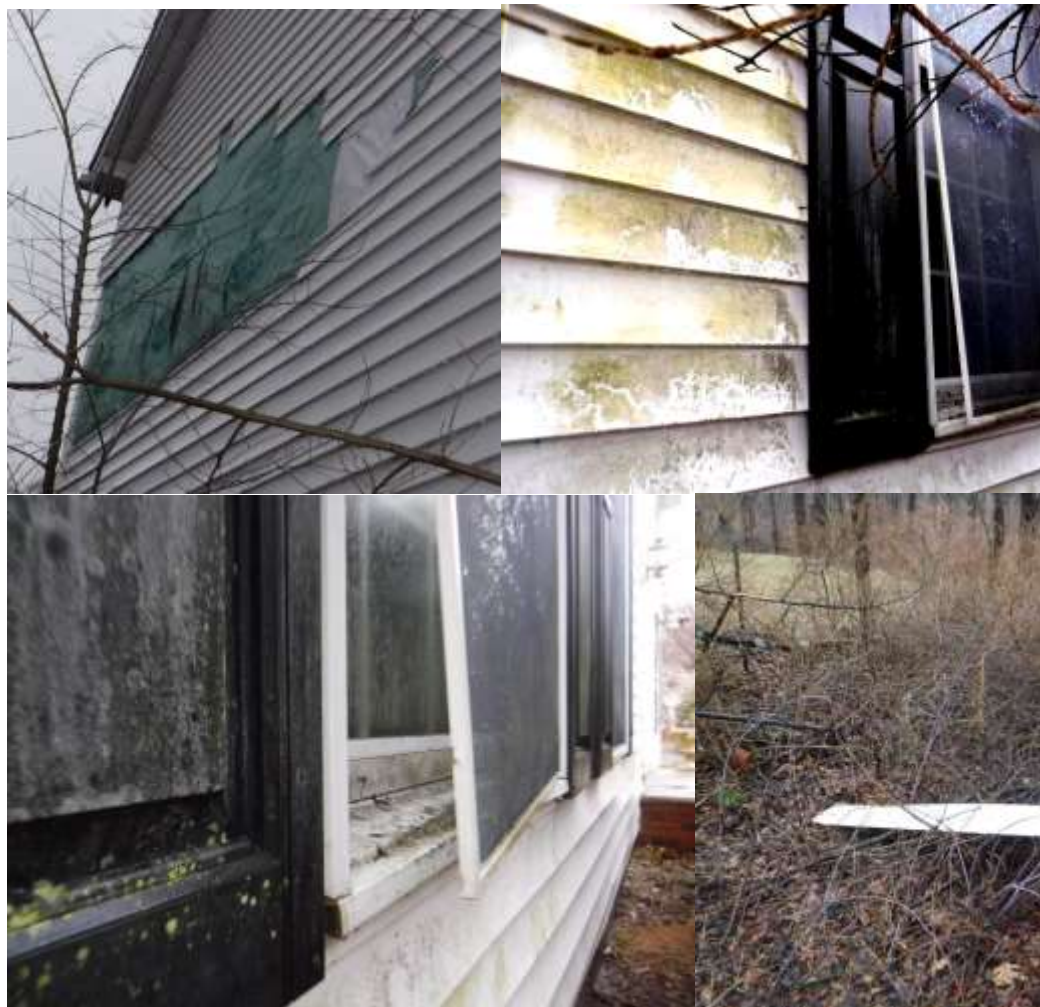
1. The home has been neglected and systems and components were in poor condition and no longer protecting the house from water entry. The siding was in poor condition and sections blown off on the left of house along with torn house wrap. There was green staining/moss, dirt, artillery spores (black specks), buckled siding by the water damaged front door assembly, cracks, holes, loose siding, damaged soffits & fascia, gaps/open junctures, dried/cracked caulk, bent or missing flashings, etc. The siding and exterior components all work together to maintain a protective envelop to keep out water, wind, and weather elements. Exterior components include roof, gutters, windows, doors, siding, trim, flashings, etc. There were active leaks in the home from several sources on exterior as well as the plumbing & heating in the interior. There were several foundation cracks (vertical, step) visible on exterior and some in the basement ; very limited view due to finished basement. Recommend a building contractor evaluate exterior systems & components (roof/gutters, siding/trim, doors, windows, steps, etc.) and foundation cracks and advise on all repairs to restore the protective exterior envelop and repair foundation cracks.

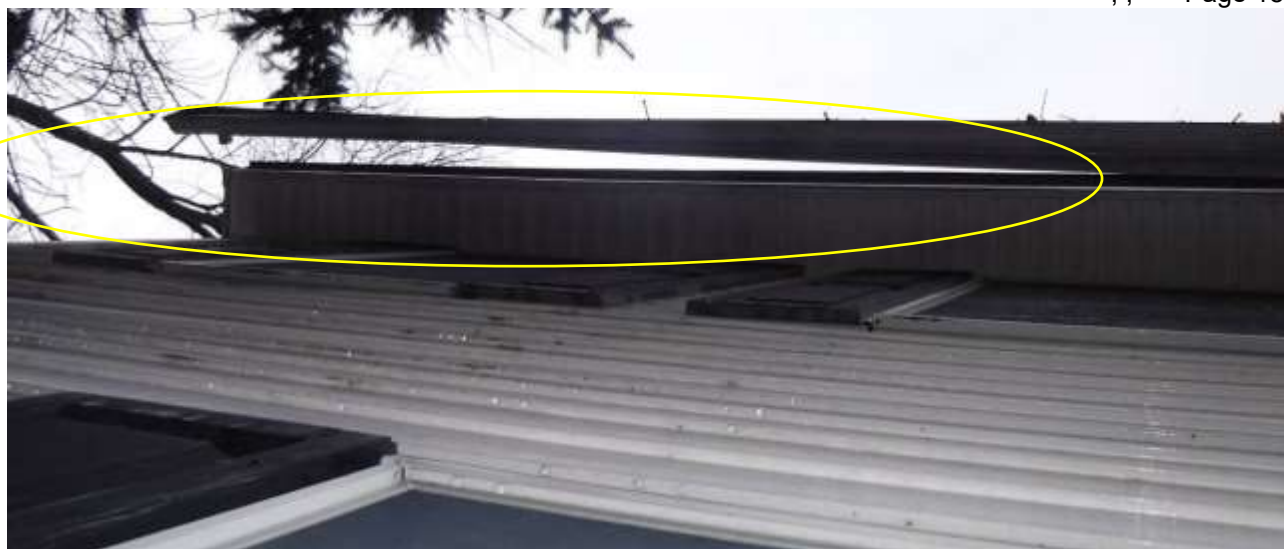
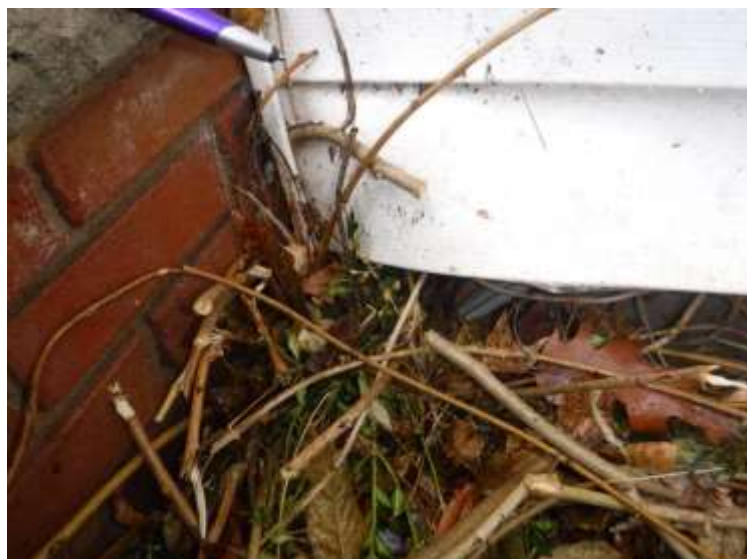
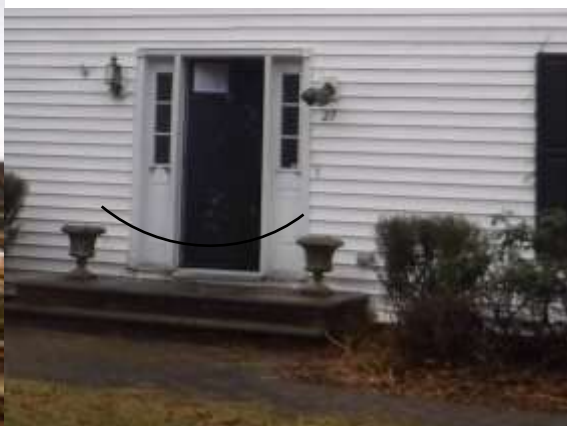
Figure 9 Buckled siding around the damaged front door assembly.

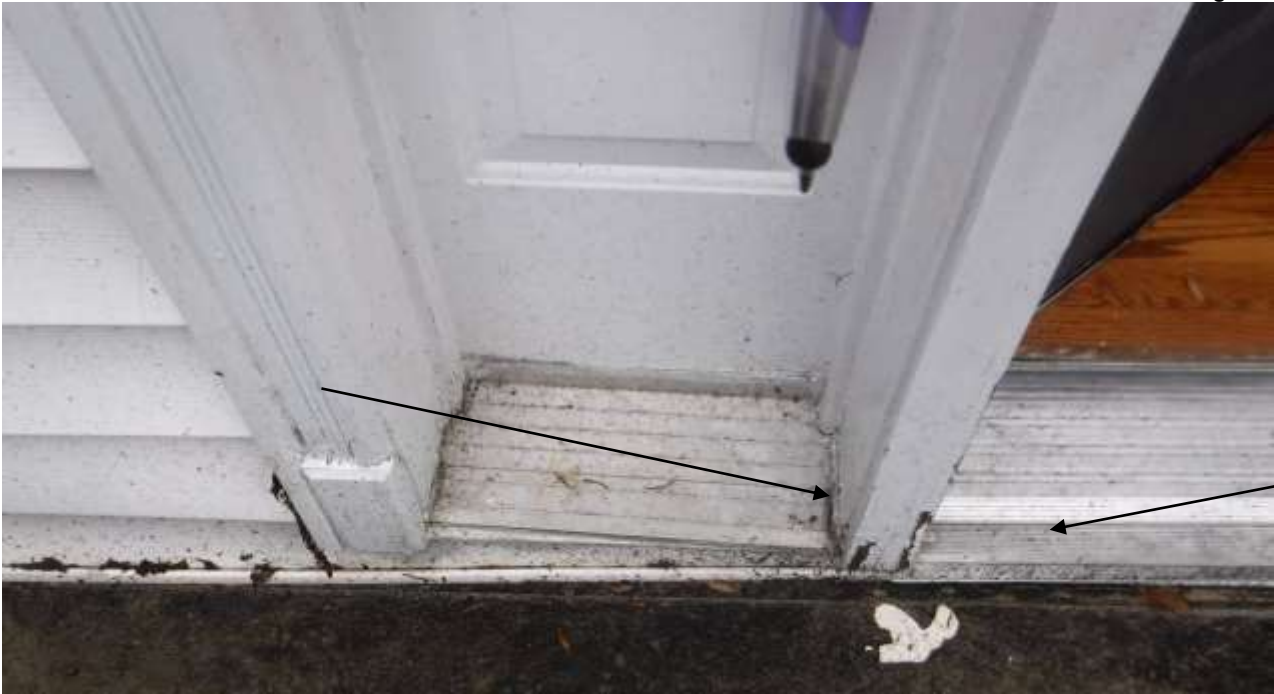
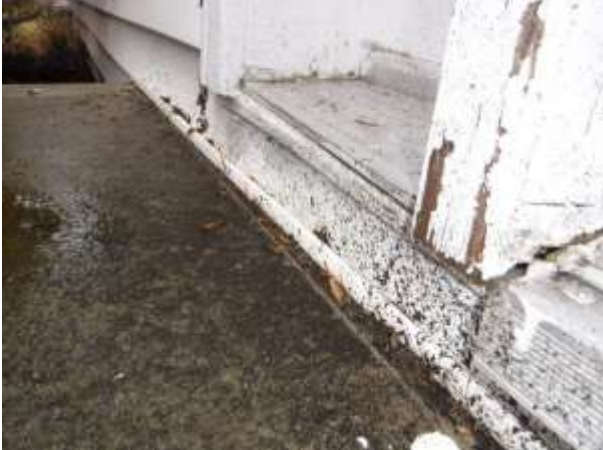
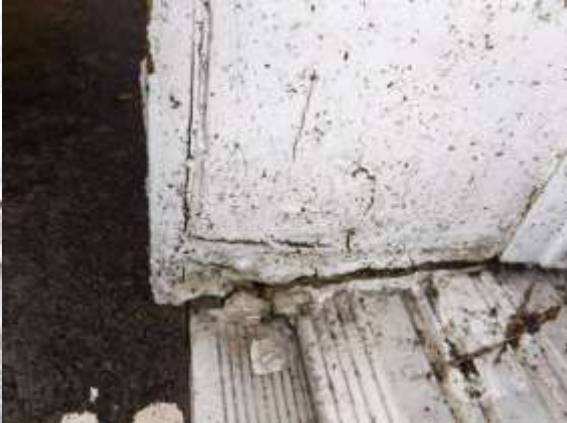
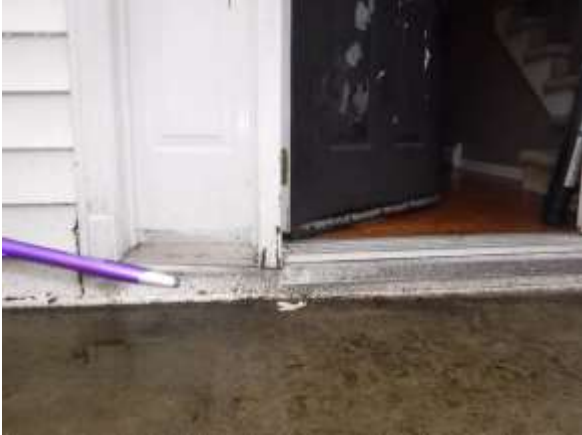
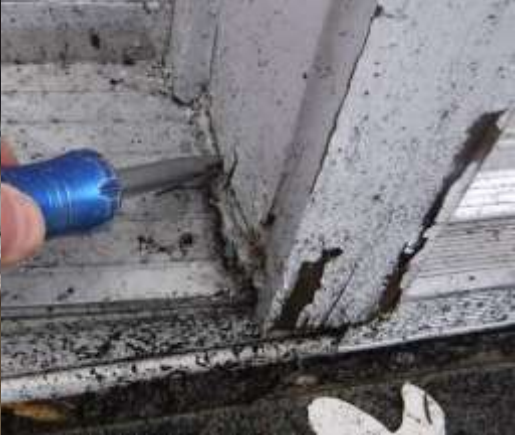
**EXTERIOR/ELECTRICAL/A/C/HEAT PUMP/GARAGE :** There were active leaks in garage on ceiling/walls; see roofing section comments. The front door assembly was protruding out, not plumb, water damage, buckled siding around door, etc. See "Grounds" section comments; have building contractor evaluate extent of damage and make repairs and determine extent of concealed damage. The man door in garage to rear yard had broken lock & handle; have replaced. The overhead doors did not align with the cross bar locks, car damaged door panels, canted or not plumb and daylight around doors and bottoms. The garage door openers were unplugged/not working. Recommend a garage door contractor evaluate overhead doors for replacement including the automatic garage openers. There were mice droppings in the garage; have all gaps, holes and daylight sealed/repairs to keep out rodents. The radon fan was leaking water, making loud noises, mold like staining on piping and fan. There was mold like staining on rafters or garage framing. Recommend a mold contractor evaluate/test and advise on mold like and environmental inspection and testing. Mold and environmental

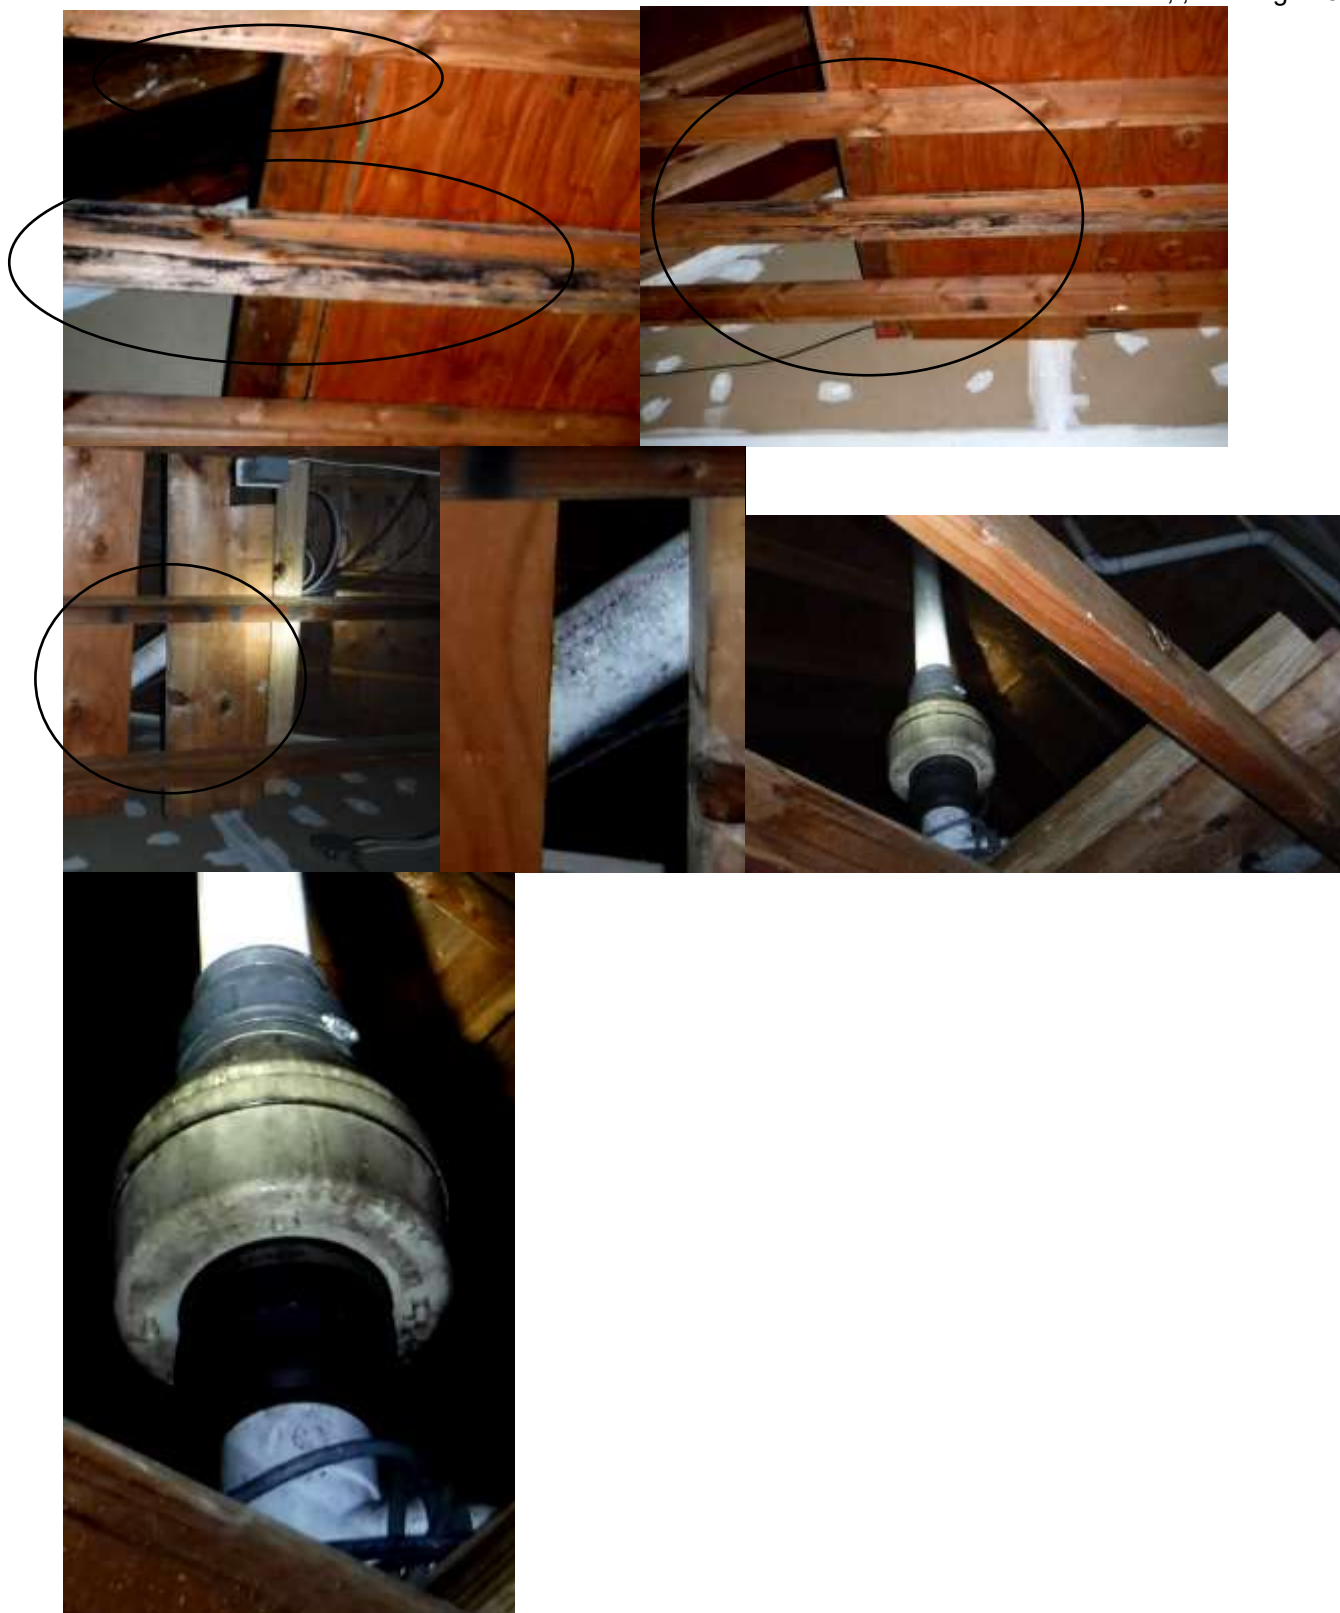
**Figure 10** Example of dark/black staining on rafters or roof lumber and radon system and water stains around the radon system on 2x4s; mold like. Recommend a mold/environmental contractor evaluate and advise on mold testing.

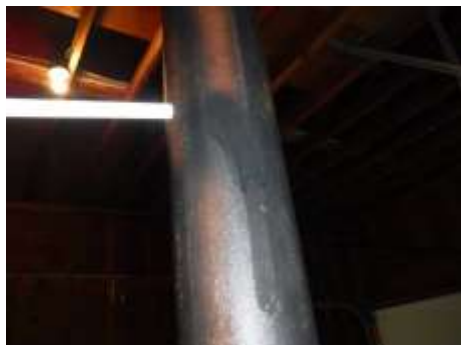
Figure 11 The lally column was covered in condensation/weeping; have evaluated. Condensation or wicking inside lally columns can deteriorate these structural supports.

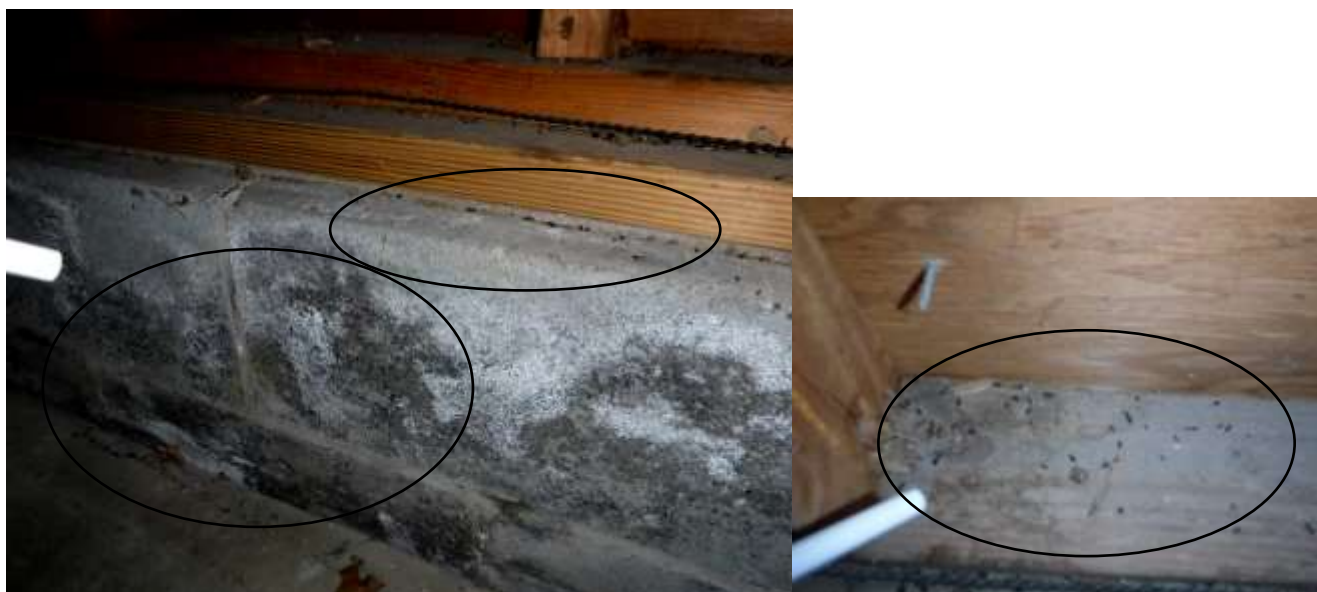
Figure 12 Example of efflorescence, water stains, seepage. The driveway drains toward the garage and grading & drainage needs to be corrected; negative grading. There were mice droppings in garage and in the home; have all gaps, daylight, openings and crevices sealed to maintain seals for water, insects and rodents.

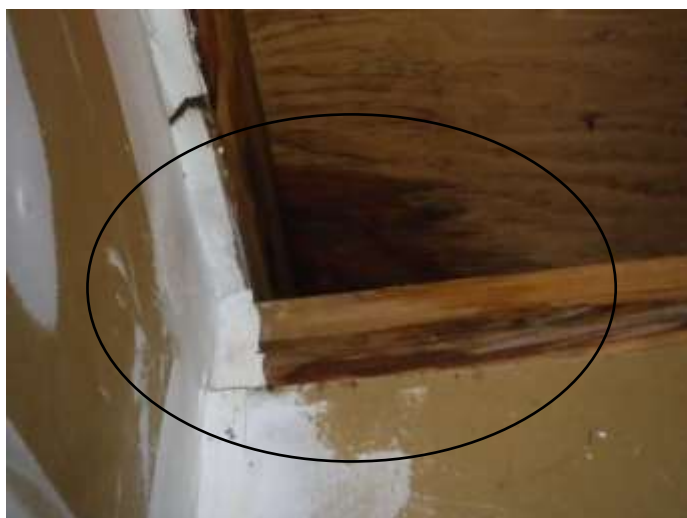
Figure 13 Example of active roof leaks; see roofing section comments.

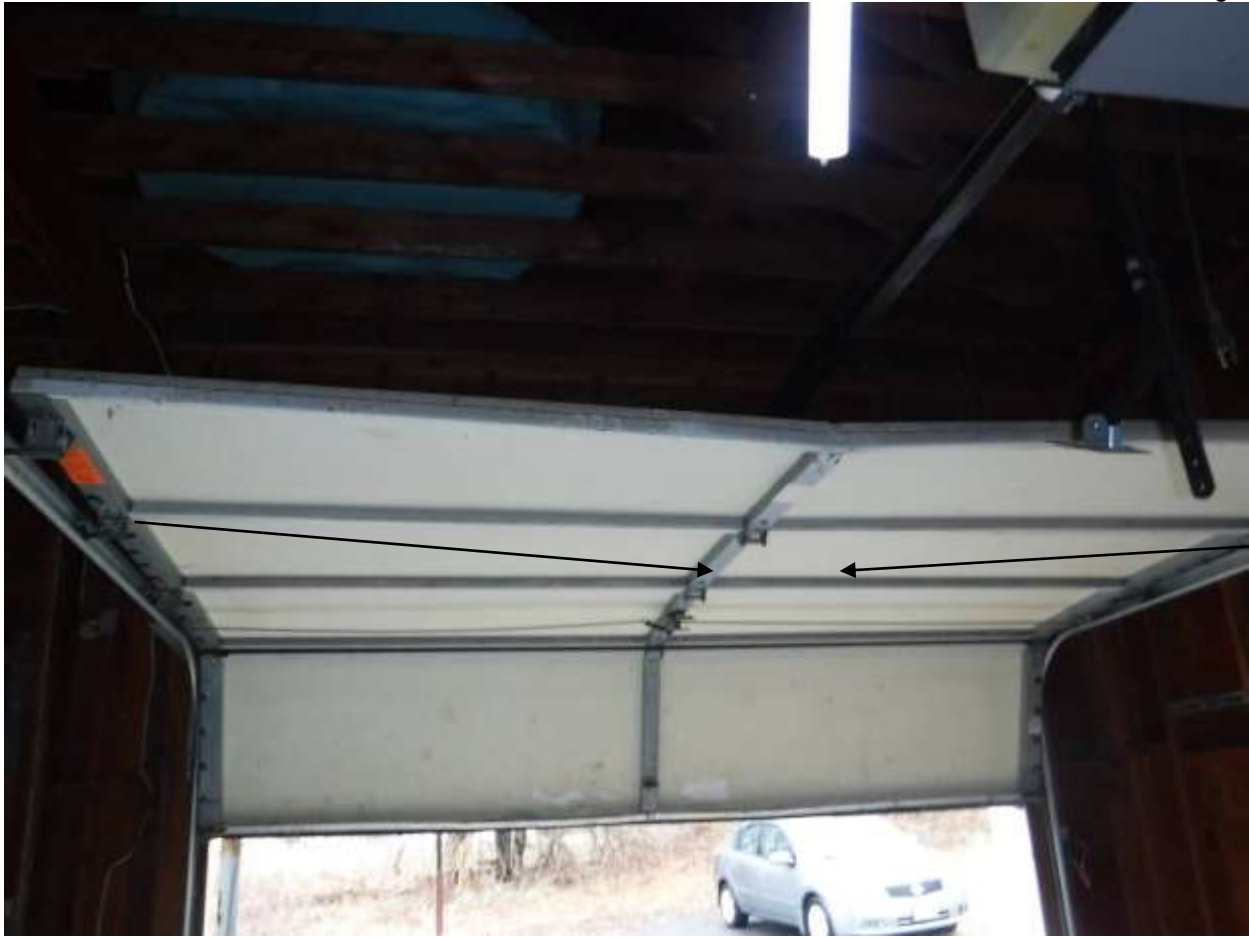
**Figure 14 Damaged door panels; have evaluated for replacements. The doors were misaligned, not locking, daylight around doors, damaged locks, door openers unplugged/not working, not plumb, etc.**

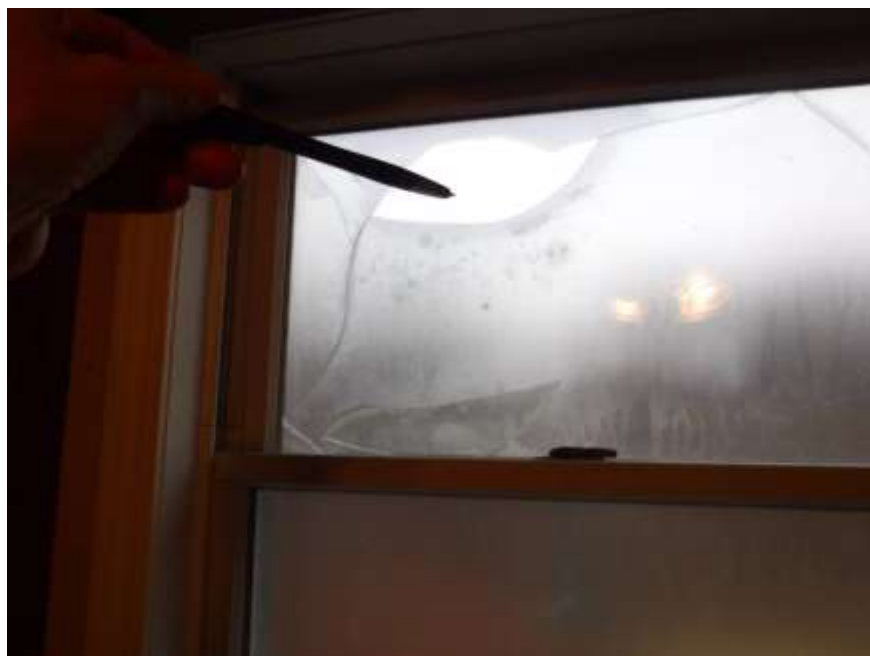
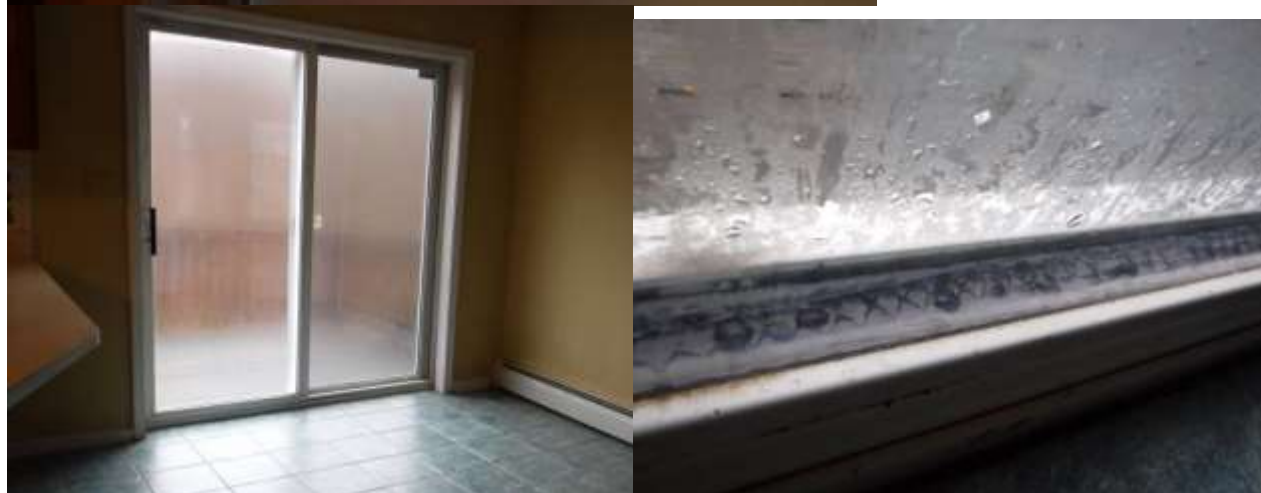
**Figure 15** Windows and doors throughout the home were in poor condition. There was broken glass on window(s) and vapor seal breaks; have replaced throughout the home.

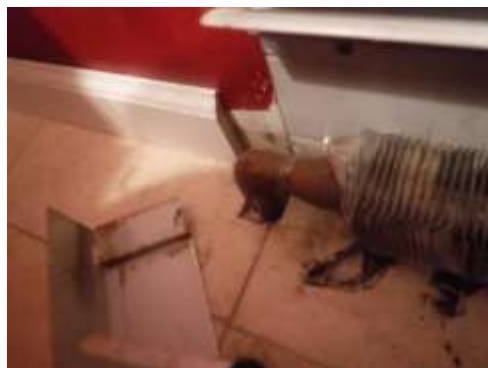
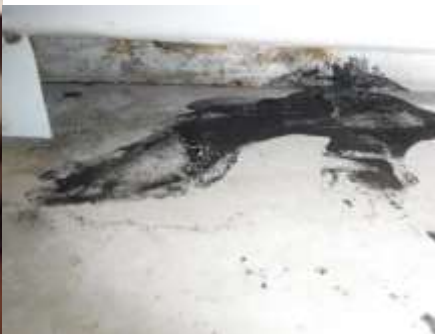
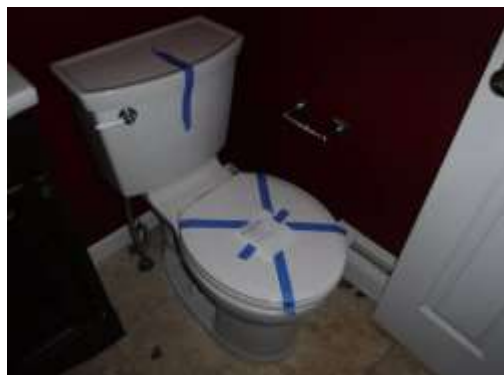
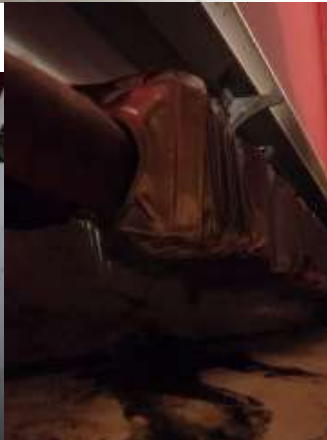
- The baseboard heating pipes were leaking black water and rupture on the elbow or copper piping; see heating section comments. Follow up with a mold/environmental contractor for mold testing to rule out mold; beyond the scope of a home inspection.

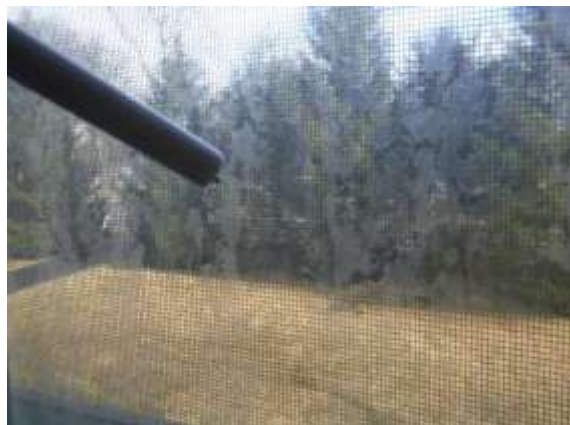
Figure 16 Example of vapor seal breaks have window in home evaluated for replacement.
