# 4 Seasons Home Inspection, LLC

## RECEIPT

Inspection Date: January 23, 2018 Tuesday 10am- 2:30pm  
Client Name: buyer name (buyer@gmail.com)  
Inspection Address: # street, town, NJ xxxxx  
Inspected by: Linda Geczi home inspection lic. #24GI00061500

Approximate Age: ~1994  
Style: Single family  
Prefab/modular (attic & basement 2 halves visible)  
Main Entrance Faces: E  
State of Occupancy: Vacant  
Weather Conditions: 45-50°F  
Ground cover: wet

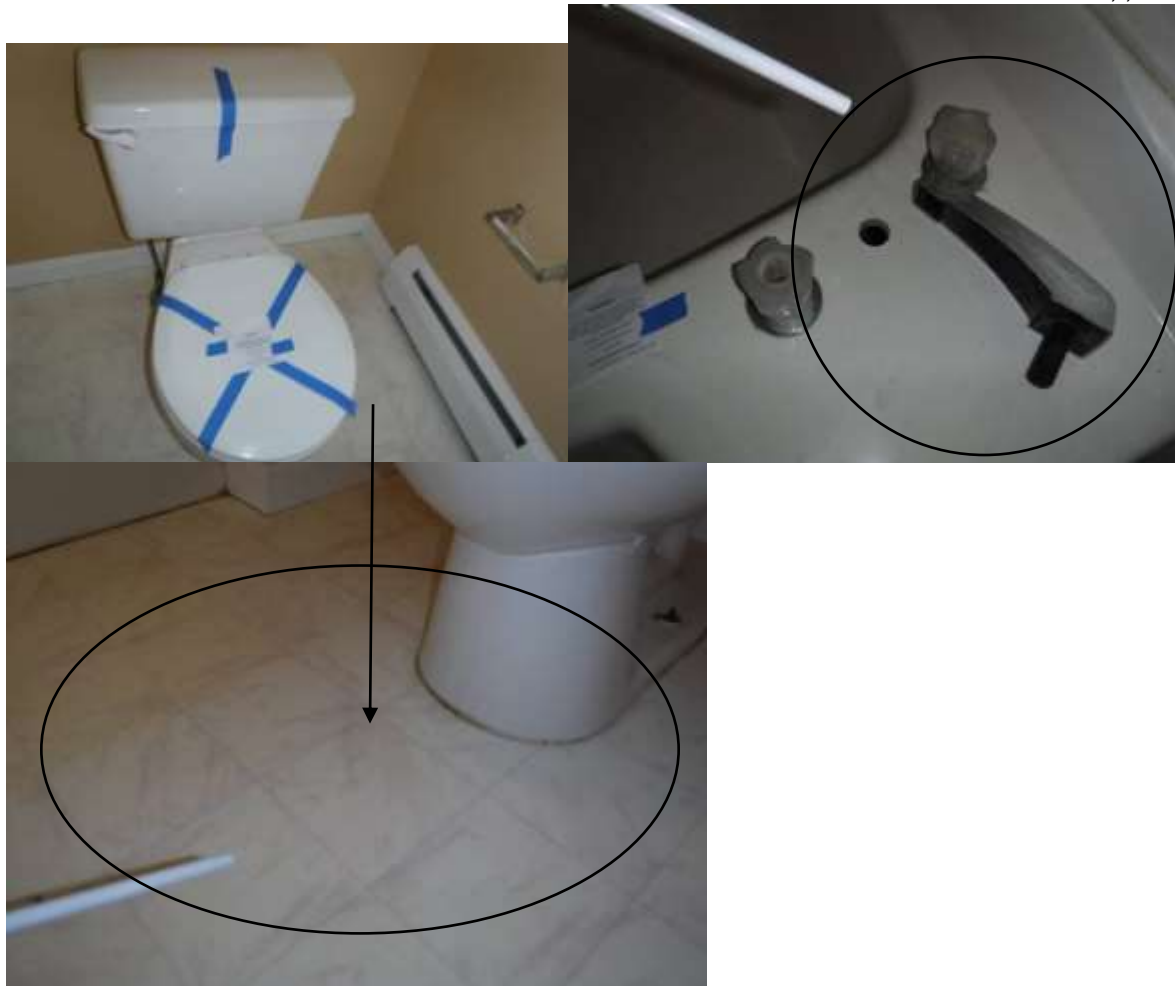
**Figure 17** Water puddle on floor around the toilet; leaking plumbing and heating baseboards in the home; freeze damage/improperly winterized and the meter was found removed and plugged on street side in basement.

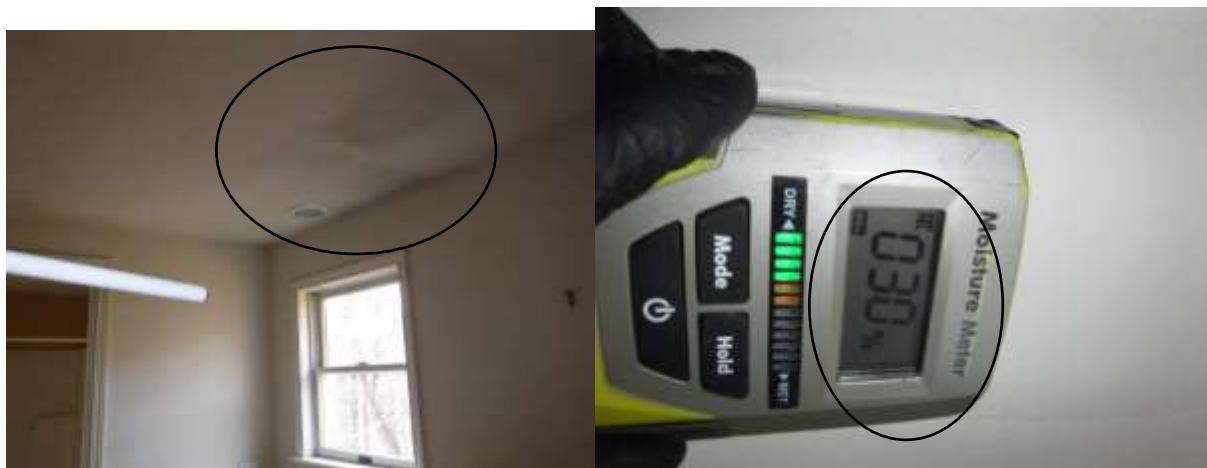
**Figure 18** Active leaking in the home; roof, plumbing and heating water sources. The home was poorly maintained and not properly winterized.

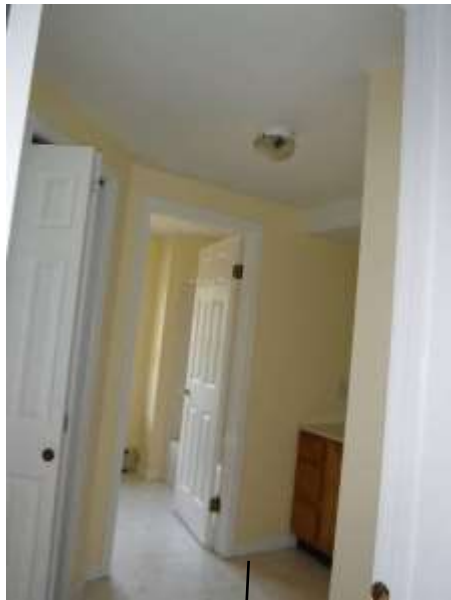
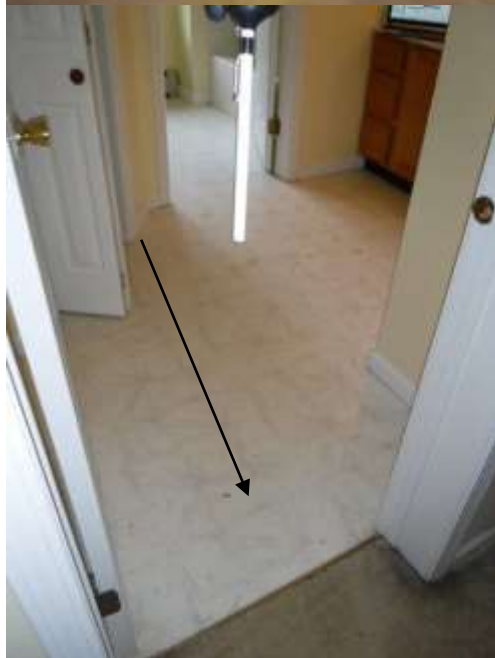
1. There was sloped, squeaking, bounce flooring in the home and very noticeable on second floor center hall and this bathroom. Recommend a building contractor and/or structural engineer (PE) further evaluate structure in home including foundation cracks and advise on structure, repairs or rule out hidden damage.

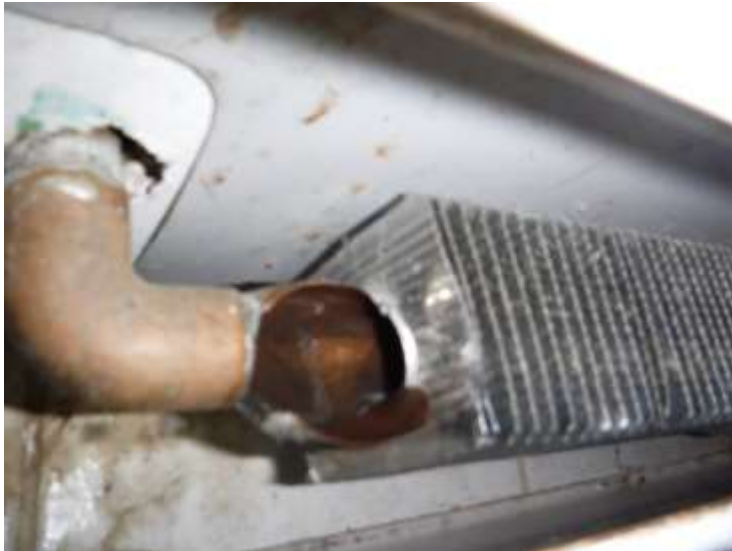
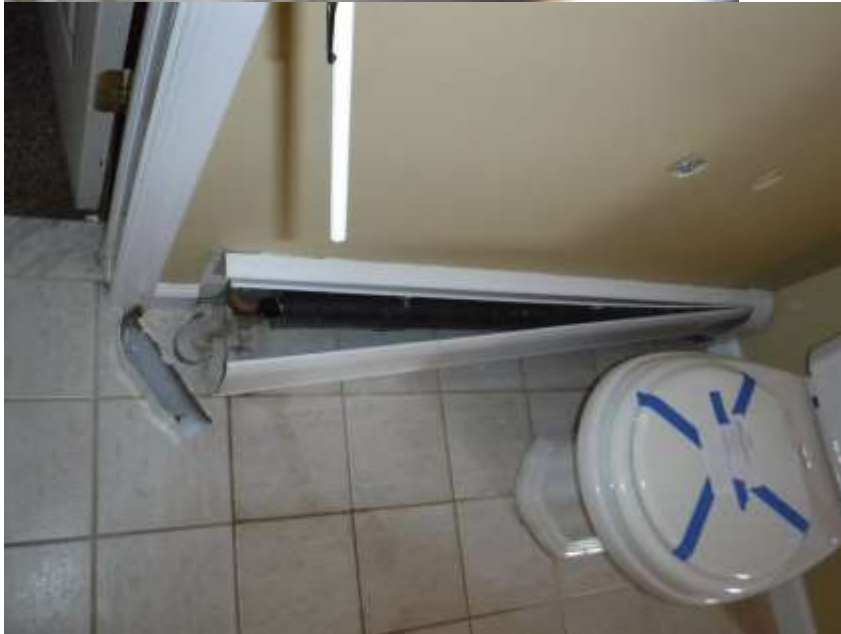
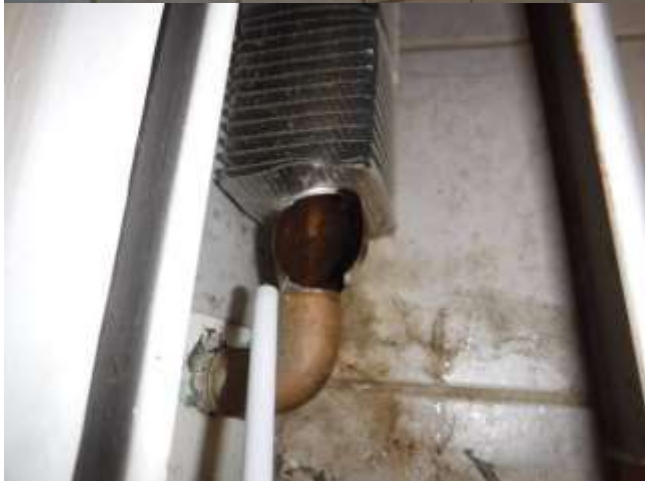
1. There were ruptured baseboards and water inside them throughout the home. See heating section comments.

**Figure 19** View of ruptured baseboard in bathroom. There were many throughout the home. The home was not winterized properly. See heating & plumbing section comments.

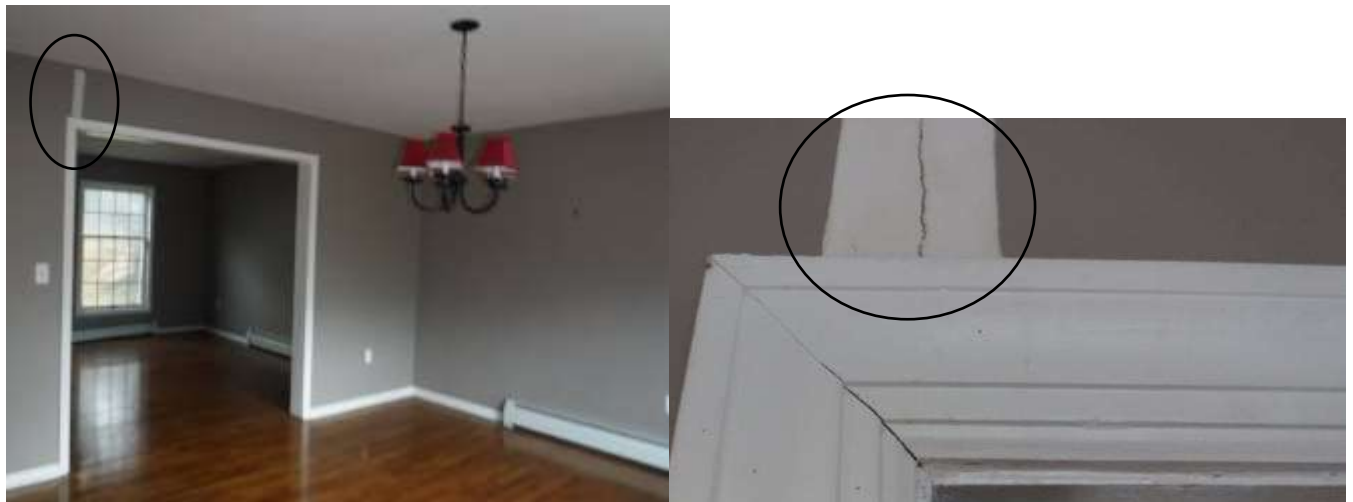
**Figure 20** Have a building contractor evaluate the canted doorway and vertical cracks.

1. There was a vertical crack on side of door frame between the living room and this dining room; canted doorway. Recommend having a building contractor evaluate and advise on structure/cracks and repairs.
2. There was sloped flooring in this room, second floor and throughout the home. See structural comments; further evaluate sloped flooring, canted doorways, foundation cracks, etc. by a building contractor and structural engineer (PE) before closing & contractual limitations.

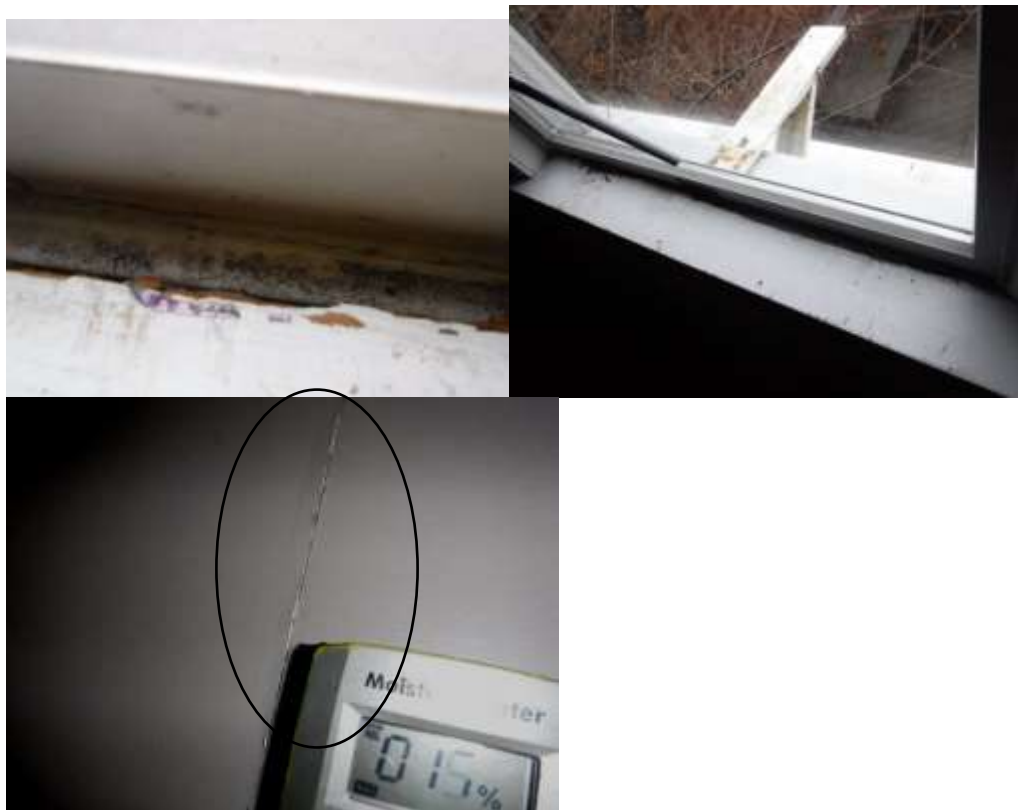
**Figure 21** Leaking around the windows, cracks on drywall and active moisture. All black staining or mold like areas in the home should be evaluated by a mold or environmental contractor.

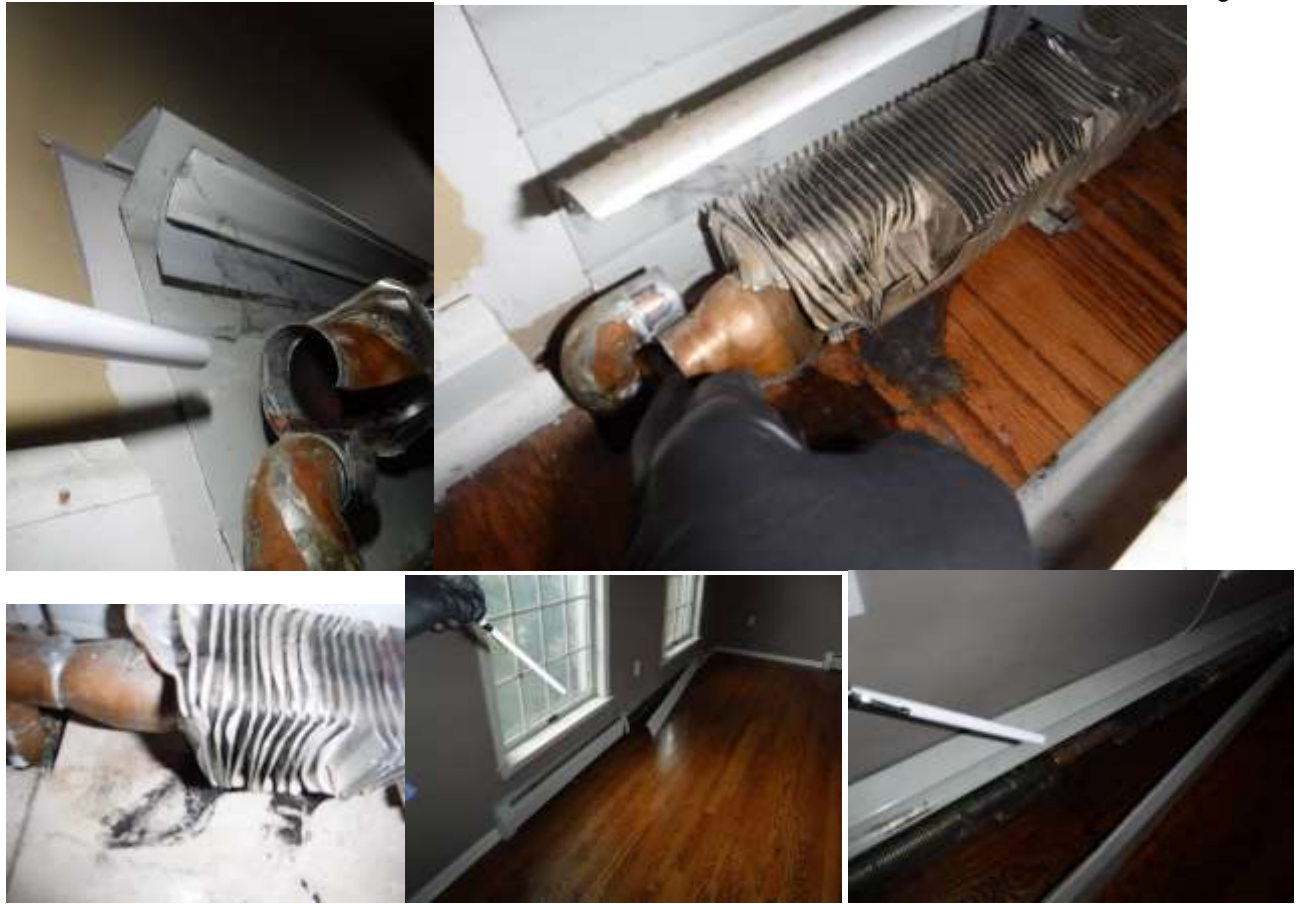
Figure 22 Example of many baseboard that had ruptured due to freeze damage; active leaking. See heating section comments.

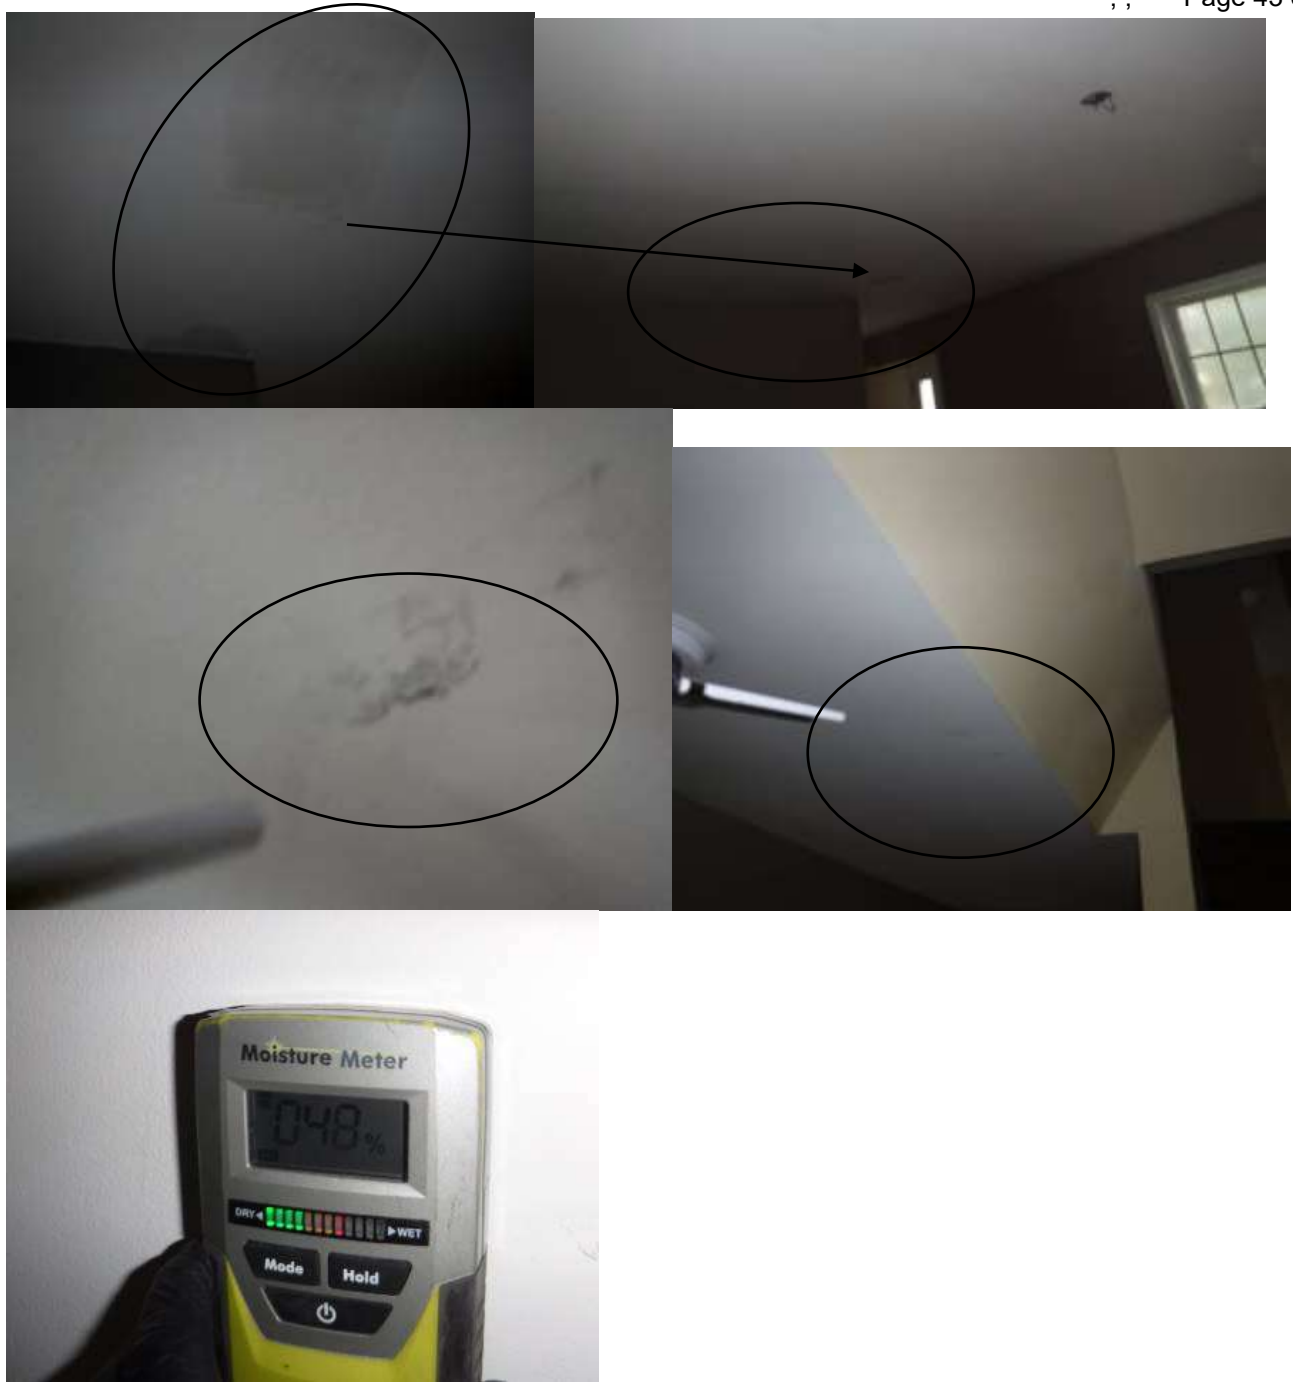
**Figure 23 Active leaking in ceiling by living room and front entrance. There were ruptured baseboards above on second floor with water inside them.**

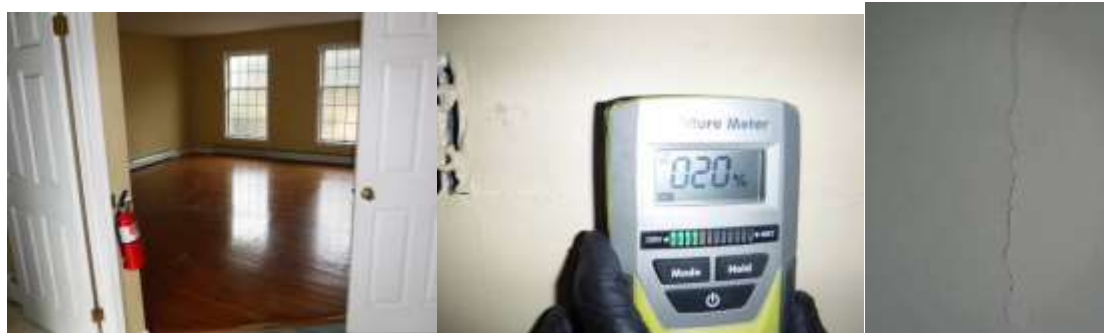
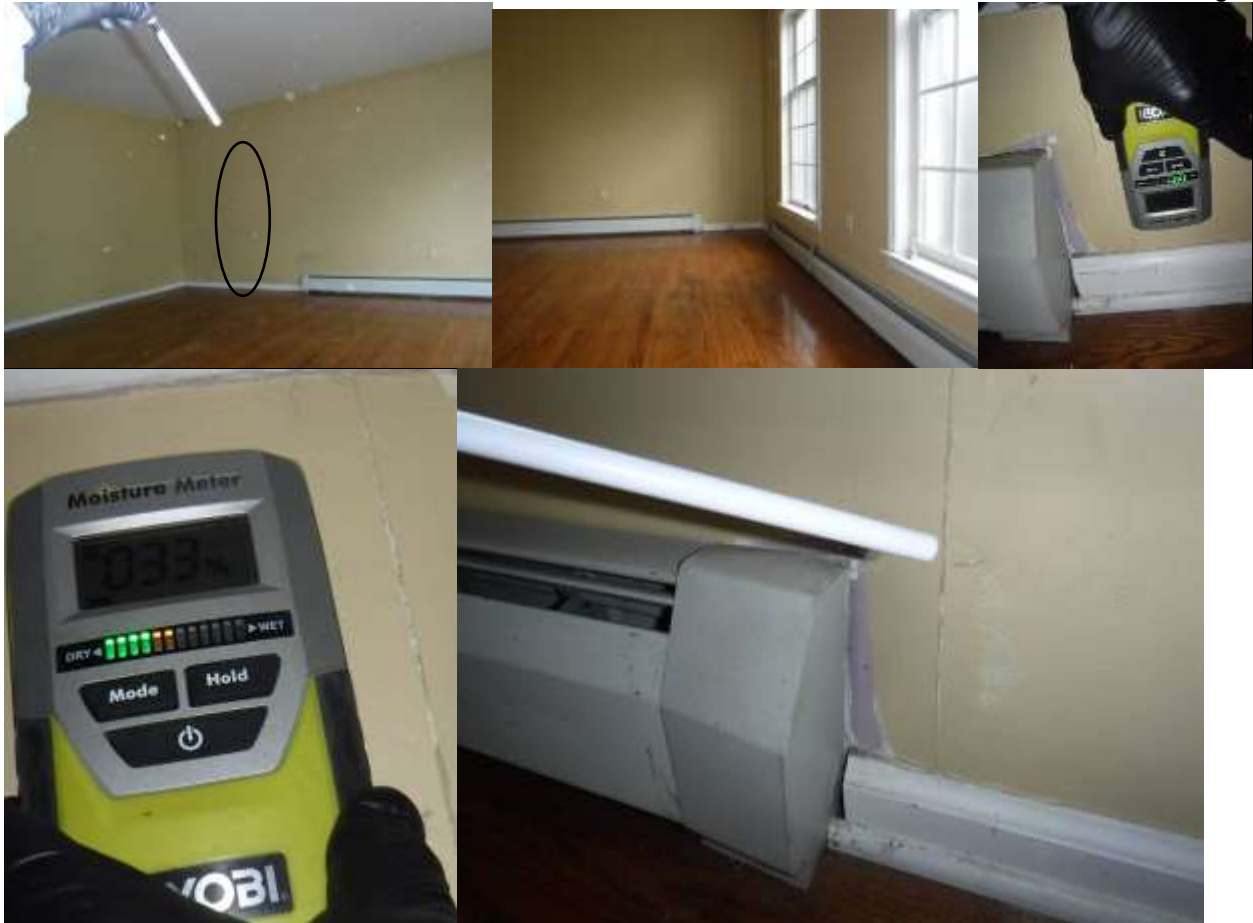
1. There were vertical cracks on walls and ceiling, uneven drywall on right side (facing house) & front wall and active moisture or leaking in the room. Recommend a building contractor and roofing contractor evaluate all water sources, wall & ceiling cracks and extent of damage including concealed areas and advise on repairs before closing & contractual limitations.
2. See structural comments; sloped flooring and canted doorways in the home.

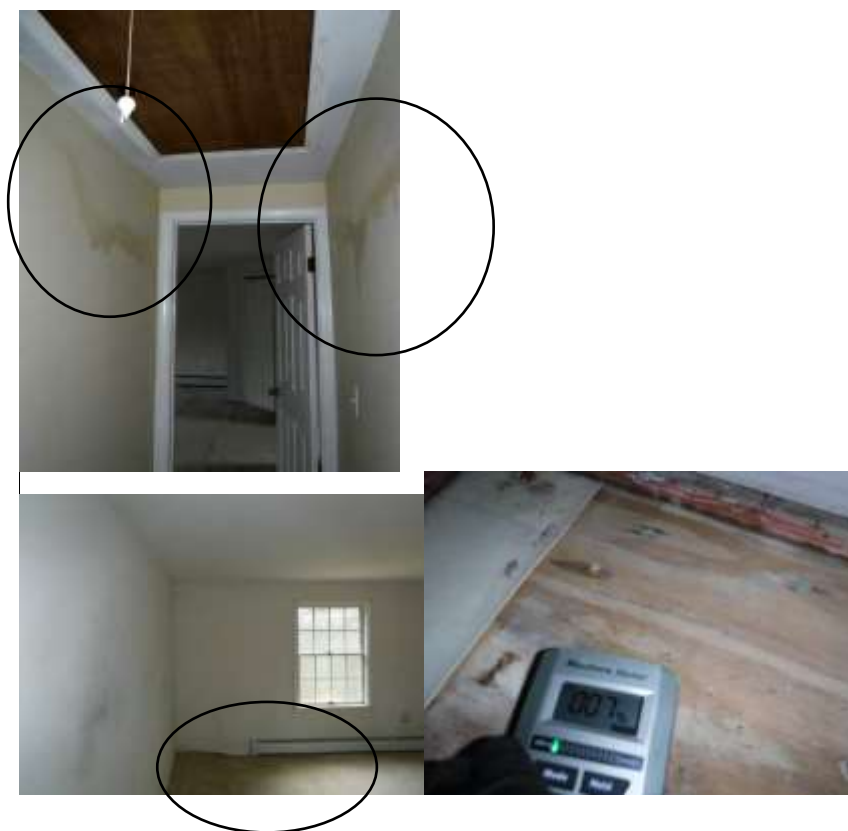
1. Recommend evaluating all water/moisture leaks, baseboards, etc.; see heating & plumbing sections.

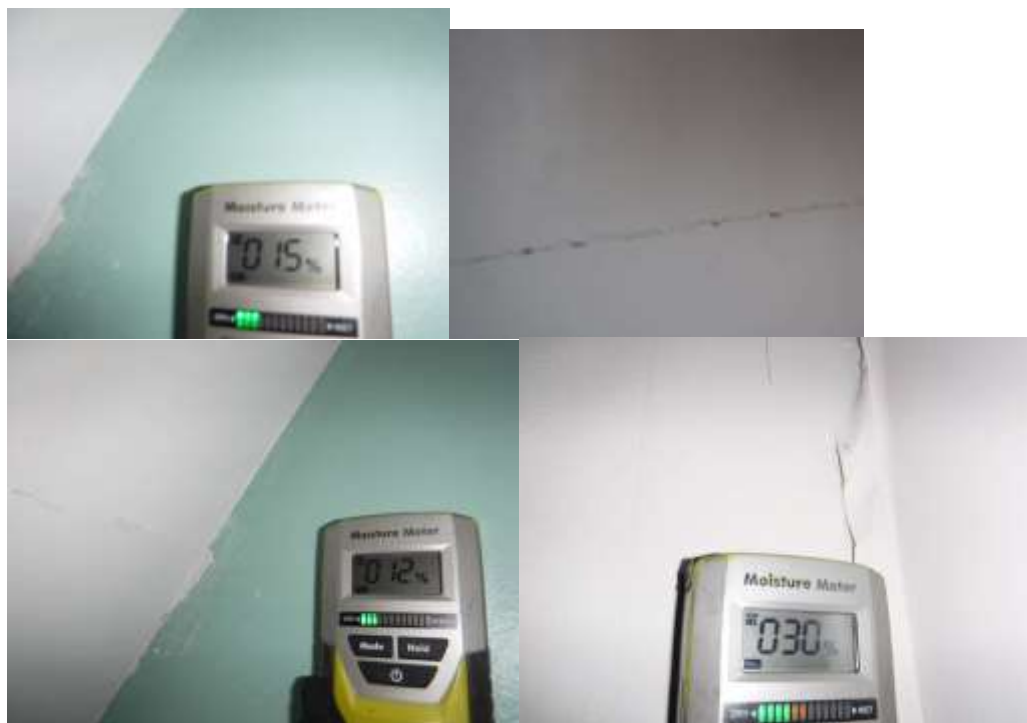
1. There were active leaks in the room and others interior rooms, attic, etc. See roofing section comment. Recommend a building contractor, heating contractor, licensed plumber and roofer evaluate all water/leak sources and make repairs. The home was poorly maintained and systems in poor condition.

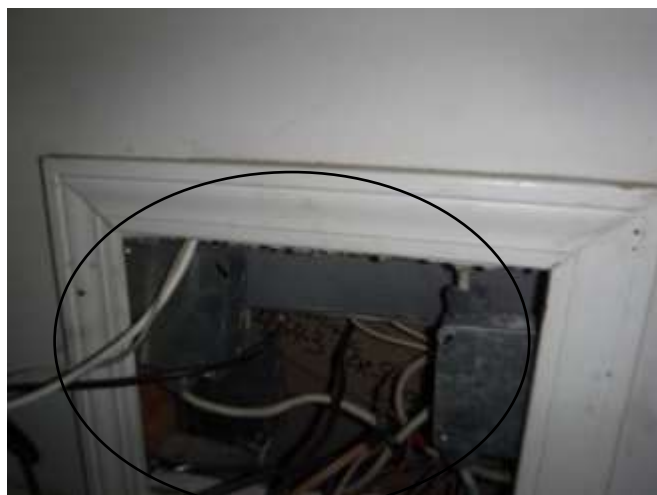
Figure 24 Electrical wiring inside wall; safety concerns. Recommend an electrician evaluate & repair.

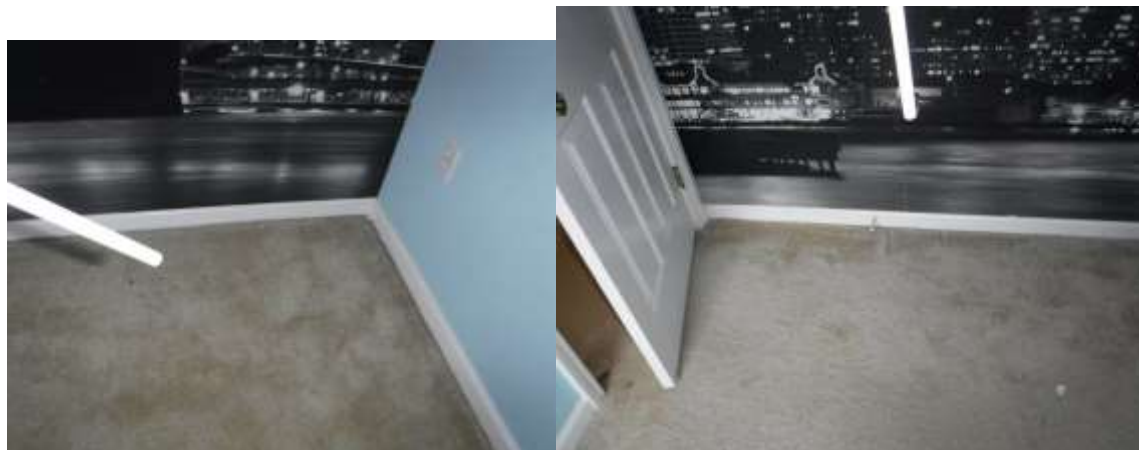
Figure 25 Sloped flooring, squeaking, and deflection or bounce when walked upon flooring.

1. There was sloped flooring in this room, second floor and throughout the home. See structural comments; further evaluate sloped flooring, canted doorways, foundation cracks, etc. by a building contractor and structural engineer (PE) before closing & contractual limitations.

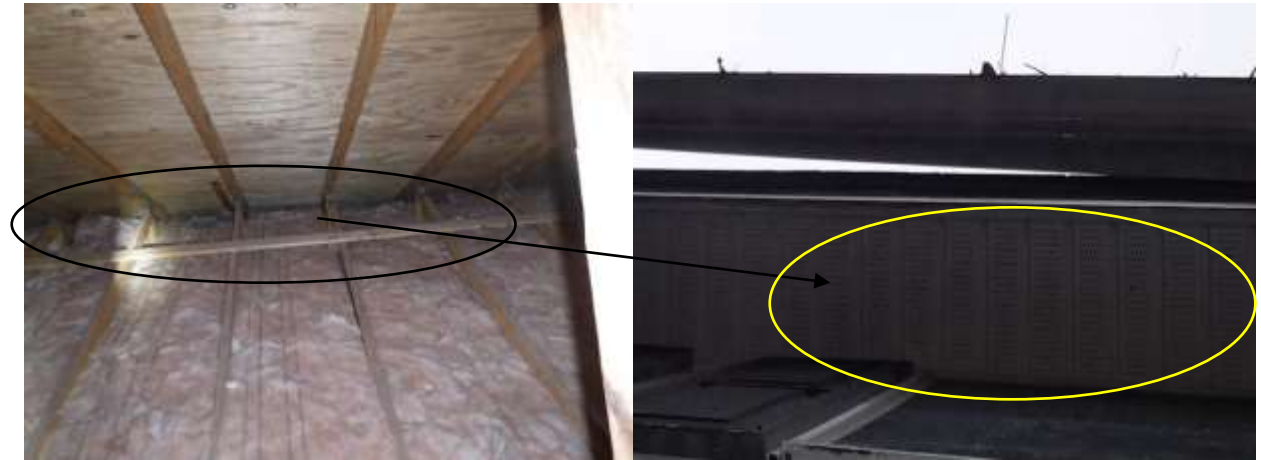
**Figure 26 Example of No baffles and insulation blocking perforated soffits, no ridge vent, no gable vent, no passive vents, no power fans, etc.; poor ventilation.**

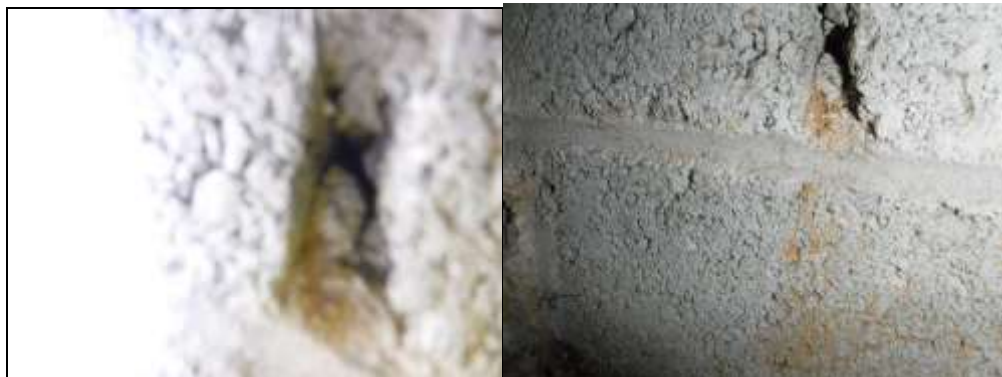
Figure 27 Termite tubes inside a gap in the foundation wall in basement. See separate NPMA-33 termite report.

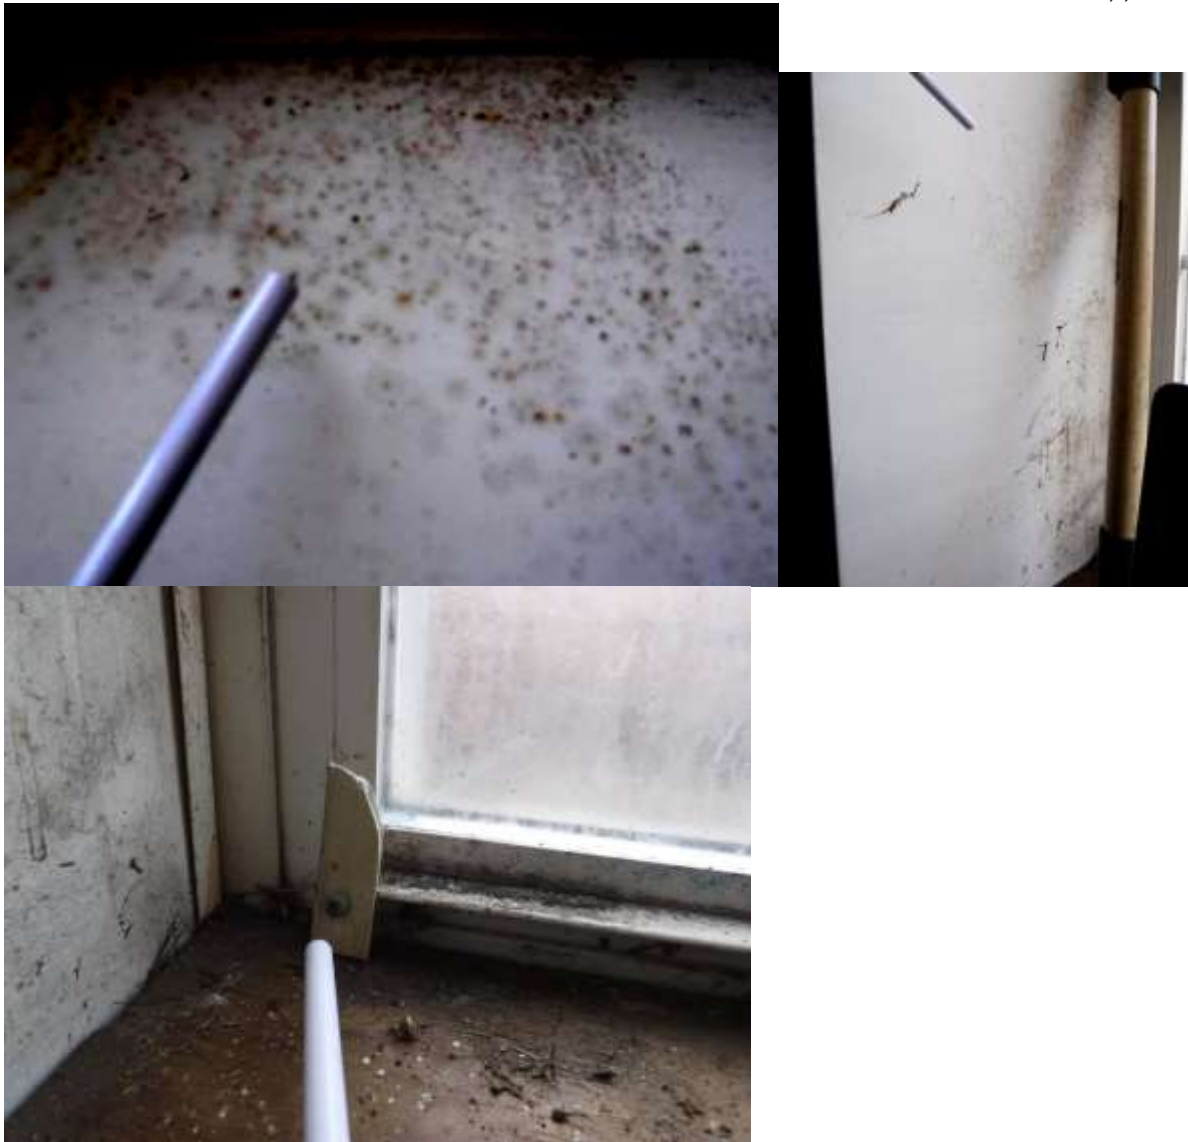
**Figure 28** Mold-like spotting/staining; follow up with a mold/environmental contractor for mold evaluation ( beyond scope of a home inspection).

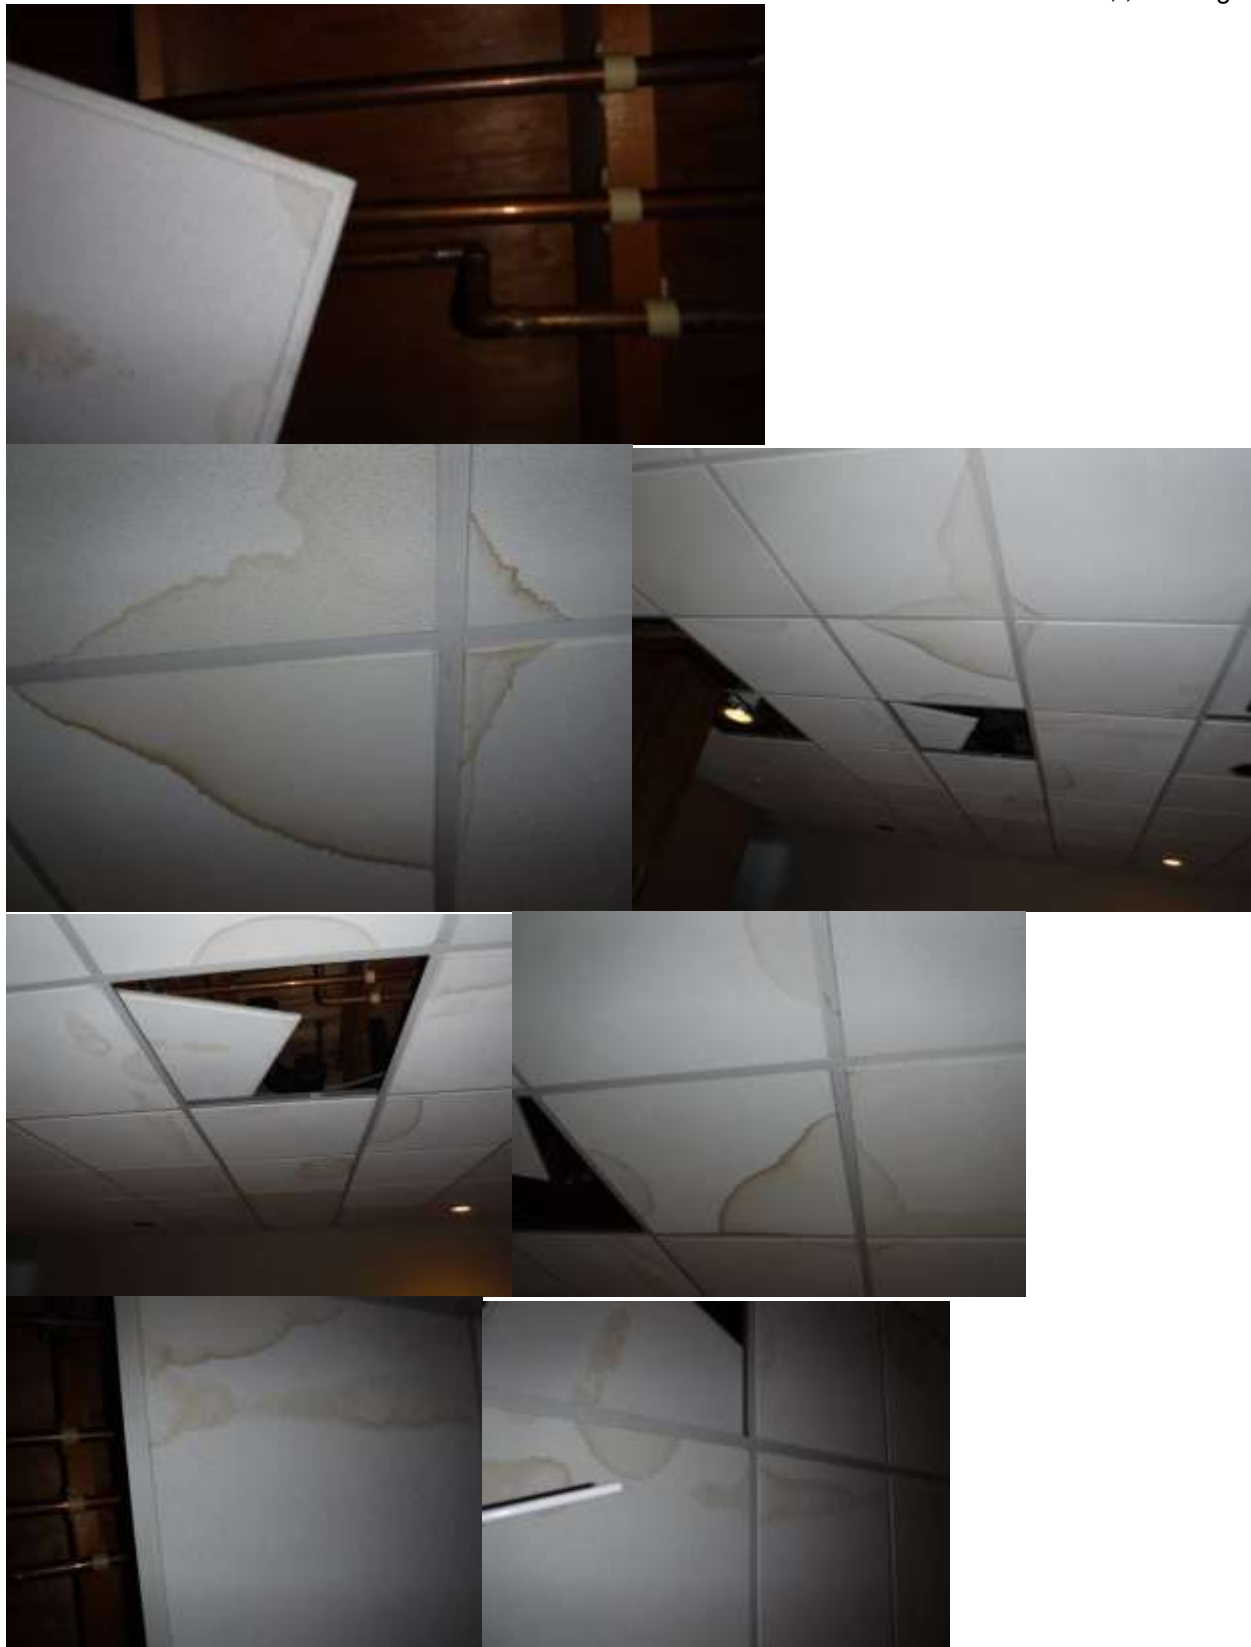
**Figure 29** Examples of ceilings that were found partially opened in the basement, water stains/leaks and plumbing exposed. The home was not properly winterized and leaking active throughout the home.

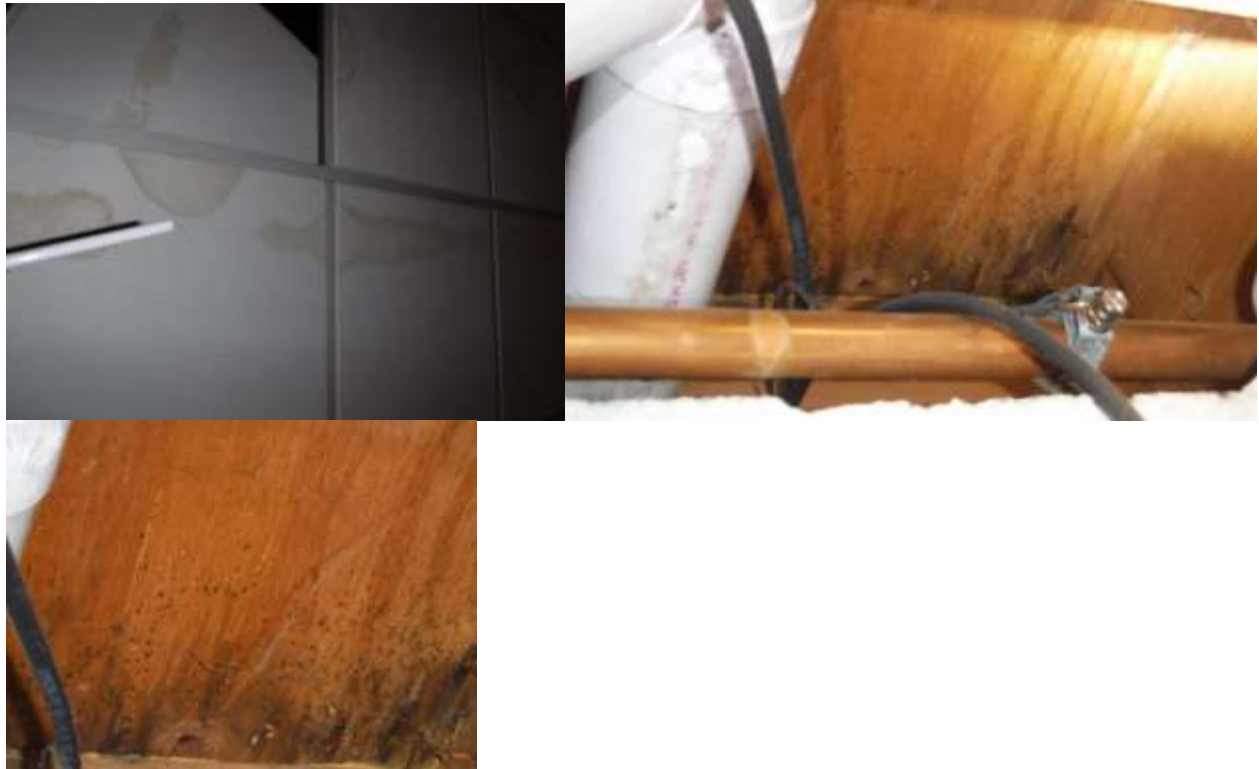
**Figure 30** Leaks and mold like substances in basement or in the home. Further evaluate by a mold contractor. See heating & plumbing section comments.

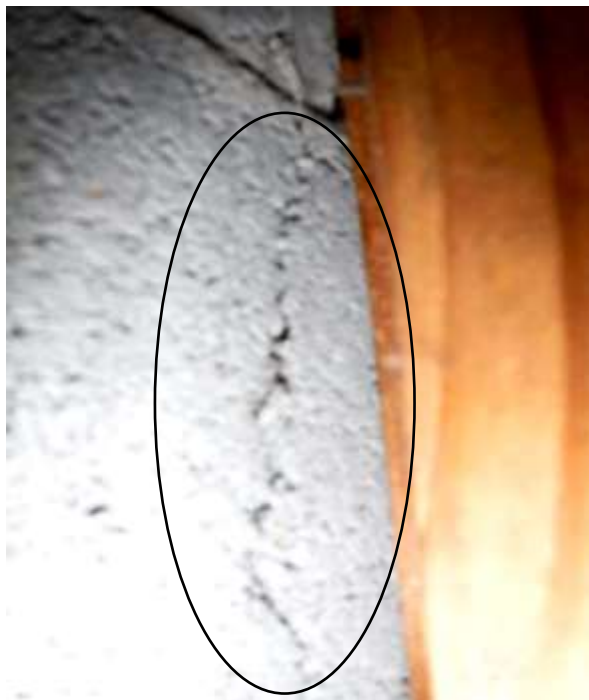
**Figure 31** Example of foundation cracks. Limited view due to finished basement. Recommend a structural engineer (PE) and building contractor further evaluate all foundation cracks and advise on repairs before closing.

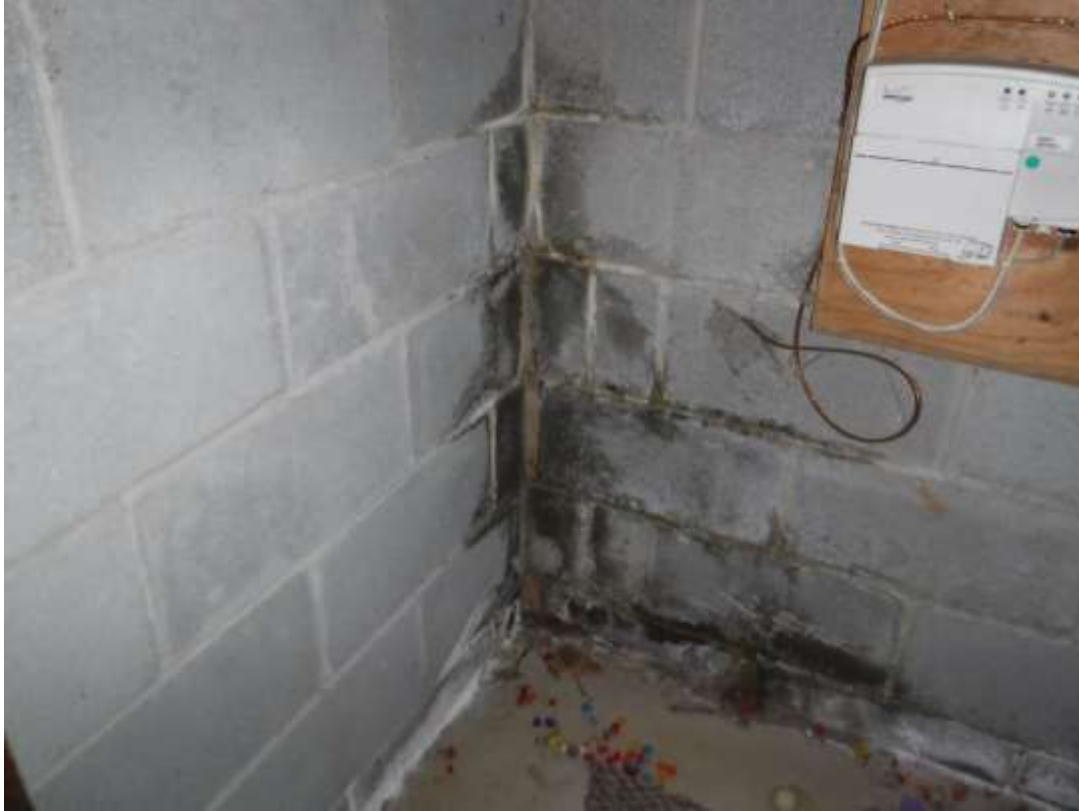
**Figure 32 Example of seepage in basement; limited access by mechanicals or utility areas.**

1. There was water infiltration/seepage in basement and garage; negative grading, poor drainage, poor roof drainage (gutters & leaders), and trees, shrubs and overgrowth on property. Conditions are conducive to wet basement and mold like growth.
2. There was suspicious black and brown spotting, dark stains, and a Musty Odor in the home on drywall and surfaces in the basement, garage (rafters, radon piping & fan) and interior rooms. Testing recommended and further evaluation by *qualified mold contractor*.

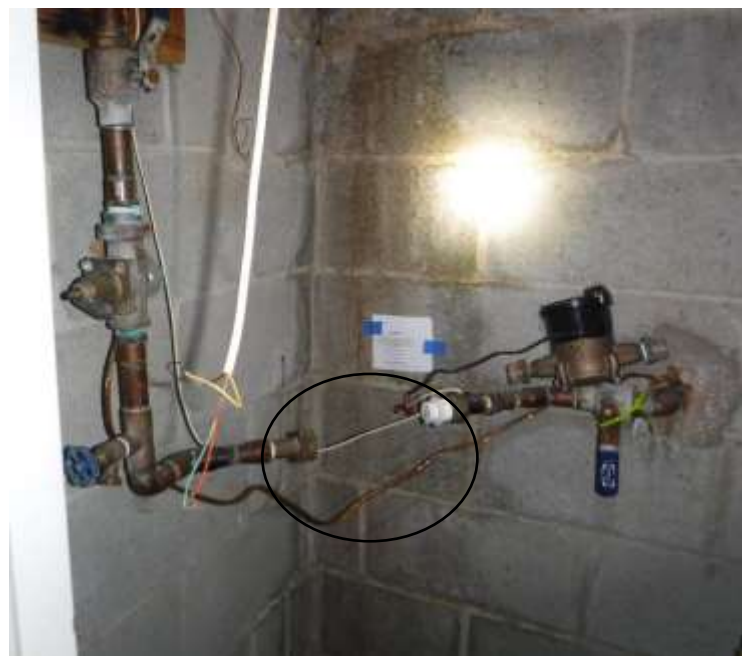
Figure 33 Water meter was apart and plugged on street side.

1. The home has been vacant, no heat and no water at time of inspection. The water meter was found apart/removed and a plug in pipe on street side. The home was not properly winterized; frozen/ruptured plumbing, fixtures, hydronic baseboard heating components & distribution piping, fitting, etc. There was visible water inside numerous ruptured baseboards from basement up to the second floor. There was leaking from the old corroded boiler off the TPR & pipe extension. Walls and ceilings should be opened up to determine the extent of water damage, baseboard/distribution and boiler replacement as well as plumbing or piping distribution to all points of water use (bathrooms, kitchen, laundry, exterior hose bibs, boiler, water heater, etc.). Leaking in the home was active and coming from several sources : plumbing, hydronic baseboard heat, roof, siding, windows and doors. The water heater was approximately 25 yrs. old and poor condition; past life replace unit. There were frozen/broken spigots/tub fixture, active leaking plumbing throughout the home. Recommend a licensed master plumber evaluate the plumbing and heating and advise on repairs/replacements.

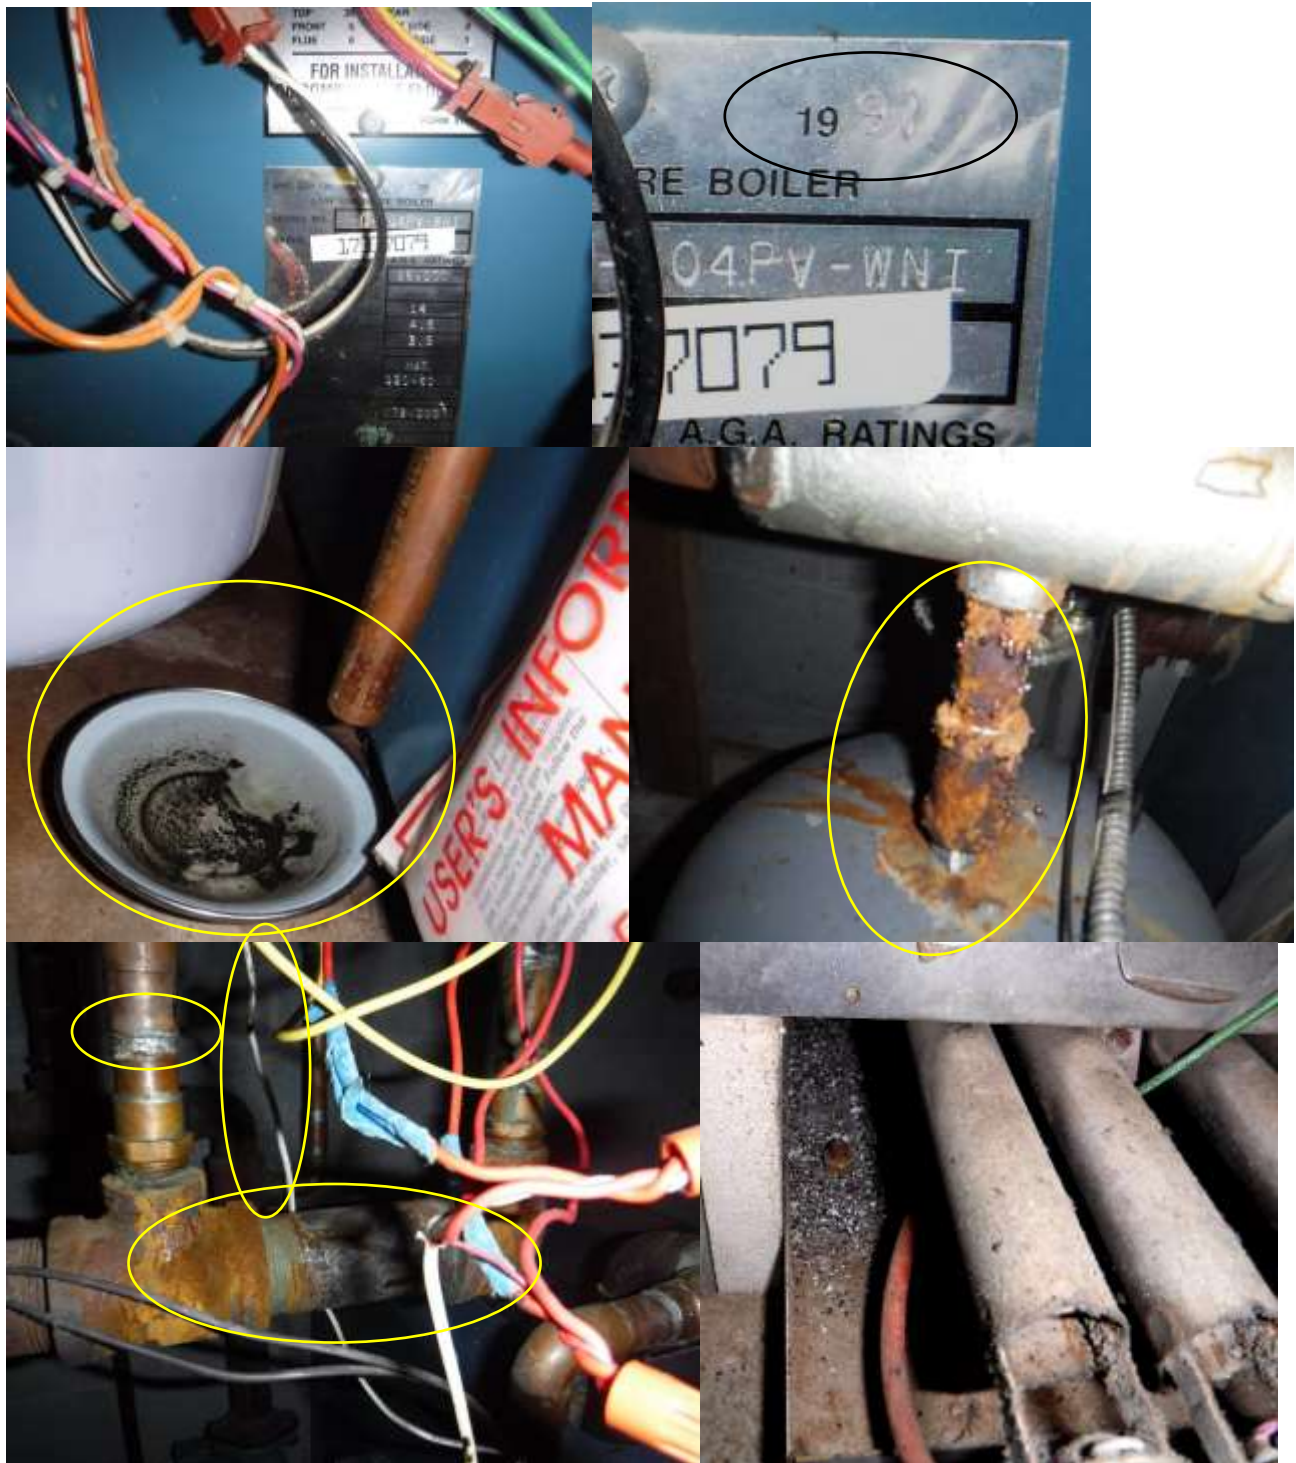
**Figure 34** Scorch marks on plastic wire sheathing near patched copper piping/solder. Piping on boiler had corrosion and dissimilar metals (galvanized and copper) and no dielectric insulators/unions; improper. Boiler was leaking, corrosion, soot & rust particulates on burners, etc.; past life and poor condition. Home was not properly winterized and water visible in ruptured baseboards throughout the home.

2. Walls and ceilings should be opened up to determined the extent of water damage, baseboard/distribution and boiler replacement as well as replacement of plumbing or piping distribution to all points of water use (bathrooms, kitchen, laundry, exterior hose bibs, boiler, water heater, etc.). The water meter was found removed and a plugged on strret side of pipe.
