# 4 Seasons Home Inspection, LLC

## RECEIPT

Inspection Date: January 23, 2018 Tuesday 10am- 2:30pm  
Client Name: buyer name (buyer@gmail.com)  
Inspection Address: # street, town, NJ xxxxx  
Inspected by: Linda Geczi home inspection lic. #24GI00061500

Approximate Age: ~1994  
Style: Single family  
Prefab/modular (attic & basement 2 halves visible)  
Main Entrance Faces: E  
State of Occupancy: Vacant  
Weather Conditions: 45-50°F  
Ground cover: wet

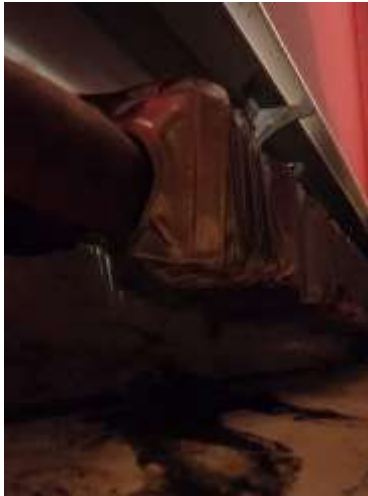
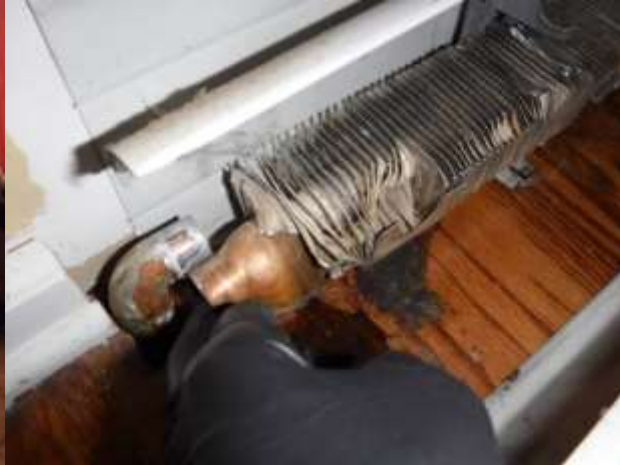
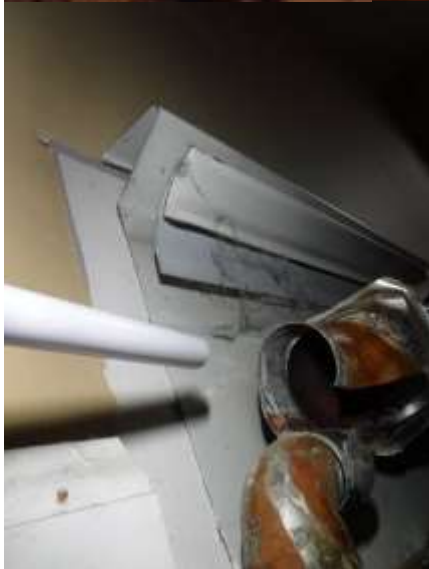
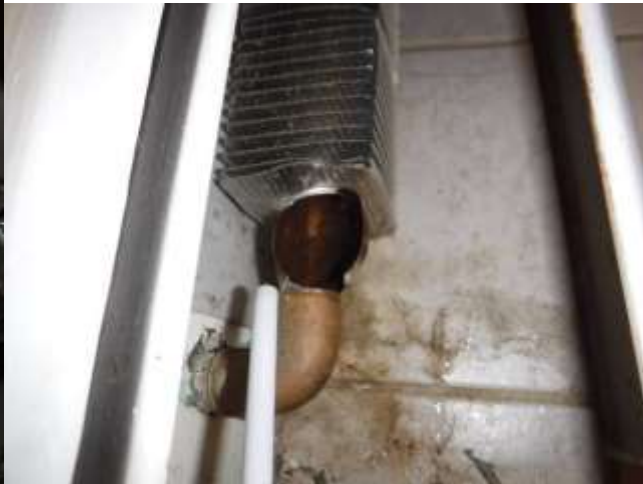
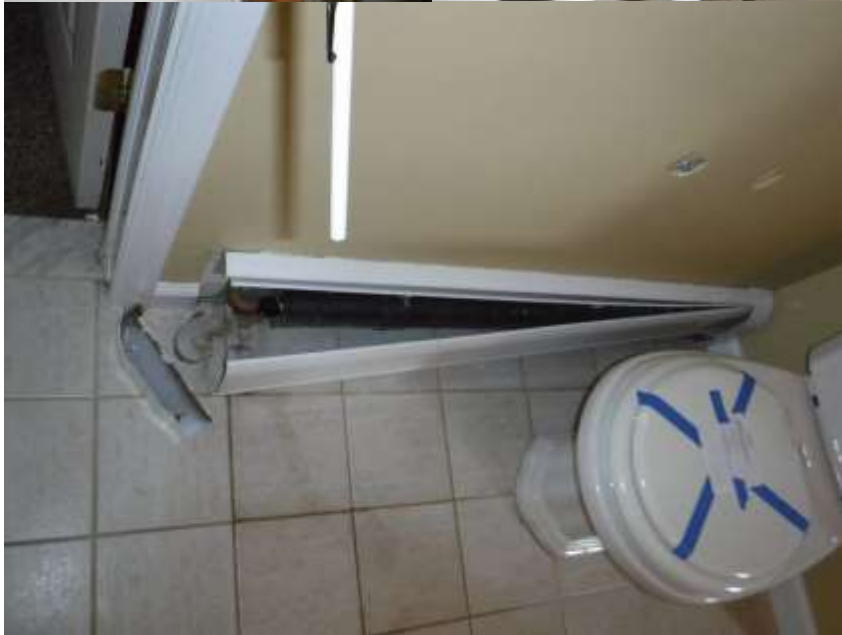
**Figure 34** Scorch marks on plastic wire sheathing near patched copper piping/solder. Piping on boiler had corrosion and dissimilar metals (galvanized and copper) and no dielectric insulators/unions; improper. Boiler was leaking, corrosion, soot & rust particulates on burners, etc.; past life and poor condition. Home was not properly winterized and water visible in ruptured baseboards throughout the home.
