**4 Seasons Home Inspection, LLC**  
 150 Maple Avenue, #128, South Plainfield, NJ 07080  
[www.4SeasonsHI.com](http://www.4SeasonsHI.com) 1-877-547-7383

Inspection Date: July 13, 2018 Friday 10am- 12:15pm  
 Client Name: buyer (buyer@verizon.net)  
 Emails: lawyer@aol.com  
 Inspection Address: # street unit # condo, town,nj xxxxx  
 Inspected by: Linda Geczi home inspection lic. #24GI00061500

Approximate Age: ~1975 (~43 yrs.)  
 Style: Condo, high rise 5<sup>th</sup> FL  
 Main Entrance Faces: S  
 State of Occupancy: Furnished/storage, not occupied  
 Weather Conditions: 80 °F  
 Ground cover: dry

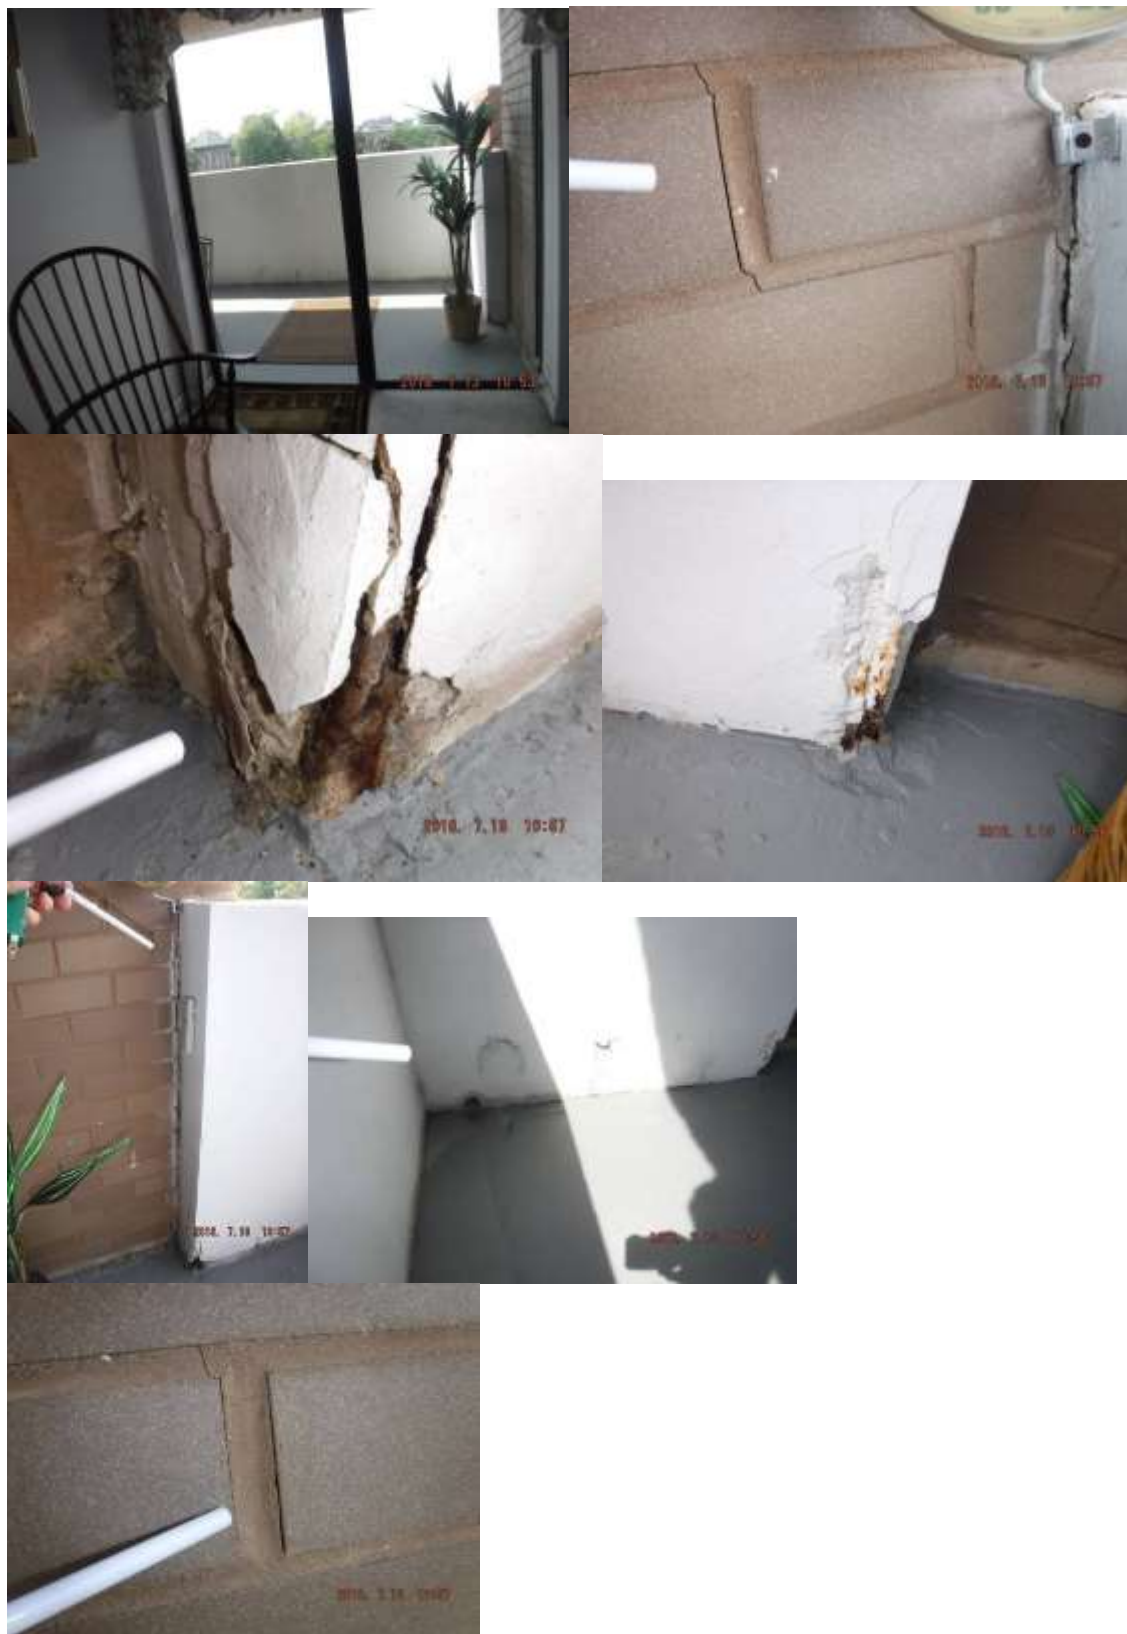
1. **Recommend a licensed electrician evaluate the outlet on balcony for replacement/repairs- not accepting the tester (TR /tamper resistant type with built in safety shutters).**
2. **Recommend contacting the Association for balcony cracks, rusted metal, chipped/deteriorated concrete, etc.; exterior should be evaluated/repared by the Association.**

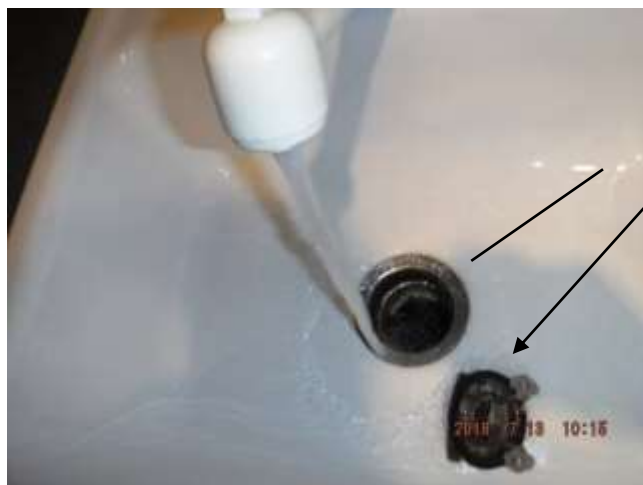
**Figure 1** The disposer did not activate or turn on when cap inserted and turned into "on" position; not working. Recommend a licensed plumber evaluate disposer and advise on repairs/replacement.

1. Recommend a licensed plumber evaluate garbage disposer, corrosion/plumbing and electric water heater, T-saddle/piercing valve and advise on all repairs/replacement and access or relocation for the water heater. The water heater is small or ~ 38 gal as per the data tag. Discuss size for family's needs with the plumber or qualified building contractor.
2. The coil type electric stovetops smell when first turning on; cooking oils. If upgrading, consider a glass top type electric stove. The appliances are older and refrigerator not part of home inspection. Ask if refrigerator staying with the home. A typical manufacturer's warranty is often 1-2 yrs. depending on the manufacturer and product installed. Plan & budget for appliance replacement/repairs due to age.

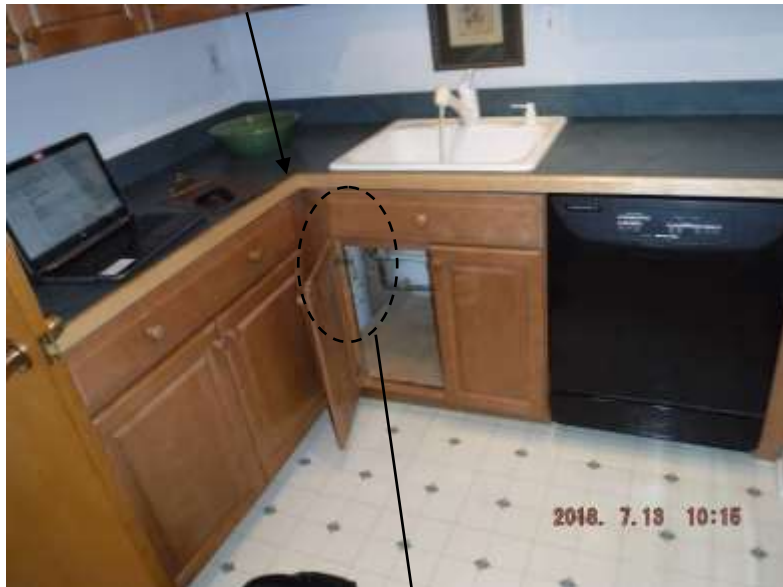
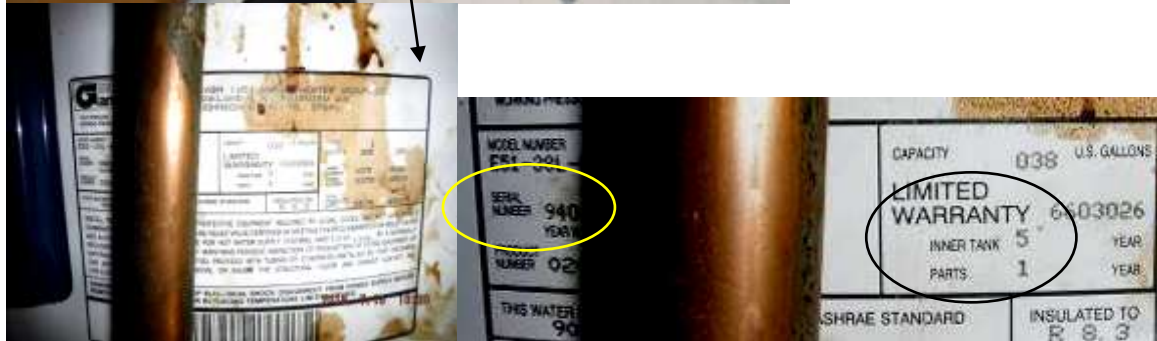
**Figure 2** Serial number indicates 1994 mfg. date and 5 yrs. warranty on unit. Water heater is inaccessible under the cabinets, 24 yrs. old and past life. Recommend a licensed plumber and building contractor evaluate and advise on relocation/access and replacement. Tank needs to be accessible and replaced.

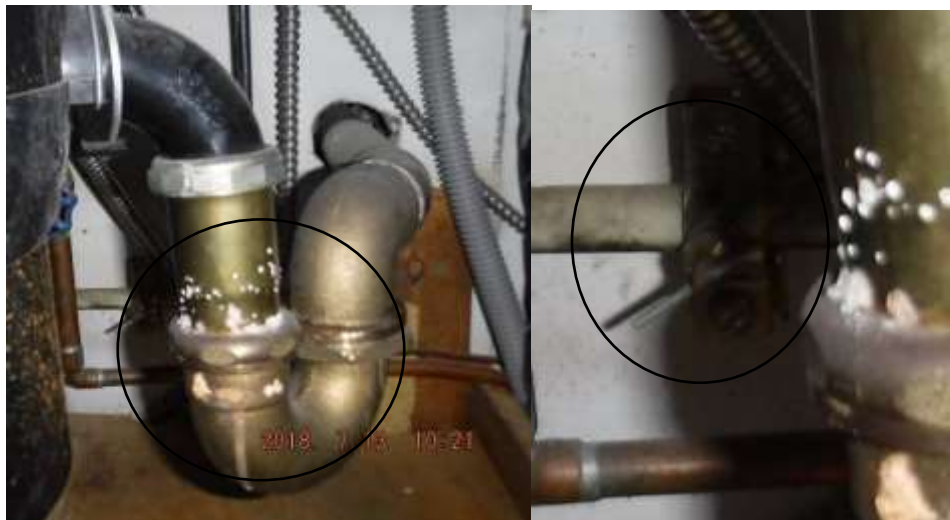
**Figure 3** Example of corrosion on drain/plumbing under sink. There was a Tee saddle valve/piercing valve; tend to leak and considered handyman.

2. **There was no water main valve found or visible in the condo. Ask Association of there is a water meter and main elsewhere in the building. There was a piercing T-saddle valve in kitchen under sink. These valves tend to leak and considered a handyman fix to get water to an ice/water dispenser. The disposer did not activate or turn on when cap inserted and turned into "on" position; not working or unable to see if a trip button. There was corrosion under sinks on drains or plumbing. The 1994 electric water heater was installed in the corner cabinet to left of sink and the counter top and cabinets installed around the unit. The unit is inaccessible and needs to be replaced; 24yrs old and the tank has a 5 yrs. warranty. A typical life expectancy is 8-10 yrs. and must be replaced and proper access or relocated to an accessible area. There was mold like staining and active moisture/leaking on ceiling (100% moisture) in bathroom. Recommend contacting the Association or neighbor above and a licensed plumber to determine all water/leak sources and advise on repairs. Mold/environmental identification/testing/etc. is beyond the scope of a home inspection. Mold and environmental contractor or qualified building contractors should rule out all water, mold or concealed damage. There was erratic flow and calcium/mineral build-up on fixtures; indicative of hard water. The bathroom and plumbing in home was original. Recommend a licensed plumber evaluate bathroom, plumbing (piping, drains, fixtures, toilet, valves, fittings, etc.), corrosion, water heater/size & location, calcium/mineral deposits, T-saddle piercing valve, etc. and advise on repairs, upgrades, bathroom renovations, water heater & relocation, etc. before closing & contractual limitations.**

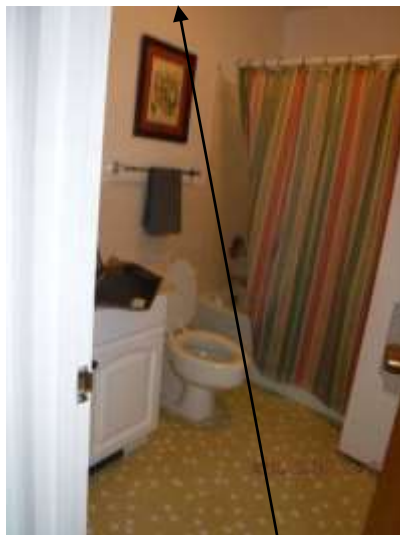
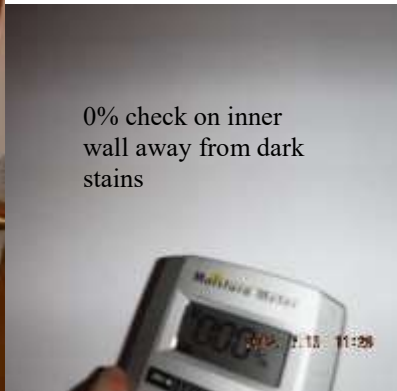
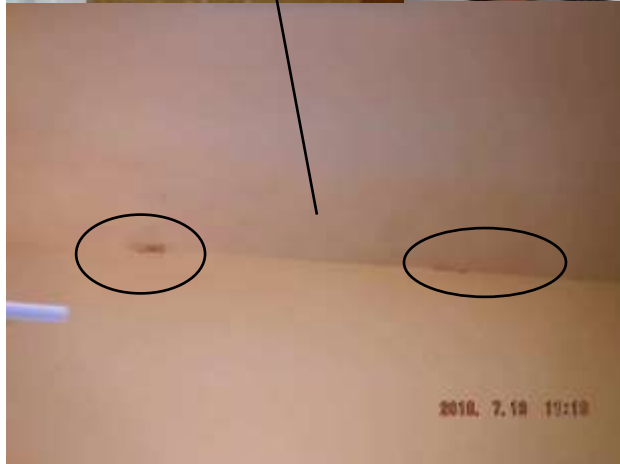
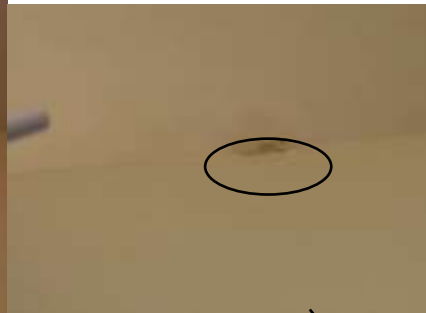
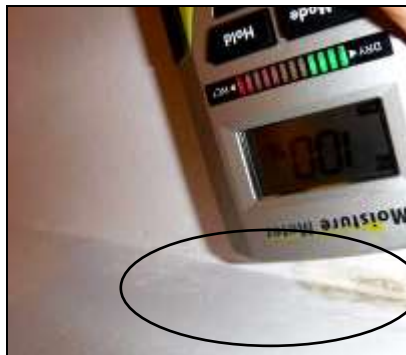
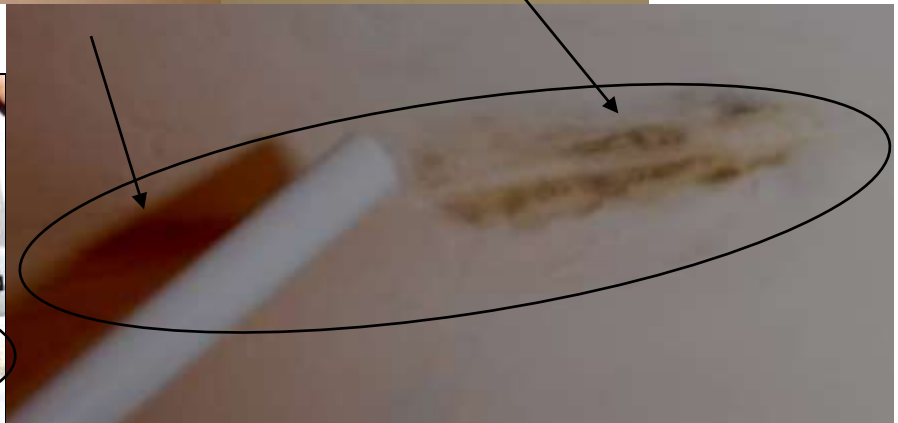
**MAIN BATH :** There is an older electric toe kick heat under the vanity. The exhaust vent is located on upper wall in tub/shower stall; original. There was mold like staining and active moisture/leaking on ceiling (100% moisture). Recommend contacting the Association or neighbor above and a licensed plumber to determine all water/leak sources and advise on repairs. Mold/environmental identification/testing/etc. are beyond the scope of a home inspection. Mold and environmental contractor or qualified building contractors should rule out all water, mold or concealed damage before closing & contractual limitations. There was erratic flow and calcium/mineral build-up on fixtures; see hard water comments in plumbing section. The bathroom was original to home, cracked ceramic tiles, older fixtures/plumbing, toilet, vanity, etc.; recommend upgrades by a building or bathroom contractor.

**Figure 4 Mold like spots and active leak/moisture (100%). Recommend a licensed plumber evaluate all sources and advise on repairs. Recommend contacting the Association to see if unit above is the source or in this unit.**

1. There was mold like staining and active moisture/leaking on ceiling (100% moisture). Recommend contacting the Association or neighbor above and a licensed plumber to determine all water/leak sources and advise on repairs. Mold/environmental identification/testing/etc. are beyond the scope of a home inspection. Mold and environmental contractor or qualified building contractors should rule out all water, mold or concealed damage before closing & contractual limitations. The bathroom was original. There was erratic flow and calcium/mineral build-up on fixtures; see hard water comments in plumbing section.
2. There was erratic flow and calcium/mineral build-up on fixtures; see hard water comments in plumbing section. The bathroom was original to home, cracked ceramic tiles, older fixtures/plumbing, toilet, shower/tub, vanity, etc.; recommend upgrades by a building or bathroom contractor.

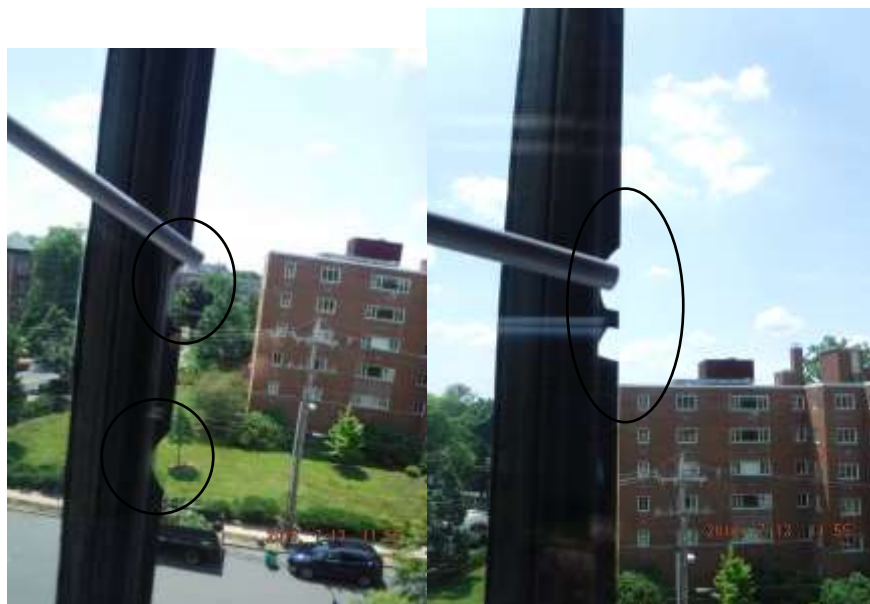
**DEN ROOM : OFF LIVIGN ROOM:** The windows in home were original/difficult to open close, cracked plastic frames, vapor seal breaks, etc. There were no screens on windows.

**Figure 5** Windows in home were original ~ 43 yrs.; difficult to open/close, stiff, broken plastic frames, vapor seal breaks, etc.

1. The windows in home were stiff/difficult to open & close, rust, vapor seal breaks, old or original to home. Recommend a window & door installer evaluate doors & windows for replacement/upgrades; past expected life and poor condition. There were no screens on windows in the home; recommend screen with new windows.
2. There was a ridge felt or uneven when walking across carpet in living room. The home was covered with carpeting or flooring. Recommend a building contractor evaluate slab floors and advise on findings & repairs before closing & contractual limitations.

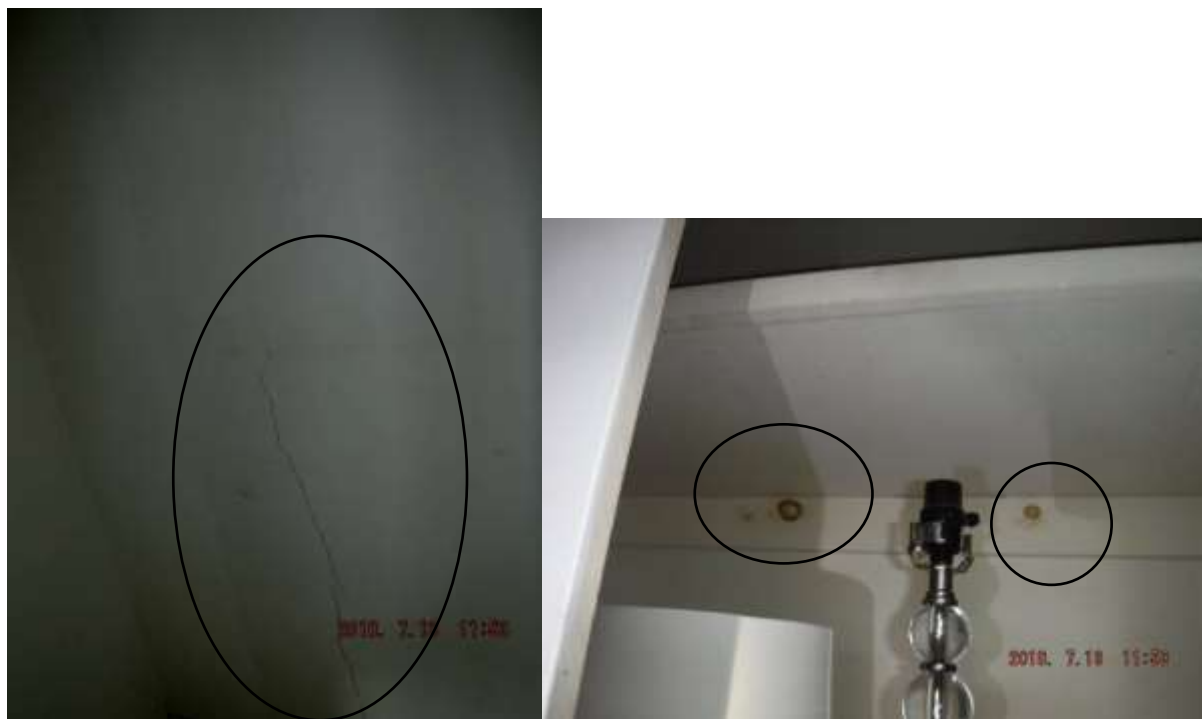
**MASTER BEDROOM :** There was a vertical crack on drywall in closet adjacent to the laundry closet. There were drywall lines where joined/not spackled or compounded well; have cracks(s) seams/lines repaired by drywall or building contractor. There were pinesap stains on knots of wood in closet; cosmetic stains. The windows in home were stiff/difficult to open & close, rust, old or original to home. See window section comments; recommend having evaluated for replacement by a window installer.

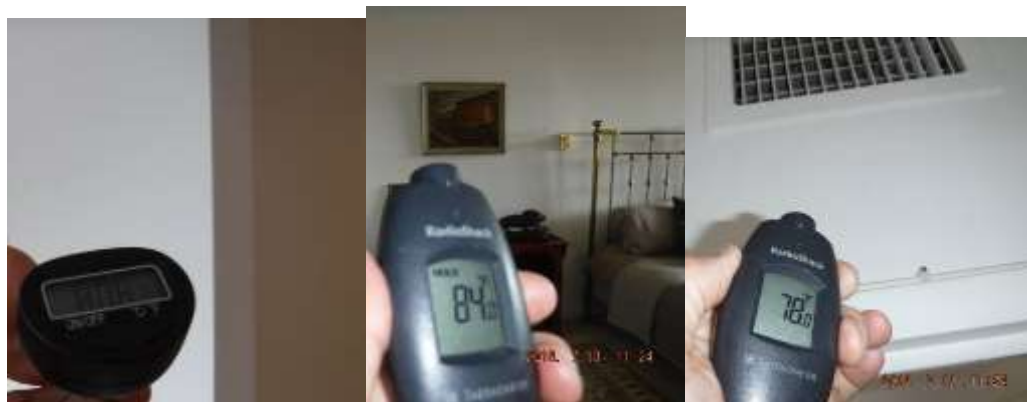
**Figure 6** The A/C unit was on 70F when arrived and lowered and checked after an hour running at lower at lowest temperature to cool off home. The room temperatures were 78 at registers and 80°F in rooms and not cooling at all. The thermostat was not reflecting the 78-80F room temperatures and did not move from a 50F reading, which was incorrect.

1. **Recommend a qualified HVAC /design contractor evaluate the cooling system, adequacy/registers/returns/design, thermostat and advise on replacement of unit, registers/returns and thermostat replacement and adequacy/registers/returns before closing & contractual limitations.**
