4 Seasons Home Inspection, LLC

1308 Centennial Avenue, Suite 160, Piscataway NJ 08854
www.4SeasonsHI.com 1-877-547-7383

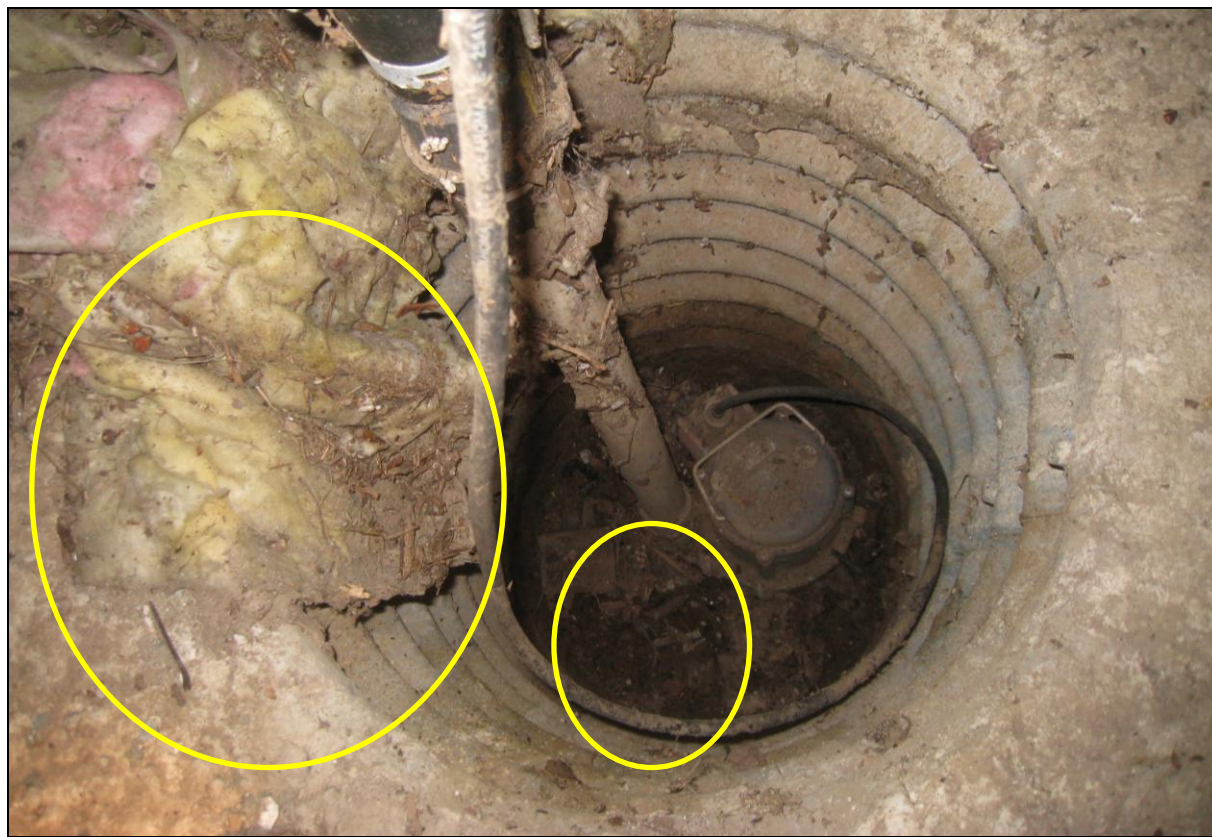
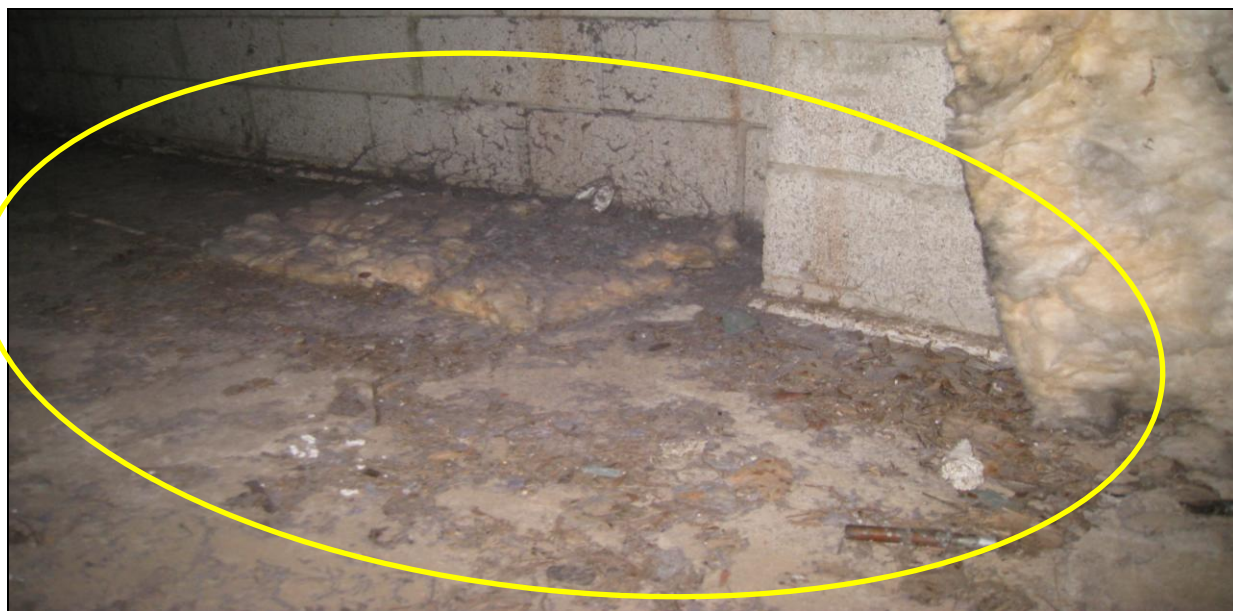
Figure 1 Heavy lint coating walls and floor in crawl space from disconnected dryer; correct venting and clean surfaces.

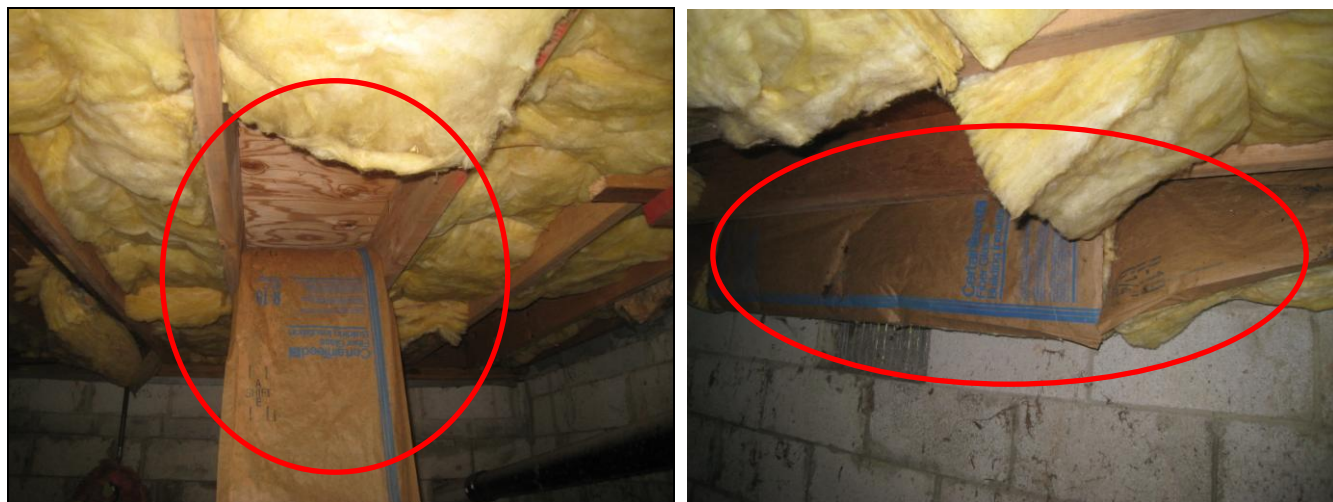
Figure 2 A & B Loose hanging insulation in crawl space.

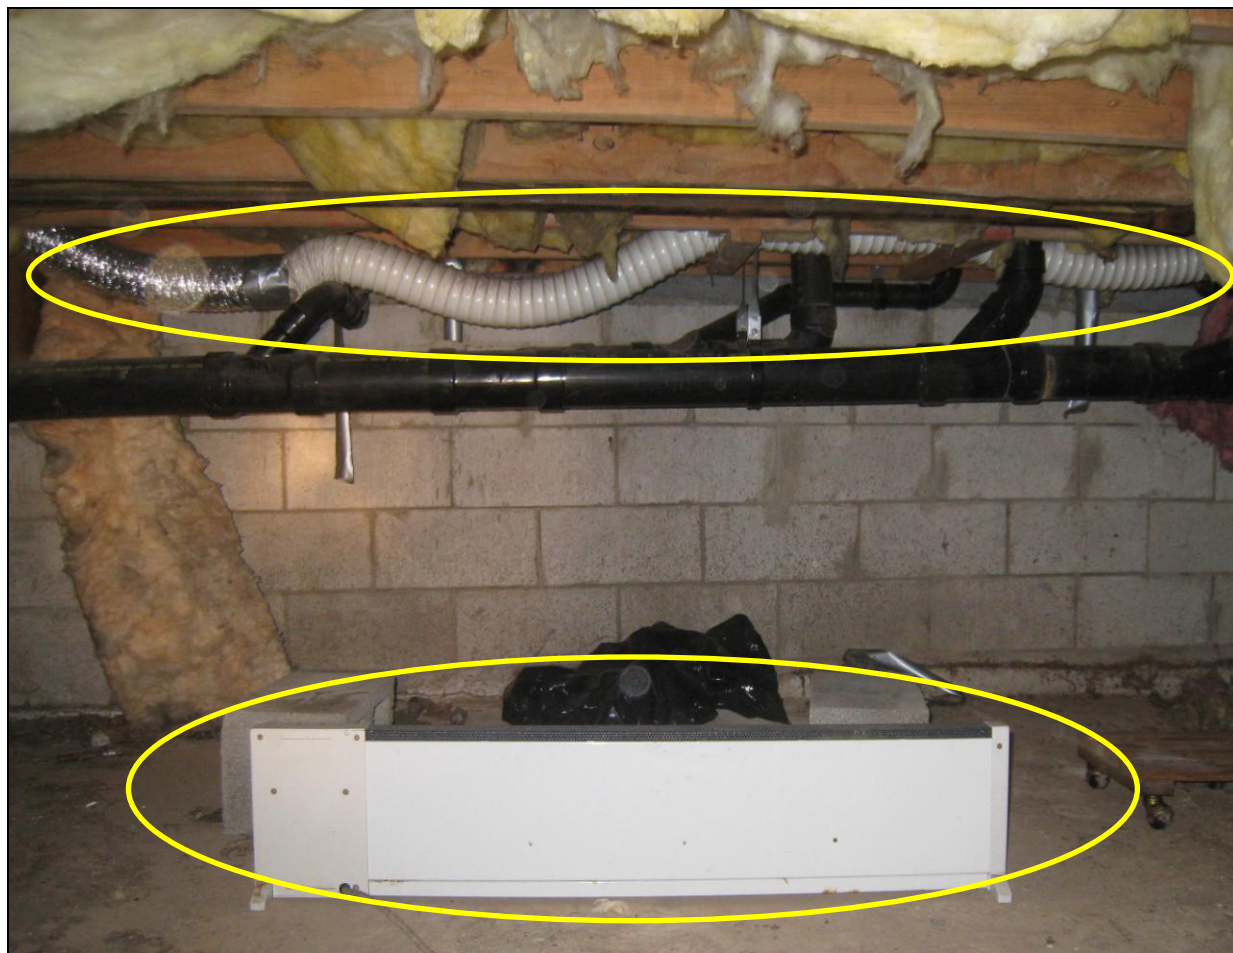
Figure 5 Electric Space heater below plumbing where repairs made. Have evaluated to install preventative measure to guard against freezing pipe, leaks, clogs and water main breaks. There is a flex vent disconnected on dryer and lint accumulating inside crawl space. Have ductwork replaced and clean yearly for fire safety.

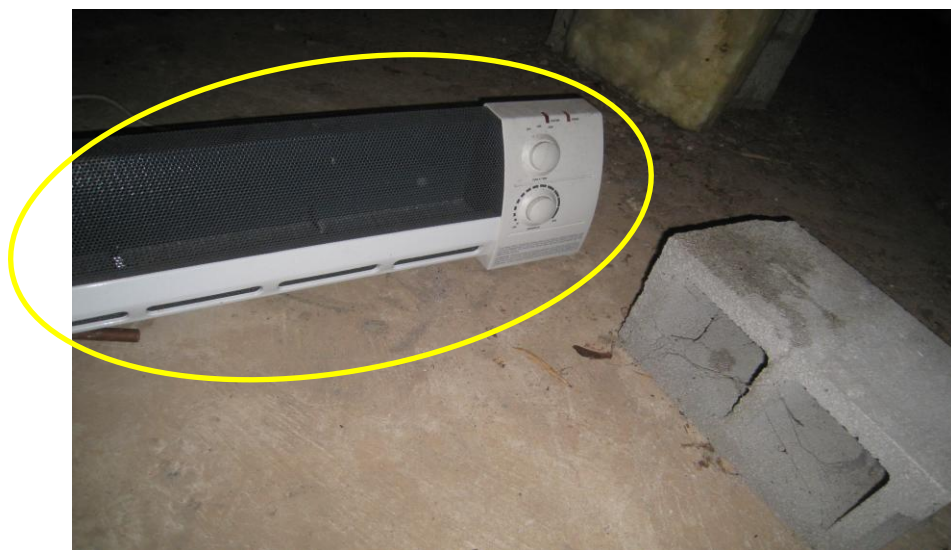
Figure 6 Long space heater under repaired pipes in crawl space; indication of freeze damage or improperly insulated plumbing.

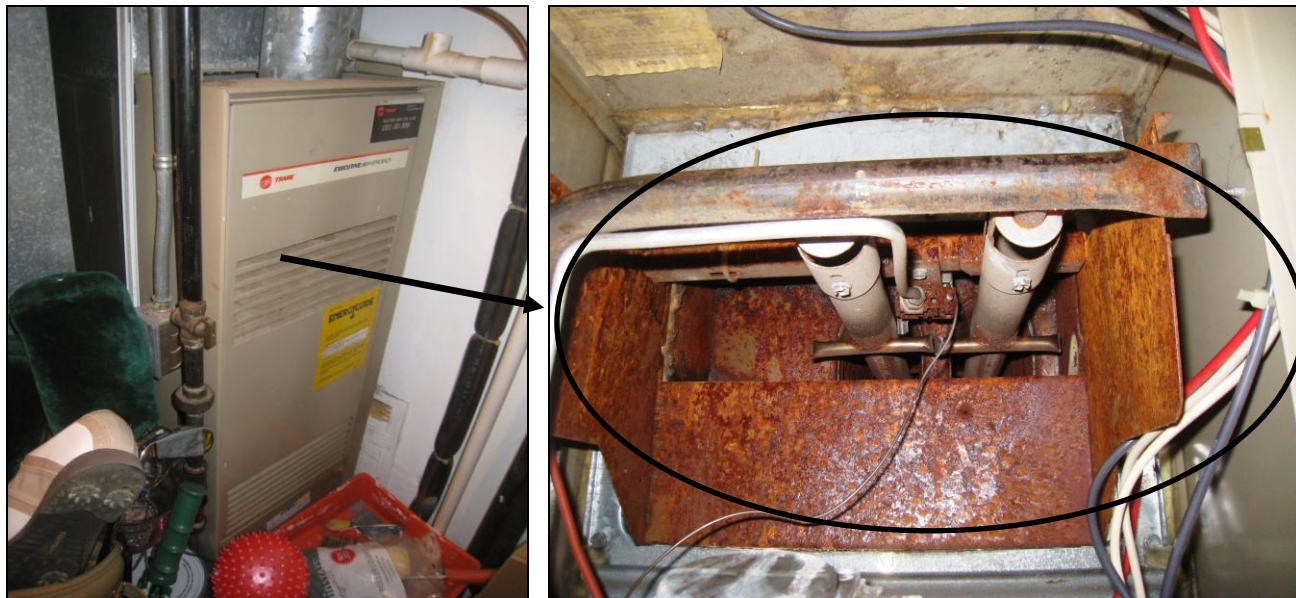
Figure 7 A & B Clutter poses a fire hazard in utility room. Heavy corrosion inside furnace; have evaluated now.

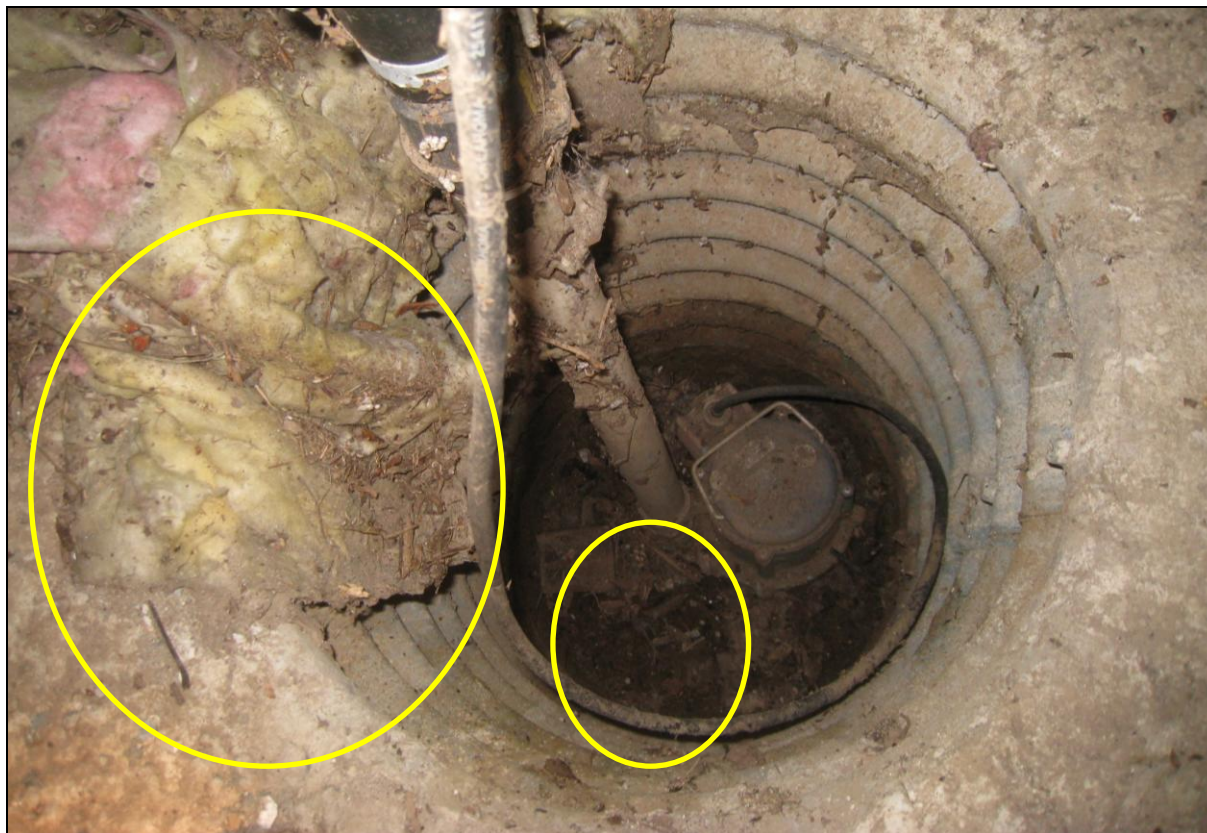
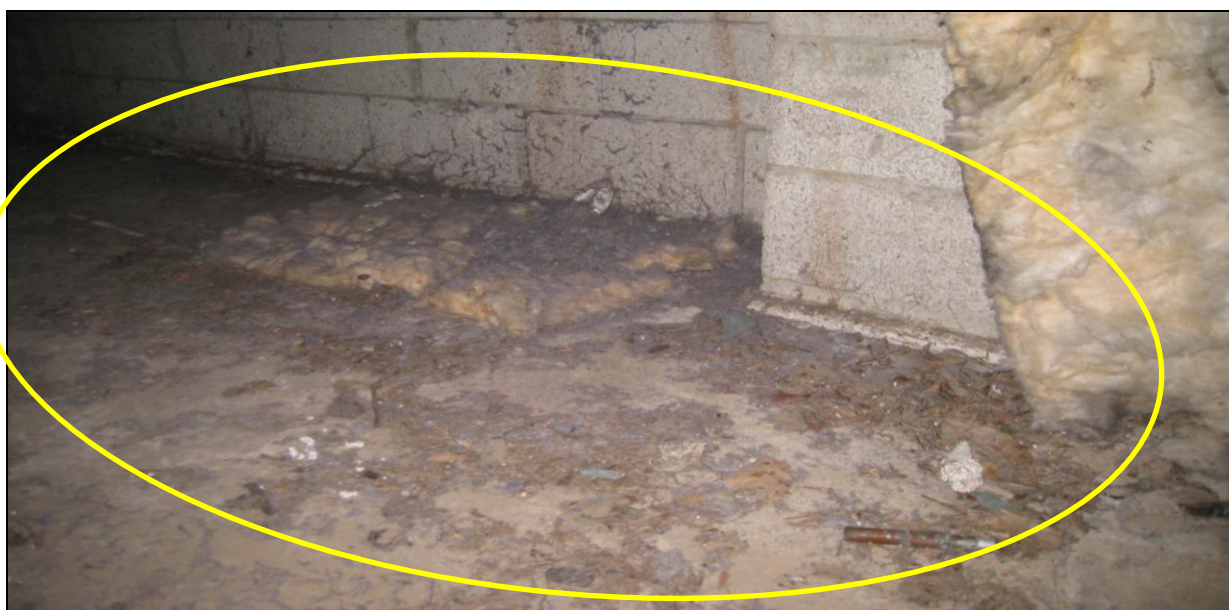
Figure 8 Heavy lint coating walls and floor in crawl space from disconnected dryer; correct venting and clean surfaces.

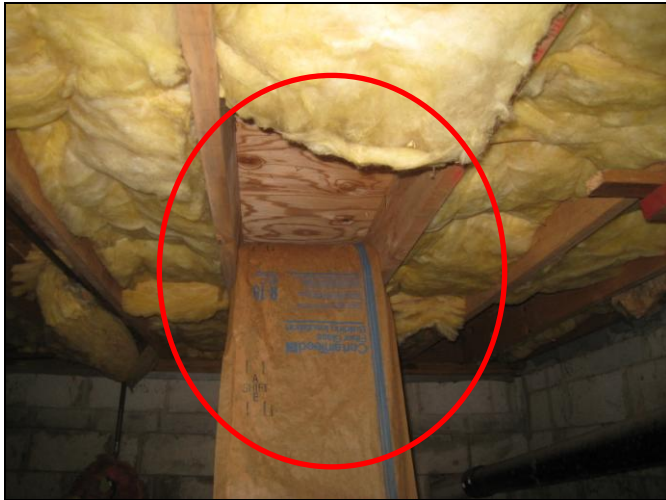
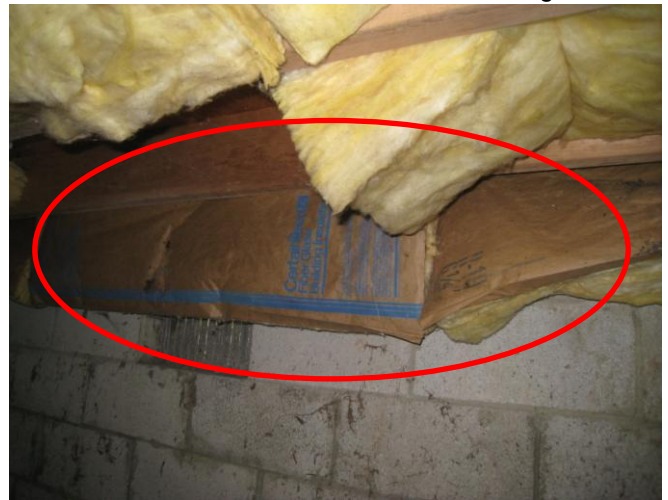
Figure 9 A & B Loose hanging insulation in crawl space.

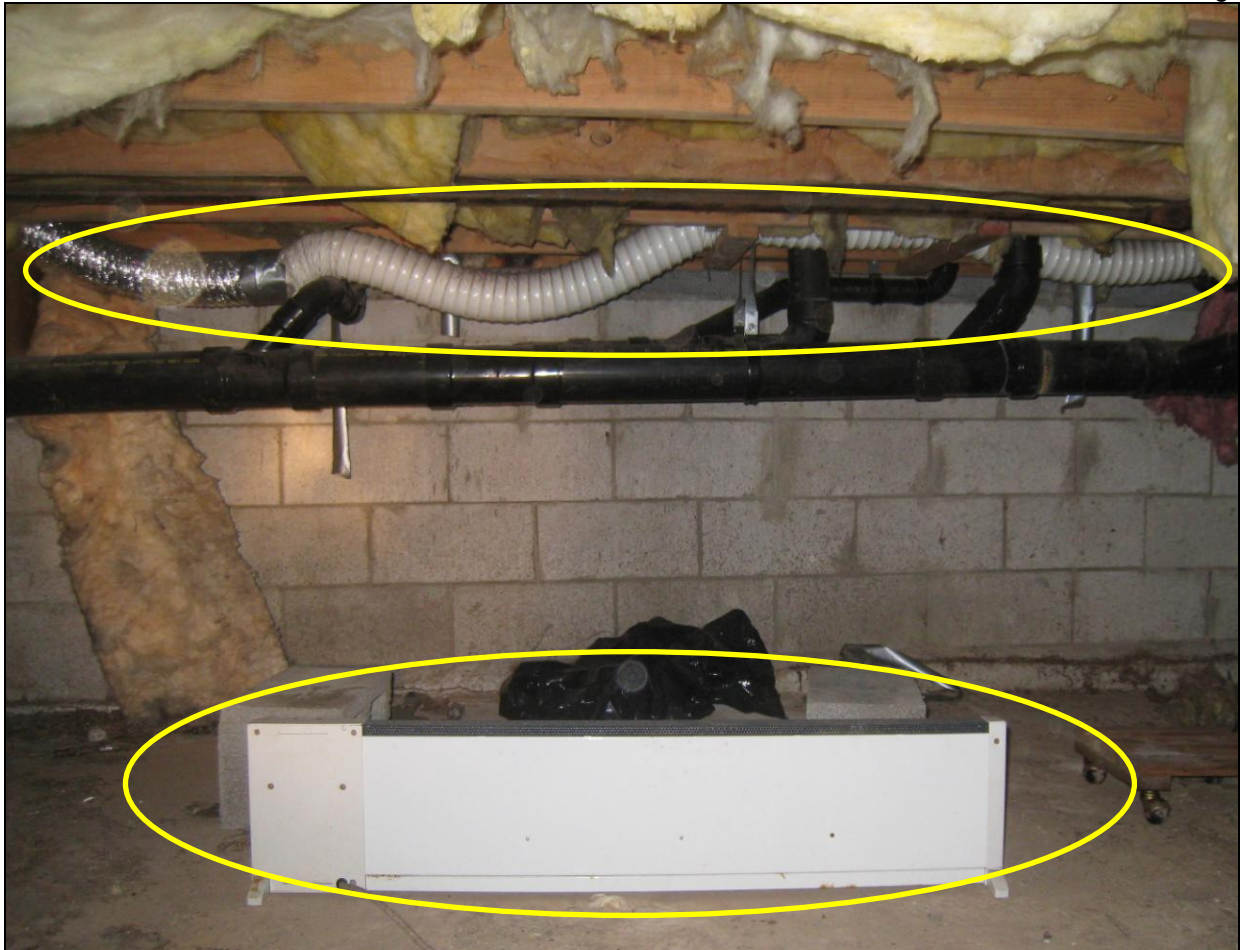
Figure 12 Electric Space heater below plumbing where repairs made. Have evaluated to install preventative measure to guard against freezing pipe, leaks, clogs and water main breaks. There is a flex vent disconnected on dryer and lint accumulating inside crawl space. Have ductwork replaced and clean yearly for fire safety.

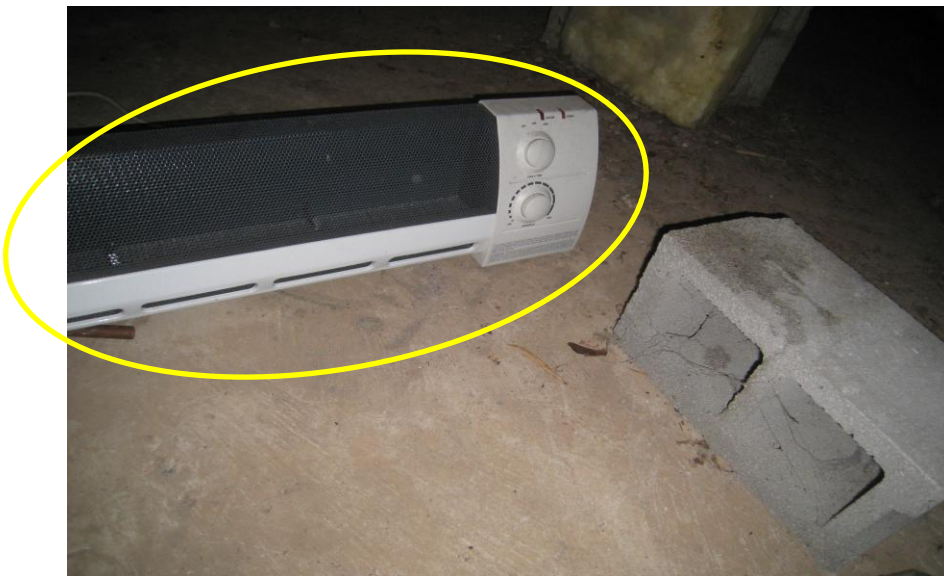
Figure 13 Long space heater under repaired pipes in crawl space; indication of freeze damage or improperly insulated plumbing.

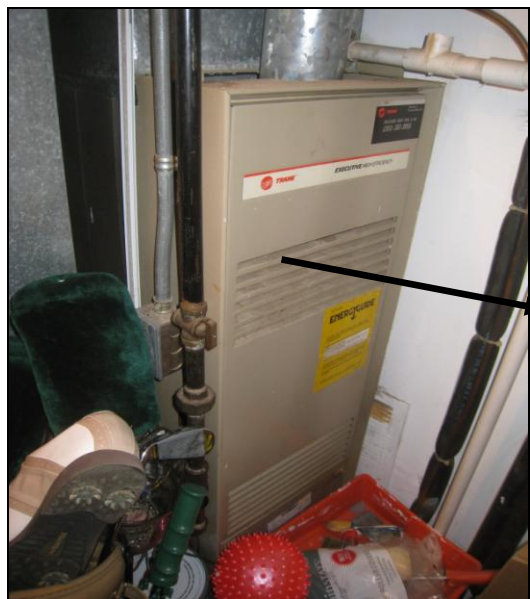
Figure 14 A & B Clutter poses a fire hazard in utility room. Heavy corrosion inside furnace; have evaluated now.
