# 4 Seasons Home Inspection, LLC

Inspection Date: June 09, 2018 Saturday 10am- 1pm  
Client Name: buyer (buyer@gmail.com)  
Inspection Address: # street town nj  
Emails: lawyer@aol.com  
Inspected by: Linda Geczi home inspection lic. #24GI00061500

Approximate Age: ~1941 (77yrs.)  
Style: Single family, Cape  
Main Entrance Faces: S  
State of Occupancy: Occupied  
Weather Conditions: 75-80°F  
Ground cover: damp

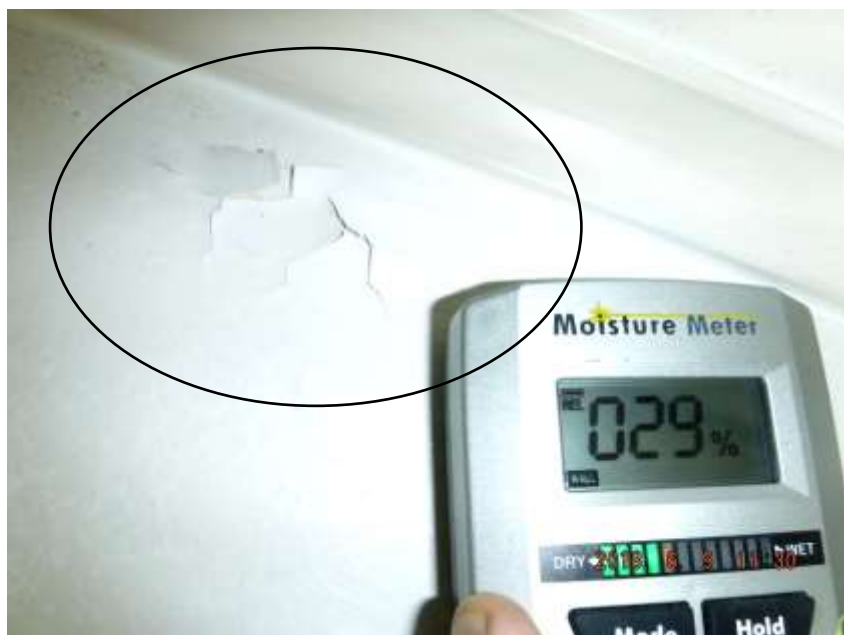
1. The home needs plumbing, electrical, bathrooms & kitchen upgrades; older or original to home.
2. There was peeled paint and water stain on ceiling; active moisture/roof leaks. See roofing section; past life.
3. There was only one heat vent or sources in this kitchen. Have an HVAC contractor evaluate home and advise on registers/returns and advise on adequate venting. See heating section comments.

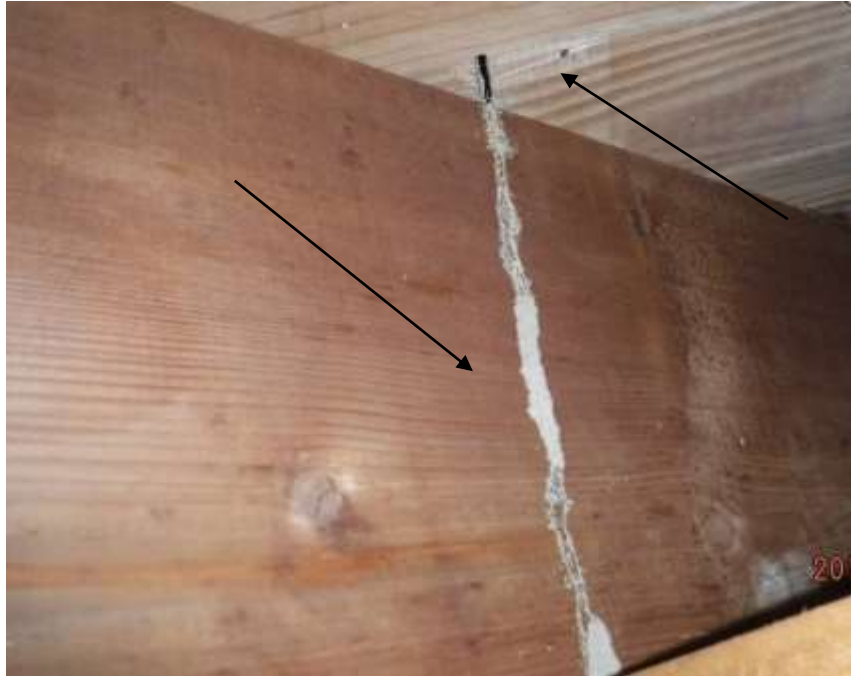
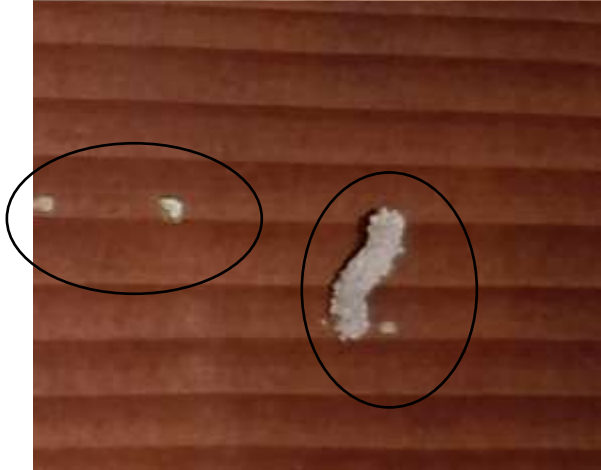
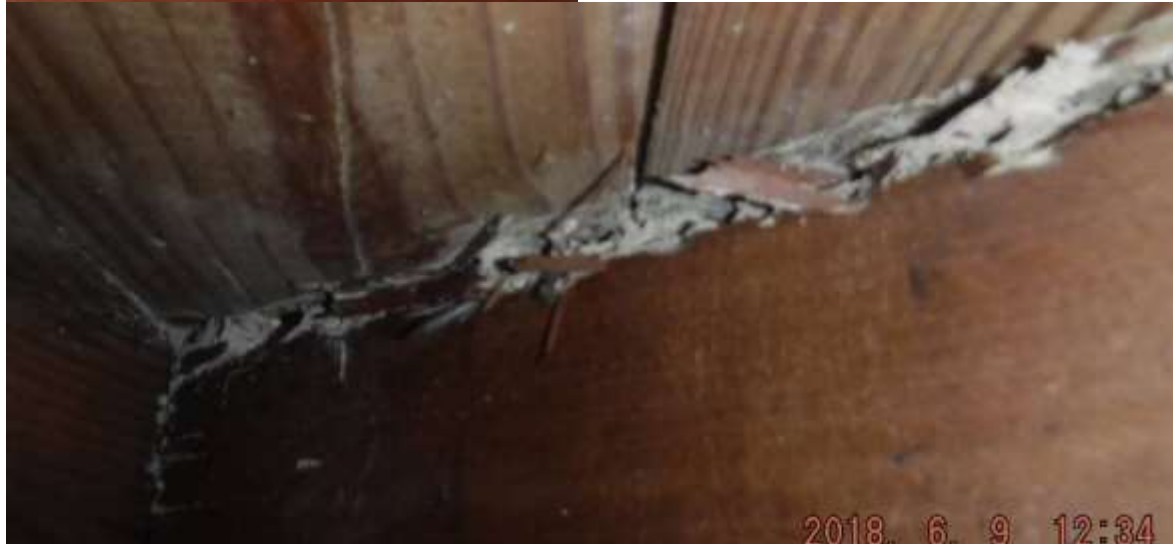
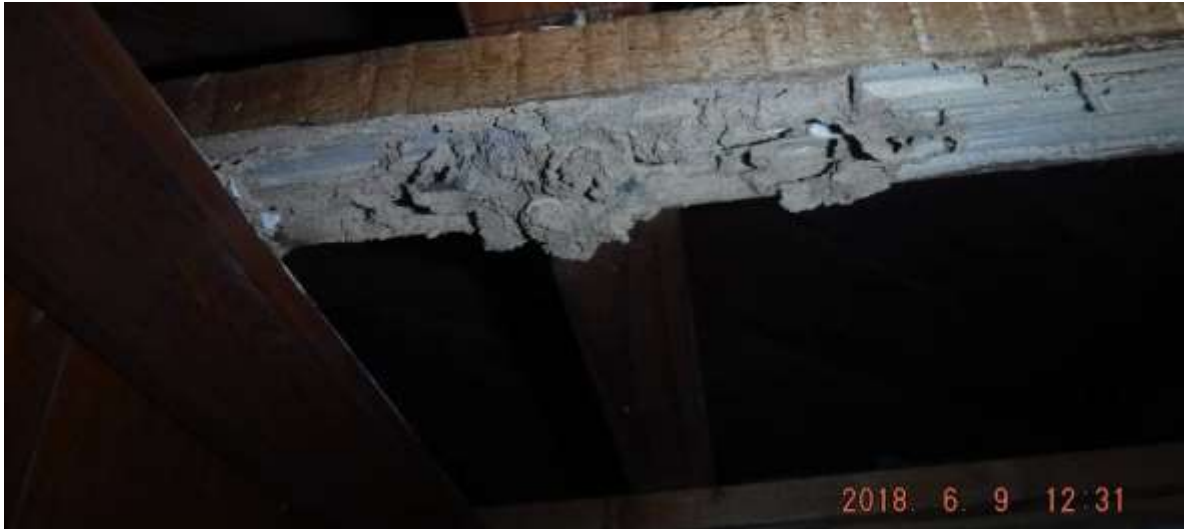
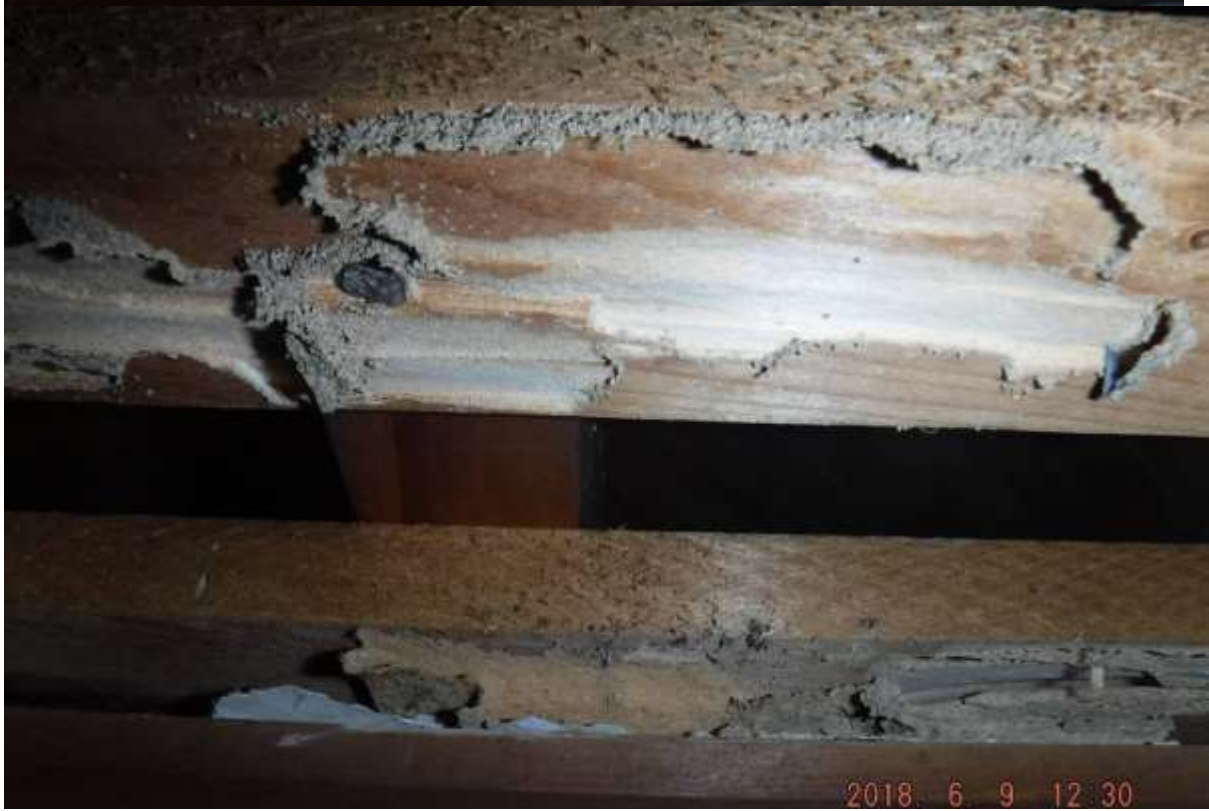
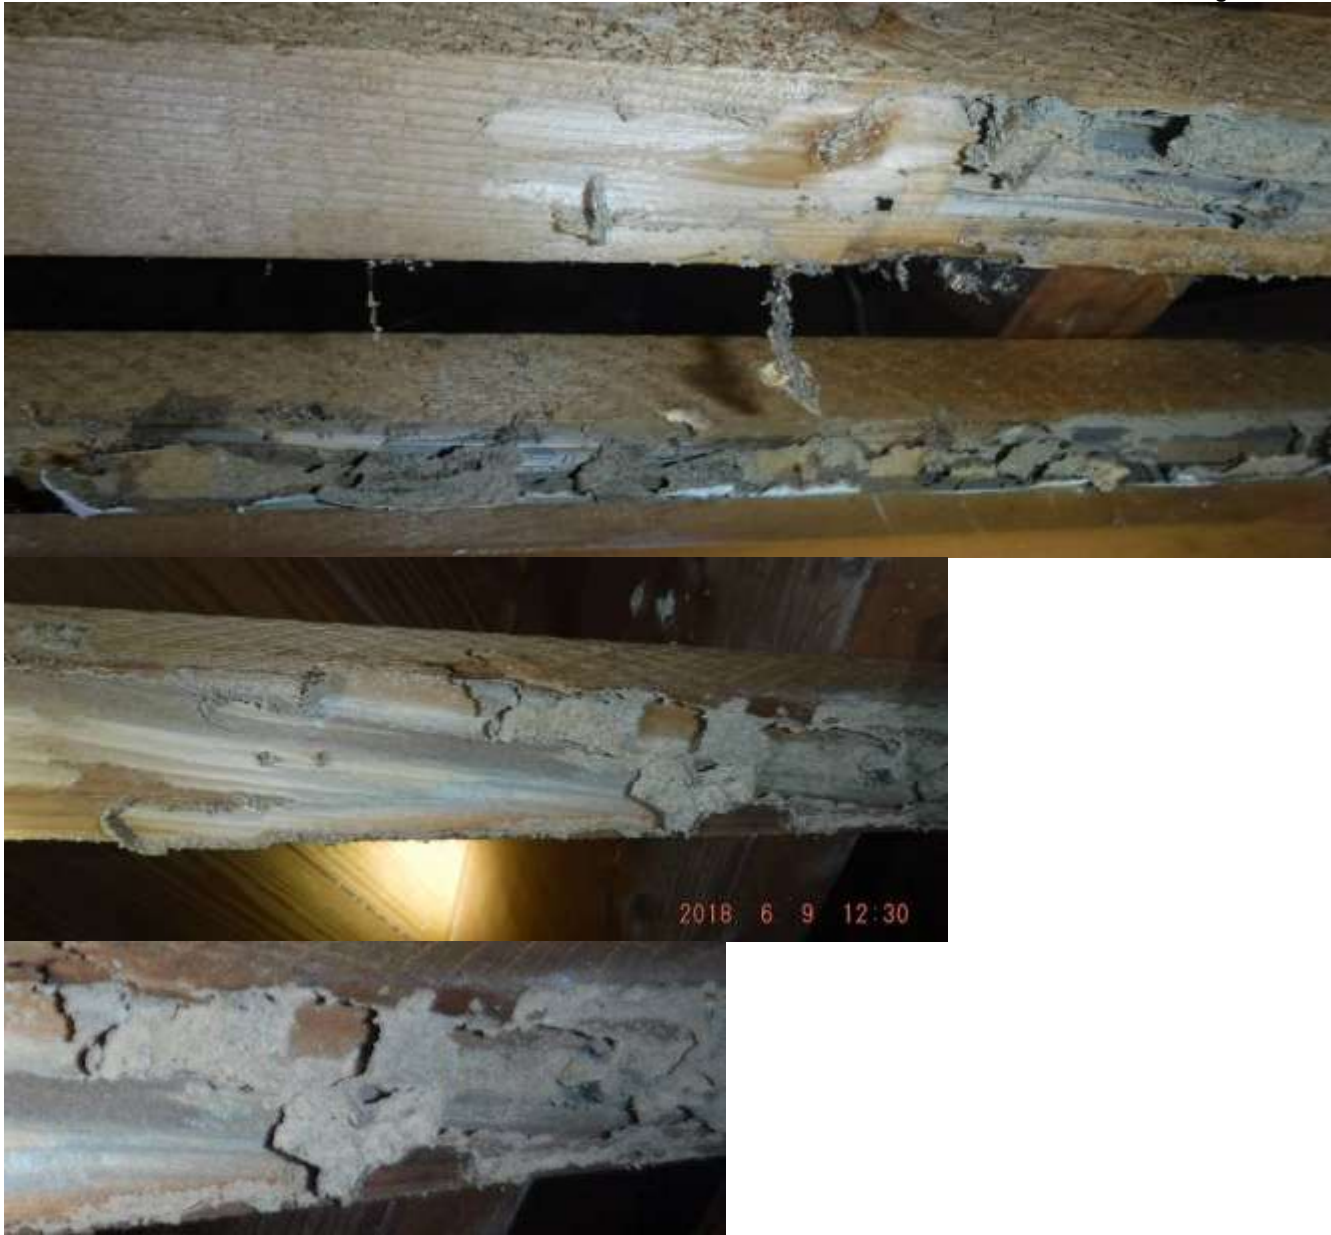
**Figure 11 Foundation cracks and termite shelter tubes; limited view peeking behind finished wall studs.**

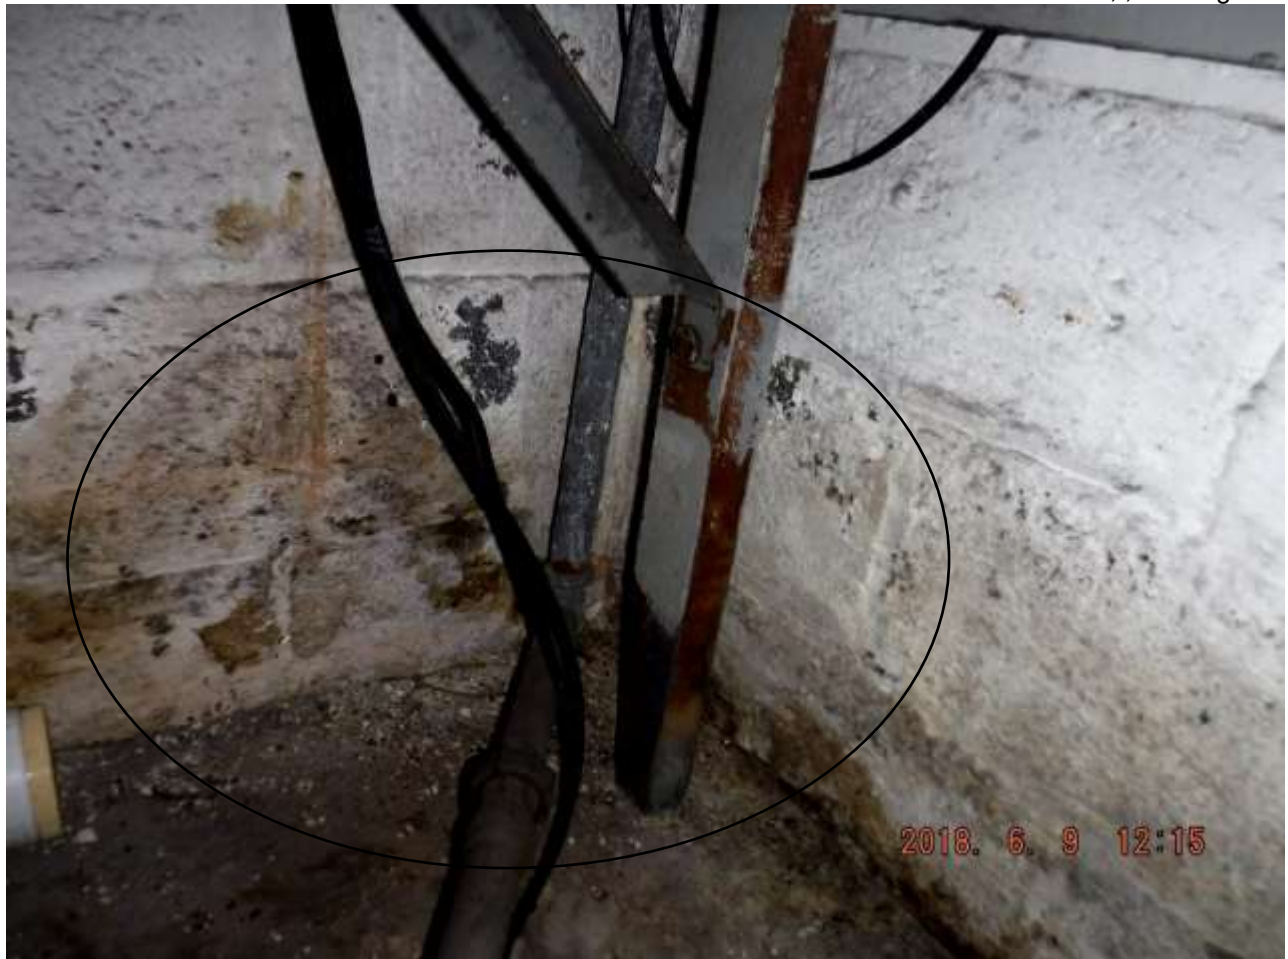
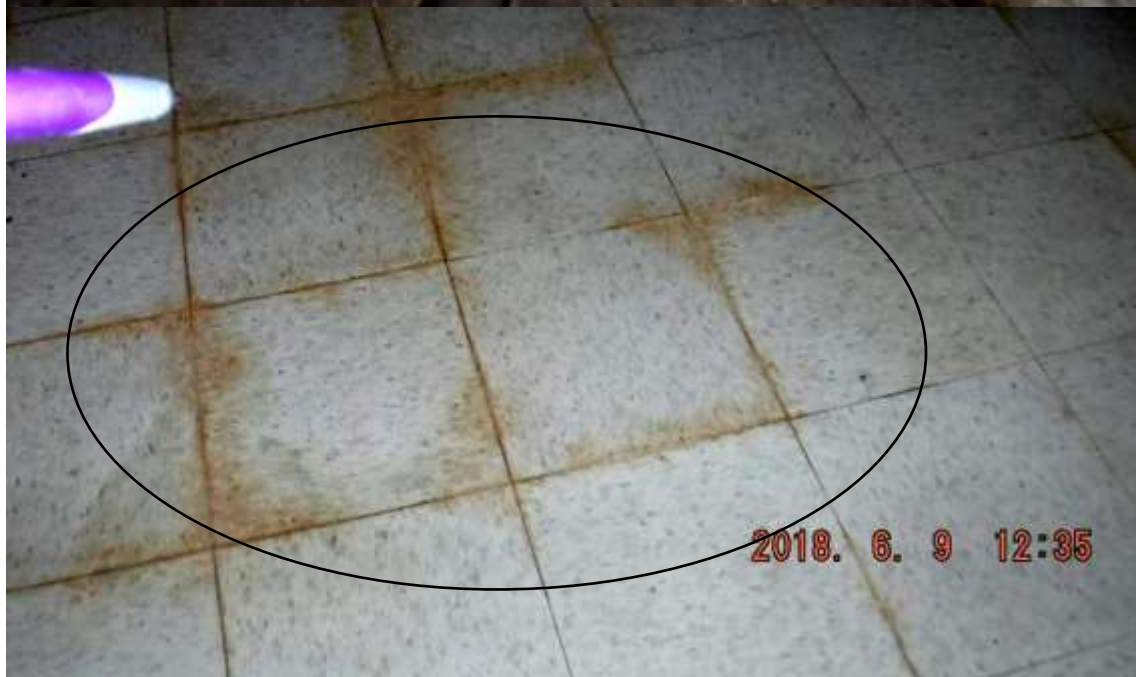
**Figure 14** Example of asbestos-like floor tiles; water damaged/broken. Follow-up with an asbestos or environmental contractor.
