4 Seasons Home Inspection, LLC

Inspection Date: February 26, 2018 Monday 12pm- 4pm
Client Name: buyer (buyer@gmail.com)
Emails: lawyer@aol.com
Inspection Address: # street town, nj xxxxx
Inspected by: Linda Geczi home inspection lic. #24GI00061500

BUILDING DATA

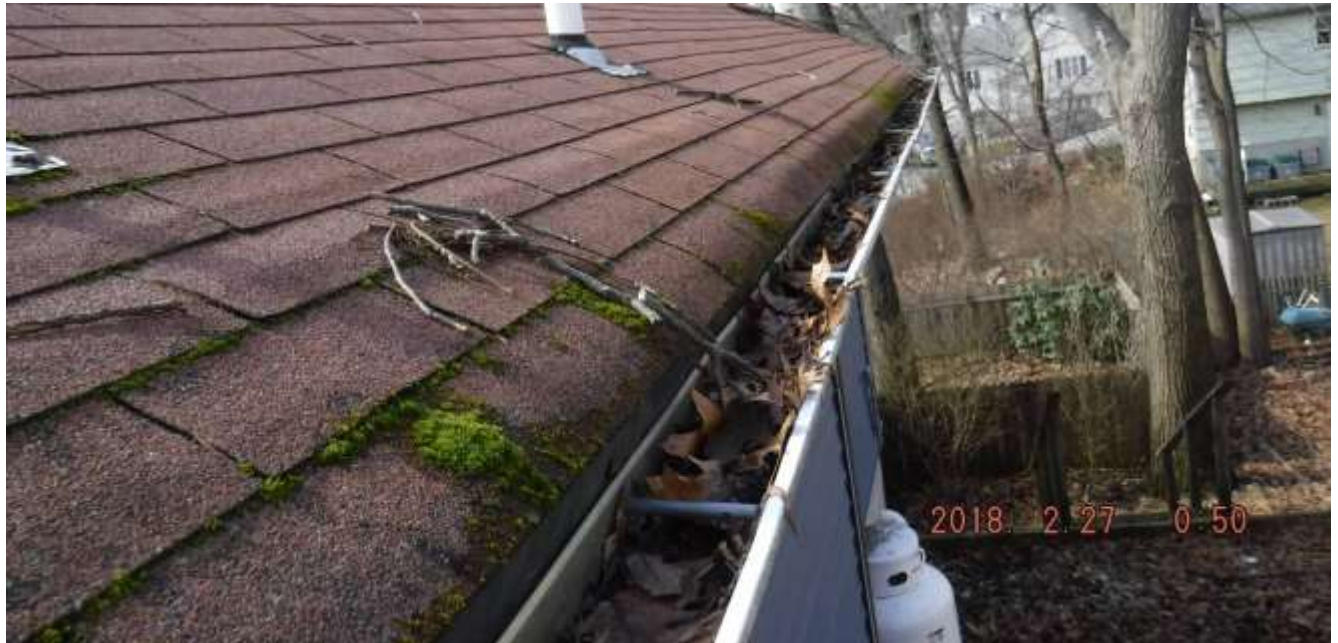
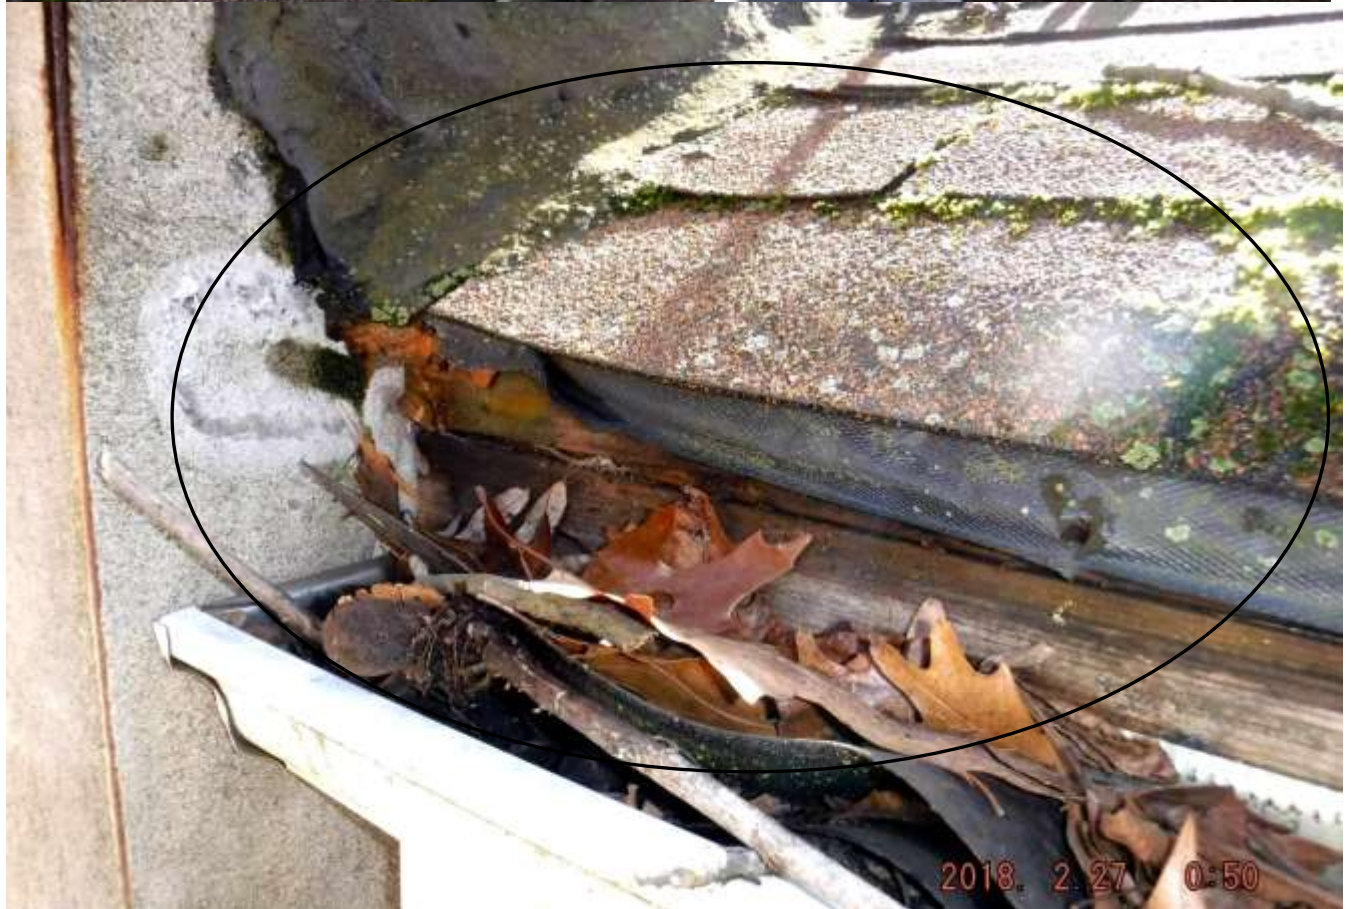
- 1. The roof was old and past expected life. There was granular/aggregate lose, curling, widening keyways, tarred/cracked roof junctures/chimney/penetrations, nail pops, cracking, brittle/sun or heat damage, exposed felt, moss build-up, chipped/broken edges, cupping, leaking around skylights (vapor seal breaks/cloudy), poor ventilation, etc.; poor condition. There was poor ventilation; see roofing section comments. There was pine sap beads on rafters/roof lumber and dark rings around roofing nails; indicative of hot humid attics. Ventilation appears inadequate. Hot humid attics will typically shorten life of roof, can potentially cause heat damage (splits, delamination, etc.) and conducive to mold/mildew. Recommend a building contractor and/or roofer evaluate roof for extent of wood/water damage, roof replacement (tear off), gutters, ventilation and skylights before closing & contractual limitations.**

Figure 2 Roof was in poor condition; have evaluated for replacement, metal/proper flashings (no tarring), skylights, ventilation, gutters.

Recommend roofer evaluate and advise on costs of roof/gutters/ventilation/skylights before closing

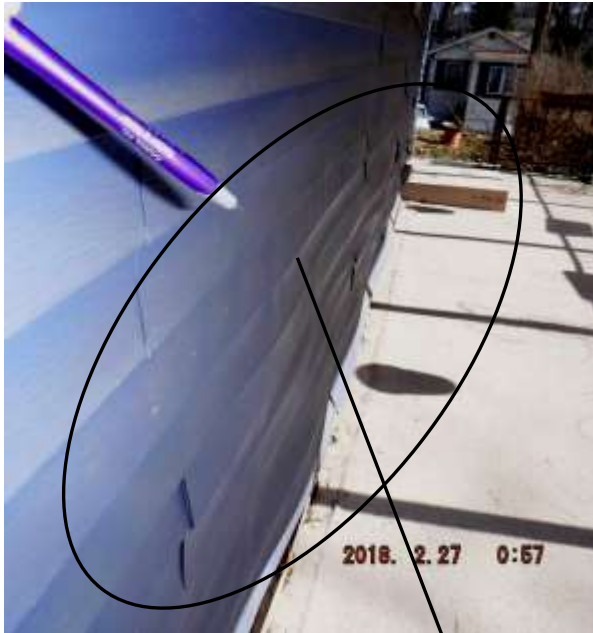
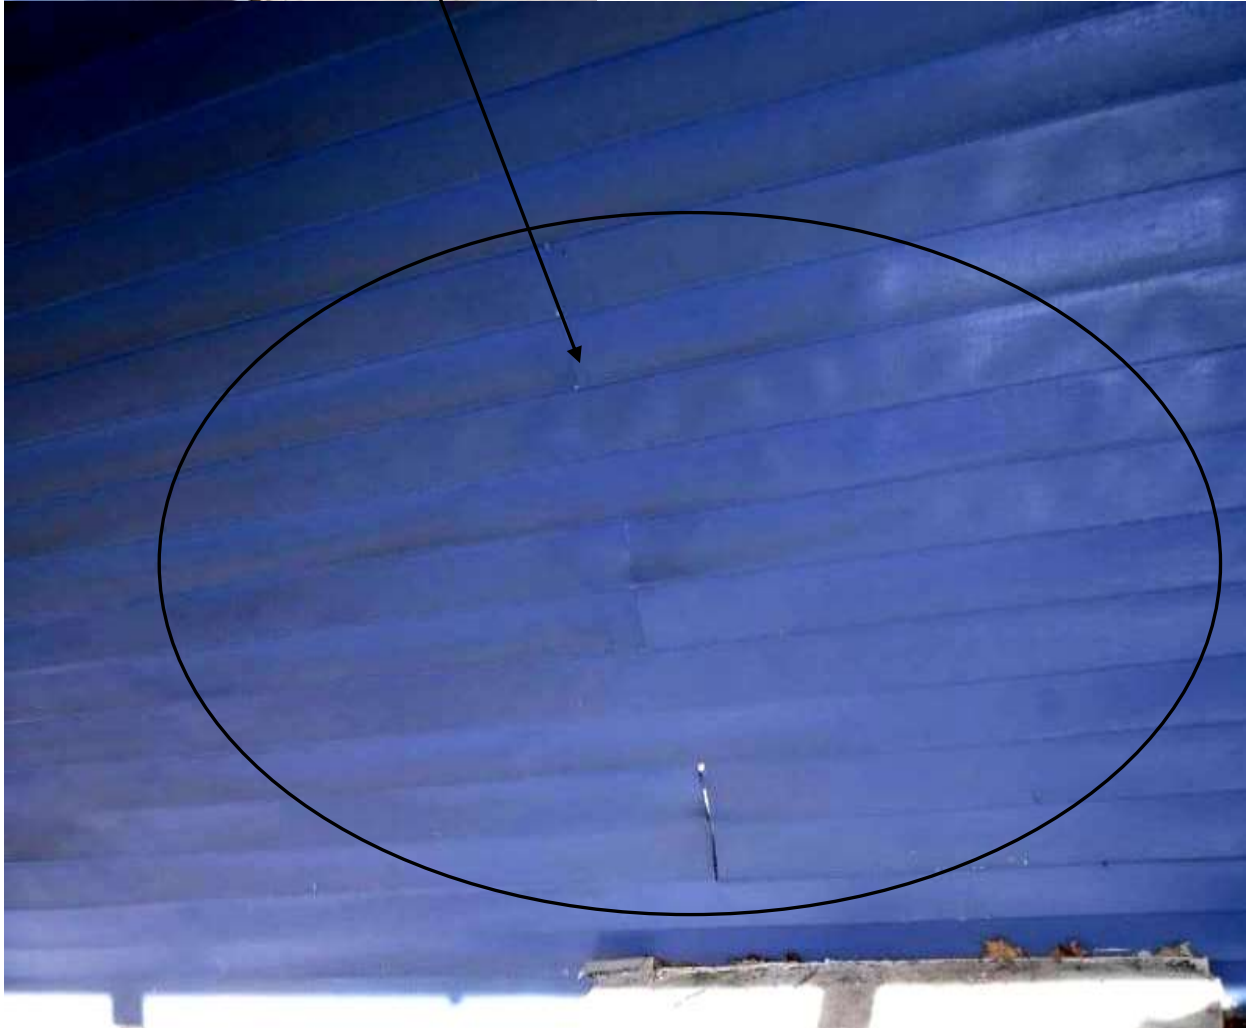
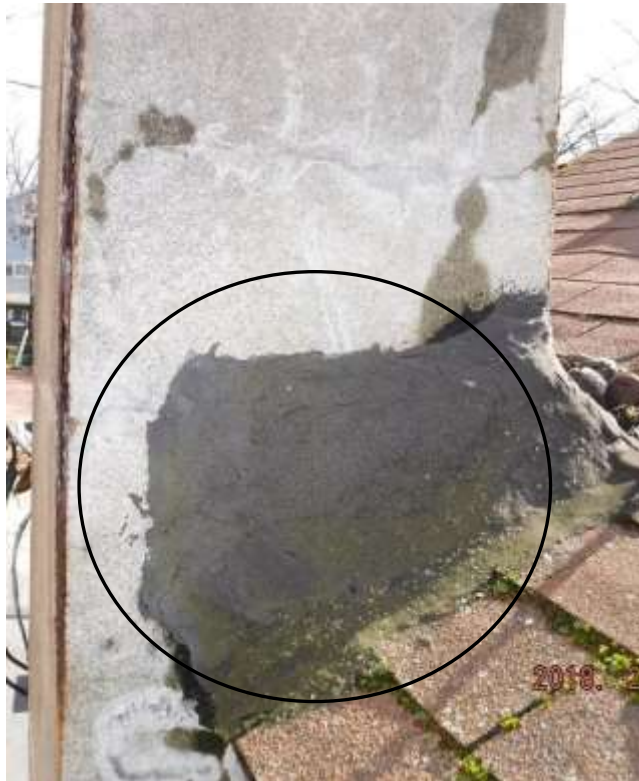
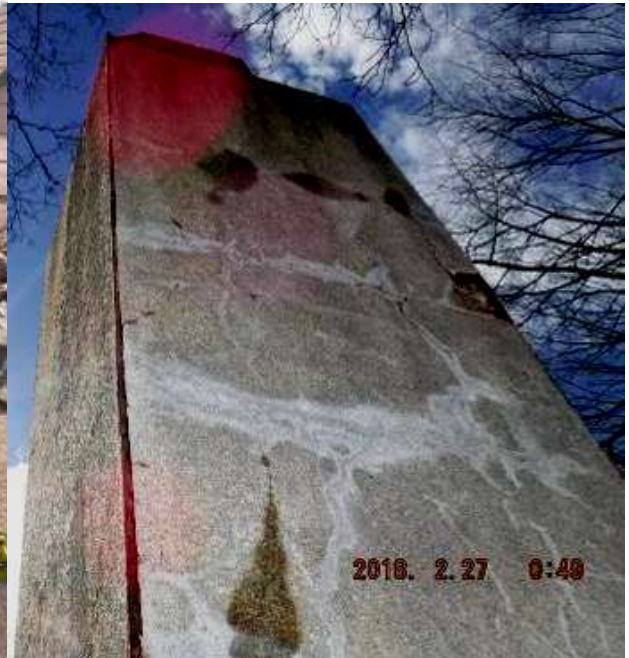
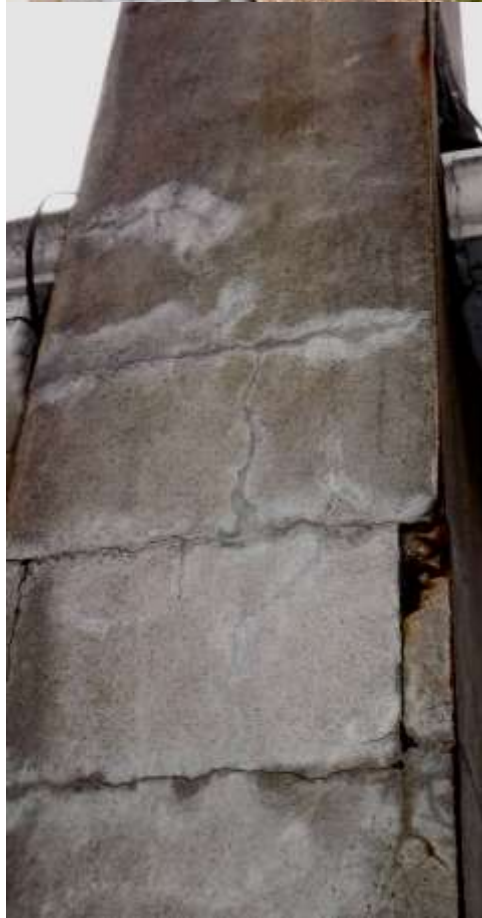
2. There was a through wall A/C unit improperly installed; gaps and open for water intrusion. Recommend a siding contractor evaluate & advise on proper installation and extent of all water & concealed damage. There was painted vinyl siding on left, right and rear side of home. The front was wood vertical siding or panels. The siding was in poor condition and unconventional installation (improper or handyman). There was siding with improper clearance to soil/ground, gaps/openings/separations/expansion spray foam, missing flashings/J-molding/capping/wrapping, exposed wood in rear to side of deck & corners, missing deck/house flashings, melted vinyl siding on left and right sides. There were foundation cracks, gaps and openings on foundation; mice or rodent droppings observed in the home and electrical panel. There were structural modifications & expansions made to the home; left side, rear addition, vaulted ceilings, enclosed doorway (by A/C living room) and basement deepened or lowered from a crawl space. Windows were in poor condition; extensive rot, missing flashings, exposed wood (not painted, no capping or flashings). The windows were not opened due to extensive rot and potential for them to not close back up if opened. There were structural defects in basement; girder/beam cracks, sagging/unsupported butt ends, moisture & wood destroying insect damaged beam (left side), etc. See structural comments; pg 2 main concerns and basement section. The homes exterior, structure & modifications should be evaluated by a building contractor and structural engineer (PE). The envelope of the home (roof, siding/exterior cladding, windows & doors) was in poor condition, water intrusion and damage observed. Rule out or determine extent of all concealed or hidden water, wood destroying insect damage, structural damage, etc. The rear basement door did not have a header and unconventional framing; improper installation. Recommend a siding & building contractor evaluate siding & trim/*heat damage & causes*/buckling/exterior, windows, doors, foundation and advise on all repairs including concealed or hidden damage before closing & contractual limitations.

Figure 4 Slab from an enclosed door in living room. Siding had heat damage and wavy or buckled; further evaluate siding and causes before closing and contractual limitations.

1. There was an apparent door enclosed by the through wall A/C; visible slab outside and outline on wall. Obtain closed permits for all structural modifications made to the home as required by the township before closing & contractual limitations.
2. There was sloping floors throughout the home; structural concerns/defects below in basement. See basement section and pg2 main concerns.
3. There is a through wall A/C unit in this room; see cooling section comments. The fan did not have a remote or a wall switch that worked and a black electrical wire hanging out of ceiling mount. Recommend an electrician evaluate fan & advise on repairs; not functioning.
4. The railing for basement should extend all the way across the steps for safety.

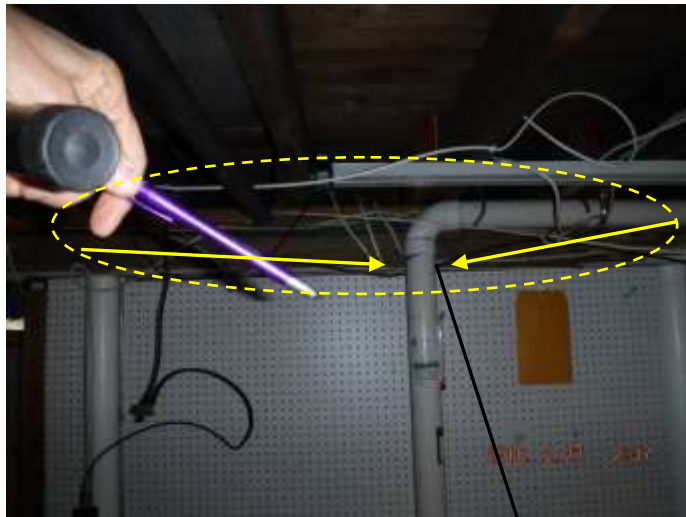
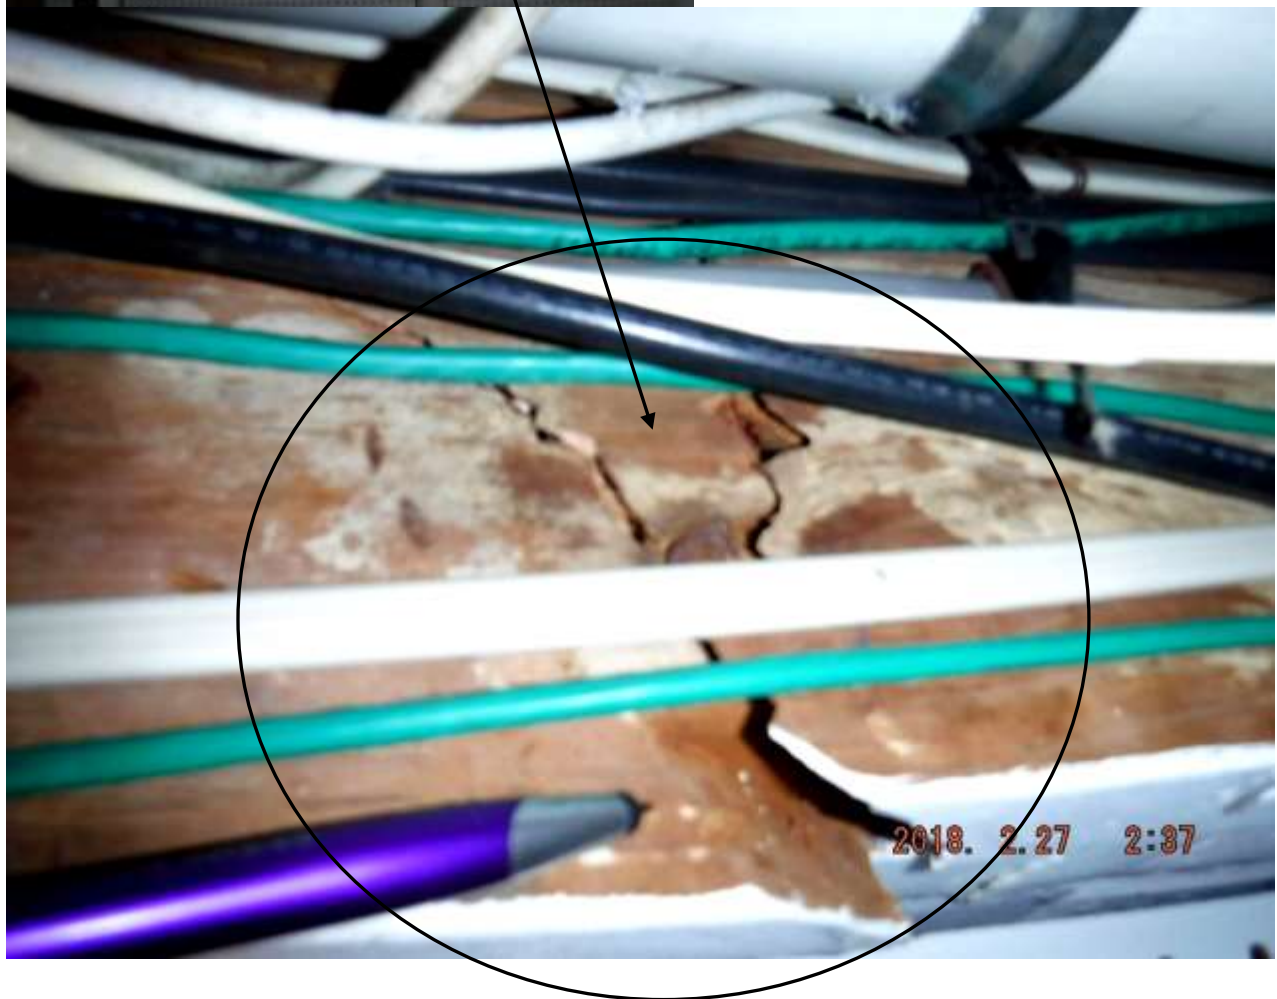
Figure 10 Broken/cracked built up beam on right basement; sloped flooring throughout the home.

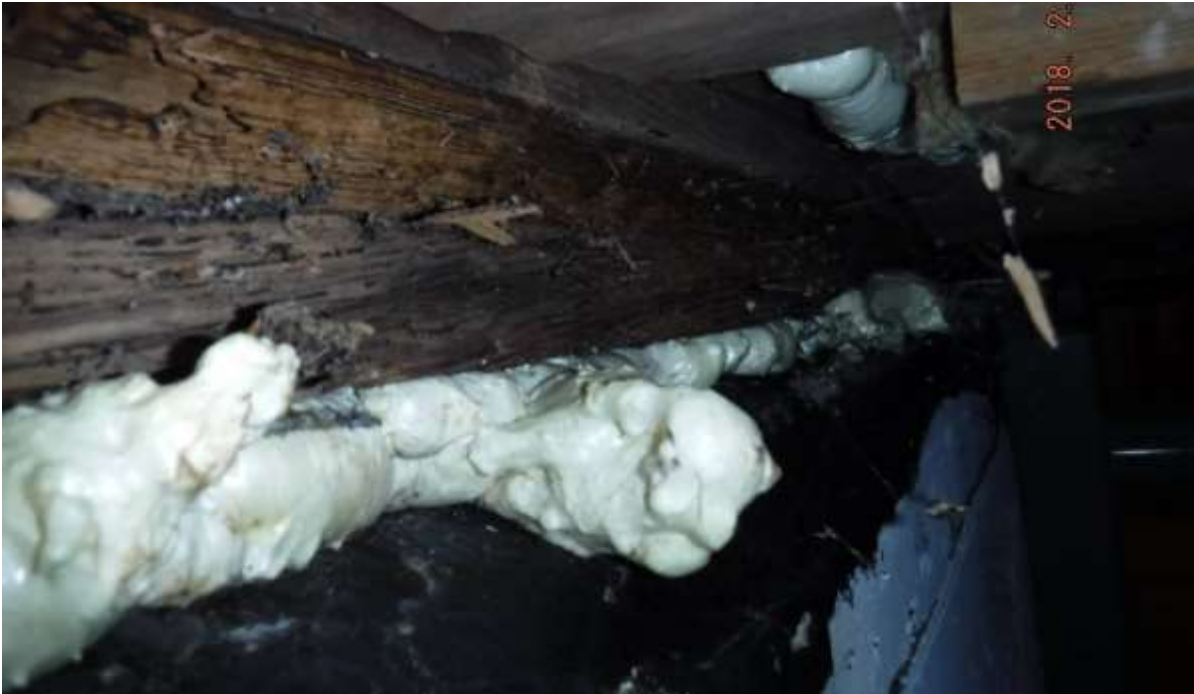
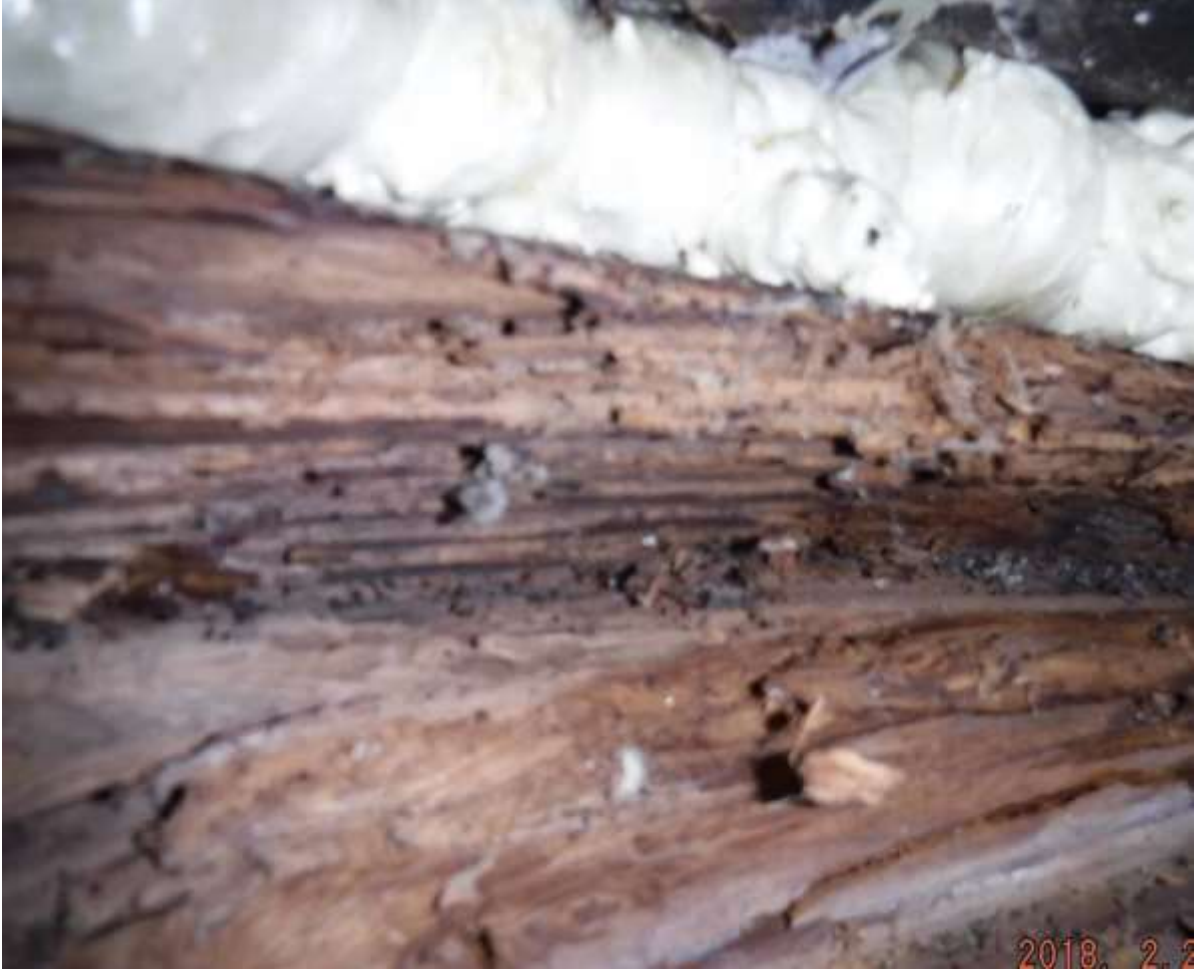
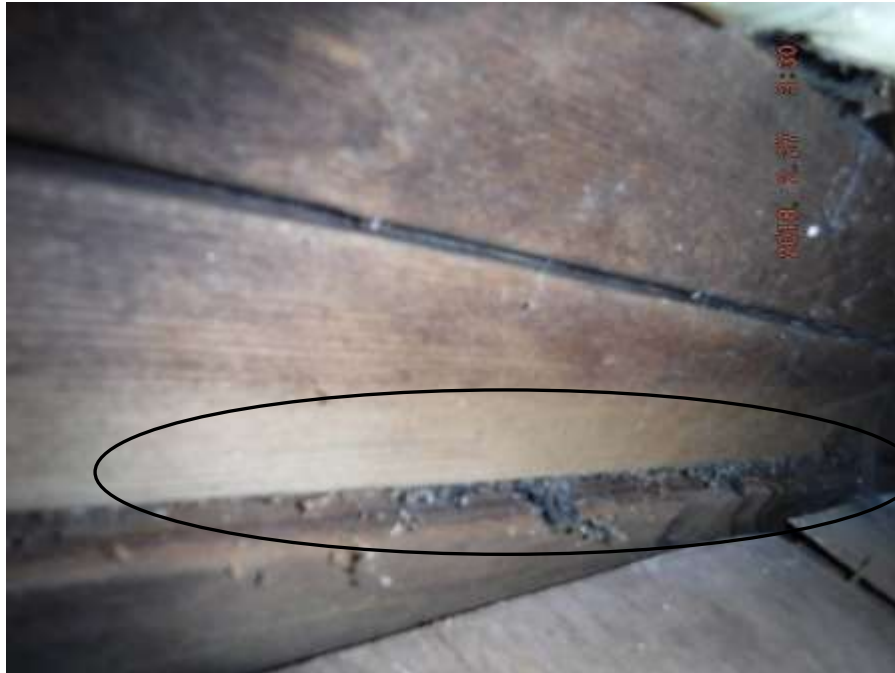
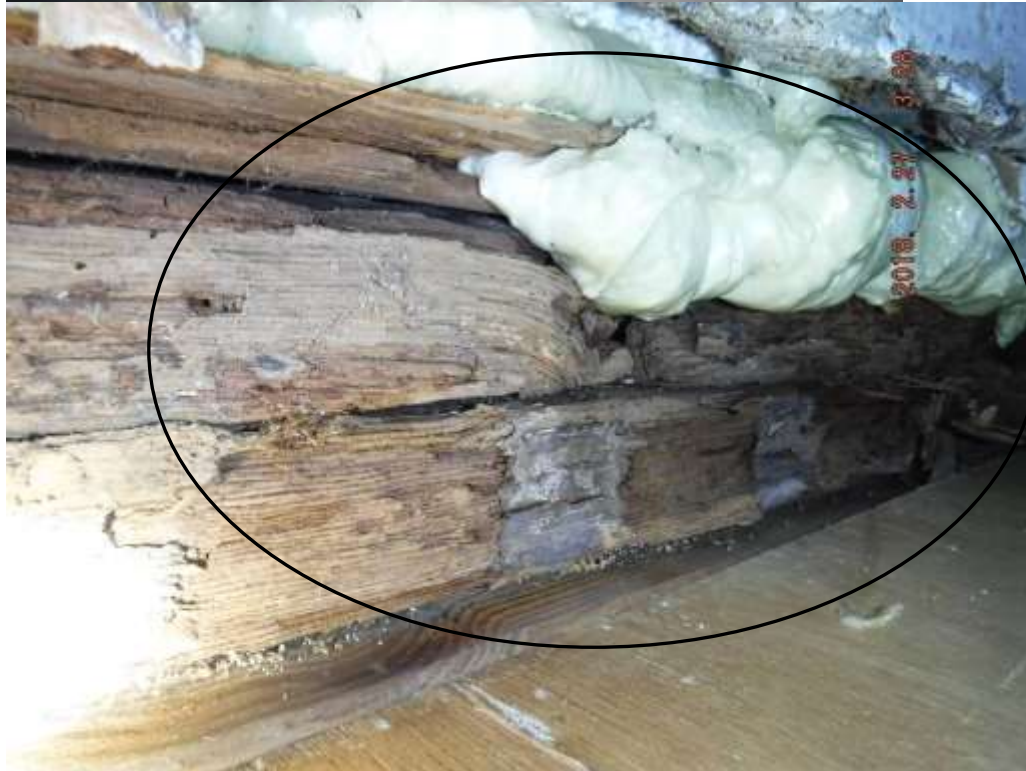
Figure 12 Moisture & carpenter ant damage to a beam on left side, mice droppings and carpenter ant frass.
