# 4 Seasons Home Inspection, LLC

## RECEIPT

Inspection Date: June 15, 2015 Monday 12pm- 3pm  
Client Name: Buyer ([buyer@gmail.com](mailto:buyer@gmail.com))  
Emails: [lawyer@gmail.com](mailto:lawyer@gmail.com)  
Inspection Address: # street, town , nj xxxxx  
Inspected by: Linda Gecz home inspection lic. #24GI00061500

## BUILDING DATA

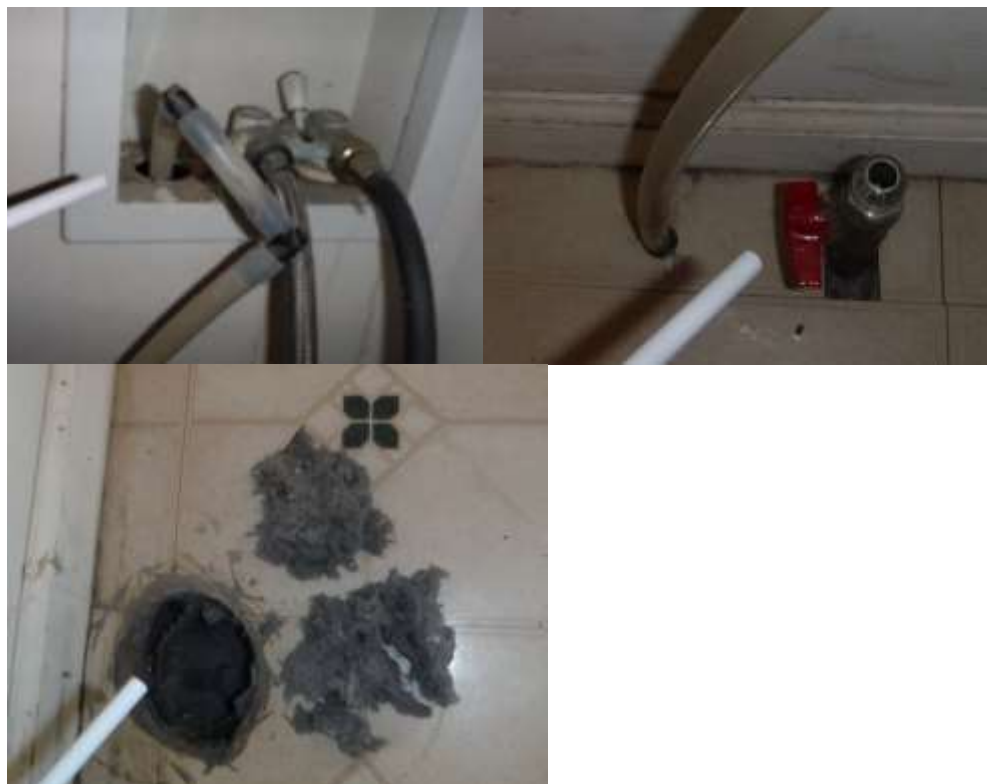
1. Recommend cleaning/replacing the dryer vent; clogged with lint/fire hazard.
2. Have gas pipe capped for safety; none present.
3. Recommend a plumber evaluate the condensate tube in the washer drain and advise on relocation.

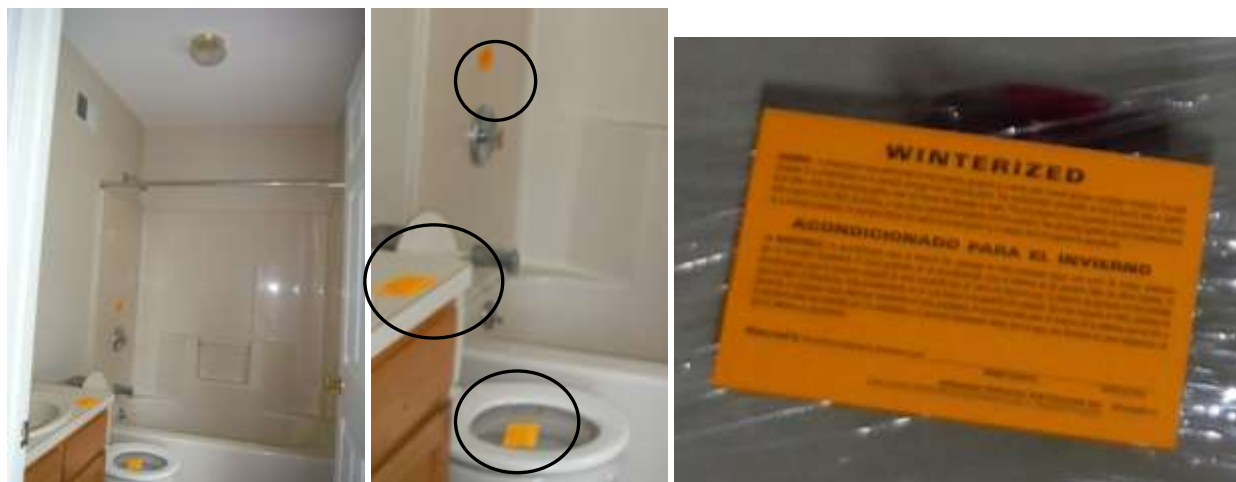
1. There was no exhaust fan and no window in bathroom; have a bathroom contractor evaluate and advise on ventilation.
2. Have a licensed plumber turn on hot water heater & evaluate all plumbing in home; "off" at time of inspection. See plumbing section comments.

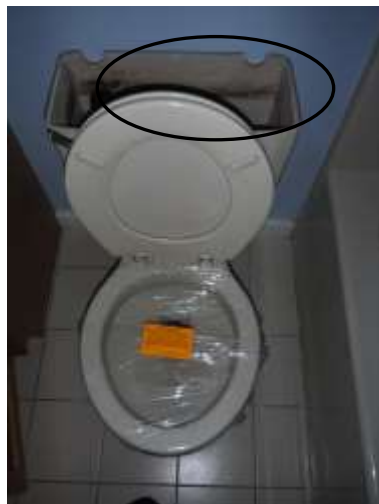
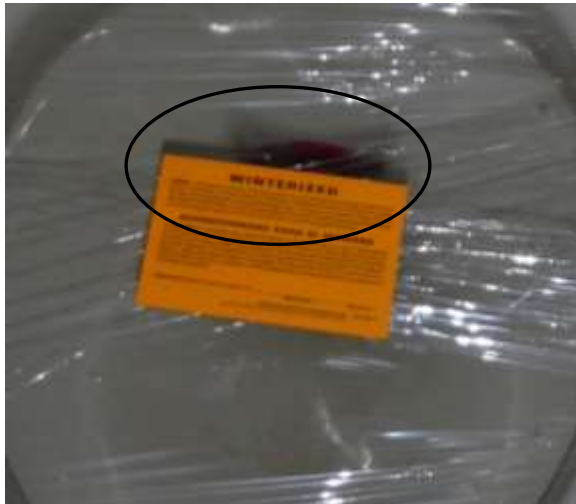
1. Have a licensed plumber turn on hot water heater & evaluate all plumbing in home; “off” at time of inspection. See plumbing section comments.

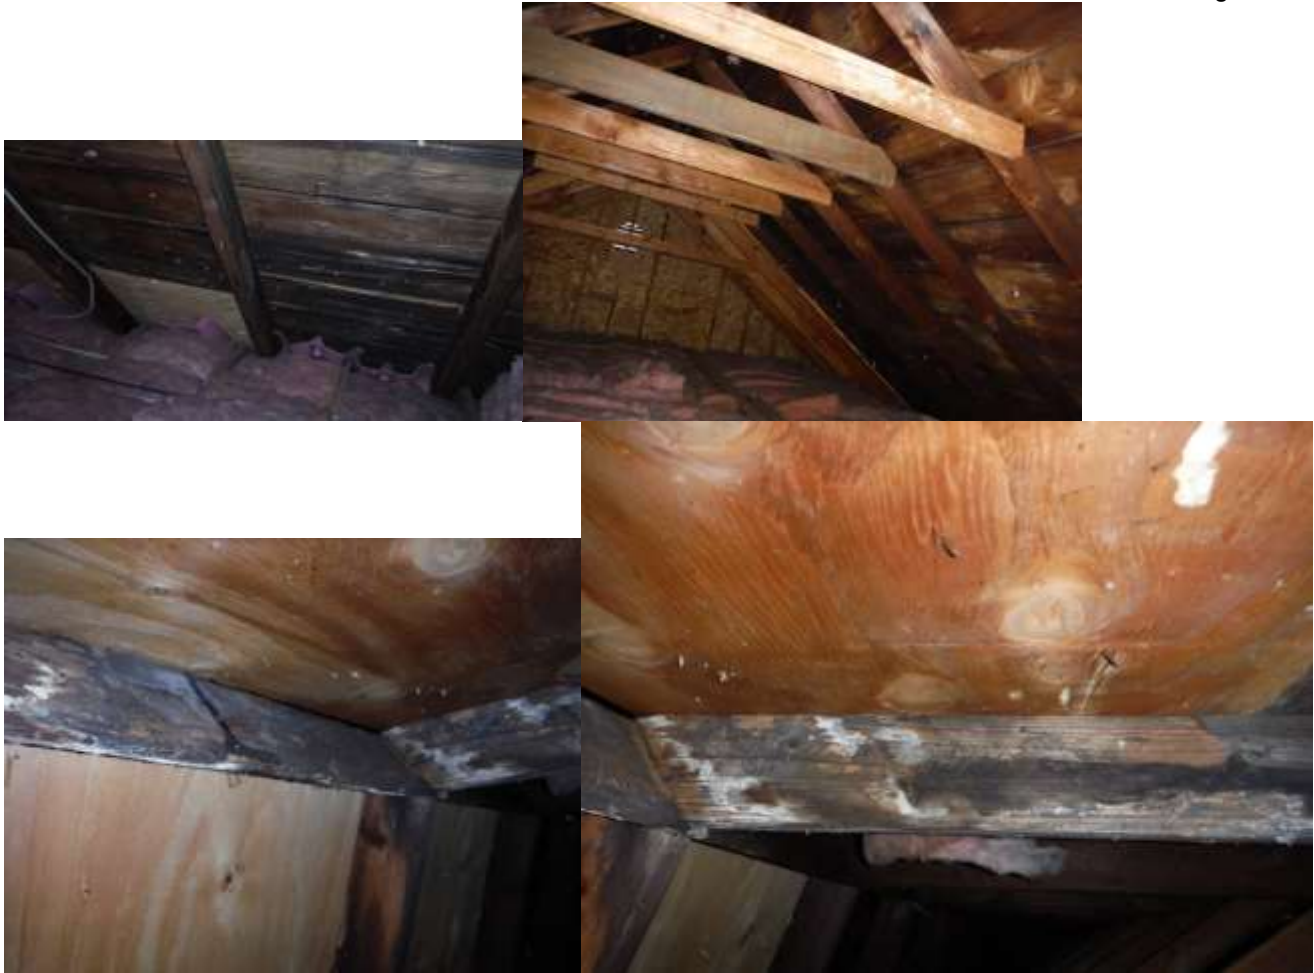
4. There were several roof vents and no ridge vent. There were pine sap beads on roof structure; very hot attic/poor ventilation. Attic needs more air flow; recommend adding baffles where missing in attic (insulation blocking perforrated soffits). Hot attics will shorten life of roof and promote conditions for mold & structural damage; have evaluated for more ventilation & baffles at eaves for air flow. There was white/gray film; possible mold. Mold identification, testing & inspection is beyond the scope of a home inspection; follow-up for mold & environmental testing with a qualified environmental company before closing.

5. There were loose wires, electrical boxes, missing covers, handyman wiring; have a licensed electrician evaluate and make all repairs/corrections for electrical/fire safety.

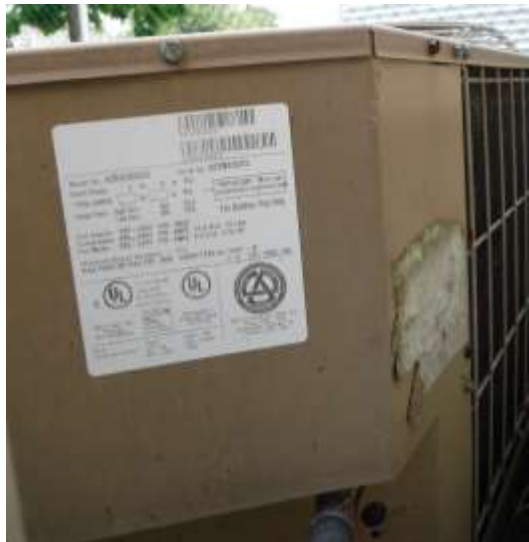
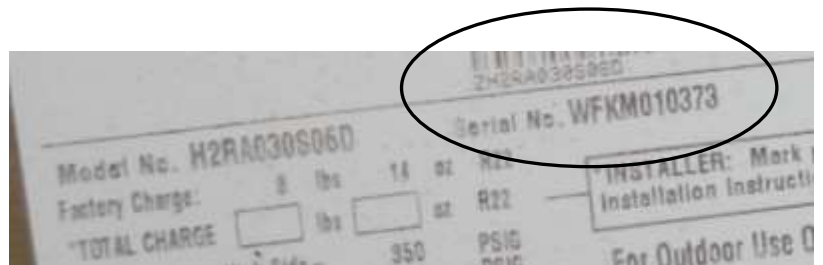
3. **COOLING:** The A/C condenser had damaged fins, oxidized/flaked off when touched and did not cool properly (~10-12F differential); poor condition. Recommend an HVAC contractor evaluate the cooling system for replacement; past expected life.

1. The A/C was not cooling properly and old/past expected life. Recommend a qualified HVAC contractor evaluate for replacement.

Figure 8 York condenser SN# WFKM010373 (K=2001)\*- past expected life/damaged fins & not cooling properly.
