# 4 Seasons Home Inspection, LLC

Inspection Date: May 03, 2018 Thursday 10am- 1pm  
 Client Name: buyers (buyer@gmail.com)  
 Emails: lawyer@aol.com  
 Inspection Address: # street town nj xxxxx  
 Inspected by: Linda Geczi home inspection lic. #24GI00061500

Approximate Age: ~1960's  
 Style: Single family  
 Main Entrance Faces: N  
 State of Occupancy: Occupied  
 Weather Conditions: 70 °F  
 Ground cover: damp

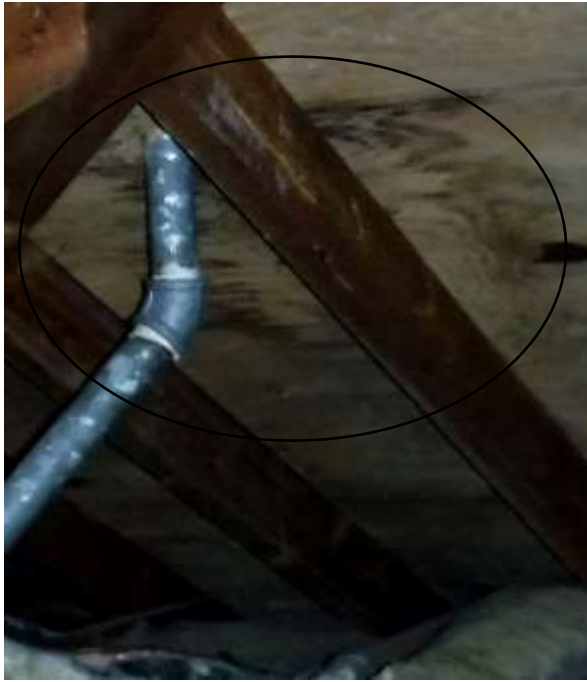
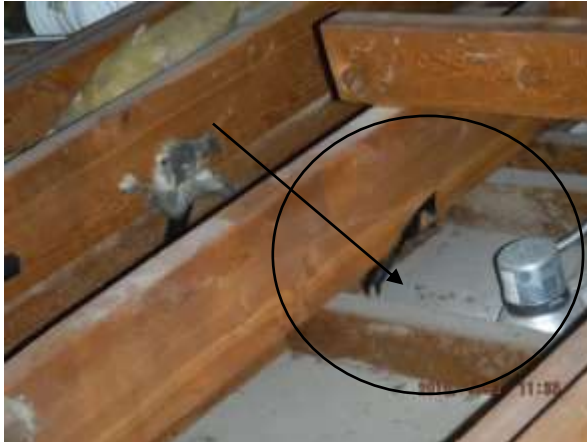
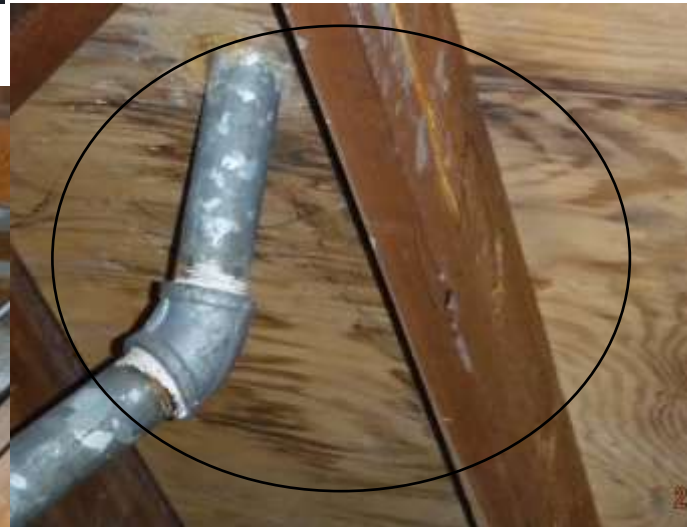
Figure 3 Example of dark mold like staining and pine sap beads; poor ventilation, hot & humid conditions.

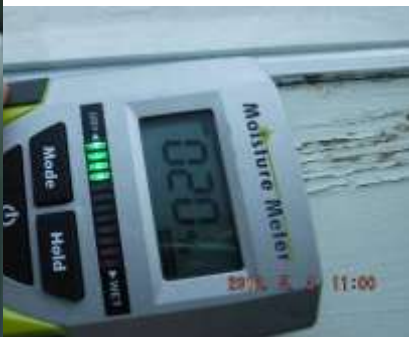
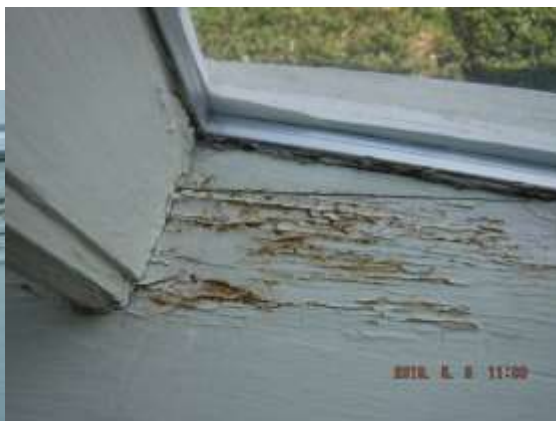
**Figure 8 Active leaking/moisture, water stains, flaking paint, vapor seal breaks, etc. Recommend a window installer evaluate window for replacement/repairs and rule out any concealed damage.**

1. **Recommend a window installer evaluate front window for replacement; active moisture/leaking, flaked paint and water stains.**
2. **The railing on steps was very loose and splits on the wood flooring around the railing. Recommend a carpenter evaluate the railing and make repairs.**
