## 4 Seasons Home Inspection, LLC

### buyer # street Town nj xxxxx

Inspection Date: June 05, 2015 Friday 10am- 2:45pm

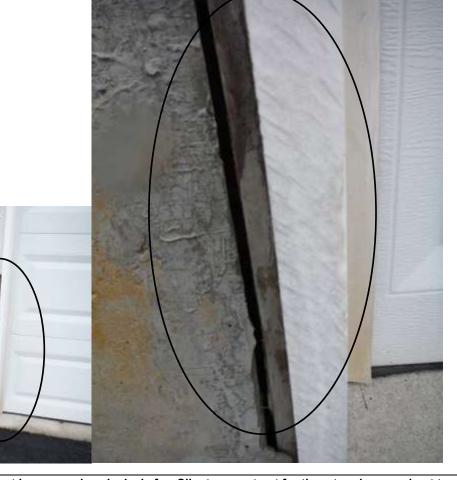
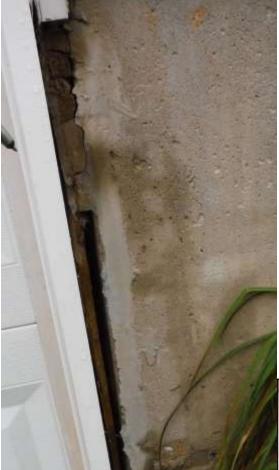
EXTERIOR/ELECTRICAL/A/C/HEAT PUMP/GARAGE: The trim around the garage doors were torn and need replacement to keep out rodents, water, weather elements. Mice and rodents can chew on electrical wiring and cause damage and health issues. There were wide gaps around the foundation (cement) and garage doors; have a structural mason evaluate/repair; water, rodents, insects can enter these gaps. Recommend having the garage door auto reverse devices adjusted for safety on both doors; did not work. There was termite tubes on rear right inner wall and tubes on a cabinet and between the drywall and foundation walls adjacent to the family room. Have the drywall removed by structural carpenter and evaluate for any concealed termite/WDI damage. The termite shelter tubes were broken open in a few spots and the live termite were visible scattering when opened. The garage was packed with storage (floor & perimeter) and inaccessible. Have all storage removed from walls for structural carpenter evaluation & determination of damage, repairs or ruling out hidden damage.

- 1. There was termite tubes on rear right inner wall and tubes on a cabinet and between the drywall and foundation walls adjacent to the family room. Have the drywall removed by structural carpenter and evaluate for any concealed termite/WDI damage. The termite shelter tubes were broken open in a few spots and the live termite were visible scattering when opened. The garage was packed with storage (floor & perimeter) and inaccessible. Have all storage removed from walls for structural carpenter evaluation & determination of damage, repairs or ruling out hidden damage.
- 2. There were gaps & exposed wood/door framing around garage doors; potential water, insect and rodent entry points. Recommend a building contractor evaluate for repairs/flashings/wrapping etc.
- 3. Pressure reverse-needs to be adjusted & retest safety devices on both doors for safety.

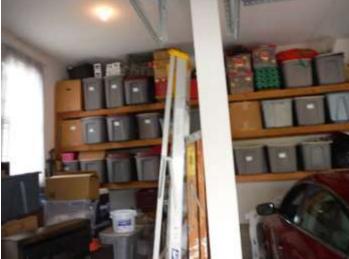
Figure 2 Garage had wall to wall & perimeter storage everywhere; inaccessible. Have removed and inspected for termite & structure before closing. See NPMA-33 Termite report.

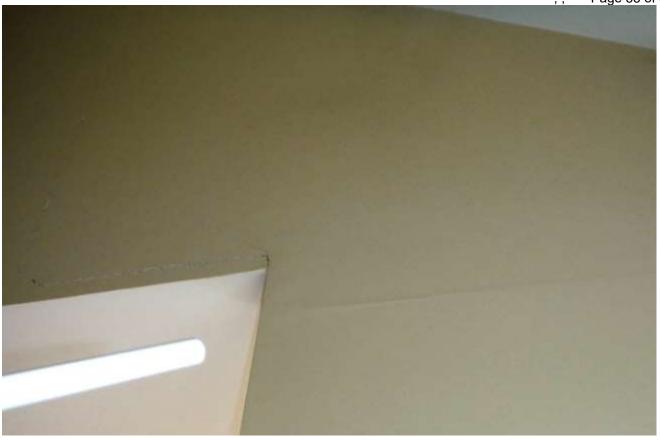
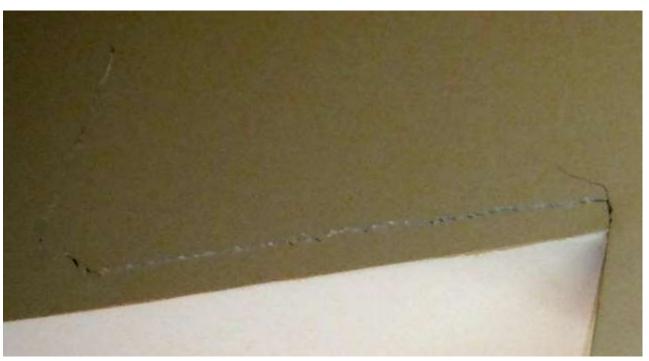
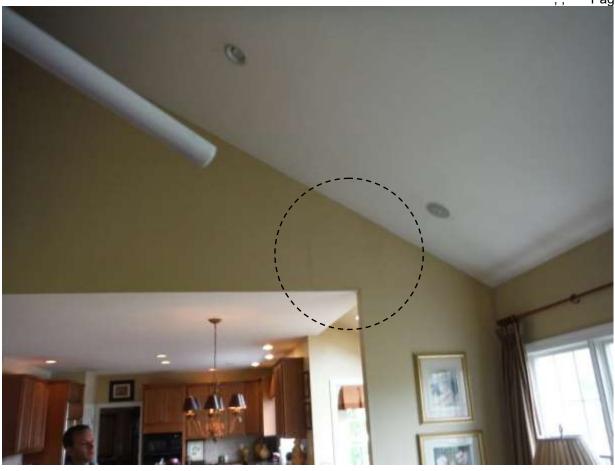
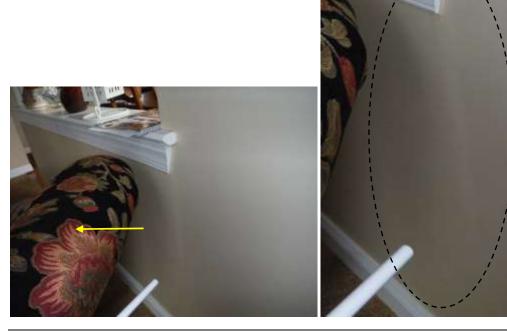
- 1. Have a building contractor and/or structural carpenter evaluate the cracks & bulges wall adjacent to the kitchen. Have a structural carpenter evaluate garage & adjacent or finished areas to rule out concealed or hidden termite damage. See garage section comments and the NPMA-33 Termite report.
- 2. Recommend having the gas fireplace turned on and tested before closing. There is a gas fireplace in this room; logs had heavy soot, heat damage and cracked logs. Recommend having a fireplace company and licensed plumber evaluate the gas/air fuel mix/ratio and components.
