4 Seasons Home Inspection, LLC

Inspection Date:	October 24, 2015 Saturday 1-5 pm
Client Name:	Robert & Donna (name@gmail.com)
Emails:	lawyer@gmail, realtor@gmail
Inspection Address:	#street, west NJ xxxxx
Inspected by:	Linda Geczi building inspection lic. #24GI00061500

Approximate Age:	1880s build
	With recent renovations past 10+ yrs.
Style:	Light commercial/Luncheonette/Catering
Main Entrance Faces:	N
State of Occupancy:	Occupied business
Weather Conditions:	~48-50°F
Ground cover:	dry

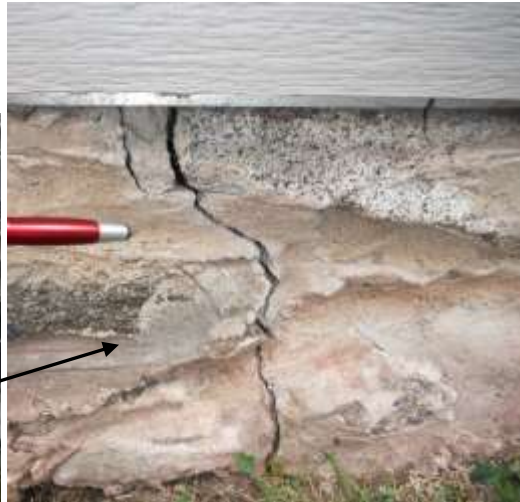
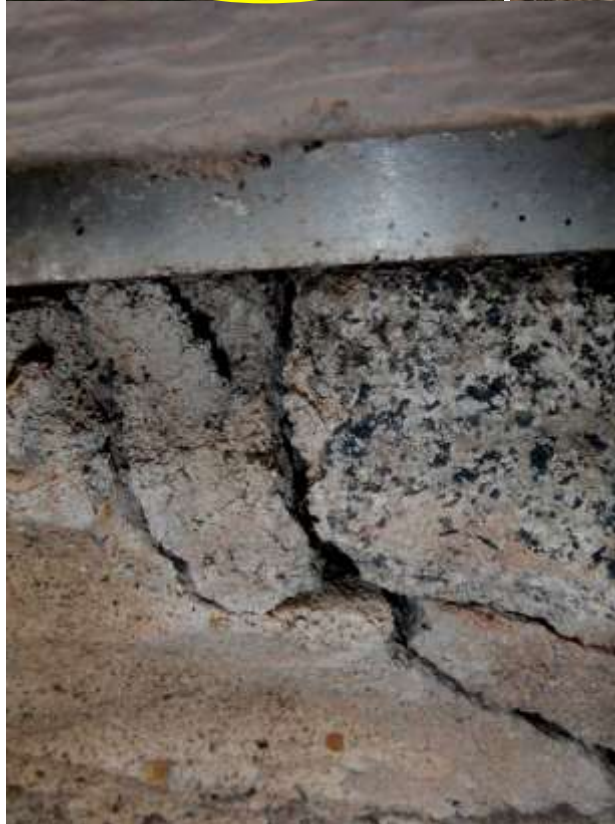
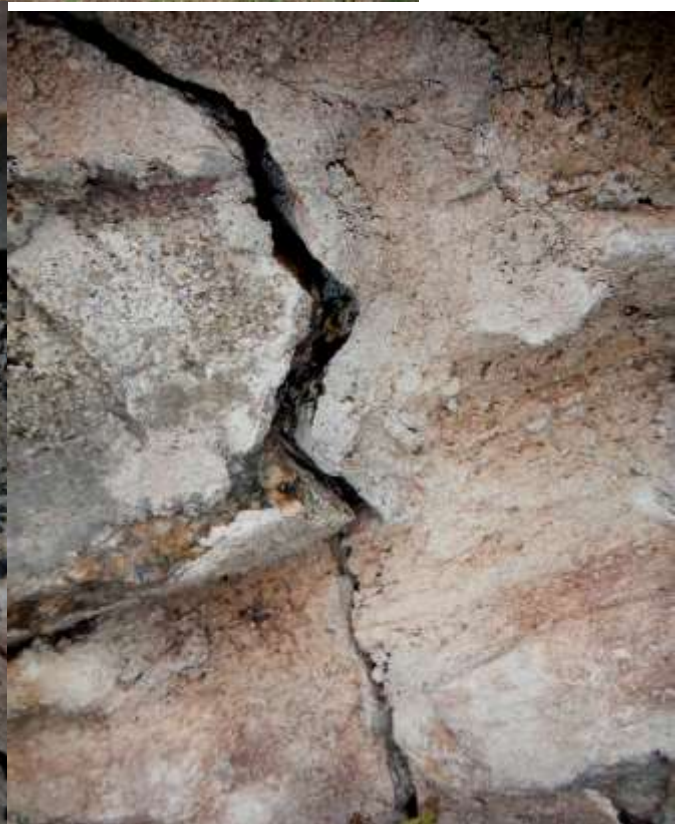
Figure 3 Bowed wall and foundation; left side building. Recommend a structural mason evaluate foundation and advise on repair, repointing, etc. Have a siding contractor or qualified building contractor evaluate bowed wall, loose siding and advise. Recommend a structural engineer (PE) evaluate structure and advise on any structural repairs.

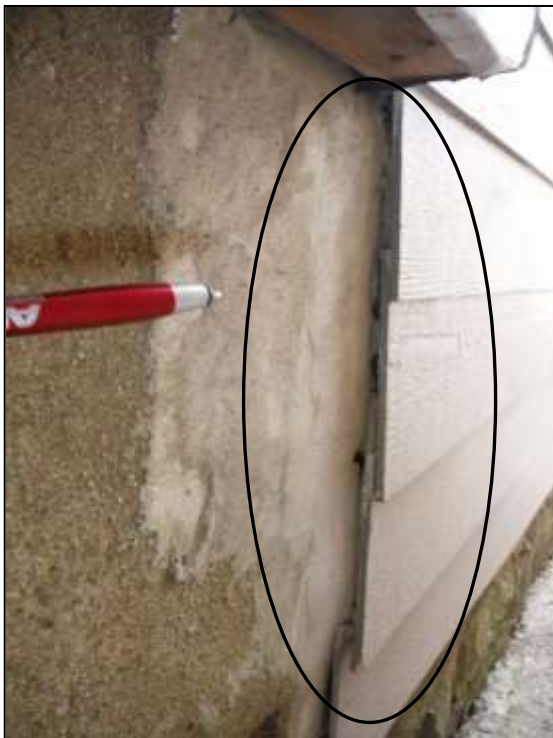
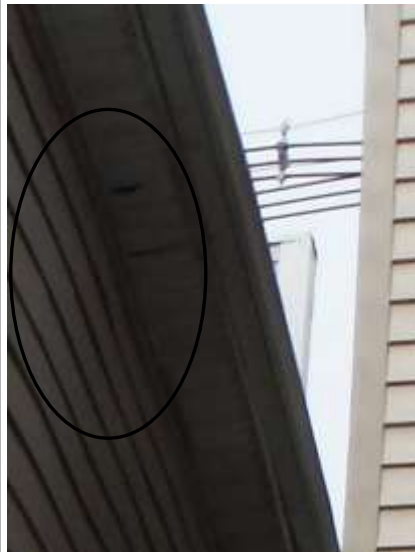
Figure 4 Foundation cracks corner in rear left side by bowed wall.

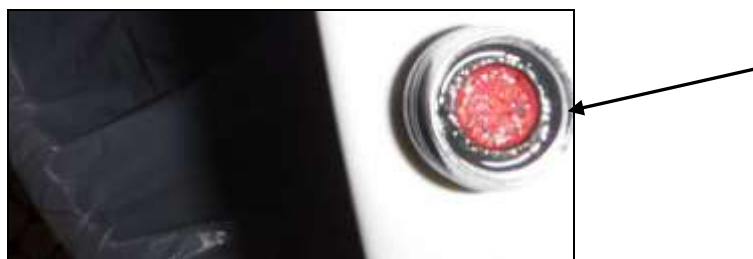
1/2 BATH: There was calcium/mineral build-up on fixtures; granules filled inside the screen/aerator. Flow went back to normal when debris removed from aerator. Recommend cleaning aerators on sink fixtures periodically. See plumbing section comments; hard water.

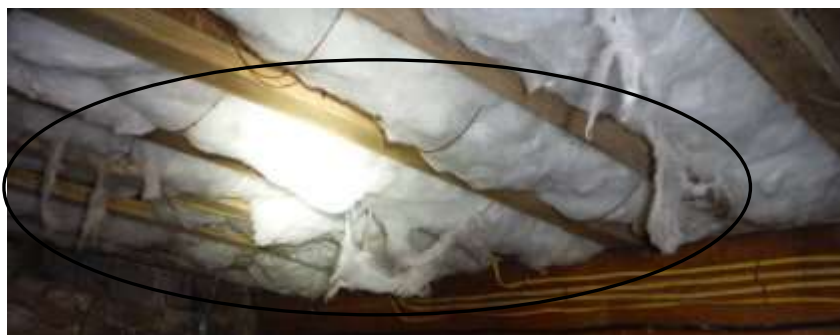
Darkening on insulation & joists/framing in crawl space; have evaluated by a mold contractor & correct wet/humid/moist conditions.

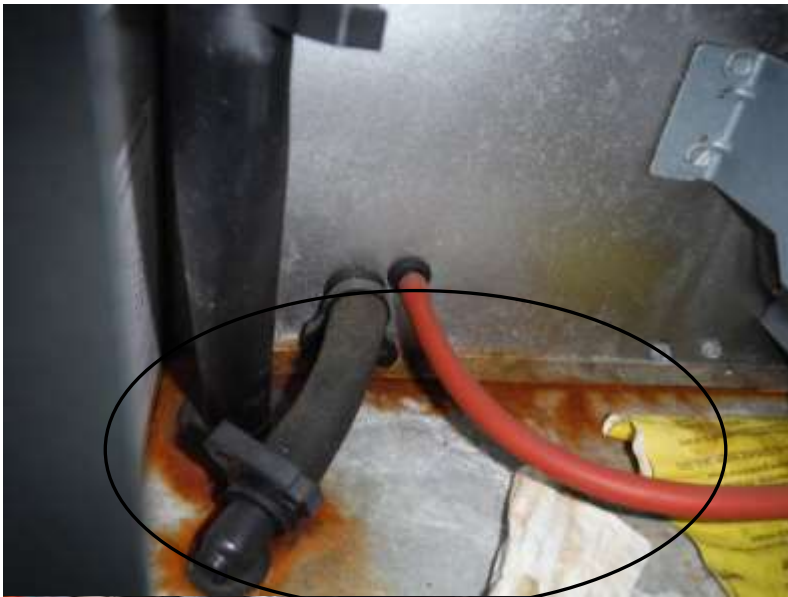
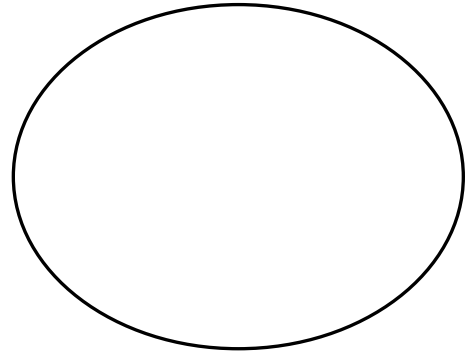
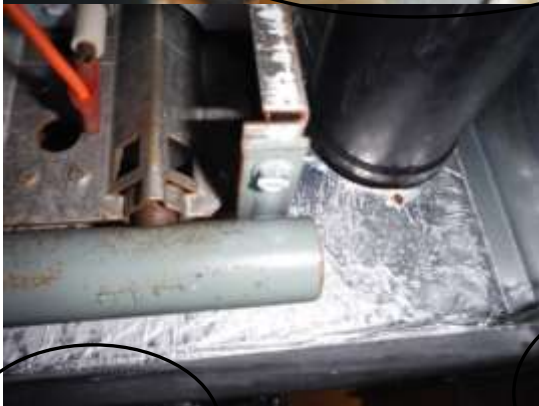
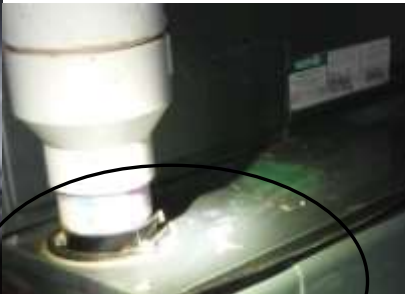
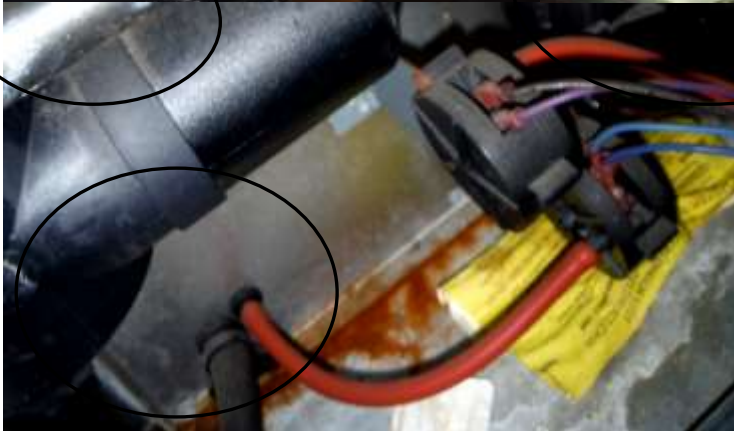
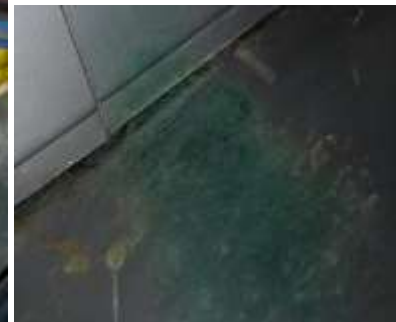
1. Recommend having ducts cleaned professionally yearly or as recommended by duct cleaning contractor for good indoor air quality. There was condensate drip marks on PVC vent connector, rust inside the furnace cabinet, green corrosion around the coolant lines or A/C evaporator cabinet above the furnace. Recommend a qualified HVAC contractor evaluate the furnace and cooling system/evaporator and advise on all needed service & repairs. Recommend having the vent checked to ensure proper drafting. Condensate drip marks/residue on PVC connections; drafting concerns.
