4 Seasons Home Inspection, LLC

Mr. and Mrs. New Construction
Street Address
Township, New Jersey zip code

Inspection Date: July 15, 2009 9am-9pm
Client Name: Client Name(Emails to send reports)
Inspection Address: Street Number, City, NJ
Inspected by: Linda Geczi home inspection lic. #24GI00061500

Detailed Summation begins on pg 5-23 w/pictures

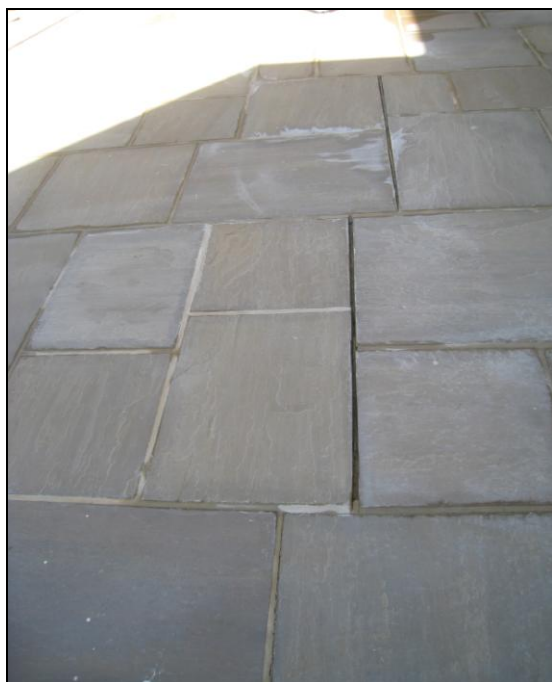
Figure 5 Gaps in patio off living room.

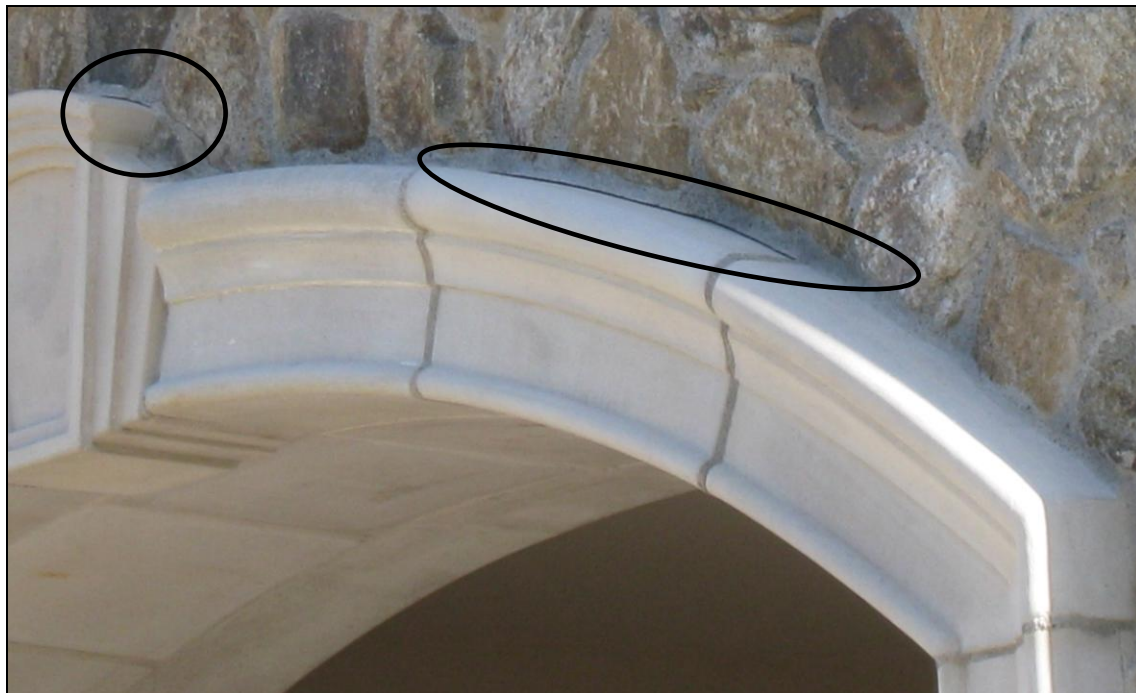
Figure 17 Gaps, mortar or caulking needed.

- 1.) Gutters leaking at corners, seams, junctures and spillage along main runs- Have gutters evaluated & corrections/repairs made. Soil ruts visible and stains on siding or EIFS.
- 2.) Recommend Structural engineer evaluate outcrop off rear kitchen; cracks
- 3.) All gaps, mortar and cracks on cladding & trim needs to be properly sealed/evaluated

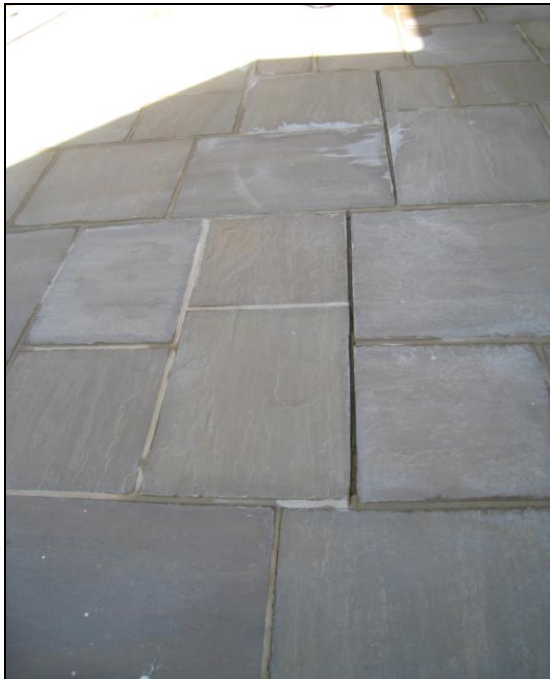
Figure 32 Gaps in patio off living room.

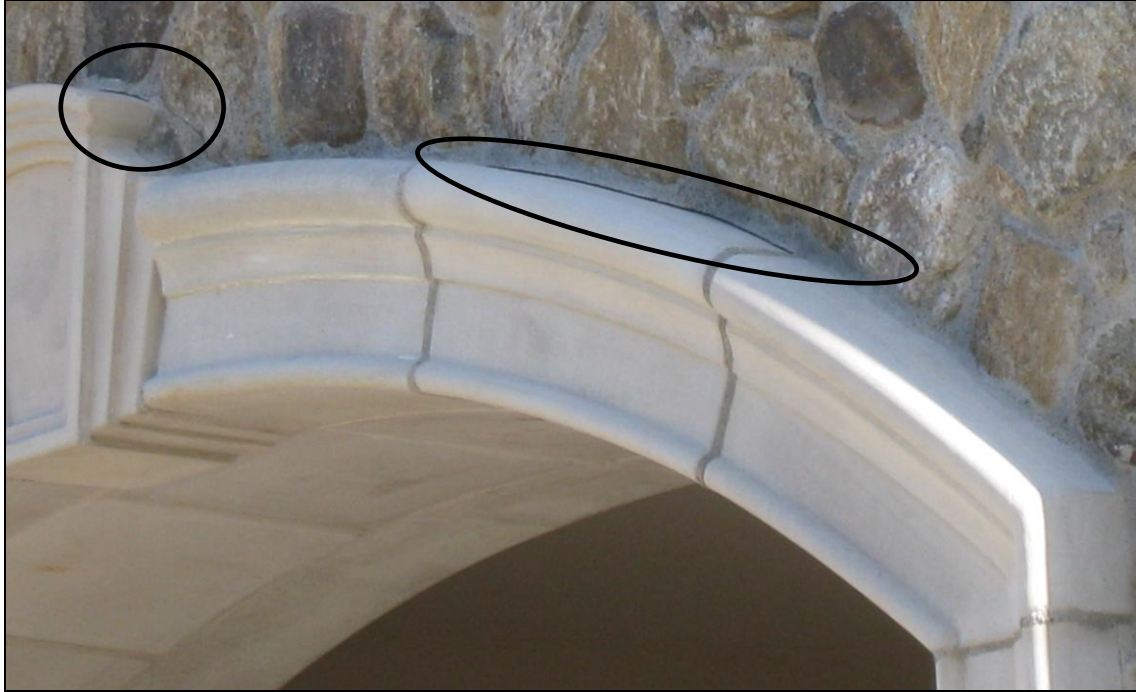
Figure 44 Gaps, mortar or caulking needed.
