4 Seasons Home Inspection, LLC

Inspection Date: March 30, 2016 10am- 1pm
Client Name: buyer (buyerbuyer@hotmail.com)
Emails: lawyer@aol.com
Inspection Address: # city, nj xxxxx
Inspected by: Linda Geczi home inspection lic. #24GI00061500

Approximate Age: ~ early 1900's
Style: Single family
Main Entrance Faces: W
State of Occupancy: Occupied
Weather Conditions: 42 °F
Ground cover: damp

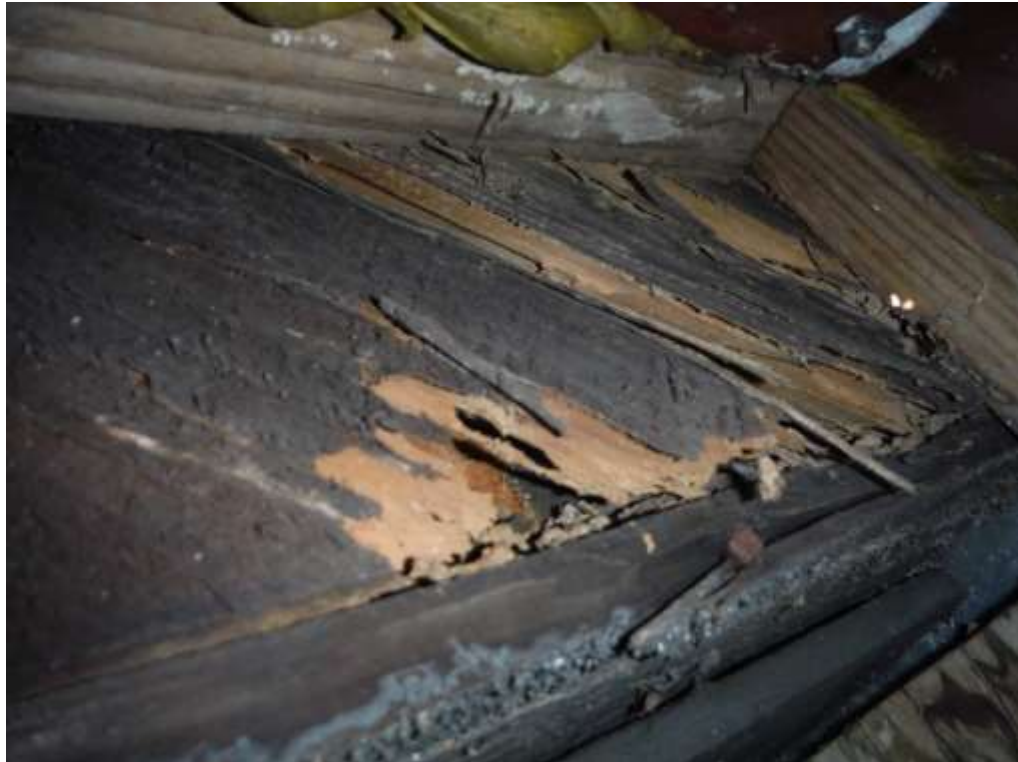
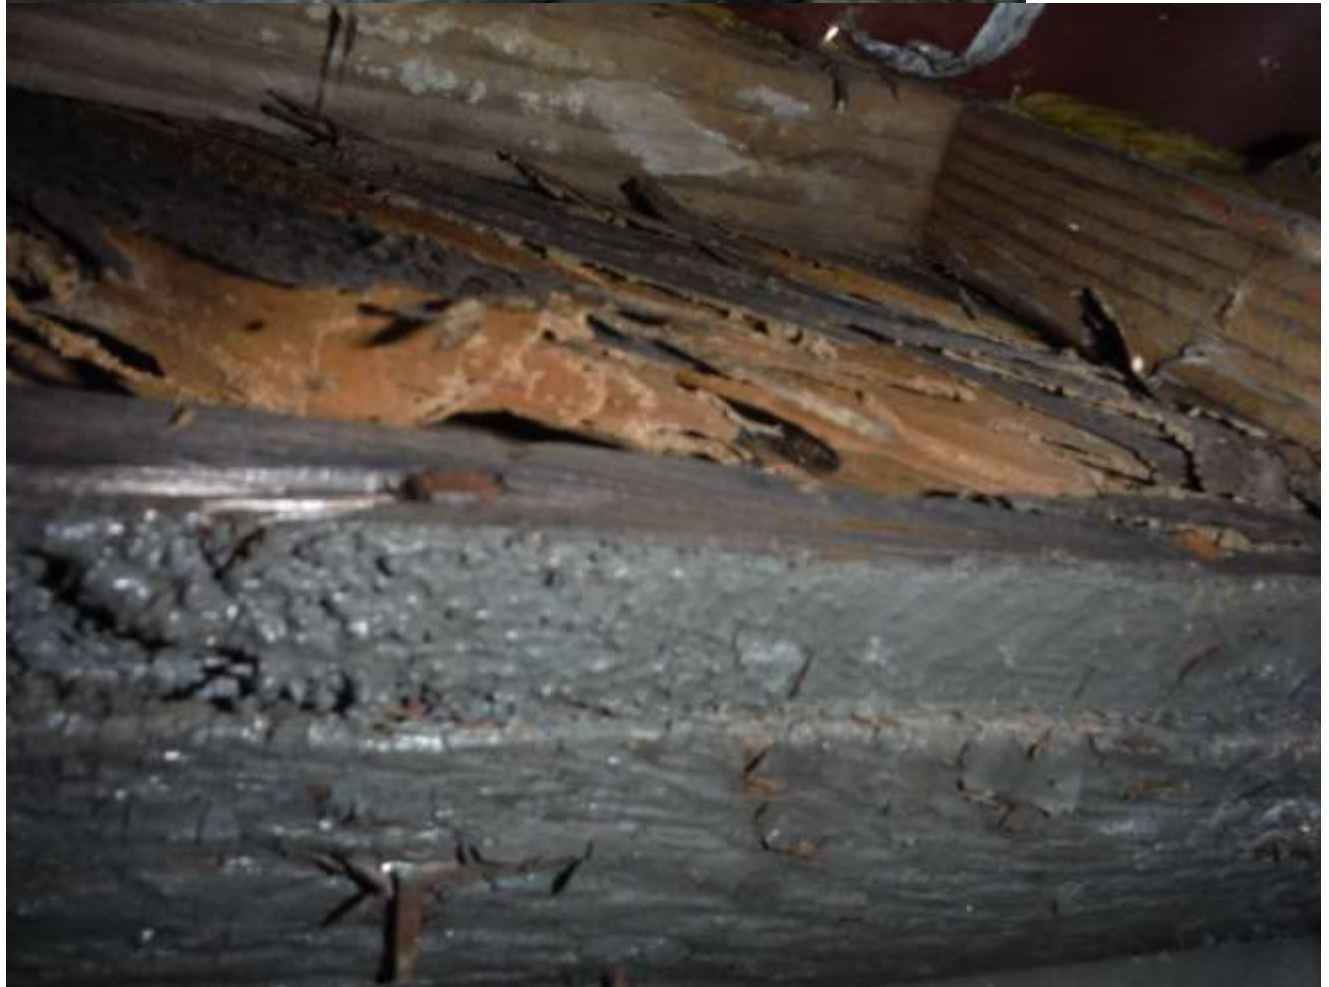
1. There were termite shelter tubes and visible damage observed in basement walk out and under the basement steps. Basement was finished (ceilings, walls, styro foam insulation, covered columns, joists, structure, etc.) and structure inaccessible. Conditions on exterior are conducive to wet basement/seepage and water & wood destroying insect damage. Recommend a building contractor evaluate exterior (siding, trim, windows/frames, roof/siding/chimney/plumbing flashings, grading & drainage, etc.) and advise on repairs/replacements. Active leaks observed in interior rooms Attic, 3rd floor and second floor, attic, etc. Recommend a structural carpenter or qualified building contractor evaluate termite damage, rule out or determine extent of termite/water/structure damage and advise on all structural repairs. The crawl spaces under the front and rear enclosed porches were inaccessible; recommend access and have inspected along with basement & termite.

2. Recommend a grading & drainage contractor and a wet basement/damp proofer contractor evaluate the property and advise on water management, grading & drainage and exterior repairs (see exterior/siding/gutters/etc.). The exterior was conducive to water seepage, leaks and attracting wood destroying insects.
