4 Seasons Home Inspection, LLC

Inspection Date: February 12, 2018 Monday 10am- 12:20pm
Client Name: buyer (buyer@gmail.com)
Emails: lwyer@gmail.com
Inspection Address: # street, jersey shore, NJ xxxxx
Inspected by: Linda Geczi home inspection lic. #24GI00061500

Approximate Age: ~ 1922 orig.
Style: Single family-
Home built over a two car garage structure
Main Entrance Faces: S
State of Occupancy: occupied
Weather Conditions: 50- 55 °F, moderate rain
Ground cover: Heavy rain past 24 hrs./ wet

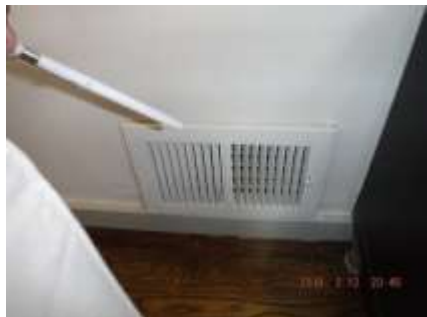
1. There were sloped floors, bowed walls and canted doors in home. See structural comments pg.2 "Overview and Main concerns."
2. There were loose registers in the home and missing cover on partially blocked vent in kitchen. See HVAC comments.
