4 Seasons Home Inspection, LLC

buyer
street
Town nj

Inspection Date: April 29, 2015 Wednesday 10am- 3pm
Client Name/Emails: buyer(buyer@hotmail.com)
Inspection Address: \$ street, town, nj xxxxx
Inspected by: Linda Geczi home inspection lic. #24GI00061500

Approximate Age: ~1950's
Style: Single family
Main Entrance Faces: N
State of Occupancy: Occupied
Weather Conditions: 39-42°F
Ground cover: damp

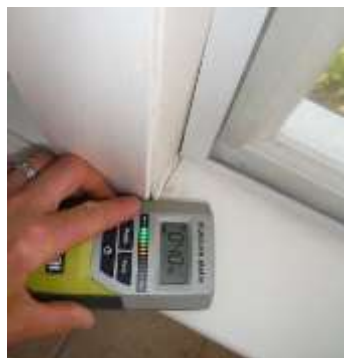
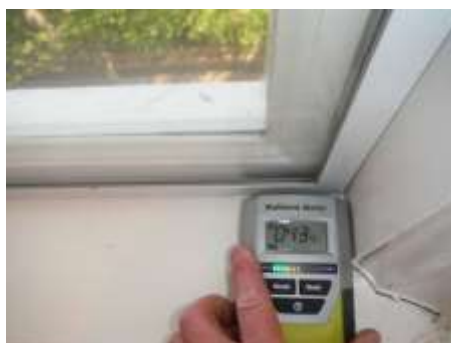
1. Have plumber evaluate all plumbing concerns. See plumbing section comments.
2. There was active leaking on the window panes. Have all leak(s) sources determined by contractor and repaired. See roof & exterior section comments.

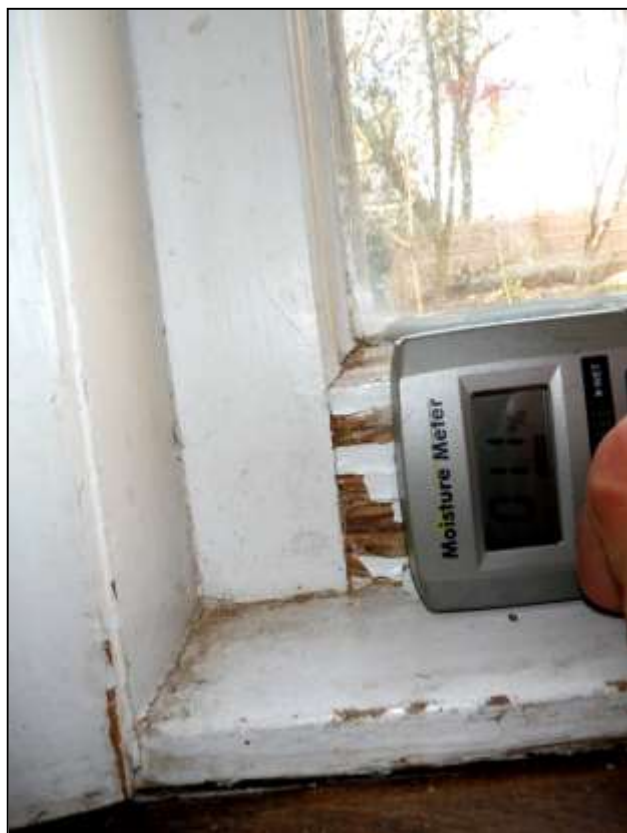
1. Have exterior contractor evaluate all water/moisture/leak sources and make repairs.

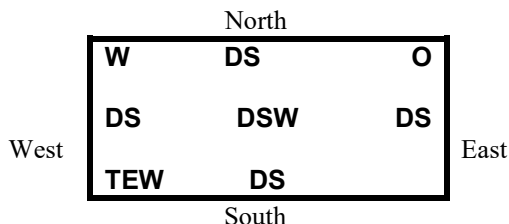
- P = Paneling C = Crack(s)
- D** = Drywall M = Monitor
- S = Storage O=Other/Sump pump
- W**=Water/seepage-limited view/finished basement
- T**= Termite tubes & damage to sills/structure
- E** = Evaluate extent of all termite damage before closing/repair
