4 Seasons Home Inspection, LLC

Inspection Date: May 30, 2018 Wednesday 10:30am- 2:20pm
Client Name: buyer (buyer@optonline.net)
Emails: attorney@gmail.com
Inspection Address: # street, town, nj xxxxx
Inspected by: Linda Geczi home inspection lic. #24GI00061500

BUILDING DATA

Approximate Age: ~1965
Style: Single family
Main Entrance Faces: W
State of Occupancy: Occupied
Weather Conditions: light rain, cloudy 75 °F
Ground cover: wet

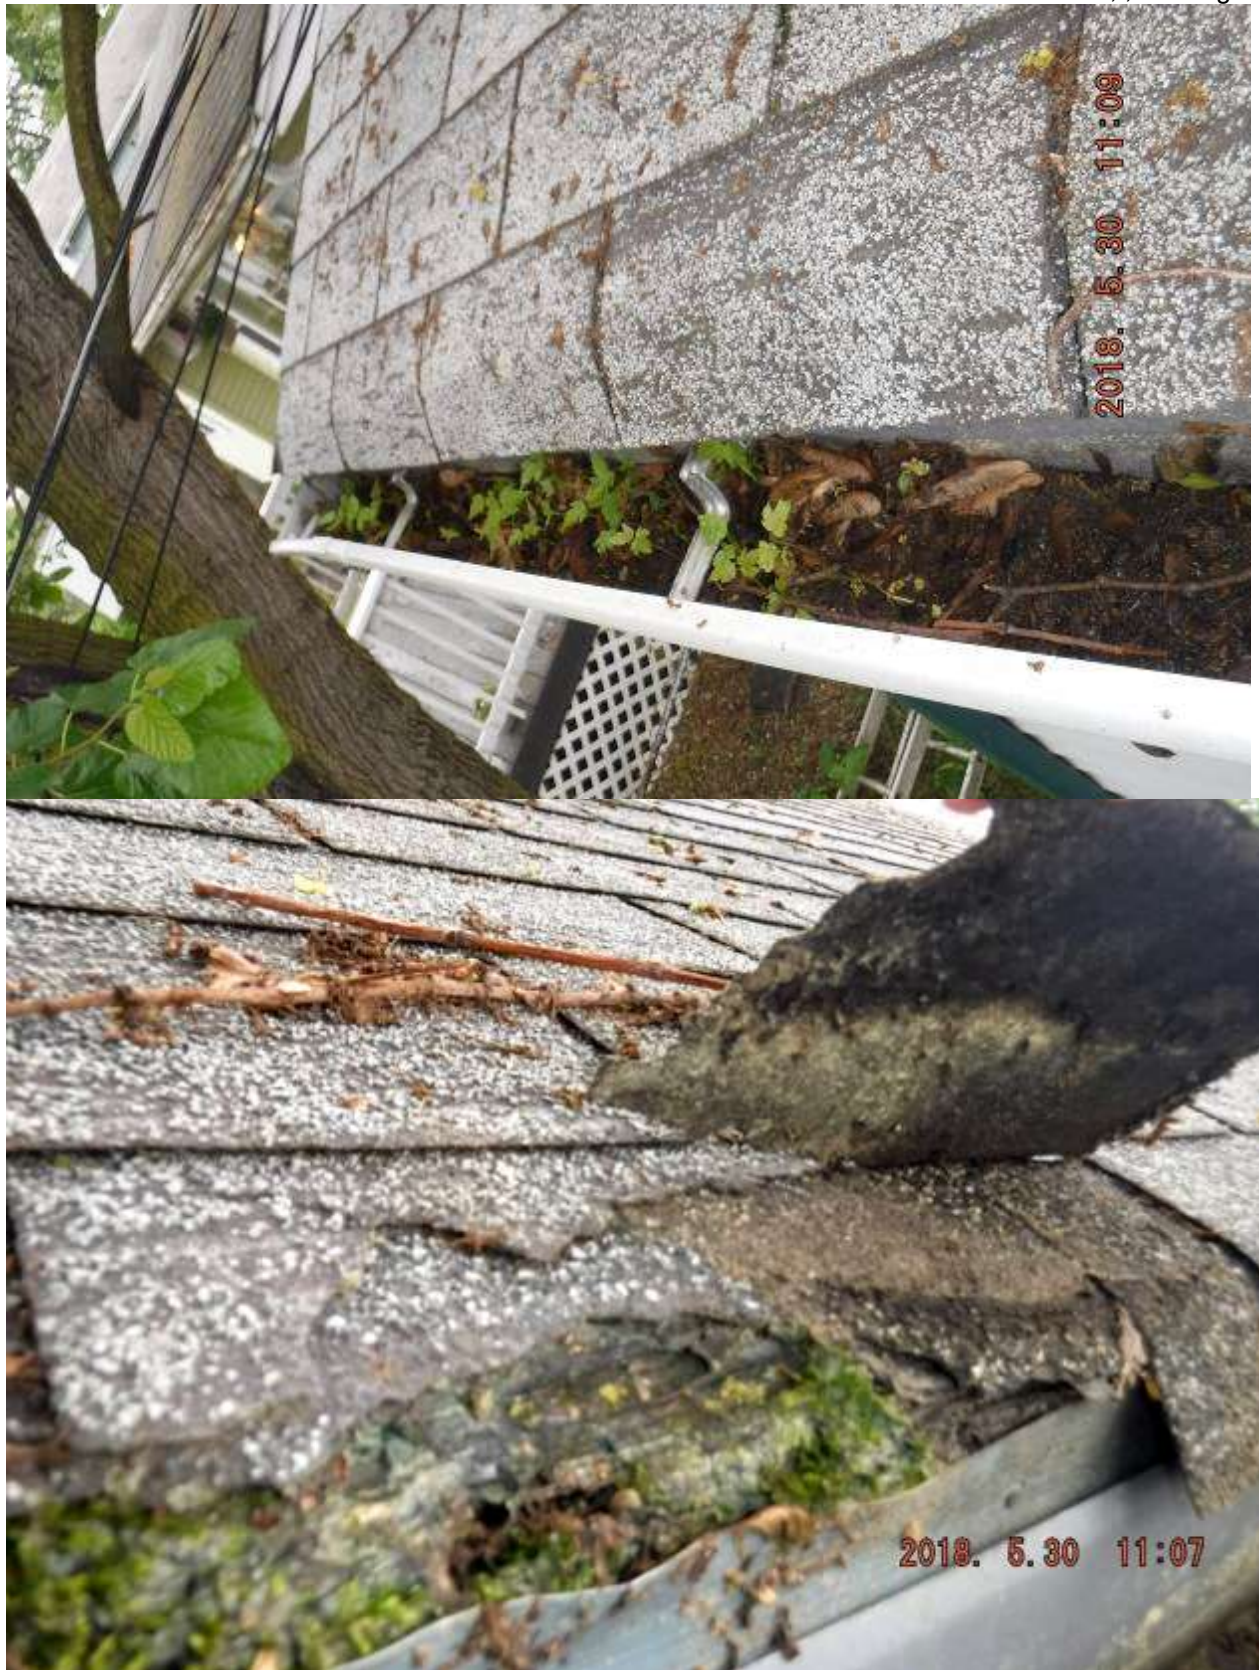
1. The roof was very old and past expected life, active leaks and poor condition; not functioning to protect the home from water entry and damage. Shingles were cracked, broken/missing, cupping, curling, heavy moss build-up, sheathing rot/delamination/peeling, leaking gutters/rot fascia & sheathing, exposed felt or backing & extensive granular/aggregate loss, improper overhang/excess, inadequate ventilation, no drip edge flashings, heat cracks/splits on rafters, poor roof drainage/gutters, etc.; poor condition. There were wet spots/water stains on sheathing, floor of attic and wet rags under leaks. Recommend a qualified roofer or building contractor evaluate roof for tear off, sheathing/rafters/framing, extent of water & structure damage (plywood, fascia, hidden damage, splits rafters/cracks, etc.), ventilation and gutters.

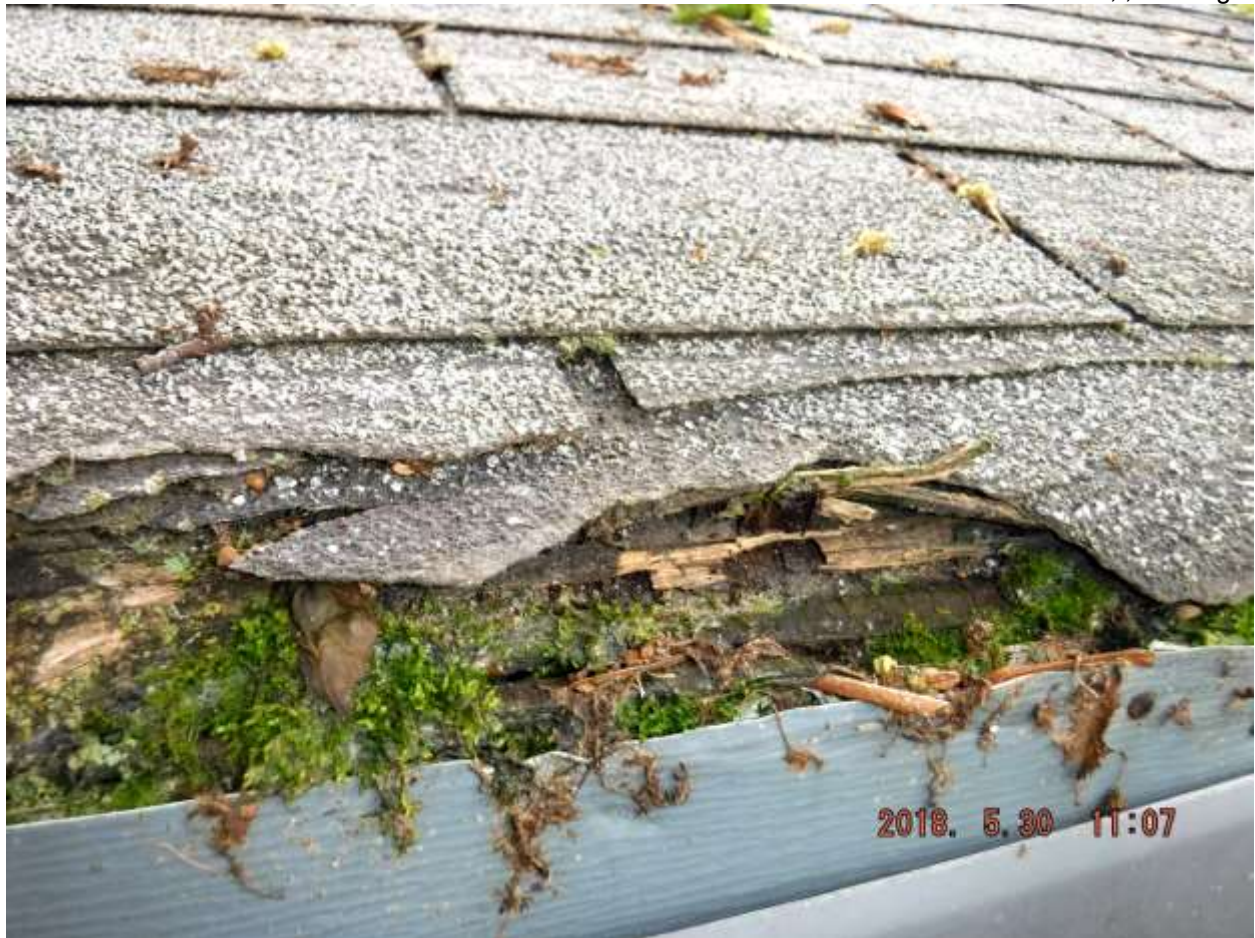
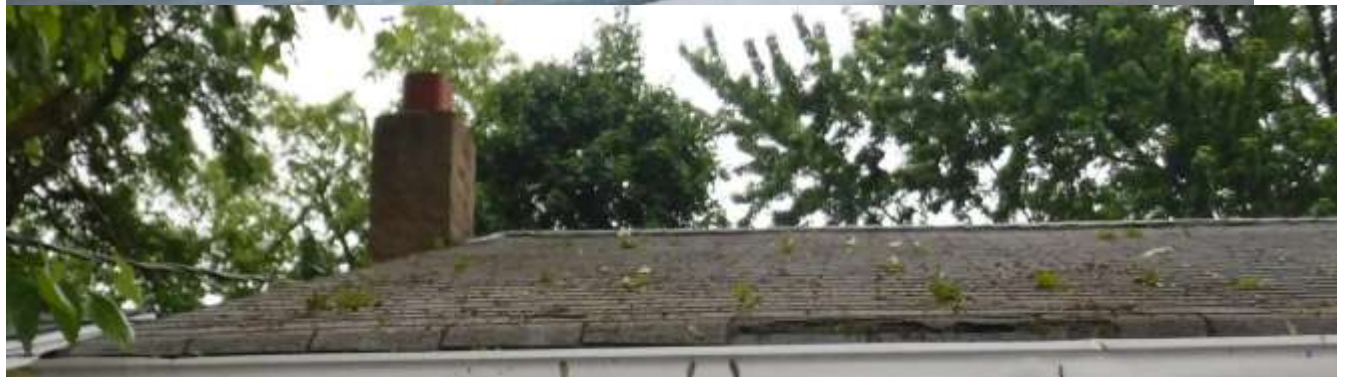
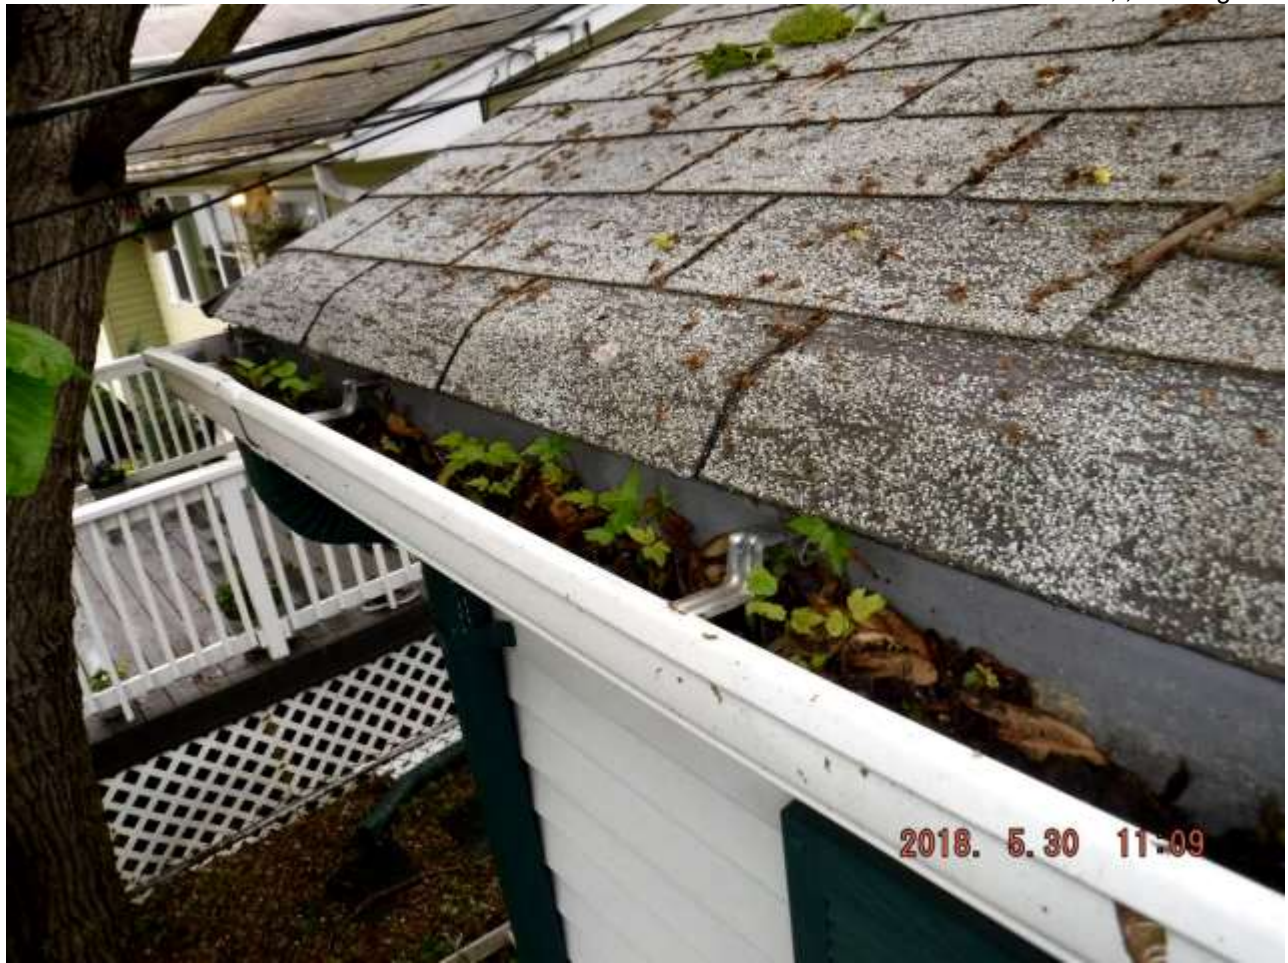
Figure 3 Much of the granules or aggregate was gone and backing visible or exposed.

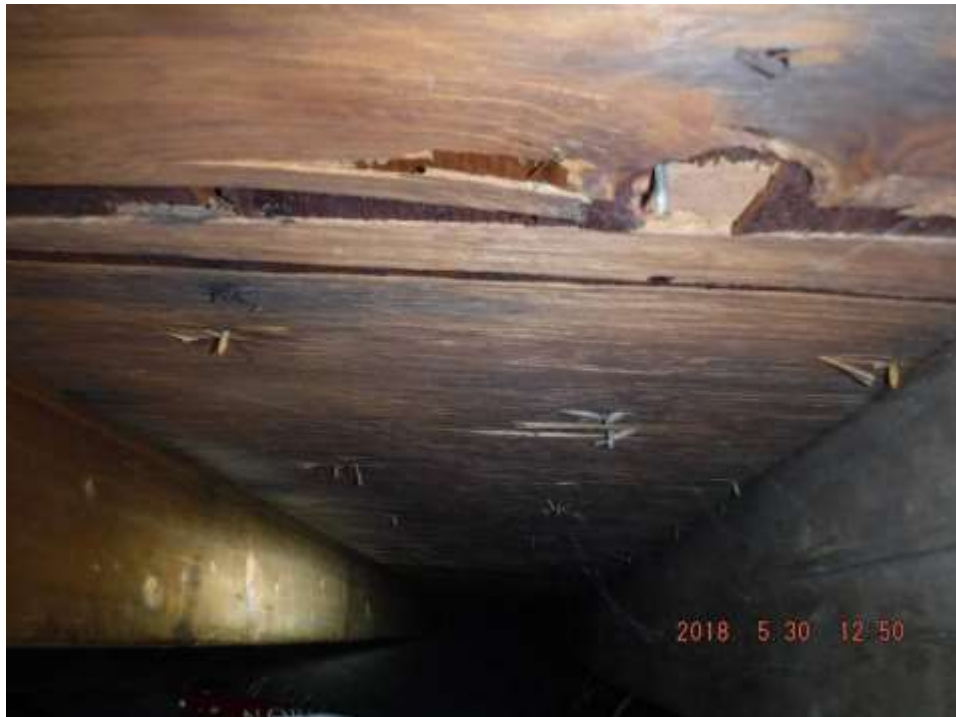
Figure 4 Example of water stains and peeled/delaminated sheathing (some hanging). Roof was poorly ventilated and leaking.

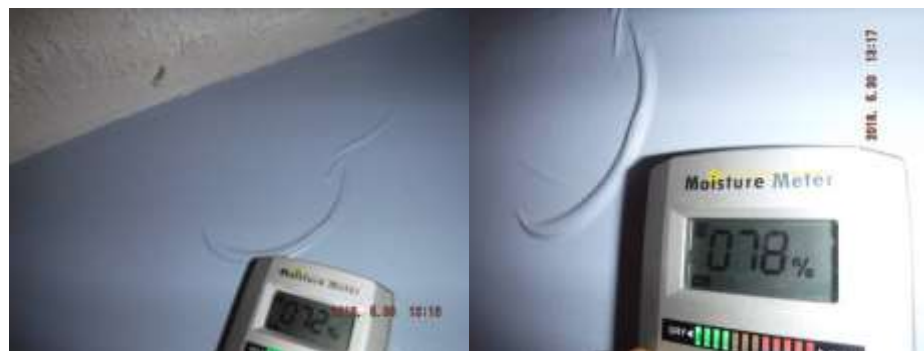
1. The bathroom had no window and no exhaust fan; have evaluated by a bathroom contractor or building contractor. Recommend having GFCI outlets evaluated by electrician; one not working properly.
2. Obtain closed permits for all structural modifications, renovations, bathrooms, etc. or changes made after time of build as required by the township before closing and contractual limitations. There were unconventional building practices observed.
3. There was active moisture and peeled paint or drywall; see roofing & siding section comments.

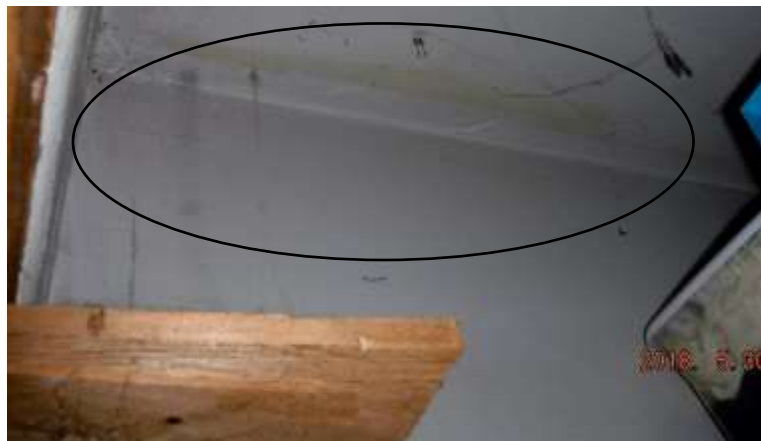
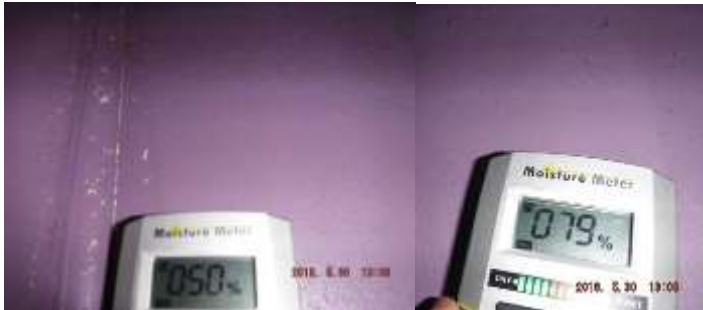
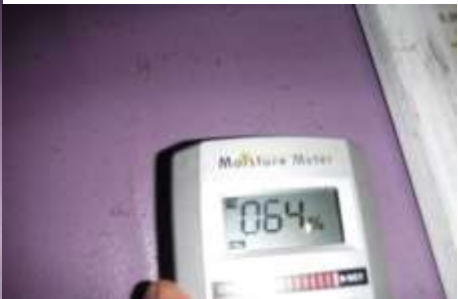
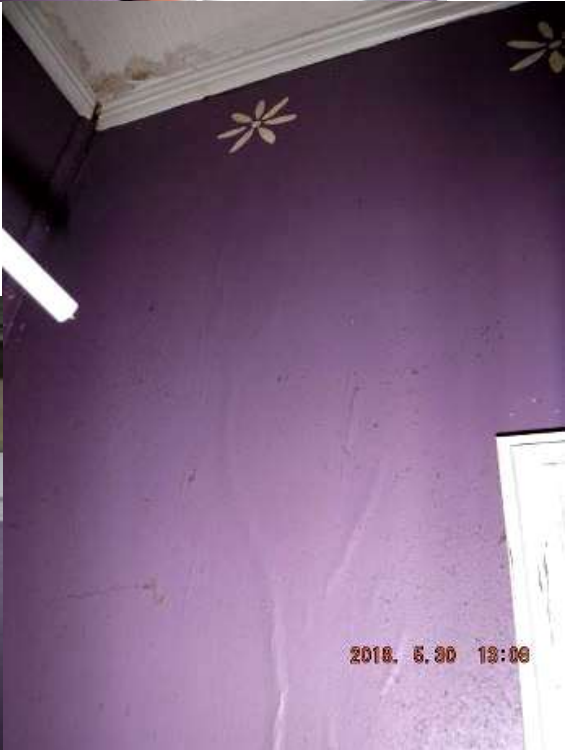
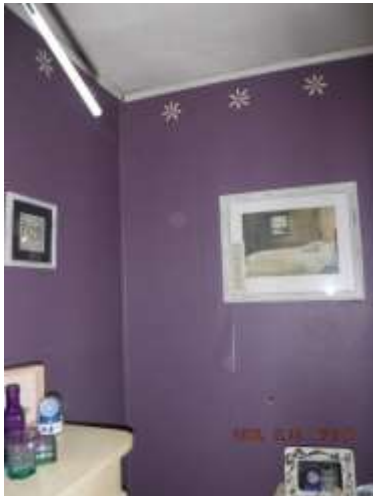
MASTER BEDROOM : There was peeled wallpaper and moisture; see siding/exterior section. There were missing handles on windows; not able to open. Recommend obtaining handles and check windows before closing. There was a broken glass mirrored closet door; cut hazard. Recommend replacing door for safety. The door to master bathroom swings into bathroom over a step; fall hazard potential. Recommend a building contractor evaluate door & step and advise on corrections for safety. Obtain all closed permits for renovations and structural modifications as required by the township; unconventional building practices observed in the home.

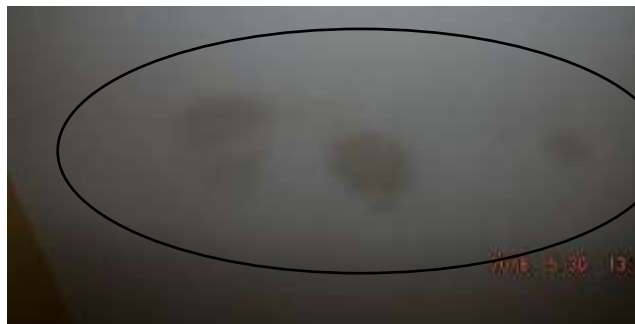
#3 BEDROOM YELLOW: There were ceiling moisture/water stains. There were open grounds on outlets; have electrician evaluate outlets and make repairs.

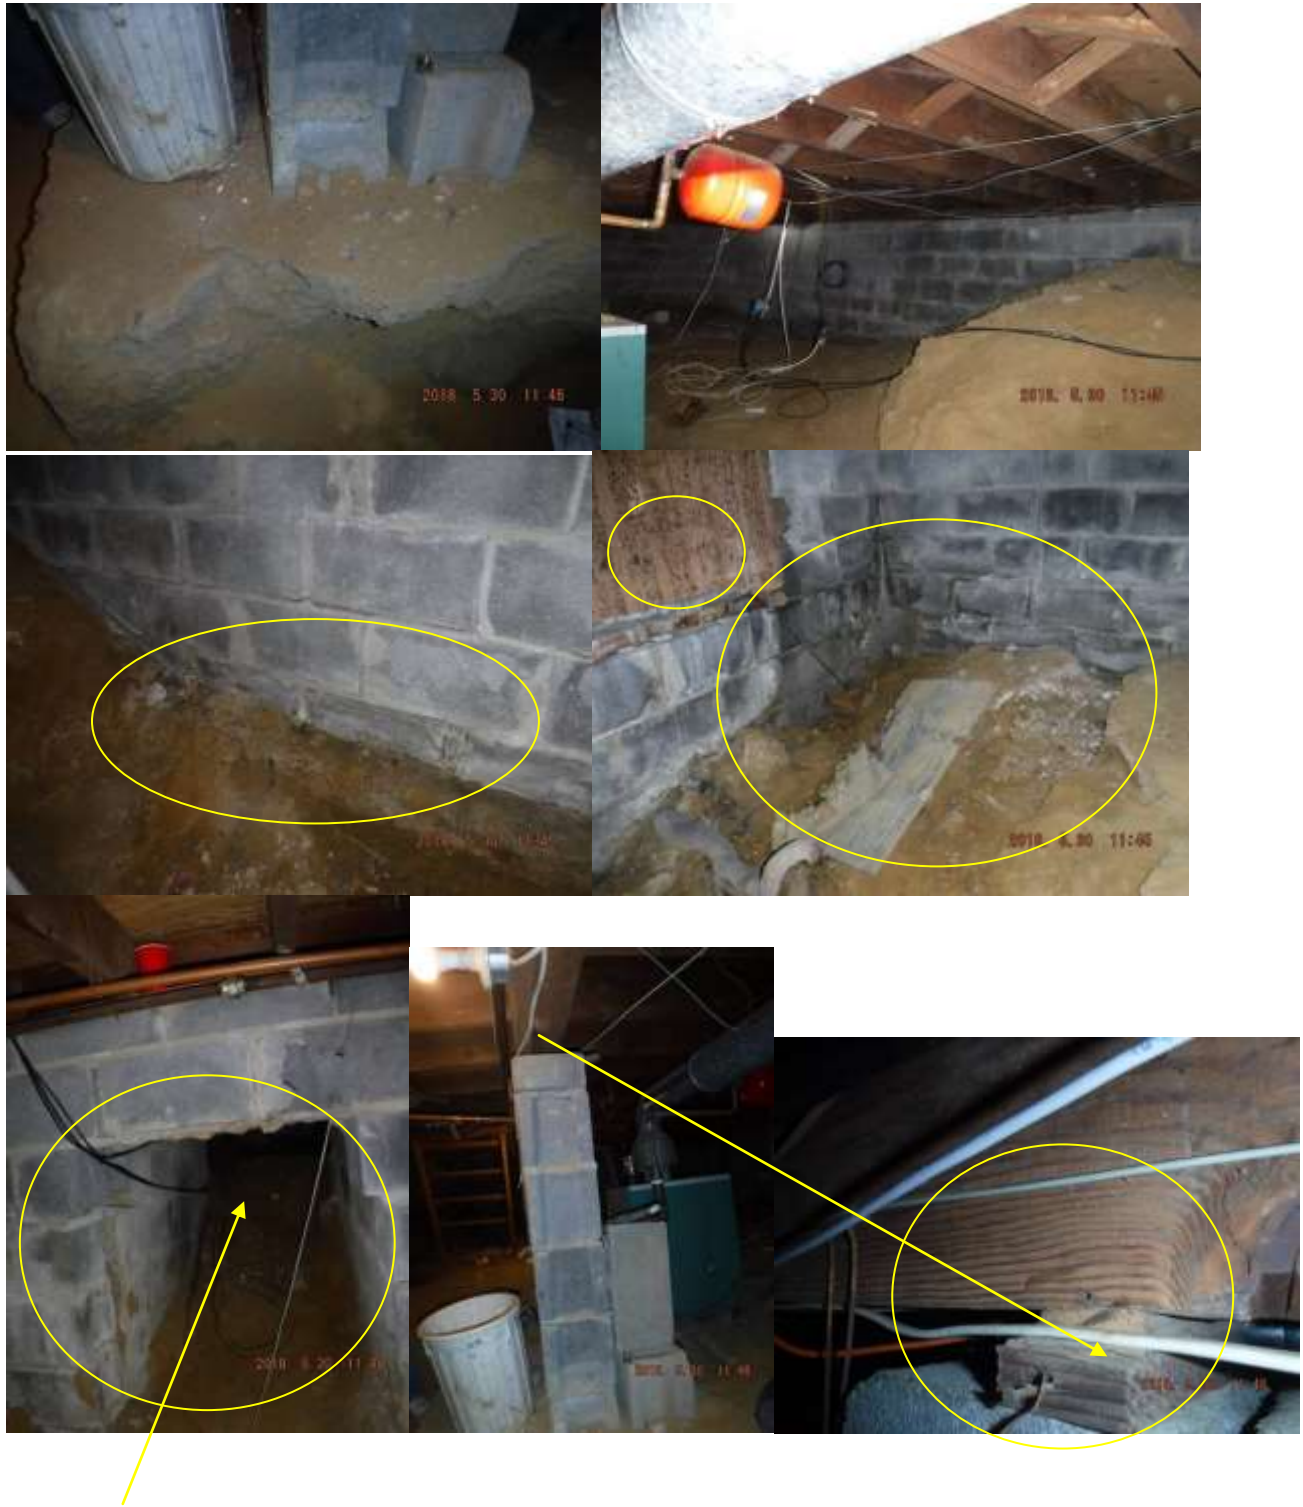
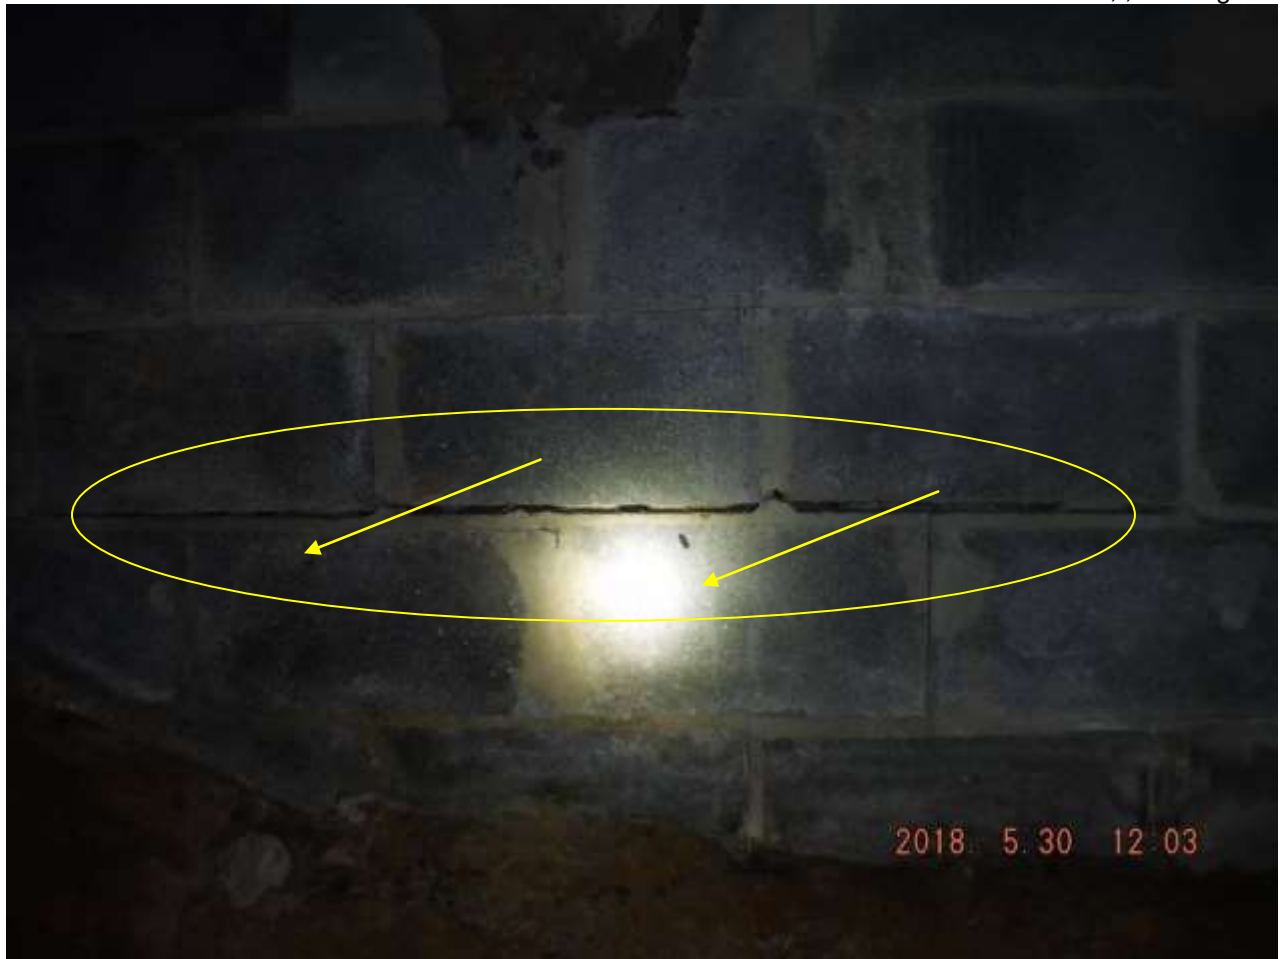
Examples of structural modifications, exposed footers/no step footers or stabilization, shimmed columns, disturbed soil around foundation & columns, water seepage/black mildew/mold-like spotting/odor, foundation cracks/movement/bowed, termite tubes/damage, etc.

Figure 15 Example of depended dirt floor, foundation cracks, old water heater in dirt, wet dirt/seepage, etc.

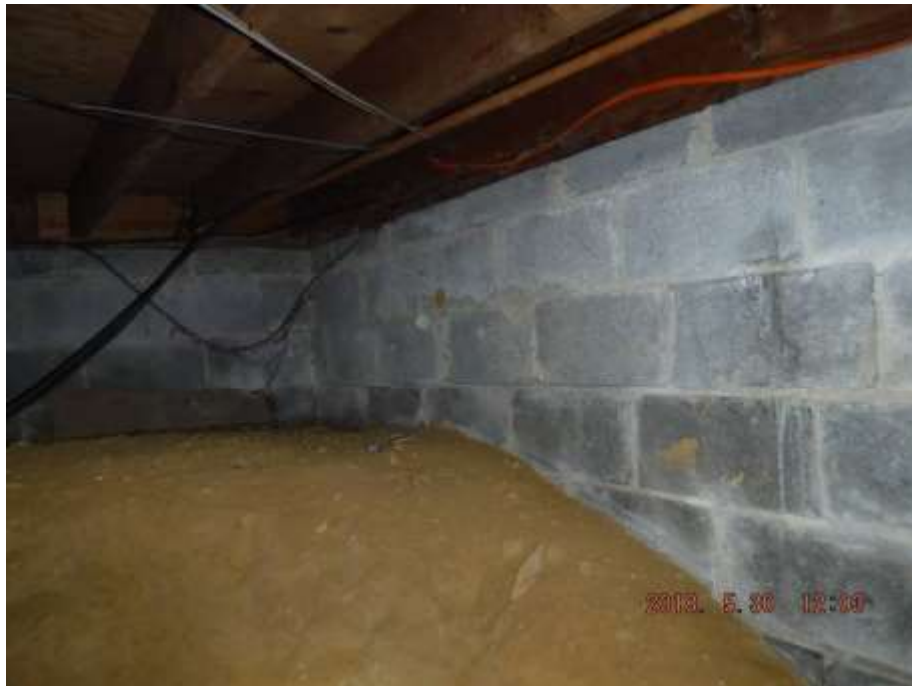
Figure 16 Example of areas with approximately 1/2" opening are bowed wall(s).

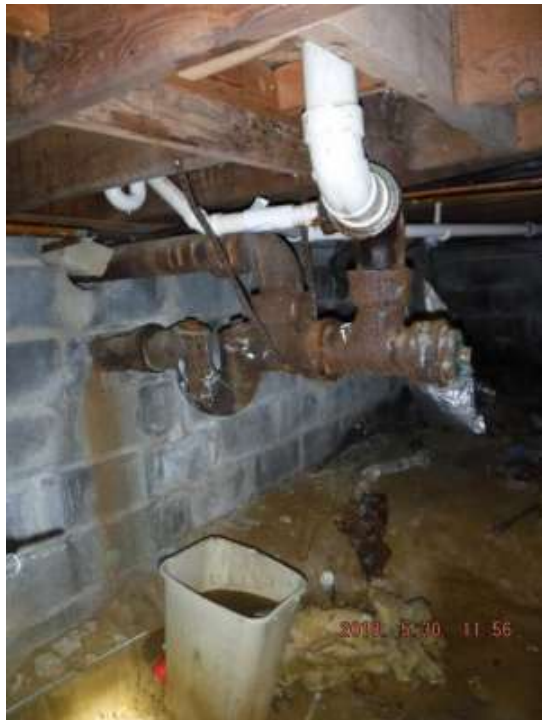
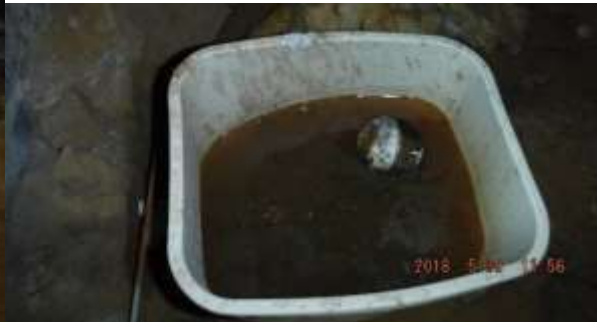
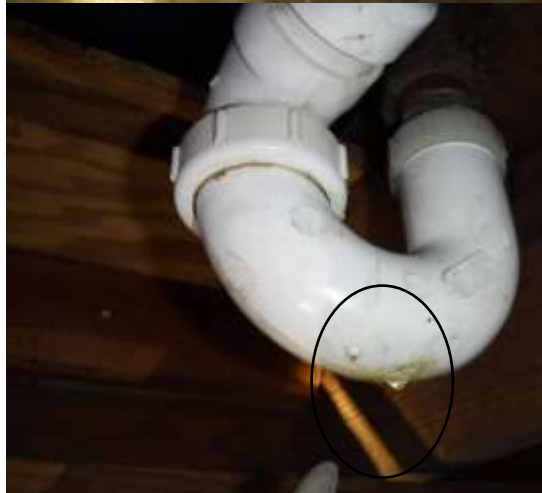
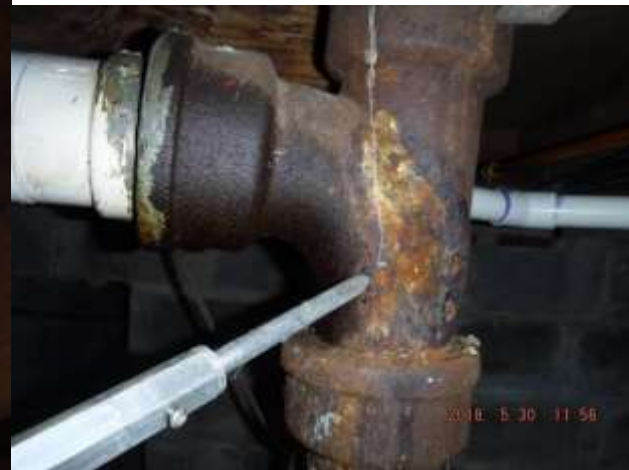
1. **The water meter was near floor joists in crawl space; visible corrosion and older gate valves. Recommend upgrading older gate valves in the home to ensure proper shut off in an emergency. Gate valves tend to leak and become difficult to operate as they age. There was an abandoned water heater just past the boiler in the dirt and other debris (boxes, pipes, etc.) on floor in crawl; recommend removing debris. There was corrosion on plumbing (cast iron, copper), leaking drains & brown water filled tall pail under the leaking plumbing, old plumbing (piping, valves, gate valves, fittings) and uninsulated plumbing in crawl space and garage. Recommend removing the tall pail of water catching/clean spillage where needed under the leaking plumbing under the drains in crawl. The water in home was not very hot when fixtures checked; further evaluate. There was no extension pipe off the TPR valve on water heater; add piping for safety. The water heater was older or approximately 8+yrs. old; recommend upgrading water heater. The toilet in main bathroom was loose; have wax seal and toilet checked/repared. The vanity in main bathroom was detached or not secured down; have secured for safety. The drain basket on kitchen sink was leaking/oozing and corroded; have replaced. Recommend a licensed plumber evaluate plumbing in home/crawl and advise on repairs and upgrades throughout the home.**

Figure 18 Partial view of water meter & gate valve shutoff. Gate valves tend to stick, leak and difficult to close to operate in an emergency. Recommend upgrading to single handle ball valves on main and in home.
