4 Seasons Home Inspection, LLC

Mr. Buyer
Bergen Cty, NJ

Inspection Date: May 02, 2018 Wednesday 12pm- 5pm
Client Name: Bob Buyer (Buyer@hotmail.com)
Emails: lawyer@lawfirm.com
Inspection Address: # street, town, NJ xxxxx
Inspected by: Linda Geczi home inspection lic. #24GI00061500

Approximate Age: ~118 yrs.
Style: Mixed Use-
2nd FL Apt. & retail store front
Main Entrance Faces: N
State of Occupancy: Vacant
Weather Conditions: 70 °F
Ground cover: damp

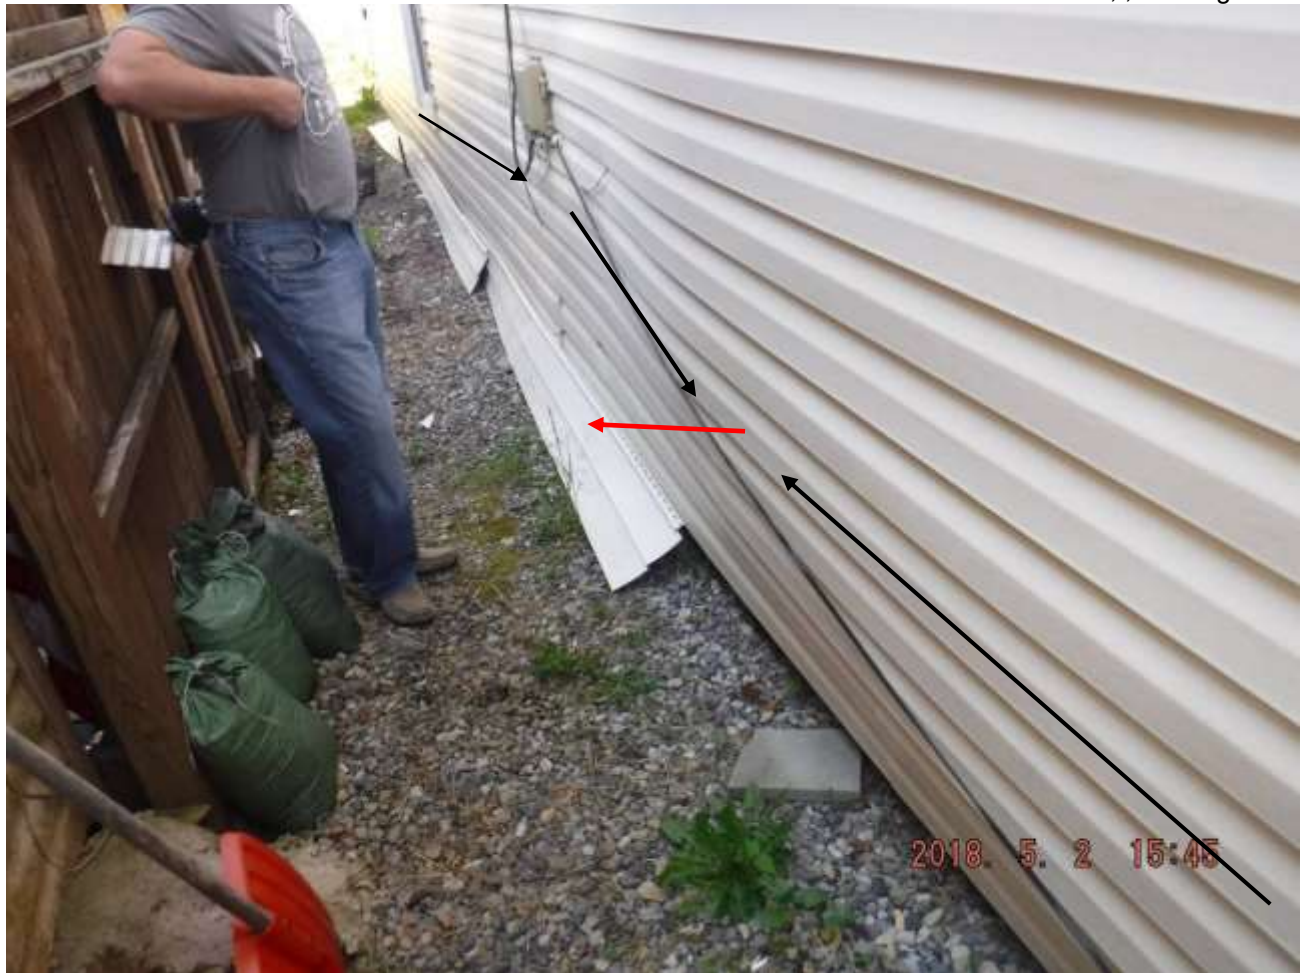
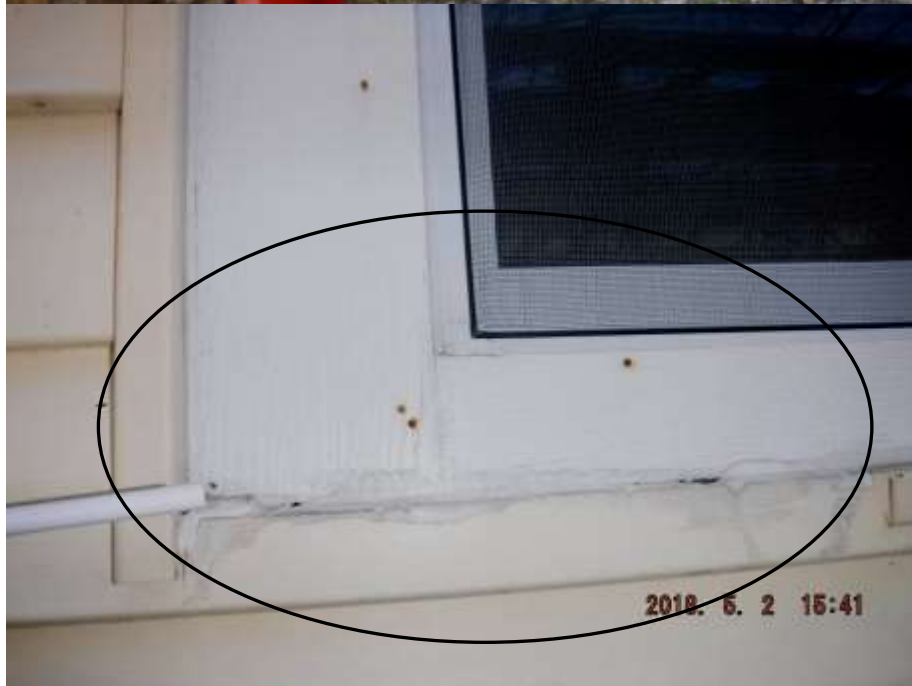
Figure 8 Visible asbestos like siding (painted gray) slipped down and loose under the vinyl siding.
